Facility Condition Assessment Summary Report

Pennell School

School District of Philadelphia
S634001;Pennell
Final
Site Assessment Report

January 31, 2017

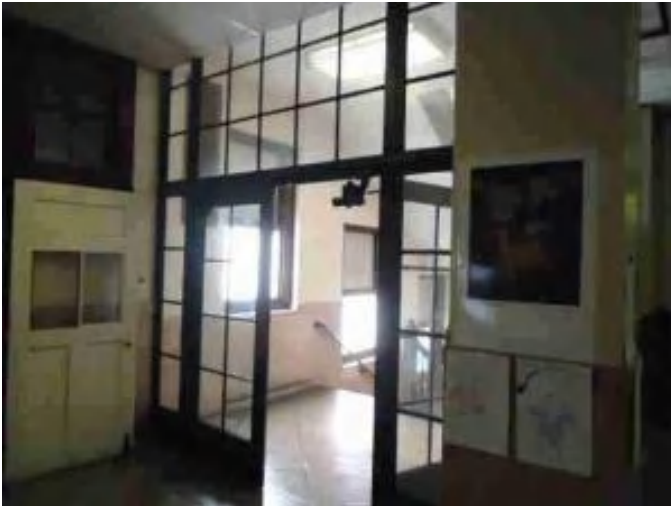
System: C1010 - Partitions

Location: Stairs

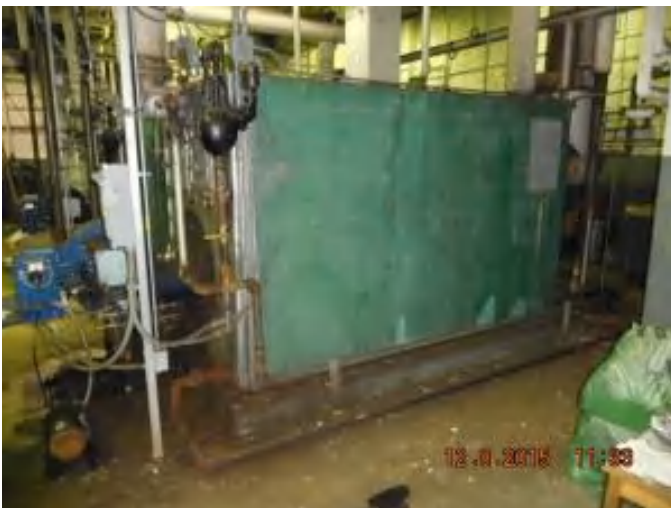
System: D3020 - Heat Generating Systems

Location: mechanical room

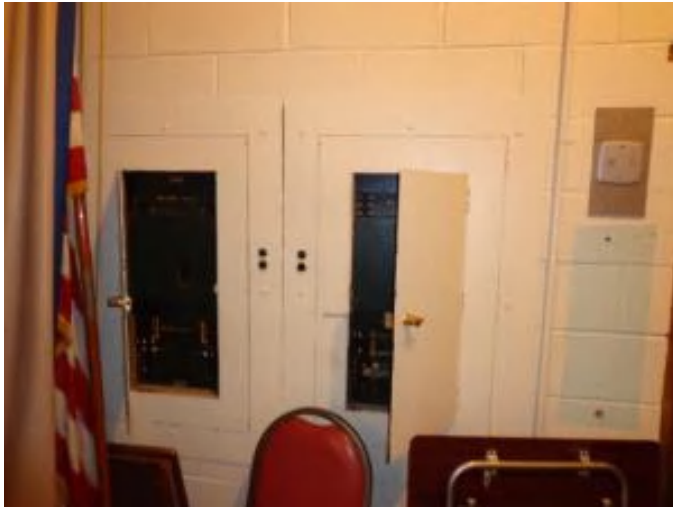
System: D5010 - Electrical Service/Distribution

Location: Building wide

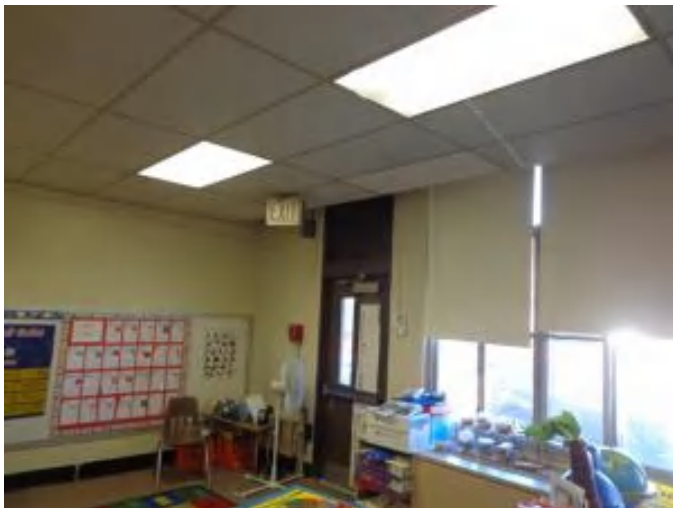
System: D5090 - Other Electrical Systems

Location: Kindergarten classroom building

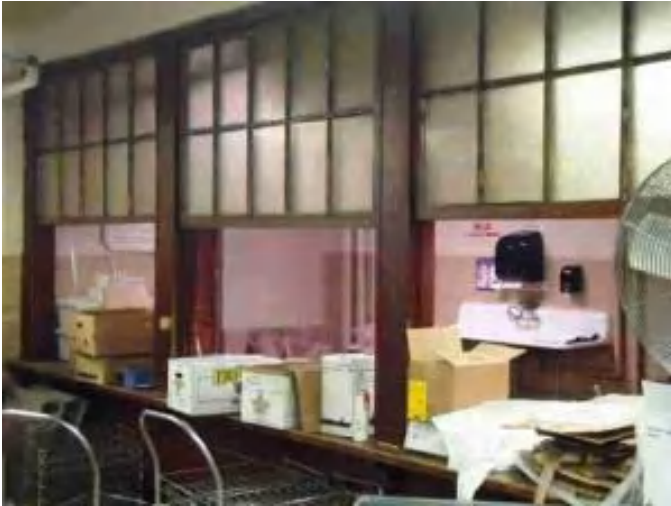
System: C1010 - Partitions

Location: Building Wide

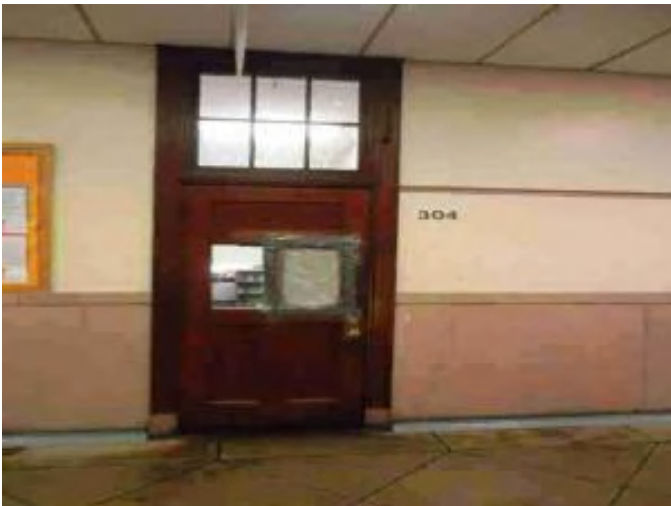
System: C1020 - Interior Doors

Location: Building Wide

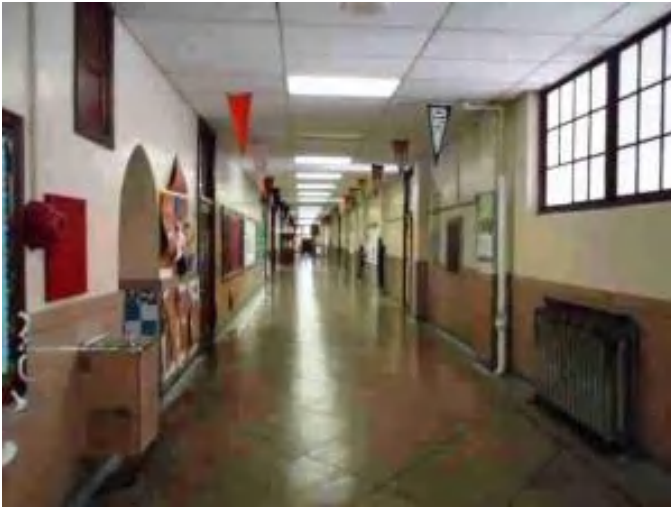
System: C1030 - Fittings

Location: Hallways
Distress: Damaged
Category: 3 - Operations / Maint.
Priority: 2 - Response Time (2-3 yrs)
Correction: Remove and replace tackboards - select size
Qty: 10.00
Unit of Measure: Ea.
Estimate: \$7,927.26
Assessor Name: System
Date Created: 02/15/2016

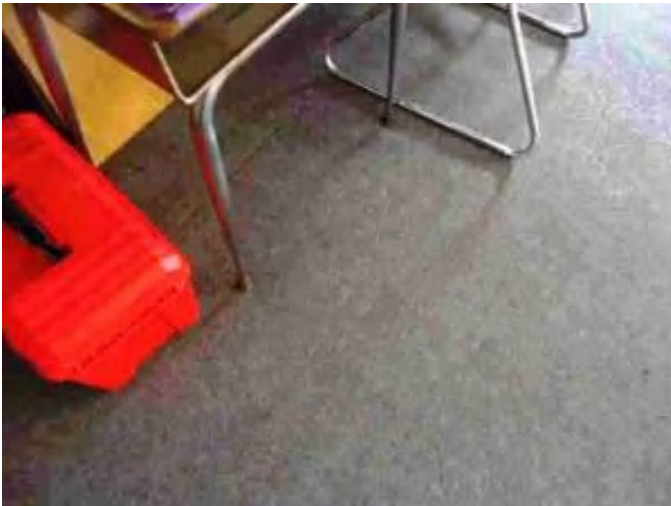
System: C3020411 - Carpet

Location: Office
Distress: Damaged
Category: 3 - Operations / Maint.
Priority: 2 - Response Time (2-3 yrs)
Correction: Remove and replace carpet
Qty: 2,000.00
Unit of Measure: S.F.
Estimate: \$22,381.52
Assessor Name: System
Date Created: 02/15/2016

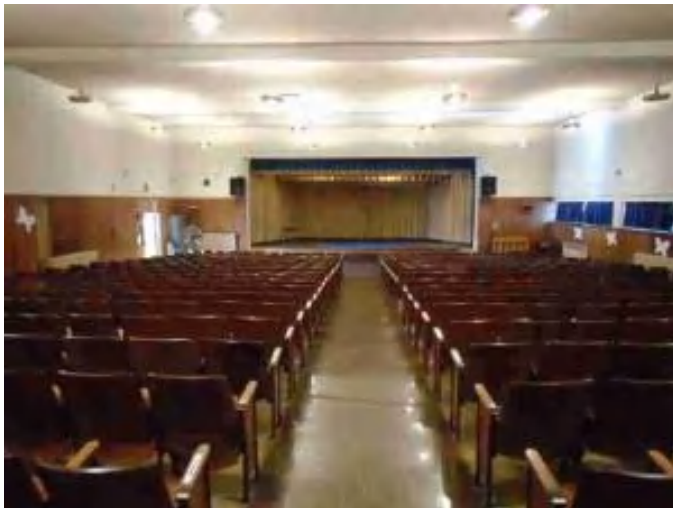
System: C3020413 - Vinyl Flooring

Location: Building Wide
Distress: Health Hazard / Risk
Category: 1 - Health & Safety
Priority: 2 - Response Time (2-3 yrs)
Correction: Remove VAT and replace with VCT - SF of area
Qty: 10,000.00
Unit of Measure: S.F.
Estimate: \$151,666.68
Assessor Name: System
Date Created: 02/15/2016

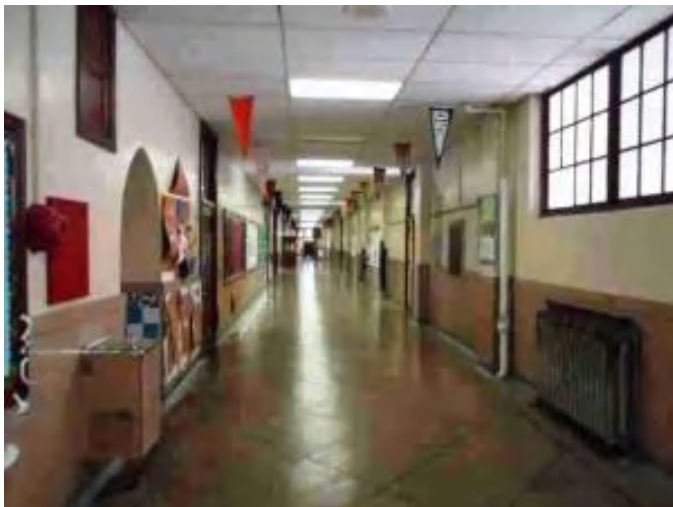
System: C3020415 - Concrete Floor Finishes

Location: Hallways
Distress: Damaged
Category: 3 - Operations / Maint.
Priority: 2 - Response Time (2-3 yrs)
Correction: Clean and reseal concrete floors
Qty: 600.00
Unit of Measure: S.F.
Estimate: \$2,306.72
Assessor Name: System
Date Created: 02/15/2016

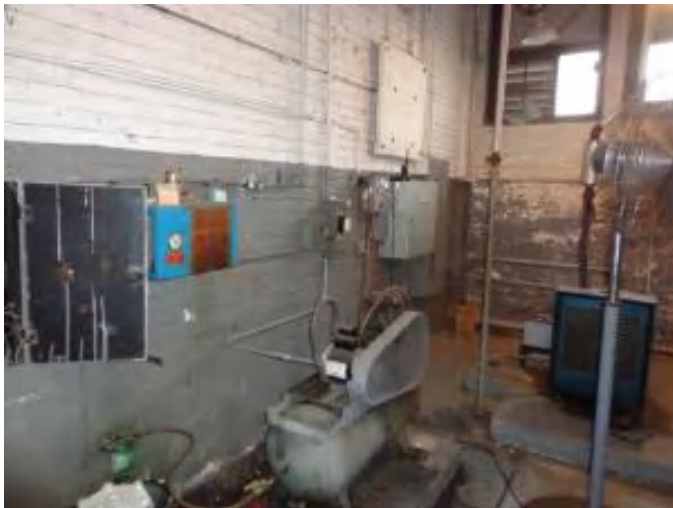
System: D5090 - Other Electrical Systems

Location: Mechanical Room 020
Distress: Beyond Service Life
Category: 3 - Operations / Maint.
Priority: 2 - Response Time (2-3 yrs)
Correction: Replace standby generator system
Qty: 1.00
Unit of Measure: Ea.
Estimate: \$102,230.39
Assessor Name: System
Date Created: 02/01/2016

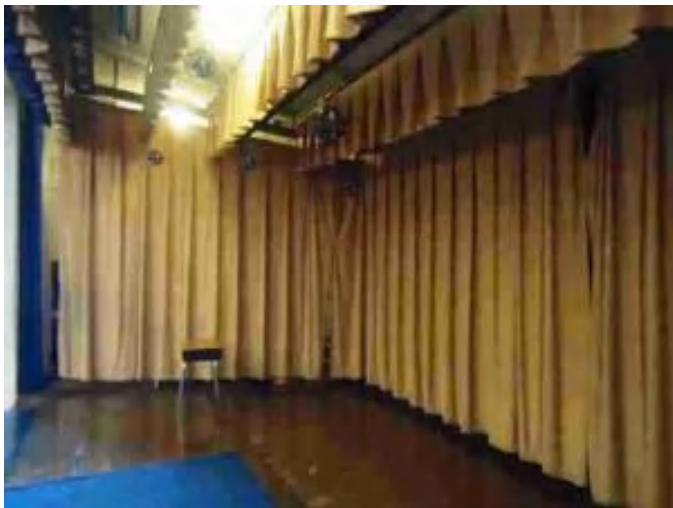
System: E2010 - Fixed Furnishings

Location: Stage
Distress: Life Safety / NFPA / PFD
Category: 1 - Health & Safety
Priority: 2 - Response Time (2-3 yrs)
Correction: Remove and replace stage curtain - insert the LF of track and SF of curtain
Qty: 1.00
Unit of Measure: Ea.
Estimate: \$15,281.89
Assessor Name: System
Date Created: 02/15/2016

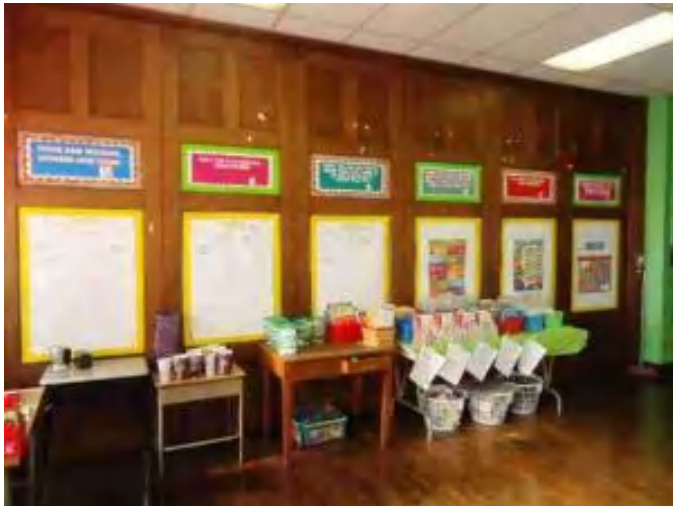
System: C1010 - Partitions

Location: Classrooms

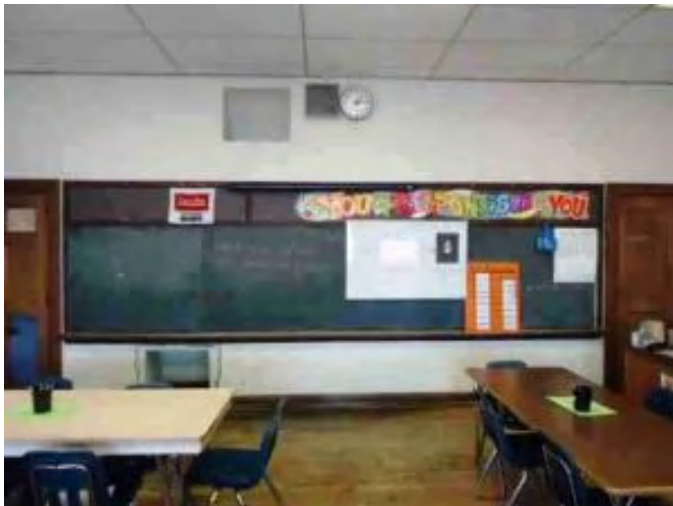
System: C1030 - Fittings

Location: Classrooms

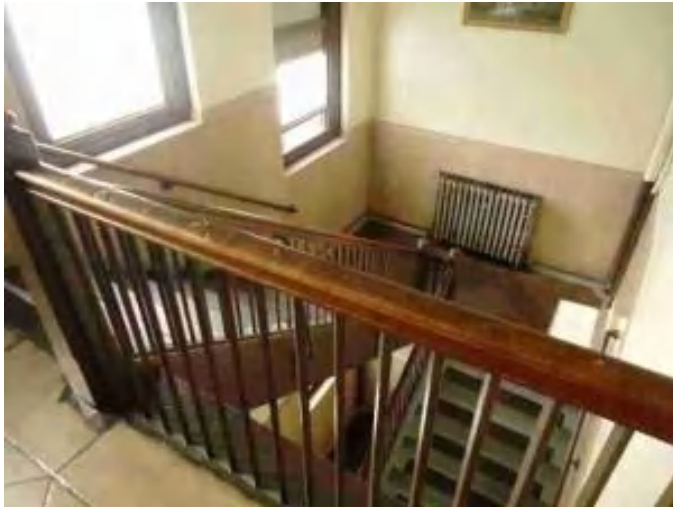
System: C2010 - Stair Construction

Location: Stairs

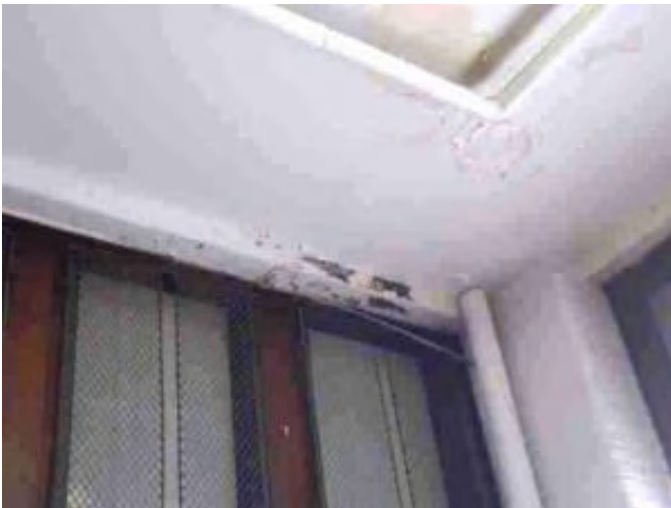
System: C3010230 - Paint & Covering

Location: Building Wide
Distress: Damaged
Category: 3 - Operations / Maint.
Priority: 3 - Response Time (3-4 yrs)
Correction: Repair and repaint all interior walls - SF of wall surface
Qty: 100,000.00
Unit of Measure: S.F.
Estimate: \$677,387.70
Assessor Name: System
Date Created: 02/15/2016

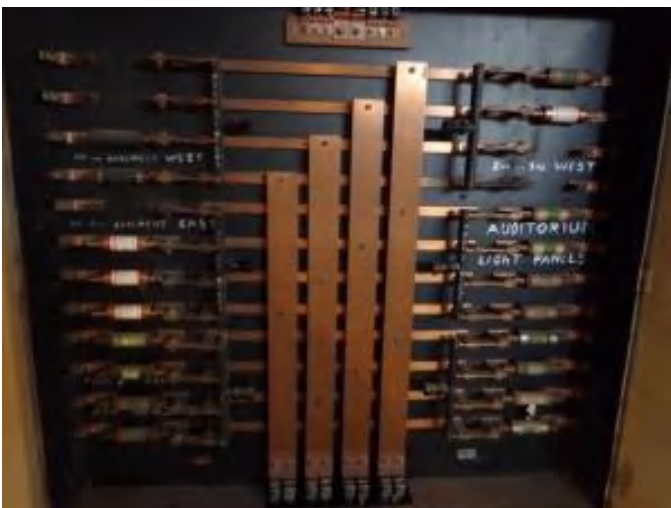
System: D5010 - Electrical Service/Distribution

Location: Mechanical Room 020
Distress: Beyond Service Life
Category: 3 - Operations / Maint.
Priority: 3 - Response Time (3-4 yrs)
Correction: Replace Switchboard
Qty: 1.00
Unit of Measure: Ea.
Estimate: \$729,997.51
Assessor Name: System
Date Created: 02/01/2016

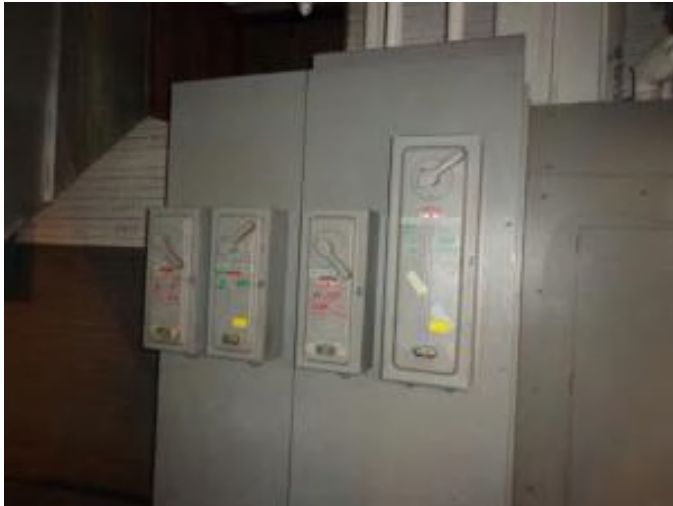
System: D5010 - Electrical Service/Distribution

Location: Mechanical Room 020 and Building wide
Distress: Beyond Service Life
Category: 3 - Operations / Maint.
Priority: 3 - Response Time (3-4 yrs)
Correction: Replace Panelboard
Qty: 12.00
Unit of Measure: Ea.
Estimate: \$346,490.90
Assessor Name: System
Date Created: 02/01/2016

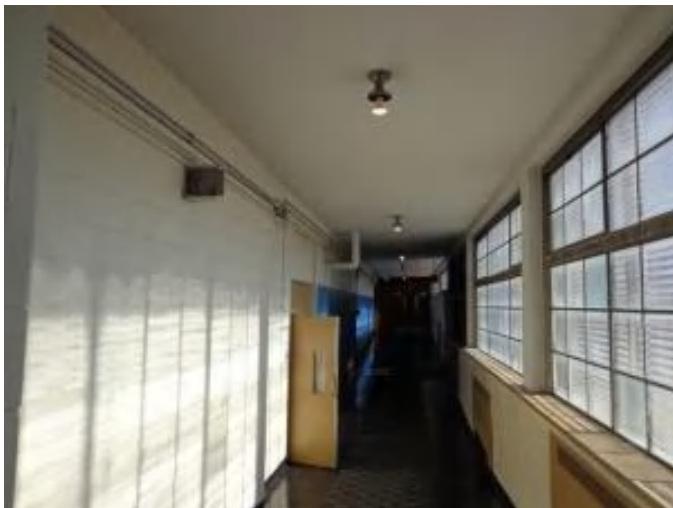
System: D5020 - Lighting and Branch Wiring

Location: Building wide
Distress: Beyond Service Life
Category: 3 - Operations / Maint.
Priority: 3 - Response Time (3-4 yrs)
Correction: Replace Lighting Fixtures (SF)
Qty: 59,176.00
Unit of Measure: S.F.
Estimate: \$948,998.42
Assessor Name: System
Date Created: 02/01/2016

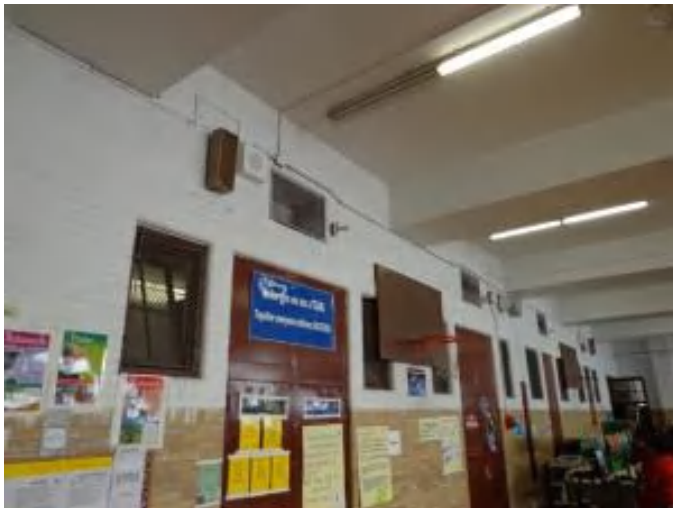
System: D5020 - Lighting and Branch Wiring

Location: Gymnasium
Distress: Beyond Service Life
Category: 3 - Operations / Maint.
Priority: 3 - Response Time (3-4 yrs)

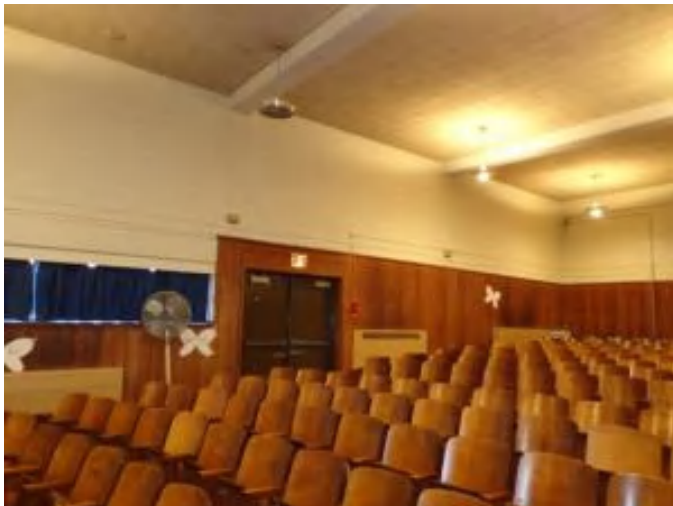
System: D5020 - Lighting and Branch Wiring

Location: Auditorium
Distress: Beyond Service Life
Category: 3 - Operations / Maint.
Priority: 3 - Response Time (3-4 yrs)

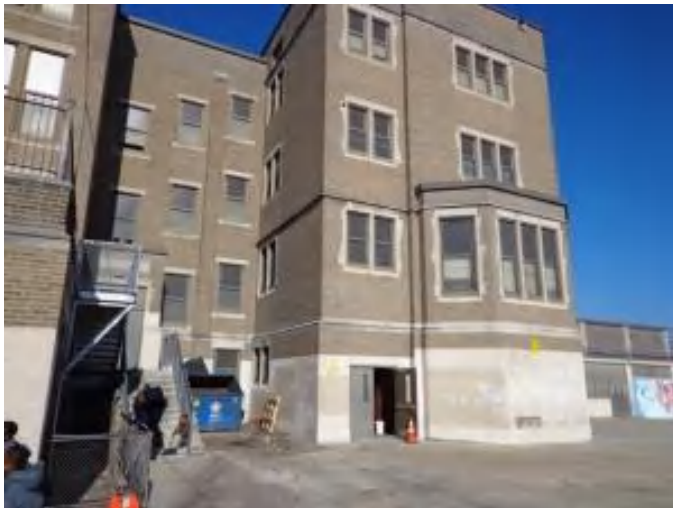
System: D5020 - Lighting and Branch Wiring

Location: Exit discharges
Distress: Beyond Service Life
Category: 3 - Operations / Maint.
Priority: 3 - Response Time (3-4 yrs)

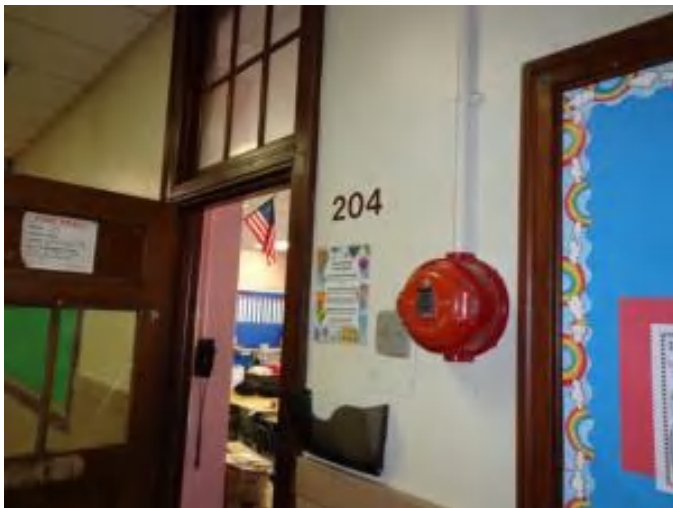
System: D5030 - Communications and Security

Location: Building wide
Distress: Life Safety / NFPA / PFD
Category: 1 - Health & Safety
Priority: 3 - Response Time (3-4 yrs)

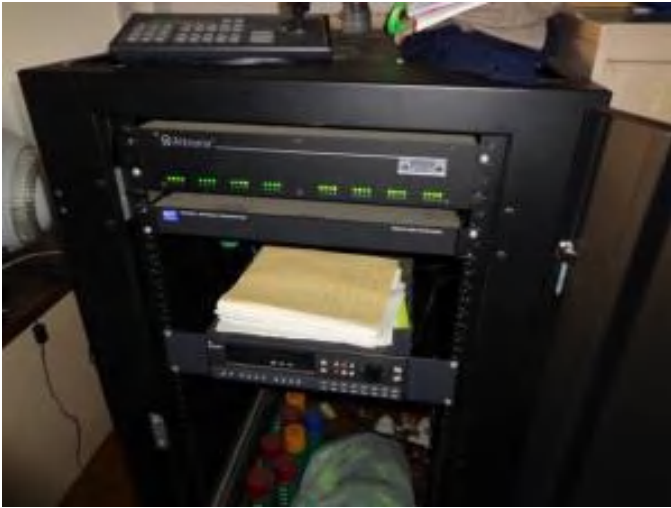
System: D5030 - Communications and Security

Location: Building wide

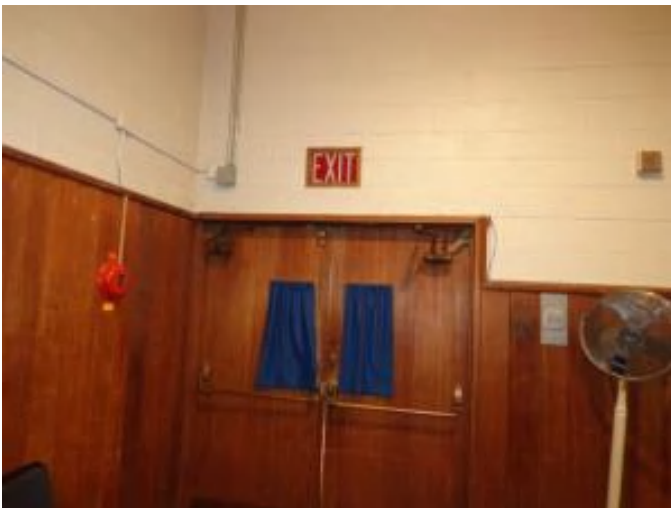
System: D5090 - Other Electrical Systems

Location: Building wide

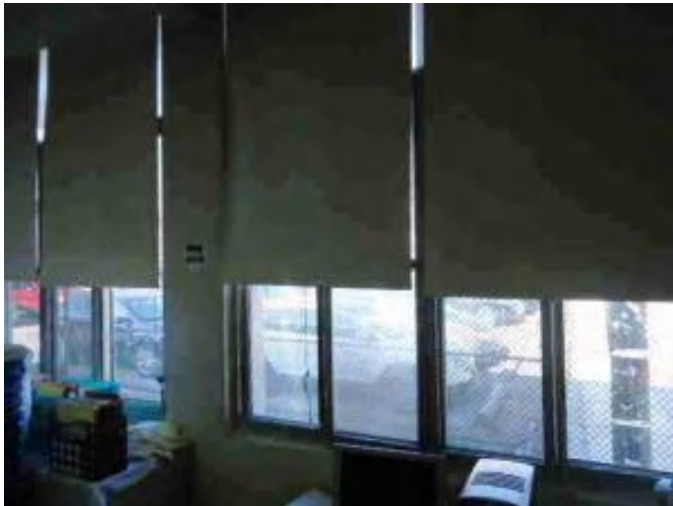
System: B2020 - Exterior Windows

Location: Building Wide

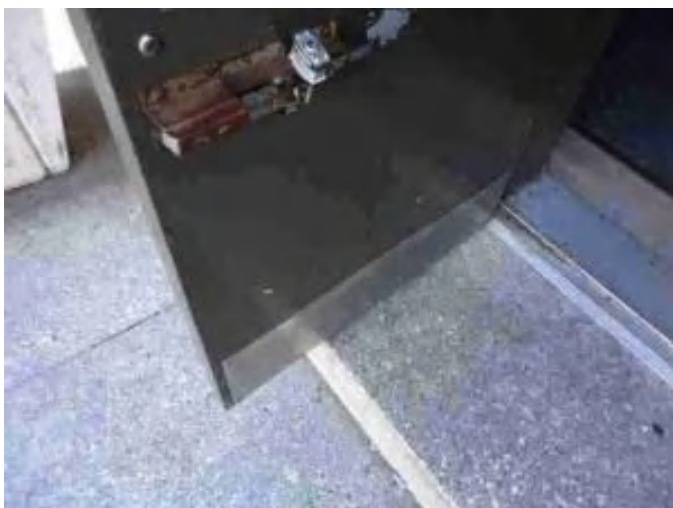
System: B2030 - Exterior Doors

Location: Exterior Elevation

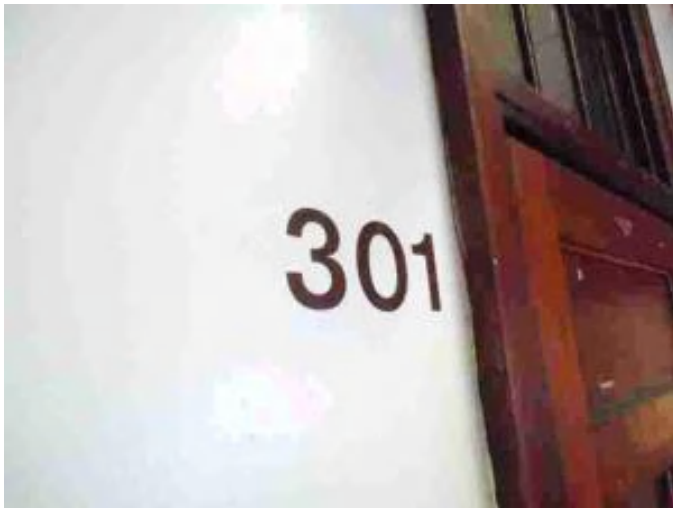
System: C1030 - Fittings

Location: Building Wide
Distress: Damaged
Category: 3 - Operations / Maint.
Priority: 4 - Response Time (4-5 yrs)
Correction: Replace missing or damaged signage - insert the number of rooms
Qty: 250.00
Unit of Measure: Ea.
Estimate: \$67,728.12
Assessor Name: System
Date Created: 02/15/2016

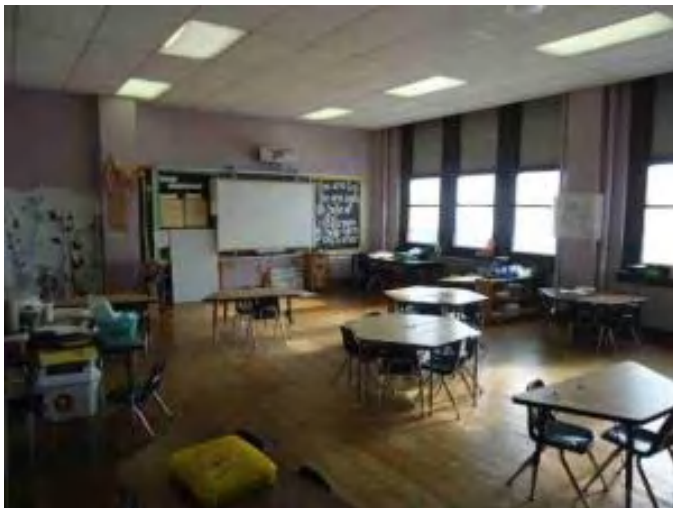
System: C3020414 - Wood Flooring

Location: Classrooms
Distress: Damaged
Category: 3 - Operations / Maint.
Priority: 4 - Response Time (4-5 yrs)
Correction: Remove and replace wood flooring
Qty: 40,000.00
Unit of Measure: S.F.
Estimate: \$1,166,082.84
Assessor Name: System
Date Created: 02/15/2016

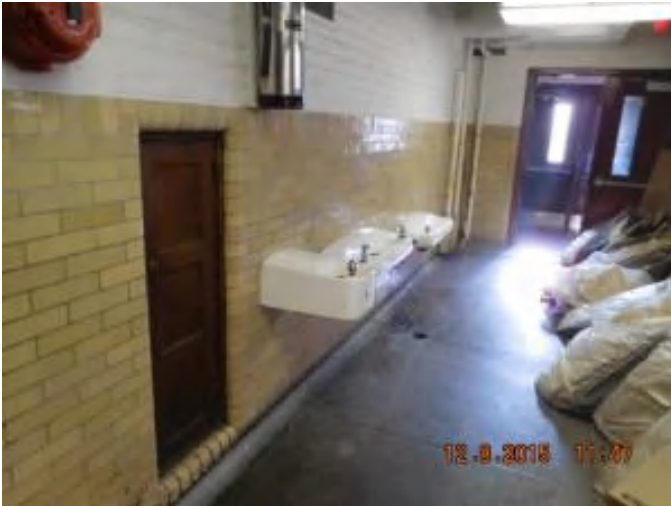
System: D2010 - Plumbing Fixtures

Location: corridors
Distress: Beyond Service Life
Category: 3 - Operations / Maint.
Priority: 4 - Response Time (4-5 yrs)
Correction: Remove and Replace Water Fountains - without ADA new recessed alcove
Qty: 6.00
Unit of Measure: Ea.
Estimate: \$45,475.14
Assessor Name: System
Date Created: 02/11/2016

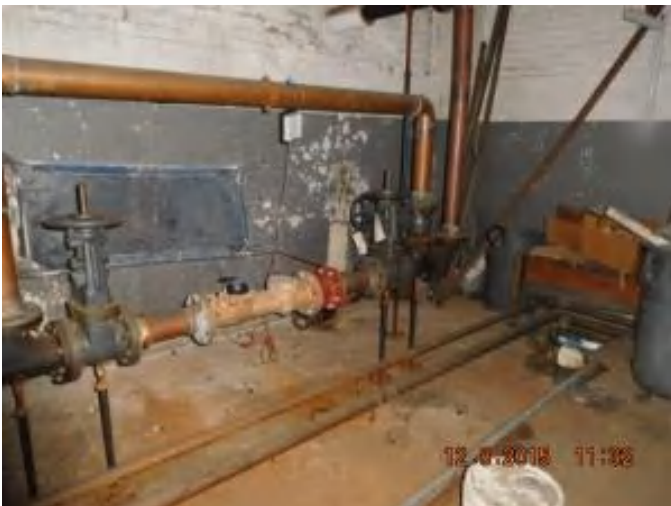
System: D2020 - Domestic Water Distribution

Location: entire building
Distress: Beyond Service Life
Category: 3 - Operations / Maint.
Priority: 4 - Response Time (4-5 yrs)
Correction: Replace domestic water piping (75 KSF)
Qty: 70,498.00
Unit of Measure: S.F.
Estimate: \$357,238.94
Assessor Name: System
Date Created: 02/11/2016

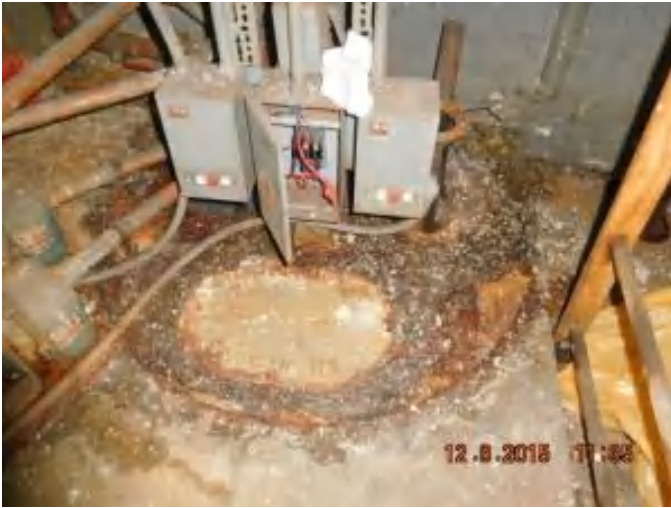
System: D2030 - Sanitary Waste

Location: entire building

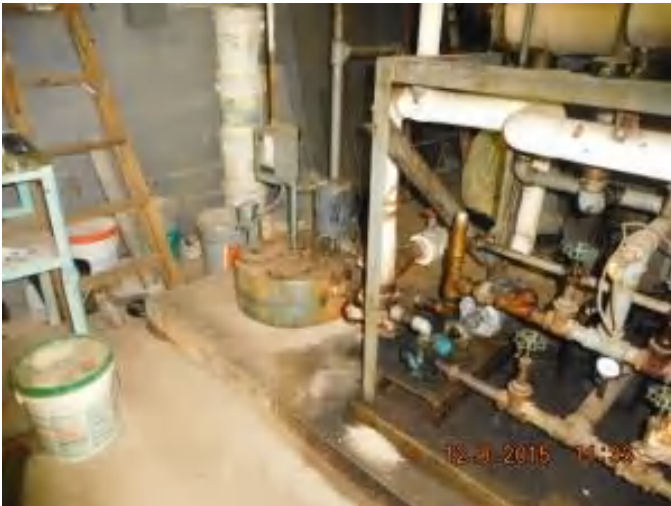
System: D3020 - Heat Generating Systems

Location: mechanical room

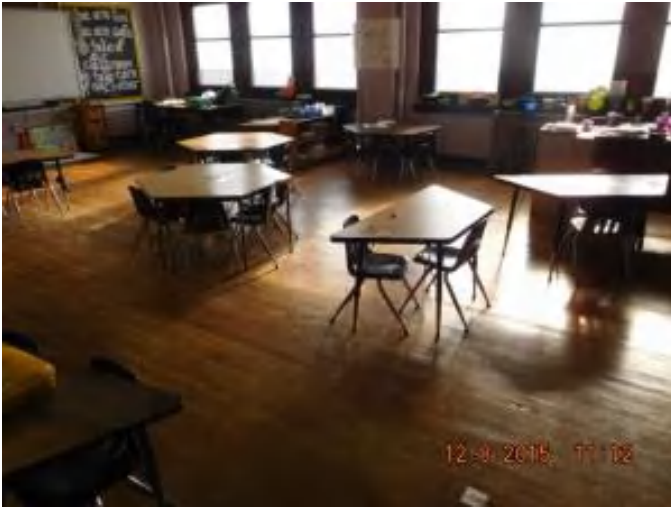
System: D3040 - Distribution Systems

Location: classrooms

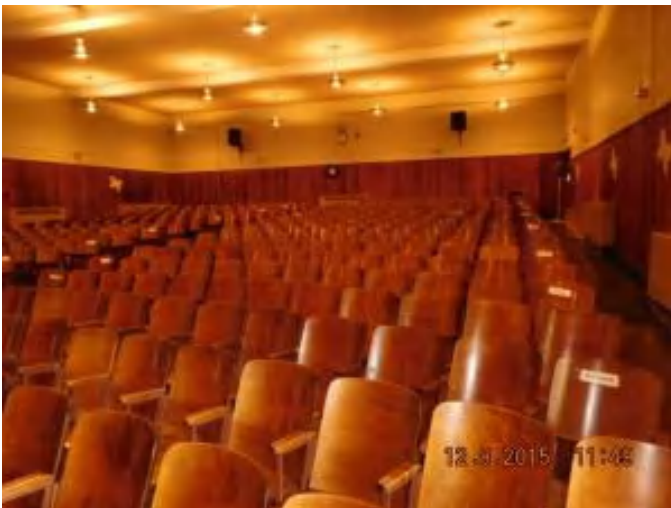
System: D3040 - Distribution Systems

Location: auditorium

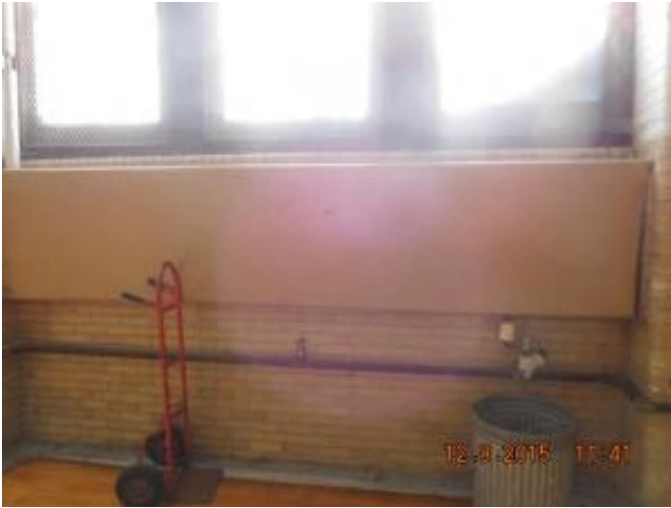
System: D3040 - Distribution Systems

Location: cafeteria/ gymnasium
Distress: Building / MEP Codes
Category: 2 - Code Compliance
Priority: 4 - Response Time (4-5 yrs)
Correction: Install HVAC unit for Gymnasium (single station).
Qty: 5,000.00
Unit of Measure: S.F.
Estimate: \$287,380.96
Assessor Name: System
Date Created: 02/11/2016

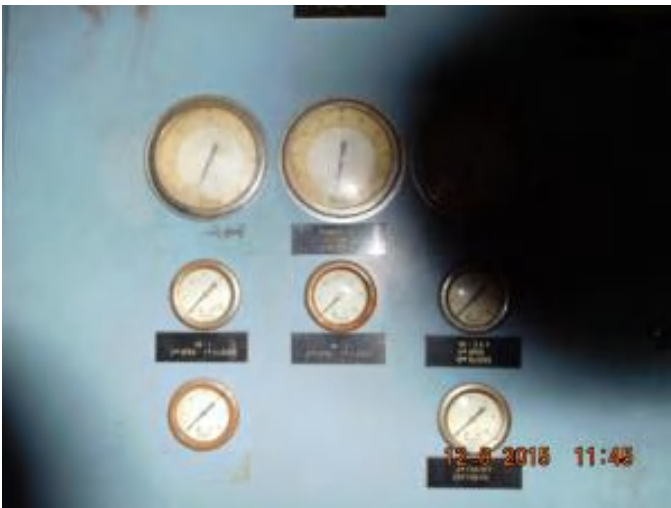
System: D3060 - Controls & Instrumentation

Location: entire building
Distress: Inadequate
Category: 4 - Capital Improvement
Priority: 4 - Response Time (4-5 yrs)
Correction: Replace pneumatic controls with DDC (75KSF)
Qty: 70,498.00
Unit of Measure: S.F.
Estimate: \$1,512,329.95
Assessor Name: System
Date Created: 02/11/2016

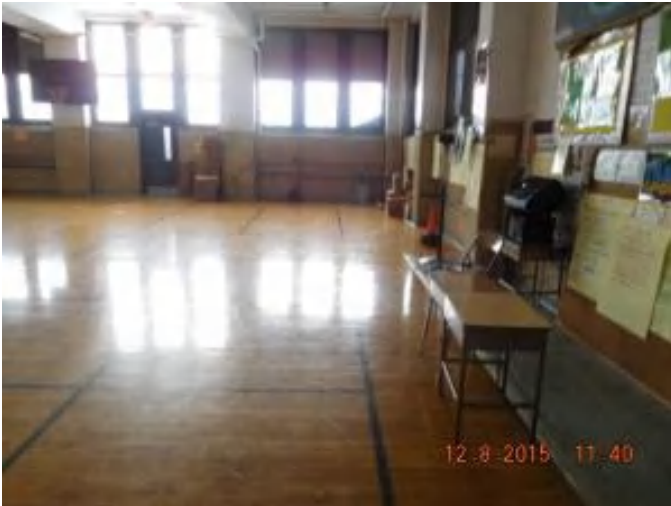
System: D4010 - Sprinklers

Location: entire building

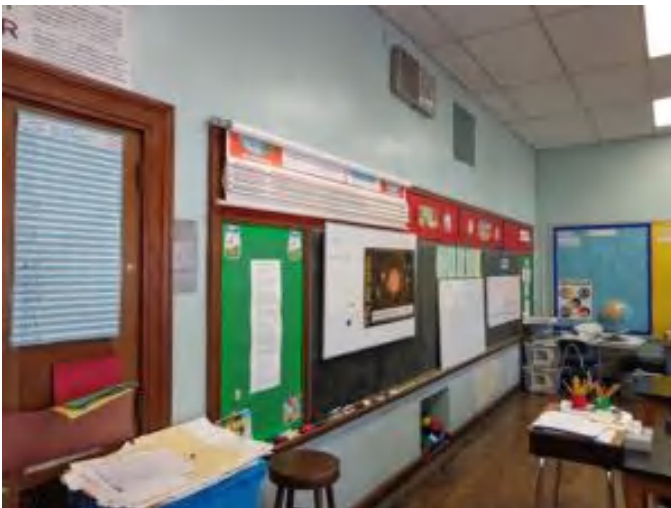
System: D5020 - Lighting and Branch Wiring

Location: Classrooms

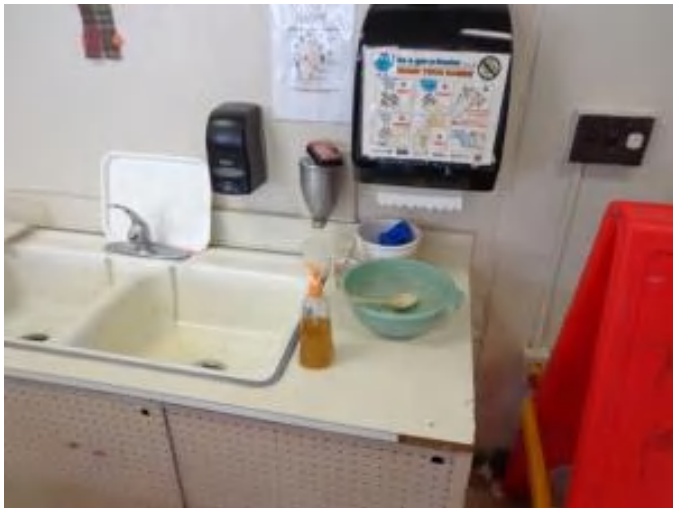
System: D5020 - Lighting and Branch Wiring

Location: Building wide
Distress: Beyond Service Life
Category: 3 - Operations / Maint.
Priority: 4 - Response Time (4-5 yrs)
Correction: Replace Wiring Device
Qty: 140.00
Unit of Measure: Ea.
Estimate: \$36,851.98
Assessor Name: System
Date Created: 02/01/2016

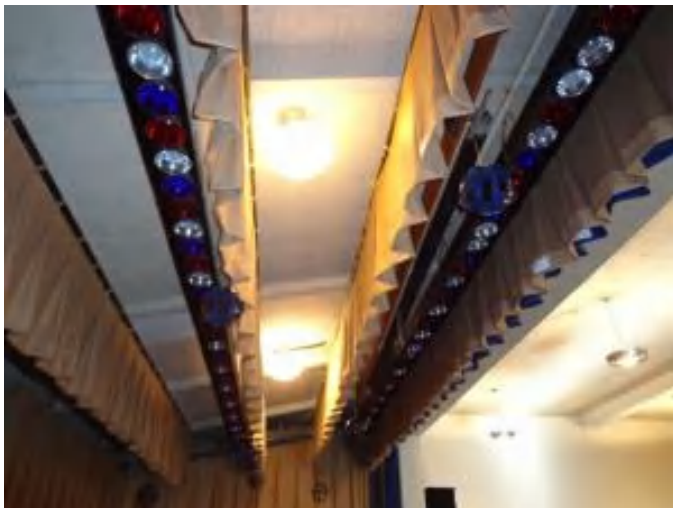
System: D5020 - Lighting and Branch Wiring

Location: Auditorium platform
Distress: Beyond Service Life
Category: 3 - Operations / Maint.
Priority: 4 - Response Time (4-5 yrs)
Correction: Replace lighting fixtures
Qty: 4.00
Unit of Measure: Ea.
Estimate: \$29,141.19
Assessor Name: System
Date Created: 02/01/2016

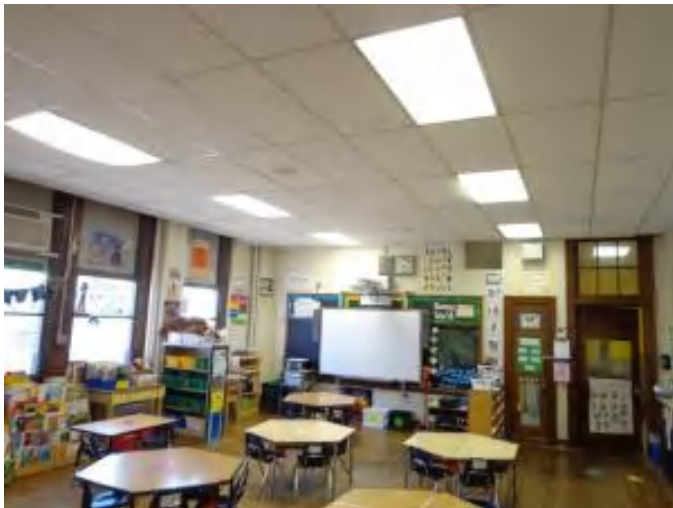
System: D5030 - Communications and Security

Location: Building wide

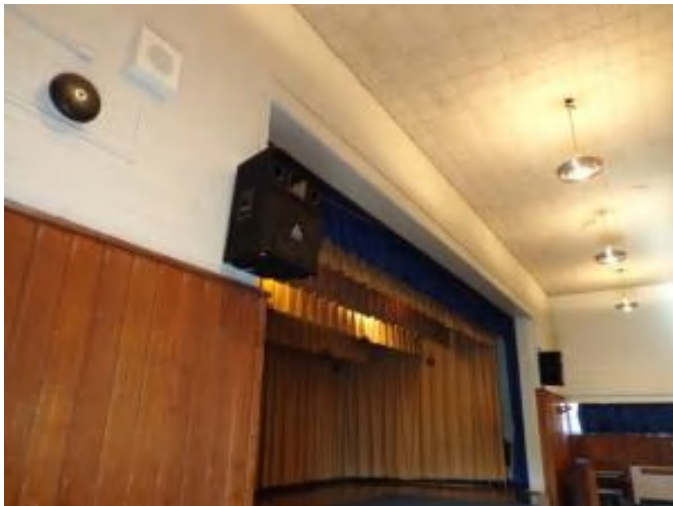
System: D5030 - Communications and Security

Location: Auditorium

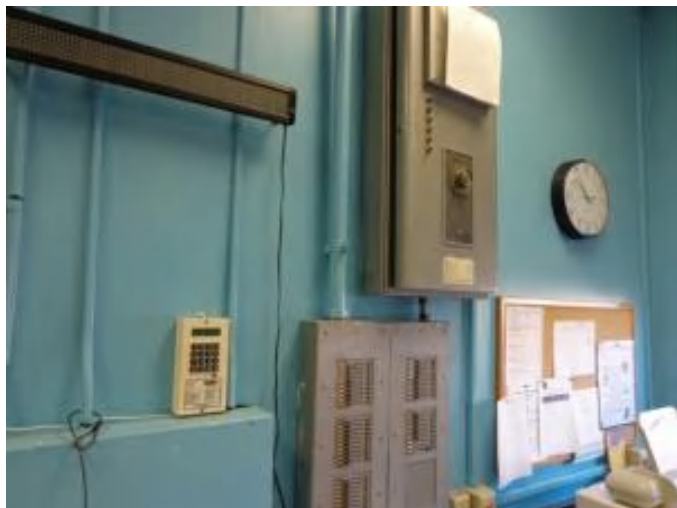
System: D5030 - Communications and Security

Location: Main Office

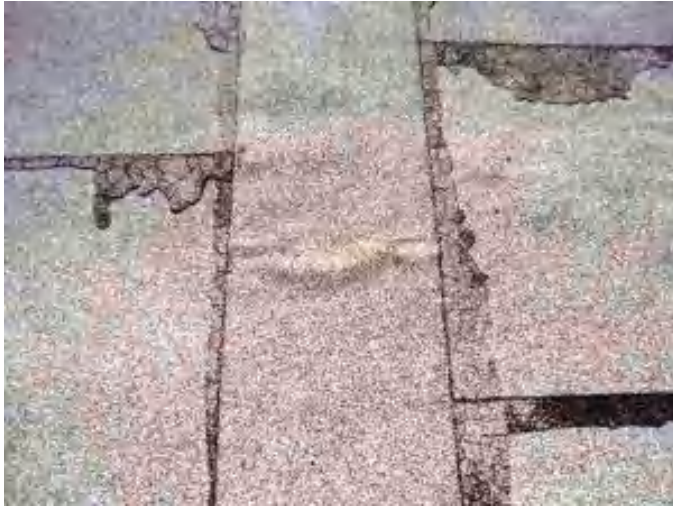
System: B3010105 - Built-Up

Location: Roof

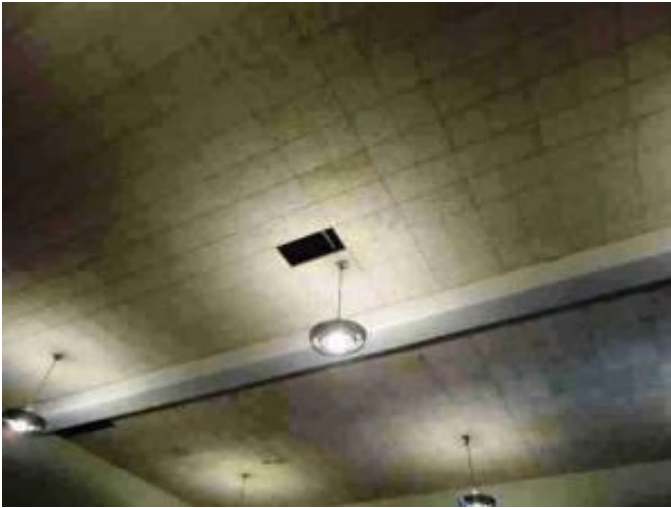
System: C3030 - Ceiling Finishes

Location: Ceiling
Distress: Damaged
Category: 3 - Operations / Maint.
Priority: 5 - Response Time (> 5 yrs)
Correction: Remove and replace suspended acoustic ceilings - lighting not included
Qty: 80,000.00
Unit of Measure: S.F.
Estimate: \$1,206,594.42
Assessor Name: System
Date Created: 02/15/2016

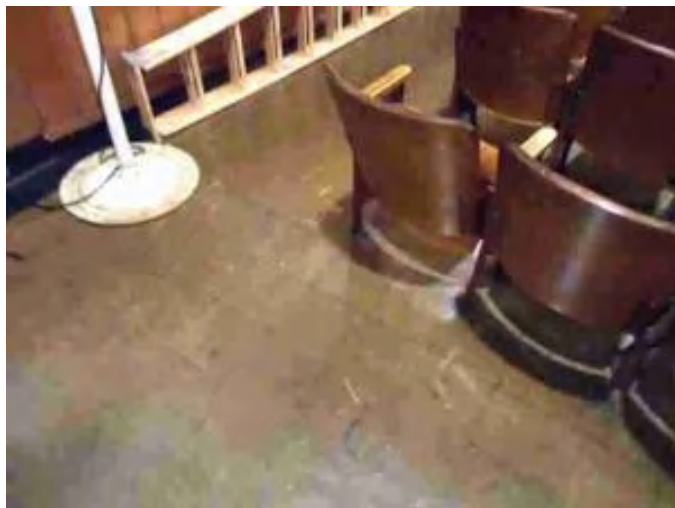
System: E2010 - Fixed Furnishings

Location: Auditorium

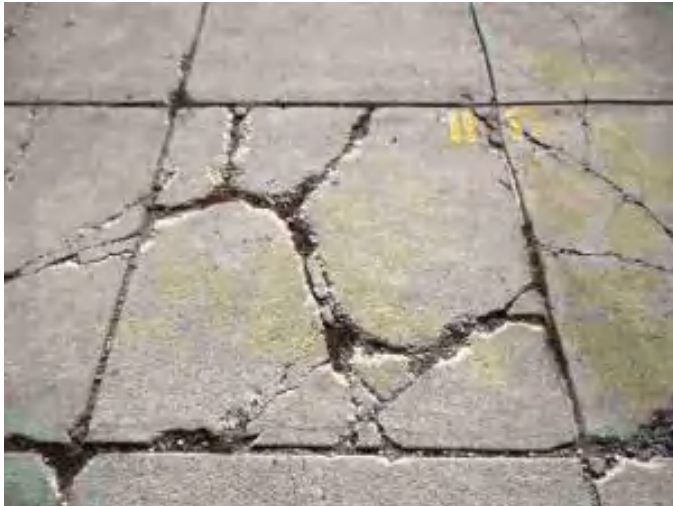
System: G2030 - Pedestrian Paving

Location: Site

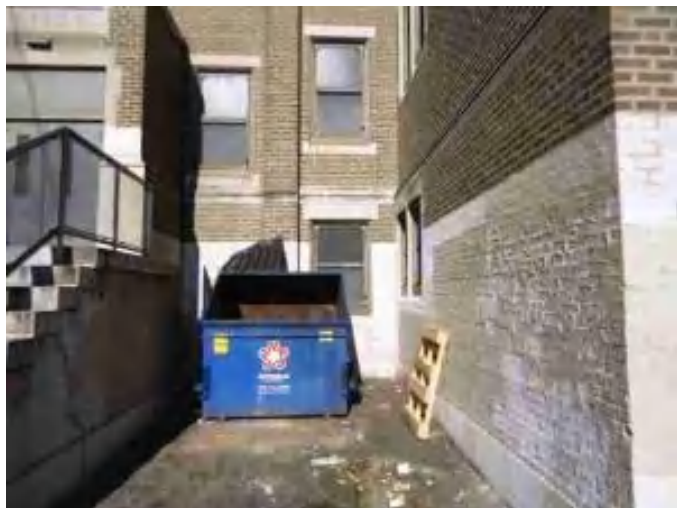
System: G2040 - Site Development

Location: Site
