Pennypacker School

School District of Philadelphia

S635001;Pennypacker

Site Assessment Report

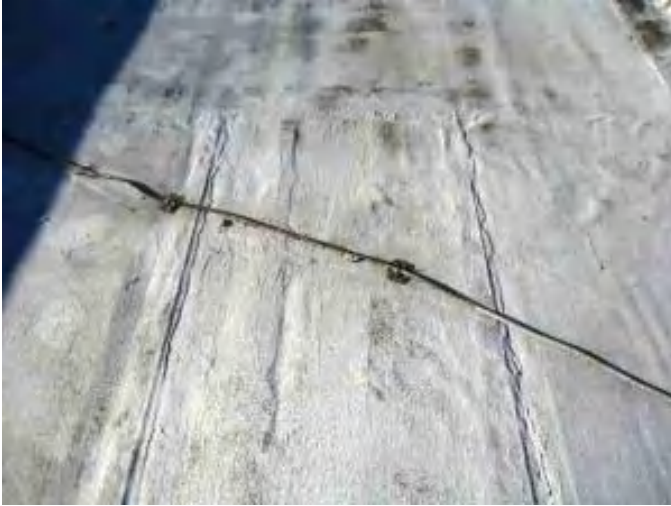
System: B3010105 - Built-Up

Location: Roof

Distress: Damaged

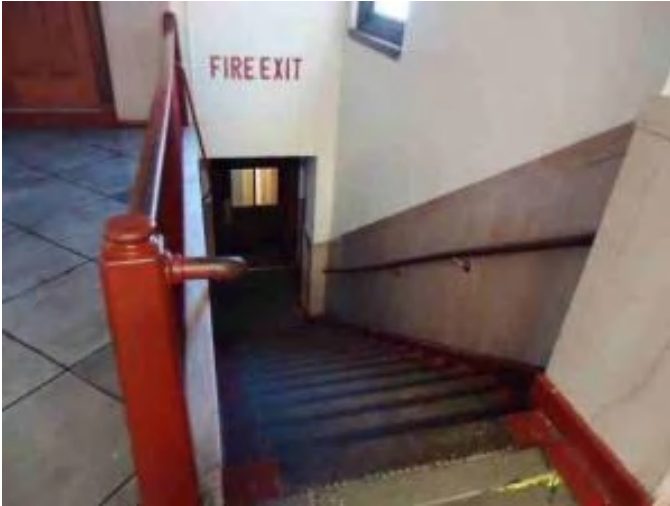
System: C1010 - Partitions

Location: Stairs

Distress: Life Safety / NFPA / PFD

Notes: This building has adequate exit pathways and no egress obstructions were noted during our building walk through. However the corridor doors on all floors are not fire rated and should be upgraded. Install new fire rated flush wood doors on all floor corridors. If the recommended lever hardware and room signage has not been implemented then these features should be incorporated into the work scope.

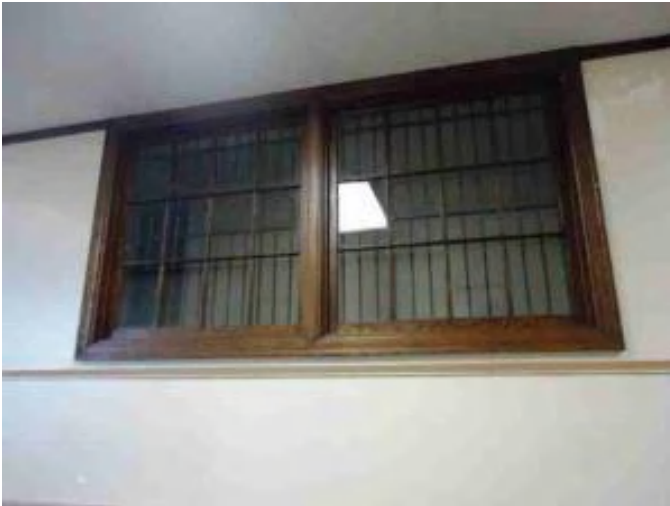
System: C1010 - Partitions

Location: Hallways

Distress: Life Safety / NFPA / PFD

Notes: There are several transom lites and sidelights constructed into hallway wall systems. It is recommended that the lites and sidelights be removed and replaced with a fire rated wall construction. The deficiency provides a budgetary consideration to correct the hallway, transoms, lites and sidelights.

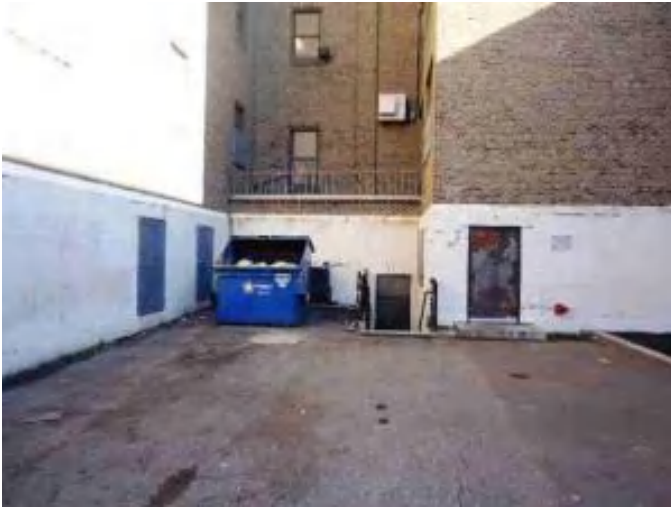
System: D1010 - Elevators and Lifts

Location: Building Wide

Distress: Inadequate

Notes: There is no elevator that services this school. Goods, services, and amenities offered in public buildings are generally required to be available to all persons. To assist those that may be physically challenged and to meet current accessibility legislation to provide wheelchair access to the upper floors of this facility, the installation of a new hydraulic elevator has been recommended on the exterior elevation of the building or at another suitable location. The new installation should blend as much as possible with the overall appearance of this historic structure and include all required ADA features, such as audible jewels and gongs, an accessible control panel, etc.

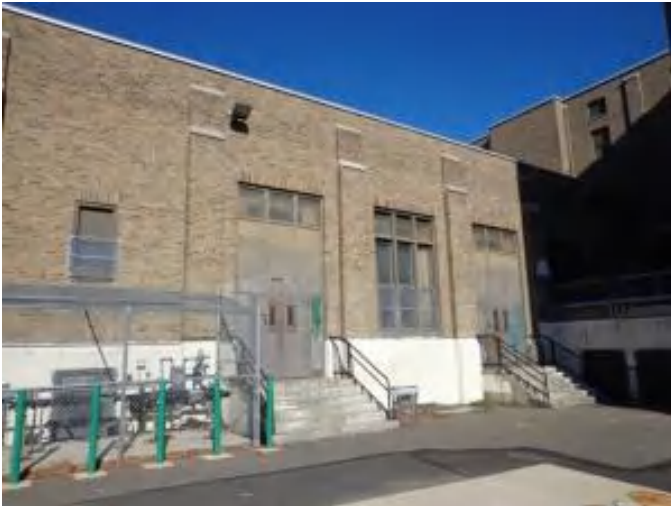
System: D5020 - Lighting and Branch Wiring

Location: Auditorium exit discharges

Distress: Life Safety / NFPA / PFD

Notes: Provide exterior LED lighting fixtures at the exit discharges above the four exterior doors from the auditorium do not have lighting fixtures at the exit discharges.

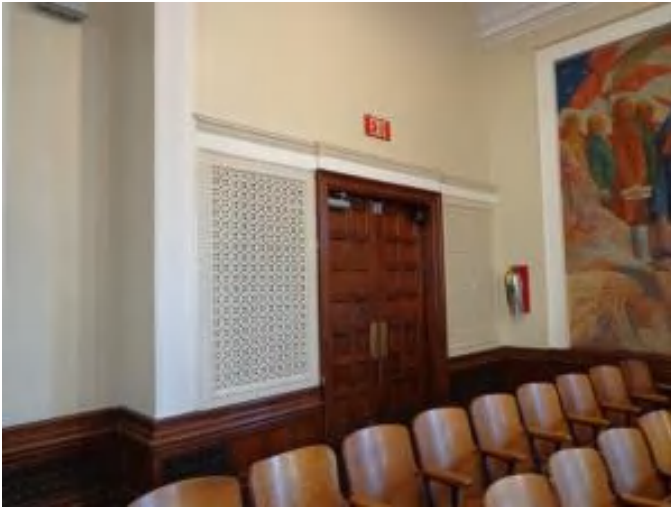
System: D5090 - Other Electrical Systems

Location: Building wide

Distress: Building / MEP Codes

Notes: Replace all existing exit signs with LED type.

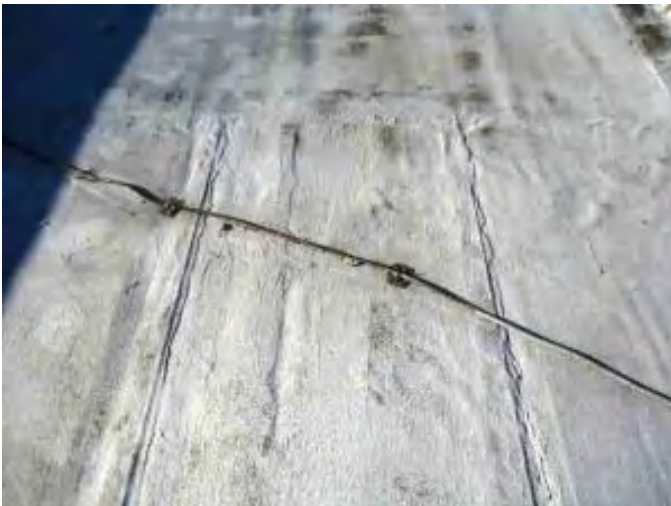
System: D5090 - Other Electrical Systems

Location: Roof

Distress: Damaged

Notes: Replace missing roof conductor for the lightning protection system protecting the building structures that extend above the roof. Verify system continuity after repair to insure the integrity of the system is maintained.

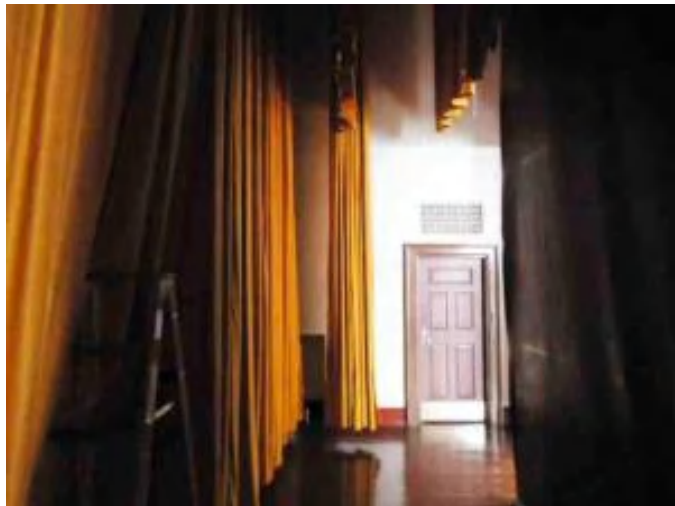
System: E2010 - Fixed Furnishings

Location: Stage

Distress: Life Safety / NFPA / PFD

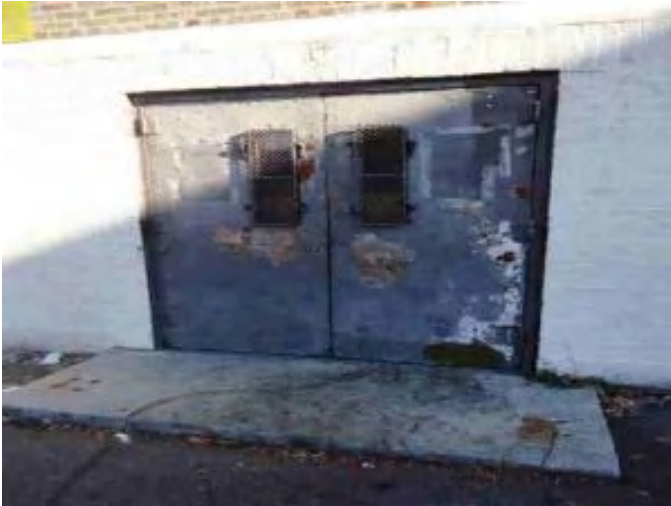
System: B2030 - Exterior Doors

Location: Exterior Elevation

Distress: Damaged

Notes: The exterior doors are metal applications with metal frames. The exterior door system for this school is a very high traffic system. The doors are in poor condition but are aging at a faster rate than expected based on traffic and condition. The exterior door system and service doors are recommended for upgrade. The new doors are expected to retain their dimensions and profiles, but that incorporate updated energy-efficient features.

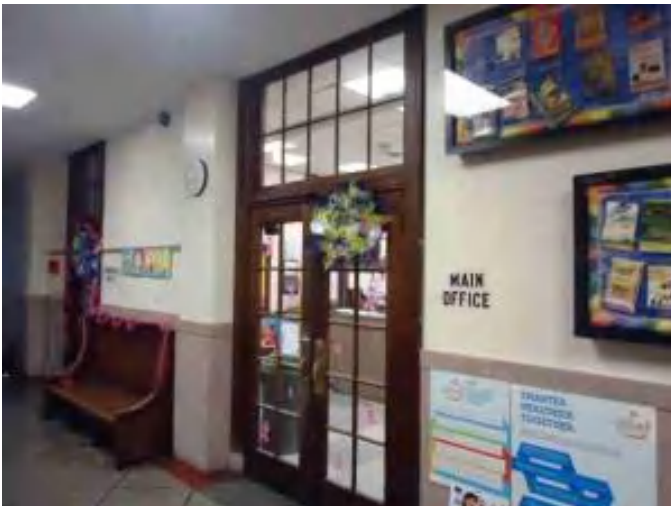
System: C1020 - Interior Doors

Location: Building Wide

Distress: Damaged

Notes: Interior doors are typically wood in wood frames with transom lites, sidelights, wired glass glazing. Other interior doors include wooden glass pane doors with original wooden pane frames, metal in hollow metal frames at stairwells and exit ways. Doors are generally in fair condition considering the age of the application. Universal upgrades are required for the interior door systems it is recommended that the interior doors system be removed and replaced with a new modern metal framed wood door system with consideration for ADA compliance.

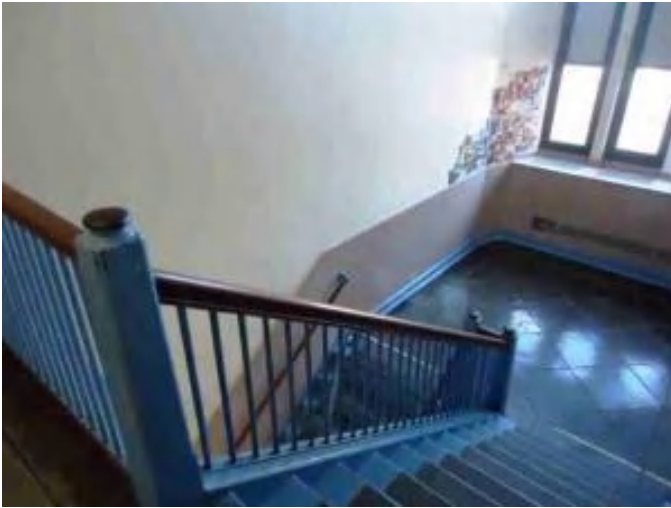
System: C2010 - Stair Construction

Location: Stairs

Distress: Life Safety / NFPA / PFD

Notes: Current requirements for stairs indicate that they have graspable handrails on both sides, that the rails have a specific end geometry, and that the handrails continue horizontally at the landings. In addition, guardrails must prevent the passage of a 4 inch diameter sphere (6 inches in the triangle formed by the lower rail and tread/riser angle). Although the stairs are compliant with the code enforced at the time of construction until a major renovation occurs, they are deficient in handrail and guardrail design relative to current standards. Future efforts should include comprehensive stair railing removal and replacement upgrades.

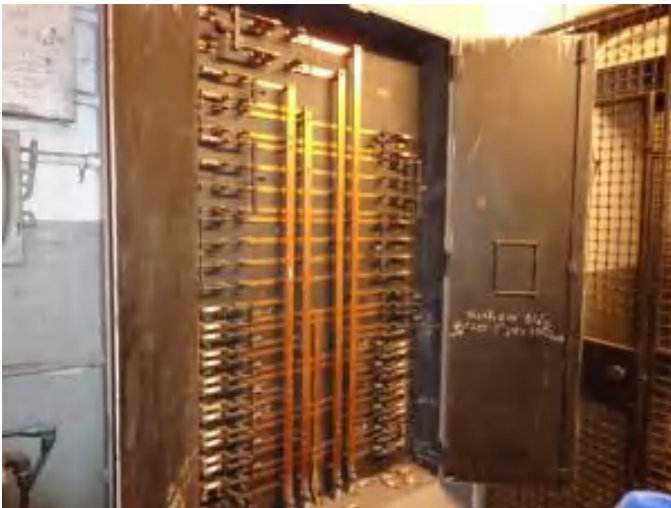
System: D5010 - Electrical Service/Distribution

Location: Mechanical Room 012A

Distress: Beyond Service Life

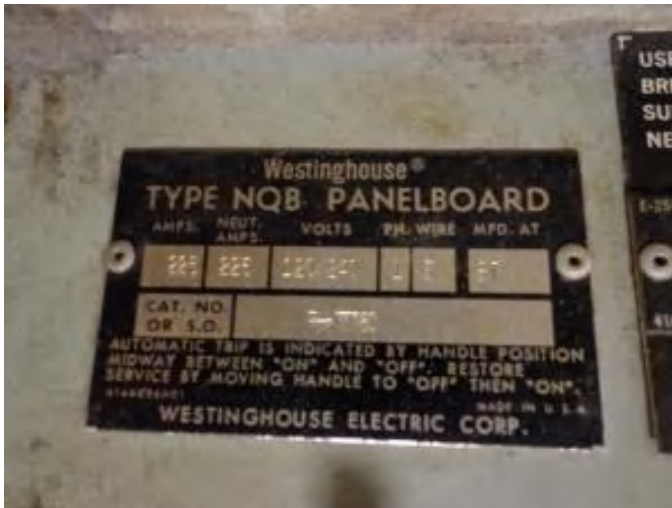
System: D5010 - Electrical Service/Distribution

Location: Building wide

Distress: Beyond Service Life

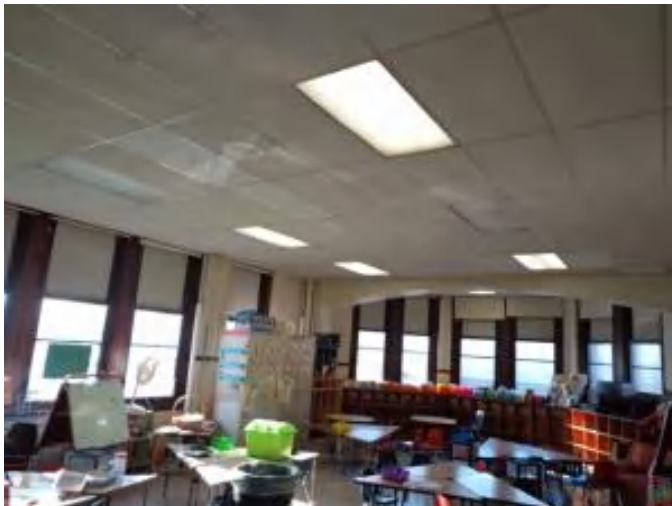
System: D5020 - Lighting and Branch Wiring

Location: Classrooms, IMC and Gym/Cafeteria

Distress: Beyond Service Life

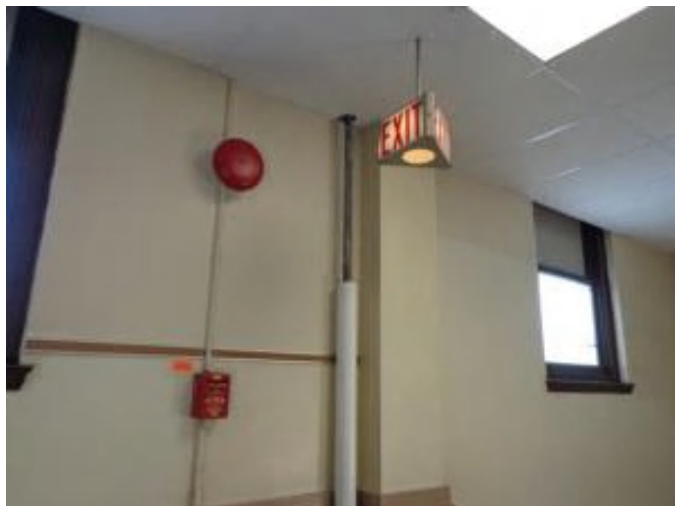
System: D5030 - Communications and Security

Location: Building wide

Distress: Life Safety / NFPA / PFD

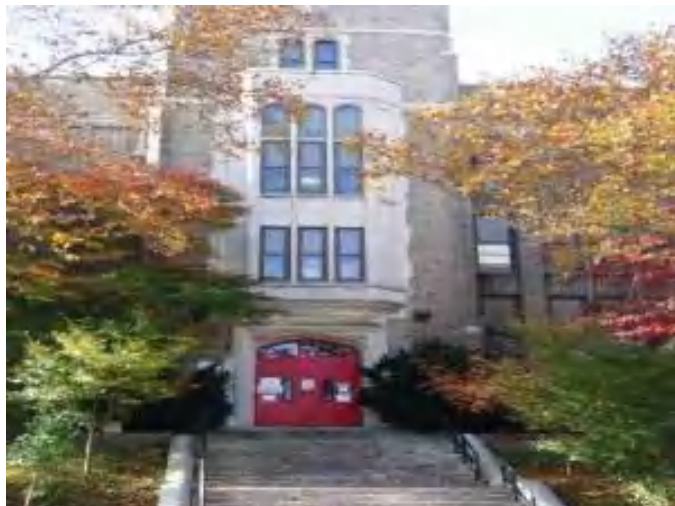
System: B2020 - Exterior Windows

Location: Exterior Elevation

Distress: Damaged

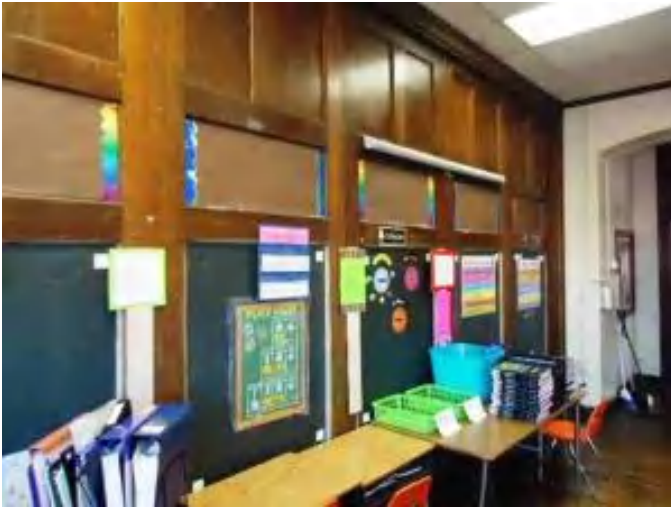
System: C1010 - Partitions

Location: Classroom

Distress: Damaged

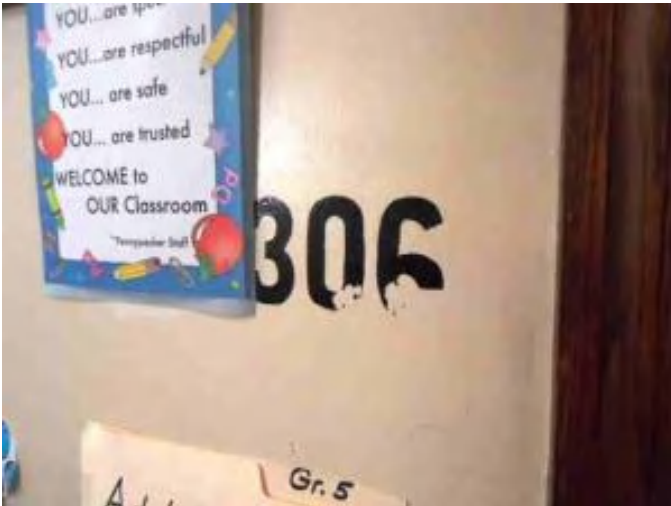
System: C1030 - Fittings

Location: Building Wide

Distress: Damaged

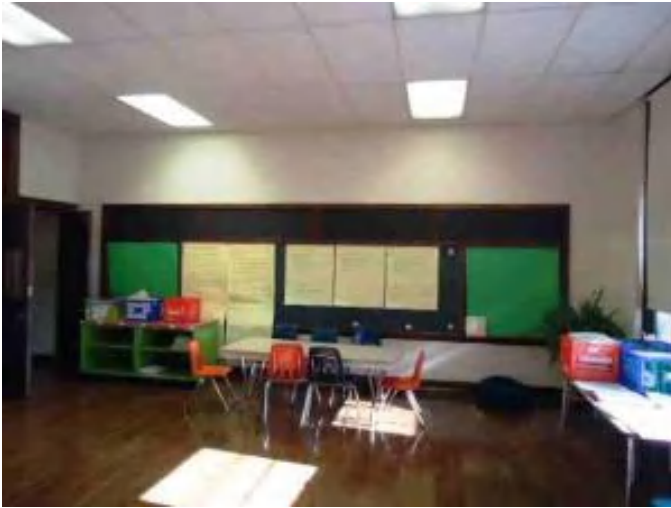
System: C1030 - Fittings

Location: Classrooms

Distress: Damaged

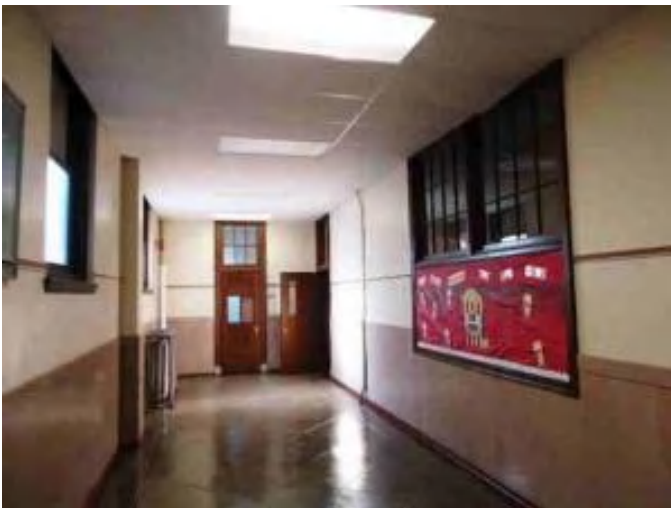
System: C1030 - Fittings

Location: Hallways

Distress: Damaged

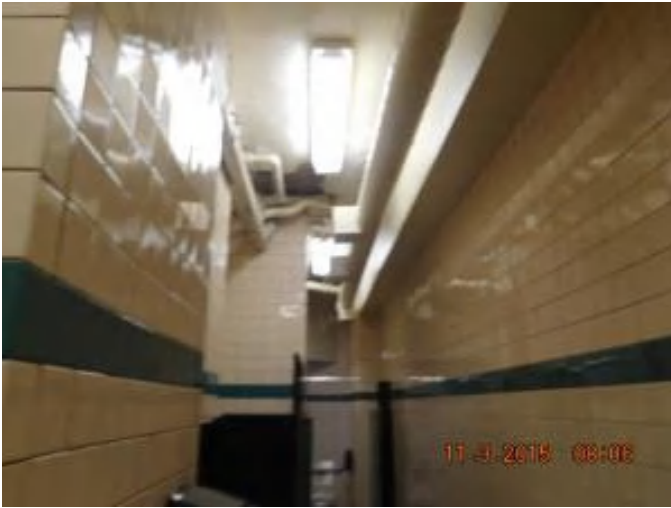
System: D2030 - Sanitary Waste

Location: entire building

Distress: Beyond Service Life

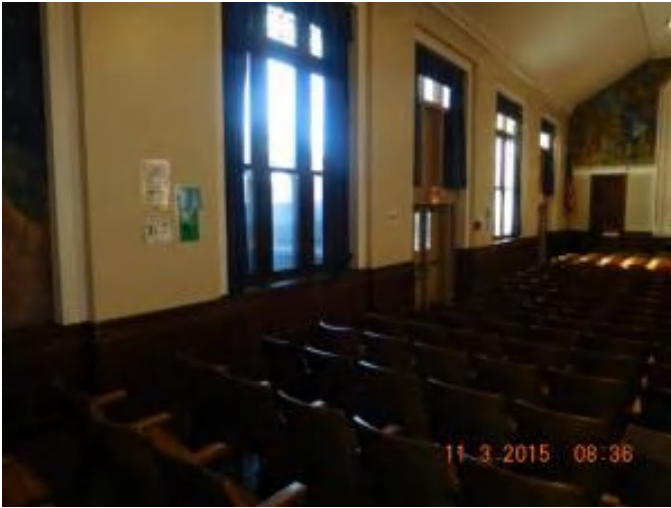
System: D3040 - Distribution Systems

Location: auditorium

Distress: Building / MEP Codes

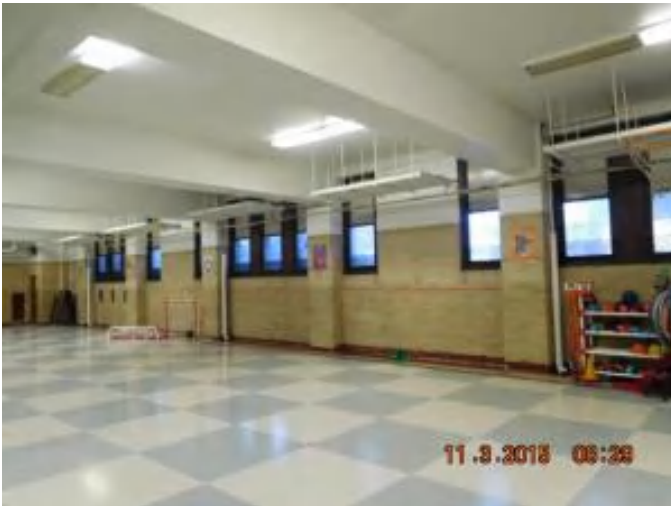
System: D3040 - Distribution Systems

Location: gymnasium

Distress: Building / MEP Codes

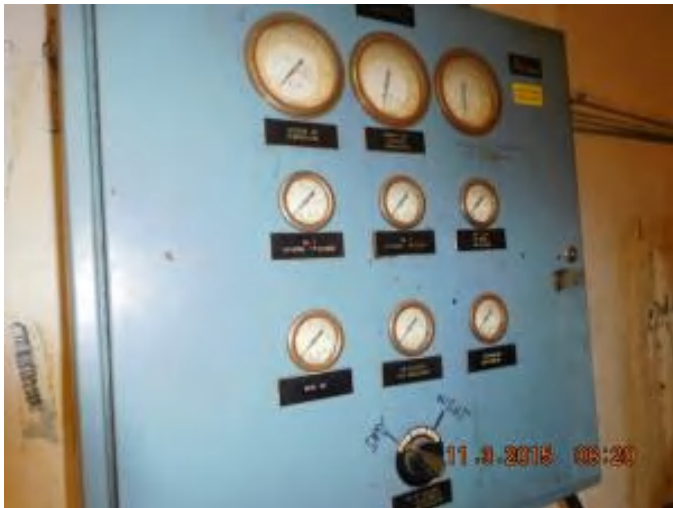
System: D3060 - Controls & Instrumentation

Location: entire building

Distress: Beyond Service Life

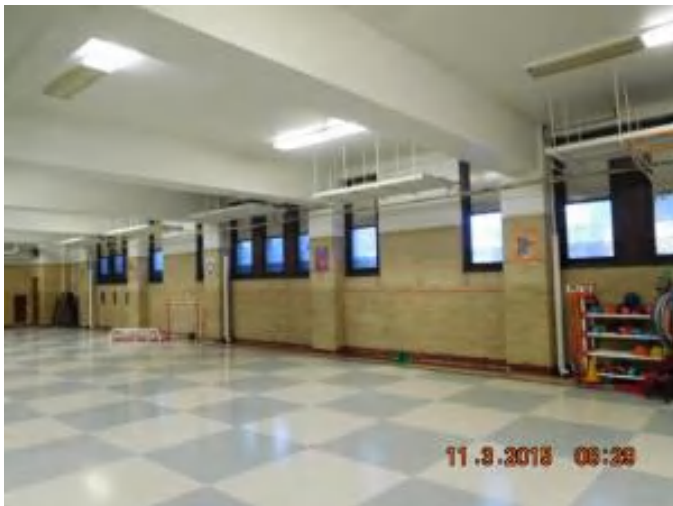
System: D4010 - Sprinklers

Location: entire building

Distress: Life Safety / NFPA / PFD

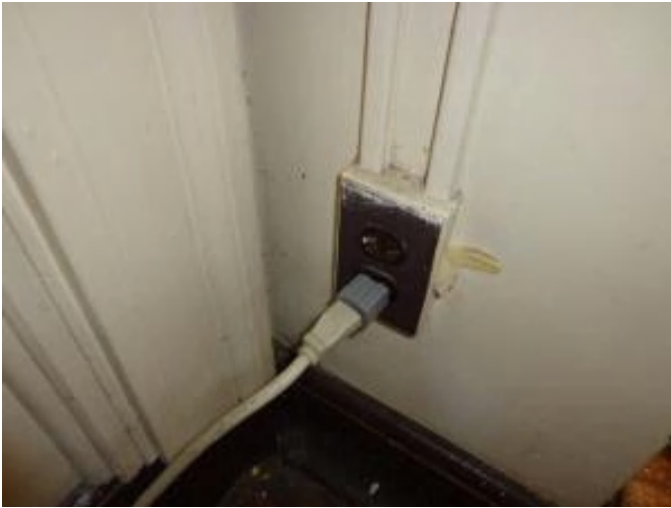
System: D5020 - Lighting and Branch Wiring

Location: Classrooms and Building wide

Distress: Inadequate

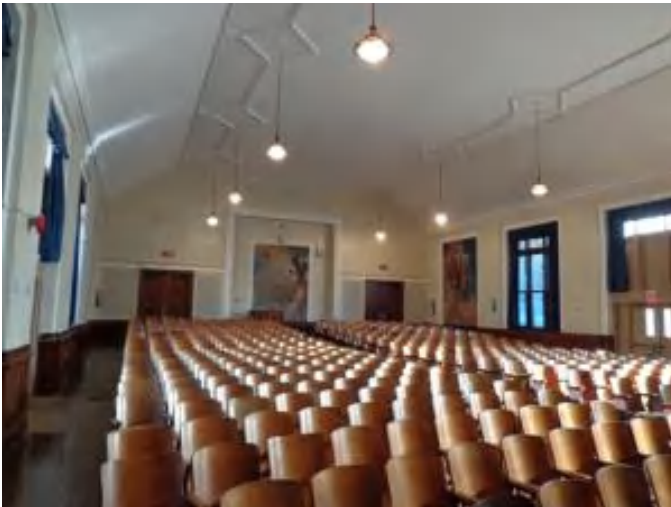
System: D5020 - Lighting and Branch Wiring

Location: Auditorium

Distress: Damaged

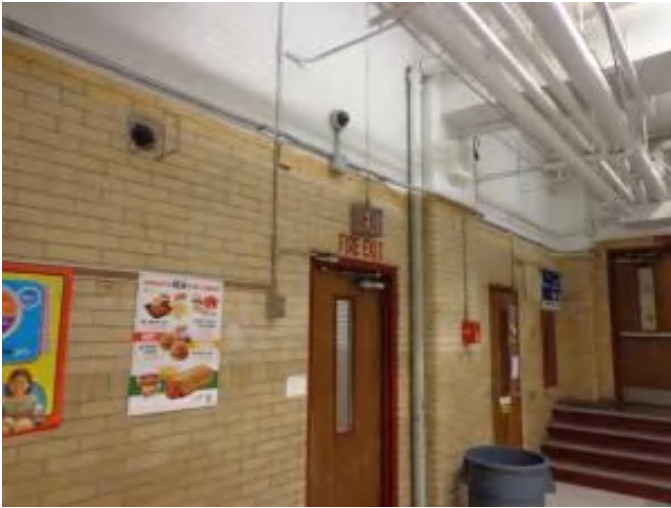
System: D5030 - Communications and Security

Location: Building wide

Distress: Failing

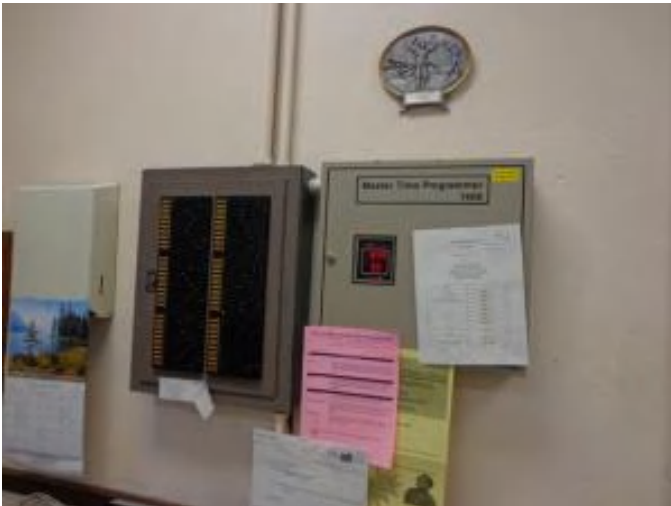
System: D5030 - Communications and Security

Location: Building wide

Distress: Failing

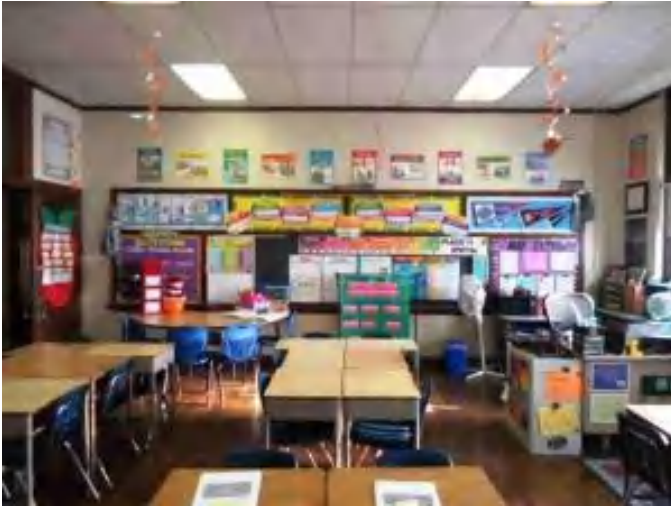
System: C3020414 - Wood Flooring

Location: Classrooms

Distress: Damaged

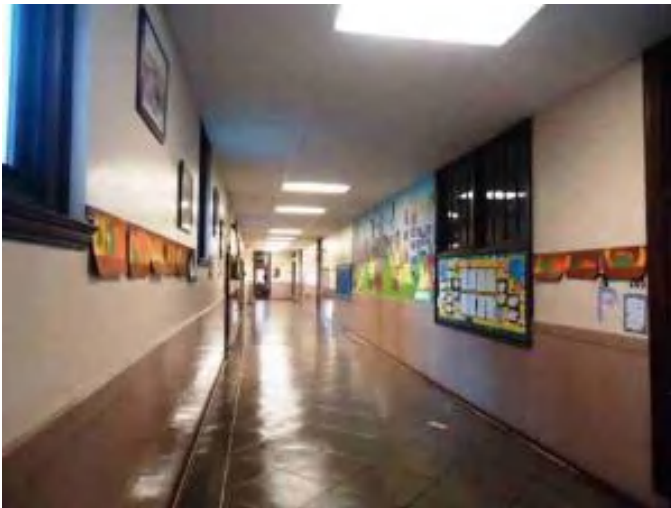
System: C3030 - Ceiling Finishes

Location: Building Wide

Distress: Damaged

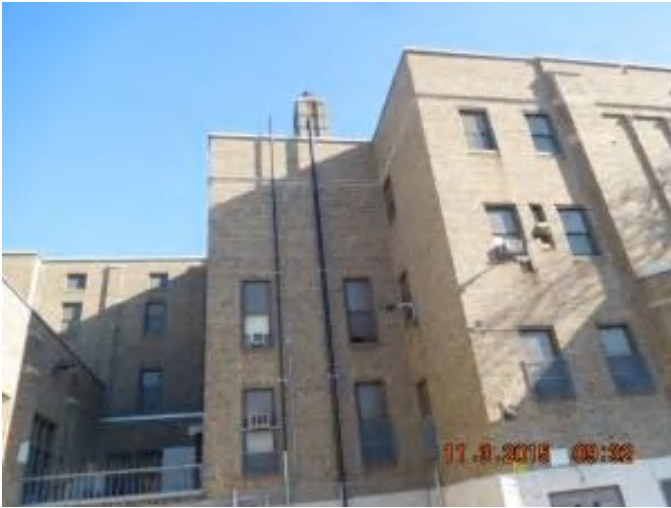
System: D3030 - Cooling Generating Systems

Location: roof, mechanical room

Distress: Inadequate

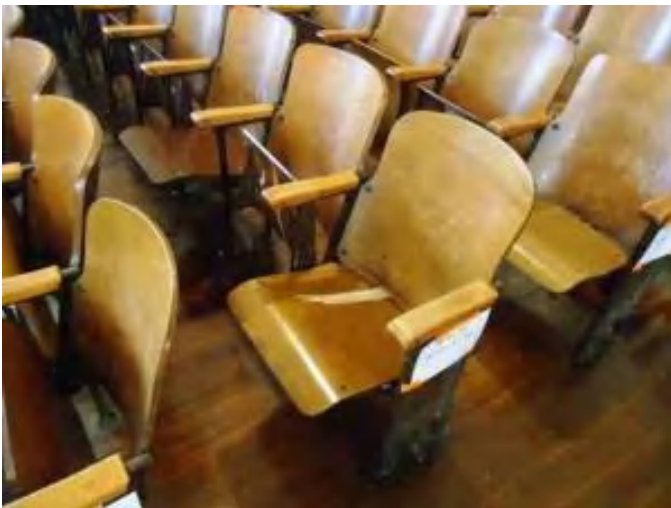
System: E2010 - Fixed Furnishings

Location: Auditorium

Distress: Damaged

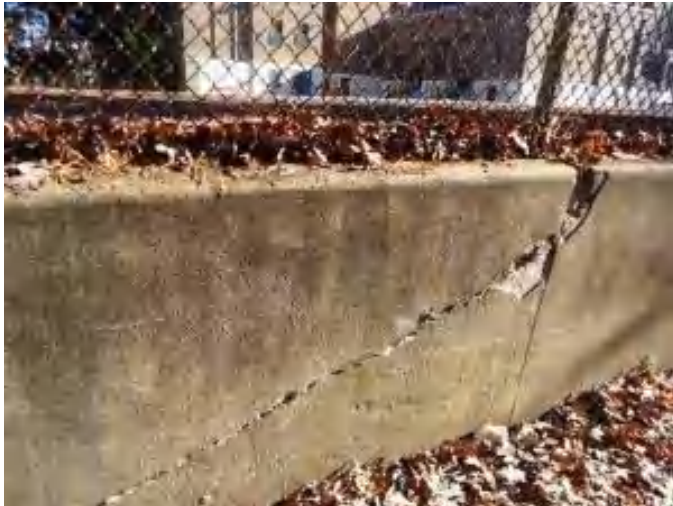
System: G2040 - Site Development

Location: Site

Distress: Failing

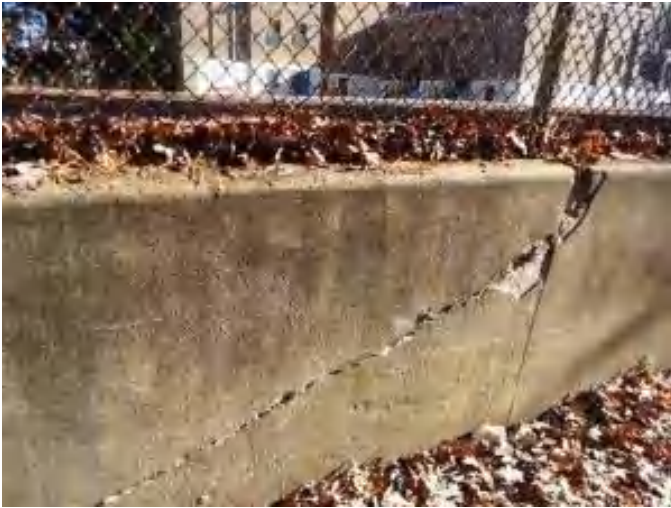
System: G2040 - Site Development

Location: Site

Distress: Failing

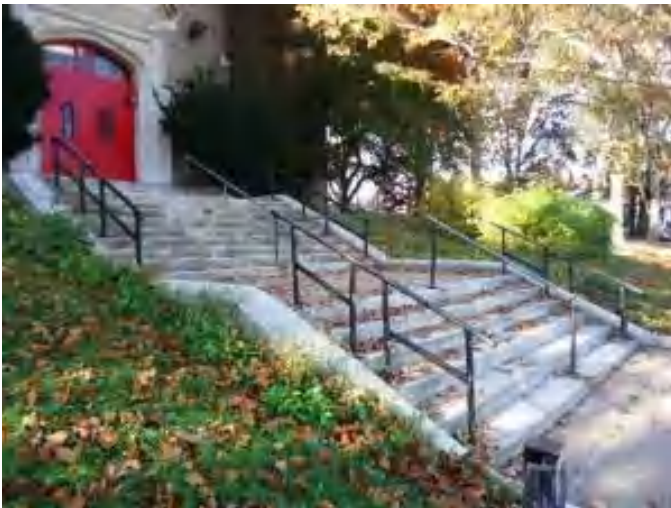
System: G2040 - Site Development

Location: Site

Distress: Damaged

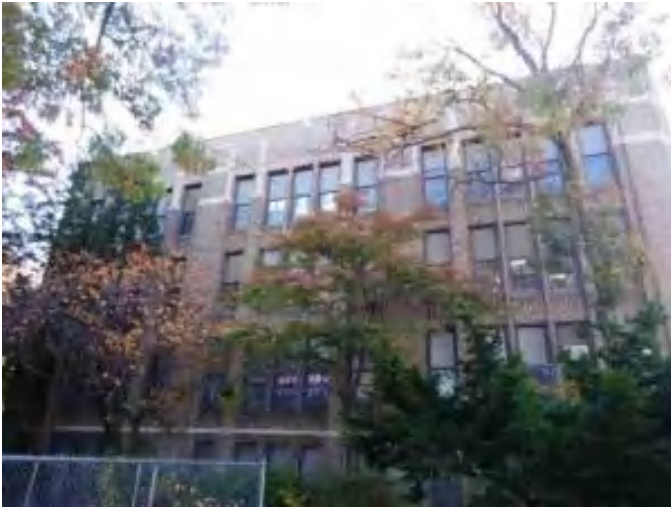
System: G2050 - Landscaping & Irrigation

Location: Site

Distress: Security Issue

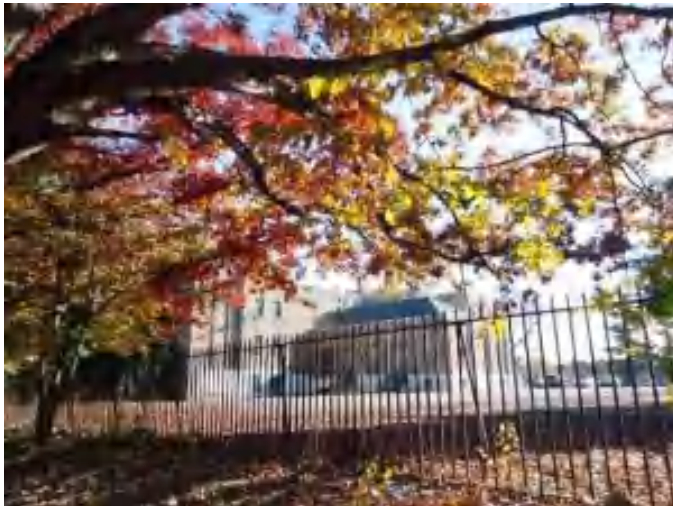
System: G2040 - Site Development

Location: Site

Distress: Damaged

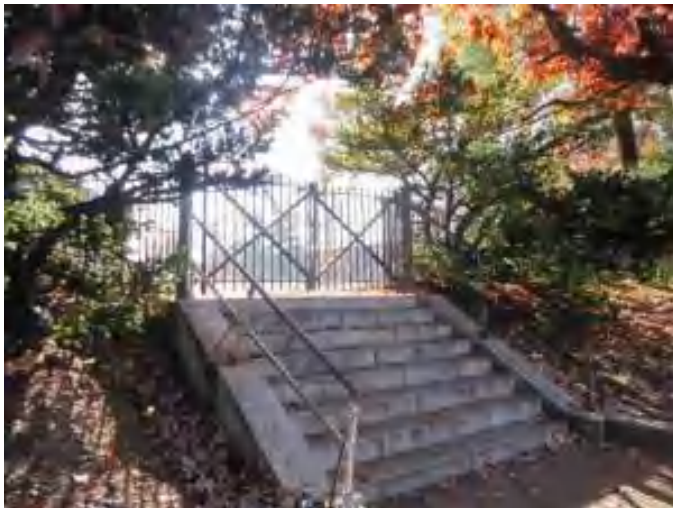
System: G2050 - Landscaping & Irrigation

Location: Site

Distress: Damaged

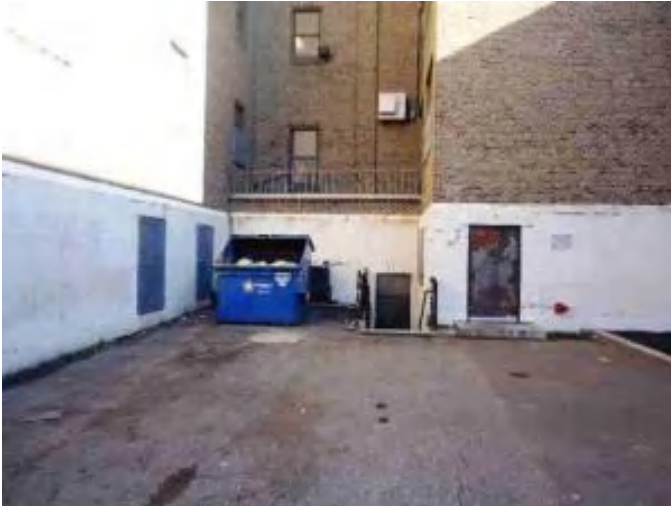
System: G2040 - Site Development

Location: Site

Distress: Health Hazard / Risk

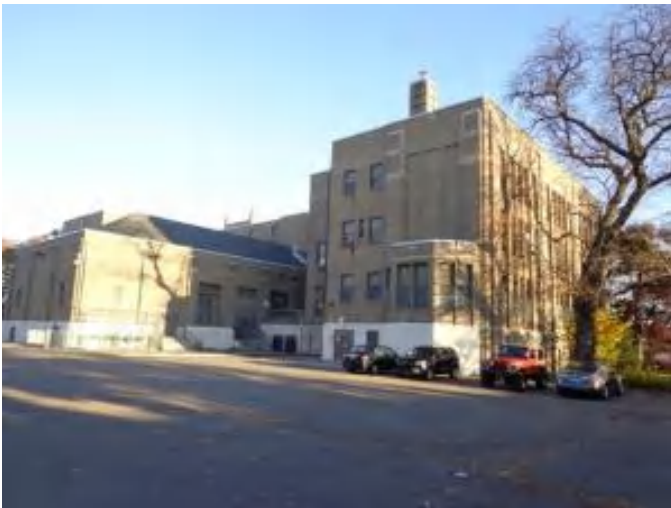
System: G4030 - Site Communications & Security

Location: Site

Distress: Inadequate

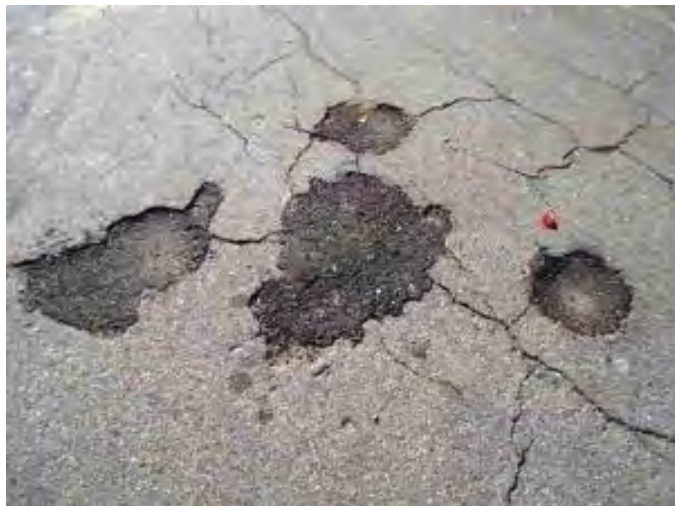
System: G2030 - Pedestrian Paving

Location: Asphalt Play Parking Area

Distress: Damaged
