Facility Condition Assessment Summary Report

Penrose School

January 30, 2017

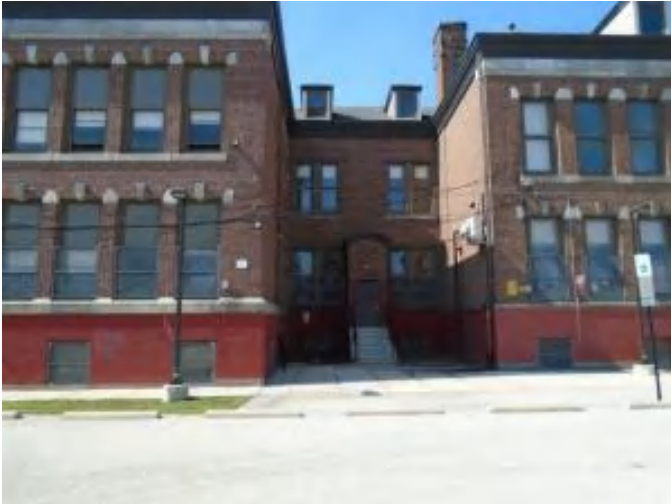
System: B2010 - Exterior Walls

Location: Entire building

Distress: Maintenance Required

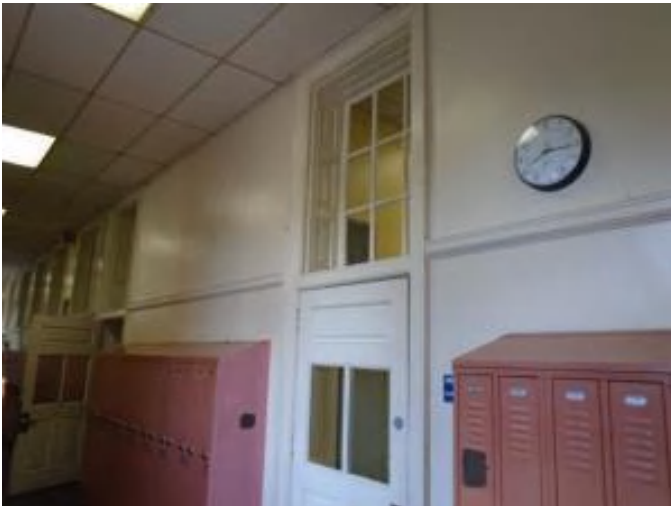
System: C1020 - Interior Doors

Location: 1st 2nd floor

Distress: Beyond Service Life

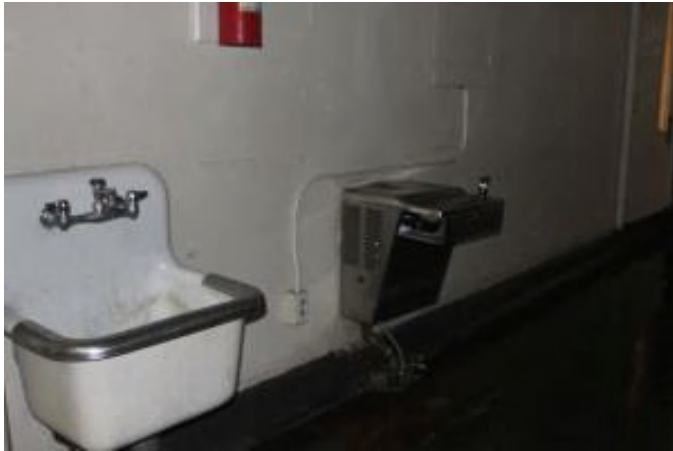
System: D2010 - Plumbing Fixtures

Location: Hallways

Distress: Accessibility

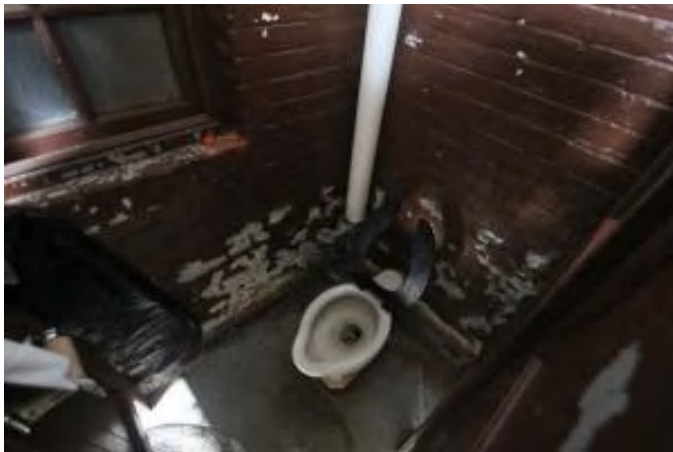
System: D2010 - Plumbing Fixtures

Location: Basement

Distress: Beyond Service Life

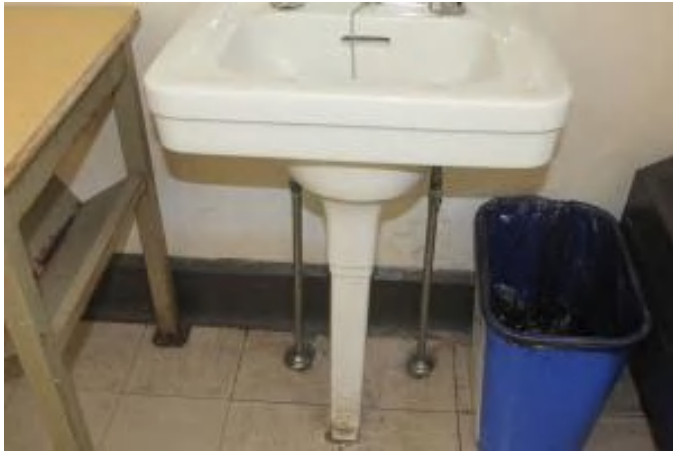
System: D2010 - Plumbing Fixtures

Location: Classrooms

Distress: Beyond Service Life

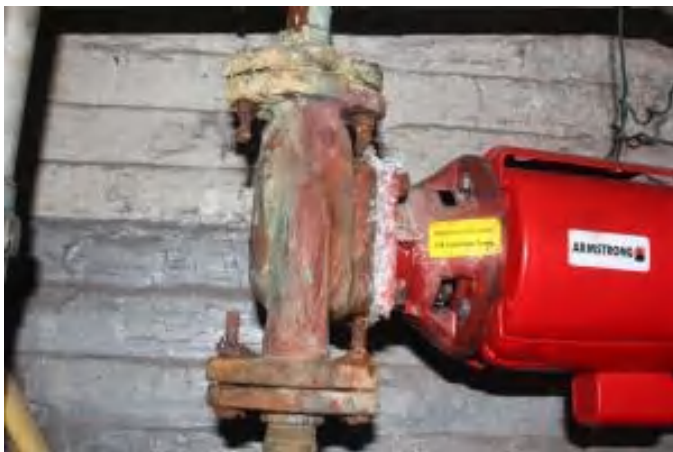
System: D2020 - Domestic Water Distribution

Location: Boiler room

Distress: Failing

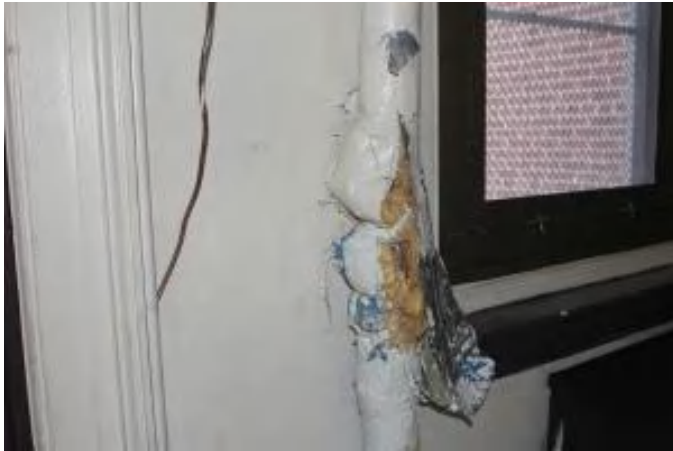
System: D3040 - Distribution Systems

Location: Hallways
Distress: Damaged
Category: 3 - Operations / Maint.
Priority: 2 - Response Time (2-3 yrs)
Correction: Replace hydronic distribution piping insulation - 100 LF of piping
Qty: 50.00
Unit of Measure: L.F.
Estimate: \$1,745.74
Assessor Name: System
Date Created: 11/13/2015

Notes: Repair insulation on steam distribution and condensate pipes, approximately 50 feet.

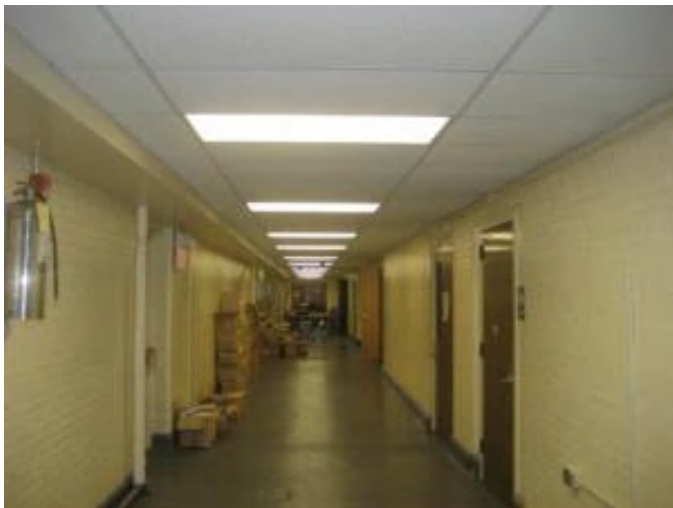
System: D5020 - Lighting and Branch Wiring

Location: Entire Building
Distress: Energy Efficiency
Category: 4 - Capital Improvement
Priority: 2 - Response Time (2-3 yrs)
Correction: Replace lighting fixtures
Qty: 400.00
Unit of Measure: Ea.
Estimate: \$340,885.97
Assessor Name: System
Date Created: 10/22/2015

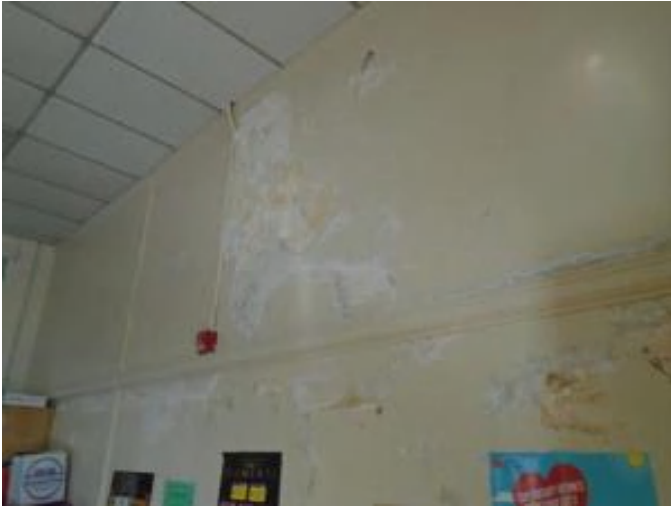
System: C3010230 - Paint & Covering

Location: Various throughout

Distress: Damaged

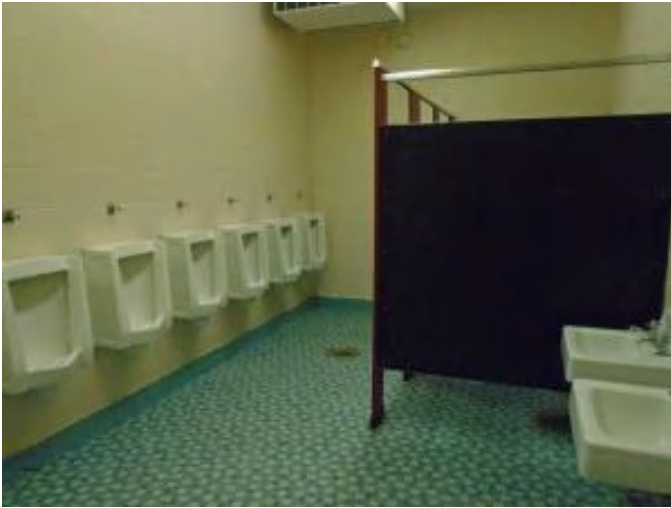
System: C3020412 - Terrazzo & Tile

Location: Toilets
Distress: Damaged
Category: 3 - Operations / Maint.
Priority: 2 - Response Time (2-3 yrs)
Correction: Replace and re-grout floor tile
Qty: 977.00
Unit of Measure: S.F.
Estimate: \$35,048.58
Assessor Name: Craig Anding
Date Created: 11/17/2015

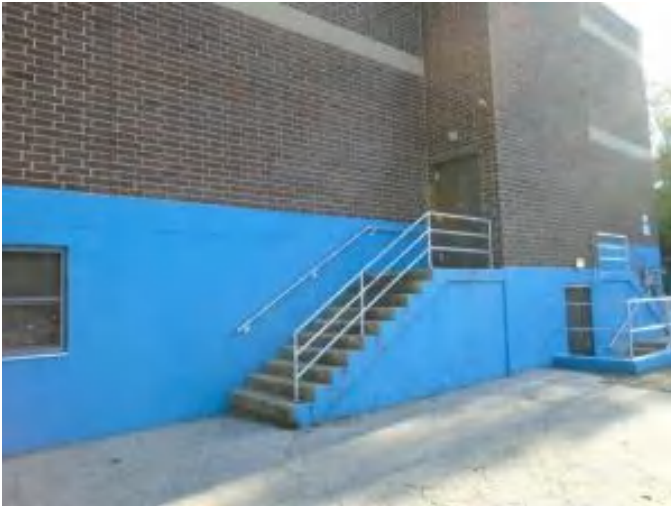
System: D1010 - Elevators and Lifts

Location: TBD
Distress: Accessibility
Category: 2 - Code Compliance
Priority: 2 - Response Time (2-3 yrs)
Correction: Add interior hydraulic elevator - 3 floors - adjust the electrical run lengths to hook up the elevator
Qty: 1.00
Unit of Measure: Ea.
Estimate: \$497,751.74
Assessor Name: Craig Anding
Date Created: 11/17/2015

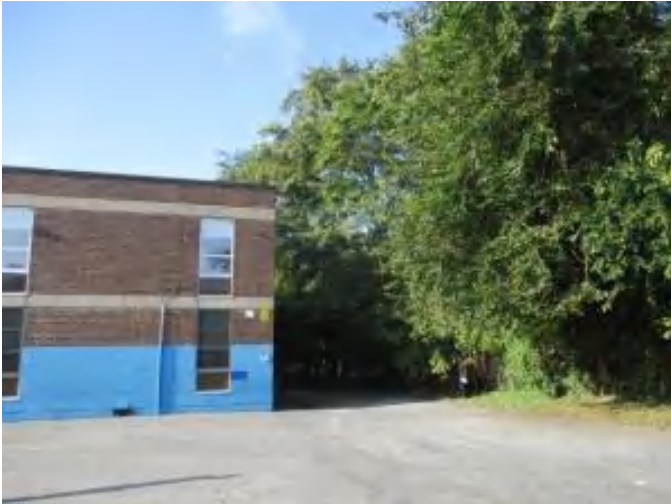
System: G4020 - Site Lighting

Location: Outdoor
Distress: Security Issue
Category: 1 - Health & Safety
Priority: 3 - Response Time (3-4 yrs)
Correction: Add Site Lighting - pole mounted - select the proper light and pole
Qty: 6.00
Unit of Measure: Ea.
Estimate: \$125,635.28
Assessor Name: Eduardo Zambrano
Date Created: 12/30/2015

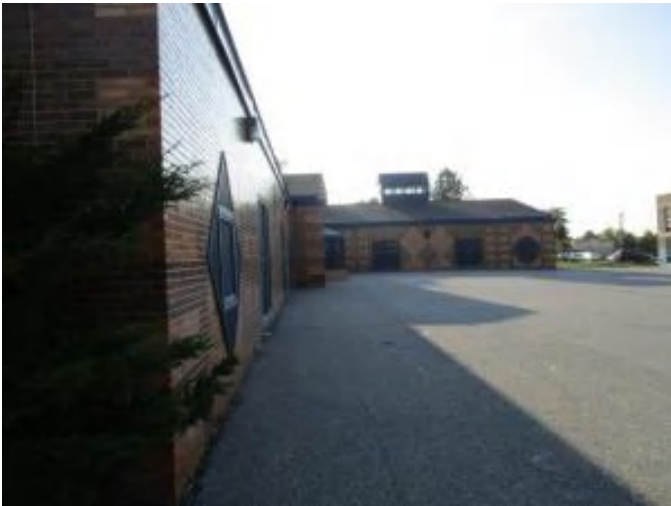
System: G4030 - Site Communications & Security

Location: LSH Building Perimeter
Distress: Security Issue
Category: 1 - Health & Safety
Priority: 3 - Response Time (3-4 yrs)
Correction: Add Video Surveillance System
Qty: 10.00
Unit of Measure: Ea.
Estimate: \$237,784.38
Assessor Name: Eduardo Zambrano
Date Created: 12/30/2015
