Facility Condition Assessment Summary Report

Pickett School

School District of Philadelphia
S615001;Pickett
Final
Site Assessment Report
February 1, 2017

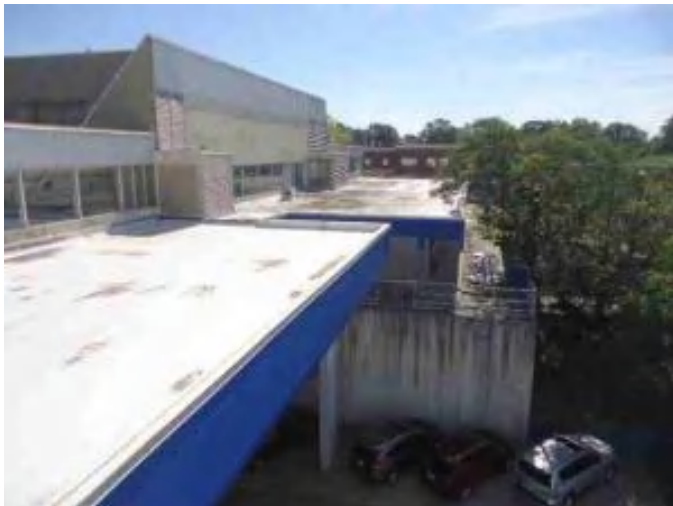
System: B3010120 - Single Ply Membrane

Location: Auditorium

Distress: Damaged

Notes: The single ply roofing system over the classrooms in the auditorium is currently leaking into the classroom. This section of the roof is considered to be failing and immediate attention is required to repair the roofing system before additional damage is done to the interior finishes. This deficiency provides a budgetary consideration to repair the roofing system for this area.

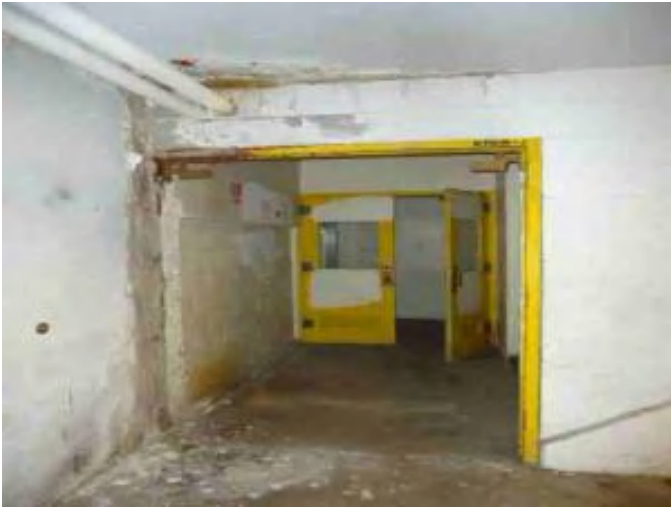
System: C1010 - Partitions

Location: Auditorium

Distress: Life Safety / NFPA / PFD

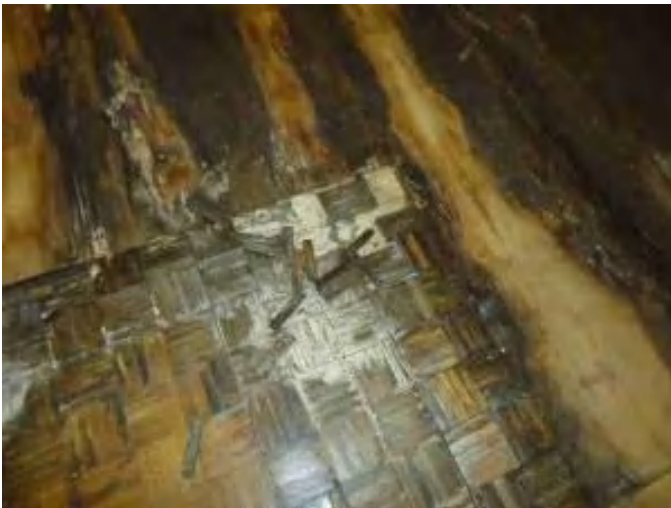
System: C3020414 - Wood Flooring

Location: Stage

Distress: Failing

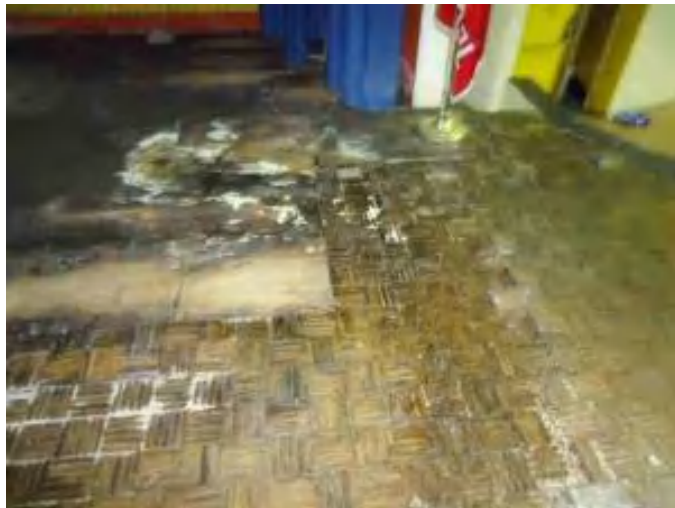
System: E2010 - Fixed Furnishings

Location: Stage

Distress: Damaged

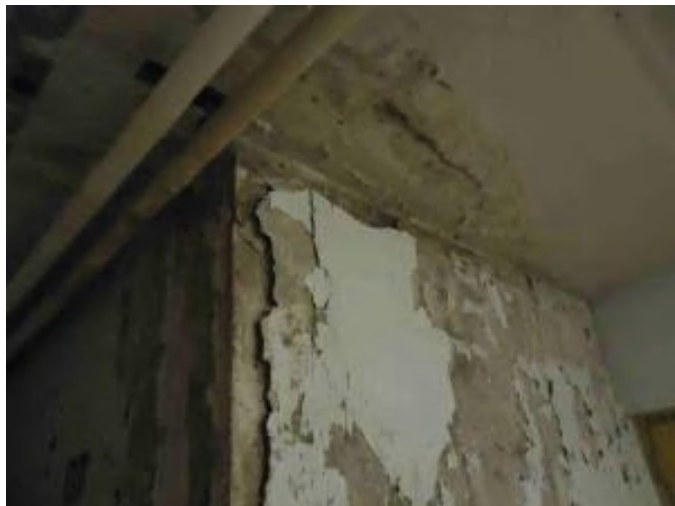
System: B2010 - Exterior Walls

Location: Auditorium Basement

Distress: Damaged

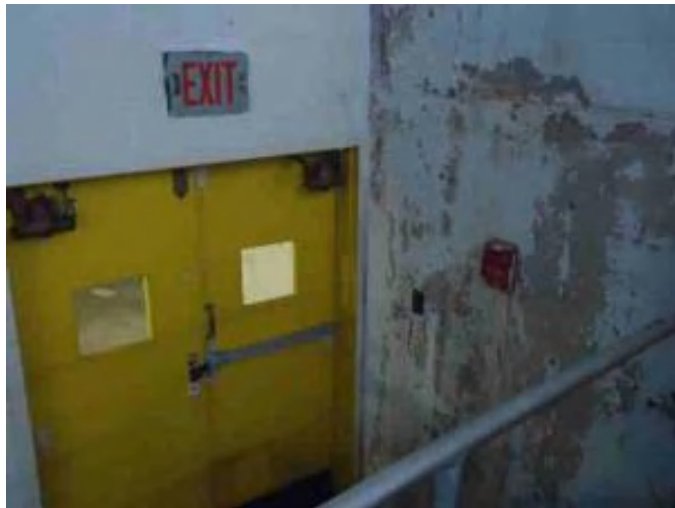
System: C3010230 - Paint & Covering

Location: Auditorium

Distress: Damaged

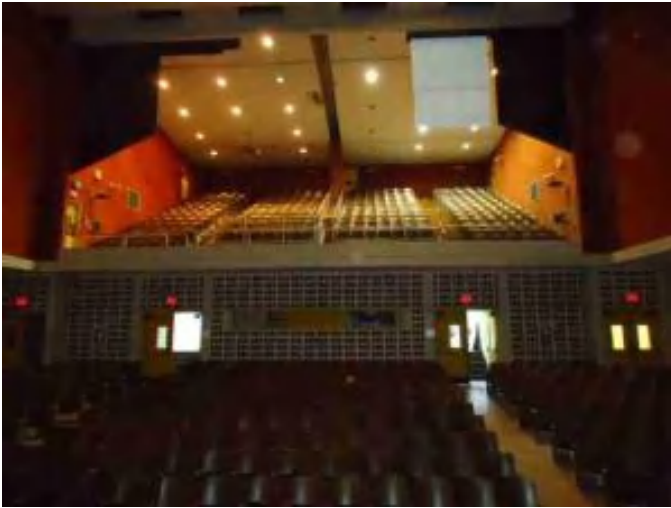
System: C3030 - Ceiling Finishes

Location: Auditorium

Distress: Damaged

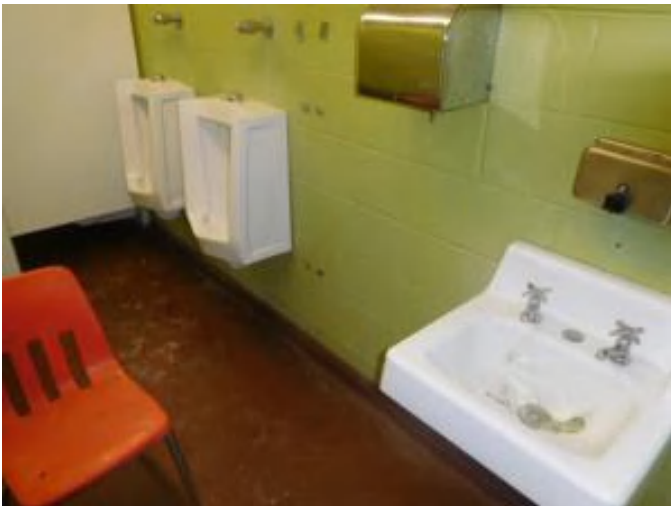
System: D3040 - Distribution Systems

Location: older toilet rooms

Distress: Building / MEP Codes

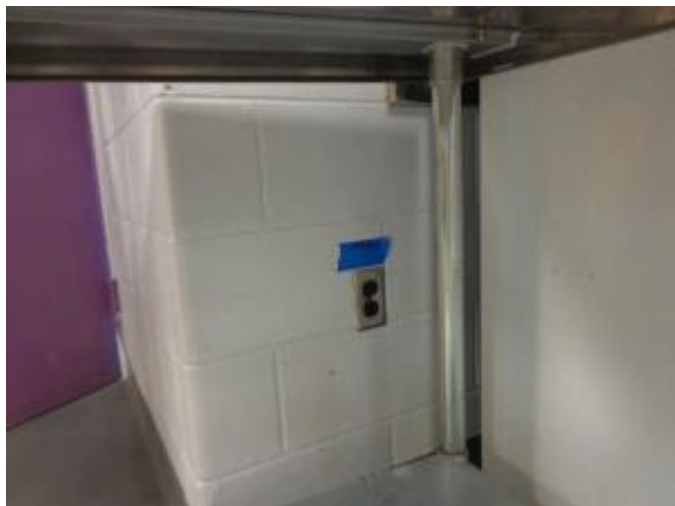
System: D5020 - Lighting and Branch Wiring

Location: Kitchen

Distress: Life Safety / NFPA / PFD

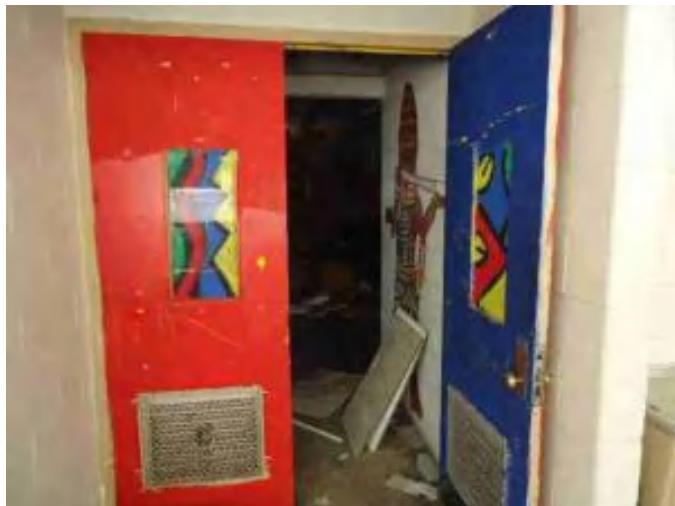
System: C1020 - Interior Doors

Location: Auditorium Extension

Distress: Damaged

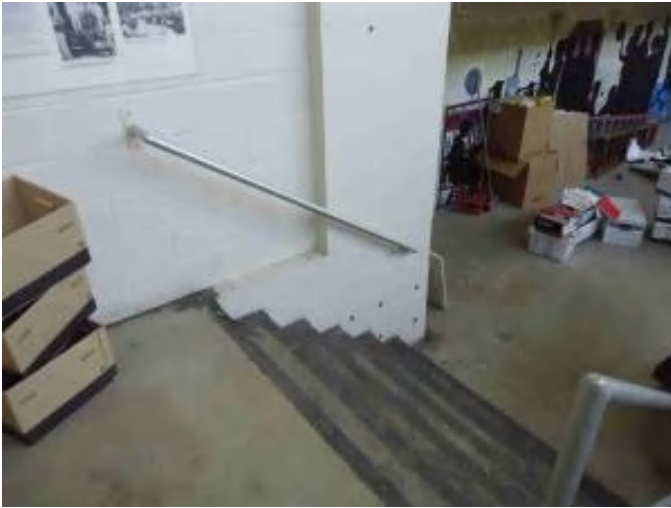
System: C2010 - Stair Construction

Location: Stairs

Distress: Life Safety / NFPA / PFD

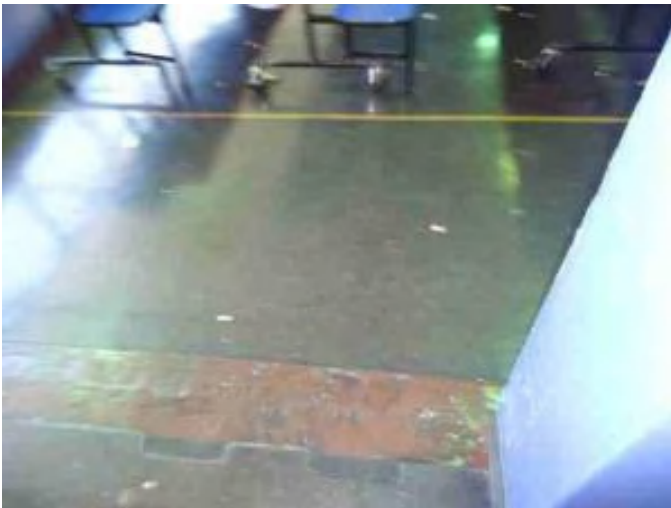
System: C3020413 - Vinyl Flooring

Location: Building Wide

Distress: Health Hazard / Risk

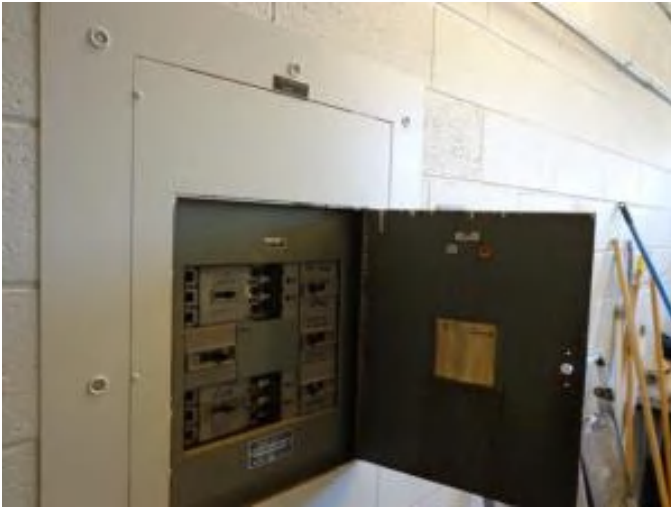
System: D5010 - Electrical Service/Distribution

Location: East side of building

Distress: Beyond Service Life

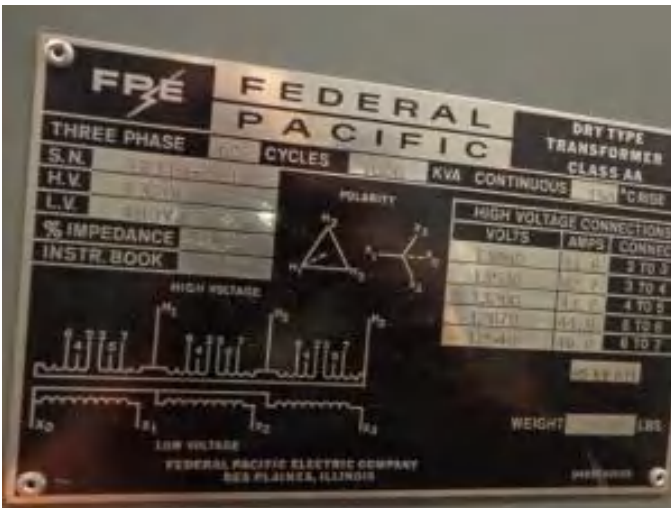
System: D5010 - Electrical Service/Distribution

Location: Main Electrical Room 023

Distress: Obsolete

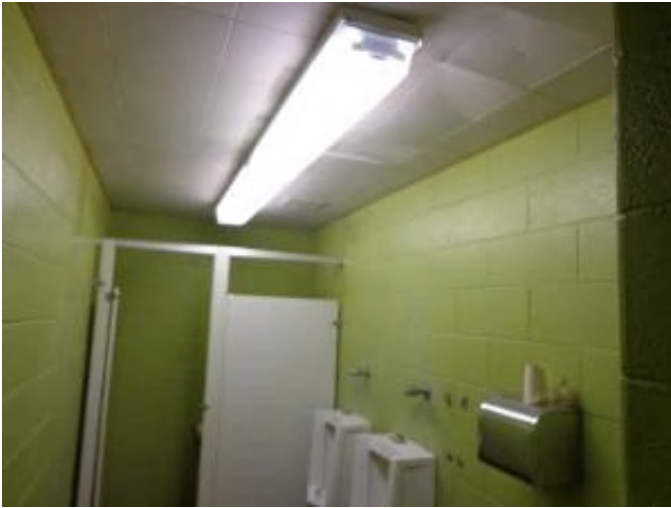
System: D5020 - Lighting and Branch Wiring

Location: Auditorium Building

Distress: Beyond Service Life

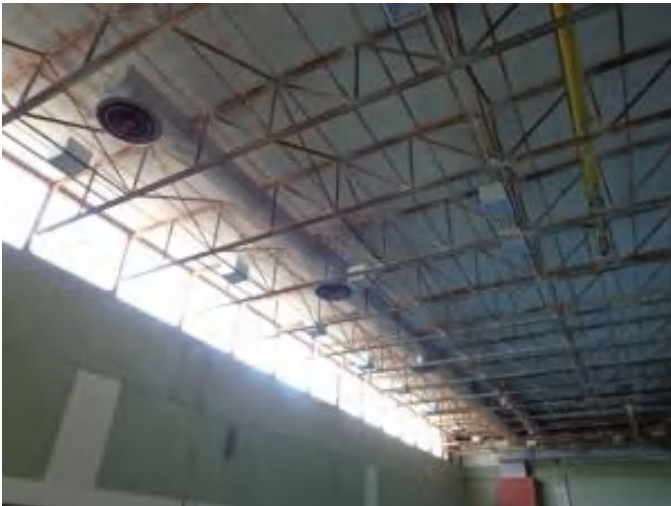
System: D5020 - Lighting and Branch Wiring

Location: Swimming Pool

Distress: Beyond Service Life

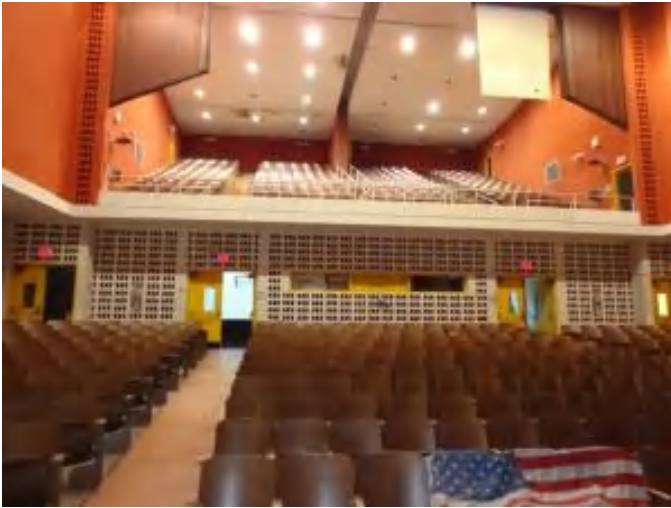
System: D5020 - Lighting and Branch Wiring

Location: Auditorium

Distress: Beyond Service Life

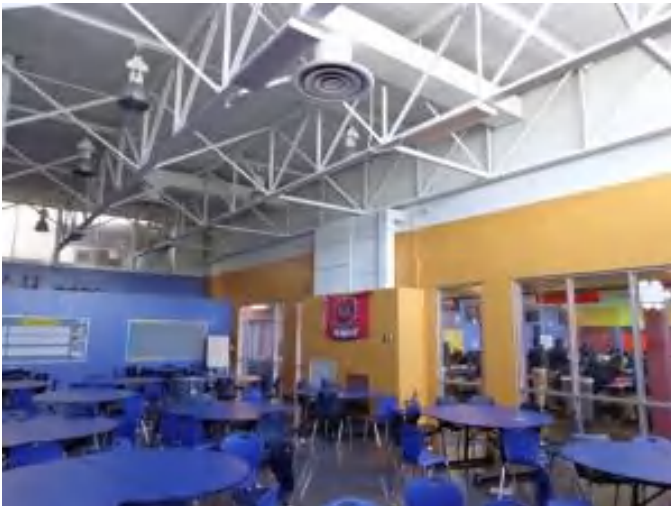
System: D5020 - Lighting and Branch Wiring

Location: Cafeteria

Distress: Beyond Service Life

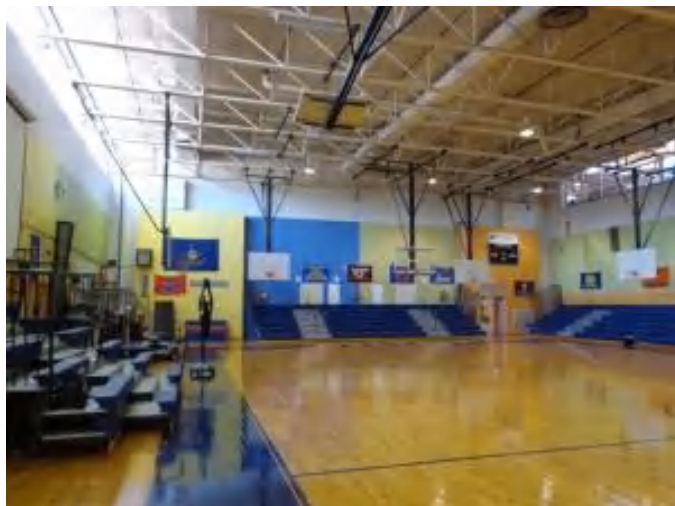
System: D5020 - Lighting and Branch Wiring

Location: Gymnasium

Distress: Beyond Service Life

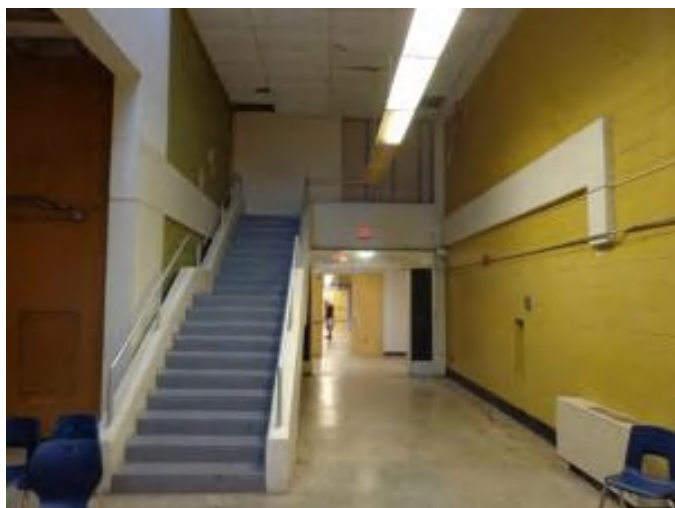
System: D5020 - Lighting and Branch Wiring

Location: Floor 1 Corridor on west side of pool

Distress: Beyond Service Life

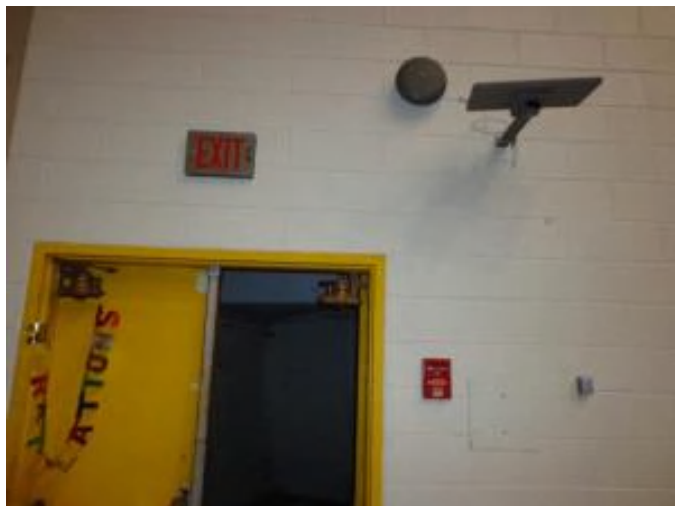
System: D5030 - Communications and Security

Location: Auditorium Building

Distress: Life Safety / NFPA / PFD

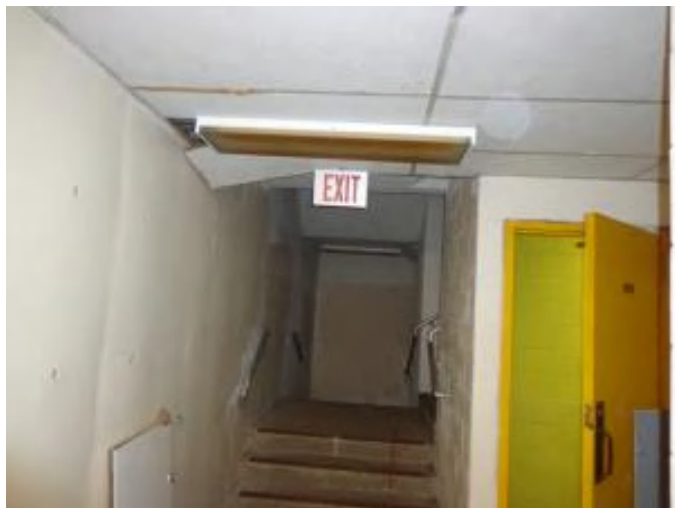
System: D5090 - Other Electrical Systems

Location: East side of building and auditorium

Distress: Life Safety / NFPA / PFD

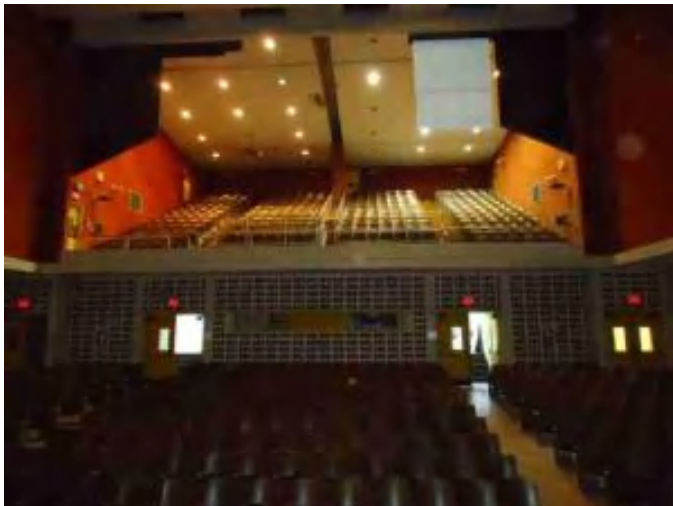
System: E2010 - Fixed Furnishings

Location: Auditorium

Distress: Damaged

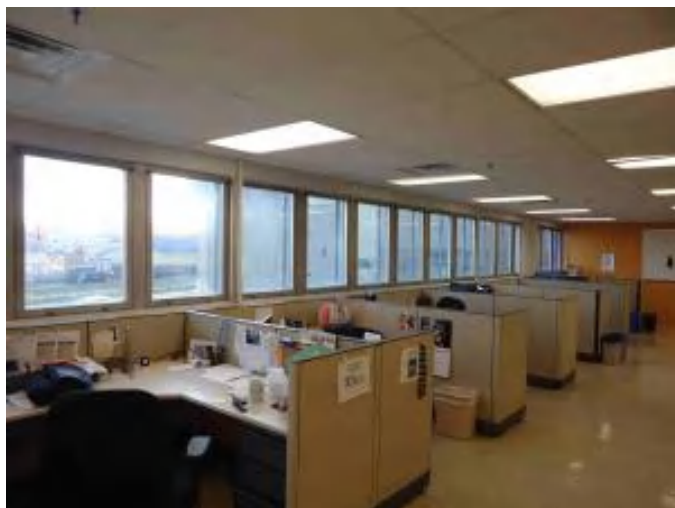
System: B2020 - Exterior Windows

Location: Exterior Elevation

Distress: Damaged

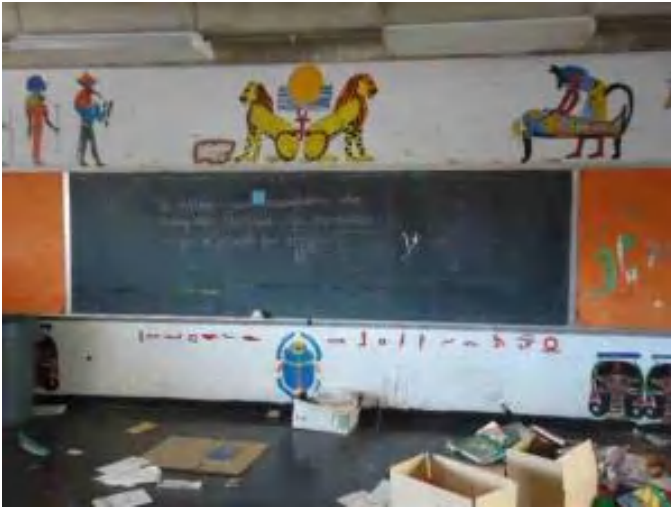
System: C1030 - Fittings

Location: Auditorium Classrooms

Distress: Damaged

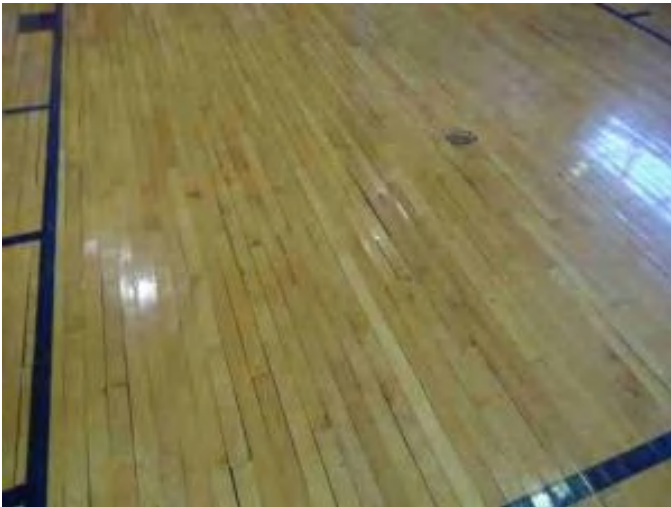
System: C3020414 - Wood Flooring

Location: Gym

Distress: Damaged

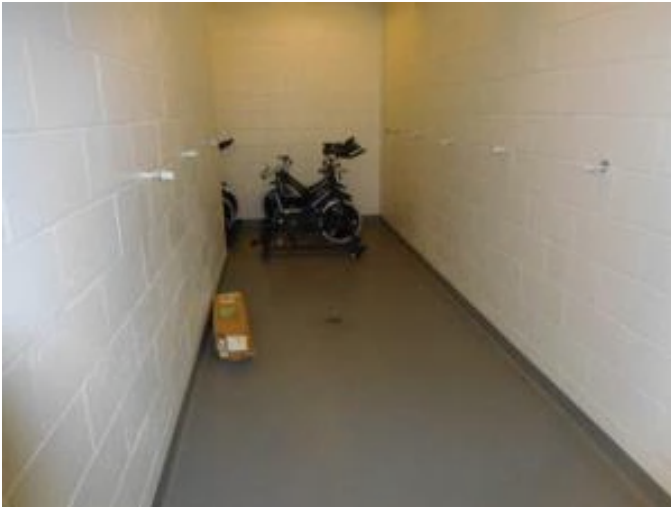
System: D2010 - Plumbing Fixtures

Location: older toilet and locker rooms

Distress: Beyond Service Life

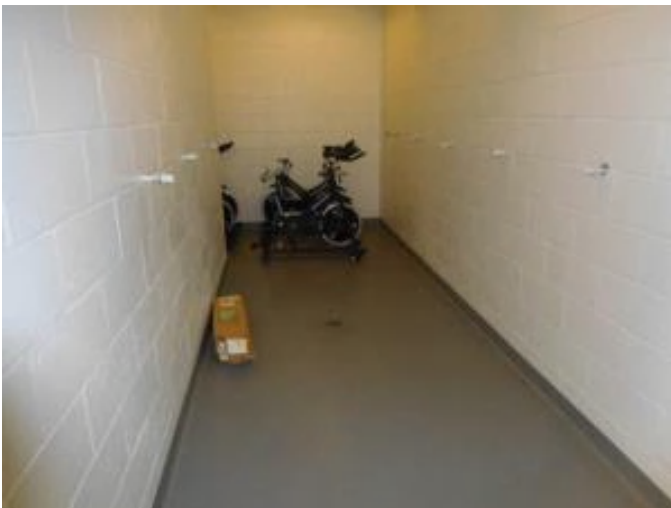
System: D2010 - Plumbing Fixtures

Location: older toilet and locker rooms

Distress: Beyond Service Life

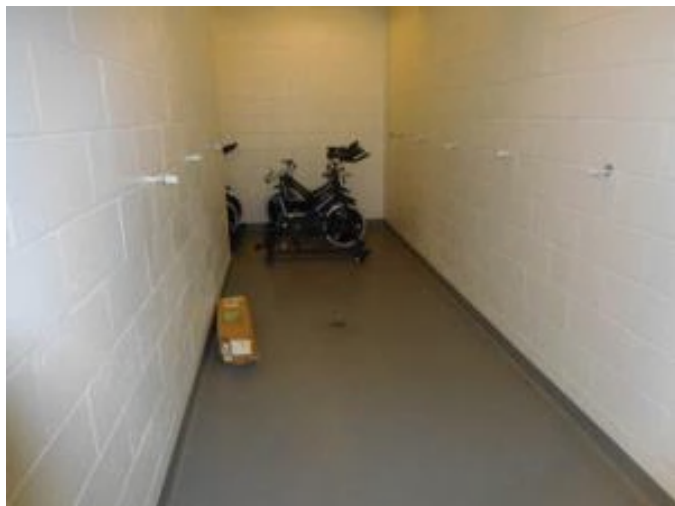
System: D2010 - Plumbing Fixtures

Location: older toilet and locker rooms

Distress: Beyond Service Life

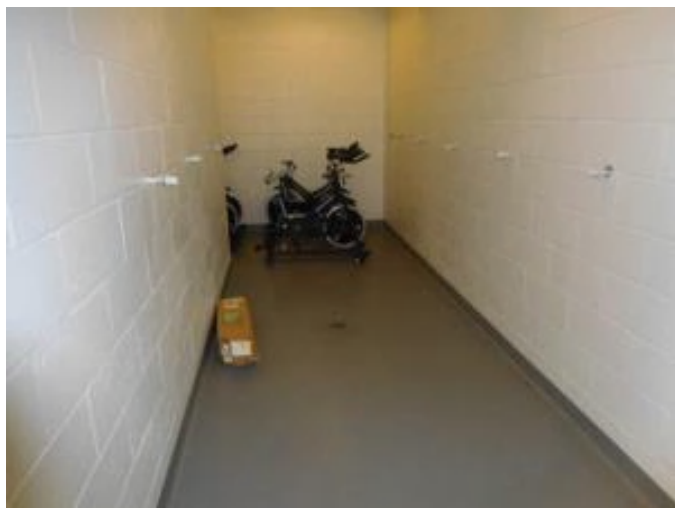
System: D2010 - Plumbing Fixtures

Location: older toilet and locker rooms

Distress: Beyond Service Life

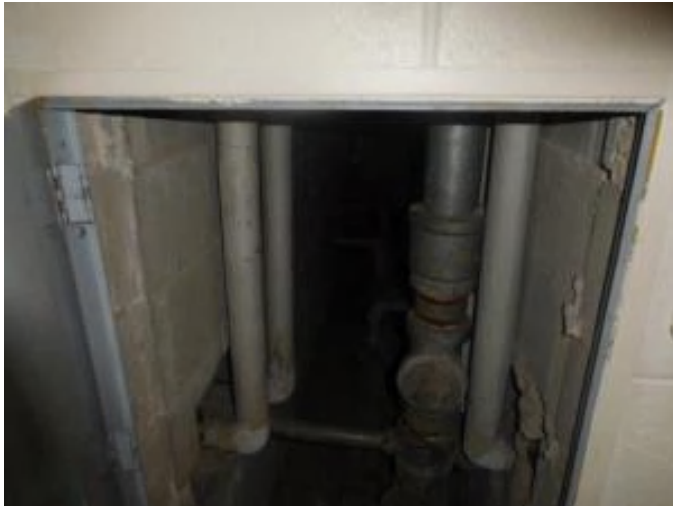
System: D2020 - Domestic Water Distribution

Location: older building area

Distress: Beyond Service Life

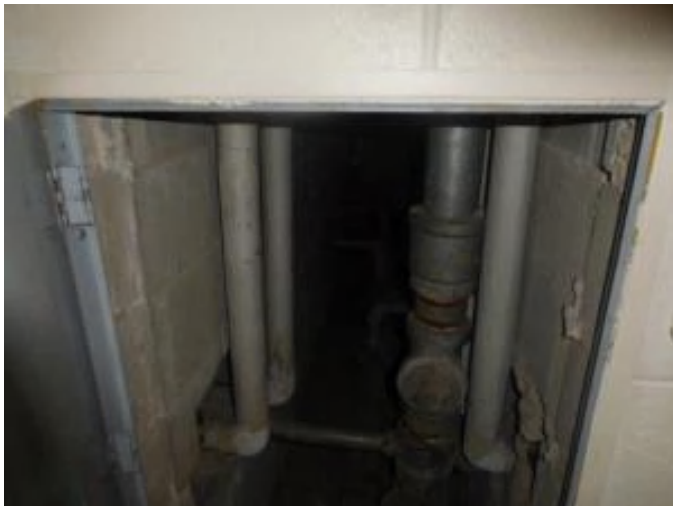
System: D2030 - Sanitary Waste

Location: entire building

Distress: Beyond Service Life

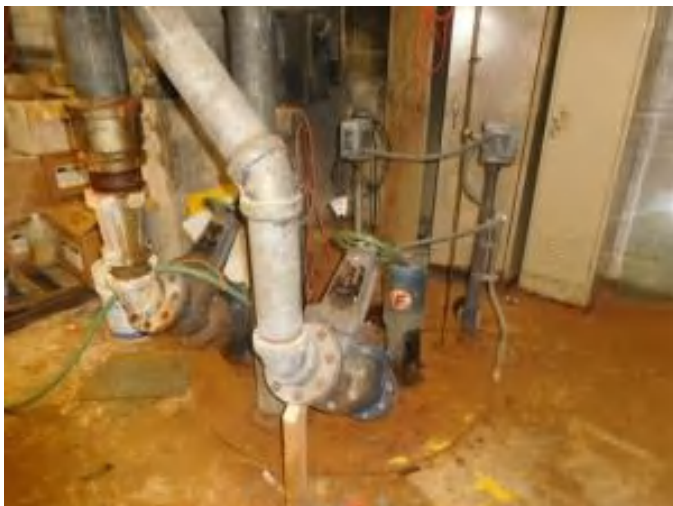
System: D2030 - Sanitary Waste

Location: lower level

Distress: Beyond Service Life

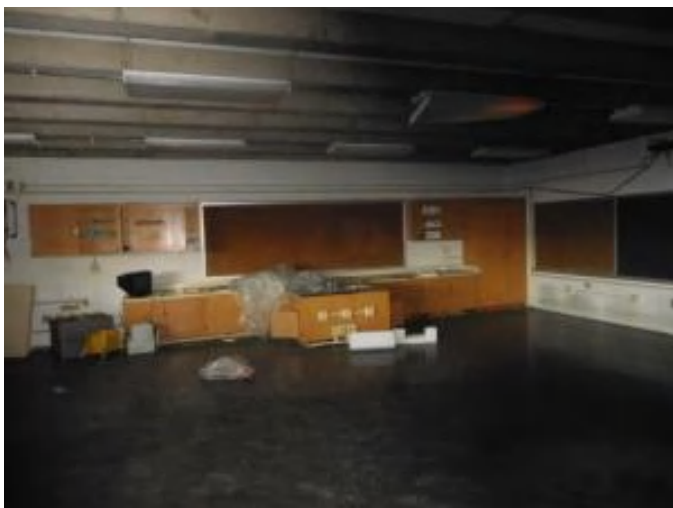
System: D3030 - Cooling Generating Systems

Location: older building area

Distress: Inadequate

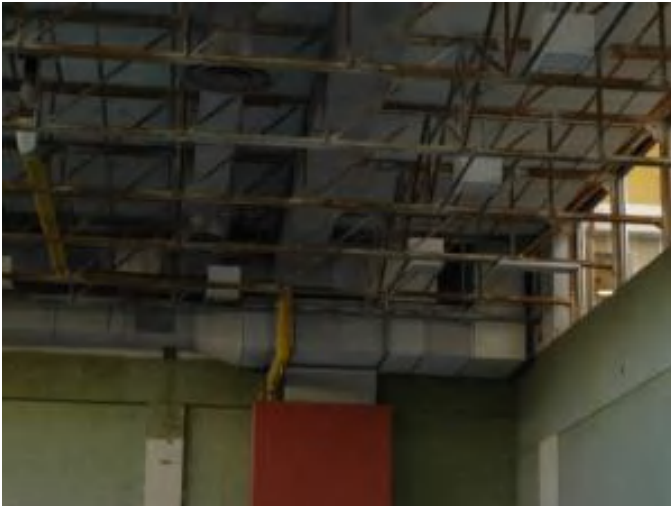
System: D3040 - Distribution Systems

Location: pool

Distress: Inadequate

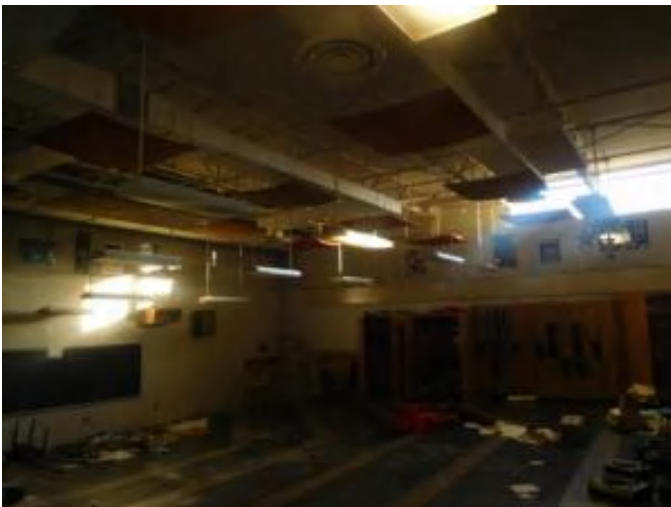
System: D3040 - Distribution Systems

Location: older building area

Distress: Building / MEP Codes

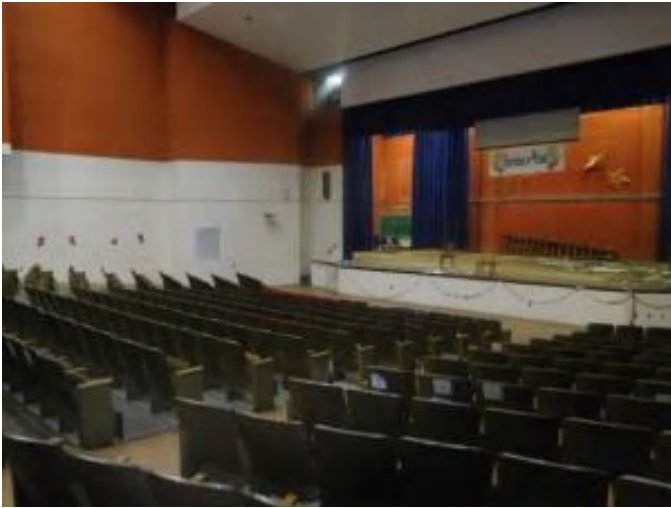
System: D3040 - Distribution Systems

Location: auditorium

Distress: Building / MEP Codes

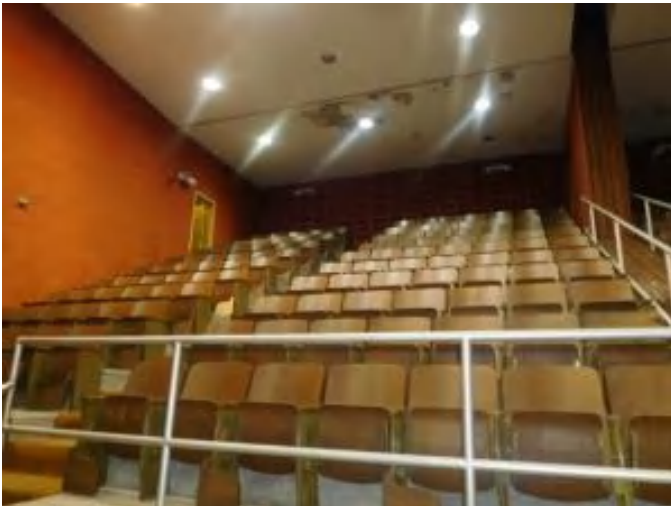
System: D3040 - Distribution Systems

Location: auditorium

Distress: Building / MEP Codes

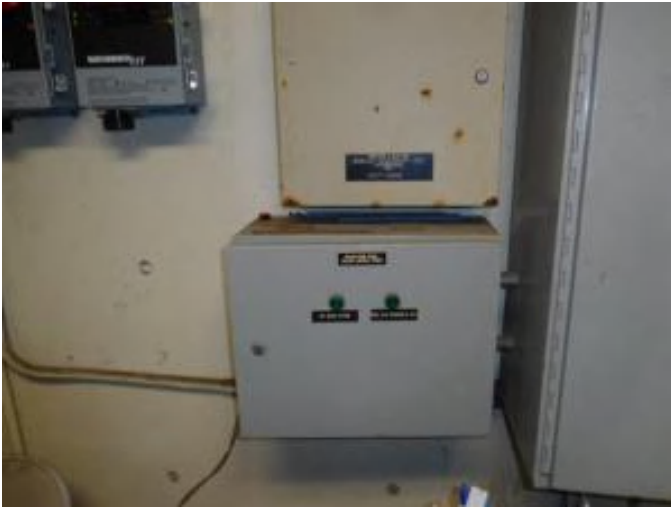
System: D3060 - Controls & Instrumentation

Location: older building area

Distress: Inadequate

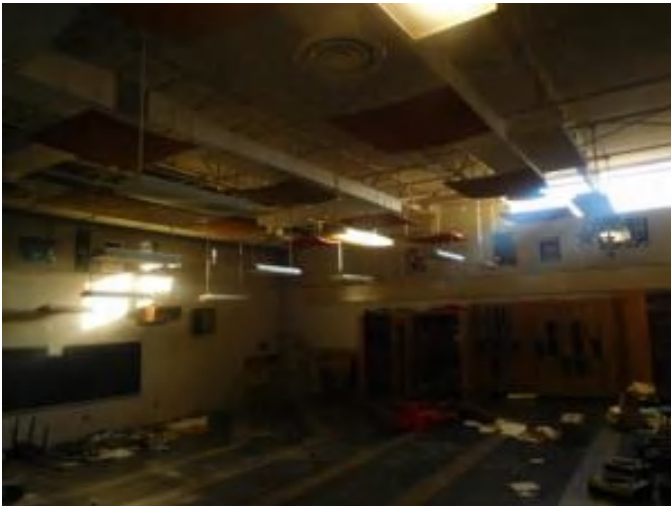
System: D4010 - Sprinklers

Location: older building area

Distress: Life Safety / NFPA / PFD

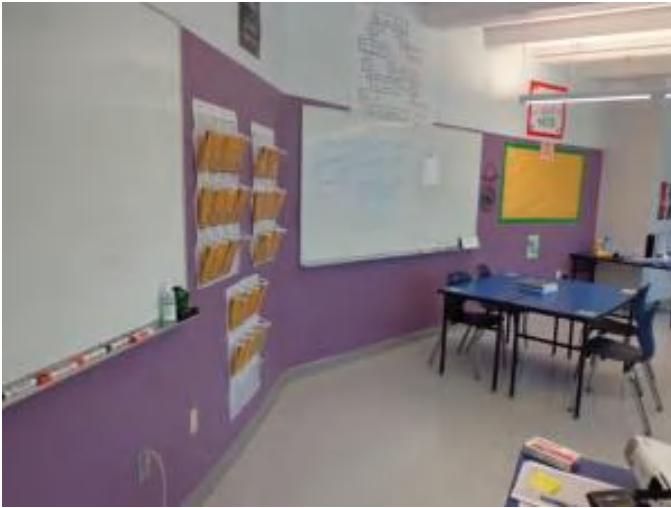
System: D5020 - Lighting and Branch Wiring

Location: Classrooms

Distress: Inadequate

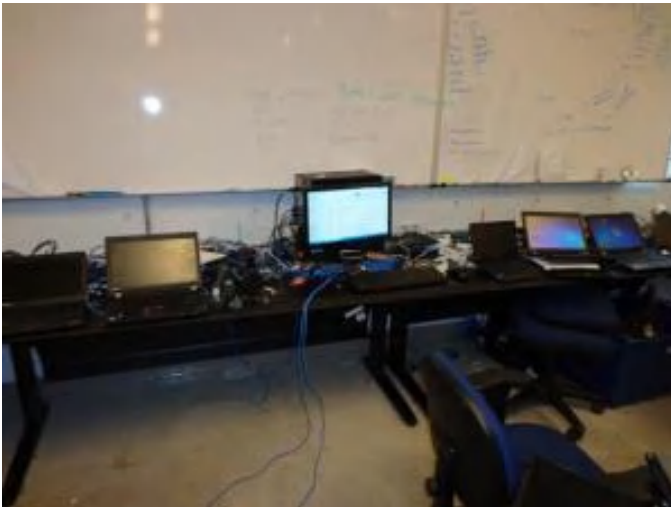
System: D5020 - Lighting and Branch Wiring

Location: Floor 2 IT Workroom

Distress: Inadequate

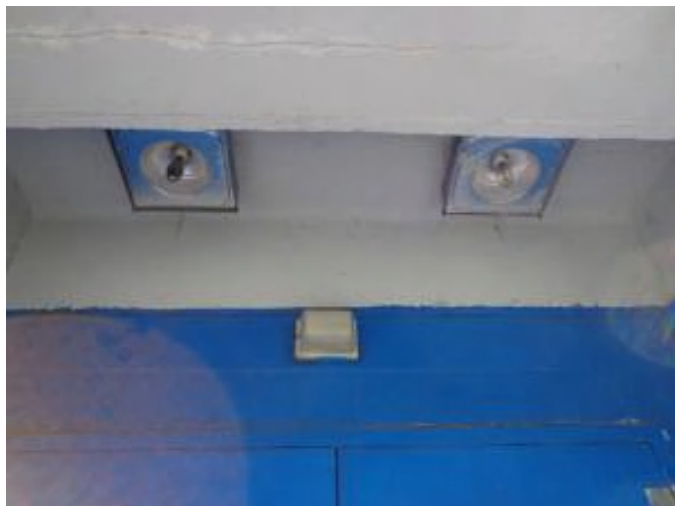
System: D5020 - Lighting and Branch Wiring

Location: Canopies at exit discharges

Distress: Beyond Service Life

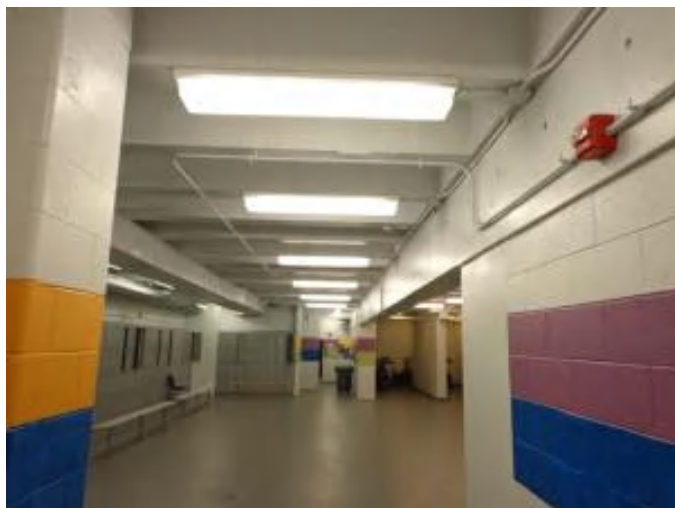
System: D5020 - Lighting and Branch Wiring

Location: Gym and Pool Locker Rooms

Distress: Beyond Service Life

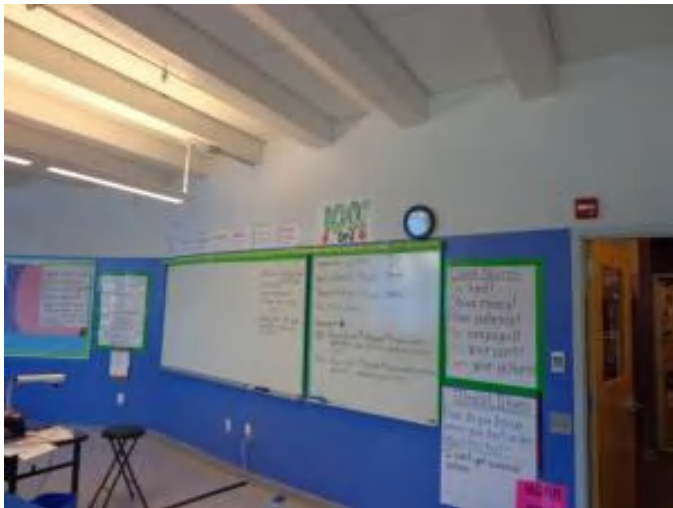
System: D5030 - Communications and Security

Location: Building wide

Notes: Provide wireless GPS clock system.

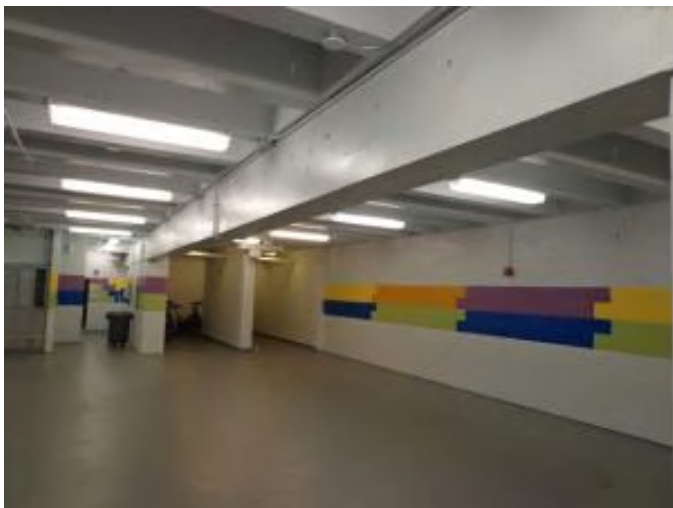
System: D5030 - Communications and Security

Location: Gym, cafeteria/kitchen and pool.

Distress: Beyond Service Life

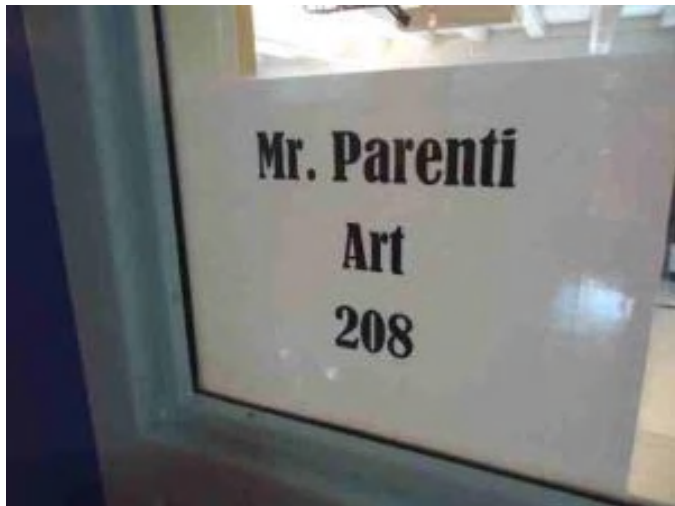
System: C1030 - Fittings

Location: Building Wide

Distress: Damaged

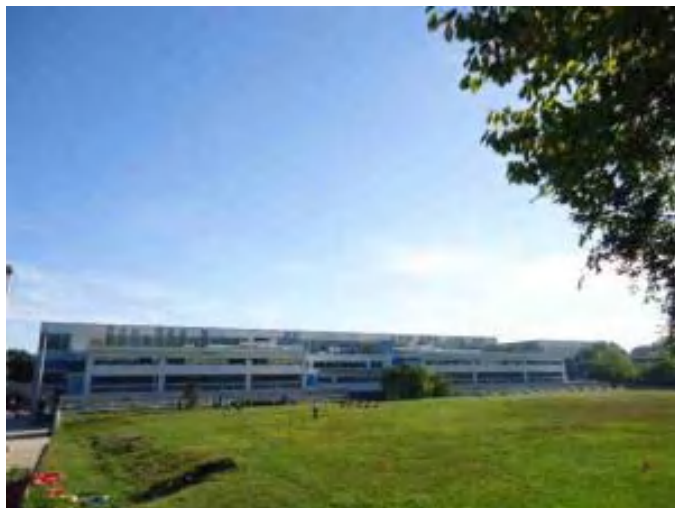
System: G2040 - Site Development

Location: Football Field

Distress: Damaged

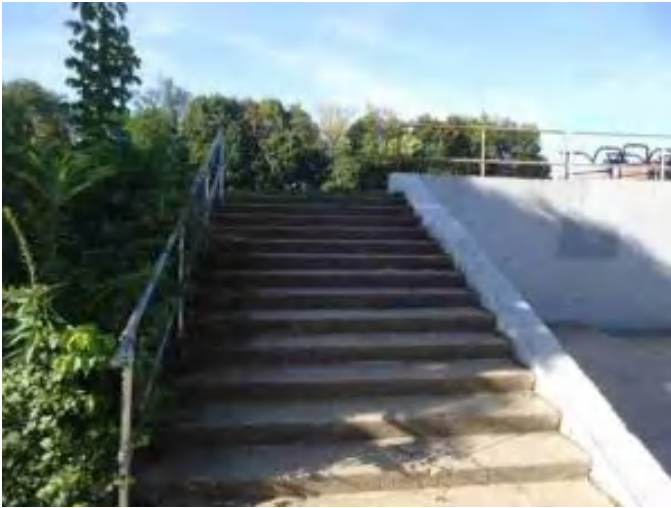
System: G2040 - Site Development

Location: Site

Distress: Life Safety / NFPA / PFD

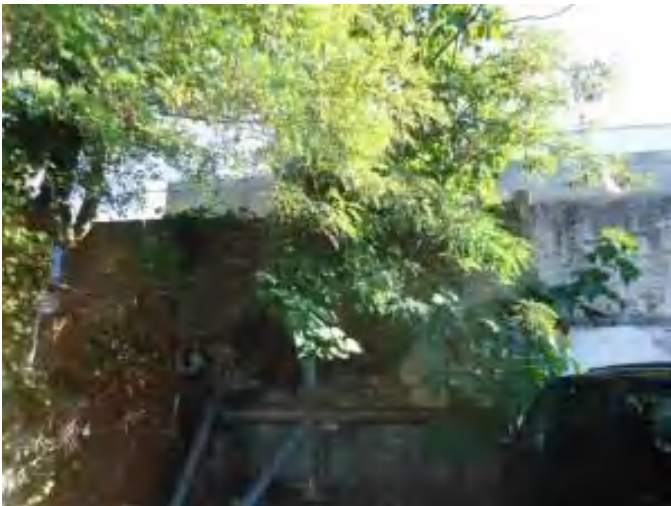
System: G2040 - Site Development

Location: Property Line Auditorium

Distress: Health Hazard / Risk

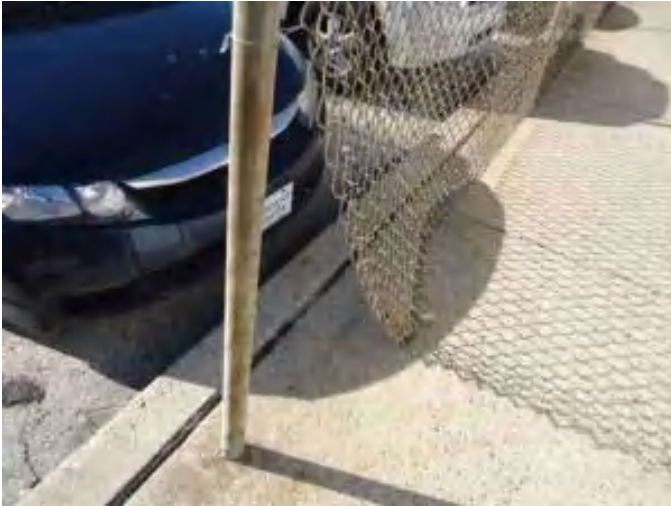
System: G2040 - Site Development

Location: Site

Distress: Damaged

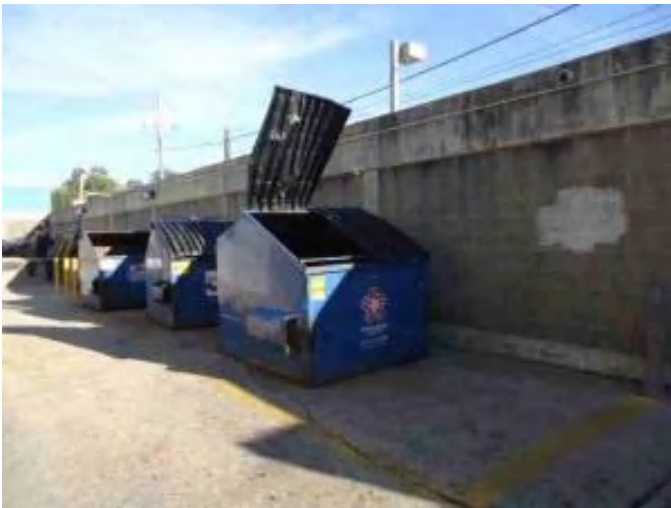
System: G2040 - Site Development

Location: Site

Distress: Health Hazard / Risk

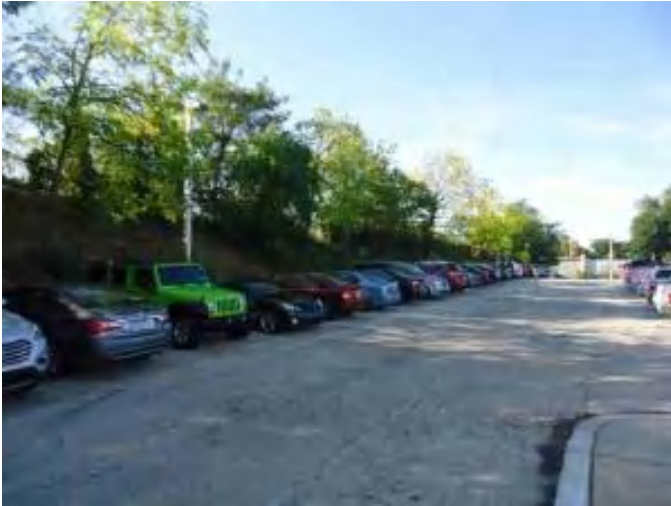
System: G2020 - Parking Lots

Location: Parking Lot

Distress: Damaged

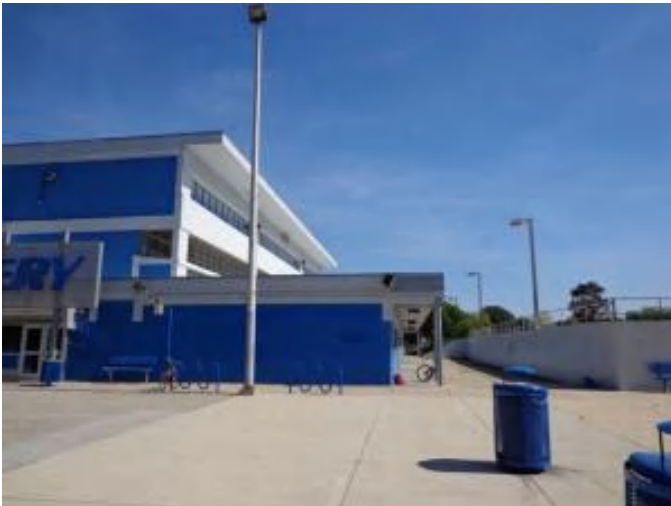
System: G4020 - Site Lighting

Location: Northwest student plaza

Distress: Damaged

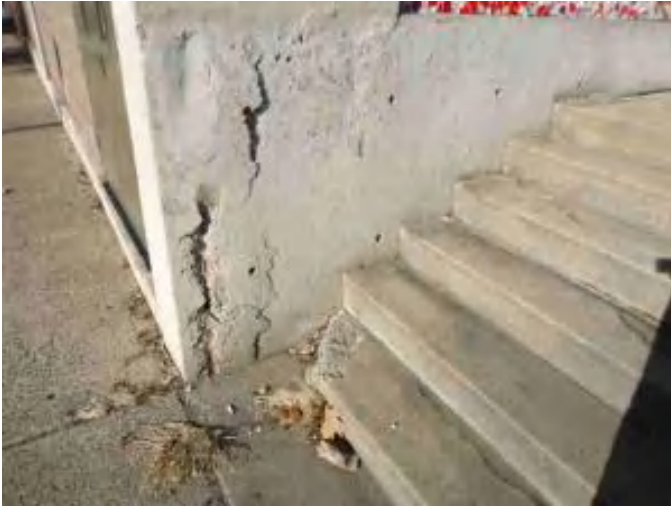
System: G2030 - Pedestrian Paving

Location: Site

Distress: Damaged

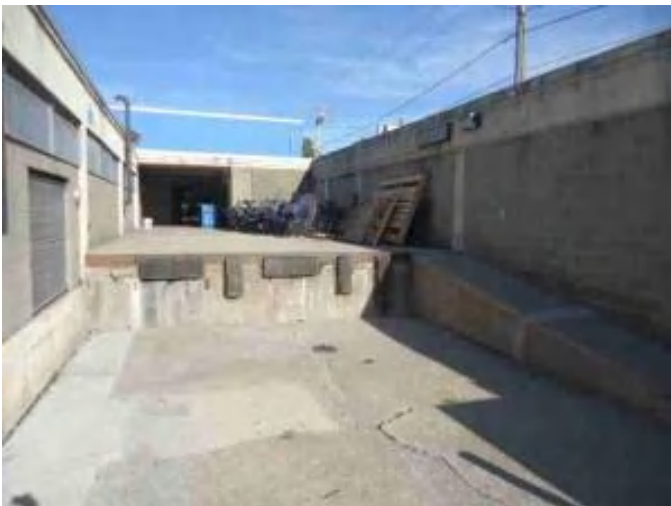
System: G2040 - Site Development

Location: Loading Dock

Distress: Damaged
