## Facility Condition Assessment Summary Report

### Pollock School

School District of Philadelphia  
**S841001; Pollock**  
Final  
**Site Assessment Report**  
January 31, 2017

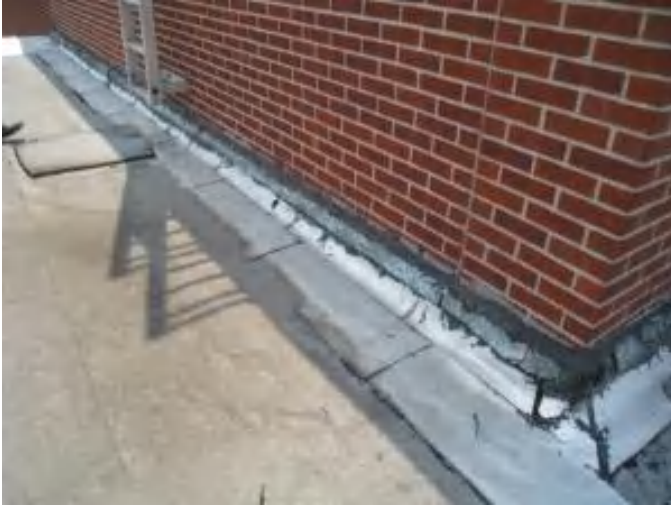
#### System: B3010105 - Built-Up

**Location:** roof flashing at brick

**Distress:** Failing

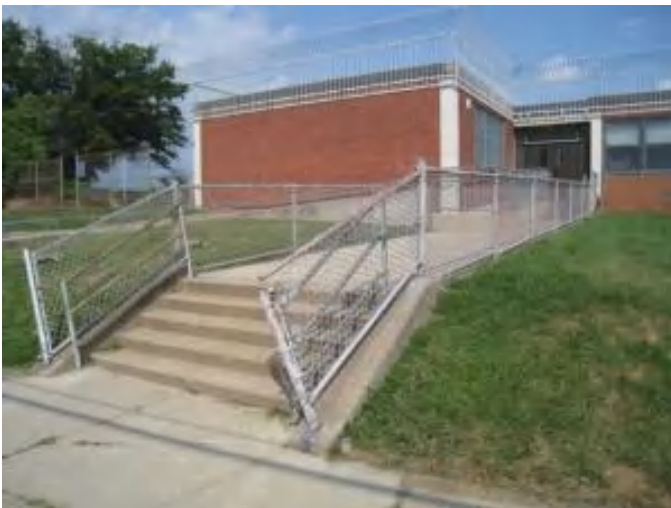
#### System: C2010 - Stair Construction

**Location:** exterior stair near ramp

**Distress:** Building / MEP Codes

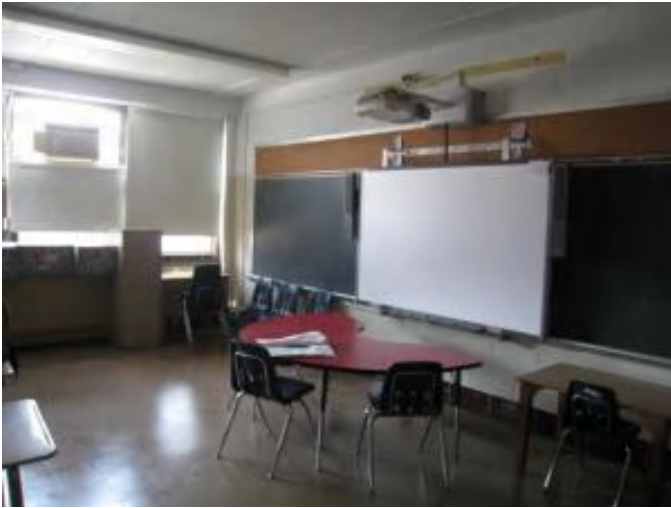
**System: D3040 - Distribution Systems**

**Location:** Throughout the school

**Distress:** Beyond Service Life

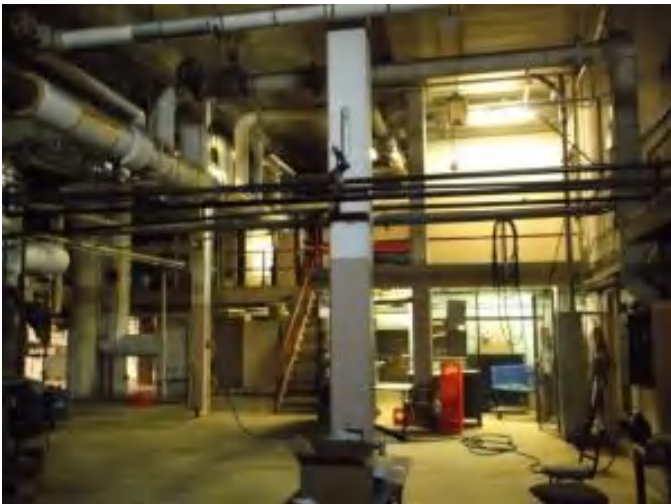
**System: D3040 - Distribution Systems**

**Location:** Throughout the building

**Distress:** Beyond Service Life

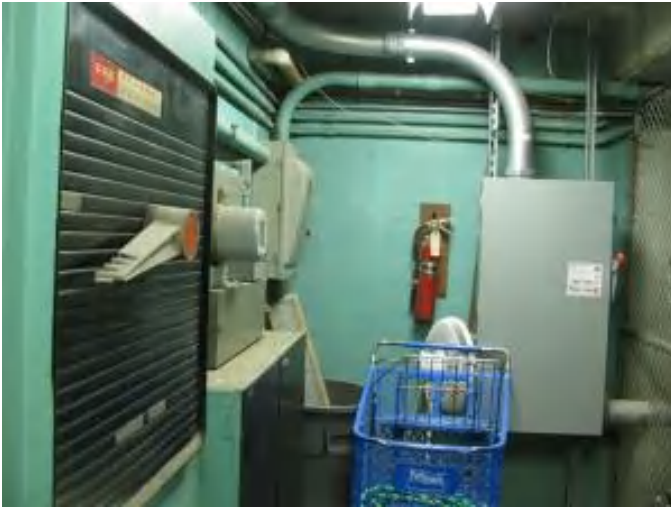
**System: D5010 - Electrical Service/Distribution**

**Location:** Boiler Room

**Distress:** Beyond Service Life

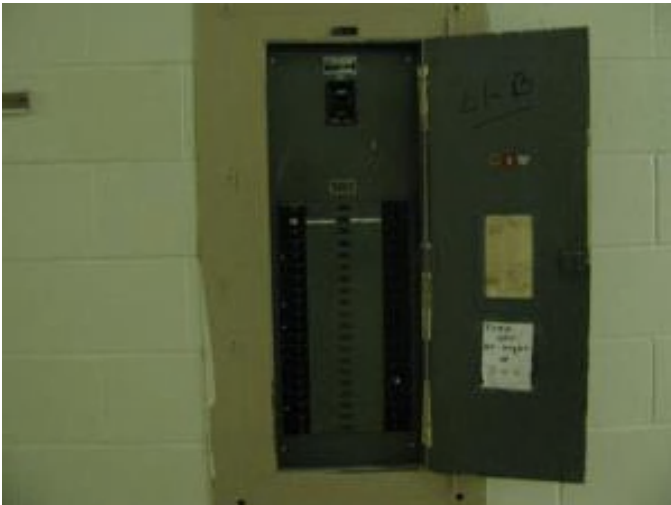
**System: D5010 - Electrical Service/Distribution**

**Location:** Entire Building

**Distress:** Beyond Service Life

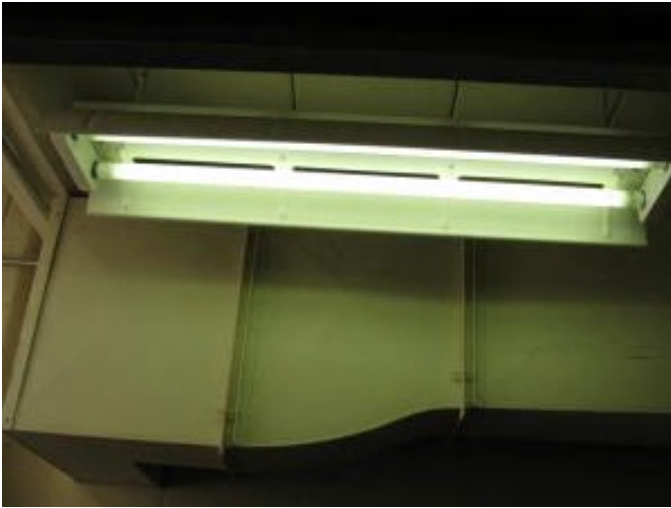
**System: D5020 - Lighting and Branch Wiring**

**Location:** entier building

**Distress:** Beyond Service Life

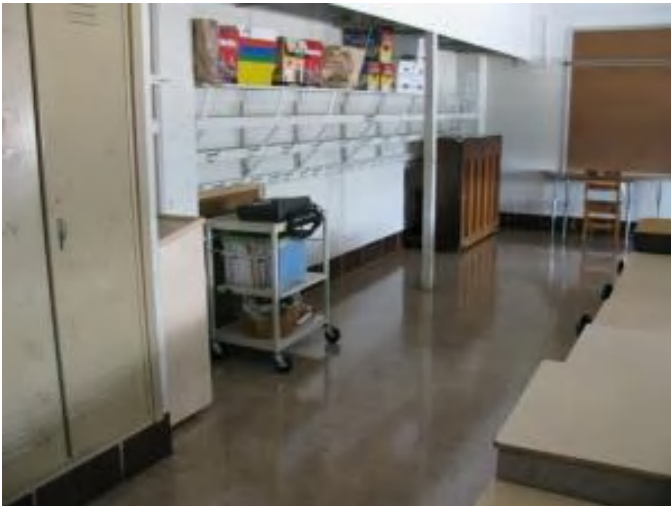
**System: D5020 - Lighting and Branch Wiring**

**Location:** Entier Building

**Distress:** Inadequate

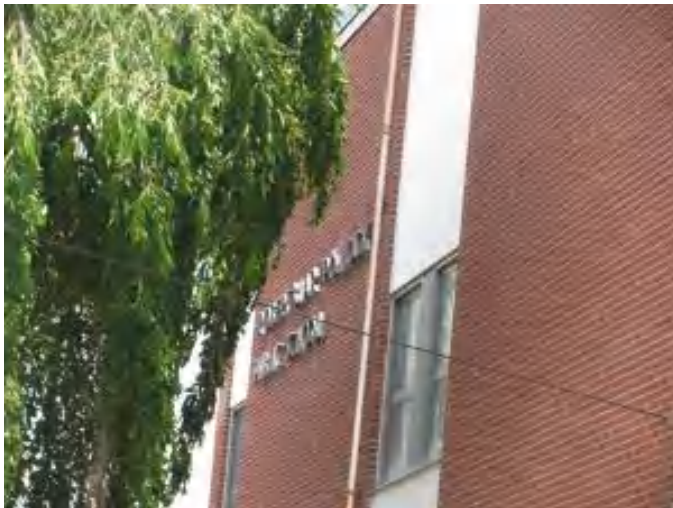
**System: D5020 - Lighting and Branch Wiring**

**Location:** Exterior wall

**Distress:** Inadequate

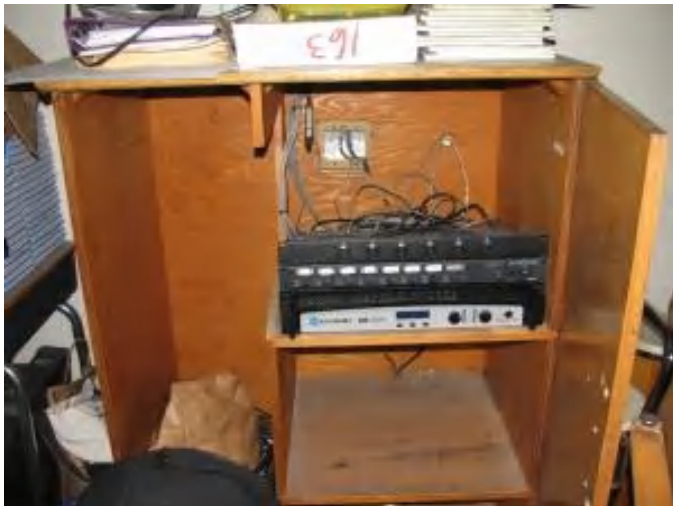
**System: D5030 - Communications and Security**

**Location:** Auditorium

**Distress:** Inadequate

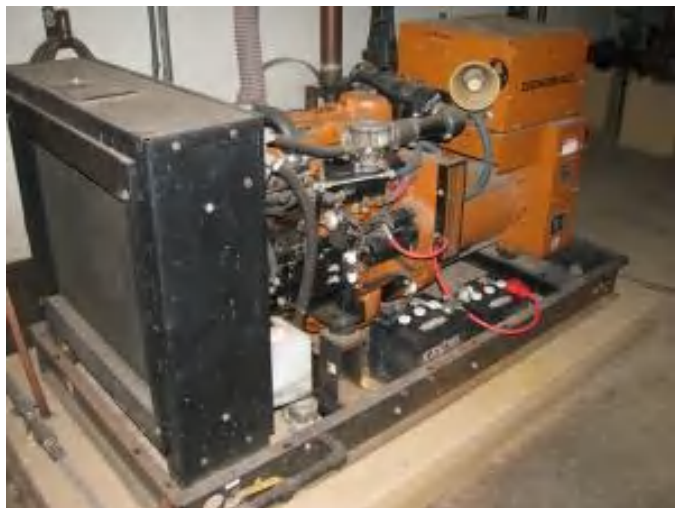
**System: D5090 - Other Electrical Systems**

**Location:** Boiler Room

**Distress:** Beyond Service Life

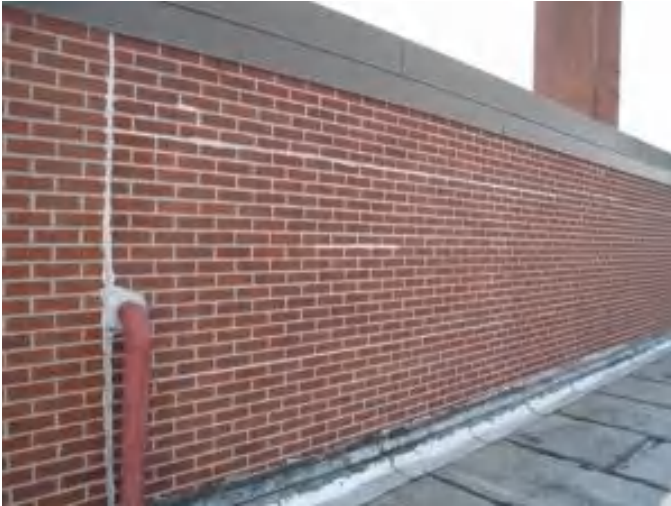
**System: B2010 - Exterior Walls**

**Location:** exterior brick walls

**Distress:** Failing

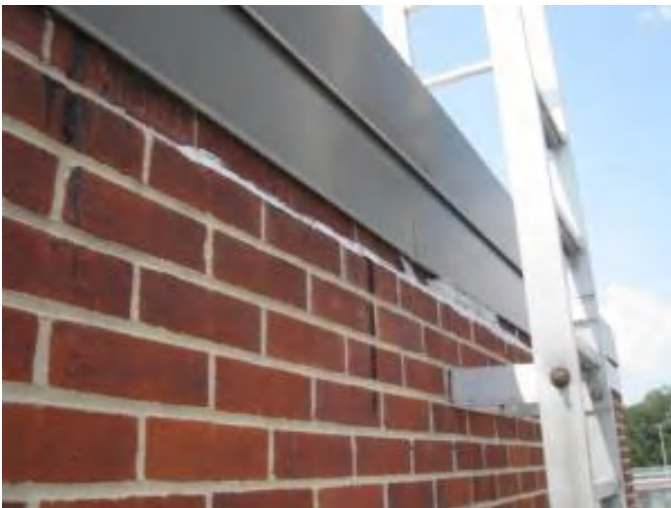
**System: B2010 - Exterior Walls**

**Location:** ladder to roof

**Distress:** Failing

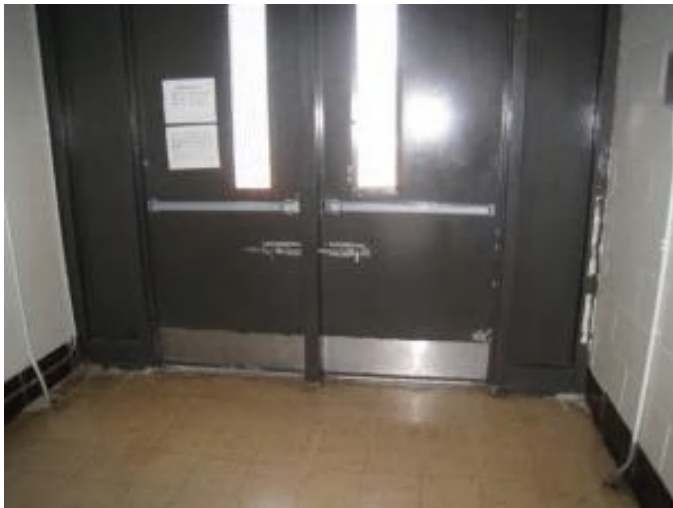
**System: B2030 - Exterior Doors**

**Location:** exterior doors at kindergarden

**Distress:** Failing

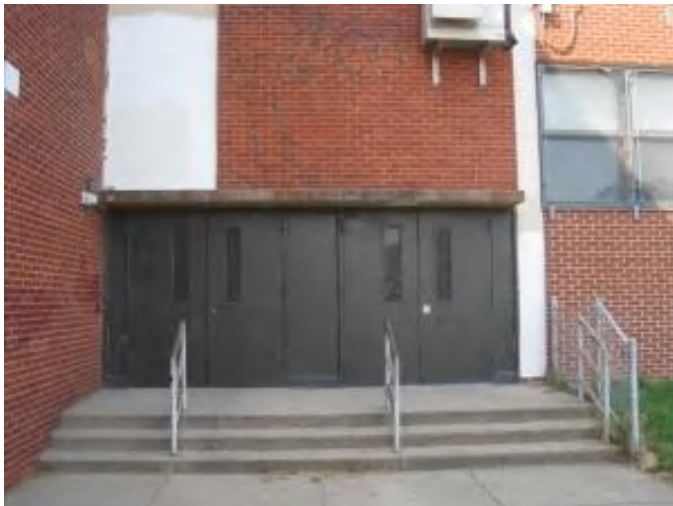
**System: B2030 - Exterior Doors**

**Location:** exterior doors

**Distress:** Appearance

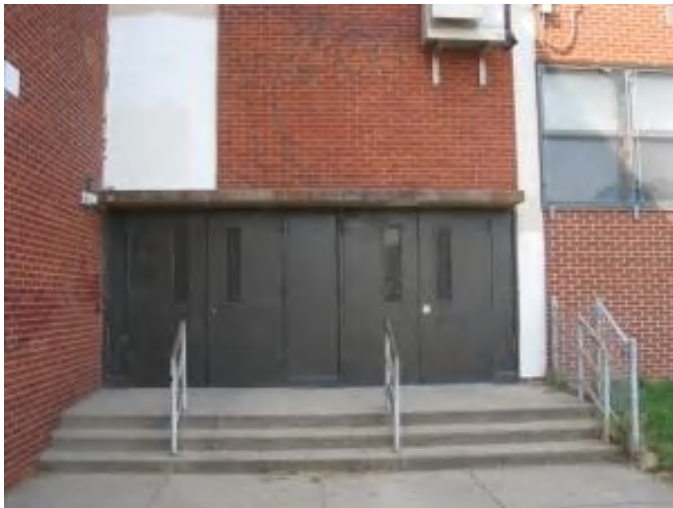
**System: B2030 - Exterior Doors**

**Location:** exterior doors

**Distress:** Building Envelope Integrity

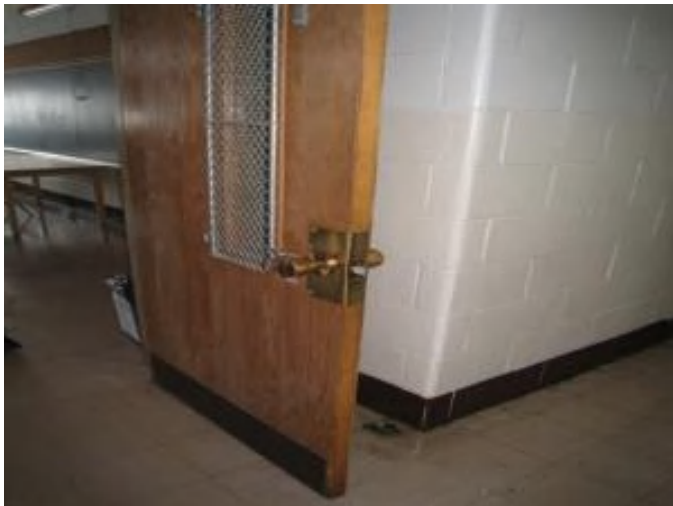
**System: C1020 - Interior Doors**

**Location:** corridor doors

**Distress:** Appearance

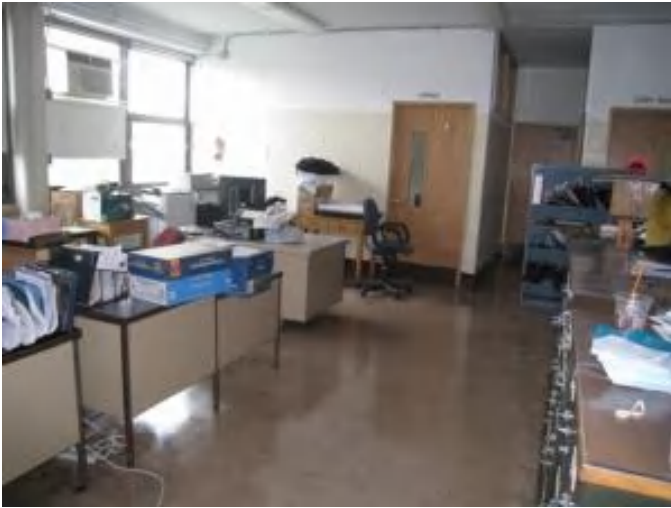
**System: C1020 - Interior Doors**

**Location:** classroom and office doors

**Distress:** Security Issue

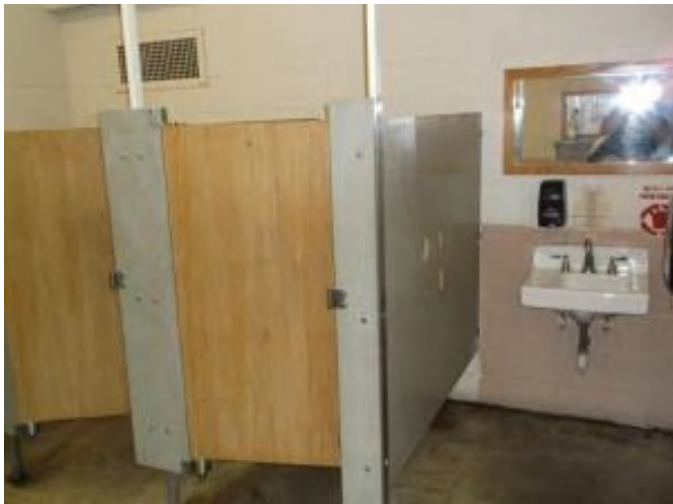
**System: C1030 - Fittings**

**Location:** toilet rooms

**Distress:** Damaged

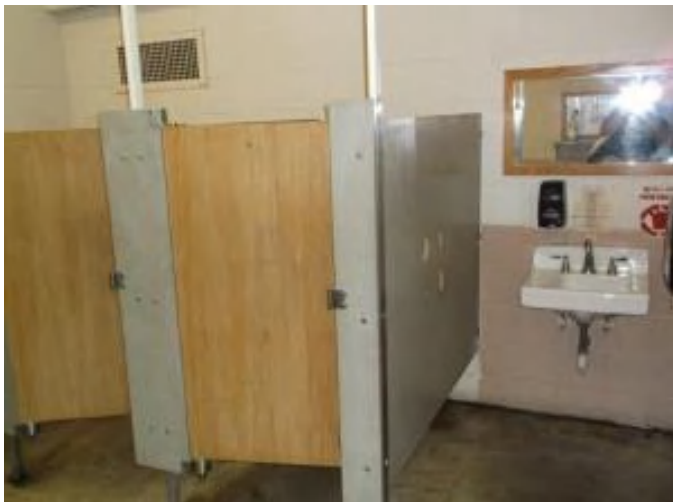
**System: C1030 - Fittings**

**Location:** toilet rooms

**Distress:** Failing

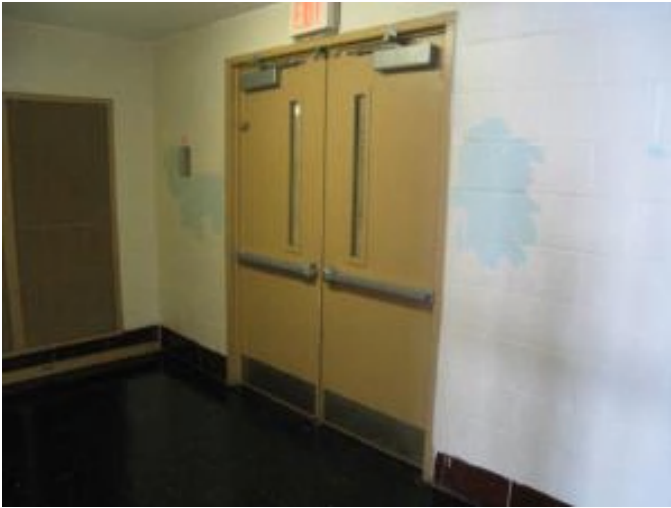
**System: C3010230 - Paint & Covering**

**Location:** interior walls

**Distress:** Appearance

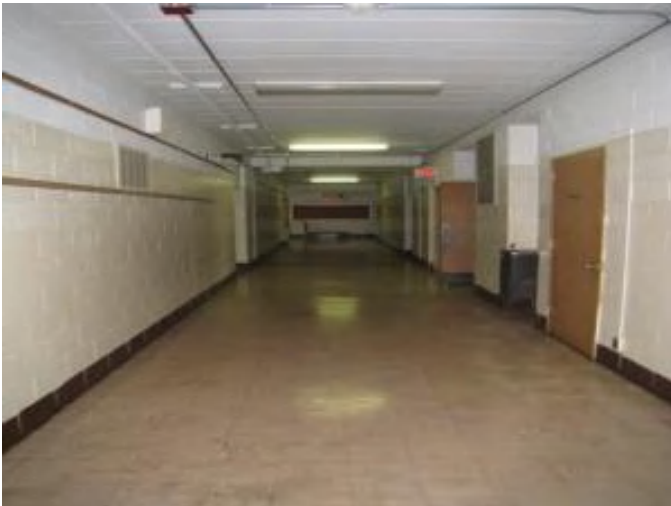
**System: C3020413 - Vinyl Flooring**

**Location:** corridors, classrooms, auditorium

**Distress:** Health Hazard / Risk

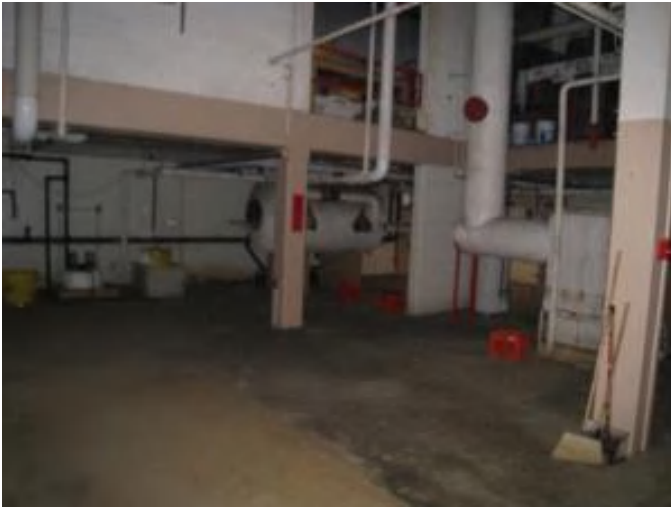
**System: C3020415 - Concrete Floor Finishes**

**Location:** basement, toilet rooms, stairs

**Distress:** Appearance

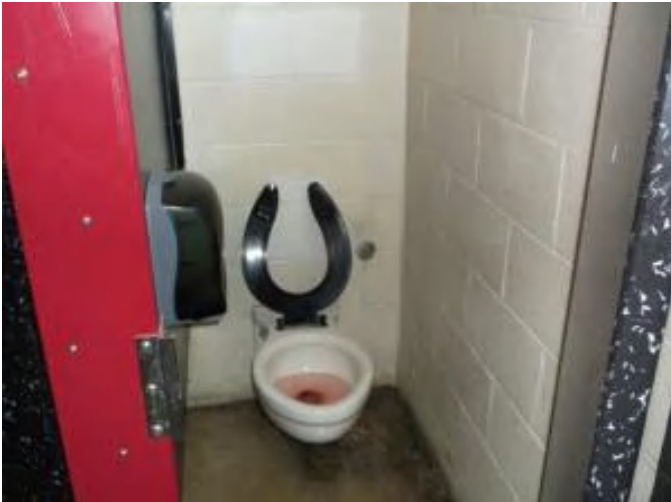
**System: D2010 - Plumbing Fixtures**

**Location:** Throughout the building

**Distress:** Beyond Service Life

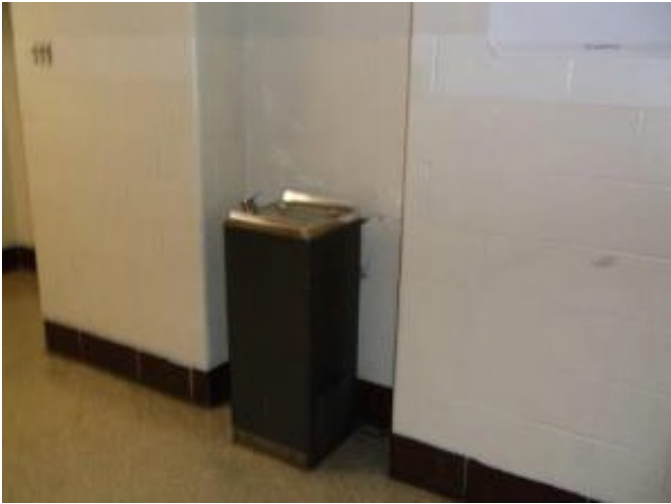
**System: D2010 - Plumbing Fixtures**

**Location:** Throughout the building

**Distress:** Beyond Service Life

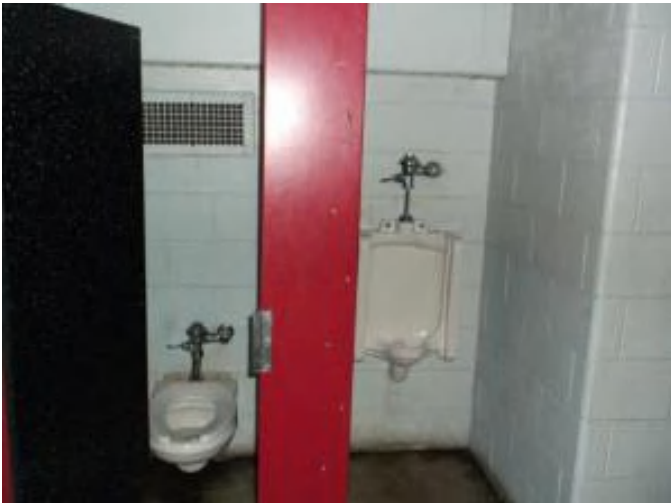
**System: D2010 - Plumbing Fixtures**

**Location:** Throughout the building

**Distress:** Beyond Service Life

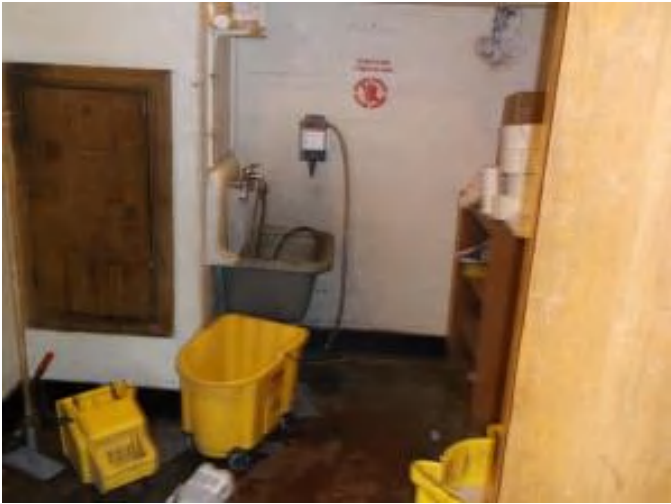
**System: D2010 - Plumbing Fixtures**

**Location:** Throughout the building

**Distress:** Beyond Service Life

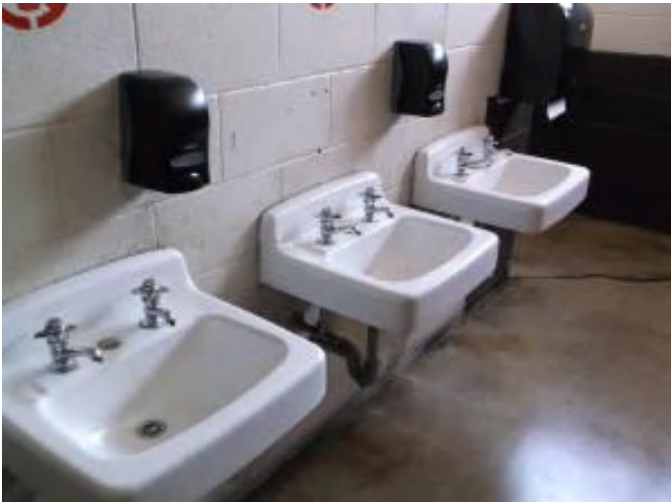
**System: D2010 - Plumbing Fixtures**

**Location:** Throughout the building

**Distress:** Beyond Service Life

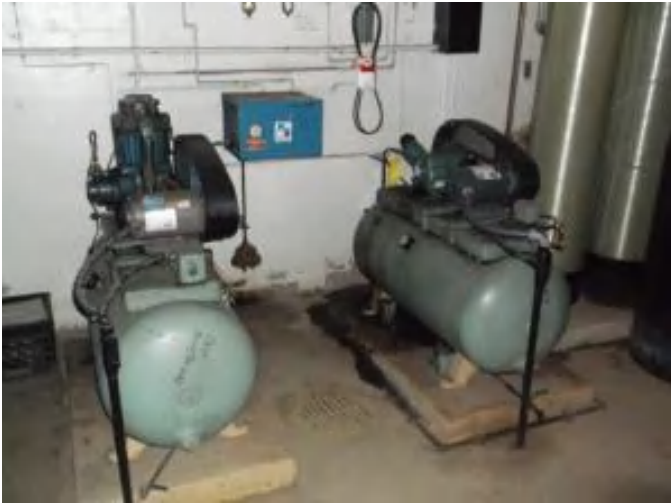
**System: D3060 - Controls & Instrumentation**

**Location:** Throughout the building

**Distress:** Beyond Service Life

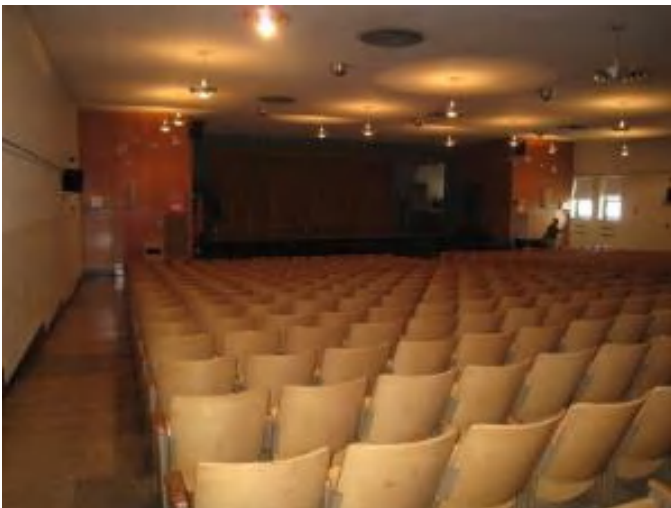
**System: E2010 - Fixed Furnishings**

**Location:** auditorium

**Distress:** Appearance

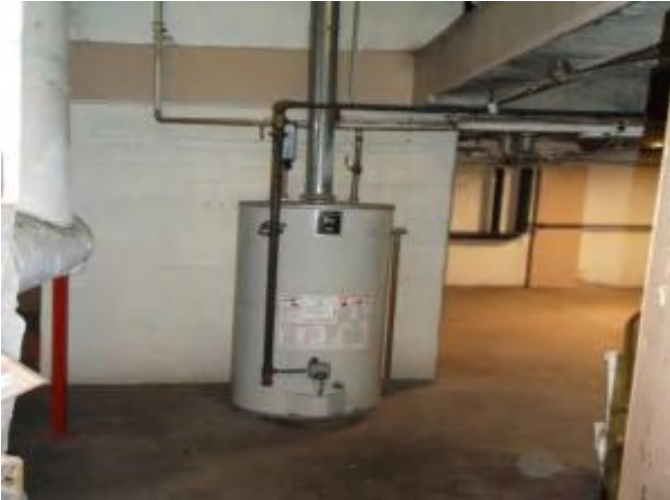
**System: D2020 - Domestic Water Distribution**

**Location:** Boiler Mechanical Equipment Room

**Distress:** Beyond Service Life

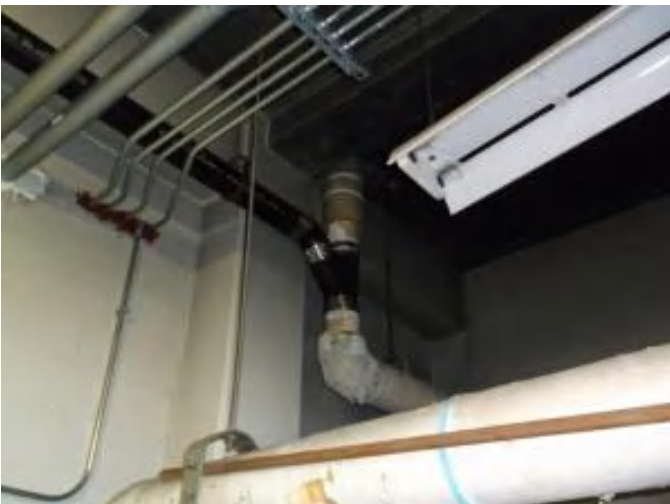
**System: D2030 - Sanitary Waste**

**Location:** Throughout the building

**Distress:** Beyond Service Life

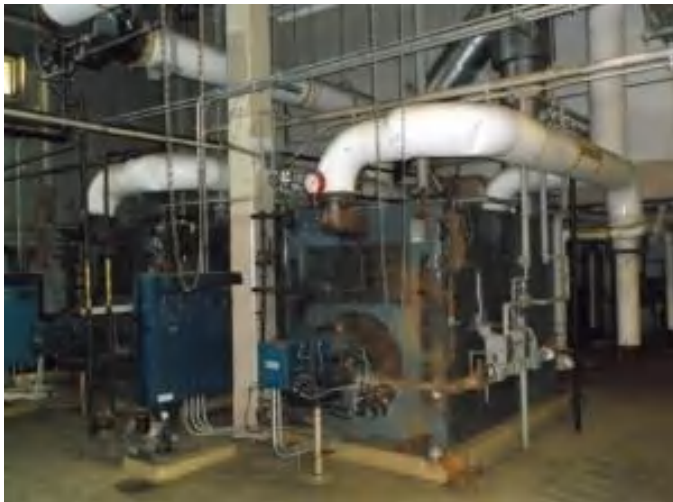
**System: D3020 - Heat Generating Systems**

**Location:** Boiler Mechanical Equipment Room

**Distress:** Beyond Service Life

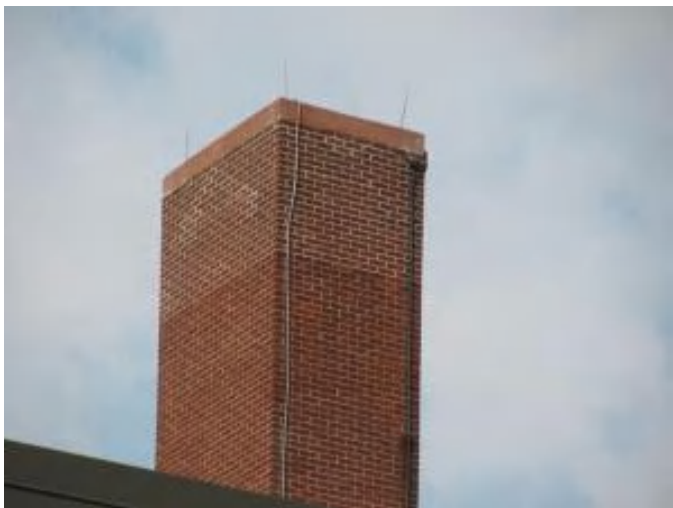
**System: D5090 - Other Electrical Systems**

**Location:** Roof

**Distress:** Life Safety / NFPA / PFD

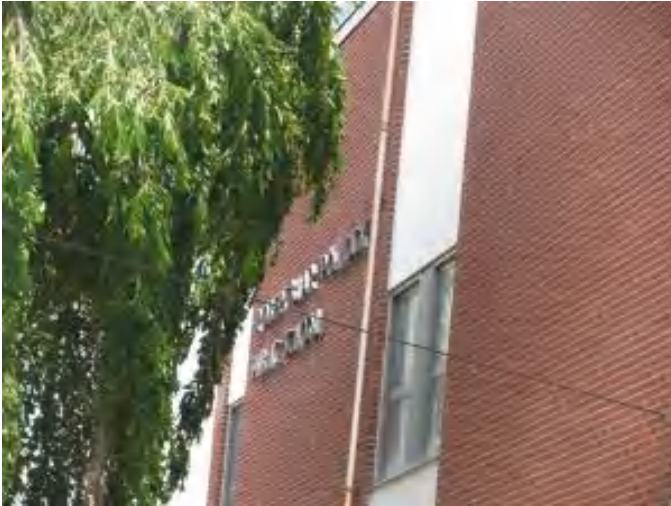
**System: D5030 - Communications and Security**

**Location:** Entire Building

**Distress:** Life Safety / NFPA / PFD

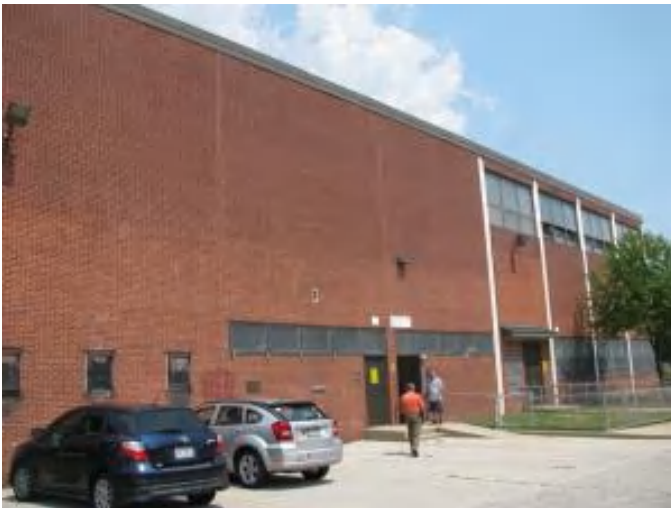
**System: D5030 - Communications and Security**

**Location:** Exterior Building

**Distress:** Inadequate

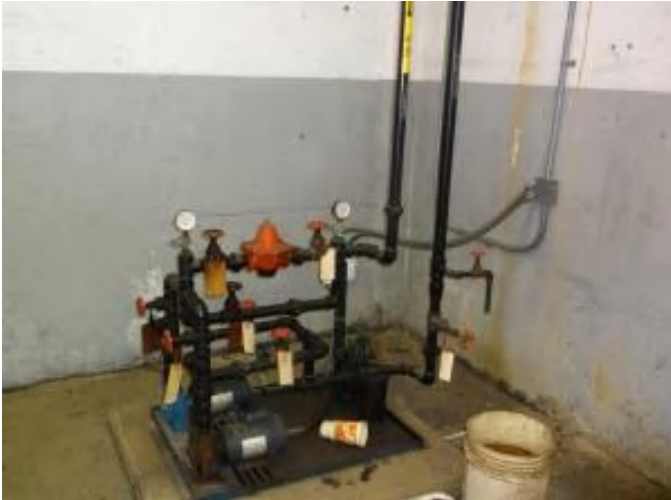
**System: D3020 - Heat Generating Systems**

**Location:** Boiler Mechanical Equipment Room

**Distress:** Beyond Service Life

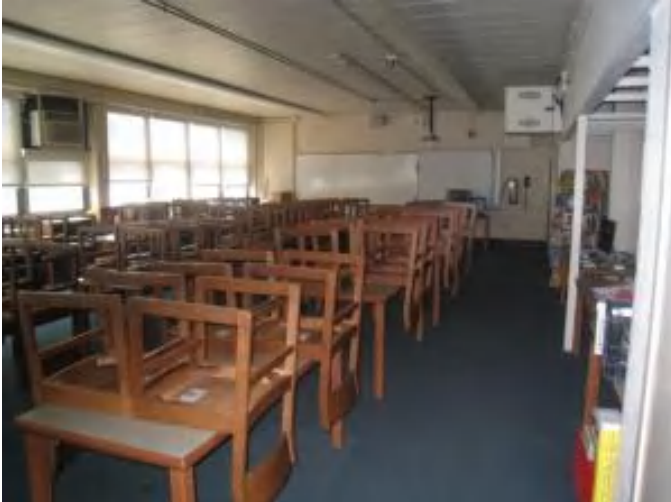
**System: D3030 - Cooling Generating Systems**

**Location:** Throughout the building

**Distress:** Inadequate

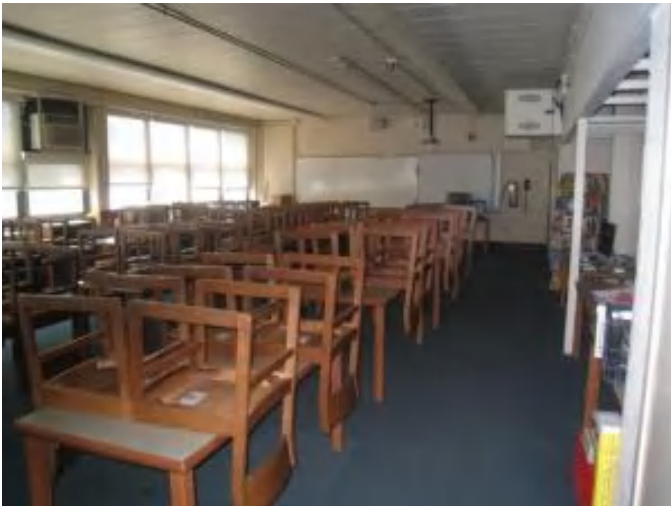
**System: D4010 - Sprinklers**

**Location:** Throughout the building

**Distress:** Life Safety / NFPA / PFD

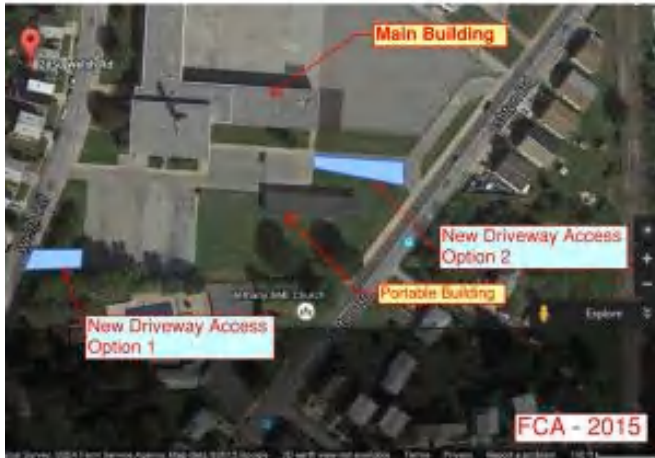
#### System: G2020 - Parking Lots

**Location:** secondary driveway access (exit) to street

**Distress:** Inadequate

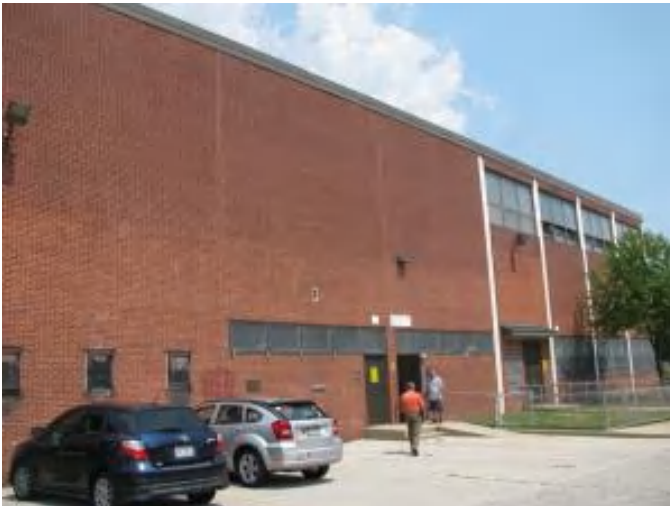
#### System: G4020 - Site Lighting

**Location:** exterior roads, parking and doors

**Distress:** Life Safety / NFPA / PFD

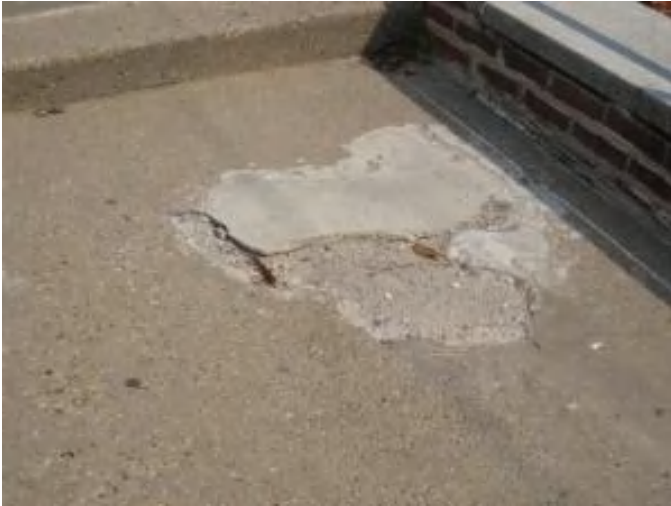
**System: G2030 - Pedestrian Paving**

**Location:** concrete walk at handicap entrance

**Distress:** Failing

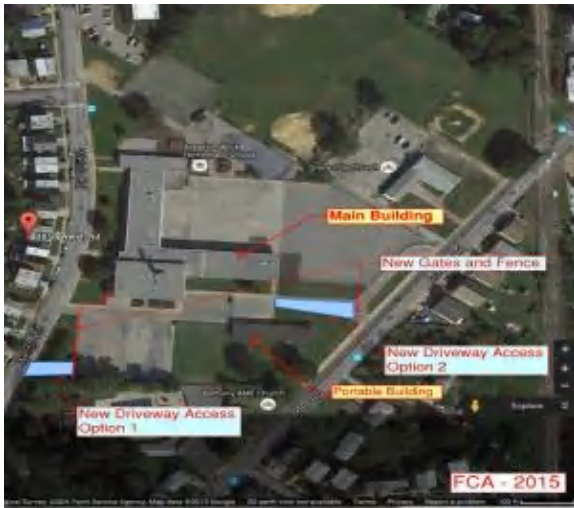
**System: G2040 - Site Development**

**Location:** roadway entrances to parking lot

**Distress:** Security Issue

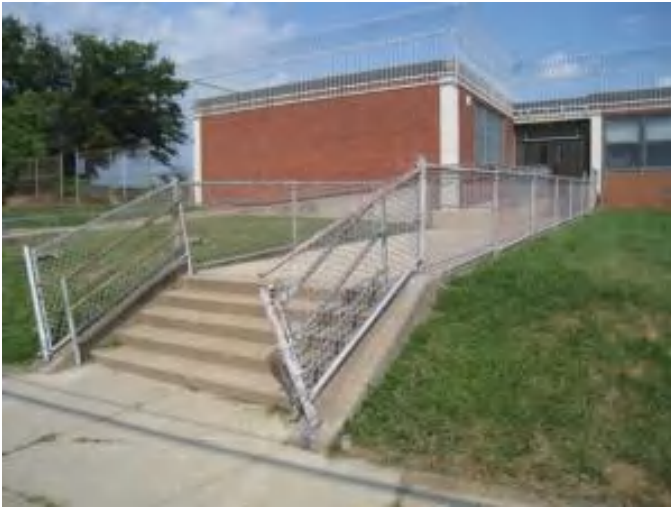
**System: G2040 - Site Development**

**Location:** fence at handicap entrance

**Distress:** Damaged

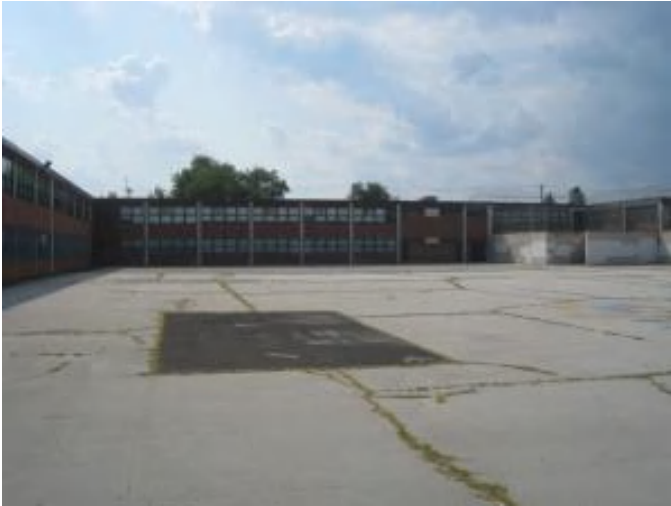
**System: G2020 - Parking Lots**

**Location:** asphalt parking lots and play areas

**Distress:** Failing
