Facility Condition Assessment Summary Report

Potter-Thomas School

School District of Philadelphia
S539001; Potter-Thomas
Final
Site Assessment Report
February 1, 2017

Site Assessment Report

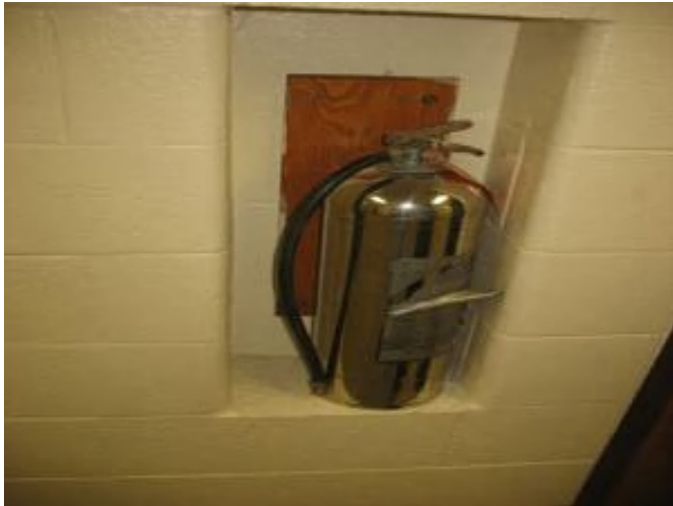
System: D4010 - Sprinklers

Location: Throughout building

Distress: Life Safety / NFPA / PFD

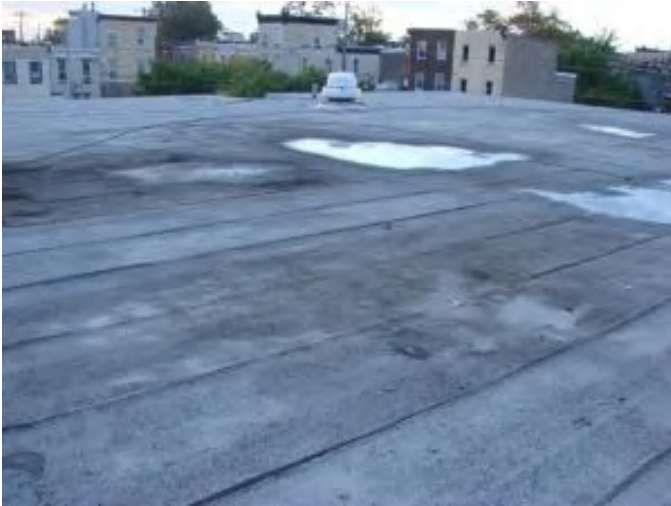
System: B3010105 - Built-Up

Roofing system is a built-up system over 25 years old and in poor condition. There is evidence of water ponding and large soft spot areas; leaks have been reported. Roof access hatch is original to the building and beyond its service life.

Location: Exterior

Distress: Building Envelope Integrity

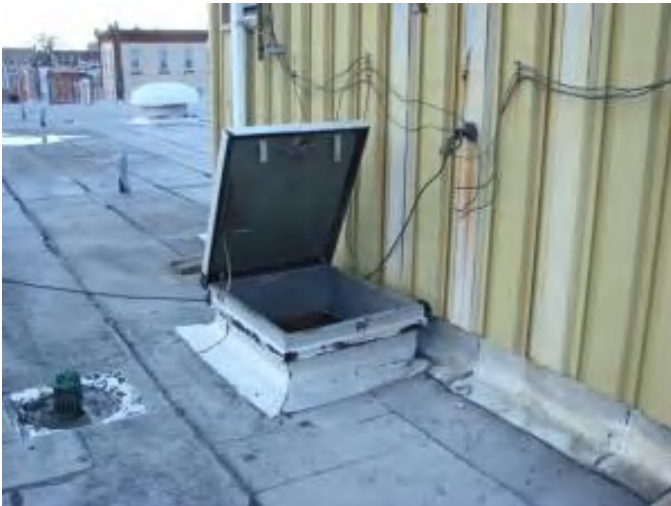
System: B3020 - Roof Openings

Location: Exterior

Distress: Beyond Service Life

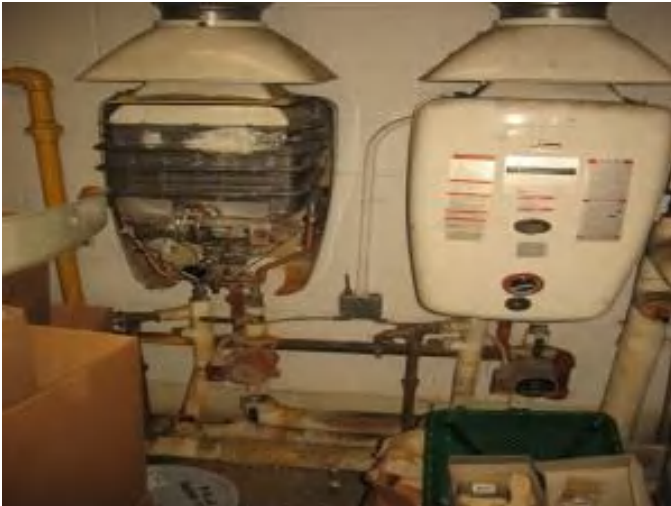
System: D2020 - Domestic Water Distribution

Two Paloma instant hot water heaters connected to two circulating pumps, installation dates unknown, supply hot water for domestic use. The units are located in a room off the boiler room. Both of the units were inoperable during the site visit and a service request was placed. These units should be replaced in the next 1-3 years.

Location: First Floor

Distress: Failing

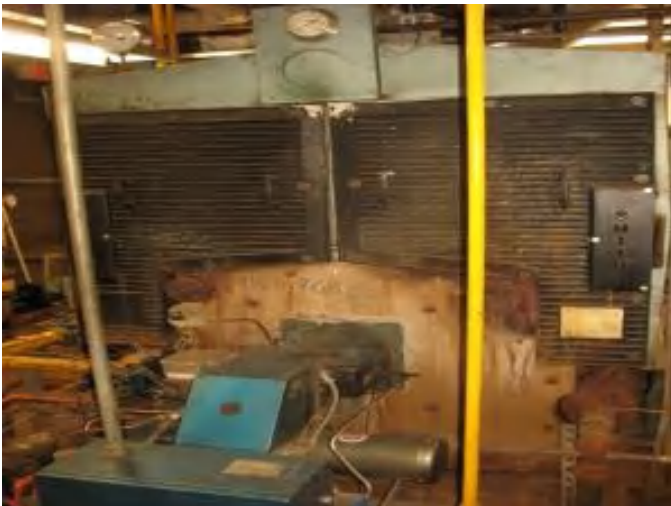
System: D3020 - Heat Generating Systems

Heat Generating Systems - Building heating hot water is generated by two 120HP Smith Mills 450 cast iron sectional boilers original to the building, located in the boiler room on the ground floor. Each boiler is equipped with a burner designed to operate on natural gas or fuel oil. Combustion air makeup is supplied by louvers equipped with motorized dampers. Burner oil pumps are not driven by the fan motor. The gas train serving the building does appear to have code required venting of the regulators and dual solenoid valves with venting of the chamber between. Cast iron sectional boilers have an anticipated service life of 35 years or more; these units have been in service approximately 48 years. The District should replace these boilers within the next 1-3 years.

Location: Boiler room

Distress: Beyond Service Life

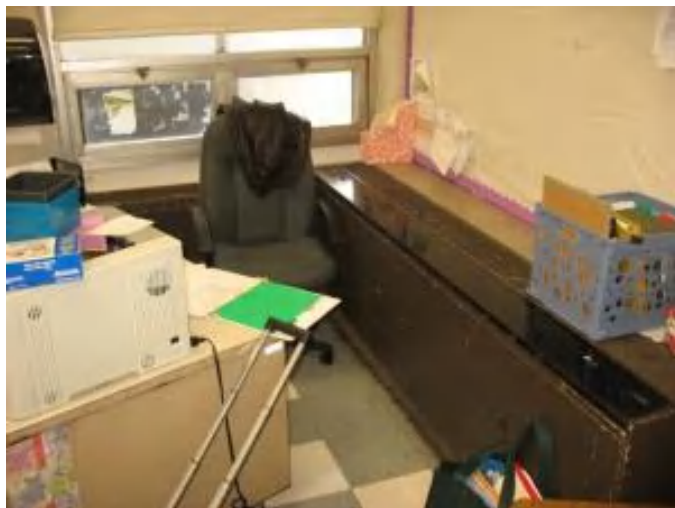
System: D3040 - Distribution Systems

Location: Classrooms

Distress: Beyond Service Life

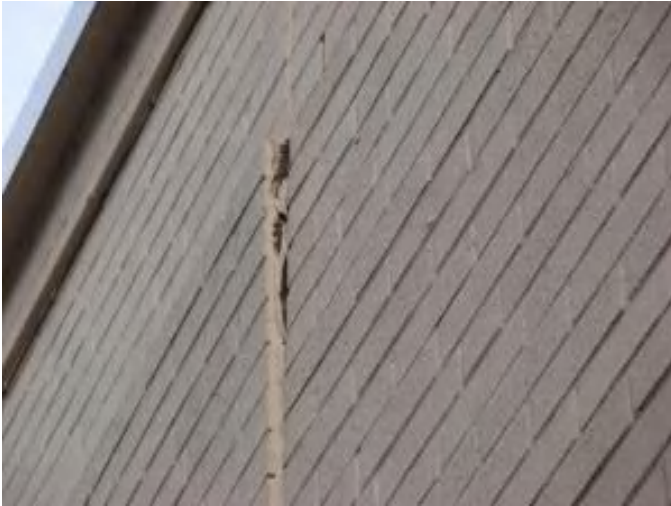
System: B2010 - Exterior Walls

The building envelope is typically face brick masonry with CMU backup. In general, masonry is in fair to good condition; however, several cracks and buckling at the roof level have been observed. Water penetration through walls has not been reported. Penthouses are clad with prefinished, standing seam metal panels. The finish is faded.

Location: Exterior

Distress: Building Envelope Integrity

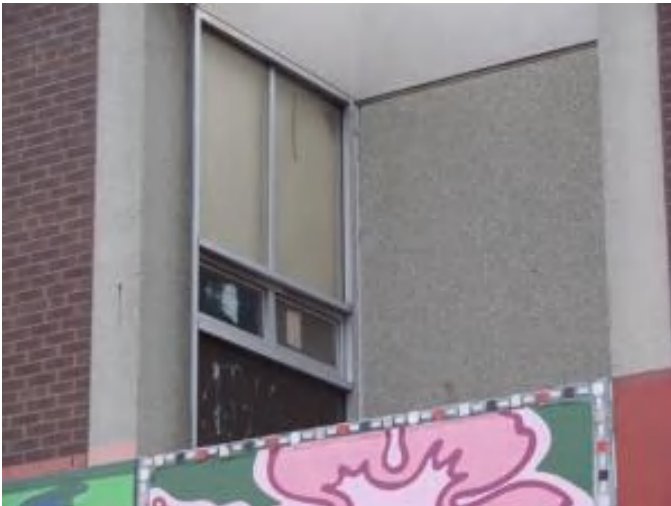
System: B2020 - Exterior Windows

The building windows are extruded aluminum curtain wall type, single acrylic glazed with tilt-in operable units. Windows are original to the building and deteriorated beyond service life. The leaks around the windows perimeters have been reported. Spandrel panels are poorly insulated and cause water pipes freezing inside the building. First floor vision glass panels are fitted with galvanized steel wire mesh security screens, generally in fair condition.

Location: Exterior

Distress: Building Envelope Integrity

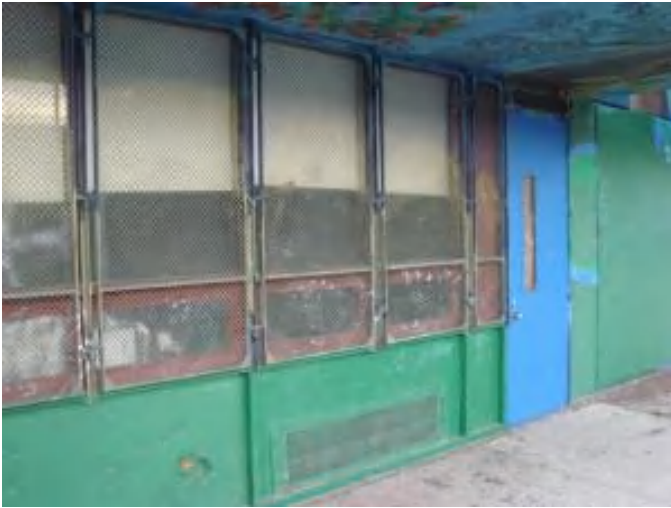
System: B2020 - Exterior Windows

Location: Exterior

Distress: Beyond Service Life

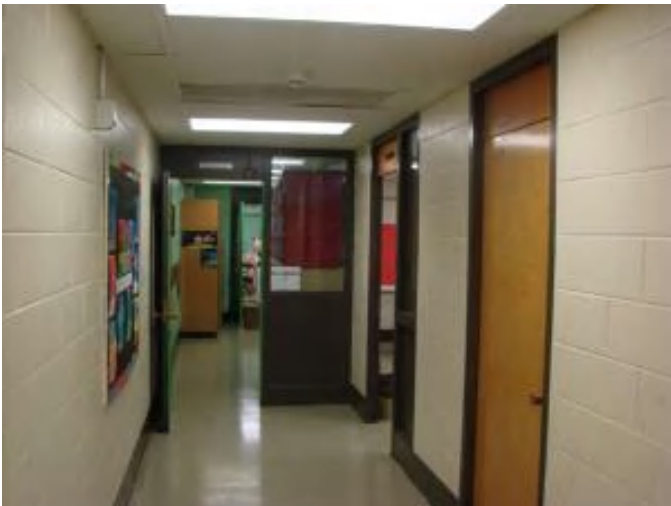
System: C1020 - Interior Doors

Location: Interior

Distress: Building / MEP Codes

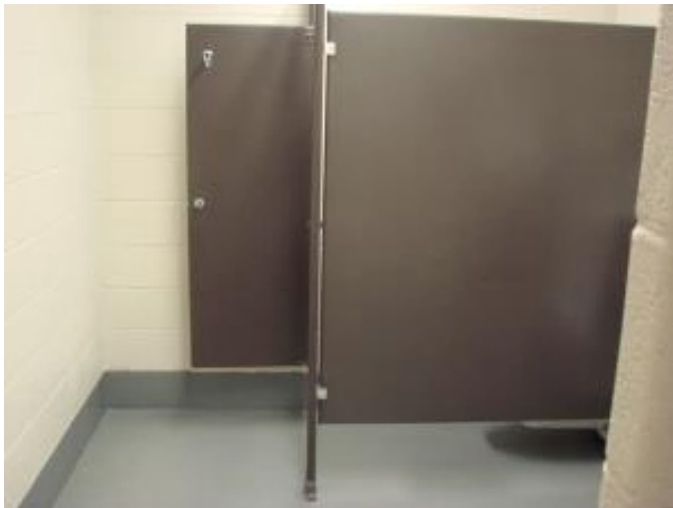
System: C1030 - Fittings

Location: Interior
Distress: Accessibility
Category: 2 - Code Compliance
Priority: 3 - Response Time (3-4 yrs)
Correction: Remove and replace damaged toilet partitions - handicap units
Qty: 26.00
Unit of Measure: Ea.
Estimate: \$84,445.85
Assessor Name: Craig Anding
Date Created: 01/13/2016

Notes: Replace non-ADA compliant toilet partitions; reconfigure remaining toilet partitions

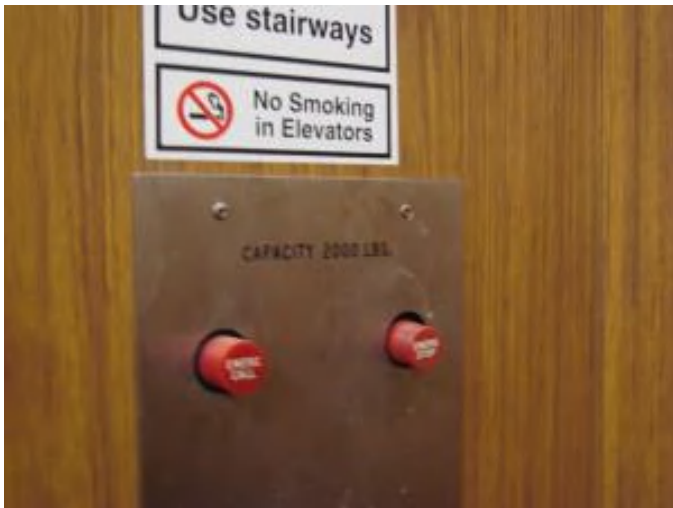
System: D1010 - Elevators and Lifts

The building has a 2,000 lb traction elevator serving 2 floors; generally in poor condition and not conforming to ADA requirements.

Location: Interior
Distress: Accessibility
Category: 2 - Code Compliance
Priority: 3 - Response Time (3-4 yrs)
Correction: Replace elevator - 2 stop hydraulic
Qty: 1.00
Unit of Measure: Ea.
Estimate: \$192,517.57
Assessor Name: Craig Anding
Date Created: 01/13/2016

Notes: Replace existing 2000 lb traction elevator with new 2500 lb elevator

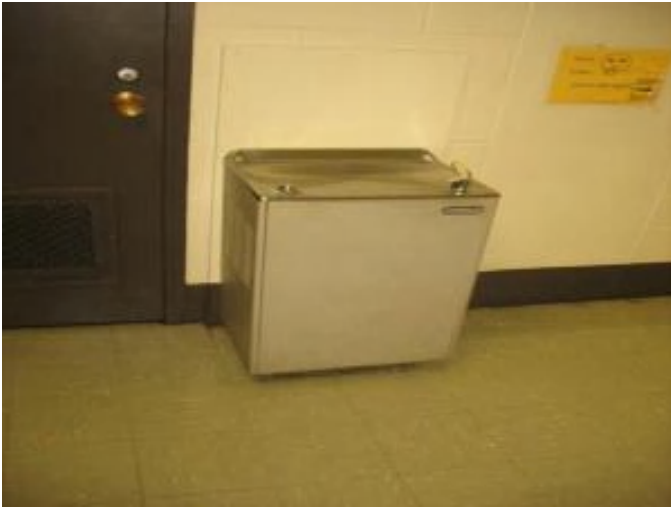
System: D2010 - Plumbing Fixtures

Drinking fountains in the corridors consist of wall hung fixtures with integral refrigerated coolers. The fixtures are well beyond their service life and should be replaced; most are NOT accessible type.

Location: Corridors
Distress: Beyond Service Life
Category: 3 - Operations / Maint.
Priority: 3 - Response Time (3-4 yrs)
Correction: Remove and Replace Water Fountains - without ADA new recessed alcove
Qty: 8.00
Unit of Measure: Ea.
Estimate: \$60,633.52
Assessor Name: Craig Anding
Date Created: 10/21/2015

Notes: Replace the wall hung drinking fountains and integral refrigerated coolers in the corridors and at the restrooms. These units are well beyond their service life and most are NOT accessible type.

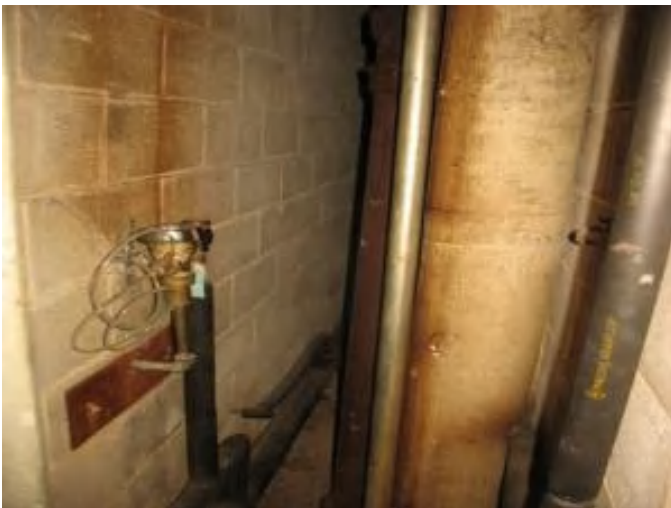
System: D2020 - Domestic Water Distribution

Location: Throughout building
Distress: Beyond Service Life
Category: 3 - Operations / Maint.
Priority: 3 - Response Time (3-4 yrs)
Correction: Replace domestic water piping (75 KSF)
Qty: 79,933.00
Unit of Measure: S.F.
Estimate: \$405,049.51
Assessor Name: Craig Anding
Date Created: 10/21/2015

Notes: Hire a qualified contractor to perform a detailed inspection of the domestic water piping in the original building, in use for almost 50 years, and replace any damaged piping.

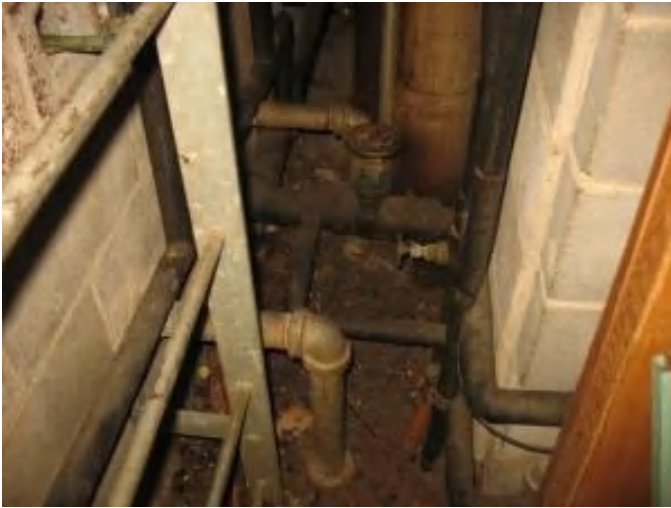
System: D2030 - Sanitary Waste

The maintenance staff reported mostly minor problems with the sanitary waste piping systems. However, the sewer piping has been in service for nearly 50 years and will require more frequent attention from the maintenance staff as time passes. The District should hire a qualified contractor to examine the sanitary waste piping using video cameras to locate and replace any damaged piping and to further quantify the extent of potential failures.

Location: Throughout building

Distress: Beyond Service Life

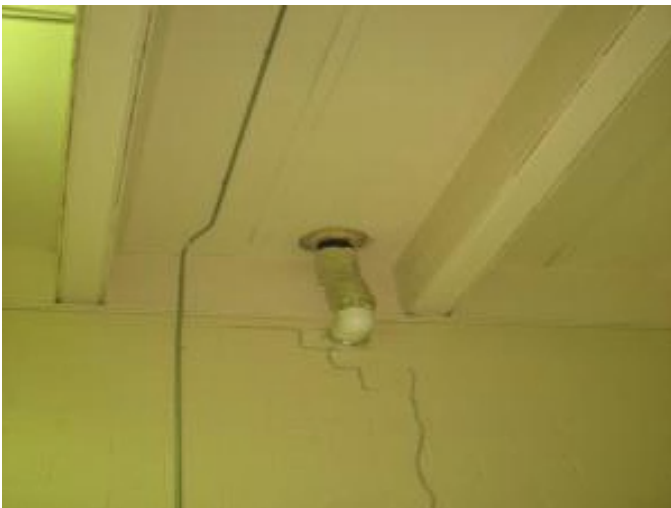
System: D2040 - Rain Water Drainage

Location: Throughout building

Distress: Beyond Service Life

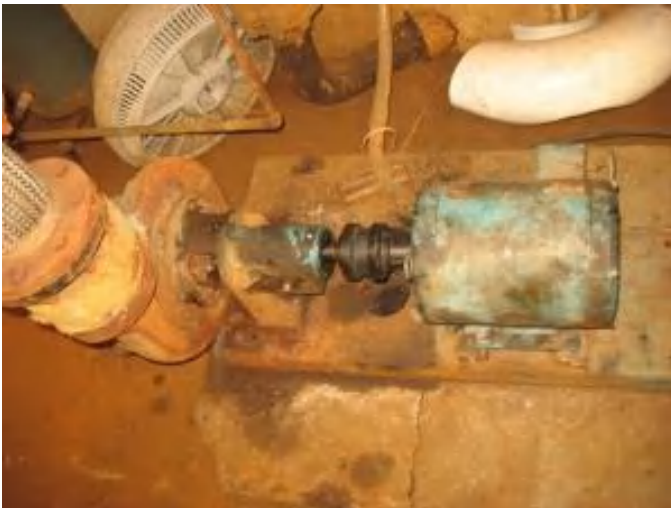
System: D3020 - Heat Generating Systems

Location: Boiler room
Distress: Damaged
Category: 3 - Operations / Maint.
Priority: 3 - Response Time (3-4 yrs)
Correction: Replace pump, base-mounted, end suction HHW (4" size, 7-1/2 HP, to 350 GPM)
Qty: 1.00
Unit of Measure: Ea.
Estimate: \$80,790.47
Assessor Name: Craig Anding
Date Created: 10/21/2015

Notes: Replace the 7.5HP end suction heating water supply pump which is beyond its service life and is in poor condition.

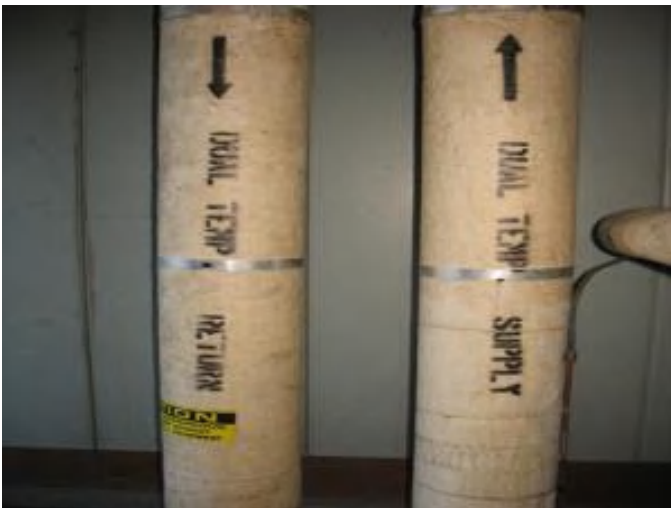
System: D3040 - Distribution Systems

Location: Throughout building
Distress: Beyond Service Life
Category: 3 - Operations / Maint.
Priority: 3 - Response Time (3-4 yrs)
Correction: Perform testing to identify and replace damaged steam and condensate piping.
Qty: 79,933.00
Unit of Measure: S.F.
Estimate: \$756,196.07
Assessor Name: Craig Anding
Date Created: 10/21/2015

Notes: Hire a qualified contractor to examine the dual temperature distribution piping, in service for nearly 50 years, and perform additional testing to locate and replace any damaged piping and to further quantify the extent of potential failures.

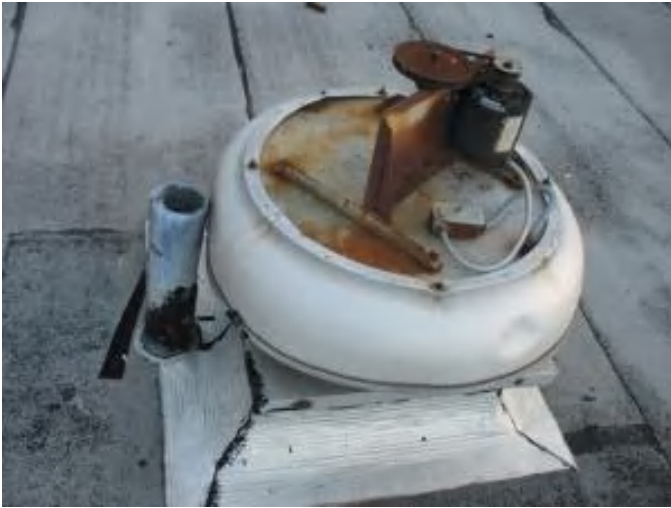
System: D3040 - Distribution Systems

Location: Roof
Distress: Beyond Service Life
Category: 3 - Operations / Maint.
Priority: 3 - Response Time (3-4 yrs)
Correction: Replace utility set exhaust fan (5 HP)
Qty: 11.00
Unit of Measure: Ea.
Estimate: \$433,668.93
Assessor Name: Craig Anding
Date Created: 10/21/2015

Notes: Replace eleven (11) roof mounted exhaust fans which are beyond their service life.

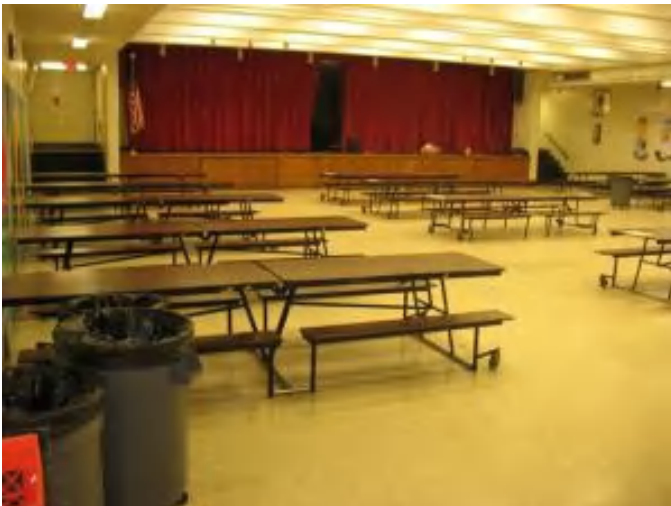
System: D3040 - Distribution Systems

Location: Cafetorium
Distress: Beyond Service Life
Category: 3 - Operations / Maint.
Priority: 3 - Response Time (3-4 yrs)
Correction: Replace HVAC unit for Cafeteria (850)
Qty: 1,236.00
Unit of Measure: Student
Estimate: \$336,435.66
Assessor Name: Craig Anding
Date Created: 02/22/2016

Notes: Replace the two (2) air handling units serving the Cafetorium which are beyond their service lives, with new more efficient units.

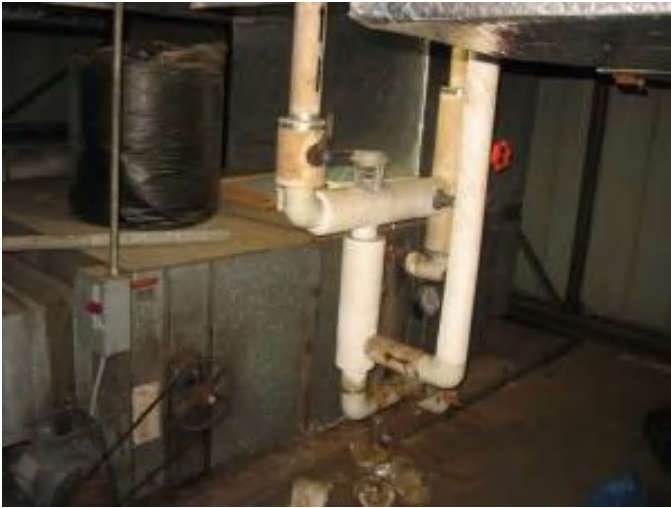
System: D3040 - Distribution Systems

Location: Penthouse mechanical room

Distress: Beyond Service Life

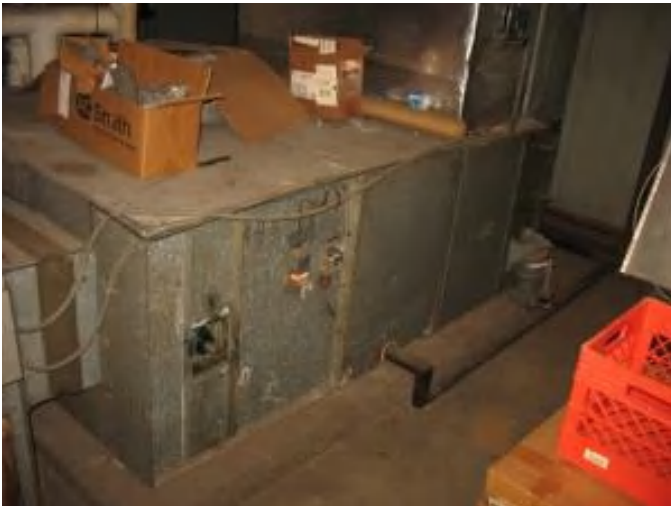
System: D3040 - Distribution Systems

Location: Penthouse mechanical room

Distress: Beyond Service Life

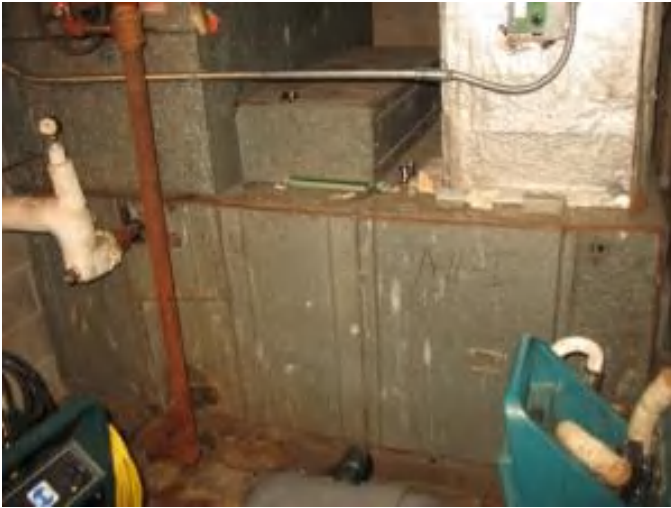
System: D3040 - Distribution Systems

Location: Mechanical room

Distress: Beyond Service Life

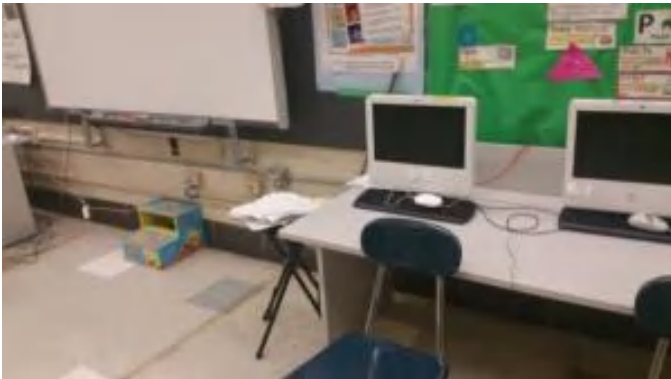
System: D5020 - Lighting and Branch Wiring

Location: throughout the building

Distress: Inadequate

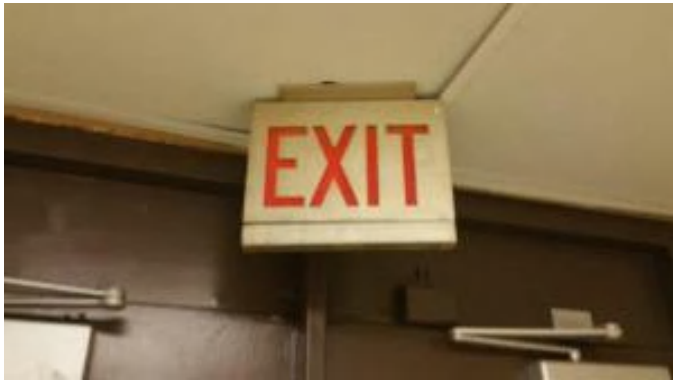
System: D5090 - Other Electrical Systems

Location: throughout the building
Distress: Beyond Service Life
Category: 4 - Capital Improvement
Priority: 3 - Response Time (3-4 yrs)
Correction: Replace Emergency/Exit Lighting
Qty: 1.00
Unit of Measure: Ea.
Estimate: \$286,693.02
Assessor Name: Craig Anding
Date Created: 12/16/2015

Notes: Install new emergency exit signs emergency lights.

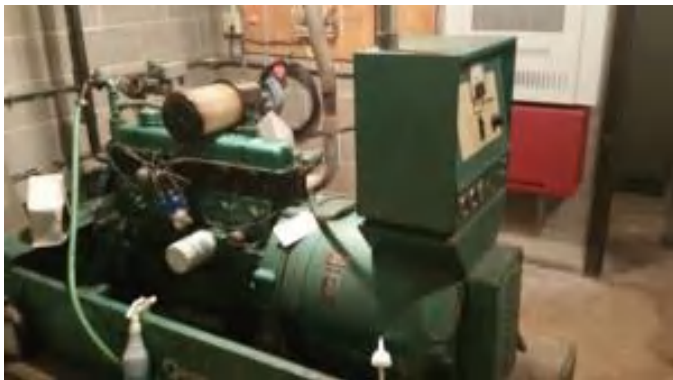
System: D5090 - Other Electrical Systems

Location: electrical room
Distress: Inadequate
Category: 4 - Capital Improvement
Priority: 3 - Response Time (3-4 yrs)
Correction: Replace standby generator system
Qty: 1.00
Unit of Measure: Ea.
Estimate: \$122,485.41
Assessor Name: Craig Anding
Date Created: 12/16/2015

Notes: Install a new 100 KW emergency generator to replace the existing inadequate 30KW Gen Set.

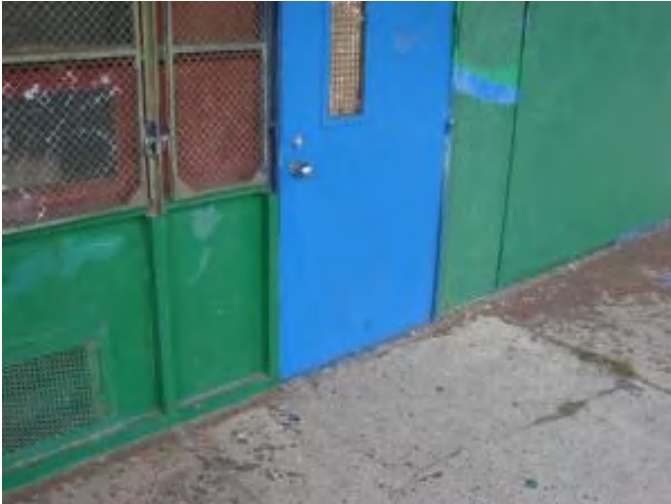
System: B2030 - Exterior Doors

The exterior doors are typically hollow metal doors and frames, painted, some with vision lights. The doors are generally in poor condition with damaged or missing hardware.

Location: Exterior

Distress: Beyond Service Life

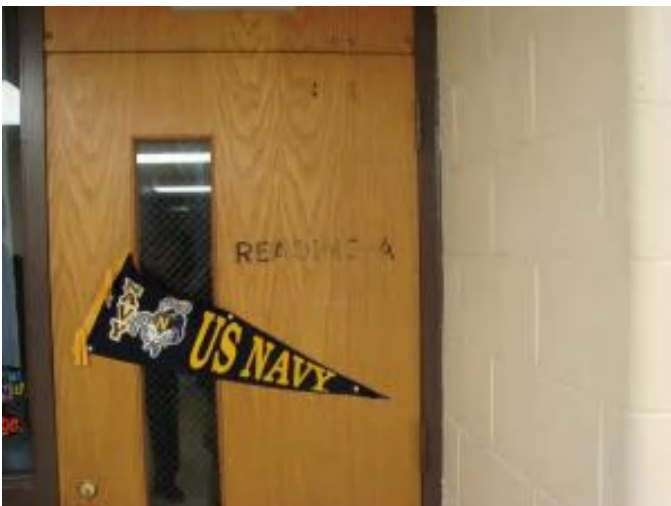
System: C1020 - Interior Doors

Location: Interior

Distress: Damaged

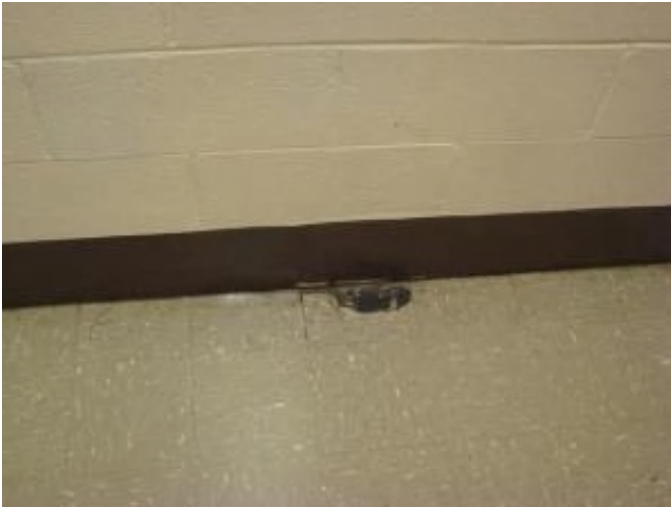
System: C3020413 - Vinyl Flooring

Location: Interior
Distress: Beyond Service Life
Category: 3 - Operations / Maint.
Priority: 4 - Response Time (4-5 yrs)
Correction: Remove VAT and replace with VCT - SF of area
Qty: 12,000.00
Unit of Measure: S.F.
Estimate: \$182,000.02
Assessor Name: Craig Anding
Date Created: 01/13/2016

Notes: Replace VAT tile throughout the building

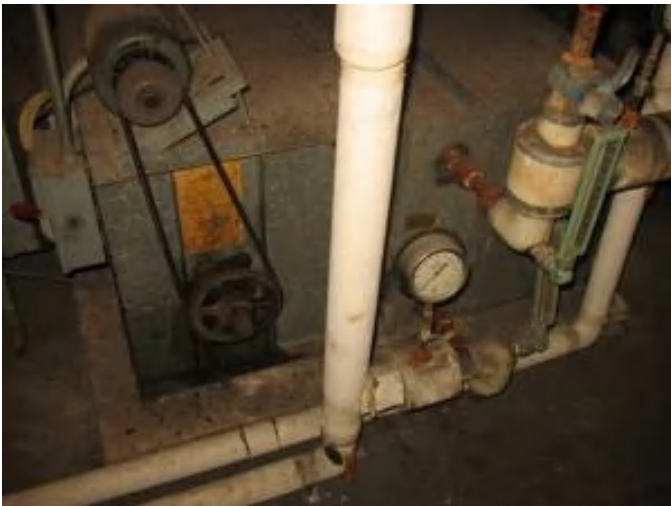
System: D3040 - Distribution Systems

Location: Gymnasium
Distress: Beyond Service Life
Category: 3 - Operations / Maint.
Priority: 4 - Response Time (4-5 yrs)
Correction: Install HVAC unit for Gymnasium (single station).
Qty: 6,000.00
Unit of Measure: Ea.
Estimate: \$308,301.04
Assessor Name: Craig Anding
Date Created: 10/21/2015

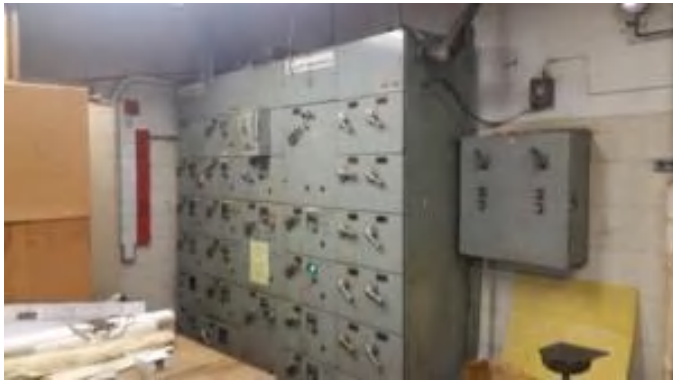
System: D5010 - Electrical Service/Distribution

Location: electrical room

Distress: Beyond Service Life

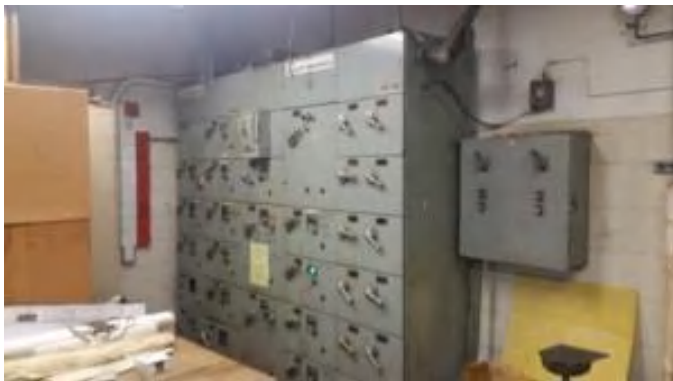
System: D5010 - Electrical Service/Distribution

Location: electrical room

Distress: Inadequate

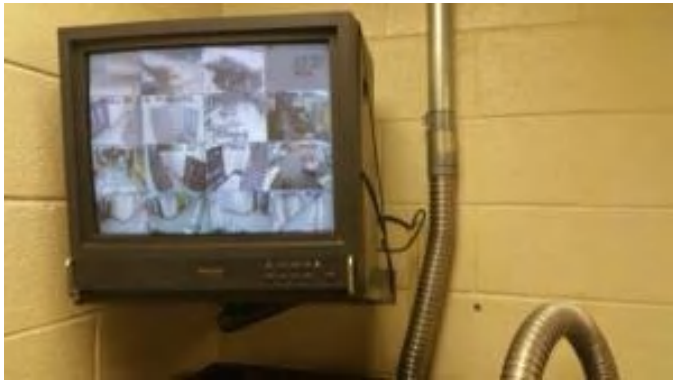
System: D5030 - Communications and Security

Location: throughout the building
Distress: Security Issue
Category: 1 - Health & Safety
Priority: 4 - Response Time (4-5 yrs)
Correction: Add/Replace Video Surveillance System
Qty: 1.00
Unit of Measure: Ea.
Estimate: \$98,648.68
Assessor Name: Craig Anding
Date Created: 12/16/2015

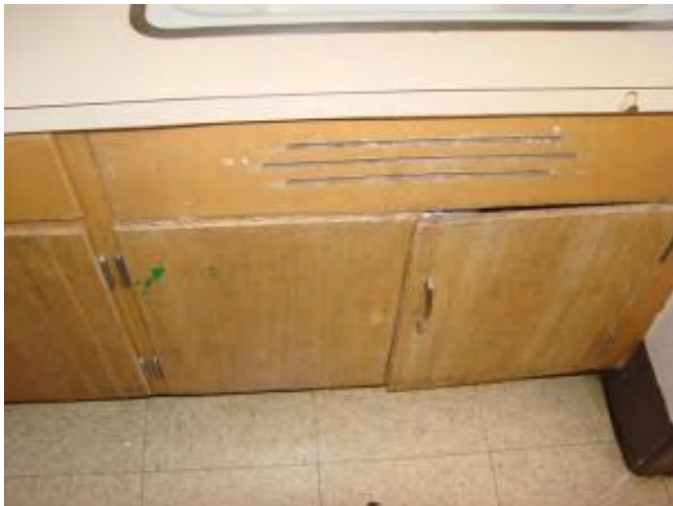
System: E2010 - Fixed Furnishings

Location: Interior
Distress: Beyond Service Life
Category: 3 - Operations / Maint.
Priority: 4 - Response Time (4-5 yrs)
Correction: Remove and replace casework - per LF - insert quantities for cabinets in the estimate
Qty: 120.00
Unit of Measure: L.F.
Estimate: \$99,739.82
Assessor Name: Craig Anding
Date Created: 01/13/2016

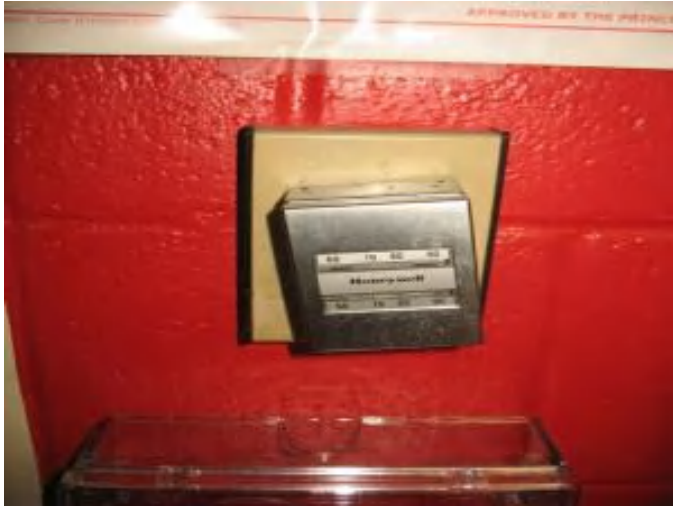
System: D3060 - Controls & Instrumentation

Location: Throughout building

Distress: Inadequate

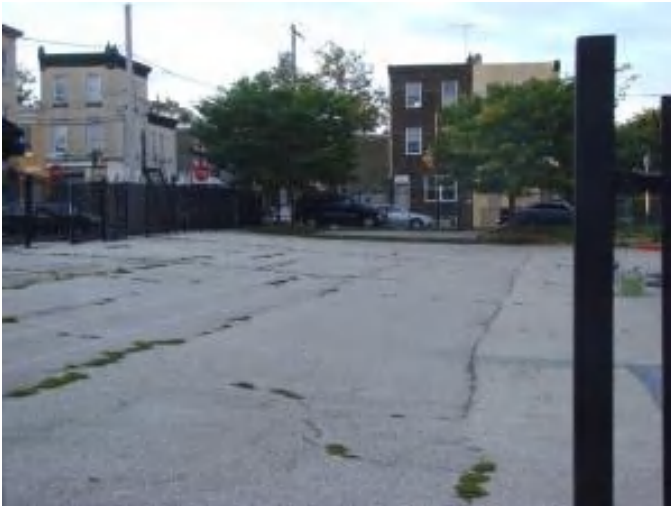
System: G2020 - Parking Lots

Location: Grounds

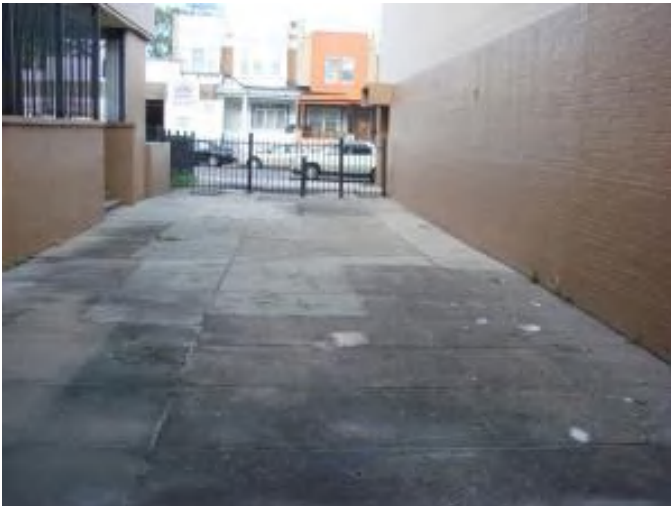
System: G2030 - Pedestrian Paving

Location: Grounds

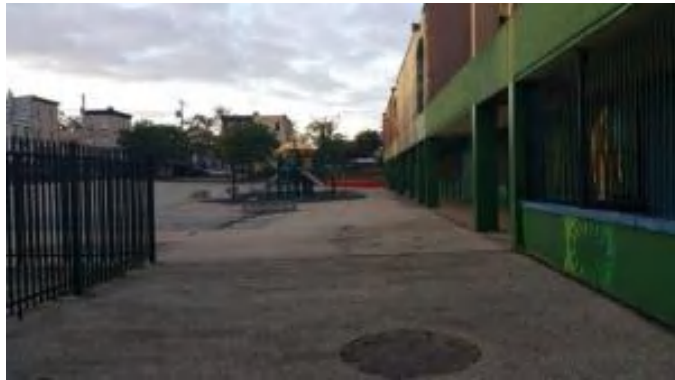
System: G4020 - Site Lighting

Location: Grounds

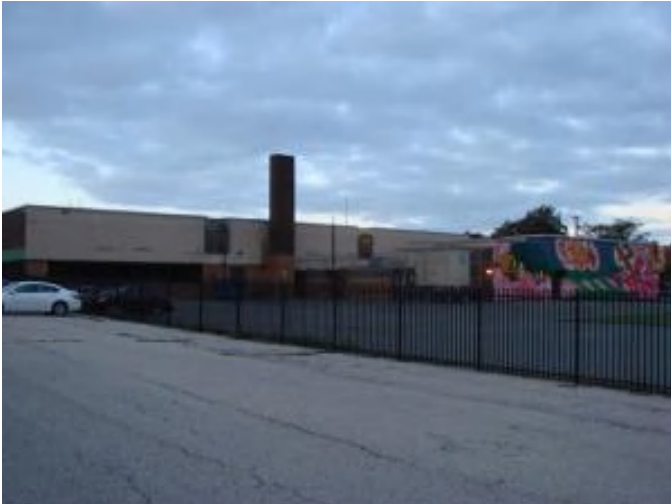
System: G2020 - Parking Lots

Location: Grounds

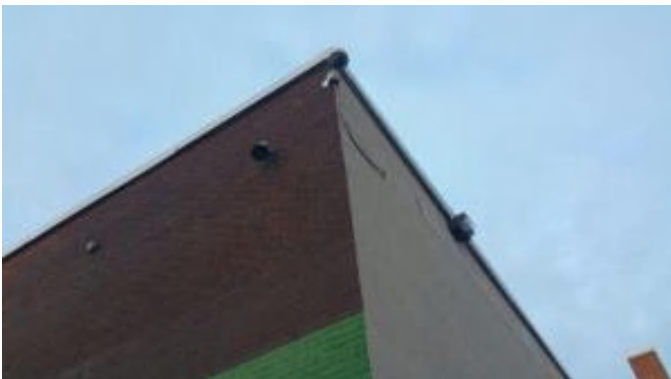
System: G4030 - Site Communications & Security

Location: Grounds
