## Facility Condition Assessment Summary Report

### Powel School

School District of Philadelphia  
**S139001;Powel**  
Final  
**Site Assessment Report**

January 30, 2017

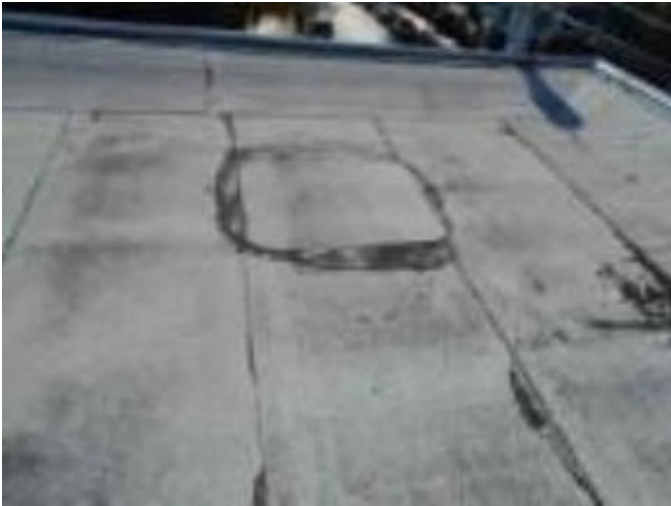
**Location:** Roof

**Distress:** Beyond Service Life

**Notes:** Remove and replace roofing

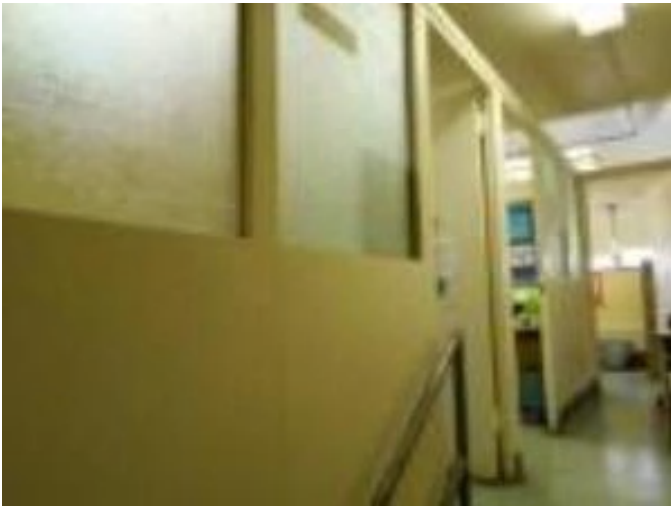
**Location:** Counselors office

**Distress:** Inadequate

**Notes:** Install full height partitions at counselor offices

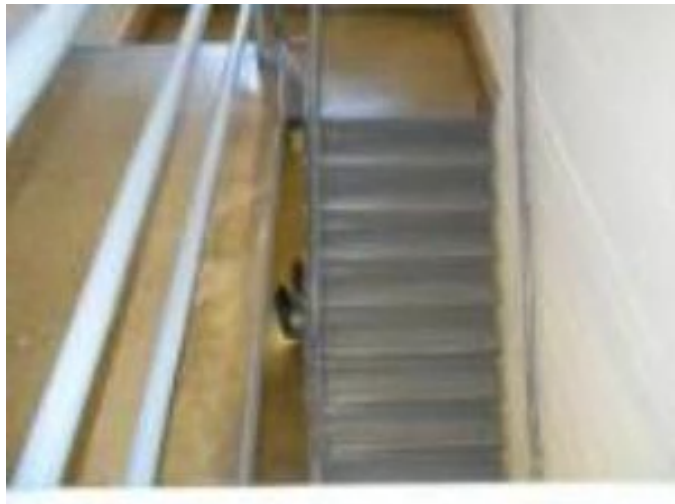
**Location:** Stairways

Stair construction is concrete with metal nosings fair condition. Treads and landings are concrete. Handrails are painted tubular steel. Handrails do not meet modern codes for configuration with no extensions at landings, and improper mounting height. Barrier rails at landings and stairs are too low.

**Distress:** Building / MEP Codes

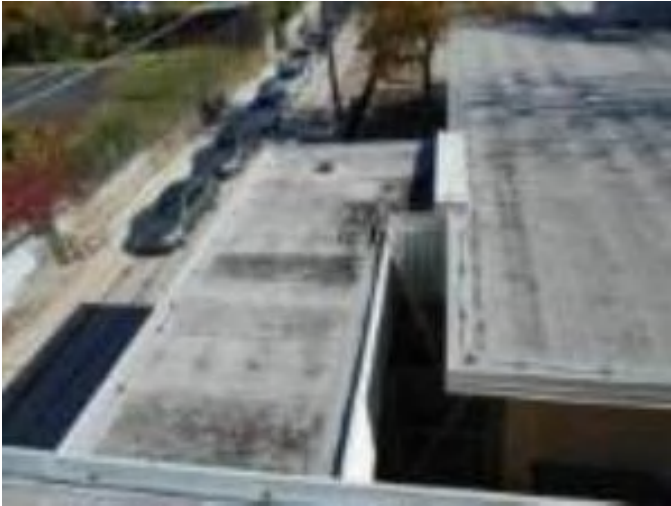
**Location:** Library roof  
**Distress:** Inadequate  
**Category:** 3 - Operations / Maint.  
**Priority:** 2 - Response Time (2-3 yrs)  
**Correction:** Add fixed ladders to wall  
**Qty:** 12.00  
**Unit of Measure:** V.L.F.  
**Estimate:** \$3,328.61  
**Assessor Name:** System  
**Date Created:** 02/23/2016

**Notes:** Install roof hatch and ladder at library addition

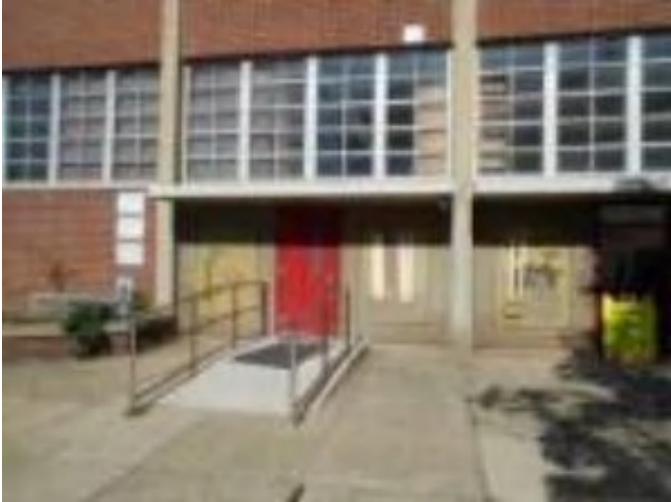
**Location:** Exterior windows  
**Distress:** Beyond Service Life  
**Category:** 3 - Operations / Maint.  
**Priority:** 2 - Response Time (2-3 yrs)  
**Correction:** Remove and replace aluminum windows - pick the appropriate size and style and insert the number of units  
**Qty:** 114.00  
**Unit of Measure:** Ea.  
**Estimate:** \$685,415.62  
**Assessor Name:** System  
**Date Created:** 02/23/2016

**Notes:** Replace exterior windows

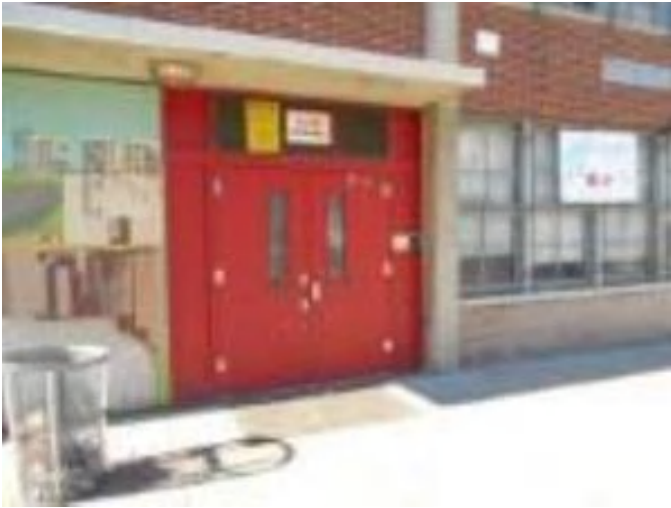
**Location:** Exterior doors

**Distress:** Beyond Service Life

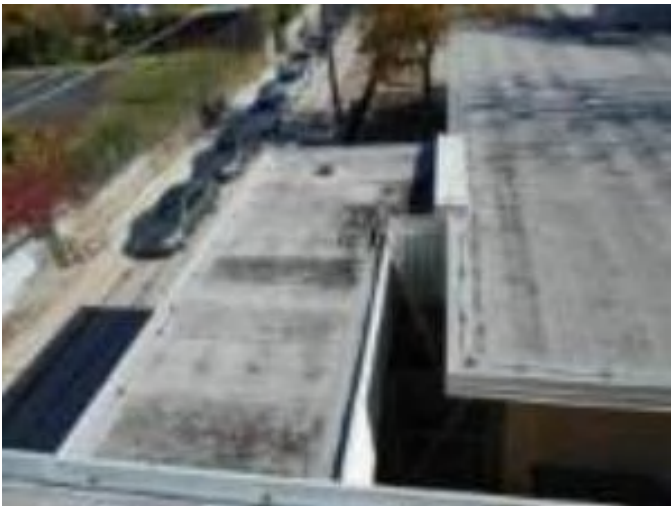
**Location:** Library roof

**Distress:** Inadequate

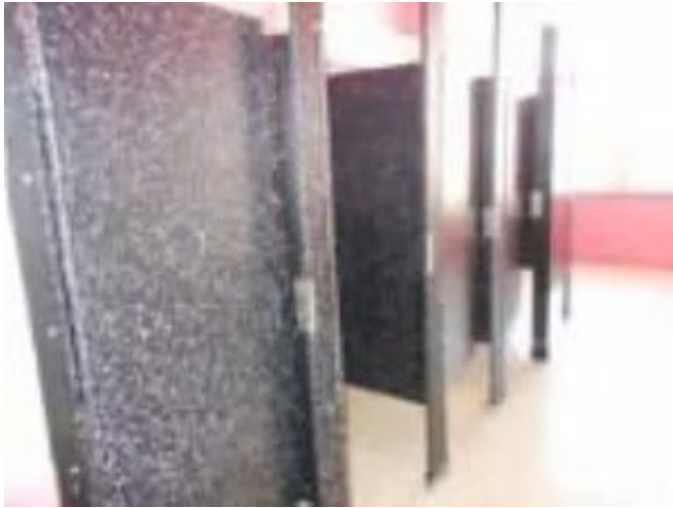
**Location:** Both floors

**Distress:** Accessibility

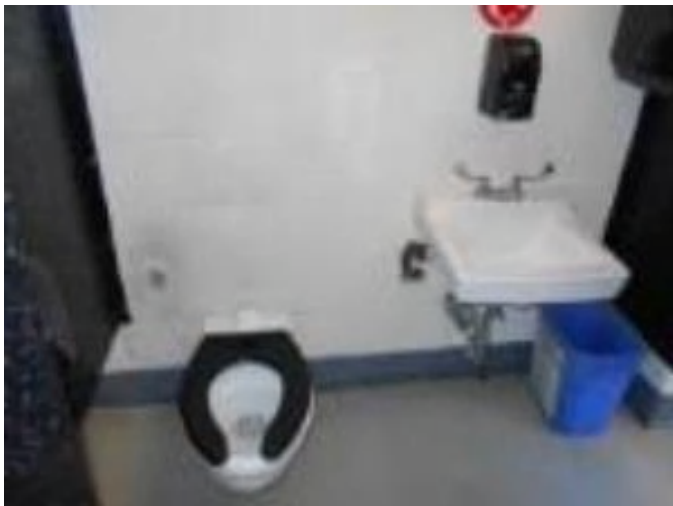
**Location:** Both floors

**Distress:** Accessibility

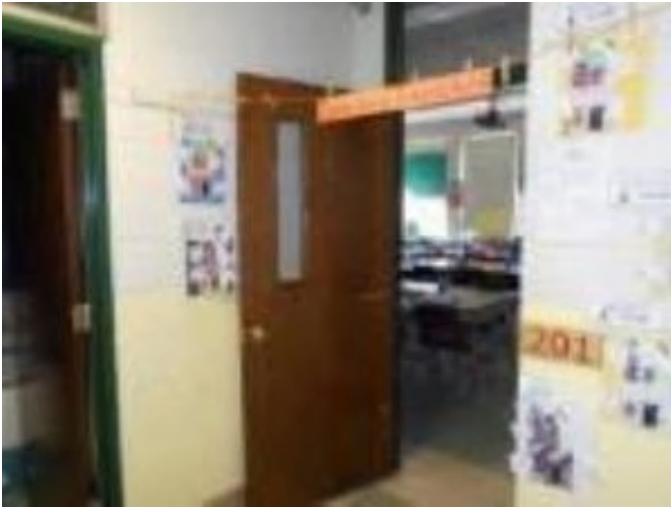
**Location:** Interior doors

**Distress:** Accessibility

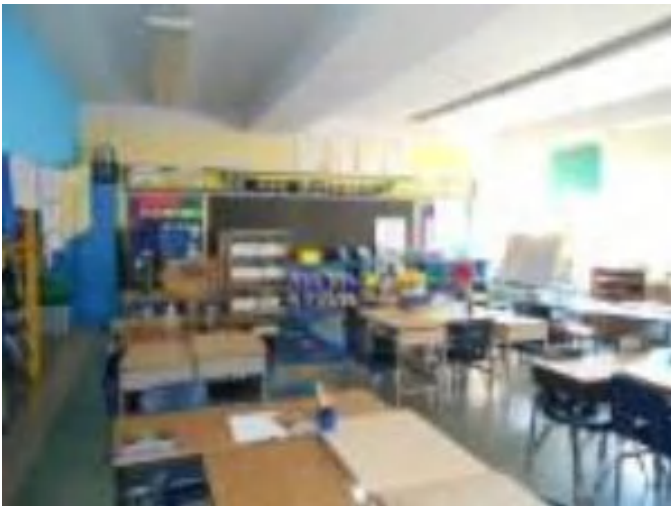
**Location:** Classrooms

**Distress:** Inadequate

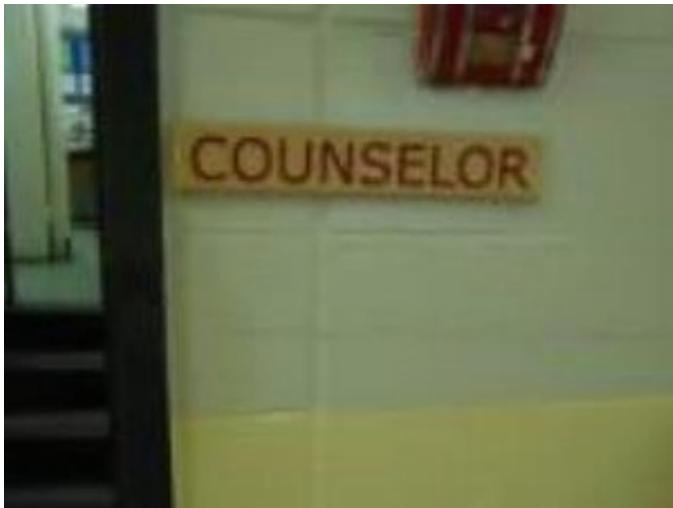
**Location:** Interior signage  
**Distress:** Inadequate  
**Category:** 2 - Code Compliance  
**Priority:** 2 - Response Time (2-3 yrs)  
**Correction:** Replace missing or damaged signage - insert the number of rooms  
**Qty:** 60.00  
**Unit of Measure:** Ea.  
**Estimate:** \$16,254.75  
**Assessor Name:** System  
**Date Created:** 02/23/2016

**Notes:** Replace interior signage

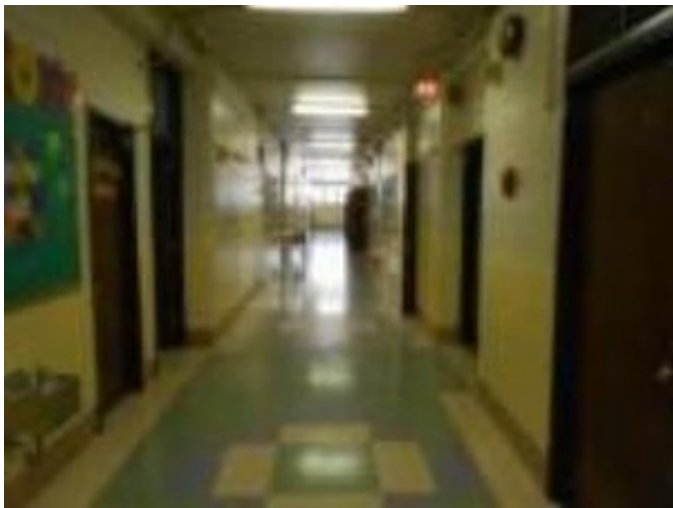
**Location:** Interior walls  
**Distress:** Beyond Service Life  
**Category:** 3 - Operations / Maint.  
**Priority:** 2 - Response Time (2-3 yrs)  
**Correction:** Repair and repaint all interior walls - SF of wall surface  
**Qty:** 36,000.00  
**Unit of Measure:** S.F.  
**Estimate:** \$243,859.57  
**Assessor Name:** System  
**Date Created:** 02/23/2016

**Notes:** Paint interior walls

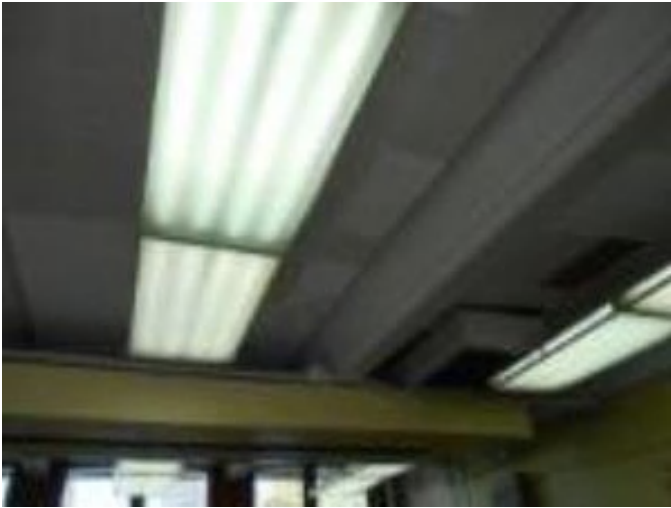
**Location:** Interior ceilings

Interior wall finishes are paint in generally good condition. A mural decorates the corridor linking the school building with the library addition. Flooring is mostly VCT in good condition. Carpet tile in good condition is installed in the library and the principal's office is carpeted. Toilet rooms have painted concrete floors and service areas have sealed concrete floors. The floor in the corridor to the library is sealed concrete. Two small storage rooms had 9" VAT. Ceilings are typically painted structure in good condition. The library, offices, and restrooms have 12" glued on acoustical tile that is in poor condition. Many water damaged and yellowed tiles were observed.

**Distress:** Beyond Service Life

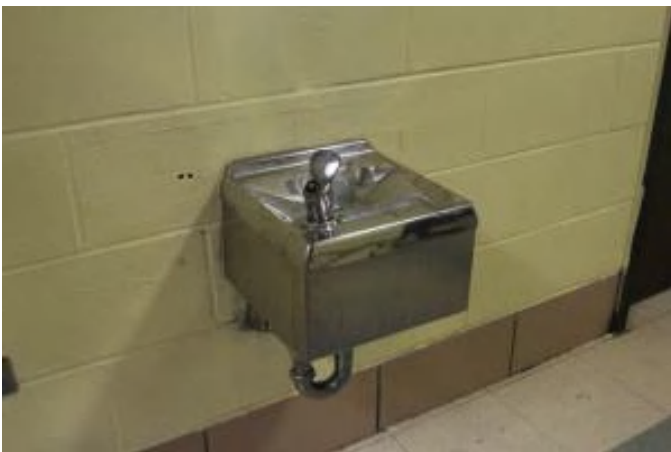
**Location:** Corridors

**Distress:** Accessibility

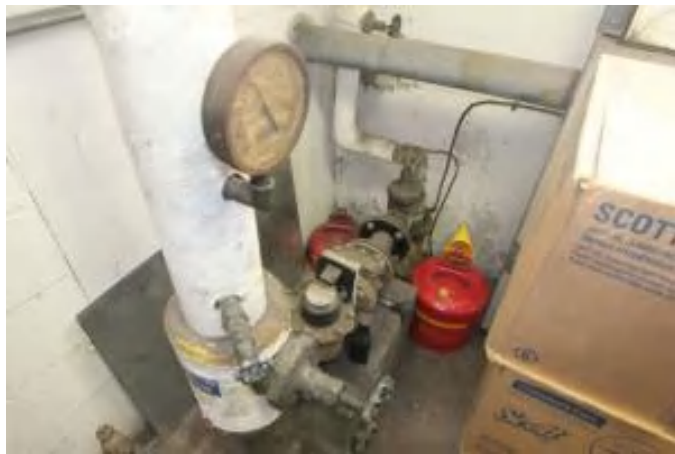
**Location:** Boiler room

**Distress:** Building / MEP Codes

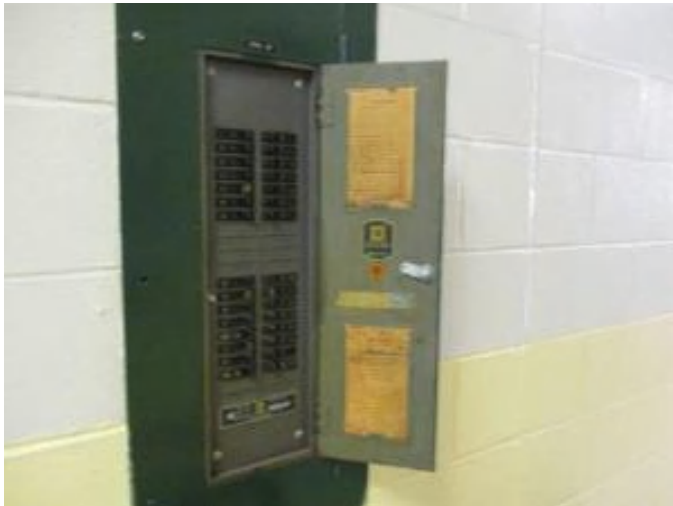
**Location:** Entire Building

**Distress:** Inadequate

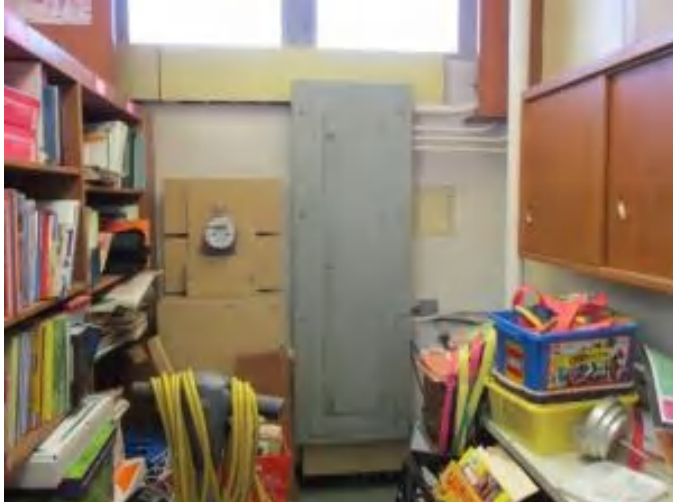
**Location:** First Floor

The first floor of the original building is provided with (2) 120/240V recessed, panel boards. The second floor of the original building is provided with (1) 120/240V, Square D panel board. The addition building is provided with (1) panelboard. Since the system voltage of the proposed electrical service is not compatible with the existing panelboards. Replace all panel boards and add (1) panelboard per floor.

**Distress:** Inadequate

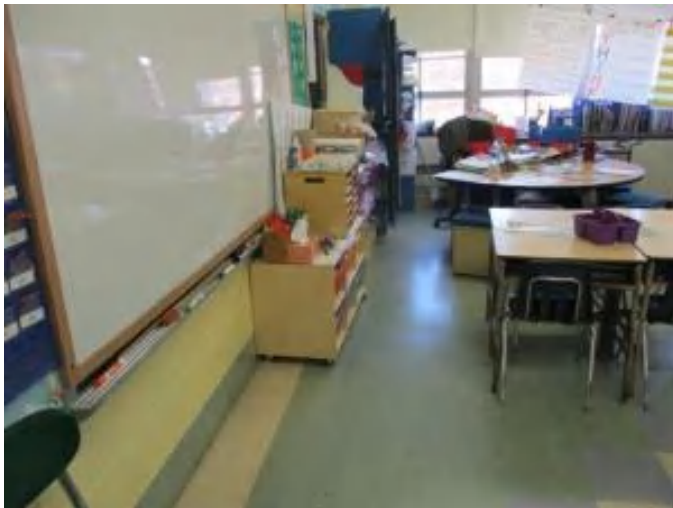
There number of receptacles in classrooms varies, approximately in 80% of the classrooms the quantity of receptacles are inadequate. Teachers use extension cords. The teacher's whiteboard wall and the opposite of it need to be provided with double compartment surface raceways, the other two walls with minimum two-duplex outlets each, when feasible.

**Location:** Entire Building  
**Distress:** Inadequate  
**Category:** 4 - Capital Improvement  
**Priority:** 3 - Response Time (3-4 yrs)  
**Correction:** Add wiring device  
**Qty:** 160.00  
**Unit of Measure:** Ea.  
**Estimate:** \$56,936.20  
**Assessor Name:** System  
**Date Created:** 01/22/2016

**Notes:** Provide (2)25FT of surface raceways with 24" receptacles on center and two-duplex wall mount receptacles. Approximate 160

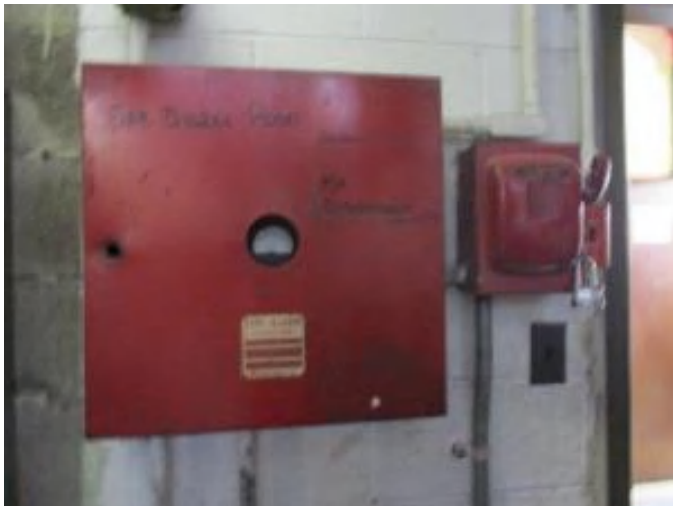
The Fire Alarm system is manufactured by S.H. Couch Inc. The system is approximately 30 years old. The present Fire Alarm system does not meet current code and needs to be replaced. Fire alarm system is tested every day in the morning.

**Location:** Entire Building  
**Distress:** Life Safety / NFPA / PFD  
**Category:** 1 - Health & Safety  
**Priority:** 3 - Response Time (3-4 yrs)  
**Correction:** Replace fire alarm system  
**Qty:** 1.00  
**Unit of Measure:** S.F.  
**Estimate:** \$87,743.47  
**Assessor Name:** System  
**Date Created:** 01/22/2016

**Notes:** Replace old fire alarm system with addressable type with audio/visual devices at corridors and classrooms. Approximate 25 devices

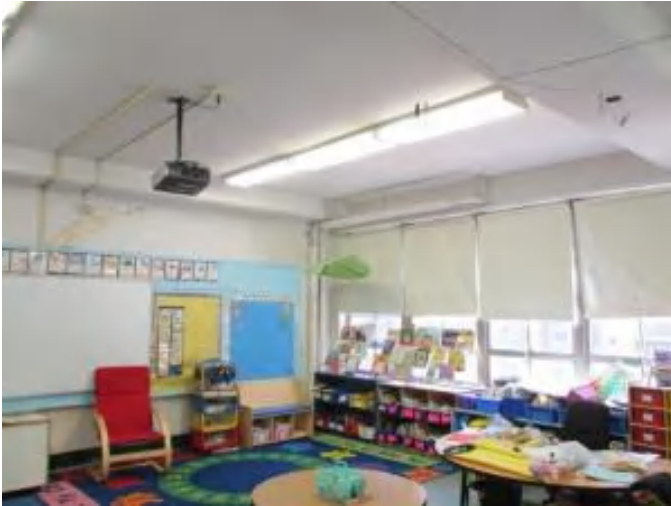
**Location:** Entire Building

Classrooms, corridors, library and the gymnasium/cafeteria are illuminated with surface mounted, wraparound lens fluorescent fixtures. Approximately 80% of the fluorescent fixtures are provided with T-12 lamps. T-12 lamps are becoming more expensive, consume more energy and are difficult to find, therefore replace all existing fluorescent fixtures with T-12 lamps with fluorescent fixtures with T-8 lamps.

**Distress:** Obsolete

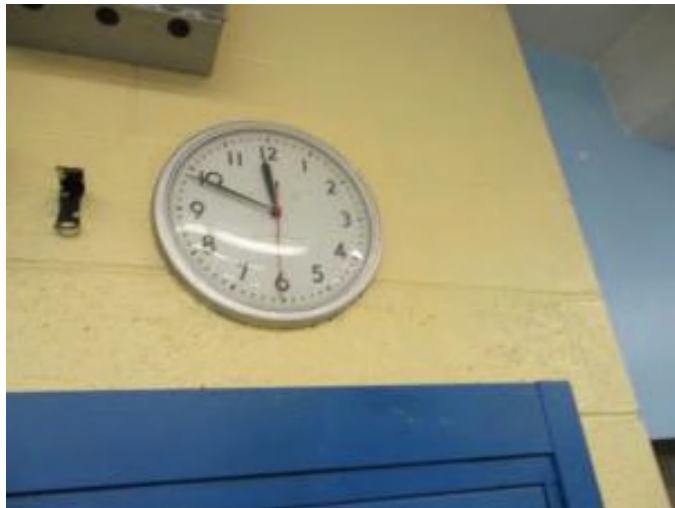
**Location:** Entire Building

**Distress:** Obsolete

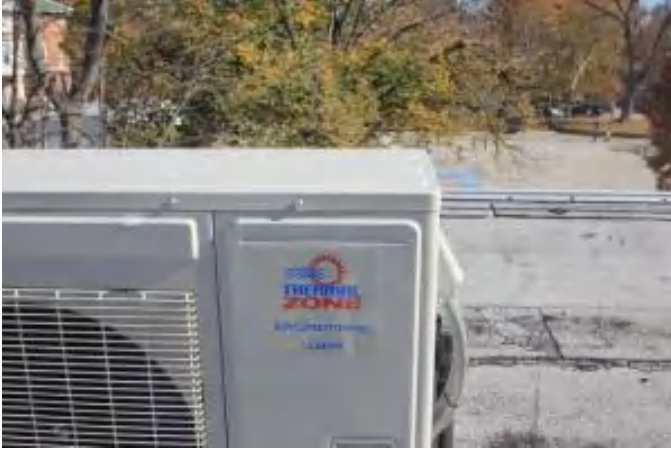
**Location:** Main building

The main building has no central cooling generating equipment. The library has a 5 ton roof top heat pump installed in 2006. It is in good condition with at least 5 years remaining life. There is also a 2 ton roof top condensing unit for a ductless air conditioner in the computer network equipment room. A 40 ton system should be installed for the main building.

**Distress:** Inadequate

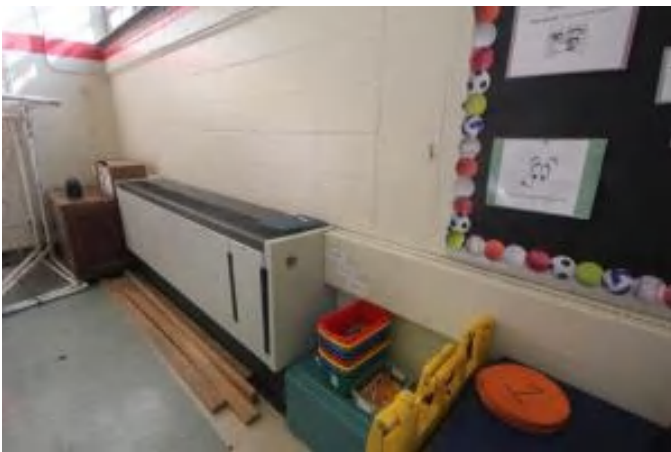
**Location:** Main building

Classrooms in the main building have unit ventilators for heating and ventilation. They are late 20<sup>th</sup> century style, likely installed in 1994 when boilers were replaced. They are reaching the end of their lifespan and lack cooling capability and should be replaced when air conditioning is added to the building. Classroom excess air discharges to the corridors through transfer ducts in the closets, then to a vertical duct chase leading to gravity vent on the roof. The library has heating, cooling, and ventilation provided by its rooftop heat pump. There is a central duct with slot diffusers running the length of the ceiling with return grills beside it at the far end. Toilet rooms exhaust into the pipe chases which lead to roof top exhaust fans. The cafeteria kitchen has a gas burning convection oven with its exhaust ducted outside and piped to above the roof level. The teacher lounge has a gas burning range without exhaust hood. It should be removed, replaced with an electric range, or have an exhaust hood installed.

**Distress:** Beyond Service Life

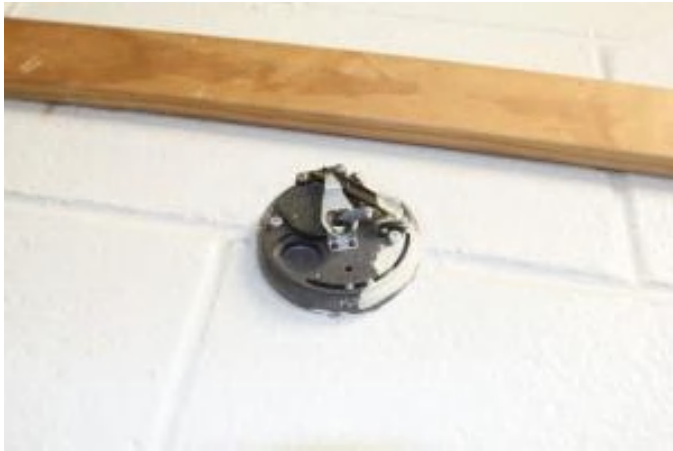
**Location:** Main building  
**Distress:** Obsolete  
**Category:** 3 - Operations / Maint.  
**Priority:** 5 - Response Time (> 5 yrs)  
**Correction:** Replace pneumatic controls with DDC (75KSF)  
**Qty:** 18,000.00  
**Unit of Measure:** S.F.  
**Estimate:** \$386,137.65  
**Assessor Name:** System  
**Date Created:** 02/15/2016

**Notes:** Upgrade controls to digital

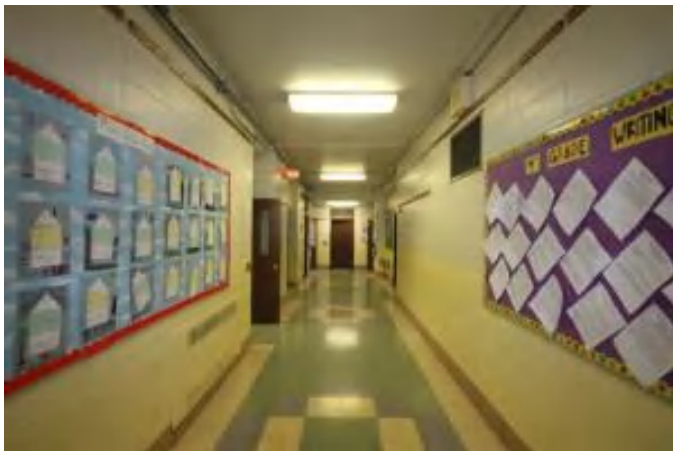
**Location:** Entire building  
**Distress:** Life Safety / NFPA / PFD  
**Category:** 1 - Health & Safety  
**Priority:** 5 - Response Time (> 5 yrs)  
**Correction:** Install a fire protection sprinkler system  
**Qty:** 18,000.00  
**Unit of Measure:** S.F.  
**Estimate:** \$257,498.03  
**Assessor Name:** System  
**Date Created:** 02/16/2016

**Notes:** Install a fire protection sprinkler system, including fire pump if required by city water pressure

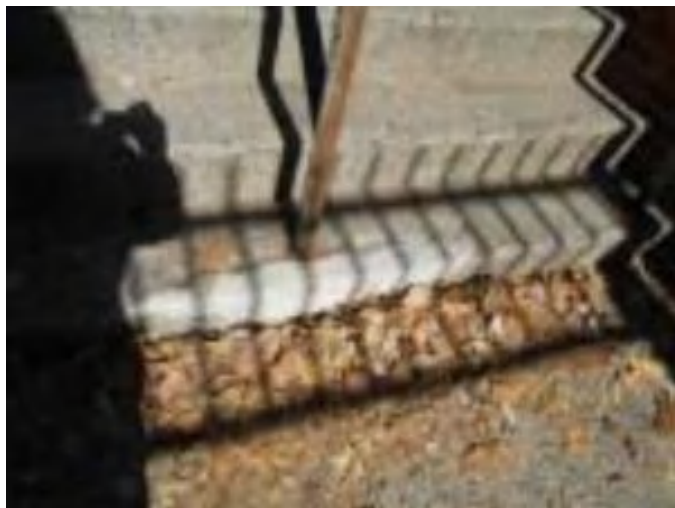
**Location:** Site steps

**Distress:** Failing

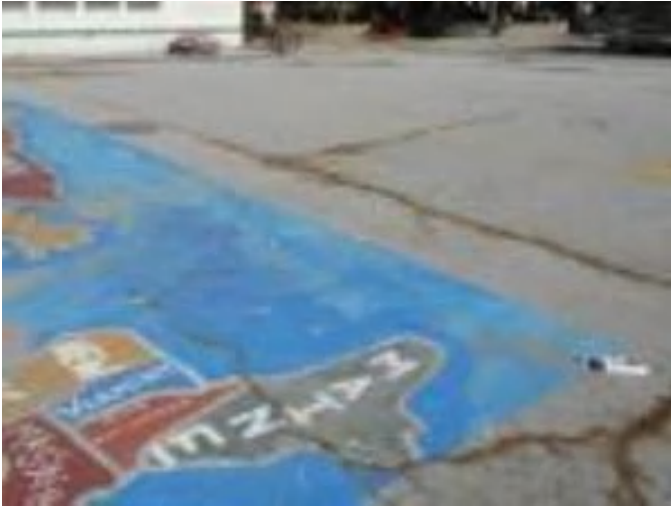
**Location:** Playground

This school has no on-site parking. Asphalt playgrounds are in fair condition with some settled areas, ponding, alligatoring, deeper cracking and vegetation in the asphalt. The playground is generally elevated above adjacent streets/sidewalks and steps are in need of repair. The south side of the building features brick screen walls enclosing a patio with picket fencing, retaining walls, planter areas, concrete paving and steps with evidence of repairs. Other pedestrian paving is concrete along city streets.

**Distress:** Beyond Service Life

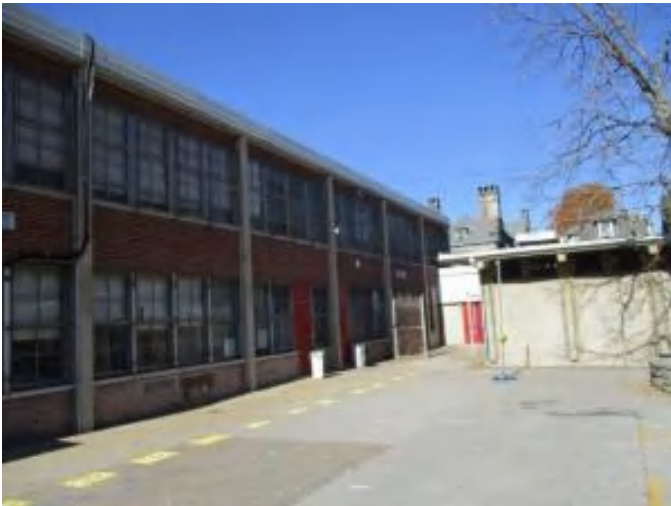
**Location:** Building Perimeter

**Distress:** Security Issue
