## Facility Condition Assessment Summary Report

### Rhawnhurst School

## **Site Assessment Report**

January 31, 2017

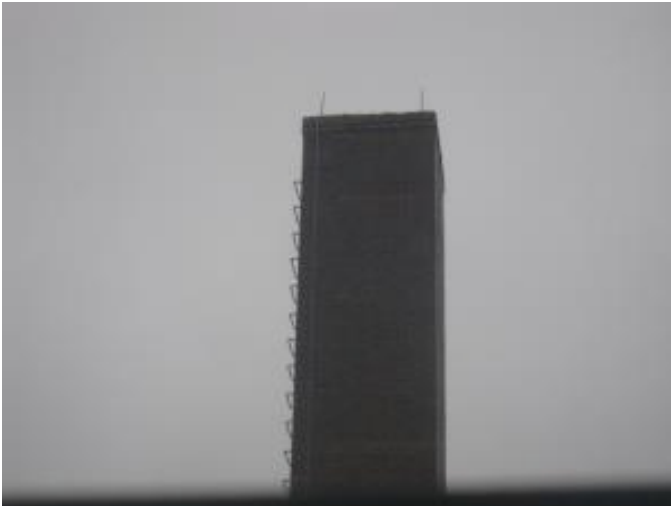
**Location:** chimney coping cap

#### System: B2010 - Exterior Walls

**Distress:** Failing

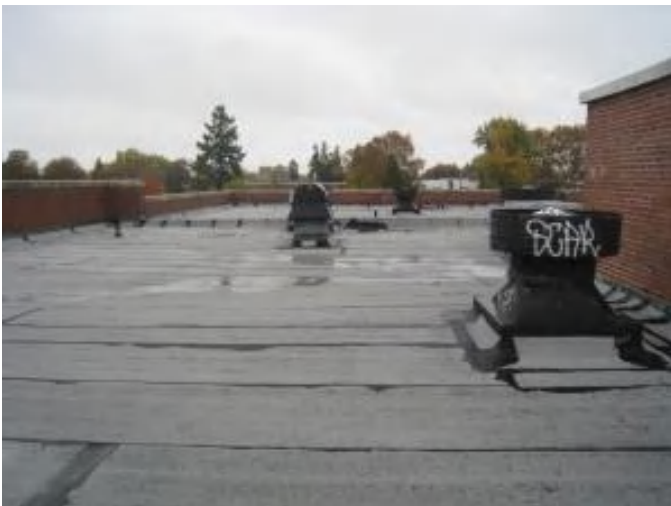
**Location:** exterior walls and walls above roof

#### System: B2010 - Exterior Walls

**Distress:** Appearance

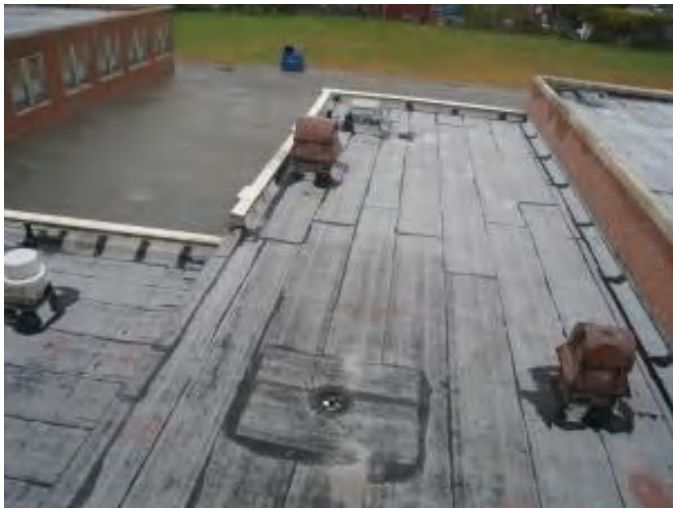
**Location:** roof

**System: B3010105 - Built-Up**

**Distress:** Failing

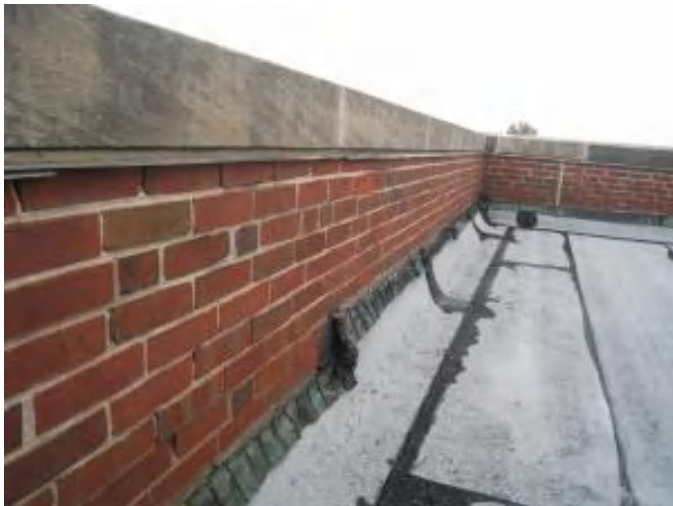
**Location:** roof

**System: B3010105 - Built-Up**

**Distress:** Building Envelope Integrity

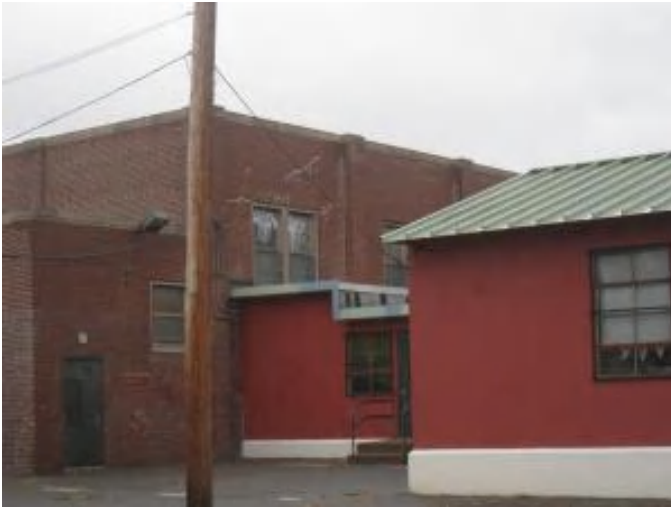
**Location:** low roof gravel stop

**System: B3010105 - Built-Up**

**Distress:** Failing

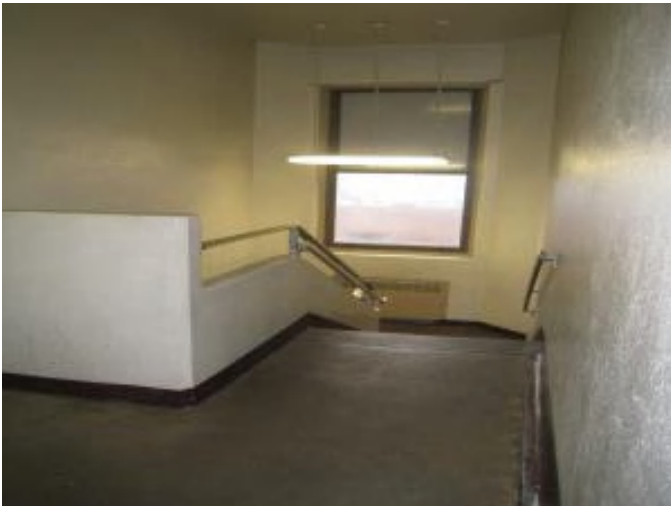
**Location:** interior stairways

**System: C2010 - Stair Construction**

**Distress:** Building / MEP Codes

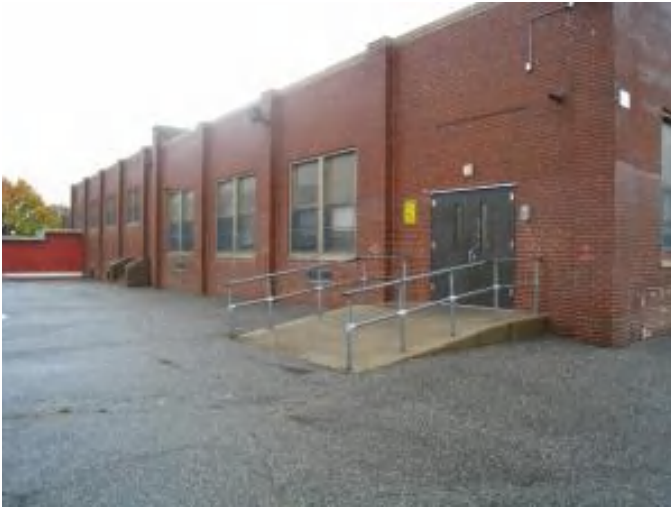
**Location:** exterior ramp handrails

**System: C2010 - Stair Construction**

**Distress:** Building / MEP Codes

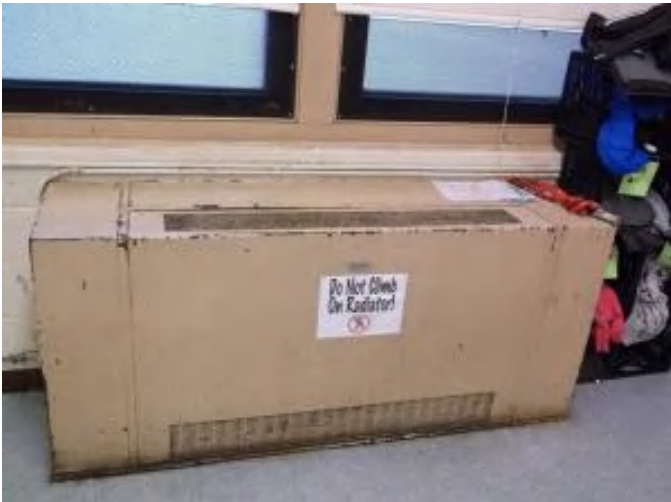
**Location:** Throughout the building

**System: D3040 - Distribution Systems**

**Distress:** Beyond Service Life

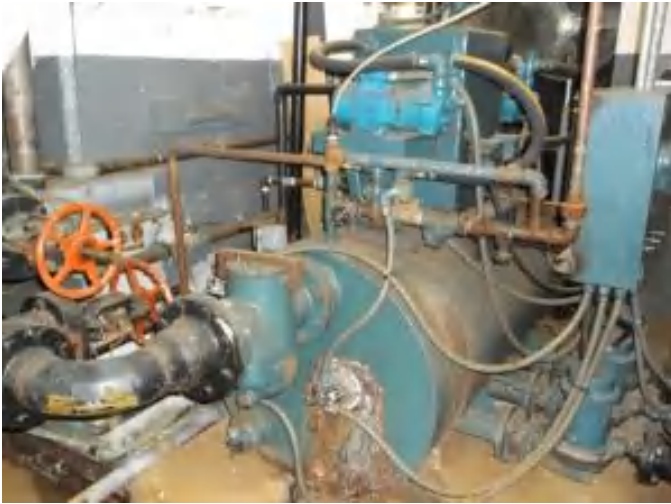
**Location:** Throughout the building

**System: D3040 - Distribution Systems**

**Distress:** Beyond Service Life

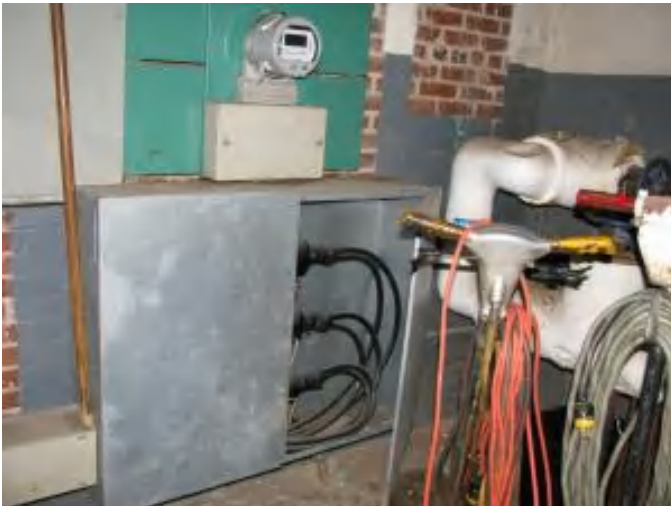
**Location:** Boiler Room

**System: D5010 - Electrical Service/Distribution**

**Distress:** Beyond Service Life

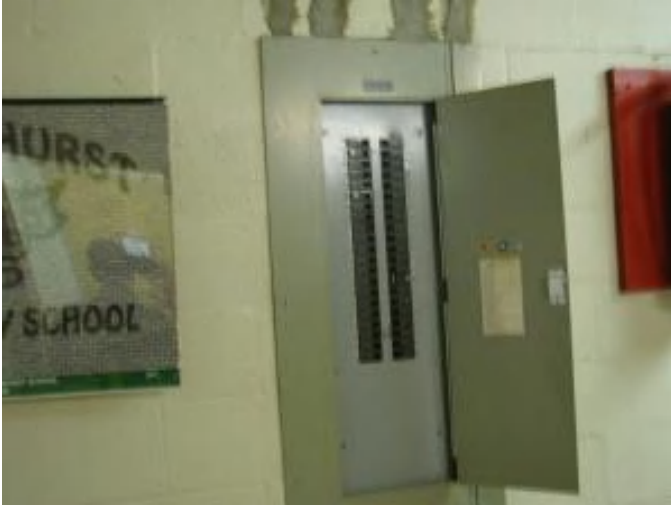
**Location:** Entire building

**System: D5010 - Electrical Service/Distribution**

**Distress:** Beyond Service Life

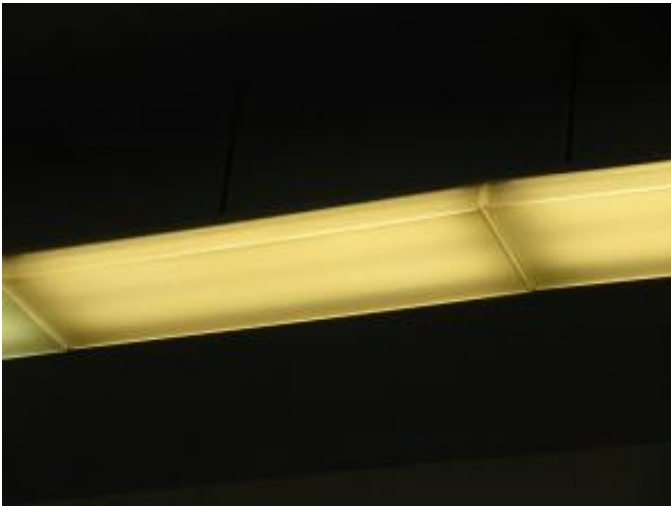
**Location:** Interior Building

**System: D5020 - Lighting and Branch Wiring**

**Distress:** Beyond Service Life

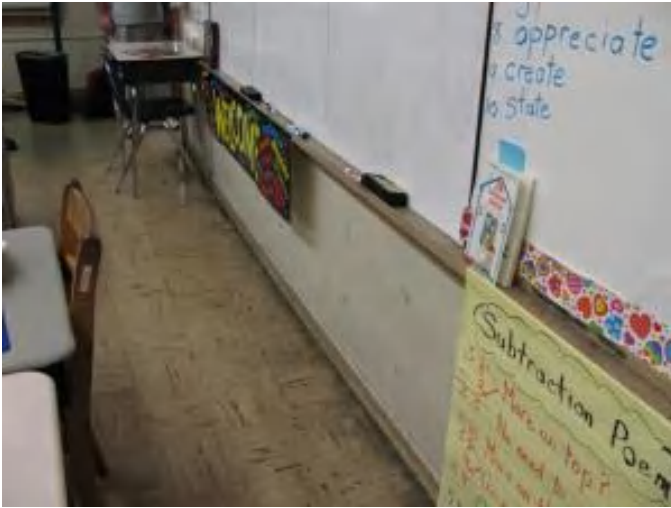
**Location:** Entire Building

**System: D5020 - Lighting and Branch Wiring**

**Distress:** Inadequate

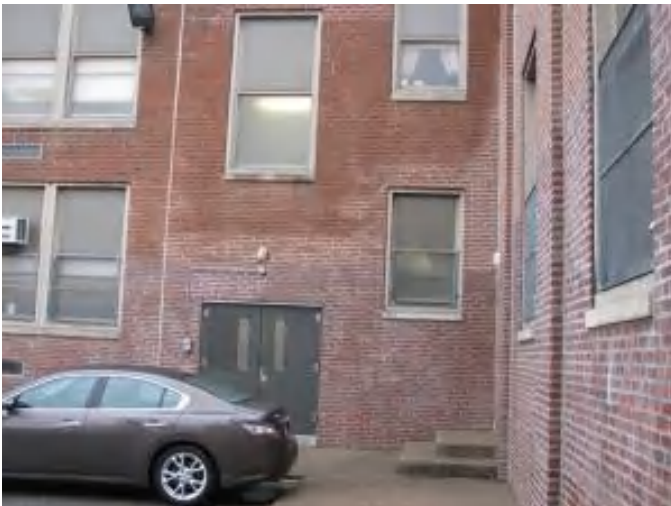
**Location:** Exterior Building

**System: D5020 - Lighting and Branch Wiring**

**Distress:** Damaged

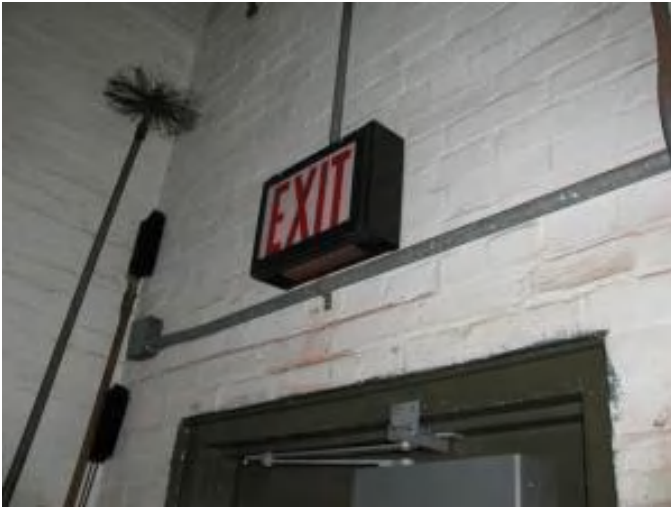
**Location:** Entire Building

**System: D5020 - Lighting and Branch Wiring**

**Distress:** Damaged

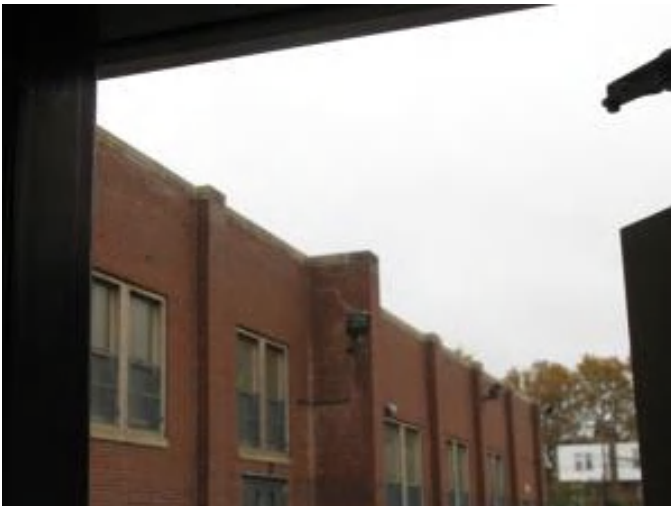
**Location:** Entire Building

**System: D5030 - Communications and Security**

**Distress:** Security Issue

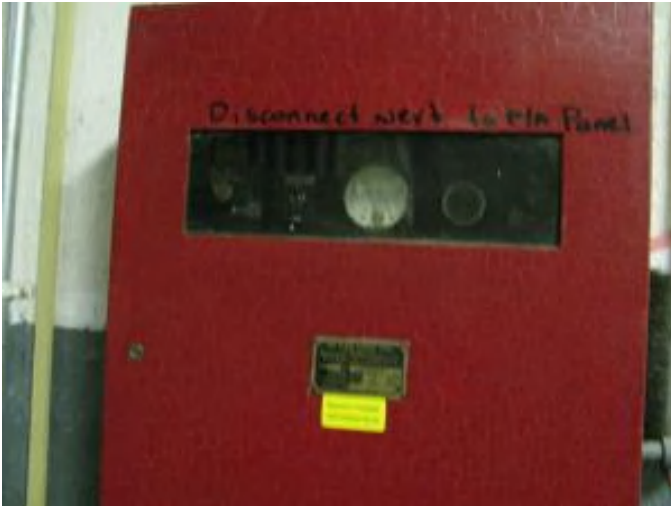
**Location:** Entire Building

**System: D5030 - Communications and Security**

**Distress:** Life Safety / NFPA / PFD

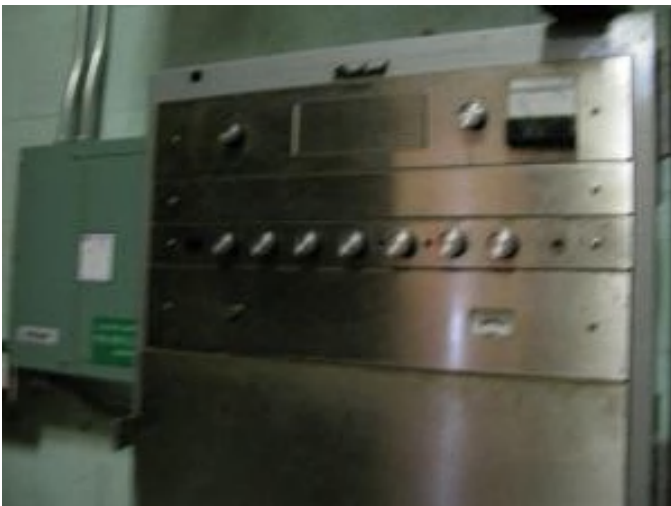
**Location:** Auditorium

**System: D5030 - Communications and Security**

**Distress:** Inadequate

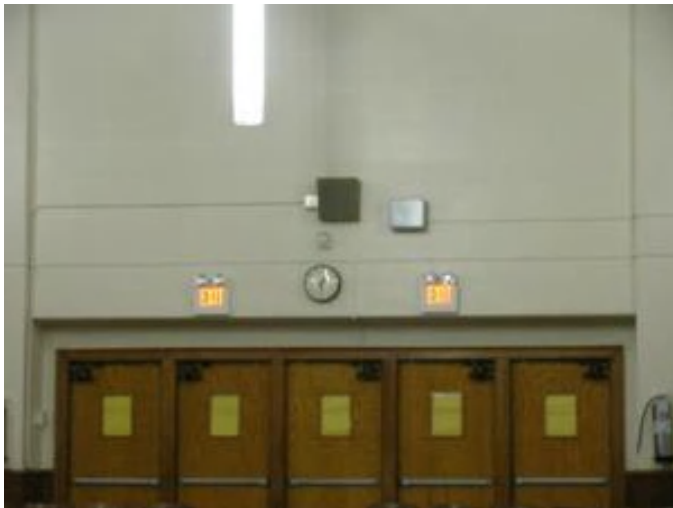
**Location:** Entier Building

**System: D5030 - Communications and Security**

**Distress:** Damaged

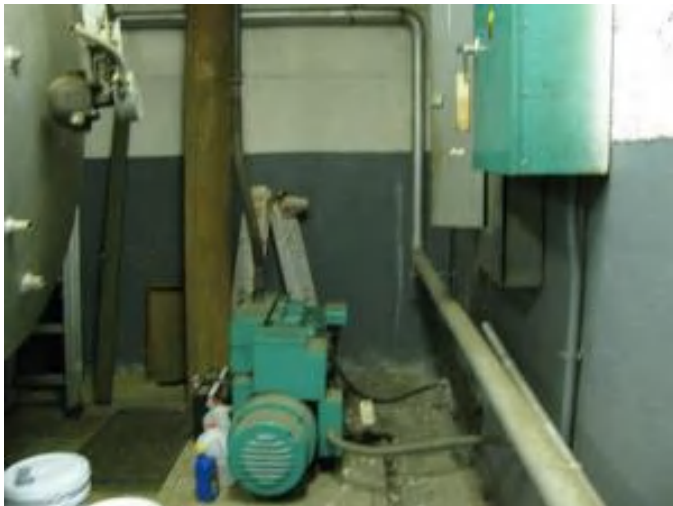
**Location:** Boiler Room

**System: D5090 - Other Electrical Systems**

**Distress:** Life Safety / NFPA / PFD

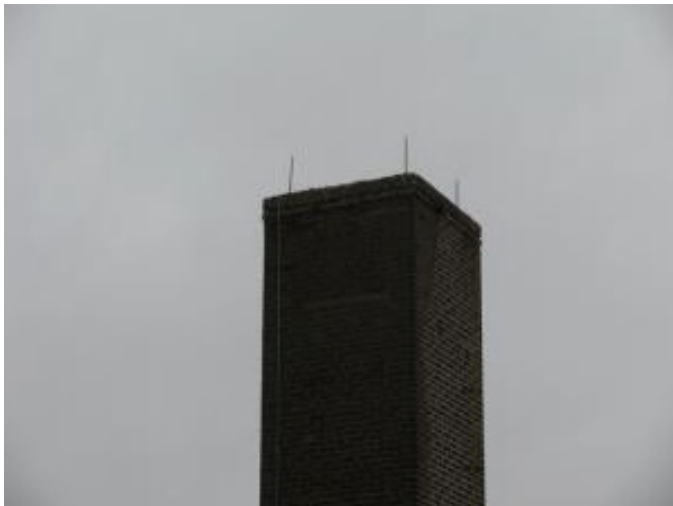
**Location:** Roof

**System: D5090 - Other Electrical Systems**

**Distress:** Health Hazard / Risk

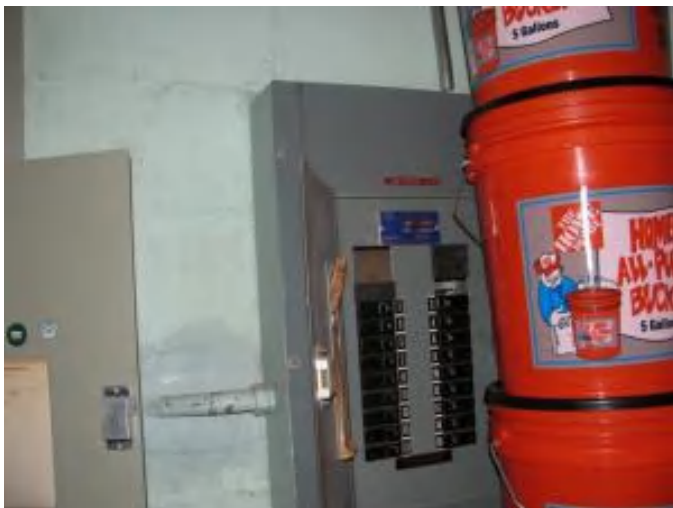
**Location:** Auditorium

**System: E1020 - Institutional Equipment**

**Distress:** Inadequate

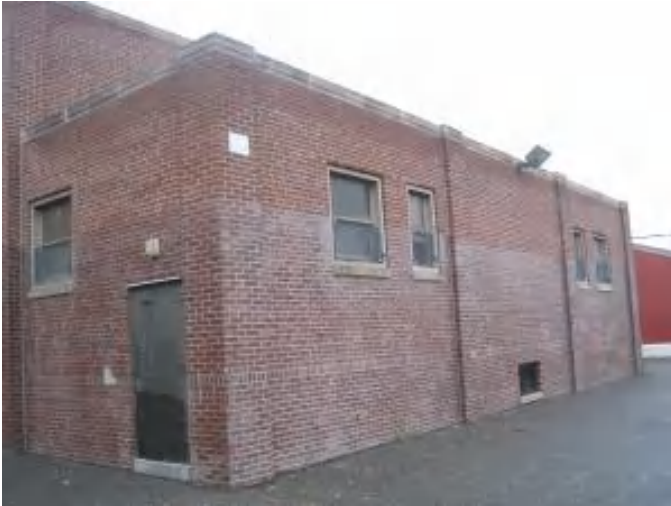
**Location:** exterior walls - first floor

**System: B2010 - Exterior Walls**

**Distress:** Appearance

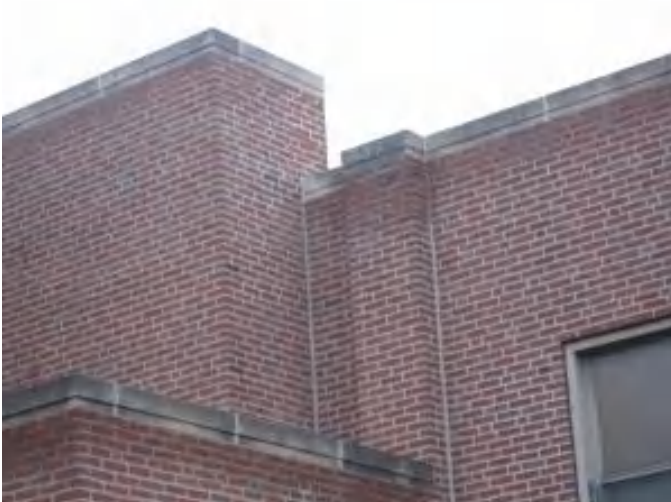
**Location:** exterior walls

**System: B2010 - Exterior Walls**

**Distress:** Building Envelope Integrity

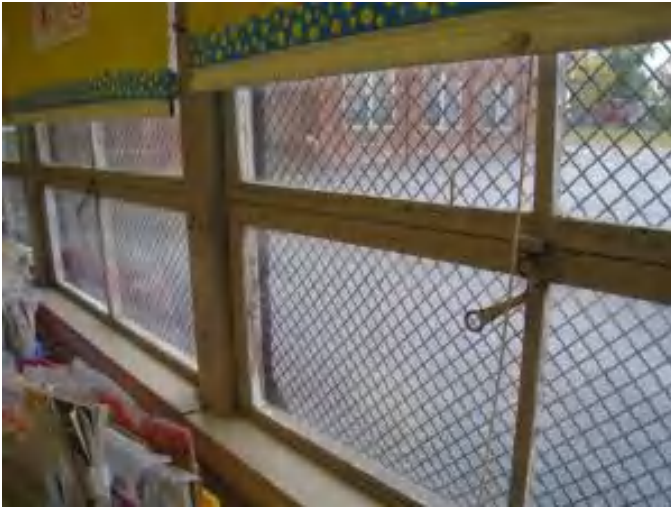
**Location:** windows

**System: B2020 - Exterior Windows**

**Distress:** Failing

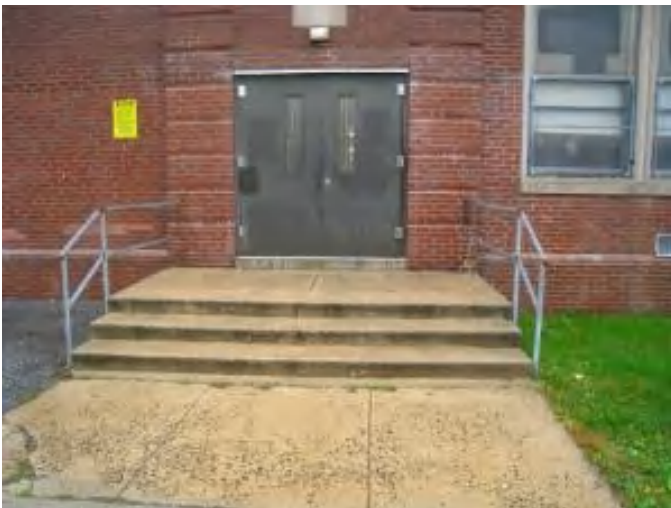
**Location:** exterior doors

**System: B2030 - Exterior Doors**

**Distress:** Building Envelope Integrity

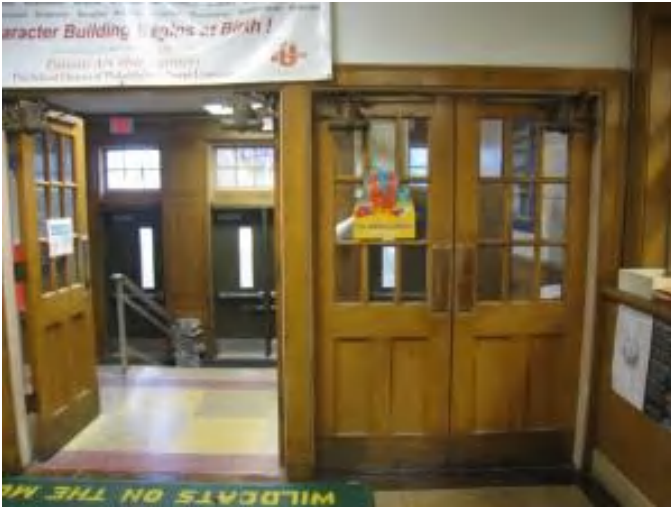
**Location:** classroom, toilet room, office doors

**System: C1020 - Interior Doors**

**Distress:** Building / MEP Codes

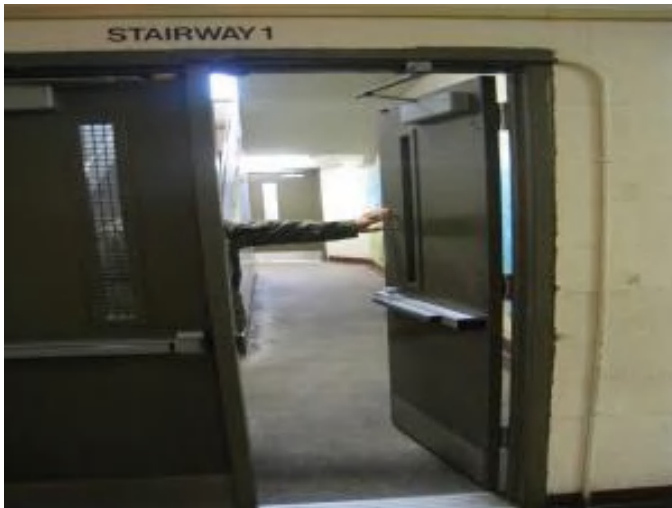
**Location:** stairway doors

**System: C1020 - Interior Doors**

**Distress:** Building / MEP Codes

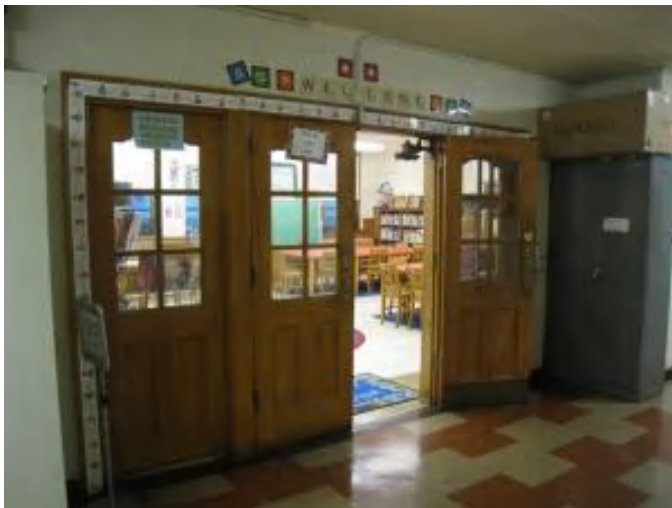
**Location:** corridor doors to classrooms and offices

**System: C1020 - Interior Doors**

**Distress:** Security Issue

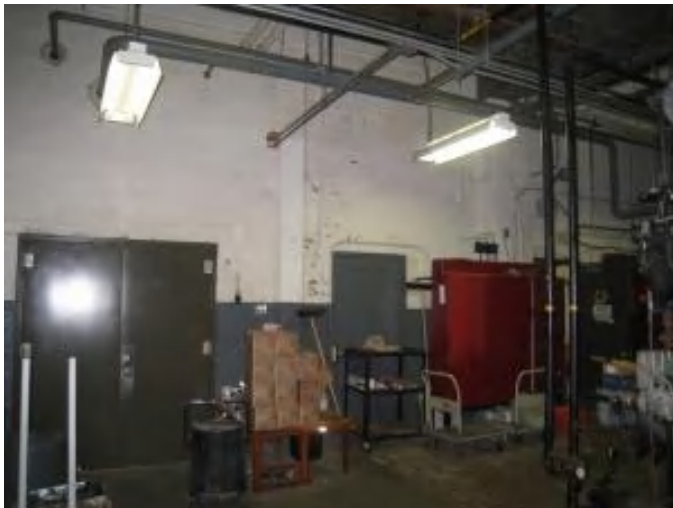
**Location:** basement doors

**System: C1020 - Interior Doors**

**Distress:** Appearance

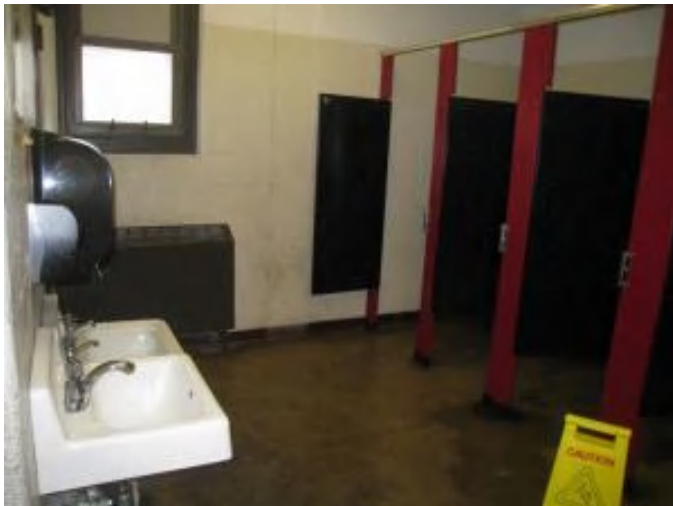
**Location:** toilet rooms

**System: C1030 - Fittings**

**Distress:** Accessibility

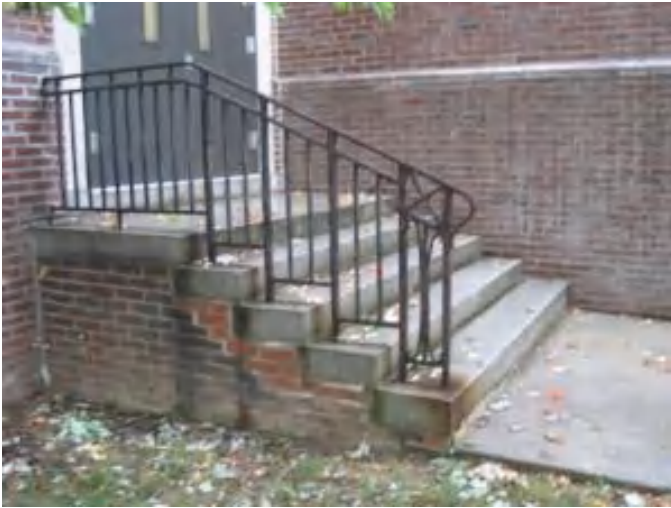
**Location:** exterior stairway handrails

**System: C2010 - Stair Construction**

**Distress:** Appearance

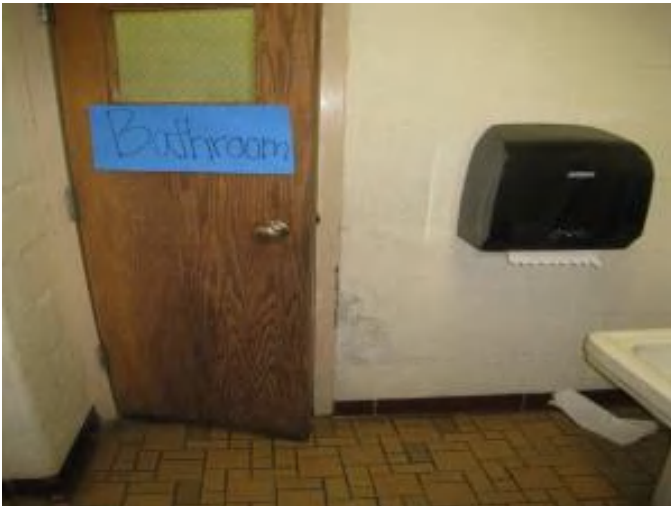
**Location:** interior block walls

**System: C3010230 - Paint & Covering**

**Distress:** Appearance

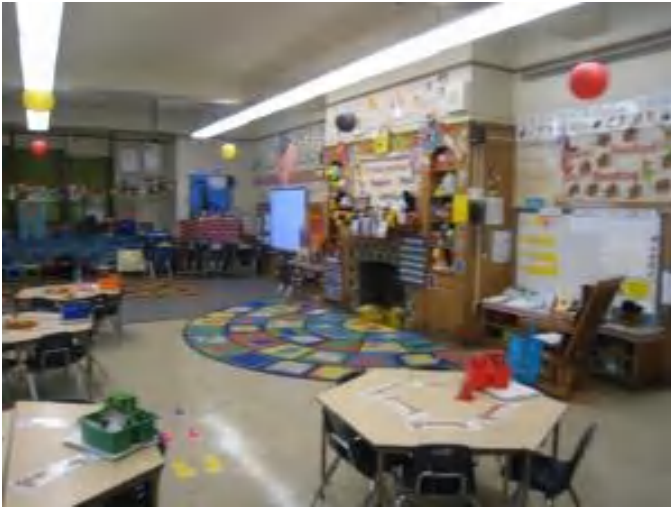
**Location:** kindergartens

**System: C3010230 - Paint & Covering**

**Distress:** Damaged

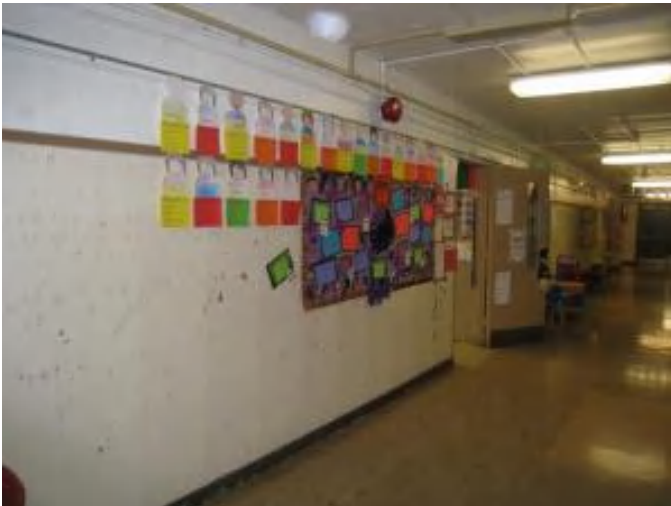
**Location:** floors

**System: C3020413 - Vinyl Flooring**

**Distress:** Failing

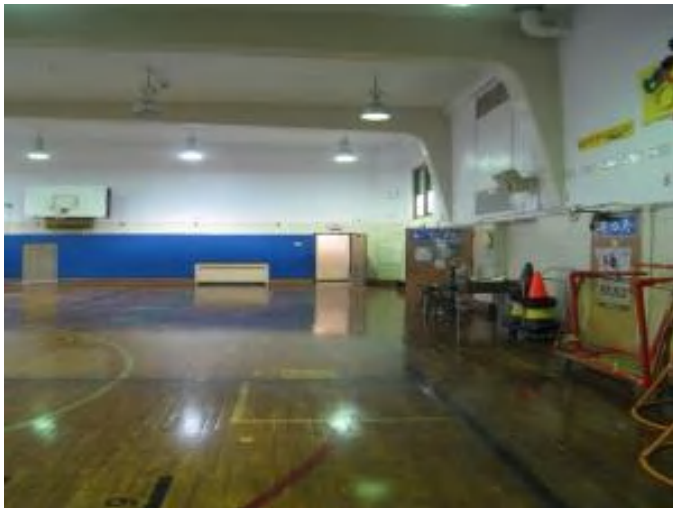
**Location:** gymnasium and stage

**System: C3020414 - Wood Flooring**

**Distress:** Appearance

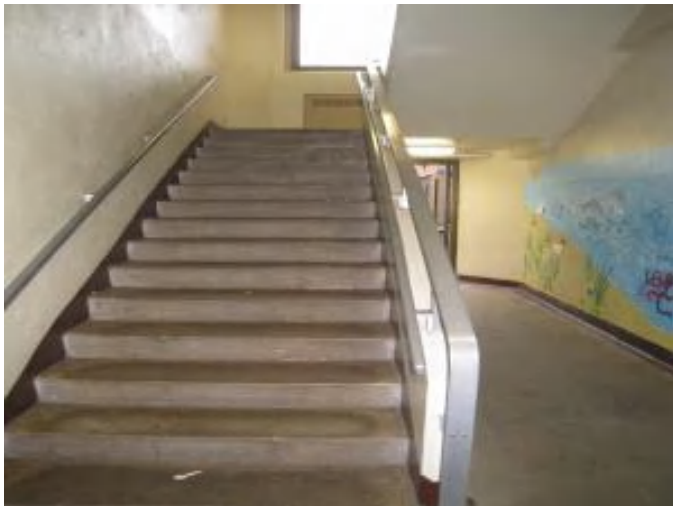
**Location:** mechanical areas, toilet rooms, stairways

**System: C3020415 - Concrete Floor Finishes**

**Distress:** Appearance

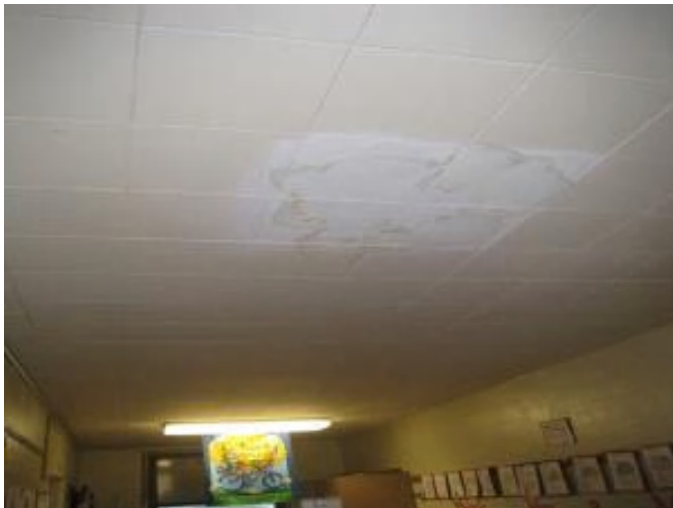
**Location:** corridor ceilings

**System: C3030 - Ceiling Finishes**

**Distress:** Damaged

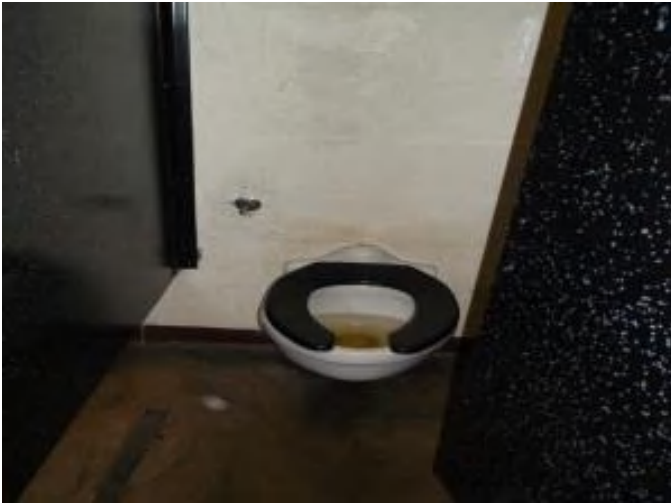
**Location:** Throughout the building

**System: D2010 - Plumbing Fixtures**

**Distress:** Beyond Service Life

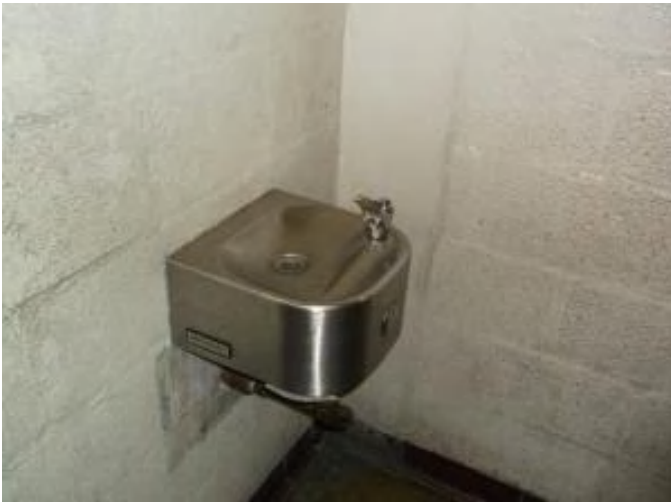
**Location:** Throughout the building

**System: D2010 - Plumbing Fixtures**

**Distress:** Beyond Service Life

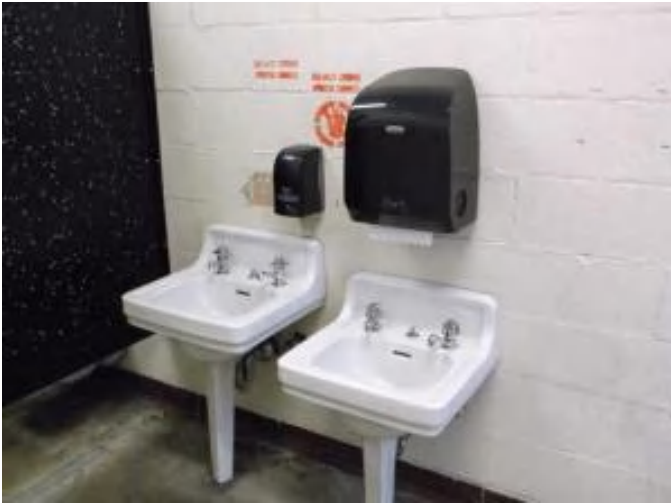
**Location:** Throughout the building

**System: D2010 - Plumbing Fixtures**

**Distress:** Beyond Service Life

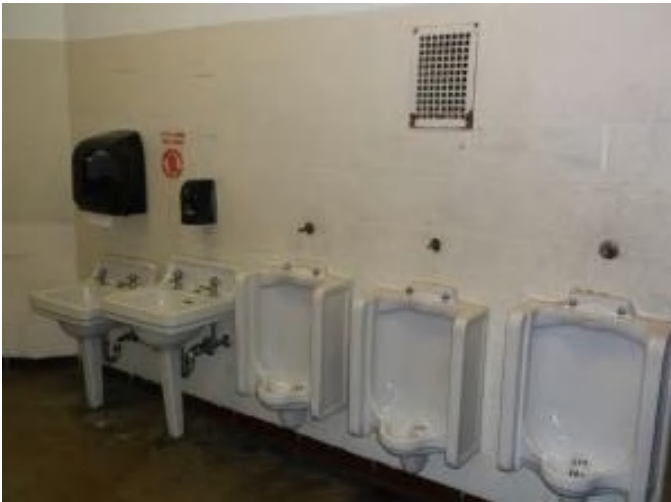
**Location:** Throughout the building

**System: D2010 - Plumbing Fixtures**

**Distress:** Beyond Service Life

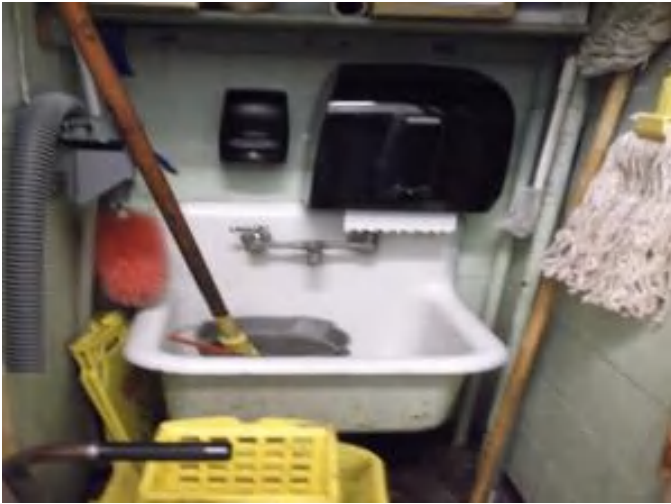
**Location:** Throughout the building

**System: D2010 - Plumbing Fixtures**

**Distress:** Beyond Service Life

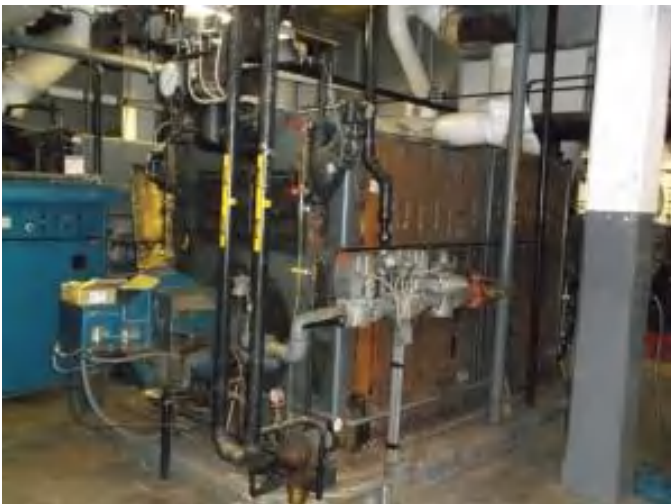
**Location:** Main boiler mechanical equipment room

**System: D3020 - Heat Generating Systems**

**Distress:** Beyond Service Life

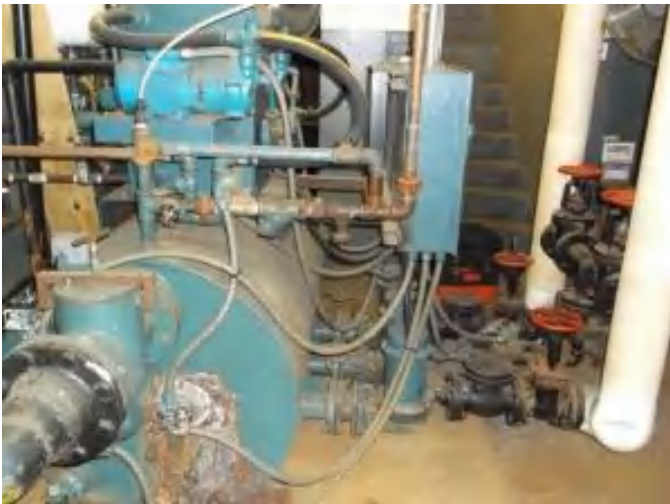
**Location:** Throughout the building

**System: D3040 - Distribution Systems**

**Distress:** Beyond Service Life

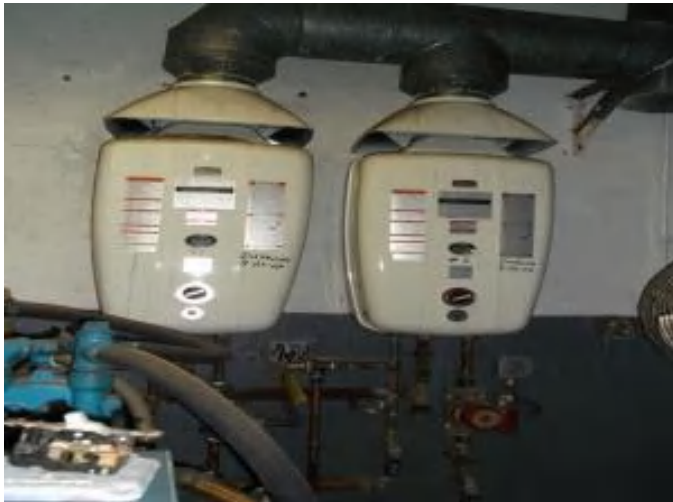
**Location:** Main boiler mechanical equipment room

**System: D2020 - Domestic Water Distribution**

**Distress:** Beyond Service Life

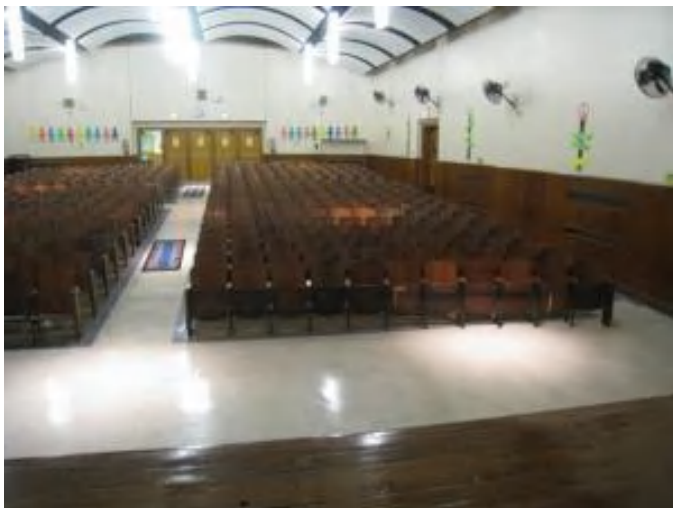
**Location:** auditorium

**System: E2010 - Fixed Furnishings**

**Distress:** Appearance

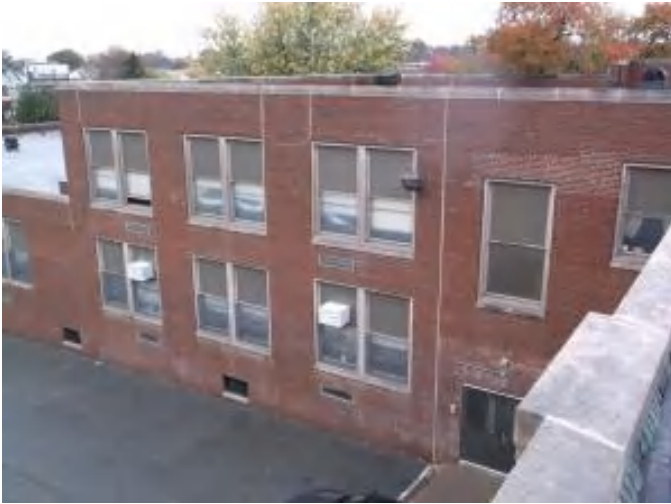
**Location:** Adjacent to the building

**System: D3030 - Cooling Generating Systems**

**Distress:** Inadequate

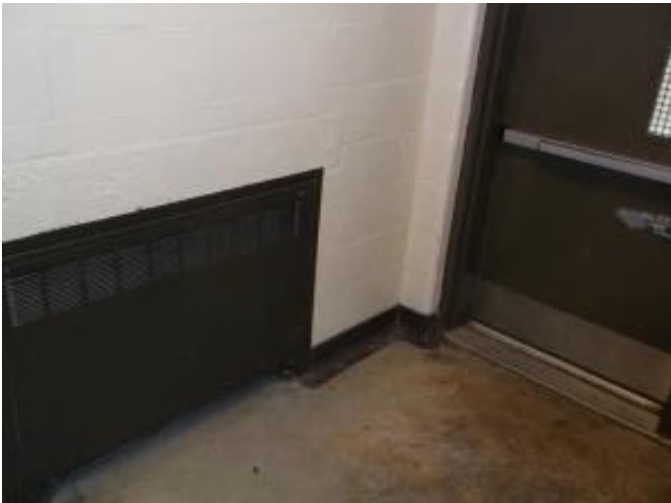
**Location:** Throughout the building

**System: D3040 - Distribution Systems**

**Distress:** Beyond Service Life

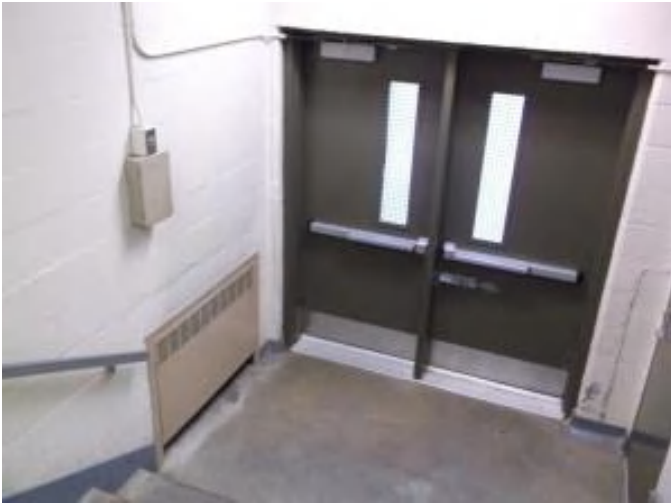
**Location:** Throughout the building

**System: D3040 - Distribution Systems**

**Distress:** Beyond Service Life

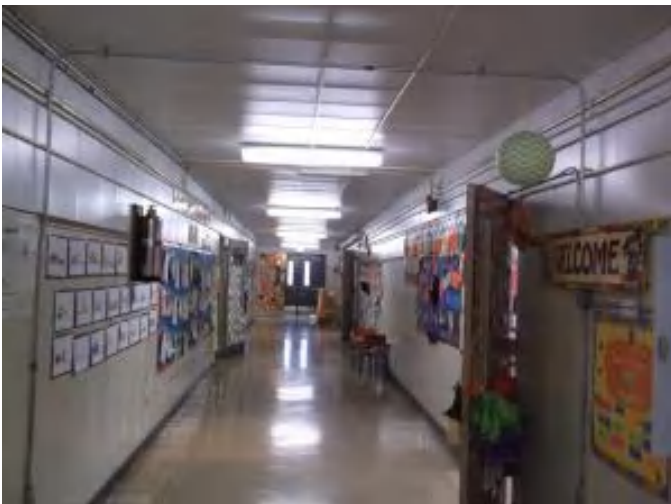
**Location:** Throughout the building

**System: D4010 - Sprinklers**

**Distress:** Life Safety / NFPA / PFD

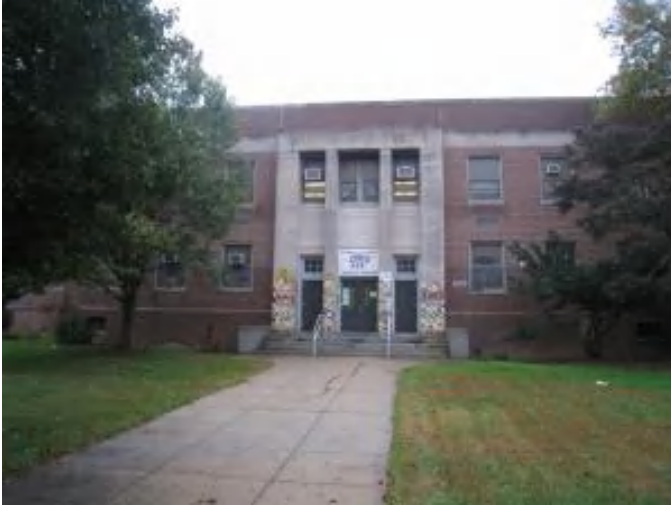
**Location:** concrete walkways

#### System: G2030 - Pedestrian Paving

**Distress:** Damaged

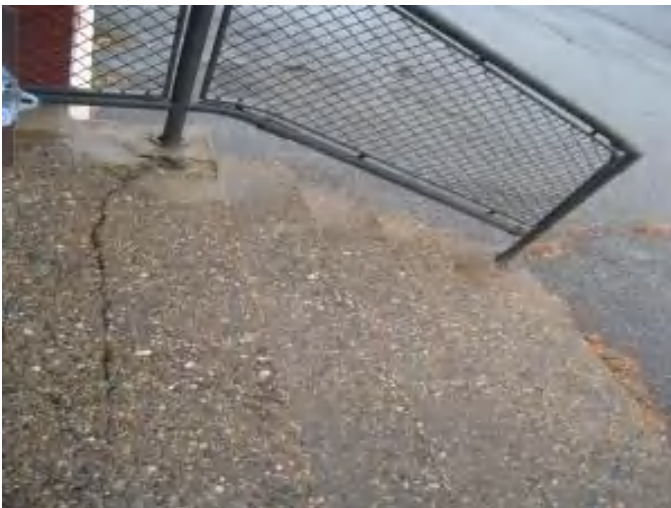
**Location:** exterior stair

#### System: G2030 - Pedestrian Paving

**Distress:** Damaged

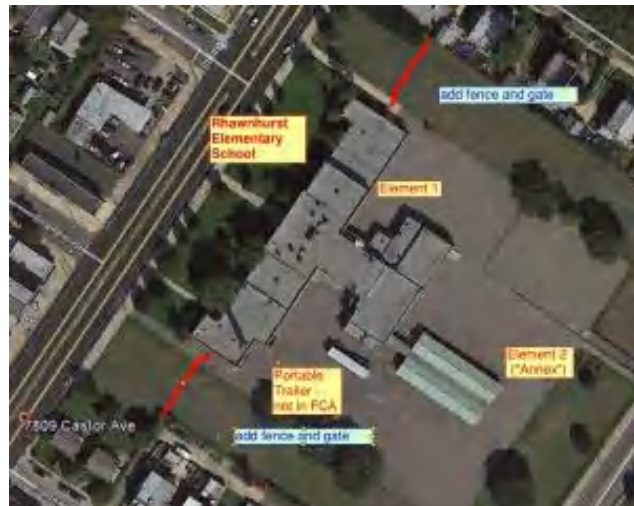
**Location:** site fence and gates at front/sides

**System: G2040 - Site Development**

**Distress:** Inadequate

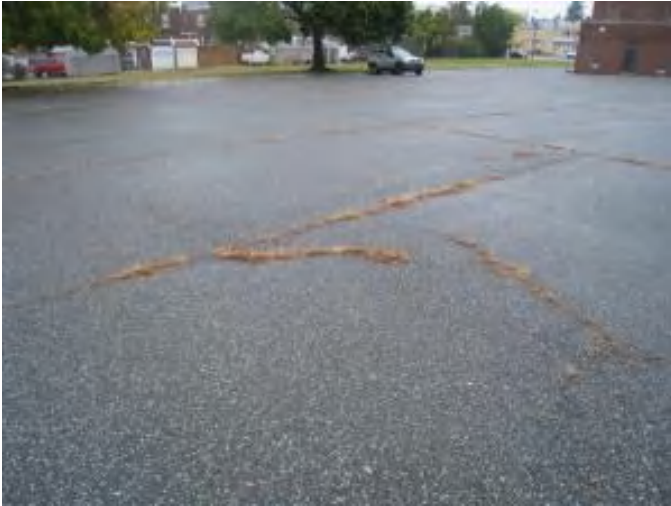
**Location:** parking lot and play area

**System: G2020 - Parking Lots**

**Distress:** Damaged
