## Facility Condition Assessment Summary Report

### Rhoads, J School

School District of Philadelphia  
**S141001;Rhoads, J**  
Final  
**Site Assessment Report**  
January 30, 2017

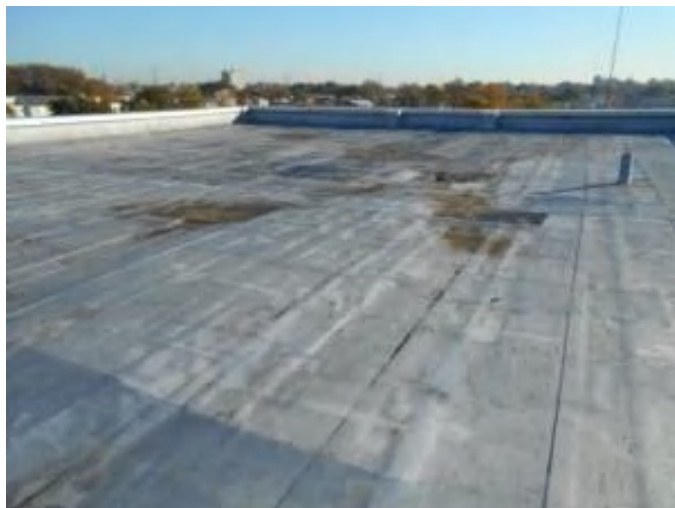
#### **System: B3010105 - Built-Up**

**Location:** Roofs

- Replace roofing
- Repair exterior walls – repoint mortar joints, replace metal panels between window sections
- Replace exterior windows
- Replace exterior doors

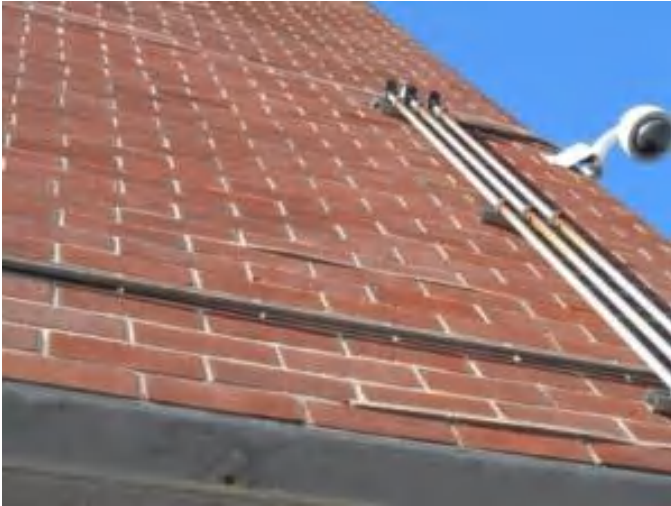
**System: B2010 - Exterior Walls**

**Location:** Exterior walls

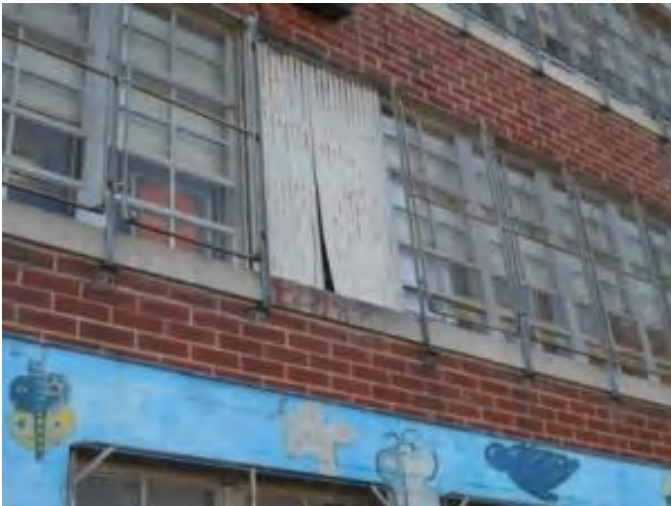
**System: B2010 - Exterior Walls**

**Location:** Metal panels between windows

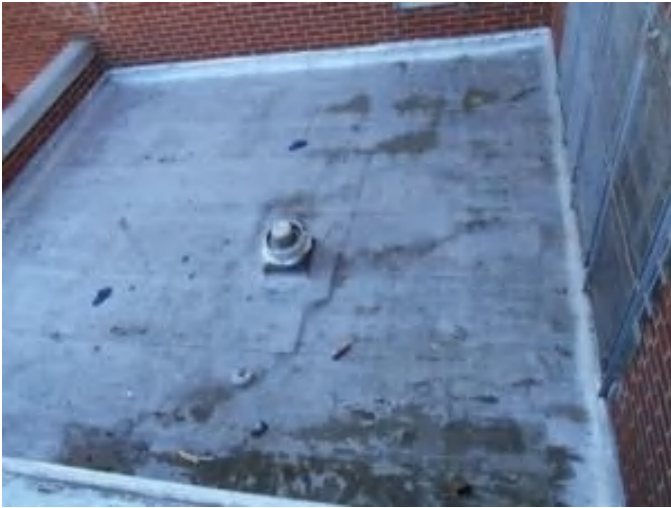
**System: B2010 - Exterior Walls**

**Location:** Gym roof to low roof  
**Distress:** OSHA  
**Category:** 2 - Code Compliance  
**Priority:** 2 - Response Time (2-3 yrs)  
**Correction:** Add fixed ladders to wall  
**Qty:** 8.00  
**Unit of Measure:** V.L.F.  
**Estimate:** \$2,219.07  
**Assessor Name:** System  
**Date Created:** 02/05/2016

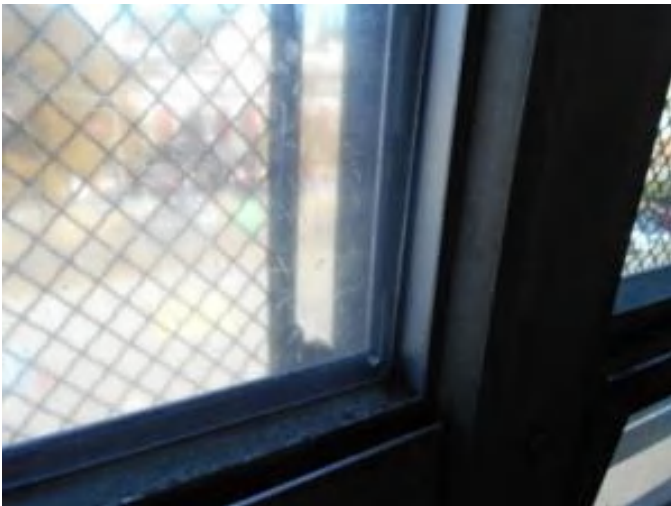
**System: B2020 - Exterior Windows**

**Location:** Exterior windows  
**Distress:** Building Envelope Integrity  
**Category:** 3 - Operations / Maint.  
**Priority:** 2 - Response Time (2-3 yrs)  
**Correction:** Remove and replace aluminum windows - pick the appropriate size and style and insert the number of units  
**Qty:** 465.00  
**Unit of Measure:** Ea.  
**Estimate:** \$2,747,298.32  
**Assessor Name:** System  
**Date Created:** 02/05/2016

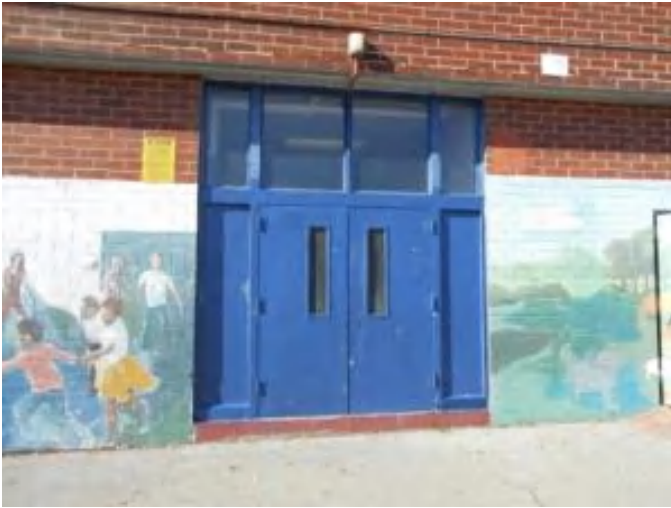
**System: B2030 - Exterior Doors**

**Location:** Exterior doors  
**Distress:** Building Envelope Integrity  
**Category:** 3 - Operations / Maint.  
**Priority:** 2 - Response Time (2-3 yrs)  
**Correction:** Remove and replace exterior doors - per leaf  
**Qty:** 22.00  
**Unit of Measure:** Ea.  
**Estimate:** \$178,113.77  
**Assessor Name:** System  
**Date Created:** 02/05/2016

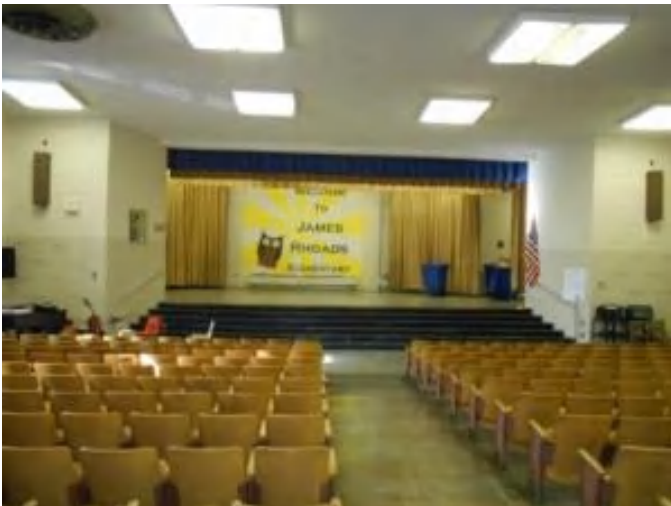
**System: B2030 - Exterior Doors**

**Location:** Auditorium  
**Distress:** Life Safety / NFPA / PFD  
**Category:** 4 - Capital Improvement  
**Priority:** 2 - Response Time (2-3 yrs)  
**Correction:** Add an exterior door in an exterior wall for safety and egress  
**Qty:** 2.00  
**Unit of Measure:** Ea.  
**Estimate:** \$13,707.90  
**Assessor Name:** System  
**Date Created:** 02/05/2016

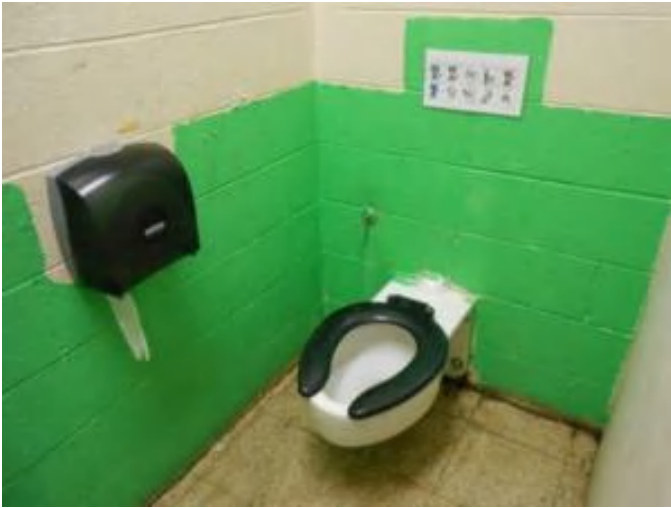
**System: C1010 - Partitions**

**Location:** Each floor TBD

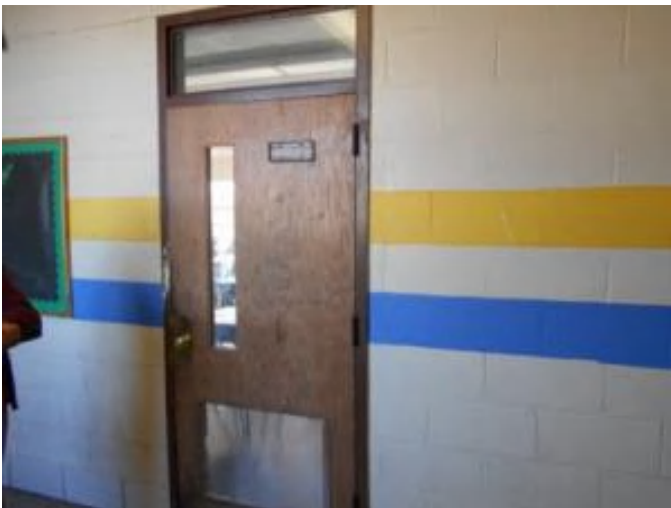
**System: C1020 - Interior Doors**

**Location:** Throughout the building

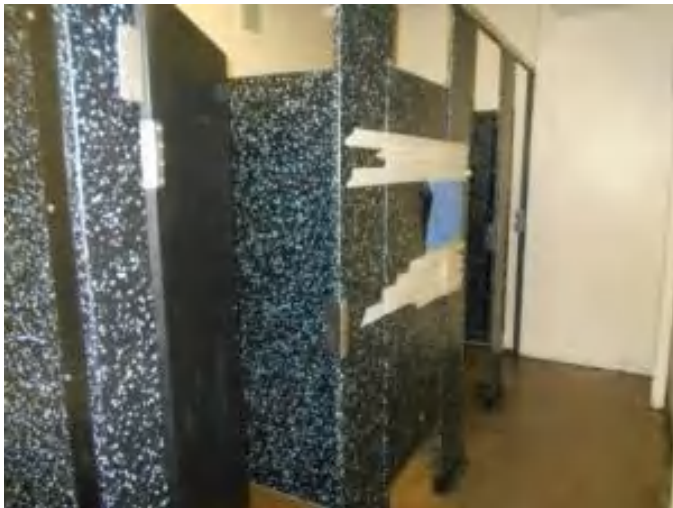
**System: C1030 - Fittings**

**Location:** Student restrooms  
**Distress:** Accessibility  
**Category:** 2 - Code Compliance  
**Priority:** 2 - Response Time (2-3 yrs)  
**Correction:** Remove and replace damaged toilet partitions - handicap units  
**Qty:** 36.00  
**Unit of Measure:** Ea.  
**Estimate:** \$97,432.75  
**Assessor Name:** System  
**Date Created:** 02/08/2016

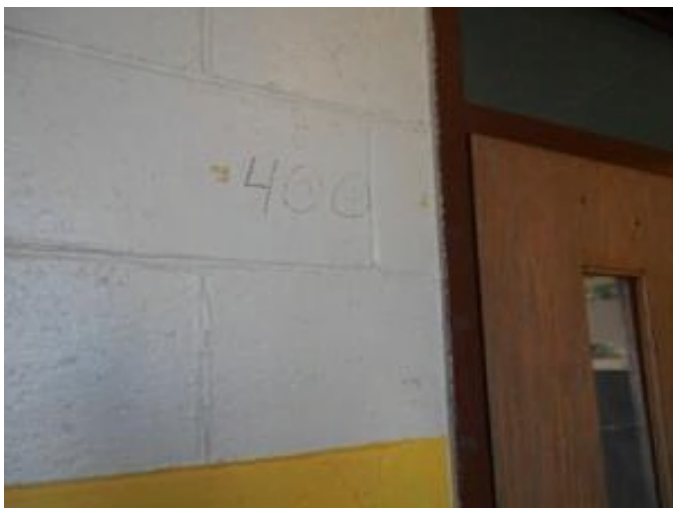
**System: C1030 - Fittings**

**Location:** Throughout the building  
**Distress:** Building / MEP Codes  
**Category:** 2 - Code Compliance  
**Priority:** 2 - Response Time (2-3 yrs)  
**Correction:** Replace missing or damaged signage - insert the number of rooms  
**Qty:** 100.00  
**Unit of Measure:** Ea.  
**Estimate:** \$27,091.25  
**Assessor Name:** System  
**Date Created:** 02/05/2016

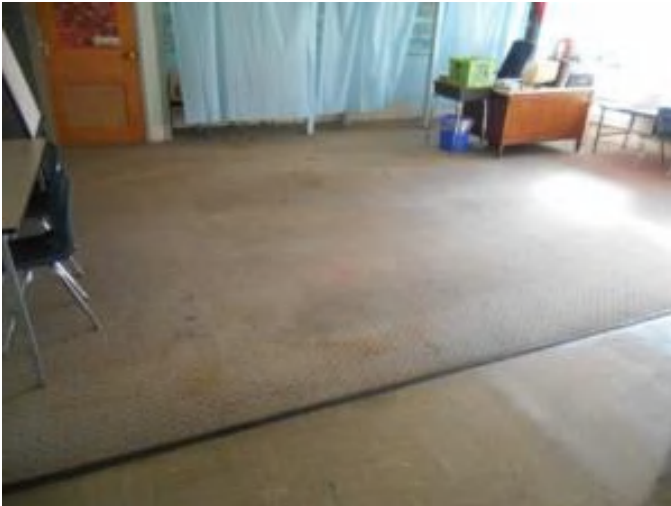
**System: C3020411 - Carpet**

**Location:** Classroom 207  
**Distress:** Beyond Service Life  
**Category:** 3 - Operations / Maint.  
**Priority:** 2 - Response Time (2-3 yrs)  
**Correction:** Remove and replace carpet  
**Qty:** 450.00  
**Unit of Measure:** S.F.  
**Estimate:** \$5,035.85  
**Assessor Name:** System  
**Date Created:** 02/05/2016

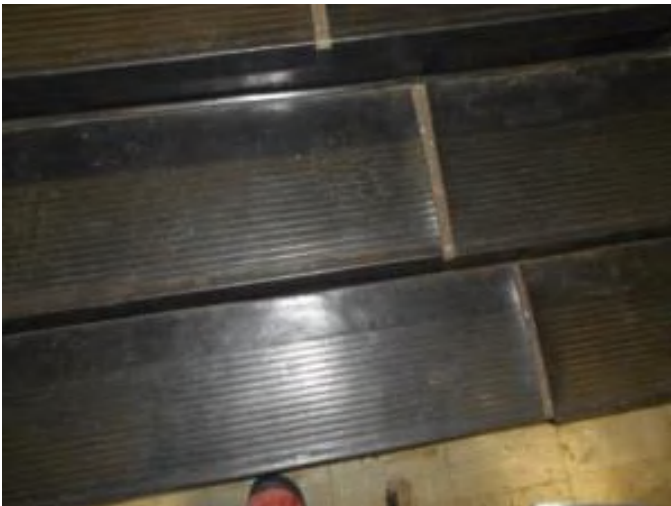
**System: C3020413 - Vinyl Flooring**

**Location:** Throughout the building  
**Distress:** Health Hazard / Risk  
**Category:** 1 - Health & Safety  
**Priority:** 2 - Response Time (2-3 yrs)  
**Correction:** Remove VAT and replace with VCT - SF of area  
**Qty:** 52,000.00  
**Unit of Measure:** S.F.  
**Estimate:** \$799,923.22  
**Assessor Name:** System  
**Date Created:** 02/05/2016

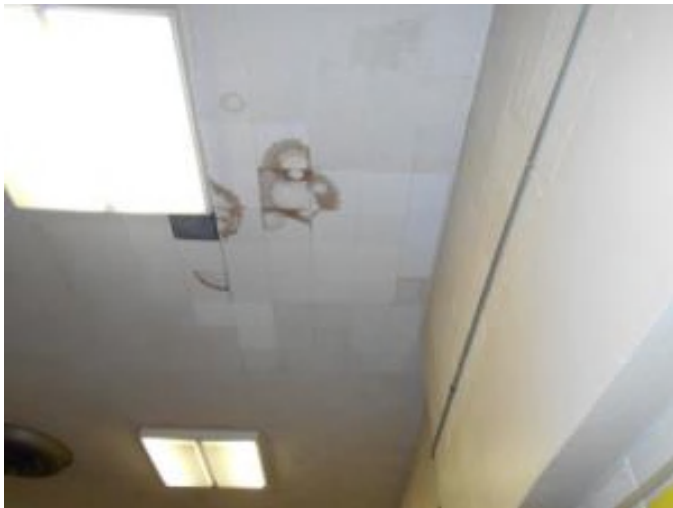
**System: C3030 - Ceiling Finishes**

**Location:** Throughout the building

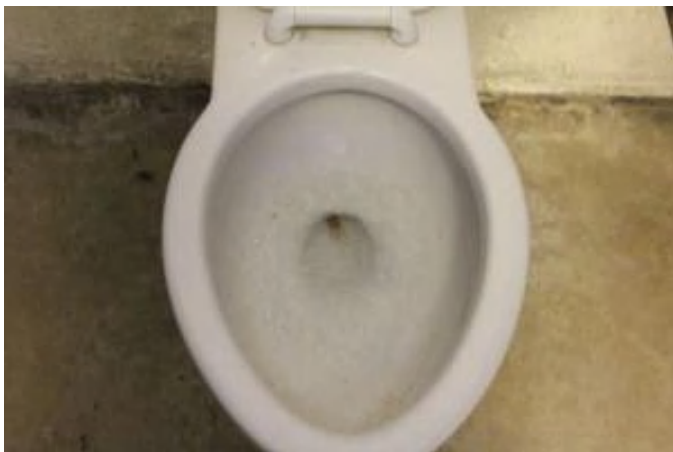
**System: D2010 - Plumbing Fixtures**

**Location:** Toilet rooms

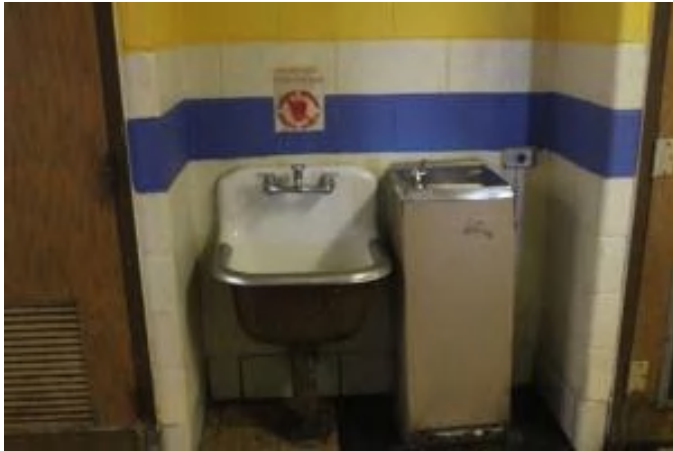
**System: D2010 - Plumbing Fixtures**

**Location:** Corridors  
**Distress:** Accessibility  
**Category:** 2 - Code Compliance  
**Priority:** 2 - Response Time (2-3 yrs)  
**Correction:** Remove and replace water fountains to meet ADA - includes high and low fountains and new recessed alcove  
**Qty:** 4.00  
**Unit of Measure:** Ea.  
**Estimate:** \$62,771.59  
**Assessor Name:** System  
**Date Created:** 02/15/2016

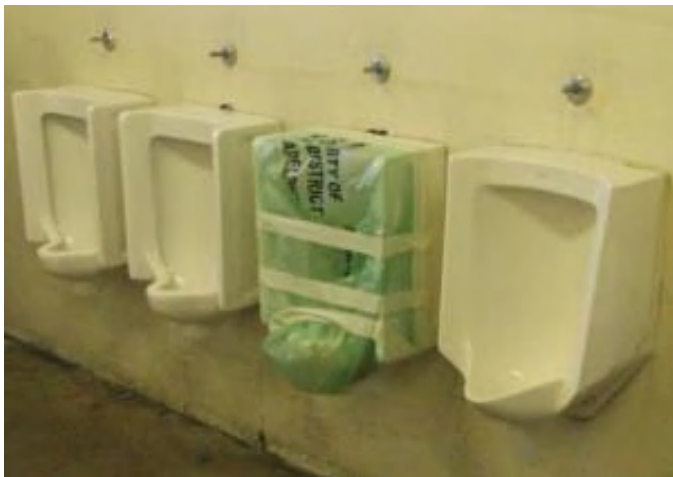
**System: D2010 - Plumbing Fixtures**

**Location:** Toilet rooms  
**Distress:** Appearance  
**Category:** 3 - Operations / Maint.  
**Priority:** 2 - Response Time (2-3 yrs)  
**Correction:** Remove and replace or replace wall hung urinals  
**Qty:** 9.00  
**Unit of Measure:** Ea.  
**Estimate:** \$33,354.49  
**Assessor Name:** System  
**Date Created:** 02/15/2016

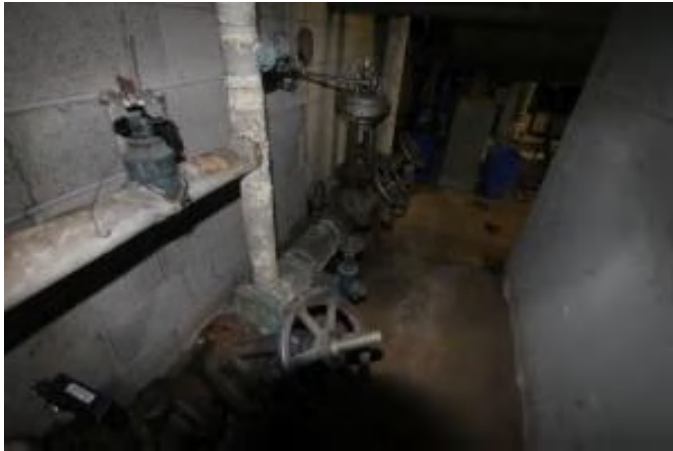
**System: D2020 - Domestic Water Distribution**

A 4" city water service enters the building from Parrish Street. The 4" meter and valves are located in the basement mechanical room. There is no backflow preventer for the entire building and one should be installed. There is a backflow preventer for boiler makeup water. The original pressure booster equipment is installed but unused: two water pumps, one air pump, and pressure vessel. The domestic hot and cold water distribution piping is copper piping and soldered connections. Portions of domestic pipe show severe corrosion, and the entire system should be inspected and repaired or replaced as needed. The water heater is a State Industries natural gas burning 70 gallon tank type manufactured in 2002 located in the boiler room. It is beyond its useful life and should be replaced. There is no circulation pump or thermal expansion tank and these should be installed with the new heater.

**Location:** Basement  
**Distress:** Building / MEP Codes  
**Category:** 2 - Code Compliance  
**Priority:** 2 - Response Time (2-3 yrs)  
**Correction:** Provide 4" reduced pressure back flow preventer  
**Qty:** 1.00  
**Unit of Measure:** Ea.  
**Estimate:** \$15,271.94  
**Assessor Name:** System  
**Date Created:** 02/15/2016

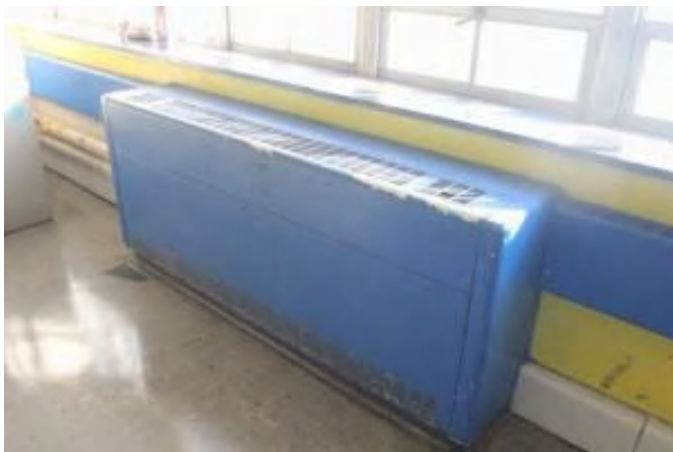
**System: D3040 - Distribution Systems**

**Location:** Classrooms  
**Distress:** Beyond Service Life  
**Category:** 3 - Operations / Maint.  
**Priority:** 2 - Response Time (2-3 yrs)  
**Correction:** Replace classroom unit ventilator (htg/clg coils, 5 tons, 2,000 CFM)  
**Qty:** 42.00  
**Unit of Measure:** Ea.  
**Estimate:** \$2,094,904.25  
**Assessor Name:** System  
**Date Created:** 02/15/2016

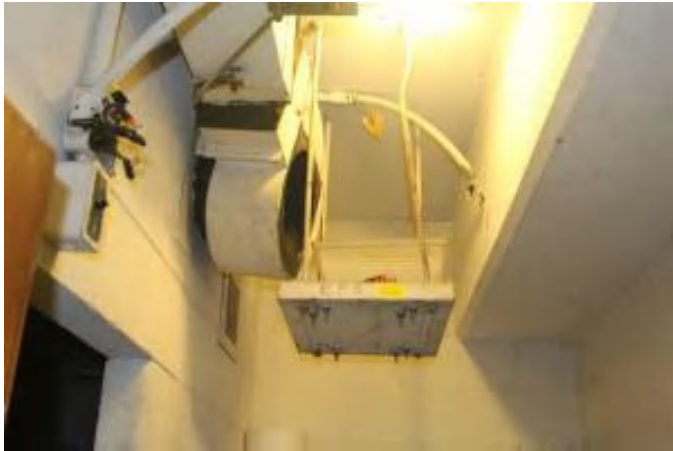
**System: D3040 - Distribution Systems**

**Location:** Toilet rooms

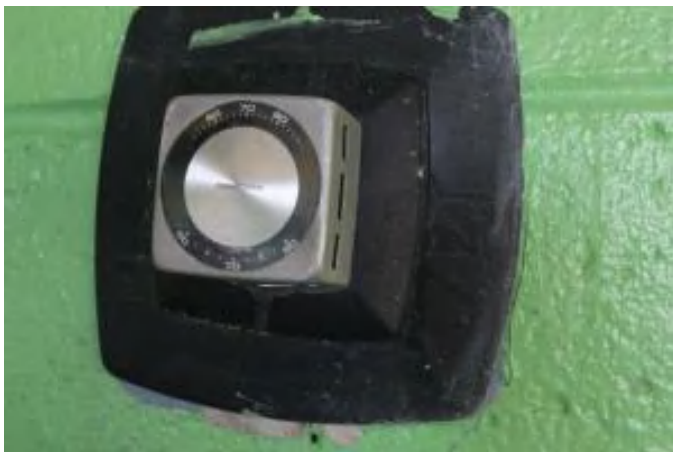
**System: D3060 - Controls & Instrumentation**

**Location:** Entire building

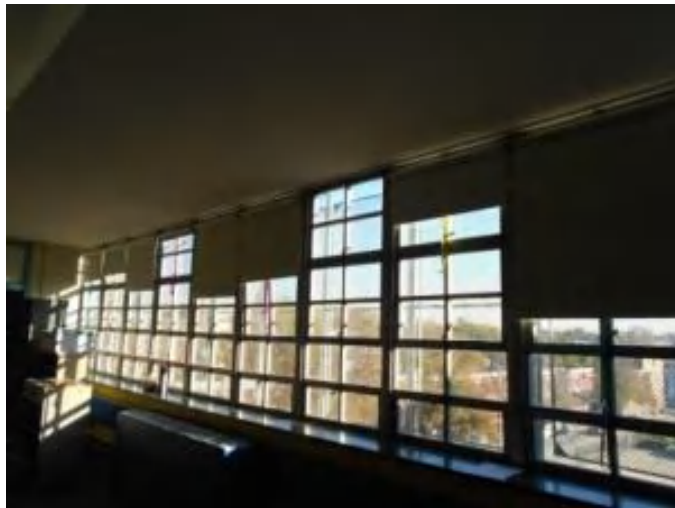
**System: E2010 - Fixed Furnishings**

**Location:** Classrooms and offices

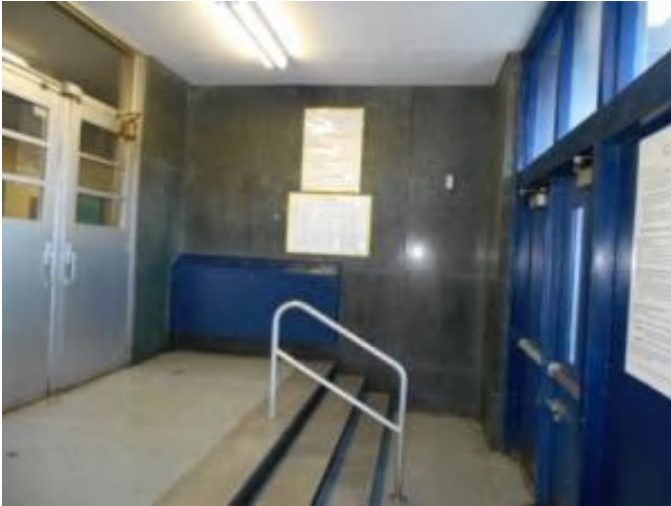
**System: A1030 - Slab on Grade**

**Location:** Front entry

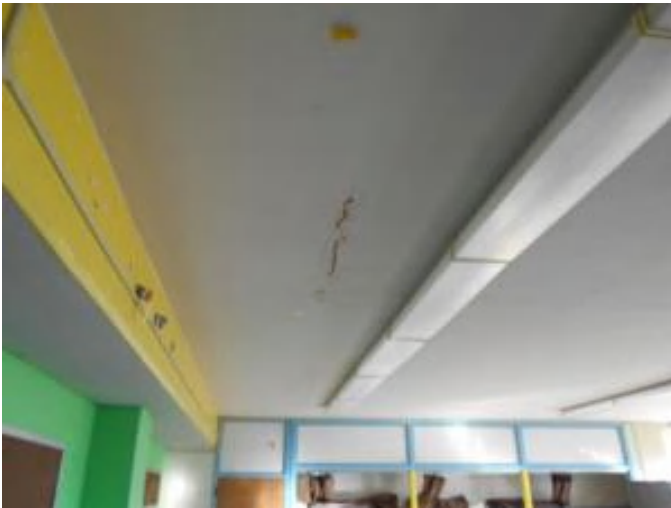
**System: C3030 - Ceiling Finishes**

**Location:** 4th Floor painted ceilings

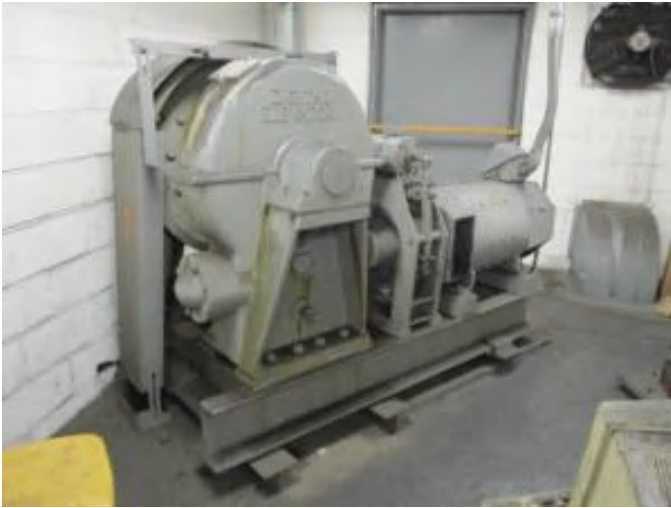
**System: D1010 - Elevators and Lifts**

The school has a traction power elevator rated 75HP at 240V. The elevator motor is manufactured by Digital Elevator. Elevator Controller cabinet was closed/locked. Elevator motor appears to be part of the original installation and has already exceeded its useful service life. Replace elevator motor, cables and controller.

**Location:** Elevator Machine Room

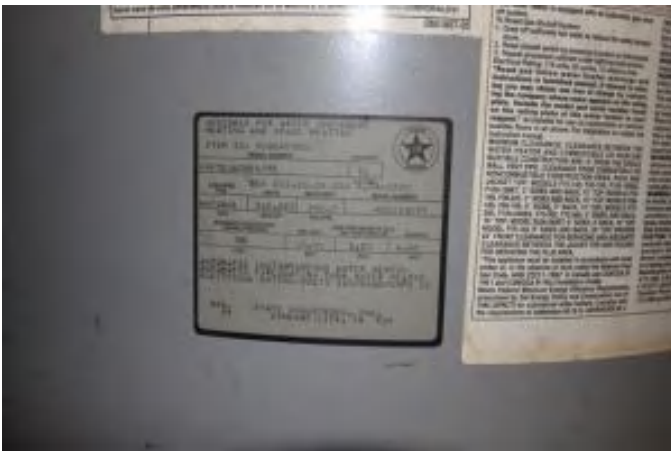
**System: D2020 - Domestic Water Distribution**

**Location:** Boiler room

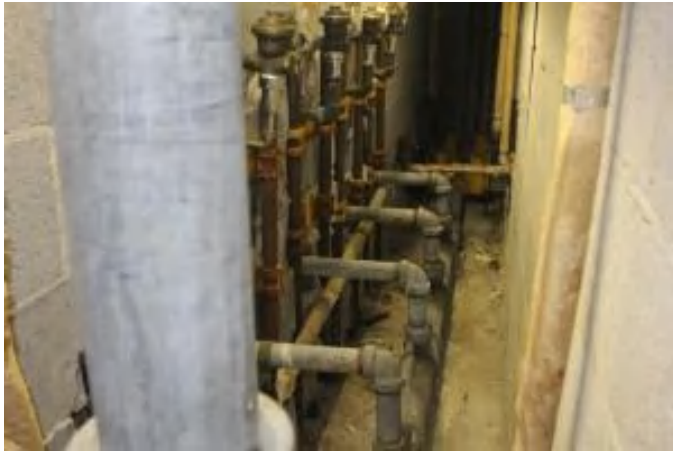
**System: D2030 - Sanitary Waste**

The sanitary sewer piping is threaded galvanized pipe. There is no sewage ejector. Many toilets were out of order, some perhaps due to drainage issues. The sewer piping is likely original, and it should be inspected in detail and repaired or replaced as needed.

**Location:** Entire building  
**Distress:** Beyond Service Life  
**Category:** 3 - Operations / Maint.  
**Priority:** 3 - Response Time (3-4 yrs)  
**Correction:** Inspect sanitary waste piping and replace damaged sections. (+50KSF)  
**Qty:** 70,000.00  
**Unit of Measure:** S.F.  
**Estimate:** \$343,402.47  
**Assessor Name:** System  
**Date Created:** 02/15/2016

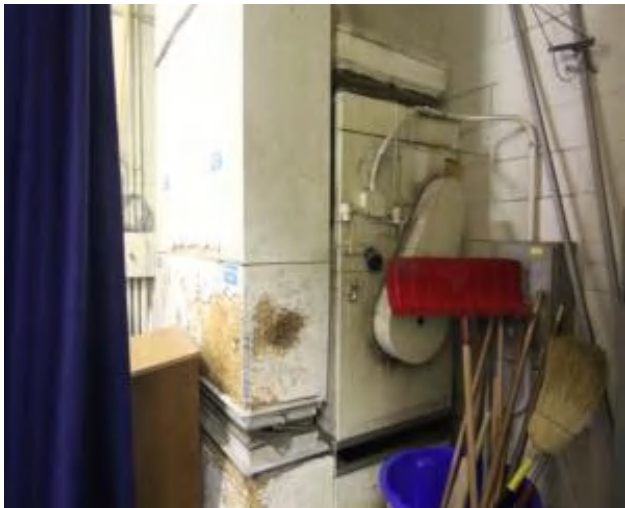
**System: D3040 - Distribution Systems**

**Location:** Auditorium  
**Distress:** Beyond Service Life  
**Category:** 3 - Operations / Maint.  
**Priority:** 3 - Response Time (3-4 yrs)  
**Correction:** Replace HVAC unit for Auditorium (800 seat).  
**Qty:** 434.00  
**Unit of Measure:** Seat  
**Estimate:** \$221,891.88  
**Assessor Name:** System  
**Date Created:** 02/15/2016

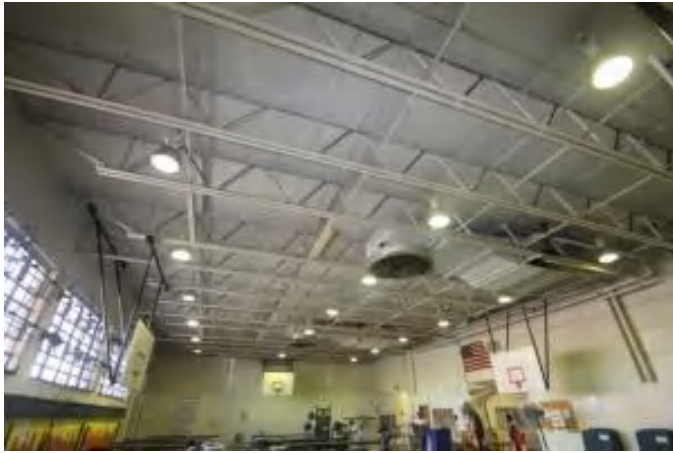
**System: D3040 - Distribution Systems**

**Location:** Gym

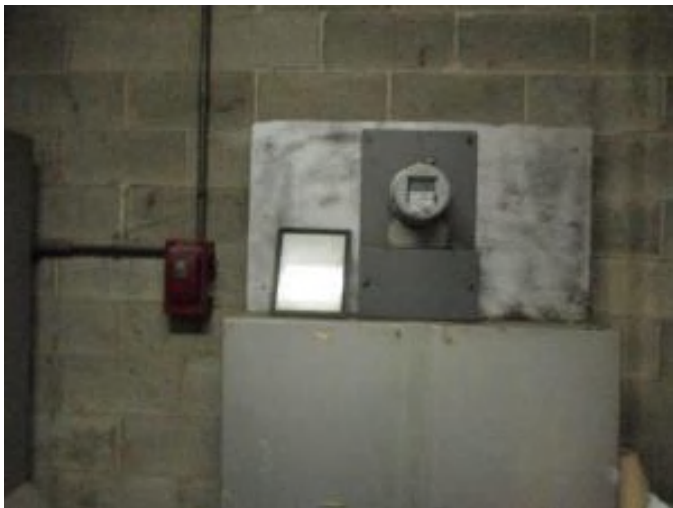
**System: D5010 - Electrical Service/Distribution**

A Medium Voltage underground feeder and a transformer vault in the basement serves this facility. The transformer vault is housing a utility transformer with 120/240 secondary voltage. The electrical service entrance is located in the basement and is composed of pull box, meter section, main disconnect and distribution section. The electrical service rating is 120/240V, 600A (estimated). The utility meter is wall mounted No PECO 225MUC 30602. The existing service has no extra capacity for expansion or new Heating, Ventilation, Air Conditioning (HVAC) system. The electrical service entrance needs to be upgraded. The new service will be 480V/277V, 3 phase power, 1200 Amperes. The new electrical service would feed a 480V Motor Control Center (MCC) and HVAC (Heating, Ventilation and Air Conditioning) equipment, and a 480V 3 phase to 120V/208V 3 phase 300 KVA step-down transformer to feed receptacles, lighting and other smaller loads.

**Location:** Basement

- Provide a new electrical service rated 1200A, 480/277V with 300KVA step-down transformer
- Replace original panelboards and associated feeders. Approximate (10) 208/120V panel boards.

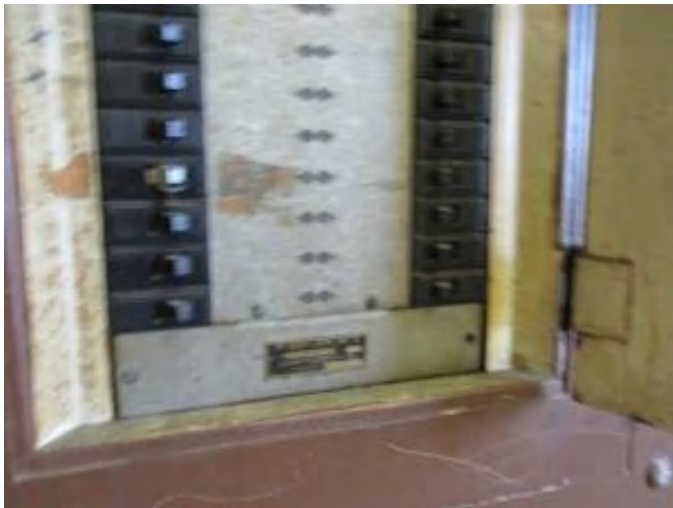
**System: D5010 - Electrical Service/Distribution**

There are panel-boards new and original in each floor for lighting and receptacles. The original panelboards are recessed mounted and have exceeded the end of their useful life. The new panels are approximately 5 years old but they cannot be reused with the proposed system voltage. Therefore replace all panelboards.

**Location:** Entire Building  
**Distress:** Beyond Service Life  
**Category:** 3 - Operations / Maint.  
**Priority:** 3 - Response Time (3-4 yrs)  
**Correction:** Replace Electrical Distribution System (U)  
**Qty:** 1.00  
**Unit of Measure:** Ea.  
**Estimate:** \$270,949.27  
**Assessor Name:** System  
**Date Created:** 01/21/2016

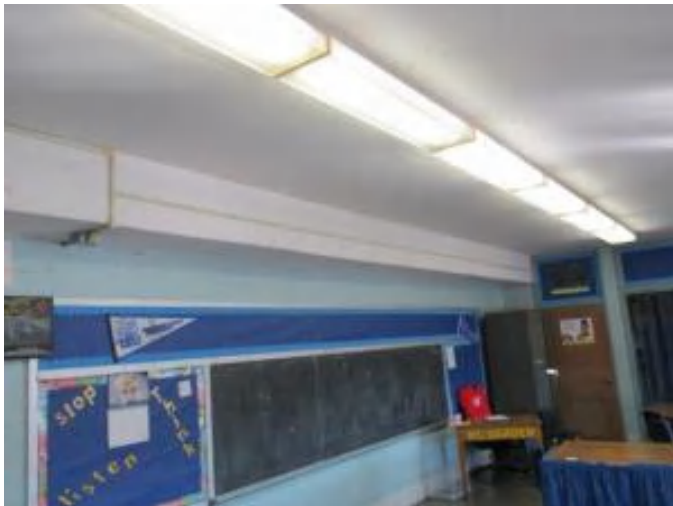
**System: D5020 - Lighting and Branch Wiring**

The number of receptacles in 40% of the classrooms are inadequate. Teachers use extension cords. The teacher's whiteboard wall and the opposite of it need to be provided with double compartment surface raceways, the other two walls with minimum two duplex outlets each, when feasible.

**Location:** Entire Building  
**Distress:** Inadequate  
**Category:** 4 - Capital Improvement  
**Priority:** 3 - Response Time (3-4 yrs)  
**Correction:** Add wiring device  
**Qty:** 256.00  
**Unit of Measure:** Ea.  
**Estimate:** \$94,046.97  
**Assessor Name:** System  
**Date Created:** 01/21/2016

- Provide (2)25FT of surface raceways with receptacles spaced 24" on center and 4 wall mount receptacles per classroom. Approximate 256 receptacles
- Replace 70% of the existing fluorescent fixtures. Approximate 650 fixtures.

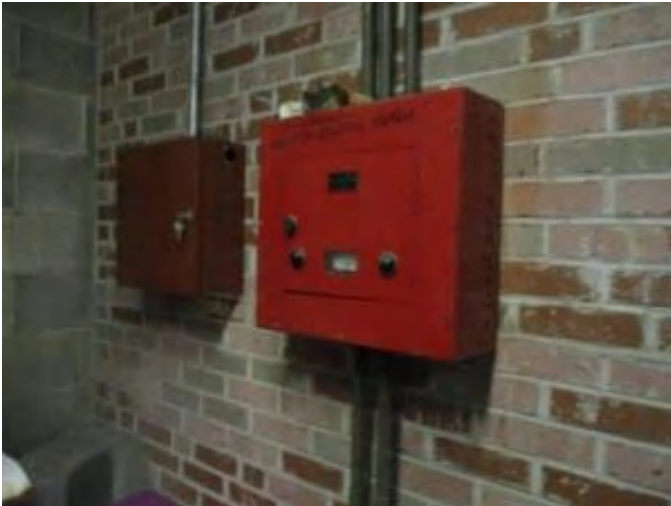
**System: D5030 - Communications and Security**

**Location:** Entire Building

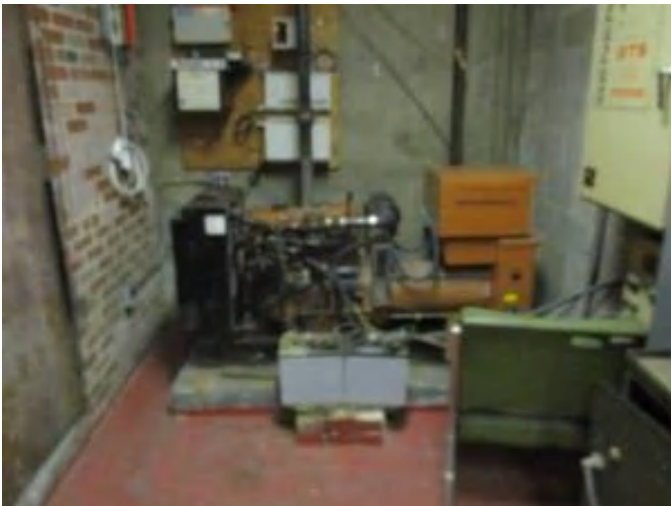
**System: D5090 - Other Electrical Systems**

**Location:** Outdoor

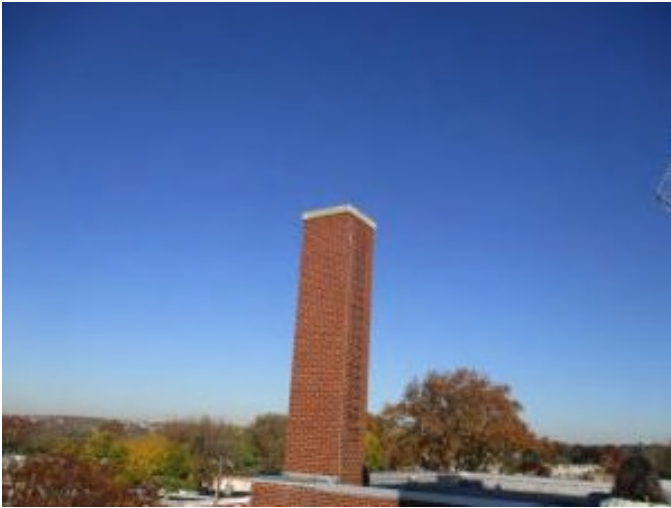
**System: D5090 - Other Electrical Systems**

**Location:** Roof  
**Distress:** Building / MEP Codes  
**Category:** 2 - Code Compliance  
**Priority:** 3 - Response Time (3-4 yrs)  
**Correction:** Repair Lightning Protection System  
**Qty:** 1.00  
**Unit of Measure:** Job  
**Estimate:** \$24,249.82  
**Assessor Name:** System  
**Date Created:** 01/21/2016

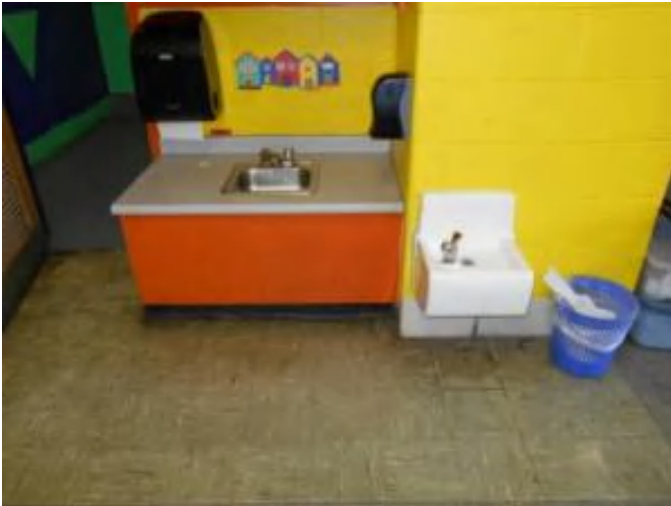
**System: E2010 - Fixed Furnishings**

**Location:** Kindergarten classrooms  
**Distress:** Failing  
**Category:** 3 - Operations / Maint.  
**Priority:** 3 - Response Time (3-4 yrs)  
**Correction:** Remove and replace casework - per LF - insert quantities for cabinets in the estimate  
**Qty:** 12.00  
**Unit of Measure:** L.F.  
**Estimate:** \$9,973.98  
**Assessor Name:** System  
**Date Created:** 02/05/2016

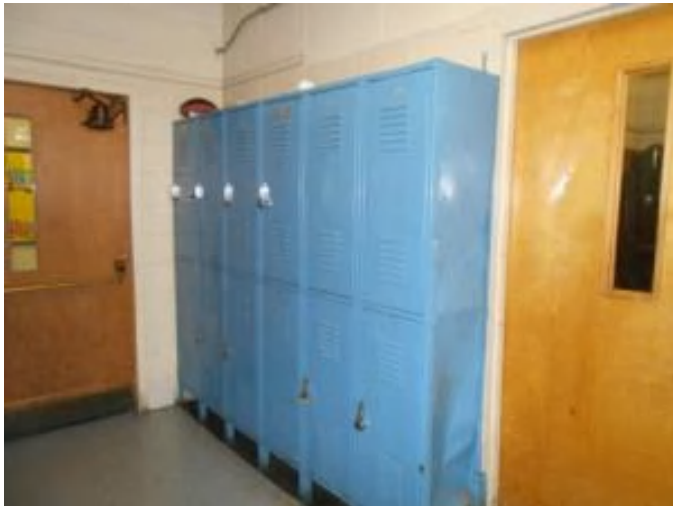
**System: C1030 - Fittings**

**Location:** Kitchen

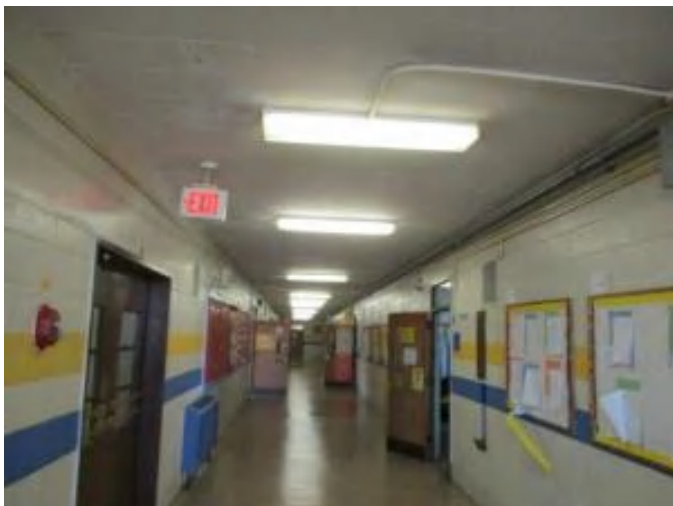
**System: D5020 - Lighting and Branch Wiring**

**Location:** Entire Building

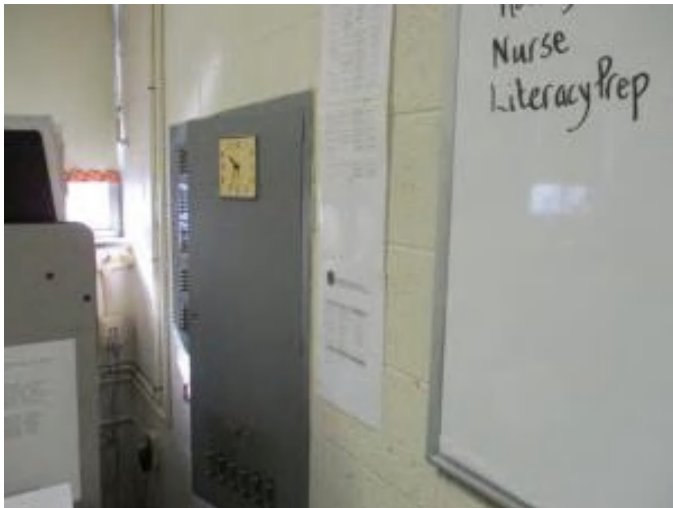
**System: D5030 - Communications and Security**

**Location:** Entire Building

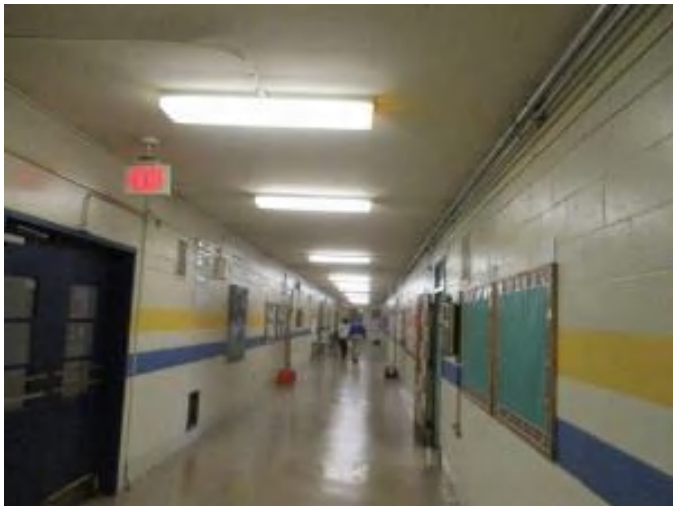
**System: D5030 - Communications and Security**

**Location:** Entire Building

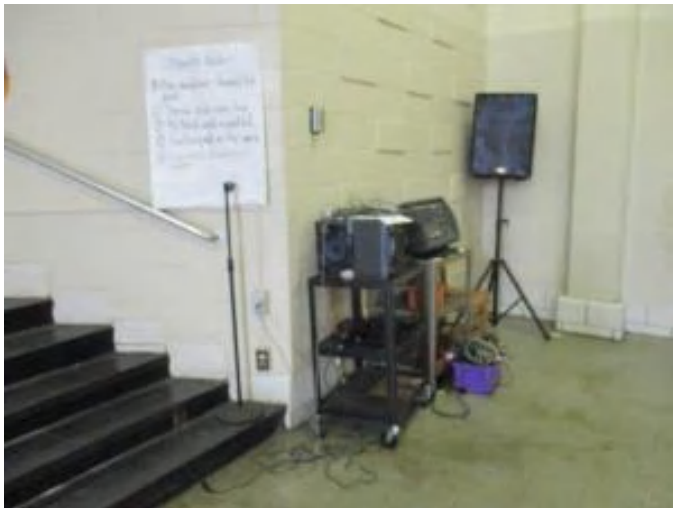
**System: D5030 - Communications and Security**

**Location:** Auditorium  
**Distress:** Inadequate  
**Category:** 4 - Capital Improvement  
**Priority:** 4 - Response Time (4-5 yrs)  
**Correction:** Add/Replace Sound System  
**Qty:** 1.00  
**Unit of Measure:** LS  
**Estimate:** \$26,806.41  
**Assessor Name:** System  
**Date Created:** 01/21/2016

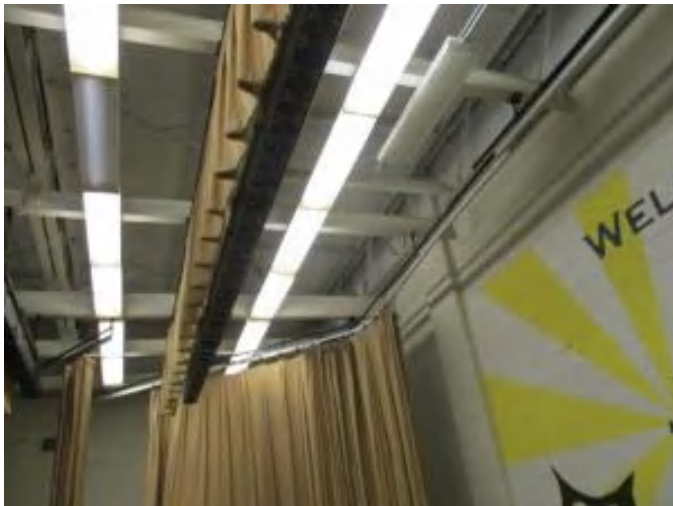
**System: E1020 - Institutional Equipment**

**Location:** Auditorium  
**Distress:** Obsolete  
**Category:** 3 - Operations / Maint.  
**Priority:** 4 - Response Time (4-5 yrs)  
**Correction:** Add/Replace Stage Theatrical Lighting System  
**Qty:** 1.00  
**Unit of Measure:** Ea.  
**Estimate:** \$293,594.70  
**Assessor Name:** System  
**Date Created:** 01/21/2016

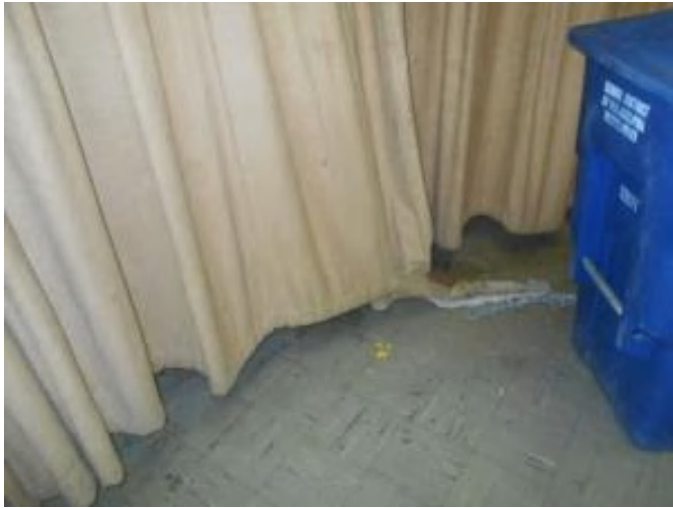
**System: E2010 - Fixed Furnishings**

**Location:** Stage

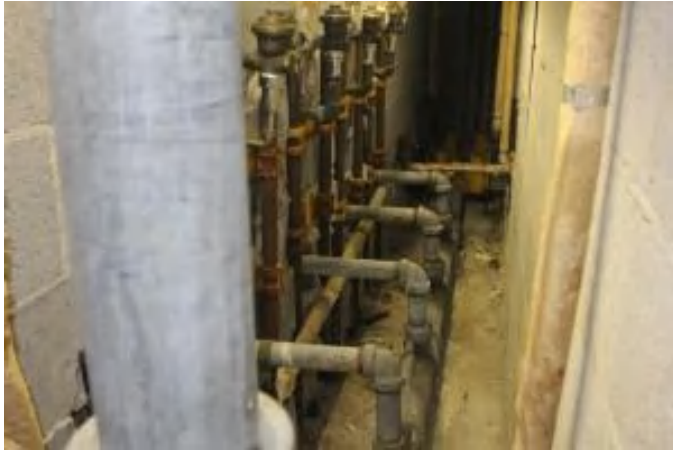
**System: D2020 - Domestic Water Distribution**

**Location:** Entire building

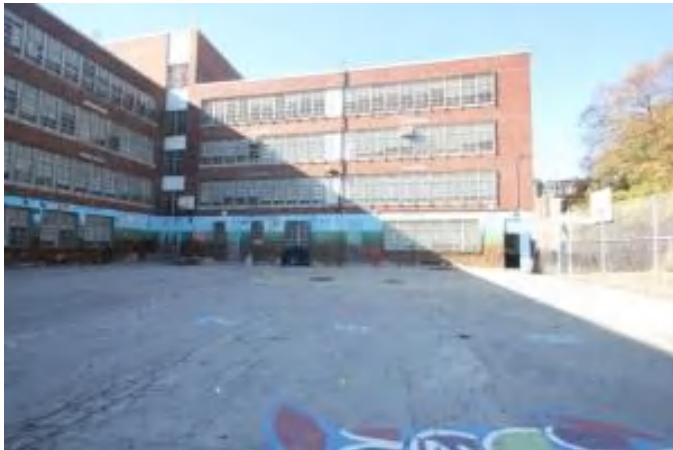
**System: D3030 - Cooling Generating Systems**

The building has no central cooling generating equipment. There are 14 window unit air conditioners and 1 ductless split system, totaling approximately 30 tons. These serve the school office, IMC, network room, and a few classrooms. A 175 ton system should be installed for the entire building.

**Location:** Entire building

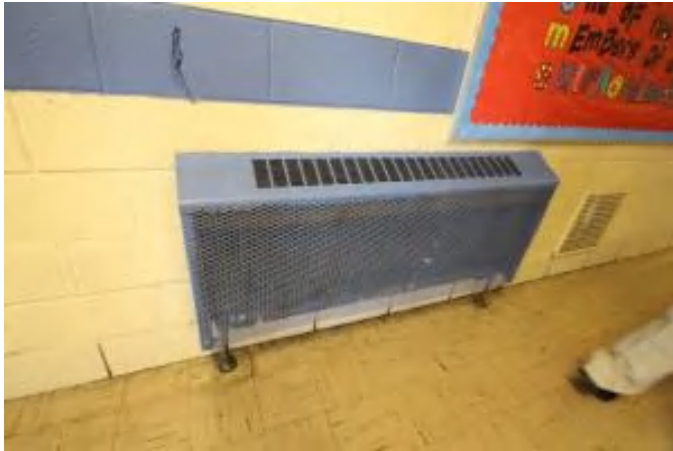
**System: D3040 - Distribution Systems**

**Location:** Entire building  
**Distress:** Beyond Service Life  
**Category:** 3 - Operations / Maint.  
**Priority:** 5 - Response Time (> 5 yrs)  
**Correction:** Replace finned tube radiation terminals (per 100 LF)  
**Qty:** 800.00  
**Unit of Measure:** L.F.  
**Estimate:** \$322,833.14  
**Assessor Name:** System  
**Date Created:** 02/15/2016

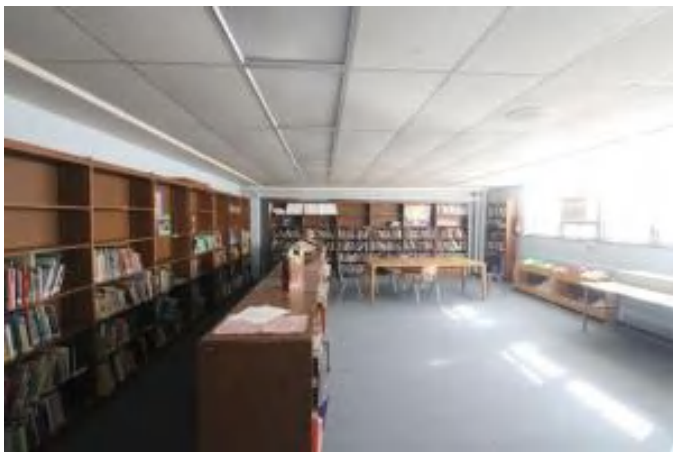
**System: D4010 - Sprinklers**

**Location:** Entire building  
**Distress:** Life Safety / NFPA / PFD  
**Category:** 1 - Health & Safety  
**Priority:** 5 - Response Time (> 5 yrs)  
**Correction:** Install a fire protection sprinkler system  
**Qty:** 70,000.00  
**Unit of Measure:** S.F.  
**Estimate:** \$1,001,382.68  
**Assessor Name:** System  
**Date Created:** 02/15/2016

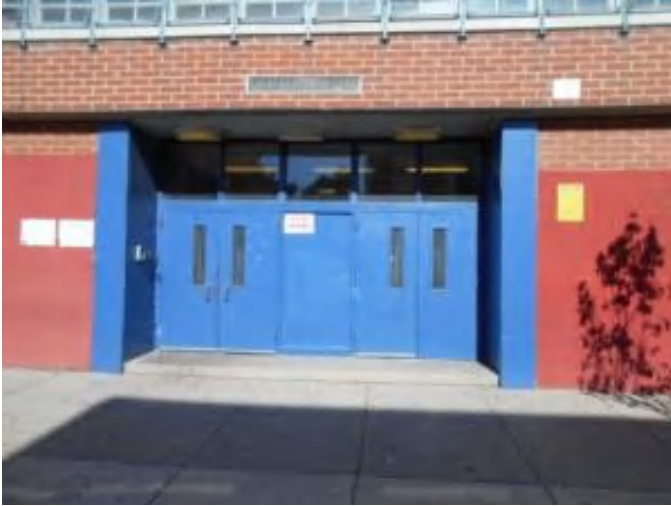
**Location:** Front entry

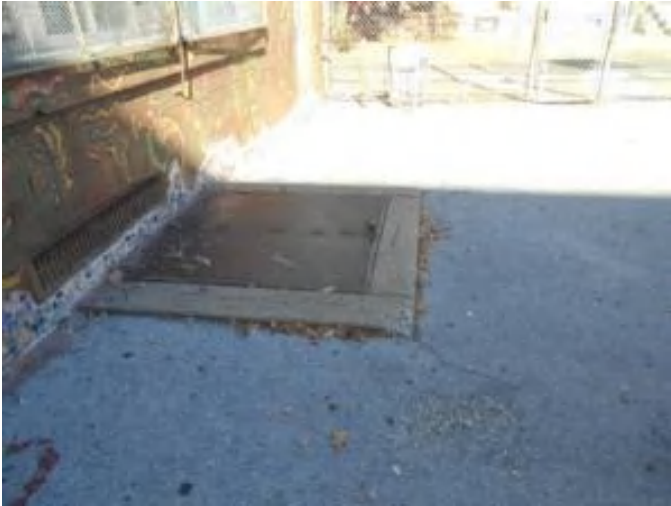
**Location:** Playground near building

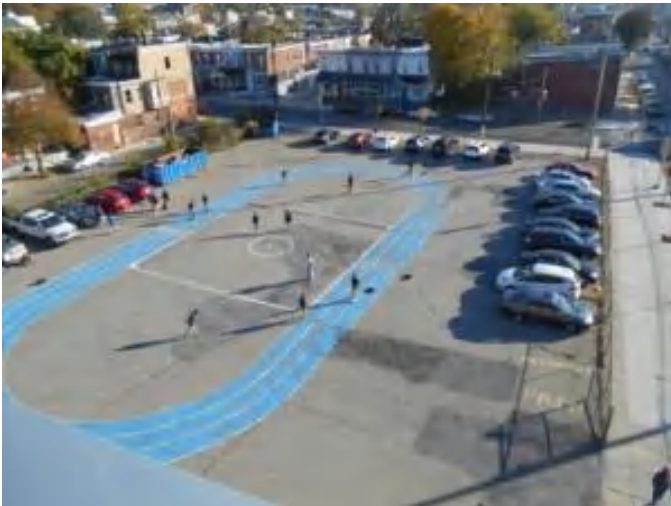
The asphalt parking lot is located at the east end of the site with access from Parrish Street. Striping is faded and there are no parking bumpers, signage, or designated handicap parking. The asphalt is in fair to poor condition with some settled areas, ponding, alligatoring, deeper cracking and vegetation in the asphalt. The entrance is gated, however the gates are damaged – a work order for repair was pending at the time of assessment. The parking lot is not segregated from playground areas, creating a safety concern. Pedestrian paving is concrete along city streets with some damaged sections. Playgrounds are asphalt surfaced is in fair to poor condition with some settled areas, ponding, and alligatoring.

**Location:** Parking lot

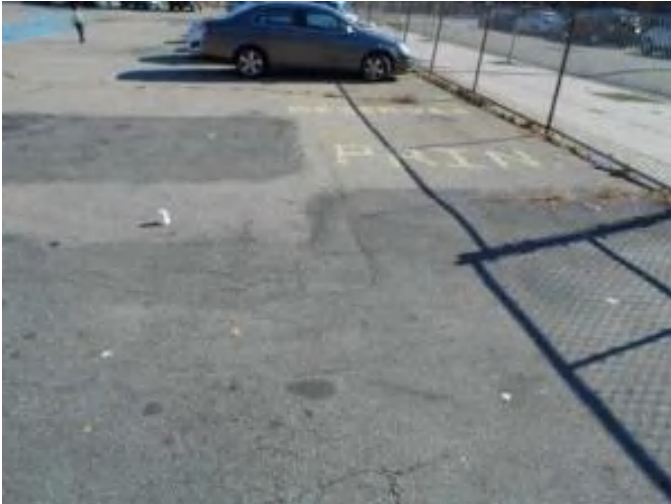
Fence surrounds the east end of the site from building corner to building corner. Antique wrought iron fencing is present around the east end of the site and is in fair condition. The remainder of the fencing is chain link in fair to good condition.

**Location:** East end of site

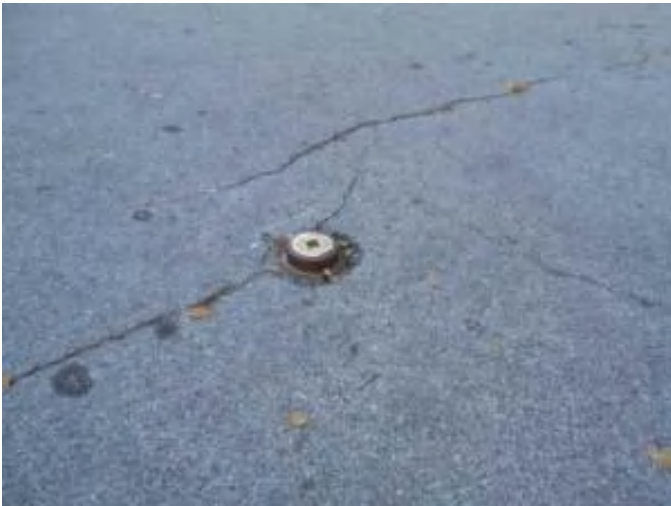
**Location:** Playground

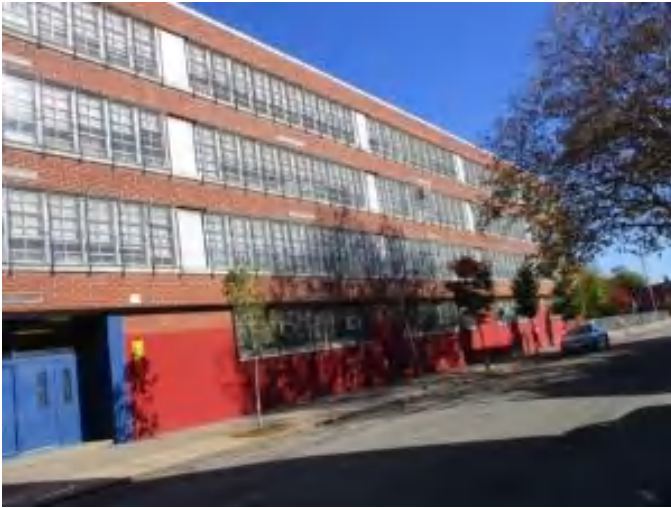
**Location:** Building Perimeter
