Facility Condition Assessment Summary Report

Rhodes, EW School

S415001;Rhodes, EW and Dobbins Field

Site Assessment Report

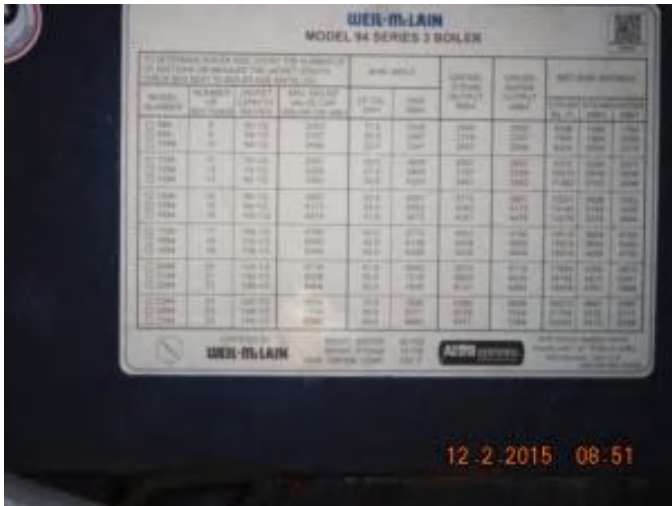
System: D3020 - Heat Generating Systems

Location: mechanical room

Distress: Beyond Service Life

Notes: Remove and replace two existing cast iron boilers.

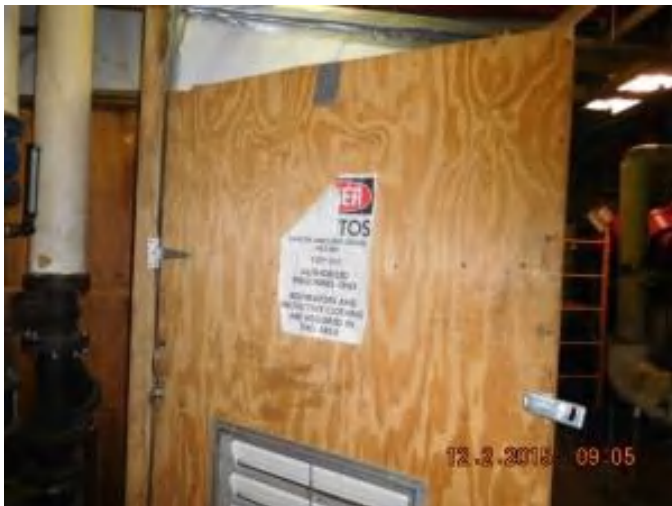
System: D3020 - Heat Generating Systems

Location: mechanical room

Distress: Beyond Service Life

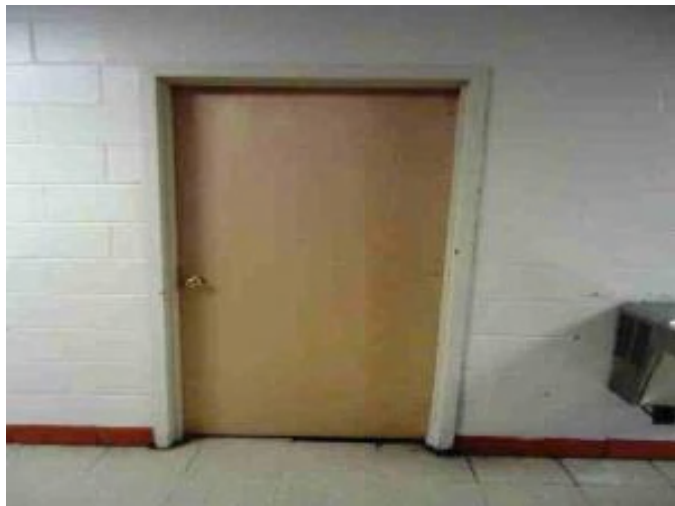
System: C1020 - Interior Doors

Location: Building Wide

Distress: Damaged

Notes: Interior doors are typically wood in wood or metal frames with wired glass glazing. Other interior doors include hollow metal in hollow metal frames at the stairwells and exit ways and access doors. Doors are generally in fair condition and is a mix of ADA compliant and non-complaint doors with both non-rated and fire rated. Several of the classroom doors are aging at a faster than normal rate for this application. Numerous repairs to locksets and door hardware have advanced the deterioration of the doors. This deficiency provides a budgetary consideration to replace a portion of the interior doors and frames with consideration for the physically challenged.

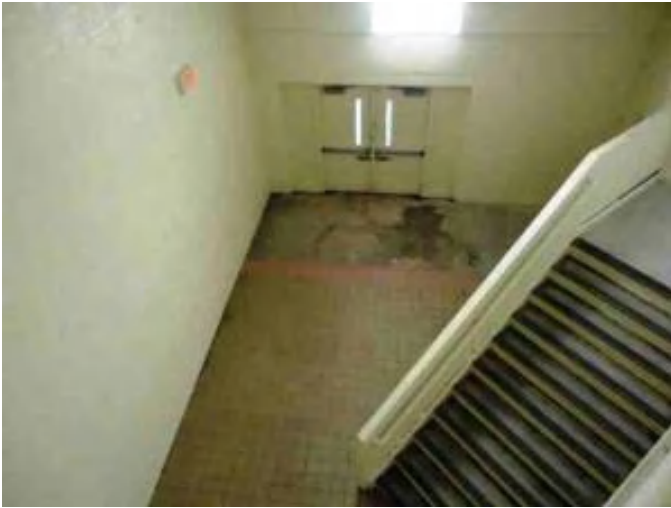
System: C3010230 - Paint & Covering

Location: Stair

Distress: Damaged

Notes: The interior painted brick finish in the fire escape stair lobby and the stairs leading to the western exterior are damaged. Several of the brick will require repairs and then repainted. This deficiency provides consideration for brick repairs and repainting of the isolated areas. The recommended railing deficiency is recommended to be completed as part of an overall correction.

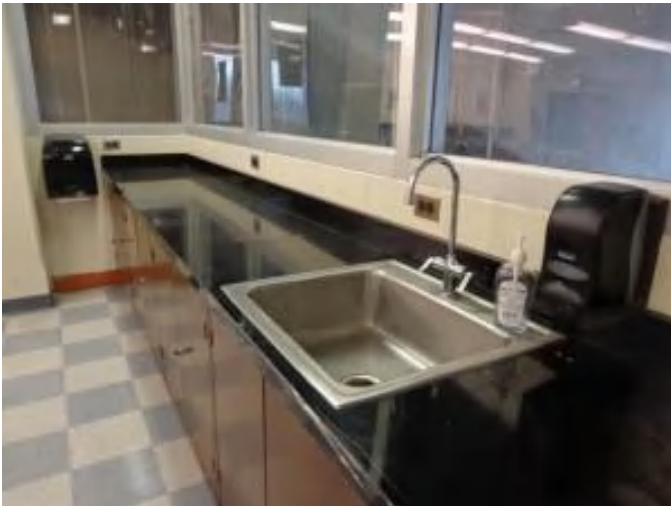
System: D5020 - Lighting and Branch Wiring

Location: Computer Room and Roof

Distress: Life Safety / NFPA / PFD

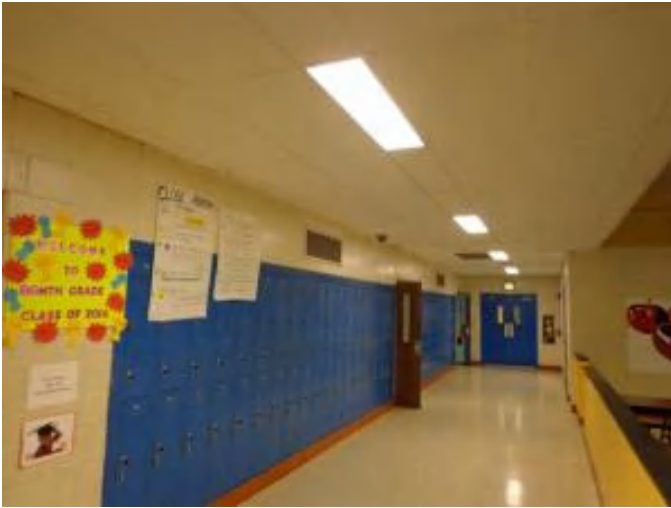
System: D5030 - Communications and Security

Location: Building wide

Distress: Security Issue

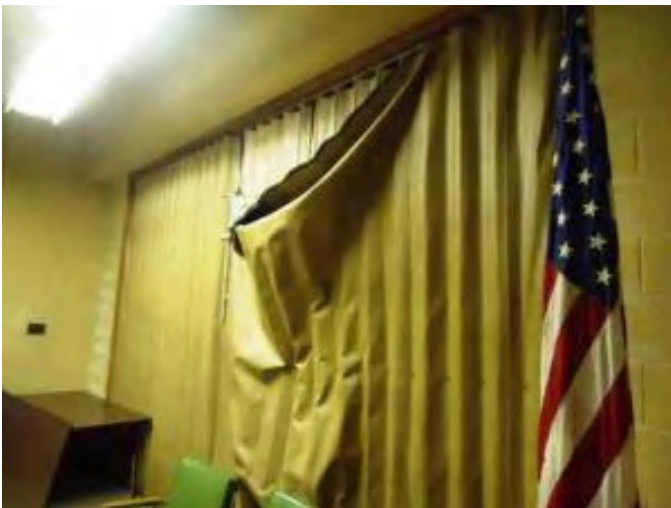
System: E2010 - Fixed Furnishings

Location: Stage

Distress: Damaged

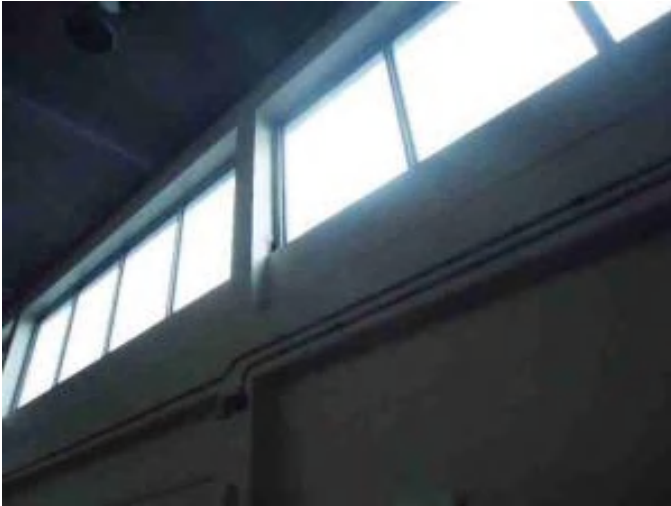
System: B2020 - Exterior Windows

Location: Exterior Elevation

Distress: Damaged

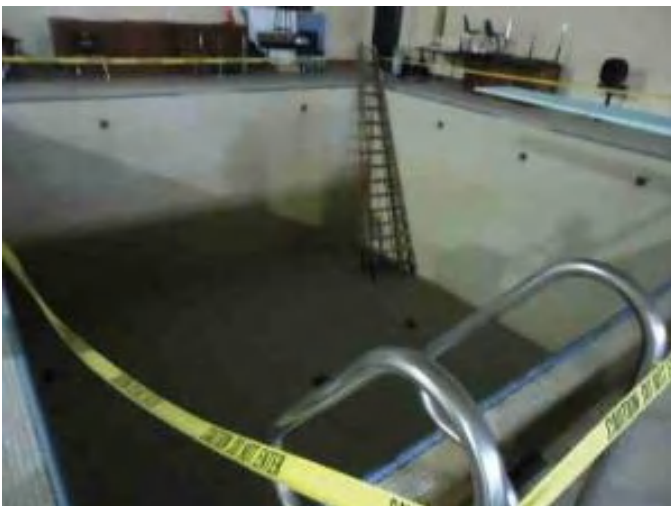
System: C3040 - Pool Finishes

Location: Pool

Distress: Failing

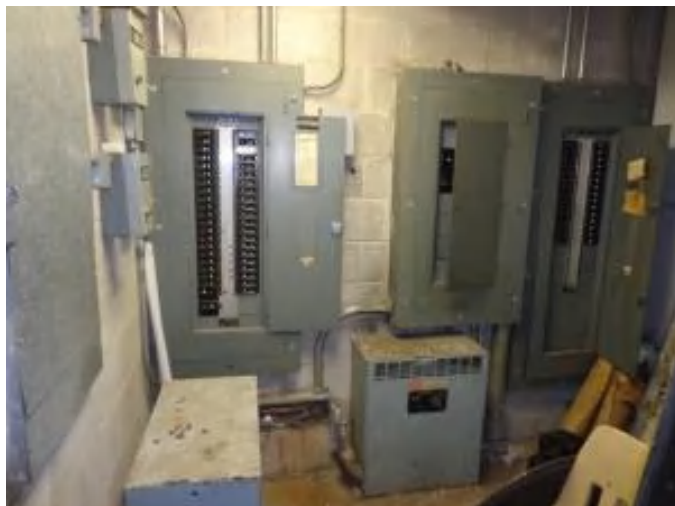
System: D5010 - Electrical Service/Distribution

Location: Building wide

Distress: Beyond Service Life

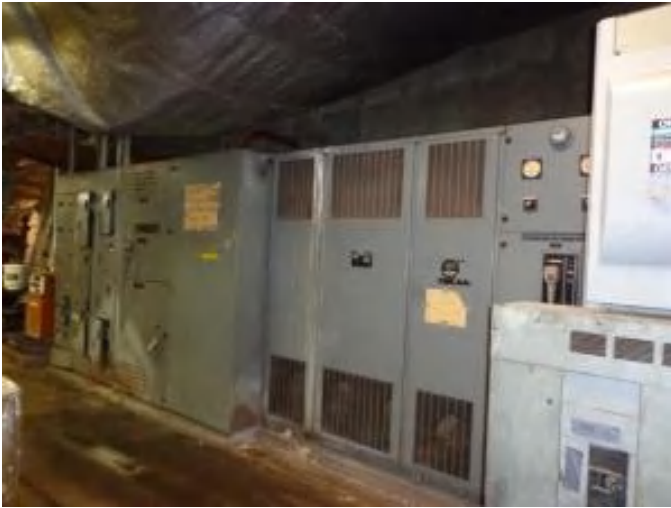
System: D5010 - Electrical Service/Distribution

Location: Boiler Room

Distress: Beyond Service Life

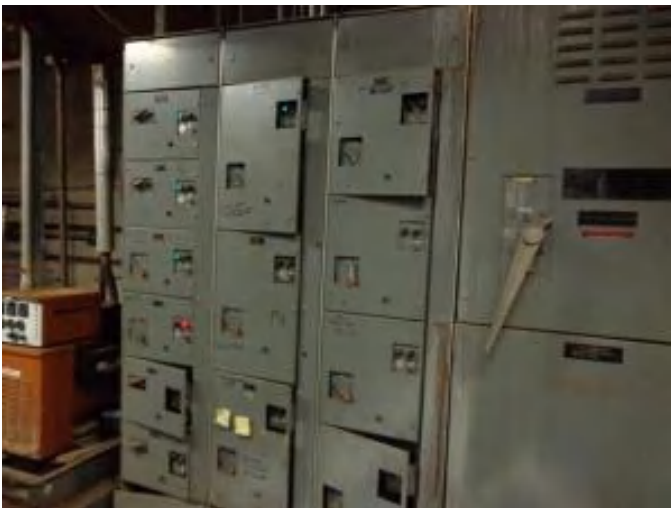
System: D5010 - Electrical Service/Distribution

Location: Boiler Room

Distress: Beyond Service Life

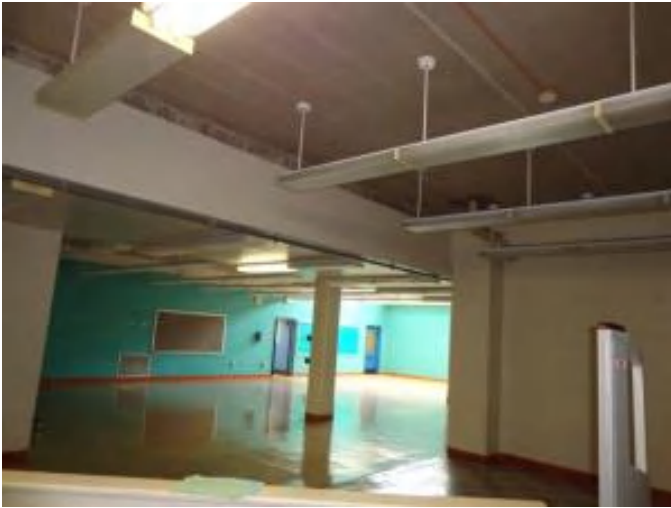
System: D5020 - Lighting and Branch Wiring

Location: Building wide

Distress: Beyond Service Life

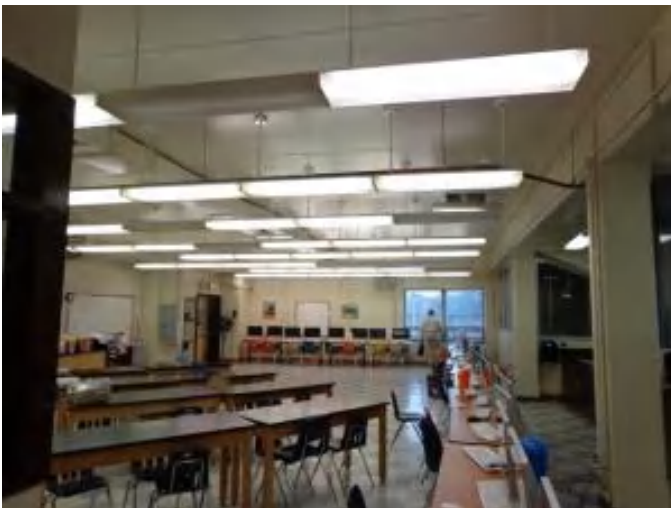
System: D5020 - Lighting and Branch Wiring

Location: Classrooms

Distress: Beyond Service Life

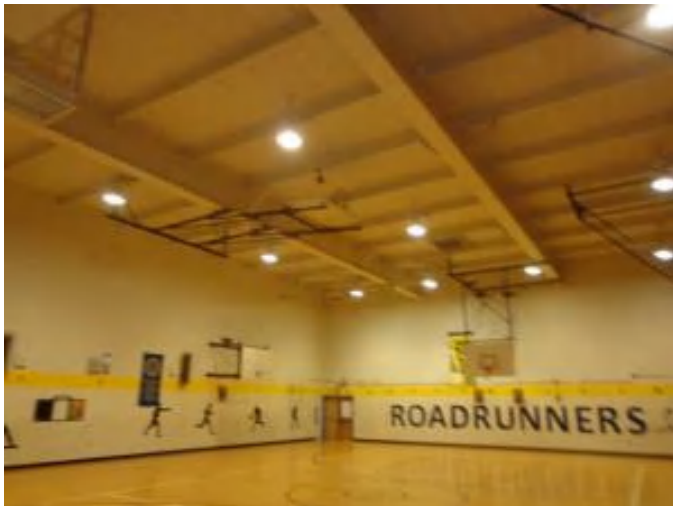
System: D5020 - Lighting and Branch Wiring

Location: Gymnasiums

Distress: Beyond Service Life

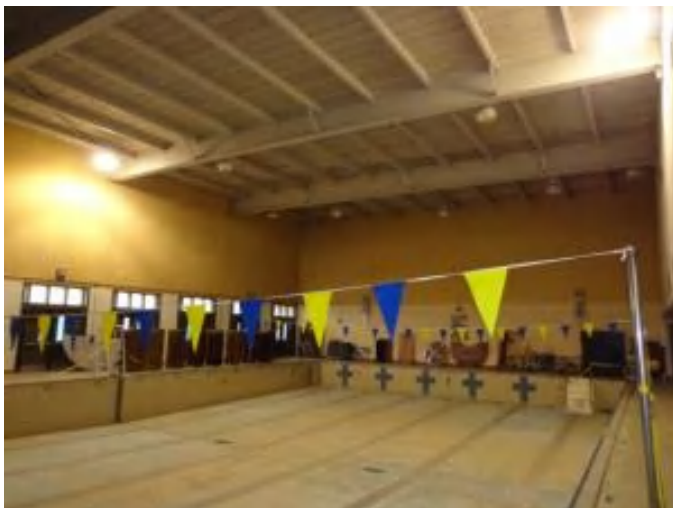
System: D5020 - Lighting and Branch Wiring

Location: Natatorium

Distress: Beyond Service Life

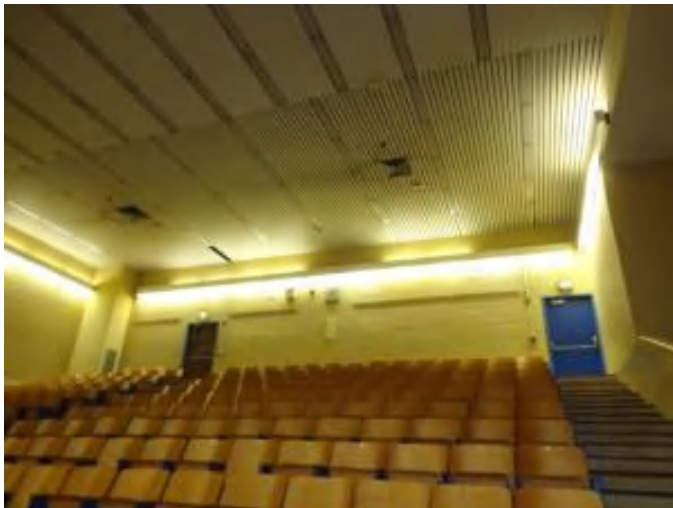
System: D5020 - Lighting and Branch Wiring

Location: Auditorium

Distress: Beyond Service Life

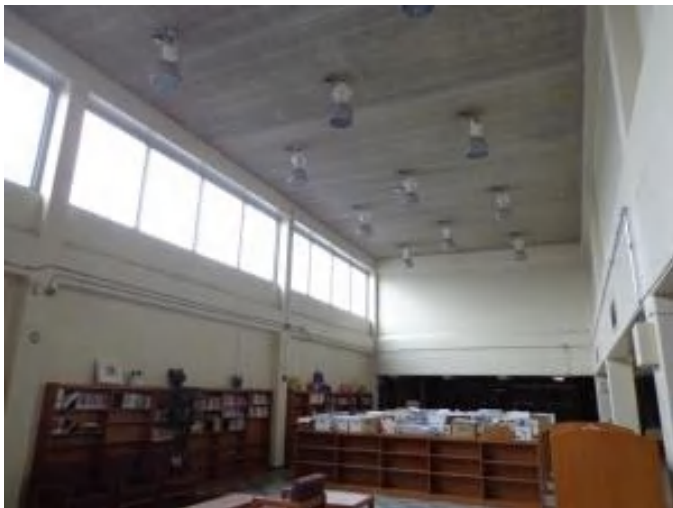
System: D5020 - Lighting and Branch Wiring

Location: IMC

Distress: Beyond Service Life

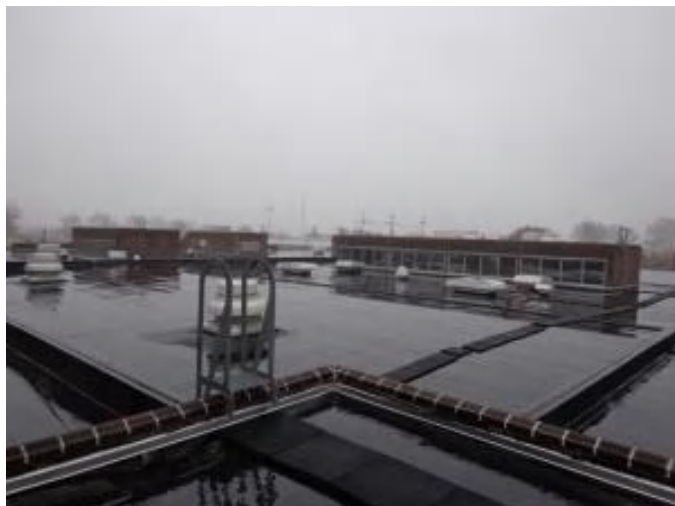
System: D5020 - Lighting and Branch Wiring

Location: Roof

Distress: Inadequate

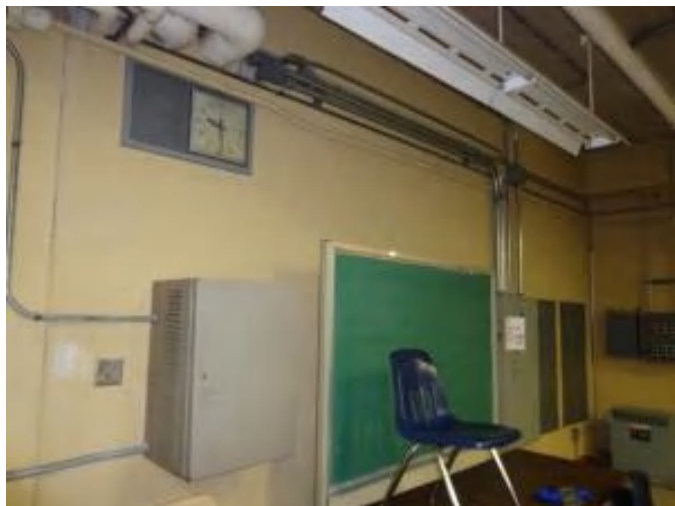
System: D5030 - Communications and Security

Location: Building wide

Distress: Damaged

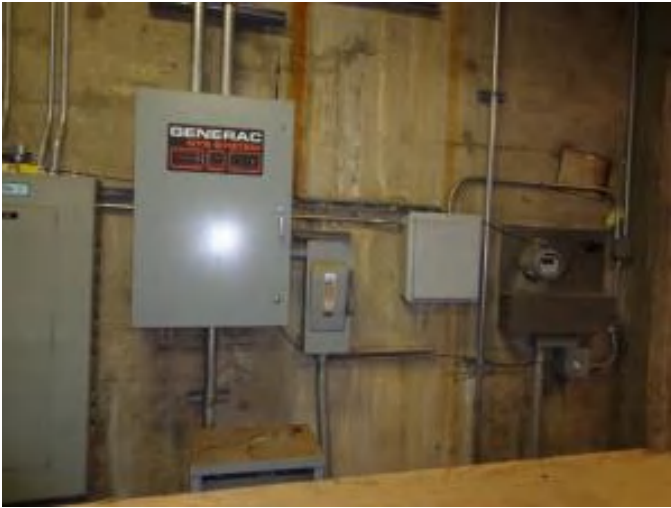
System: D5090 - Other Electrical Systems

Location: Boiler Room

Distress: Beyond Service Life

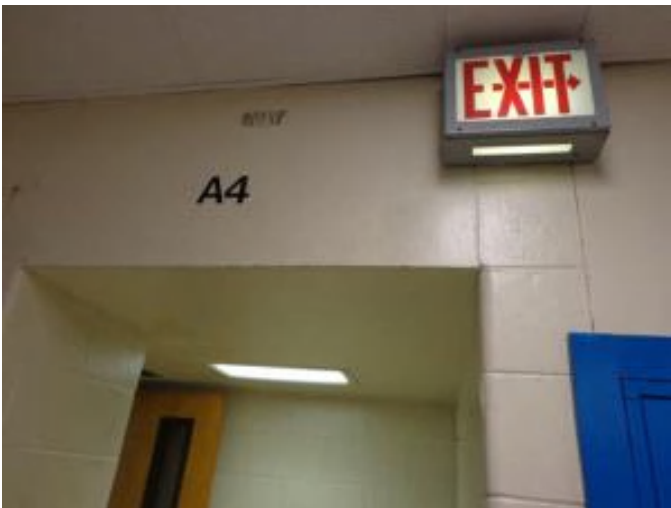
System: D5090 - Other Electrical Systems

Location: Building wide

Distress: Beyond Service Life

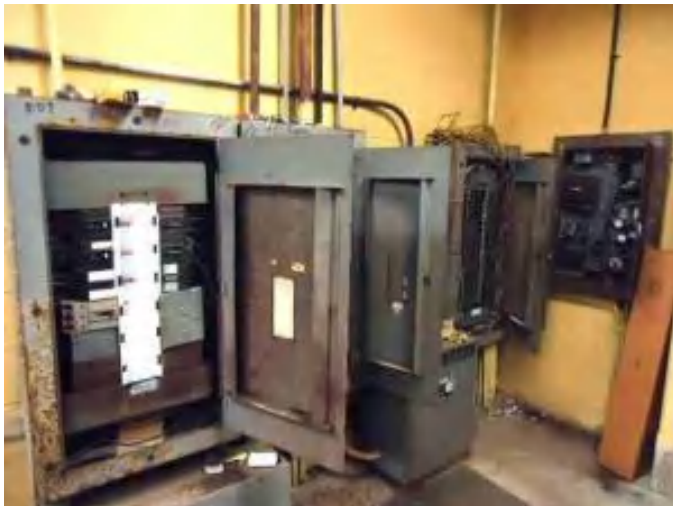
System: E1090 - Other Equipment

Location: Pool

Distress: Failing

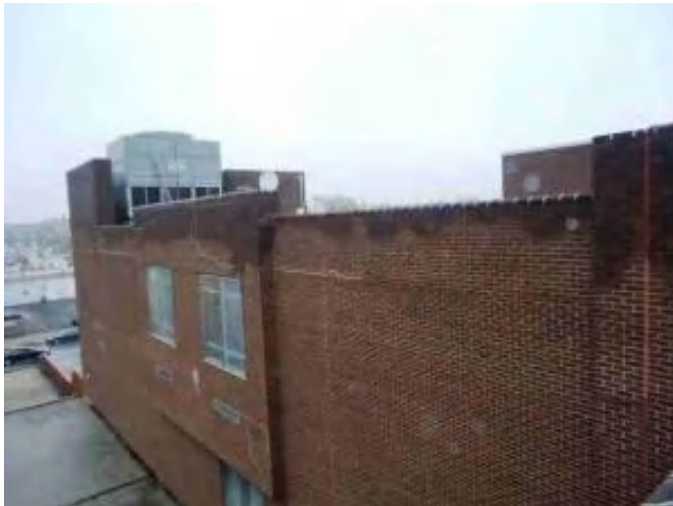
System: B2010 - Exterior Walls

Location: Exterior Elevation

Distress: Damaged

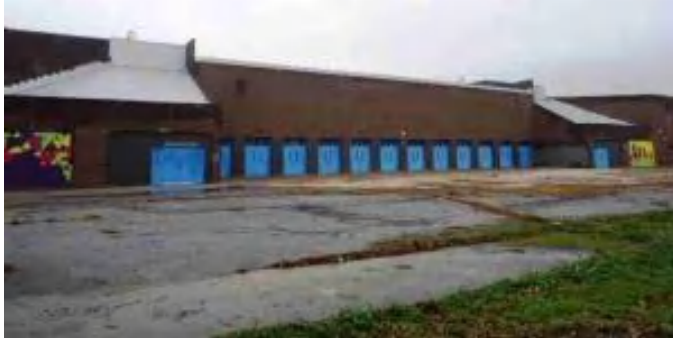
System: B2030 - Exterior Doors

Location: Exterior Elevaiton

Distress: Damaged

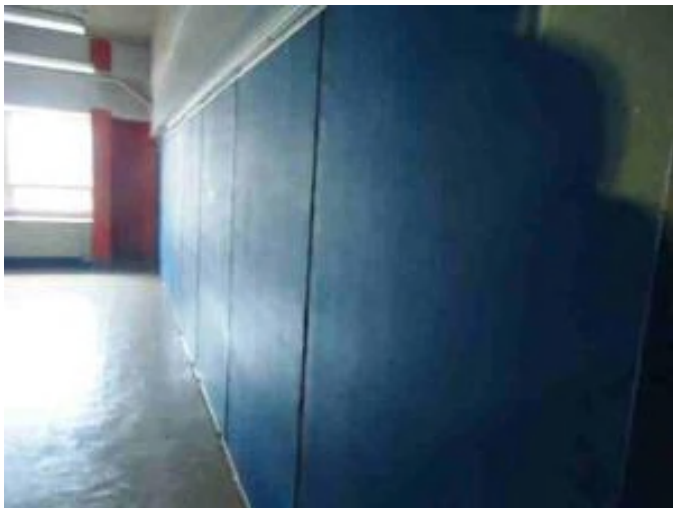
System: C1010 - Partitions

Location: Pods

Distress: Damaged

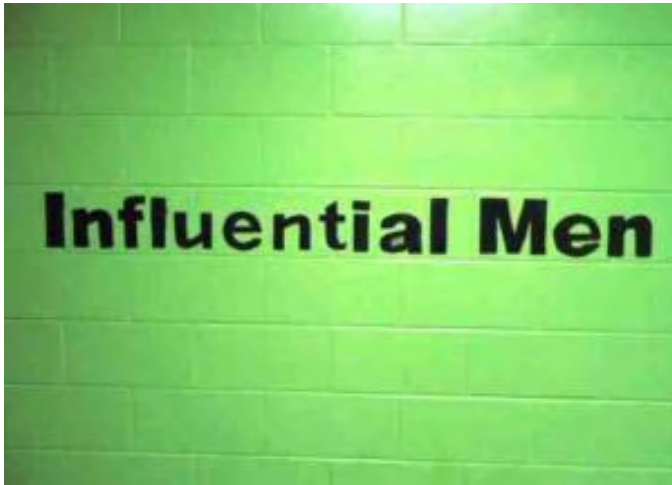
System: C1030 - Fittings

Location: Building Wide

Distress: Damaged

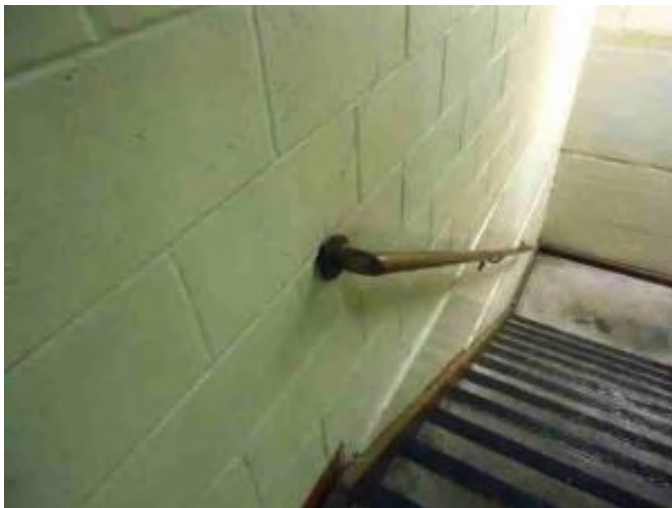
System: C2010 - Stair Construction

Location: Stairs

Distress: Life Safety / NFPA / PFD

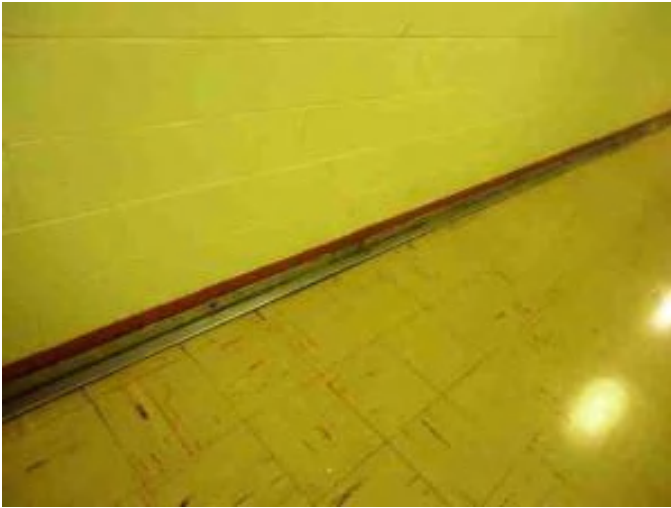
System: C3020413 - Vinyl Flooring

Location: Building Wide

Distress: Health Hazard / Risk

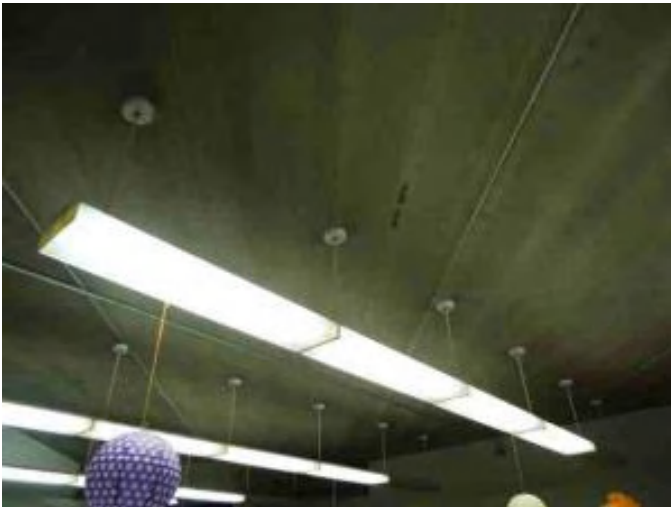
System: C3030 - Ceiling Finishes

Location: Building

Distress: Damaged

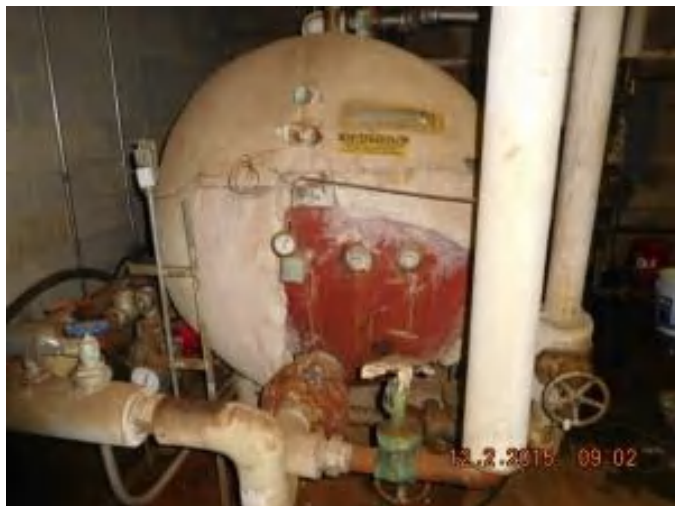
System: D2020 - Domestic Water Distribution

Location: entire building

Distress: Beyond Service Life

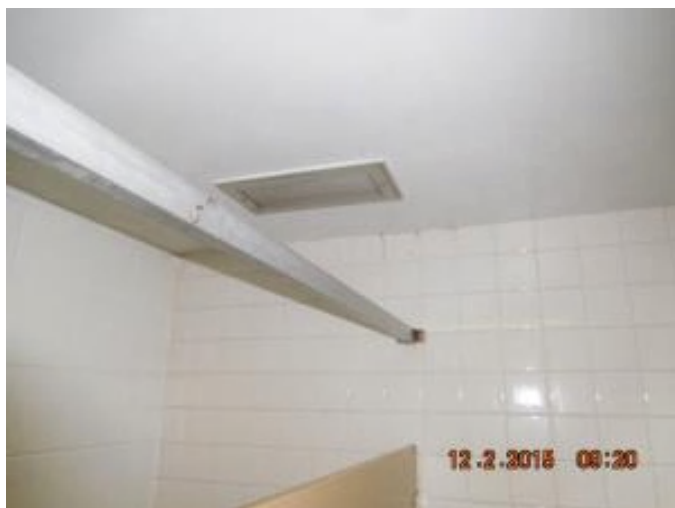
System: D2030 - Sanitary Waste

Location: entire building

Distress: Beyond Service Life

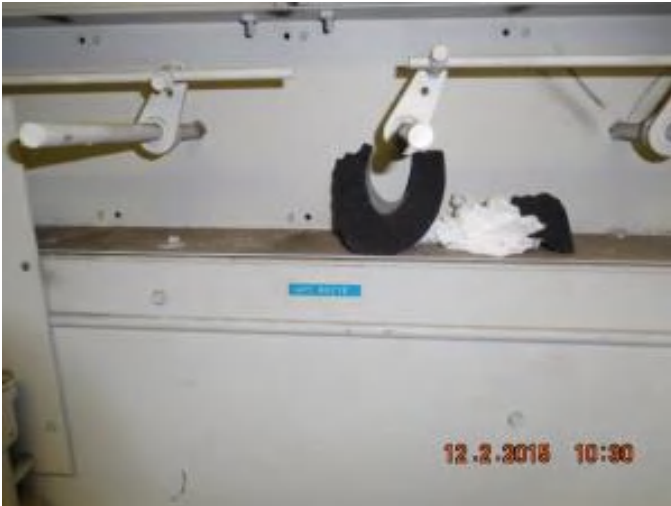
System: D3040 - Distribution Systems

Location: interior space

Distress: Building / MEP Codes

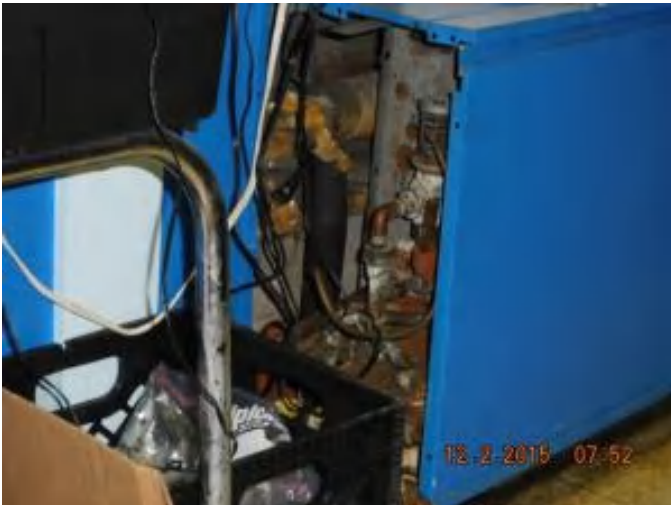
System: D3040 - Distribution Systems

Location: classrooms

Distress: Building / MEP Codes

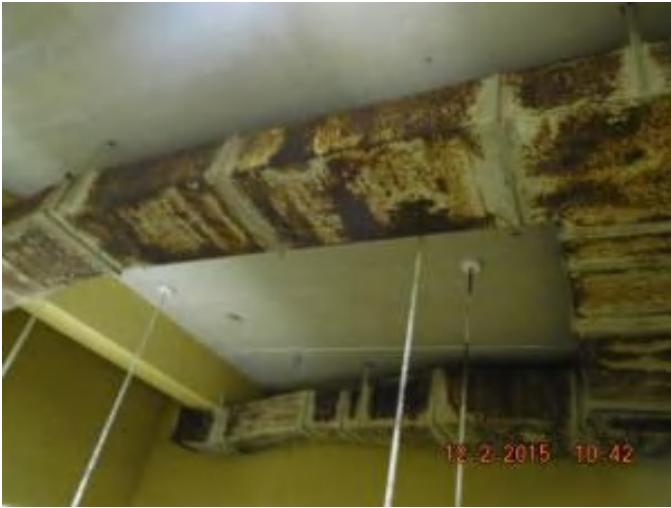
System: D3040 - Distribution Systems

Location: pool

Distress: Beyond Service Life

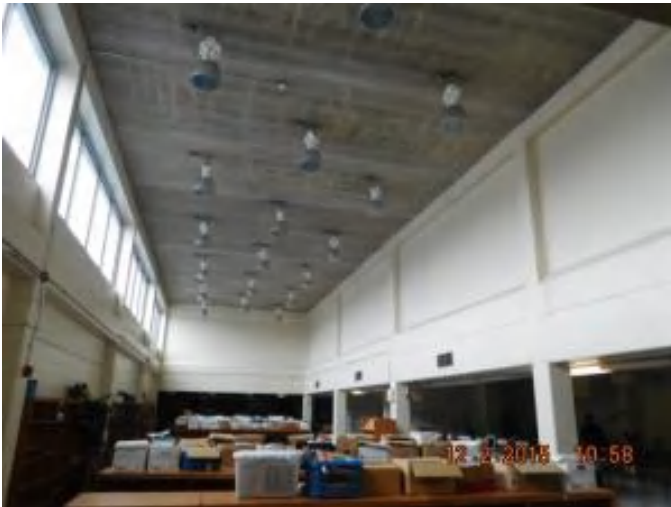
System: D3040 - Distribution Systems

Location: IMC

Distress: Building / MEP Codes

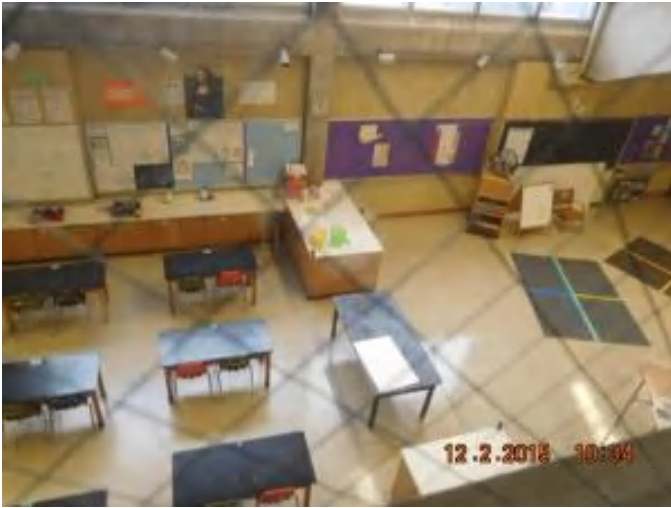
System: D3040 - Distribution Systems

Location: multi purpose room

Distress: Building / MEP Codes

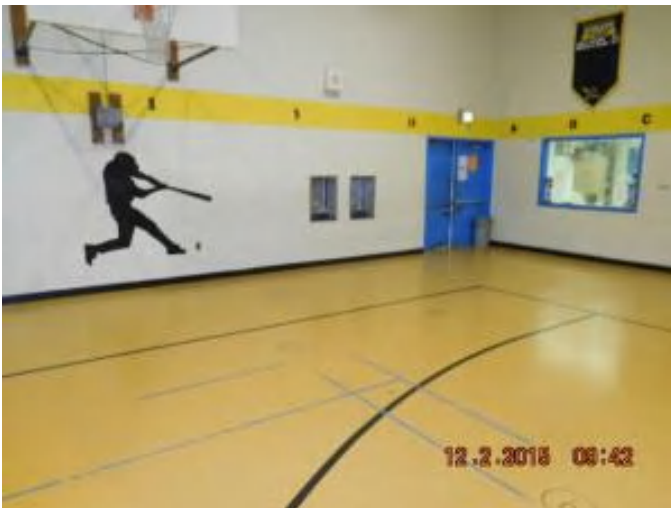
System: D3040 - Distribution Systems

Location: gymnasiums

Distress: Building / MEP Codes

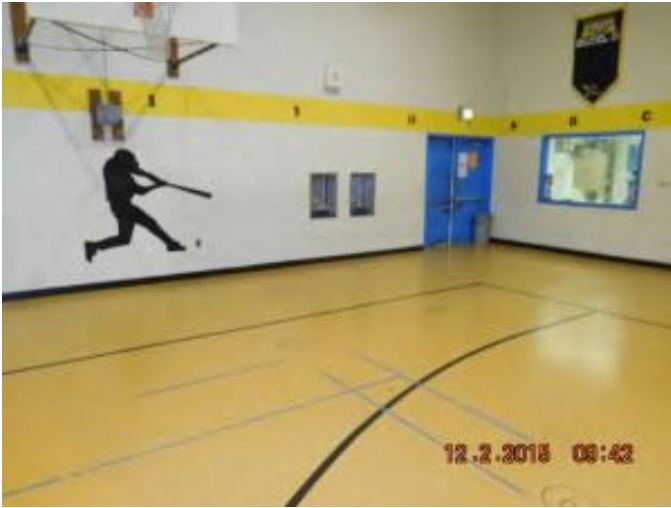
System: D3040 - Distribution Systems

Location: gymnasiums

Distress: Building / MEP Codes

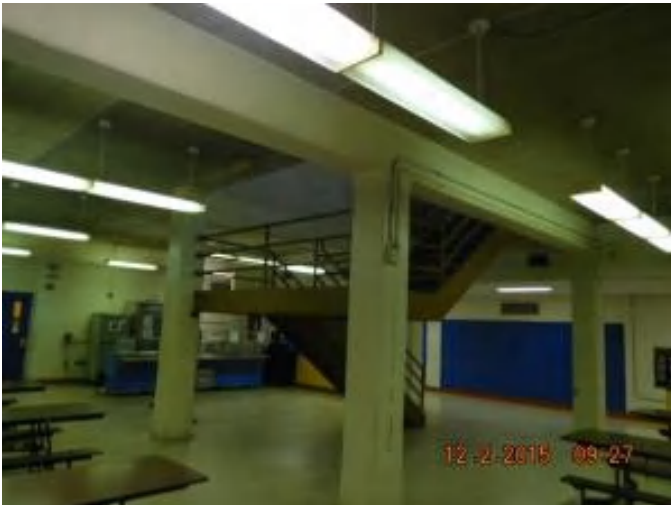
System: D3040 - Distribution Systems

Location: cafeteria

Distress: Building / MEP Codes

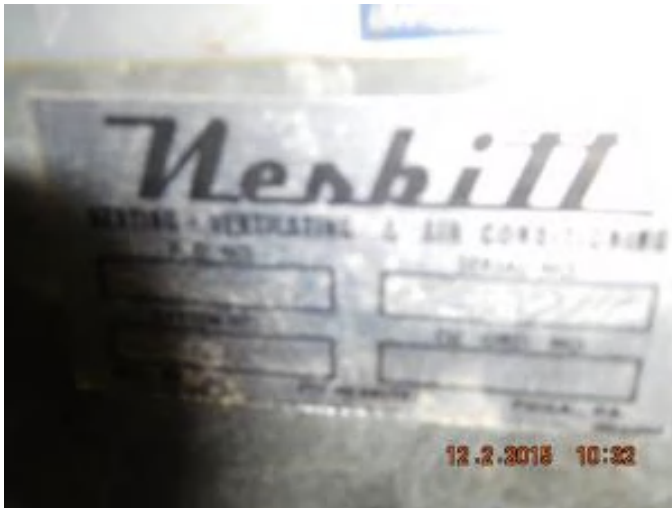
System: D3040 - Distribution Systems

Location: cafeteria

Distress: Building / MEP Codes

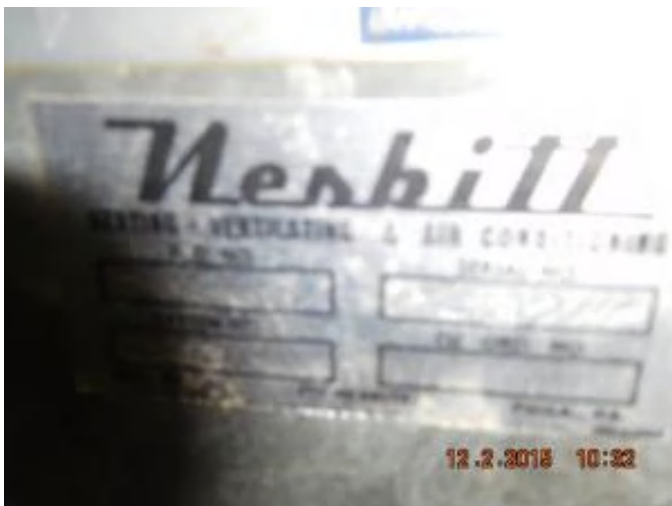
System: D3040 - Distribution Systems

Location: cafeteria

Distress: Building / MEP Codes

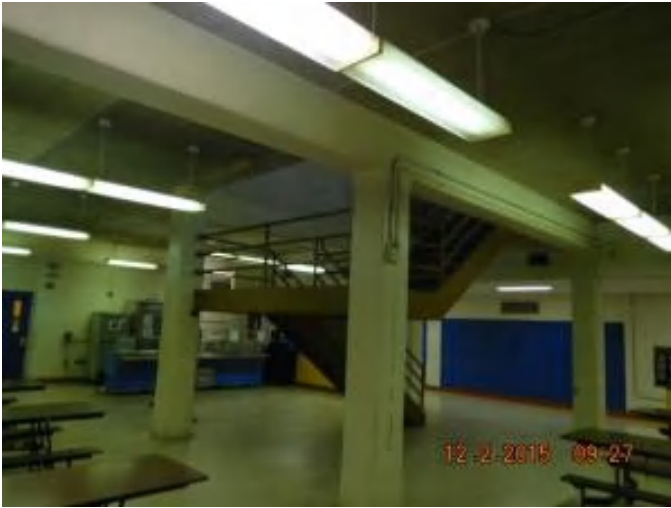
System: D3040 - Distribution Systems

Location: cafeteria

Distress: Building / MEP Codes

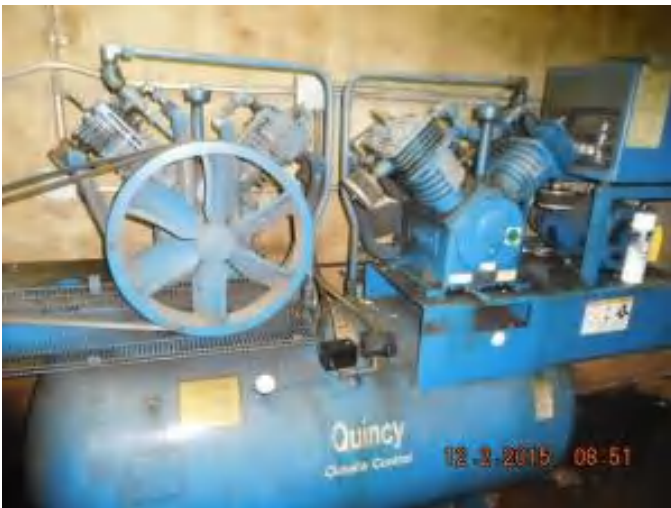
System: D3060 - Controls & Instrumentation

Location: entire building

Distress: Inadequate

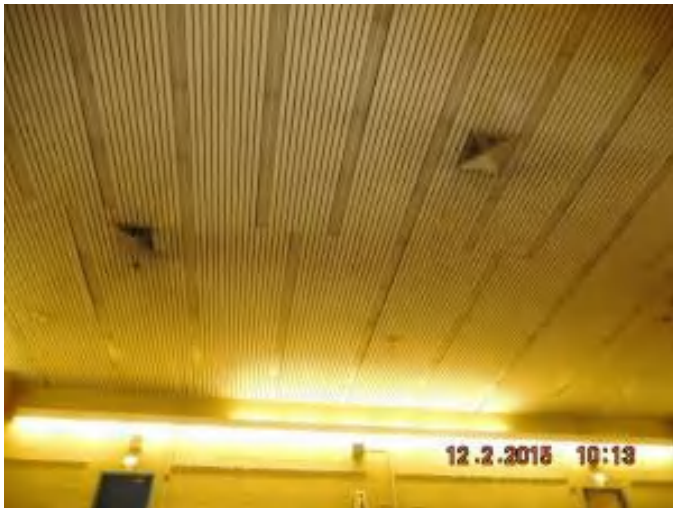
System: D4010 - Sprinklers

Location: entire building

Distress: Life Safety / NFPA / PFD

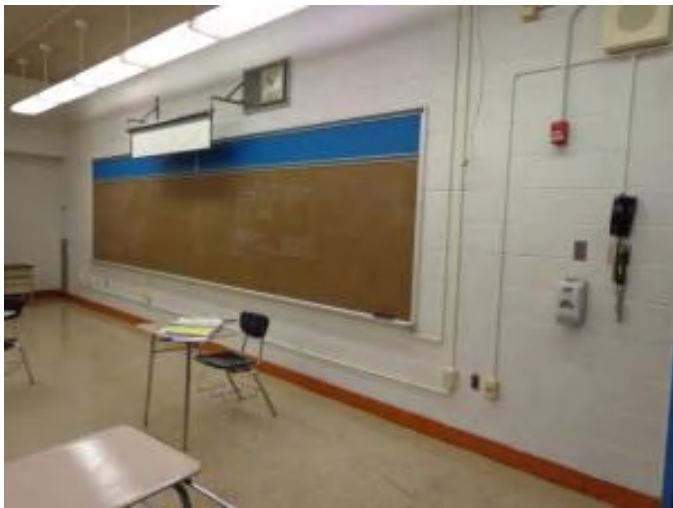
System: D5020 - Lighting and Branch Wiring

Location: Classrooms

Distress: Inadequate

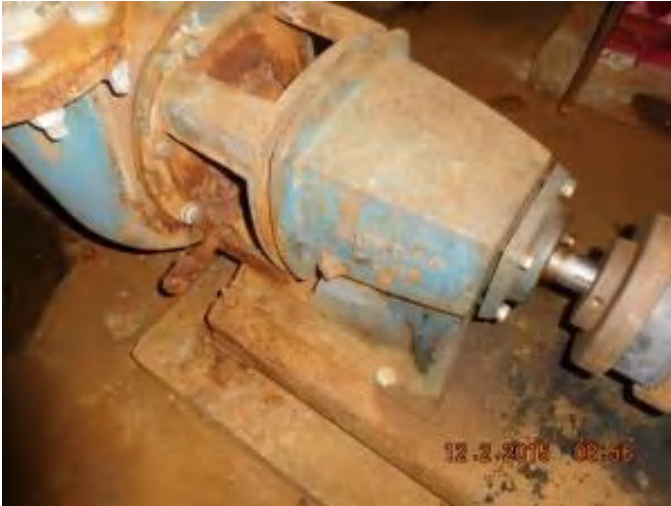
System: D3030 - Cooling Generating Systems

Location: roof, mechanical room

Distress: Inadequate

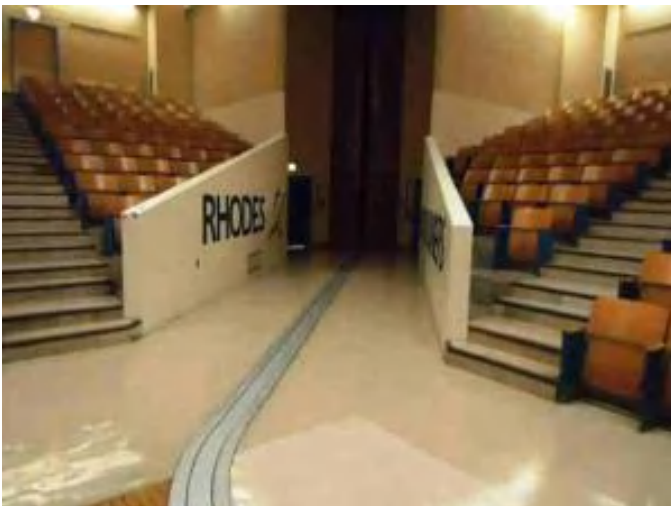
System: E2010 - Fixed Furnishings

Location: Building Wide

Distress: Damaged

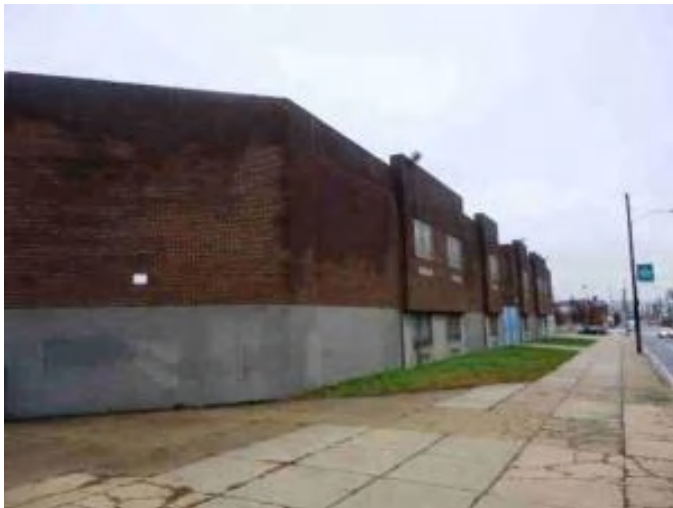
System: G2030 - Pedestrian Paving

Location: Site

Distress: Damaged

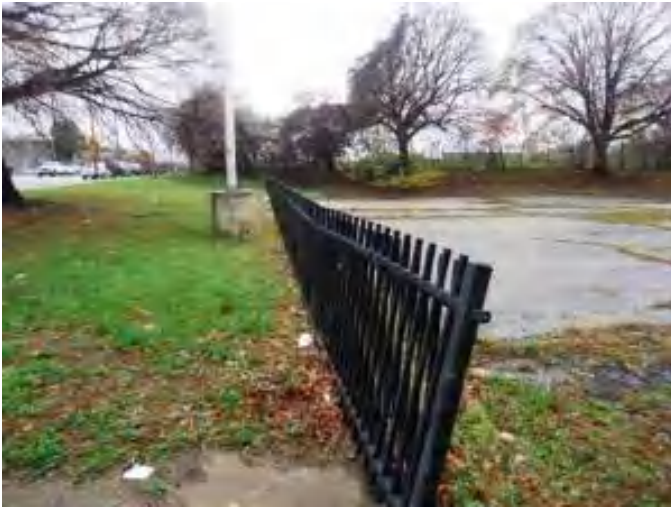
System: G2040 - Site Development

Location: site

Distress: Damaged

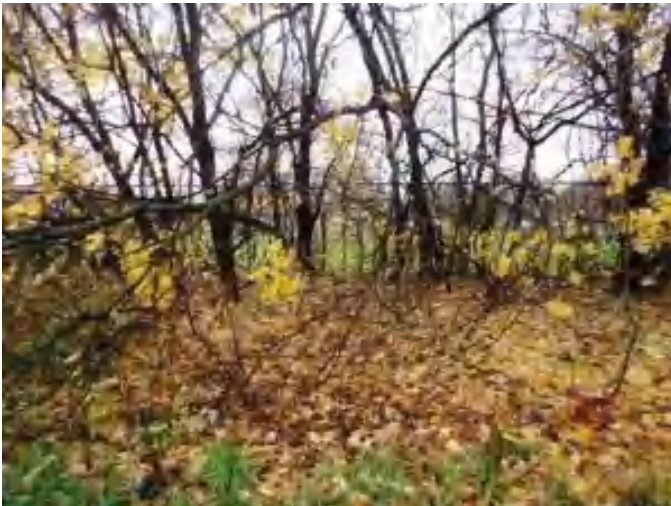
System: G2040 - Site Development

Location: Site

Distress: Damaged

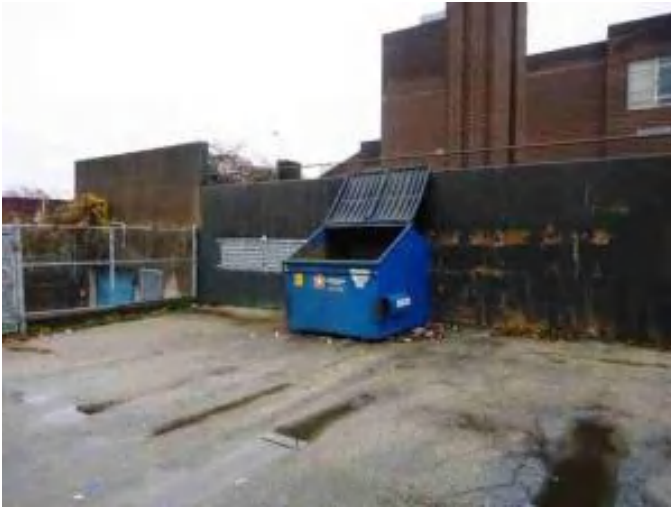
System: G2040 - Site Development

Location: Site

Distress: Damaged

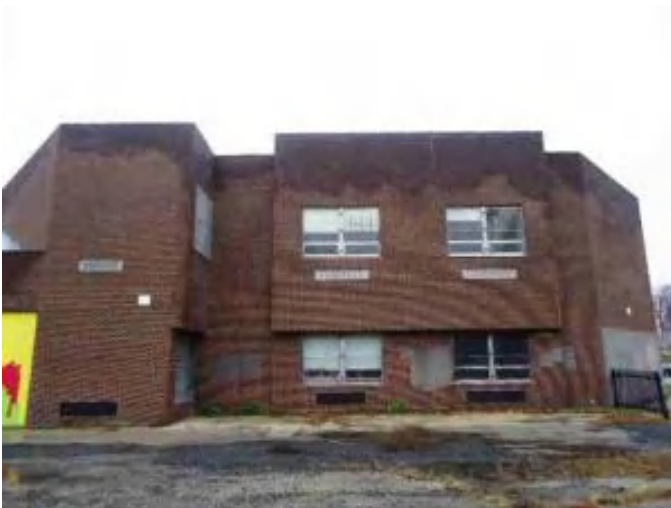
System: G4030 - Site Communications & Security

Location: Site

Distress: Security Issue

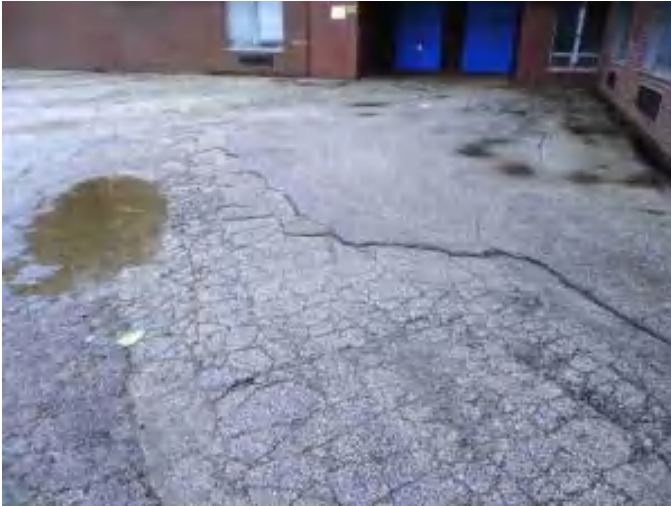
System: G2020 - Parking Lots

Location: Parking Lot

Distress: Damaged

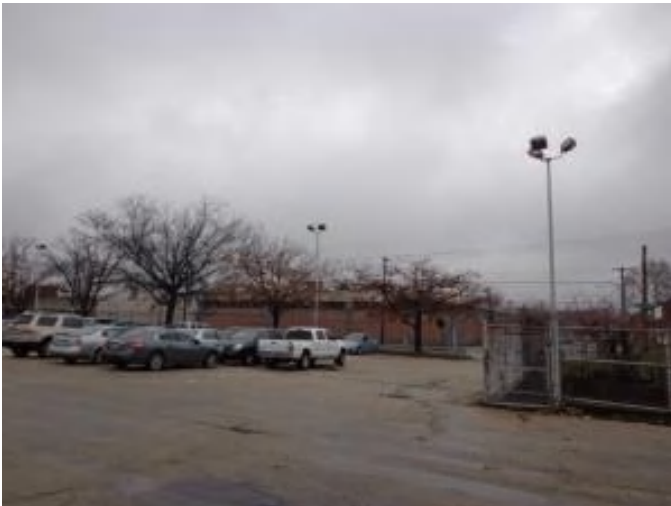
System: G4020 - Site Lighting

Location: Site Parking and Play Areas

Distress: Beyond Service Life
