## Facility Condition Assessment Summary Report

### Richmond School

School District of Philadelphia  
**S540001;Richmond**  
Final  
**Site Assessment Report**  
January 31, 2017

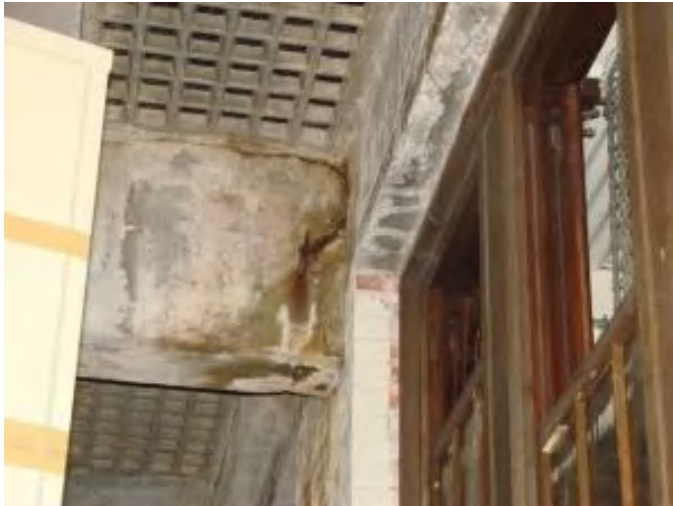
#### System: B1010 - Floor Construction

**Location:** Exterior/Interior

**Distress:** Health Hazard / Risk

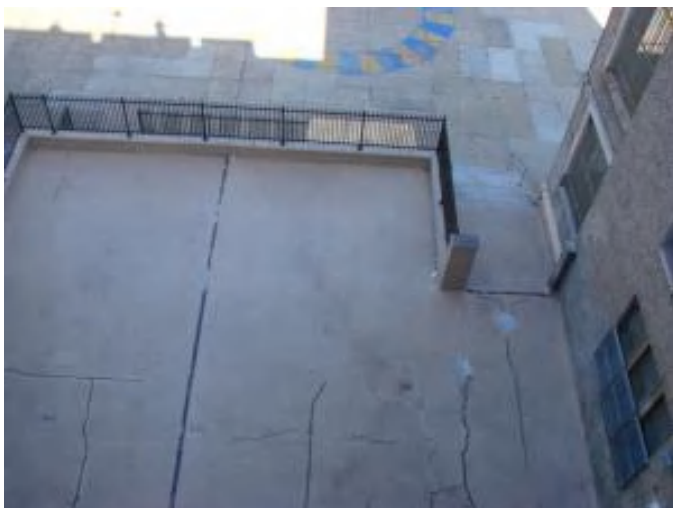
#### System: B3010120 - Single Ply Membrane

**Location:** Exterior

**Distress:** Building Envelope Integrity

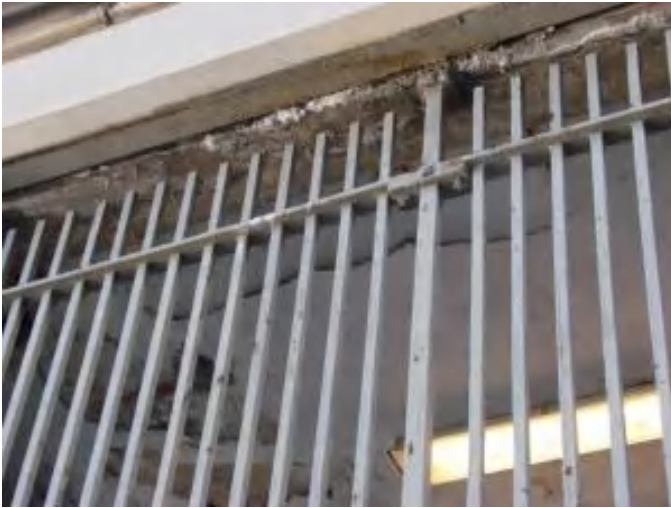
**System: C2010 - Stair Construction**

**Location:** Exterior/Interior

**Distress:** Damaged

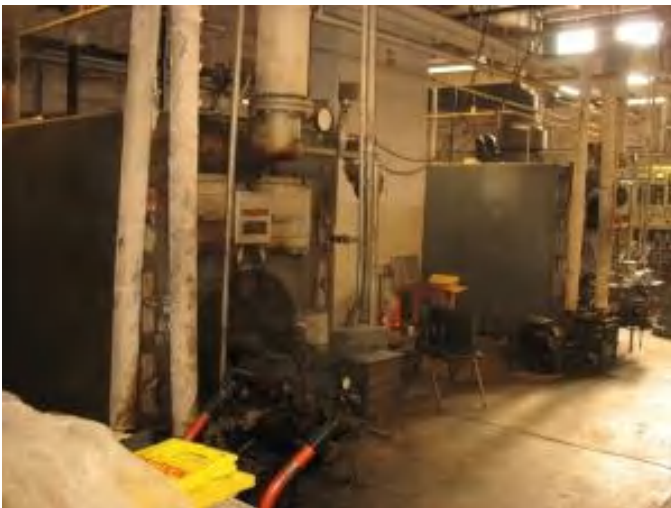
**System: D3020 - Heat Generating Systems**

**Location:** Boiler room

**Distress:** Beyond Service Life

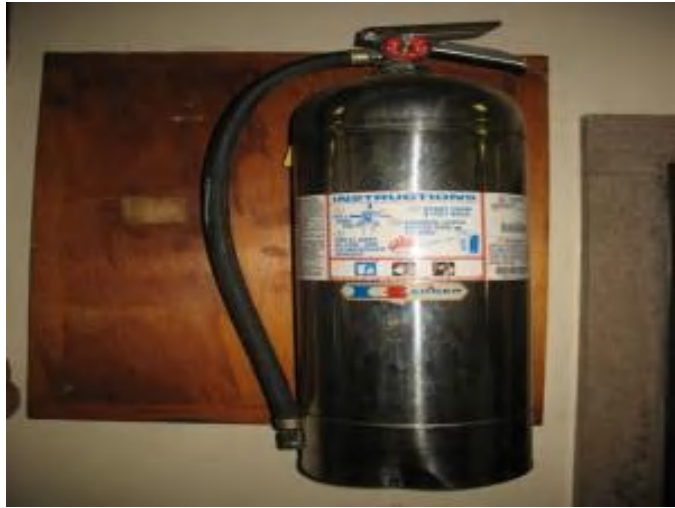
**System: D4010 - Sprinklers**

**Location:** Throughout building

**Distress:** Life Safety / NFPA / PFD

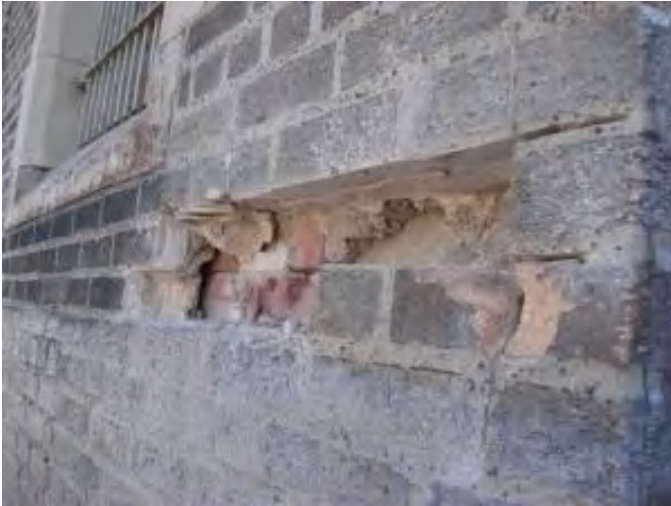
**System: B2010 - Exterior Walls**

**Location:** Exterior

**Distress:** Beyond Service Life

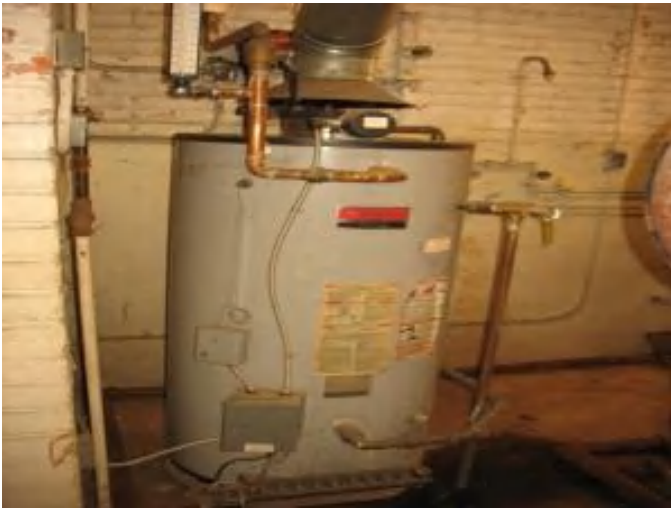
**System: D2020 - Domestic Water Distribution**

**Location:** Boiler room

**Distress:** Beyond Service Life

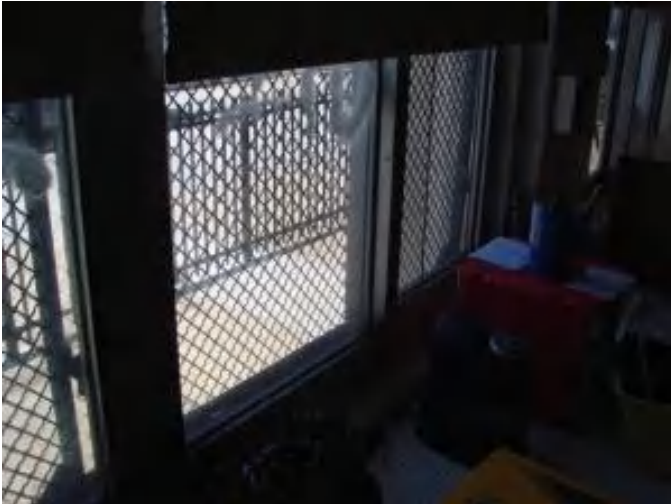
**System: B2020 - Exterior Windows**

**Location:** Exterior

**Distress:** Beyond Service Life

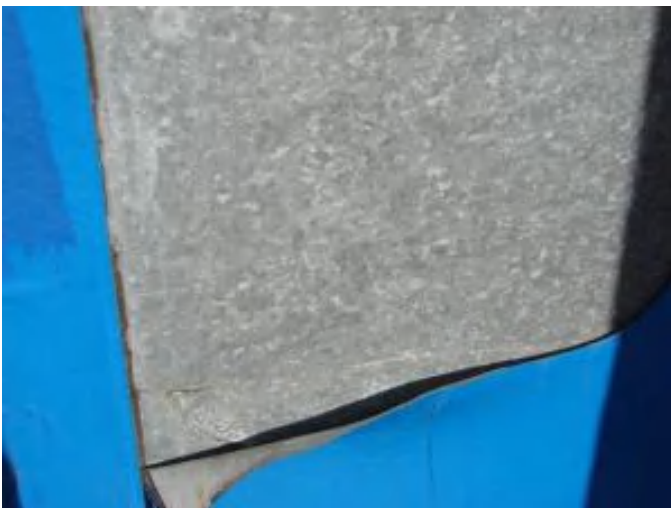
**System: B2030 - Exterior Doors**

**Location:** Exterior

**Distress:** Beyond Service Life

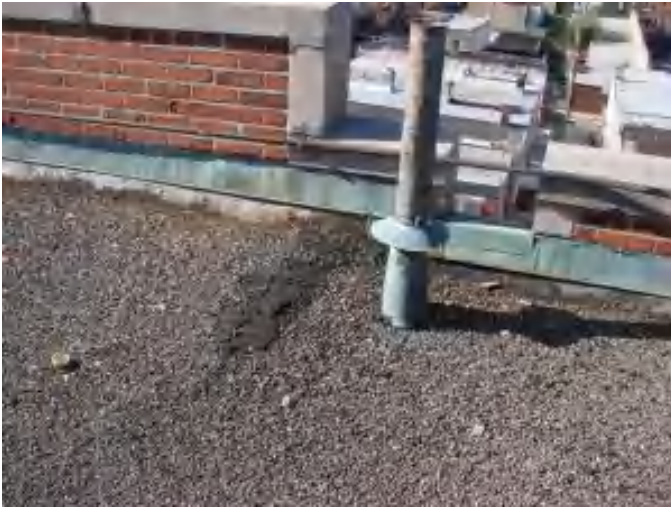
**System: B3010105 - Built-Up**

**Location:** Exterior

**Distress:** Building Envelope Integrity

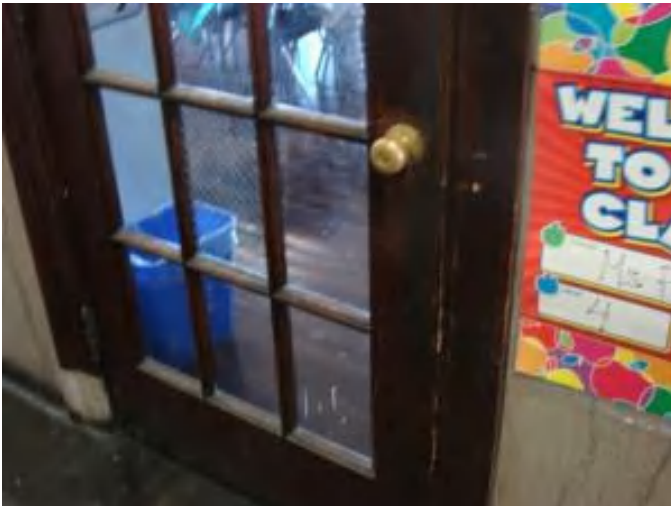
**System: C1020 - Interior Doors**

**Location:** Interior

**Distress:** Accessibility

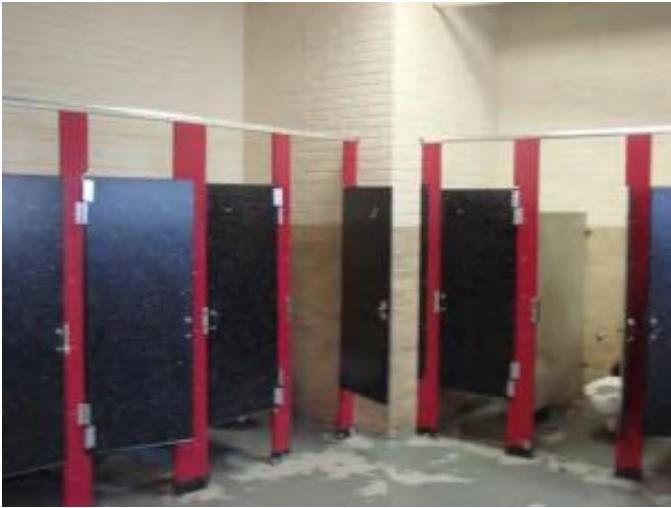
**System: C1030 - Fittings**

**Location:** Interior  
**Distress:** Accessibility  
**Category:** 2 - Code Compliance  
**Priority:** 3 - Response Time (3-4 yrs)  
**Correction:** Remove and replace damaged toilet partitions - handicap units  
**Qty:** 40.00  
**Unit of Measure:** Ea.  
**Estimate:** \$123,509.97  
**Assessor Name:** System  
**Date Created:** 01/14/2016

**Notes:** Reconfigure toilets on each floor for accessibility, provide new toilet partitions.

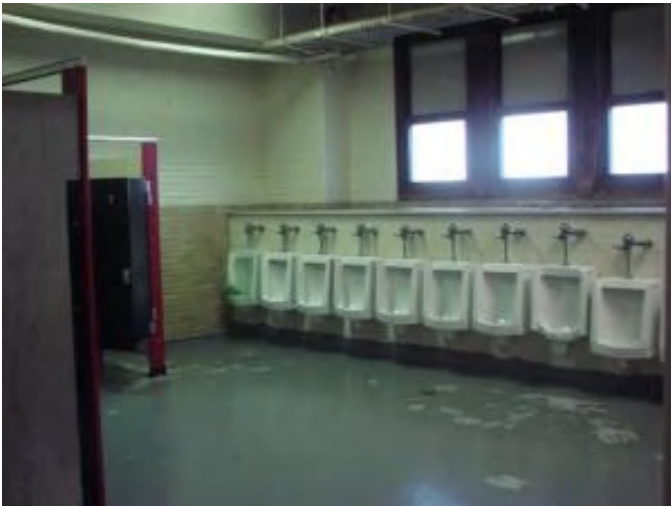
**System: C1030 - Fittings**

**Location:** Interior  
**Distress:** Accessibility  
**Category:** 2 - Code Compliance  
**Priority:** 3 - Response Time (3-4 yrs)  
**Correction:** Replace toilet accessories - select accessories and quantity  
**Qty:** 40.00  
**Unit of Measure:** Ea.  
**Estimate:** \$49,194.85  
**Assessor Name:** System  
**Date Created:** 01/14/2016

**Notes:** Provide new toilet accessories including grab bars

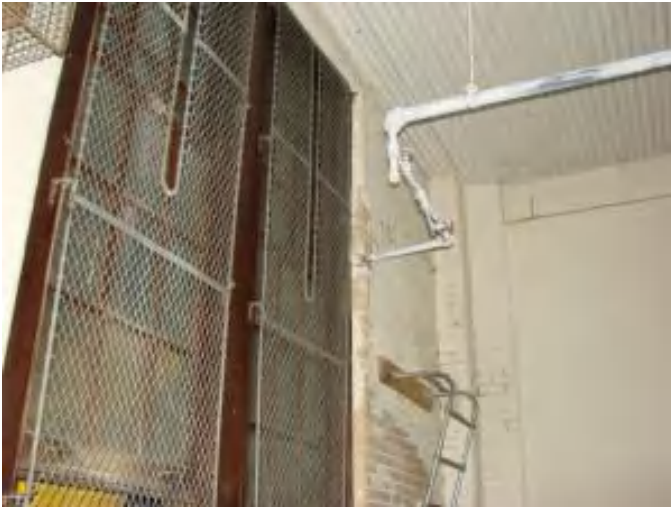
**System: C3010230 - Paint & Covering**

**Location:** Interior

**Distress:** Beyond Service Life

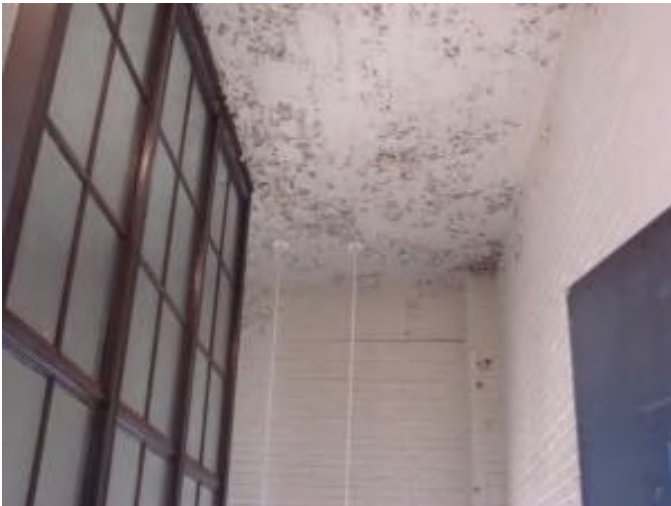
**System: C3030 - Ceiling Finishes**

**Location:** Interior

**Distress:** Beyond Service Life

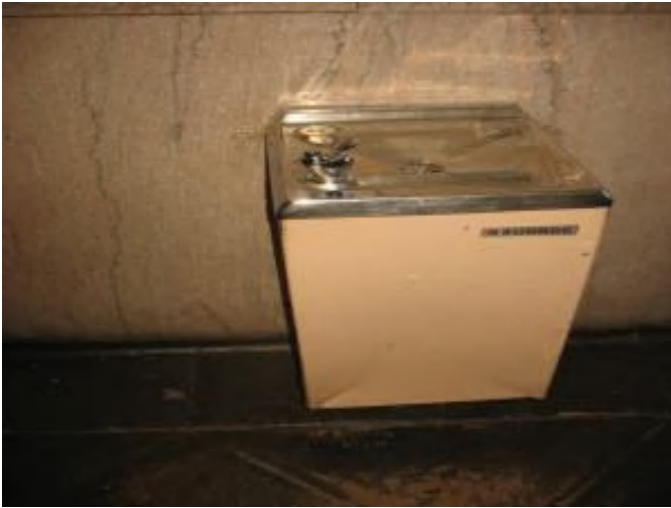
**System: D2010 - Plumbing Fixtures**

**Location:** Corridors  
**Distress:** Beyond Service Life  
**Category:** 3 - Operations / Maint.  
**Priority:** 3 - Response Time (3-4 yrs)  
**Correction:** Remove and Replace Water Fountains - without ADA new recessed alcove  
**Qty:** 8.00  
**Unit of Measure:** Ea.  
**Estimate:** \$53,067.85  
**Assessor Name:** System  
**Date Created:** 10/20/2015

**Notes:** Replace eight (8) wall hung drinking fountains and integral refrigerated coolers in the corridors and at the restrooms. These units are beyond their service life and most are NOT accessible type.

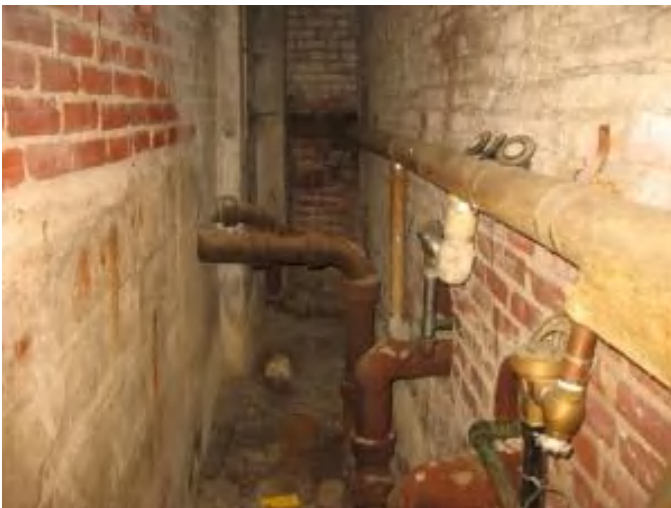
**System: D2030 - Sanitary Waste**

**Location:** Throughout building  
**Distress:** Beyond Service Life  
**Category:** 3 - Operations / Maint.  
**Priority:** 3 - Response Time (3-4 yrs)  
**Correction:** Inspect sanitary waste piping and replace damaged sections. (+50KSF)  
**Qty:** 48,300.00  
**Unit of Measure:** S.F.  
**Estimate:** \$211,028.07  
**Assessor Name:** System  
**Date Created:** 10/20/2015

**Notes:** Hire a qualified contractor to perform a detailed examination of the sanitary waste piping using visual inspection and video cameras to locate and replace any damaged piping and to further quantify the extent of potential failures.

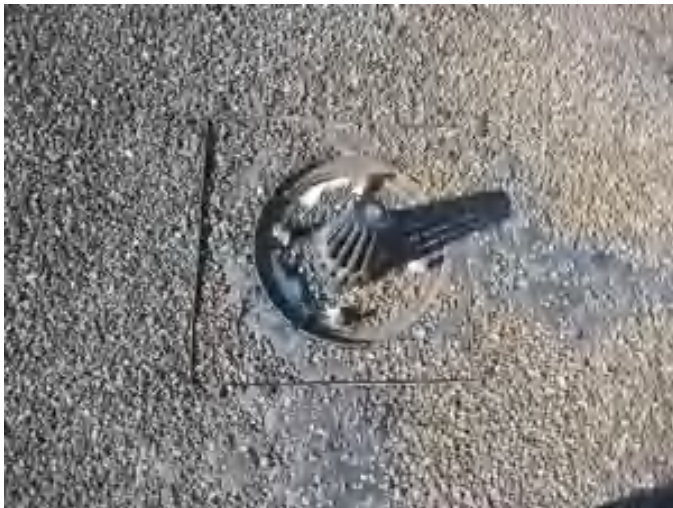
**System: D2040 - Rain Water Drainage**

**Location:** Throughout building

**Distress:** Beyond Service Life

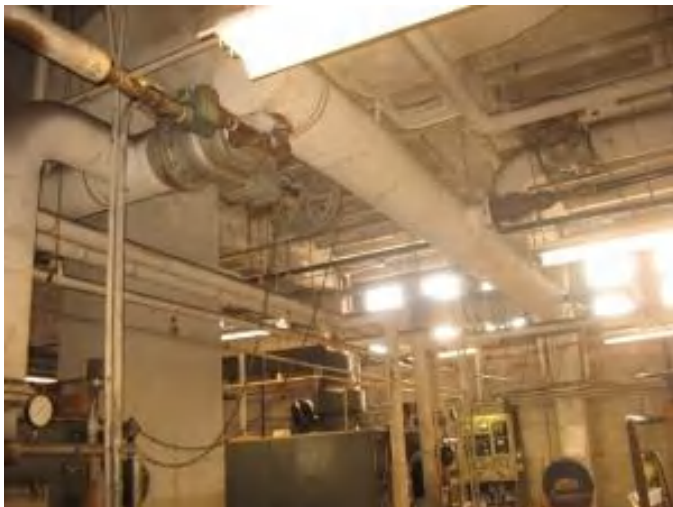
**System: D3040 - Distribution Systems**

**Location:** Throughout building

**Distress:** Beyond Service Life

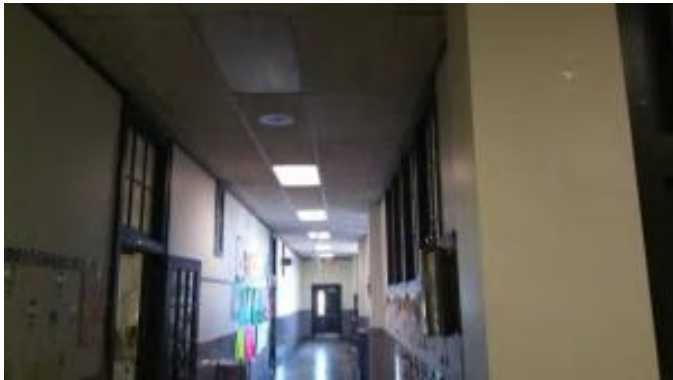
**System: D5020 - Lighting and Branch Wiring**

**Location:** throughout the building  
**Distress:** Beyond Service Life  
**Category:** 3 - Operations / Maint.  
**Priority:** 3 - Response Time (3-4 yrs)  
**Correction:** Replace Lighting Fixtures (SF)  
**Qty:** 0.00  
**Unit of Measure:** S.F.  
**Estimate:** \$425,236.04  
**Assessor Name:** System  
**Date Created:** 01/08/2016

**Notes:** Install new a lighting system for the entire building (including the small annex).

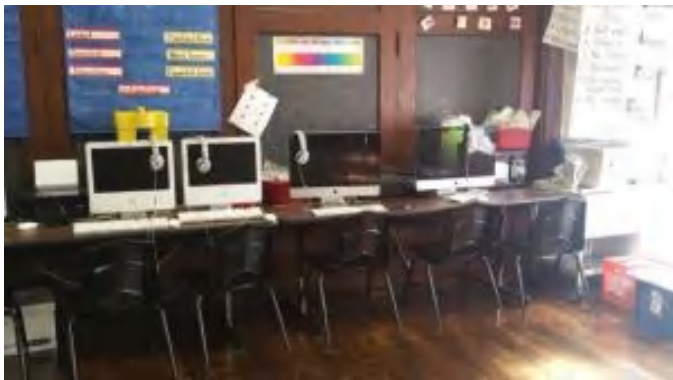
**System: D5020 - Lighting and Branch Wiring**

**Location:** throughout the building  
**Distress:** Beyond Service Life  
**Category:** 3 - Operations / Maint.  
**Priority:** 3 - Response Time (3-4 yrs)  
**Correction:** Replace Wiring Devices (SF) - surface mounted conduit and boxes  
**Qty:** 0.00  
**Unit of Measure:** S.F.  
**Estimate:** \$264,068.89  
**Assessor Name:** System  
**Date Created:** 01/08/2016

**Notes:** Install new receptacles in all classrooms and other areas (minimum two receptacles on each wall), including the small annex.

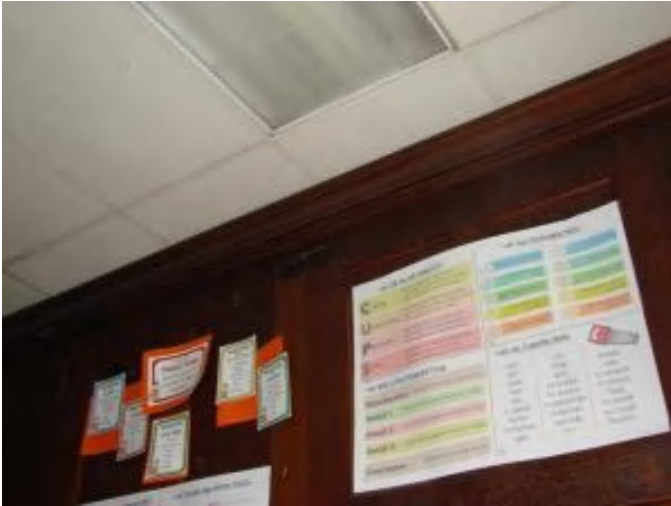
**System: C1010 - Partitions**

**Location:** Interior

**Distress:** Beyond Service Life

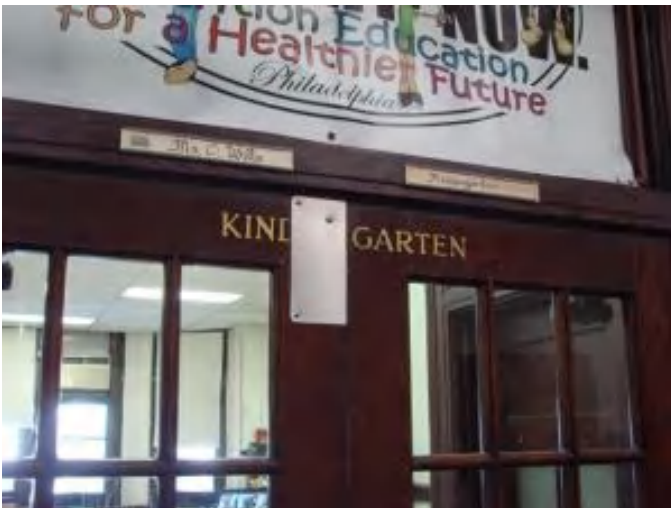
**System: C1030 - Fittings**

**Location:** Interior

**Distress:** Beyond Service Life

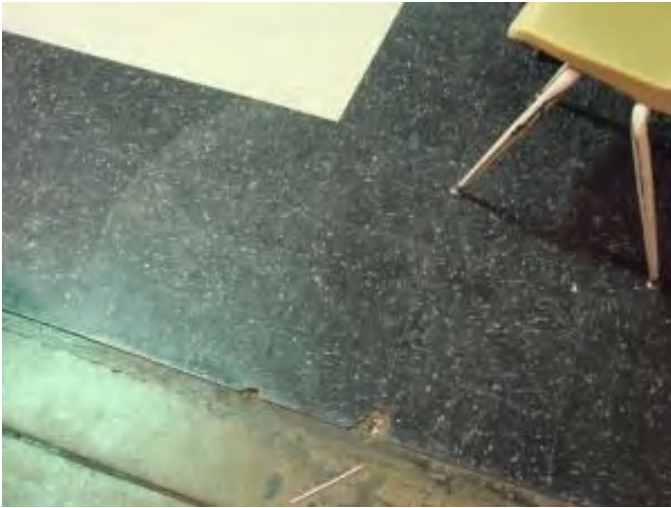
**System: C3020413 - Vinyl Flooring**

**Location:** Interior  
**Distress:** Beyond Service Life  
**Category:** 3 - Operations / Maint.  
**Priority:** 4 - Response Time (4-5 yrs)  
**Correction:** Remove VAT and replace with VCT - SF of area  
**Qty:** 8,500.00  
**Unit of Measure:** S.F.  
**Estimate:** \$121,904.61  
**Assessor Name:** System  
**Date Created:** 01/14/2016

**Notes:** Replace all VAT/VCT flooring

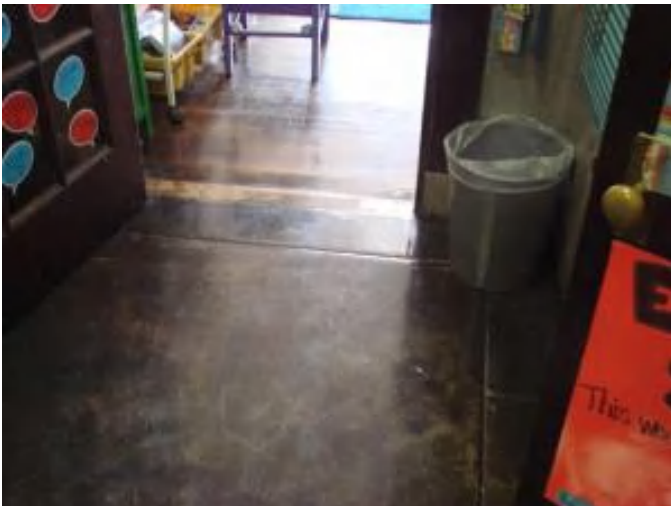
**System: C3020414 - Wood Flooring**

**Location:** Interior  
**Distress:** Beyond Service Life  
**Category:** 3 - Operations / Maint.  
**Priority:** 4 - Response Time (4-5 yrs)  
**Correction:** Remove and replace partial area of wood flooring and refinish entire floor - set replacement area  
**Qty:** 19,200.00  
**Unit of Measure:** S.F.  
**Estimate:** \$184,623.97  
**Assessor Name:** System  
**Date Created:** 01/14/2016

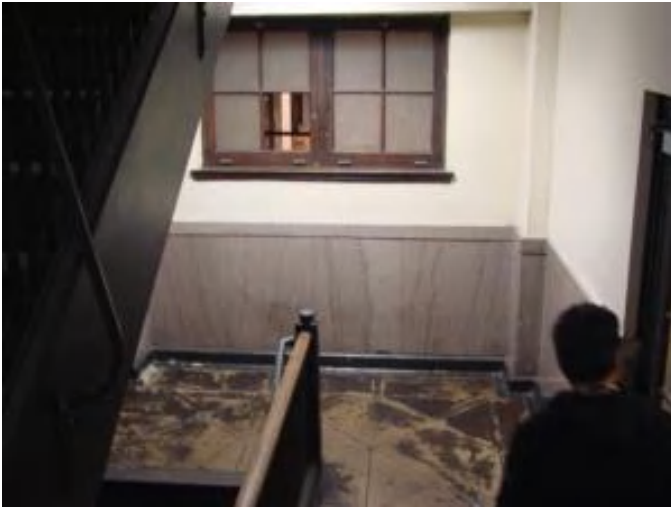
**System: C3020415 - Concrete Floor Finishes**

**Location:** Interior  
**Distress:** Beyond Service Life  
**Category:** 3 - Operations / Maint.  
**Priority:** 4 - Response Time (4-5 yrs)  
**Correction:** Prepare and repaint concrete floor  
**Qty:** 18,100.00  
**Unit of Measure:** S.F.  
**Estimate:** \$86,575.11  
**Assessor Name:** System  
**Date Created:** 01/14/2016

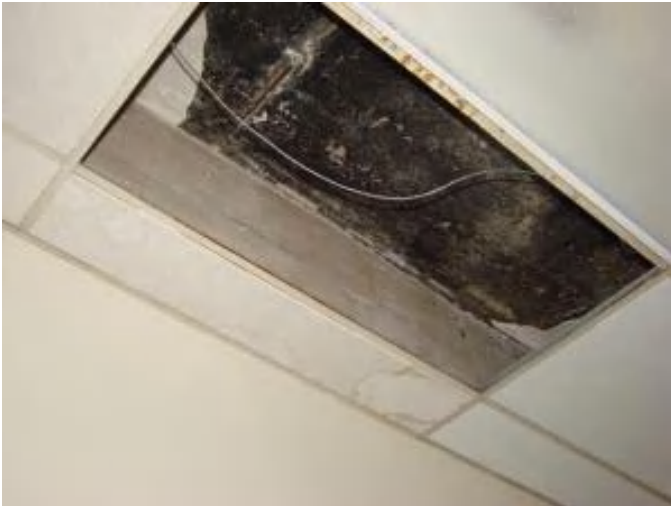
**System: C3030 - Ceiling Finishes**

**Location:** Interior  
**Distress:** Beyond Service Life  
**Category:** 3 - Operations / Maint.  
**Priority:** 4 - Response Time (4-5 yrs)  
**Correction:** Remove and replace suspended acoustic ceilings - lighting not included  
**Qty:** 15,100.00  
**Unit of Measure:** S.F.  
**Estimate:** \$191,237.12  
**Assessor Name:** System  
**Date Created:** 01/14/2016

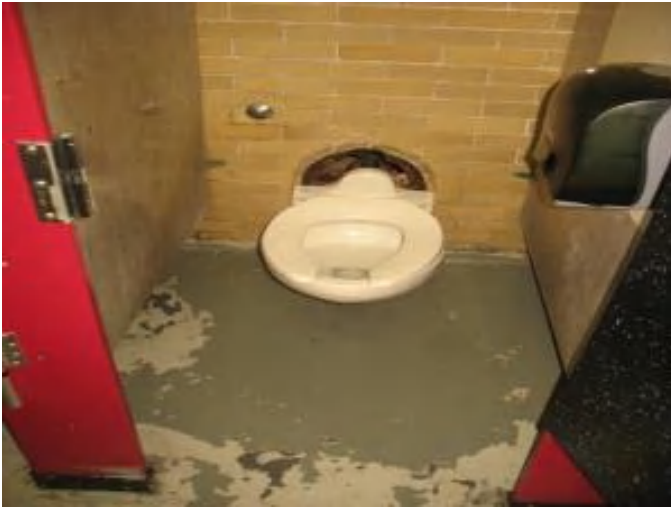
**System: D2010 - Plumbing Fixtures**

**Location:** Restrooms  
**Distress:** Beyond Service Life  
**Category:** 3 - Operations / Maint.  
**Priority:** 4 - Response Time (4-5 yrs)  
**Correction:** Remove and replace or replace water closet - quantify additional units  
**Qty:** 25.00  
**Unit of Measure:** Ea.  
**Estimate:** \$158,841.41  
**Assessor Name:** System  
**Date Created:** 10/20/2015

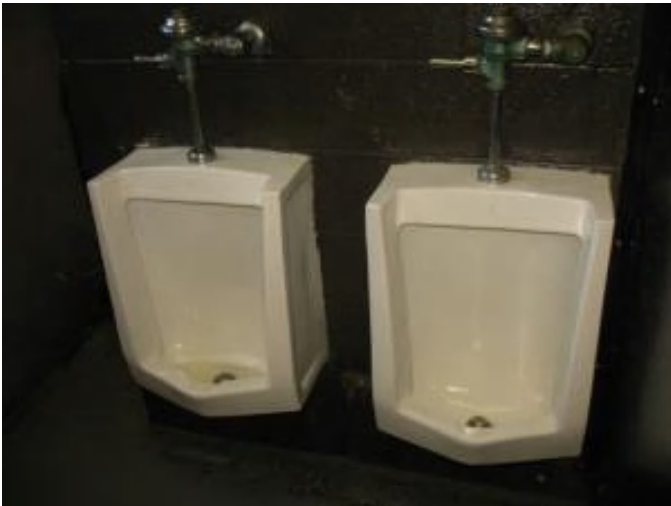
**System: D2010 - Plumbing Fixtures**

**Location:** Restrooms  
**Distress:** Beyond Service Life  
**Category:** 3 - Operations / Maint.  
**Priority:** 4 - Response Time (4-5 yrs)  
**Correction:** Remove and replace or replace wall hung urinals  
**Qty:** 18.00  
**Unit of Measure:** Ea.  
**Estimate:** \$55,116.66  
**Assessor Name:** System  
**Date Created:** 10/20/2015

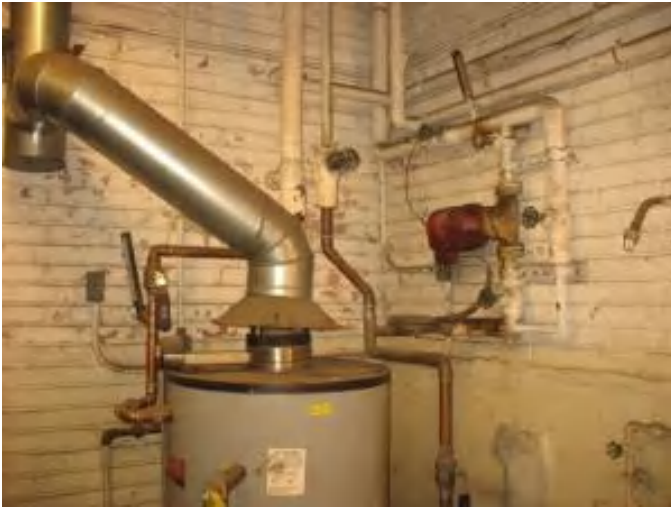
**System: D2020 - Domestic Water Distribution**

**Location:** Throughout building

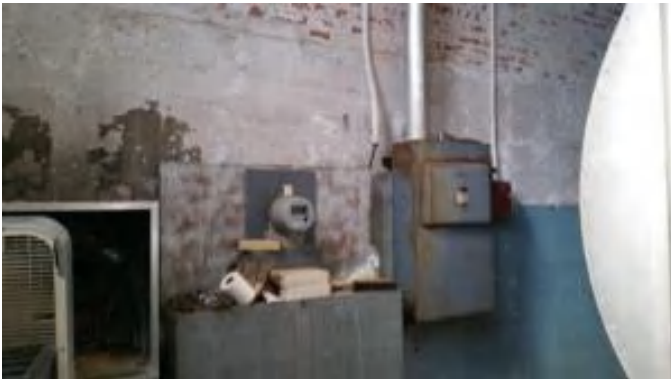
**System: D5010 - Electrical Service/Distribution**

**Location:** electrical room

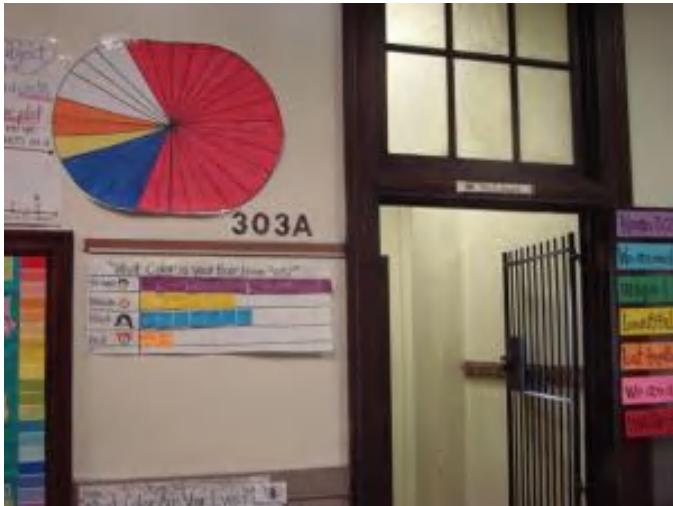
**System: C1020 - Interior Doors**

**Location:** Interior

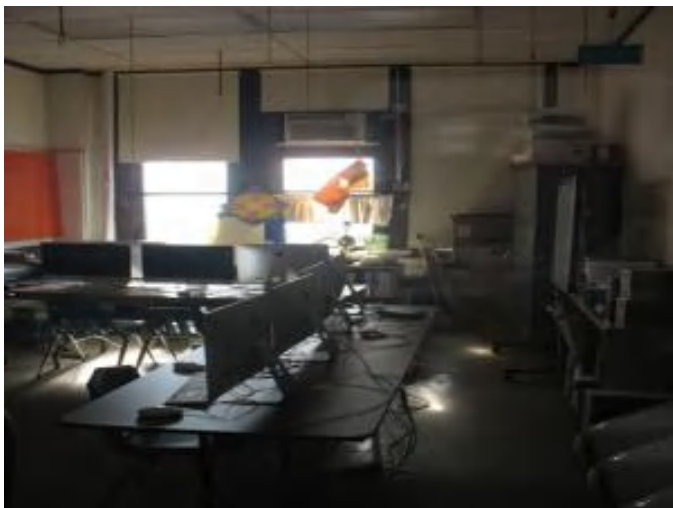
**System: D3030 - Cooling Generating Systems**

**Location:** Throughout building

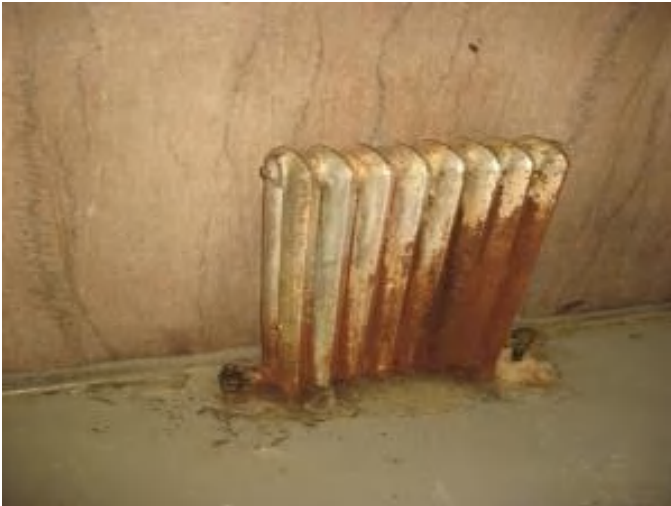
**System: D3040 - Distribution Systems**

**Location:** Throughout building

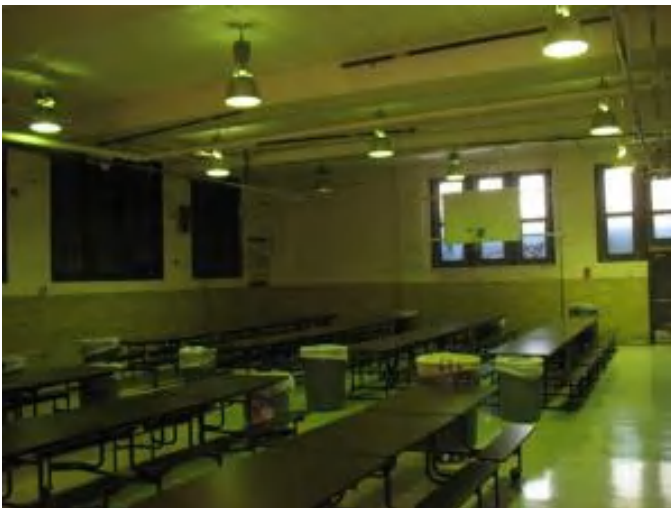
**System: D3040 - Distribution Systems**

**Location:** Cafeteria/Gymnasium

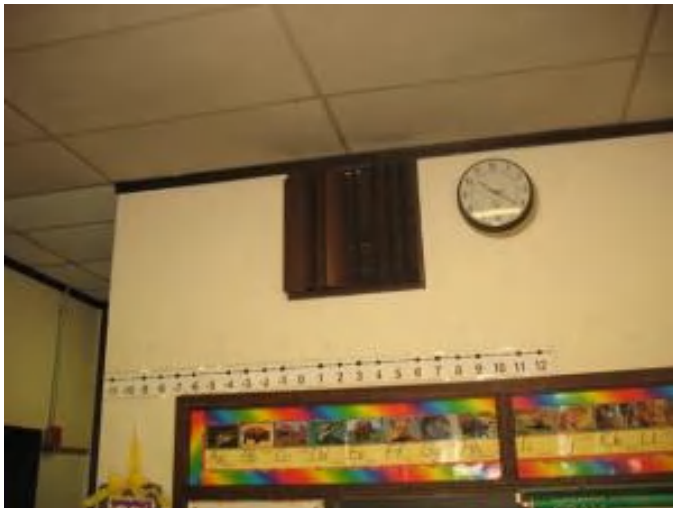
**System: D3040 - Distribution Systems**

**Location:** Administration  
**Distress:** Building / MEP Codes  
**Category:** 2 - Code Compliance  
**Priority:** 5 - Response Time (> 5 yrs)  
**Correction:** Install HVAC unit for Administration (2000 students).  
**Qty:** 556.00  
**Unit of Measure:** Pr.  
**Estimate:** \$217,685.12  
**Assessor Name:** System  
**Date Created:** 10/20/2015

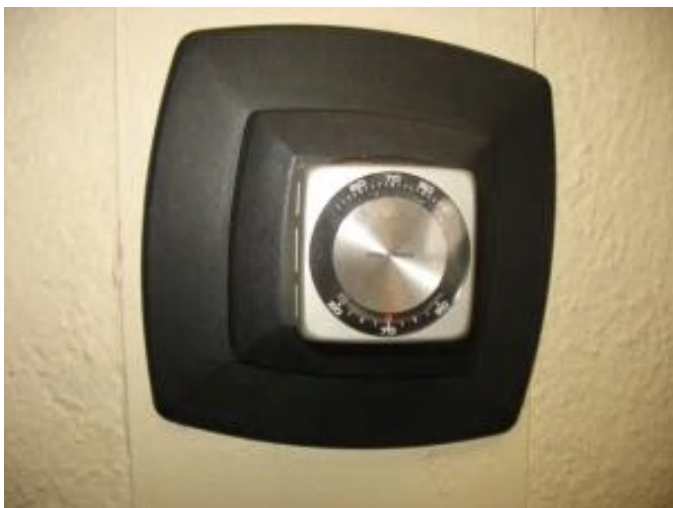
**System: D3060 - Controls & Instrumentation**

**Location:** Throughout building  
**Distress:** Inadequate  
**Category:** 4 - Capital Improvement  
**Priority:** 5 - Response Time (> 5 yrs)  
**Correction:** Replace pneumatic controls with DDC (75KSF)  
**Qty:** 48,300.00  
**Unit of Measure:** S.F.  
**Estimate:** \$897,742.85  
**Assessor Name:** System  
**Date Created:** 10/20/2015

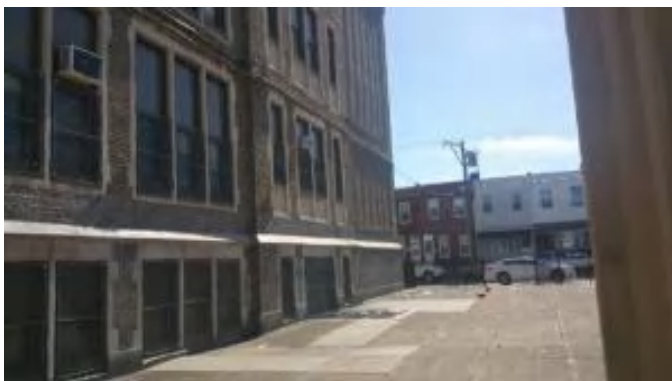
#### System: G4020 - Site Lighting

**Location:** Grounds

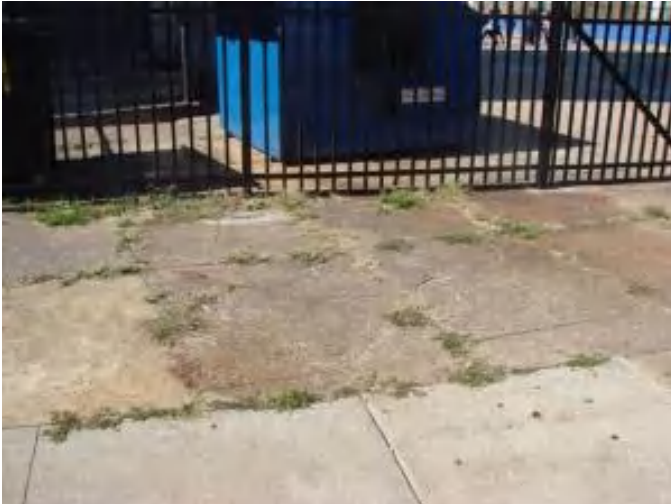
**System: G2030 - Pedestrian Paving**

**Location:** Grounds

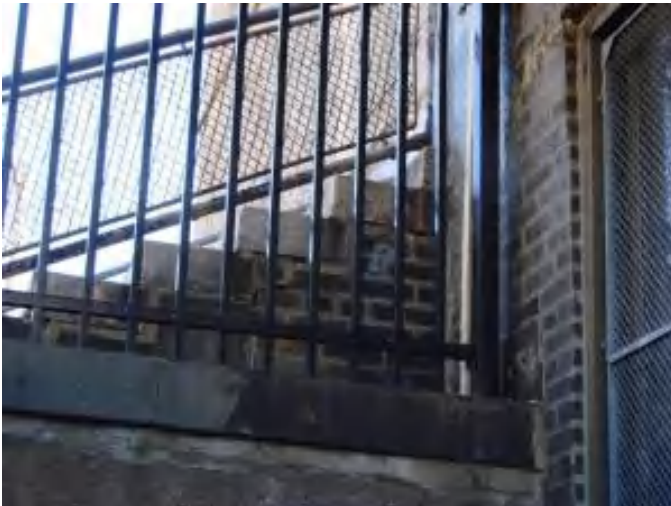
**System: G2040 - Site Development**

**Location:** Grounds

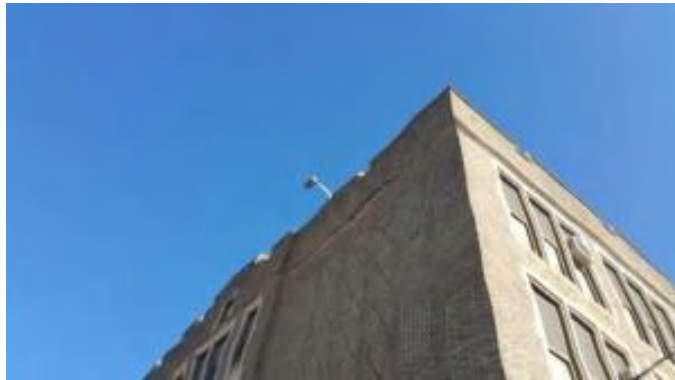
**System: G4030 - Site Communications & Security**

**Location:** Grounds
