## Facility Condition Assessment Summary Report

### Robeson School

School District of Philadelphia  
**S105001;Robeson**  
Final  
**Site Assessment Report**  
January 30, 2017

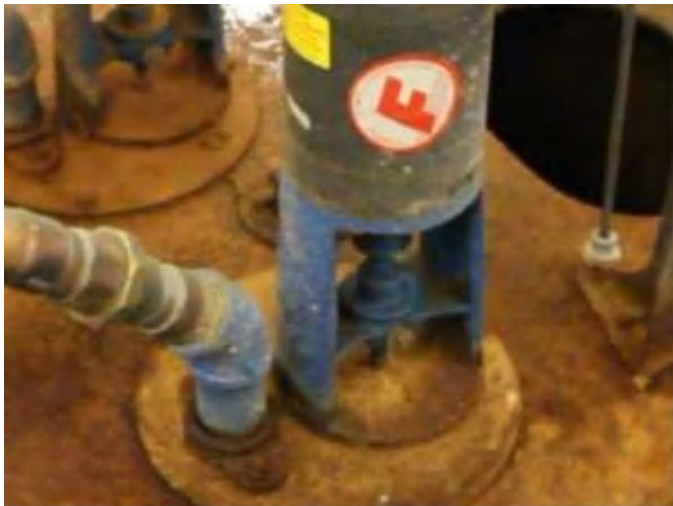
#### System: A2020 - Basement Walls

**Location:** Boiler room

**Distress:** Failing

**Notes:** Replace seized sump pump

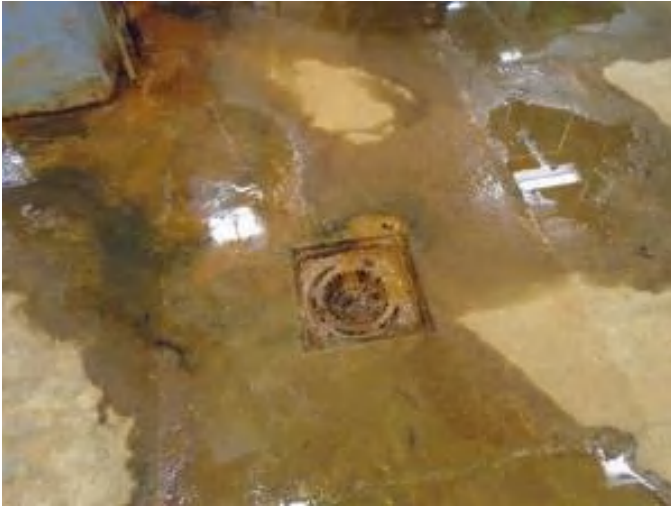
**System: A1010 - Standard Foundations**

**Location:** Basement

**Distress:** Maintenance Required

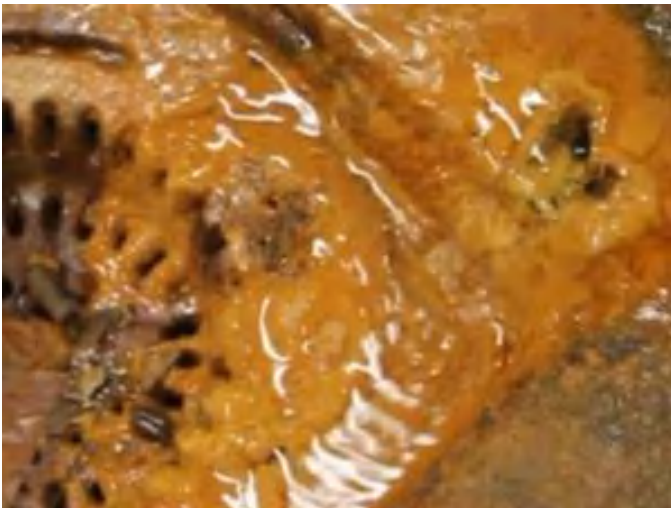
**System: A1030 - Slab on Grade**

**Location:** Boiler room

**Distress:** Building Envelope Integrity

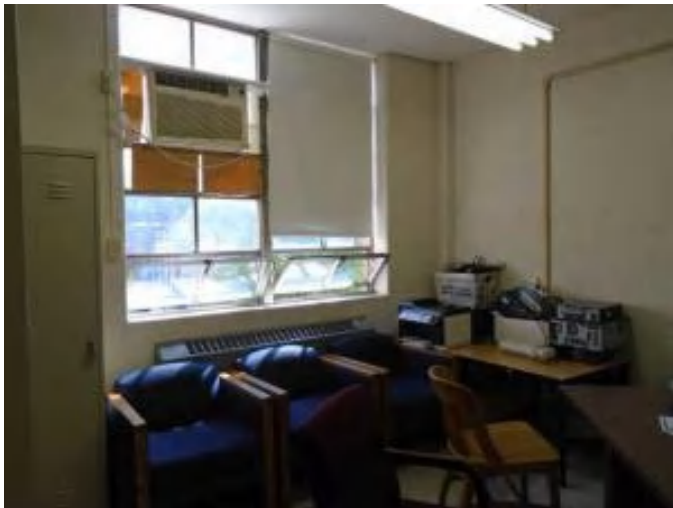
**System: B2020 - Exterior Windows**

**Location:** Throughout

**Distress:** Beyond Service Life

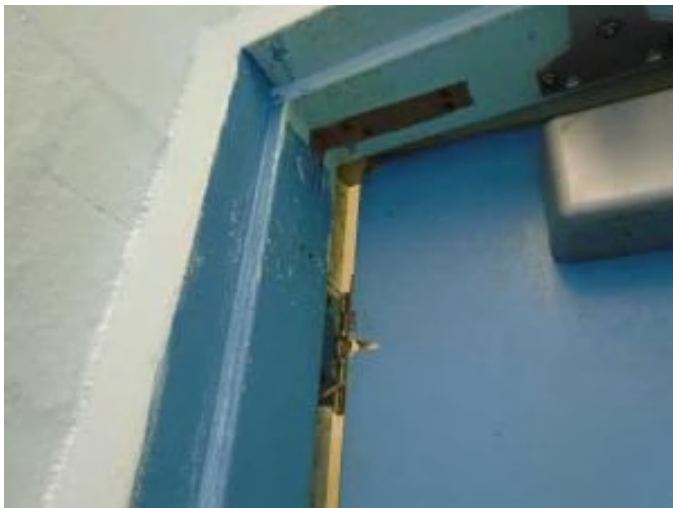
**System: C1020 - Interior Doors**

**Location:** Various

**Distress:** Damaged

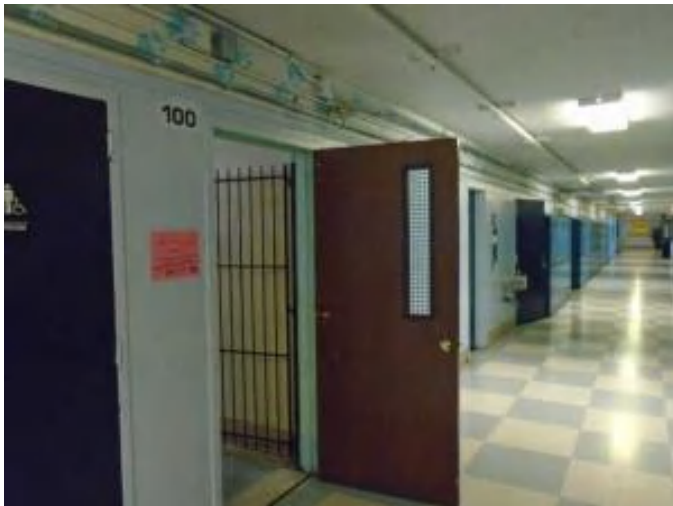
**System: C1020 - Interior Doors**

**Location:** Throughout

**Distress:** Accessibility

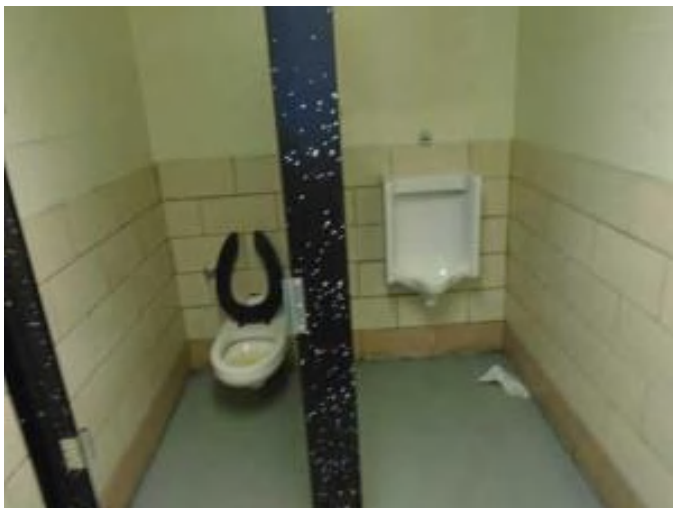
**System: C1030 - Fittings**

**Location:** Toilets

**Distress:** Accessibility

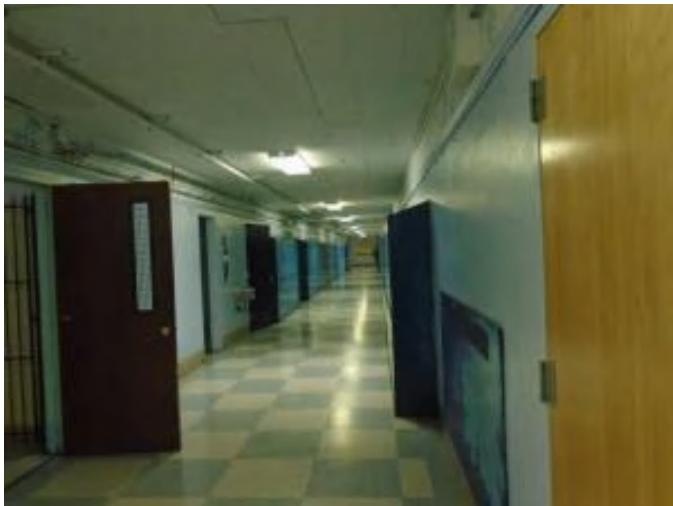
**System: C3030 - Ceiling Finishes**

**Location:** Corridors

**Distress:** Appearance

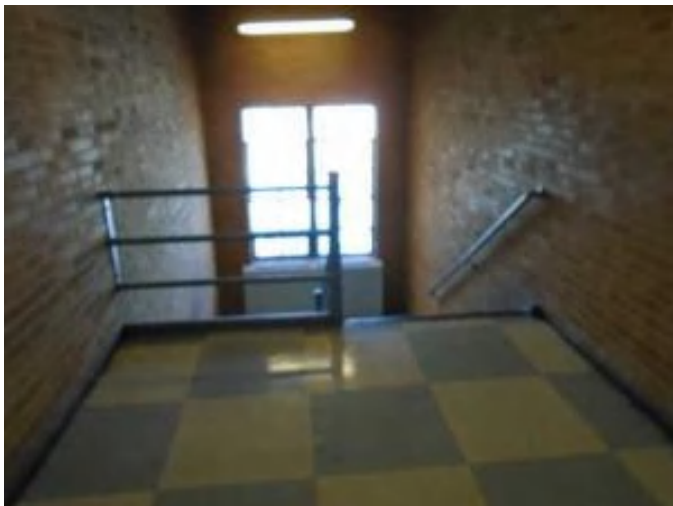
**System: D1010 - Elevators and Lifts**

**Location:** TBD

**Distress:** Accessibility

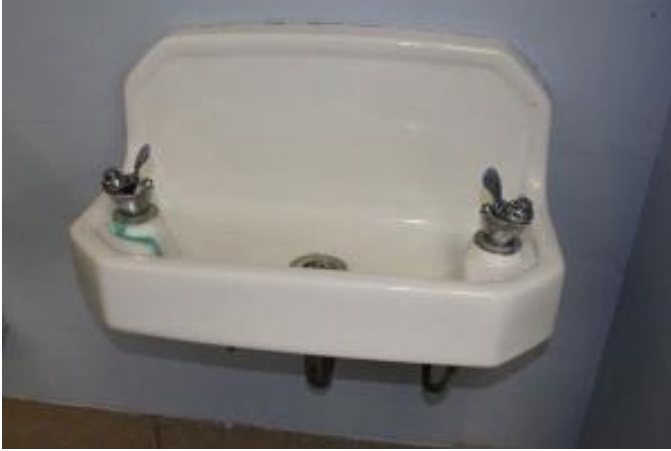
**System: D2010 - Plumbing Fixtures**

**Location:** Corridors

**Distress:** Accessibility

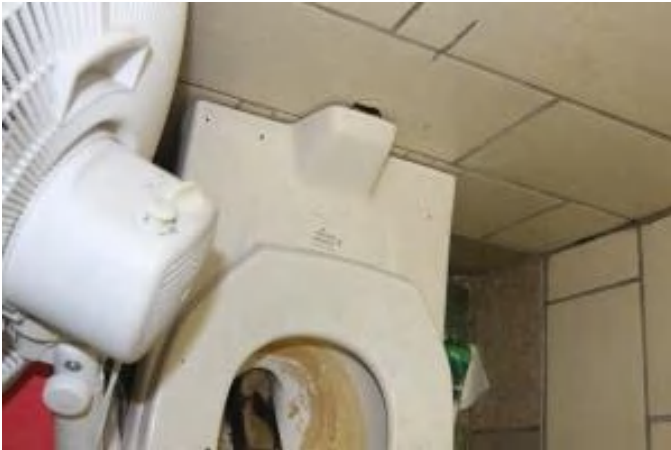
**System: D2010 - Plumbing Fixtures**

**Location:** Toilet rooms

**Distress:** Failing

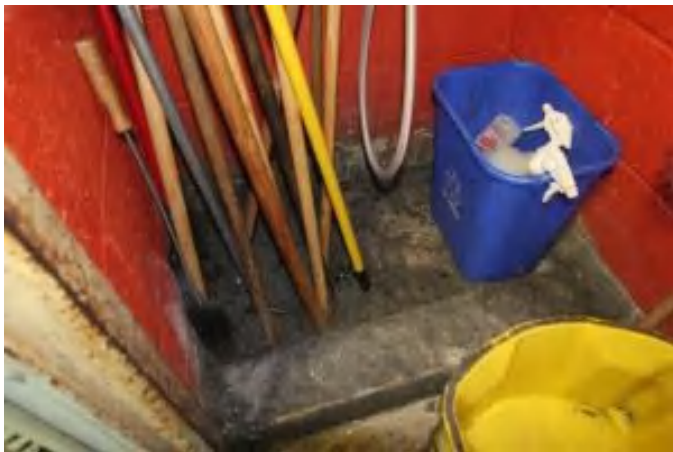
**System: D2010 - Plumbing Fixtures**

**Location:** Cleaning closets

**Distress:** Beyond Service Life

**Notes:** Replace service sinks due to age

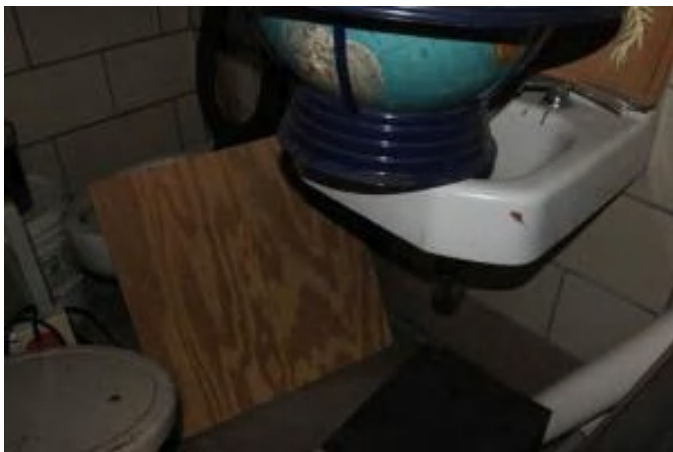
**System: D2010 - Plumbing Fixtures**

**Location:** Toilet rooms

**Distress:** Failing

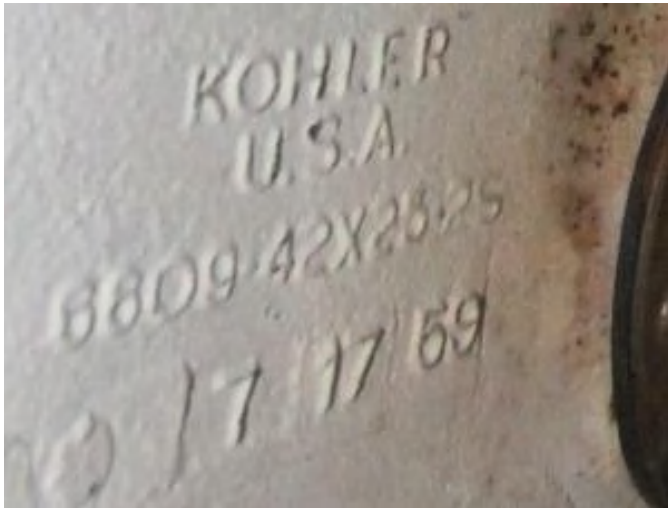
**System: D2010 - Plumbing Fixtures**

**Location:** Faculty lounge

**Distress:** Beyond Service Life

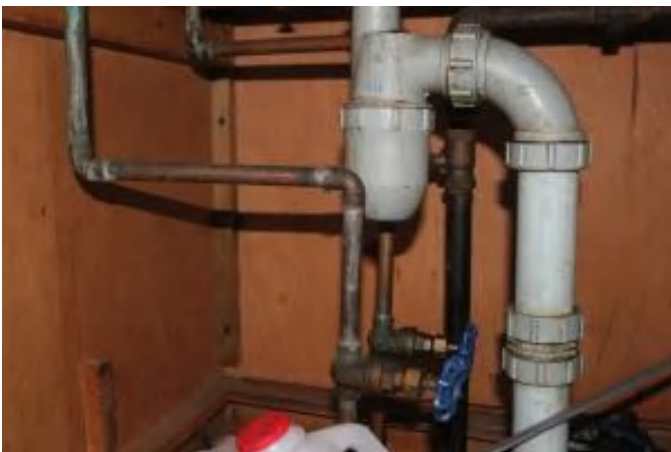
**System: D2010 - Plumbing Fixtures**

**Location:** Science classroom

**Distress:** Failing

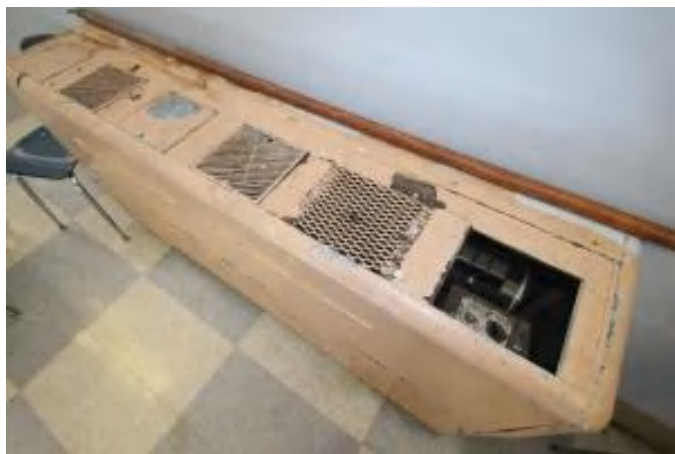
**System: D3040 - Distribution Systems**

**Location:** Classrooms

**Distress:** Damaged

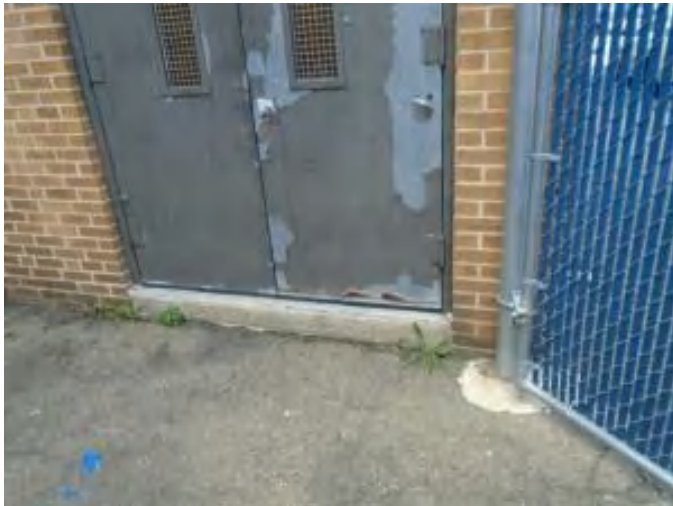
**System: B2030 - Exterior Doors**

**Location:** Throughout

**Distress:** Beyond Service Life

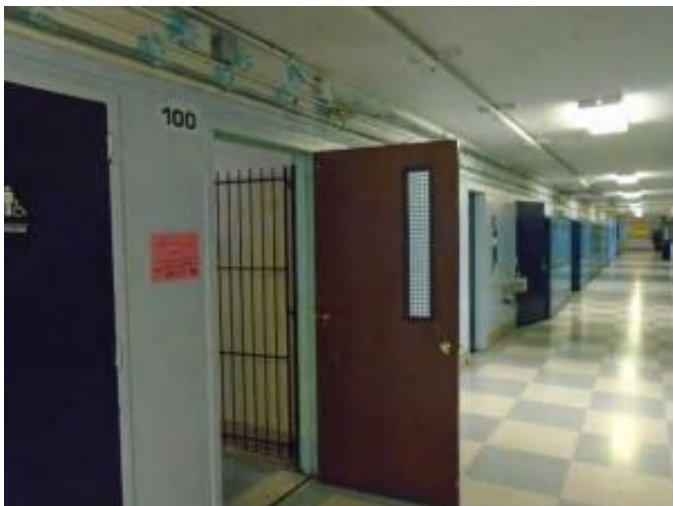
**System: C1030 - Fittings**

**Location:** Throughout

**Distress:** Inadequate

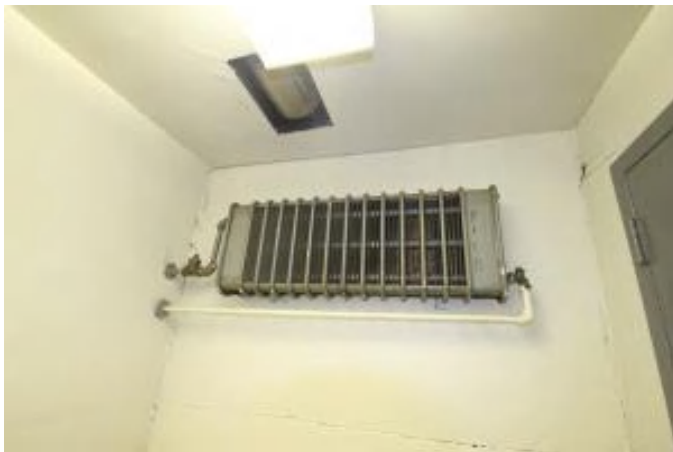
**System: D3040 - Distribution Systems**

**Location:** Entire building

**Distress:** Beyond Service Life

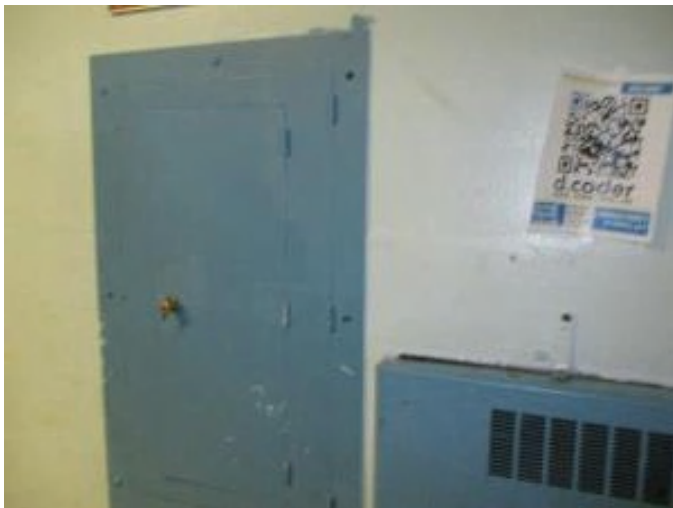
**System: D5010 - Electrical Service/Distribution**

**Location:** Entire Building

**Distress:** Inadequate

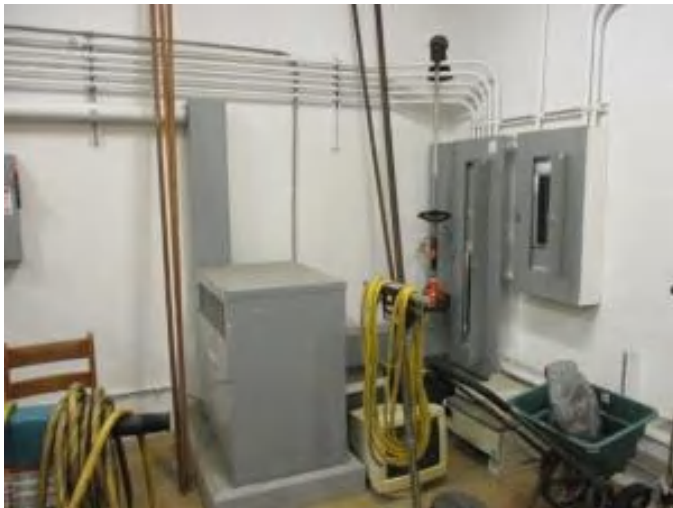
**System: D5010 - Electrical Service/Distribution**

**Location:** Basement

**Distress:** Inadequate

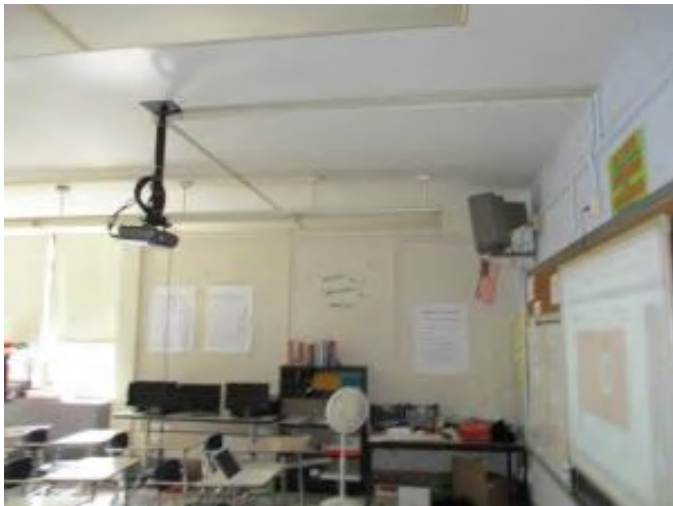
**System: D5020 - Lighting and Branch Wiring**

**Location:** Entire Building

**Distress:** Inadequate

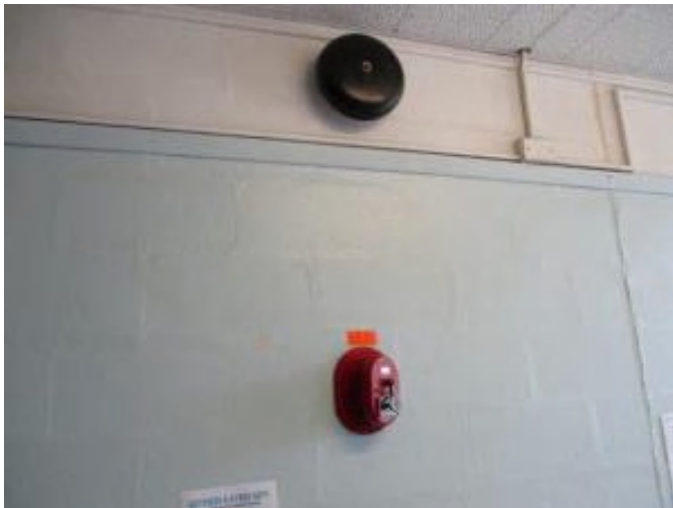
**System: D5030 - Communications and Security**

**Location:** Entire Building

**Distress:** Life Safety / NFPA / PFD

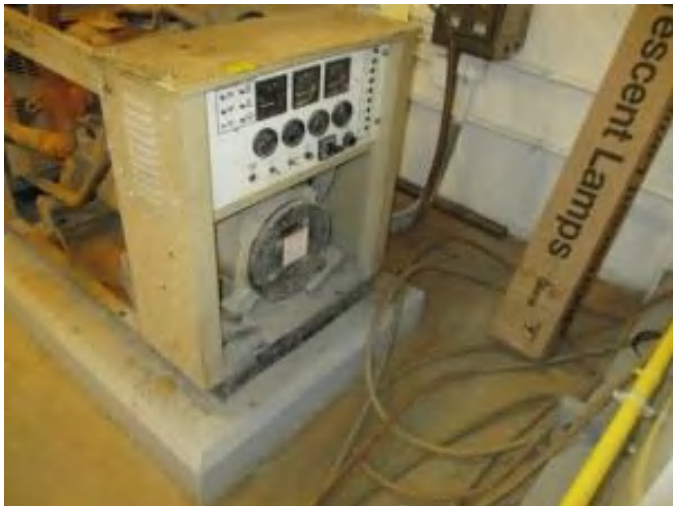
**System: D5090 - Other Electrical Systems**

**Location:** Outdoor

**Distress:** Beyond Service Life

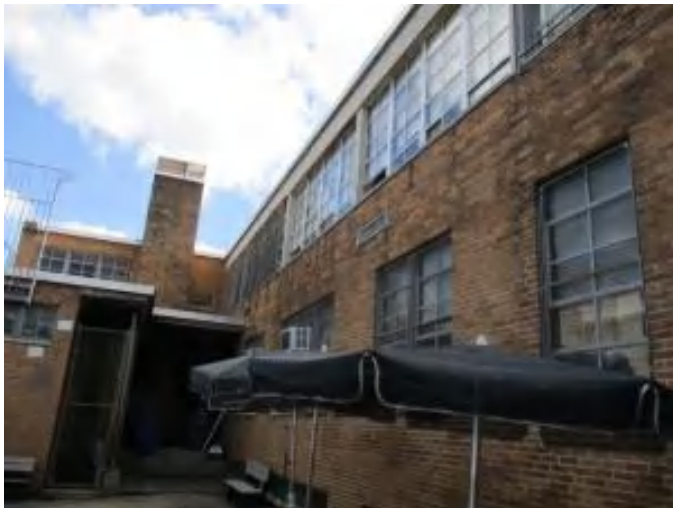
**System: D5090 - Other Electrical Systems**

**Location:** Roof

**Distress:** Building / MEP Codes

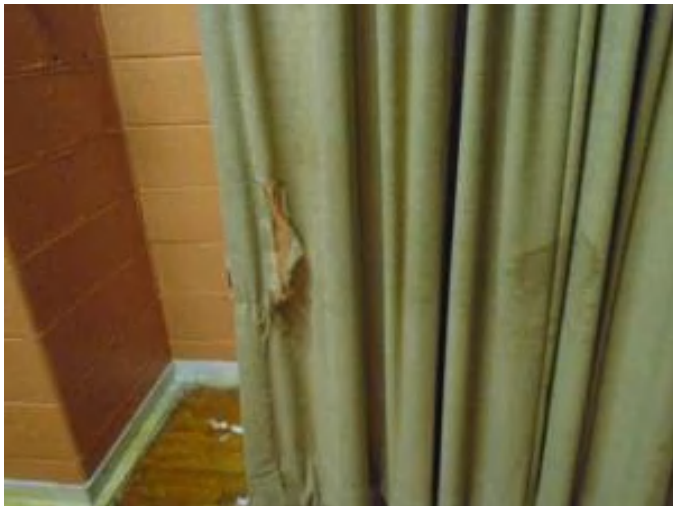
**System: E2010 - Fixed Furnishings**

**Location:** Stage

**Distress:** Damaged

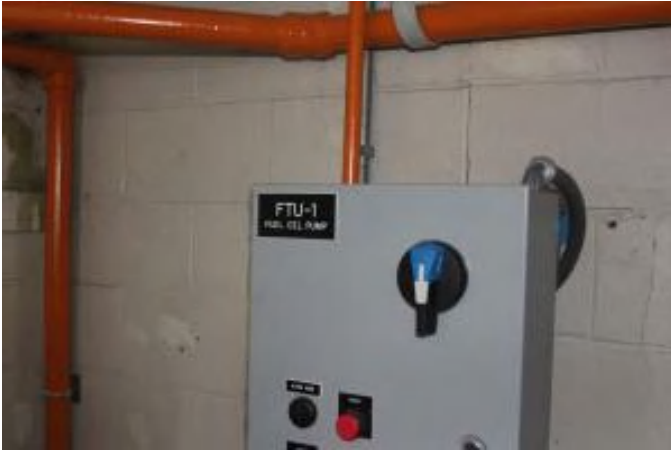
**System: D3020 - Heat Generating Systems**

**Location:** Gymnasium

**Distress:** Failing

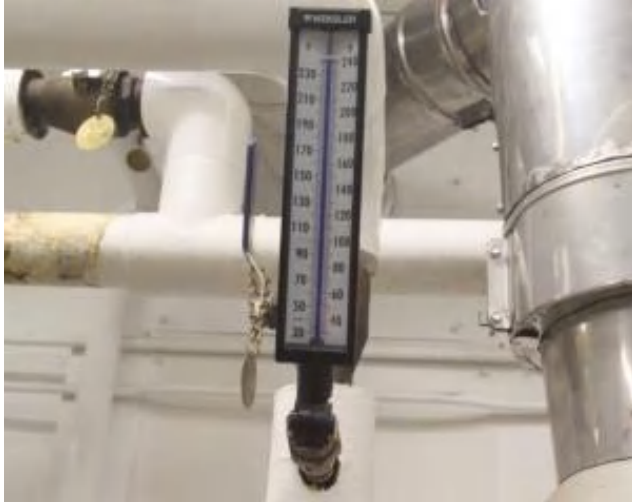
**System: D3060 - Controls & Instrumentation**

**Location:** Boiler room

**Distress:** Damaged

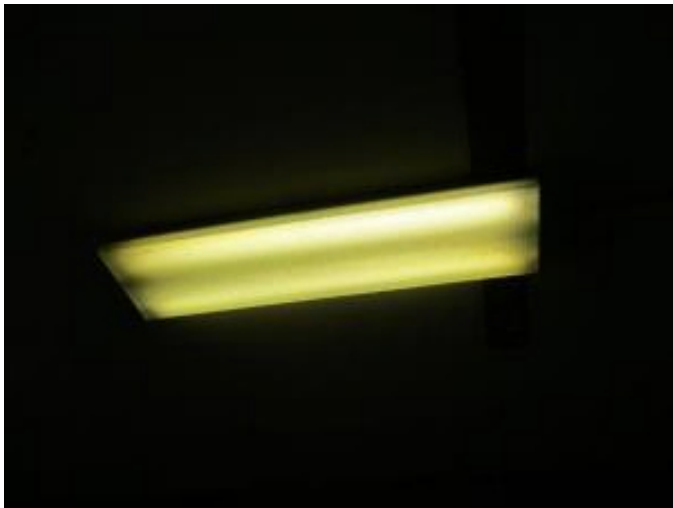
**System: D5020 - Lighting and Branch Wiring**

**Location:** Entire Building

**Distress:** Obsolete

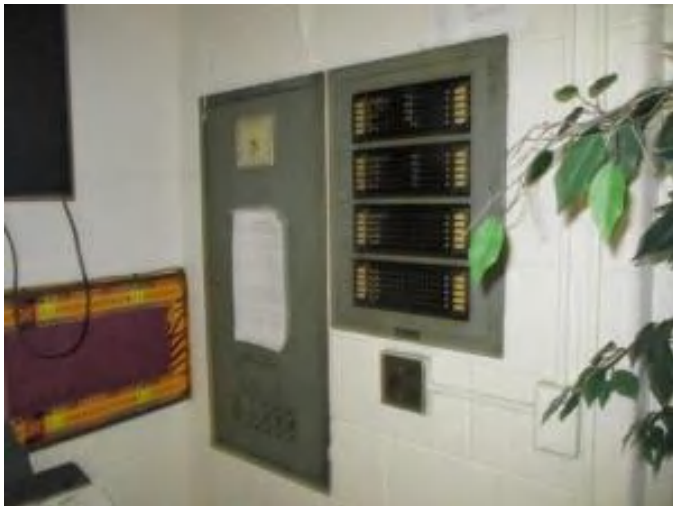
**System: D5030 - Communications and Security**

**Location:** Entire Building

**Distress:** Obsolete

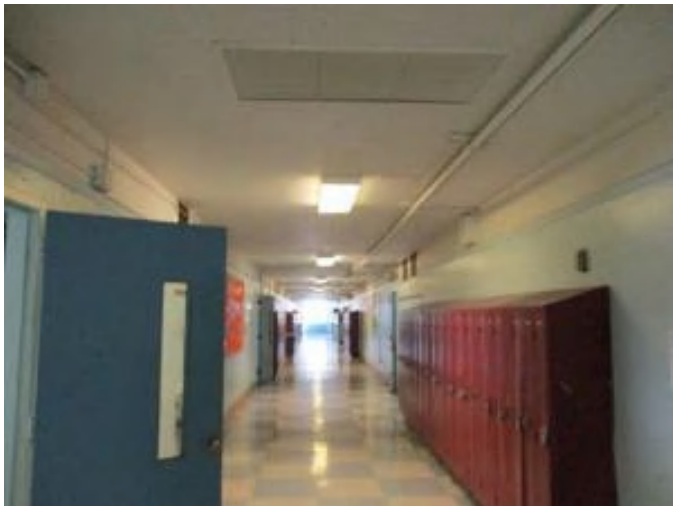
**System: D5030 - Communications and Security**

**Location:** Entire Building

**Distress:** Security Issue

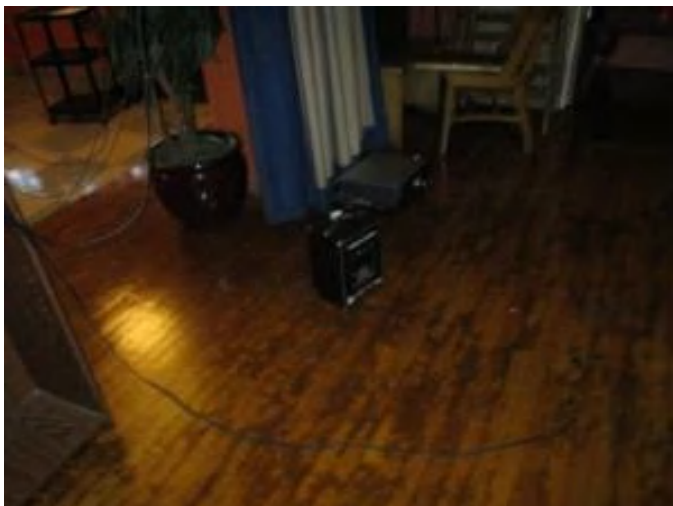
**System: D5030 - Communications and Security**

**Location:** Auditorium

**Distress:** Beyond Service Life

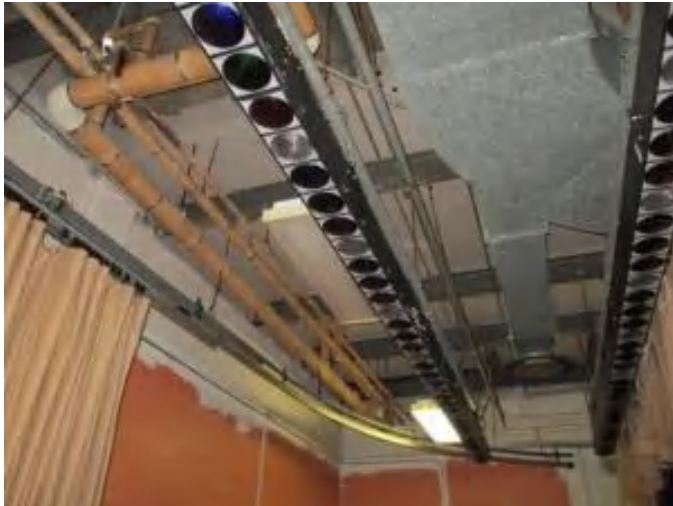
**System: E1020 - Institutional Equipment**

**Location:** Auditorium

**Distress:** Inadequate

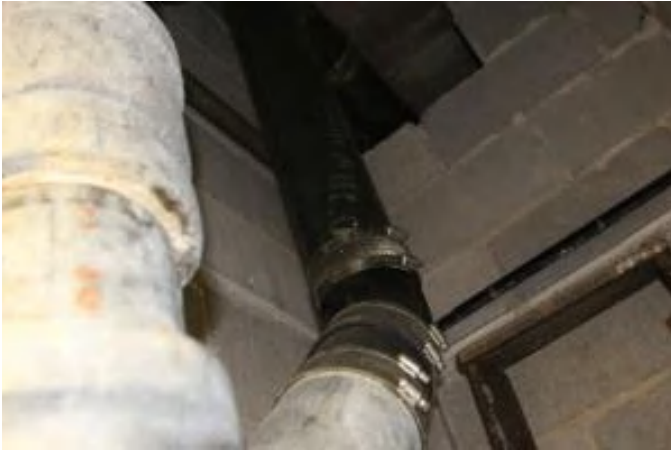
**System: D2030 - Sanitary Waste**

**Location:** Entire building

**Distress:** Beyond Service Life

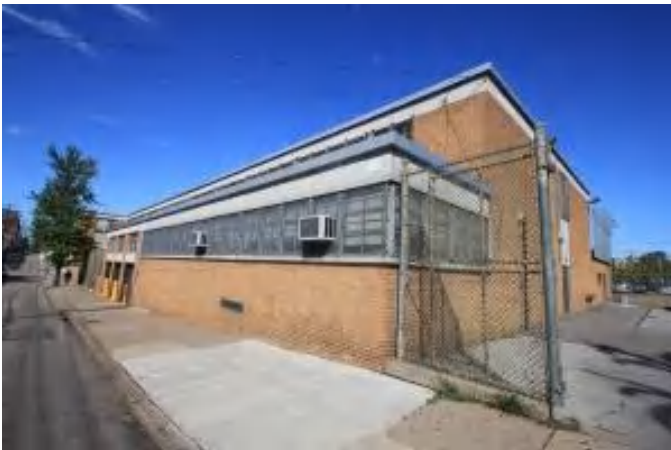
**System: D3030 - Cooling Generating Systems**

**Location:** Entire building

**Distress:** Inadequate

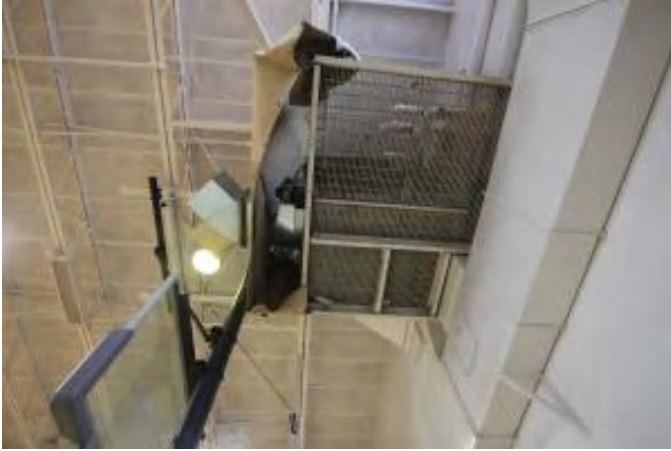
**System: D3040 - Distribution Systems**

**Location:** Gymnasium

**Distress:** Beyond Service Life

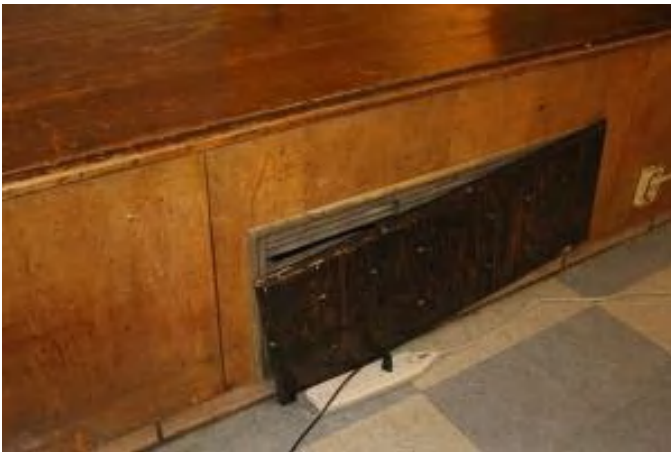
**System: D3040 - Distribution Systems**

**Location:** Auditorium

**Distress:** Beyond Service Life

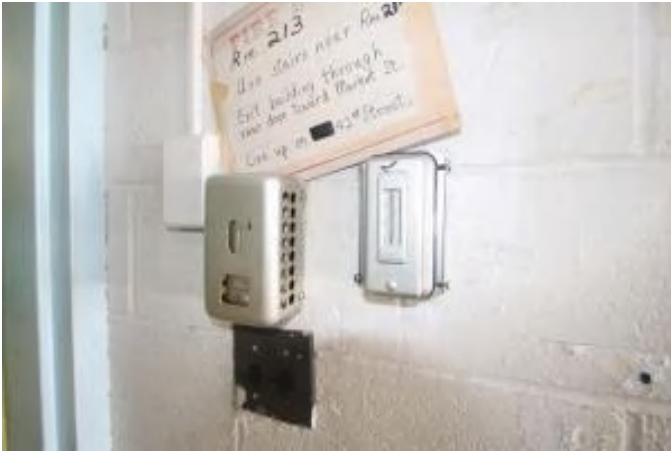
**System: D3060 - Controls & Instrumentation**

**Location:** Entire building

**Distress:** Energy Efficiency

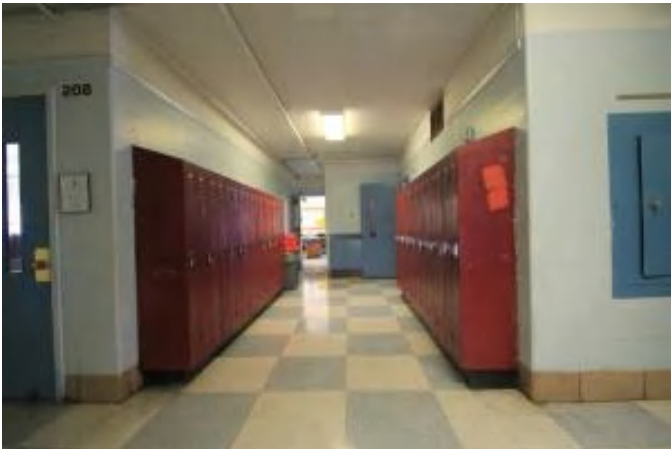
**System: D4010 - Sprinklers**

**Location:** Entire building

**Distress:** Life Safety / NFPA / PFD

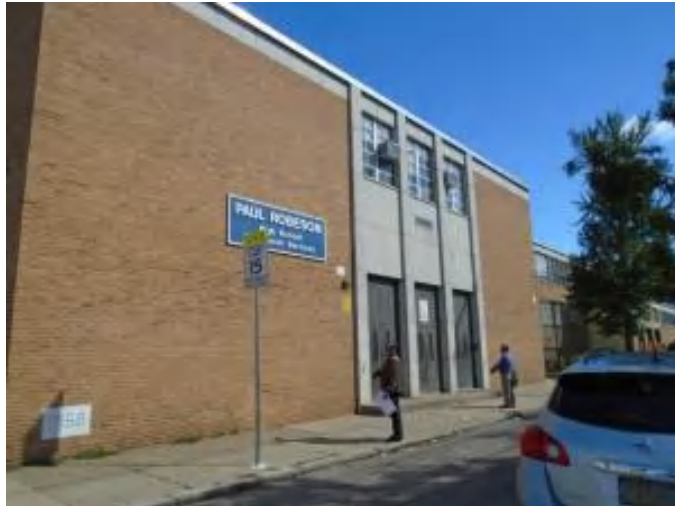
#### System: G2030 - Pedestrian Paving

**Location:** Entrance

**Distress:** Accessibility

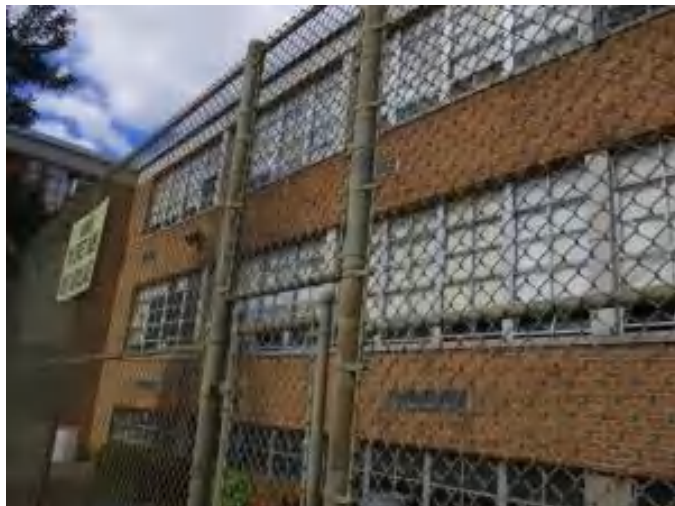
**System: G4030 - Site Communications & Security**

**Location:** Building Perimeter

**Distress:** Security Issue

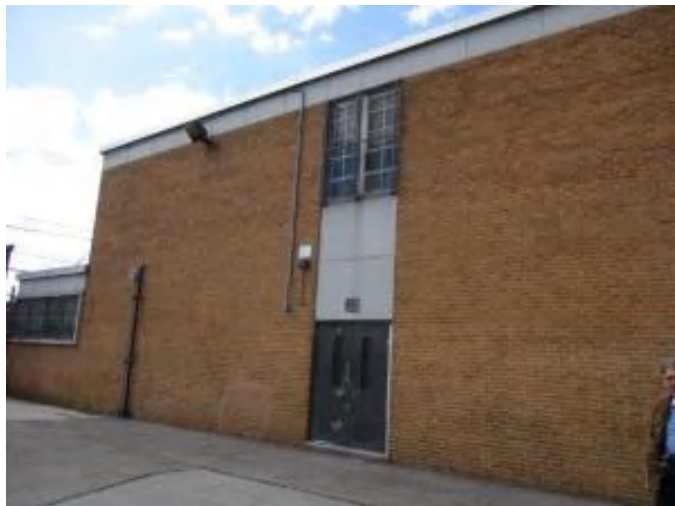
**System: G4030 - Site Communications & Security**

**Location:** Building Exterior

**Distress:** Inadequate
