## Facility Condition Assessment Summary Report

### Rowen School

School District of Philadelphia  
**S753001;Rowen**  
Final  
**Site Assessment Report**  
January 31, 2017

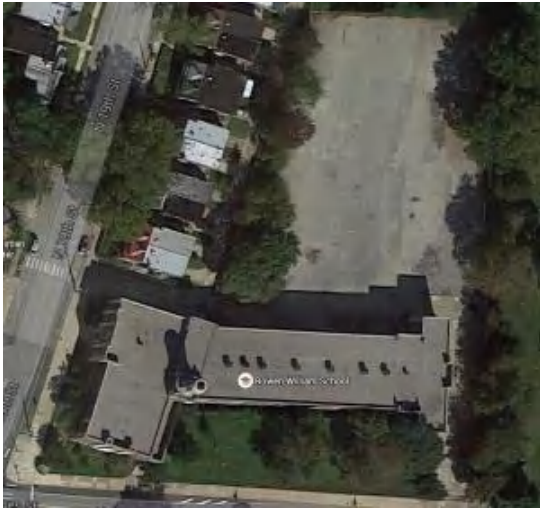
#### System: B3010105 - Built-Up

**Location:** Roof

**Distress:** Beyond Service Life

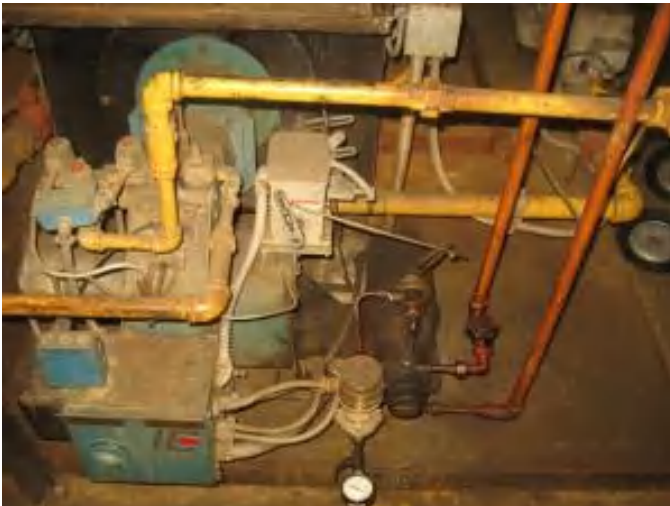
#### System: D3020 - Heat Generating Systems

**Location:** Boiler room

**Distress:** Beyond Service Life

**Notes:** Replace the three (3) dual fuel boiler burners, which are beyond their service lives, with new more efficient burners within the next 0-2 years.

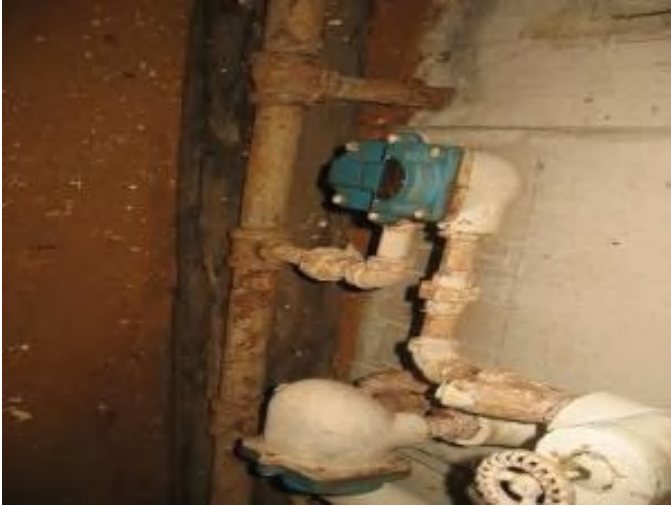
**System: D3040 - Distribution Systems**

**Location:** Throughout building

**Distress:** Failing

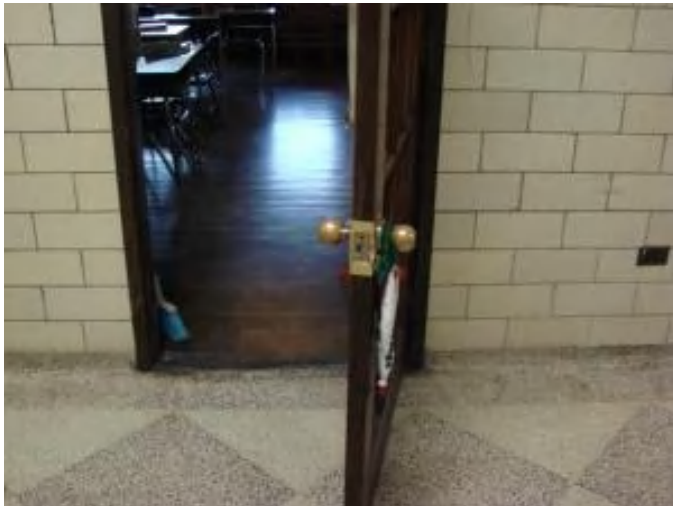
**System: C1020 - Interior Doors**

**Location:** Throughout

**Distress:** Accessibility

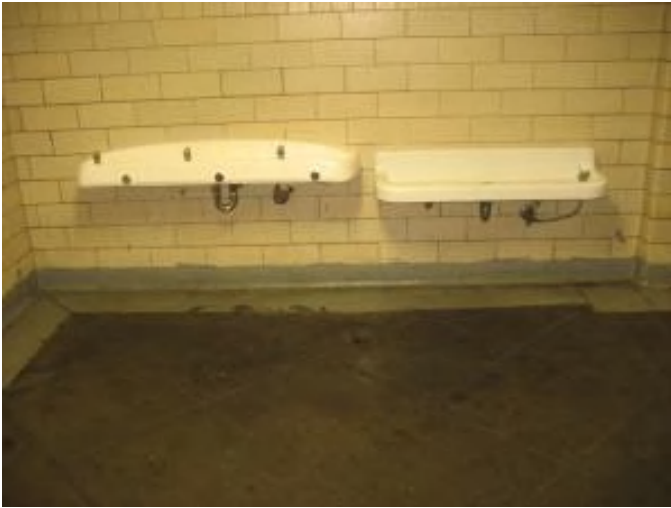
**System: D2010 - Plumbing Fixtures**

**Location:** Corridors

**Distress:** Beyond Service Life

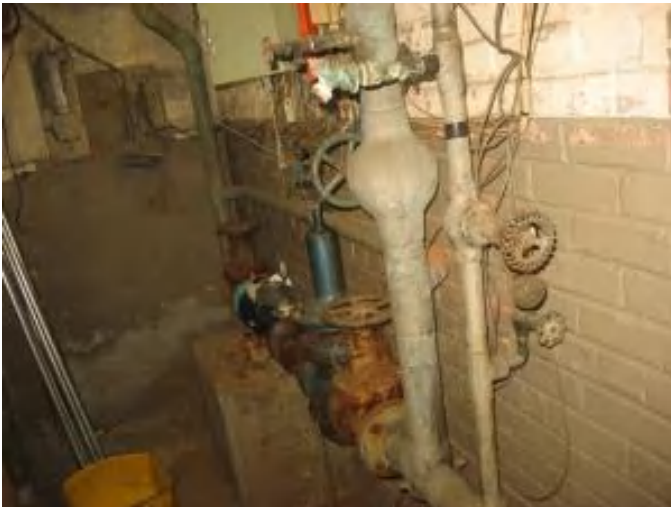
**System: D2020 - Domestic Water Distribution**

**Location:** Boiler room

**Distress:** Inadequate

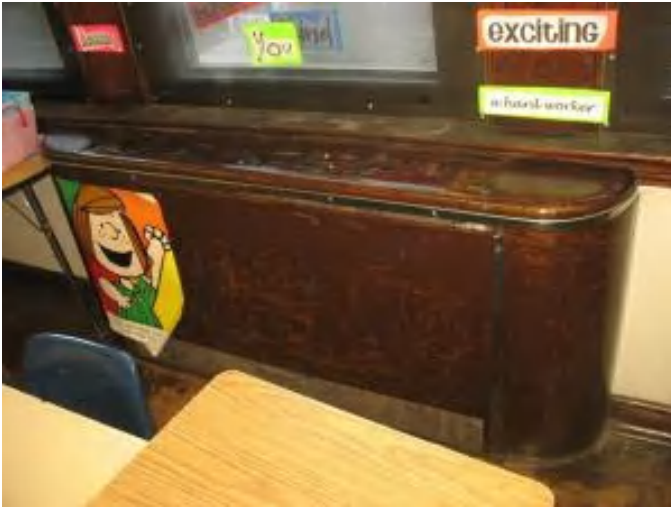
**System: D3040 - Distribution Systems**

**Location:** Classrooms

**Distress:** Beyond Service Life

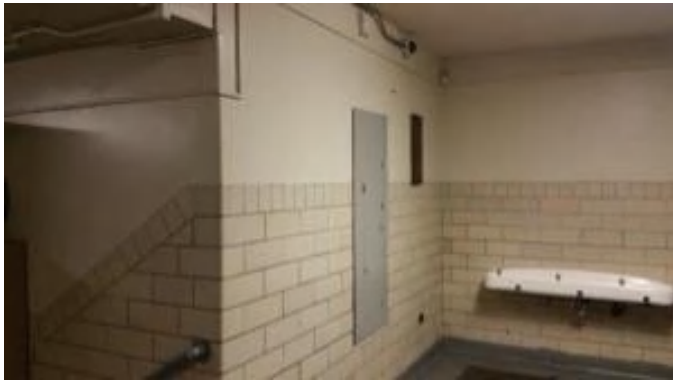
**System: D5010 - Electrical Service/Distribution**

**Location:** throughout the building

**Distress:** Beyond Service Life

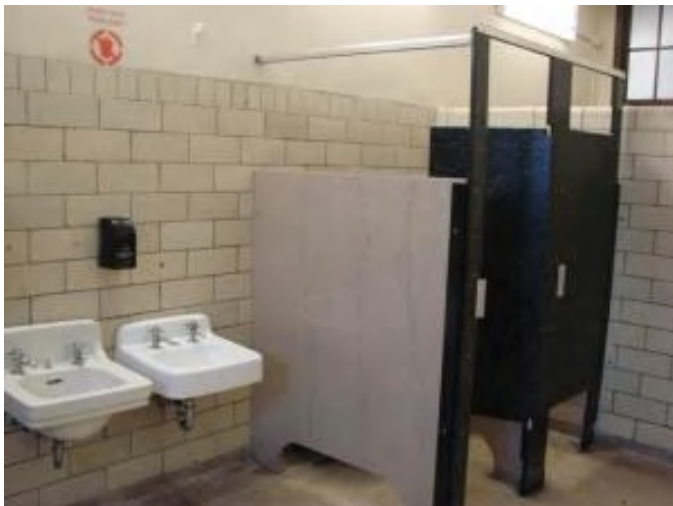
**System: C1030 - Fittings**

**Location:** Toilets

**Distress:** Accessibility

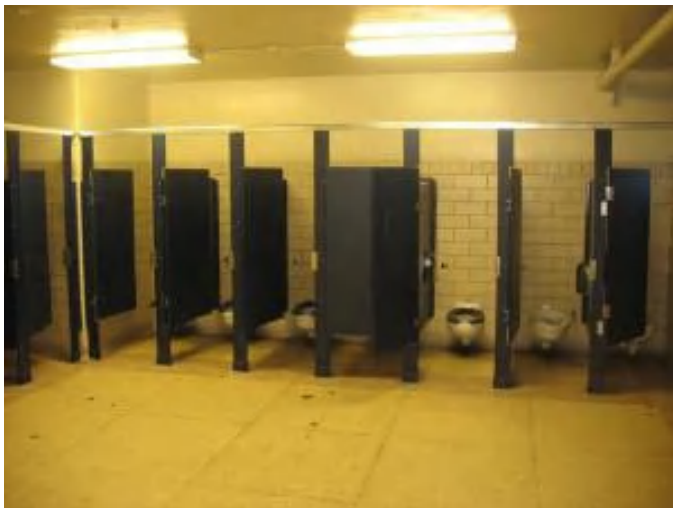
**System: D2010 - Plumbing Fixtures**

**Location:** Restrooms

**Distress:** Beyond Service Life

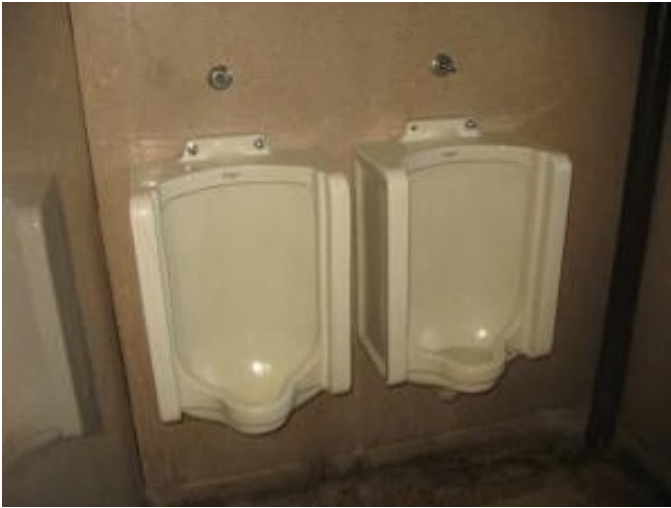
**System: D2010 - Plumbing Fixtures**

**Location:** Restrooms

**Distress:** Beyond Service Life

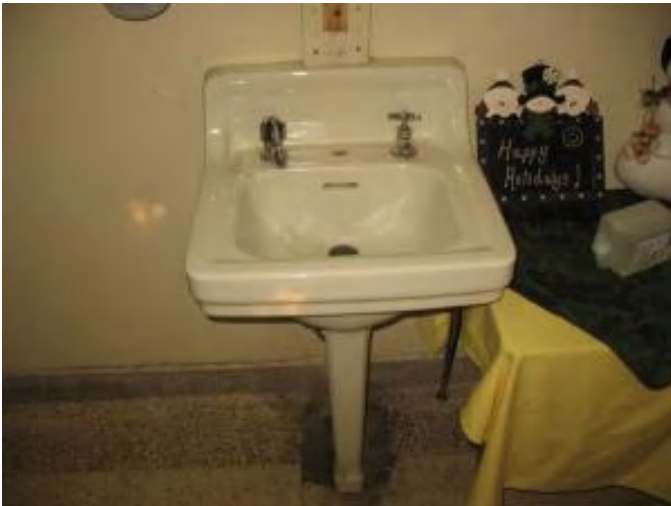
**System: D2010 - Plumbing Fixtures**

**Location:** Restrooms

**Distress:** Beyond Service Life

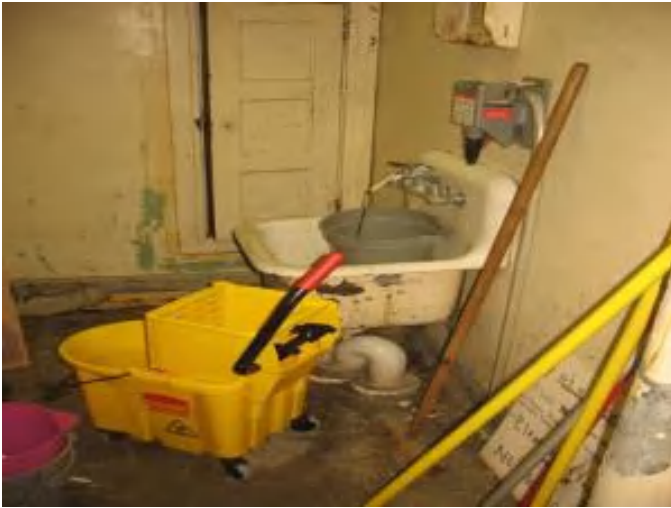
**System: D2010 - Plumbing Fixtures**

**Location:** Corridors

**Distress:** Beyond Service Life

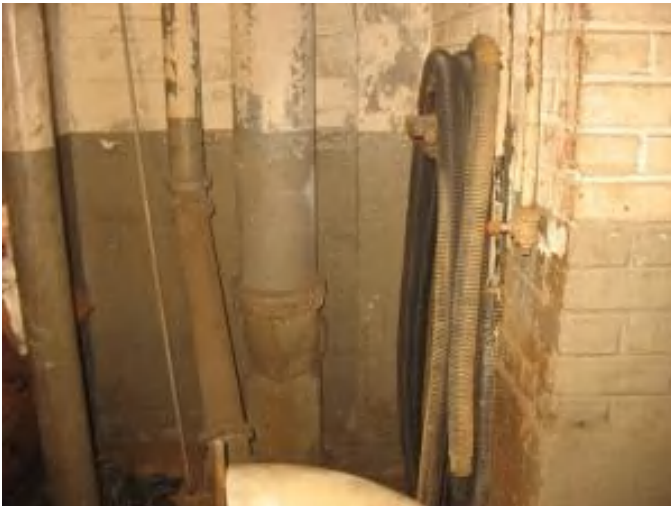
**System: D2030 - Sanitary Waste**

**Location:** Throughout building

**Distress:** Beyond Service Life

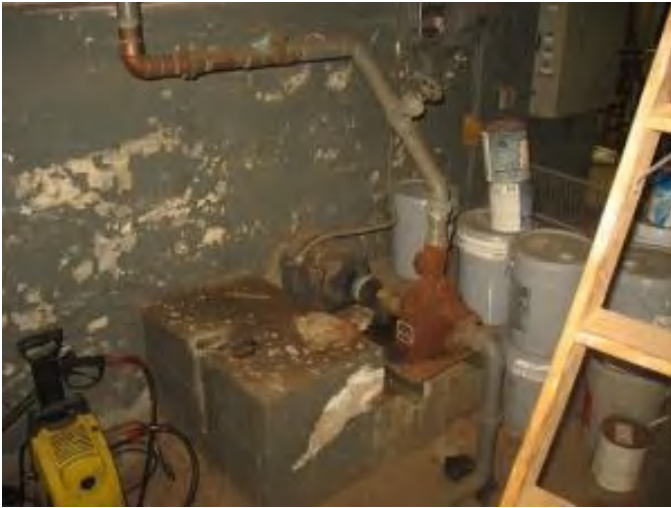
**System: D2030 - Sanitary Waste**

**Location:** Boiler room

**Distress:** Damaged

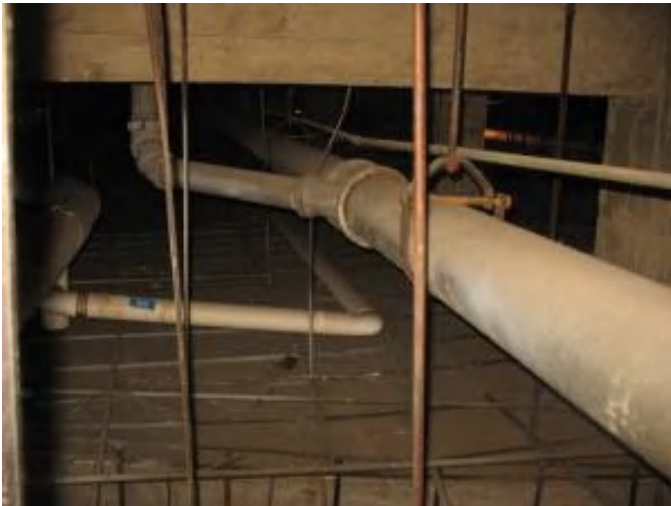
**System: D2040 - Rain Water Drainage**

**Location:** Throughout building

**Distress:** Beyond Service Life

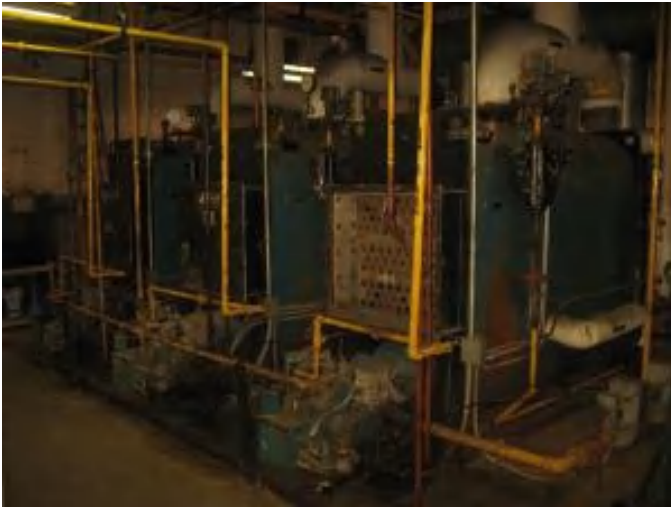
**System: D3020 - Heat Generating Systems**

**Location:** Boiler room

**Distress:** Not Reliable

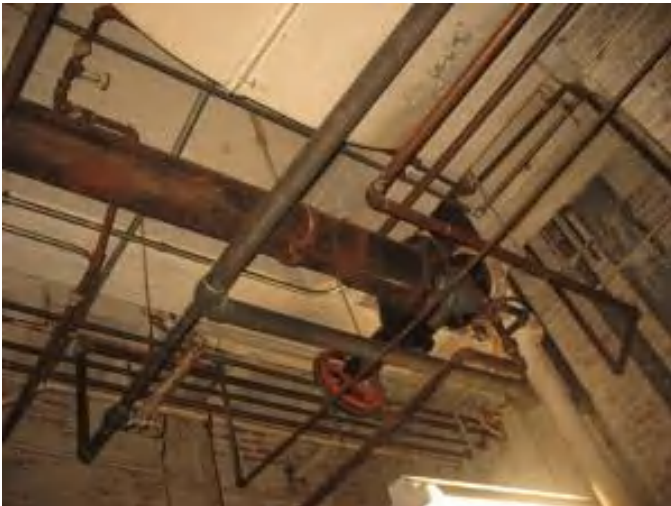
**System: D3040 - Distribution Systems**

**Location:** Throughout building

**Distress:** Beyond Service Life

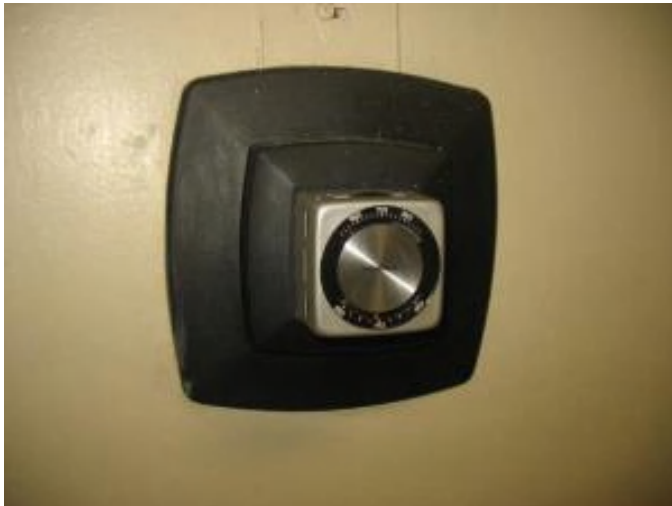
**System: D3060 - Controls & Instrumentation**

**Location:** Throughout building

**Distress:** Failing

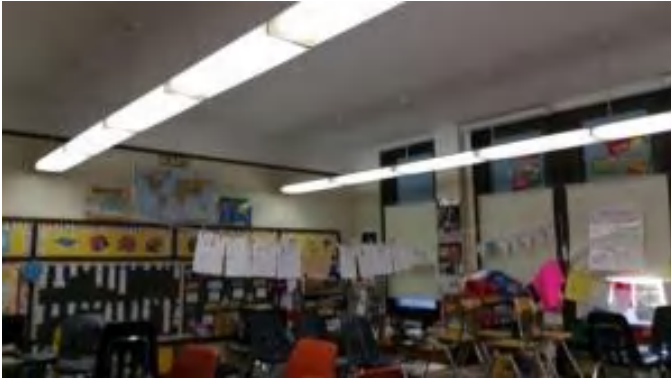
**System: D5020 - Lighting and Branch Wiring**

**Location:** throughout the building

**Notes:** Install new lighting system for 80% of the building.  
 $56,400 \text{ SF} \times 80\% = 45,120 \text{ SF}$

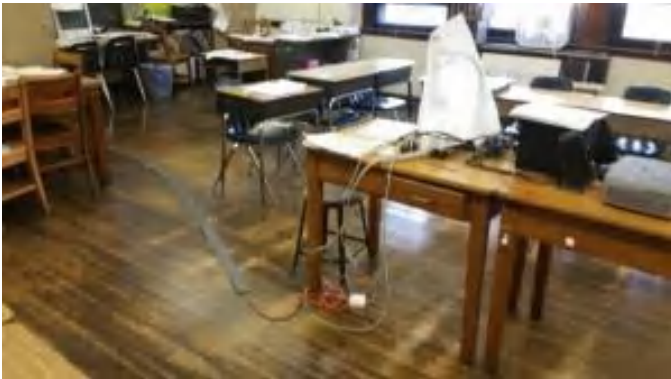
**System: D5020 - Lighting and Branch Wiring**

**Location:** throughout the building

**Notes:** Install new receptacles for 80% of the building

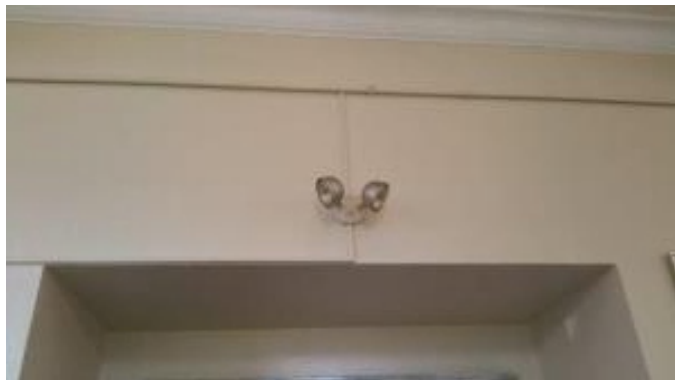
**System: D5090 - Other Electrical Systems**

**Location:** throughout the building

**Distress:** Beyond Service Life

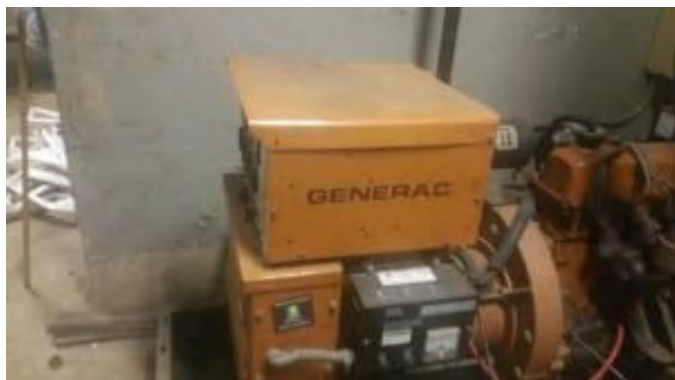
**System: D5090 - Other Electrical Systems**

**Location:** electrical room

**Distress:** Health Hazard / Risk

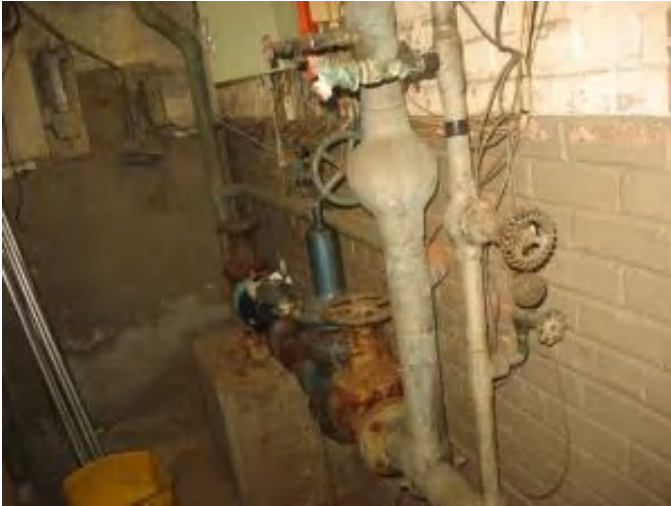
**System: D2020 - Domestic Water Distribution**

**Location:** Throughout building

**Distress:** Beyond Service Life

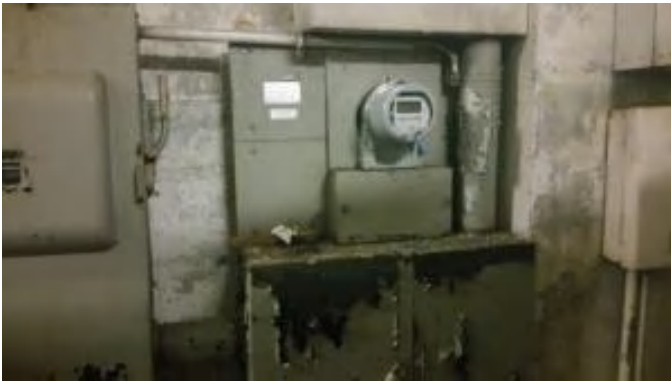
**System: D5010 - Electrical Service/Distribution**

**Location:** electrical room

**Distress:** Beyond Service Life

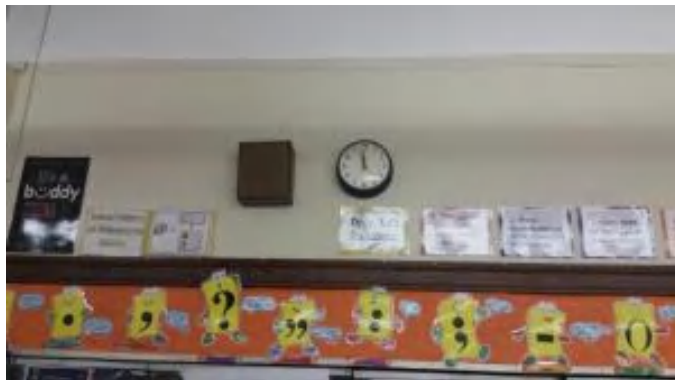
**System: D5030 - Communications and Security**

**Location:** throughout the building

**Distress:** Beyond Service Life

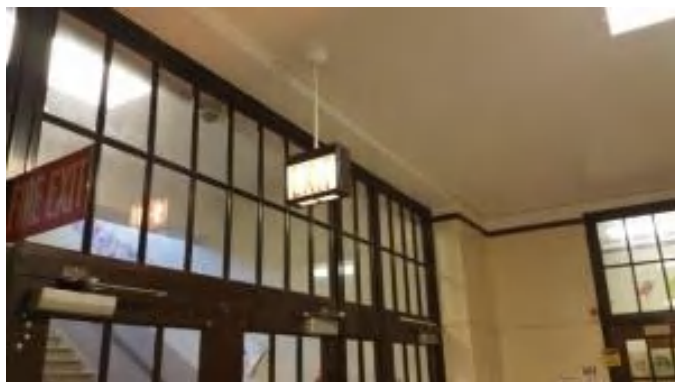
**System: D5030 - Communications and Security**

**Location:** throughout the building

**Distress:** Inadequate

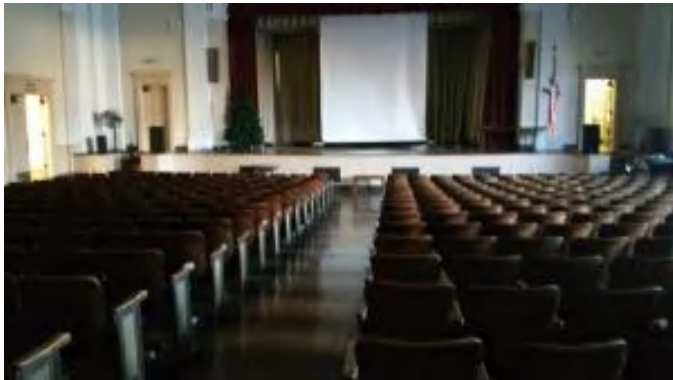
**System: E1020 - Institutional Equipment**

**Location:** Auditorium

**Distress:** Beyond Service Life

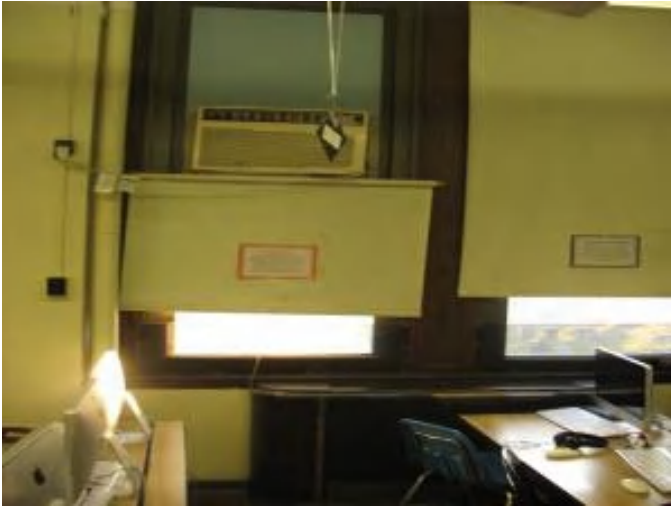
**System: D3030 - Cooling Generating Systems**

**Location:** Throughout building

**Distress:** Inadequate

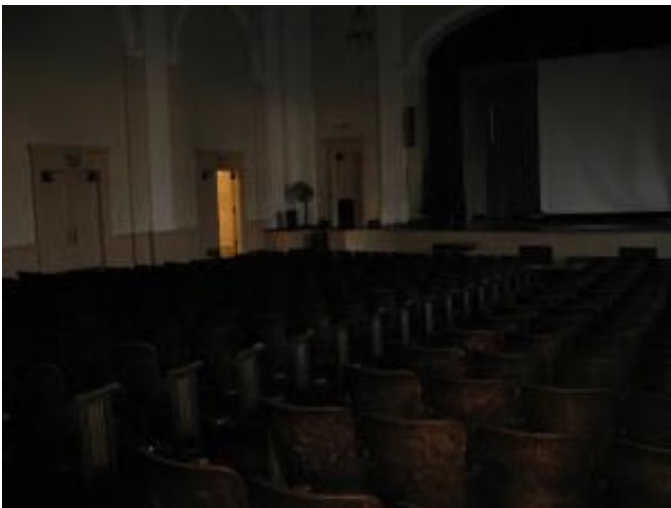
**System: D3040 - Distribution Systems**

**Location:** Auditorium

**Distress:** Building / MEP Codes

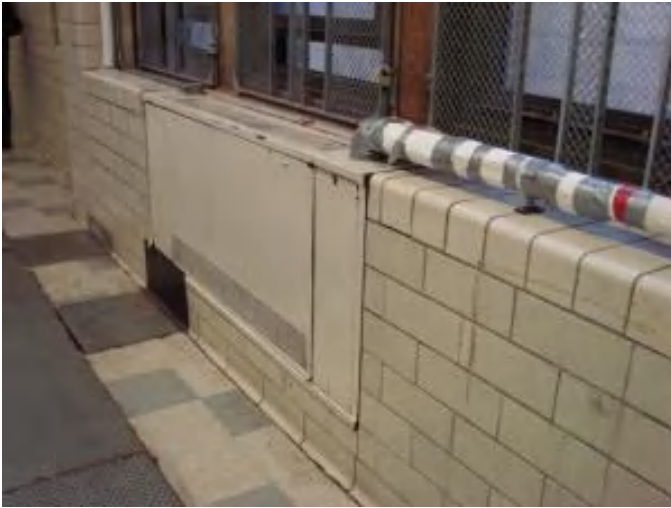
**System: D3040 - Distribution Systems**

**Location:** Gymnasium/Cafeteria

**Distress:** Building / MEP Codes

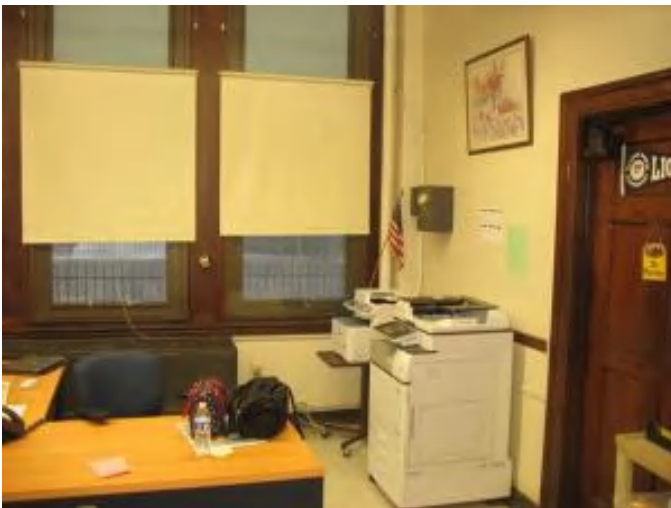
**System: D3040 - Distribution Systems**

**Location:** Administration offices

**Distress:** Building / MEP Codes

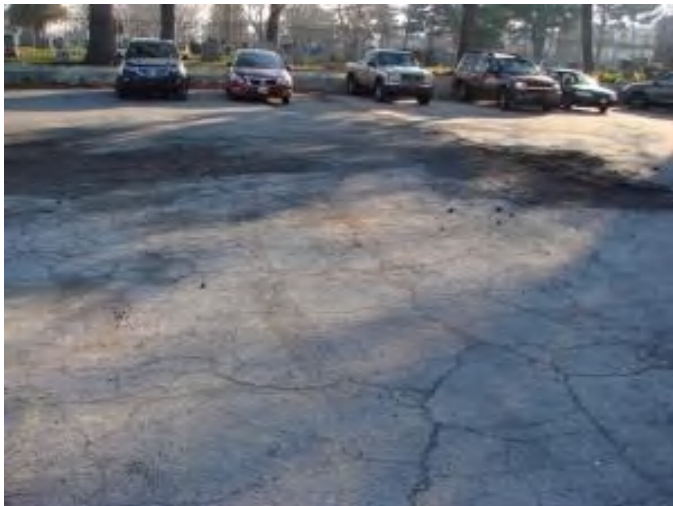
#### System: G2020 - Parking Lots

**Location:** Parking

**Distress:** Accessibility

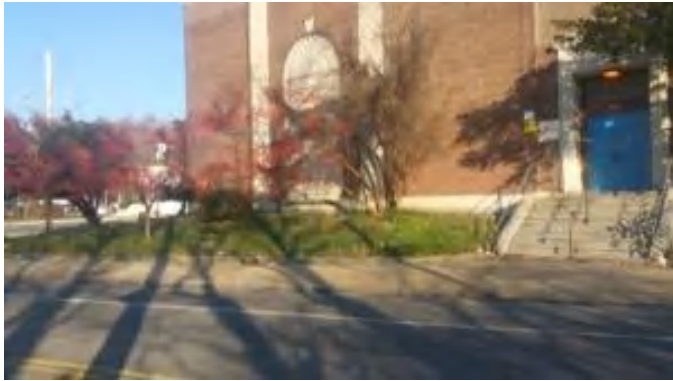
**System: G4020 - Site Lighting**

**Location:** grounds

**Distress:** Inadequate

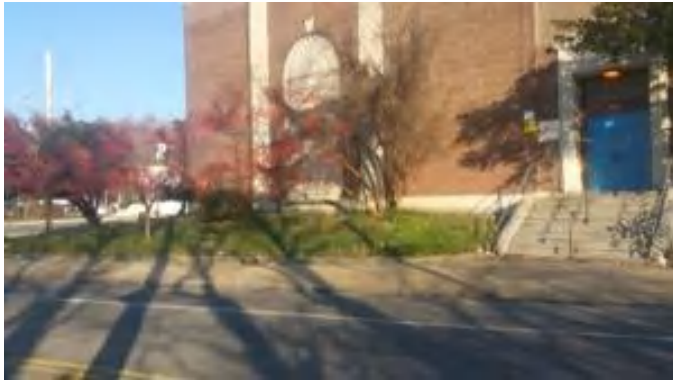
**System: G4030 - Site Communications & Security**

**Location:** grounds

**Distress:** Inadequate
