## Facility Condition Assessment Summary Report

### Roxborough High School

# **S603001;Roxborough**

## **Site Assessment Report**

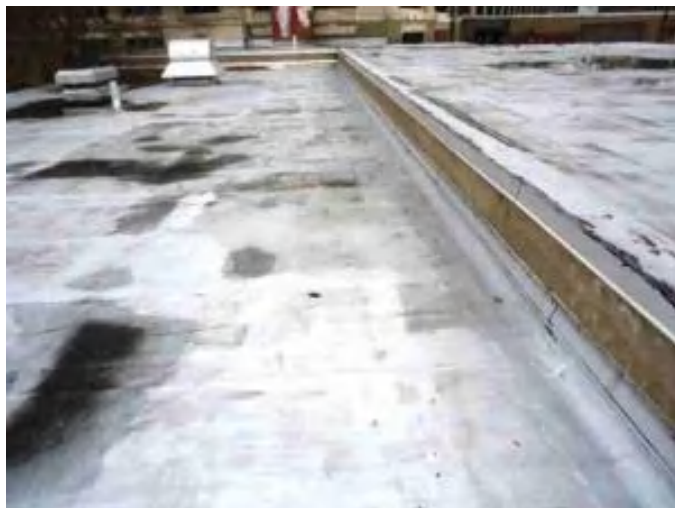
#### System: B3010105 - Built-Up

There are a number of roof sections and different roof elevations ranging from the main roof to the addition roof. Parapet heights, coping materials, and the height of the flashing also varies in different sections. The main roof is a built up application that was installed in the early 1990'S. The other built up roofs have not conclusive installation dates and have been seal coated several times to extend the life cycle of the application. During the time of the inspection it was reported that several leaks are active and a consistent repair program is consuming efforts to maintain the roof. Considering the age and condition of the roofing systems, universal upgrades are recommended. Remove and replace all roof sections. This deficiency is expected to be completed as part of an exterior effort coordinated with other recommendations included in this report.

**Location:** Roof

**Distress:** Damaged

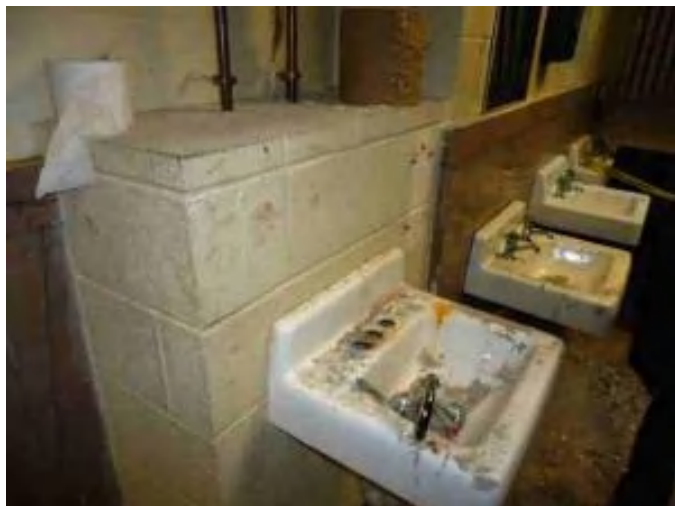
**System: C1010 - Partitions**

There are two abandoned gang restrooms on the floors that are not being used. The restrooms are original and the marble, wooden or missing partitions show the excessive problems with the restrooms. These restrooms warrant unique renovations to restore the systems to modern operations options and service to the school. Accessibility legislation requires that goods, amenities, and services offered in buildings, such as restrooms, be generally accessible to all people. There are no compliant restrooms located in this school. A unisex, compliant restroom should be added on each of the eight floors. Recommended modifications include the construction of new single occupancy restrooms in existing academic areas to accommodate requirements. This involves adding two new partitions to enclose 50 square feet of area and installing a door with hardware, ceramic tile and plaster surfaces, suspended ceilings, plumbing fixtures, electrical fixtures, piping, HVAC equipment, and accessories for each new restroom. Also, the renovation of the existing restrooms and modification to new layouts and floor plans to support modern designs and requirements for ADA legislation.

**Location:** Abandoned Restrooms

**Distress:** Damaged

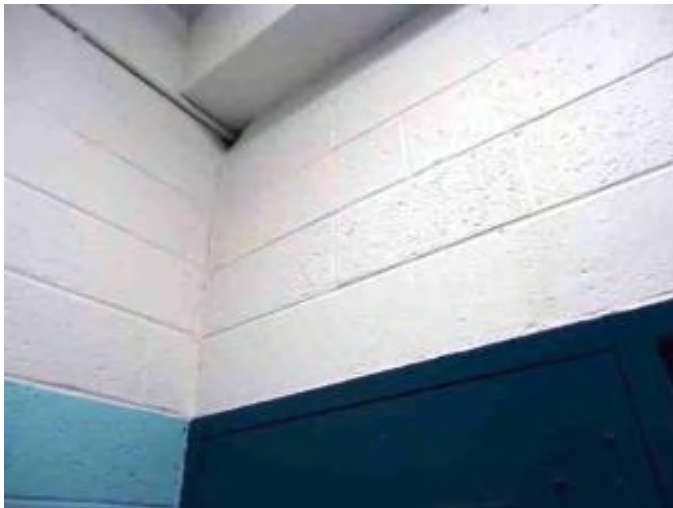
**System: C1010 - Partitions**

As indicted in the photos the wall failure and penetrations have not been conducted with the latest code in mind. This deficiency provides a budgetary consideration to build a fire rated wall or fill to enhance this oversight. This deficiency is expected to be coordinated with other interior efforts.

**Location:** Building Wide

**Distress:** Life Safety / NFPA / PFD

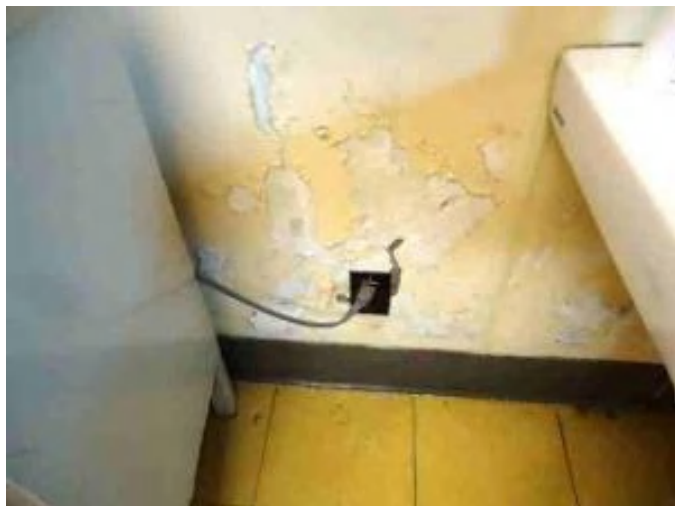
**System: C3010230 - Paint & Covering**

There are painted walls, trim, and some painted ceilings in this building. Sections of the building, some textured concrete surfaces have been painted as well. The interior finishes are in fair to poor condition depending on the location of the finish. For example due to recent roof leaks over the auditorium several areas will require repair and repainting. Also, sections of the fifth floor are damaged due to neglect. This school will require an almost continuous program of renewal of the applied finishes to maintain an acceptable appearance. Cyclical painting should be considered for a standard approach to maintaining the quality of the interior finishes. It is recommended that all previously painted surfaces be repainted according to established cycles for this occupancy and use type. Minor repairs should be completed before work begins. The abandoned section of the fifth floor is expected to require major repairs and additional efforts to restore the finishes. This effort is expected to be coordinated with other mechanical electrical efforts in order to prevent overlapping efforts.

**Location:** Building Wide

**Distress:** Damaged

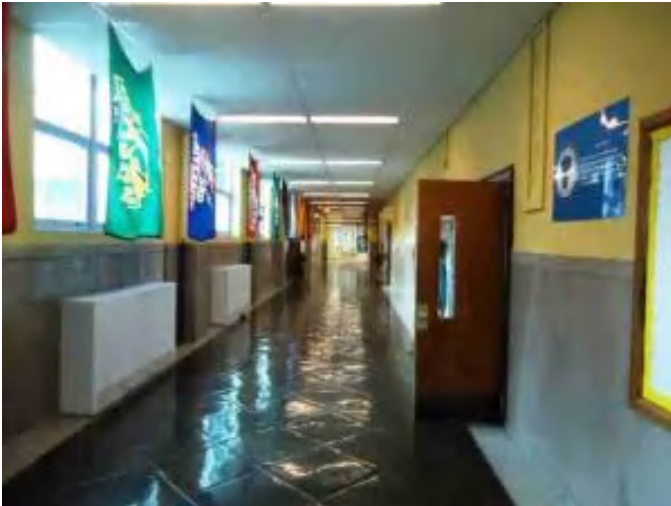
**System: C3030 - Ceiling Finishes**

The ceiling finish is a mix of 12 x 12 ceiling grid, painted and 2 x 4 Acoustical tile finish. Ceilings have been repaired in several areas and is in good condition considering the age of the application and the current condition of the school. The ceiling finish is expected to require upgrades to support the recommended mechanical electrical efforts in this report. This deficiency provides a budgetary consideration for removal and replacement of the current ceiling finish to a new acoustical tile finish. Considering the recommended mechanical and electrical upgrades this effort should be completed as part of an overall renewal program for the school. No work should be considered until after the recommended exterior efforts are complete.

**Location:** Building Wide

**Distress:** Damaged

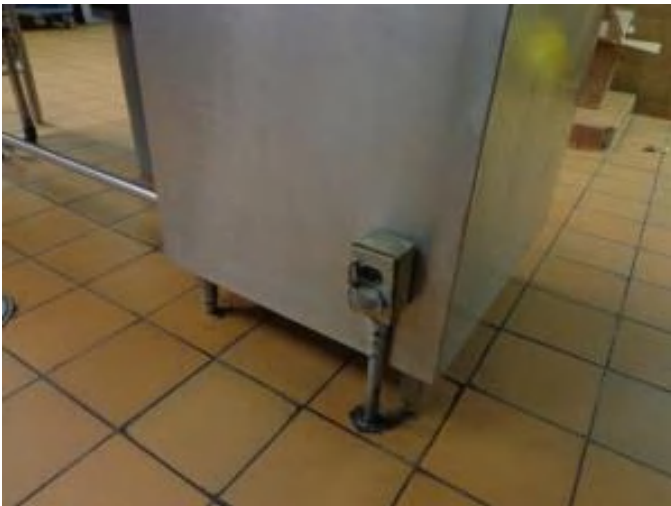
**System: D5020 - Lighting and Branch Wiring**

**Location:** Kitchen

**Distress:** Life Safety / NFPA / PFD

**Notes:** Receptacles in the kitchen were not ground-fault circuit-interrupting (GFCI) type, as required by NFPA 70, National Electrical Code (NEC), Article 210.8 (B). Replace 12 duplex receptacles in the kitchen with GFCI type.

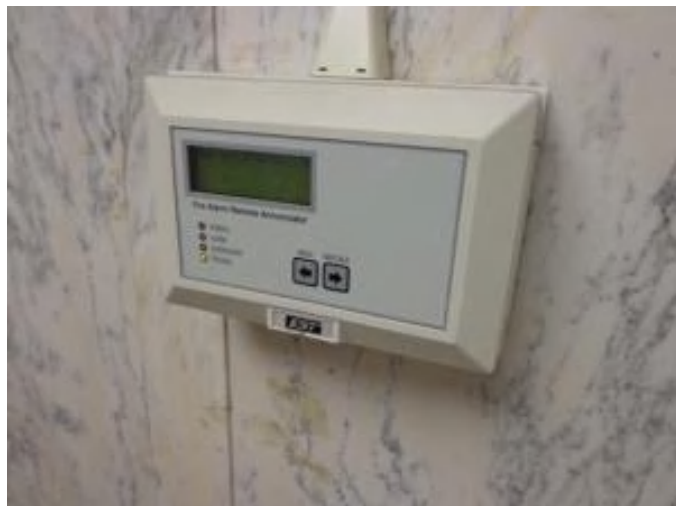
**System: D5030 - Communications and Security**

**Location:** Various locations

**Distress:** Building / MEP Codes

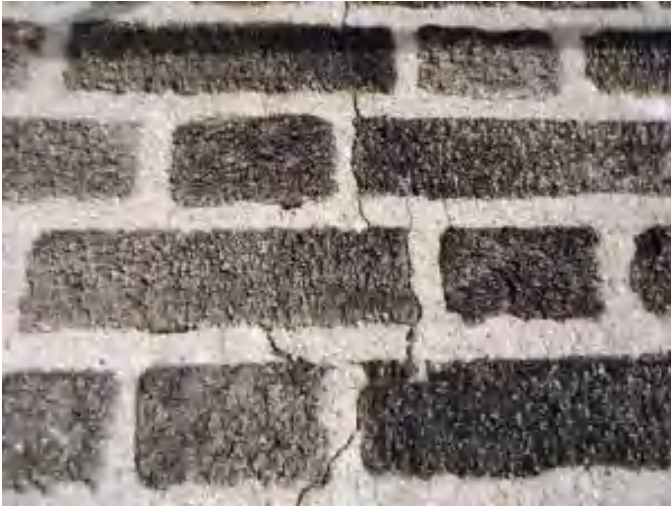
#### **System: B2010 - Exterior Walls**

The exterior brick surfaces are generally in fair to good condition for their age. In some locations, bricks have cracked or spalled and should be replaced. The repointing of deteriorated mortar joints is also recommended, using mortar of a similar color and consistency as the original. Following the detailed examination of the brick and repair of mortar construction joints, the entire building should be pressure washed to remove stains and embedded pollutants. If moisture is found to be penetrating the masonry facade, the application of a spray sealant to the suspected exterior masonry surface is recommended.

**Location:** Exterior Elevation

**Distress:** Damaged

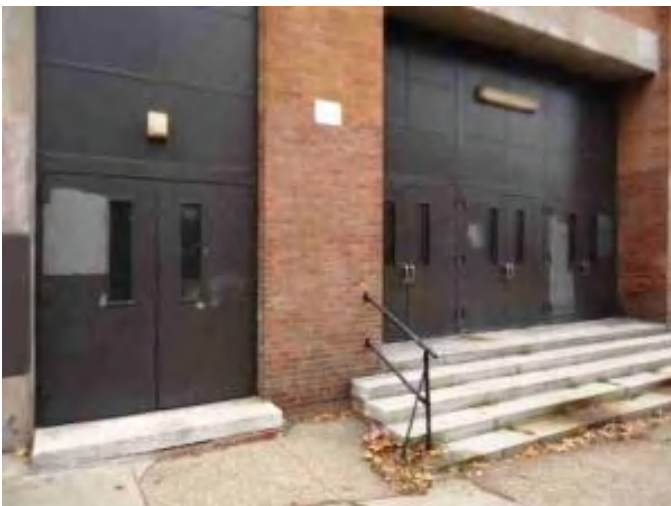
#### **System: B2030 - Exterior Doors**

**Location:** Exterior Elevation

**Distress:** Damaged

**Notes:** The exterior doors are metal applications with metal frames. The exterior door system for this school is a very high traffic system. Most of the doors are in fair condition but are aging at a faster rate than expected based on traffic and condition. The service doors on the roof have expired and failed compromising access to elevator rooms and tower rooms. The exterior door system, store front and service doors are recommended for upgrade.

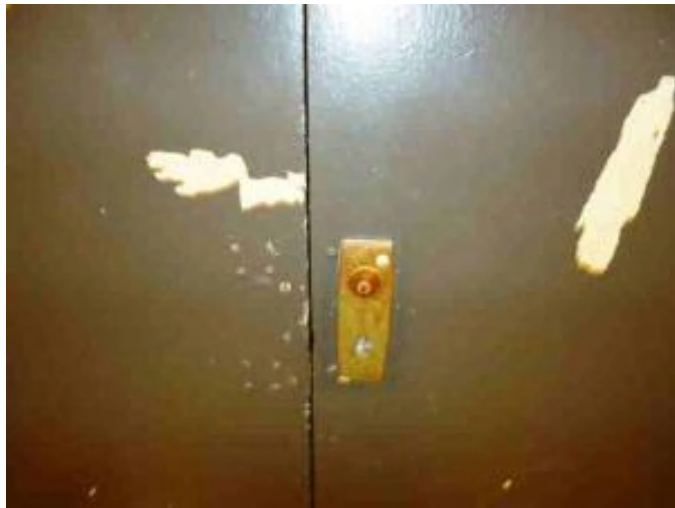
**System: C1010 - Partitions**

A large portion of the interior corridor, exit stair doors are not code compliant. Several doors are typically wood or metal in metal frames with transom lites or sidelights, glass glazing. The older doors are generally in good condition considering the age of the application. To restore the door finishes, universal upgrades are required for the older door applications. Remove and replace original door systems with new code compliant fire rated door system.

**Location:** Building Wide

**Distress:** Life Safety / NFPA / PFD

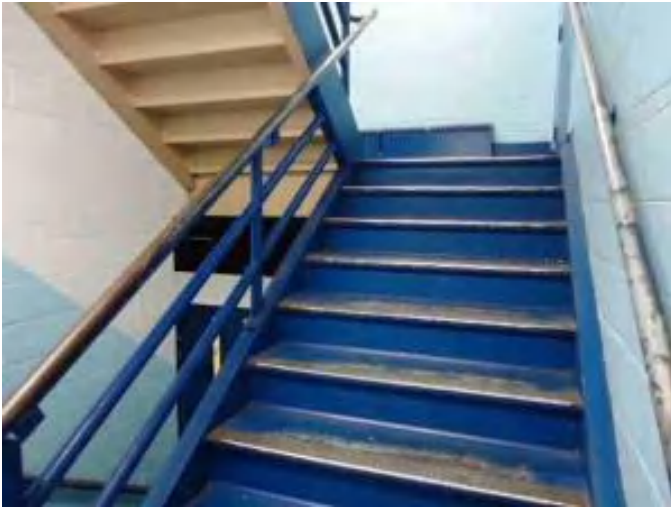
**System: C2010 - Stair Construction**

Current requirements for stairs indicate that they have graspable handrails on both sides, that the rails have a specific end geometry, and that the handrails continue horizontally at the landings. In addition, guardrails must prevent the passage of a 4 inch diameter sphere (6 inches in the triangle formed by the lower rail and tread/riser angle). Although the stairs are compliant with the code enforced at the time of construction until a major renovation occurs, they are deficient in handrail and guardrail design relative to current standards. Future efforts should include comprehensive stair railing removal and replacement upgrades.

**Location:** Stairs

**Distress:** Life Safety / NFPA / PFD

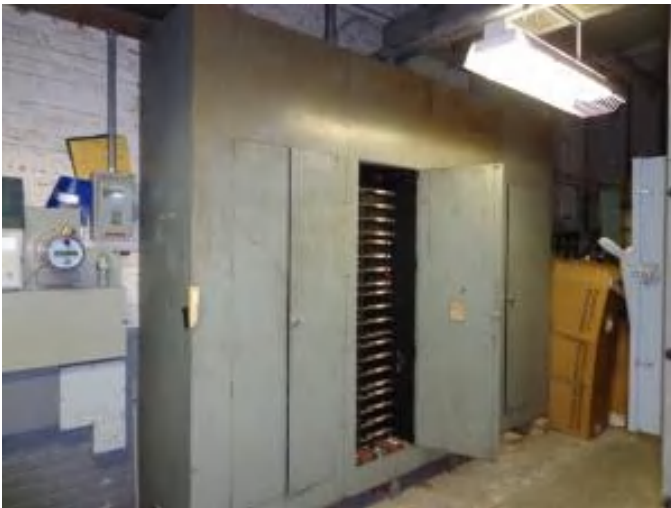
**System: D5010 - Electrical Service/Distribution**

**Location:** Mechanical Room 006

**Distress:** Beyond Service Life

**Notes:** Remove service entrance equipment, including utility medium voltage line circuit breakers, two (2) 577 kVA transformers and the double-ended 2500A, 120/240V, 2 phase, 5 wire Main Switchboard and 750A Panelboard MDP#2. Replace with new utility switchgear, a 1500 kVA, 5000A, 208/120V, 3 phase, 4 wire package unit substation to serve the existing building loads, thereby eliminating the need for five phase converter transformers. Provide 1500 kVA, 2500A, 480/277V, 3 phase, 4 wire package unit substation to serve central air conditioning equipment and larger mechanical loads.

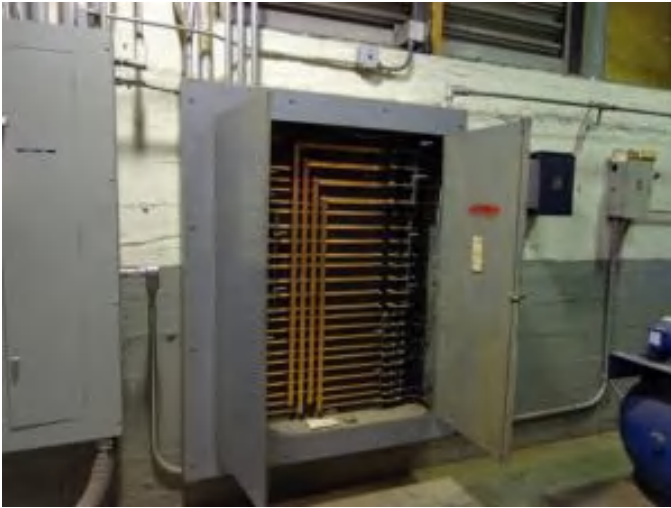
**System: D5010 - Electrical Service/Distribution**

**Location:** Mechanical Room 006

**Distress:** Beyond Service Life

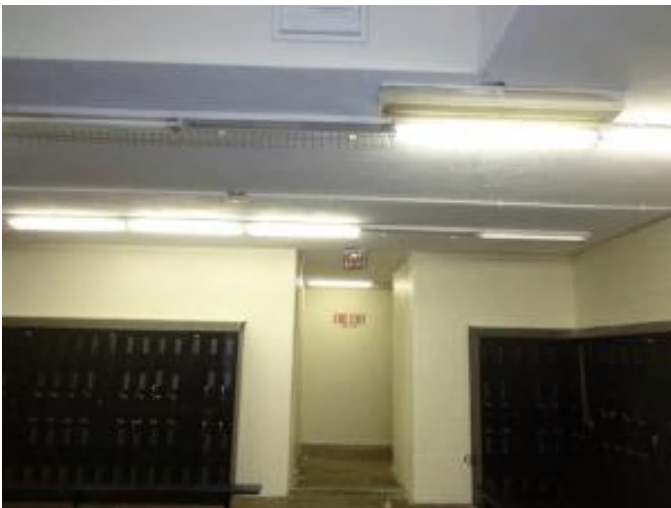
**System: D5020 - Lighting and Branch Wiring**

**Location:** Building wide

**Distress:** Beyond Service Life

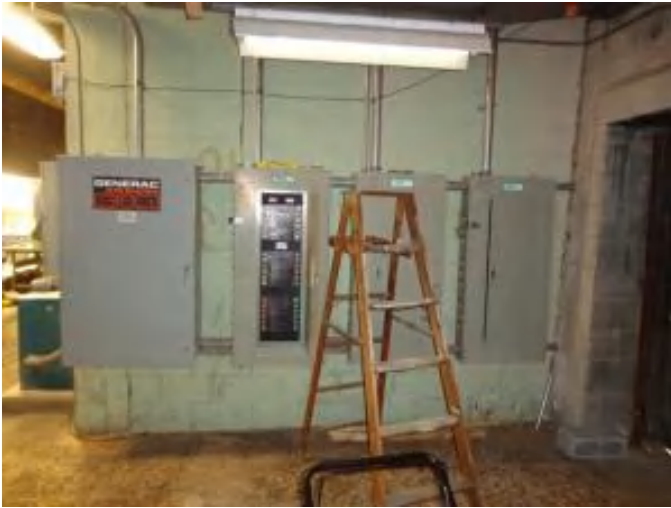
**System: D5090 - Other Electrical Systems**

**Location:** Basement Mechanical Room

**Distress:** Beyond Service Life

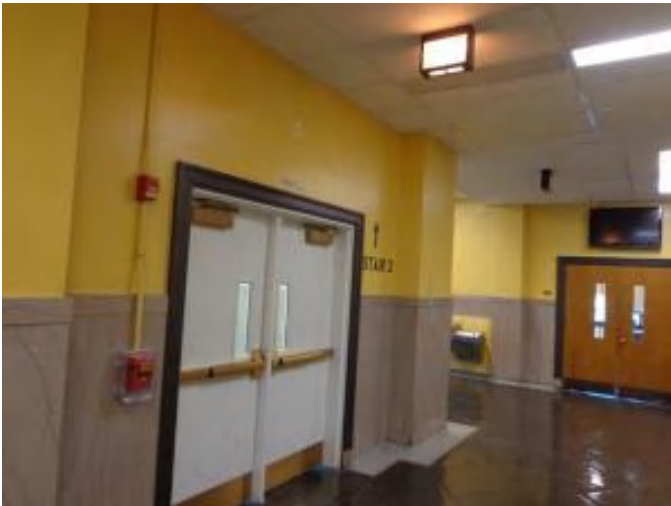
**System: D5090 - Other Electrical Systems**

**Location:** Building wide

**Distress:** Beyond Service Life

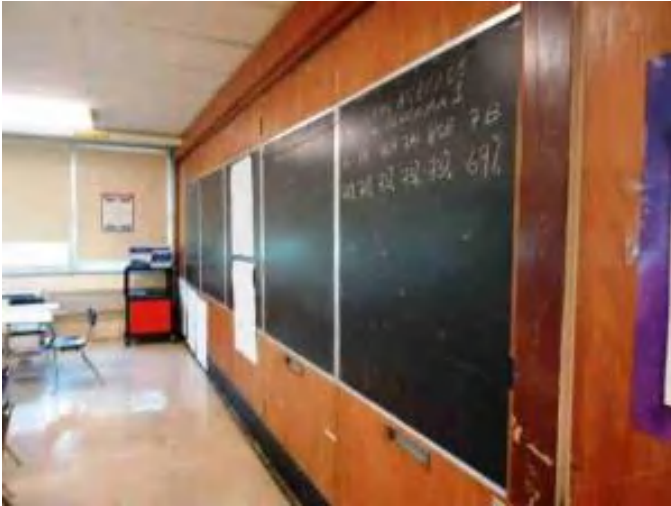
##### System: C1010 - Partitions

There are several movable partitions that remain in classrooms. These wall systems are no longer used and in most cases cannot be used due to damage or wall modifications to support classroom needs. This deficiency provides a budgetary consideration to remove and replace the wall systems with universal removal of the existing movable partitions and upgrades to a permeate wall systems.

**Location:** Building Wide

**Distress:** Damaged

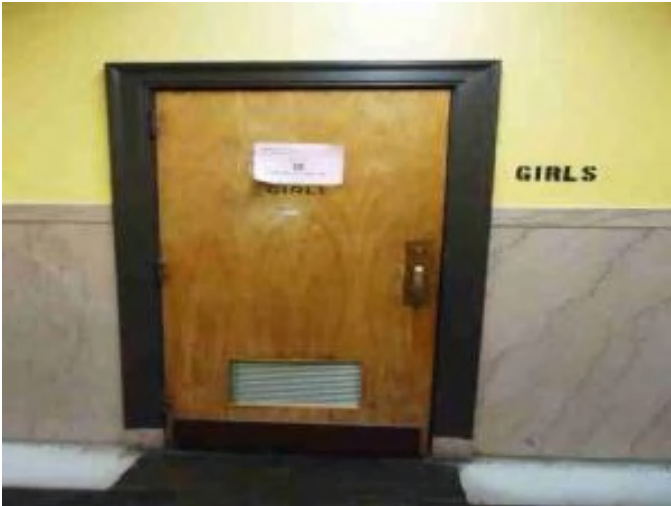
##### System: C1030 - Fittings

**Location:** Building Wide

**Distress:** Damaged

**Notes:** There is no directional signage and room signage is a custom design in places and scarce or painted with no consistency in others. Accessibility signage criteria have been established for the physically challenged. These include mounting heights, contrast and finish, raised and Braille characters and pictograms, and character proportions and heights. It is recommended that compliant signage be installed throughout the building.

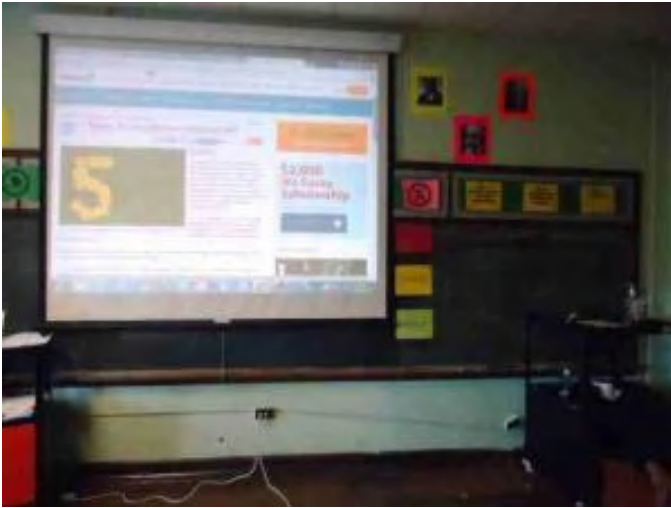
**System: C1030 - Fittings**

**Location:** Classrooms

**Distress:** Damaged

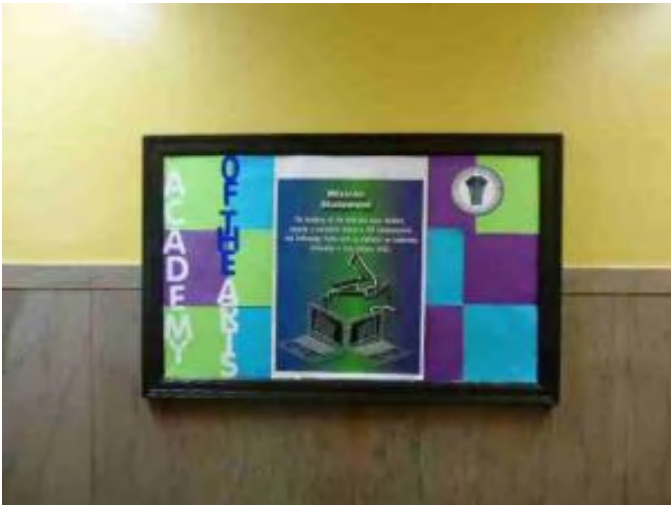
**System: C1030 - Fittings**

There are several tack boards in the hallways for student displays. The systems are beyond the expected service life for this application. Remove and replace tack boards is recommended.

**Location:** Building Wide

**Distress:** Damaged

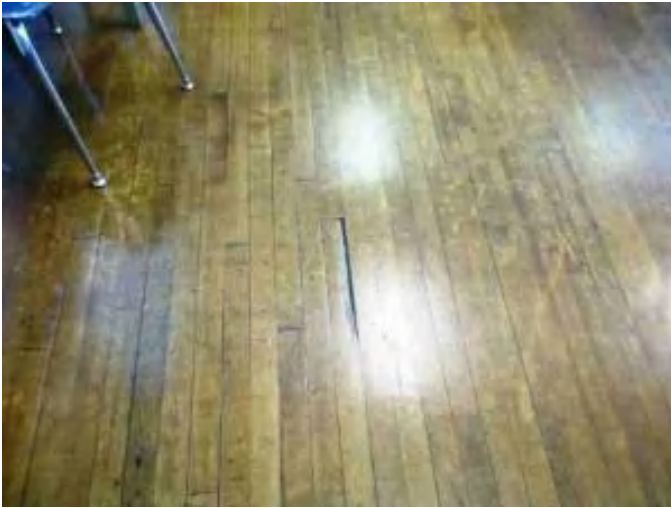
**System: C3020414 - Wood Flooring**

The classrooms and auditorium in this school have a wood floor finish that appears to be from original construction. As indicated in the photos the floors in the basement level were under water during the time of the inspection as a result of a water line leak discovered during the inspection. Also, on the third floor the wooden floor under the 12x12 tile floor was saturated with water as a result of a backed up condensation line. Other sections of wooden flooring is showing signs of age such as the effects of sanding and refinishing with yearly cleaning and waxing with some repairs. Most of the floor finish is in fair condition however, the finish is beyond its expected life cycle. It is recommended that the wooden floor finish be removed and replaced with an in kind finish.

**Location:** Building Wide

**Distress:** Damaged

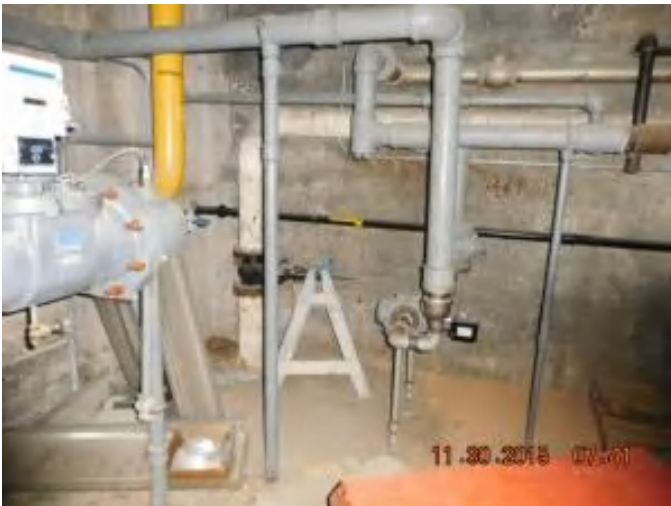
**System: D2020 - Domestic Water Distribution**

**Location:** mechanical room

**Distress:** Building / MEP Codes

**Notes:** Install backflow preventer in existing three inch water service.

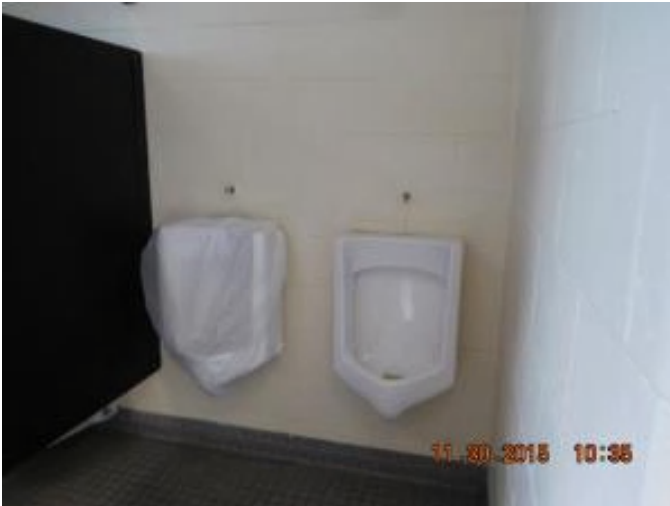
**System: D2030 - Sanitary Waste**

The water heater should be serviceable for fifteen years. The cast iron piping has exceeded the anticipated service life. Rainwater and vent piping should continue functioning, but the sanitary and waste piping should be inspected to determine condition and replace damaged portions. Plumbing fixtures and most of the domestic water supply piping were replaced in 2007 and should be serviceable twenty seven more years for fixtures and seventeen years for distribution.

**Location:** entire building

**Distress:** Beyond Service Life

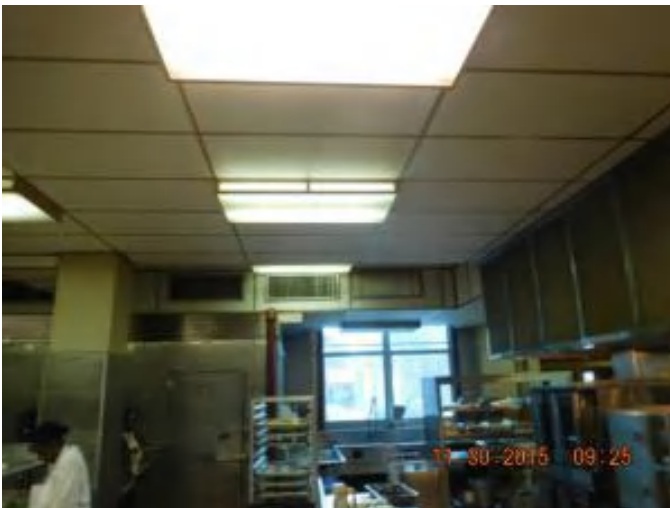
**System: D3040 - Distribution Systems**

**Location:** cafeteria

**Distress:** Building / MEP Codes

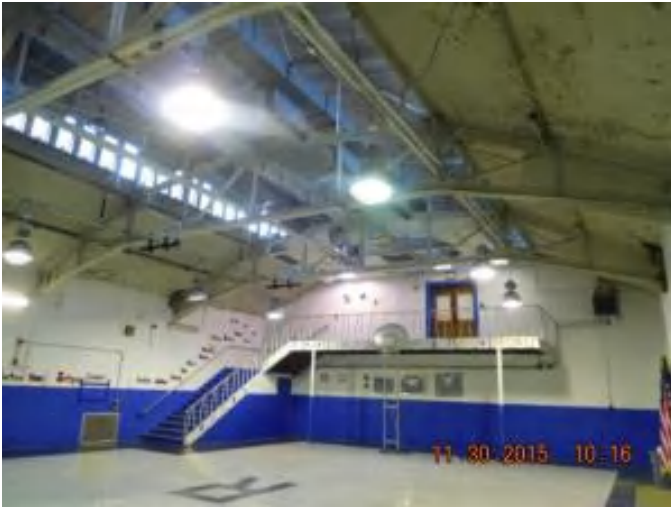
**System: D3040 - Distribution Systems**

The original building is heated by steam and the addition has a hot water heating system. Steam piping is insulated welded black steel and reportedly has leaks throughout the building. A mechanical room near the intersection of the two structures contains two Armstrong shell and tube heat exchangers and three Armstrong inline hot water pumps. Hot water piping is insulated black steel with screwed or welded fittings. Classrooms and some other areas have unit ventilators, with steam coils in older units and hot water coils in newer units. A renovation project in 2007 replaced both the steam and hot water unit ventilators with AAF units. Other areas requiring heat are served by steam or hot water radiators. Some radiators in corridors have sheet metal covers that are secured with several screws that must be removed entirely to access control valves. These should be modified to provide a small maintenance access panel. There are two inoperable house fan systems in basement fan rooms that provided ventilation to large spaces. The gymnasium has eight free blow suspended heating and ventilating units. The old gymnasium now used by Army ROTC has an inoperable heating and ventilating unit.

**Location:** original building

**Distress:** Beyond Service Life

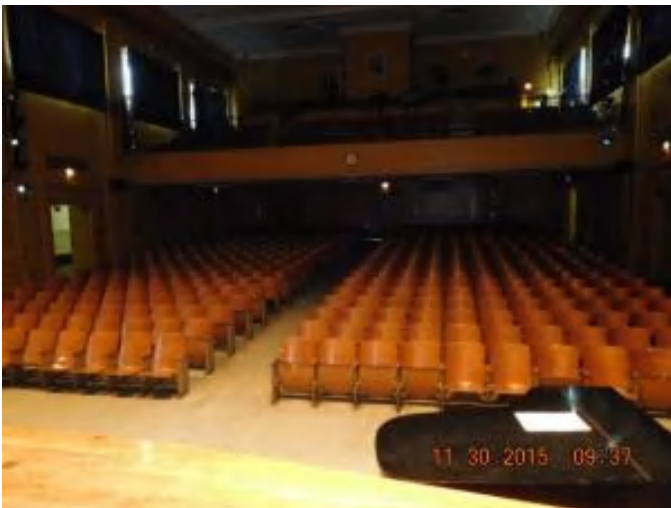
**System: D3040 - Distribution Systems**

**Location:** auditorium

**Distress:** Building / MEP Codes

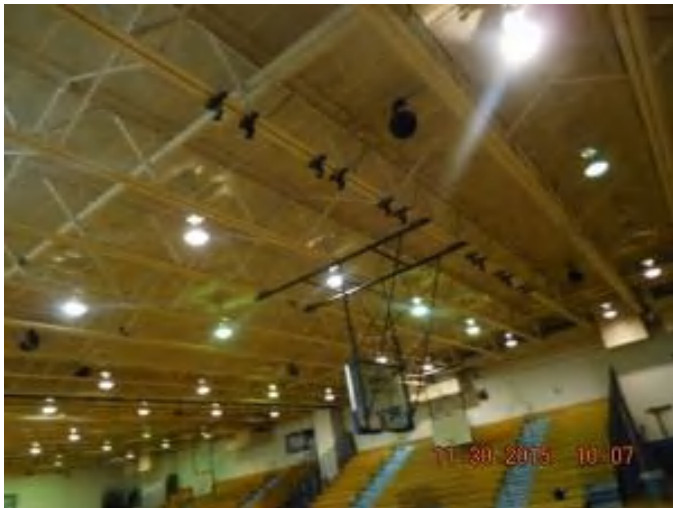
**System: D4010 - Sprinklers**

**Location:** entire building

**Distress:** Life Safety / NFPA / PFD

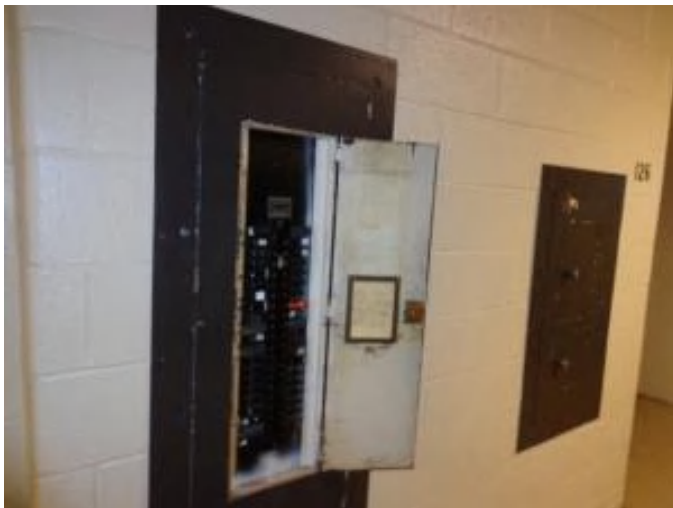
**System: D5010 - Electrical Service/Distribution**

**Location:** Building wide

**Distress:** Beyond Service Life

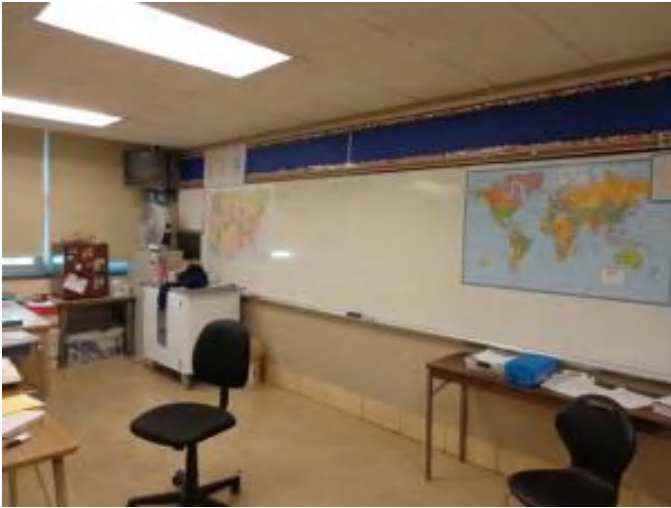
**System: D5020 - Lighting and Branch Wiring**

**Location:** Classrooms

**Distress:** Inadequate

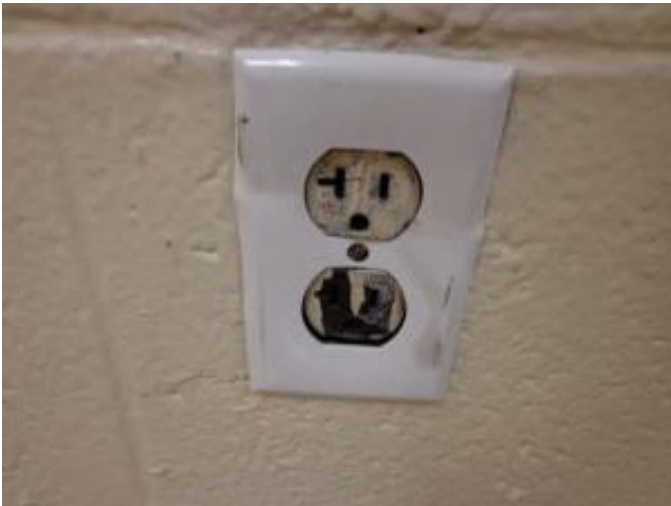
**System: D5020 - Lighting and Branch Wiring**

**Location:** Building wide

**Distress:** Failing

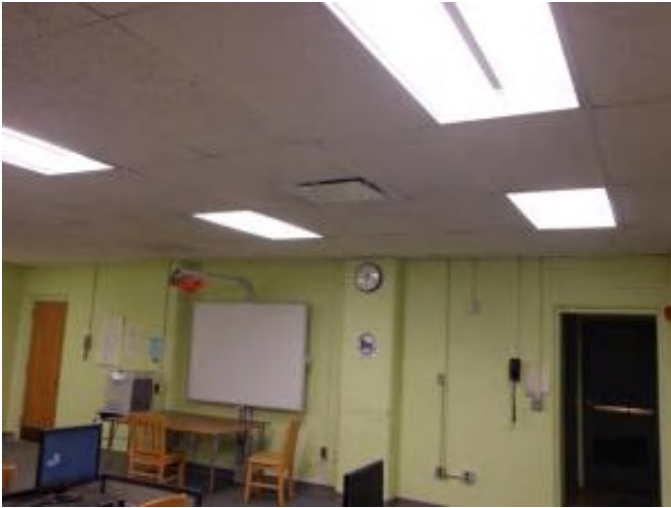
**System: D5020 - Lighting and Branch Wiring**

**Location:** Classrooms and corridors

**Distress:** Damaged

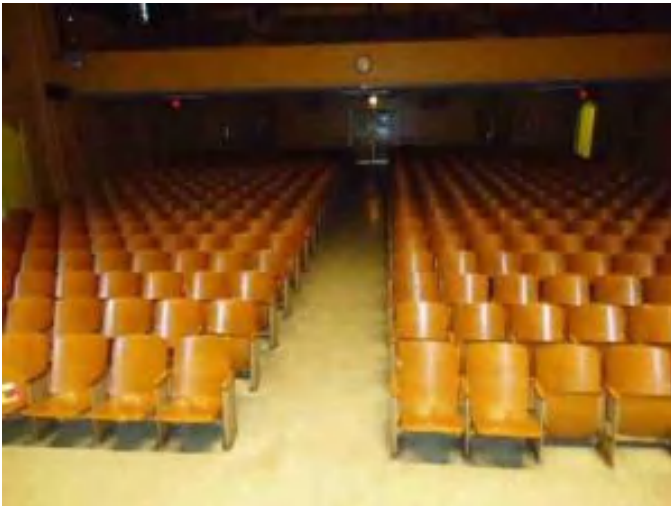
**System: E2010 - Fixed Furnishings**

The fixed seating for this school is from the original construction. The systems are in fair condition considering the age and usage. This project provides a budgetary consideration for universal upgrades for the fixed seating and furnishing of this school. Ensure that ADA requirements are followed with the new seating layout.

**Location:** Auditorium

**Distress:** Damaged

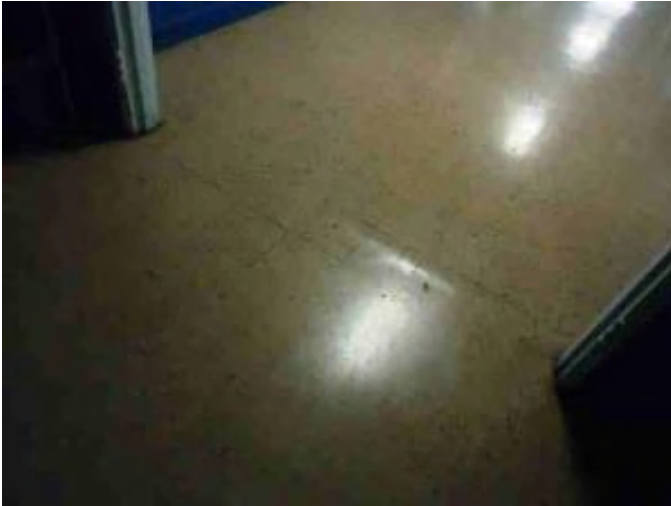
**System: C3020413 - Vinyl Flooring**

**Location:** Classrooms

**Distress:** Damaged

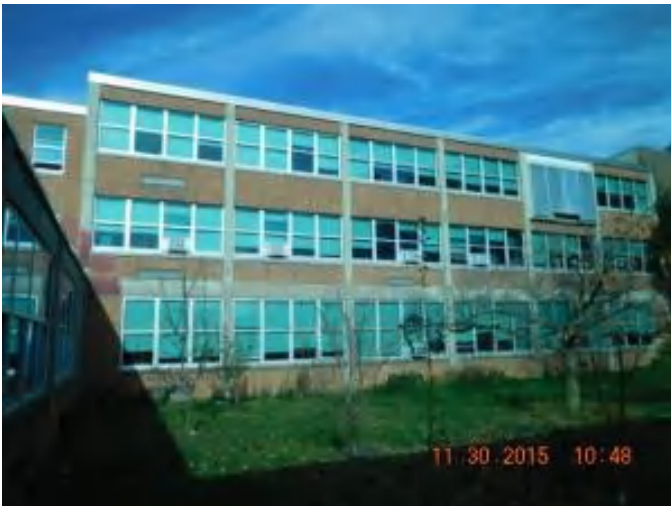
**System: D3030 - Cooling Generating Systems**

**Location:** roof, mechanical room

**Distress:** Inadequate

**Notes:** Provide an eighty ton chilled water system with air cooled package chillers on the roof with pumps, piping and controls. Connect to new air handling units.

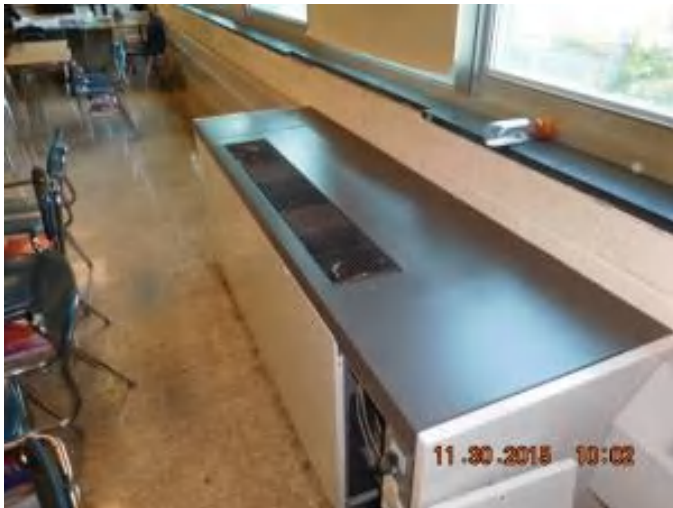
**System: D3060 - Controls & Instrumentation**

There are older pneumatic controls that are inoperable as well as new digital controls. The control air compressor in the mechanical room runs continuously due to leaks in the compressed air piping throughout the building. As part of the 2007 renovation new digital control valves were installed on existing steam radiators. All the 2007 unit ventilators have digital controls. There is a Honeywell Symmetre building automation system with a computer terminal in room 205. The system could not demonstrate some control functions during this survey, and apparently training and operation verification should be addressed.

**Location:** entire building

**Distress:** Energy Efficiency

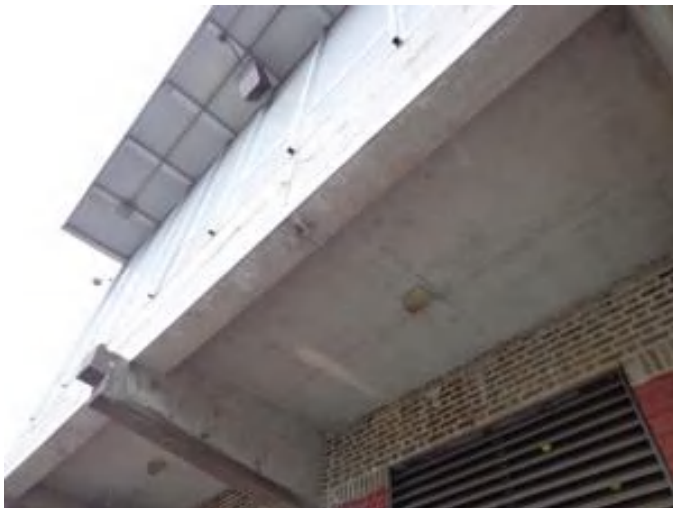
**System: D5020 - Lighting and Branch Wiring**

**Location:** Exterior Building

**Distress:** Obsolete

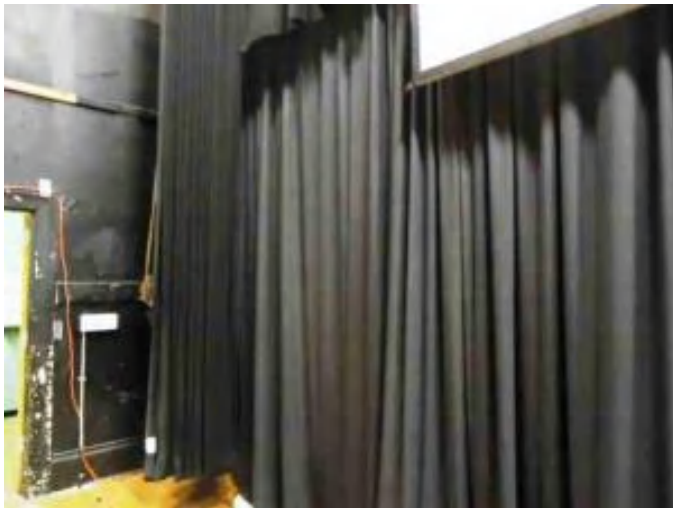
**System: E2010 - Fixed Furnishings**

The school stage has a stage curtain assembly that appears to be from the original construction. Modern applications are typically fire-proof applications with adjustable tracks and electric support for operation. The curtains are torn in a few section and the track is not functioning properly, overall the system is in poor condition. It is recommended that the curtain and track system be upgraded to a new system. Special care should be considered in regards to modern fire proofing for the new installation.

**Location:** Stage

**Distress:** Health Hazard / Risk

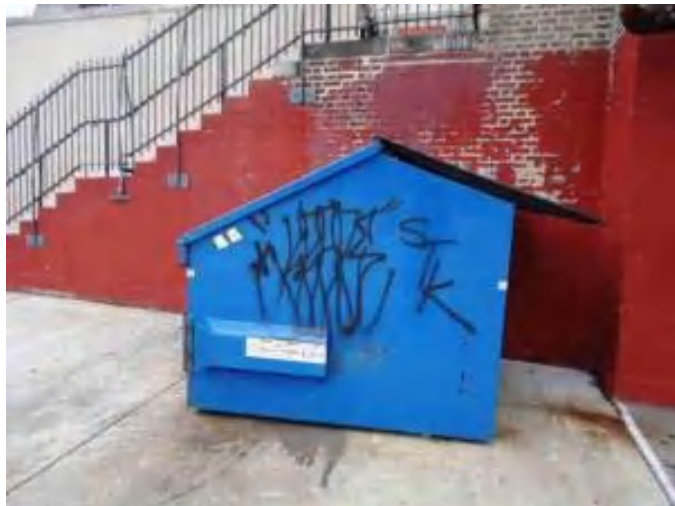
#### System: G2040 - Site Development

**Location:** Site

**Distress:** Health Hazard / Risk
