## Facility Condition Assessment Summary Report

### Rush School

Facility Condition Assessment

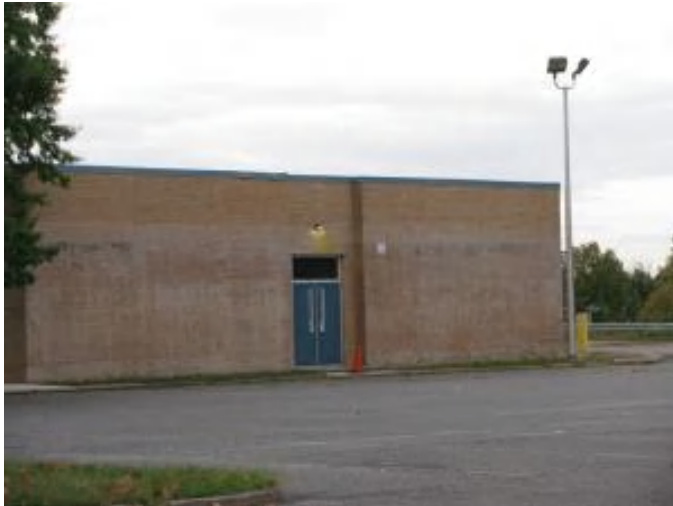
**System: D5030 - Communications and Security**

**Location:** Rush - Exterior Walls  
**Distress:** Inadequate  
**Category:** 4 - Capital Improvement  
**Priority:** 1 - Response Time (< 2 yr)  
**Correction:** Add/Replace Paging System  
**Qty:** 1.00  
**Unit of Measure:** Ea.  
**Estimate:** \$18,772.62  
**Assessor Name:** Craig Anding  
**Date Created:** 10/22/2015

**Notes:** Provide outdoor speakers to cover the school yard. Estimated 10 each.

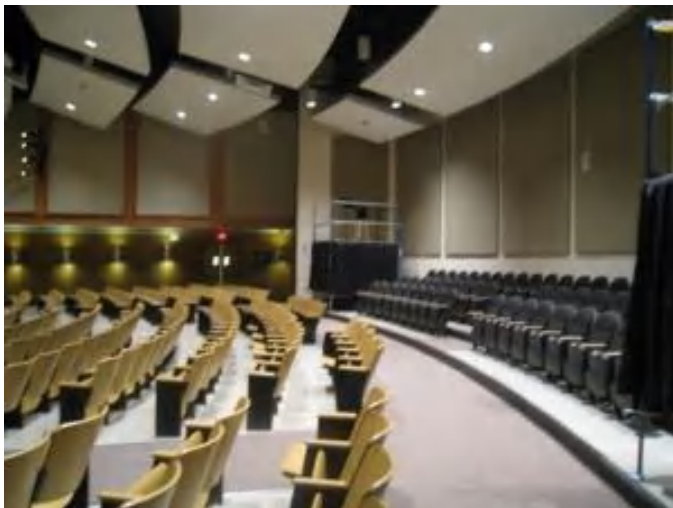
**System: C3020411 - Carpet**

**Location:** Rush - auditorium

**Distress:** Failing

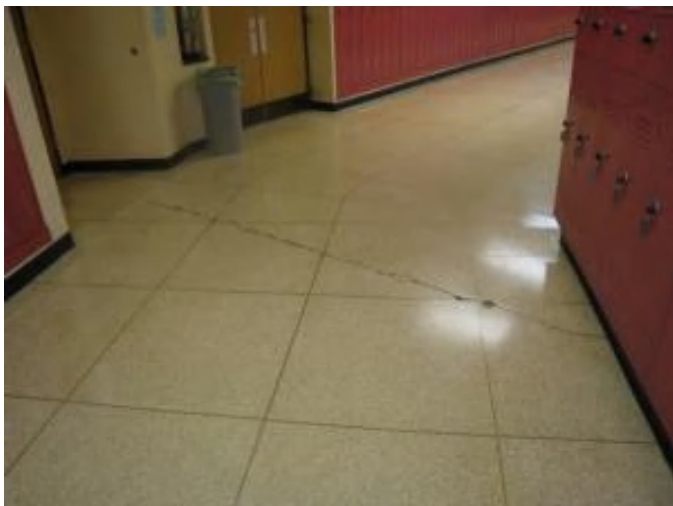
**System: C3020412 - Terrazzo & Tile**

**Location:** Rush - terrazzo floors - first floor

**Distress:** Failing

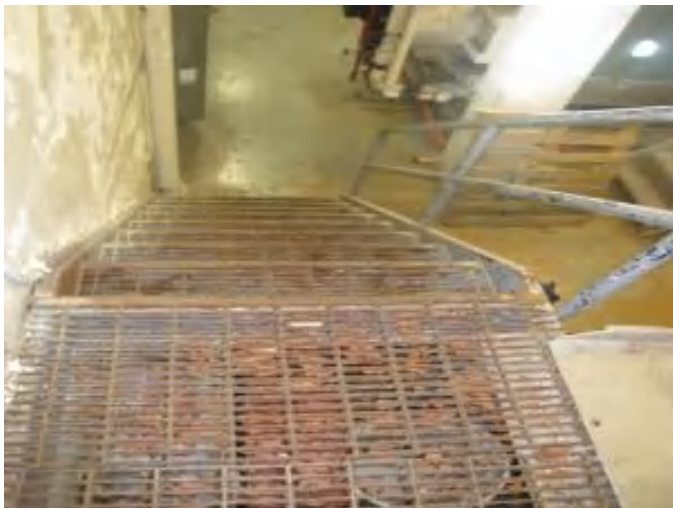
**System: C2010 - Stair Construction**

**Location:** Fitzpatrick - boiler room stairs

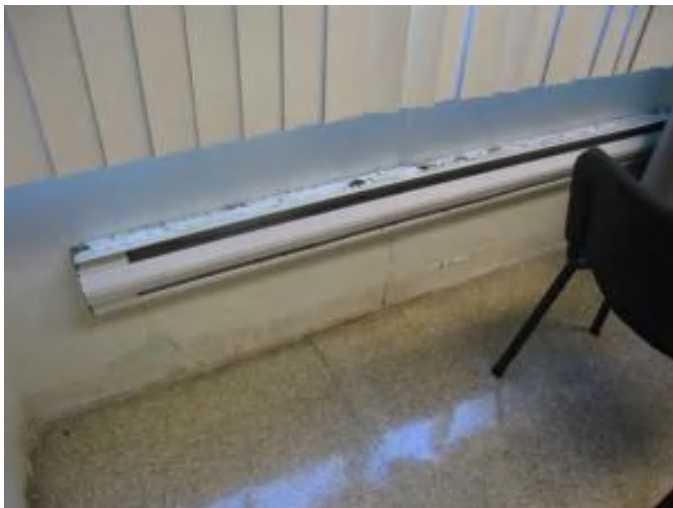
**System: C3010230 - Paint & Covering**

**Location:** Fitzpatrick Annex - interior walls

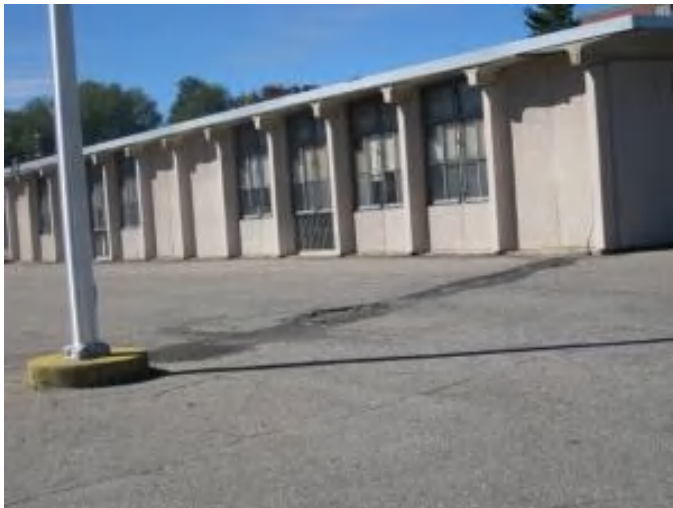
**System: G2020 - Parking Lots**

**Location:** Fitzpatrick Annex - parking lot

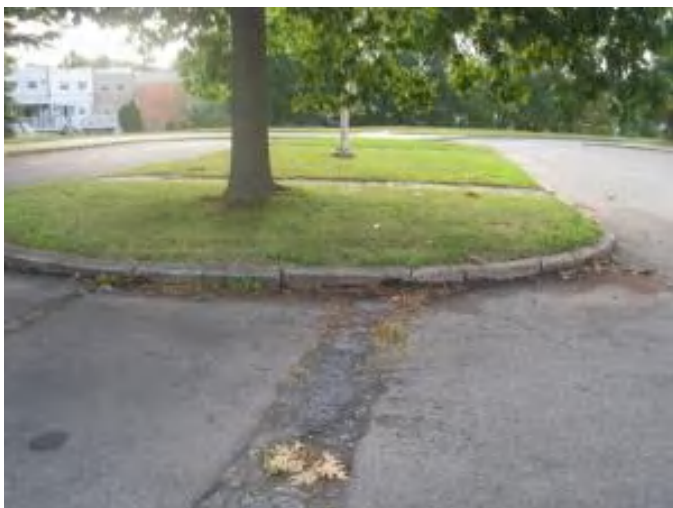
**System: G2020 - Parking Lots**

**Location:** Rush - roadways

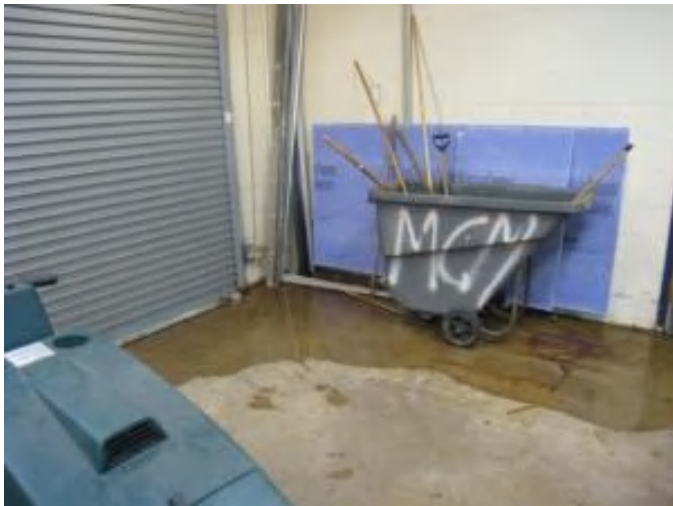
**System: G2020 - Parking Lots**

**Location:** Rush - loading dock

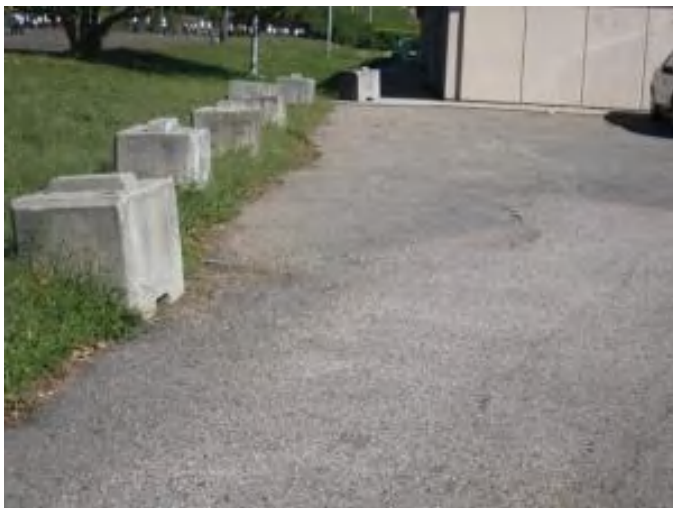
**System: G2020 - Parking Lots**

**Location:** Fitzpatrick Annex - parking lot entrance

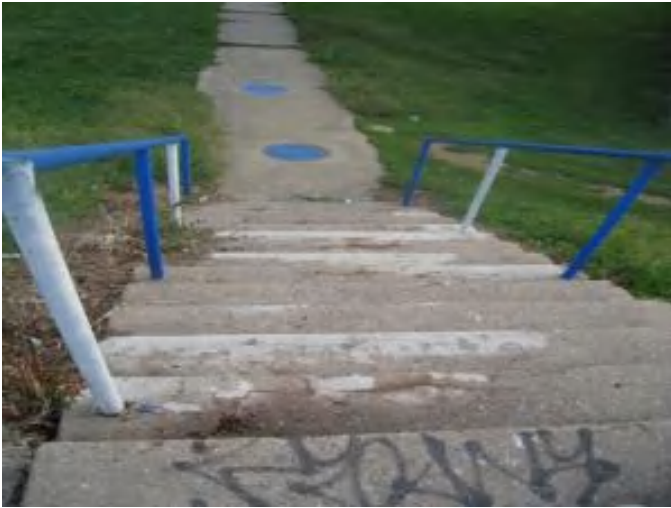
**System: G2030 - Pedestrian Paving**

**Location:** Rush - stair down from Library parking lot

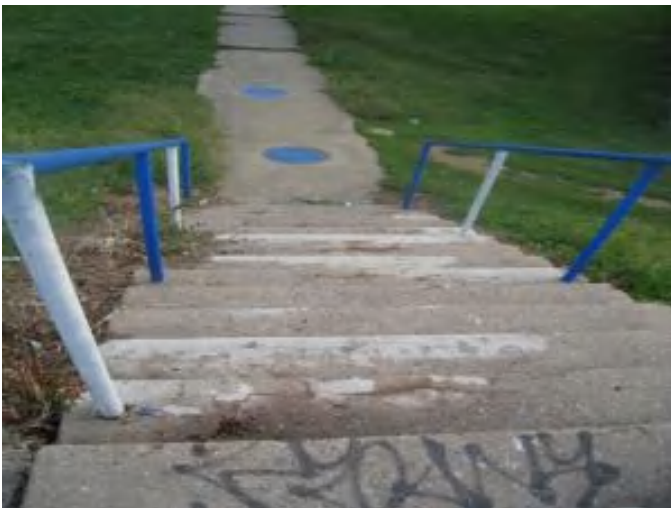
**System: G2030 - Pedestrian Paving**

**Location:** Rush - stair down from Library parking lot

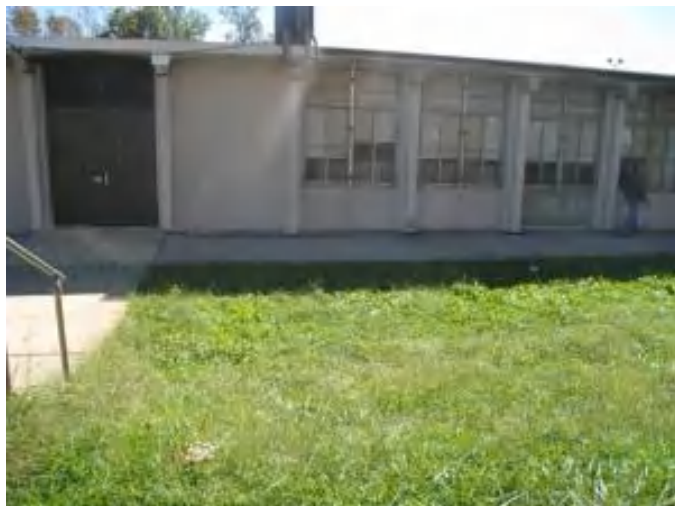
**System: G2040 - Site Development**

**Location:** Fitzpatrick Annex - regrading

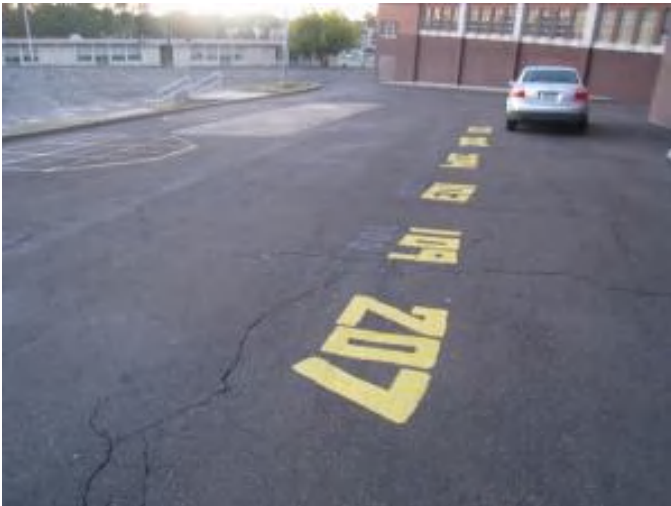
**System: G2020 - Parking Lots**

**Location:** Fitzpatrick - parking and delivery area

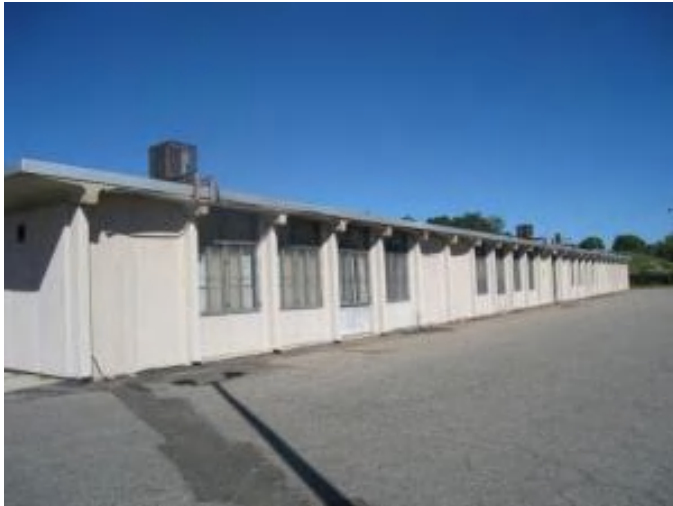
**System: G2020 - Parking Lots**

**Location:** Fitzpatrick Annex - repaving
