Facility Condition Assessment Summary Report

SLA at Beeber School

S410001;Beeber

Site Assessment Report

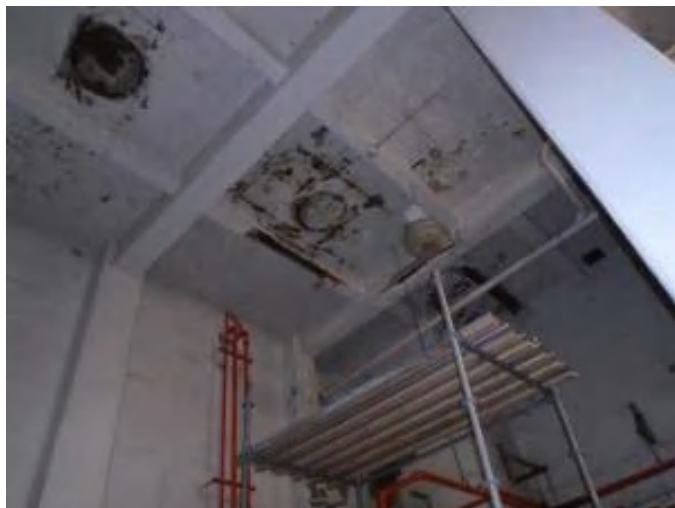
System: A2020 - Basement Walls

Location: Basement

Distress: Health Hazard / Risk

Notes: Abandon/fill coal ash rooms in basement and replace decking to address failing concrete

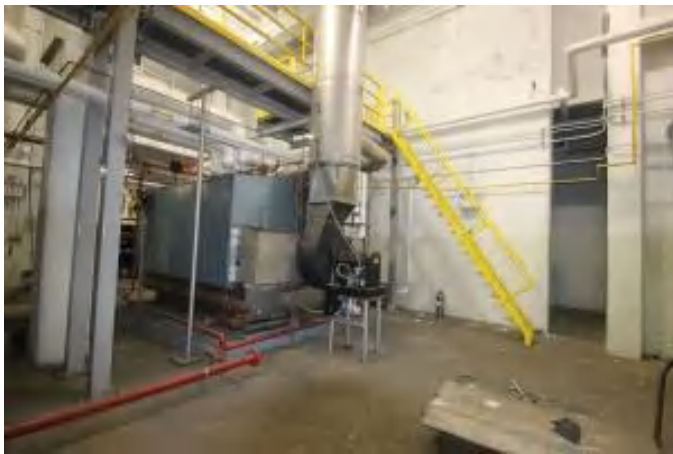
System: D3020 - Heat Generating Systems

Three Smith brand, model 6500A-S-19, 7,691 MBH (230 HP) cast iron steam boilers are in the boiler room. Two of them were not operational at the time of the inspection. Boilers should be replaced due to age and chronic repair needs. Power Flame oil fueled burners were manufactured in 2005. The 12,000 oil tank is behind the building. The two oil circulation pumps do not run well, and should be replaced. Boiler feedwater tank has three pumps for the three boilers and a fourth spare pump. Feed pumps are 1 HP. There is a condensate vacuum system with two 5 HP pumps located above the feedwater tank. The boiler chemical injection tank and pump are located next to the feedwater tank. There is a water softener for boiler makeup water. Combustion make up air enters through ceiling level automatic louvers. Boiler exhausts have draft fans. The building has a 1 inch natural gas supply line for the boiler pilot lights, water heater, and kitchen appliance. It enters the building from 59th Street in the basement north east mechanical room.

Location: Boiler room

Distress: Failing

Notes: Replace boilers due to age and chronic repair needs

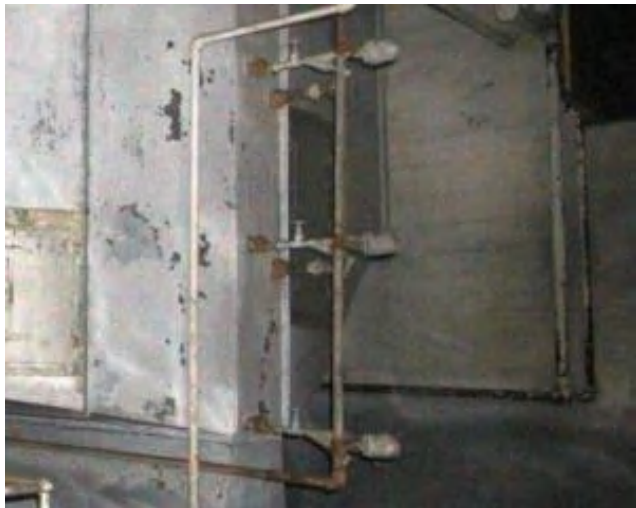
System: D3040 - Distribution Systems

Location: Entire building

Distress: Failing

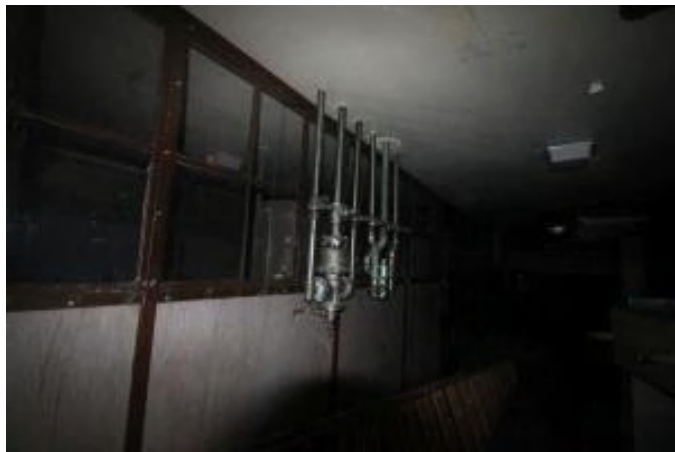
System: C1010 - Partitions

Location: Locker rooms

Distress: Obsolete

Notes: Completely remodel boys' and girls' showers

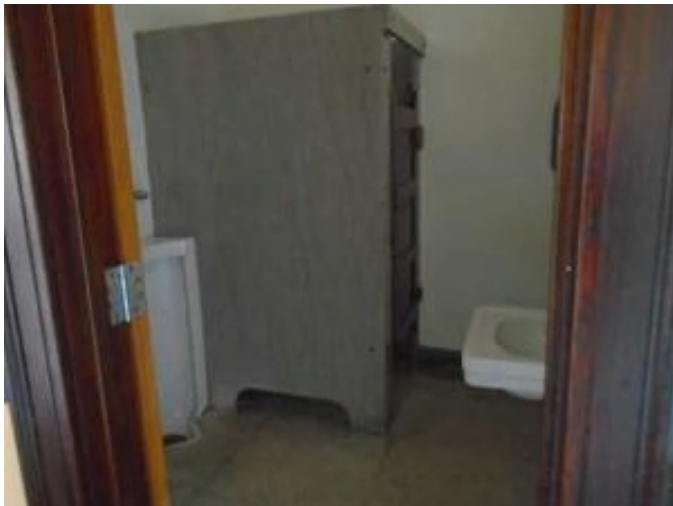
System: C1030 - Fittings

Location: Toilets

Distress: Accessibility

Notes: Install accessible toilet partitions to meet building code

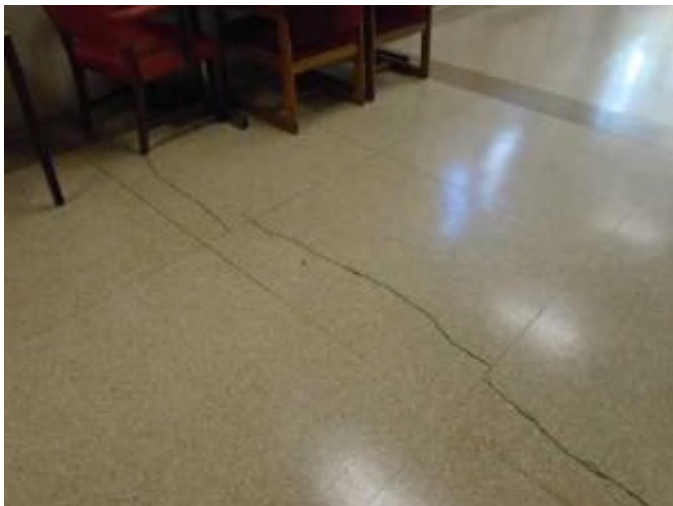
System: C3020412 - Terrazzo & Tile

Location: Various

Distress: Damaged

Notes: Repair cracked terrazzo flooring

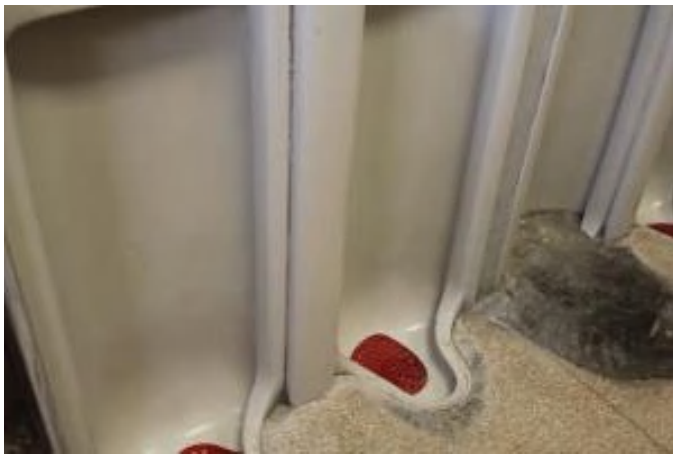
System: D2010 - Plumbing Fixtures

Location: Boys' toilets

Distress: Obsolete

Notes: Replace all floor standing urinals

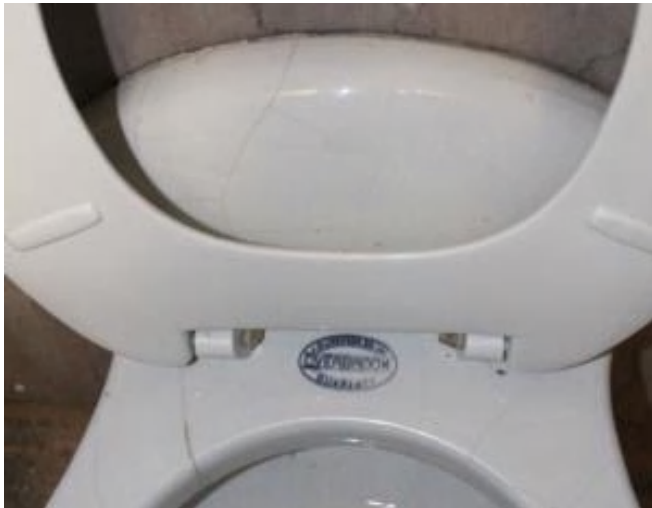
System: D2010 - Plumbing Fixtures

Toilet room plumbing fixtures include both floor and wall mounts for water closets, urinals, and lavatories. Most fixtures are vitreous china, but some replacement lavatories are enameled cast iron. Vintage water closets exist throughout the building, and many are in excellent condition despite their age. There are still floor level urinals in some boys' toilets. These are well beyond their service life, and several of them are out of service. District should budget to replace 25% of water closets and 100% of urinals.

Location: Toilet rooms

Distress: Beyond Service Life

Notes: Replace 25% water closets

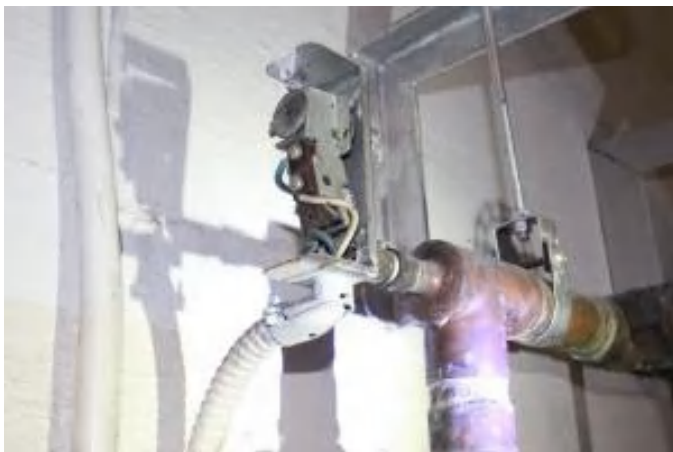
System: D2020 - Domestic Water Distribution

Location: Boiler room

Distress: Failing

Notes: Repair or replace inoperative hot water circulation pump

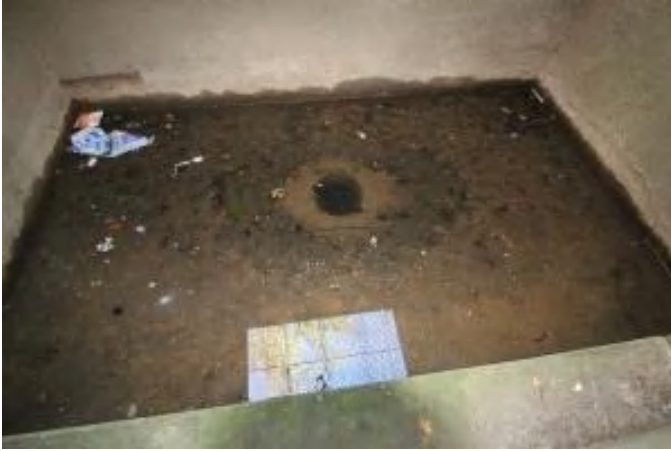
System: D2040 - Rain Water Drainage

Rain water drain pipes are threaded galvanized steel fed from cast iron roof drains. Drain pipes run inside the building. There are no overflow drains on the roof. Roof drains appear to have been recently replaced, likely in 2005 when the roof was last replaced. The pipe appears older than 10 years. There are drainage problems throughout the building and especially at basement level stairwells where there is ponding. The rain water drain system should be inspected in detail and repaired where needed.

Location: Entire building

Distress: Failing

Notes: Inspect and repair rain water drain system due to ponding and age

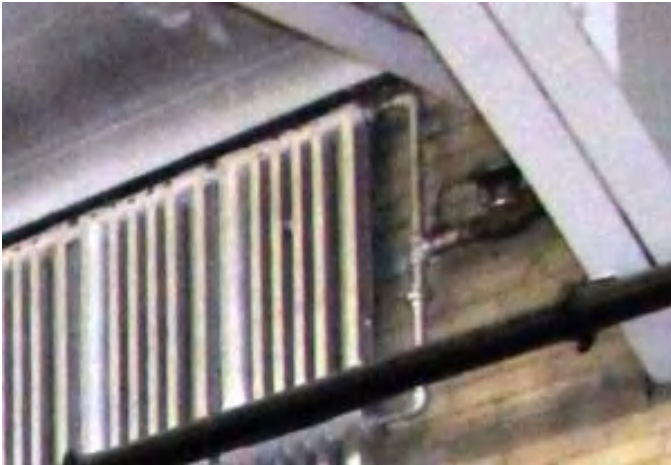
System: D3060 - Controls & Instrumentation

Location: Entire building

Distress: Obsolete

Notes: Upgrade pneumatic HVAC control system to DDC

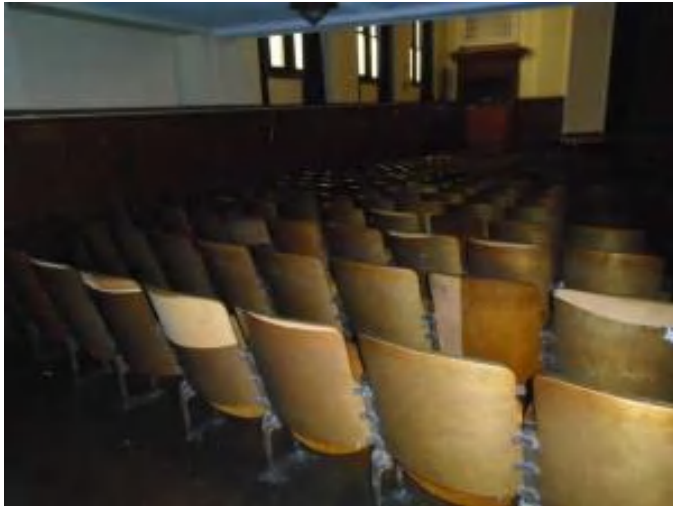
System: E2010 - Fixed Furnishings

Fixed furnishings include: fixed casework in classrooms, corridors and library, generally in fair to good condition; window shades/blinds, generally in fair condition; and fixed auditorium seating generally in poor condition with some damaged and missing seats and failing veneer.

Location: Auditorium/balcony

Distress: Beyond Service Life

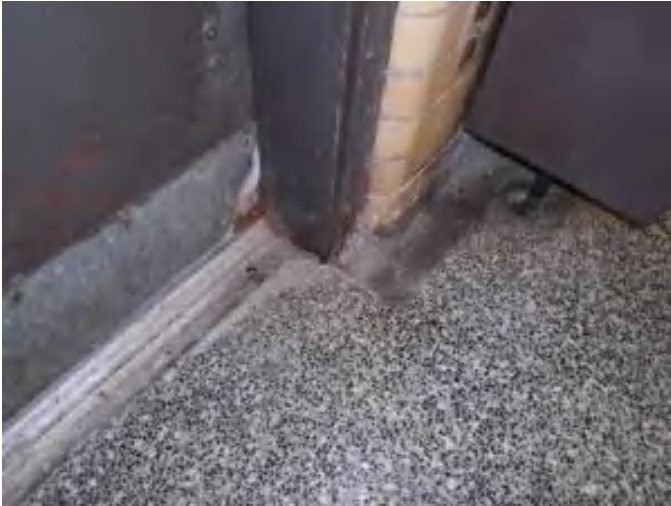
System: B2030 - Exterior Doors

Location: Throughout

Distress: Failing

Notes: Replace exterior metal doors – rusted, failing, and beyond service life

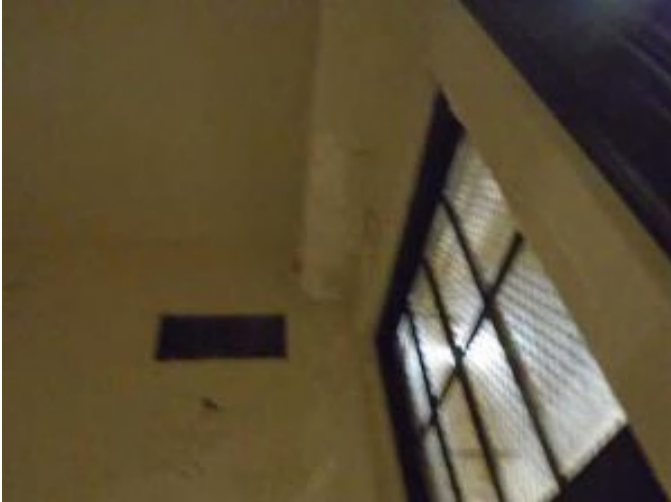
System: C3010230 - Paint & Covering

Location: Throughout

Distress: Damaged

Notes: Repair and paint interior plaster walls – water damaged (10% of plaster wall area)

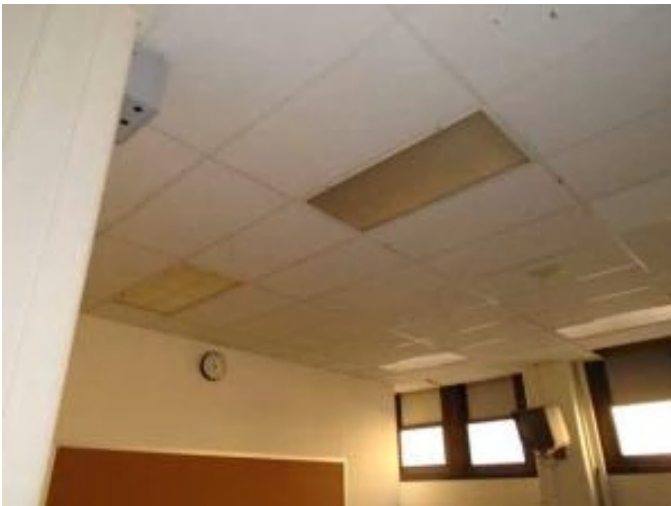
System: C3030 - Ceiling Finishes

Location: Throughout

Distress: Beyond Service Life

Notes: Replace suspended acoustic ceiling system – rusted beyond service life (90% of suspended ceiling area)

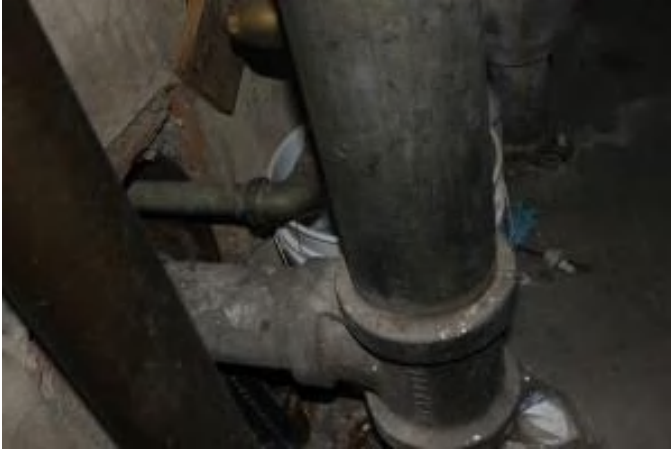
System: D2030 - Sanitary Waste

Sanitary drain piping is threaded galvanized steel pipe. Precise age is unknown, but it has certainly surpassed its expected lifespan and flows poorly. The sanitary drain pipes should be inspected in detail and repaired or replaced as needed. The building has a sewage ejector located in a sump in the basement mechanical room at the front of the building. The sump is flooded with water and appears to have an electric submerged sump pump to prevent overflow. The sewage ejector appears to be pneumatically operated and there is one air pump in the sump room and a second

Location: Entire building

Distress: Beyond Service Life

Notes: Inspect and repair sanitary drainage system based on age and appearance

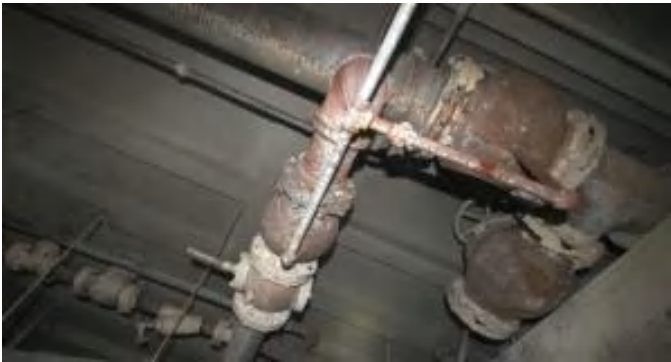
System: D3040 - Distribution Systems

Location: Entire building

Distress: Failing

Notes: Repair or replace steam and condensate pipe due to reported leaks

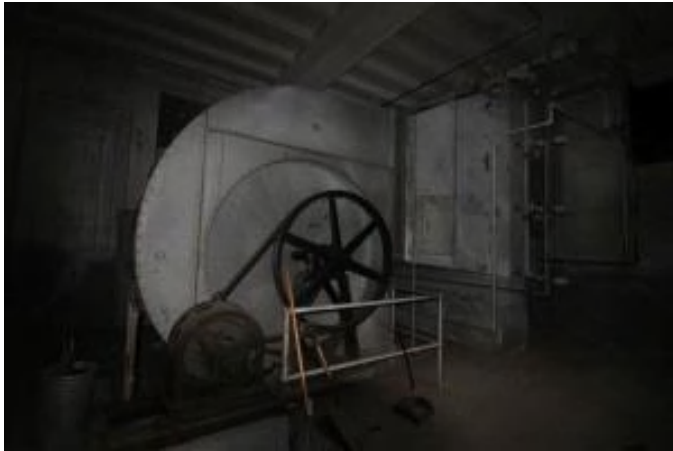
System: D3040 - Distribution Systems

The original three air handlers are still installed in mechanical rooms in the basement. They each consist of primary steam heating coils, air washers, fans, and secondary heat coils. Two units have 25 HP fans and ventilated the east and west sides of the building. The third unit has a 15 HP fan and served the gyms and locker rooms. The gym unit intakes 100% outside air. (The other two units had inaccessible intake sections). They are all obsolete and should be replaced with modern units including cooling and humidification and dehumidification sections.

Location: Entire building

Distress: Obsolete

Notes: Replace original AHUs due to age and lack of cooling

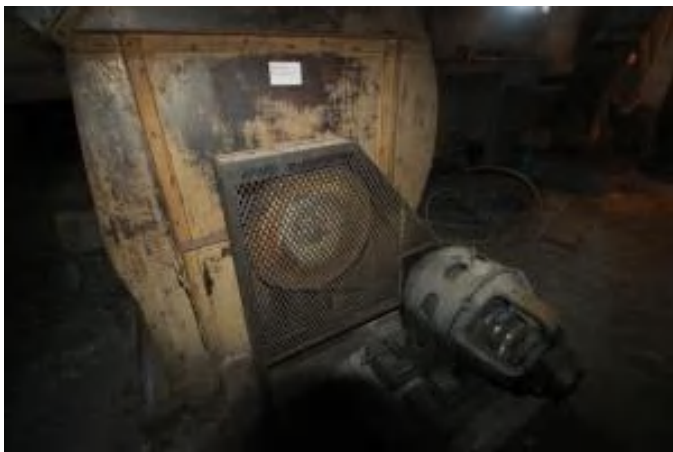
System: D3040 - Distribution Systems

Location: Attic mechanical rooms

Distress: Obsolete

Notes: Replace exhaust fans for toilet rooms, lunchroom, etc.

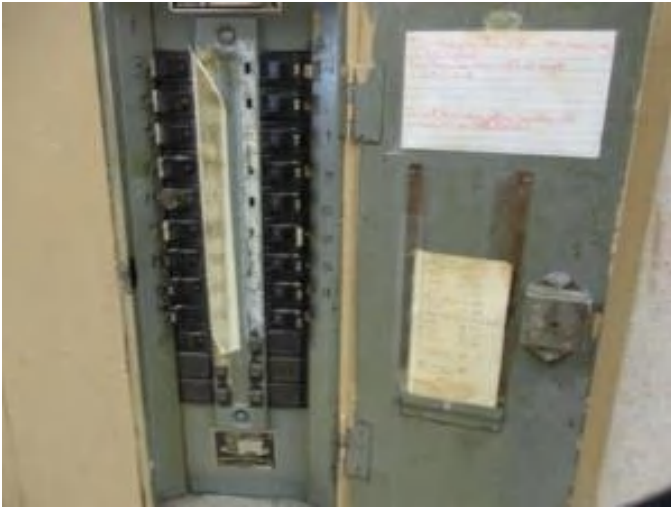
System: D5010 - Electrical Service/Distribution

There are 120/240V panel-boards in each floor for lighting and receptacles. These panelboards and associated wiring have exceeded the end of their useful life and are undersized to absorb new loads. The entire distribution system needs to be replaced with new 208/120 volt, 3 phase panelboards and new wiring. The raceway is mainly conduits run above the ceiling.

Location: Entire Building

Distress: Inadequate

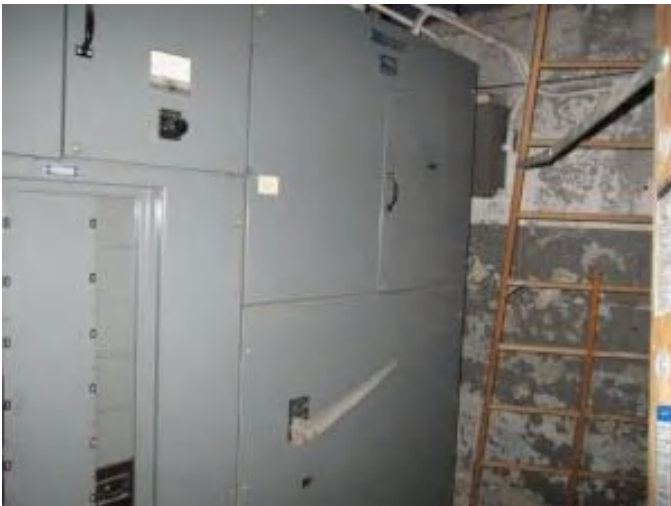
System: D5010 - Electrical Service/Distribution

Location: Basement

Distress: Inadequate

Notes: Provide new service 480V/277V, 3 phase power, approximate 2000 Amperes.

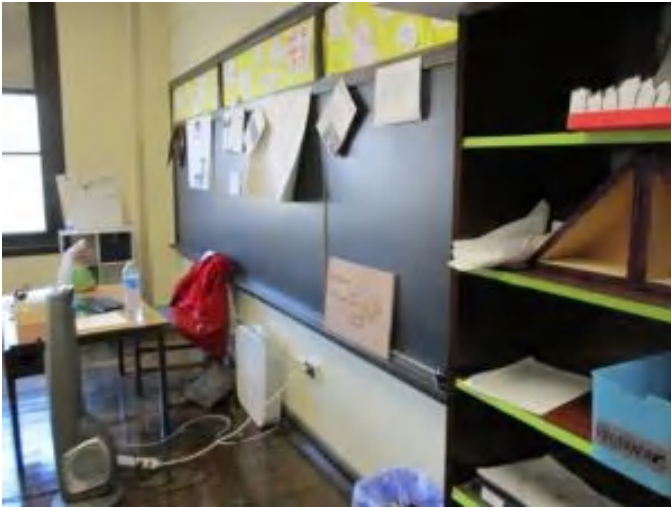
System: D5020 - Lighting and Branch Wiring

Location: Entire Building

Distress: Inadequate

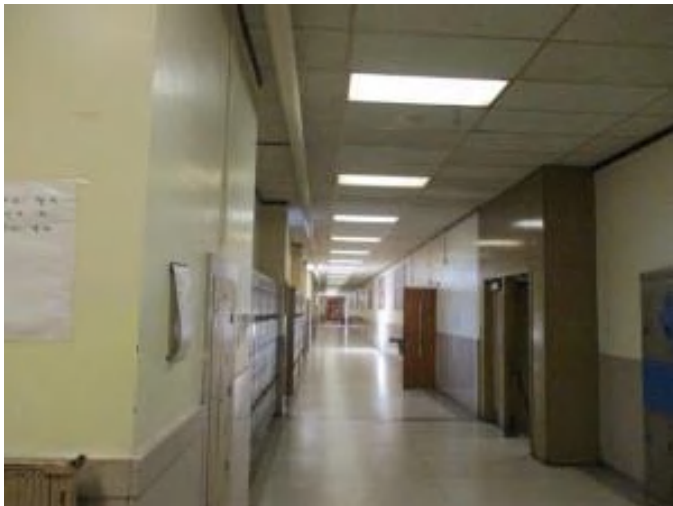
System: D5090 - Other Electrical Systems

Location: Entire Building

Distress: Health Hazard / Risk

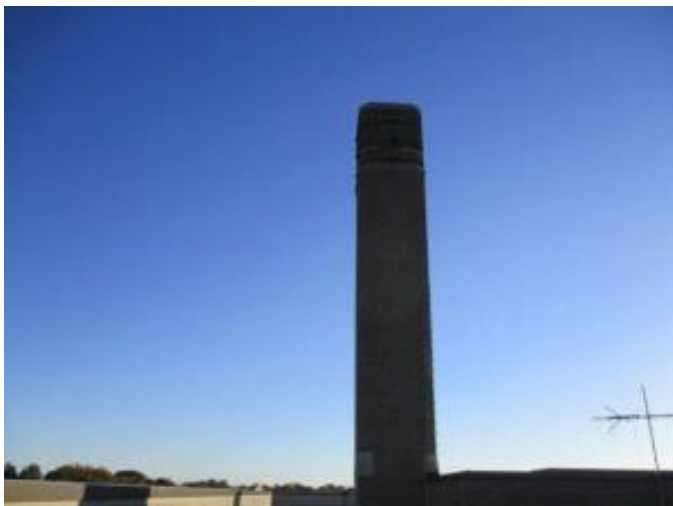
System: D5090 - Other Electrical Systems

Location: Roof

Distress: Building / MEP Codes

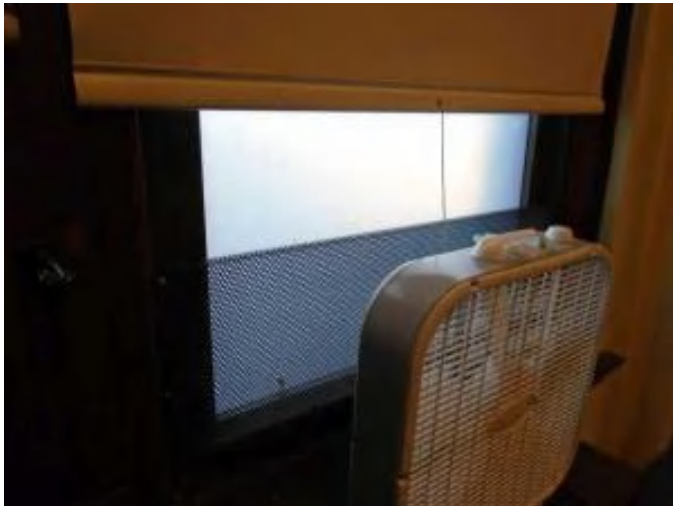
System: B2020 - Exterior Windows

Location: Throughout

Distress: Energy Efficiency

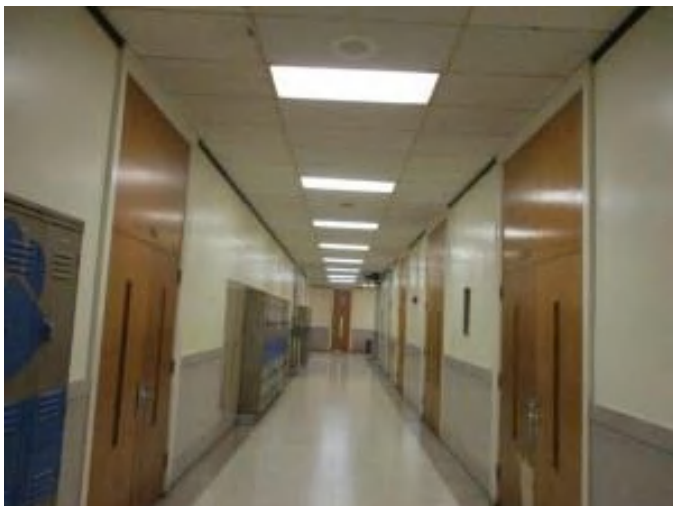
System: D5030 - Communications and Security

Location: Entire Building

Distress: Security Issue

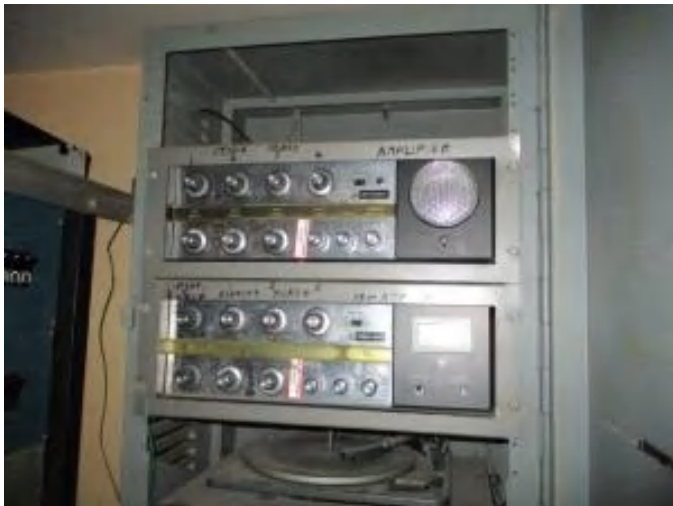
System: D5030 - Communications and Security

Location: Auditorium

Distress: Beyond Service Life

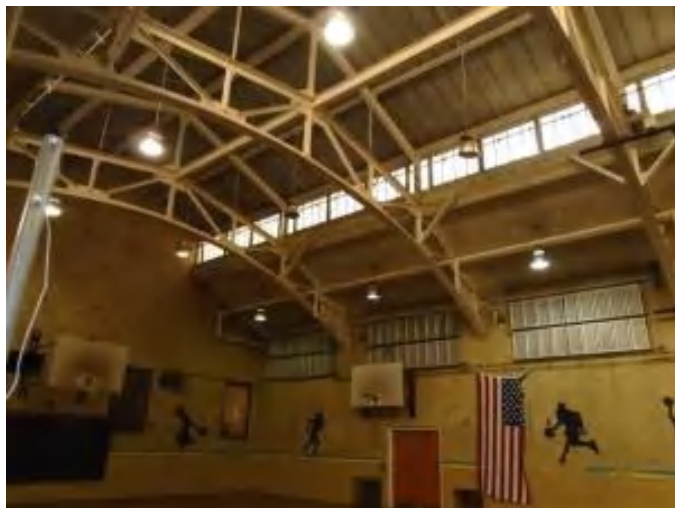
System: E1020 - Institutional Equipment

Commercial and institutional equipment includes: stage equipment, generally in fair condition and gym equipment in poor condition and beyond service life. Other equipment includes food preparation and food service equipment in good

Location: Gyms

Distress: Beyond Service Life

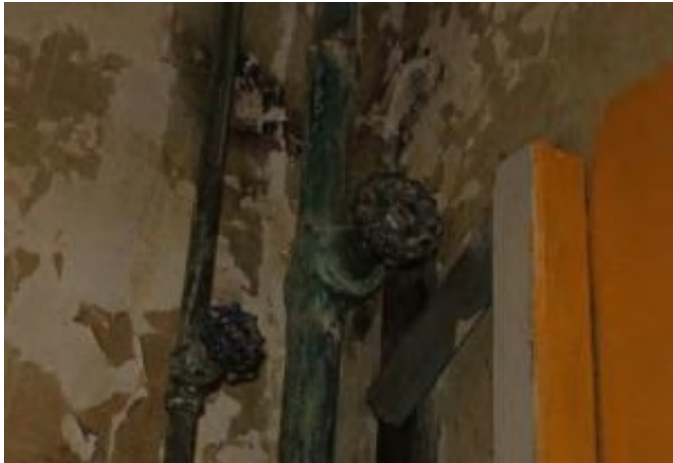
System: D2020 - Domestic Water Distribution

Domestic water distribution pipe is mostly soldered copper, but sections of red brass pipe and also threaded copper pipe with bronze fittings still exist. Iron valves in the domestic water system are heavily rusted. Cuprous pipes are corroded in many areas. The water distribution pipe has exceeded its service life and should be replaced. Municipal water service enters the boiler room under the stairs at the back of the building through a 4 inch pipe. There is a compound meter with a bypass line and then a double backflow preventer without bypass. The backflow preventer is not a reduced pressure zone device. There is a reduced pressure zone backflow preventer for the boiler water supply line. The water entry pipe, valves, and meter are in good condition and should last 5 years or longer. There is no pressure booster system. A Bradford White 75 gallon water heater was installed in 2013. It has 8 years expected life left. There is a hot water circulation pump (3/4 HP) with aquastat and timer, but it has an electrical fault that causes the pump's circuit breaker to trip. The circulation pump system should be repaired or replaced.

Location: Entire bulding

Distress: Beyond Service Life

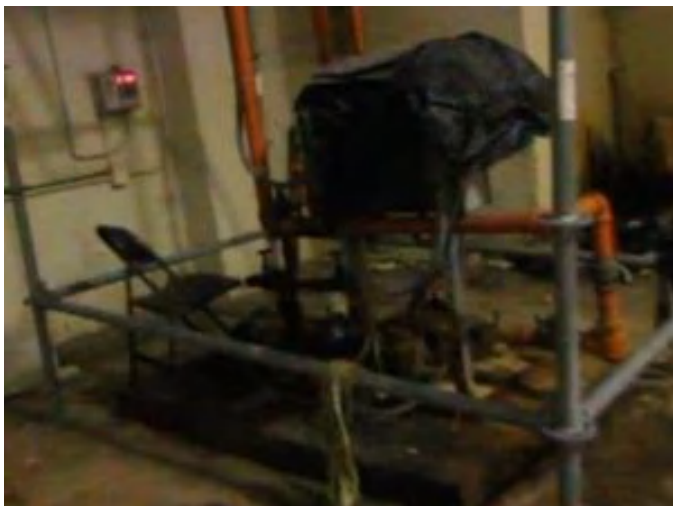
System: D3020 - Heat Generating Systems

Location: Boiler room

Distress: Failing

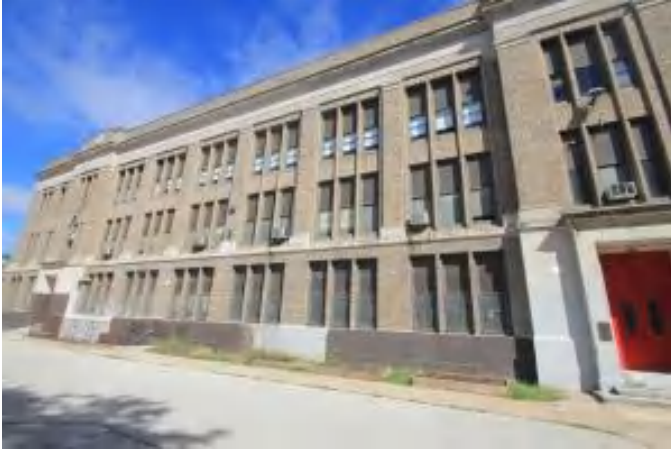
System: D3030 - Cooling Generating Systems

There is no central cooling generating equipment in the building. Twelve window unit air conditioners are installed in offices, the IMC, and a few classrooms. The units in the IMC do not work. Window units should be removed and replaced with a central cooling plant to air condition the entire building, 350 ton estimated capacity.

Location: Entire building

Distress: Inadequate

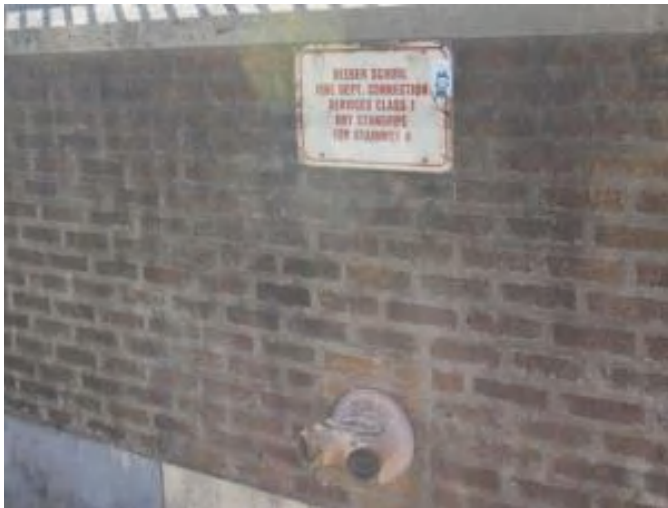
System: D4010 - Sprinklers

Location: Entire building

Distress: Life Safety / NFPA / PFD

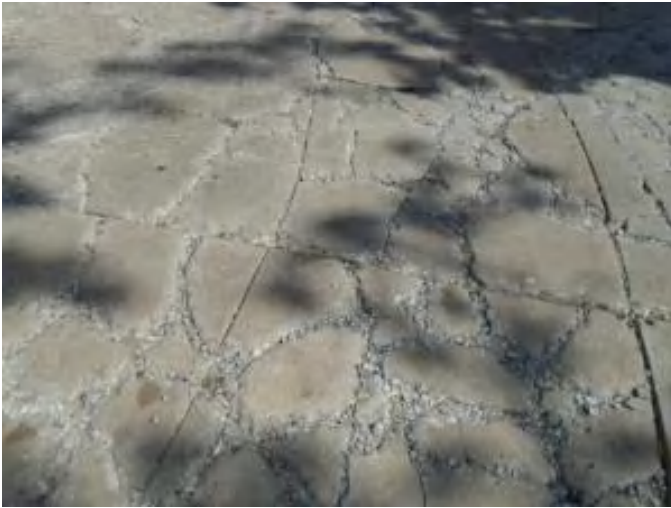
System: G2030 - Pedestrian Paving

Location: Yard

Distress: Damaged

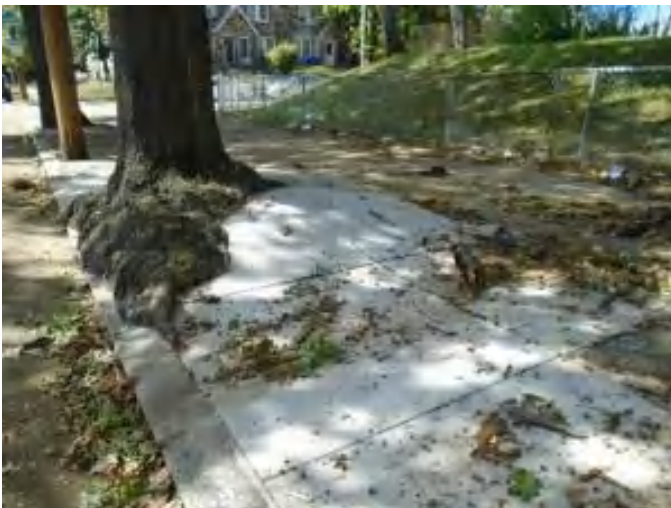
System: G2030 - Pedestrian Paving

Location: Sidewalks

Distress: Damaged

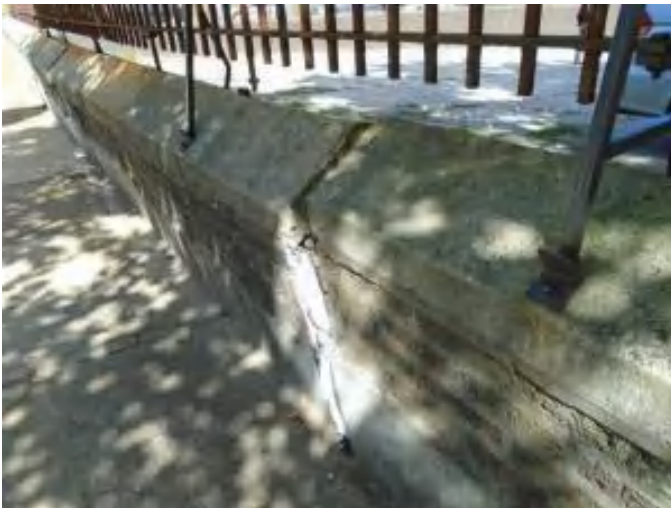
System: G2040 - Site Development

Location: Site

Distress: Damaged

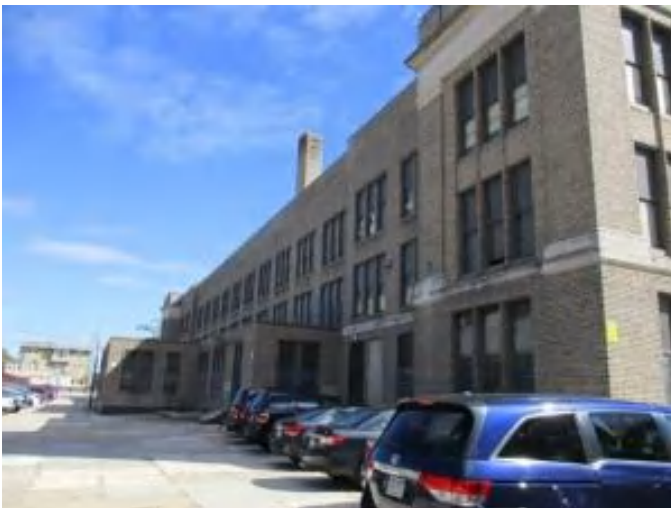
System: G4030 - Site Communications & Security

Location: Building Perimeter

Distress: Security Issue

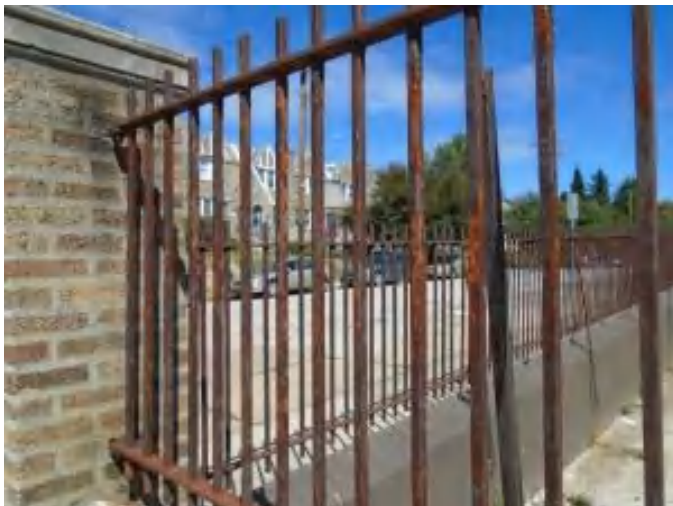
System: G2040 - Site Development

Location: Site

Distress: Failing
