Facility Condition Assessment Summary Report

Saul School

S604001;Saul

February 2, 2017

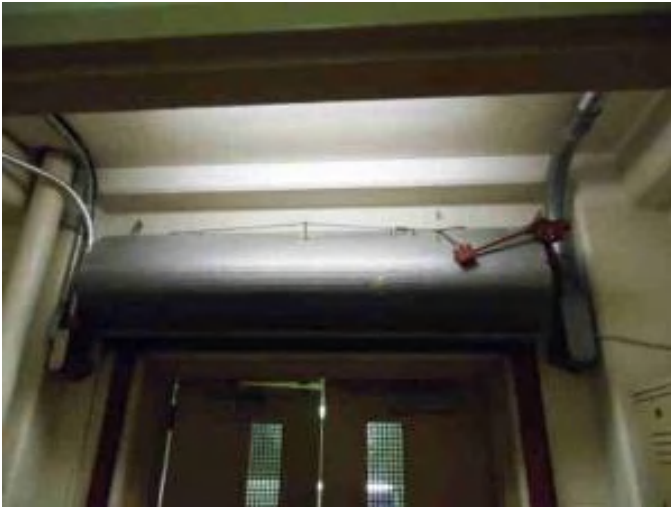
System: C1020 - Interior Doors

Location: Main Hallway

Distress: Life Safety / NFPA / PFD

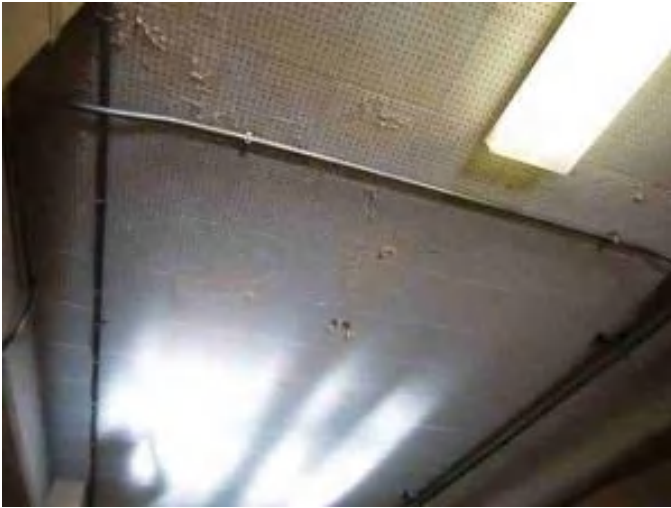
System: C3030 - Ceiling Finishes

Location: Main Building Wide

Distress: Damaged

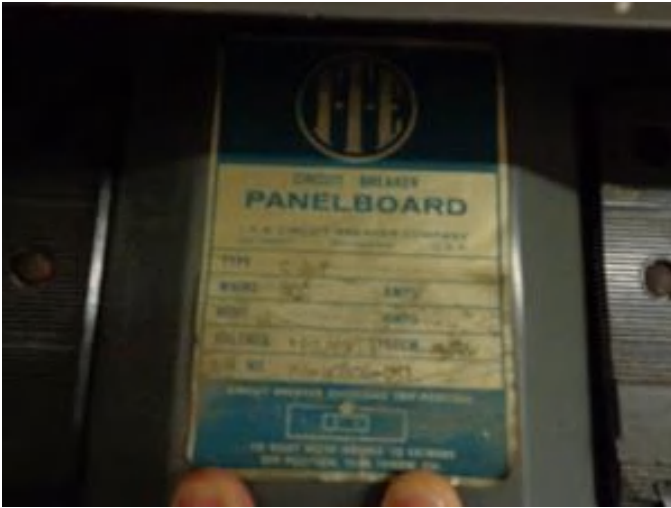
System: D5010 - Electrical Service/Distribution

Location: Building Engineer's Office

Distress: Beyond Service Life

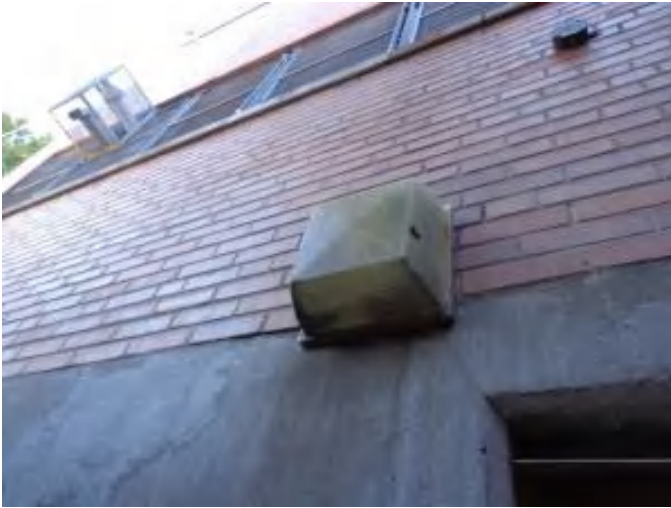
System: D5020 - Lighting and Branch Wiring

Location: Exit discharges

Distress: Beyond Service Life

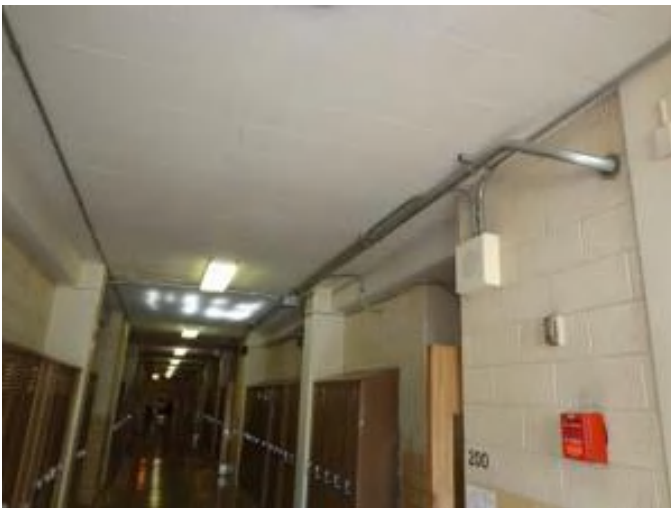
System: D5030 - Communications and Security

Location: Building wide

Distress: Life Safety / NFPA / PFD

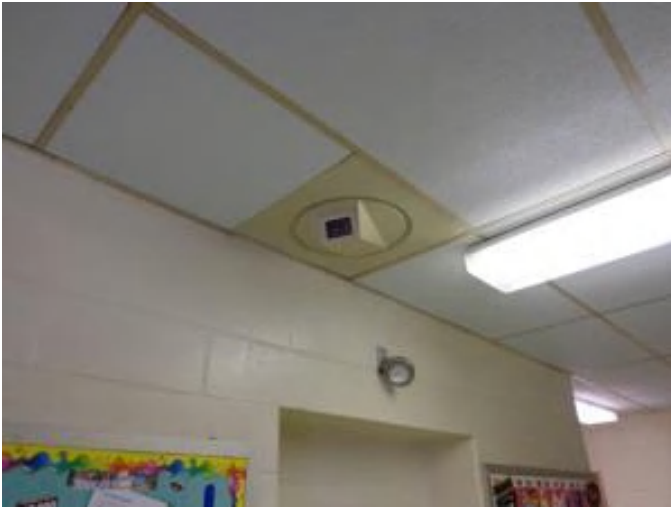
System: D5030 - Communications and Security

Location: Building wide

Distress: Beyond Service Life

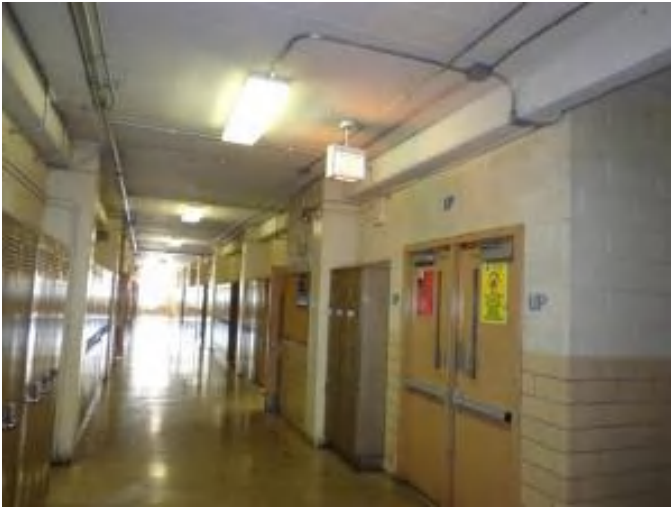
System: D5090 - Other Electrical Systems

Location: Building wide

Distress: Beyond Service Life

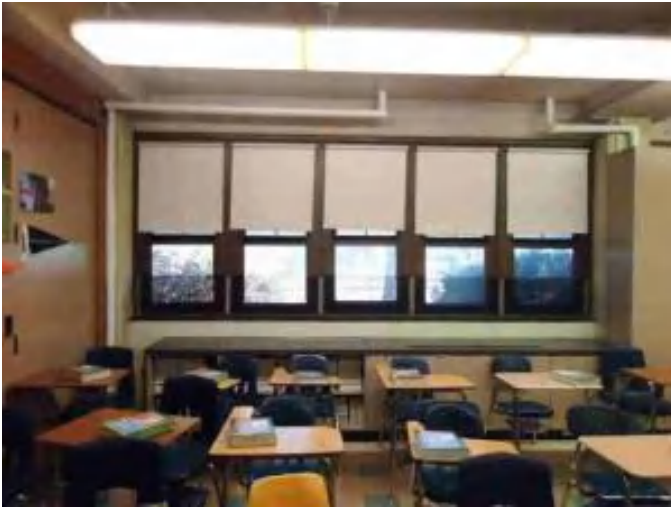
System: B2020 - Exterior Windows

Location: Main Exterior Elevation

Distress: Damaged

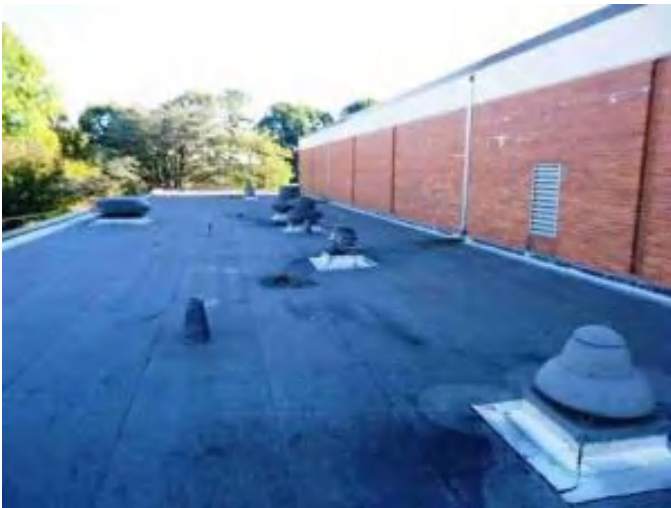
System: B3010105 - Built-Up

Location: Main Roof

Distress: Damaged

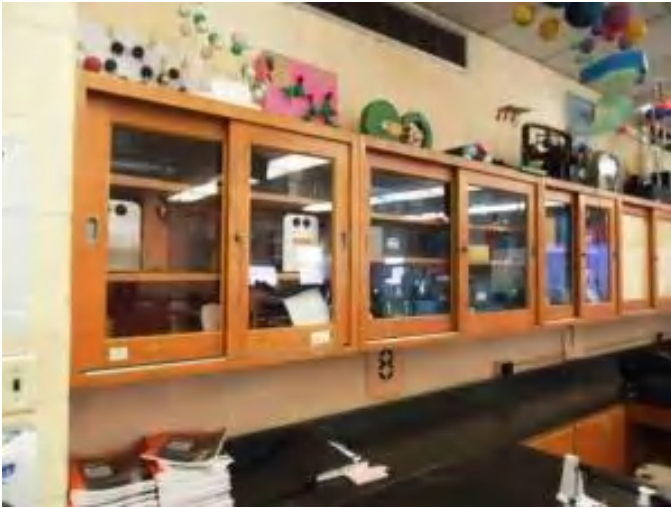
System: C1010 - Partitions

Location: Main Building Wide

Distress: Inadequate

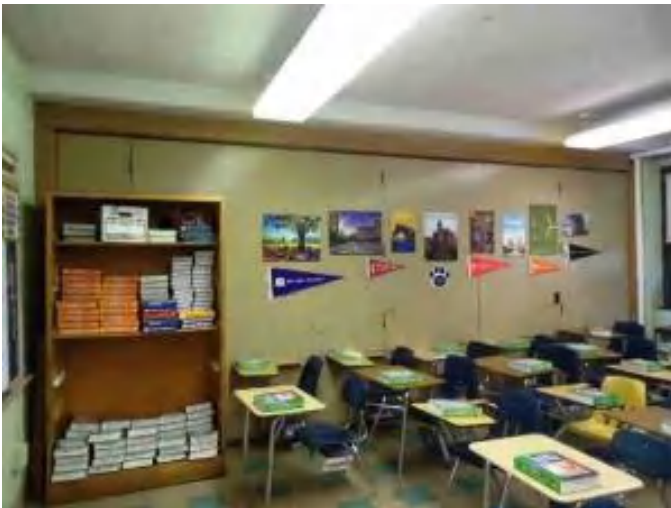
System: C1010 - Partitions

Location: Main Classroom 102

Distress: Damaged

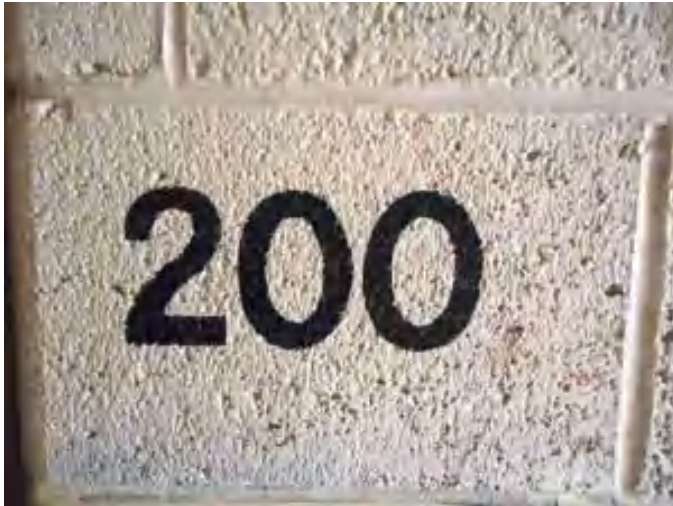
System: C1030 - Fittings

Location: Main Building WId

Distress: Damaged

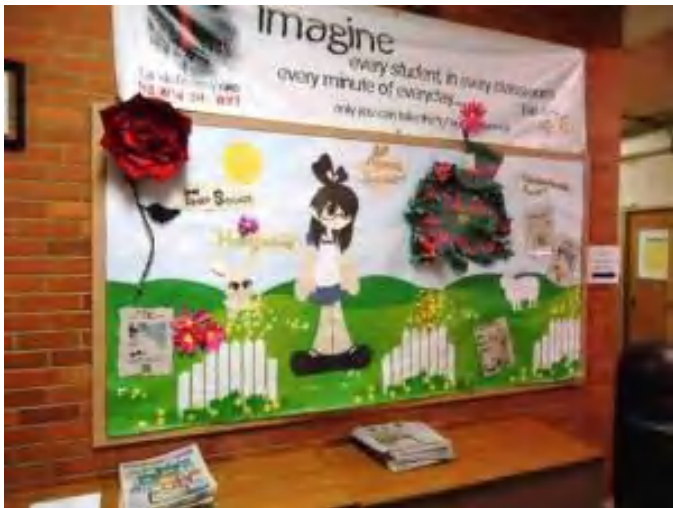
System: C1030 - Fittings

Location: Main Building Wide

Distress: Damaged

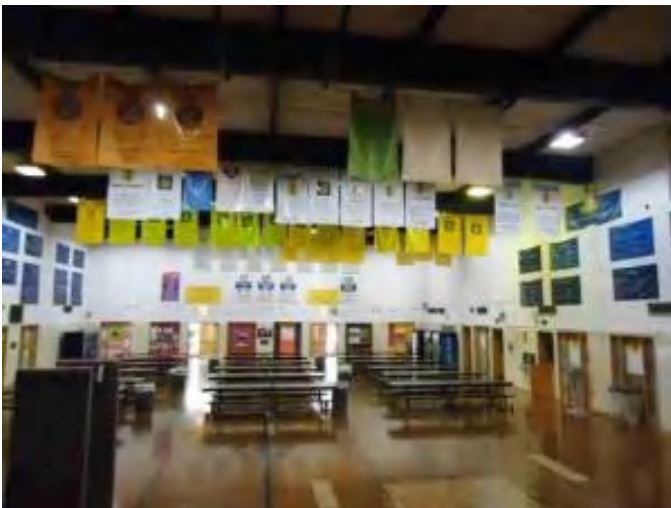
System: C3020414 - Wood Flooring

Location: Main Gym Auditorium

Distress: Damaged

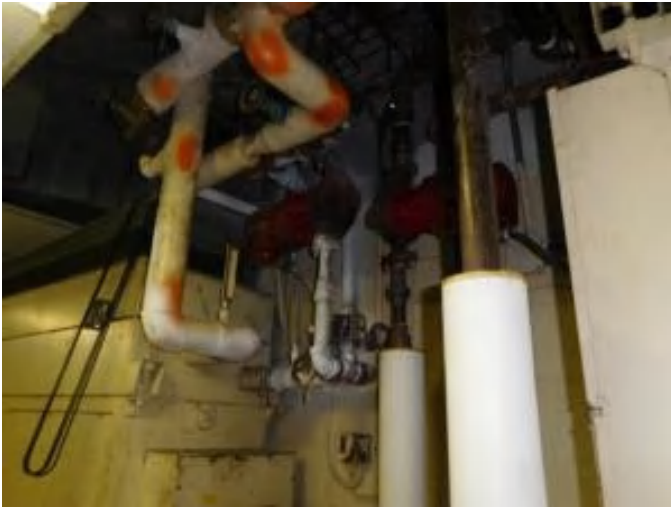
System: D2020 - Domestic Water Distribution

Location: entire building

Distress: Beyond Service Life

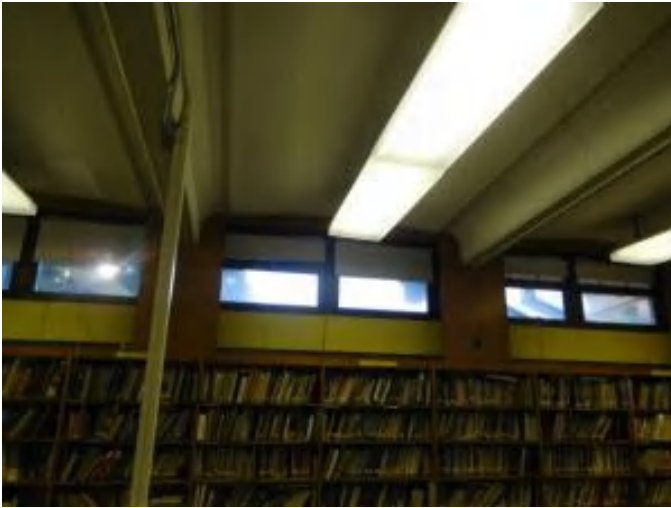
System: D3040 - Distribution Systems

Location: IMC/library

Distress: Building / MEP Codes

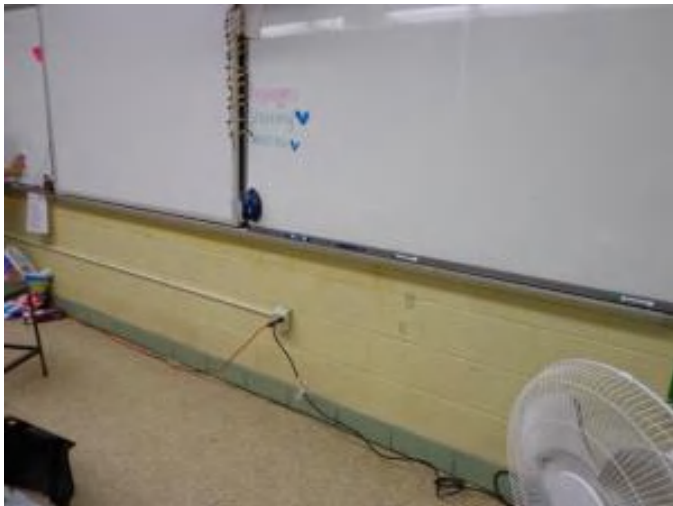
System: D5020 - Lighting and Branch Wiring

Location: Classrooms

Distress: Inadequate

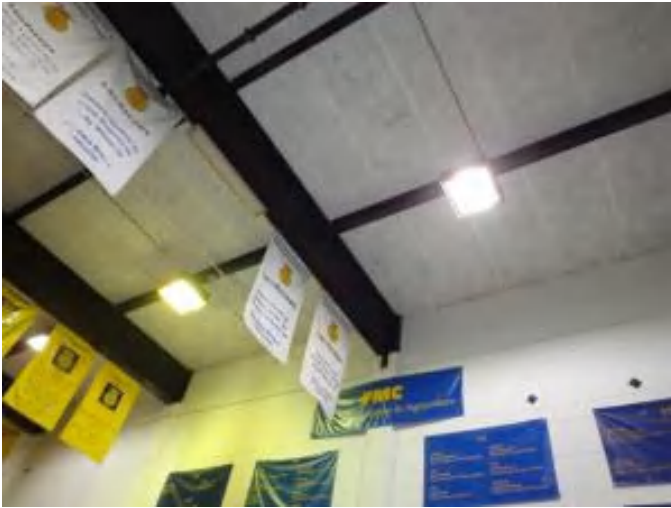
System: D5020 - Lighting and Branch Wiring

Location: Multi-Purpose Room

Distress: Inadequate

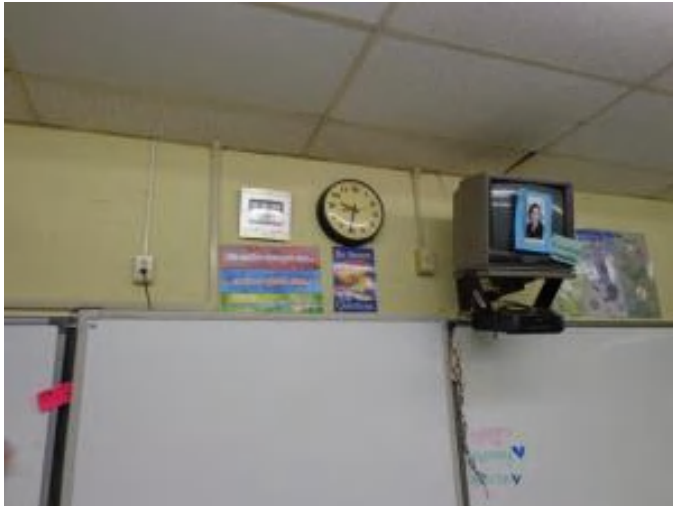
System: D5030 - Communications and Security

Location: Building wide

Distress: Damaged

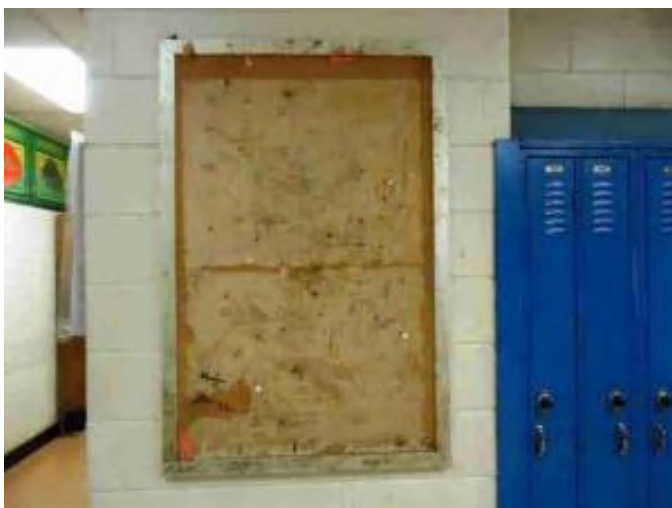
System: C1030 - Fittings

Location: AG Building Wide

Distress: Damaged

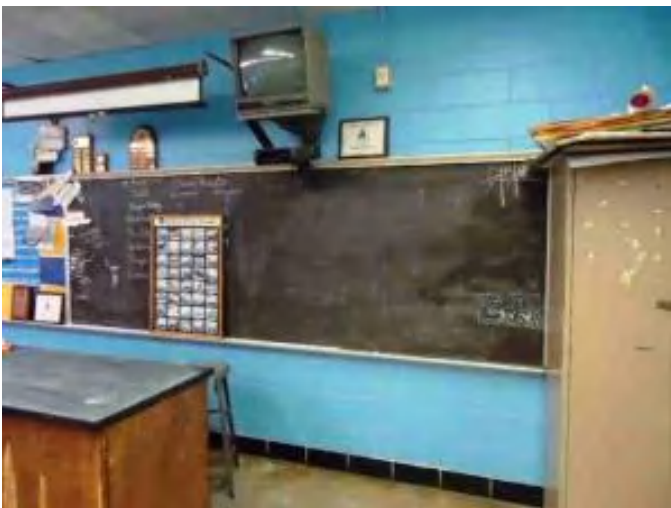
System: C1030 - Fittings

Location: AG Classrooms

Distress: Damaged

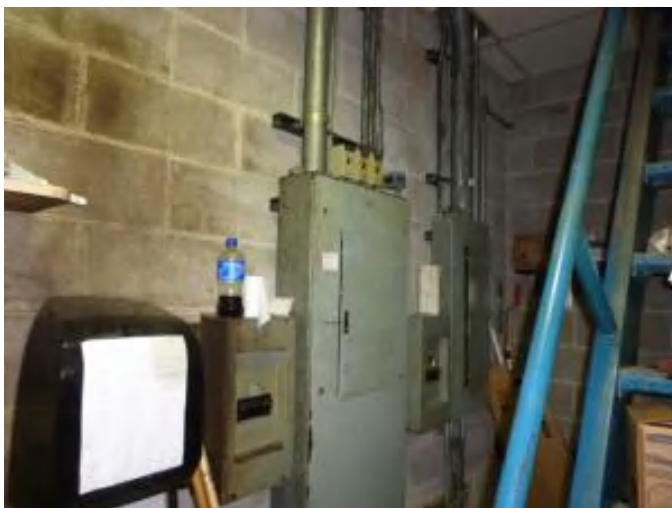
System: D5010 - Electrical Service/Distribution

Location: Building wide

Distress: Beyond Service Life

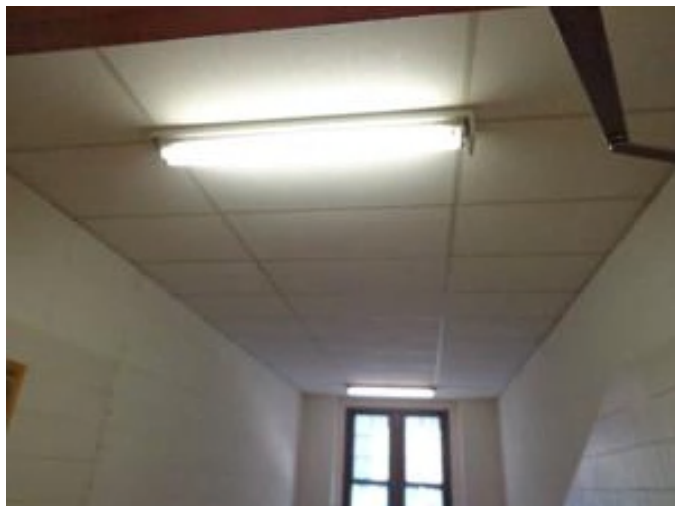
System: D5020 - Lighting and Branch Wiring

Location: Building wide

Distress: Beyond Service Life

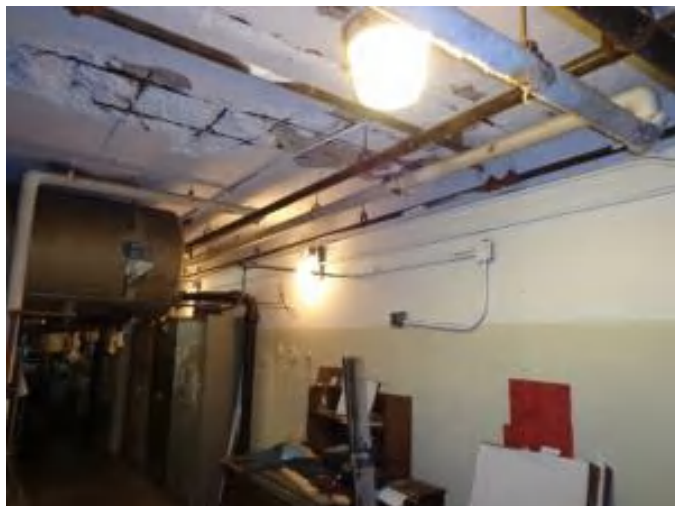
System: D5020 - Lighting and Branch Wiring

Location: Ag Bldg. Basement

Distress: Beyond Service Life

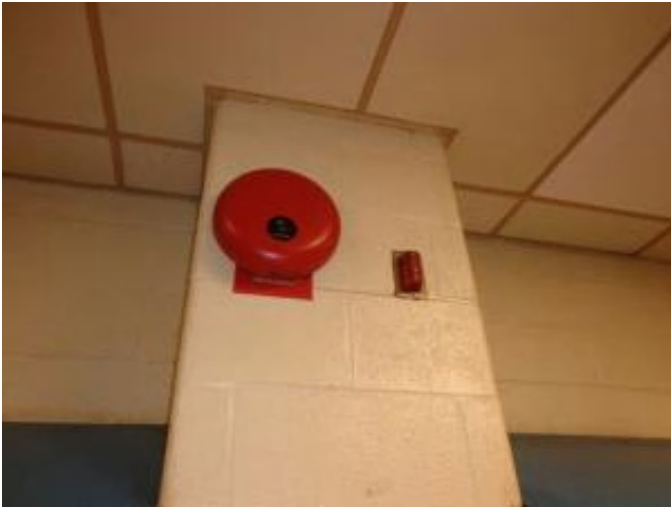
System: D5030 - Communications and Security

Location: Building wide

Distress: Beyond Service Life

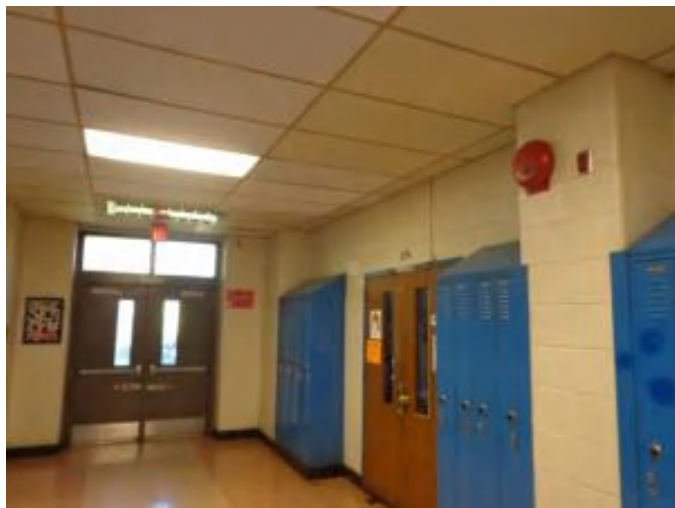
System: D5090 - Other Electrical Systems

Location: Building wide

Distress: Beyond Service Life

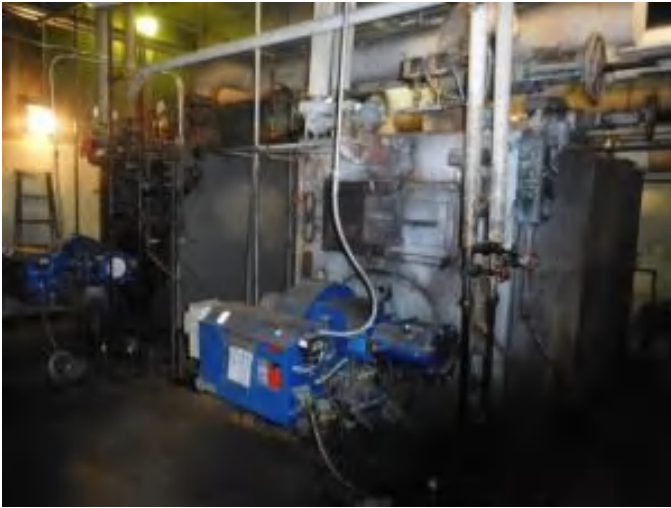
System: D3020 - Heat Generating Systems

Location: mechanical room

Distress: Beyond Service Life

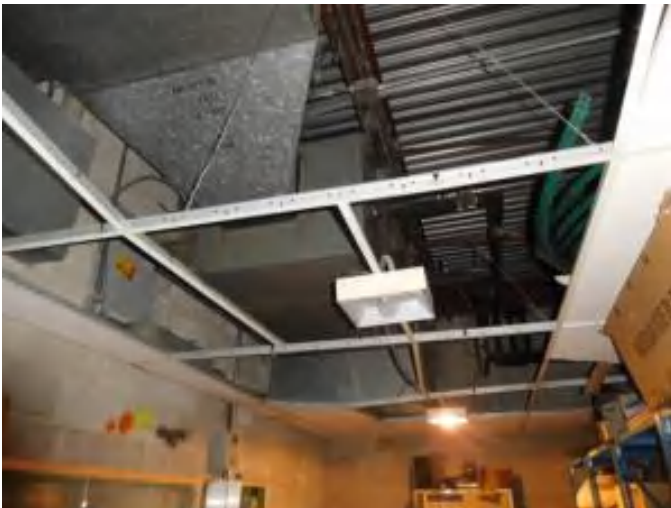
System: D3040 - Distribution Systems

Location: shop areas

Distress: Building / MEP Codes

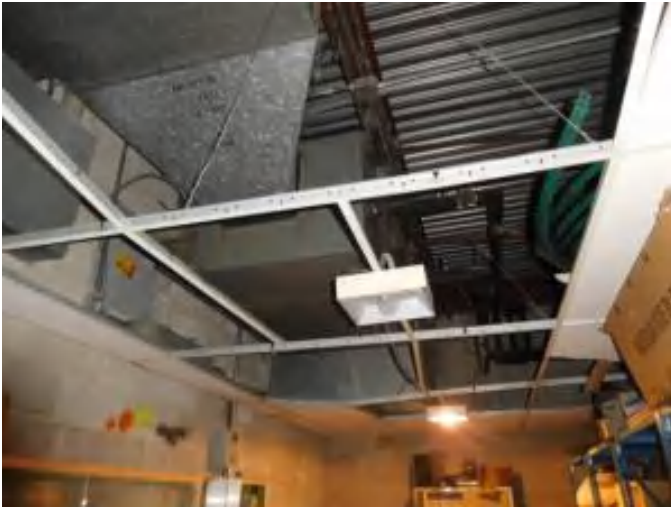
System: D3040 - Distribution Systems

Location: shop areas

Distress: Building / MEP Codes

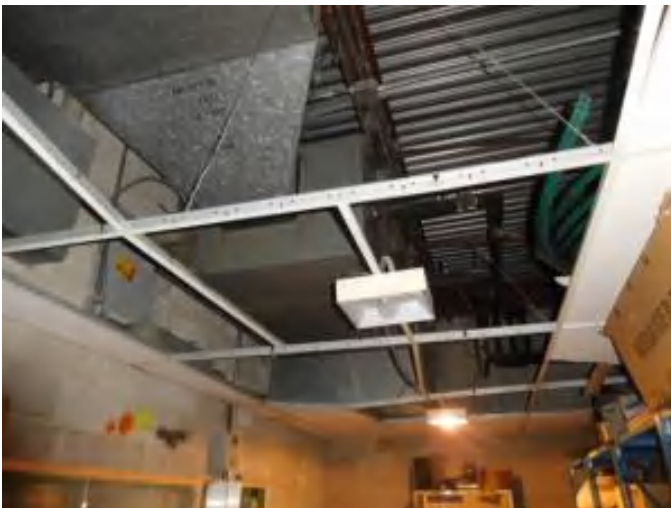
System: D3040 - Distribution Systems

Location: shop areas

Distress: Building / MEP Codes

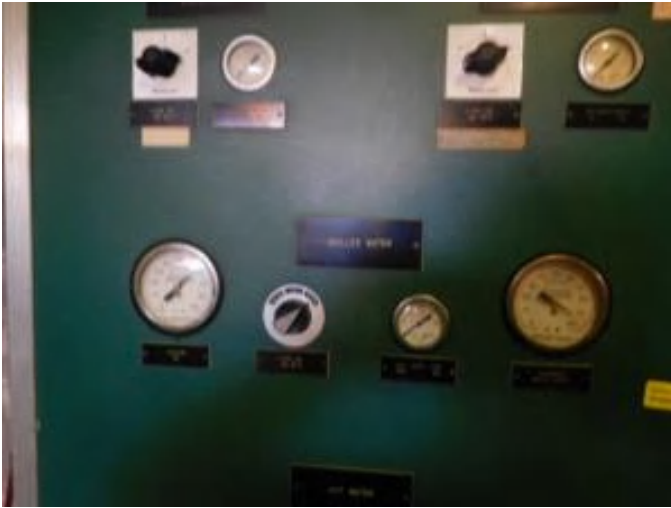
System: D3060 - Controls & Instrumentation

Location: entire building

Distress: Inadequate

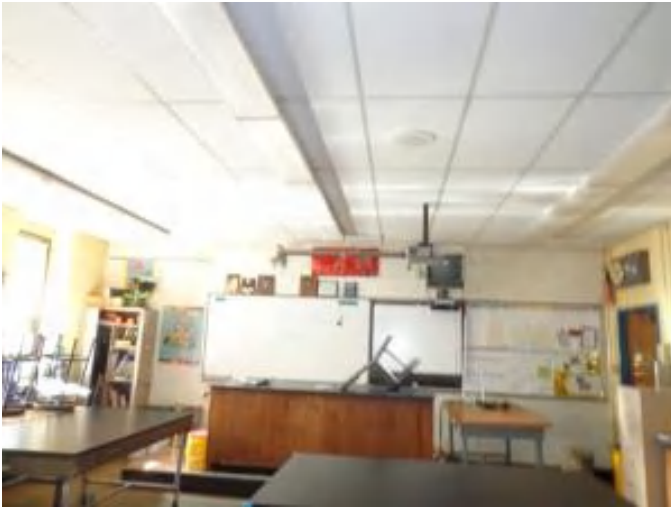
System: D5020 - Lighting and Branch Wiring

Location: Classrooms

Distress: Inadequate

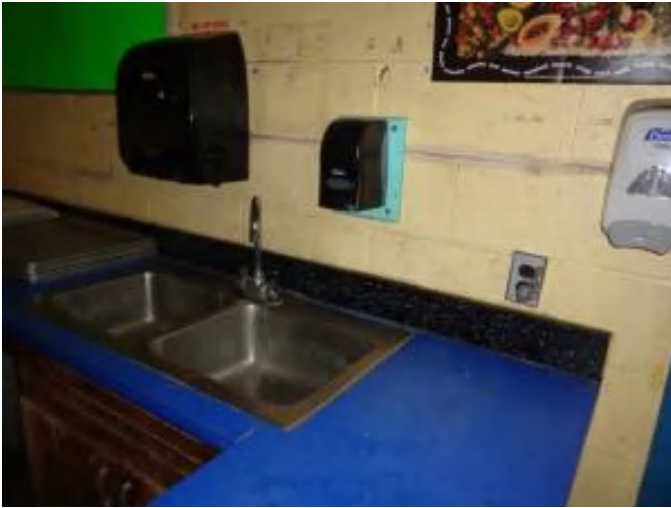
System: D5020 - Lighting and Branch Wiring

Location: Receptacles at sinks

Distress: Life Safety / NFPA / PFD

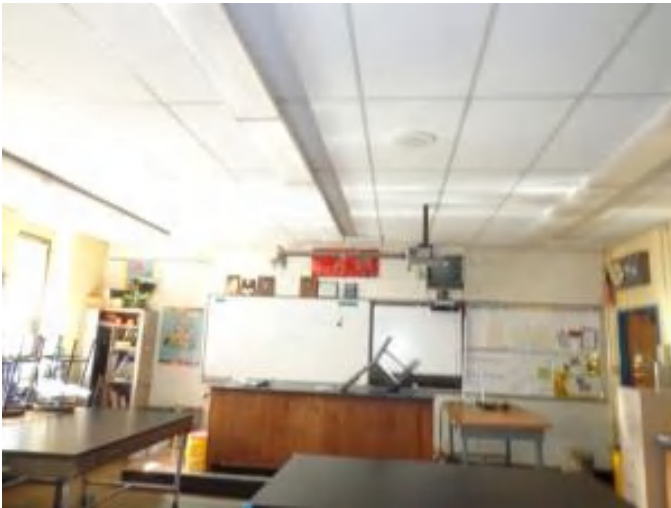
System: D5030 - Communications and Security

Location: Building wide

Distress: Damaged

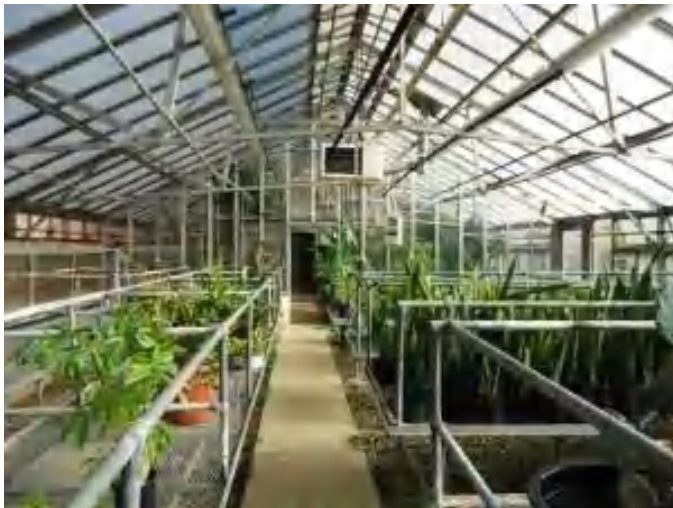
System: F1010 - Special Structures

Location: AG Annex Greenhouse

Distress: Damaged

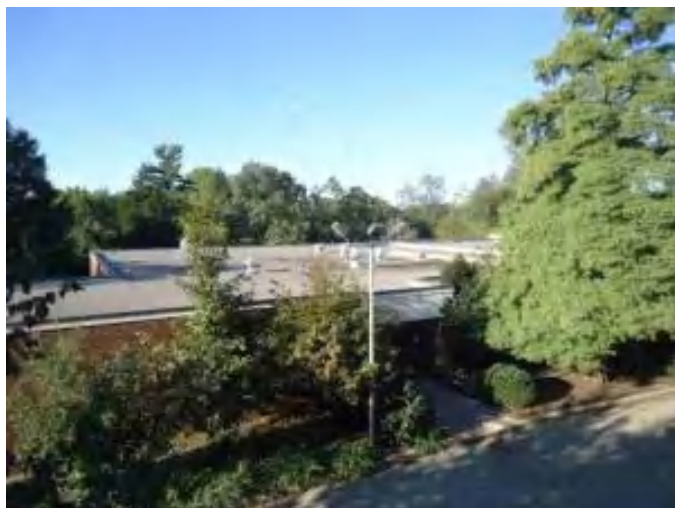
System: B3010105 - Built-Up

Location: AG Roof

Distress: Damaged

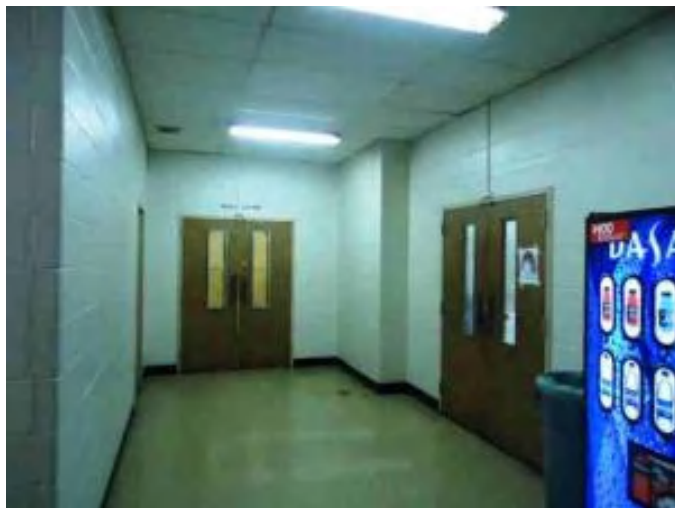
System: C1020 - Interior Doors

Location: GYM Building Wide

Distress: Damaged

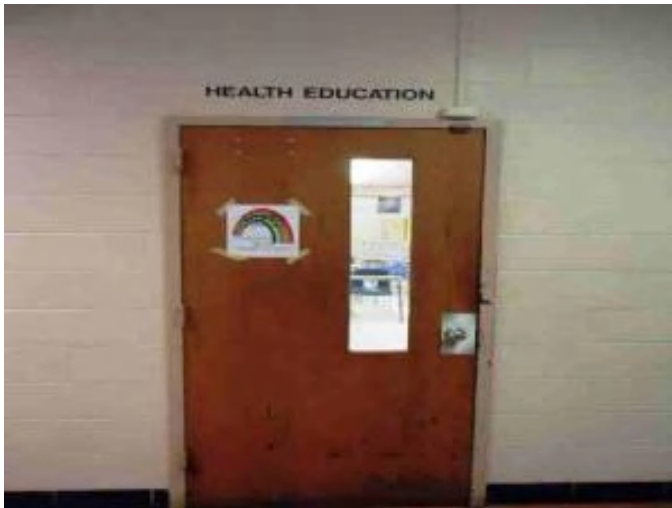
System: C1030 - Fittings

Location: Main Building Wide

Distress: Damaged

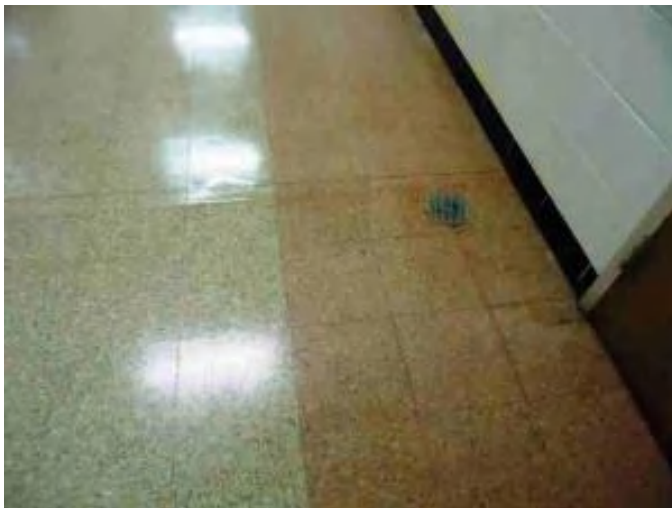
System: C3020413 - Vinyl Flooring

Location: GYM Building Wide

Distress: Damaged

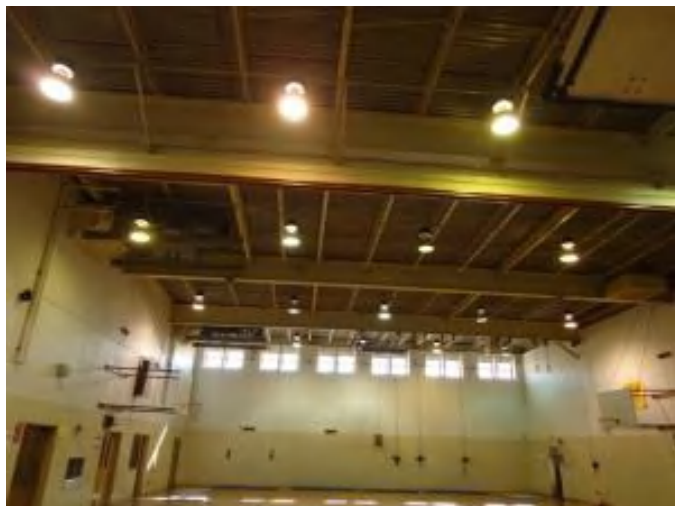
System: D5020 - Lighting and Branch Wiring

Location: Gymnasium

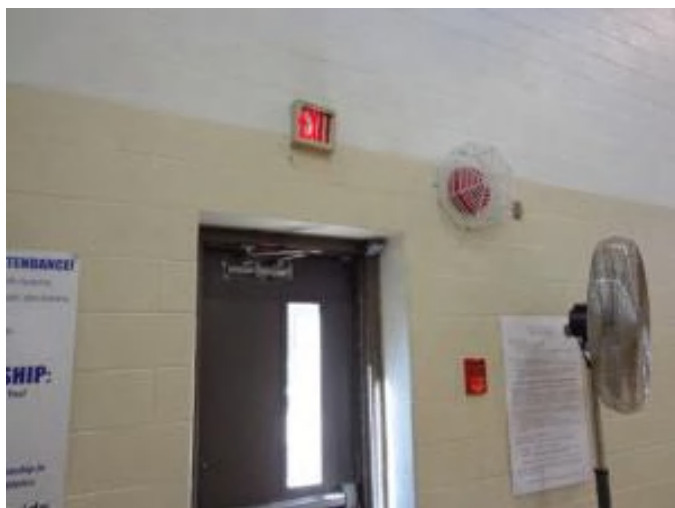
System: D5030 - Communications and Security

Location: Building wide

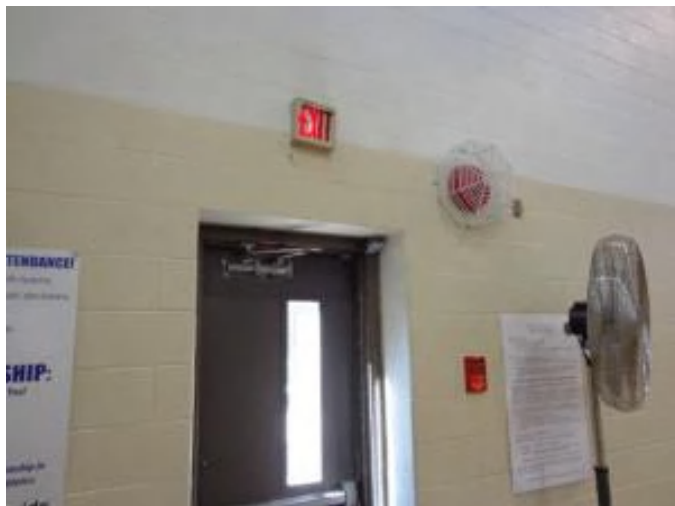
System: D5090 - Other Electrical Systems

Location: Building wide

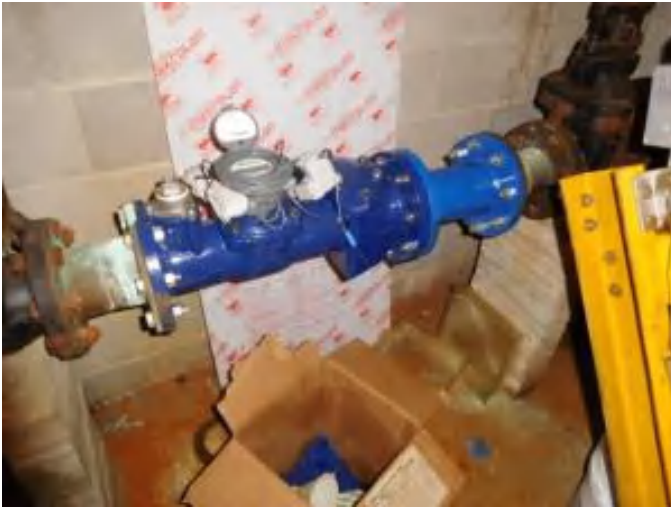
System: D2020 - Domestic Water Distribution

Location: mechanical room

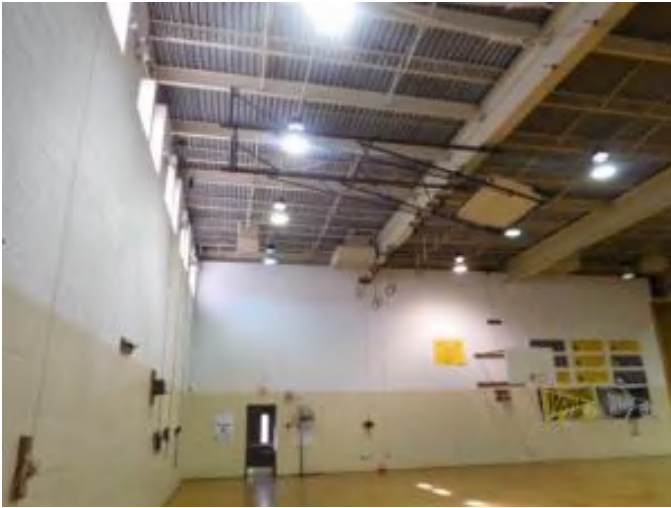
System: D3040 - Distribution Systems

Location: gymnasium

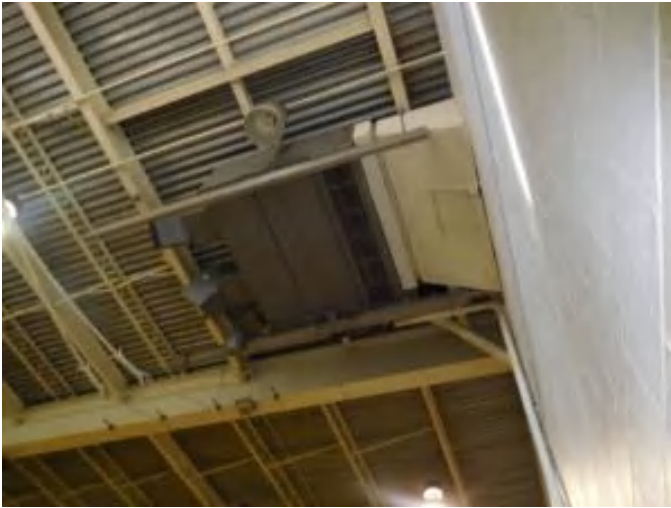
System: D3040 - Distribution Systems

Location: gymnasium

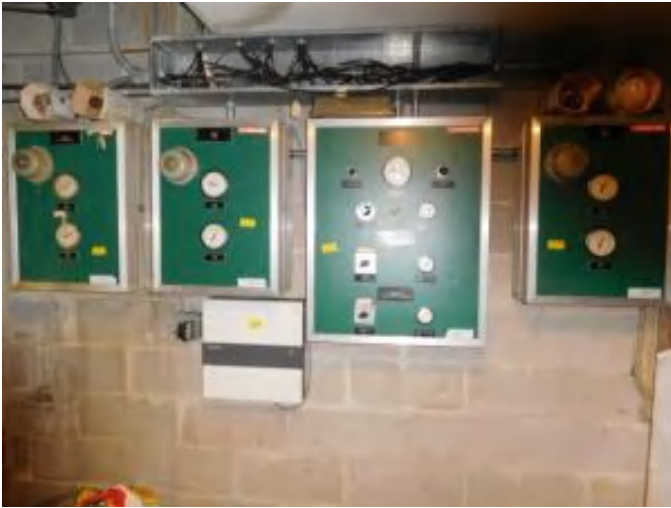
System: D3040 - Distribution Systems

Location: boys and girls locker rooms

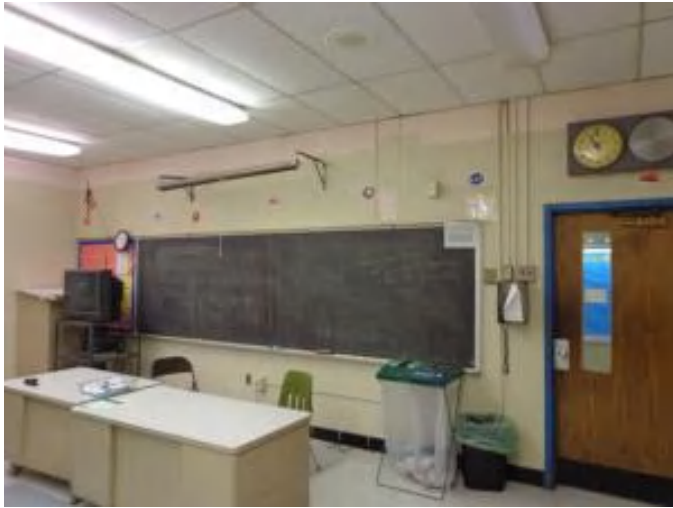
System: D5030 - Communications and Security

Location: Building wide

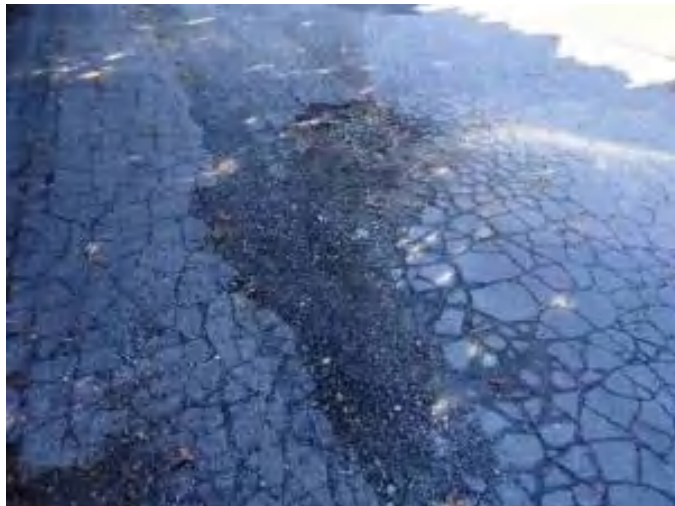
System: G2020 - Parking Lots

Location: Site
