Facility Condition Assessment Summary Report

Sharswood School

School District of Philadelphia
S263001;Sharswood
Final
Site Assessment Report
January 31, 2017

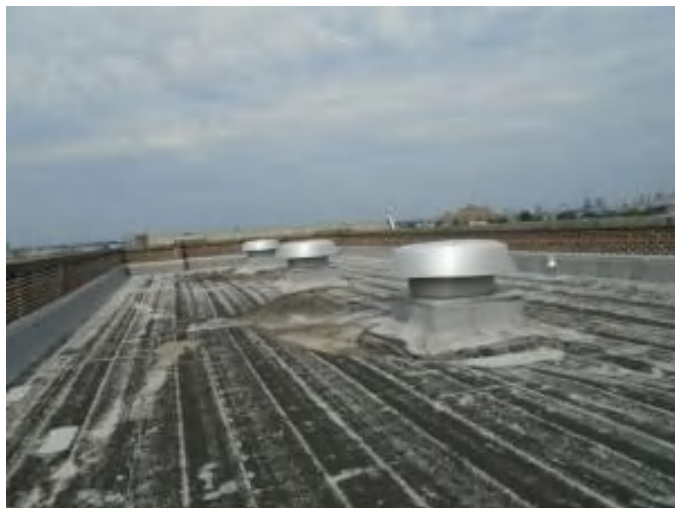
System: B3010105 - Built-Up

Location: Roof

Distress: Beyond Service Life

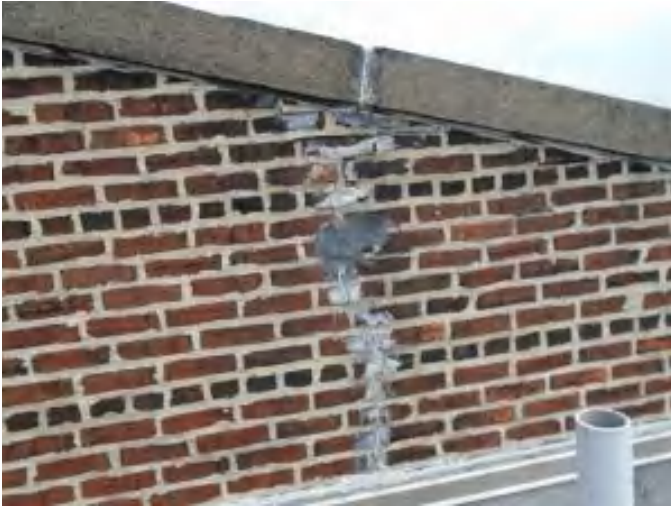
System: B2010 - Exterior Walls

Location: Parapit wall

Distress: Damaged

Notes: Repair and re-point parapet walls

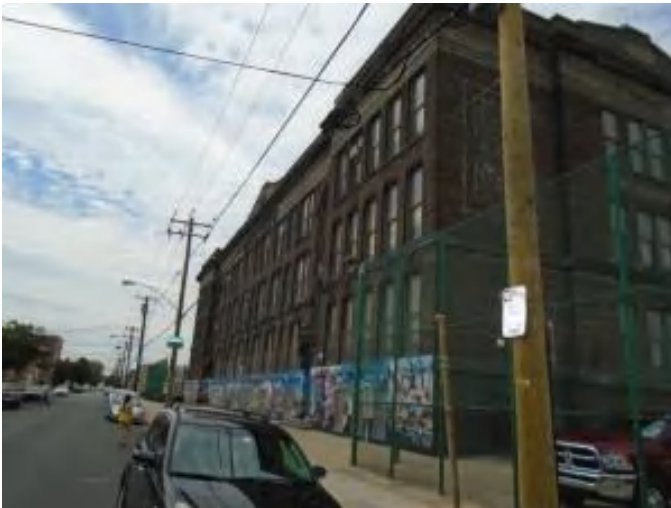
System: B2030 - Exterior Doors

Location: Ext. Entrance

Distress: Accessibility

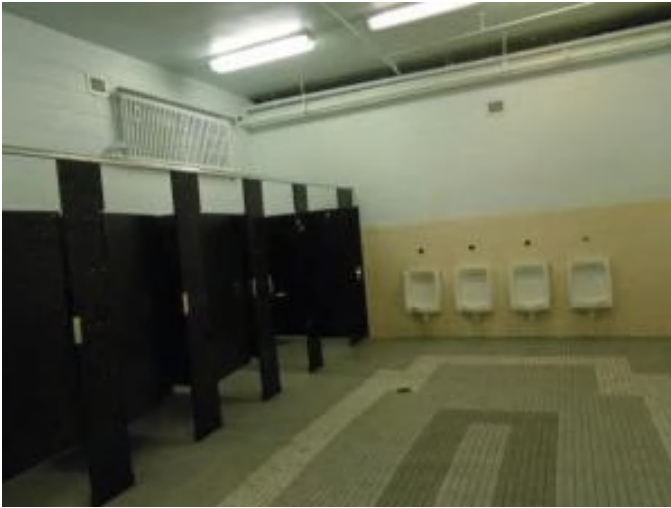
System: C1030 - Fittings

Location: Toiles

Distress: Accessibility

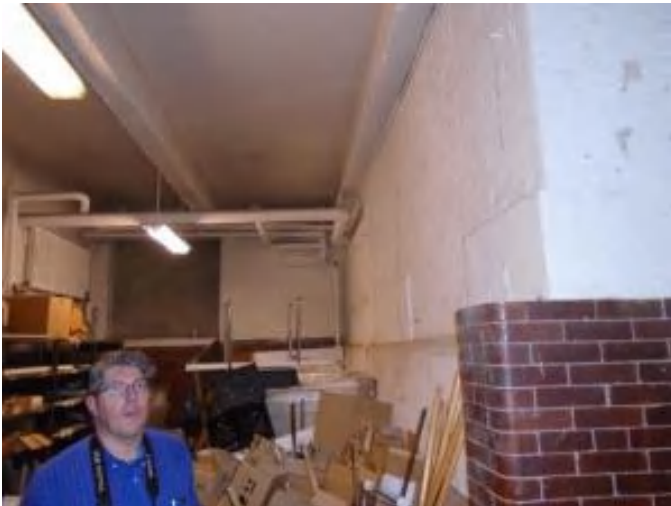
System: D1010 - Elevators and Lifts

Location: B263001;Sharswood

Distress: Accessibility

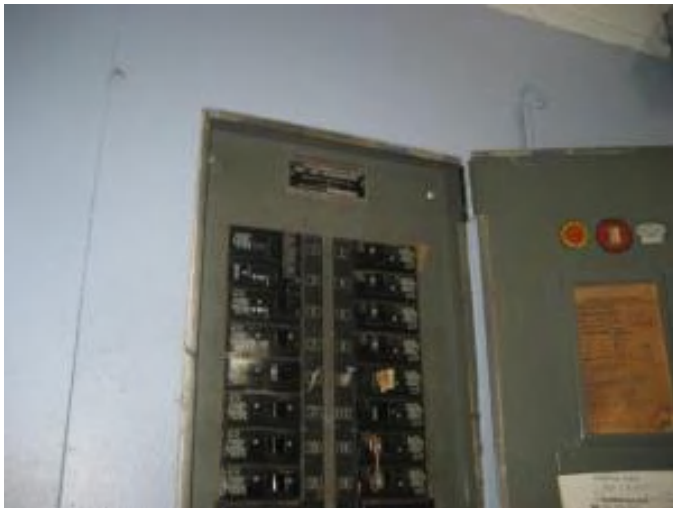
System: D5010 - Electrical Service/Distribution

Location: Corridors
Distress: Beyond Service Life
Category: 3 - Operations / Maint.
Priority: 2 - Response Time (2-3 yrs)
Correction: Add Panelboard
Qty: 15.00
Unit of Measure: Ea.
Estimate: \$451,856.62
Assessor Name: System
Date Created: 08/12/2015

Notes: Replace the entire distribution system with new panels and new wiring/conduits. Approximate (15) 208/120V

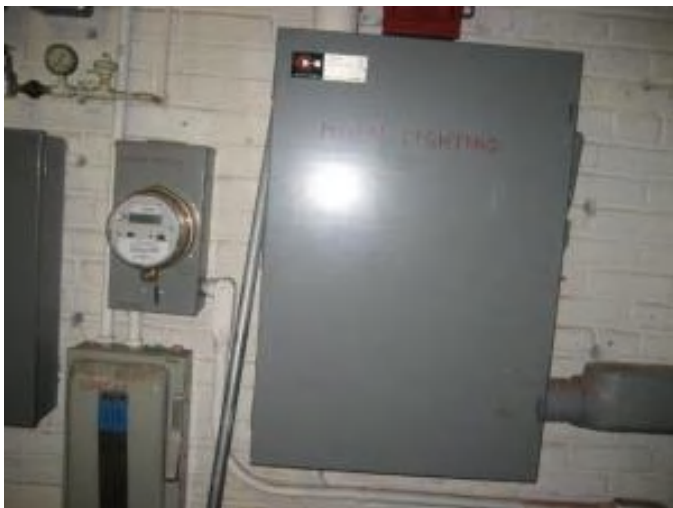
System: D5010 - Electrical Service/Distribution

Location: Fan room
Distress: Inadequate
Category: 4 - Capital Improvement
Priority: 2 - Response Time (2-3 yrs)
Correction: Replace Switchboard
Qty: 1.00
Unit of Measure: Ea.
Estimate: \$414,124.67
Assessor Name: System
Date Created: 08/12/2015

Notes: The new service will be 480V/277V, 3 phase power, approximate 1000 Amperes and will be located in the vicinity of the existing electrical service.

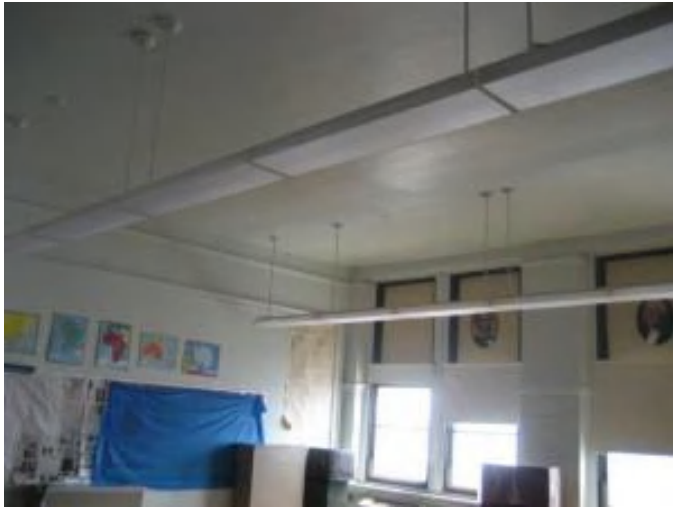
System: D5020 - Lighting and Branch Wiring

Location: Entire school
Distress: Energy Efficiency
Category: 4 - Capital Improvement
Priority: 2 - Response Time (2-3 yrs)
Correction: Add Lighting Fixtures
Qty: 869.00
Unit of Measure: Ea.
Estimate: \$516,591.62
Assessor Name: System
Date Created: 08/12/2015

Notes: Approximate 90% of the lighting fixtures are provided with T-12 lamps. Provide lighting fixtures with T-8 lamps. Approximate 869 fixtures.

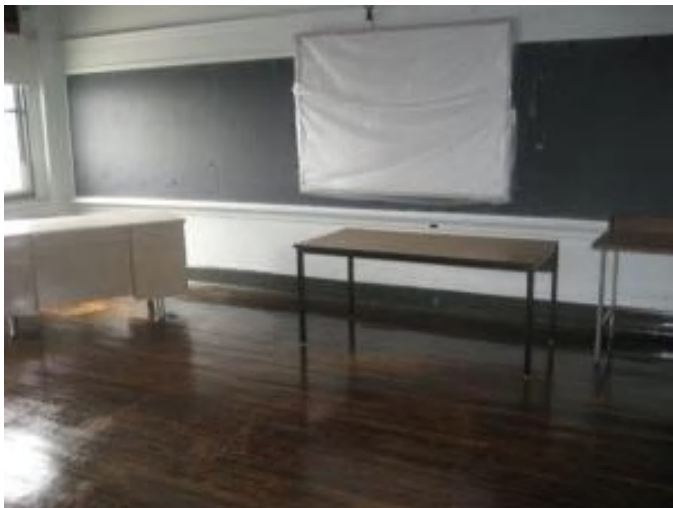
System: D5020 - Lighting and Branch Wiring

Location: Classrooms
Distress: Inadequate
Category: 4 - Capital Improvement
Priority: 2 - Response Time (2-3 yrs)
Correction: Add wiring device
Qty: 432.00
Unit of Measure: Ea.
Estimate: \$158,704.27
Assessor Name: System
Date Created: 08/12/2015

Notes: Provide (2)25FT of surface raceways with 24" receptacles on center and two-duplex wall mount receptacles. Approximate 27 classrooms

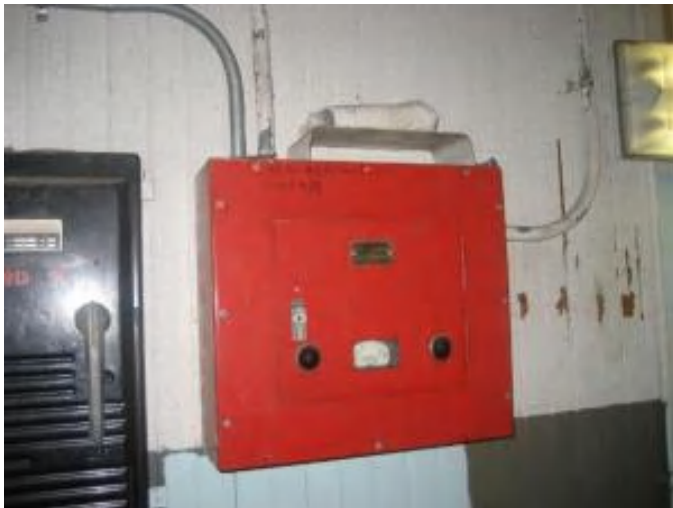
System: D5030 - Communications and Security

Location: Entire school
Distress: Life Safety / NFPA / PFD
Category: 1 - Health & Safety
Priority: 2 - Response Time (2-3 yrs)
Correction: Add fire alarm device
Qty: 100.00
Unit of Measure: Ea.
Estimate: \$187,360.25
Assessor Name: System
Date Created: 08/12/2015

Notes: Replace old fire alarm system with addressable type with audio/visual devices in the entire school. Approximate 100 devices

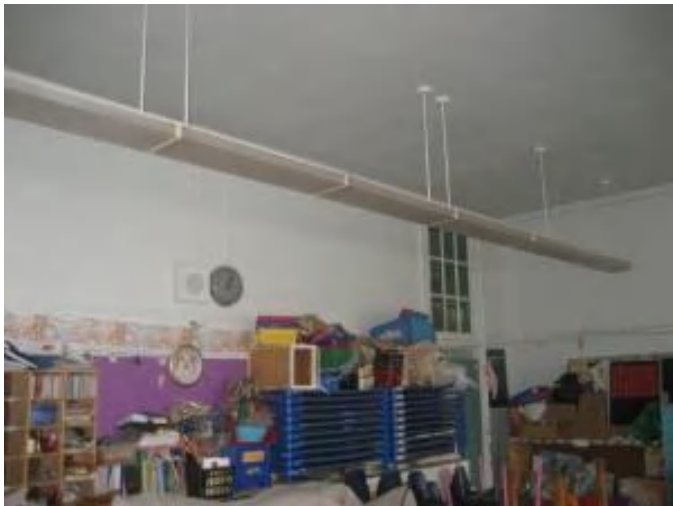
System: D5030 - Communications and Security

Location: Classrooms
Distress: Beyond Service Life
Category: 3 - Operations / Maint.
Priority: 2 - Response Time (2-3 yrs)
Correction: Add/Replace Clock System or Components
Qty: 55.00
Unit of Measure: Ea.
Estimate: \$112,560.22
Assessor Name: System
Date Created: 08/12/2015

Notes: Provide a new clock system, wireless battery operated. Approximate 55 clocks

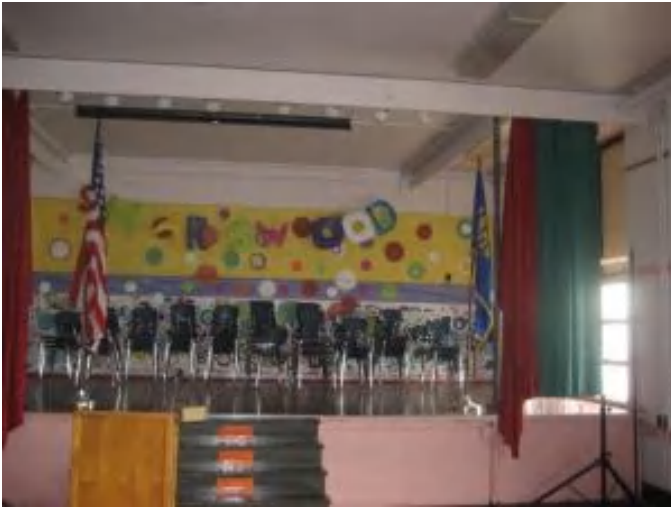
System: D5030 - Communications and Security

Location: Auditorium
Distress: Inadequate
Category: 4 - Capital Improvement
Priority: 2 - Response Time (2-3 yrs)
Correction: Add/Replace Sound System
Qty: 1.00

Notes: Provide a more complete sound system

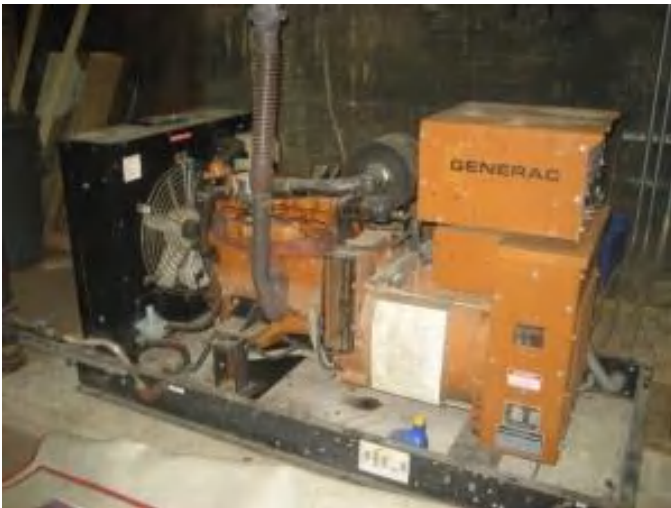
System: D5090 - Other Electrical Systems

Location: Outdoor
Distress: Beyond Service Life
Category: 3 - Operations / Maint.
Priority: 2 - Response Time (2-3 yrs)
Correction: Add Standby Generator System
Qty: 1.00

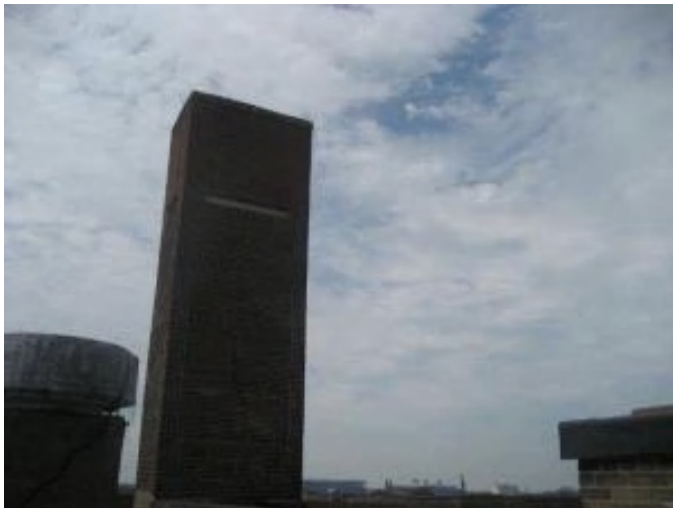
System: D5090 - Other Electrical Systems

Location: Roof
Distress: Building / MEP Codes
Category: 2 - Code Compliance
Priority: 2 - Response Time (2-3 yrs)
Correction: Repair Lightning Protection System
Qty: 1.00
Unit of Measure: Job
Estimate: \$24,249.82
Assessor Name: System
Date Created: 08/12/2015

Notes: Prepare a study to determine if existing lightning protection system provide the proper coverage to the school building.

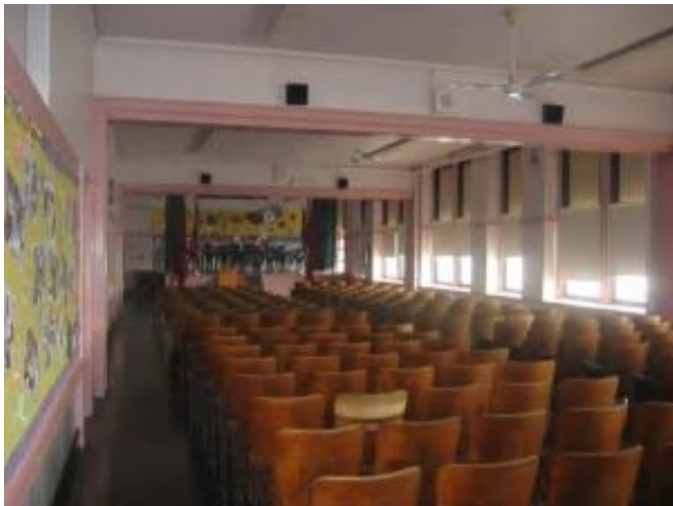
System: E1020 - Institutional Equipment

Location: Auditorium
Distress: Inadequate
Category: 4 - Capital Improvement
Priority: 2 - Response Time (2-3 yrs)
Correction: Add/Replace Stage Theatrical Lighting System
Qty: 1.00
Unit of Measure: Ea.
Estimate: \$90,802.49
Assessor Name: System
Date Created: 08/12/2015

Notes: The auditorium is not provided with theatrical lighting nor dimming control system. Provide theatrical lighting and dimming control system

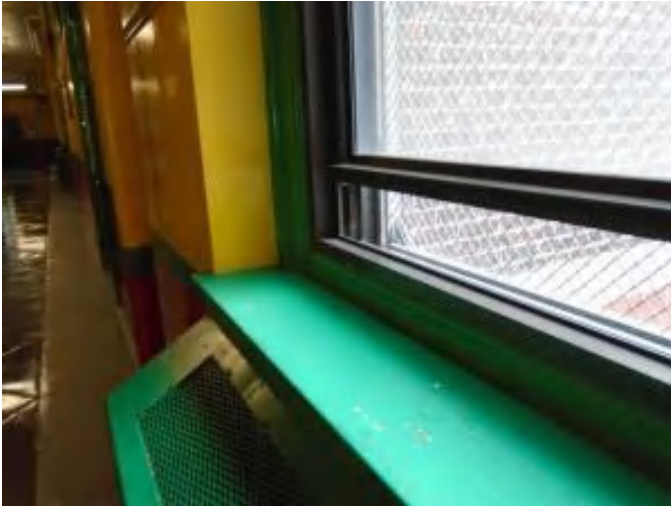
System: B2020 - Exterior Windows

Location: Throughout

Distress: Energy Efficiency

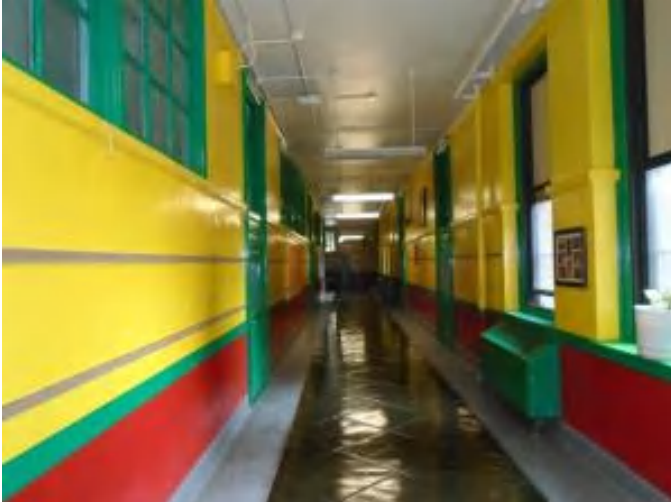
System: C1020 - Interior Doors

Location: Int. doors

Distress: Accessibility

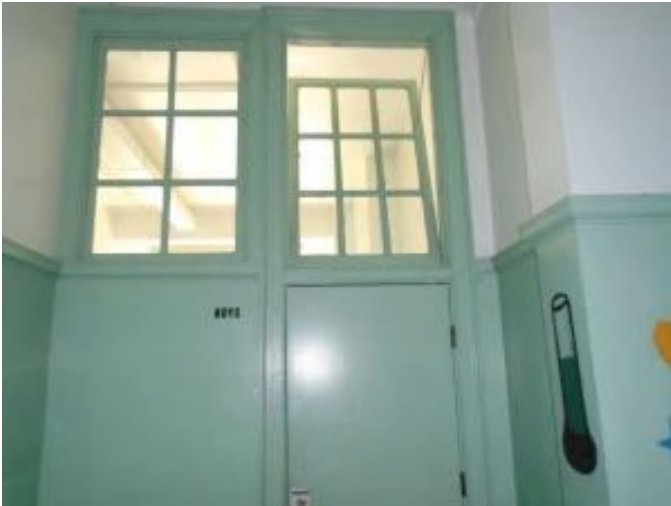
System: C1030 - Fittings

Location: Throughout
Distress: Inadequate
Category: 4 - Capital Improvement
Priority: 3 - Response Time (3-4 yrs)
Correction: Replace missing or damaged signage - insert the number of rooms
Qty: 80.00
Unit of Measure: Ea.
Estimate: \$12,222.99
Assessor Name: System
Date Created: 09/01/2015

Notes: Install new ID signage

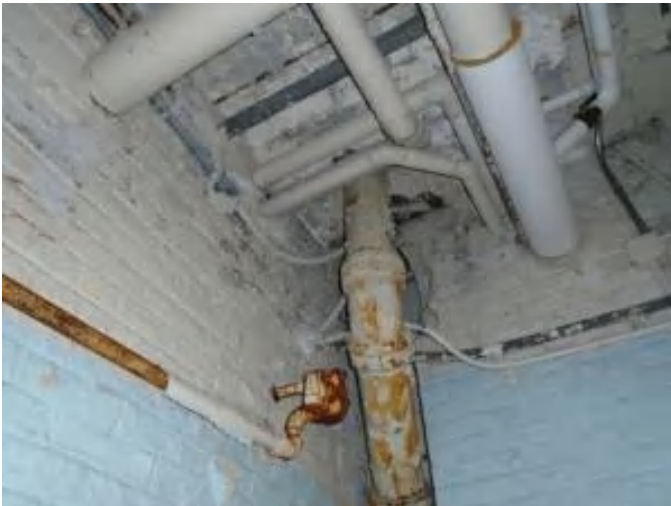
System: C3030 - Ceiling Finishes

Location: Basement
Distress: Appearance
Category: 3 - Operations / Maint.
Priority: 3 - Response Time (3-4 yrs)
Correction: Re-paint ceilings - SF of ceilings
Qty: 18,250.00
Unit of Measure: S.F.
Estimate: \$87,363.26
Assessor Name: System
Date Created: 09/01/2015

Notes: Repaint ceilings in basement

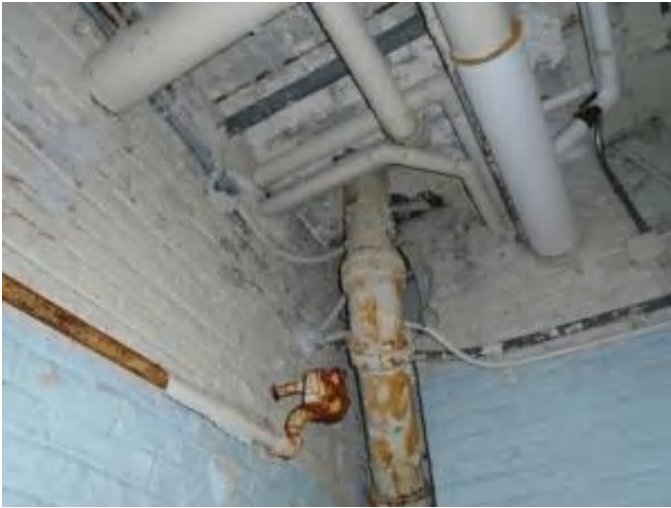
System: D2030 - Sanitary Waste

Sanitary drain pipes are primarily hub and spigot cast iron with hubless banded connection pipe for repairs in some locations. Due to their age they should be inspected in detail and repaired as needed. There is no sewage ejector.

Location: Entire building

Distress: Beyond Service Life

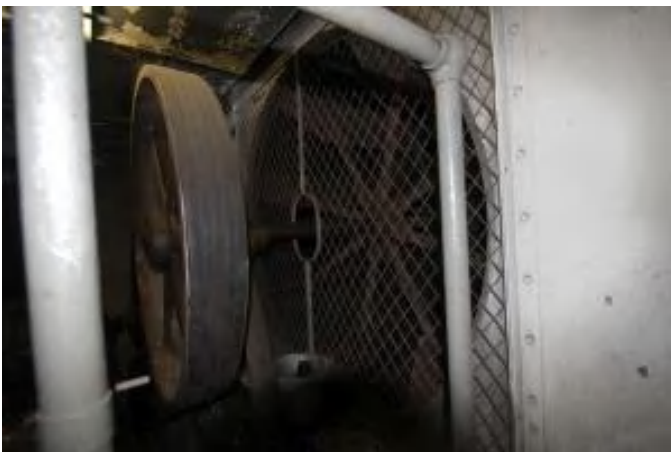
System: D3040 - Distribution Systems

Location: Mechanical rooms

Distress: Obsolete

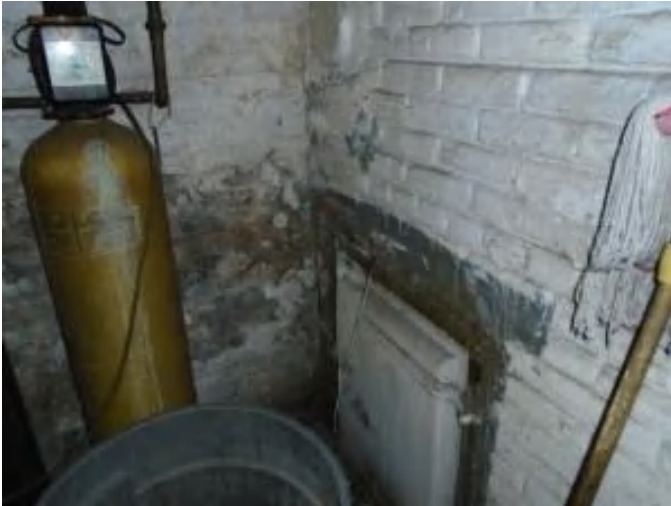
System: C3010230 - Paint & Covering

Location: Basement, fire tower

Distress: Appearance

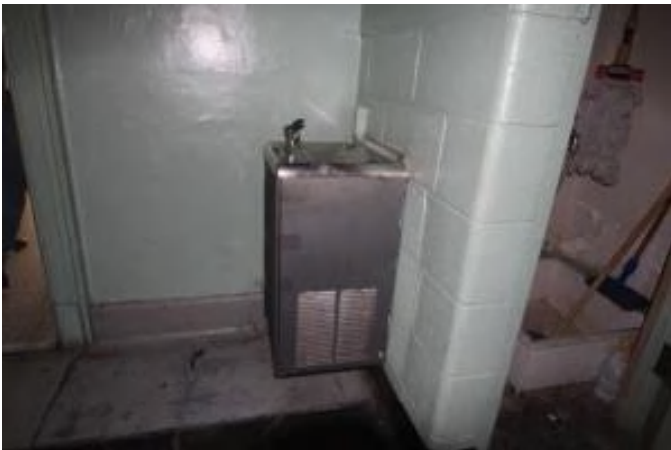
System: D2010 - Plumbing Fixtures

Drinking fountains in the corridors, kindergarten room, and teacher lounge are a variety of styles, generally non-accessible. They have exceeded their service life and should be replaced.

Location: Entire building

Distress: Accessibility

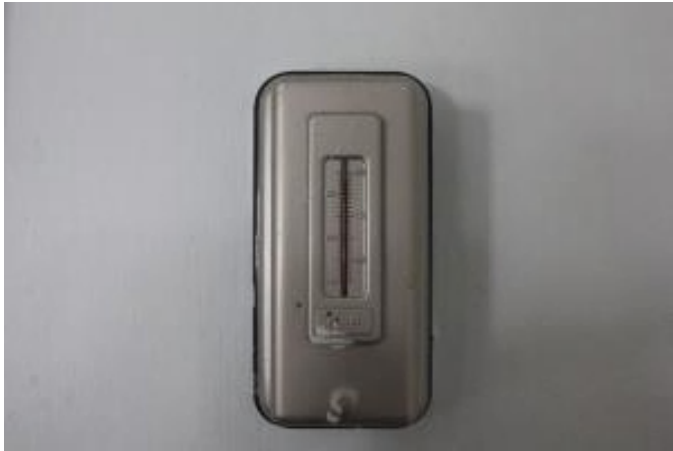
System: D3060 - Controls & Instrumentation

Pneumatic controls were added to the build some time ago. They include wall mounted thermostats in the classrooms and remote control steam valves on the convectors and radiators. They are past their service life, obsolete, damaged, and most likely inoperable. They should be upgraded to DDC when other HVAC system components replaced.

Location: Entire building
Distress: Obsolete
Category: 3 - Operations / Maint.
Priority: 4 - Response Time (4-5 yrs)
Correction: Replace pneumatic controls with DDC (150KSF)
Qty: 73,000.00
Unit of Measure: S.F.
Estimate: \$1,307,532.64
Assessor Name: System
Date Created: 09/08/2015

Notes: Upgrade obsolete pneumatic control system to digital.

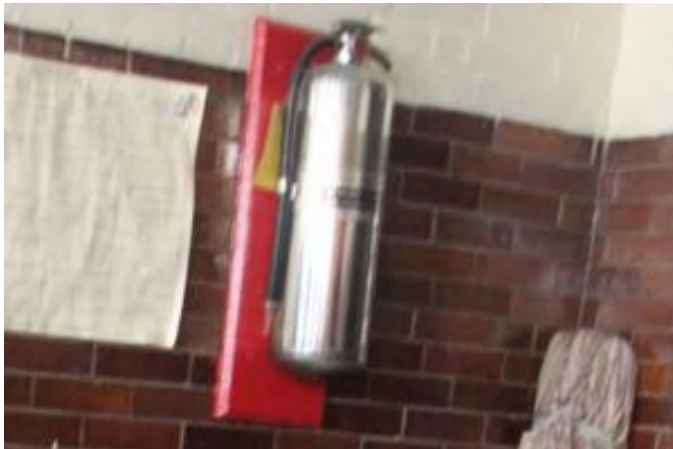
System: D4010 - Sprinklers

Location: Entire building
Distress: Life Safety / NFPA / PFD
Category: 1 - Health & Safety
Priority: 4 - Response Time (4-5 yrs)
Correction: Install a fire protection sprinkler system
Qty: 73,000.00
Unit of Measure: S.F.
Estimate: \$1,044,299.01
Assessor Name: System
Date Created: 09/08/2015

Notes: Install fire sprinkler system including fire pump if needed.

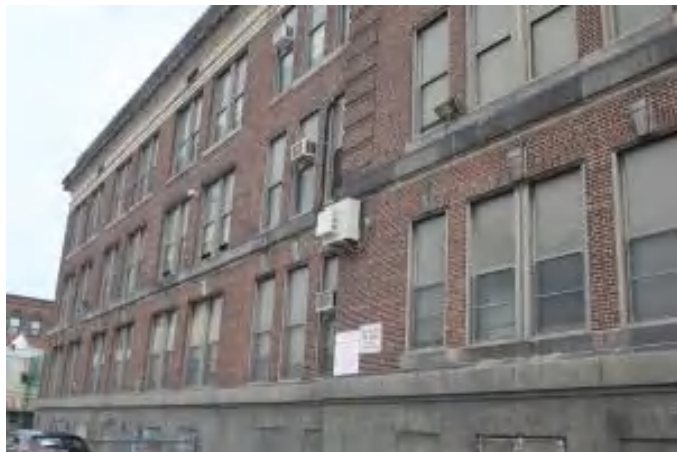
System: D3030 - Cooling Generating Systems

Location: Entire building

Distress: Inadequate

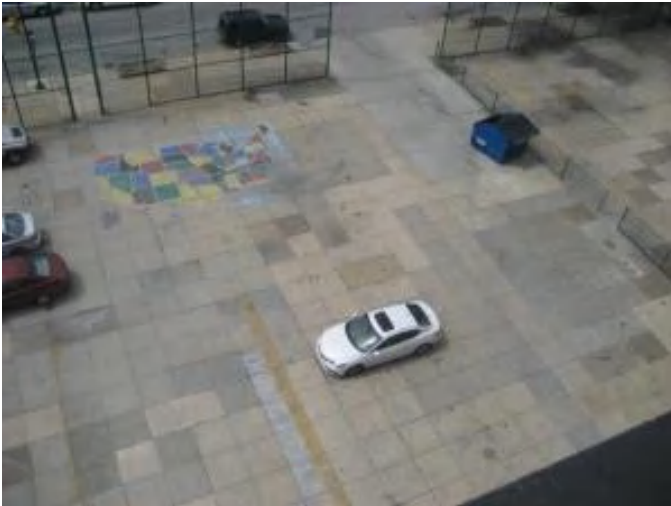
System: G4020 - Site Lighting

Location: Outdoor

Distress: Health Hazard / Risk

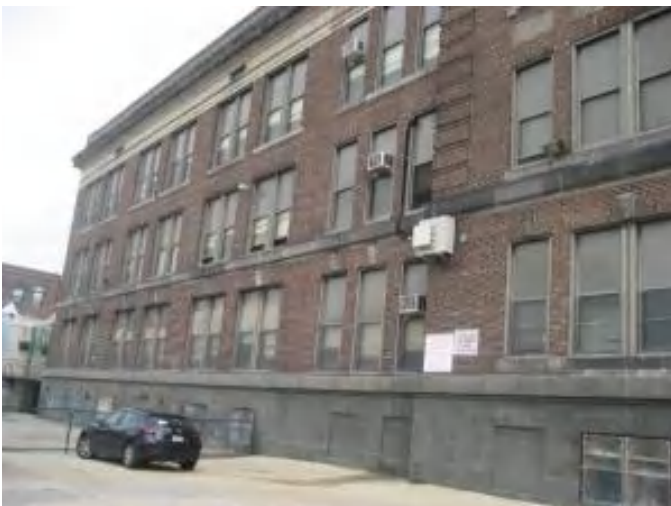
System: G4030 - Site Communications & Security

Location: Outdoor

Distress: Health Hazard / Risk

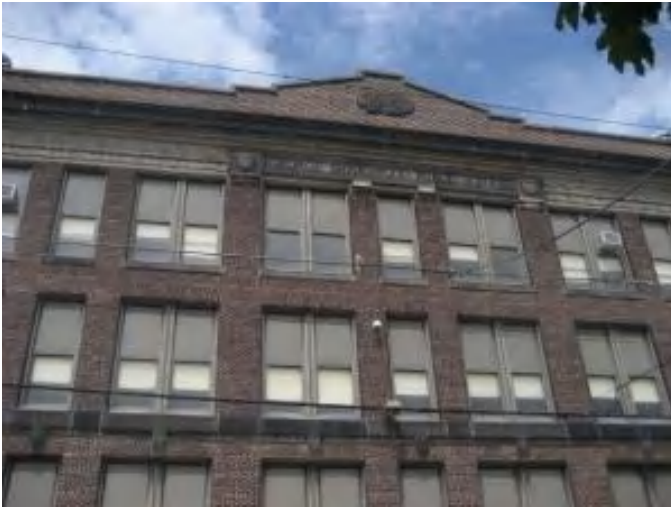
System: G4030 - Site Communications & Security

Location: Outdoor

Distress: Inadequate

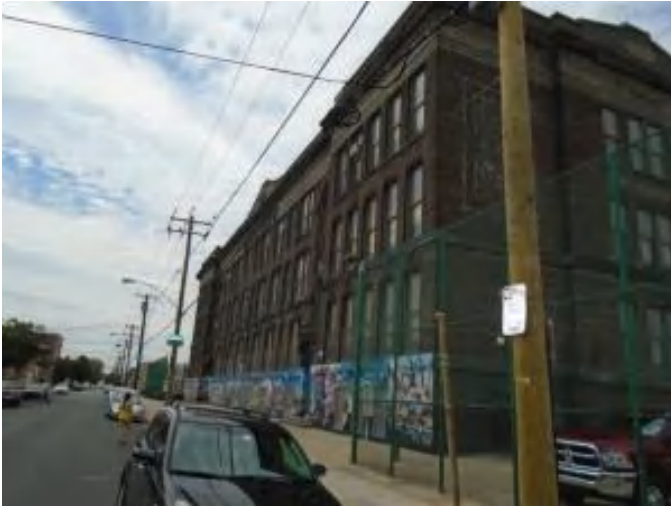
System: G2030 - Pedestrian Paving

Location: Entrance

Distress: Accessibility
