Facility Condition Assessment Summary Report

Shawmont School

School District of Philadelphia
S638001; Shawmont
Final
Site Assessment Report
January 31, 2017

Site Assessment Report

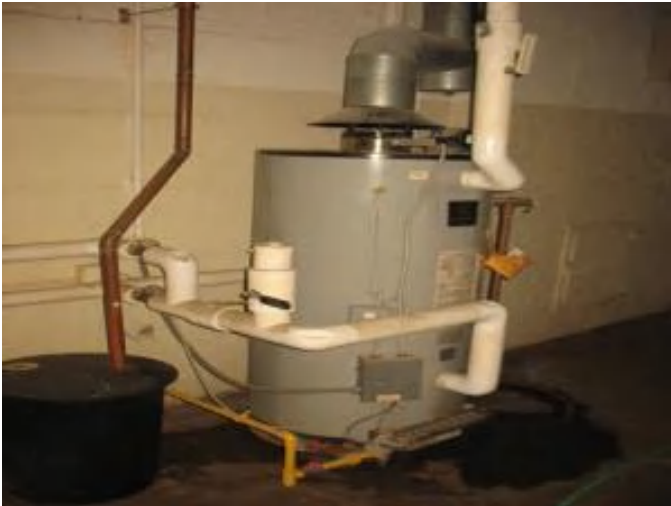
System: D2020 - Domestic Water Distribution

One (1) State Sandblaster gas fired, 70 gallon, vertical hot water heater with two (2) circulating pumps supplies hot water for domestic use. The unit is located in the boiler room on the basement level and has an installation date of 1999. The hot water heater is equipped with a T&P relief valve. The domestic hot water heater is beyond its useful service life and should be replaced within the next 0-2 years.

Location: Boiler room

Distress: Beyond Service Life

Notes: Replace the existing vertical gas fired, 70 gallon, domestic hot water heater which is beyond its service life with a new gas fired hot water heater within the next 0-2 years.

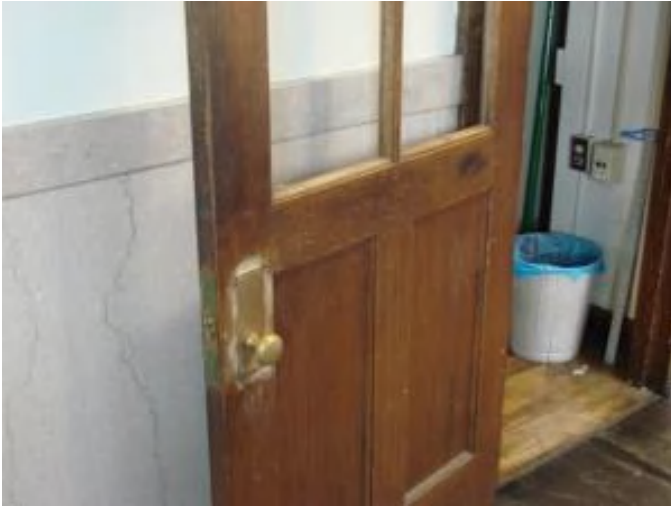
System: C1020 - Interior Doors

Interior doors are generally rail and stile wood doors, most glazed, in wood frames with transoms and solid core in hollow metal frames. Doors are typically in good condition. Most doors are fitted with door knobs and are not ADA compliant.

Location: Throughout

Distress: Building / MEP Codes

Notes: Provide ADA compliant hardware on interior doors

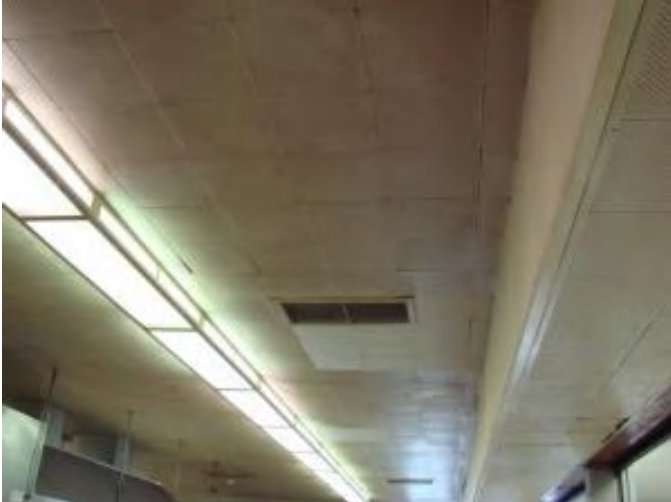
System: C3030 - Ceiling Finishes

Most ceilings are painted plaster in classrooms, auditorium and gym. 2x4 suspended acoustical panels are installed in some classrooms, offices and library; cafeteria and kitchen has 1x1 perforated metal tiles with concealed grid in poor condition and deteriorating.

Location: Kitchen, Cafeteria

Distress: Beyond Service Life

Notes: Replace acoustic tile in cafeteria and kitchen

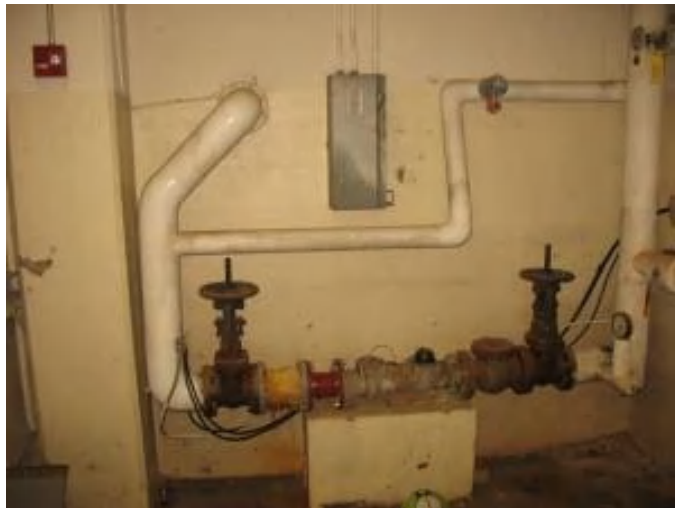
System: D2020 - Domestic Water Distribution

Location: Boiler room

Distress: Inadequate

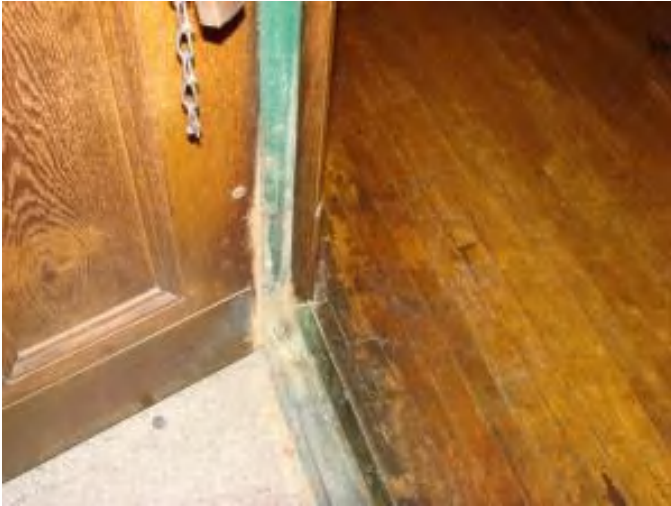
System: C3020414 - Wood Flooring

Location: Various

Distress: Appearance

Notes: Repair refinish hardwood flooring (10% of wood flooring)

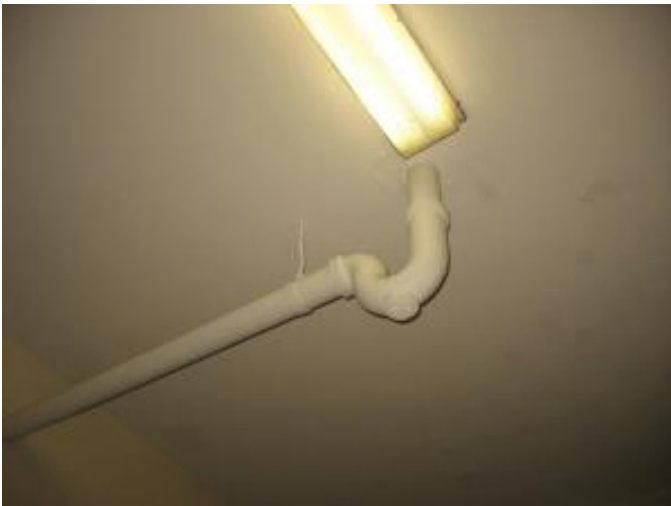
System: D2030 - Sanitary Waste

The maintenance staff reported mostly minor problems with the sanitary waste piping systems. The sewer piping has been in service for an unknown amount of time and will require more frequent attention from the maintenance staff as time passes. The District should hire a qualified contractor to examine the sanitary waste piping using video cameras to locate and replace any damaged piping and to further quantify the extent of potential failures.

Location: Throughout building

Distress: Beyond Service Life

Notes: Hire a qualified contractor to perform a detailed examination of the sanitary waste piping using visual inspection and video cameras to locate and replace any damaged piping and to further quantify the extent of potential failures.

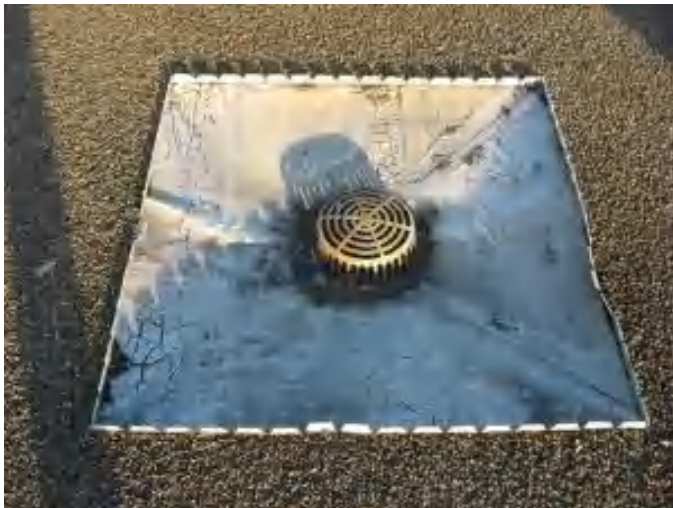
System: D2040 - Rain Water Drainage

Rain water drains from the roof are routed through mechanical chases in the building and appear to be original. The piping is a mixture of galvanized piping with threaded fittings and cast iron piping with hub and spigot fittings. Sections of the piping have been replaced with cast iron piping and no-hub fittings. The District should hire a qualified contractor to examine the rain water drainage piping using video cameras to locate and replace any damaged piping and to further quantify the extent of potential failures.

Location: Throughout building

Distress: Beyond Service Life

Notes: Hire a qualified contractor to perform a detailed examination of the rain water drainage piping using visual inspection and video cameras to locate and replace any damaged piping and to further quantify the extent of potential failures.

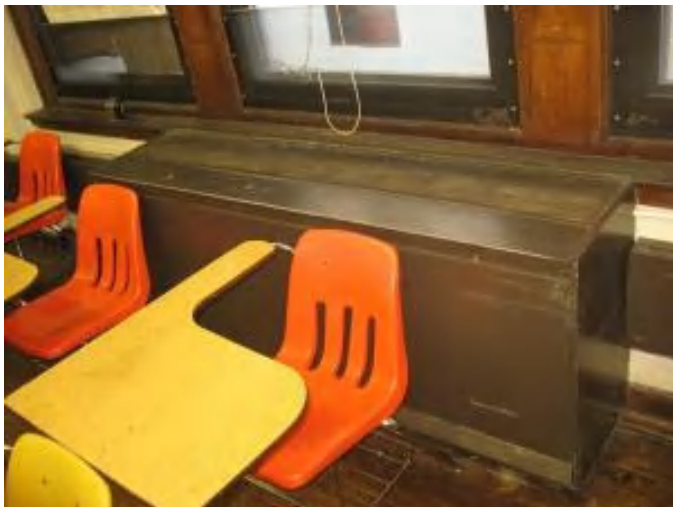
System: D3040 - Distribution Systems

Unit ventilators and fin tube radiators provide heating for the majority of classrooms, offices, and the corridors. Six (6) unit ventilators provide heating for the Cafeteria. The unit ventilators are beyond their service lives and in poor condition; they should be removed and new unit ventilators installed. Outdoor air for the building is provided by wall openings in the unit ventilators. Supplemental heating is provided in the corridors and along the perimeter of classrooms by fin tube radiators. Ventilation for the Cafeteria should be provided by installing a constant volume air handling unit with distribution ductwork and registers.

Location: Classrooms

Distress: Beyond Service Life

Notes: Replace the existing unit ventilators, which are beyond their service life and in poor condition, with two pipe units that have integral heat exchangers to introduce outdoor air to the building.

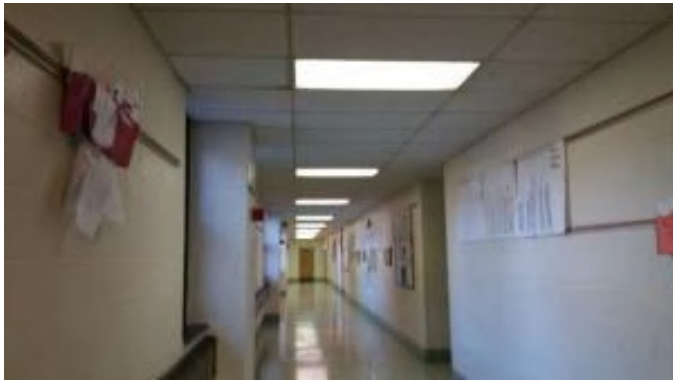
System: D5020 - Lighting and Branch Wiring

Location: throughout the building
Distress: Beyond Service Life
Category: 3 - Operations / Maint.
Priority: 3 - Response Time (3-4 yrs)
Correction: Replace Lighting Fixtures (SF)
Qty: 0.00
Unit of Measure: S.F.
Estimate: \$831,965.97
Assessor Name: System
Date Created: 02/10/2016

Notes: Install new a lighting system for 70% of the entire building.
83,510 SF x 70% = 58,457 SF

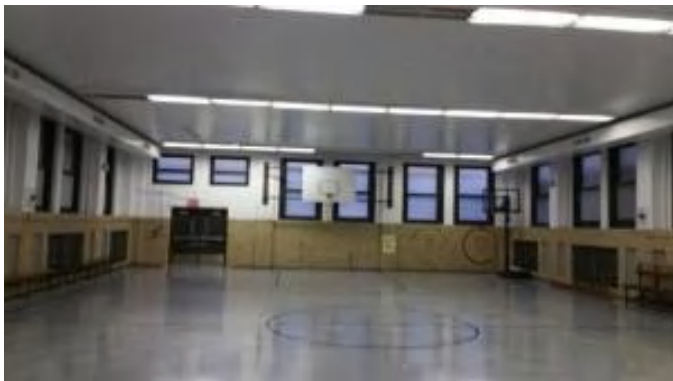
System: D5020 - Lighting and Branch Wiring

Location: throughout the building
Distress: Beyond Service Life
Category: 3 - Operations / Maint.
Priority: 3 - Response Time (3-4 yrs)
Correction: Replace Wiring Devices (SF) - surface mounted conduit and boxes
Qty: 0.00
Unit of Measure: S.F.
Estimate: \$325,688.16
Assessor Name: System
Date Created: 02/10/2016

Notes: Install new receptacles in all classrooms and other areas the building with minimum two receptacles on each wall (70% of the total building).
83,510 SF x 70% = 58,457 SF

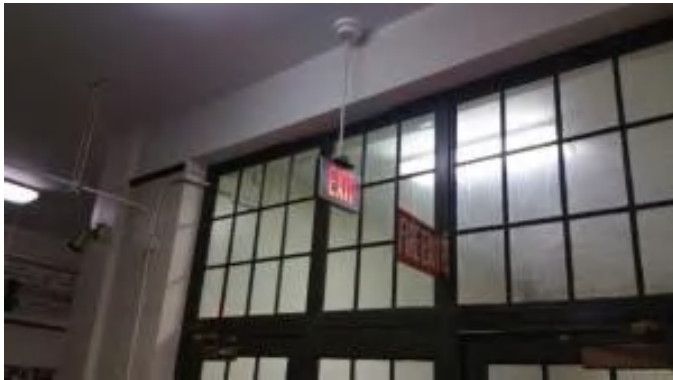
System: D5090 - Other Electrical Systems

Location: throughout the building
Distress: Beyond Service Life
Category: 3 - Operations / Maint.
Priority: 3 - Response Time (3-4 yrs)
Correction: Replace Emergency/Exit Lighting
Qty: 1.00
Unit of Measure: Ea.
Estimate: \$166,122.65
Assessor Name: System
Date Created: 02/10/2016

Notes: Install new emergency exit signs emergency lights.

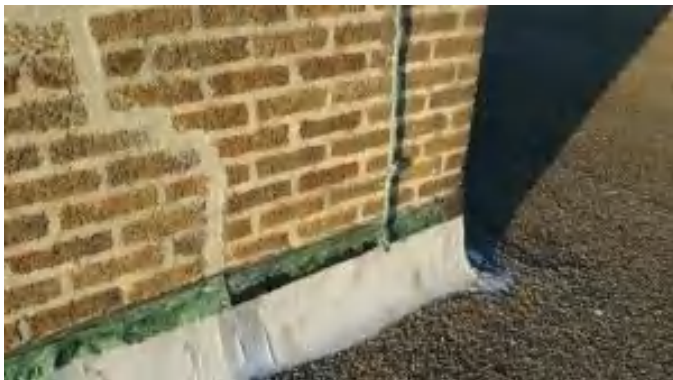
System: D5090 - Other Electrical Systems

Lightning Protection System - There is inadequate lightning protection system in the school. The roof has lightning rods, however they are not connected to the ground properly. The stranded aluminum cables are disconnected (removed) and the rods are not connected all the way to the

Location: roof
Distress: Damaged
Category: 3 - Operations / Maint.
Priority: 3 - Response Time (3-4 yrs)
Correction: Repair Lightning Protection System
Qty: 1.00
Unit of Measure: Job
Estimate: \$22,099.92
Assessor Name: System
Date Created: 02/10/2016

Notes: Install a new Lightning Rods with aluminum cables all the way to the ground.

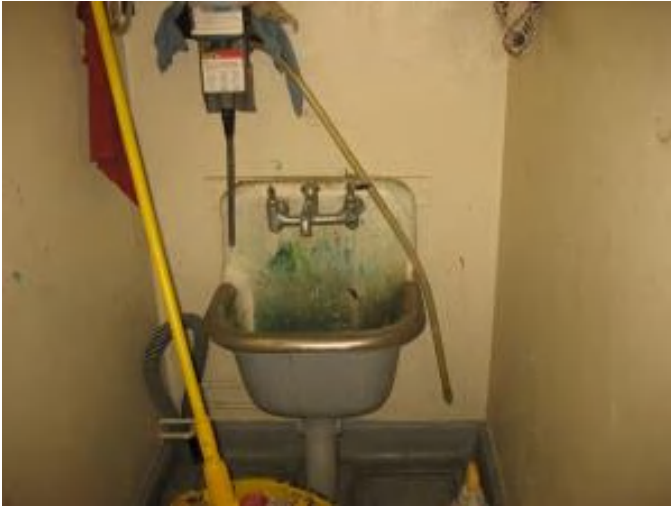
System: D2010 - Plumbing Fixtures

A service sink is available in a janitor closet in the corridor on each floor for use by the janitorial staff. The service sinks are beyond their service lives, in poor condition, and should be replaced.

Location: Corridors

Distress: Beyond Service Life

Notes: Replace four (4) existing service sinks which are beyond their service lives and in poor condition.

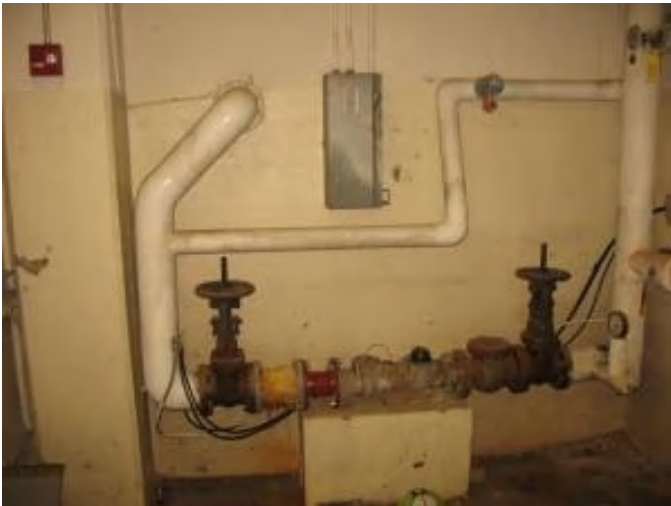
System: D2020 - Domestic Water Distribution

Location: Throughout building

Distress: Beyond Service Life

Notes: Hire a qualified contractor to perform a detailed inspection of the domestic water piping, in use for an unknown amount of time, and replace any damaged piping.

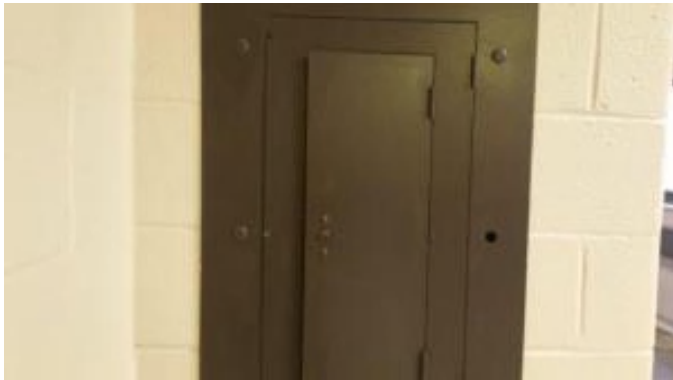
System: D5010 - Electrical Service/Distribution

Location: throughout the building

Distress: Beyond Service Life

Notes: Install new 120V panel-boards throughout the building for lighting, and receptacles loads.

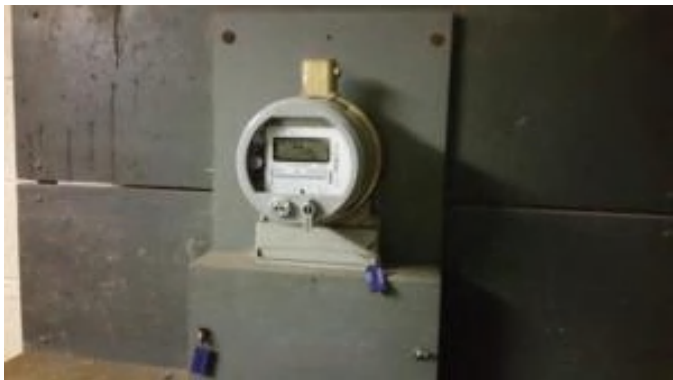
System: D5010 - Electrical Service/Distribution

Location: electrical room

Distress: Beyond Service Life

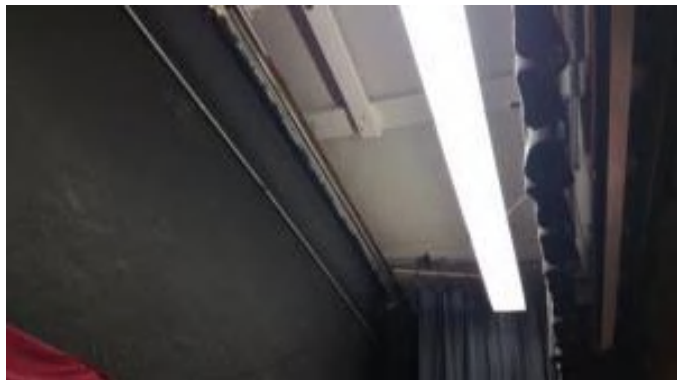
System: E1020 - Institutional Equipment

Location: auditorium

Distress: Beyond Service Life

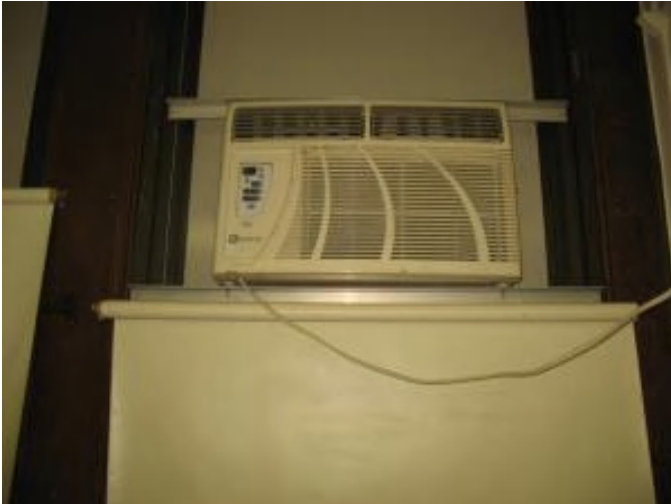
System: D3030 - Cooling Generating Systems

Several of the classrooms in the school building have window air conditioning units that have an anticipated service life of only 10 years. Installing a 250 ton air-cooled chiller with pumps located in a mechanical room and chilled water distribution piping would supply more reliable air conditioning for the building with a much longer service life.

Location: Throughout building

Distress: Inadequate

Notes: Remove the window air conditioning units and install a 250 ton air-cooled chiller with chilled water distribution piping and pumps located in a mechanical room to supply more reliable air conditioning for the building with a much longer service life.

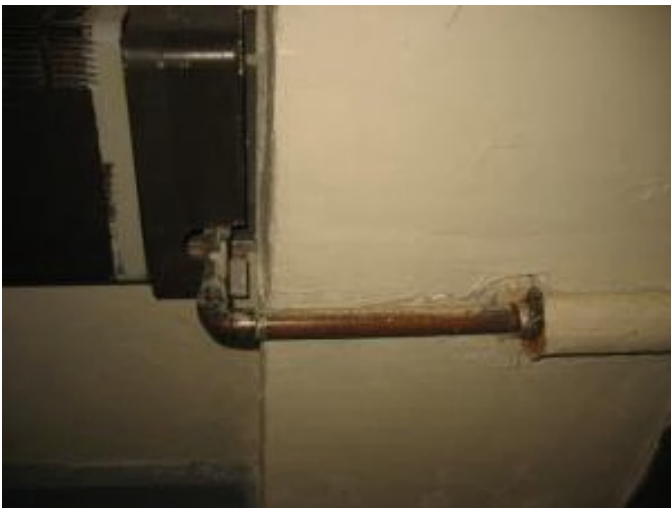
System: D3040 - Distribution Systems

Location: Throughout building

Distress: Beyond Service Life

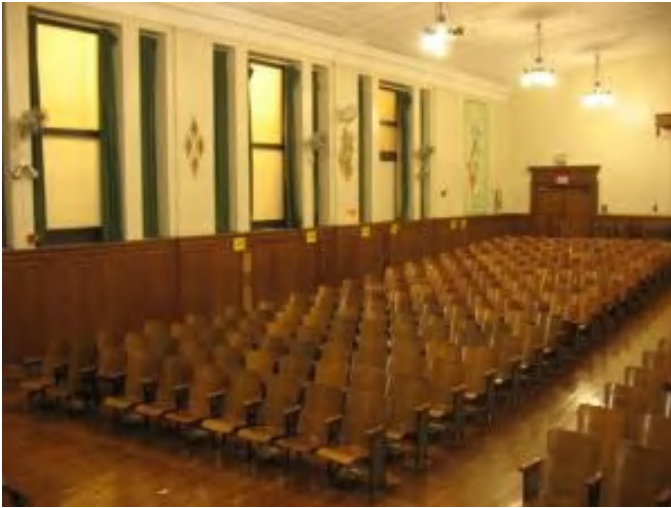
System: D3040 - Distribution Systems

Location: Auditorium

Distress: Building / MEP Codes

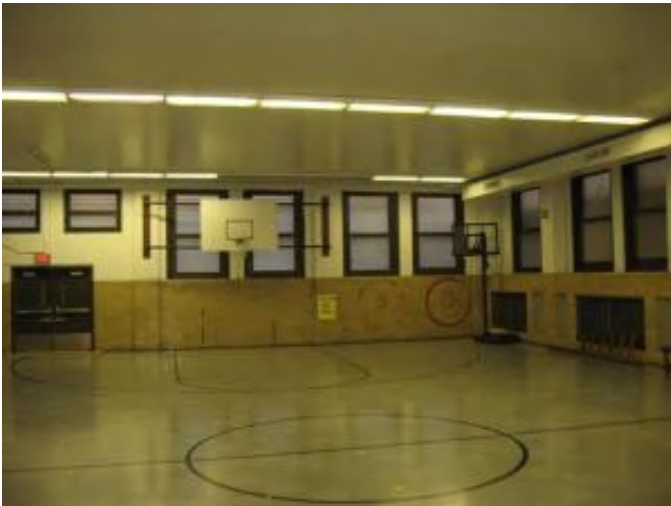
System: D3040 - Distribution Systems

Location: Gymnasium

Distress: Building / MEP Codes

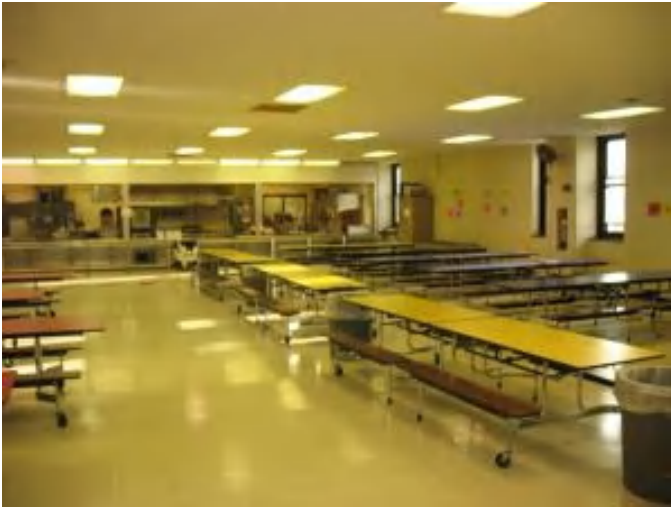
System: D3040 - Distribution Systems

Location: Cafeteria

Distress: Building / MEP Codes

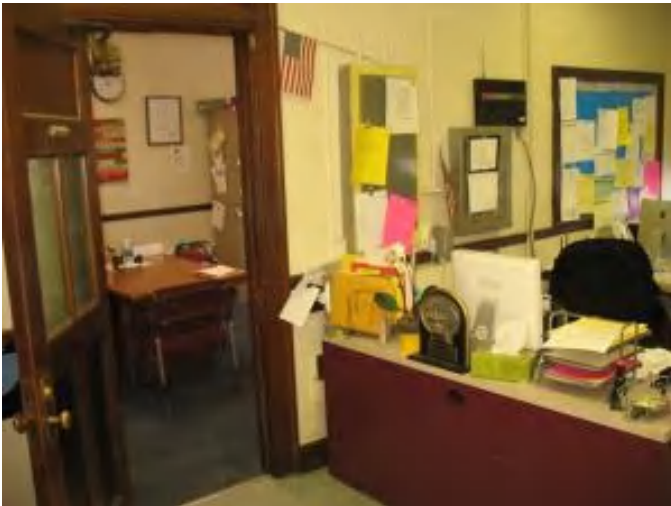
System: D3040 - Distribution Systems

Location: Administration offices

Distress: Building / MEP Codes

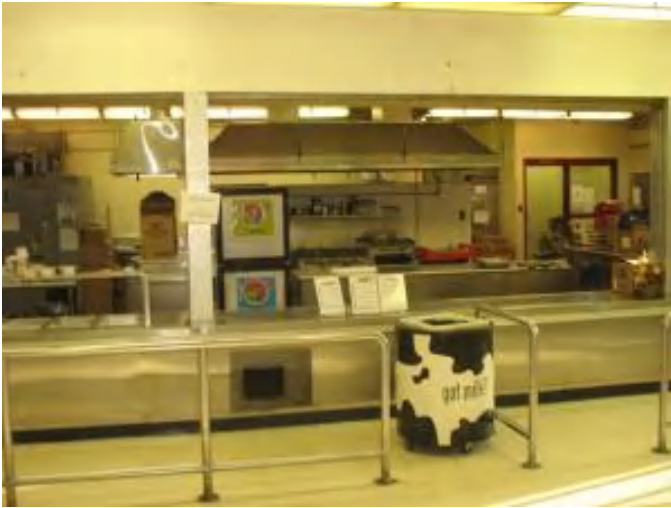
System: D3040 - Distribution Systems

Location: Kitchen

Distress: Inadequate

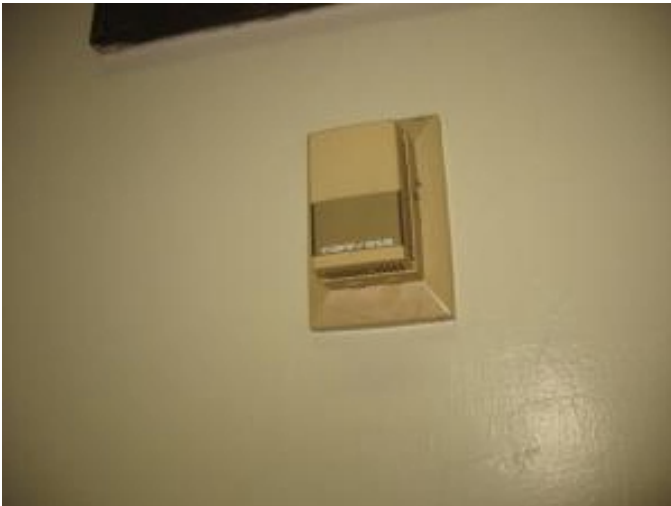
System: D3060 - Controls & Instrumentation

A Niagara building monitoring system (BMS) is installed in this building; which allows the mechanical equipment to be monitored, but not controlled. The Building Engineer reported that the BMS, installed when the boilers were replaced in 2003, is operational. The Building Engineer can monitor the set points of the boilers, HVs, unit ventilators, exhaust fans, and temperatures of each classroom. The system provides no control over the equipment, all equipment is controlled at the panel board or wall mounted switches and is either "on" or "off". This system is within its service life and should provide reliable operation for the next 5-8 years. These controls should be updated with a new DDC system and computer interface to provide more efficient operation.

Location: Throughout building

Distress: Inadequate

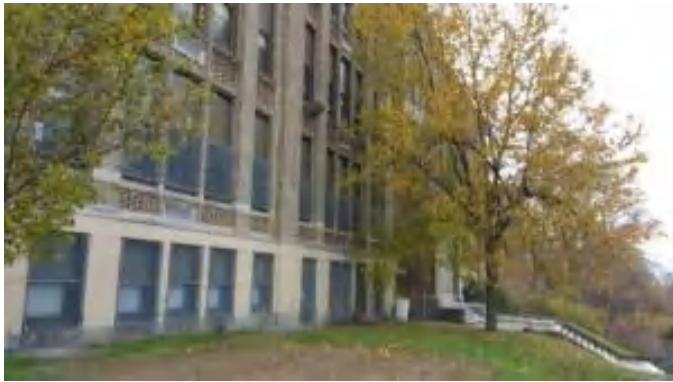
System: G4020 - Site Lighting

Location: grounds

Distress: Security Issue

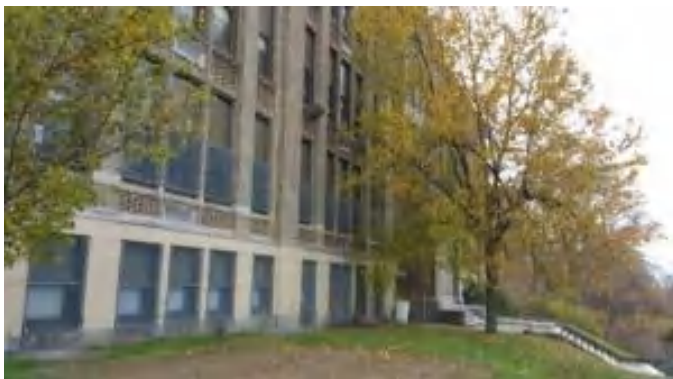
System: G4030 - Site Communications & Security

Location: grounds

Distress: Inadequate

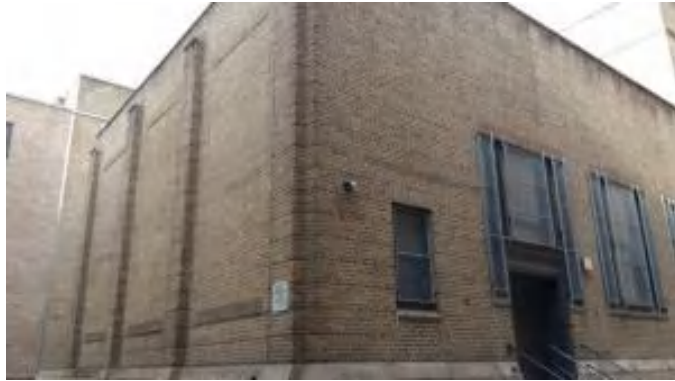
System: G4030 - Site Communications & Security

Location: grounds

Distress: Inadequate
