Facility Condition Assessment Summary Report

Sheridan School

School District of Philadelphia
S553001;Sheridan
Final
Site Assessment Report
January 31, 2017

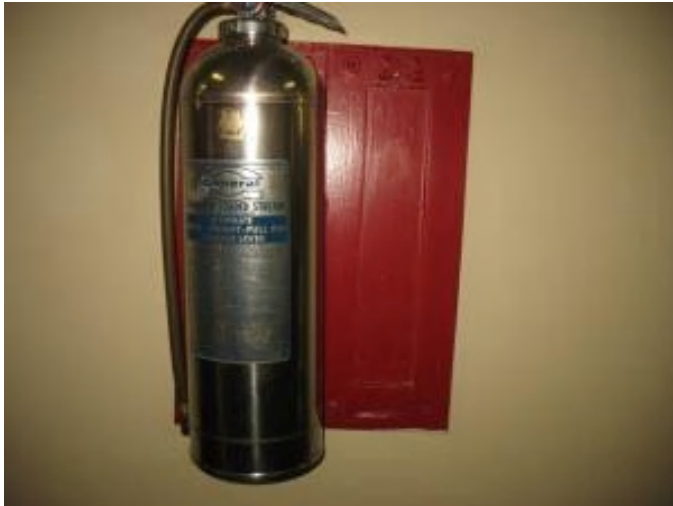
System: D4010 - Sprinklers

Location: Throughout building

Distress: Life Safety / NFPA / PFD

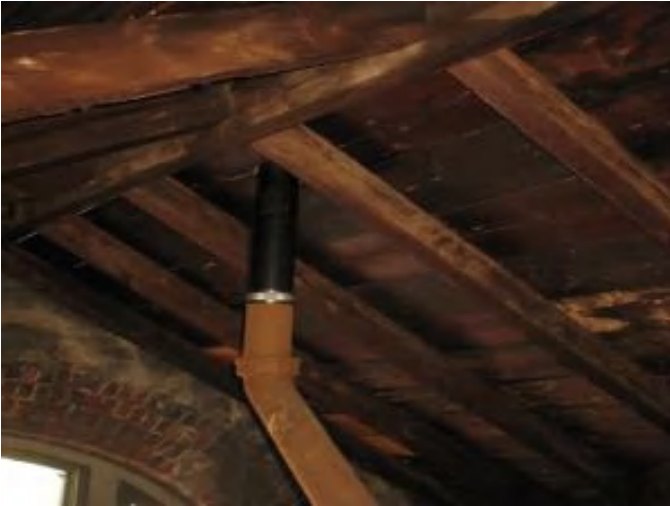
System: D2040 - Rain Water Drainage

Location: Throughout building

Distress: Beyond Service Life

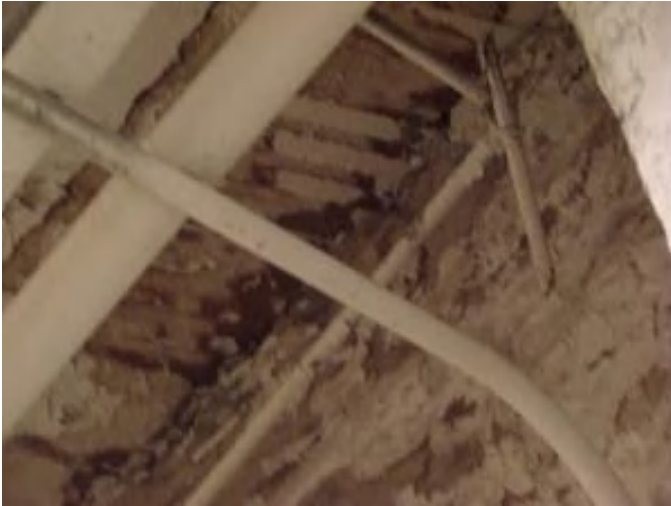
System: C3030 - Ceiling Finishes

Location: Interior

Distress: Damaged

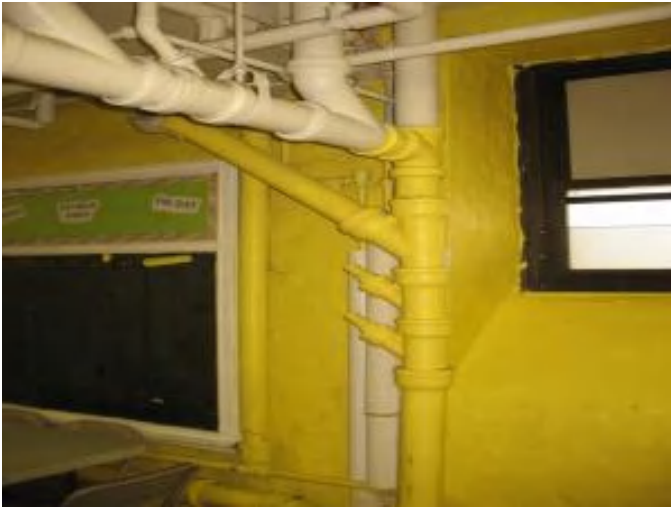
System: D2030 - Sanitary Waste

Location: Throughout building

Distress: Beyond Service Life

Notes: Hire a qualified contractor to perform a detailed examination of the sanitary waste piping using visual inspection and video cameras to locate and replace any damaged piping and to further quantify the extent of potential failures.

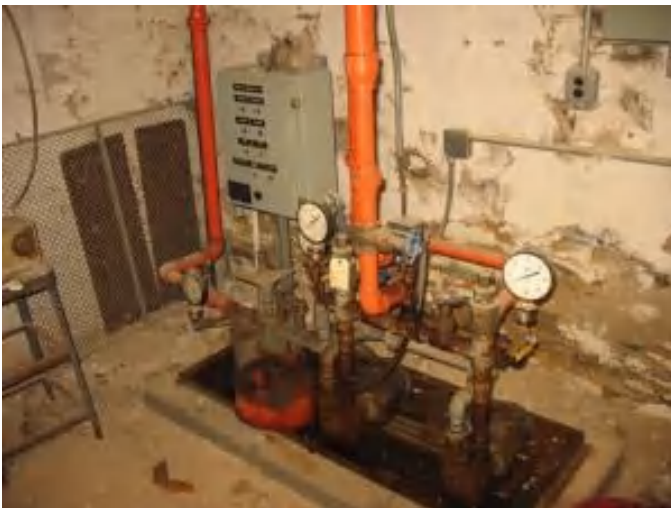
System: D3020 - Heat Generating Systems

Location: Boiler room

Distress: Damaged

Notes: Inspect and replace the current fuel oil pumping system, which was in poor condition during site visit, with a new system and control scheme.

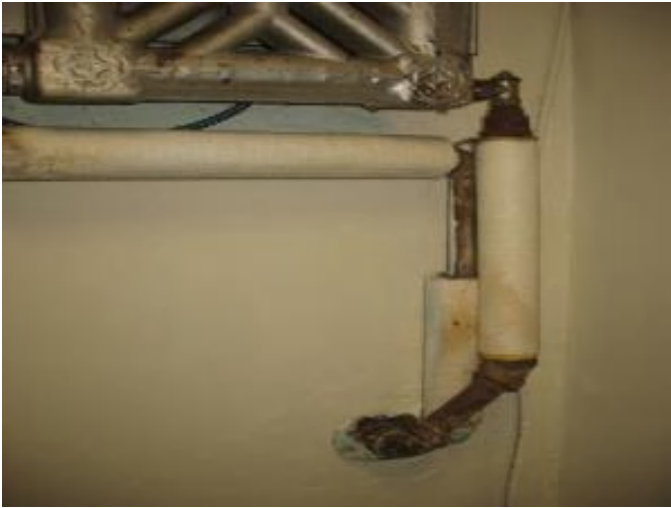
System: D3040 - Distribution Systems

Location: Throughout building

Distress: Beyond Service Life

Notes: Hire a qualified contractor to examine the steam piping, in service for over 100 years, and perform additional testing to locate and replace any damaged piping and to further quantify the extent of potential failures.

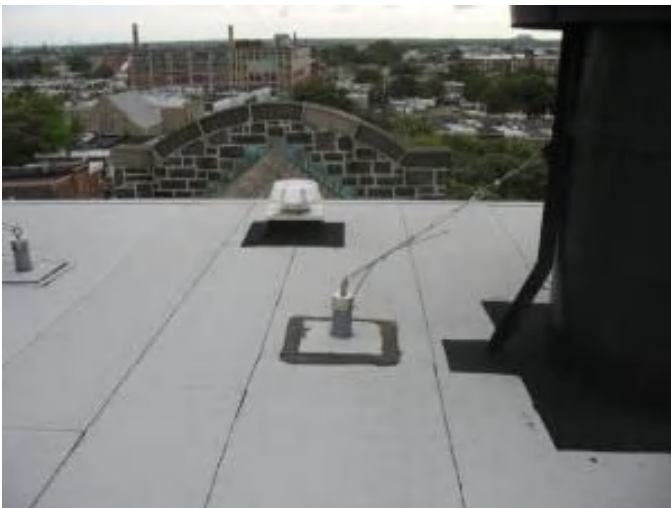
System: D3040 - Distribution Systems

Location: Roof

Distress: Failing

Notes: Replace the two (2) exhaust fans serving the restrooms, which were not operational during the site visit.

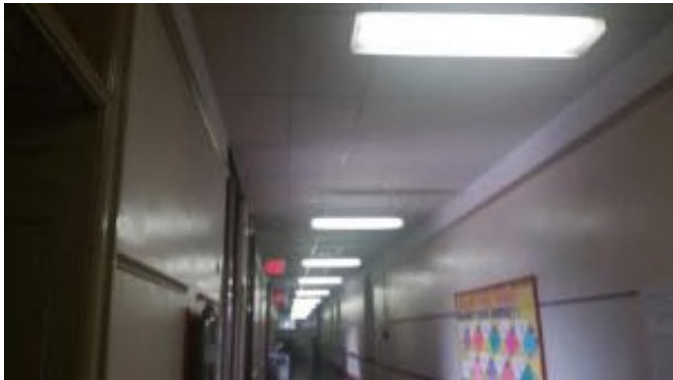
System: D5020 - Lighting and Branch Wiring

Location: Throughout the building
Distress: Beyond Service Life
Category: 3 - Operations / Maint.
Priority: 3 - Response Time (3-4 yrs)
Correction: Replace Lighting Fixtures (SF)
Qty: 0.00
Unit of Measure: S.F.
Estimate: \$684,284.87
Assessor Name: System
Date Created: 10/23/2015

Notes: Install new lighting system for the entire building.

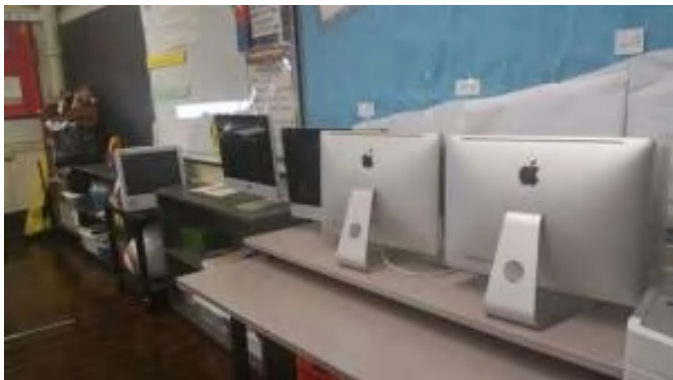
System: D5020 - Lighting and Branch Wiring

Location: Throughout the building
Distress: Inadequate
Category: 4 - Capital Improvement
Priority: 3 - Response Time (3-4 yrs)
Correction: Replace Wiring Devices (SF) - surface mounted conduit and boxes
Qty: 0.00
Unit of Measure: S.F.
Estimate: \$404,994.81
Assessor Name: System
Date Created: 10/23/2015

Notes: Install adequate (two on each wall minimum) surface-mounted receptacles in all classrooms and other areas within the building.

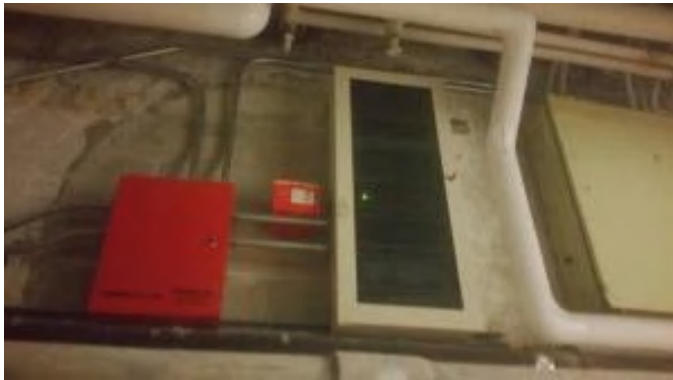
System: D5030 - Communications and Security

Location: Throughout the building
Distress: Building / MEP Codes
Category: 2 - Code Compliance
Priority: 3 - Response Time (3-4 yrs)
Correction: Replace fire alarm system
Qty: 1.00
Unit of Measure: S.F.
Estimate: \$366,542.27
Assessor Name: System
Date Created: 10/23/2015

Notes: Install new automated FA system.

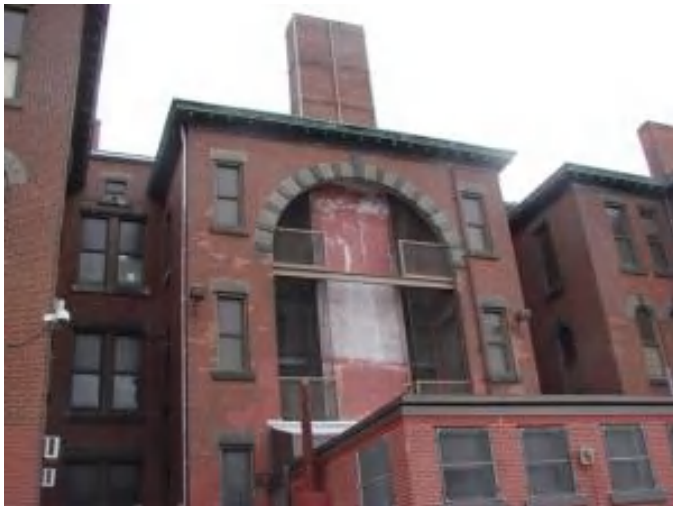
System: D5030 - Communications and Security

Location: Throughout the building
Distress: Security Issue
Category: 1 - Health & Safety
Priority: 3 - Response Time (3-4 yrs)
Correction: Replace Communications and Alarm Systems
Qty: 0.00
Unit of Measure: S.F.
Estimate: \$273,064.70
Assessor Name: System
Date Created: 10/23/2015

Notes: Install new Video Surveillance System with Cameras and CCTV.

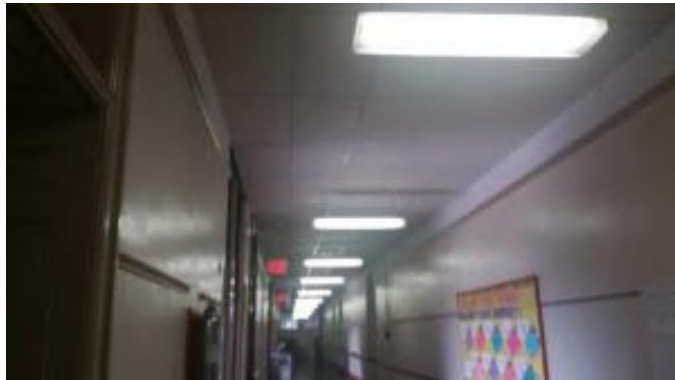
System: D5090 - Other Electrical Systems

Location: Throughout the building

Distress: Life Safety / NFPA / PFD

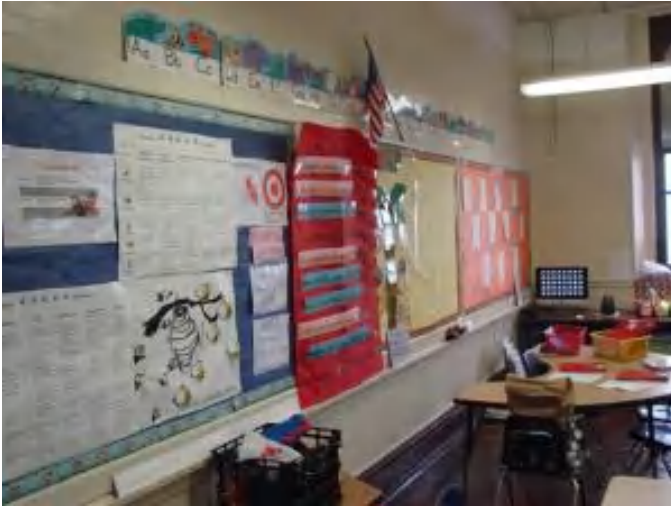
System: C1030 - Fittings

Location: Interior

Distress: Beyond Service Life

Notes: Replace original chalkboards with marker boards

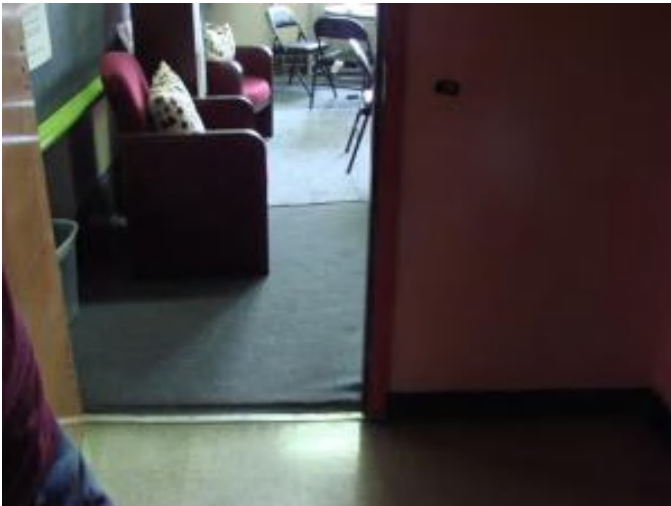
System: C3020411 - Carpet

Location: Interior

Distress: Beyond Service Life

Notes: Replace all carpet

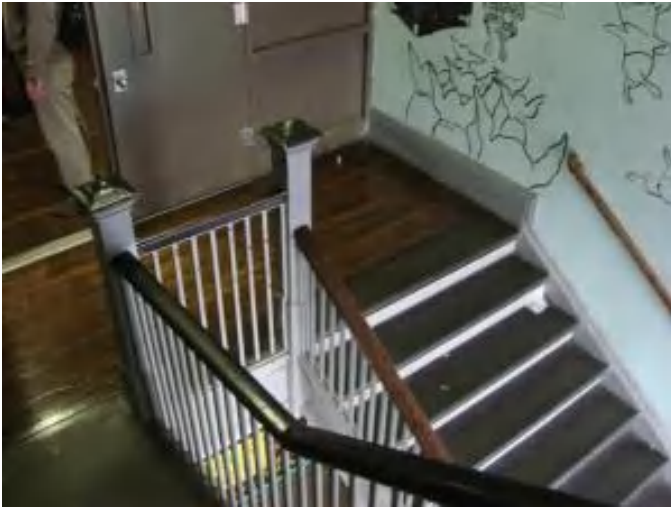
System: C3020414 - Wood Flooring

Location: Interior

Distress: Beyond Service Life

Notes: Repair and refinish hardwood flooring throughout the building

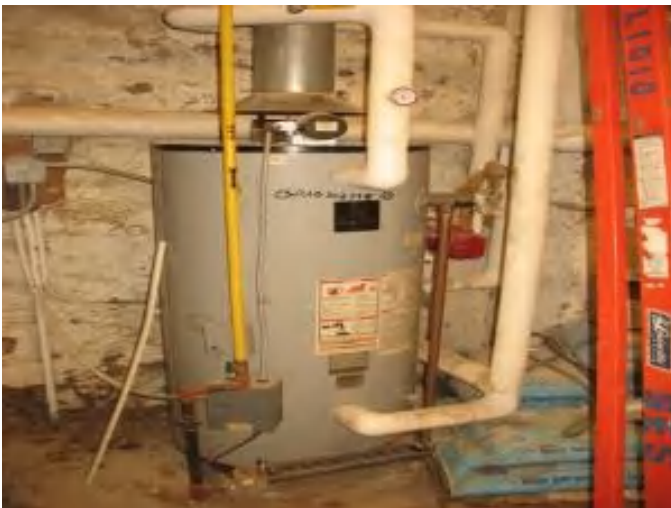
System: D2020 - Domestic Water Distribution

Location: Boiler room

Distress: Beyond Service Life

Notes: Replace the existing vertical gas fired, 70 gallon, domestic hot water heater which is approaching the end of its service life with a new gas fired hot water heater.

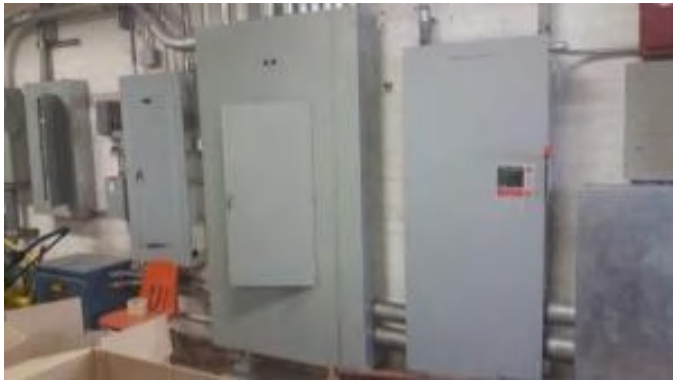
System: D5010 - Electrical Service/Distribution

Location: Electrical Room
Distress: Inadequate
Category: 4 - Capital Improvement
Priority: 4 - Response Time (4-5 yrs)
Correction: Add Electrical Switchgear and Distribution System
Qty: 0.00
Unit of Measure: Ea.
Estimate: \$583,760.81
Assessor Name: System
Date Created: 10/23/2015

Notes: Install two new 480 V MCCs to handle the new HVAC loads.
Also, install a new 120V switchboard to handle 120V loads.

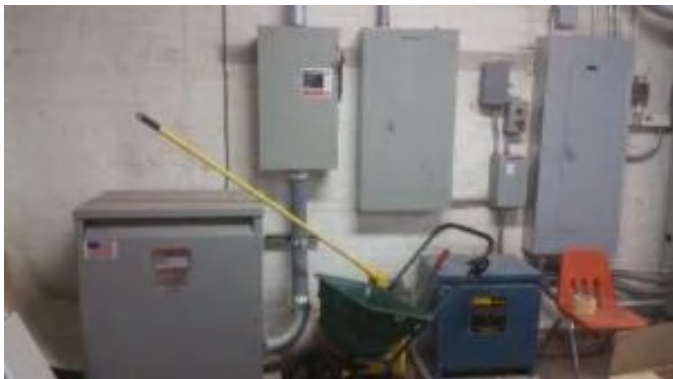
System: D5010 - Electrical Service/Distribution

Location: Electrical Room
Distress: Inadequate
Category: 4 - Capital Improvement
Priority: 4 - Response Time (4-5 yrs)
Correction: Replace Service Transformer, Add Switchboard
Qty: 0.00
Unit of Measure: Ea.
Estimate: \$272,651.55
Assessor Name: System
Date Created: 10/23/2015

Notes: Install a new 1000 KVA, electric service, including a new 1600A, 480V switchgear.

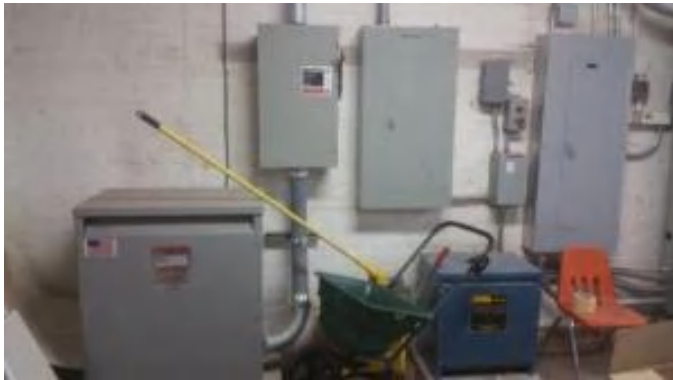
System: D5010 - Electrical Service/Distribution

Location: Electrical Room

Distress: Inadequate

Notes: Install a new 300KV transformer (480V- 120V) to feed the existing 120V distribution panels.
Note: A multiplier of 1.4 is used instead of 1.0 to cover the cost for conduits/wiring and other related work.

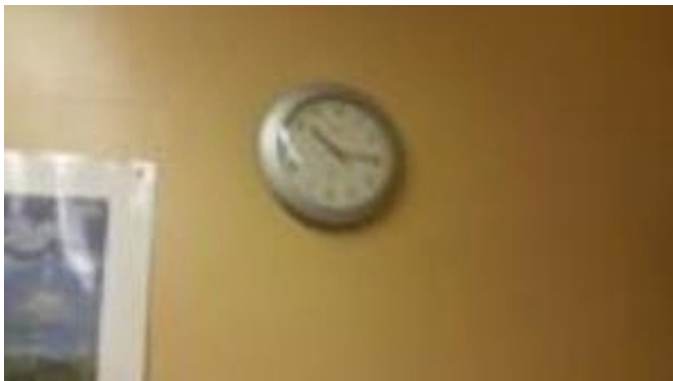
System: D5030 - Communications and Security

Location: Throughout the building

Distress: Inadequate

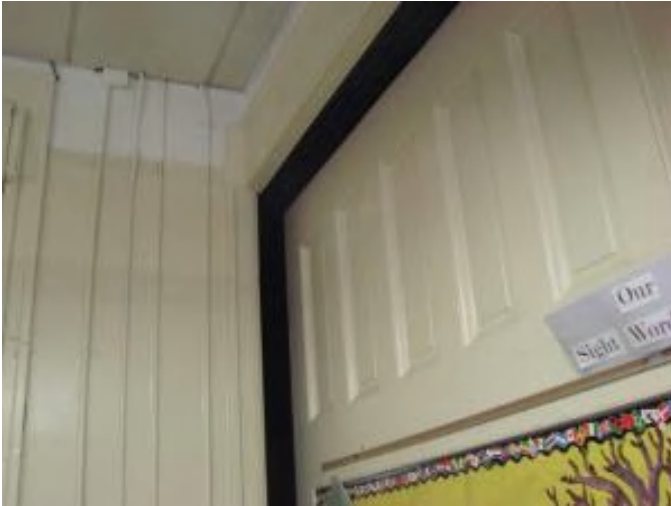
System: C1010 - Partitions

Location: Interior

Distress: Inadequate

Notes: Replace sliding partitions with drywall partitions

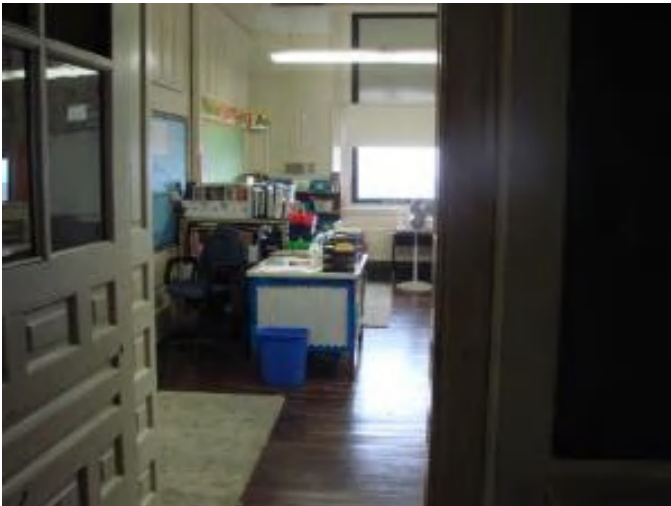
System: C1020 - Interior Doors

Location: Interior

Distress: Beyond Service Life

Notes: Replace all original interior doors

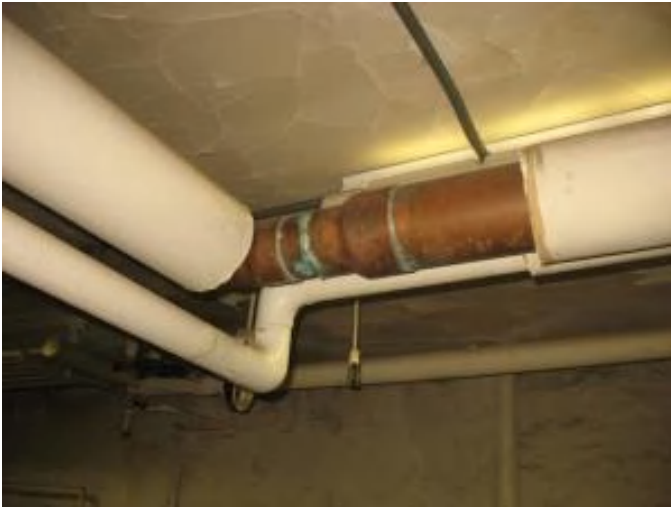
System: D2020 - Domestic Water Distribution

Location: Throughout building

Distress: Beyond Service Life

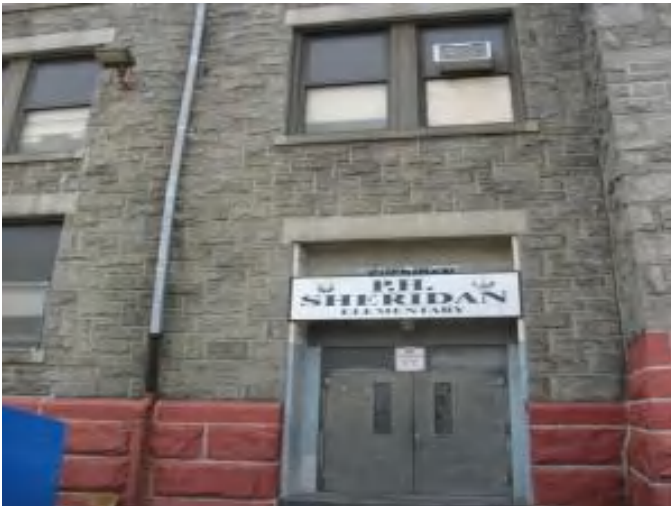
System: D3030 - Cooling Generating Systems

Location: Throughout building

Distress: Inadequate

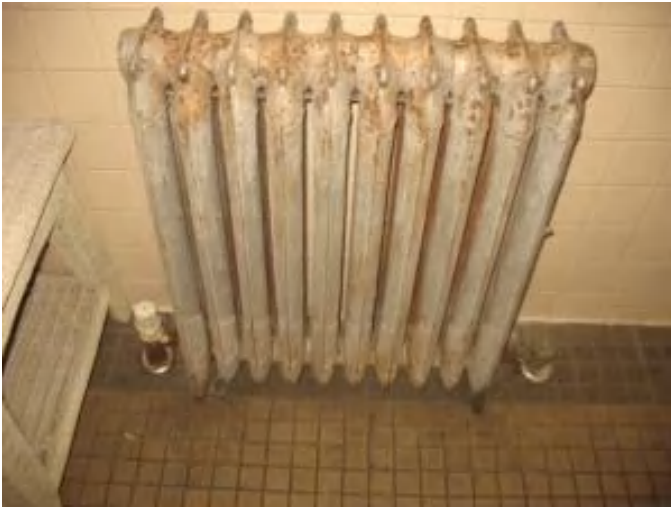
System: D3040 - Distribution Systems

Location: Classrooms

Distress: Building / MEP Codes

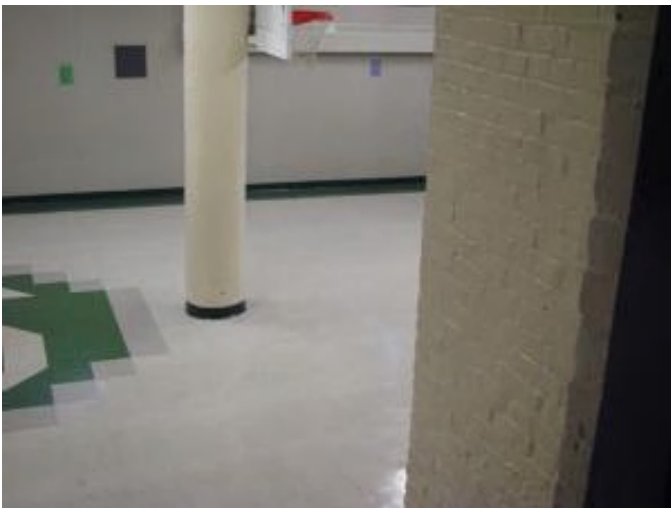
System: D3040 - Distribution Systems

Location: Gymnasium

Distress: Building / MEP Codes

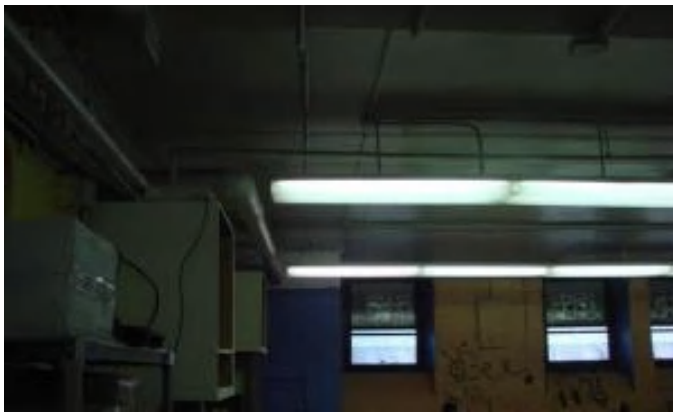
System: D3040 - Distribution Systems

Location: Cafeteria

Distress: Building / MEP Codes

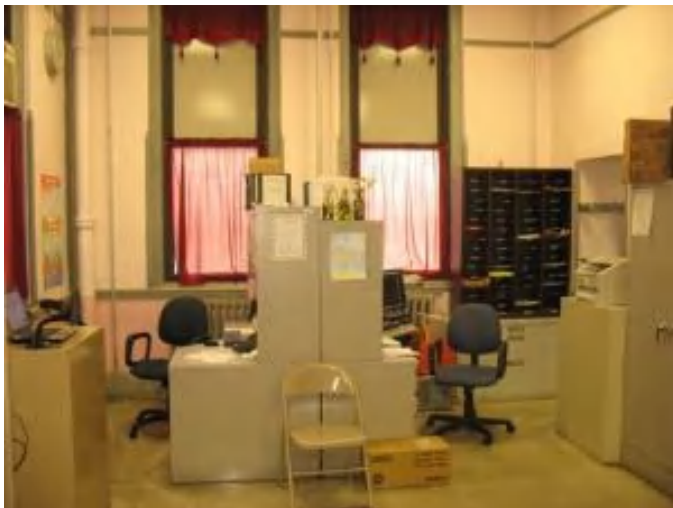
System: D3040 - Distribution Systems

Location: Administration

Distress: Building / MEP Codes

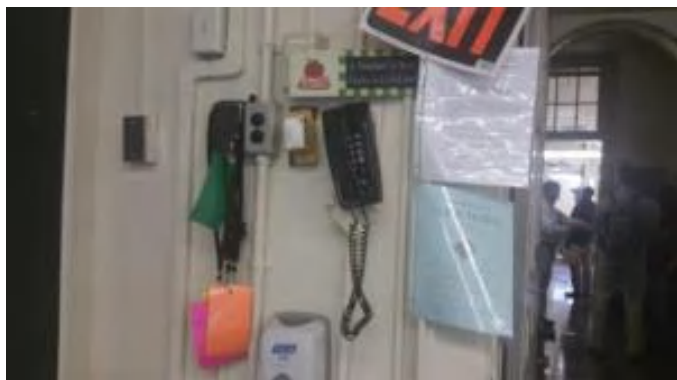
System: D3060 - Controls & Instrumentation

Location: Throughout building

Distress: Inadequate

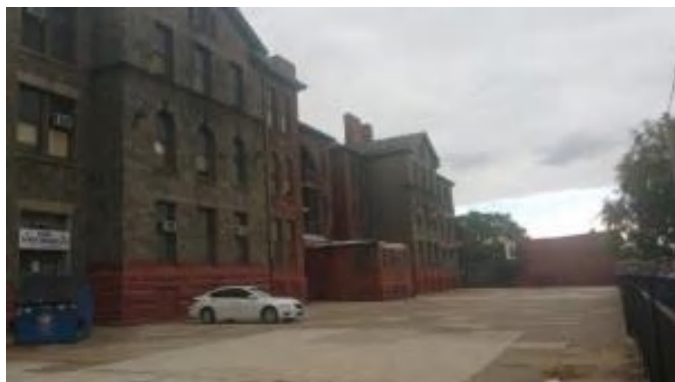
System: G4020 - Site Lighting

Location: Grounds

Distress: Health Hazard / Risk

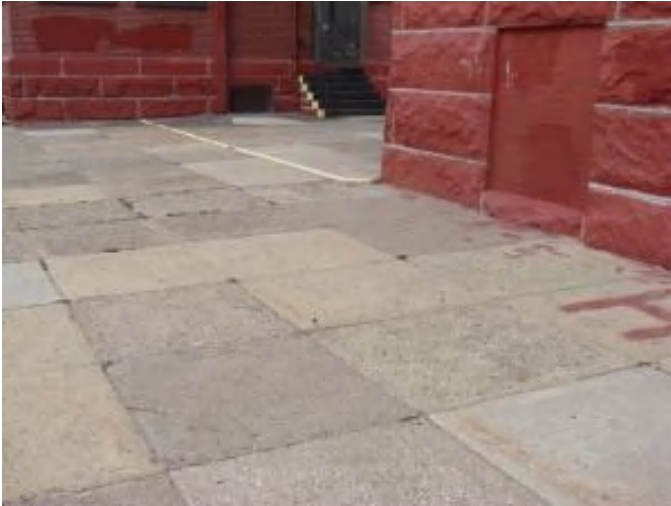
System: G2030 - Pedestrian Paving

Location: Grounds

Distress: Beyond Service Life

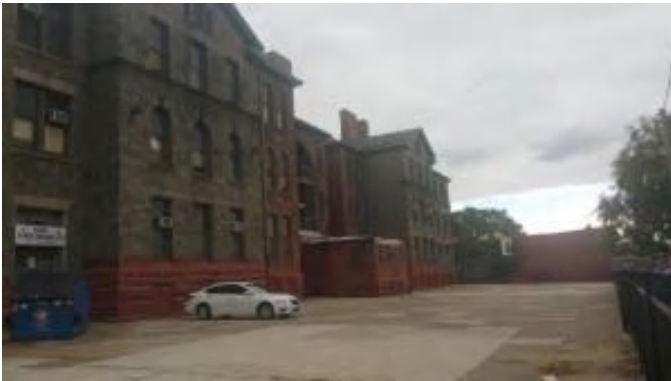
System: G4030 - Site Communications & Security

Location: Grounds

Distress: Life Safety / NFPA / PFD
