### Shoemaker School

# **S413001;Shoemaker**

## **Site Assessment Report**

February 1, 2017

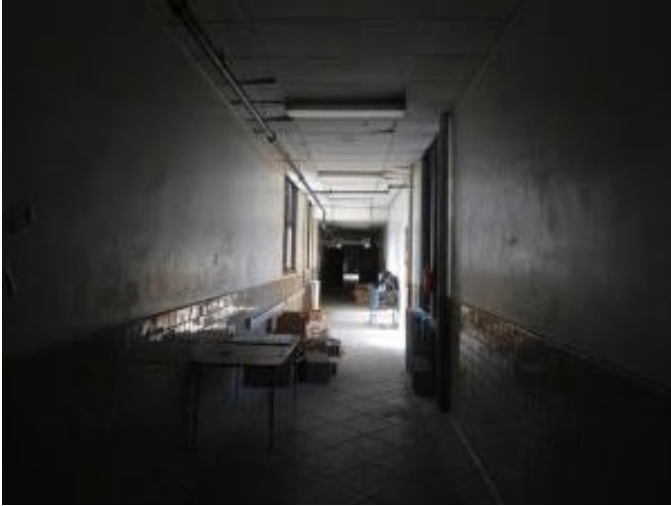
#### System: C1010 - Partitions

**Location:** Building wide

**Distress:** Building / MEP Codes

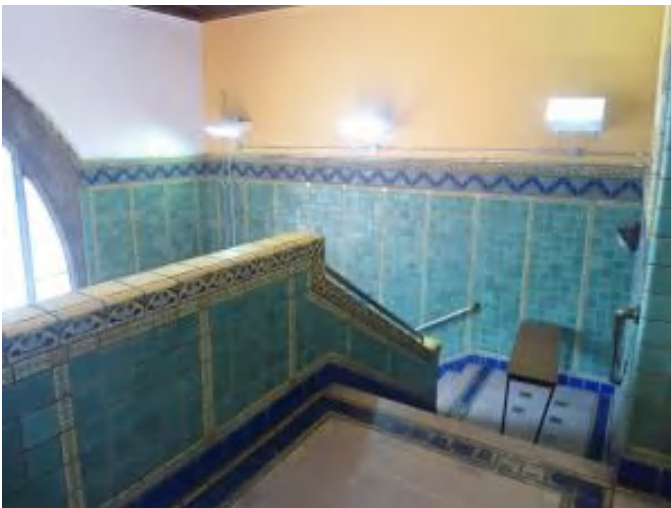
#### System: C2010 - Stair Construction

**Location:** Building Stairs

**Distress:** Life Safety / NFPA / PFD

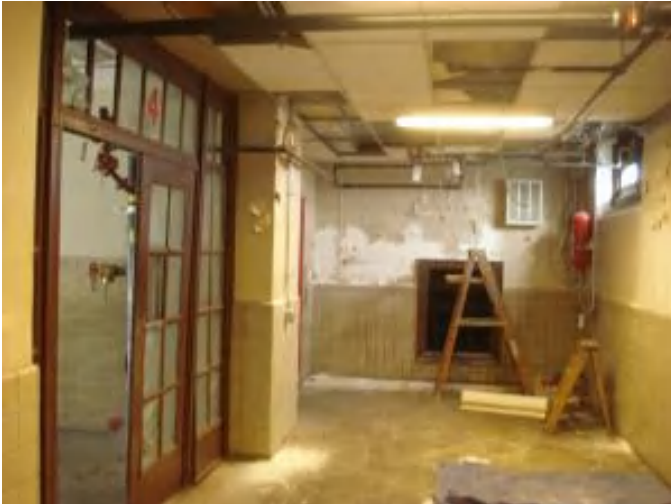
**System: B1010 - Floor Construction**

**Location:** Building Wide Abandoned

**Distress:** Damaged

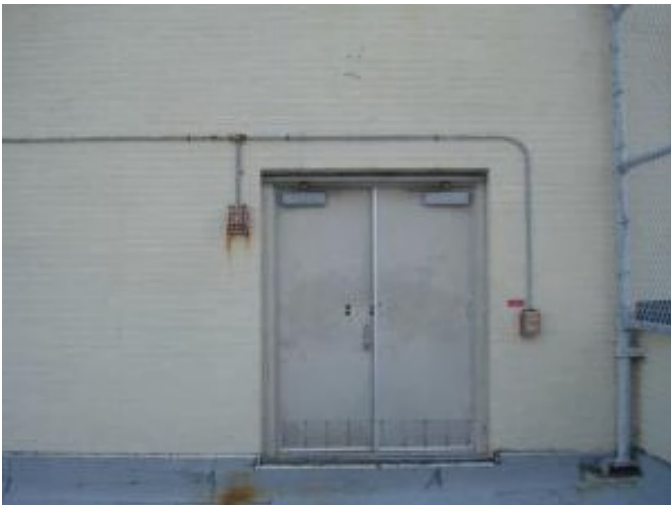
**System: B2030 - Exterior Doors**

**Location:** Roof Service Doors

**Distress:** Damaged

**Notes:** Remove and replace service doors.

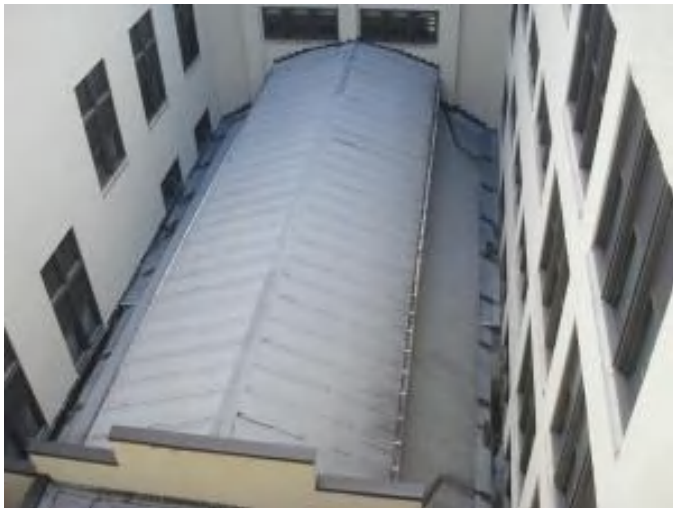
**System: B3010140 - Shingle & Tile**

**Location:** Roof Well 1 and Well 2

**Distress:** Beyond Service Life

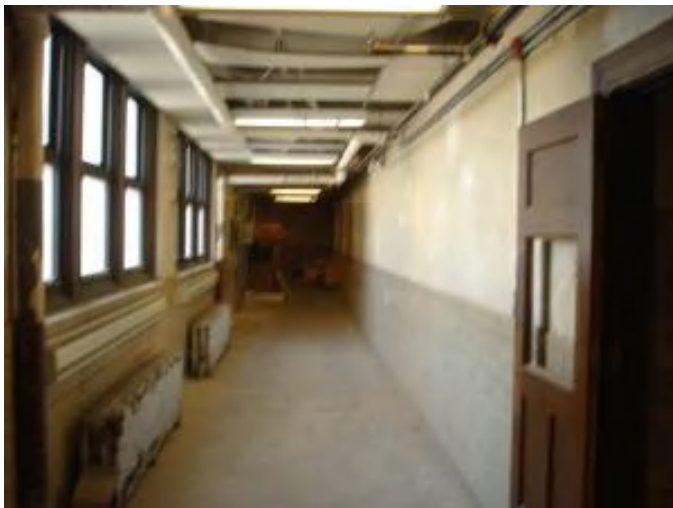
**System: C1020 - Interior Doors**

**Location:** Unoccupied Spaces

**Distress:** Beyond Service Life

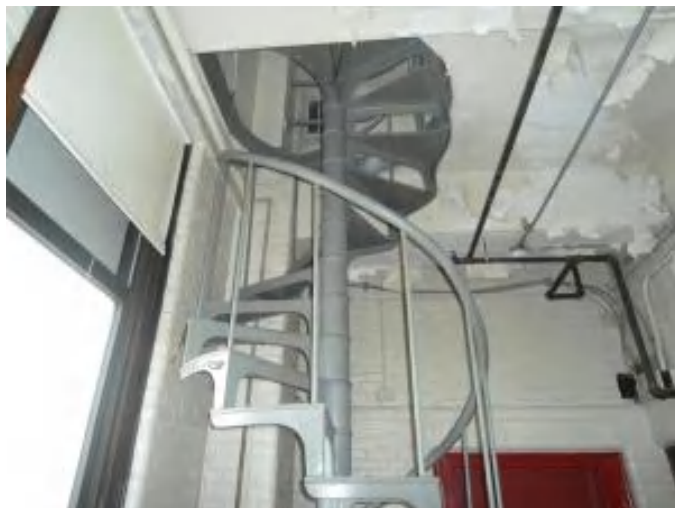
**System: C3010230 - Paint & Covering**

**Location:** Building Wide

**Distress:** Beyond Service Life

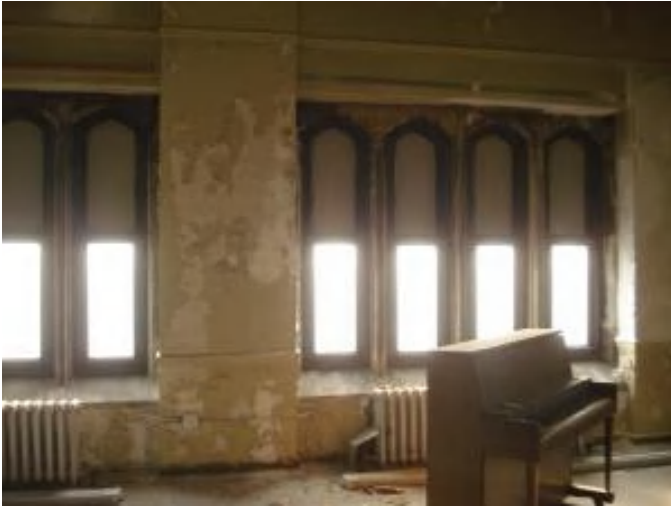
**System: B2020 - Exterior Windows**

**Location:** Exterior Windows

**Distress:** Beyond Service Life

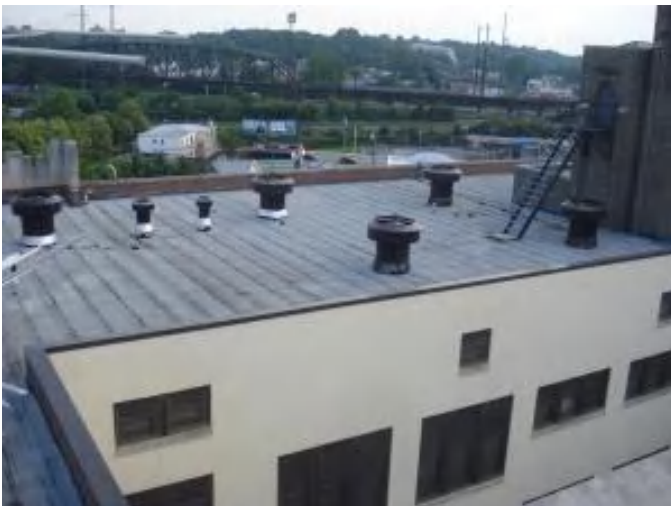
**System: B3010105 - Built-Up**

**Location:** Main Roof

**Distress:** Beyond Service Life

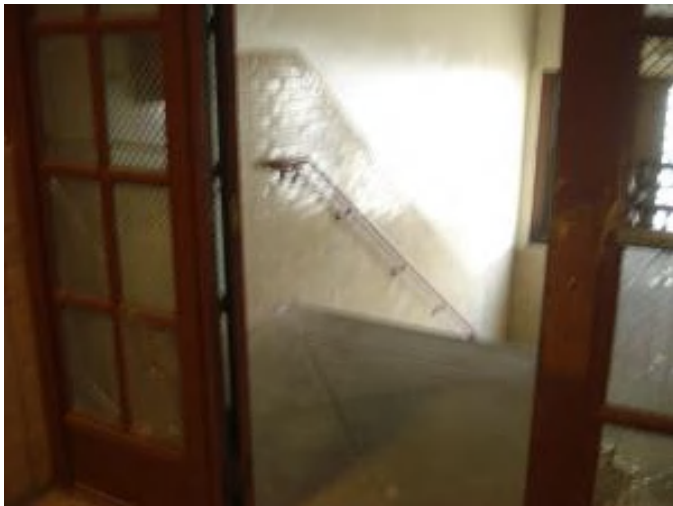
**System: C3010230 - Paint & Covering**

**Location:** Building Wide

**Distress:** Damaged

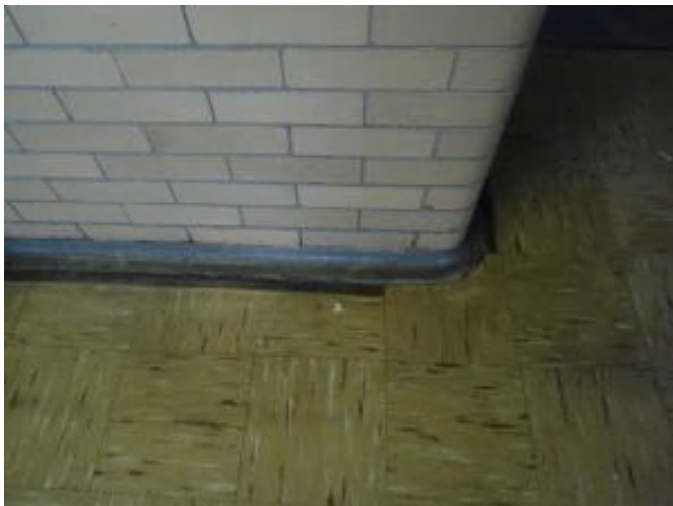
**System: C3020413 - Vinyl Flooring**

**Location:** Building Wide

**Distress:** Health Hazard / Risk

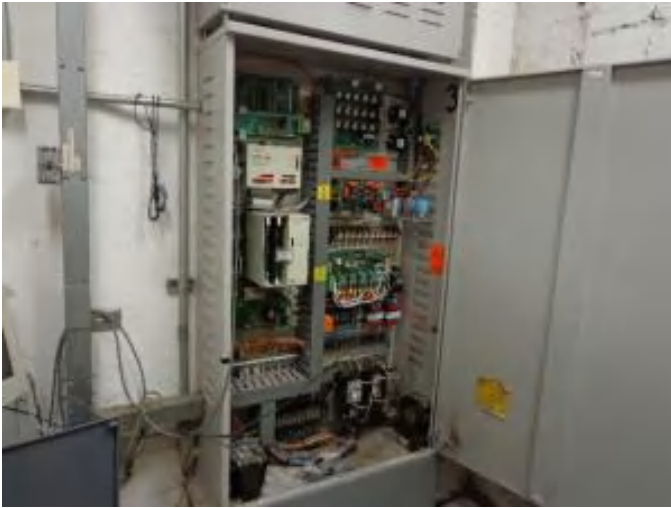
**System: D1010 - Elevators and Lifts**

**Location:** B413001;Shoemaker

**Distress:** Beyond Service Life

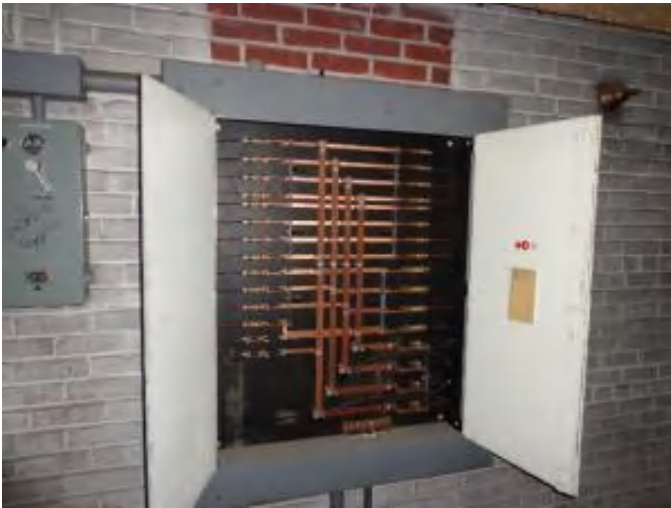
**System: D5010 - Electrical Service/Distribution**

**Location:** 5th Floor

**Distress:** Life Safety / NFPA / PFD

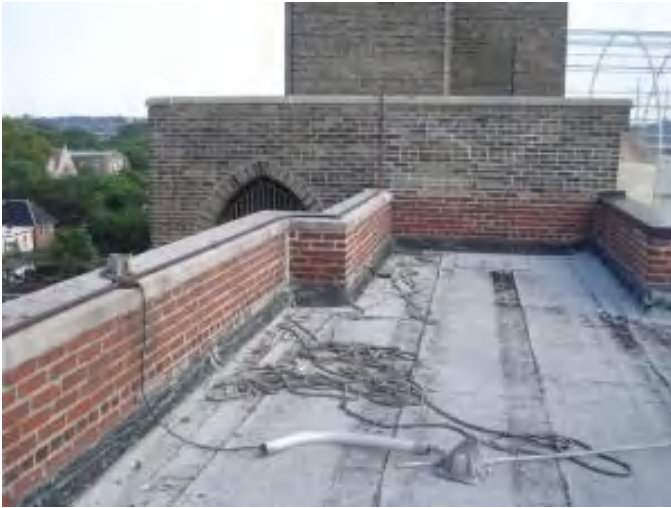
**System: D5020 - Lighting and Branch Wiring**

There are quartz floodlighting fixtures mounted along the perimeter of the roof. Eight fixtures are not operational and need to be repaired or replaced. There are also wall mounted, high intensity discharge (HID) lighting fixtures that illuminate the front façade of the building.

**Location:** Roof

**Distress:** Damaged

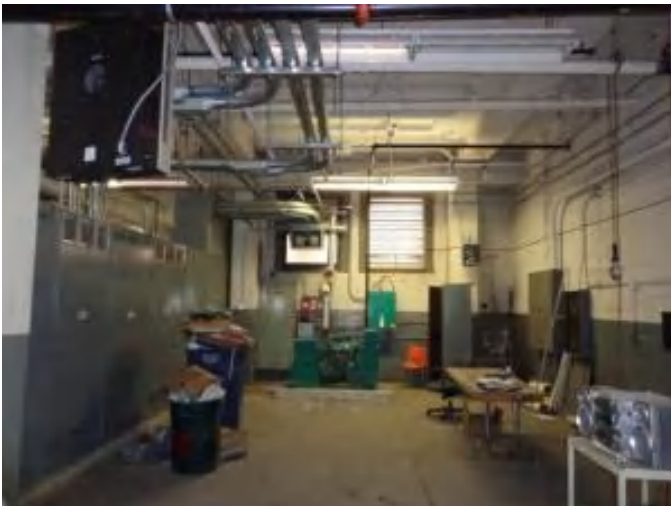
**System: D5020 - Lighting and Branch Wiring**

Lighting in the Sub-basement and old coal room consists of 4 foot, industrial fluorescent fixtures with T12 lamps. These fixtures are beyond their useful life and need to be replaced.

**Location:** Sub-basement

**Distress:** Obsolete

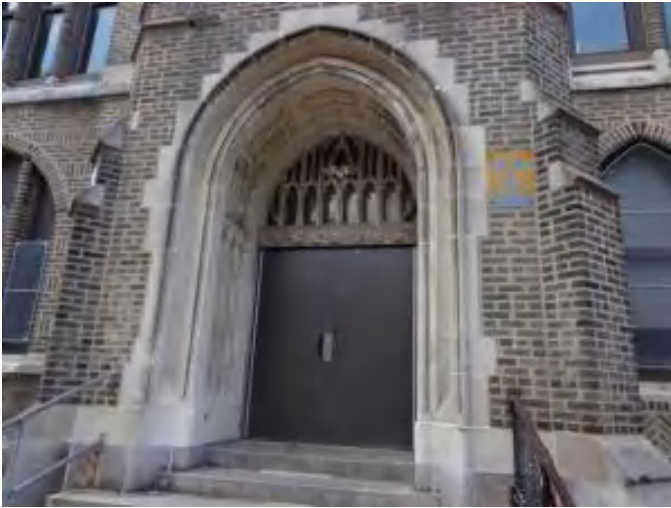
**System: D5020 - Lighting and Branch Wiring**

Remote emergency lighting heads are mounted above the exterior doors. These remote heads provide lighting only when there is a utility outage, and not at night. To comply with code, the remote heads need to be replaced with exterior wall mounted fixtures, with battery backup, that provide illumination at night and when utility service is interrupted.

**Location:** Exterior Doors

**Distress:** Life Safety / NFPA / PFD

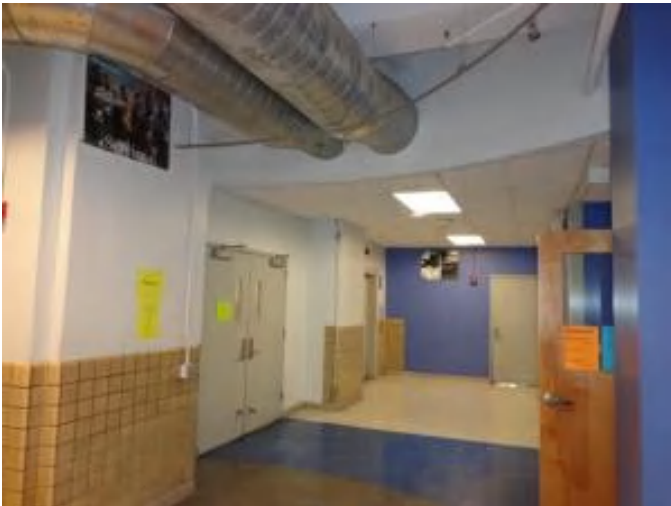
**System: D5090 - Other Electrical Systems**

**Location:** Corridors

**Distress:** Life Safety / NFPA / PFD

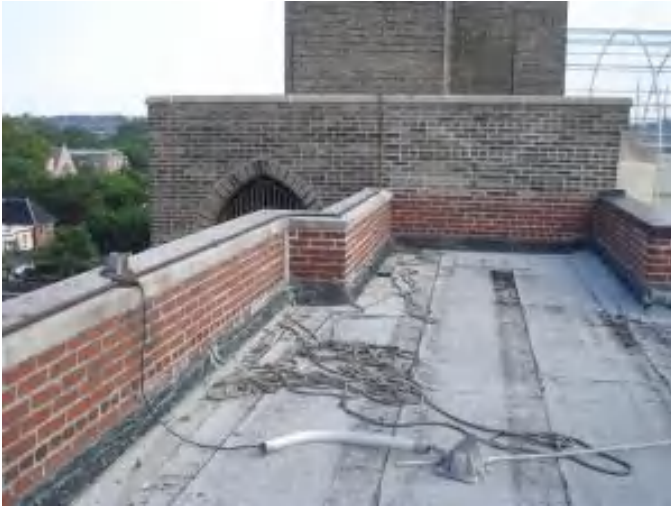
**System: B2010 - Exterior Walls**

**Location:** Exterior Brick Finish

**Distress:** Damaged

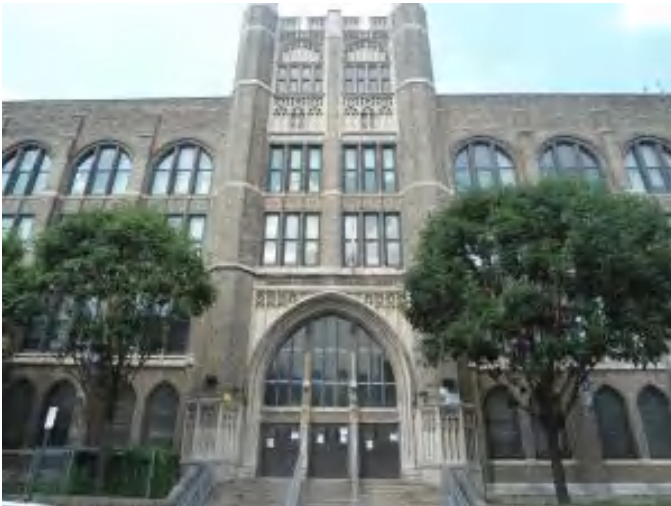
**System: B2030 - Exterior Doors**

**Location:** Entrance Door Systems

**Distress:** Building Envelope Integrity

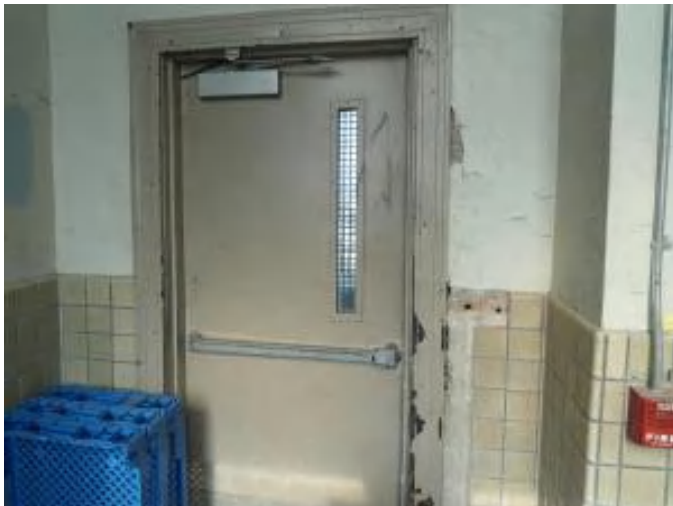
**System: C3010232 - Wall Tile**

**Location:** Unoccupied Spaces

**Distress:** Damaged

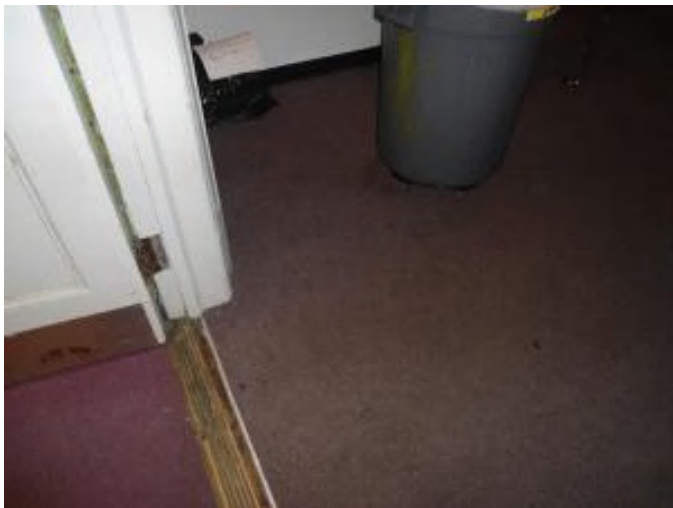
**System: C3020411 - Carpet**

**Location:** Office

**Distress:** Beyond Service Life

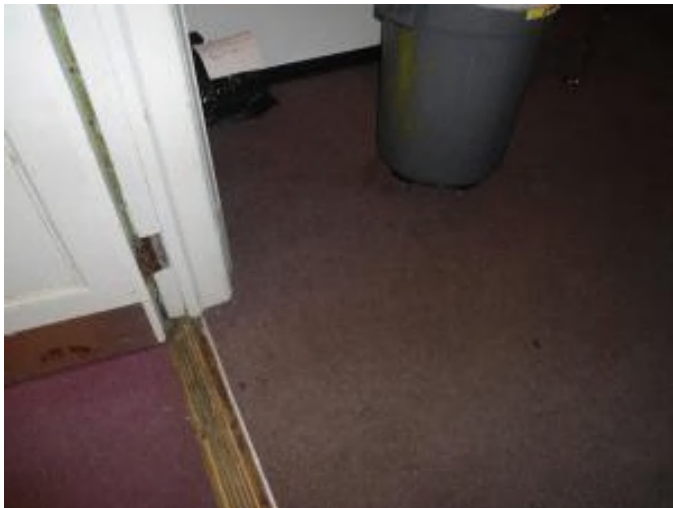
**System: C3020411 - Carpet**

**Location:** Office and Administrative area

**Distress:** Damaged

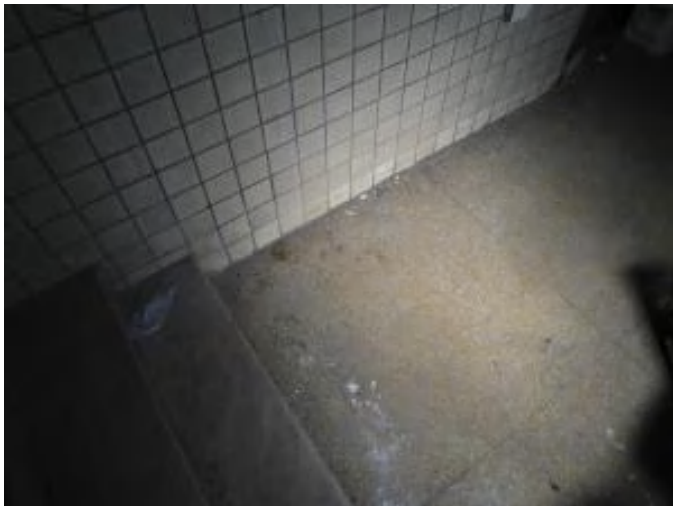
**System: C3020412 - Terrazzo & Tile**

**Location:** Unoccupied Spaces

**Distress:** Beyond Service Life

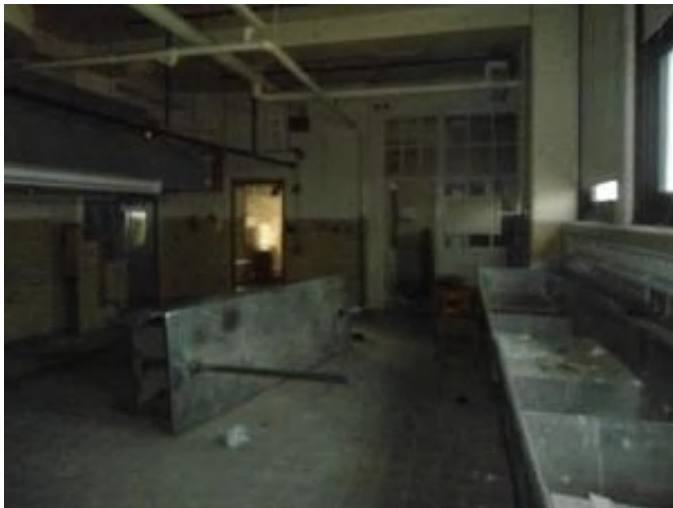
**System: C3020412 - Terrazzo & Tile**

**Location:** Kitchen

**Distress:** Damaged

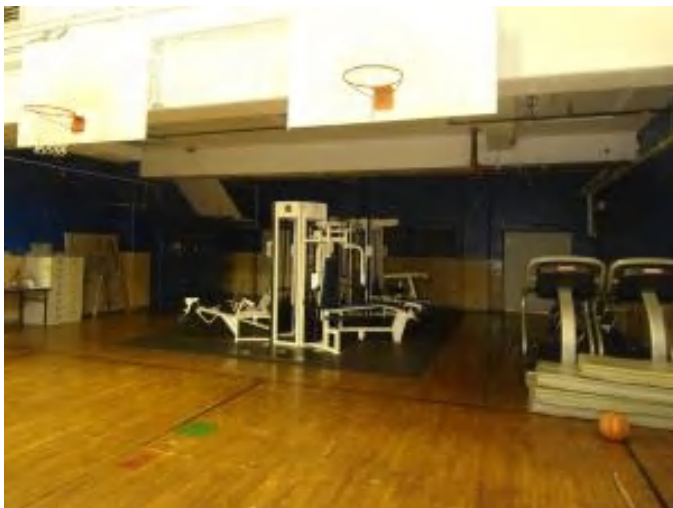
**System: C3020414 - Wood Flooring**

**Location:** Boys and Girls Gym

**Distress:** Beyond Service Life

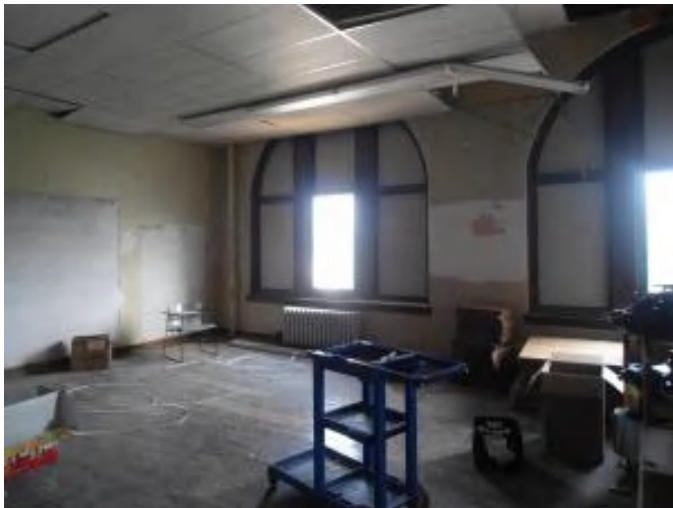
**System: C3020414 - Wood Flooring**

**Location:** Classrooms

**Distress:** Damaged

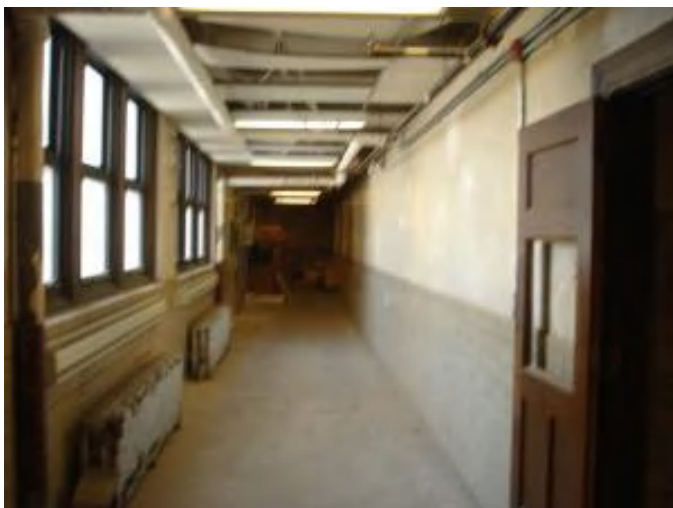
**System: C3020415 - Concrete Floor Finishes**

**Location:** Unoccupied Spaces

**Distress:** Appearance

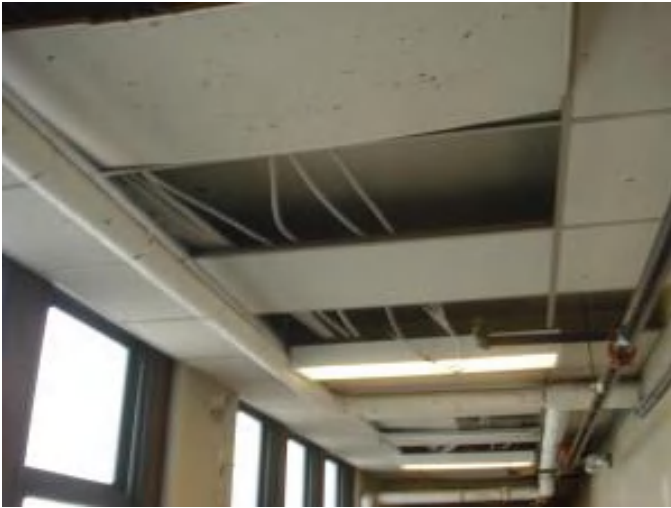
**System: C3030 - Ceiling Finishes**

**Location:** Unoccupied Spaces

**Distress:** Failing

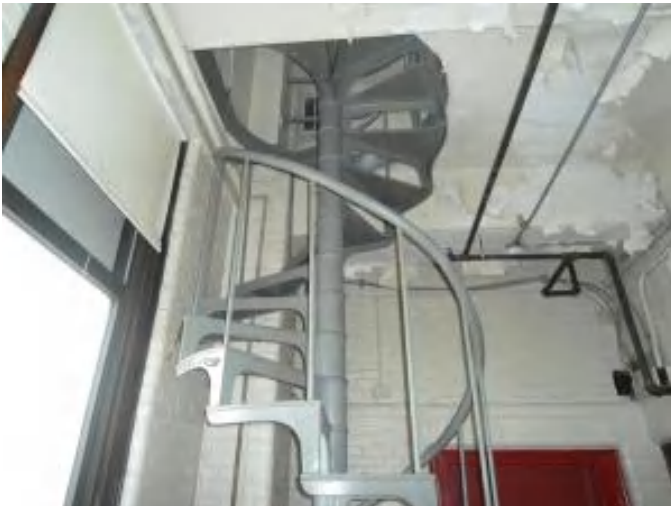
**System: C3030 - Ceiling Finishes**

**Location:** Unoccupied Spaces

**Distress:** Damaged

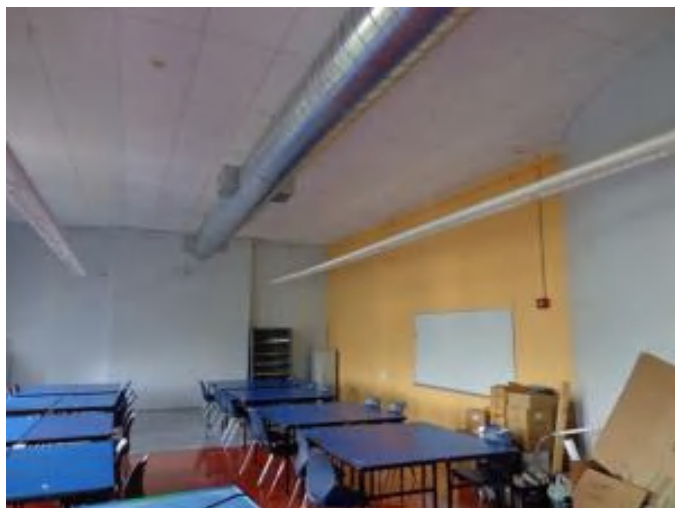
**System: D5020 - Lighting and Branch Wiring**

**Location:** Classrooms

**Distress:** Inadequate

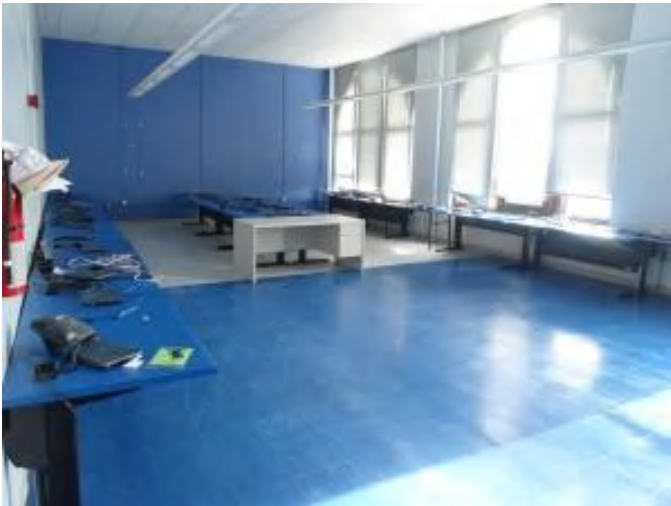
**System: C1010 - Partitions**

**Location:** Shared Classrooms

**Distress:** Damaged

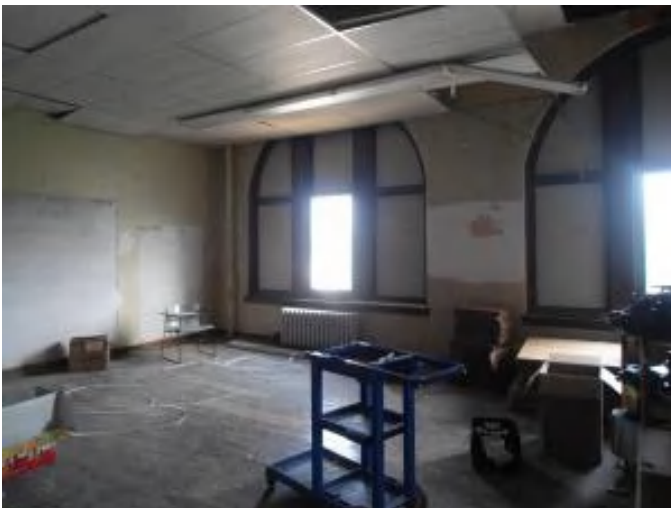
**System: C1030 - Fittings**

**Location:** Classrooms

**Distress:** Inadequate

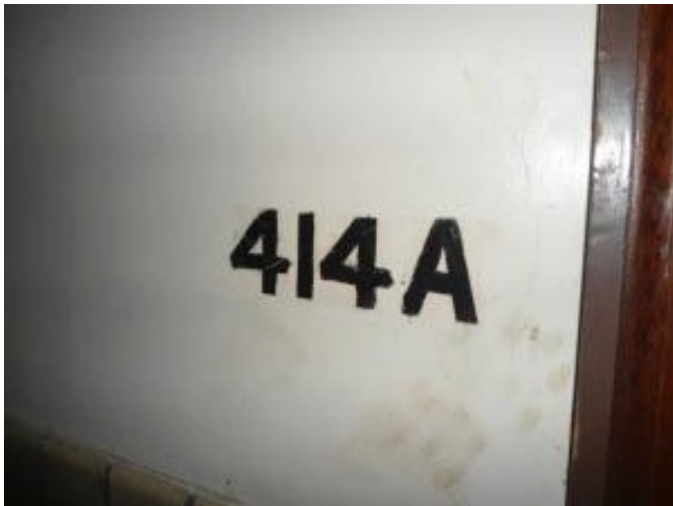
**System: C1030 - Fittings**

**Location:** Building Wide Signage

**Distress:** Beyond Service Life

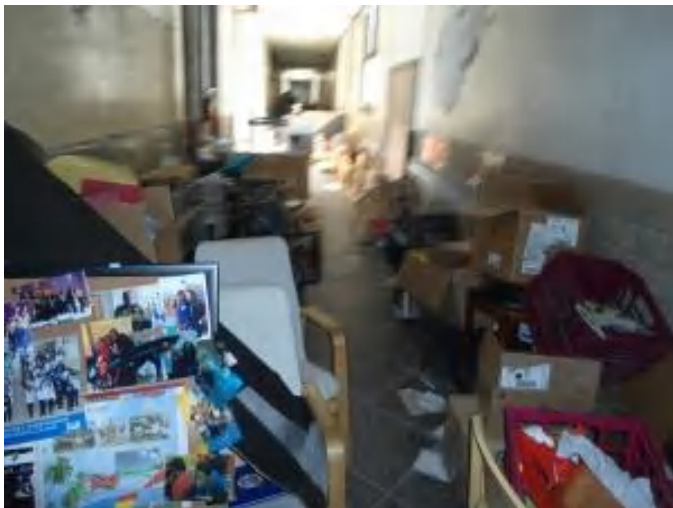
**System: C1030 - Fittings**

**Location:** Hallways

**Distress:** Damaged
