## Facility Condition Assessment Summary Report

### Smedley School

School District of Philadelphia  
**S742001;Smedley**  
Final  
**Site Assessment Report**  
February 1, 2017

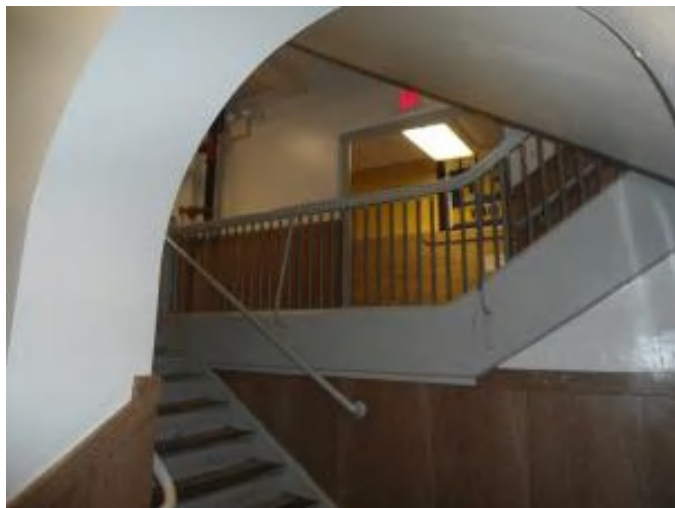
#### System: C2010 - Stair Construction

**Location:** Building Wide

**Distress:** Building / MEP Codes

- Present code and legislation regarding building accessibility by the handicapped requires that stairs have graspable handrails on both sides, that the rails have specific end geometry, and that the handrails continue past the newel posts. To comply with this legislation, the reinstallation of wall-mounted handrails and replacement center well handrails, including balustrades, on interior stairs throughout the building is recommended.

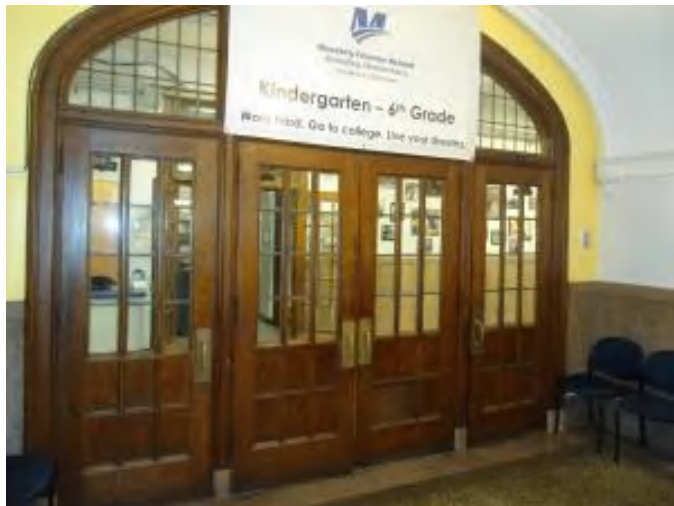
**System: C1010 - Partitions**

**Location:** Building Wide

**Distress:** Building / MEP Codes

requirements. This deficiency recommends universal removal of the existing movable partitions and upgrades to a permeate wall systems.

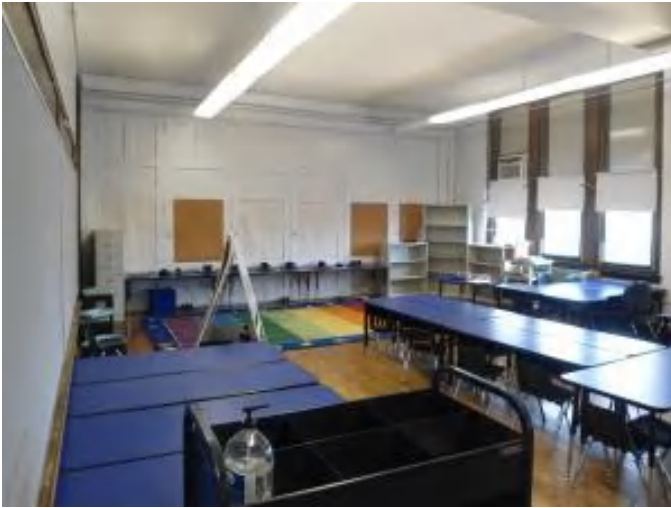
**System: C1010 - Partitions**

**Location:** Room 209

**Distress:** Building / MEP Codes

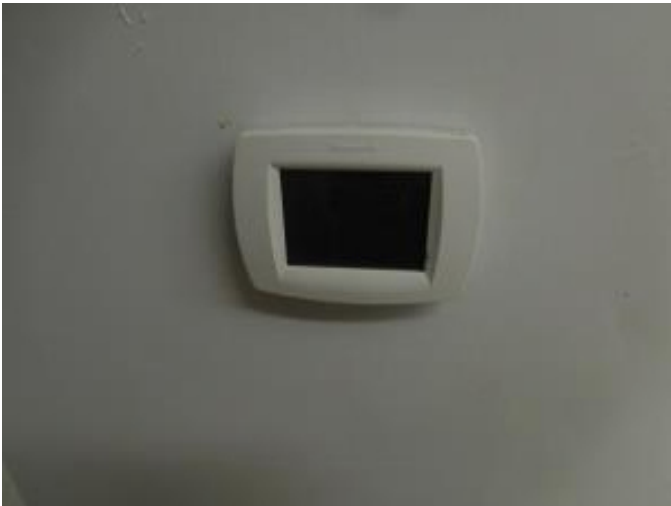
**System: D3060 - Controls & Instrumentation**

**Location:** entire building

**Distress:** Inadequate

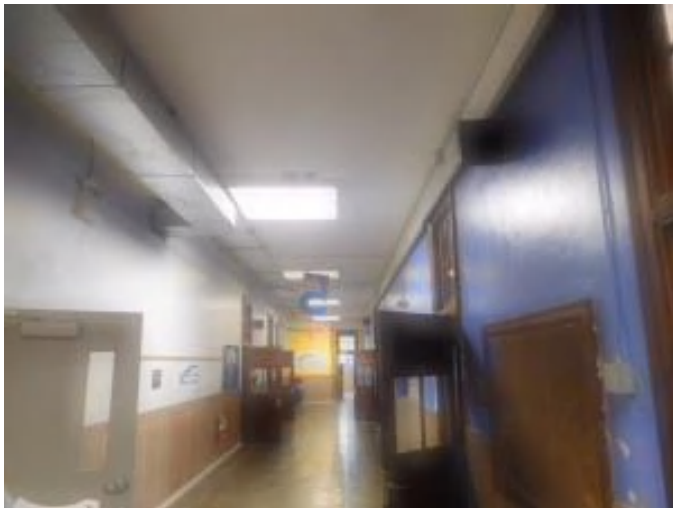
**System: D4010 - Sprinklers**

**Location:** original building

**Distress:** Life Safety / NFPA / PFD

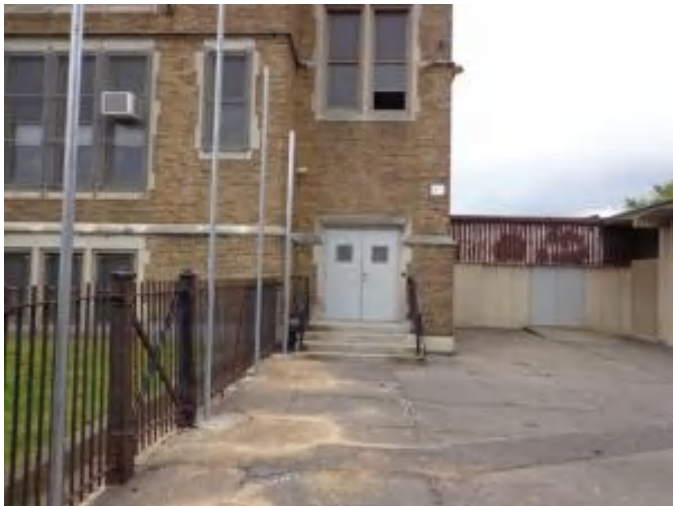
**System: D5090 - Other Electrical Systems**

**Location:** Exterior doors

**Distress:** Life Safety / NFPA / PFD

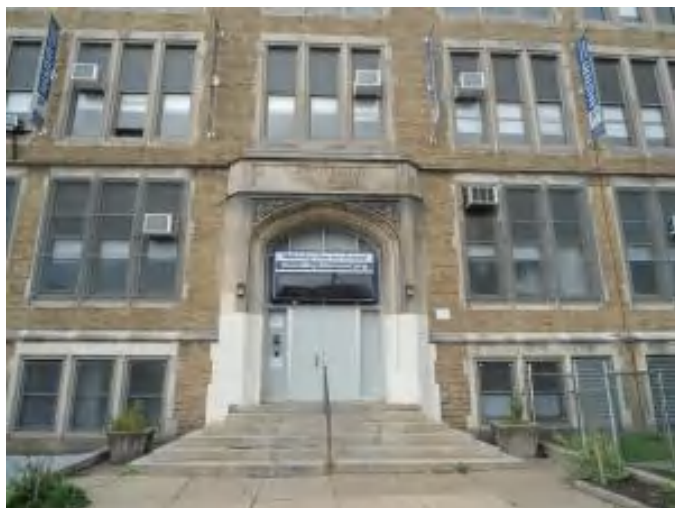
#### System: B2030 - Exterior Doors

The exterior doors are metal applications with metal frames. There is a storefront system at the main entrance with a metal-framed metal door application. The exterior door system for this school is a very high traffic system. The doors are in fair condition but are aging at a faster rate than expected based on traffic and condition. The exterior door system, store front and service doors are recommended for upgrade.

**Location:** Exterior Elevation

**Distress:** Beyond Service Life

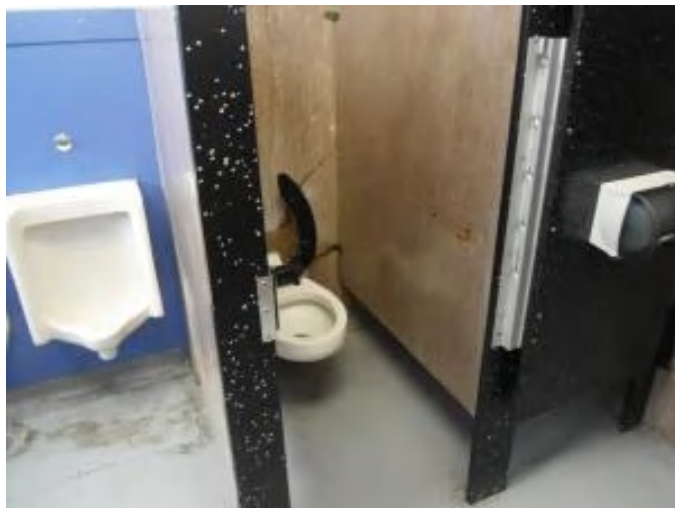
#### System: C1030 - Fittings

**Location:** Restrooms

**Distress:** Beyond Service Life

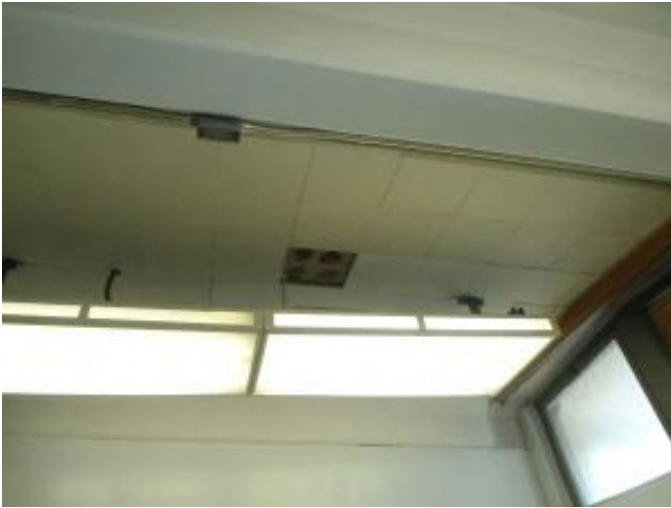
**System: C3030 - Ceiling Finishes**

The ceiling finish for this pod is a 12x12 glue on ceiling tile finish. The finish is damaged and several sections are missing and other sections are damaged from water stains. It is recommended that the ceiling finish be removed and replaced with an acoustical tile ceiling finish. The building is expected to require major upgrades and additional efforts to restore the fittings and general finishes, universal upgrades are required.

**Location:** POD 2

**Distress:** Damaged

- The ceiling finish for this pod is a 12x12 glue on ceiling tile finish. The finish is damaged and several sections are missing and other sections are damaged from water stains. It is recommended that the ceiling finish be removed and replaced with an acoustical tile ceiling finish.

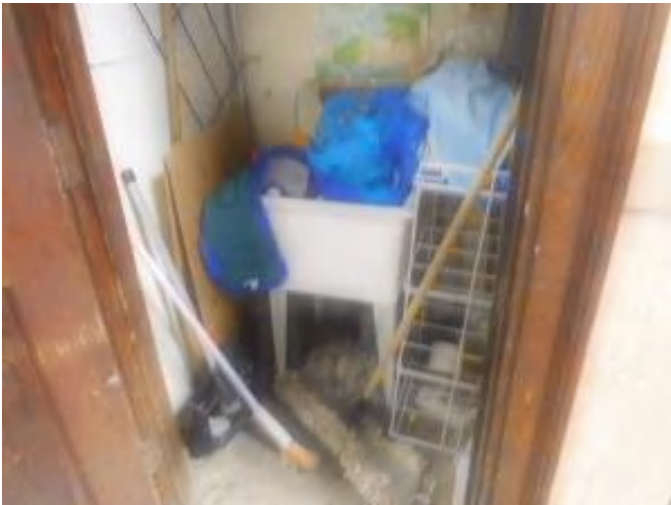
**System: D2030 - Sanitary Waste**

The newer plumbing system from the 2007 renovation has substantial remaining service life, from twenty to twenty five years. There are no visual or reported problems with the system, however the drainage piping systems in the original building have been in service since 1927 and should be inspected for damages and replaced in part. The water piping is copper and was replaced from the original installation, but based on age probably has lead solder and should be replaced.

**Location:** original building

**Distress:** Beyond Service Life

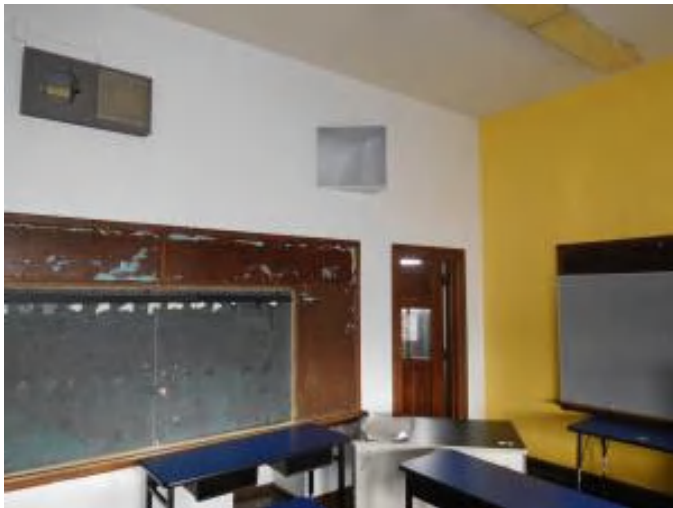
**System: D3040 - Distribution Systems**

**Location:** classrooms

**Distress:** Inadequate

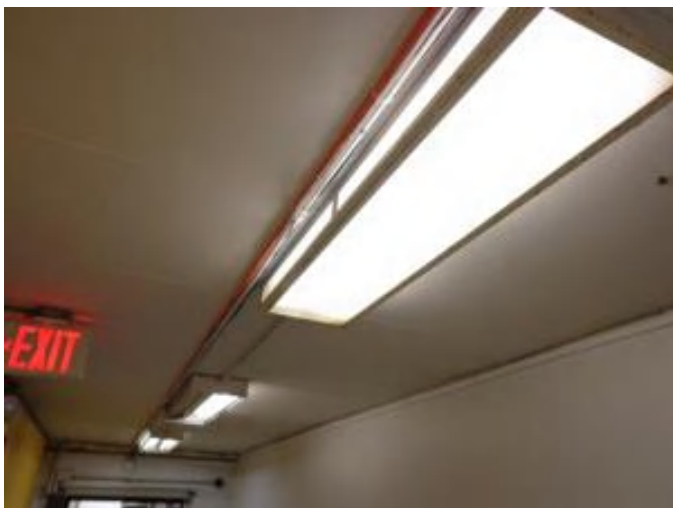
**System: D5020 - Lighting and Branch Wiring**

The lighting fixtures in the 1968 POD 1 addition have been replaced and have an expected remaining useful life that exceeds the outlook of this report. Lighting fixtures in the POD 2 addition are beyond their useful life.

**Location:** POD 2

**Distress:** Obsolete

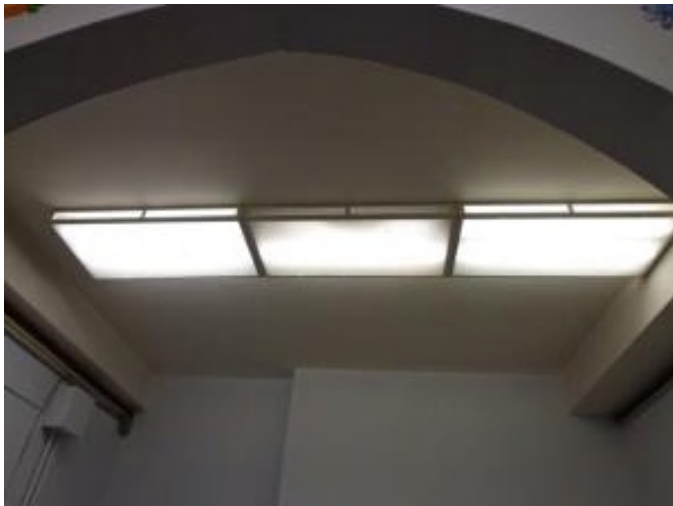
**System: D5020 - Lighting and Branch Wiring**

There are a few offices and rooms on Floors 1 and 2 that have obsolete 2x4 surface mounted modular fluorescent fixtures with T12 lamps that need to be replaced with new fixtures. An allowance is included in this report to replace obsolete fixtures.

**Location:** Offices

**Distress:** Obsolete

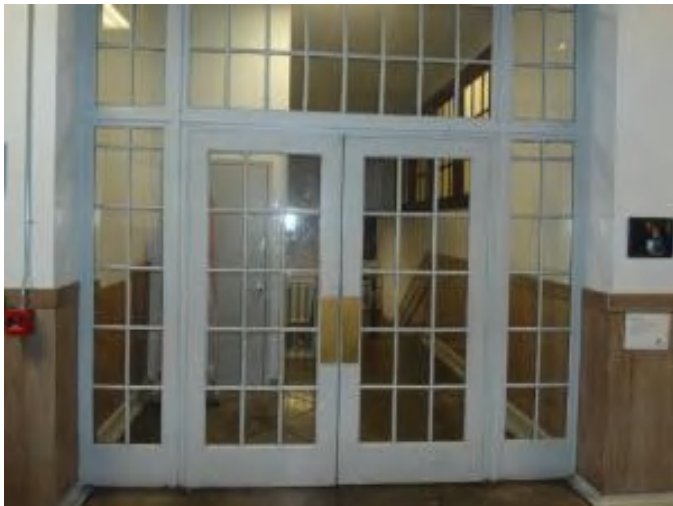
**System: D5090 - Other Electrical Systems**

**Location:** Corridors - Missing Exit Signs

**Distress:** Life Safety / NFPA / PFD

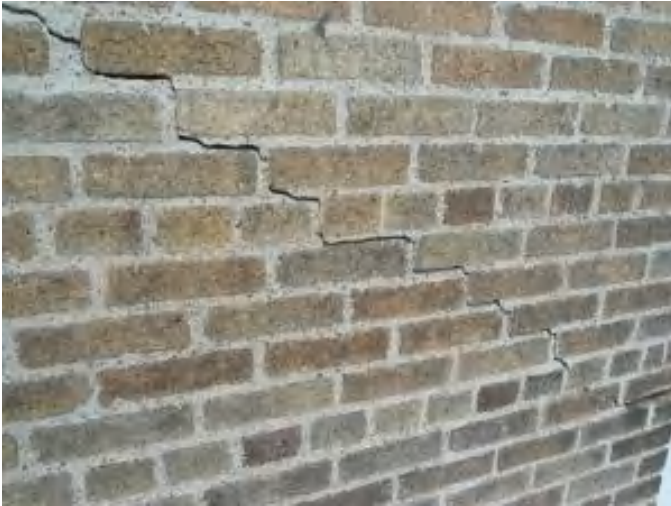
**System: B2010 - Exterior Walls**

The exterior brick surfaces are generally in fair to good condition for their age. In some locations, bricks have cracked or spalled and should be replaced. The repointing of deteriorated mortar joints is also recommended, using mortar of a similar color and consistency as the original. Following the detailed examination of the brick and repair of mortar construction joints, the entire building should be pressure washed to remove stains and embedded pollutants. If moisture is found to be penetrating the masonry facade, the application of a spray sealant to the suspected exterior masonry surface is recommended.

**Location:** Exterior Elevation

**Distress:** Damaged

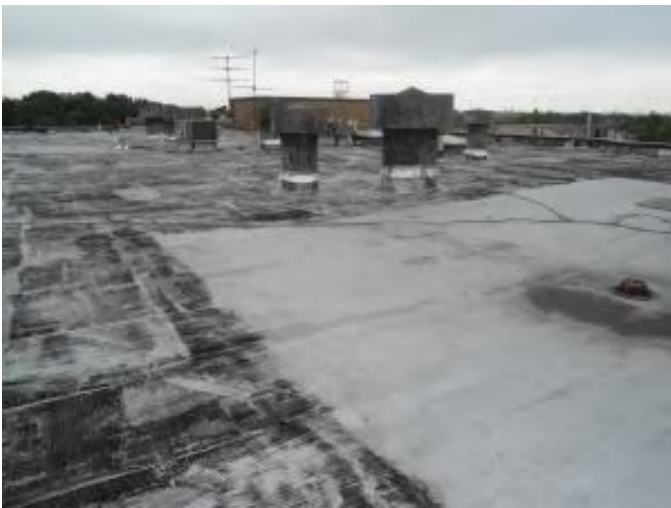
**System: B3010105 - Built-Up**

There are a number of roof sections and three different roof elevations ranging from the main, Gym roof and the POD roofs. Parapet heights, coping materials, and the height of the flashing also varies in different sections. The main roof is a built up application that was installed in the early 1980's, two small sections over the POD's and the PVC application over the Gym. Considering the age and condition of the main roofing and POD systems, universal upgrades are recommended.

**Location:** Roof

**Distress:** Beyond Service Life

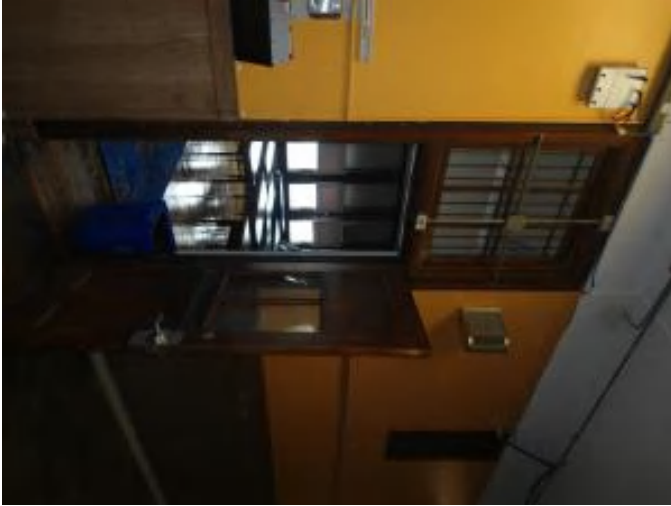
**System: C1020 - Interior Doors**

Interior doors are typically wood in wood frames with transom lites, sidelights, wired glass glazing. Other interior doors include wooden glass pane doors with original wooden pane frames, hollow metal in hollow metal frames at the new classrooms, Gym and some stairwells and exit ways, access doors. Doors are generally in good to poor condition and are a mix of ADA compliant and non-complaint doors with both non-rated and fire rated. Doors swing in the direction of exit and do not obstruct hallways. . This building is expected to require major repairs and additional efforts to restore the door finishes, universal upgrades are required however, limited upgrades will be required for the newly renovated section of this school.

**Location:** Building Wide

**Distress:** Beyond Service Life

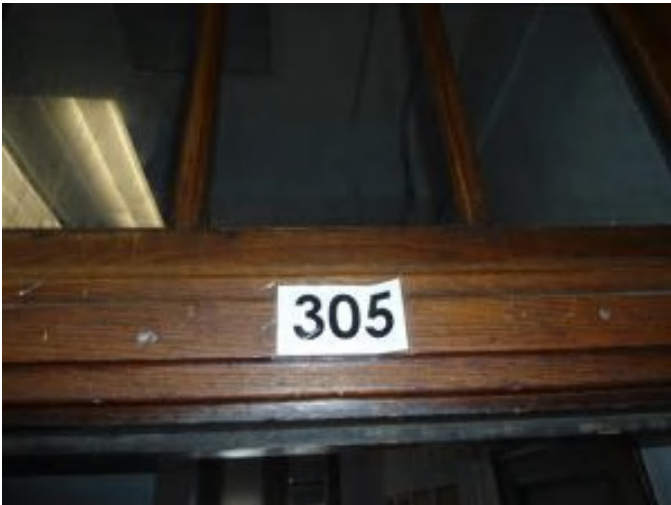
**System: C1030 - Fittings**

**Location:** Building Wide Signage

**Distress:** Beyond Service Life

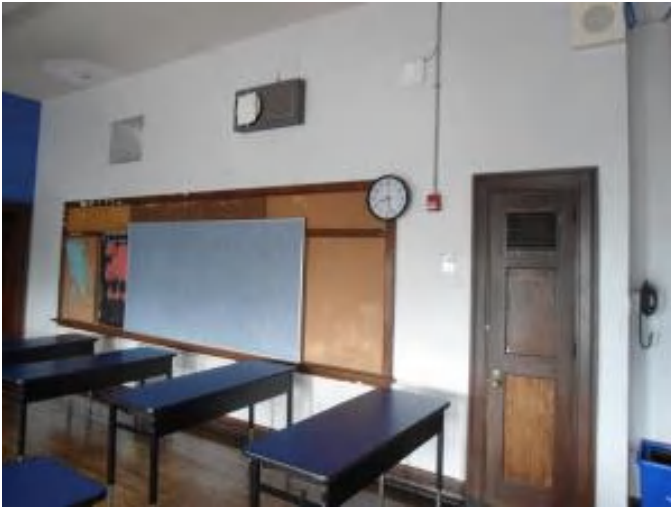
**System: C1030 - Fittings**

**Location:** Classrooms

**Distress:** Beyond Service Life

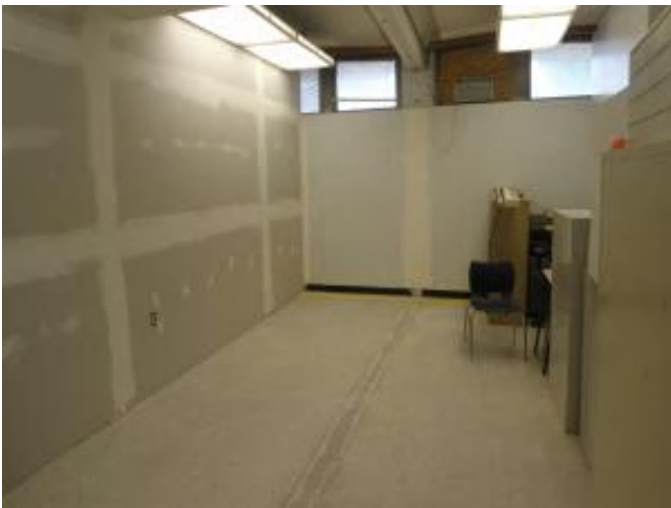
**System: C3010230 - Paint & Covering**

**Location:** Building Wide

**Distress:** Damaged

- There are several minor areas of wall damage that ranges from serious to minor. Although the school is on a cyclical program of renewal and each painted surface is renewed at year's end this system is at the point in which repairs are necessary. Remove damaged wall finishes and repair areas then apply primer and paint finish.

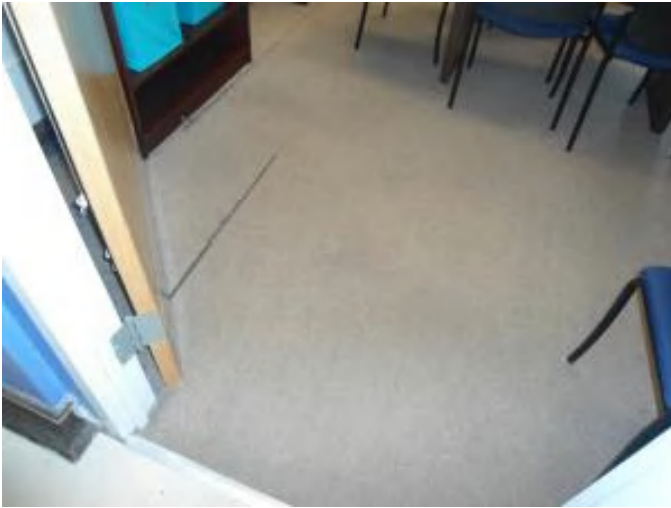
**System: C3020411 - Carpet**

**Location:** Administration Area

**Distress:** Beyond Service Life

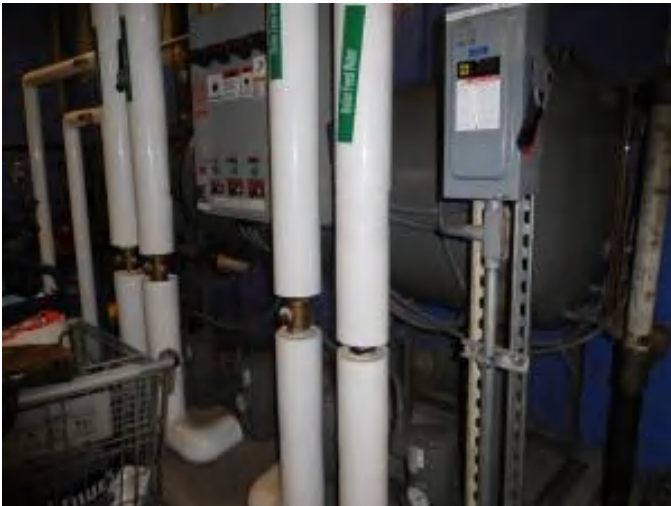
**System: D2020 - Domestic Water Distribution**

**Location:** original building

**Distress:** Beyond Service Life

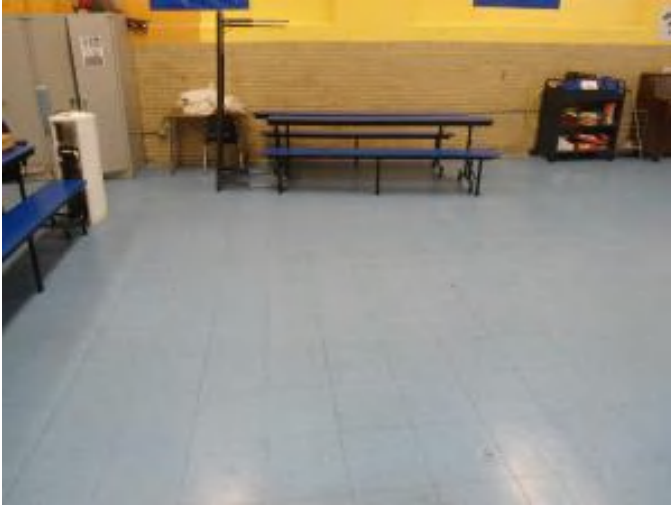
**System: D3040 - Distribution Systems**

**Location:** cafeteria

**Distress:** Inadequate

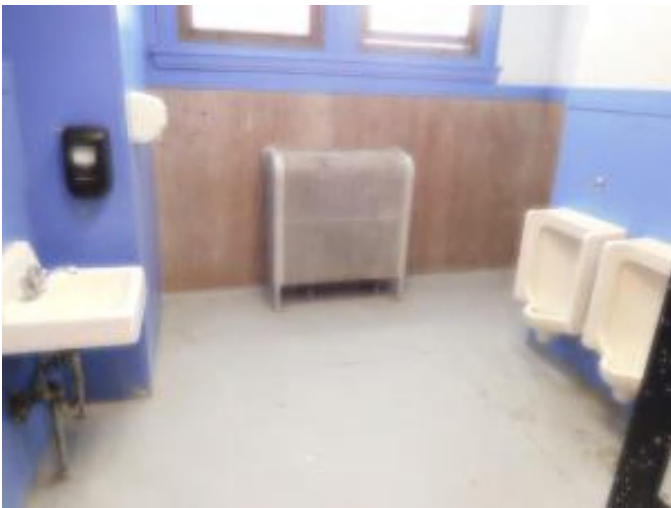
**System: D3040 - Distribution Systems**

**Location:** toilet rooms

**Distress:** Building / MEP Codes

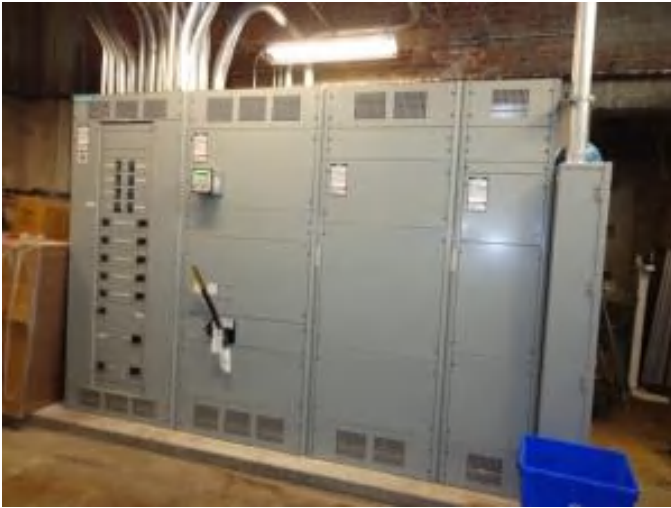
**System: D5010 - Electrical Service/Distribution**

**Location:** Main Electrical Room

**Distress:** Inadequate

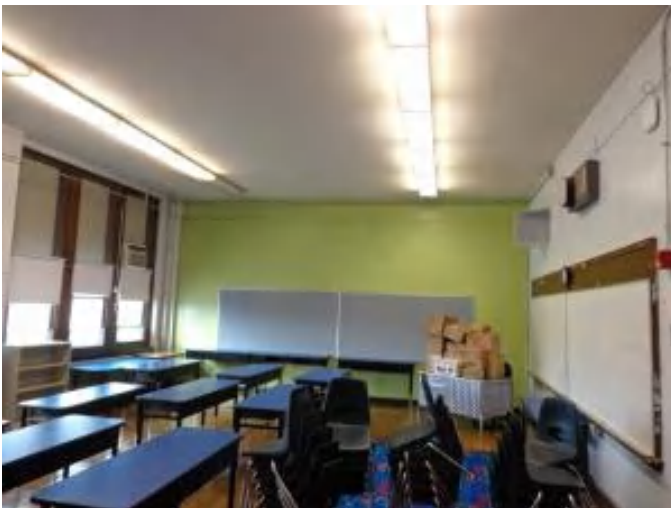
**System: D5020 - Lighting and Branch Wiring**

**Location:** Classrooms

**Distress:** Inadequate

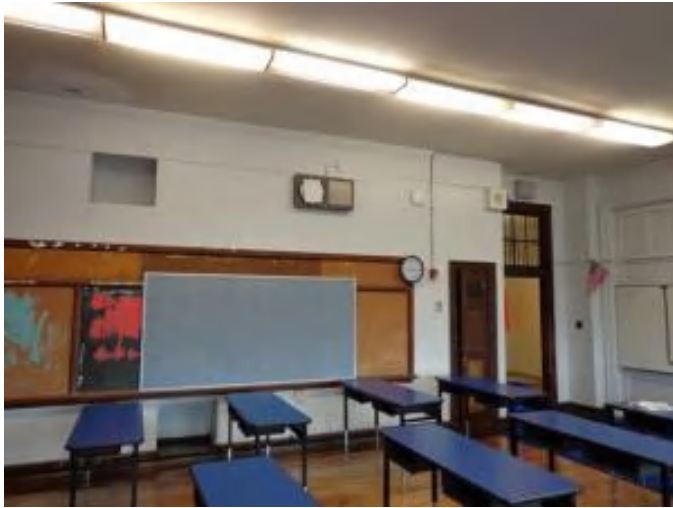
**System: D5030 - Communications and Security**

**Location:** Classrooms/Offices

**Distress:** Beyond Service Life

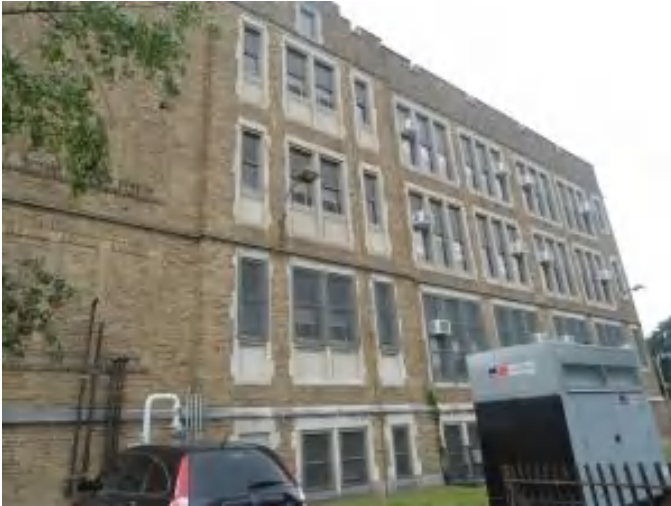
**System: B2020 - Exterior Windows**

Exterior windows are aluminum framed single pane windows. Windows are in fair condition based on the year of installation or last renovation. The exterior window system is recommended to be replaced with units that retain their dimensions and profiles, but that incorporate updated energy-efficient features.

**Location:** Exterior Elevation

**Distress:** Beyond Service Life

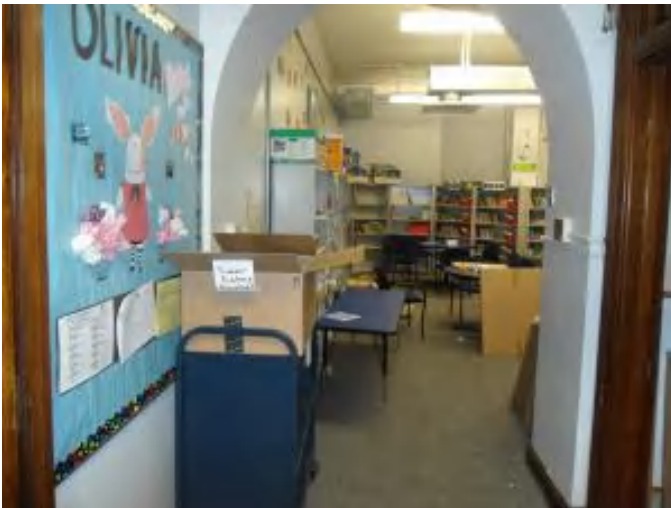
**System: C1030 - Fittings**

**Location:** Building Wide

**Distress:** Beyond Service Life

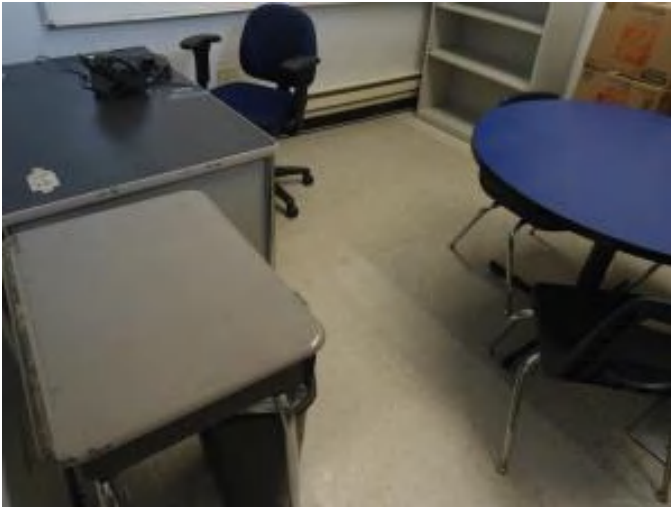
**System: C3020413 - Vinyl Flooring**

The cafeteria, both educational pods and select areas such as the staff restrooms has a 12x12 vinyl floor tile finish. Some of the flooring was upgraded during the 2011 renovation effort and is in very good condition. There are some sections that were not a part of that effort and the finish is beyond the expected life cycle. The older finishes are in fair condition and upgrades are recommended within the next five years. Remove and replace 12x12 vinyl tile application.

**Location:** Building Wide

**Distress:** Beyond Service Life

- The cafeteria, both educational pods and select areas such as the staff restrooms has a 12x12 vinyl floor tile finish. Some of the flooring was upgraded during the 2011 renovation effort and is in very good condition. There are some sections that were not a part of that effort and the finish is beyond the expected life cycle. The older finishes are in fair condition and upgrades are recommended within the next five years. Remove and replace 12x12 vinyl tile application.

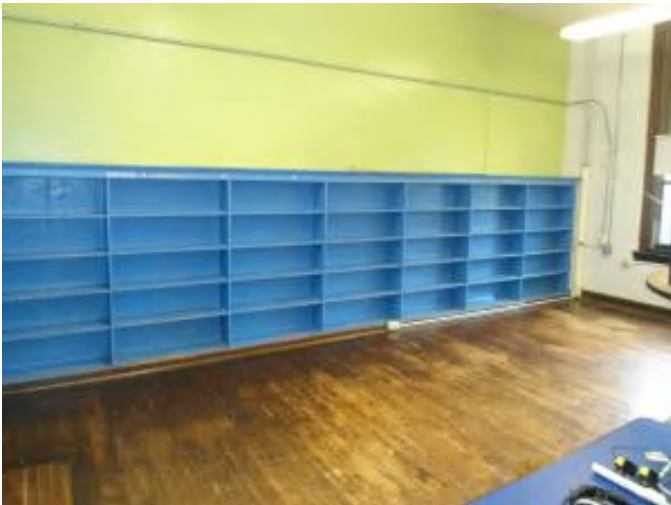
**System: C3020414 - Wood Flooring**

**Location:** Classrooms

**Distress:** Damaged

- It is recommended that the wooden floor finish be removed and replaced with an in kind finish.
- The interior carpet finish was installed in 2011 and is in fair condition considering the age and high traffic conditions. This finish will exceed its expected life within the next five years and is recommended for upgrade.

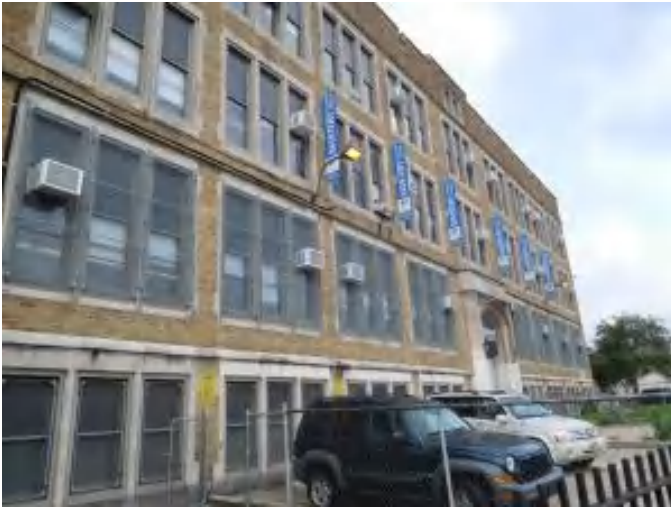
**System: D3030 - Cooling Generating Systems**

**Location:** roof, mechanical room

**Distress:** Inadequate

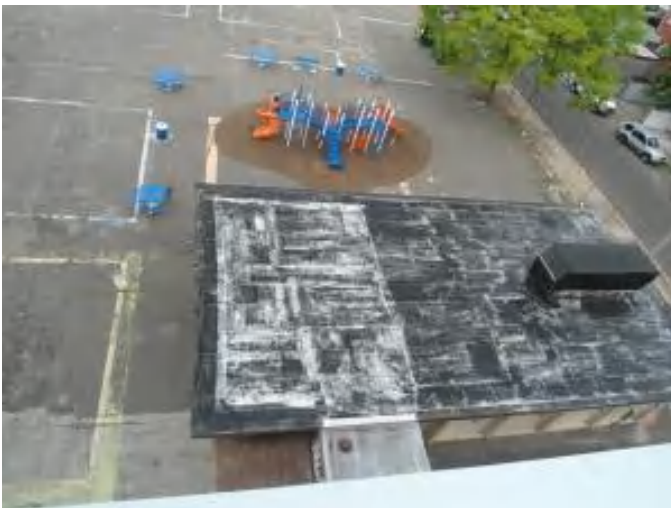
**System: D3050 - Terminal & Package Units**

The original portion of the building has approximately sixty window air conditioners for cooling as well as (2) four ton rooftop units on the addition roof. There is a Mitsubishi ductless split system for the IT room with a console indoor unit and the condensing unit mounted on an exterior wall. The pods also have window air conditioners. The gym and classroom addition roof houses four York rooftop units. There are two four ton units serving portions of the original building, one twenty ton unit for the gym and one thirty ton VAV unit serving new classrooms and hallways. There is no central cooling for the cafeteria or two pod areas.

**Location:** two pod additions

**Distress:** Inadequate

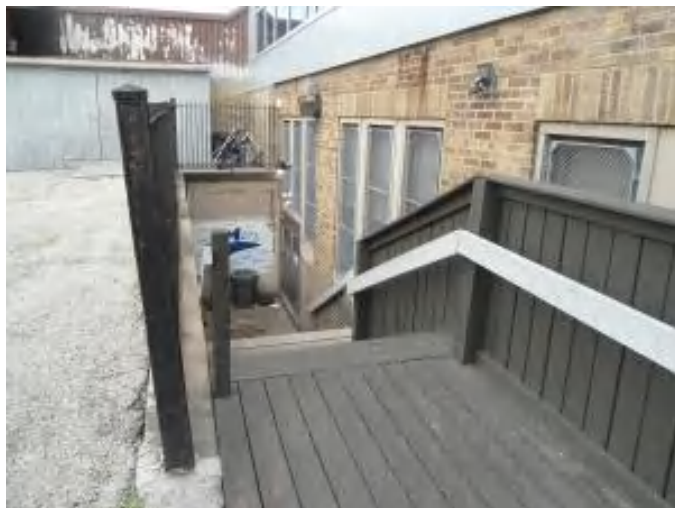
#### System: G2040 - Site Development

The wooden hand rails to the basement level entrance are not current with requirements that the hand rails be graspable and continuous. Remove the wooden application and replace with a metal hand and guard rail system.

**Location:** Site

**Distress:** Building / MEP Codes

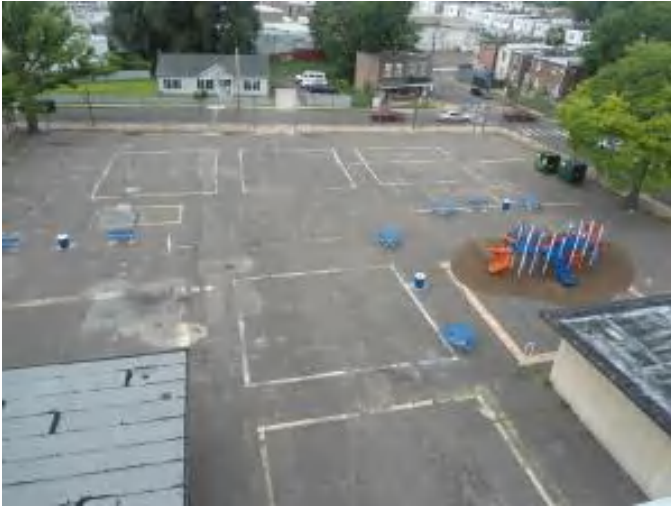
**System: G2020 - Parking Lots**

The parking lots are in poor condition, the harsh environmental conditions associated with snow removal have taken its toll on the asphalt surface. Also, there is no marked path of ingress to the main entrance. This project provides a budgetary consideration for a parking lot renewal program that includes all aspects of the current ADA legislation. Universal upgrades are recommended.

**Location:** Site

**Distress:** Beyond Service Life

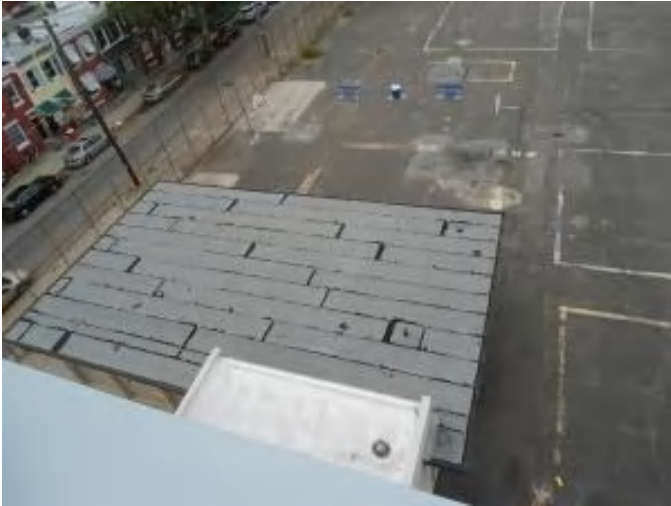
**System: G2040 - Site Development**

This school has a perimeter fence surrounding the parking / playground area. The fence has several areas of repairs and the mounting posts are damaged in several areas, overall the fence is in fair condition. This fence system is recommended to be removed and replaced with a new system within the next five to ten years

**Location:** Site

**Distress:** Beyond Service Life

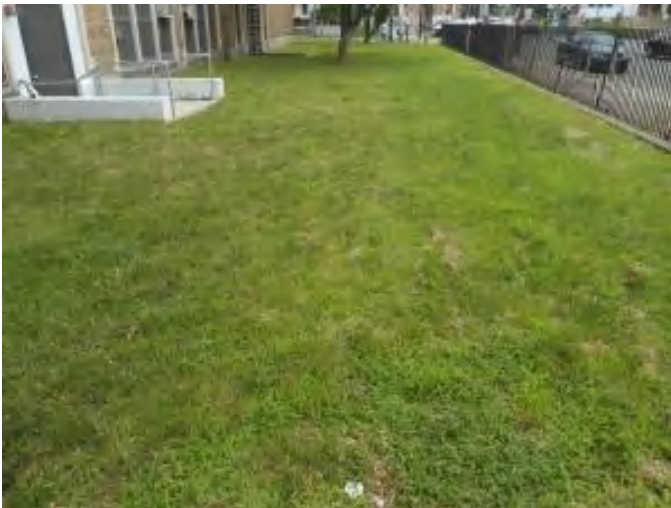
**System: G2050 - Landscaping & Irrigation**

The landscaping is in good condition and well maintained but with no irrigation system. The landscaping is generally located on the northern and eastern sides of the site. This deficiency provides a budgetary consideration for the installation of an irrigation system for this site.

**Location:** Site

**Distress:** Inadequate
