Facility Condition Assessment Summary Report

Solis-Cohen School

School District of Philadelphia
S834001;Solis-Cohen
Final
Site Assessment Report
January 31, 2017

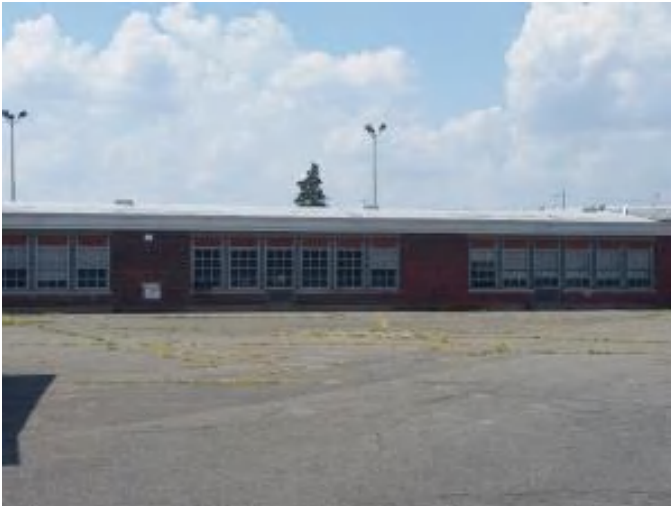
System: B3010105 - Built-Up

Location: roof

Distress: Failing

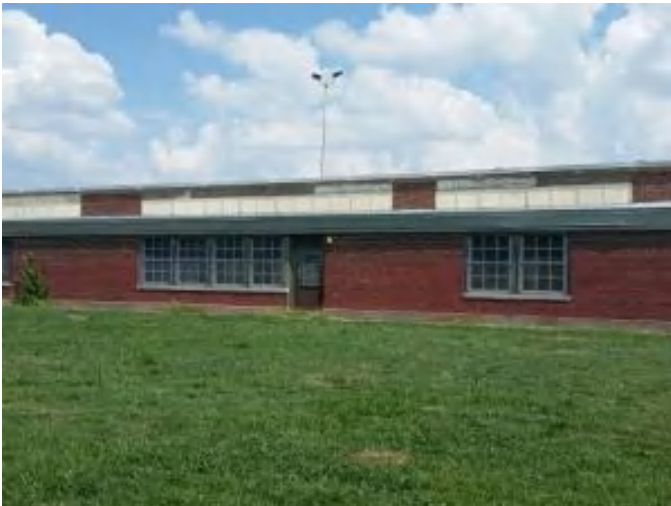
System: B3010105 - Built-Up

Location: edges of all built-up roofs

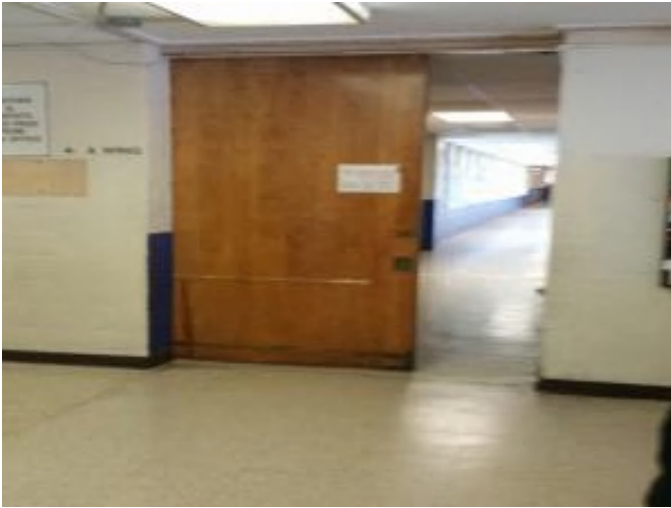
System: C1010 - Partitions

Location: fire doors at beginning of each corridor

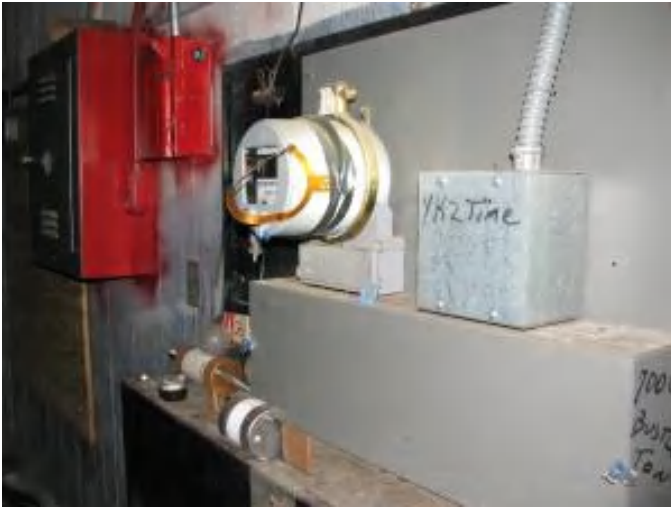
System: D5010 - Electrical Service/Distribution

Location: Basement
Distress: Beyond Service Life
Category: 3 - Operations / Maint.
Priority: 1 - Response Time (< 2 yr)
Correction: Add Electrical Switchgear and Distribution System
Qty: 0.00
Unit of Measure: Ea.
Estimate: \$1,029,400.43
Assessor Name: System
Date Created: 08/23/2015

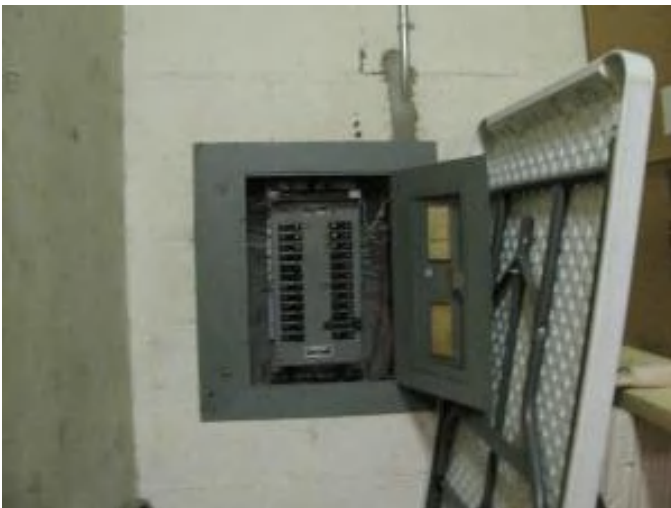
System: D5010 - Electrical Service/Distribution

Location: Entire Building
Distress: Beyond Service Life
Category: 3 - Operations / Maint.
Priority: 1 - Response Time (< 2 yr)
Correction: Replace Electrical Distribution System (U)
Qty: 1.00
Unit of Measure: Ea.
Estimate: \$453,802.84
Assessor Name: System
Date Created: 09/08/2015

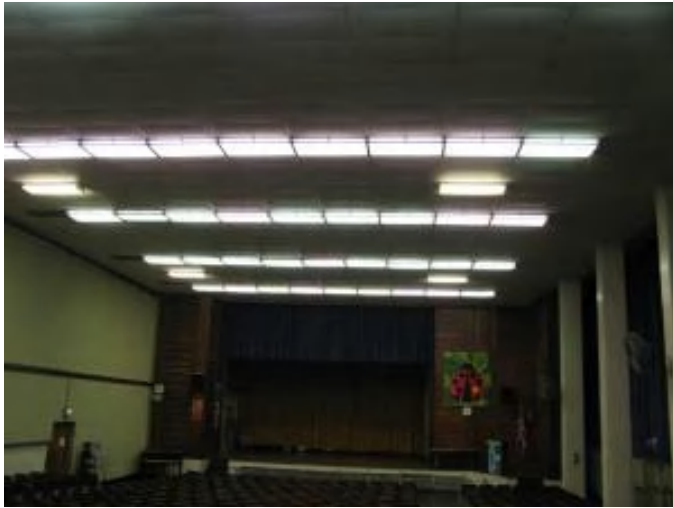
System: D5020 - Lighting and Branch Wiring

Location: Entire Building
Distress: Beyond Service Life
Category: 3 - Operations / Maint.
Priority: 1 - Response Time (< 2 yr)
Correction: Replace Lighting Fixtures (SF)
Qty: 1.00
Unit of Measure: S.F.
Estimate: \$1,300,761.38
Assessor Name: System
Date Created: 09/08/2015

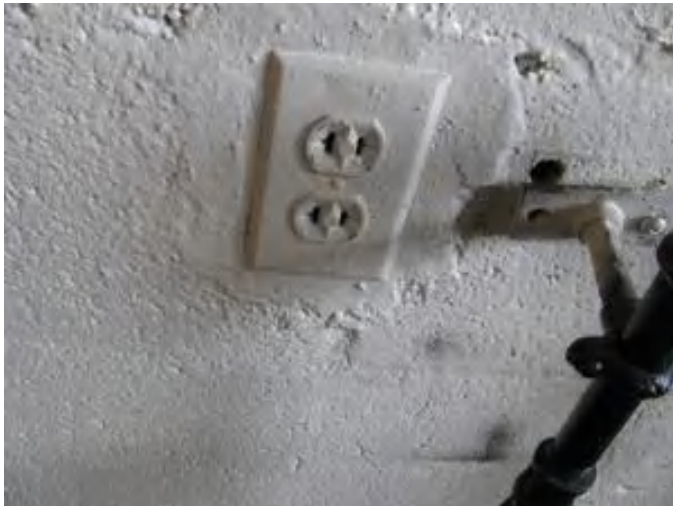
System: D5020 - Lighting and Branch Wiring

Location: Entire Building
Distress: Inadequate
Category: 4 - Capital Improvement
Priority: 1 - Response Time (< 2 yr)
Correction: Replace Wiring Devices (SF) - surface mounted conduit and boxes
Qty: 1.00
Unit of Measure: S.F.
Estimate: \$463,598.10
Assessor Name: System
Date Created: 09/08/2015

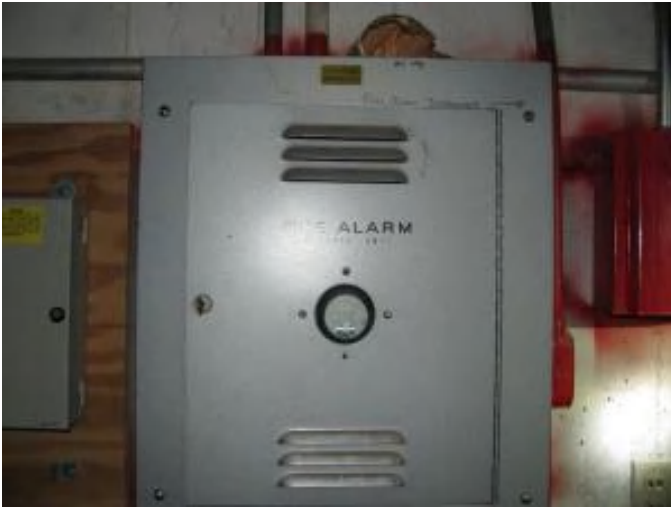
System: D5030 - Communications and Security

Location: Entire Building
Distress: Beyond Service Life
Category: 3 - Operations / Maint.
Priority: 1 - Response Time (< 2 yr)
Correction: Replace fire alarm system
Qty: 1.00
Unit of Measure: S.F.
Estimate: \$416,863.62
Assessor Name: System
Date Created: 09/08/2015

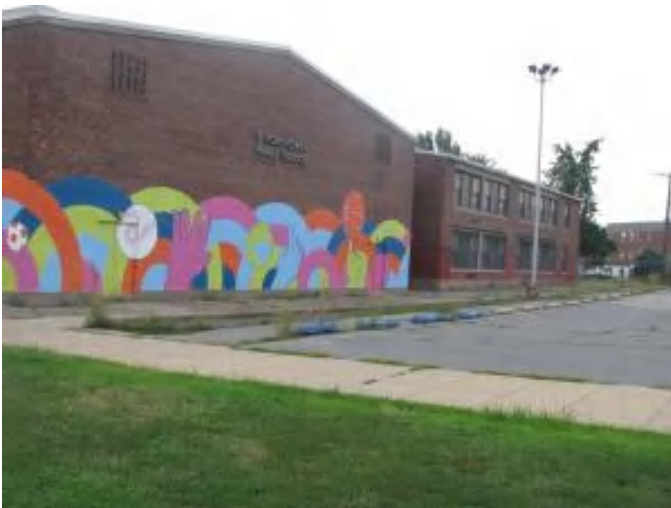
System: D5030 - Communications and Security

Location: Entire Building
Distress: Life Safety / NFPA / PFD
Category: 1 - Health & Safety
Priority: 1 - Response Time (< 2 yr)
Correction: Add/Replace Video Surveillance System
Qty: 1.00
Unit of Measure: Ea.
Estimate: \$252,769.70
Assessor Name: System
Date Created: 09/08/2015

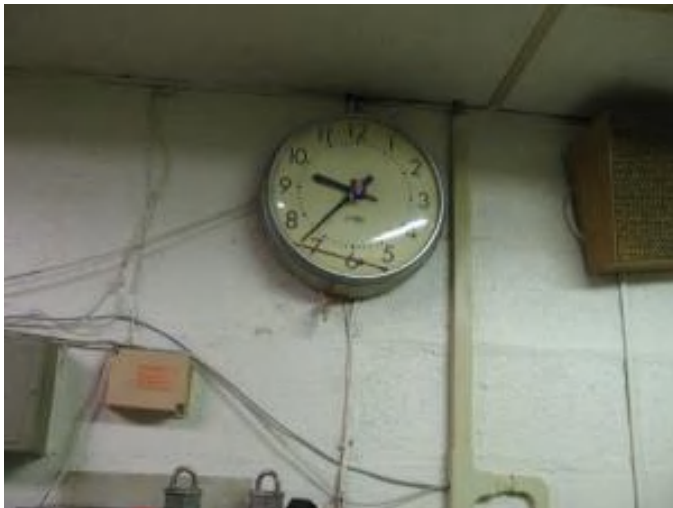
System: D5030 - Communications and Security

Location: Entire building
Distress: Inadequate
Category: 4 - Capital Improvement
Priority: 1 - Response Time (< 2 yr)
Correction: Add/Replace Clock System or Components
Qty: 1.00
Unit of Measure: Ea.
Estimate: \$216,559.96
Assessor Name: System
Date Created: 09/08/2015

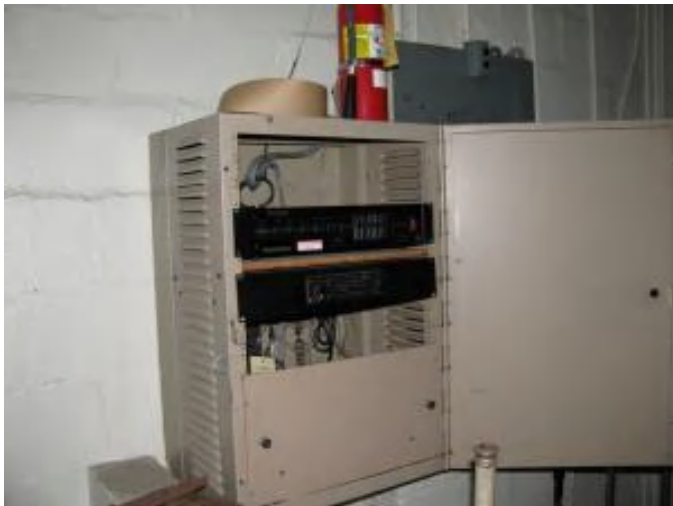
System: D5030 - Communications and Security

Location: Auditorium
Distress: Inadequate
Category: 4 - Capital Improvement
Priority: 1 - Response Time (< 2 yr)
Correction: Add/Replace Sound System
Qty: 1.00
Unit of Measure: LS
Estimate: \$45,710.66
Assessor Name: System
Date Created: 09/08/2015

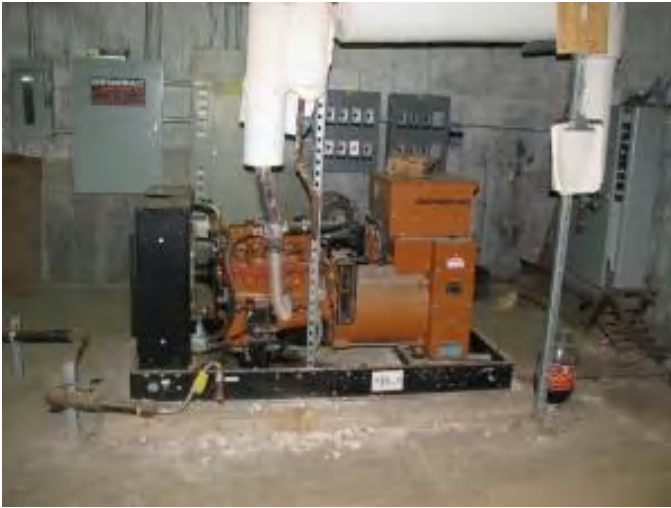
System: D5090 - Other Electrical Systems

Location: Boiler Room
Distress: Beyond Service Life
Category: 3 - Operations / Maint.
Priority: 1 - Response Time (< 2 yr)
Correction: Add Standby Generator System
Qty: 1.00
Unit of Measure: Ea.
Estimate: \$235,102.20
Assessor Name: System
Date Created: 09/08/2015

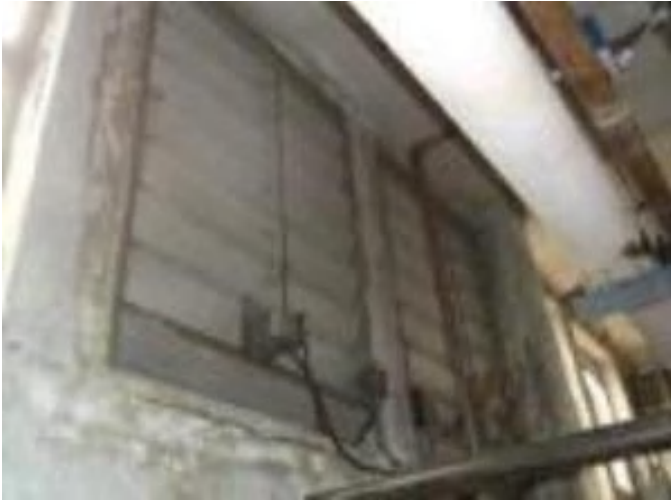
System: A2020 - Basement Walls

Location: basement

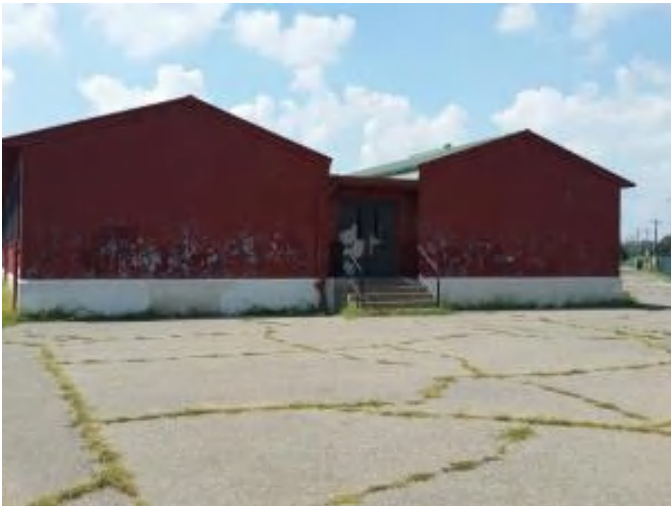
System: B2010 - Exterior Walls

Location: Wing D

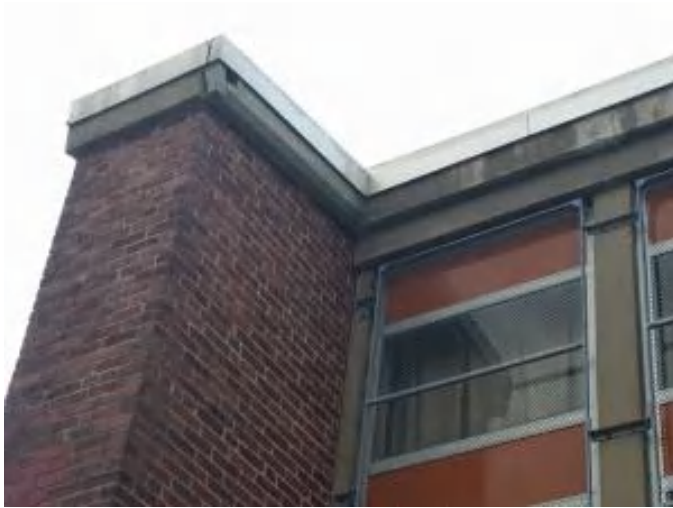
System: B2010 - Exterior Walls

Location: concrete roof deck

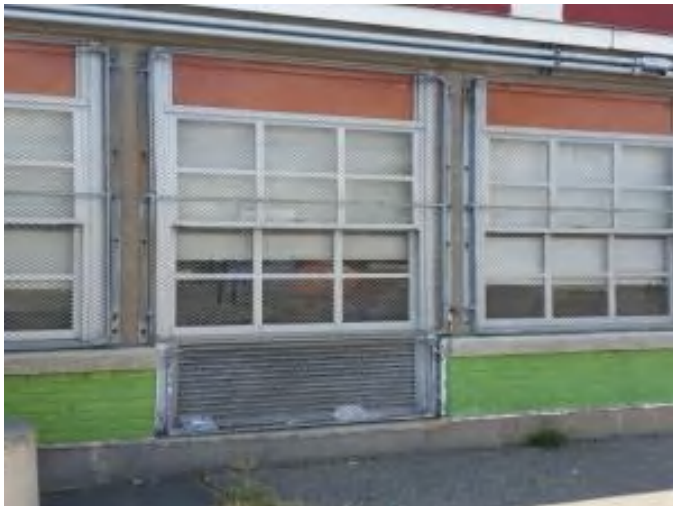
System: B2010 - Exterior Walls

Location: exterior walls

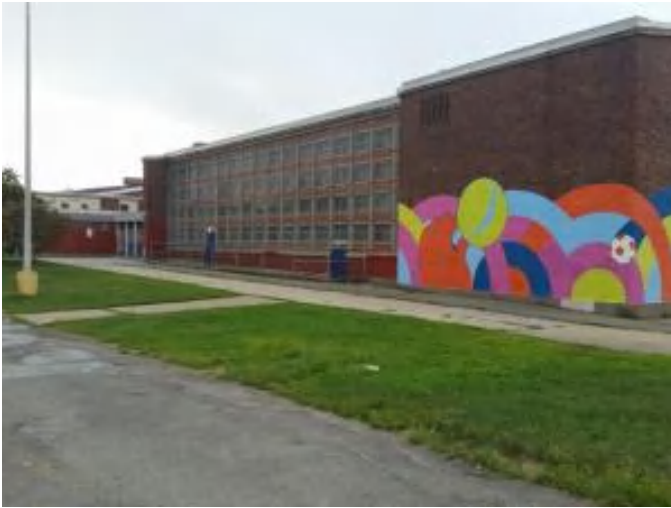
System: B2010 - Exterior Walls

Location: exterior walls at univents

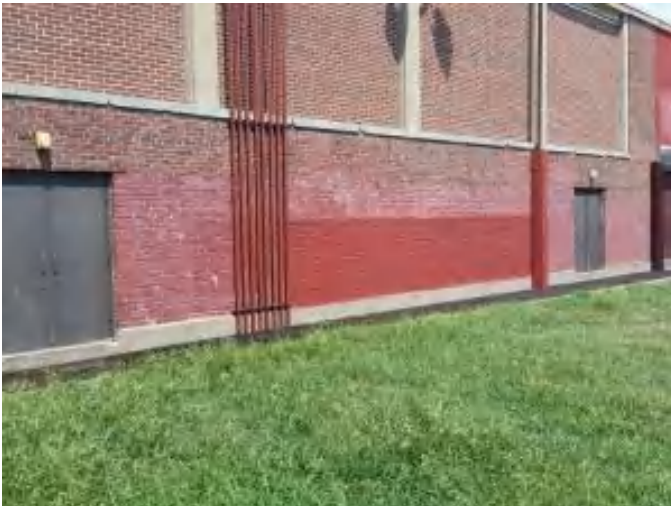
System: B2010 - Exterior Walls

Location: exterior window sills and heads

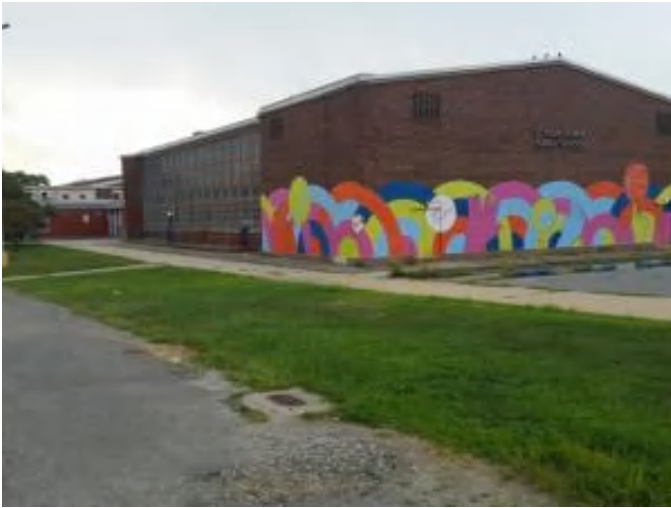
System: B2010 - Exterior Walls

Location: exterior walls
Distress: Damaged
Category: 3 - Operations / Maint.
Priority: 2 - Response Time (2-3 yrs)
Correction: Repair cracks in masonry - replace missing mortar and repoint - SF of wall area
Qty: 500.00
Unit of Measure: S.F.
Estimate: \$16,144.74
Assessor Name: System
Date Created: 09/15/2015

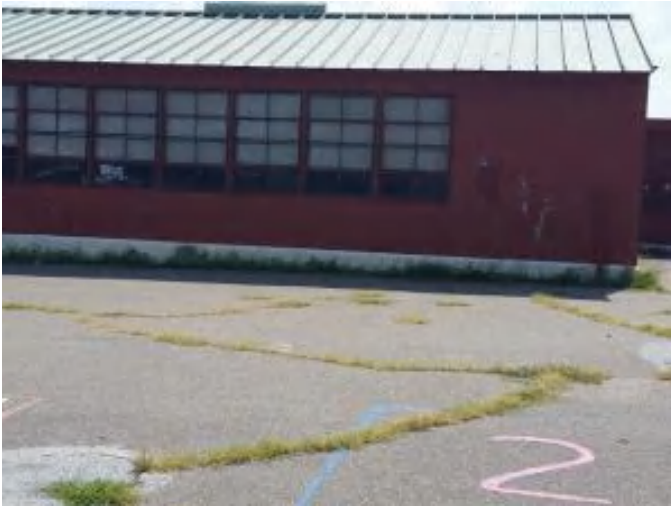
System: B2020 - Exterior Windows

Location: all exterior walls
Distress: Beyond Service Life
Category: 3 - Operations / Maint.
Priority: 2 - Response Time (2-3 yrs)
Correction: Remove and replace aluminum windows - pick the appropriate size and style and insert the number of units
Qty: 400.00
Unit of Measure: Ea.
Estimate: \$1,918,025.79
Assessor Name: System
Date Created: 09/15/2015

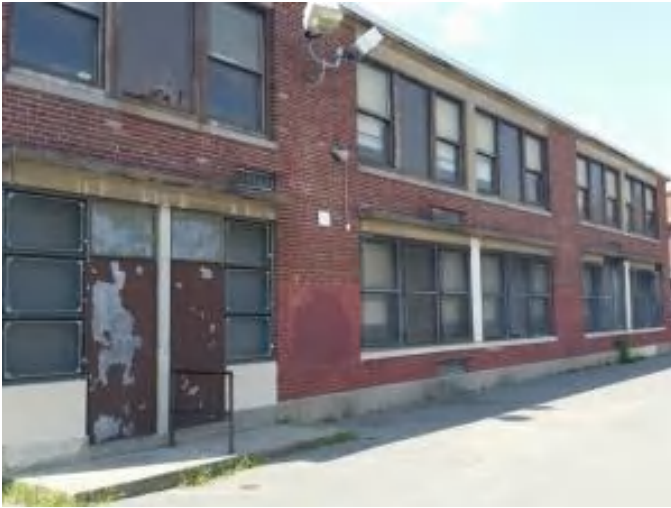
System: B2030 - Exterior Doors

Location: all exterior doors

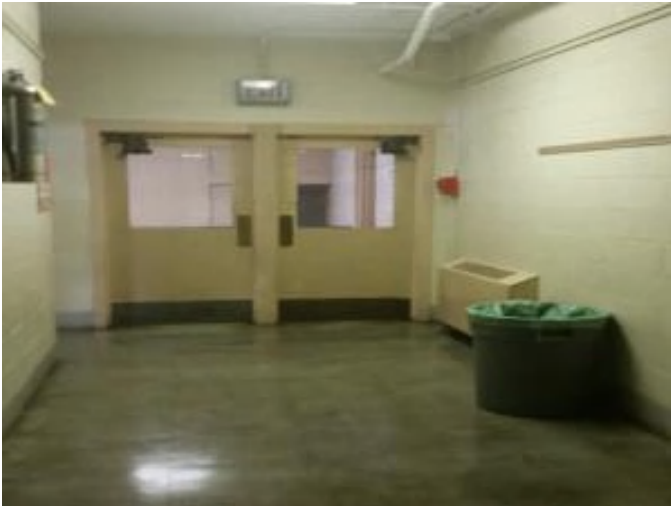
System: C1020 - Interior Doors

Location: interior doors

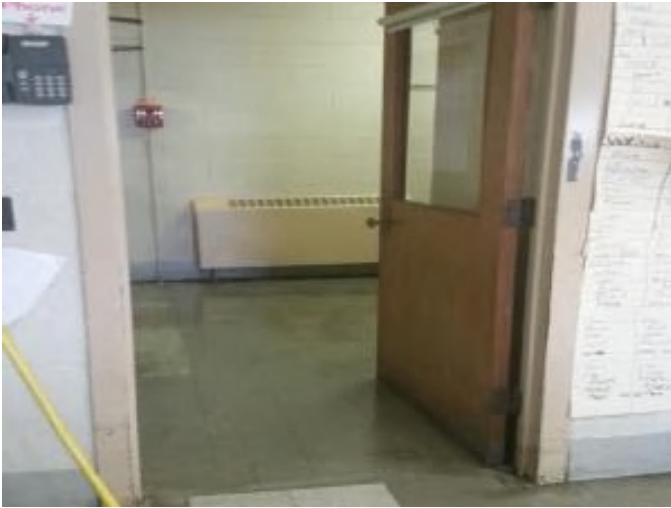
System: C1020 - Interior Doors

Location: all interior doors

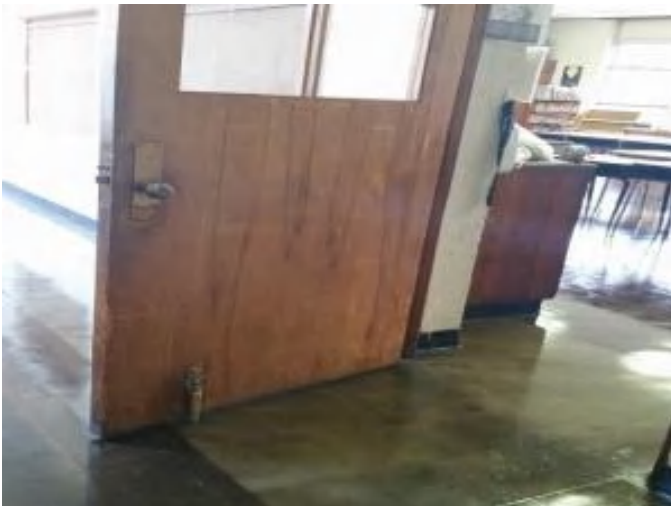
System: C1020 - Interior Doors

Location: classrooms and offices

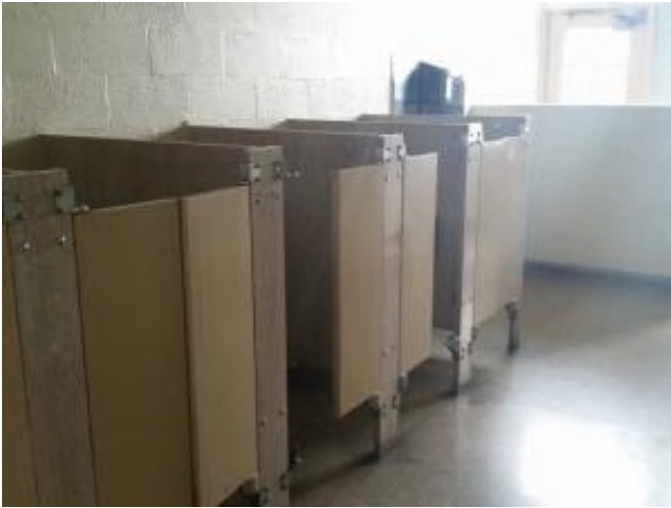
System: C1030 - Fittings

Location: toilet rooms

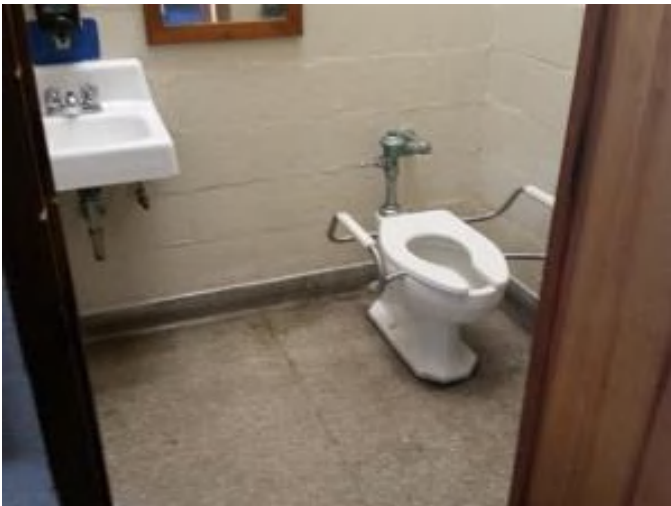
System: C1030 - Fittings

Location: toilet rooms

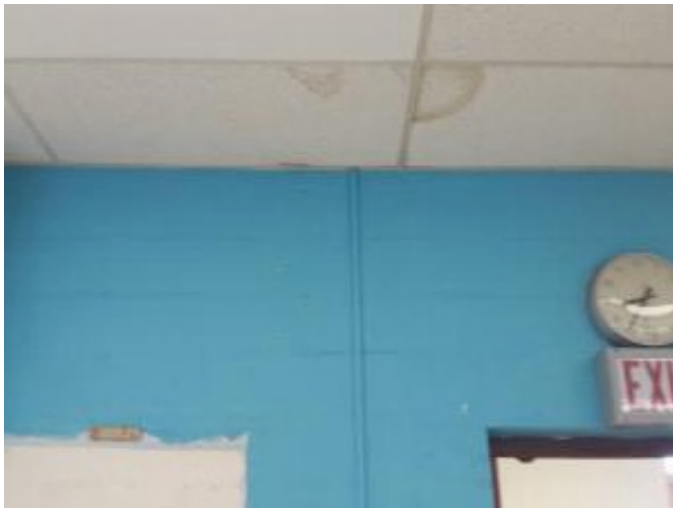
System: C3010230 - Paint & Covering

Location: interior walls
Distress: Appearance
Category: 3 - Operations / Maint.
Priority: 2 - Response Time (2-3 yrs)
Correction: Repair and repaint all interior walls - SF of wall surface
Qty: 100,000.00
Unit of Measure: S.F.
Estimate: \$510,848.70
Assessor Name: System
Date Created: 09/15/2015

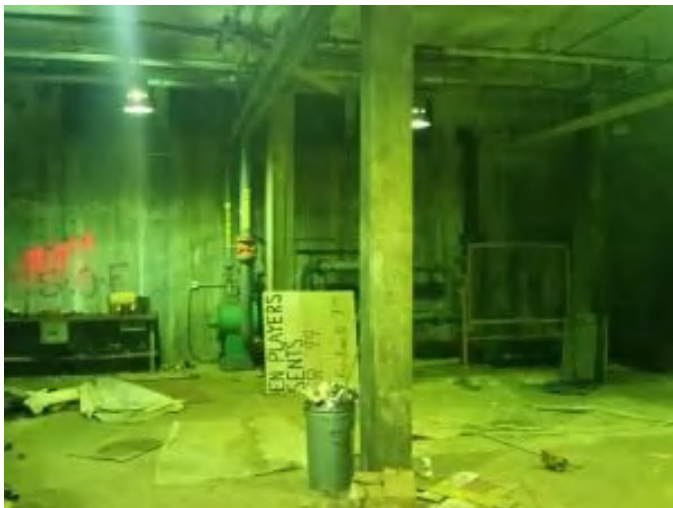
System: C3010230 - Paint & Covering

Location: mechanical areas
Distress: Failing
Category: 3 - Operations / Maint.
Priority: 2 - Response Time (2-3 yrs)
Correction: Repair substrate and repaint interior concrete or CMU walls - SF of wall surface
Qty: 3,000.00
Unit of Measure: S.F.
Estimate: \$16,231.74
Assessor Name: System
Date Created: 09/15/2015

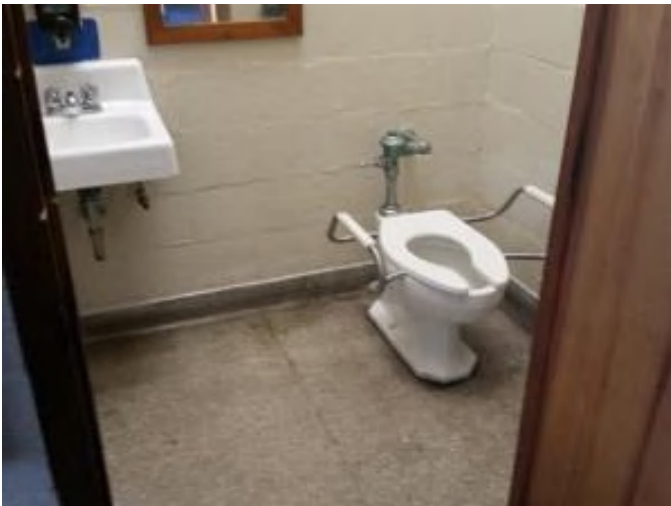
System: C3020412 - Terrazzo & Tile

Location: Room 9A toilet room

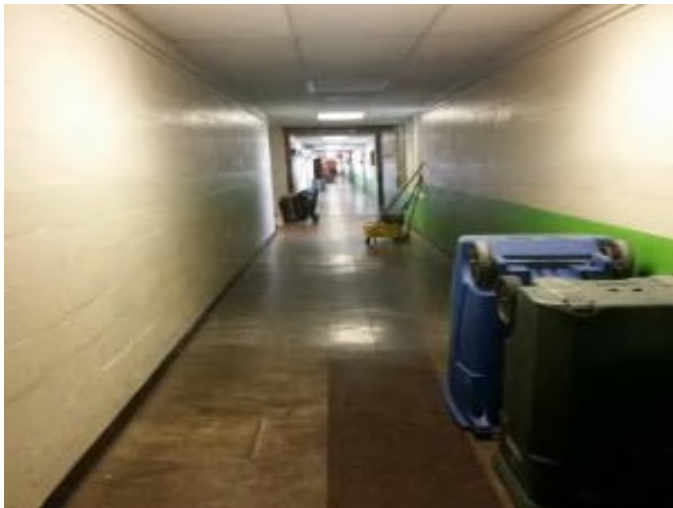
System: C3020413 - Vinyl Flooring

Location: floors
Distress: Health Hazard / Risk
Category: 1 - Health & Safety
Priority: 2 - Response Time (2-3 yrs)
Correction: Remove VAT and replace with VCT - SF of area
Qty: 60,000.00
Unit of Measure: S.F.
Estimate: \$646,248.78
Assessor Name: System
Date Created: 09/15/2015

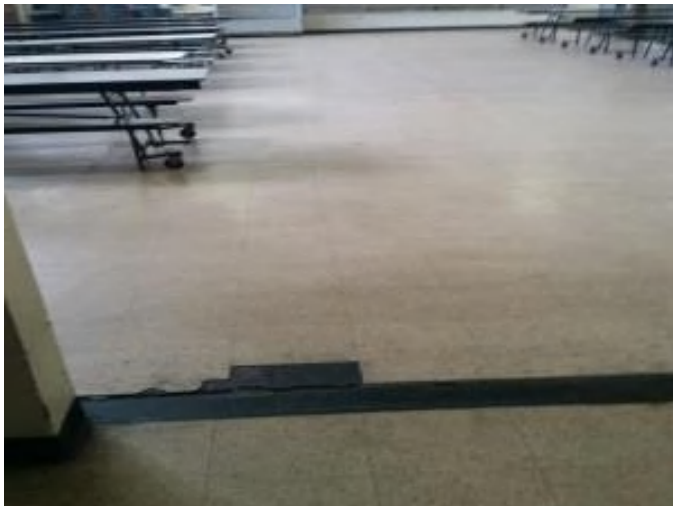
System: C3020413 - Vinyl Flooring

Location: cafeteria and other rooms
Distress: Appearance
Category: 3 - Operations / Maint.
Priority: 2 - Response Time (2-3 yrs)
Correction: Remove and replace VCT
Qty: 8,000.00
Unit of Measure: S.F.
Estimate: \$96,140.25
Assessor Name: System
Date Created: 09/15/2015

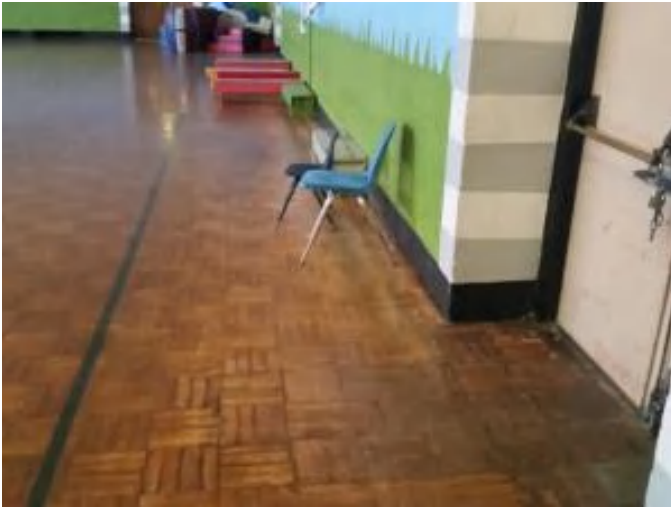
System: C3020414 - Wood Flooring

Location: gymnasium

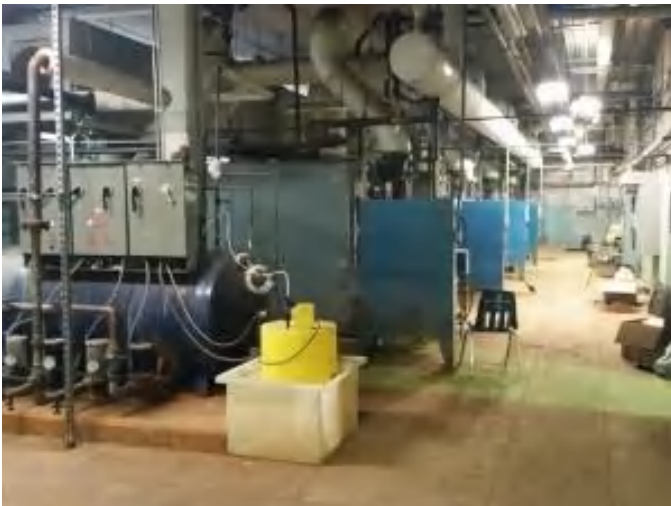
System: C3020415 - Concrete Floor Finishes

Location: mechanical areas and stairs

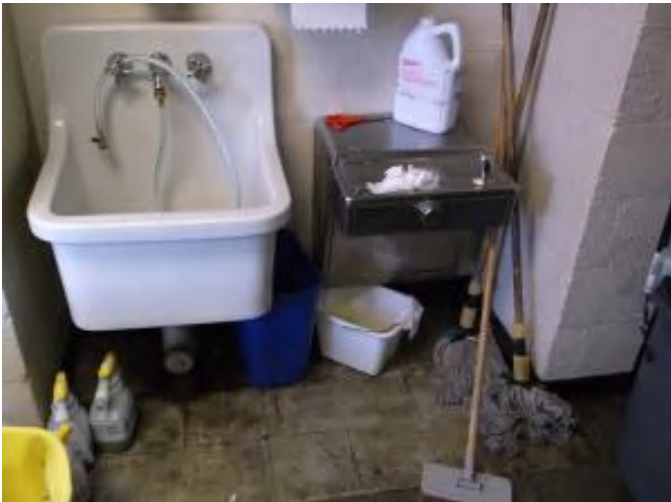
System: D2010 - Plumbing Fixtures

Location: Throughout the building

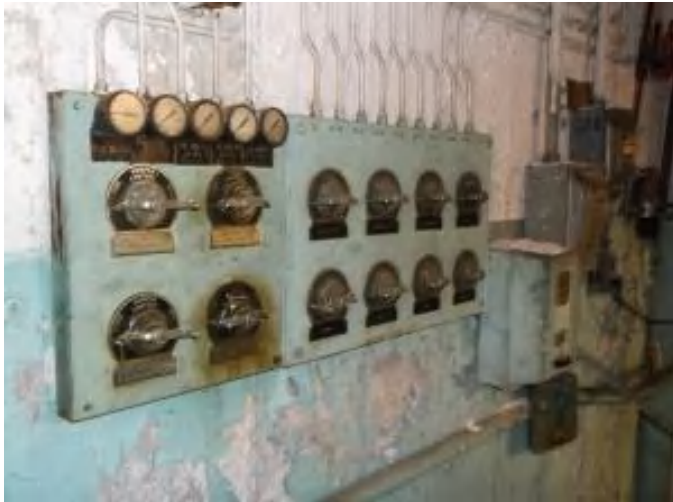
System: D3060 - Controls & Instrumentation

Location: Throughout the building

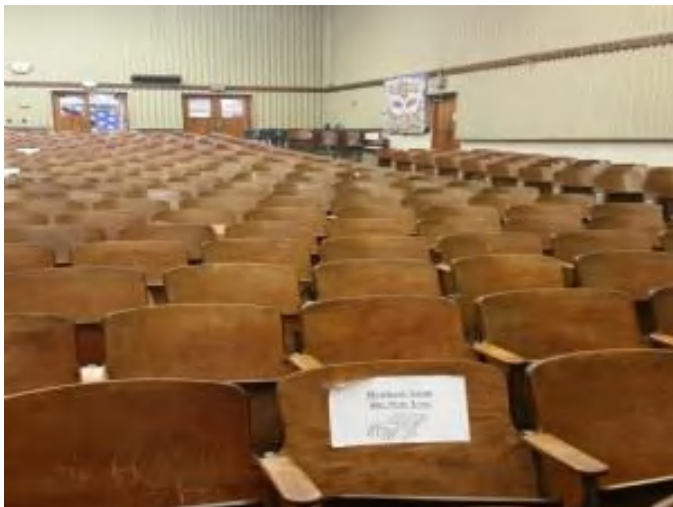
System: E2010 - Fixed Furnishings

Location: auditorium

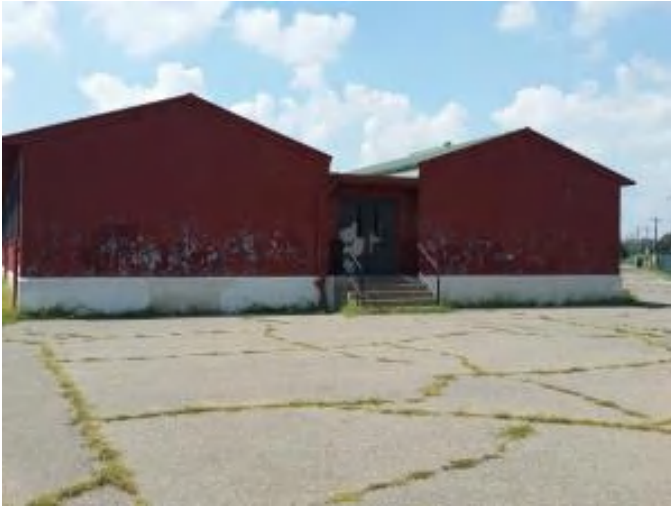
System: B3010130 - Prefomed Metal Roofing

Location: Wing D

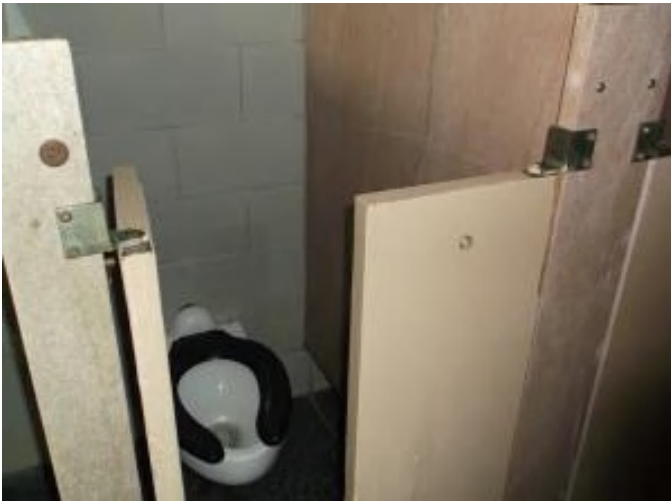
System: D2010 - Plumbing Fixtures

Location: Throughout the building

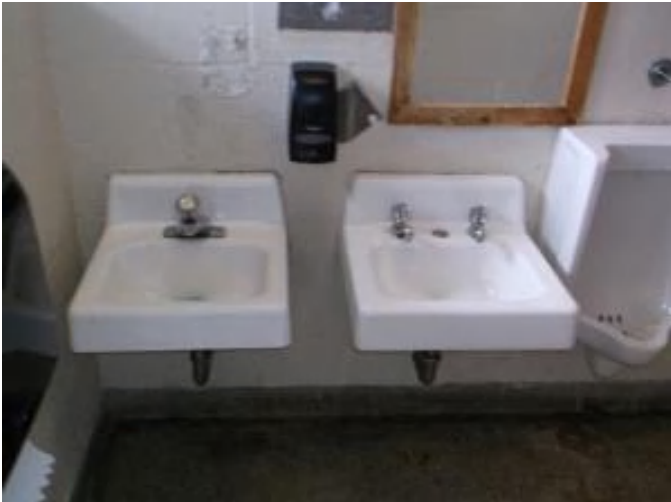
System: D2010 - Plumbing Fixtures

Location: Throughout the building

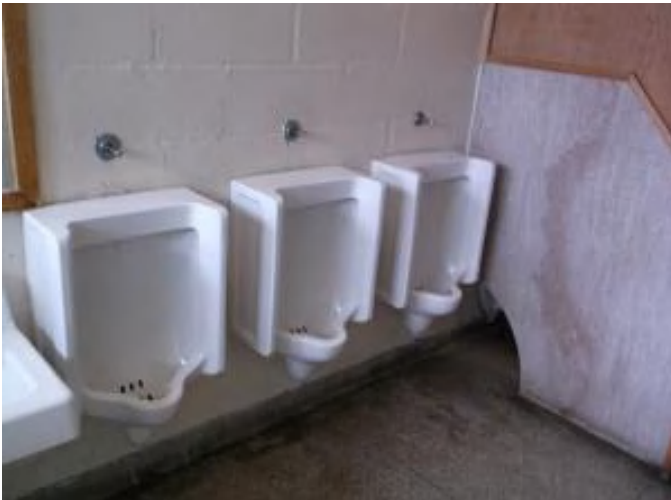
System: D2010 - Plumbing Fixtures

Location: Throughout the building

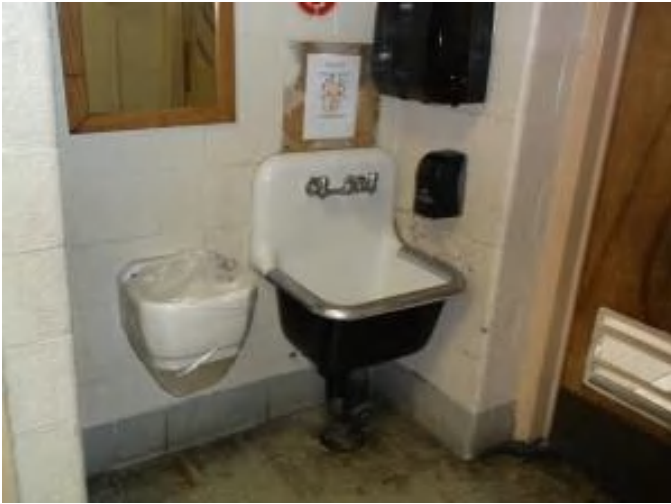
System: D2010 - Plumbing Fixtures

Location: Throughout the building

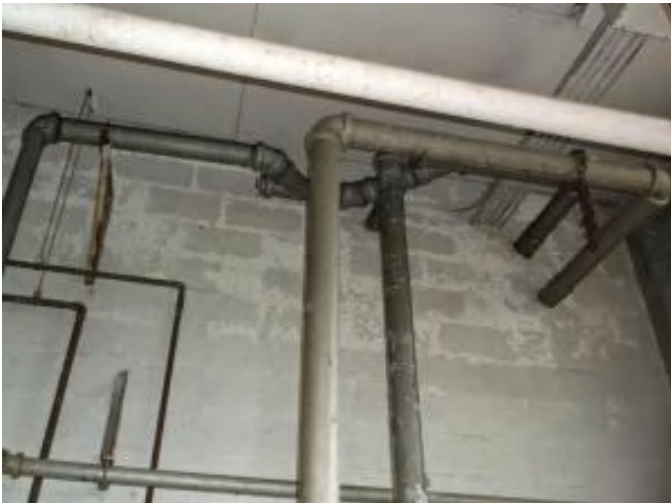
System: D2030 - Sanitary Waste

Location: Throughout the building

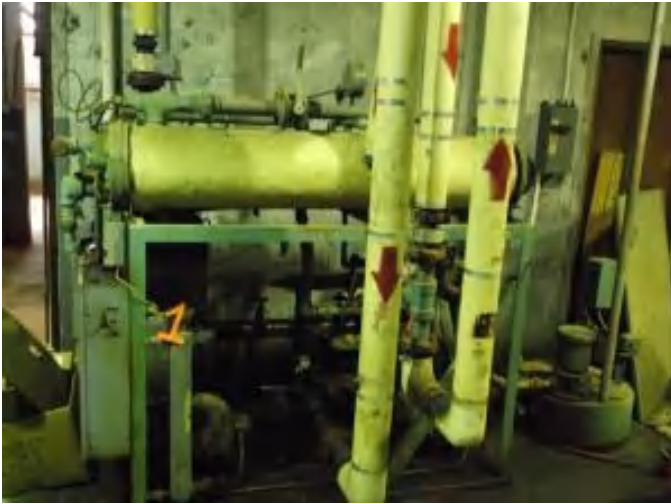
System: D3020 - Heat Generating Systems

Location: Boiler Mechanical Equipment Room

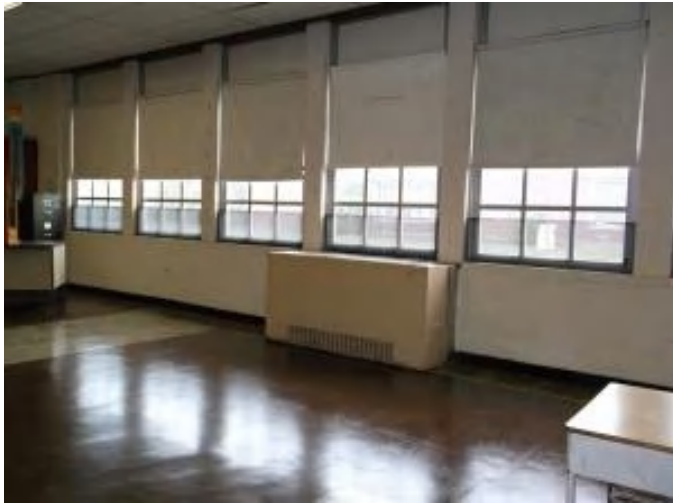
System: D3040 - Distribution Systems

Location: Throughout the building
Distress: Building / MEP Codes
Category: 2 - Code Compliance
Priority: 5 - Response Time (> 5 yrs)
Correction: Provide classroom FC units and dedicated OA ventilation system. (20 clsrms)
Qty: 20.00
Unit of Measure: C
Estimate: \$1,661,219.77
Assessor Name: System
Date Created: 09/18/2015

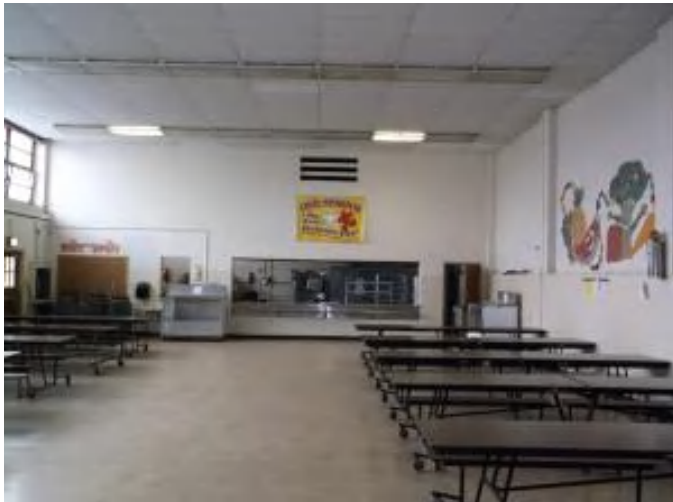
System: D3040 - Distribution Systems

Location: Cafeteria
Distress: Building / MEP Codes
Category: 2 - Code Compliance
Priority: 5 - Response Time (> 5 yrs)
Correction: Install HVAC unit for Cafeteria (850 students).
Qty: 850.00
Unit of Measure: Pr.
Estimate: \$397,410.06
Assessor Name: System
Date Created: 09/21/2015

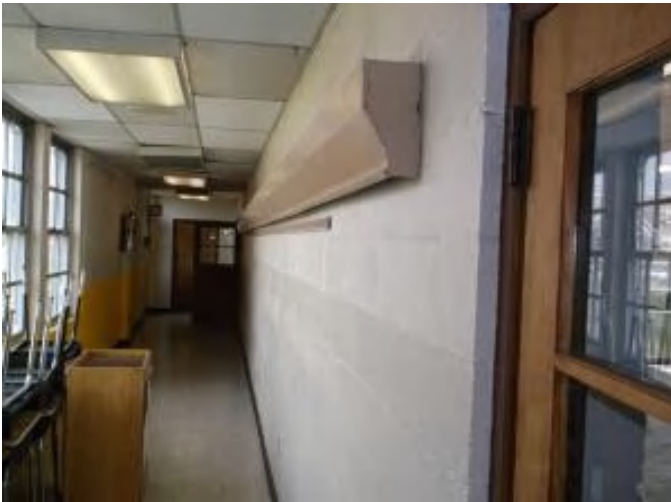
System: D4010 - Sprinklers

Location: entire building

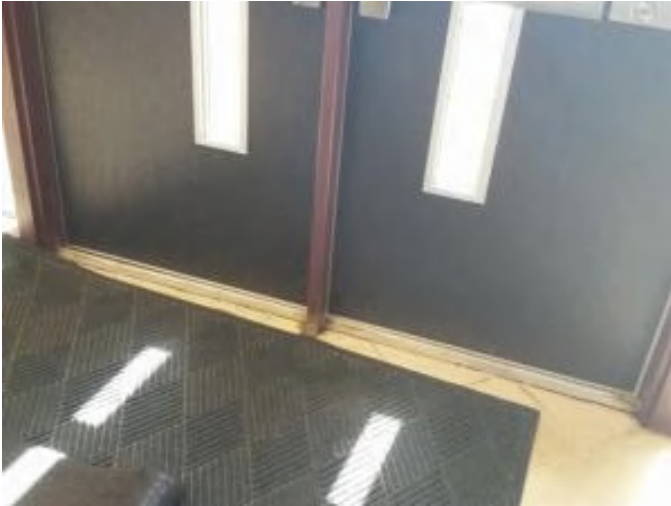
System: B2030 - Exterior Doors

Location: PEC exterior door frames

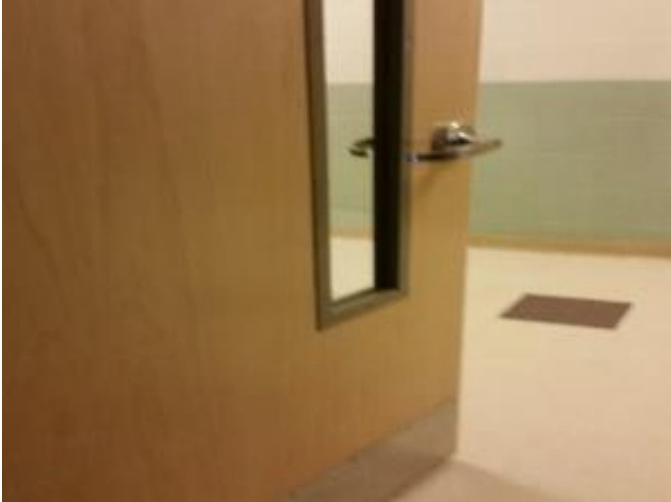
System: C1020 - Interior Doors

Location: PEC classrooms and offices

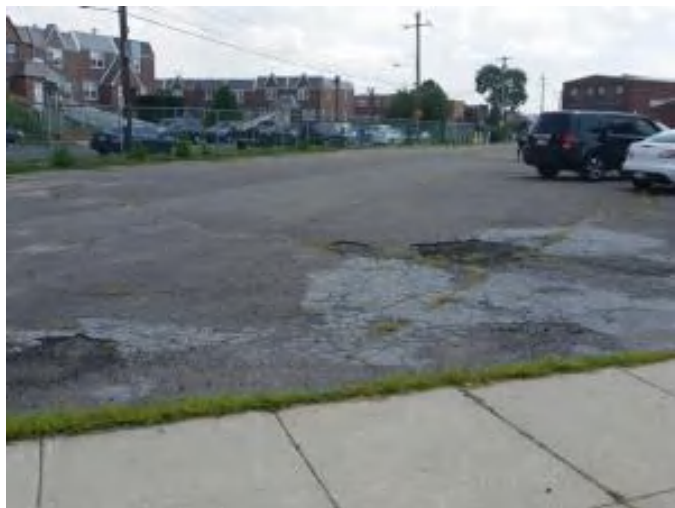
System: G2020 - Parking Lots

Location: parking and roadways

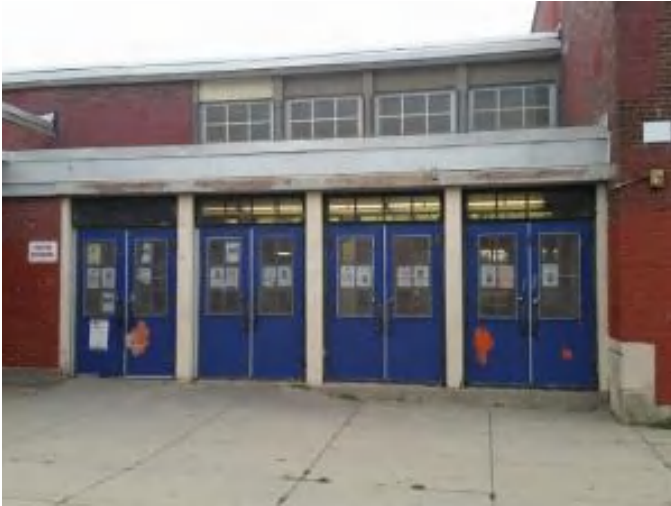
System: G2030 - Pedestrian Paving

Location: front walkway

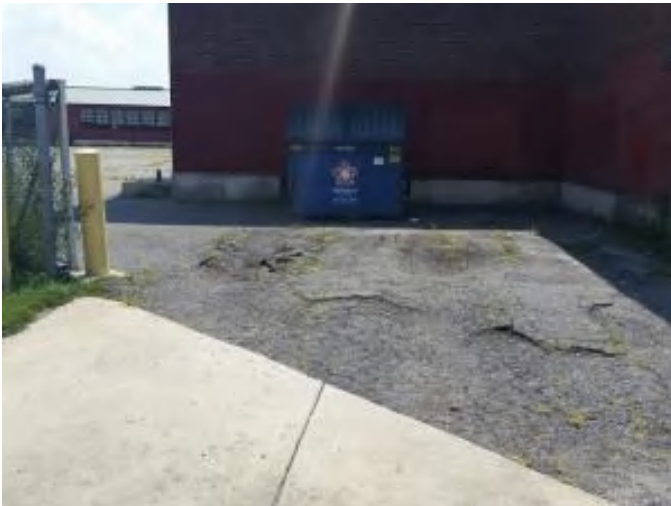
System: G2040 - Site Development

Location: site fence

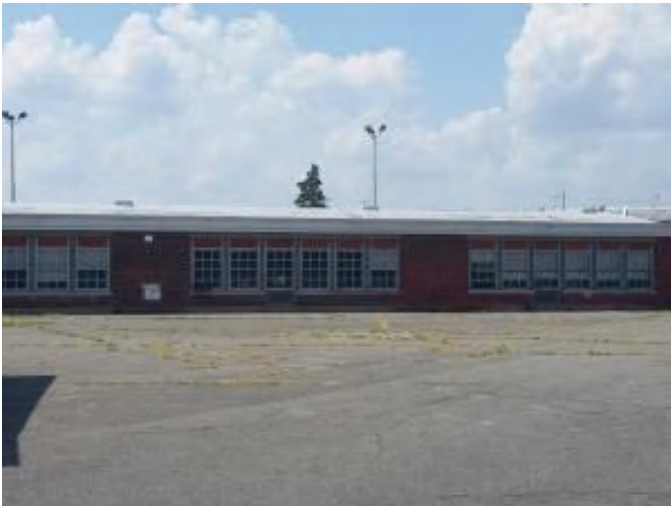
Location: parking lots
