Facility Condition Assessment Summary Report

South Philadelphia High School

School District of Philadelphia
S200001;South Philadelphia
Final
Site Assessment Report
January 30, 2017

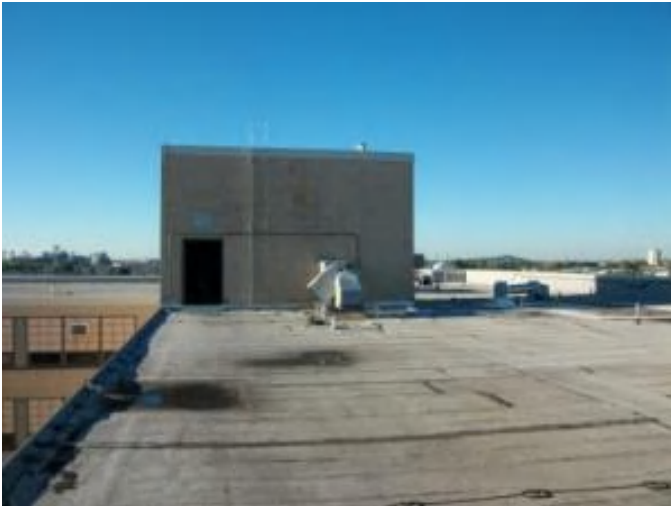
System: B3010105 - Built-Up

Location: Roofs

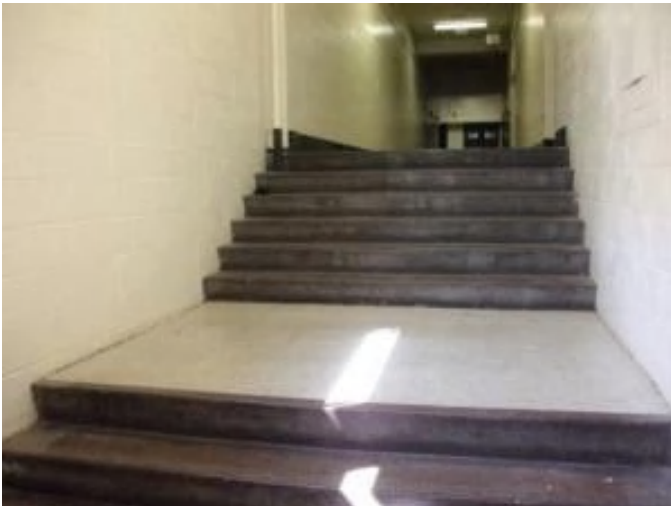
System: C2010 - Stair Construction

Location: Level 1 stairs to shops

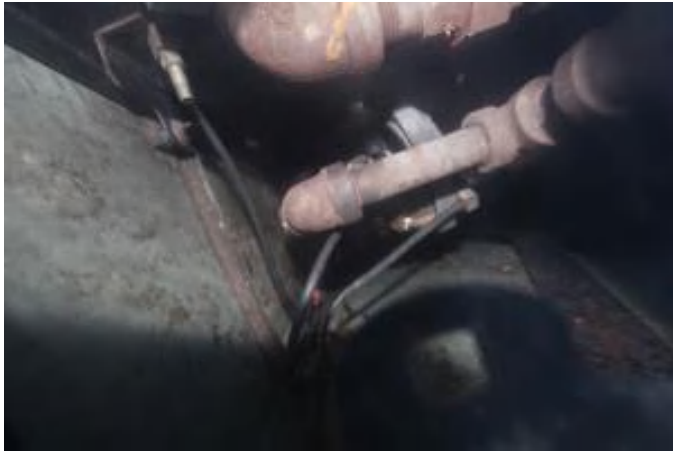
System: D3040 - Distribution Systems

Location: Classrooms

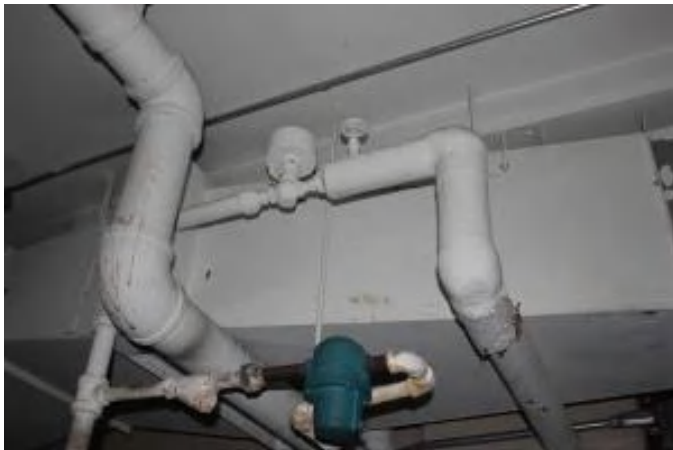
System: D3040 - Distribution Systems

Location: Entire building

Distress: Failing

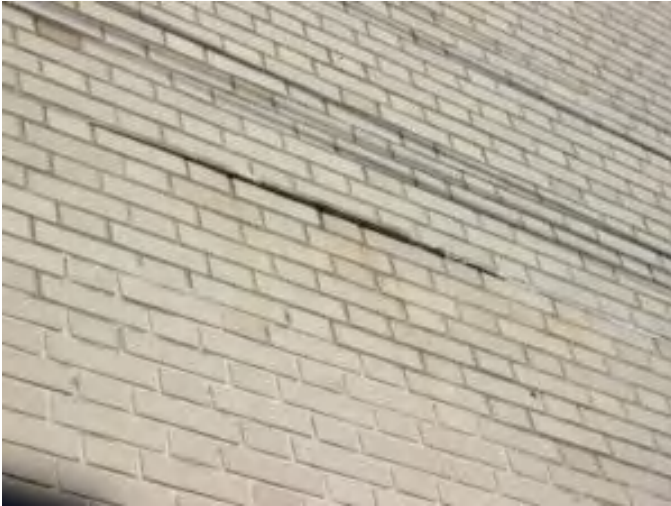
System: B2010 - Exterior Walls

Location: Brick Exterior Walls

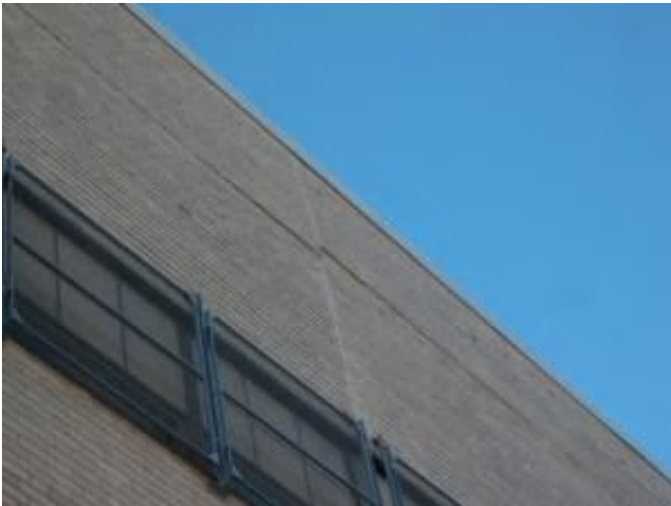
System: B2010 - Exterior Walls

Location: Gym Exterior Wall - North end

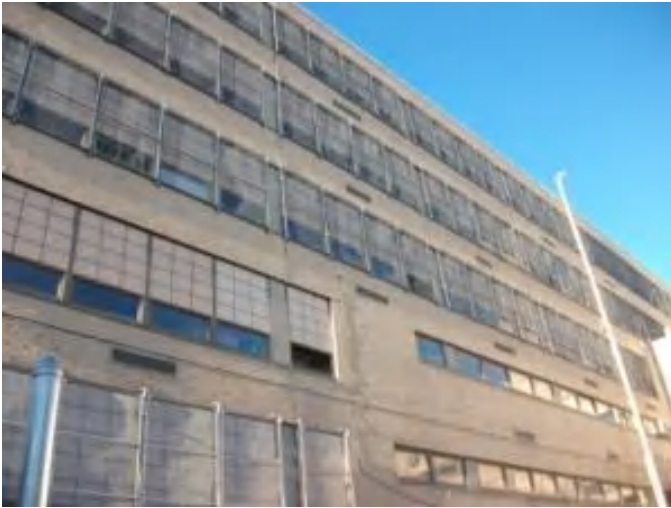
System: B2020 - Exterior Windows

Location: Exterior windows

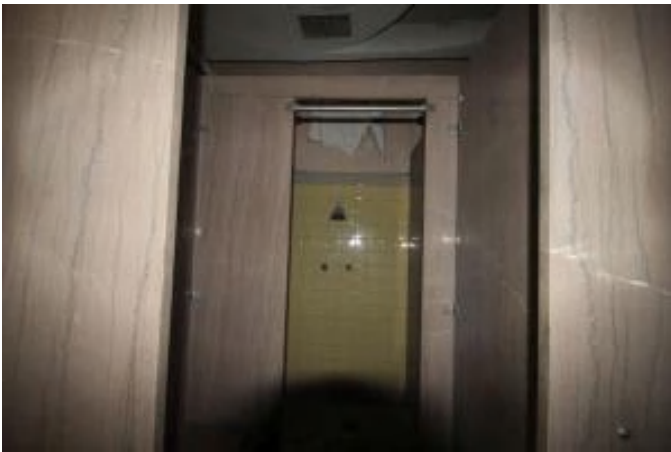
System: C1010 - Partitions

Location: Gym locker rooms

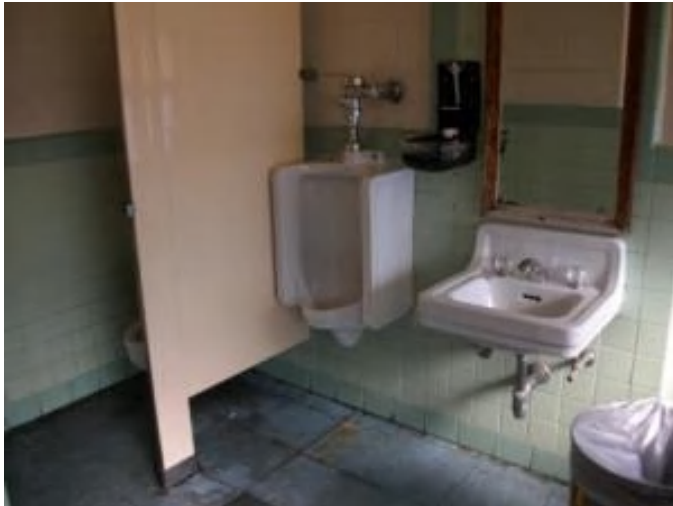
System: C1010 - Partitions

Location: Each floor of building
Distress: Accessibility
Category: 2 - Code Compliance
Priority: 2 - Response Time (2-3 yrs)
Correction: Build new single restroom to meet code requirements
Qty: 6.00
Unit of Measure: Ea.
Estimate: \$421,955.84
Assessor Name: System
Date Created: 01/11/2016

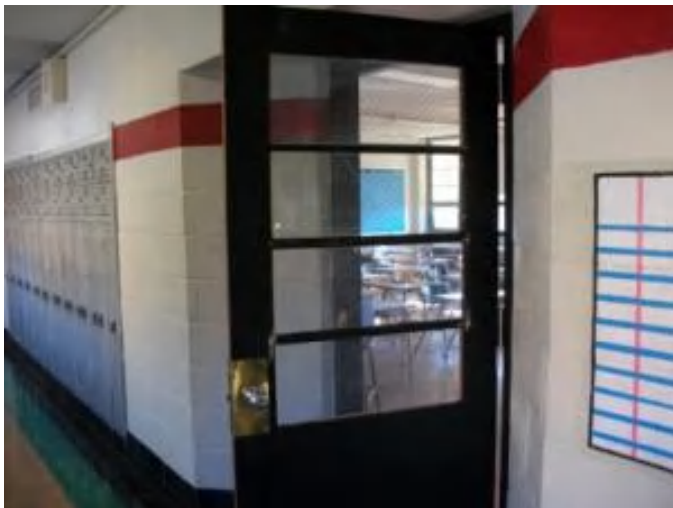
System: C1020 - Interior Doors

Location: Interior doors
Distress: Building / MEP Codes
Category: 2 - Code Compliance
Priority: 2 - Response Time (2-3 yrs)
Correction: Remove and replace interior doors - wood doors with hollow metal frames - per leaf
Qty: 500.00
Unit of Measure: Ea.
Estimate: \$2,385,293.56
Assessor Name: System
Date Created: 01/11/2016

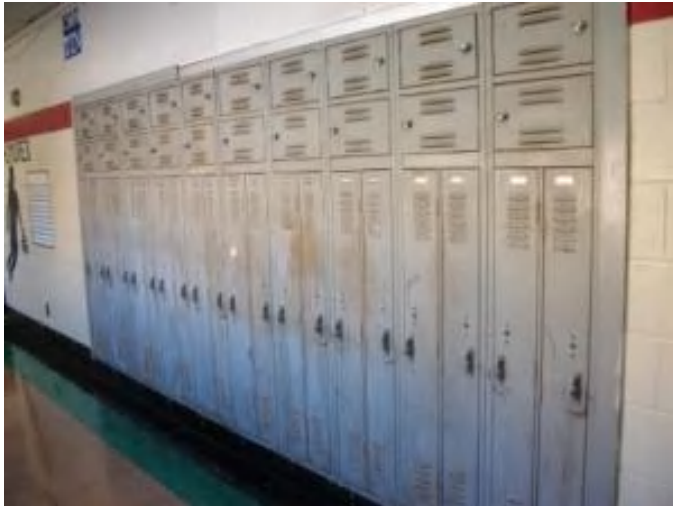
System: C1030 - Fittings

Location: Corridors and locker rooms

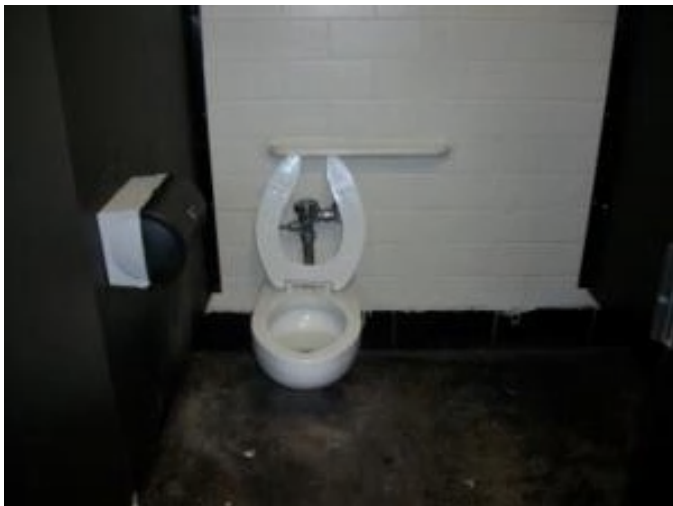
System: C1030 - Fittings

Location: Student restrooms

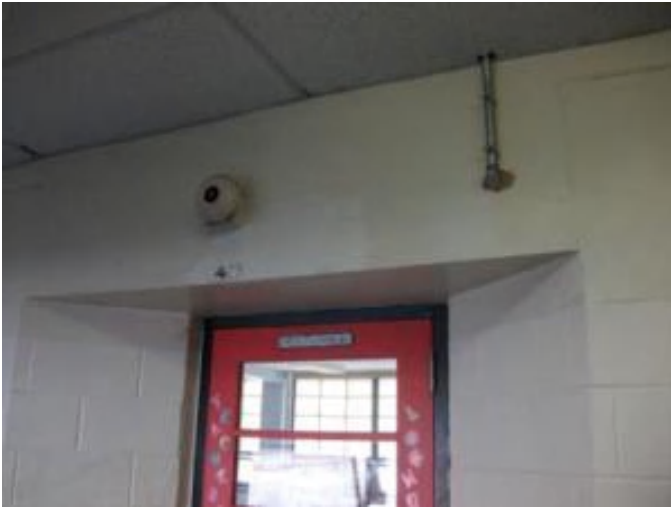
System: C1030 - Fittings

Location: Building-wide
Distress: Building / MEP Codes
Category: 2 - Code Compliance
Priority: 2 - Response Time (2-3 yrs)
Correction: Replace missing or damaged signage - insert the number of rooms
Qty: 500.00
Unit of Measure: Ea.
Estimate: \$135,456.24
Assessor Name: System
Date Created: 01/11/2016

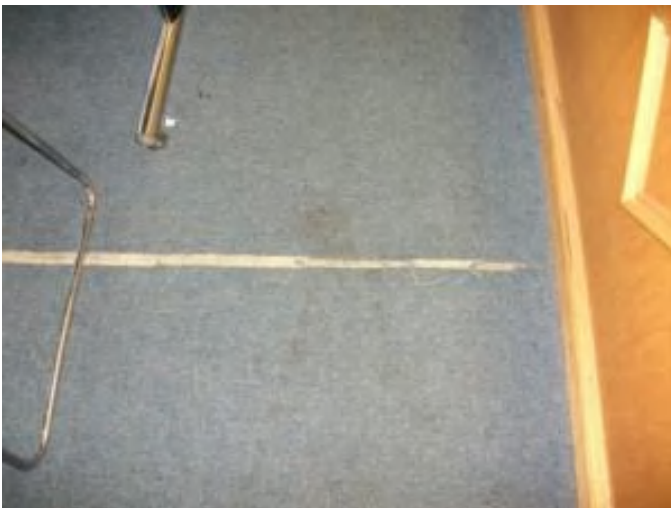
System: C3020411 - Carpet

Location: 2nd floor classrooms, alumni room, student court
Distress: Beyond Service Life
Category: 3 - Operations / Maint.
Priority: 2 - Response Time (2-3 yrs)
Correction: Remove and replace carpet
Qty: 5,000.00
Unit of Measure: S.F.
Estimate: \$55,953.81
Assessor Name: System
Date Created: 01/11/2016

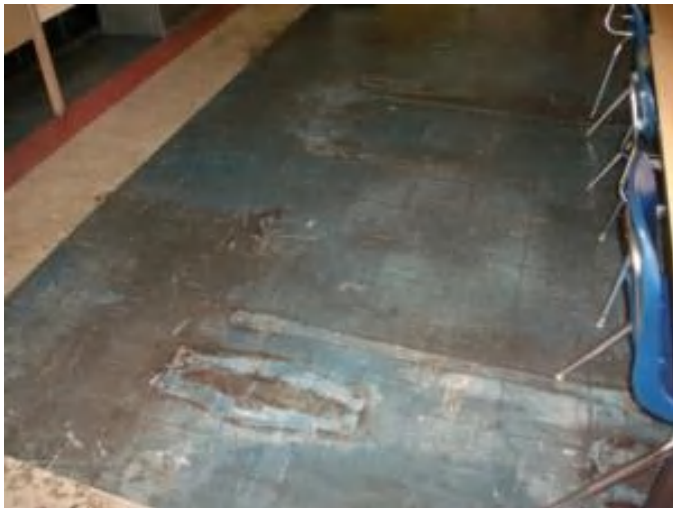
System: C3020413 - Vinyl Flooring

Location: Throughout the building
Distress: Health Hazard / Risk
Category: 2 - Code Compliance
Priority: 2 - Response Time (2-3 yrs)
Correction: Remove VAT and replace with VCT - SF of area
Qty: 250,000.00
Unit of Measure: S.F.
Estimate: \$3,791,667.00
Assessor Name: System
Date Created: 01/11/2016

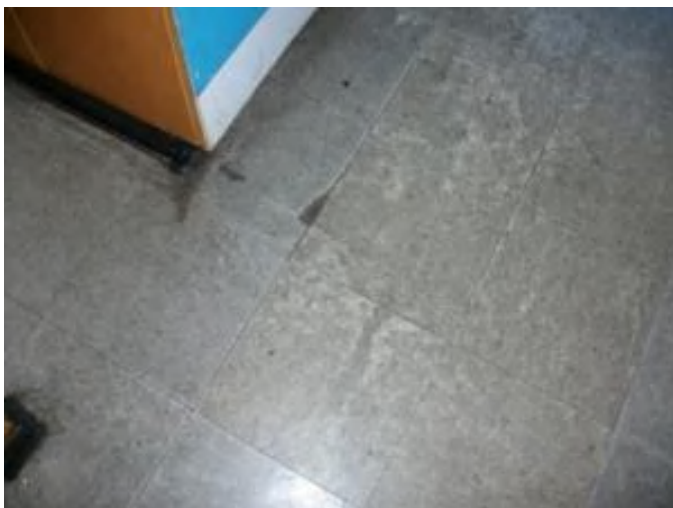
System: C3020413 - Vinyl Flooring

Location: Classrooms 304, 305, 306
Distress: Failing
Category: 3 - Operations / Maint.
Priority: 2 - Response Time (2-3 yrs)
Correction: Remove and replace VCT
Qty: 3,000.00
Unit of Measure: S.F.
Estimate: \$64,693.43
Assessor Name: System
Date Created: 01/11/2016

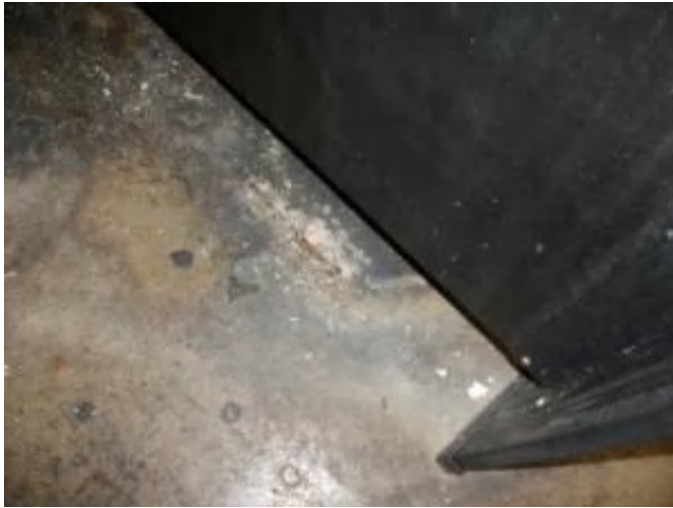
System: C3020415 - Concrete Floor Finishes

Location: Throughout the building

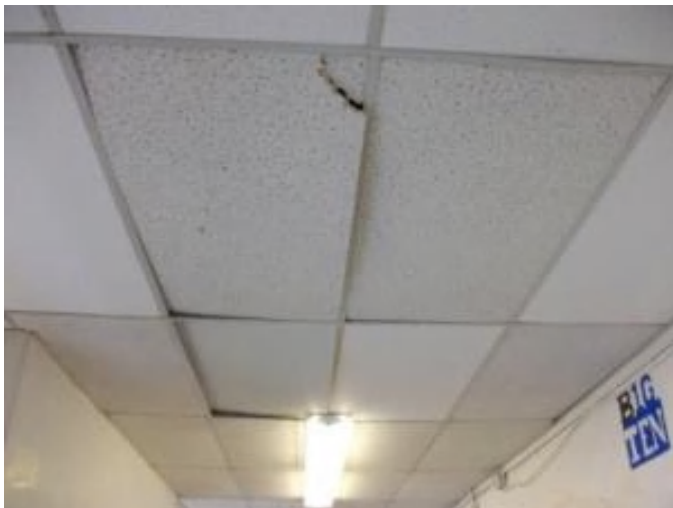
System: C3030 - Ceiling Finishes

Location: Corridors, classrooms

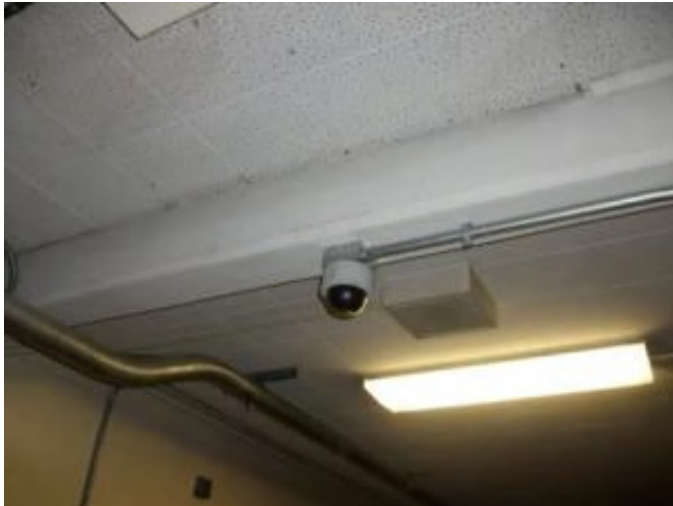
System: C3030 - Ceiling Finishes

Location: Corridors
Distress: Damaged
Category: 3 - Operations / Maint.
Priority: 2 - Response Time (2-3 yrs)
Correction: Remove and replace glued on or mechanically attached acoustical ceiling tiles
Qty: 5,000.00
Unit of Measure: S.F.
Estimate: \$62,394.03
Assessor Name: System
Date Created: 01/12/2016

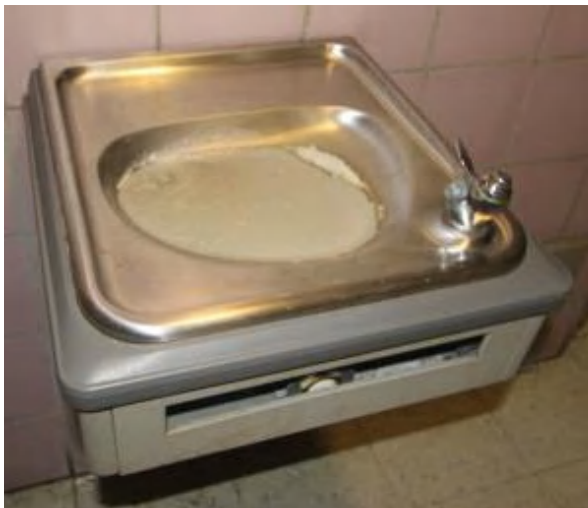
System: D2010 - Plumbing Fixtures

Location: Entire building
Distress: Beyond Service Life
Category: 3 - Operations / Maint.
Priority: 2 - Response Time (2-3 yrs)
Correction: Remove and replace water fountains to meet ADA - includes high and low fountains and new recessed alcove
Qty: 20.00
Unit of Measure: Ea.
Estimate: \$313,857.93
Assessor Name: System
Date Created: 12/21/2015

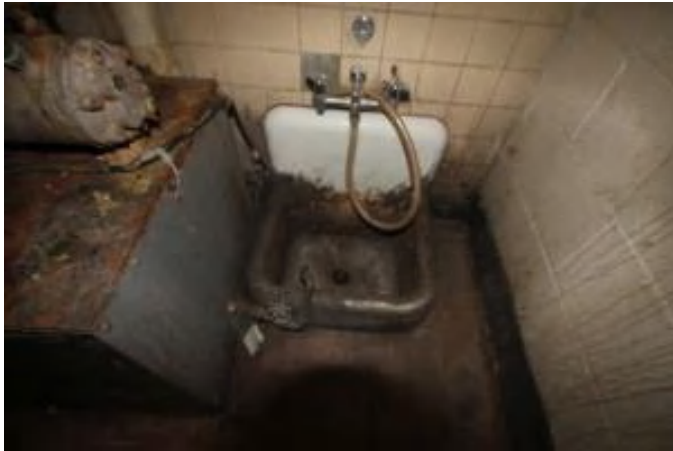
System: D2010 - Plumbing Fixtures

Location: Mop closets

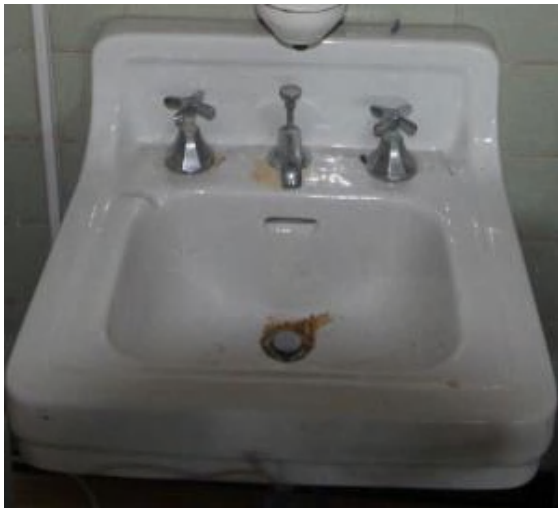
System: D2010 - Plumbing Fixtures

Location: Toilet rooms

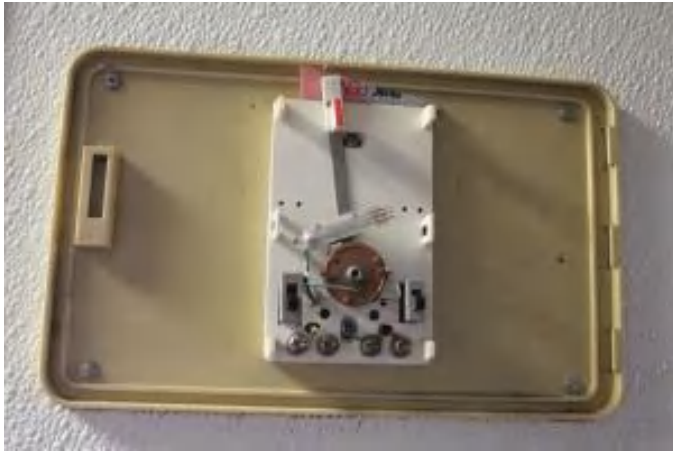
System: D3060 - Controls & Instrumentation

Location: Entire building
Distress: Obsolete
Category: 3 - Operations / Maint.
Priority: 2 - Response Time (2-3 yrs)
Correction: Replace pneumatic controls with DDC (350KSF)
Qty: 331,440.00
Unit of Measure: S.F.
Estimate: \$6,106,267.70
Assessor Name: System
Date Created: 12/21/2015

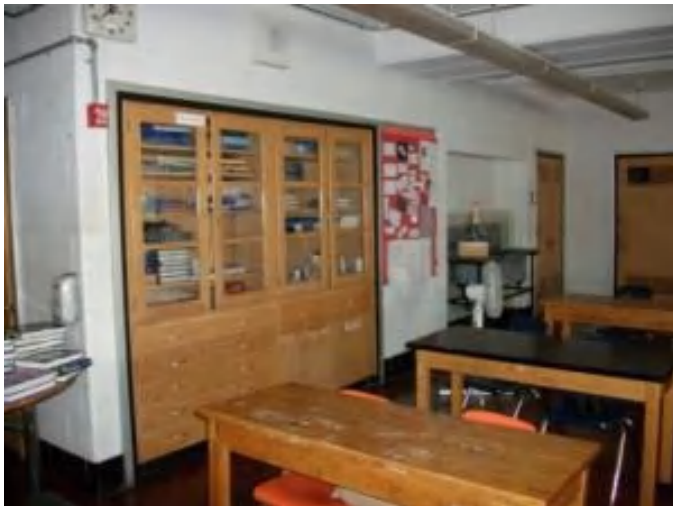
System: E1020 - Institutional Equipment

Location: Science classrooms
Distress: Beyond Service Life
Category: 3 - Operations / Maint.
Priority: 2 - Response Time (2-3 yrs)
Correction: Remove and replace lab base cabinets and countertops - per LF - add sinks in plumbing fixtures if required
Qty: 480.00
Unit of Measure: L.F.
Estimate: \$858,253.28
Assessor Name: System
Date Created: 01/12/2016

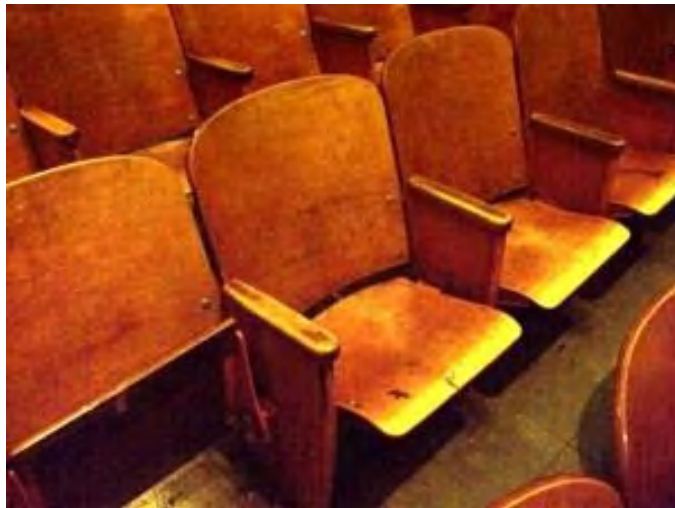
System: E2010 - Fixed Furnishings

Location: Auditorium

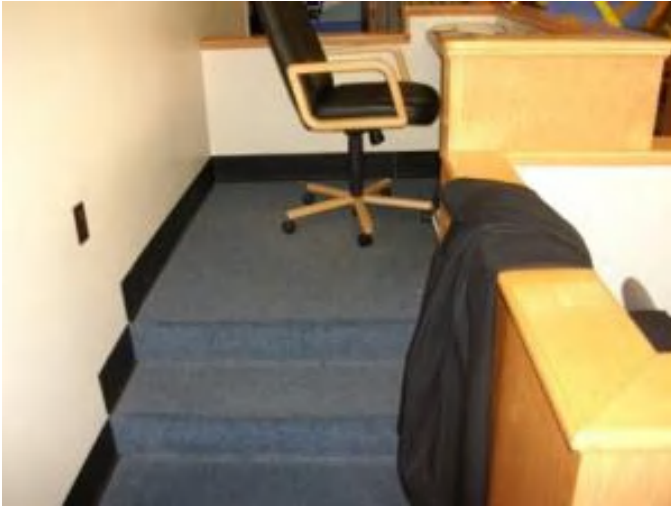
System: B1010 - Floor Construction

Location: Student courtroom

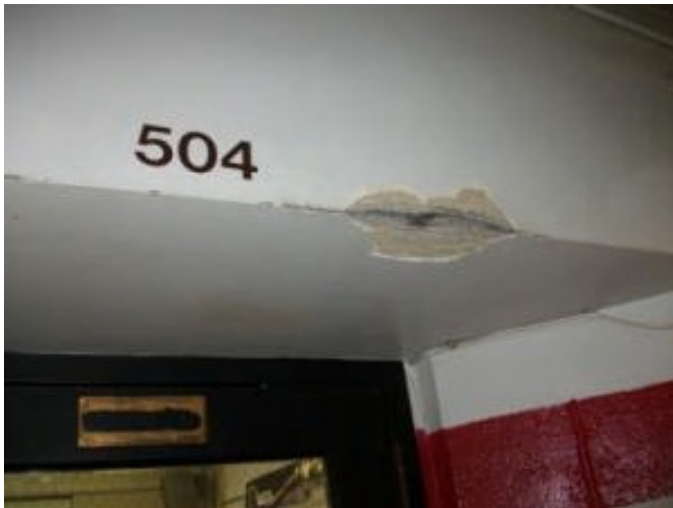
System: C3010230 - Paint & Covering

Location: Classrooms, corridors, locker rooms, restrooms

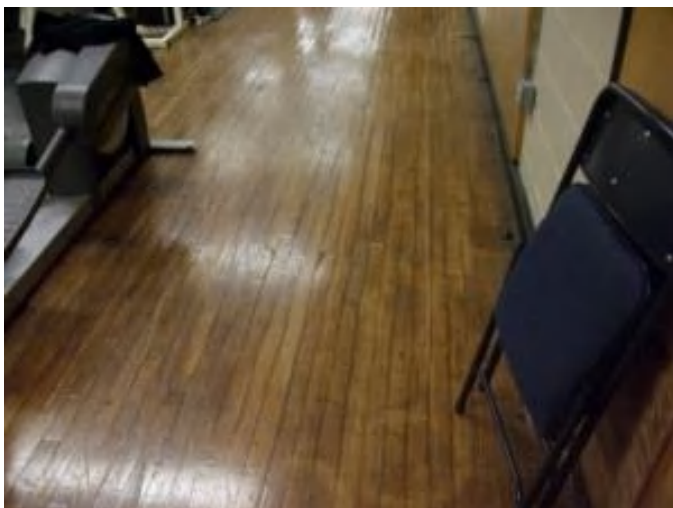
System: C3020414 - Wood Flooring

Location: Basement weight room and stage

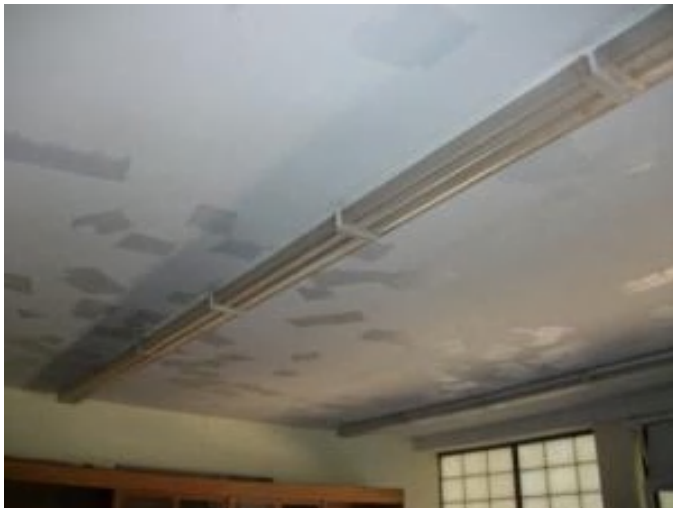
System: C3030 - Ceiling Finishes

Location: Classroom ceilings

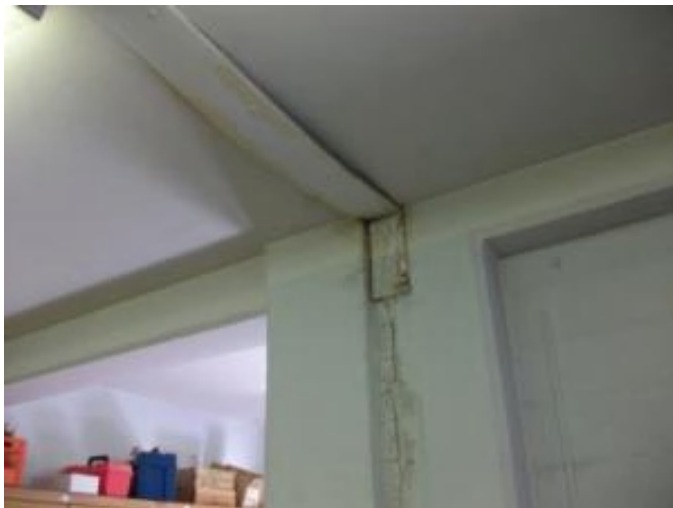
System: C3030 - Ceiling Finishes

Location: 3rd and 5th Floors

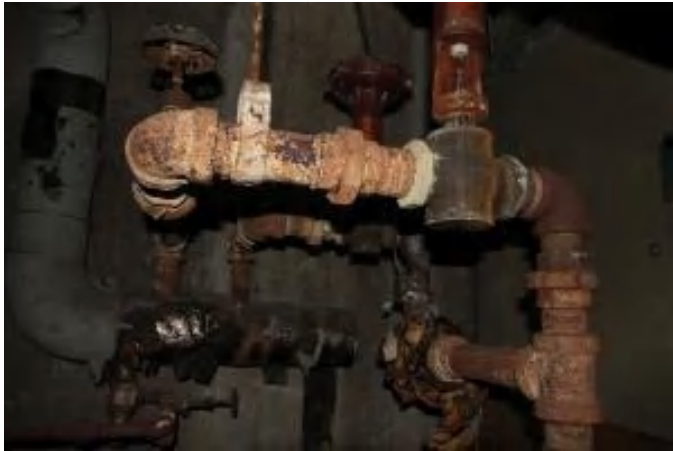
System: D3040 - Distribution Systems

Location: Entire building

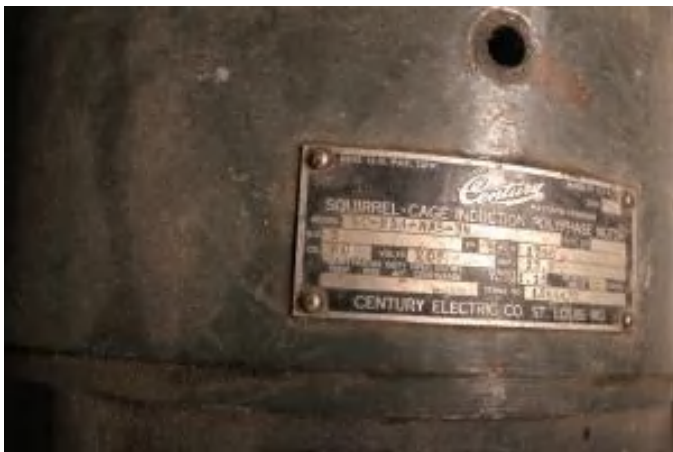
System: D3040 - Distribution Systems

Location: Auditorium and music room

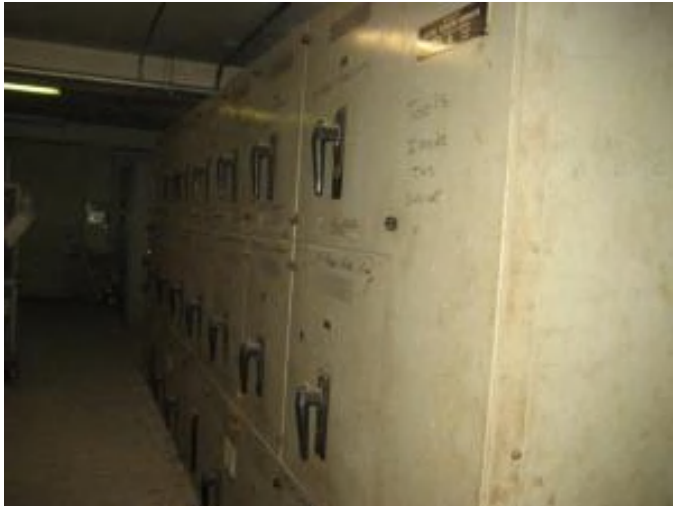
System: D5010 - Electrical Service/Distribution

Location: Basement electrical room
Distress: Inadequate
Category: 4 - Capital Improvement
Priority: 3 - Response Time (3-4 yrs)
Correction: Replace unit substation
Qty: 1.00
Unit of Measure: Ea.
Estimate: \$2,837,525.35
Assessor Name: System
Date Created: 12/14/2015

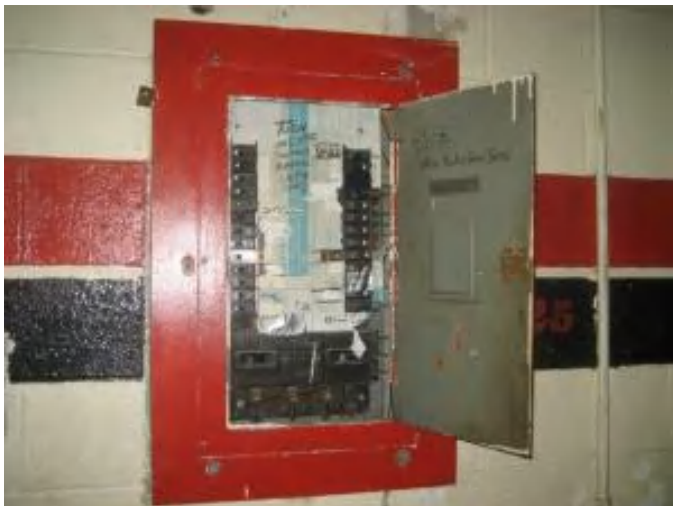
System: D5010 - Electrical Service/Distribution

Location: Entire Building
Distress: Inadequate
Category: 4 - Capital Improvement
Priority: 3 - Response Time (3-4 yrs)
Correction: Replace Electrical Distribution System (U)
Qty: 36.00
Unit of Measure: Ea.
Estimate: \$1,229,700.52
Assessor Name: System
Date Created: 12/14/2015

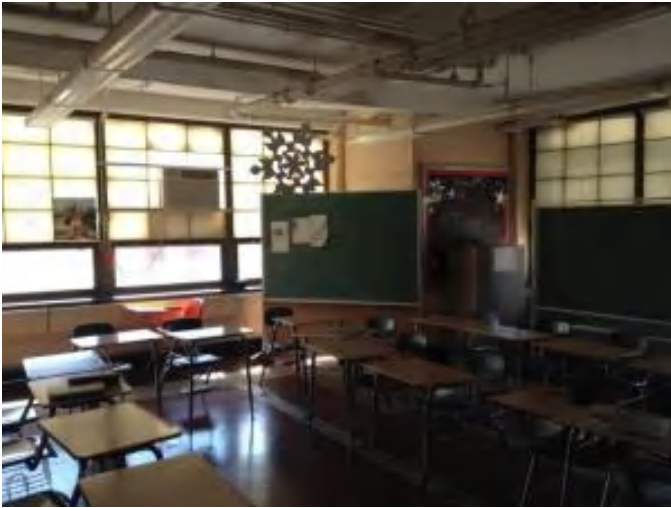
System: D5020 - Lighting and Branch Wiring

Location: Entire Building
Distress: Obsolete
Category: 3 - Operations / Maint.
Priority: 3 - Response Time (3-4 yrs)
Correction: Replace lighting fixtures
Qty: 3,100.00
Unit of Measure: Ea.
Estimate: \$2,999,774.06
Assessor Name: System
Date Created: 12/15/2015

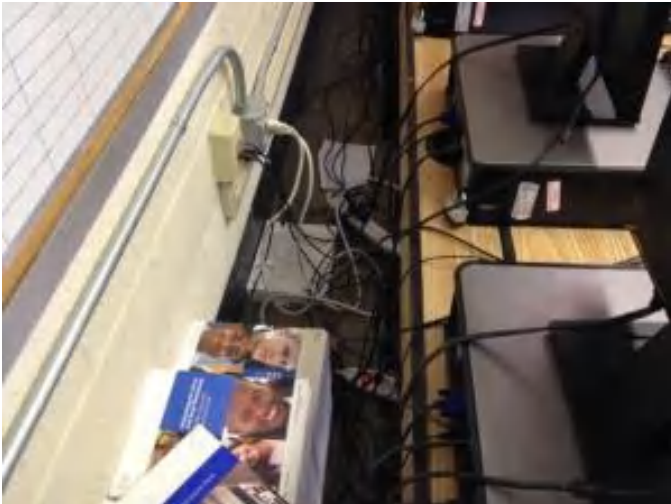
System: D5020 - Lighting and Branch Wiring

Location: Entire Building
Distress: Inadequate
Category: 4 - Capital Improvement
Priority: 3 - Response Time (3-4 yrs)
Correction: Add wiring device
Qty: 896.00
Unit of Measure: Ea.
Estimate: \$329,164.41
Assessor Name: System
Date Created: 12/15/2015

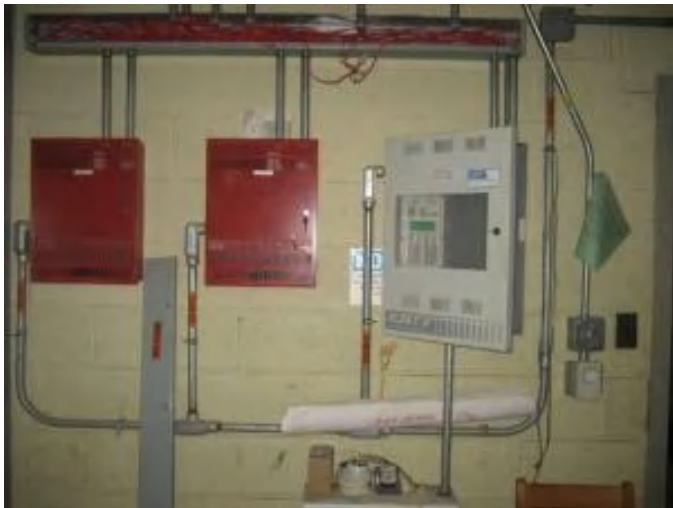
System: D5030 - Communications and Security

Location: Entire Building
Distress: Life Safety / NFPA / PFD
Category: 1 - Health & Safety
Priority: 3 - Response Time (3-4 yrs)
Correction: Replace fire alarm system
Qty: 442.00
Unit of Measure: S.F.
Estimate: \$749,679.32
Assessor Name: System
Date Created: 12/15/2015

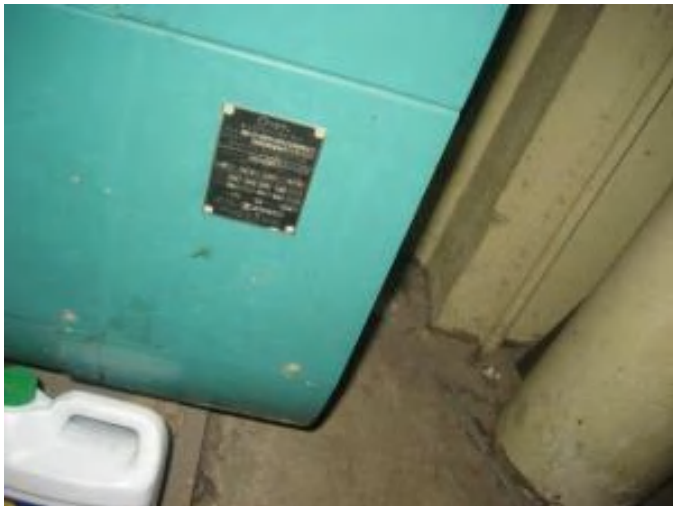
System: D5090 - Other Electrical Systems

Location: Outdoor
Distress: Beyond Service Life
Category: 3 - Operations / Maint.
Priority: 3 - Response Time (3-4 yrs)
Correction: Add Standby Generator System
Qty: 1.00
Unit of Measure: Ea.
Estimate: \$357,281.98
Assessor Name: System
Date Created: 12/15/2015

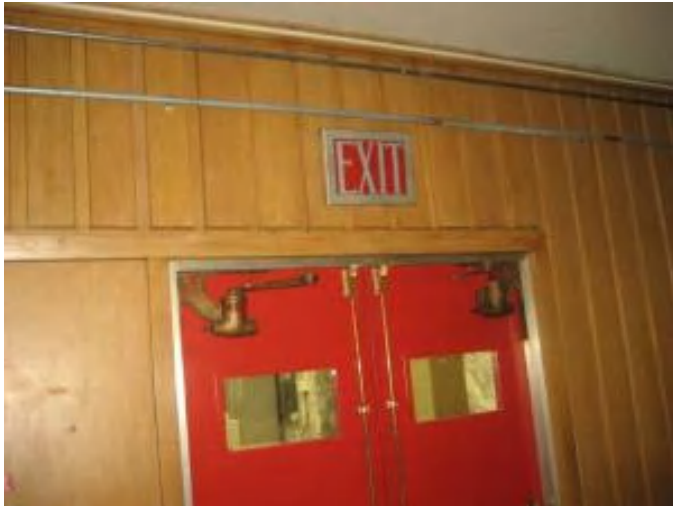
System: D5090 - Other Electrical Systems

Location: Exit Corridors
Distress: Not Reliable
Category: 3 - Operations / Maint.
Priority: 3 - Response Time (3-4 yrs)
Correction: Replace Emergency/Exit Lighting
Qty: 200.00
Unit of Measure: Ea.
Estimate: \$215,261.34
Assessor Name: System
Date Created: 12/15/2015

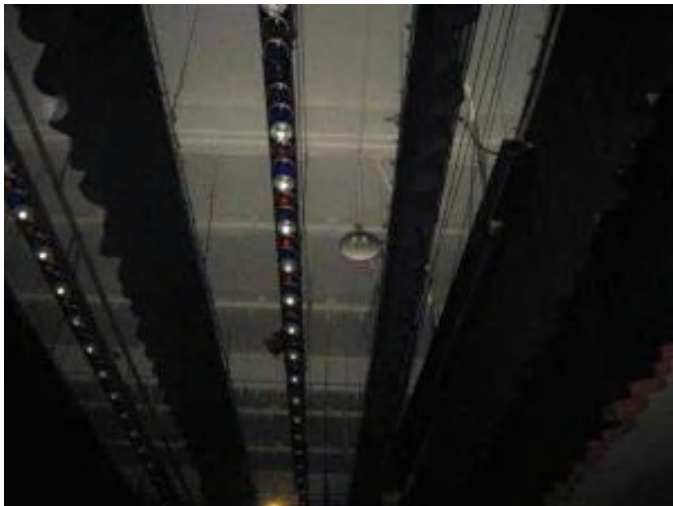
System: E1020 - Institutional Equipment

Location: Stage
Distress: Damaged
Category: 3 - Operations / Maint.
Priority: 3 - Response Time (3-4 yrs)
Correction: Remove and replace motorized projection screen - heavy duty stage size
Qty: 1.00
Unit of Measure: Ea.
Estimate: \$14,768.16
Assessor Name: System
Date Created: 01/12/2016

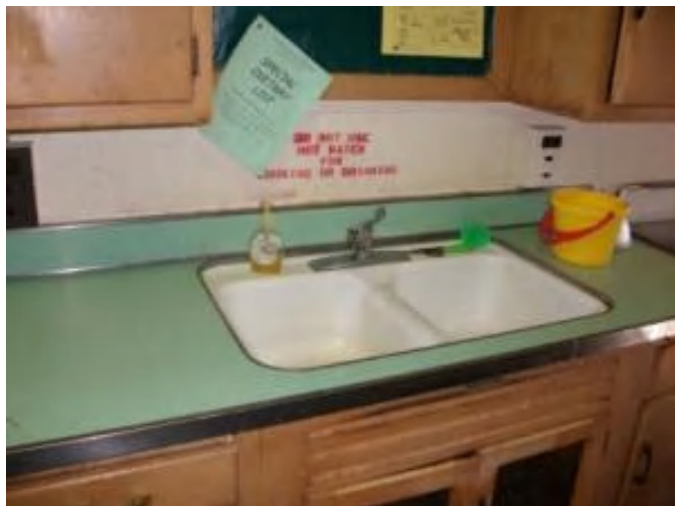
System: E2010 - Fixed Furnishings

Location: Classrooms

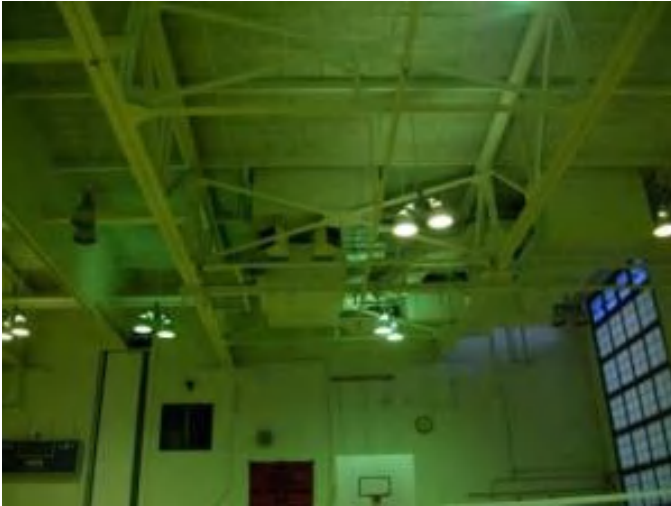
System: C3030 - Ceiling Finishes

Location: Gym ceiling

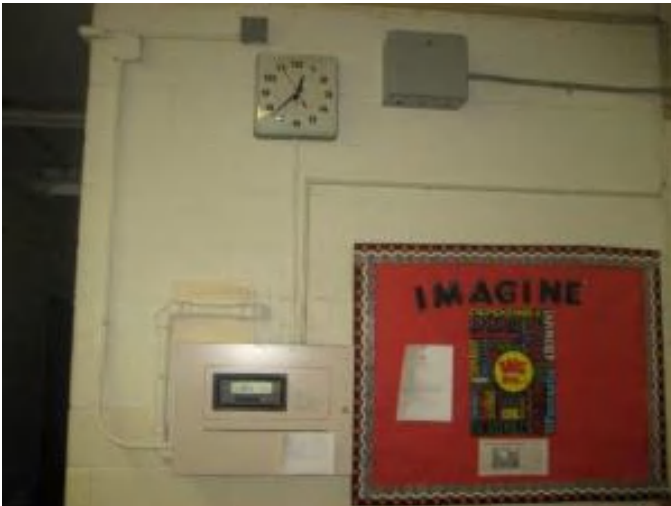
System: D5030 - Communications and Security

Location: Entire Building

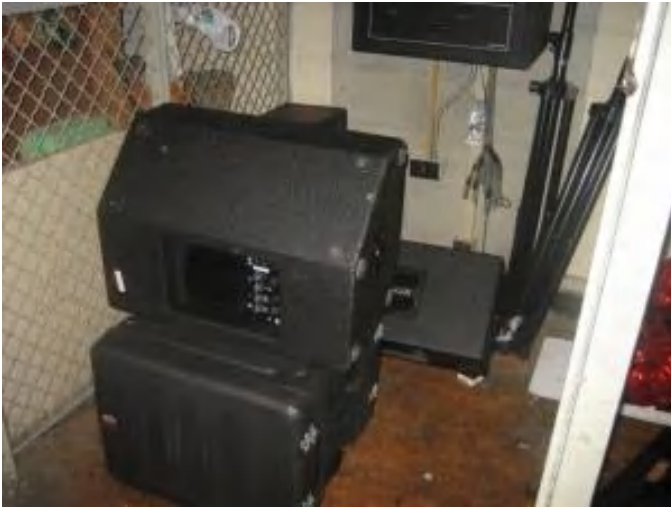
System: D5030 - Communications and Security

Location: Auditorium
Distress: Beyond Service Life
Category: 3 - Operations / Maint.
Priority: 4 - Response Time (4-5 yrs)
Correction: Add/Replace Sound System
Qty: 1.00
Unit of Measure: LS
Estimate: \$25,947.38
Assessor Name: System
Date Created: 12/15/2015

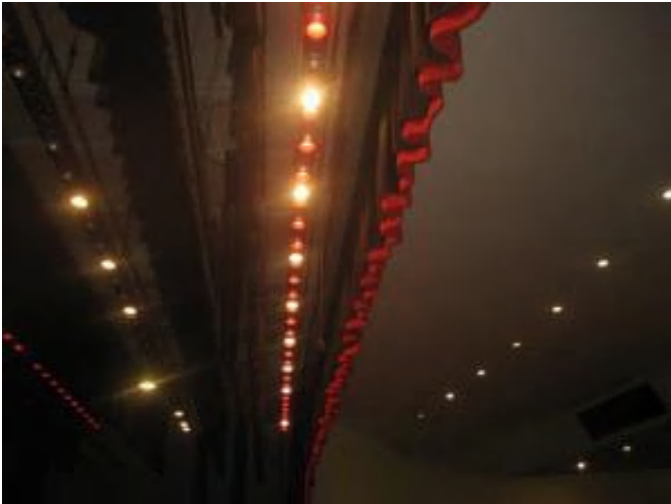
System: E1020 - Institutional Equipment

Location: Auditorium
Distress: Beyond Service Life
Category: 3 - Operations / Maint.
Priority: 4 - Response Time (4-5 yrs)
Correction: Add/Replace Stage Theatrical Lighting System
Qty: 1.00
Unit of Measure: Ea.
Estimate: \$293,594.70
Assessor Name: System
Date Created: 12/15/2015

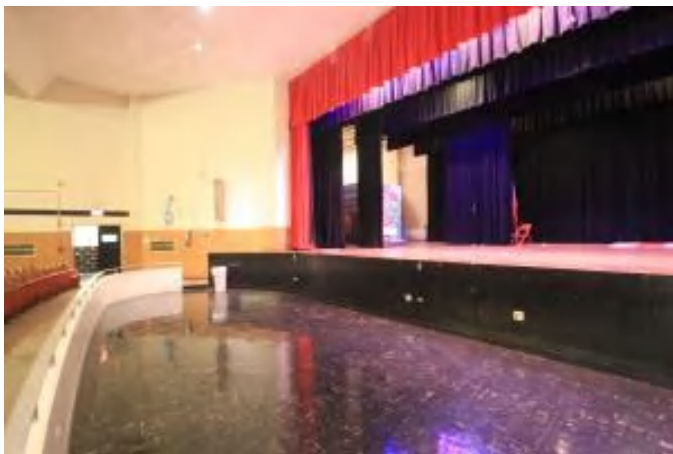
System: E2010 - Fixed Furnishings

Location: Auditorium

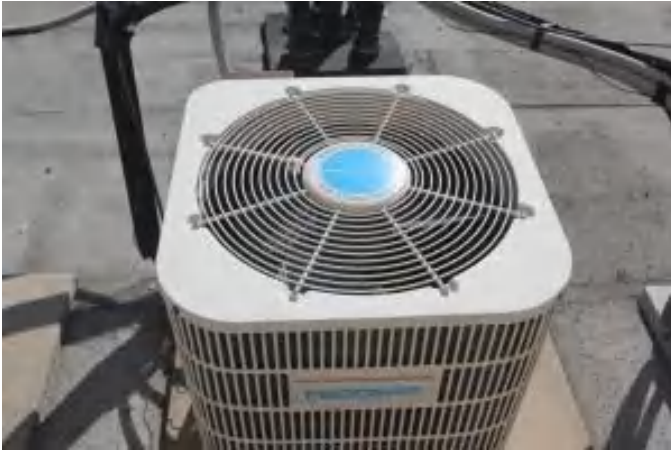
System: D3030 - Cooling Generating Systems

Location: Entire building

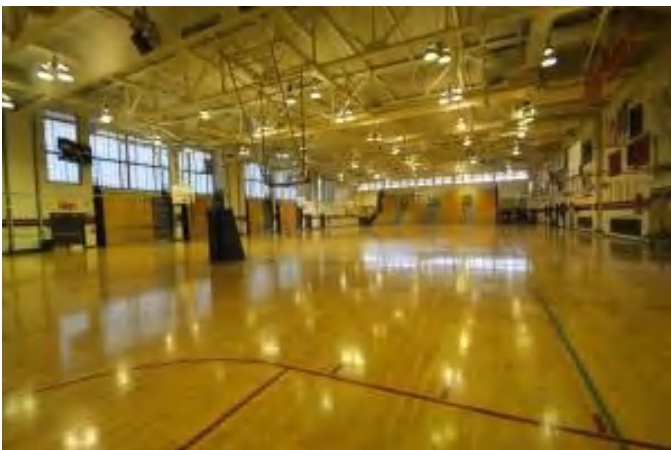
System: D3040 - Distribution Systems

Location: Gymnasium and locker rooms

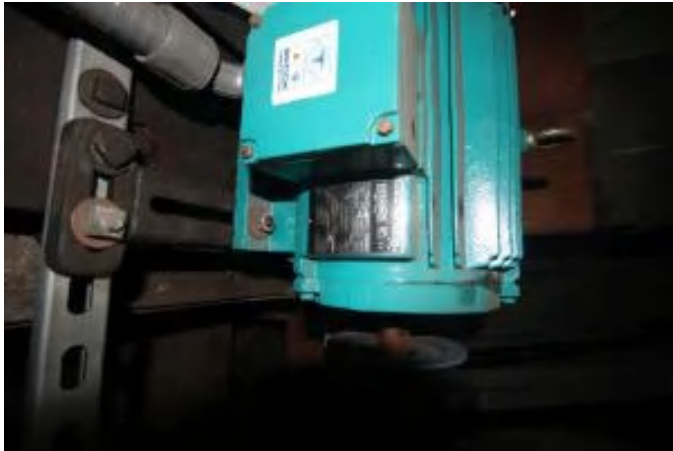
System: D3040 - Distribution Systems

Location: Kitchen and cafeteria

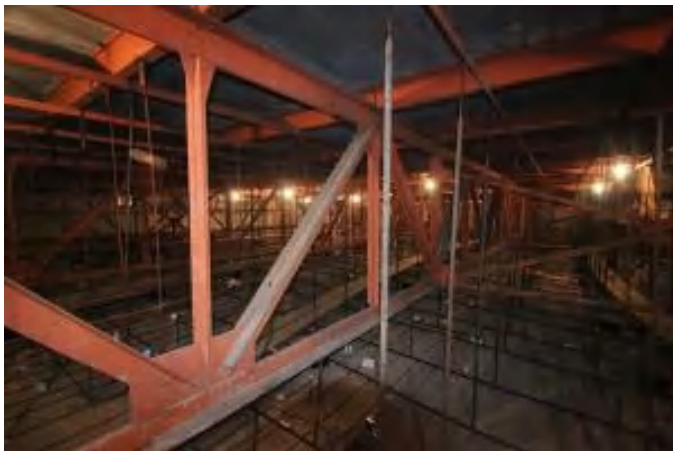
System: D4010 - Sprinklers

Location: Entire building

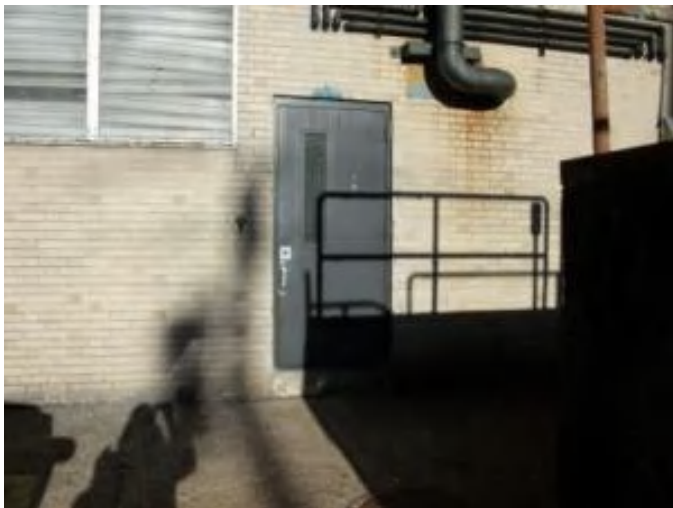
System: G2030 - Pedestrian Paving

Location: Exterior stairs at gym, plaza area, doors at dock courtyard.

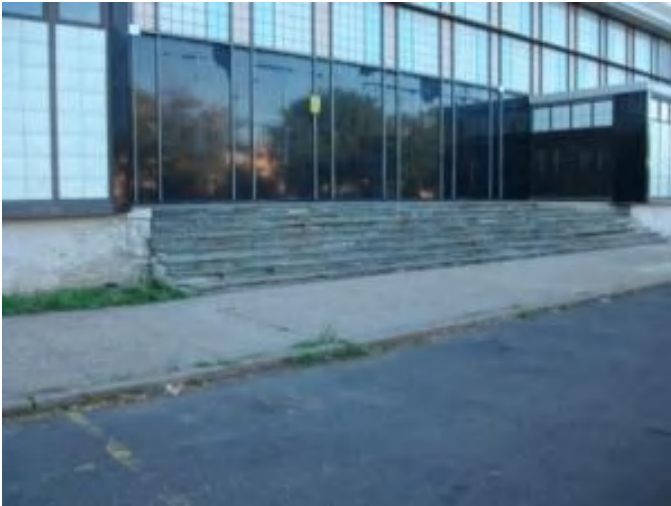
System: G2030 - Pedestrian Paving

Location: Gym entrance

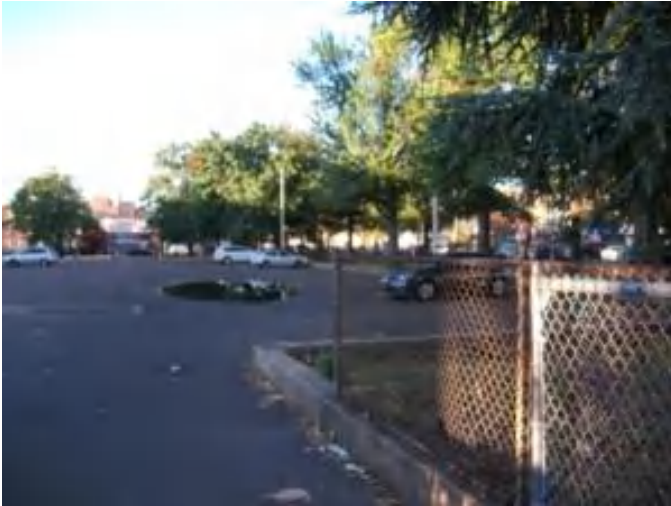
System: G2020 - Parking Lots

Location: West parking lot
