Facility Condition Assessment Summary Report

Southwark School

School District of Philadelphia
S264001;Southwark
Final
Site Assessment Report
January 30, 2017

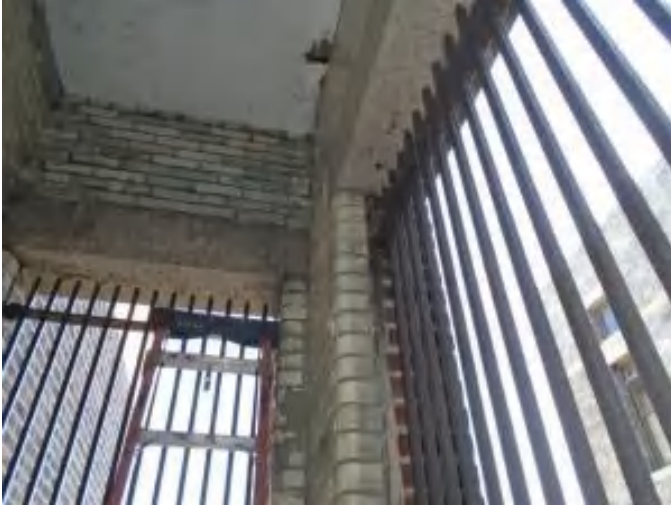
System: B2010 - Exterior Walls

Location: Fire towers

Distress: Failing

Notes: Repair brickwork on fire tower and replace metal grating – rusted and failing

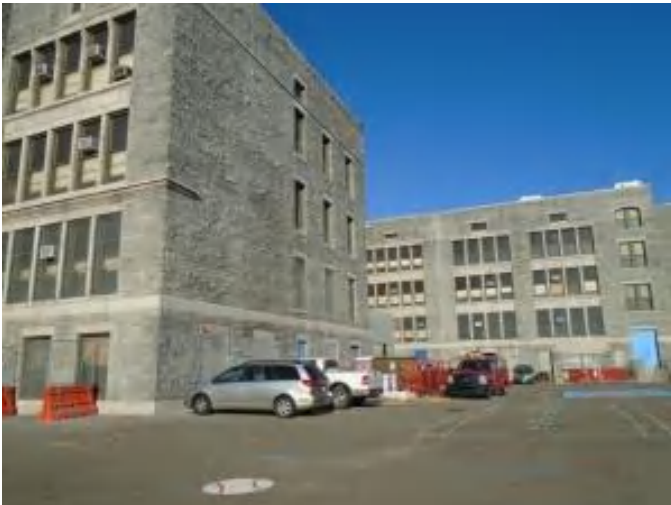
System: B2030 - Exterior Doors

Location: Entrance

Distress: Accessibility

Notes: Provide ADA compliant exterior door hardware at one entrance

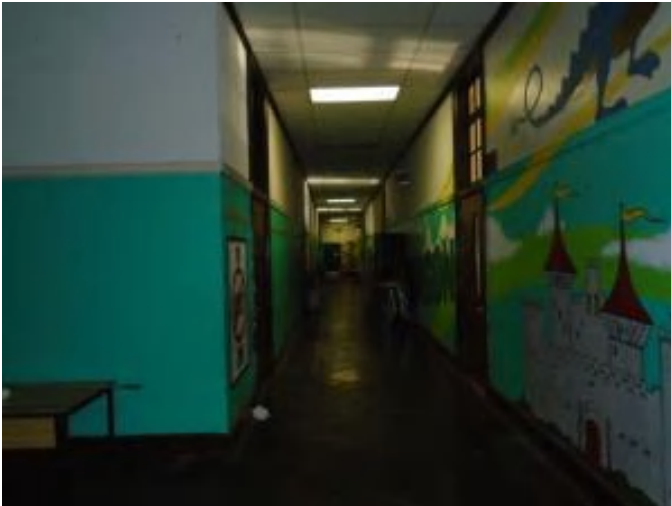
System: C1020 - Interior Doors

Location: Int. Doors

Distress: Accessibility

Notes: Provide ADA lever handle lock/latchsets on interior doors

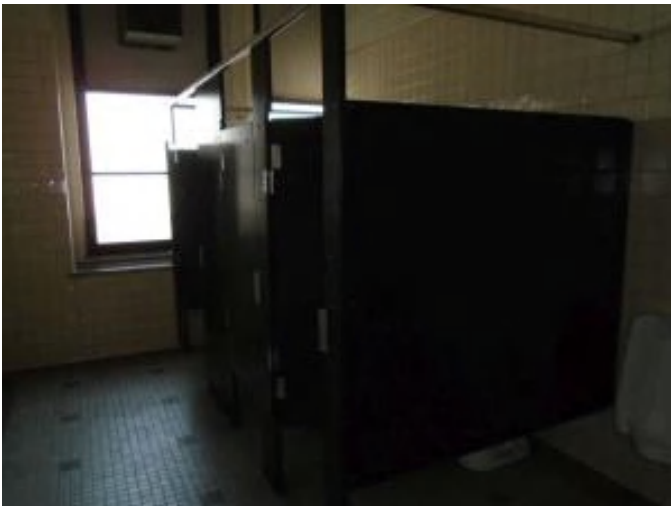
System: C1030 - Fittings

Location: Toilets

Distress: Accessibility

Notes: Provide new toilet partitions and toilet accessories including grab bars for accessibility

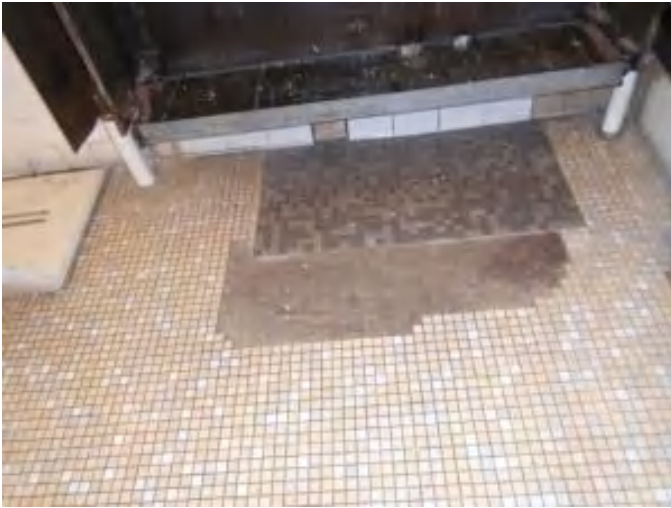
System: C3020412 - Terrazzo & Tile

Location: Toilets

Distress: Failing

Notes: Repair ceramic tile flooring – failing

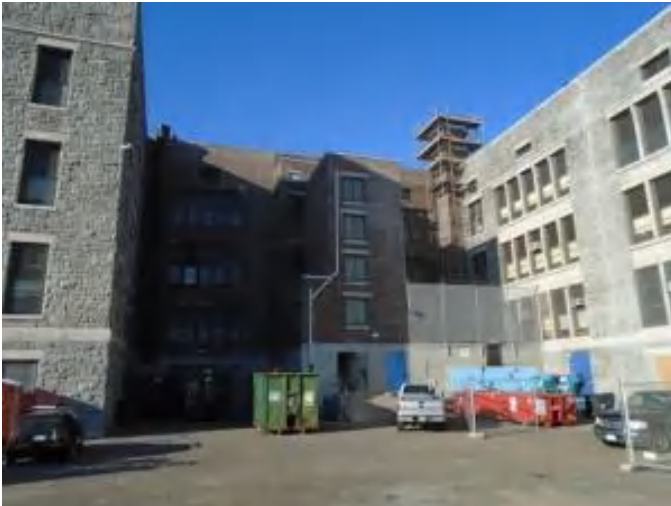
System: D1010 - Elevators and Lifts

Location: TBD

Notes: Install elevator for accessibility (location TBD)

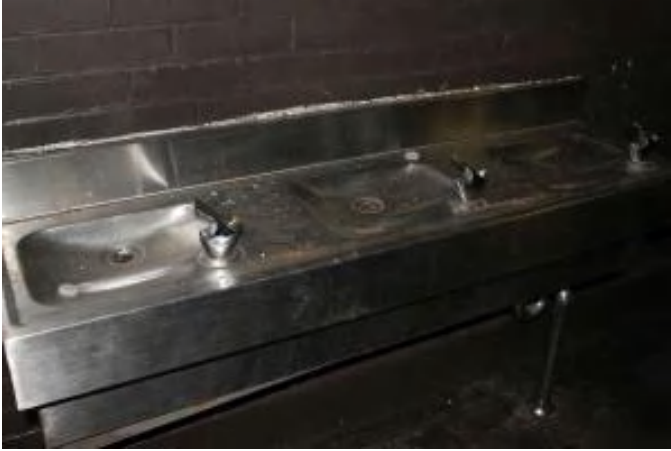
System: D2010 - Plumbing Fixtures

Drinking fountains in the corridors are mixture of porcelain and stainless steel, wall hung without coolers. They are not accessible and have exceeded their service life and should be replaced.

Location: Entire building

Distress: Accessibility

Notes: Replace aged, non-accessible drinking fountains.

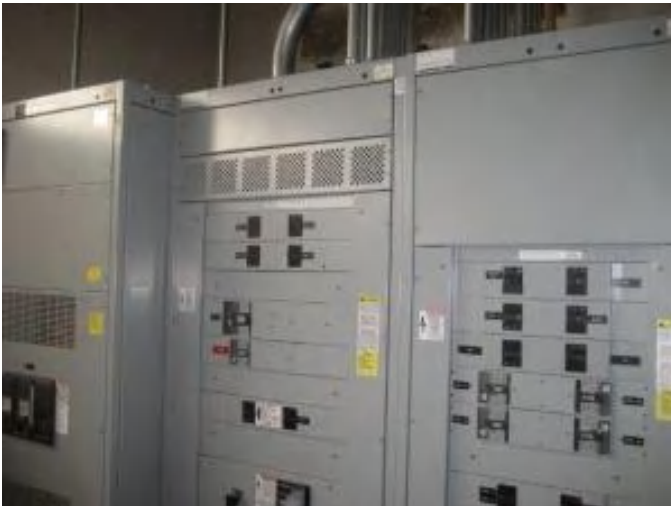
System: D5010 - Electrical Service/Distribution

Location: Basement electrical room

Distress: Inadequate

Notes: Provide a 1200 Amperes 480/277V new electrical service

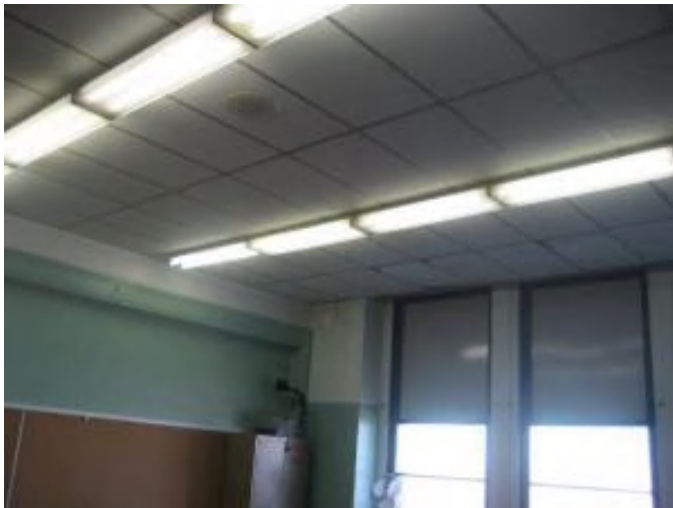
System: D5020 - Lighting and Branch Wiring

Location: Ekntire school
Distress: Energy Efficiency
Category: 4 - Capital Improvement
Priority: 2 - Response Time (2-3 yrs)
Correction: Add Lighting Fixtures
Qty: 1,500.00
Unit of Measure: Ea.
Estimate: \$1,166,489.51
Assessor Name: System
Date Created: 08/12/2015

Notes: Approximate 90% of the lighting fixtures are provided with T-12 lamps. Replace lighting fixtures with T-8 lamps. Approximate 1500 fixtures.

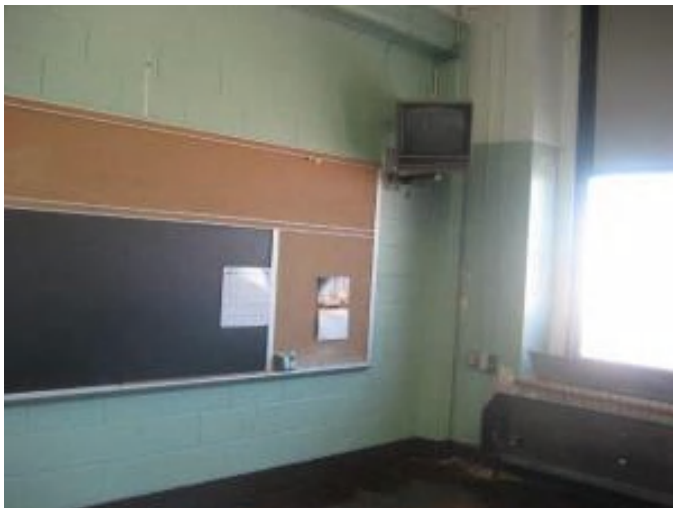
System: D5020 - Lighting and Branch Wiring

There number of receptacles in classrooms varies, approximate 15% of the classrooms have been remodeled and provided with the proper amount of receptacles but 85% of them the quantity of receptacles are inadequate. Teachers use extension cords. Provide approximate 39 classrooms with the teacher's whiteboard wall and the opposite of it with double compartment surface raceways, the other two walls with minimum two duplex outlets each, when feasible.

Location: classrooms
Distress: Inadequate
Category: 4 - Capital Improvement
Priority: 2 - Response Time (2-3 yrs)
Correction: Add wiring device
Qty: 624.00
Unit of Measure: Ea.
Estimate: \$229,239.50
Assessor Name: System
Date Created: 08/12/2015

Notes: Provide (2)25FT of surface raceways with 24" receptacles on center and two-duplex wall mount receptacles. Approximate 39 classrooms

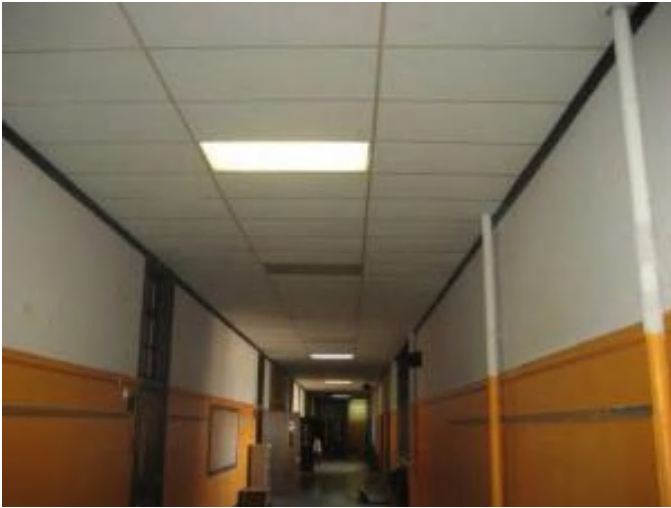
System: D5030 - Communications and Security

Location: Entire school

Distress: Obsolete

Notes: Provide a new fire alarm system Replace old fire alarm system with addressable type with audio/visual devices in the entire school. Approximate 184 devices

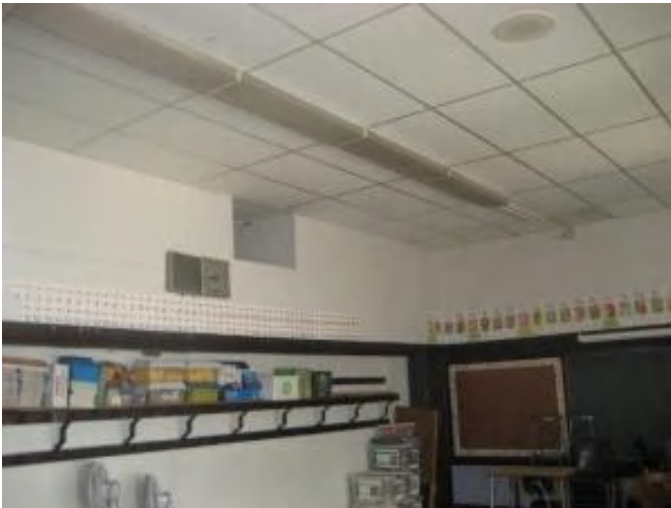
System: D5030 - Communications and Security

Location: classrooms

Distress: Obsolete

Notes: Provide a new clock system, wireless battery operated. Approximate 80 clocks

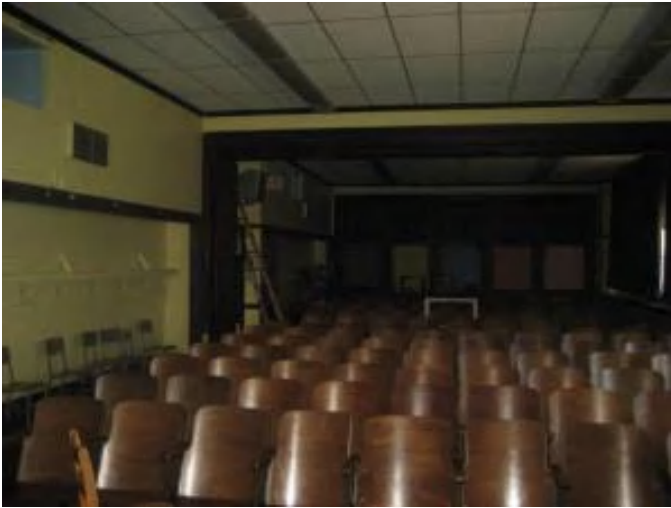
System: D5030 - Communications and Security

Location: Auditorium
Distress: Inadequate
Category: 4 - Capital Improvement
Priority: 2 - Response Time (2-3 yrs)
Correction: Add/Replace Sound System
Qty: 1.00

Notes: Provide a more complete sound system

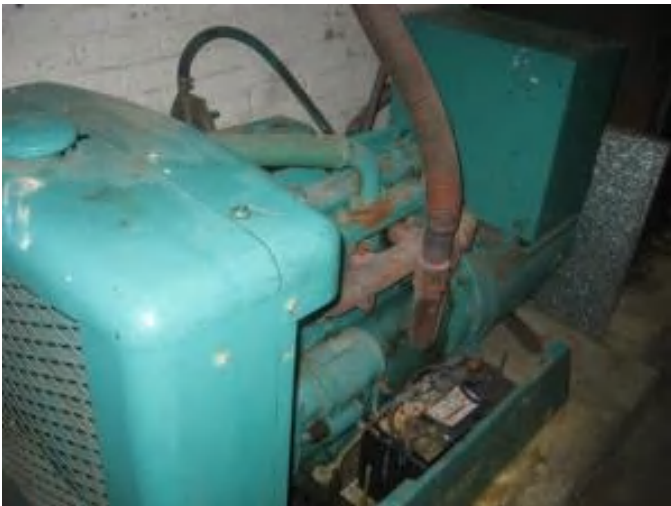
System: D5090 - Other Electrical Systems

Location: outdoor
Distress: Beyond Service Life
Category: 3 - Operations / Maint.
Priority: 2 - Response Time (2-3 yrs)
Correction: Add Standby Generator System
Qty: 1.00

Notes: Provide 150KW, outdoor, diesel powered generator.

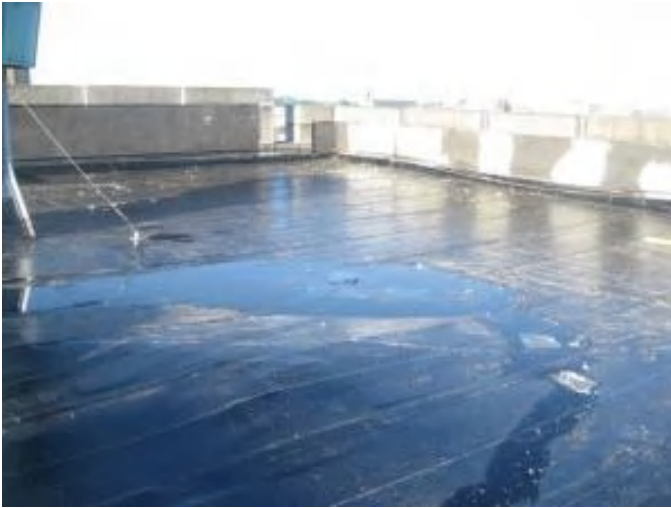
System: D5090 - Other Electrical Systems

Location: Roof
Distress: Building / MEP Codes
Category: 2 - Code Compliance
Priority: 2 - Response Time (2-3 yrs)
Correction: Repair Lightning Protection System
Qty: 1.00
Unit of Measure: Job
Estimate: \$24,249.82
Assessor Name: System
Date Created: 08/12/2015

Notes: Prepare a study to determine if lightning protection system is required.

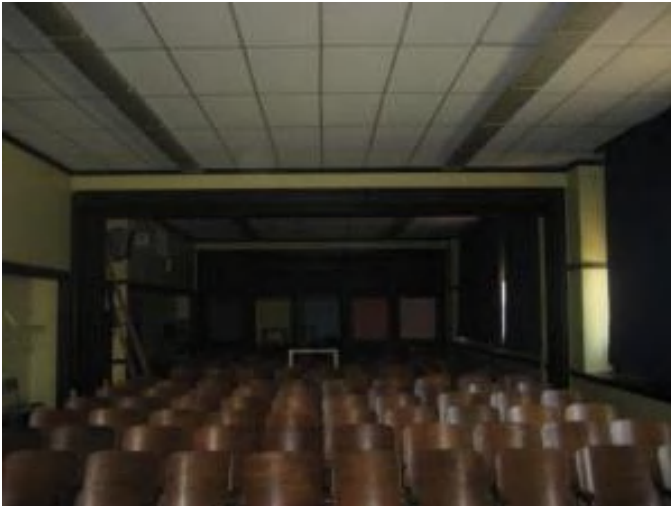
System: E1020 - Institutional Equipment

Location: Auditorium
Distress: Inadequate
Category: 4 - Capital Improvement
Priority: 2 - Response Time (2-3 yrs)
Correction: Add/Replace Stage Theatrical Lighting System
Qty: 1.00
Unit of Measure: Ea.
Estimate: \$323,055.06
Assessor Name: System
Date Created: 08/12/2015

Notes: The auditorium is not provided with theatrical lighting nor dimming control system. Provide theatrical lighting and dimming control system

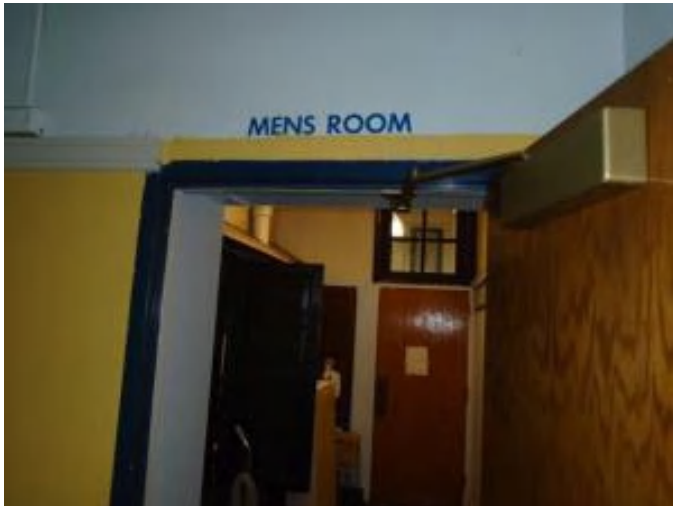
System: C1030 - Fittings

Location: Entire Building

Distress: Building / MEP Codes

Notes: Install new ID signage to meet ADA requirements

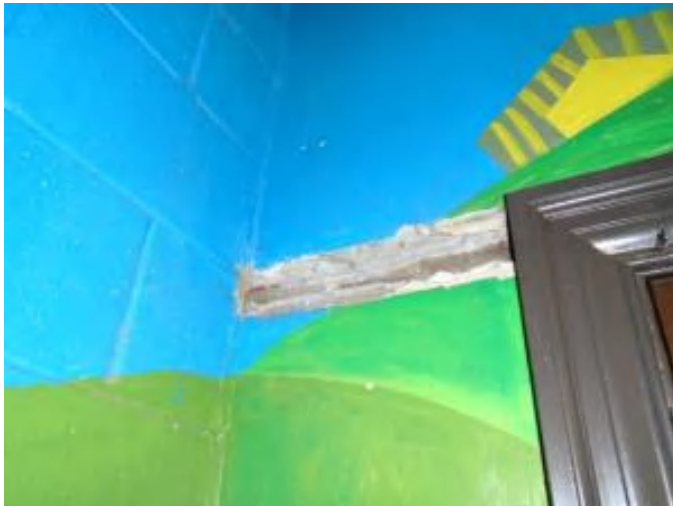
System: C3010230 - Paint & Covering

Location: Int. walls

Distress: Damaged

Notes: Repair and paint interior walls – damaged (10% of painted wall area)

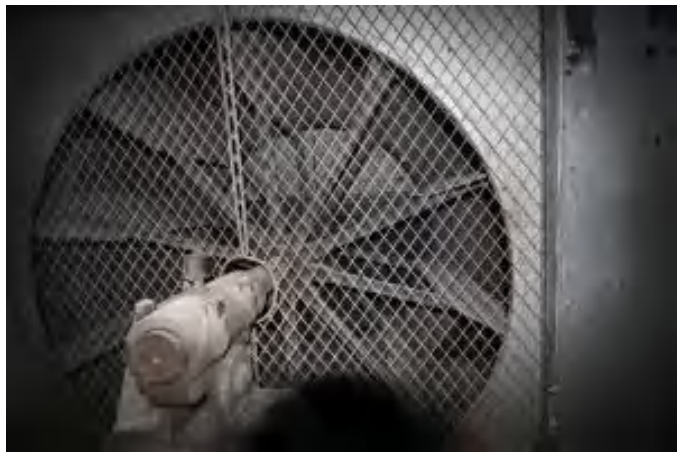
System: D3040 - Distribution Systems

The original air handler in the basement mechanical room is inoperable and obsolete. The outside air intake louver has been removed and the resulting open space in the wall was filled in with concrete masonry units. The original masonry ducts connecting the air handler to the classrooms and then to the attic plenum are blocked in most of the rooms by plywood, cardboard, cabinets, etc. At the basement level, the brick and mortar return air duct from the attic is still open to the fan room. The existing air handler should be removed and replaced with a modern unit including cooling section and digital controls and the duct work renovated to restore classroom ventilation. Steam pipes were being partially replaced with the new boilers, and the remaining steam pipes should be serviceable for at least 10 more years.

Location: Mechanical room

Distress: Obsolete

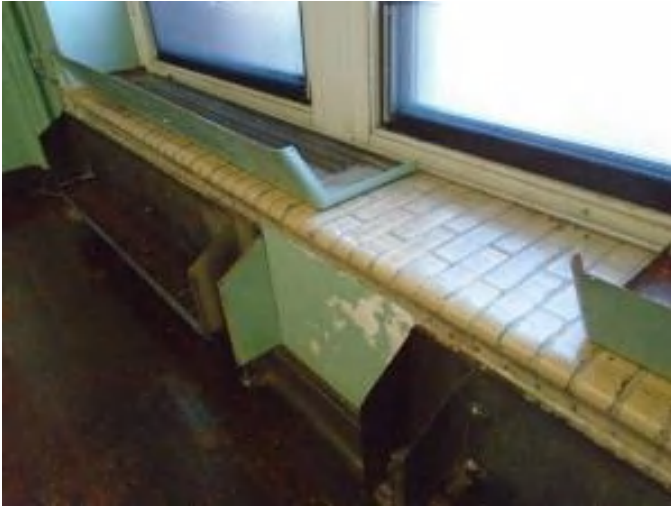
System: B2020 - Exterior Windows

Location: Throughout

Distress: Energy Efficiency

Notes: Replace Plexiglas windows – hazed

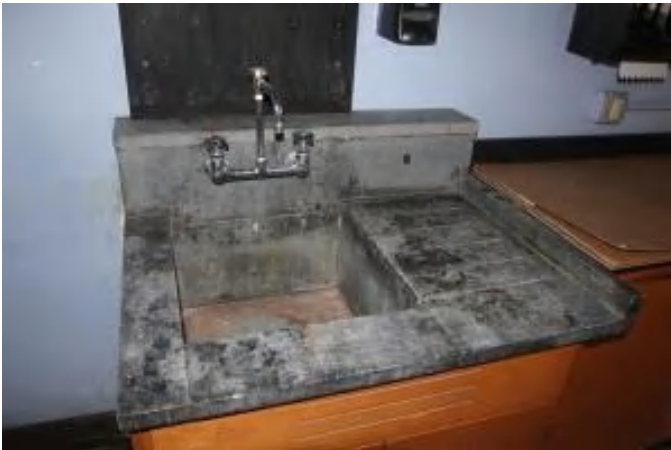
System: D2010 - Plumbing Fixtures

There is a single basin, rim mounted, stainless steel kitchen sink in the second floor teacher lounge which is in good condition. The basement art room (formerly home economics) has two kitchen sinks which have exceeded their service life and should be replaced. Third floor science classroom has multiple laboratory sinks installed within the past 10 years. These are in very good condition and will not need replacement before 20 years. Another science classroom has a soapstone lab sink with lead drain trap which should be replaced due to age. Service sinks are located in janitor closets on each floor. They include wall hung stainless steel and floor mounted polymer with mixing faucets with vacuum breaker spouts. Floor mounted sinks have exceeded their service life and should be replaced.

Location: Classrooms, lounge, service closets

Distress: Beyond Service Life

Notes: Replace multiple aged laboratory, service, and kitchen sinks.

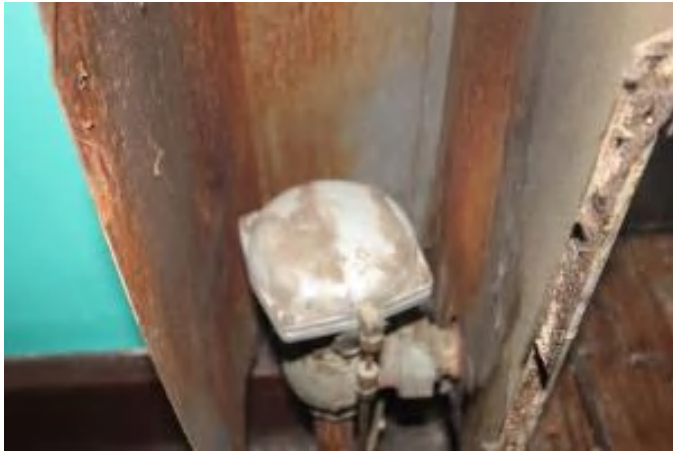
System: D3060 - Controls & Instrumentation

Pneumatic controls were added to the build some time ago. They include wall mounted thermostats in the classrooms and remote control steam valves on the finned tube units. They are past their service life, obsolete, damaged, and most likely inoperable. They should be replaced with digital controls when other HVAC system components replaced.

Location: Entire building
Distress: Obsolete
Category: 3 - Operations / Maint.
Priority: 4 - Response Time (4-5 yrs)
Correction: Replace pneumatic controls with DDC (150KSF)
Qty: 138,000.00
Unit of Measure: S.F.
Estimate: \$2,471,773.46
Assessor Name: System
Date Created: 09/05/2015

Notes: Upgrade obsolete pneumatic control system to digital.

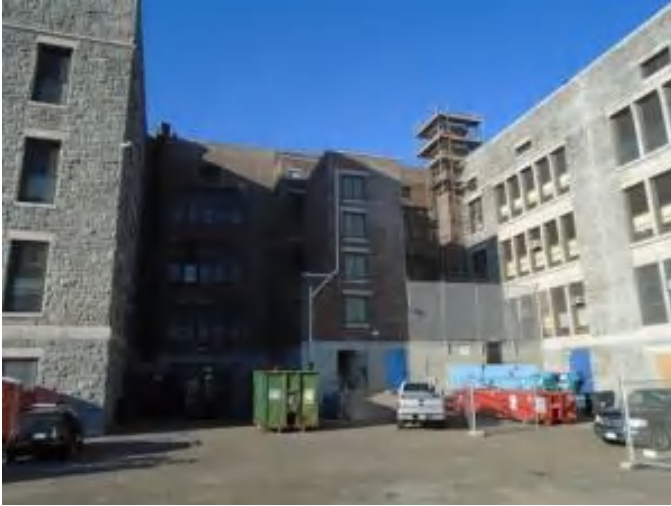
System: G2030 - Pedestrian Paving

Location: Entrance

Distress: Accessibility

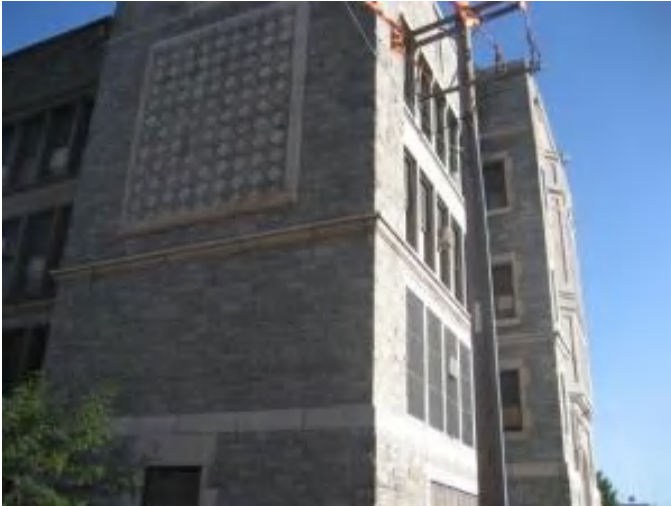
System: G4020 - Site Lighting

Location: Outdoor

Distress: Health Hazard / Risk

Notes: The school perimeter is illuminated from wall mounted fixtures, as a safety issue provide 6 wall mounted lighting fixtures in the parking and playground area.

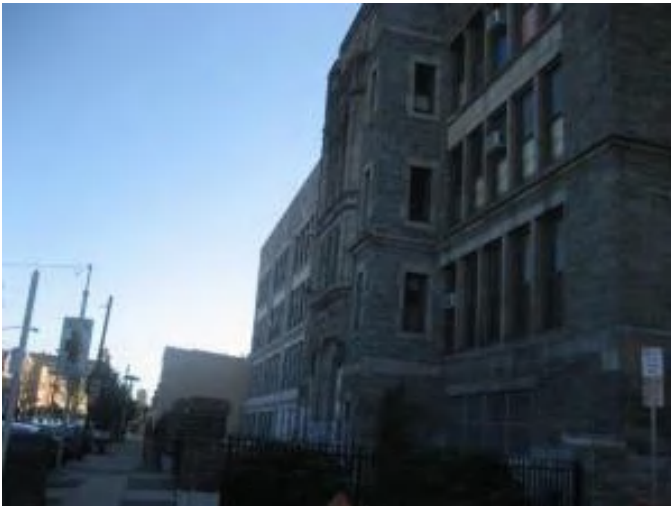
System: G4030 - Site Communications & Security

Location: Outdoor

Distress: Inadequate
