Facility Condition Assessment Summary Report

Spring Garden School

School District of Philadelphia
S556001;Spring Garden
Final
Site Assessment Report
January 31, 2017

Site Assessment Report

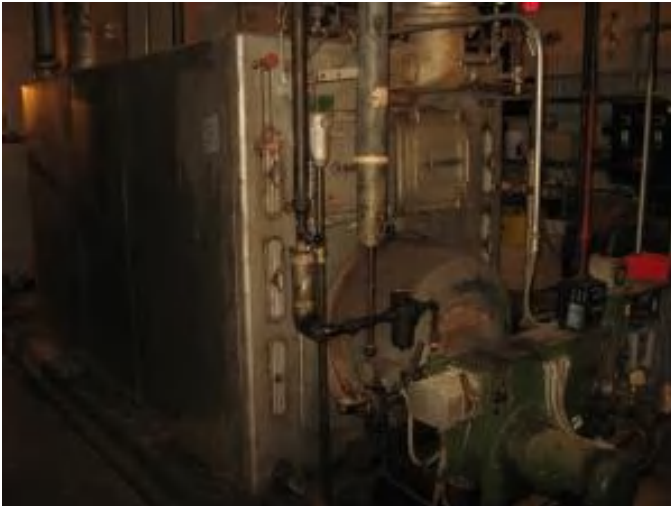
System: D3020 - Heat Generating Systems

Location: Boiler room

Distress: Beyond Service Life

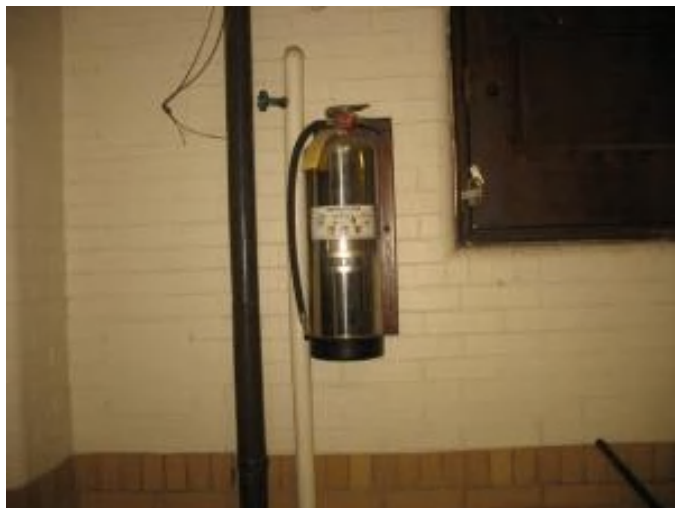
System: D4010 - Sprinklers

Location: Throughout building

Distress: Life Safety / NFPA / PFD

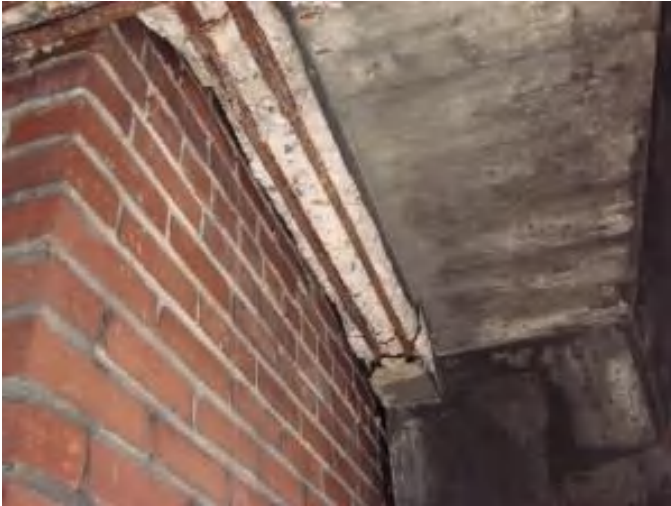
System: B1020 - Roof Construction

Location: Exterior/Interior

Distress: Damaged

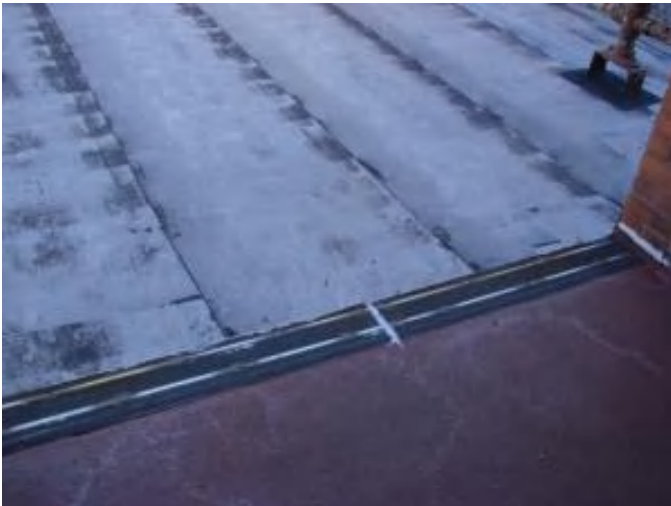
System: B3010120 - Single Ply Membrane

Location: Exterior

Distress: Building Envelope Integrity

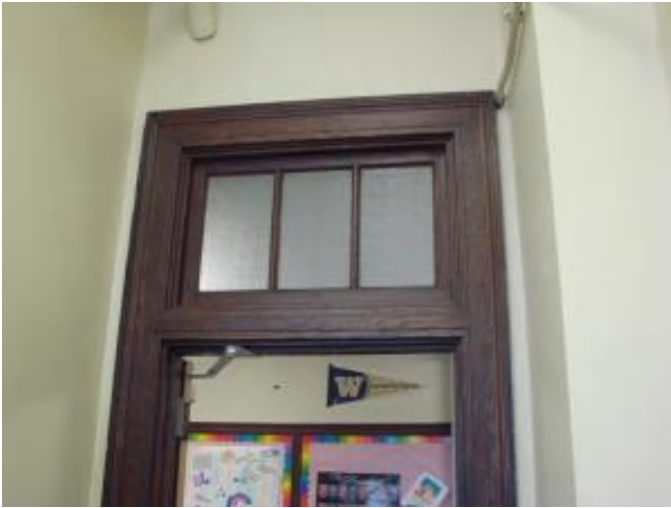
System: C1020 - Interior Doors

Location: Interior
Distress: Appearance
Category: 3 - Operations / Maint.
Priority: 2 - Response Time (2-3 yrs)
Correction: Refinish interior doors
Qty: 95.00
Unit of Measure: Ea.
Estimate: \$59,186.02
Assessor Name: System
Date Created: 01/18/2016

Notes: Repair and refinish all interior doors

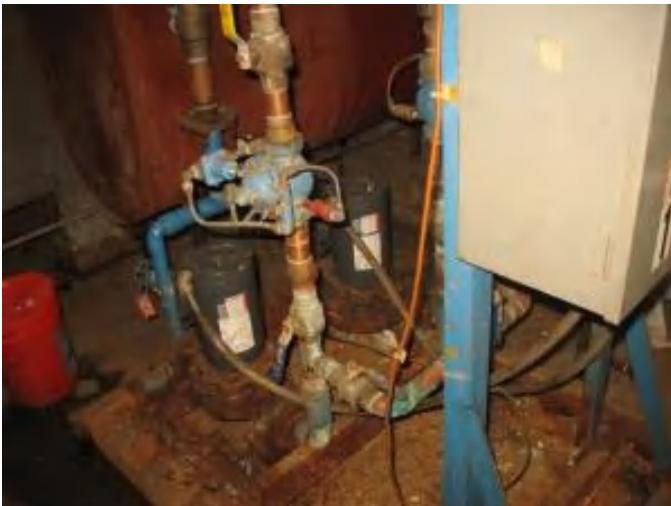
System: D2020 - Domestic Water Distribution

Location: Basement
Distress: Damaged
Category: 3 - Operations / Maint.
Priority: 2 - Response Time (2-3 yrs)
Correction: Replace duplex domestic booster pump set (5 HP)
Qty: 1.00
Unit of Measure: Ea.
Estimate: \$42,298.97
Assessor Name: System
Date Created: 10/20/2015

Notes: Replace the duplex 3HP domestic water booster pumps and isolation valves on incoming domestic water line.

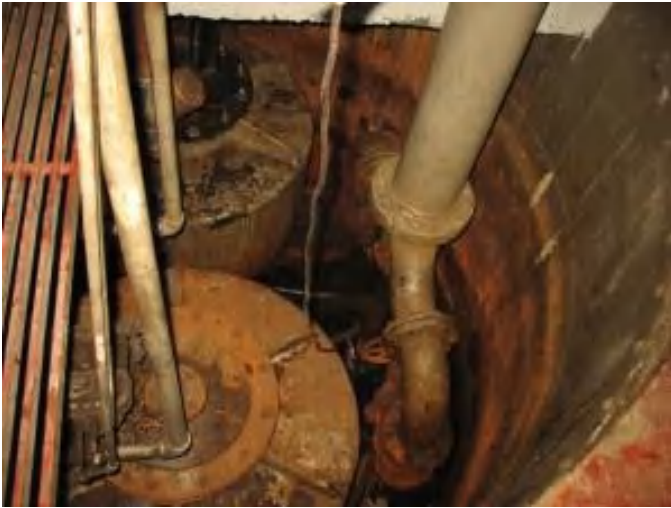
System: D2030 - Sanitary Waste

Location: Basement

Distress: Health Hazard / Risk

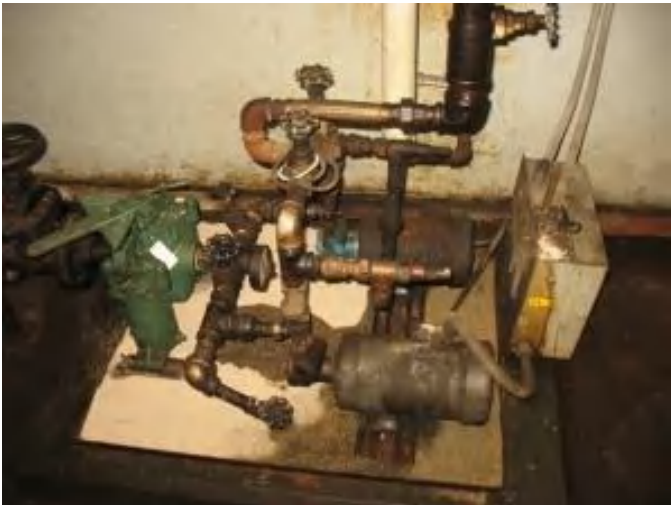
System: D3020 - Heat Generating Systems

Location: Boiler room

Distress: Damaged

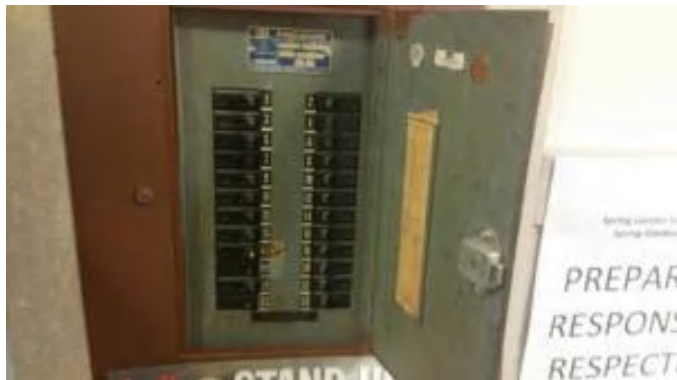
System: D5010 - Electrical Service/Distribution

Location: throughout the building

Distress: Beyond Service Life

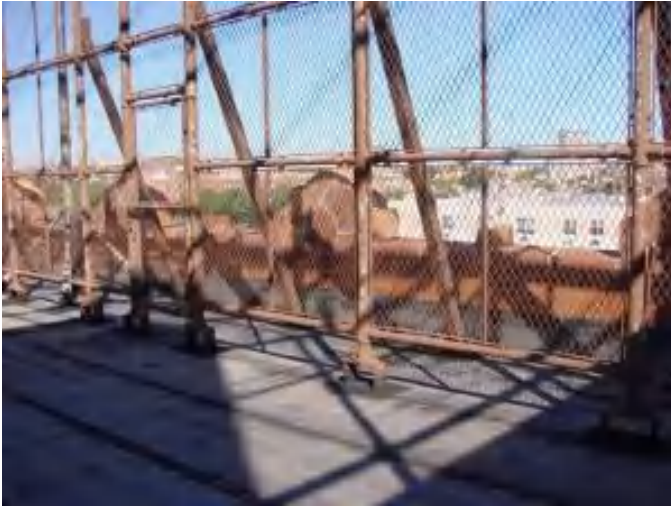
System: B1020 - Roof Construction

Location: Exterior

Distress: Beyond Service Life

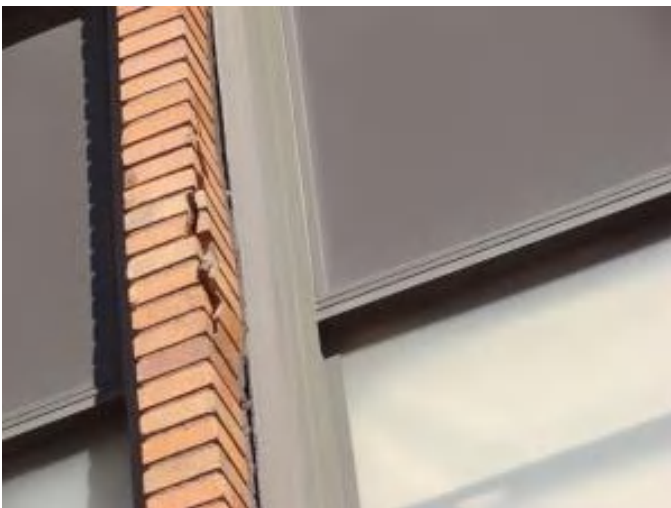
System: B2010 - Exterior Walls

Location: Exterior

Distress: Building Envelope Integrity

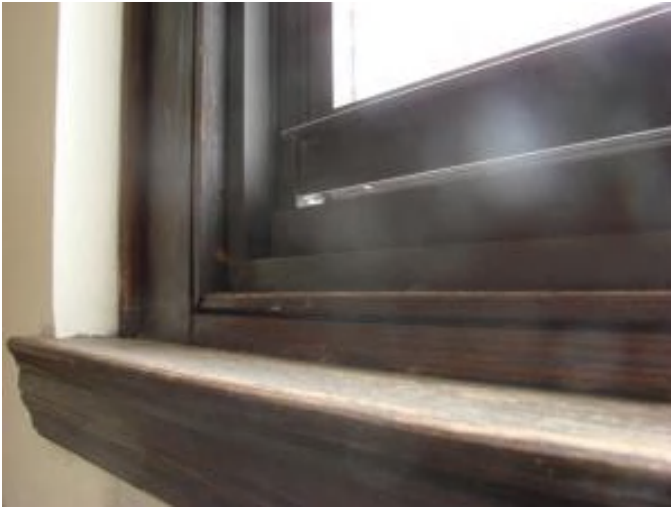
System: B2020 - Exterior Windows

Location: Exterior

Distress: Building Envelope Integrity

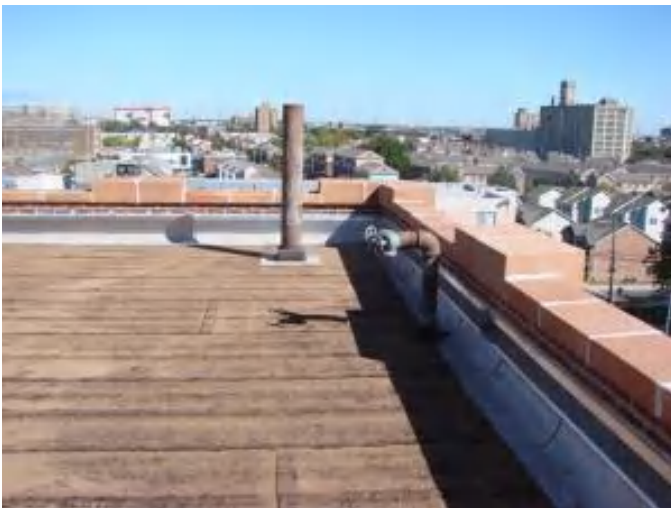
System: B3010105 - Built-Up

Location: Exterior

Distress: Beyond Service Life

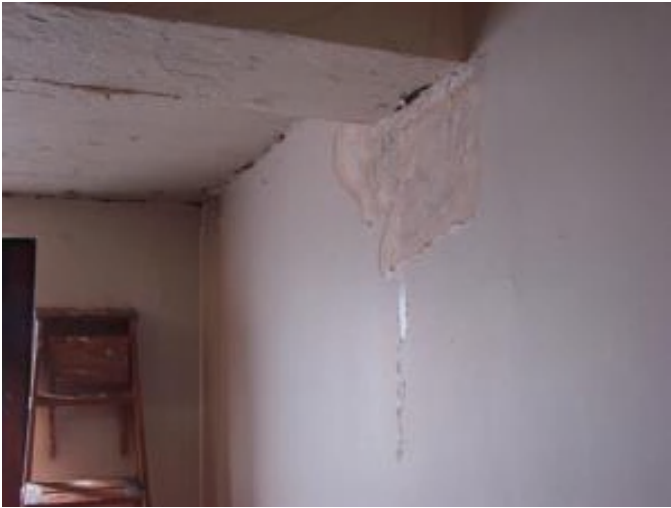
System: C3010230 - Paint & Covering

Location: Interior

Distress: Beyond Service Life

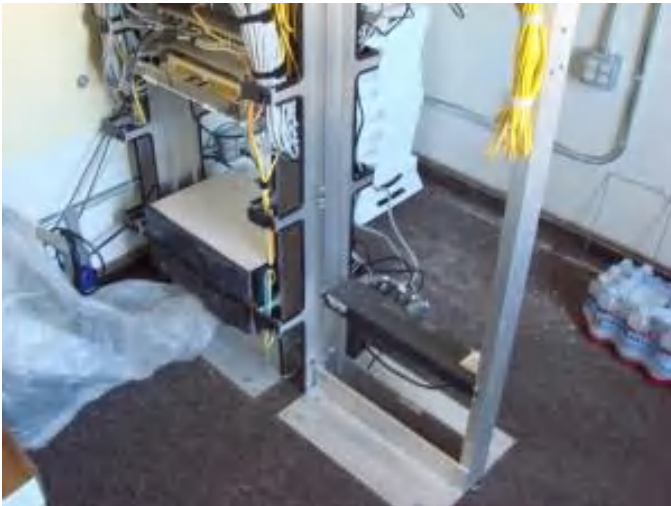
System: C3020411 - Carpet

Location: Interior

Distress: Beyond Service Life

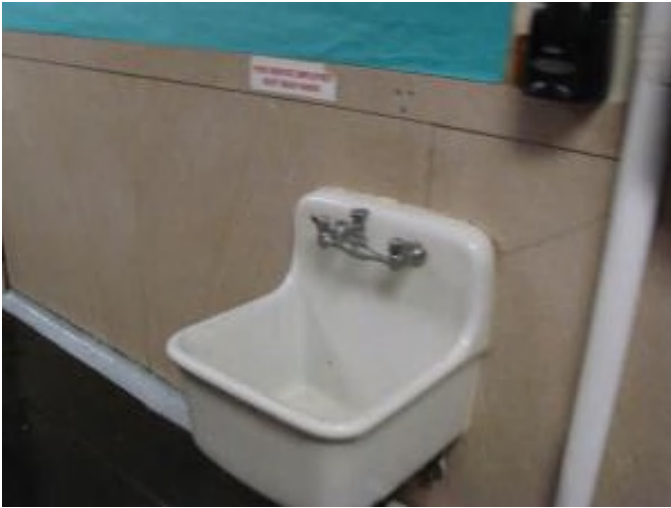
System: C3020413 - Vinyl Flooring

Location: Interior
Distress: Beyond Service Life
Category: 3 - Operations / Maint.
Priority: 3 - Response Time (3-4 yrs)
Correction: Remove VAT and replace with VCT - SF of area
Qty: 4,640.00
Unit of Measure: S.F.
Estimate: \$66,545.58
Assessor Name: System
Date Created: 01/18/2016

Notes: Replace all VAT tile with VCT tile

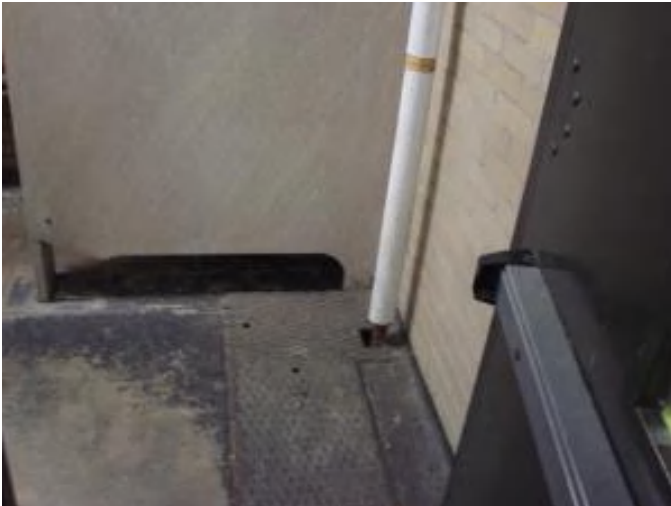
System: C3020415 - Concrete Floor Finishes

Location: Interior
Distress: Beyond Service Life
Category: 3 - Operations / Maint.
Priority: 3 - Response Time (3-4 yrs)
Correction: Prepare and repaint concrete floor
Qty: 9,400.00
Unit of Measure: S.F.
Estimate: \$44,961.66
Assessor Name: System
Date Created: 01/18/2016

Notes: Refinish concrete flooring in toilets and kitchen

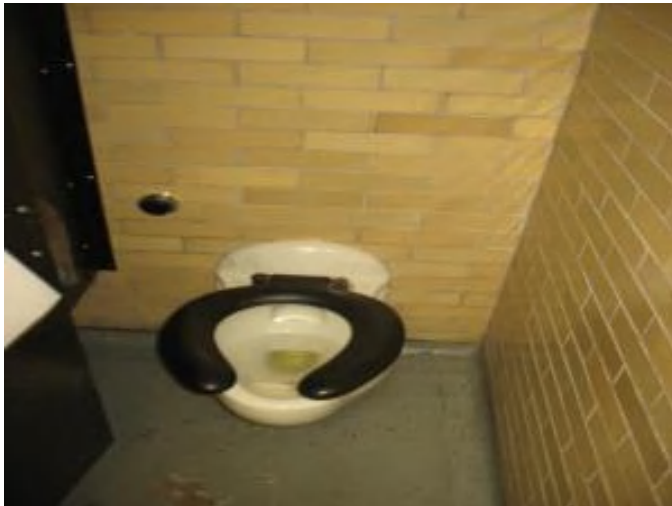
System: D2010 - Plumbing Fixtures

Location: Restrooms

Distress: Beyond Service Life

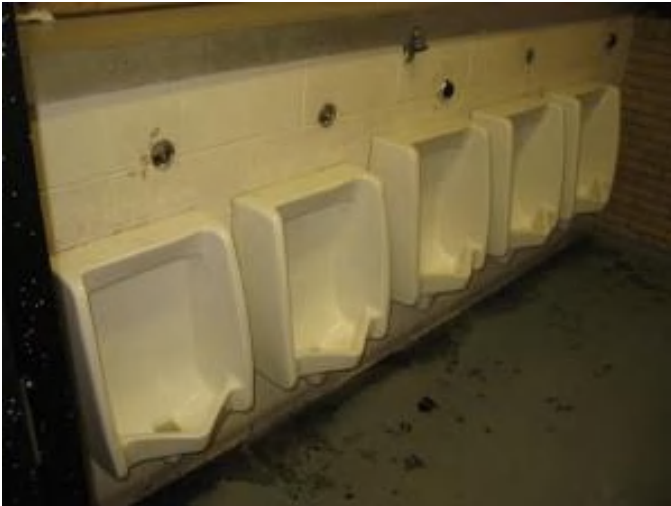
System: D2010 - Plumbing Fixtures

Location: Restrooms

Distress: Beyond Service Life

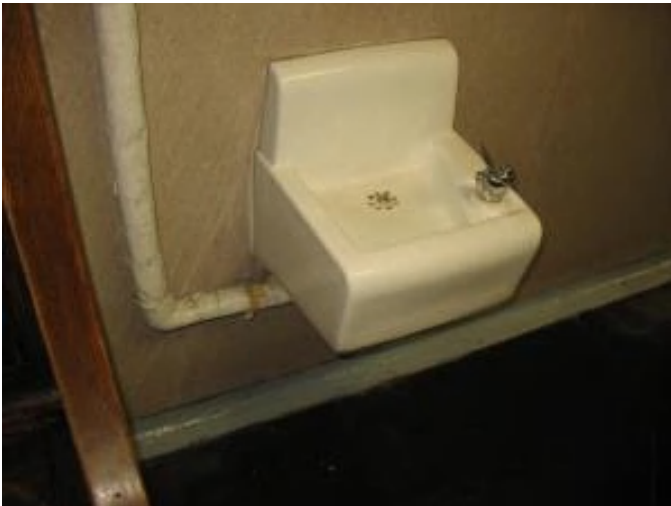
System: D2010 - Plumbing Fixtures

Location: Corridors

Distress: Beyond Service Life

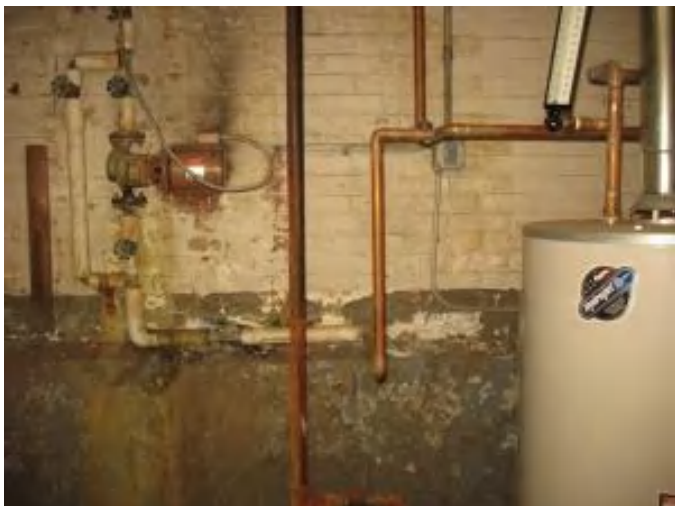
System: D2020 - Domestic Water Distribution

Location: Throughout building

Distress: Beyond Service Life

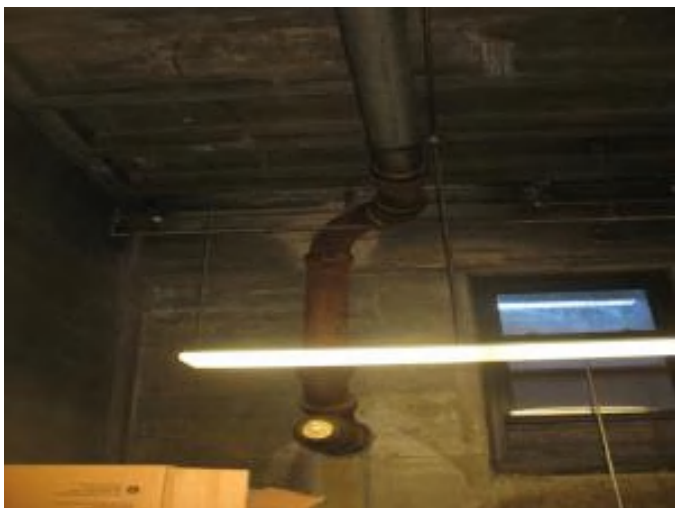
System: D2030 - Sanitary Waste

Location: Throughout building

Distress: Beyond Service Life

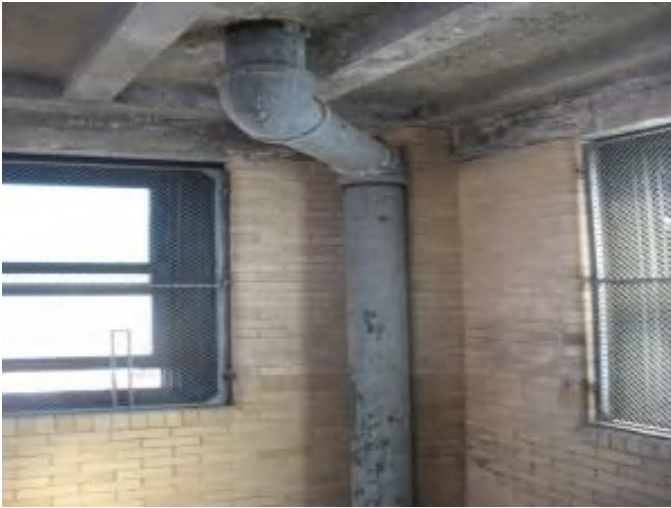
System: D2040 - Rain Water Drainage

Location: Throughout building

Distress: Beyond Service Life

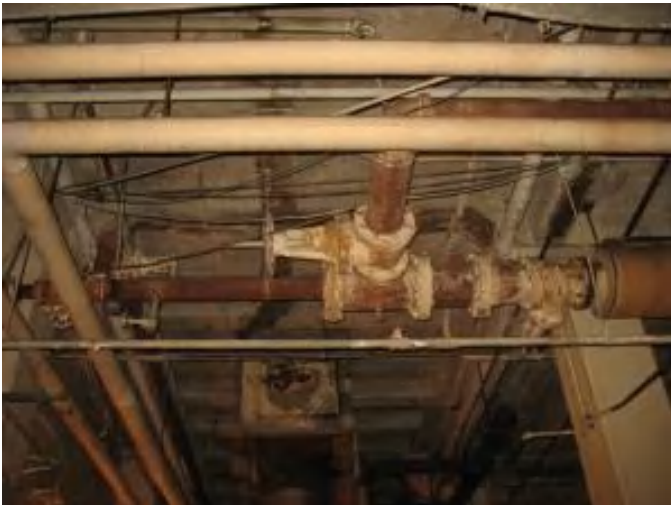
System: D3040 - Distribution Systems

Location: Throughout building

Distress: Beyond Service Life

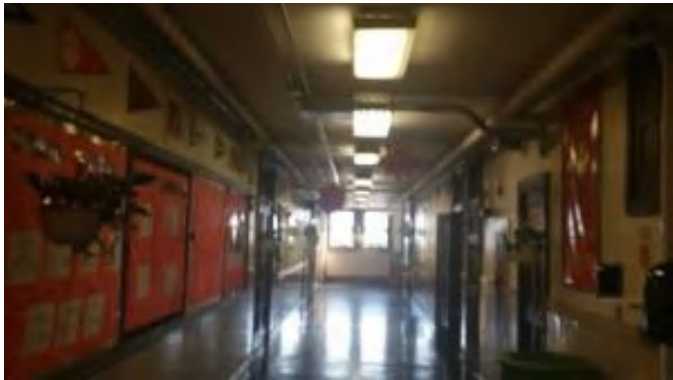
System: D5020 - Lighting and Branch Wiring

Location: throughout the building

Distress: Beyond Service Life

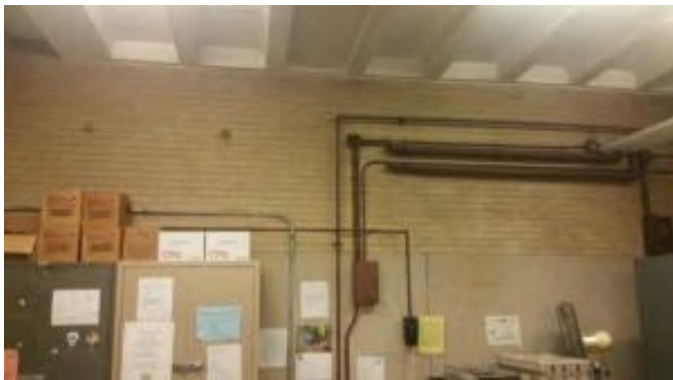
System: D5020 - Lighting and Branch Wiring

Location: throughout the building

Distress: Inadequate

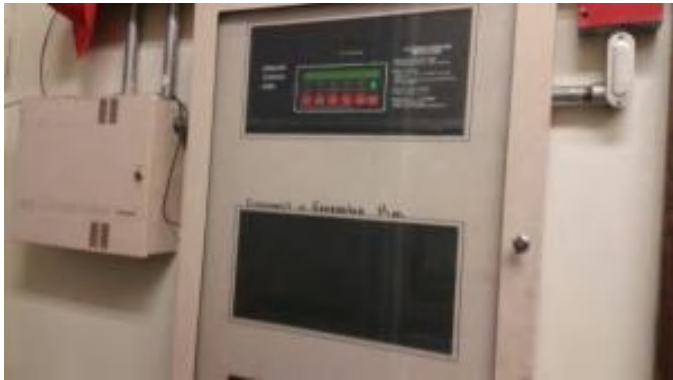
System: D5030 - Communications and Security

Location: throughout the building
Distress: Health Hazard / Risk
Category: 1 - Health & Safety
Priority: 3 - Response Time (3-4 yrs)
Correction: Replace fire alarm system
Qty: 1.00
Unit of Measure: S.F.
Estimate: \$208,222.16
Assessor Name: System
Date Created: 01/18/2016

Notes: Install new automated FA system.

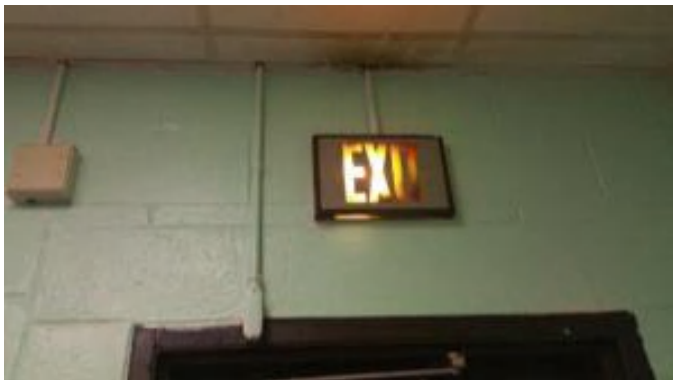
System: D5090 - Other Electrical Systems

Location: throughout the building
Distress: Beyond Service Life
Category: 3 - Operations / Maint.
Priority: 3 - Response Time (3-4 yrs)
Correction: Add Emergency/Exit Lighting
Qty: 1.00
Unit of Measure: Ea.
Estimate: \$175,679.28
Assessor Name: System
Date Created: 01/18/2016

Notes: Install new emergency exit signs emergency lights.

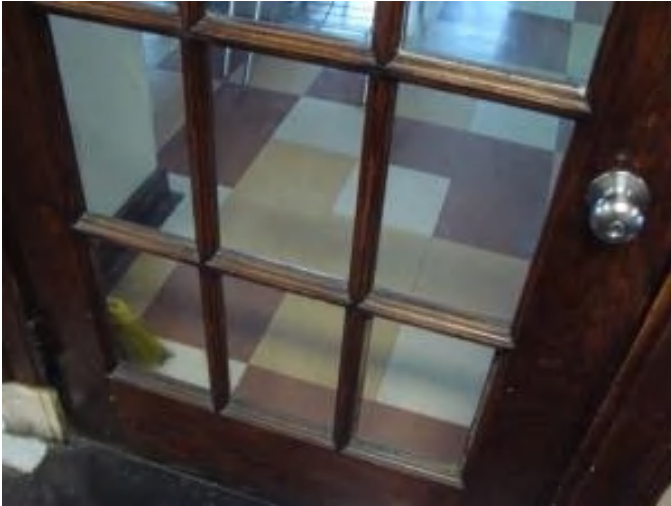
System: C1020 - Interior Doors

Location: Interior

Distress: Accessibility

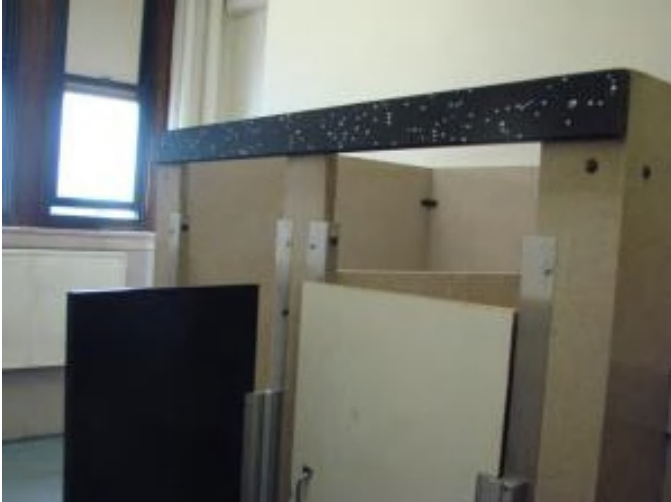
System: C1030 - Fittings

Location: Interior

Distress: Beyond Service Life

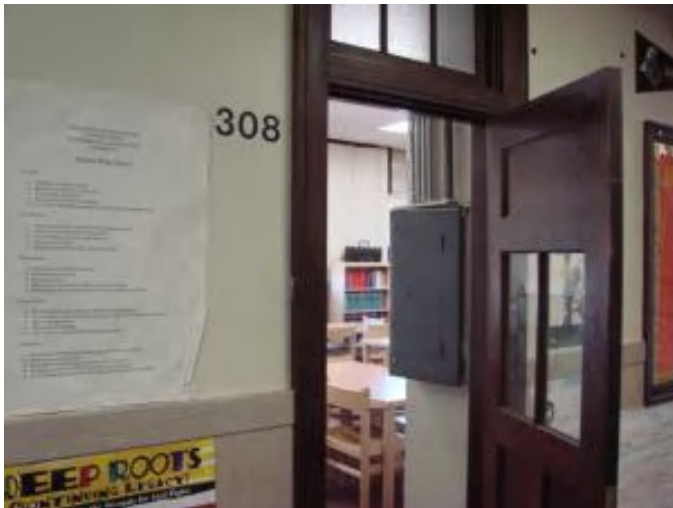
System: C1030 - Fittings

Location: Interior

Distress: Beyond Service Life

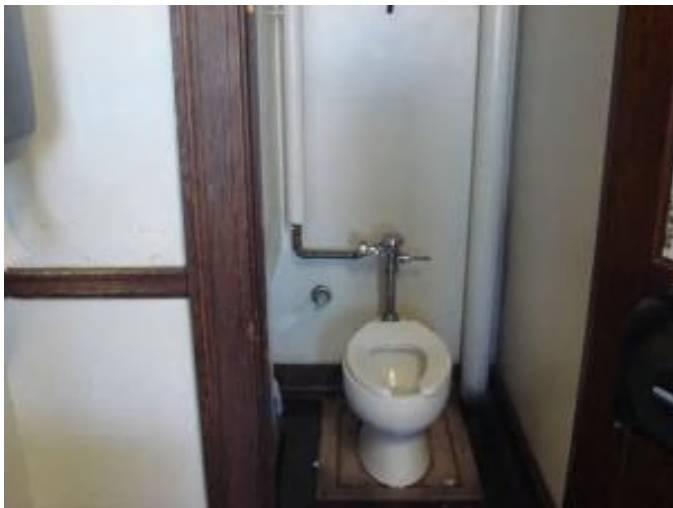
System: C1030 - Fittings

Location: Interior

Distress: Damaged

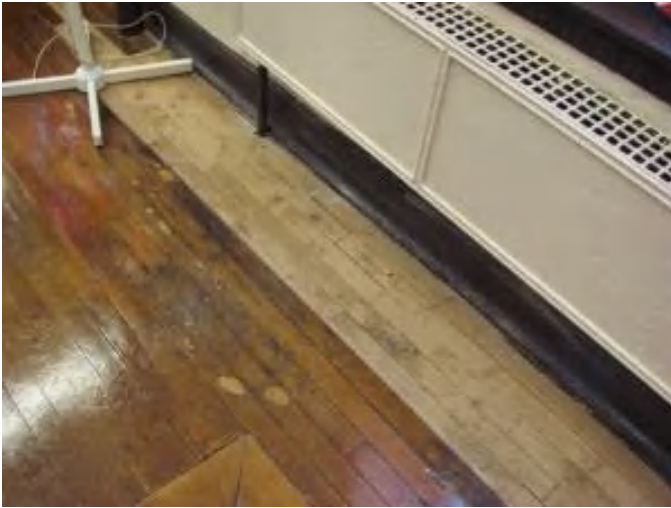
System: C3020414 - Wood Flooring

Location: Interior

Distress: Beyond Service Life

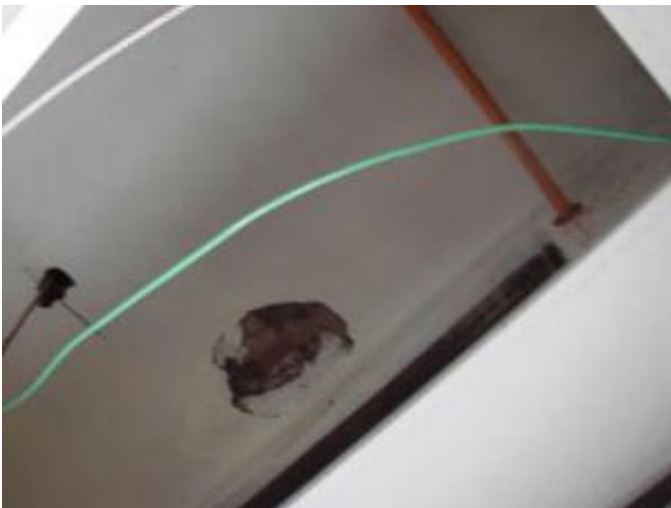
System: C3030 - Ceiling Finishes

Location: Interior

Distress: Beyond Service Life

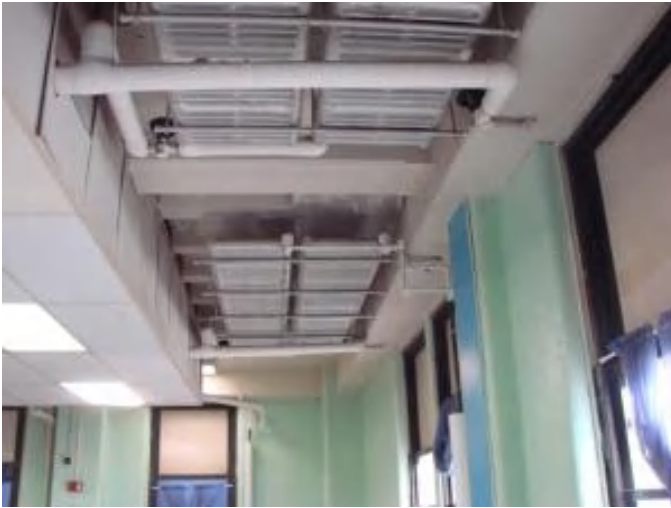
System: C3030 - Ceiling Finishes

Location: Interior
Distress: Beyond Service Life
Category: 3 - Operations / Maint.
Priority: 4 - Response Time (4-5 yrs)
Correction: Remove and replace suspended acoustic ceilings - lighting not included
Qty: 3,800.00
Unit of Measure: S.F.
Estimate: \$48,125.90
Assessor Name: System
Date Created: 01/18/2016

Notes: Replace suspended acoustical ceilings (30% area)

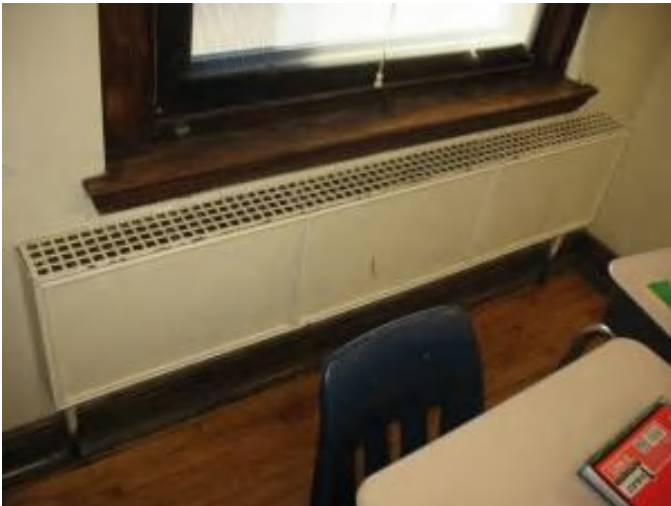
System: D3040 - Distribution Systems

Location: Throughout building
Distress: Health Hazard / Risk
Category: 1 - Health & Safety
Priority: 4 - Response Time (4-5 yrs)
Correction: Provide classroom FC units and dedicated OA ventilation system. (20 clsrms)
Qty: 18.00
Unit of Measure: C
Estimate: \$1,337,224.67
Assessor Name: System
Date Created: 10/20/2015

Notes: Remove the existing fin tube steam radiators and install units with hot and chilled water coils and integral heat exchangers to introduce outdoor air to the building.

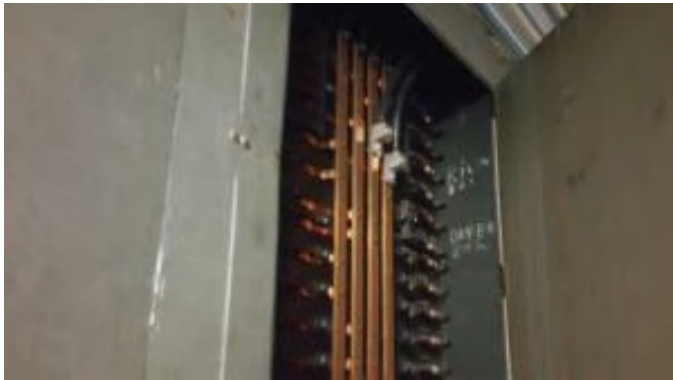
System: D5010 - Electrical Service/Distribution

Location: electrical room

Distress: Beyond Service Life

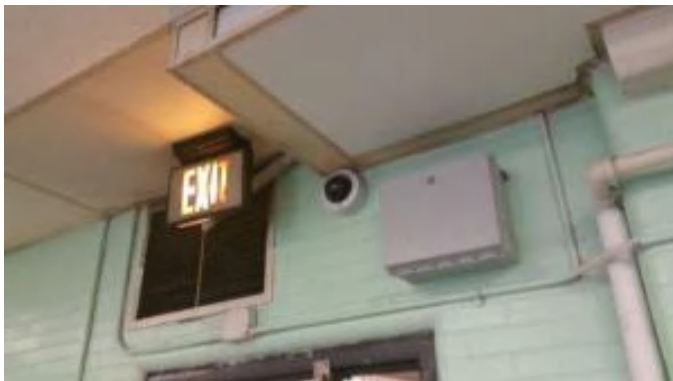
System: D5030 - Communications and Security

Location: throughout the building

Distress: Inadequate

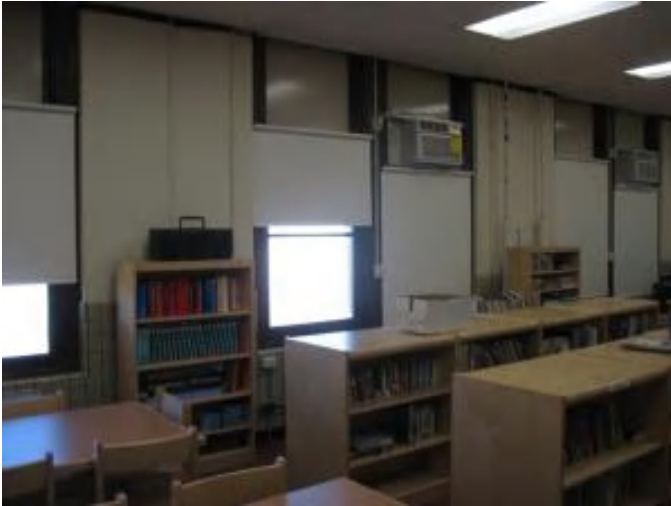
System: D3030 - Cooling Generating Systems

Location: Throughout building

Distress: Inadequate

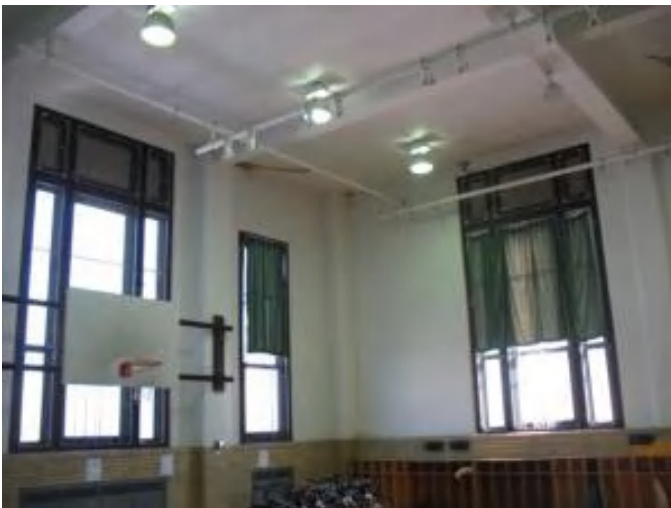
System: D3040 - Distribution Systems

Location: Gymnasium

Distress: Building / MEP Codes

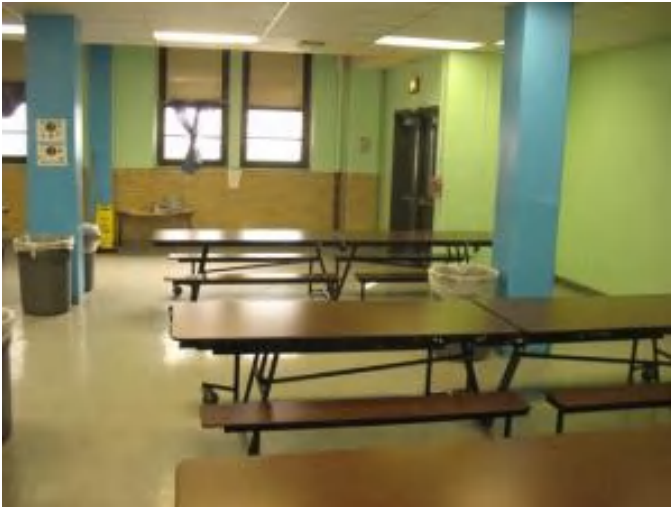
System: D3040 - Distribution Systems

Location: Cafeteria

Distress: Building / MEP Codes

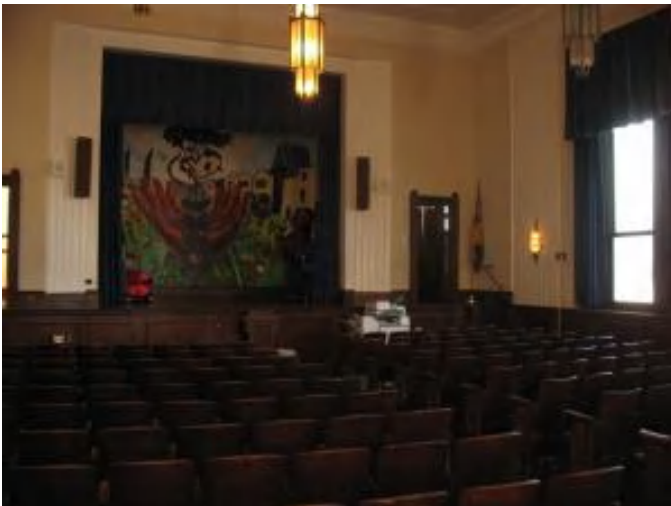
System: D3040 - Distribution Systems

Location: Auditorium

Distress: Building / MEP Codes

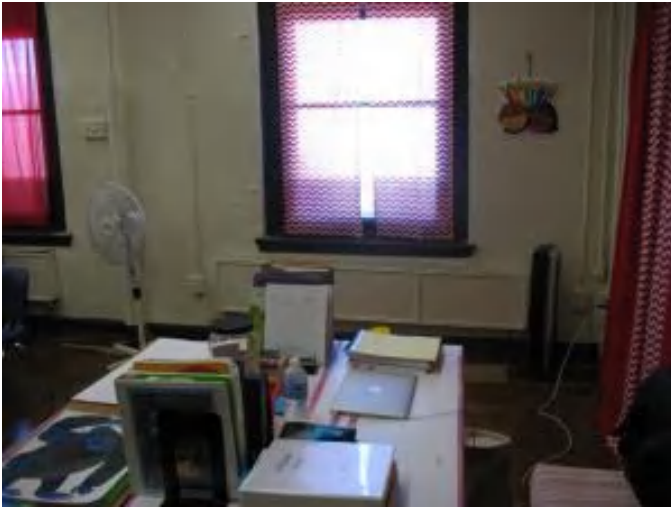
System: D3040 - Distribution Systems

Location: Administration

Distress: Building / MEP Codes

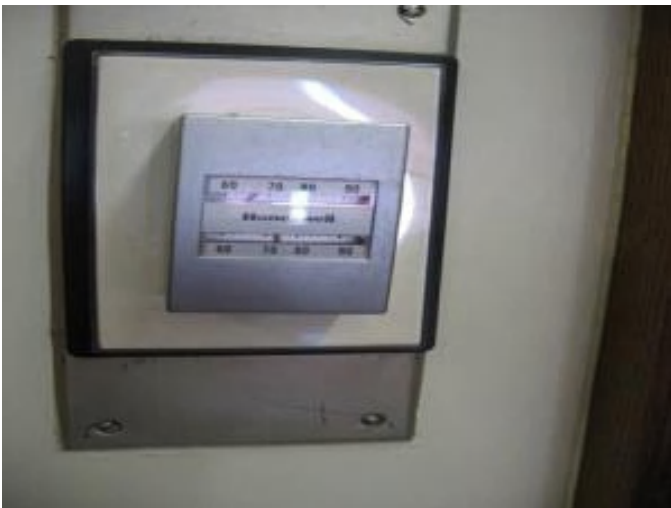
System: D3060 - Controls & Instrumentation

Location: Throughout building

Distress: Inadequate

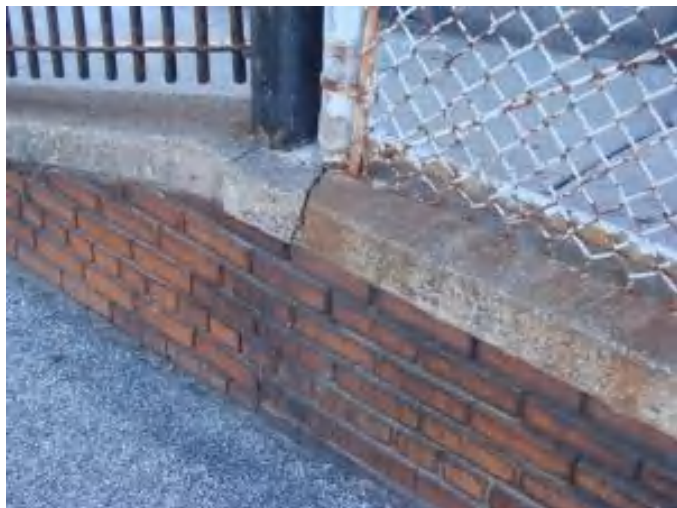
System: G2040 - Site Development

Location: Grounds

Distress: Beyond Service Life

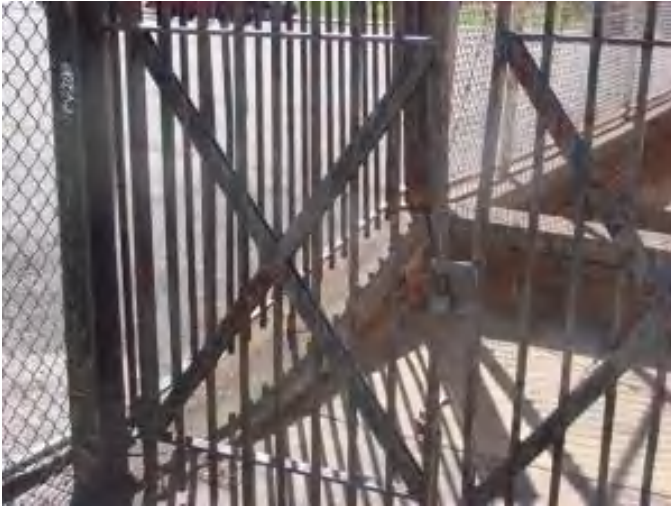
System: G2020 - Parking Lots

Location: Grounds

Distress: Beyond Service Life

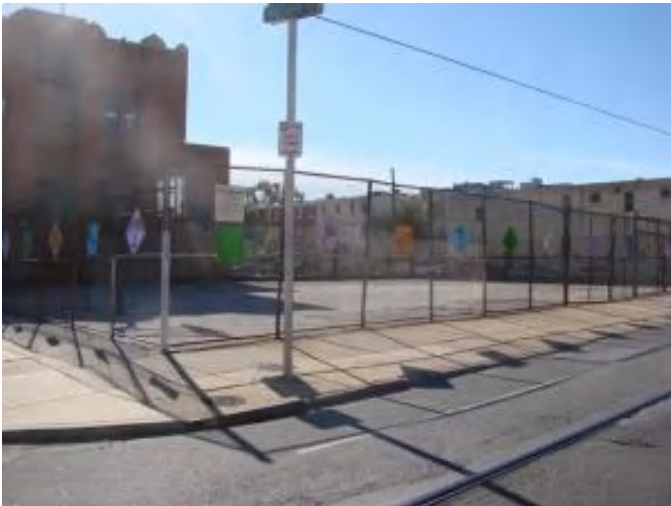
System: G2030 - Pedestrian Paving

Location: Grounds

Distress: Beyond Service Life

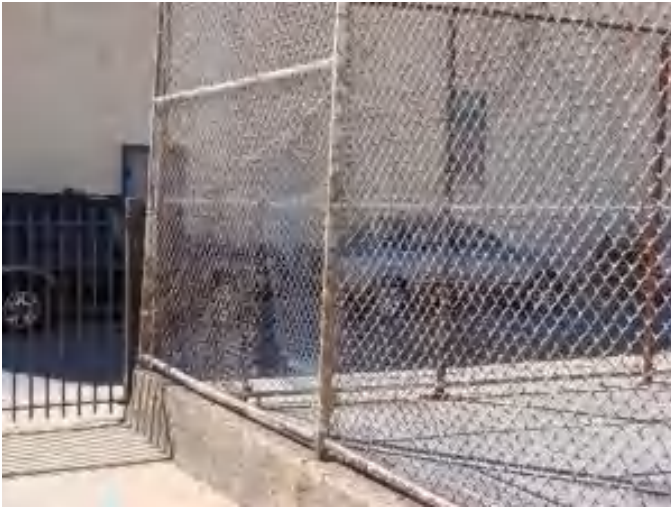
System: G2040 - Site Development

Location: Grounds

Distress: Beyond Service Life

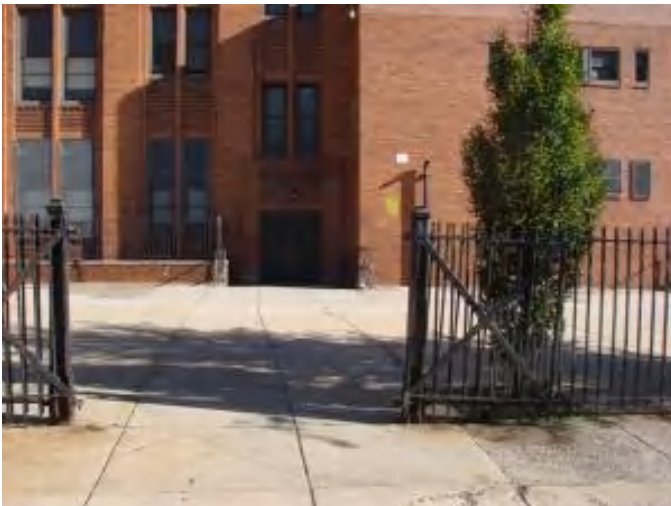
System: G2040 - Site Development

Location: Grounds

Distress: Beyond Service Life

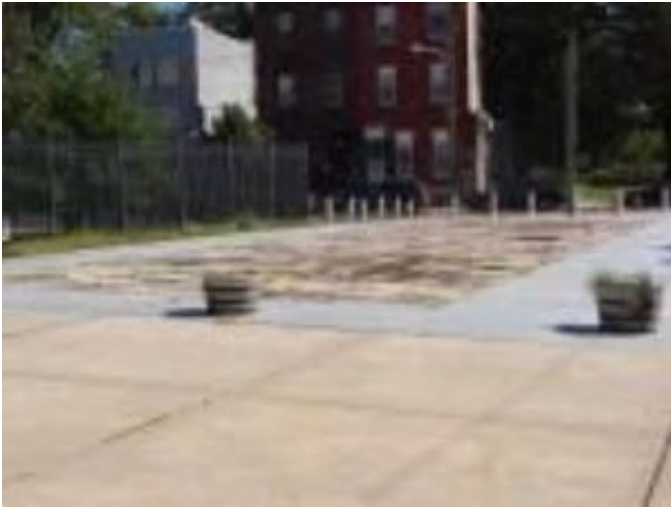
System: G4020 - Site Lighting

Location: Grounds

Distress: Inadequate

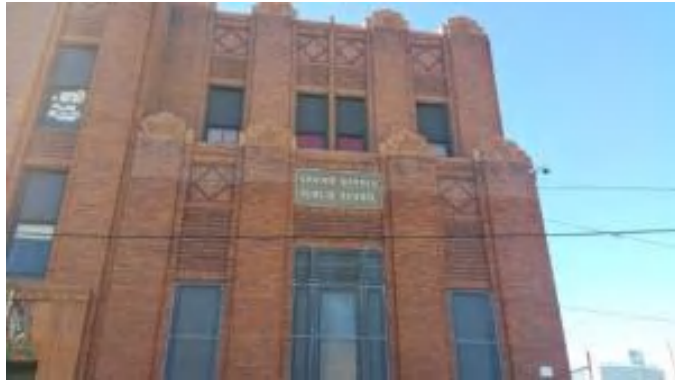
System: G4030 - Site Communications & Security

Location: Grounds

Distress: Inadequate
