Facility Condition Assessment Summary Report

Spruance School

School District of Philadelphia
S835001; Spruance
Final
Site Assessment Report
January 31, 2017

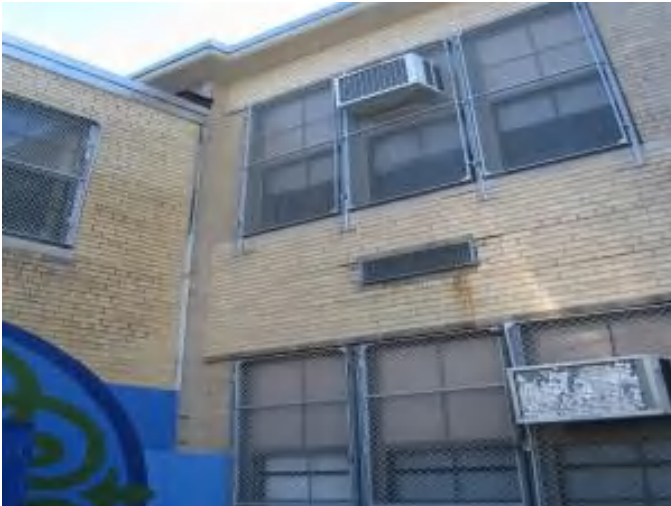
System: B2010 - Exterior Walls

Location: vertical expansion joints

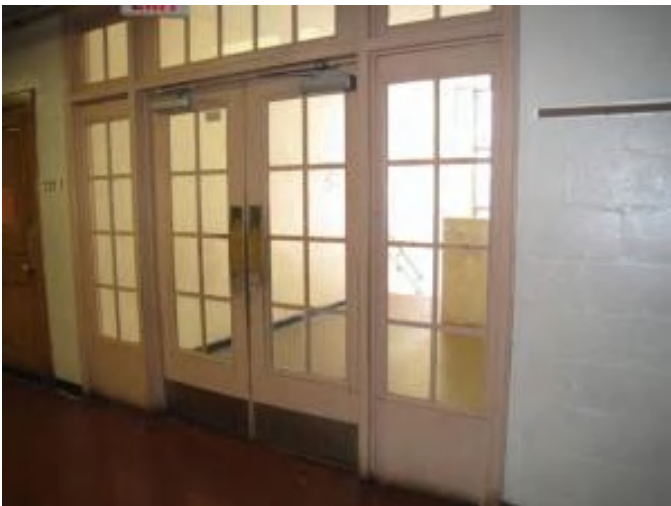
System: C1010 - Partitions

Location: fire rated stair vestibules

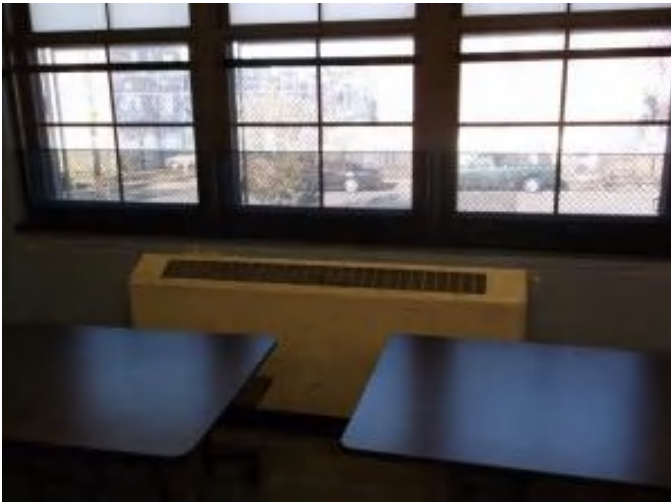
System: D3040 - Distribution Systems

Location: Throughout the building

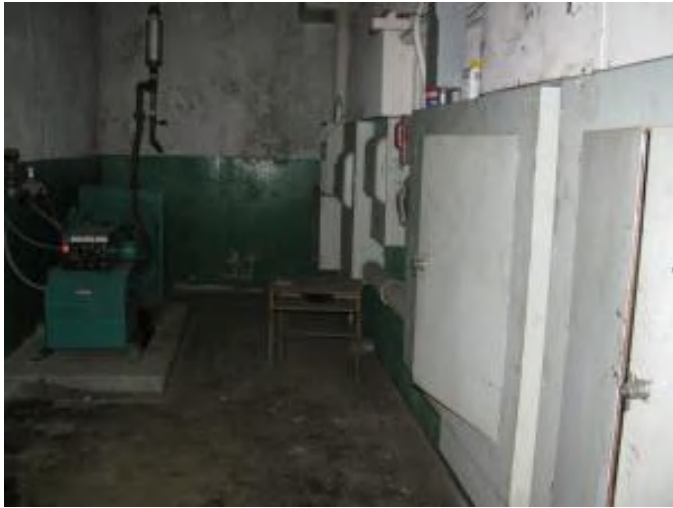
System: D5010 - Electrical Service/Distribution

Location: Boiler Room
Distress: Beyond Service Life
Category: 4 - Capital Improvement
Priority: 1 - Response Time (< 2 yr)
Correction: Replace Switchboard
Qty: 1.00
Unit of Measure: Ea.
Estimate: \$372,503.16
Assessor Name: System
Date Created: 12/29/2015

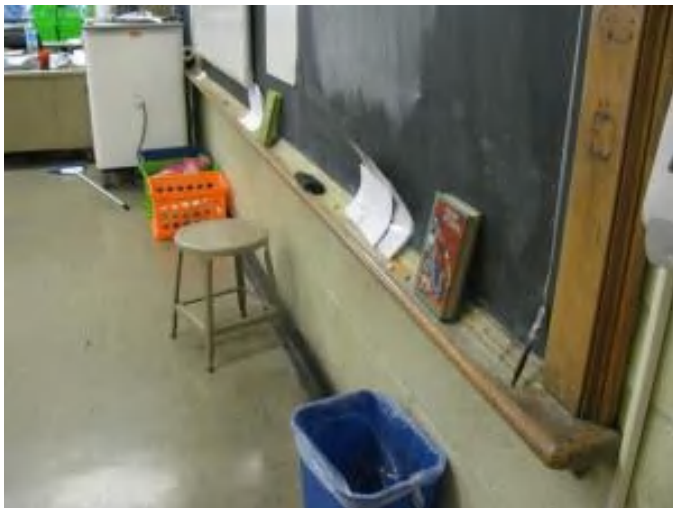
System: D5020 - Lighting and Branch Wiring

Location: B835001;Spruance
Distress: Beyond Service Life
Category: 3 - Operations / Maint.
Priority: 1 - Response Time (< 2 yr)
Correction: Add receptacles and branch circuits
Qty: 1.00
Unit of Measure: Ea.
Estimate: \$52,046.92
Assessor Name: System
Date Created: 12/29/2015

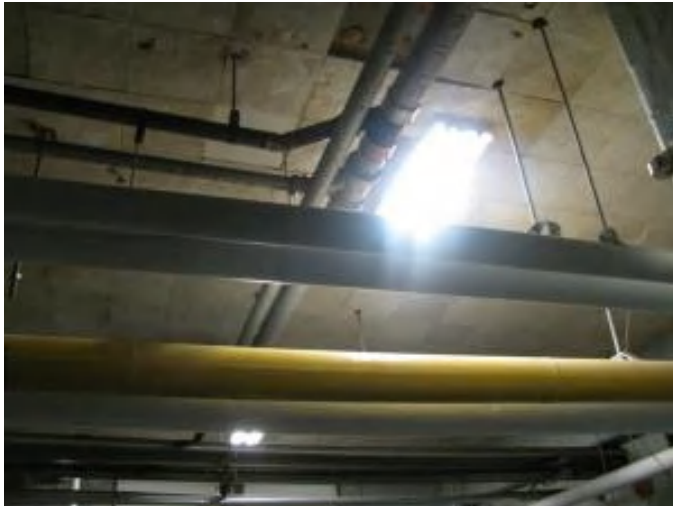
System: D5020 - Lighting and Branch Wiring

Location: Entire Building
Distress: Beyond Service Life
Category: 4 - Capital Improvement
Priority: 1 - Response Time (< 2 yr)
Correction: Replace lighting fixtures
Qty: 1.00
Unit of Measure: Ea.
Estimate: \$51,230.11
Assessor Name: System
Date Created: 12/29/2015

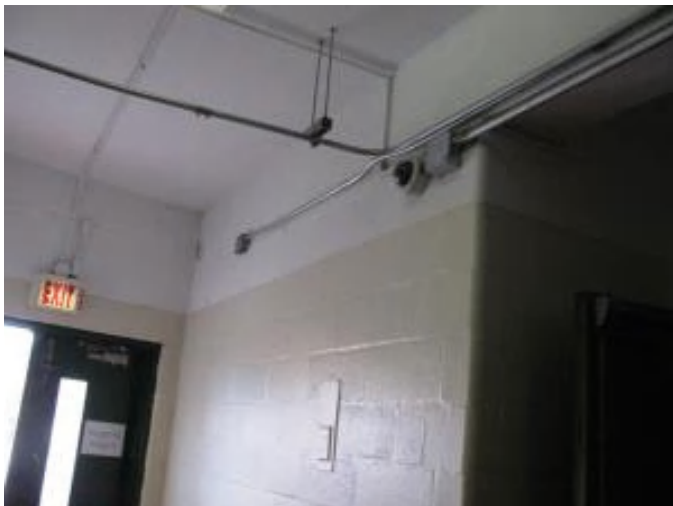
System: D5020 - Lighting and Branch Wiring

Location: Entire Building
Distress: Inadequate
Category: 3 - Operations / Maint.
Priority: 1 - Response Time (< 2 yr)
Correction: Replace lighting fixtures
Qty: 1.00
Unit of Measure: Ea.
Estimate: \$23,450.05
Assessor Name: System
Date Created: 12/29/2015

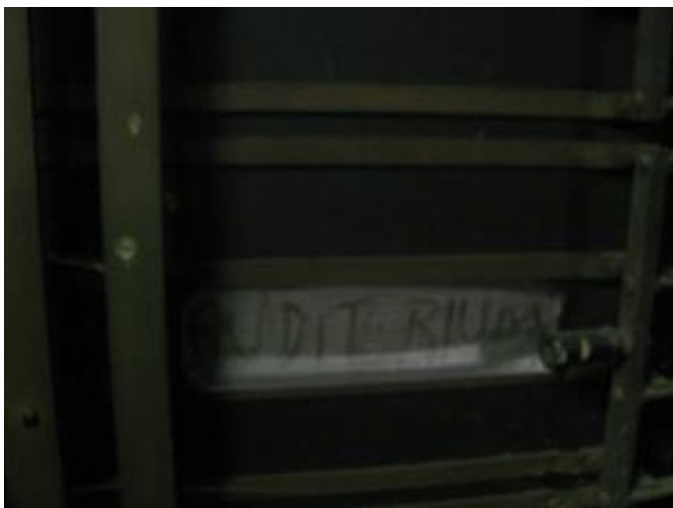
System: D5030 - Communications and Security

Location: Auditorium
Distress: Inadequate
Category: 3 - Operations / Maint.
Priority: 1 - Response Time (< 2 yr)
Correction: Add/Replace Sound System
Qty: 1.00
Unit of Measure: LS
Estimate: \$45,561.12
Assessor Name: System
Date Created: 12/29/2015

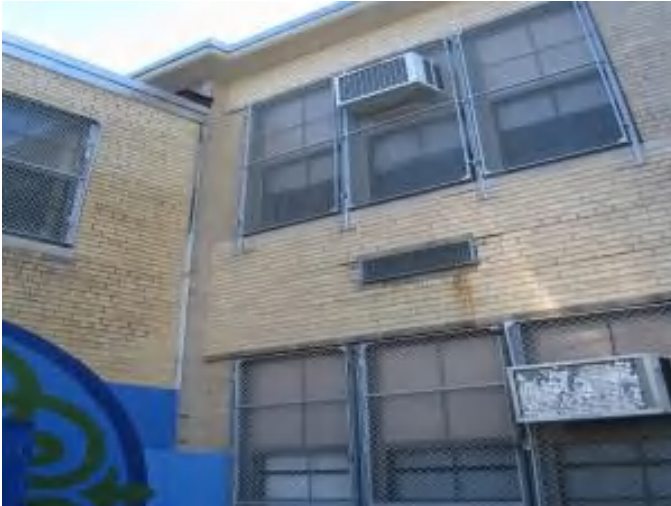
System: B2010 - Exterior Walls

Location: univent masonry joints

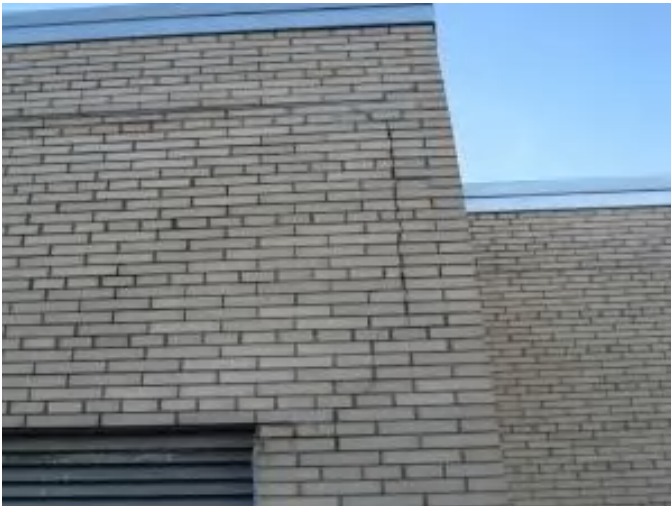
System: B2010 - Exterior Walls

Location: exterior walls above windows

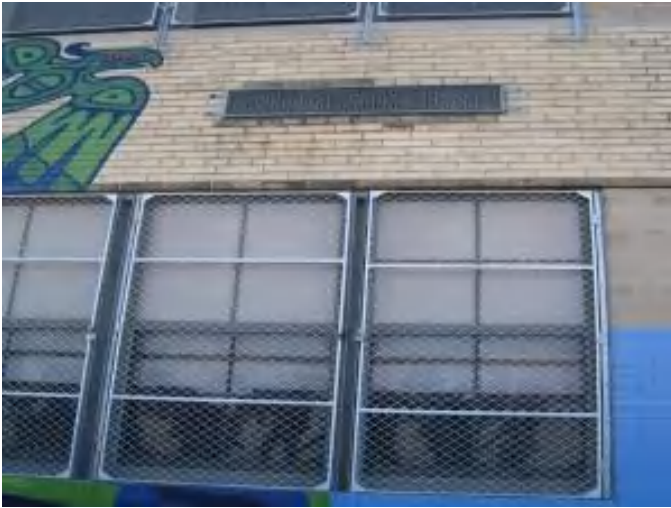
System: B2020 - Exterior Windows

Location: exterior windows

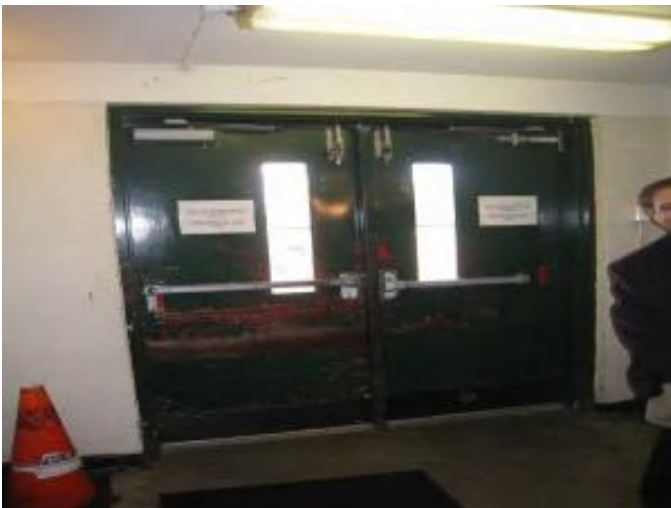
System: B2030 - Exterior Doors

Location: exterior doors

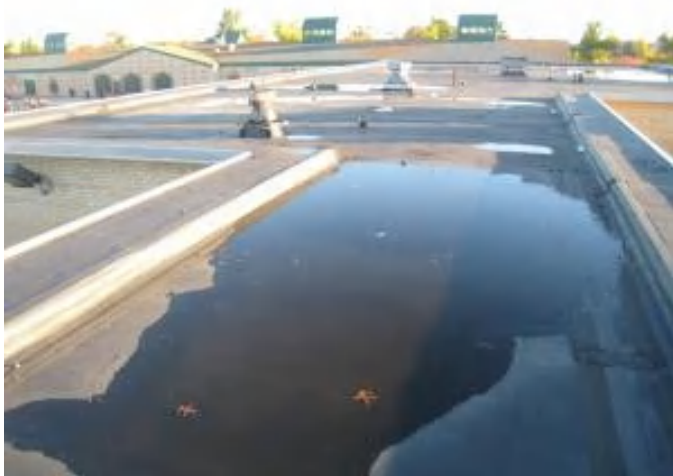
System: B3010120 - Single Ply Membrane

Location: roof

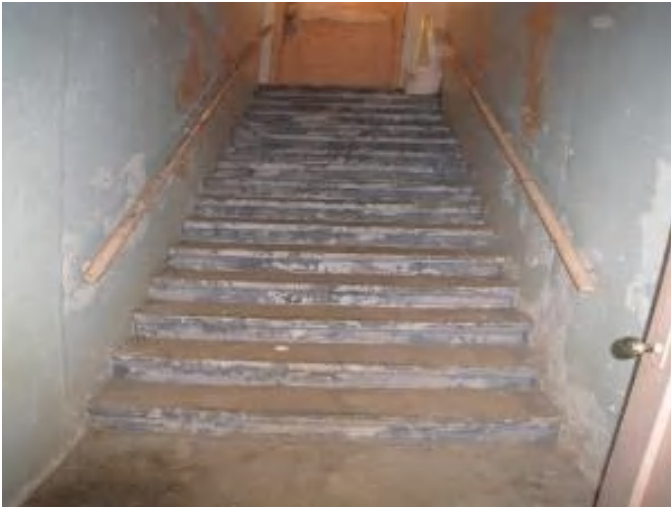
System: C2010 - Stair Construction

Location: basement stairs

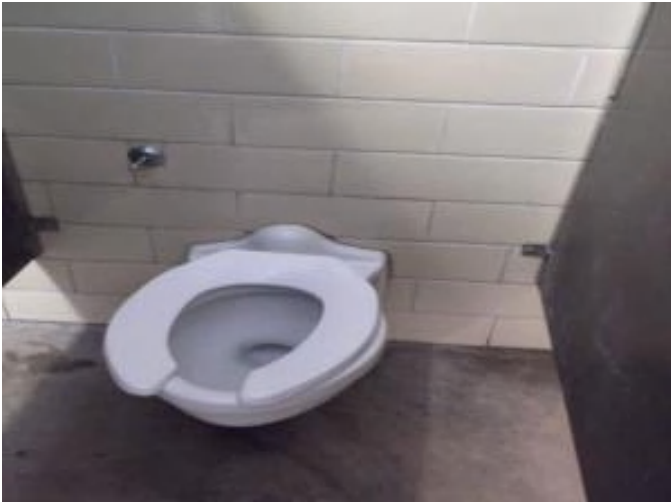
System: D2010 - Plumbing Fixtures

Location: Throughout the building
Distress: Beyond Service Life
Category: 3 - Operations / Maint.
Priority: 2 - Response Time (2-3 yrs)
Correction: Remove and replace or replace water closet - quantify additional units
Qty: 45.00
Unit of Measure: Ea.
Estimate: \$335,796.65
Assessor Name: System
Date Created: 02/08/2016

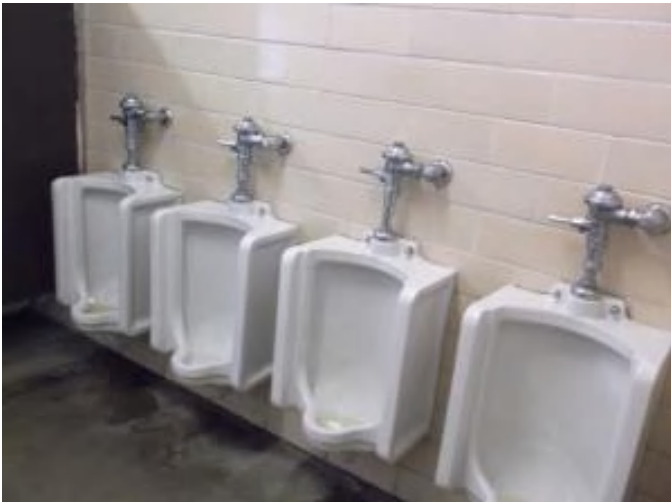
System: D2010 - Plumbing Fixtures

Location: Throughout the building
Distress: Beyond Service Life
Category: 3 - Operations / Maint.
Priority: 2 - Response Time (2-3 yrs)
Correction: Remove and replace or replace stall or floor type urinal
Qty: 36.00
Unit of Measure: Ea.
Estimate: \$187,647.08
Assessor Name: System
Date Created: 02/08/2016

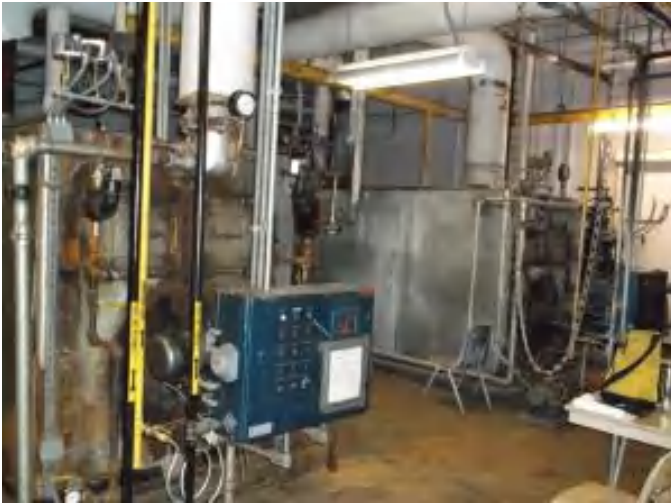
System: D3020 - Heat Generating Systems

Location: Main boiler mechanical equipment room
Distress: Beyond Service Life
Category: 3 - Operations / Maint.
Priority: 3 - Response Time (3-4 yrs)
Correction: Replace boiler, cast iron sectional (150 HP)
Qty: 2.00
Unit of Measure: Ea.
Estimate: \$1,012,205.26
Assessor Name: System
Date Created: 02/08/2016

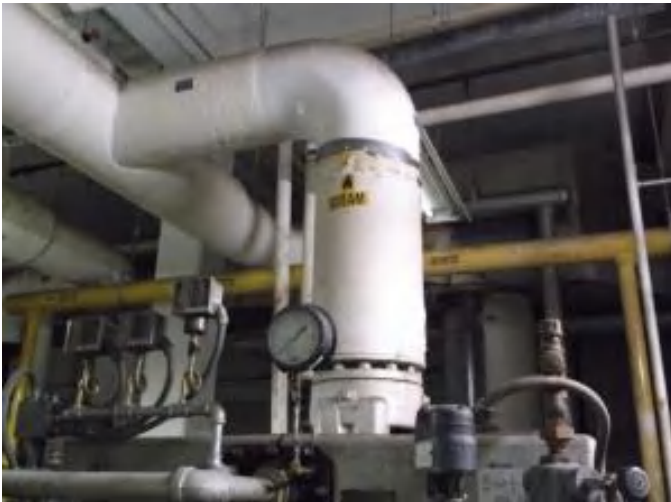
System: D3040 - Distribution Systems

Location: Throughout the building
Distress: Beyond Service Life
Category: 3 - Operations / Maint.
Priority: 3 - Response Time (3-4 yrs)
Correction: Perform testing to identify and replace damaged steam and condensate piping.
Qty: 102,143.00
Unit of Measure: S.F.
Estimate: \$966,310.69
Assessor Name: System
Date Created: 02/08/2016

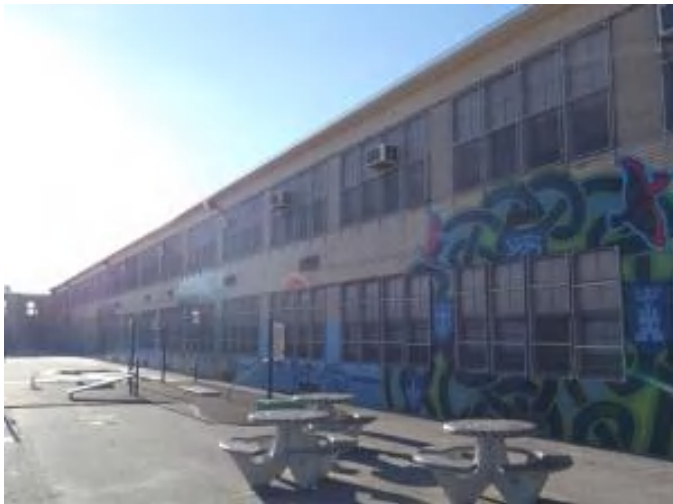
System: D3030 - Cooling Generating Systems

Location: Adjacent to building
Distress: Inadequate
Category: 4 - Capital Improvement
Priority: 5 - Response Time (> 5 yrs)
Correction: Install chilled water system with distribution piping and pumps. (+75KSF)
Qty: 102,143.00
Unit of Measure: S.F.
Estimate: \$1,640,351.06
Assessor Name: System
Date Created: 02/08/2016

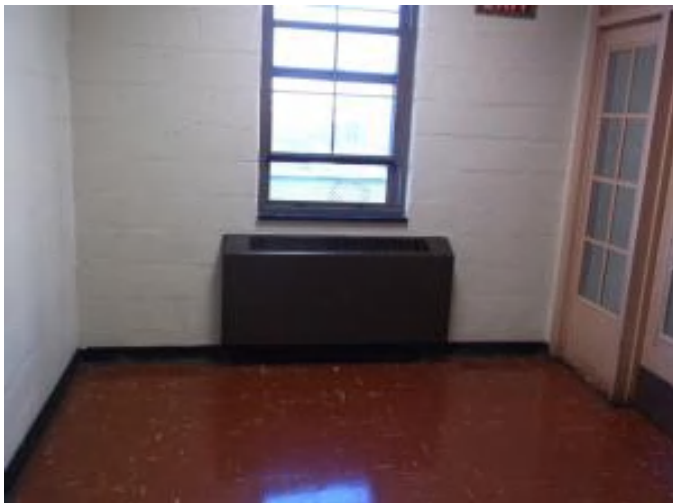
System: D3040 - Distribution Systems

Location: Throughout the building
Distress: Beyond Service Life
Category: 3 - Operations / Maint.
Priority: 5 - Response Time (> 5 yrs)
Correction: Provide classroom FC units and dedicated OA ventilation system. (20 clsrms)
Qty: 10.00
Unit of Measure: C
Estimate: \$830,609.93
Assessor Name: System
Date Created: 02/08/2016

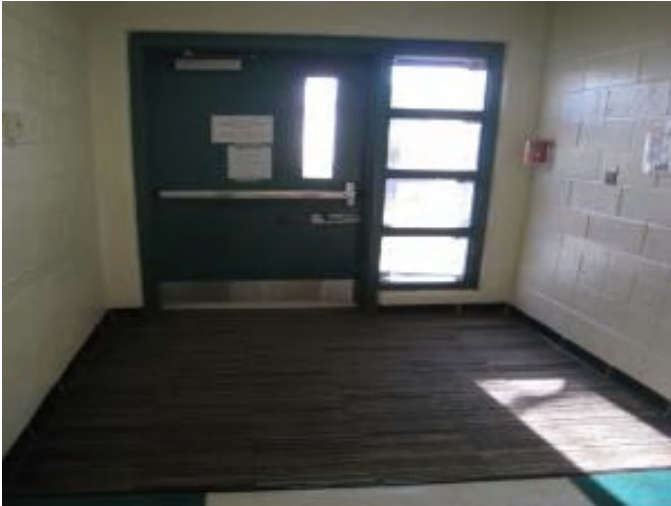
System: B1010 - Floor Construction

Location: vestibule floor grating

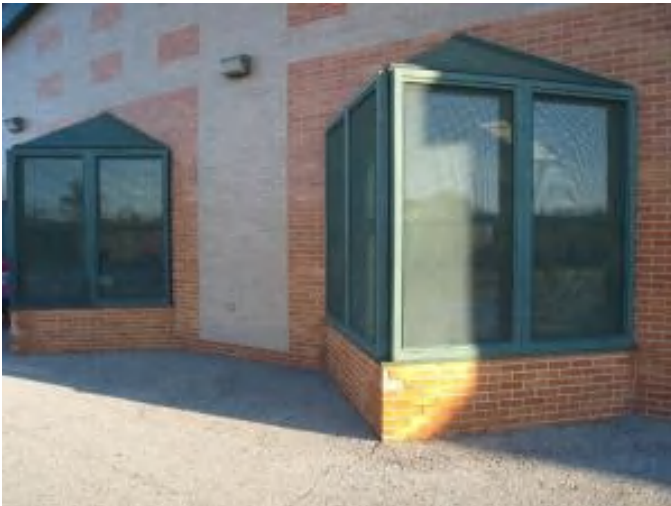
System: B2010 - Exterior Walls

Location: brick below MPR windows

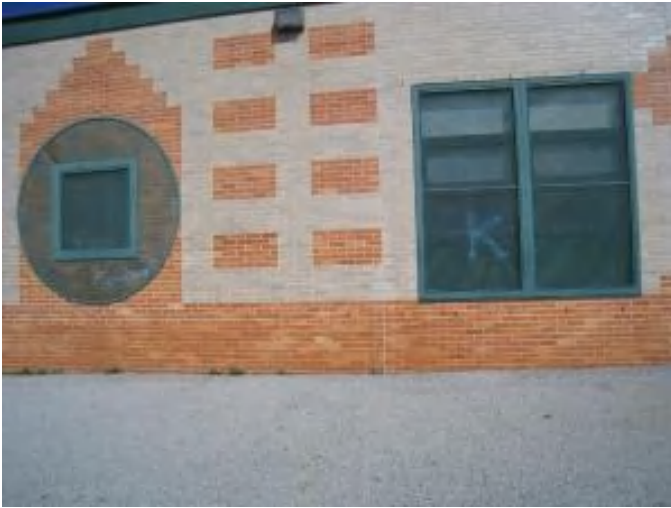
System: B2020 - Exterior Windows

Location: exterior windows - security screens

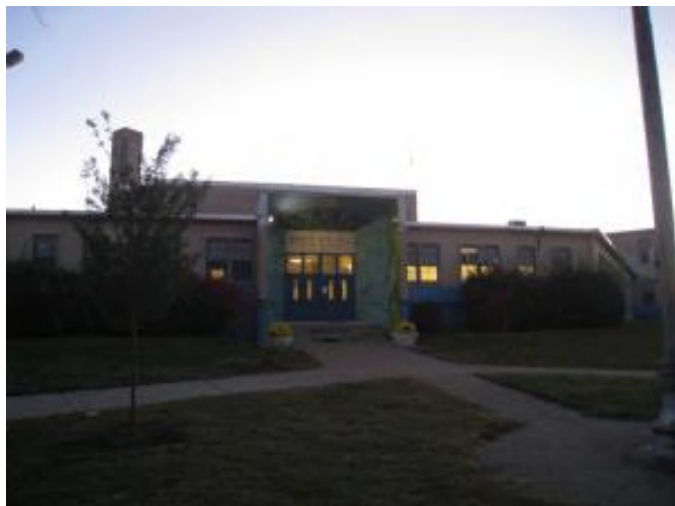
System: G2030 - Pedestrian Paving

Location: sidewalks - LSH and main bldg

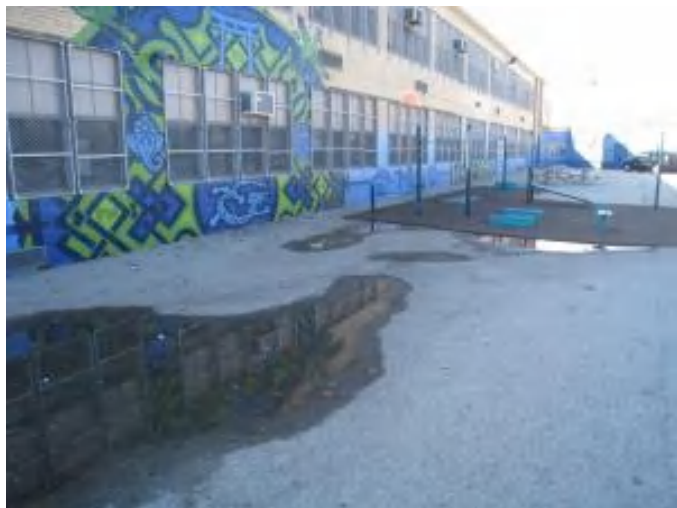
System: G2040 - Site Development

Location: playground near entrance to main building and faculty parking lot
