## Facility Condition Assessment Summary Report

### Stanton, E M School

School District of Philadelphia  
**S245001;Stanton, E M**  
Final  
**Site Assessment Report**  
January 30, 2017

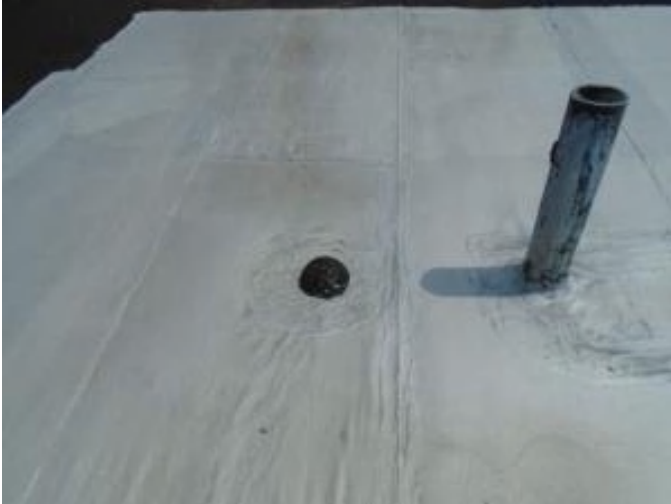
#### System: B3010105 - Built-Up

**Location:** Roof

**Distress:** Damaged

- Provide ADA compliant exterior door hardware at one entrance
  - Repair roofing near drains – trapped water
  - Replace interior door handles with lever type handles and latch sets

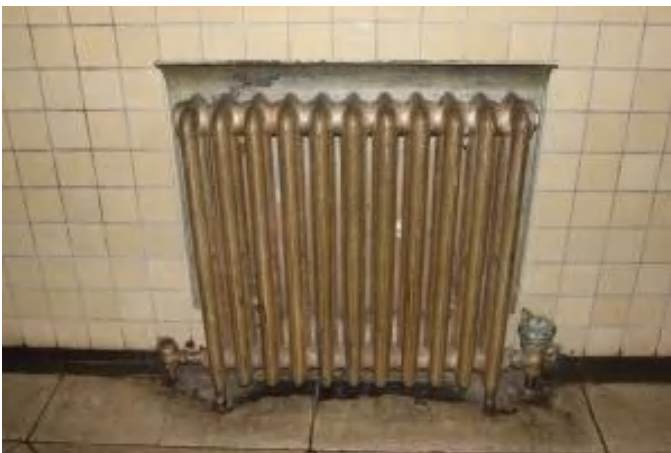
#### System: D3040 - Distribution Systems

**Location:** Entire building

**Distress:** Maintenance Required

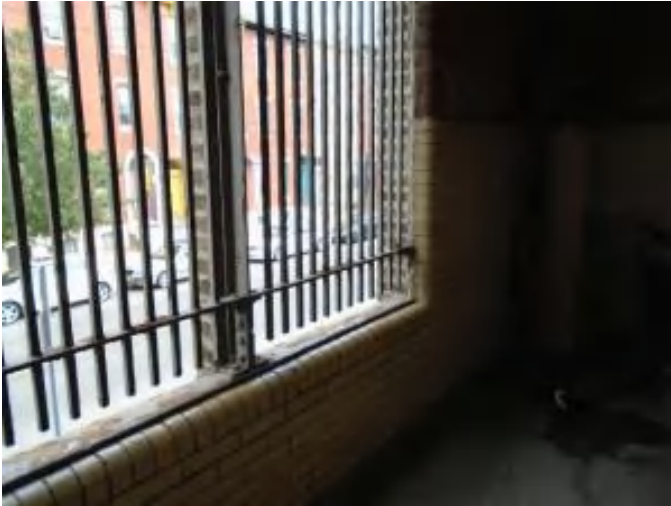
**System: B2010 - Exterior Walls**

**Location:** Fire tower

**Distress:** Failing

- Re-caulk capstone joints on parapet wall – allowing water intrusion
  - Repair stonework on fire tower and replace metal grating – rusted and failing
  - Replace Plexiglas window – hazed

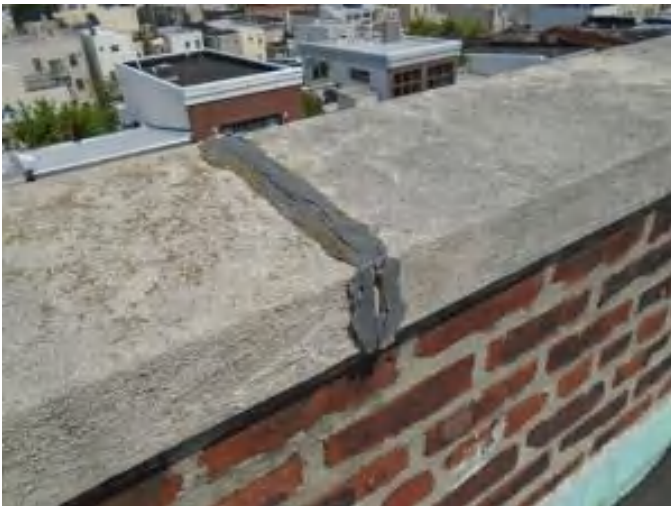
**System: B2010 - Exterior Walls**

**Location:** Parapet walls

**Distress:** Maintenance Required

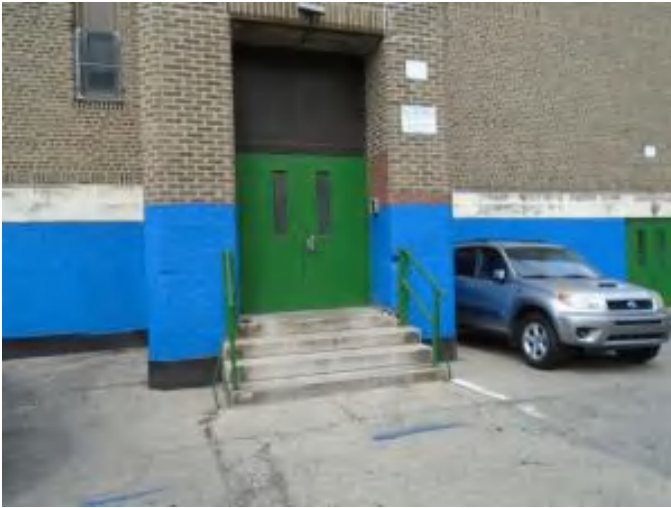
**System: B2030 - Exterior Doors**

**Location:** Entrance

**Distress:** Accessibility

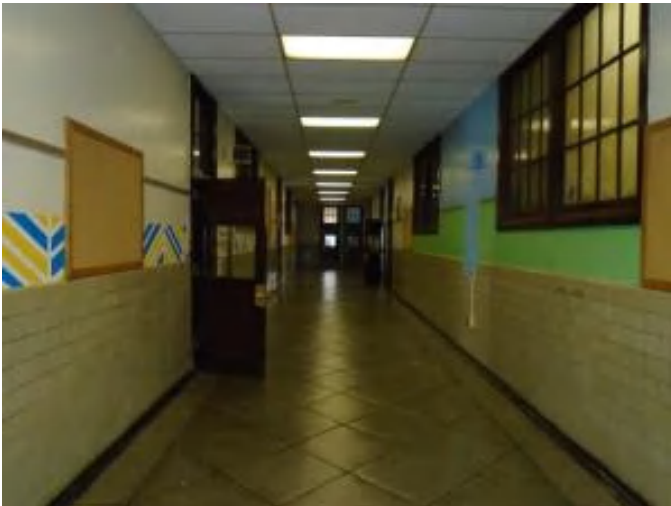
**System: C1020 - Interior Doors**

**Location:** Throughout

**Distress:** Accessibility

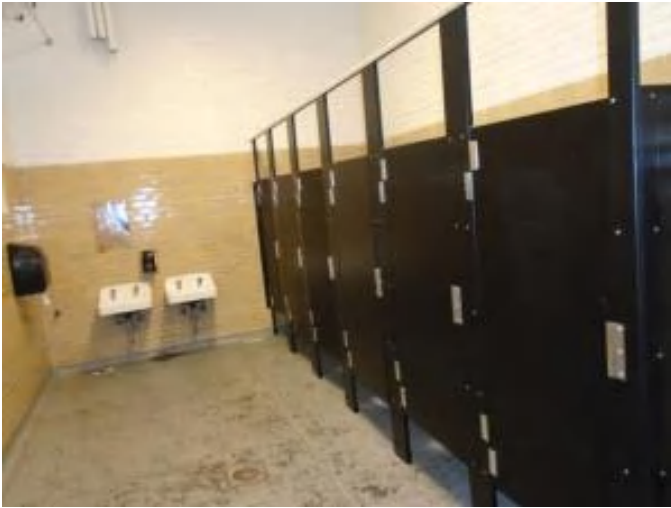
**System: C1030 - Fittings**

**Location:** Toilets  
**Distress:** Accessibility  
**Category:** 2 - Code Compliance  
**Priority:** 2 - Response Time (2-3 yrs)  
**Correction:** Remove and replace damaged toilet partitions - handicap units  
**Qty:** 8.00  
**Unit of Measure:** Ea.  
**Estimate:** \$7,822.84  
**Assessor Name:** System  
**Date Created:** 09/17/2015

**Notes:** Provide new toilet partitions and toilet accessories including grab bars for accessibility

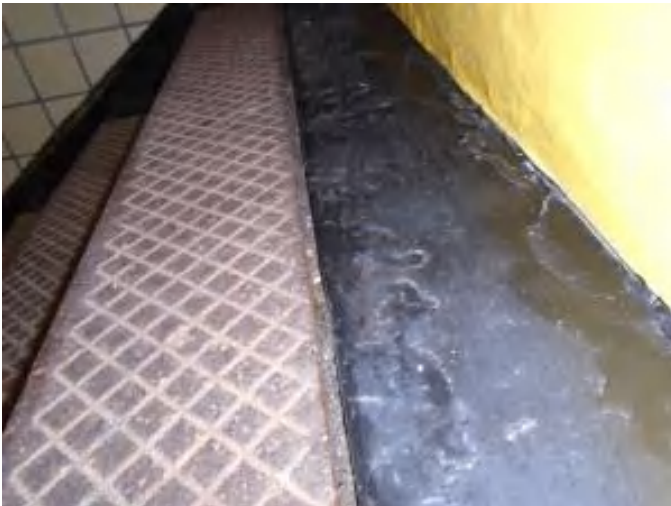
**System: C2010 - Stair Construction**

**Location:** Stairs  
**Distress:** Health Hazard / Risk  
**Category:** 1 - Health & Safety  
**Priority:** 2 - Response Time (2-3 yrs)  
**Correction:** Regrout joints between stone treads and risers - LF of grout  
**Qty:** 660.00  
**Unit of Measure:** L.F.  
**Estimate:** \$9,863.78  
**Assessor Name:** System  
**Date Created:** 09/17/2015

**Notes:** Repair stairs and nosing – failing and hazard to safety

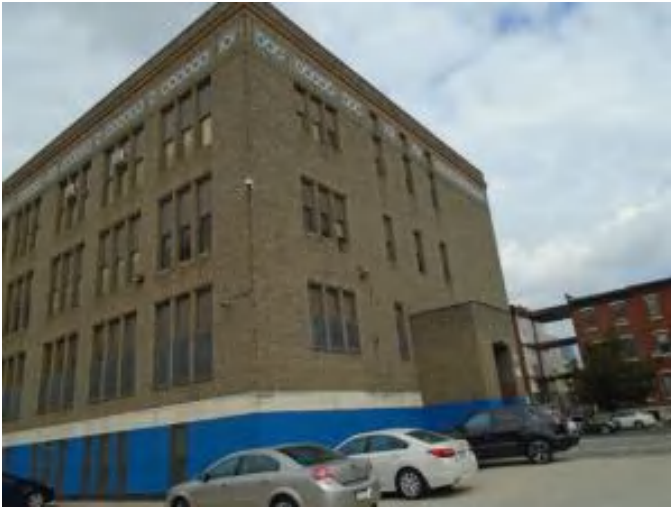
**System: D1010 - Elevators and Lifts**

**Location:** TBD

**Distress:** Accessibility

- Repair and paint interior plaster walls – damaged (10% of plaster area)
  - Replace VCT tiles – damaged (5% of vinyl floor area)
  - Install elevator for accessibility

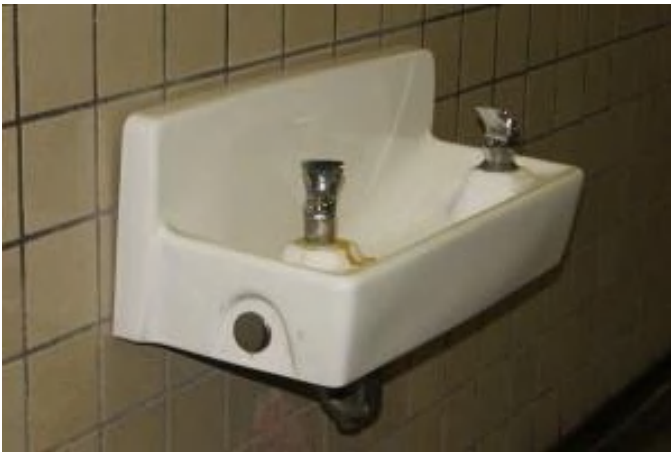
**System: D2010 - Plumbing Fixtures**

Vitreous china drinking fountains are located in the hallways on each floor as well as some classrooms. They are non-accessible without coolers. Fountains have exceeded their expected lifespan and should be replaced with accessible fountains including integral coolers.

**Location:** Hallways

**Distress:** Accessibility

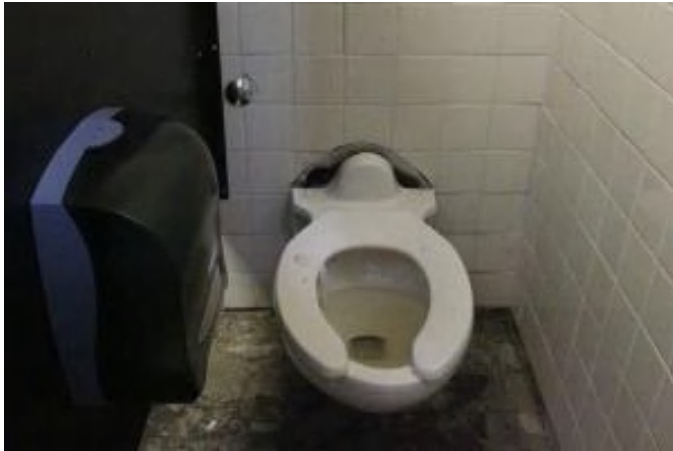
**System: D2010 - Plumbing Fixtures**

**Location:** Toilet rooms

**Distress:** Beyond Service Life

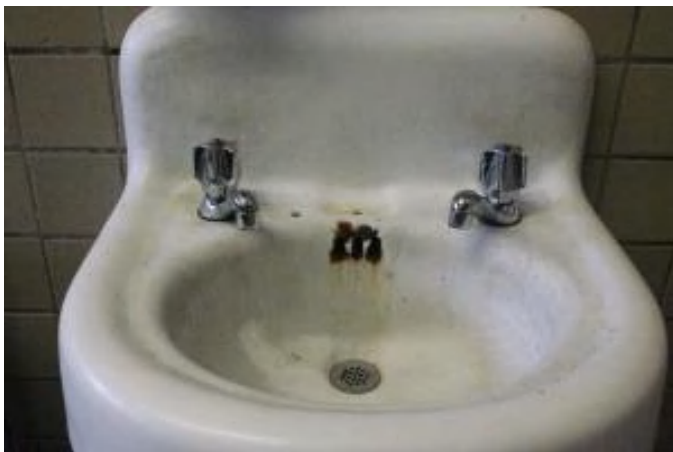
**System: D2010 - Plumbing Fixtures**

**Location:** Toilet rooms

**Distress:** Beyond Service Life

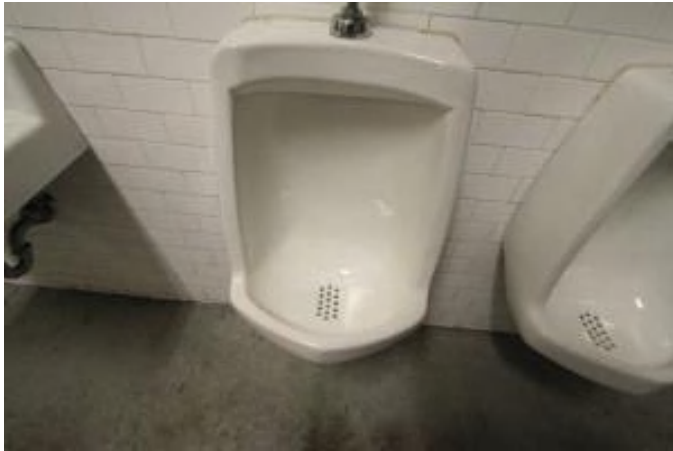
**System: D2010 - Plumbing Fixtures**

**Location:** Toilet rooms  
**Distress:** Beyond Service Life  
**Category:** 3 - Operations / Maint.  
**Priority:** 2 - Response Time (2-3 yrs)  
**Correction:** Remove and replace or replace wall hung urinals  
**Qty:** 5.00  
**Unit of Measure:** Ea.  
**Estimate:** \$17,262.25  
**Assessor Name:** System  
**Date Created:** 11/17/2015

**Notes:** Replace 5 urinals due to age.

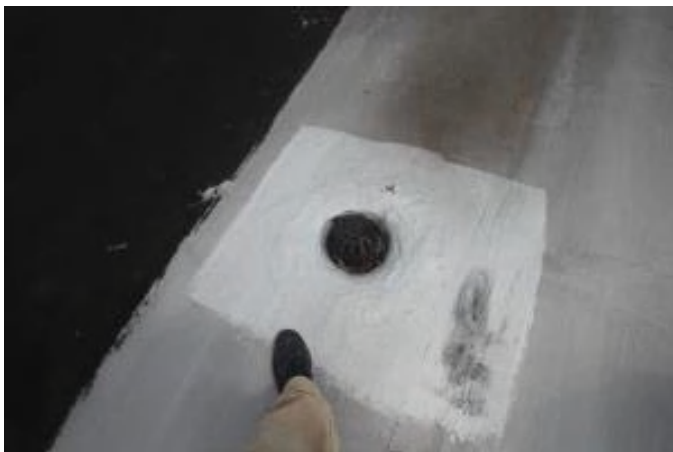
**System: D2040 - Rain Water Drainage**

Rain water drain pipes are galvanized steel running inside the building. Connections to roof drains were leaking and allowing water entry into the roofing material layers. The system appears original to the building and has greatly exceeded its expected lifespan, and it should be entirely replaced. There is a groundwater sump in the basement boiler room with two pumps. The engineer did not report any problems with the pumps and they can be expected to last 10 years.

**Location:** Entire building  
**Distress:** Beyond Service Life  
**Category:** 3 - Operations / Maint.  
**Priority:** 2 - Response Time (2-3 yrs)  
**Correction:** Remove and replace rain water drainage piping - based on +- 30 KSF roof area on 3-4 story building - insert the SF of roof area to be drained  
**Qty:** 12,000.00  
**Unit of Measure:** S.F.  
**Estimate:** \$161,245.91  
**Assessor Name:** System  
**Date Created:** 11/17/2015

**Notes:** Replace rainwater drain system due to age and leaks at roof.

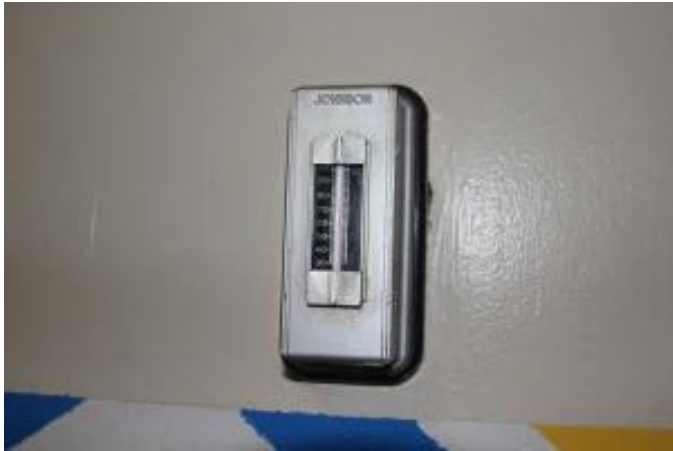
**System: D3060 - Controls & Instrumentation**

The building HVAC controls are pneumatic with thermostats in the classrooms and steam flow control valves on the radiators. Ducts have manually operated dampers for air flow control. The controls are inoperative and obsolete. Pneumatics should be replaced with direct digital controls when systems are renovated, replaced, or installed.

**Location:** Entire building  
**Distress:** Obsolete  
**Category:** 3 - Operations / Maint.  
**Priority:** 2 - Response Time (2-3 yrs)  
**Correction:** Replace pneumatic controls with DDC (75KSF)  
**Qty:** 30,000.00  
**Unit of Measure:** S.F.  
**Estimate:** \$643,562.74  
**Assessor Name:** System  
**Date Created:** 11/17/2015

**Notes:** Install direct digital control system to replace obsolete pneumatics.

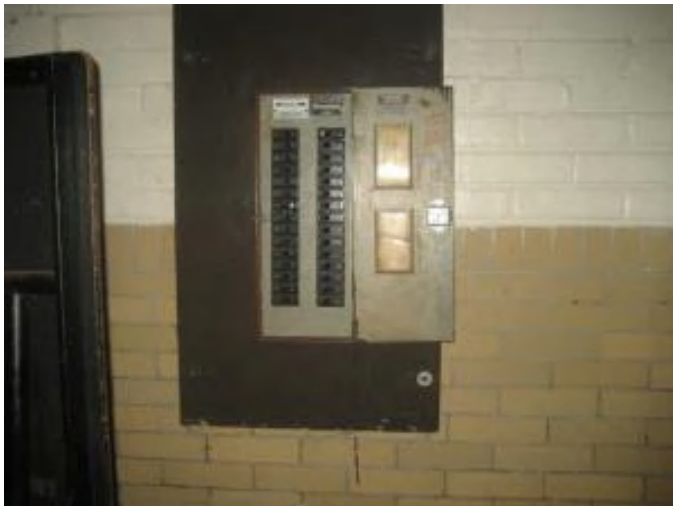
**System: D5010 - Electrical Service/Distribution**

There are 120/240V panel-boards in each floor for lighting and receptacles. These panel-boards and associated wiring have exceeded the end of their useful life and are undersized to absorb additional loads. They need to be replaced. There are (1) 15KVA phase converters from 240V to 120/208V which normally feeds newest mechanical equipment. Panel-board's doors at corridors are not locked and represent a potential hazard for students. As a safety issue all panel-boards at corridor or in areas where students are present must be provided with lockable devices.

**Location:** Entire Building  
**Distress:** Inadequate  
**Category:** 4 - Capital Improvement  
**Priority:** 2 - Response Time (2-3 yrs)  
**Correction:** Replace Panelboard  
**Qty:** 8.00  
**Unit of Measure:** Ea.  
**Estimate:** \$345,497.39  
**Assessor Name:** System  
**Date Created:** 10/21/2015

**Notes:** Replace the entire distribution system with new panels and new wiring/conduits. Approximate (8) 208/120V panel boards.

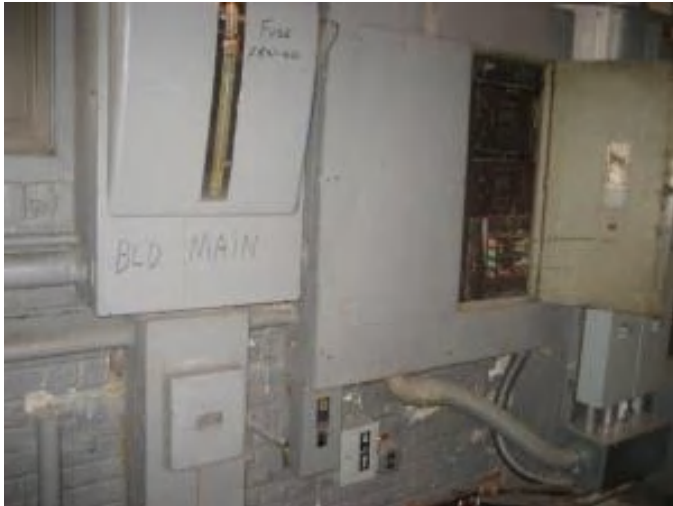
**System: D5010 - Electrical Service/Distribution**

distribution section. The existing service has no extra capacity for expansion or new Heating, Ventilation, Air Conditioning (HVAC) system. The electrical service entrance needs to be upgraded. The new service will be 120/208V, 3 phase power, approximate 1200 Amperes and will be located in the vicinity of the existing electrical service. The new electrical service would feed a Motor Control Center (MCC) and HVAC (Heating, Ventilation and Air Conditioning) equipment, receptacles, lighting and other smaller loads.

**Location:** Basement  
**Distress:** Inadequate  
**Category:** 4 - Capital Improvement  
**Priority:** 2 - Response Time (2-3 yrs)  
**Correction:** Replace Switchboard  
**Qty:** 1.00  
**Unit of Measure:** Ea.  
**Estimate:** \$342,940.28  
**Assessor Name:** System  
**Date Created:** 10/21/2015

**Notes:** Provide a new electrical service 120/208V, 3 phase power, approximate 1200 Amperes and will be located in the vicinity of the existing electrical service

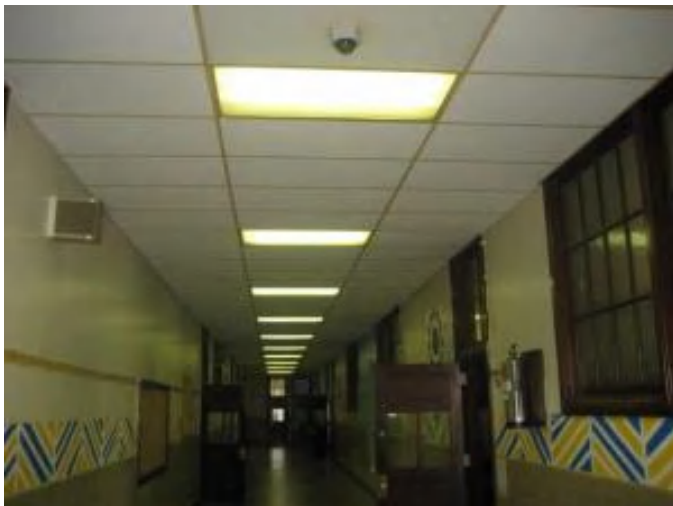
**System: D5020 - Lighting and Branch Wiring**

Most of the classrooms, corridors, stairways and gymnasium are illuminated with recessed mounted fluorescent fixtures. Remodeled classrooms are illuminated with recessed, up/down, modern fluorescent fixtures. Fluorescent lighting fixtures in remodeled areas use T-8 lamps. Fluorescent fixtures in non-remodeled areas use T-12 lamps. Building Engineer replaced burned T-12 lamps with T-8 when ballast/time allows. Approximately 90% of the fixtures need to be replaced.

**Location:** Entire Building  
**Distress:** Energy Efficiency  
**Category:** 4 - Capital Improvement  
**Priority:** 2 - Response Time (2-3 yrs)  
**Correction:** Replace lighting fixtures  
**Qty:** 480.00  
**Unit of Measure:** Ea.  
**Estimate:** \$409,063.16  
**Assessor Name:** System  
**Date Created:** 10/21/2015

**Notes:** Replace 90% of the existing lighting fixtures with up/down, recessed fluorescent fixtures with T8 lamps. Approximate 480 fixtures.

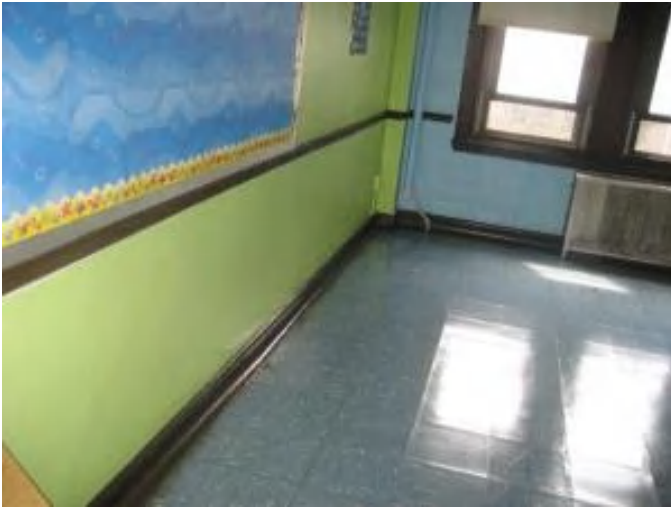
**System: D5020 - Lighting and Branch Wiring**

There number of receptacles in 80% of the classrooms are inadequate. Teachers use extension cords. The teacher's whiteboard wall and the opposite of it need to be provided with double compartment surface raceways, the other two walls with minimum two duplex outlets each, when feasible.

**Location:** Classrooms  
**Distress:** Inadequate  
**Category:** 4 - Capital Improvement  
**Priority:** 2 - Response Time (2-3 yrs)  
**Correction:** Add wiring device  
**Qty:** 320.00  
**Unit of Measure:** Ea.  
**Estimate:** \$117,558.72  
**Assessor Name:** System  
**Date Created:** 10/21/2015

**Notes:** Provide (2)25FT of surface raceways with receptacles spaced 24" on center/classroom and 4 wall mount receptacles/classroom. Approximate 320 receptacles.

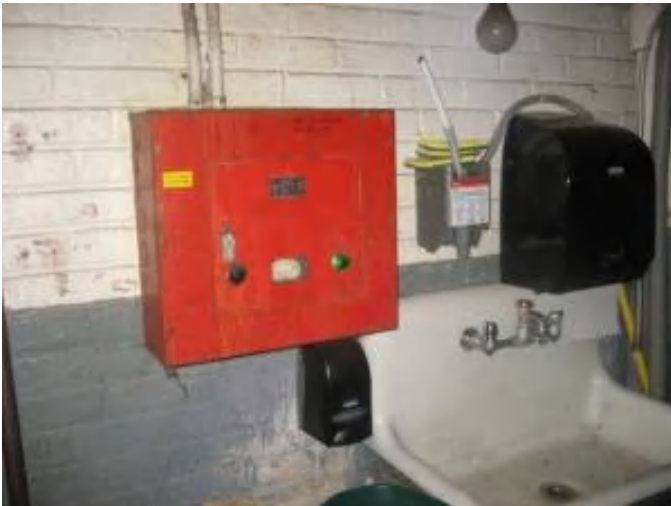
**System: D5030 - Communications and Security**

The Fire Alarm system is manufactured by S.H. Couch Co Inc. The system is approximately 30 years old. The present Fire Alarm system does not meet current code and needs to be replaced. Fire alarm system is tested every day in the morning.

**Location:** Entire Building  
**Distress:** Building / MEP Codes  
**Category:** 2 - Code Compliance  
**Priority:** 2 - Response Time (2-3 yrs)  
**Correction:** Replace fire alarm system  
**Qty:** 1.00  
**Unit of Measure:** S.F.  
**Estimate:** \$167,212.22  
**Assessor Name:** System  
**Date Created:** 10/21/2015

**Notes:** Replace old fire alarm system with addressable type with audio/visual devices at corridors and classrooms. Approximate 54 devices

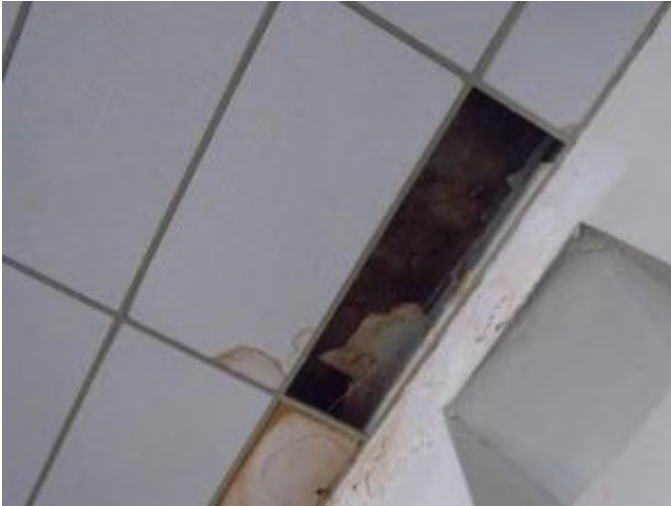
**System: C3010230 - Paint & Covering**

**Location:** Various

**Distress:** Damaged

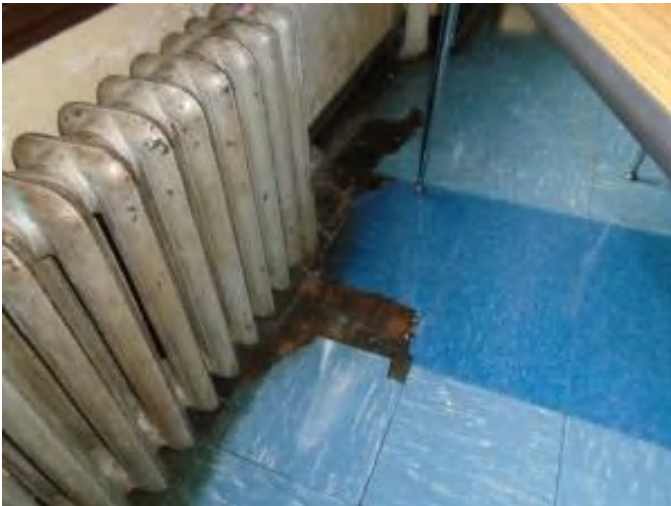
**System: C3020413 - Vinyl Flooring**

**Location:** Various

**Distress:** Damaged

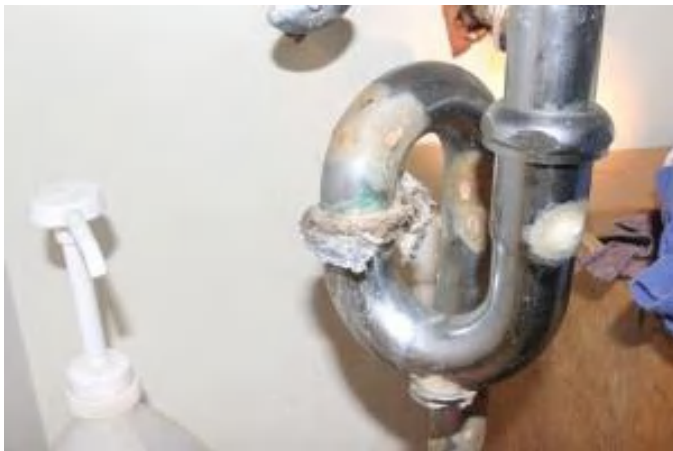
**System: D2030 - Sanitary Waste**

Sanitary drain piping is mainly cast iron with hub and spigot connections, but includes galvanized steel vent stack pipes, copper sink drain connections, and hubless cast iron pipe with banded coupling for spot repairs. Due to age and appearance including external rust, the entire sanitary drain piping system should be inspected and repaired as needed.

**Location:** Entire building  
**Distress:** Beyond Service Life  
**Category:** 3 - Operations / Maint.  
**Priority:** 3 - Response Time (3-4 yrs)  
**Correction:** Inspect sanitary waste piping and replace damaged sections. (+50KSF)  
**Qty:** 40,000.00  
**Unit of Measure:** S.F.  
**Estimate:** \$196,229.92  
**Assessor Name:** System  
**Date Created:** 11/17/2015

**Notes:** Inspect and repair sanitary drain piping due to age and corrosion.

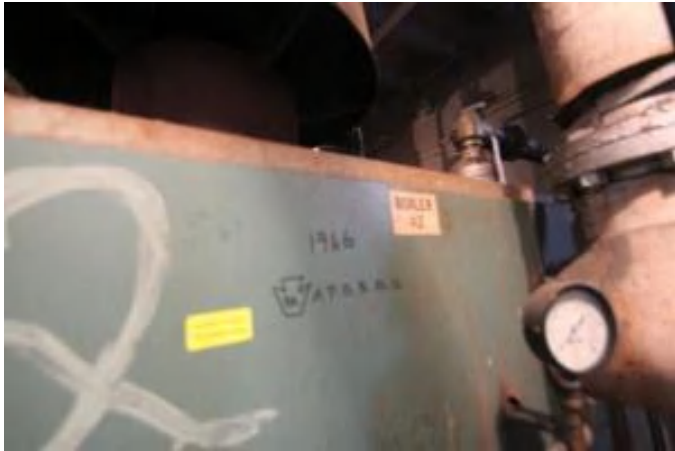
**System: D3020 - Heat Generating Systems**

The building has 2 Peerless, cast iron, model 210-25-S, steam boilers installed in 1966. Each boiler has a maximum steam output of 4,032 MBH (120 HP). The boilers are in fair condition, but they have greatly exceeded their useful life expectancy and should be replaced. They have integral burners for gas only. The boiler feedwater comes from a single feed water tank with two pumps that connect to a single line which supplies both boilers. When the boilers are replaced, each boiler should be supplied independently.

**Location:** Boiler room.

**Distress:** Beyond Service Life

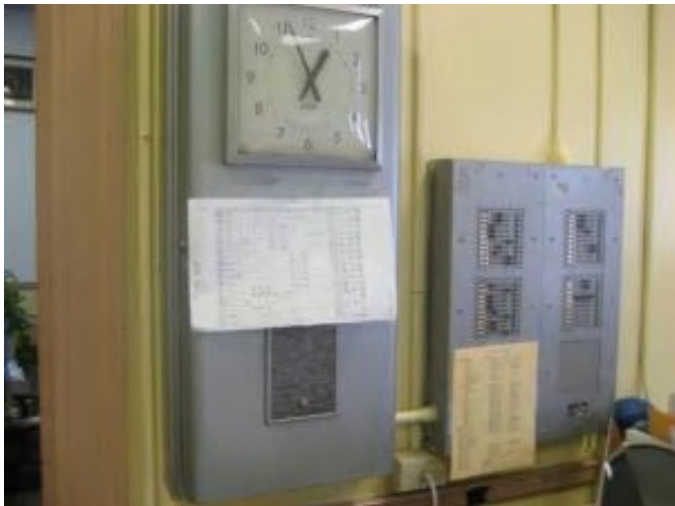
**System: D5030 - Communications and Security**

**Location:** Entire Building

**Distress:** Inadequate

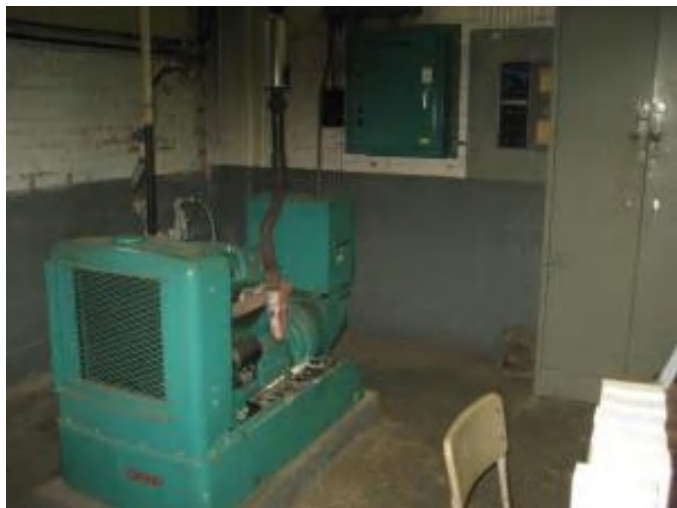
**System: D5090 - Other Electrical Systems**

**Location:** Outdoor

**Distress:** Inadequate

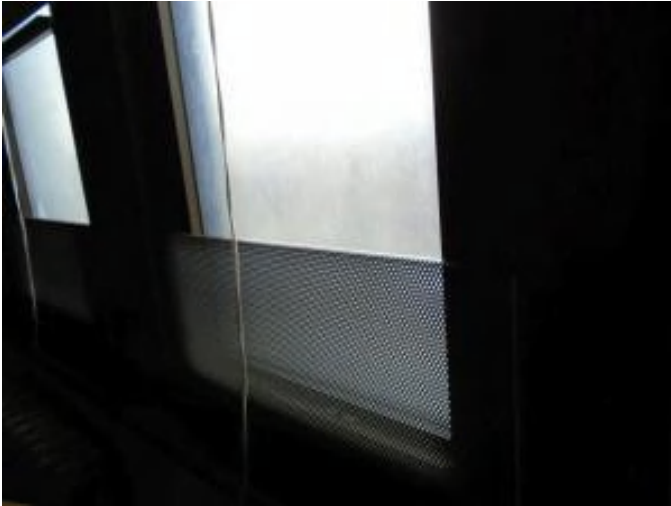
**System: B2020 - Exterior Windows**

**Location:** Windows

**Distress:** Energy Efficiency

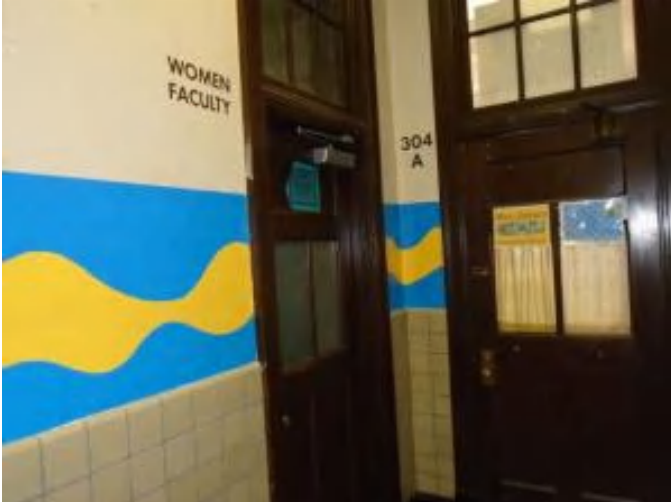
**System: C1030 - Fittings**

**Location:** Throughout

**Distress:** Inadequate

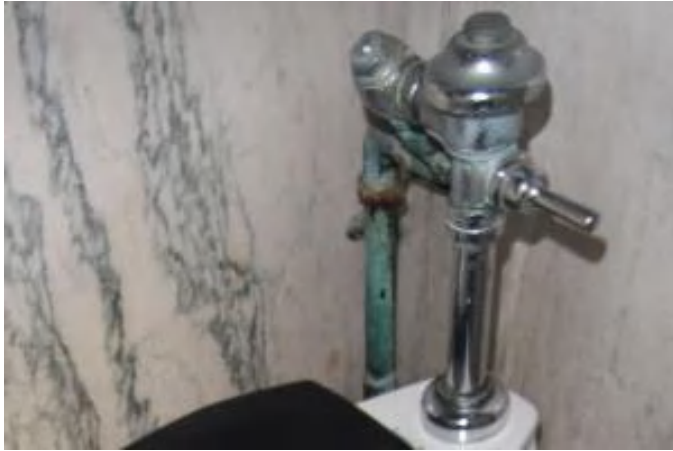
**System: D2020 - Domestic Water Distribution**

Domestic water piping is soldered copper. Visible areas of pipe at different locations in the building show pipe of different age and condition indicating multiple repairs and renovations over the history of the building. Some areas are excessively corroded from age and could fail imminently while other areas look like they have been replaced within the past 5 years. The domestic water distribution piping should be surveyed in detail and repaired or replaced as needed. There is a two pump domestic water pressure booster system with hydro-pneumatic storage tank. The water heater is a gas burning, A. O. Smith, model BT 80 112, 74 gallon, vertical tank, and was manufactured in 2004. The water heater is visibly in good condition and can be expected to last 5 more years. The domestic hot water circulation system has an Armstrong pump which is also in good condition. Water service enters the boiler room from the Christian St. side of the property through a 4 inch line with non-compound water meter and 2 double back flow preventers (mainline and bypass).

**Location:** Entire building

**Distress:** Beyond Service Life

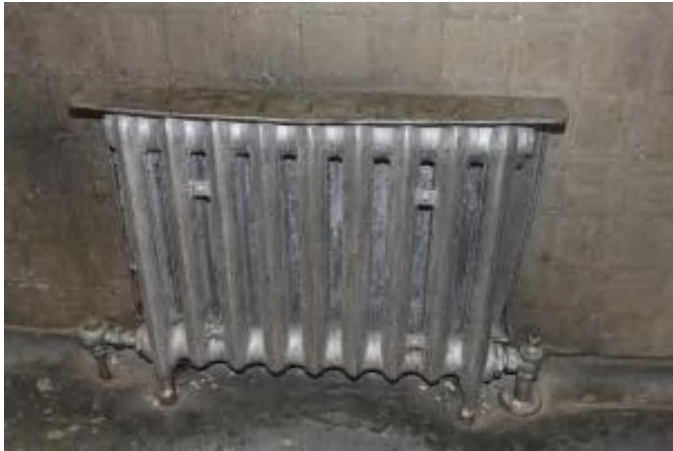
**System: D3040 - Distribution Systems**

Distribution system in the building consists of ducts and steam pipes. The original sheet metal ducts in the basement should be replaced with insulated ducts as part of converting to air-conditioning. The basement ducts lead from a single air handler to built-in clay tile block ducts leading to the classrooms. Exhaust ducts lead from the classrooms to the attic which serves as the exhaust plenum and discharges up through gravity vents in the roof or back down to the basement fan room through a large (approx. 2 feet by 8 feet) return duct. Built-in ducts are in good condition and with renovation they will not need additional maintenance for 20 years. The duct openings in the classrooms are approximately 2 feet by 2 feet in size and do not have diffusers or grills preventing entry into the ducts and they should be installed during renovation. The basement air handler is original to the building including primary and secondary steam heating coils, air washer, and fan. It is not operational because the fan drive belts have failed. The fan motor is 10 HP, 1,200 RPM, two phase, 220VAC. There are dampers to control outside air intake and attic plenum recirculation. The air handler is obsolete and should be replaced with a new unit including filtration, heating, cooling, humidification, and dehumidification sections. Steam and condensate pipe are threaded steel. The piping was in the process of being replaced in the basement during the assessment, i.e. workmen were in the basement cafeteria dining room installing new pipes and finned tube radiators on the day of the inspection. There is a single hot tank that collects condensate and also holds boiler feedwater. The steam trap system should be surveyed in detail and repaired as needed.

**Location:** Basement

**Distress:** Beyond Service Life

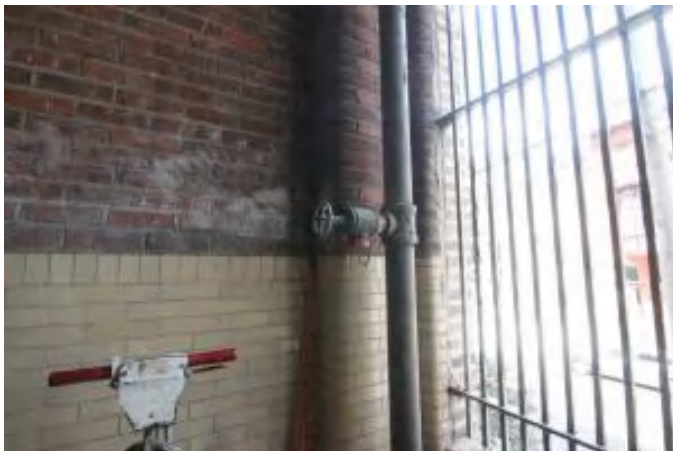
**System: D4010 - Sprinklers**

**Location:** Entire building

**Distress:** Life Safety / NFPA / PFD

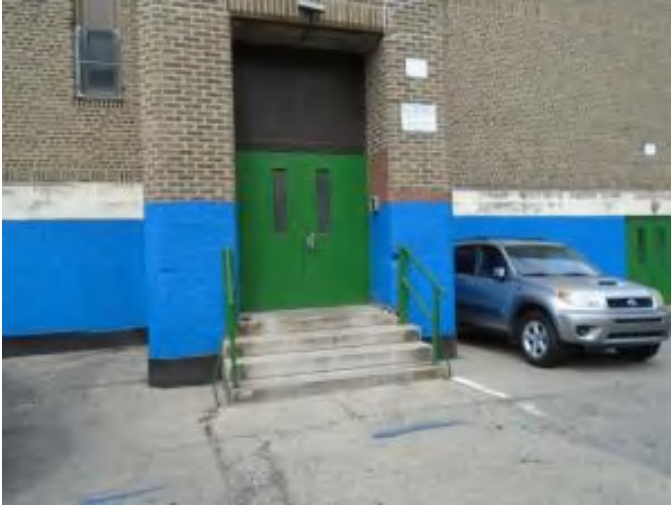
#### System: G2030 - Pedestrian Paving

**Location:** Entrance

**Distress:** Accessibility

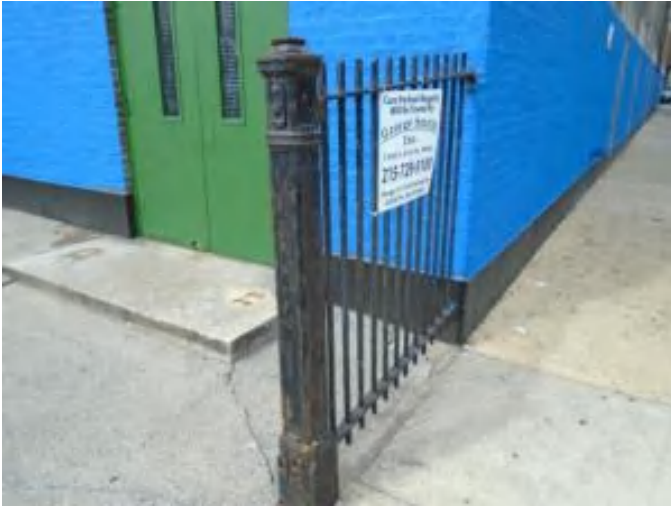
**System: G2040 - Site Development**

**Location:** Parking lot

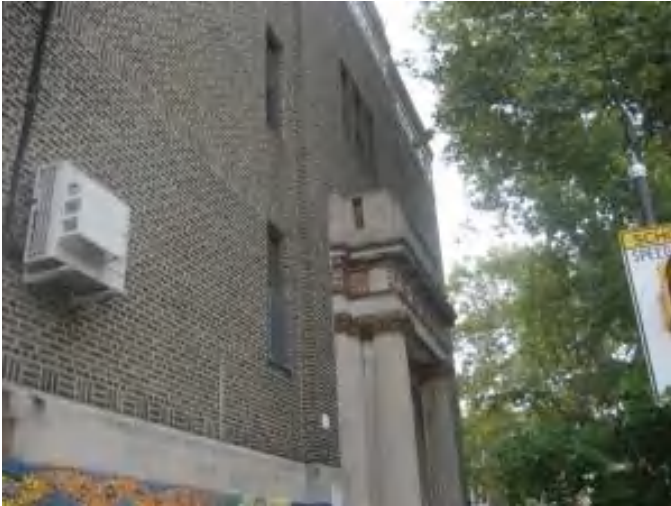
**System: G4020 - Site Lighting**

**Location:** Outdoor

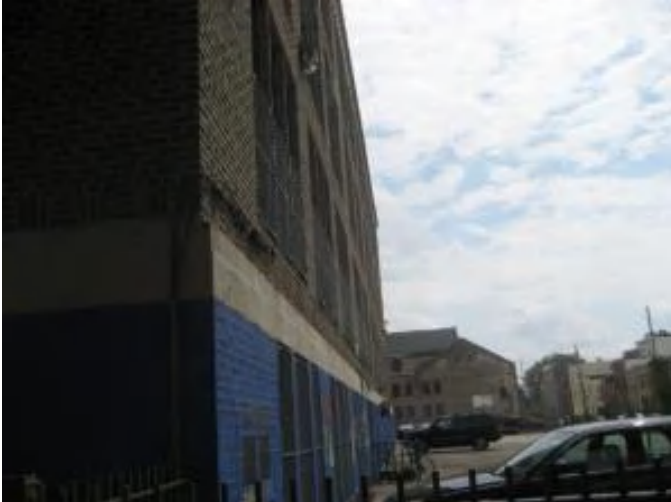
**System: G4030 - Site Communications & Security**

**Location:** Outdoor
