Facility Condition Assessment Summary Report

Stearne School

School District of Philadelphia
S729001;Stearne
Final
Site Assessment Report
January 31, 2017

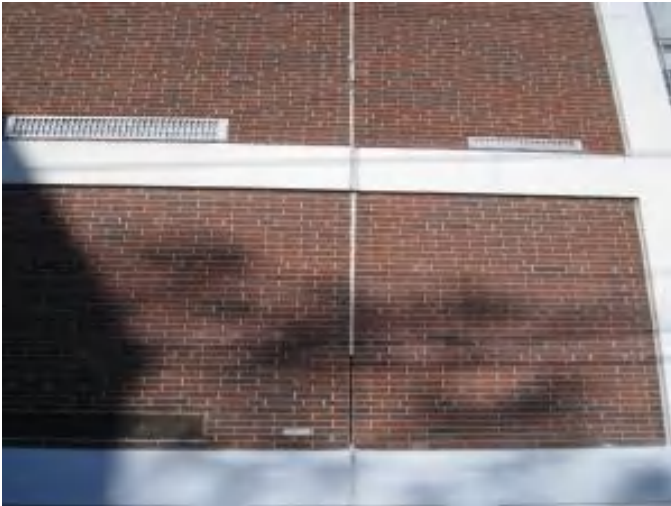
System: B2010 - Exterior Walls

Location: exterior wall - Unity St.

Distress: Failing

Notes: Vertical expansion joint in brick on Unity Street needs to be recaulked (25ft)

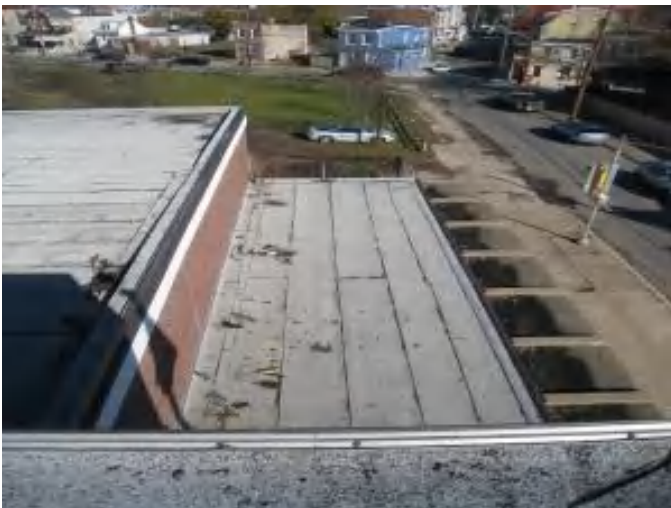
System: B3010105 - Built-Up

Location: roof

Distress: Failing

Notes: Replace roof, improving drainage into roof drains and eliminating flat spots (29,002sf)

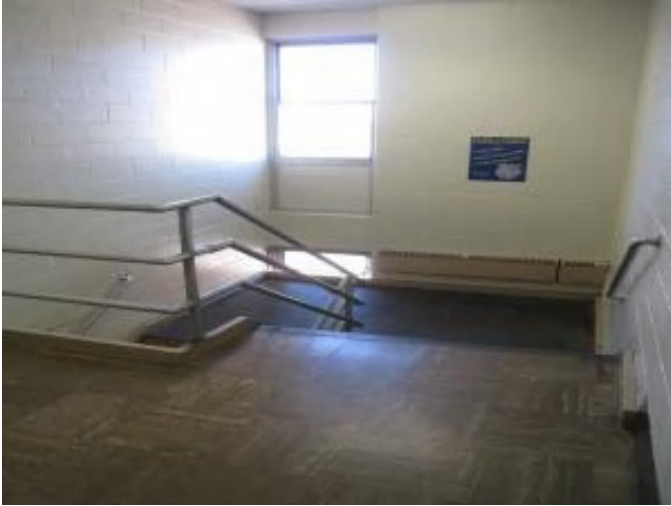
System: C2010 - Stair Construction

Location: stairways

Distress: Building / MEP Codes

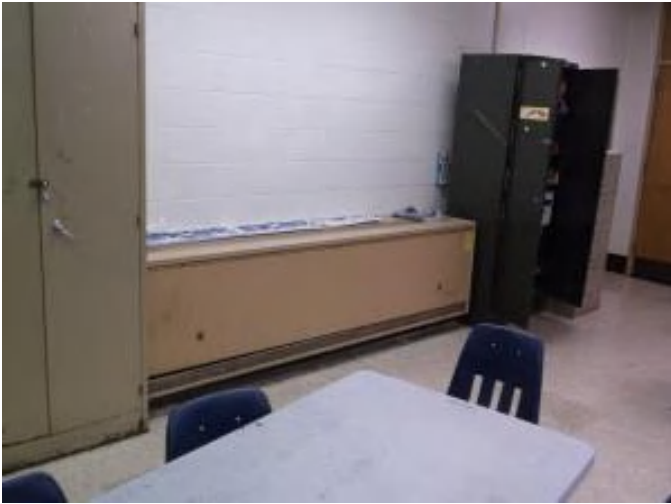
System: D3040 - Distribution Systems

Location: Classrooms

Distress: Health Hazard / Risk

Notes: Install a fan coil unit to provide heating and code required minimum outdoor air ventilation for new Room 108B created by the construction of new partition walls.

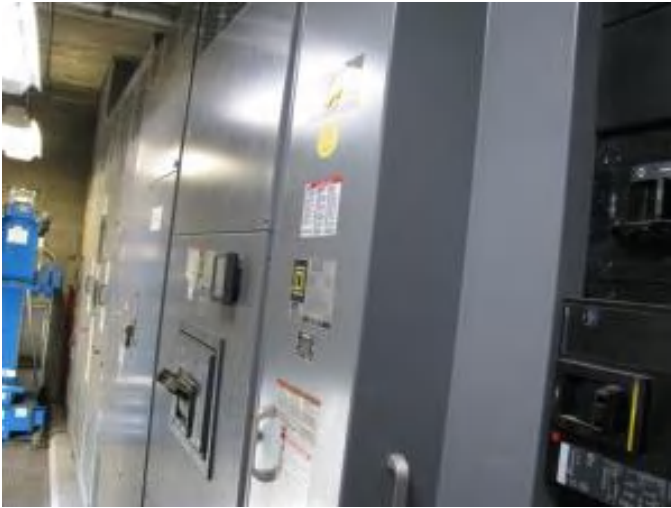
System: D5010 - Electrical Service/Distribution

Location: Electrical Room

Distress: Beyond Service Life

Notes: Upgrade the existing electrical service with a new service. Replace the existing substation with new 3000A, 480/277V substation.

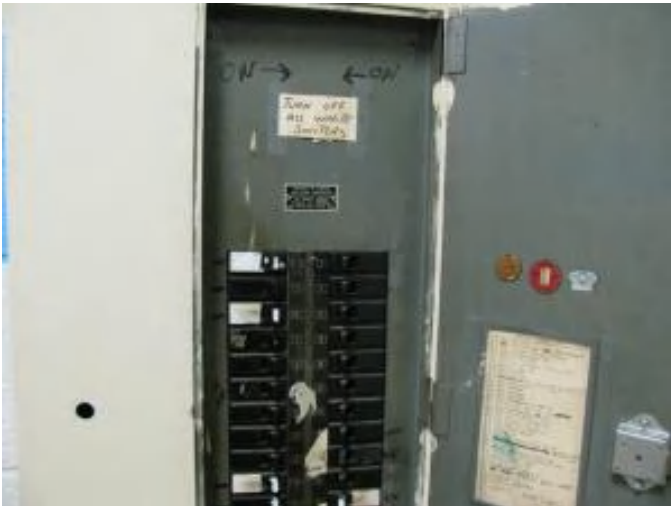
System: D5010 - Electrical Service/Distribution

Location: Entire Building

Distress: Beyond Service Life

Notes: Replace the entire distribution system with new panels and new wiring/conduits. Estimated 10 panel boards Provide arc flash label on the electrical equipment.

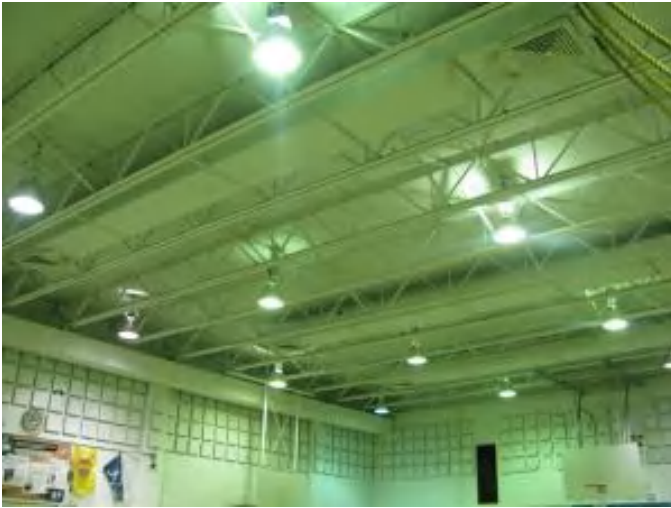
System: D5020 - Lighting and Branch Wiring

Location: Entier Building

Distress: Beyond Service Life

Notes: Replace lighting fixtures with new fluorescent lighting fixtures with T-8 lamp throughout the buildings. Replace metal halide fixtures in gymnasium with LED high bay lighting fixtures in gymnasium.

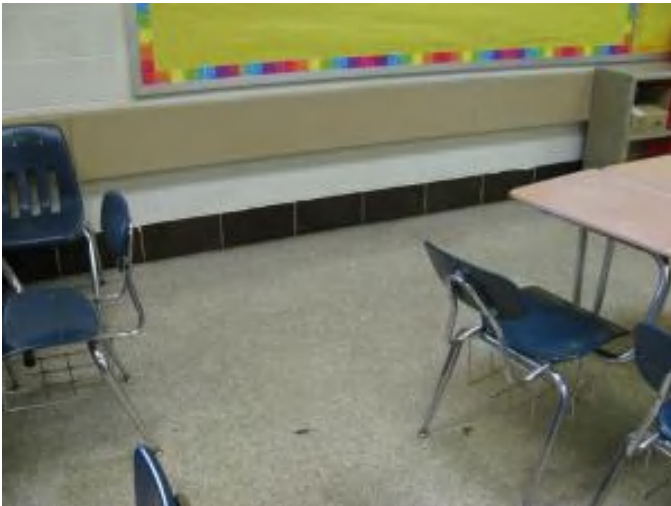
System: D5020 - Lighting and Branch Wiring

Location: Classrooms

Distress: Inadequate

Notes: Install minimum two receptacles in each wall of class rooms. We recommend using two-compartment Power pole in the computer room. Estimated 80 total.

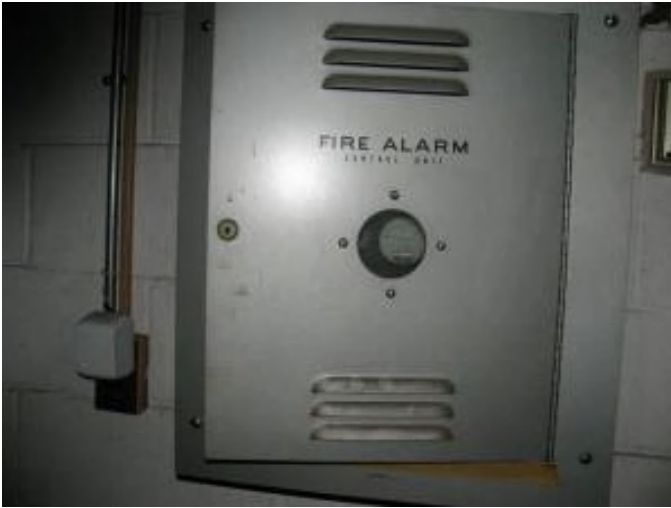
System: D5030 - Communications and Security

Location: Entire Building

Distress: Life Safety / NFPA / PFD

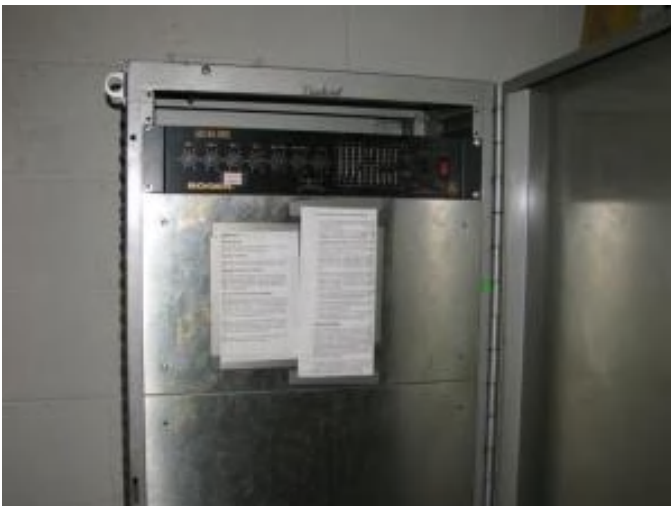
System: D5030 - Communications and Security

Location: Auditorium

Distress: Inadequate

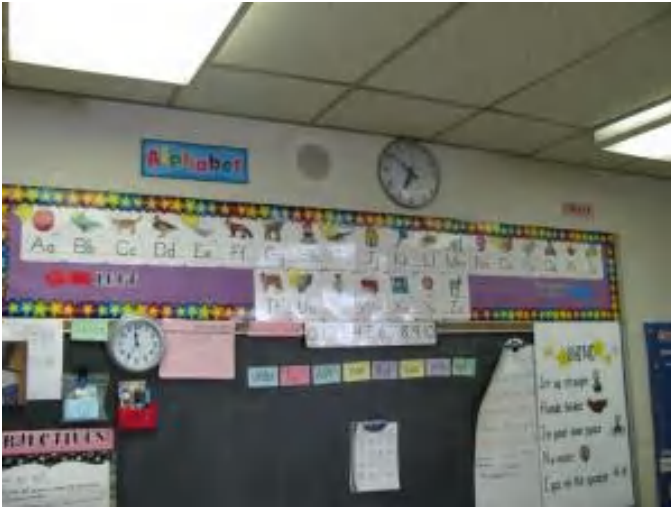
System: D5030 - Communications and Security

Location: Entire Building

Distress: Beyond Service Life

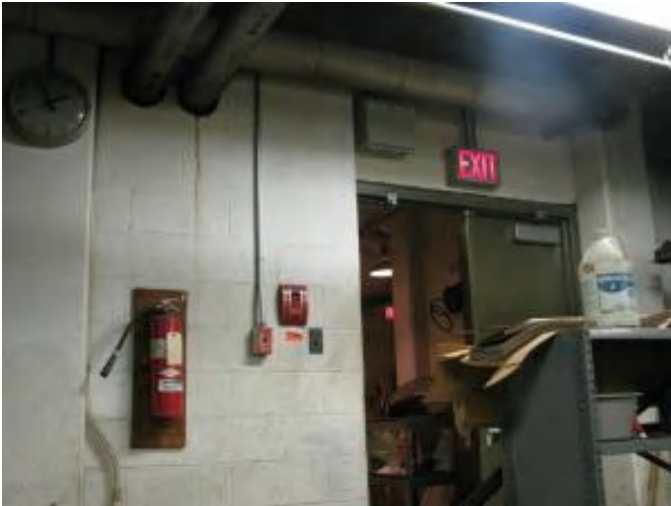
System: D5090 - Other Electrical Systems

Location: Entire Building

Distress: Life Safety / NFPA / PFD

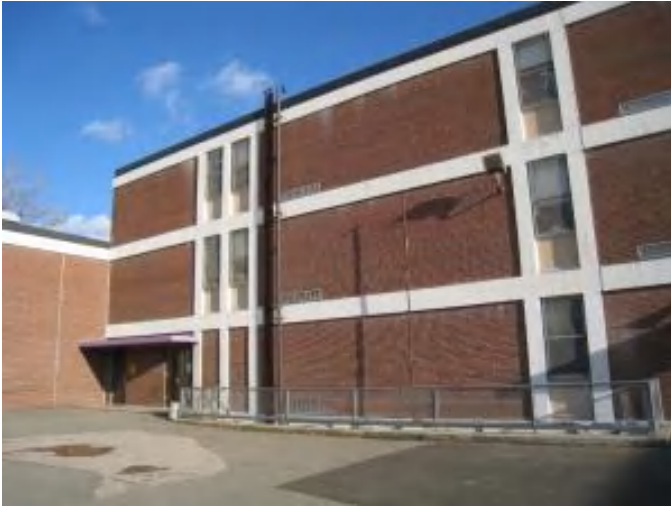
System: B2010 - Exterior Walls

Location: exterior walls

Distress: Damaged

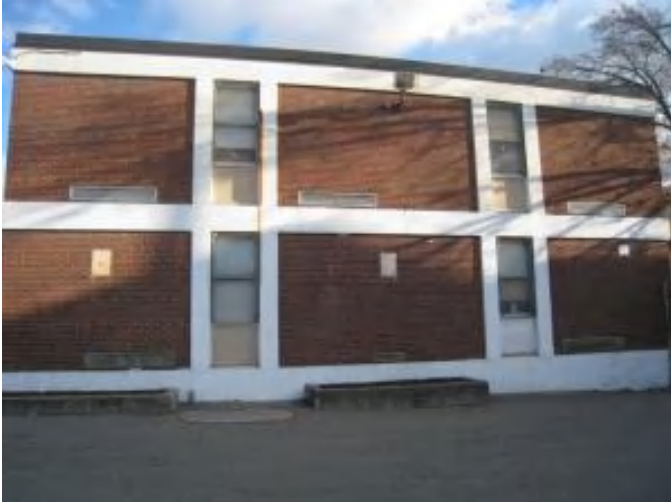
System: B2010 - Exterior Walls

Location: univent louvers

Distress: Damaged

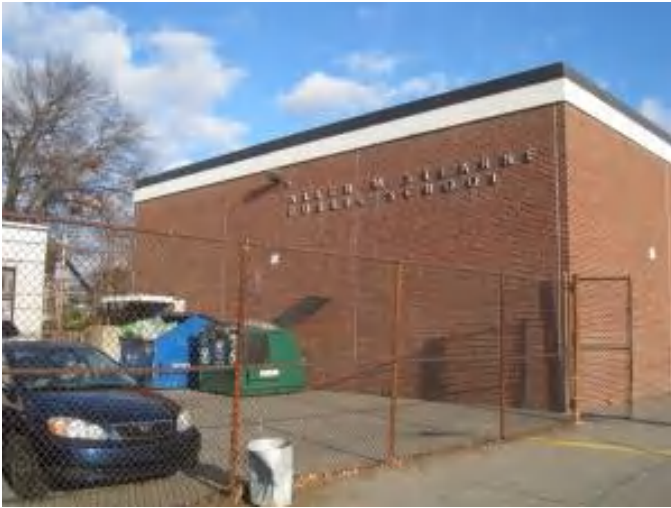
System: B2010 - Exterior Walls

Location: exterior walls

Distress: Appearance

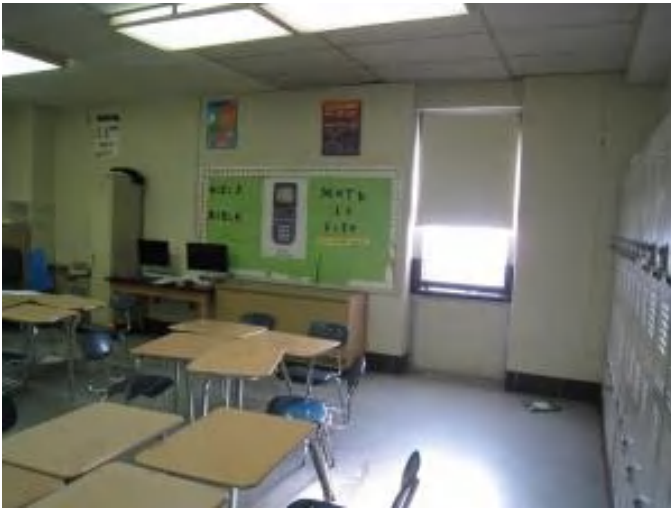
System: B2020 - Exterior Windows

Location: exterior windows

Distress: Beyond Service Life

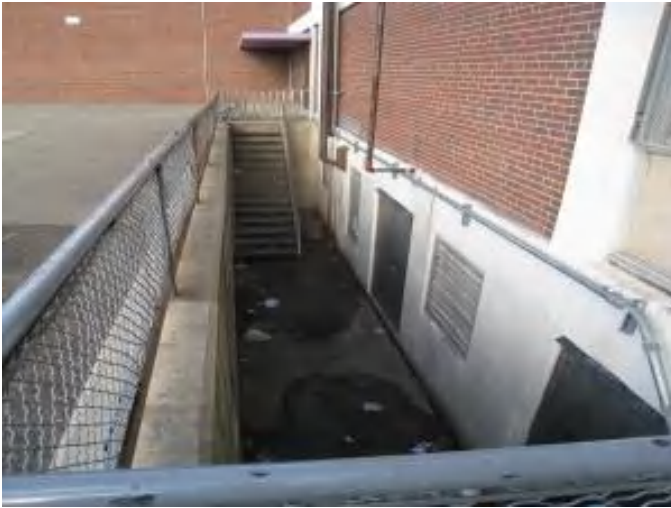
System: B2030 - Exterior Doors

Location: exterior dors

Distress: Failing

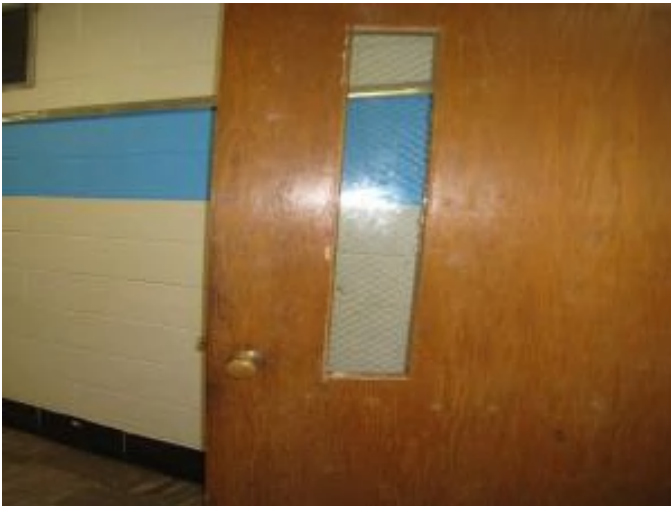
System: C1020 - Interior Doors

Location: interior doors

Distress: Damaged

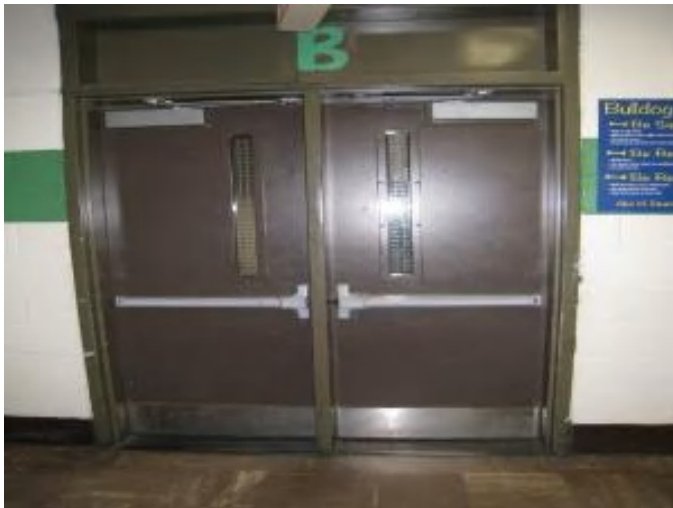
System: C1020 - Interior Doors

Location: stairways and mech rooms

Distress: Damaged

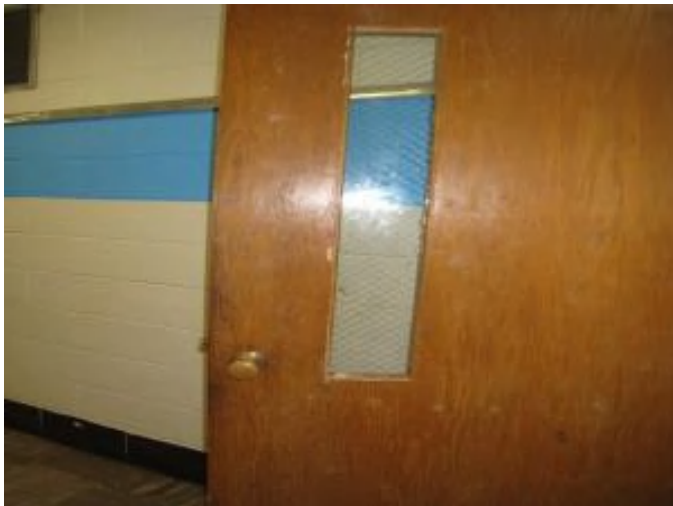
System: C1020 - Interior Doors

Location: corridor doors

Distress: Security Issue

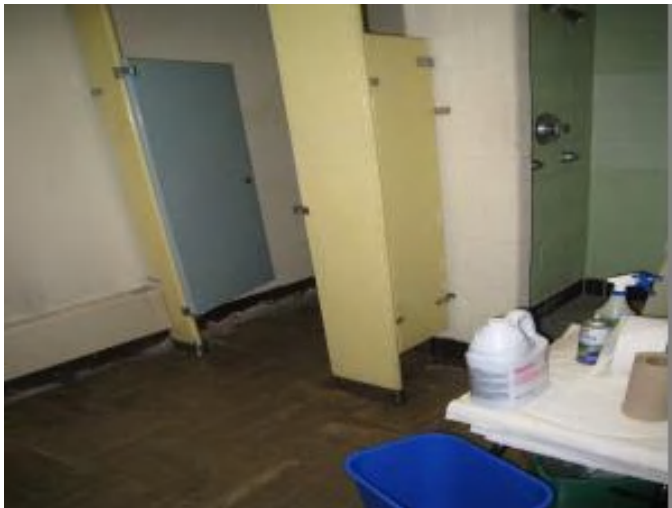
System: C1030 - Fittings

Location: toilet rooms

Distress: Beyond Service Life

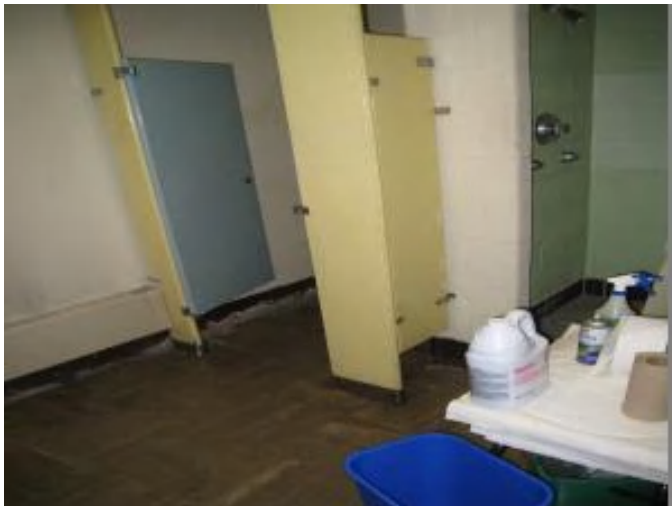
System: C1030 - Fittings

Location: toilet rooms

Distress: Inadequate

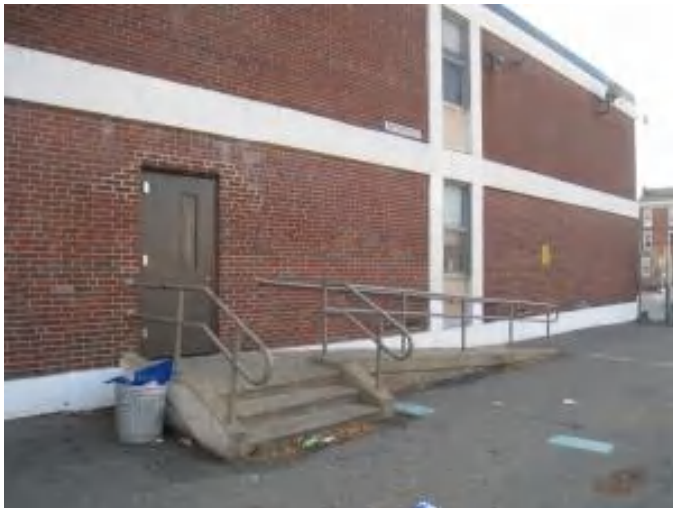
System: C2010 - Stair Construction

Location: exterior ramp into building

Distress: Appearance

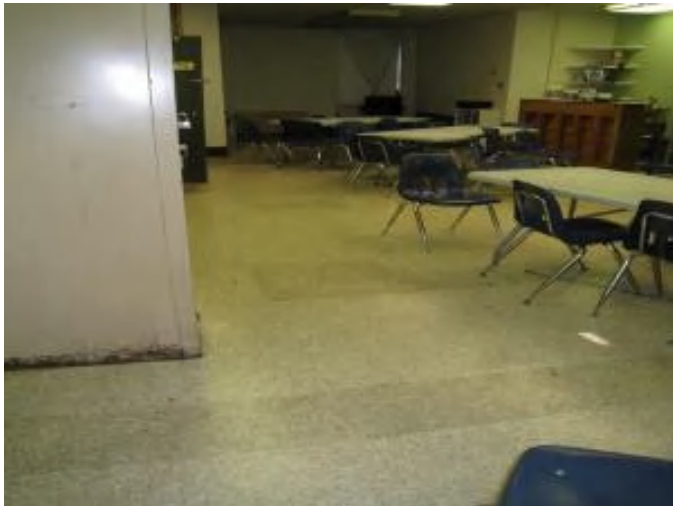
System: C3010230 - Paint & Covering

Location: interior walls

Distress: Appearance

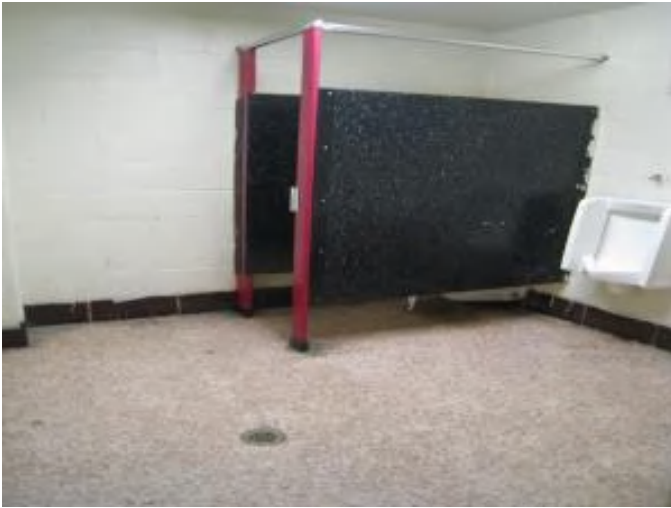
System: C3020412 - Terrazzo & Tile

Location: terrazzo floors

Distress: Appearance

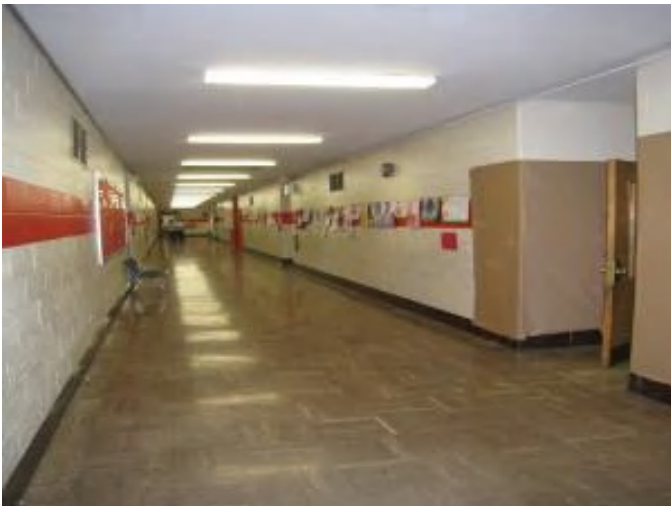
System: C3020413 - Vinyl Flooring

Location: vinyl floors

Distress: Beyond Service Life

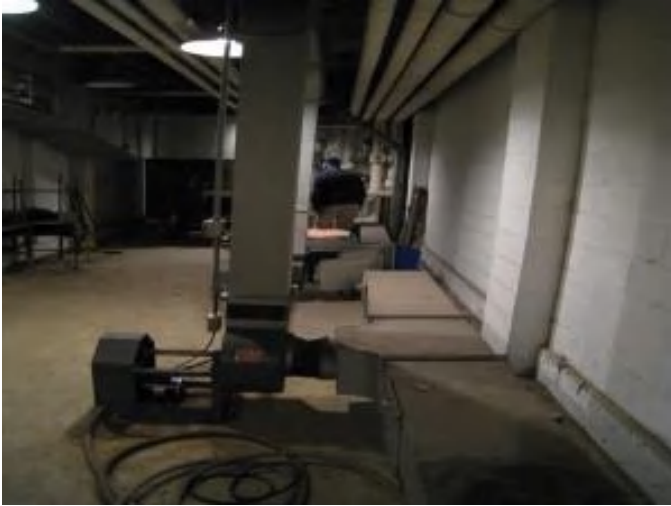
System: C3020415 - Concrete Floor Finishes

Location: concrete slabs

Distress: Appearance

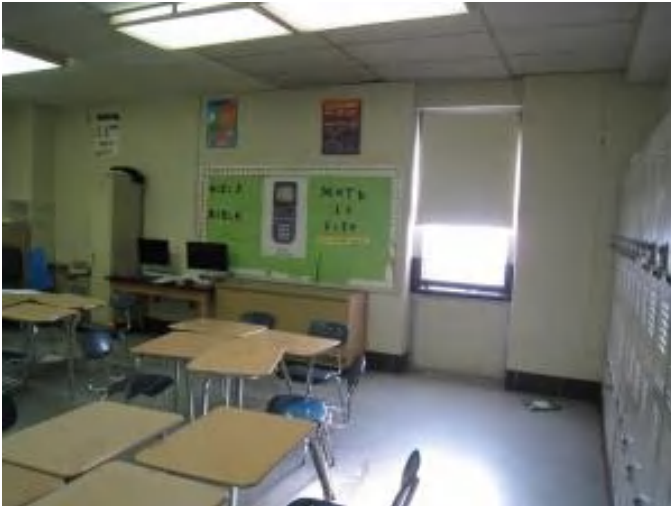
System: C3030 - Ceiling Finishes

Location: ceilings

Distress: Beyond Service Life

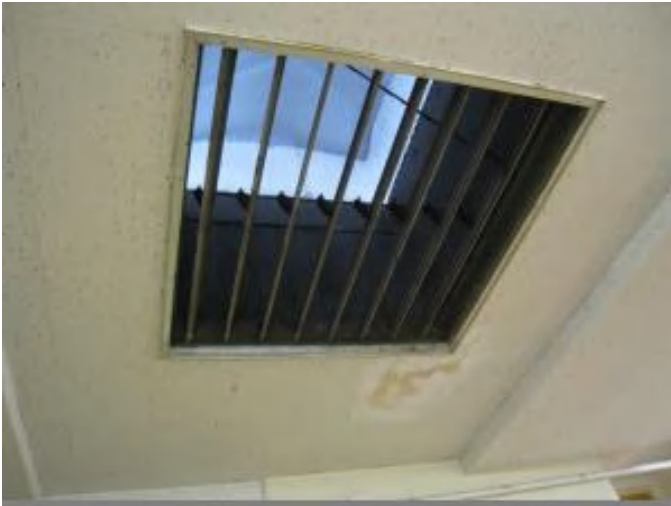
System: C3030 - Ceiling Finishes

Location: ceiling

Distress: Damaged

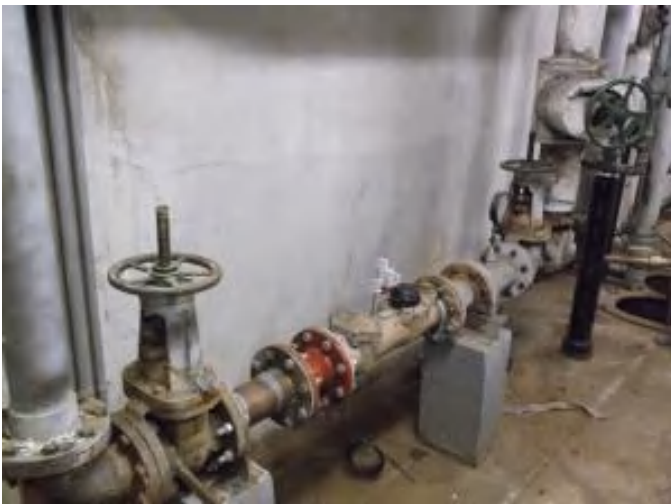
System: D2020 - Domestic Water Distribution

Location: Throughout Building

Distress: Building / MEP Codes

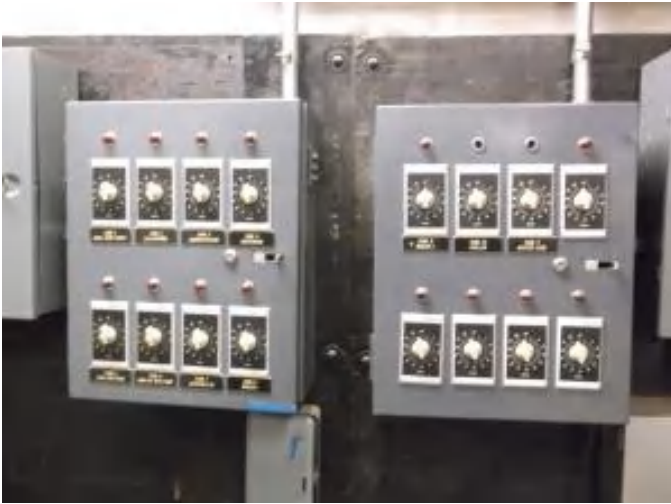
System: D3060 - Controls & Instrumentation

Location: Throughout Building

Distress: Energy Efficiency

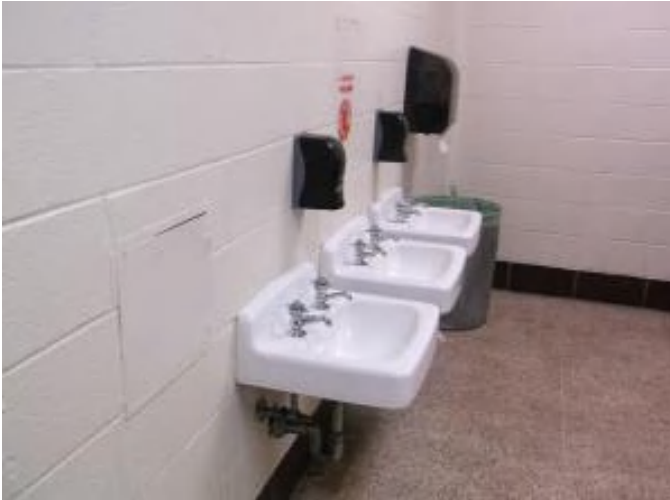
System: D2010 - Plumbing Fixtures

Distress: Accessibility

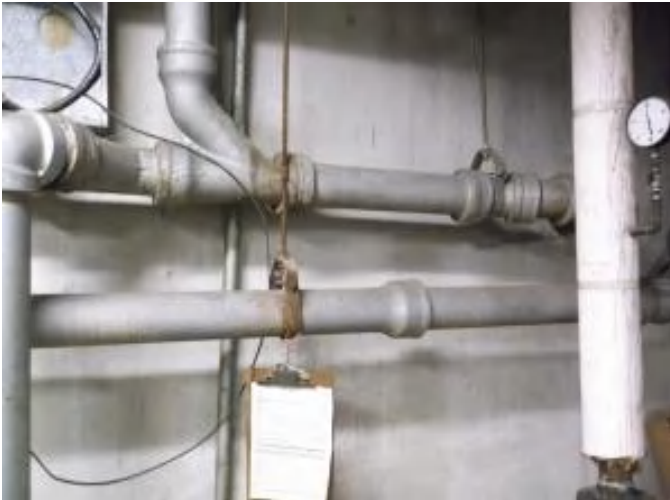
System: D2030 - Sanitary Waste

Location: Throughout Building

Distress: Beyond Service Life

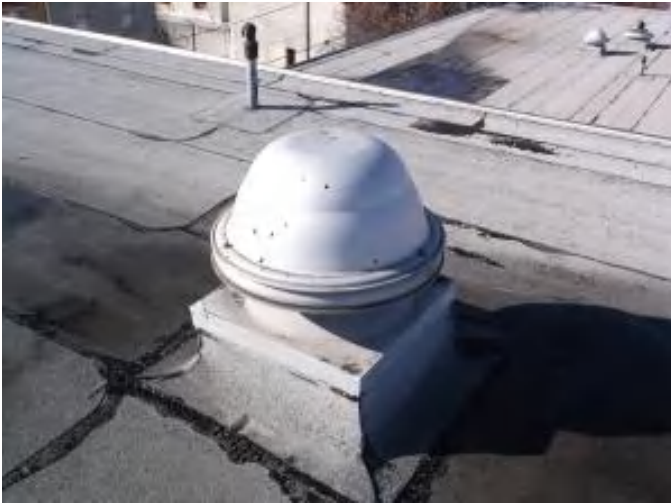
System: D3040 - Distribution Systems

Location: Roof

Distress: Beyond Service Life

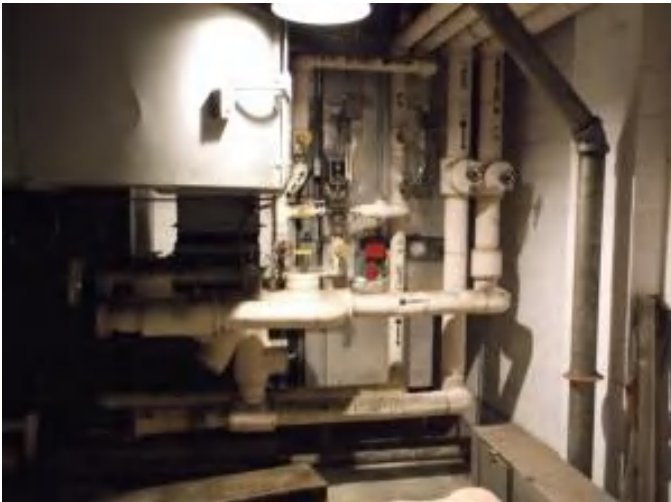
System: D3040 - Distribution Systems

Location: 2nd Floor MER

Distress: Health Hazard / Risk

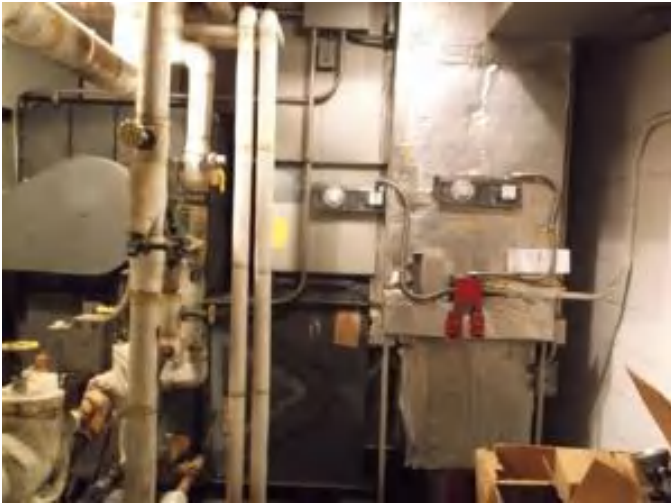
System: D3040 - Distribution Systems

Location: 2nd Floor MER

Distress: Health Hazard / Risk

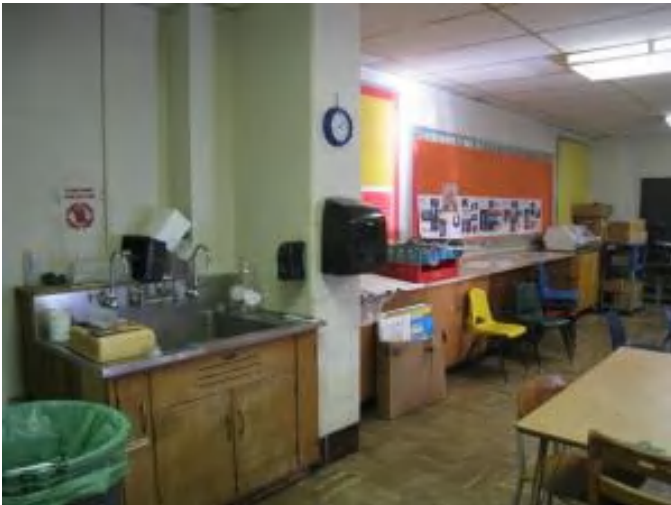
System: E1020 - Institutional Equipment

Location: kindergarten and art cabinets

Distress: Damaged

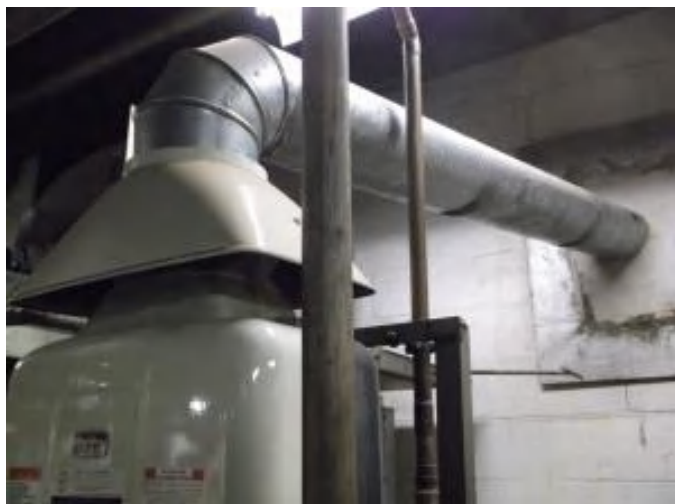
System: D2020 - Domestic Water Distribution

Location: Boiler Room

Distress: Beyond Service Life

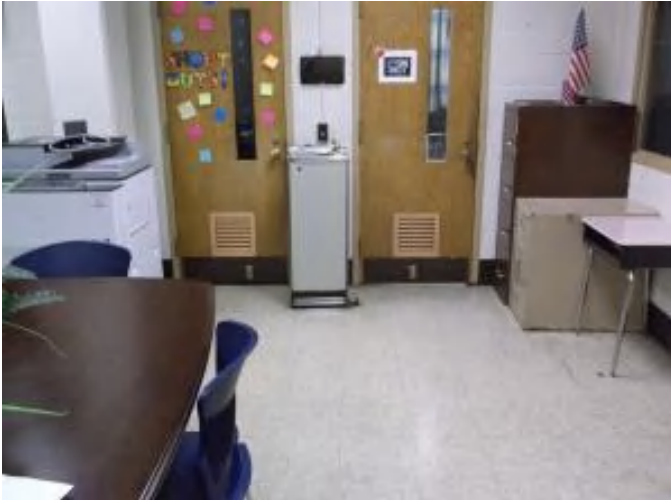
System: D2010 - Plumbing Fixtures

Location: Corridors

Distress: Accessibility

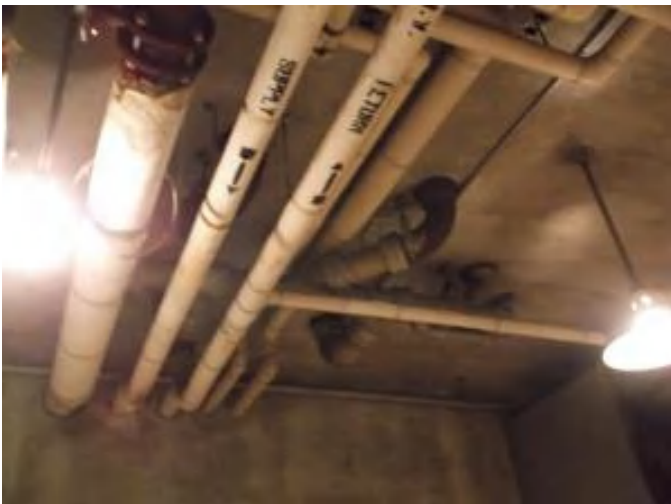
System: D2020 - Domestic Water Distribution

Location: Throughout Building

Distress: Beyond Service Life

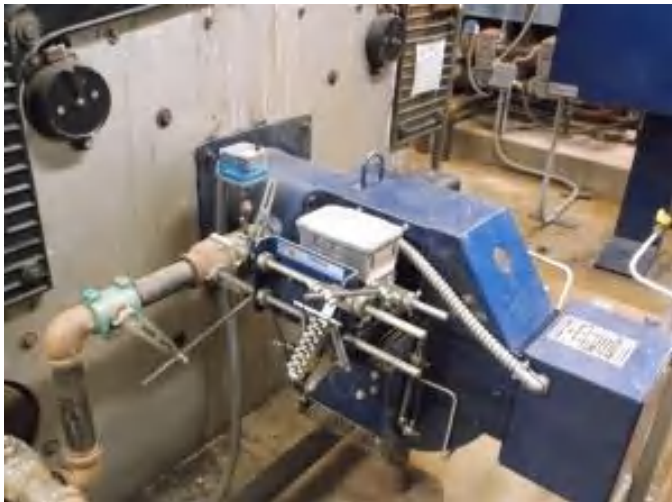
System: D3020 - Heat Generating Systems

Location: Boiler Room

Distress: Energy Efficiency

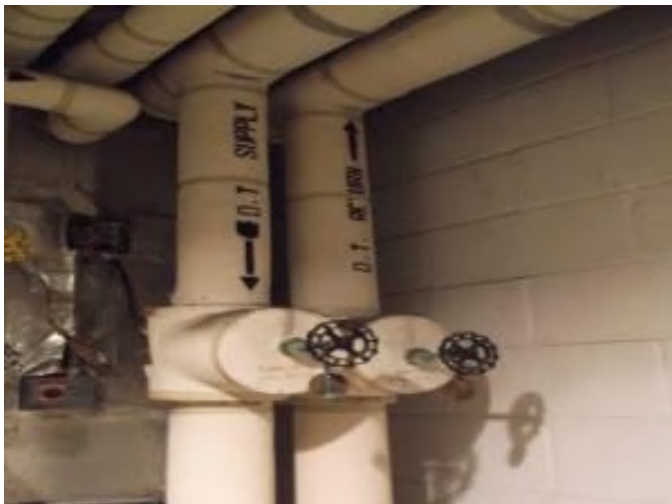
System: D3040 - Distribution Systems

Location: Throughout Building

Distress: Beyond Service Life

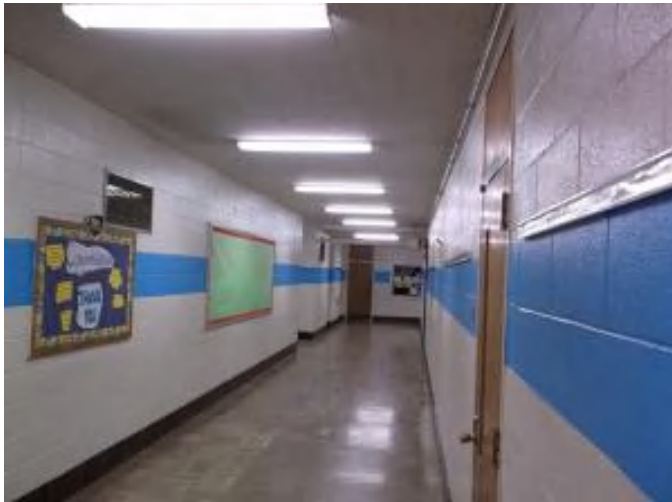
System: D4010 - Sprinklers

Location: Throughout Building

Distress: Life Safety / NFPA / PFD

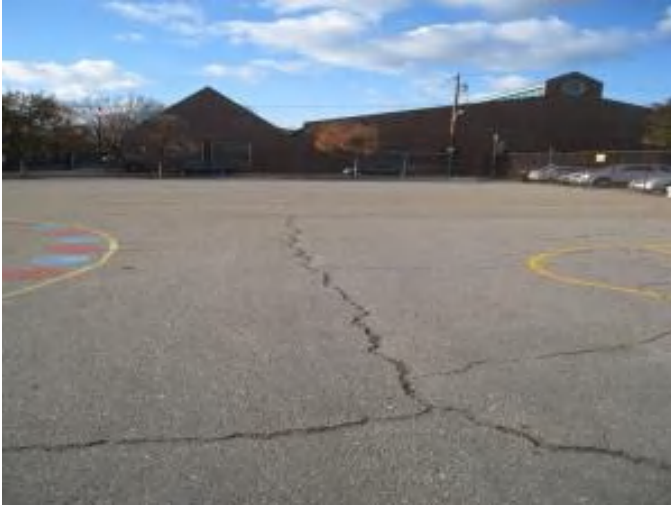
System: G2020 - Parking Lots

Location: play area

Distress: Failing

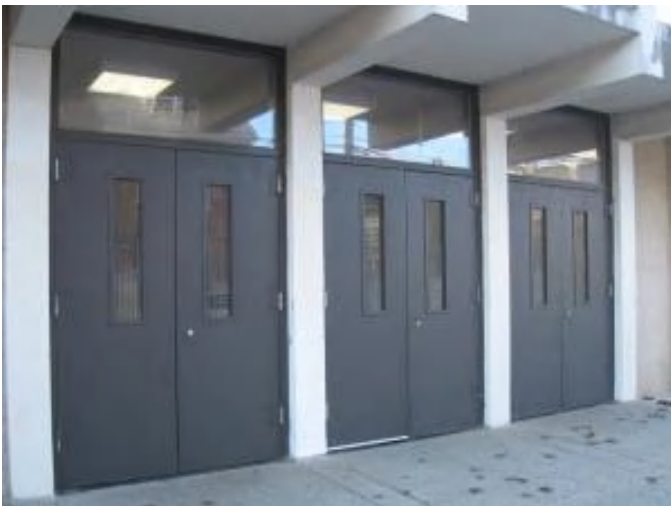
System: G2030 - Pedestrian Paving

Location: sidewalks

Distress: Damaged

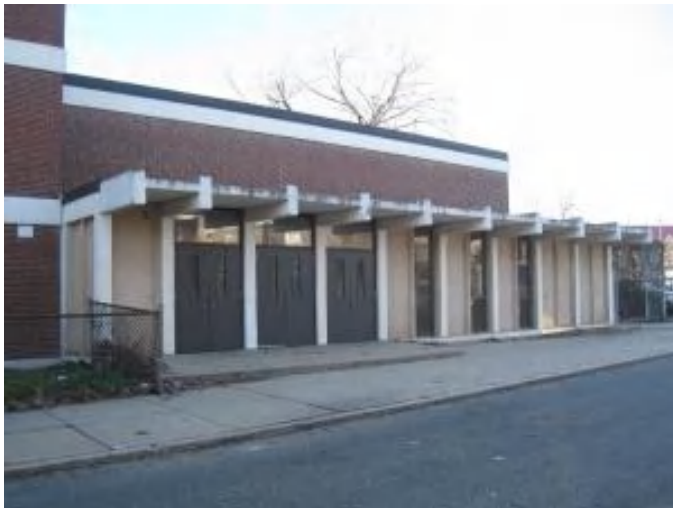
System: G2030 - Pedestrian Paving

Location: entrance to auditorium

Distress: Accessibility

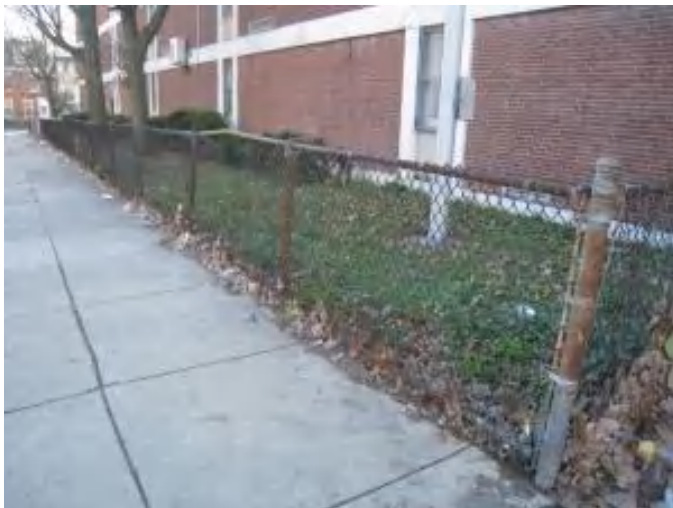
System: G2040 - Site Development

Location: site fencing

Distress: Failing

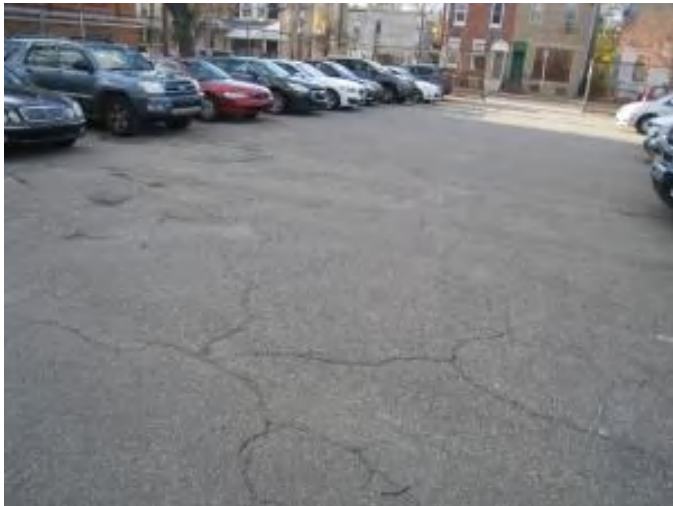
System: G2020 - Parking Lots

Location: faculty parking lots

Distress: Damaged
