## Facility Condition Assessment Summary Report

### Steel School

School District of Philadelphia  
**S639001;Steel**  
Final  
Site Assessment Report

January 30, 2017

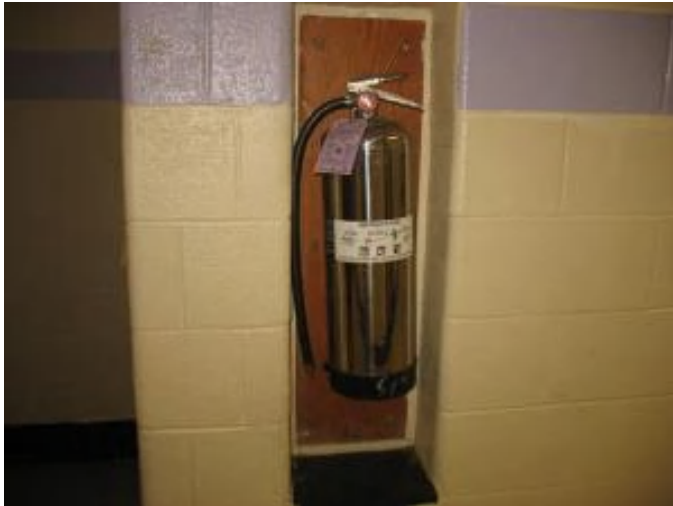
**Location:** Throughout building

#### System: D4010 - Sprinklers

**Distress:** Building / MEP Codes

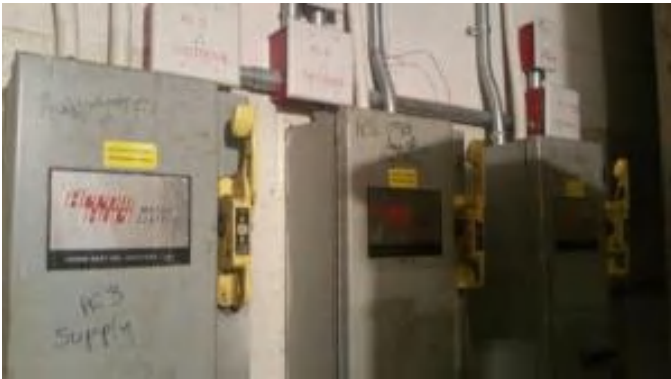
**Location:** throughout the building

**System: D5010 - Electrical Service/Distribution**

**Distress:** Beyond Service Life

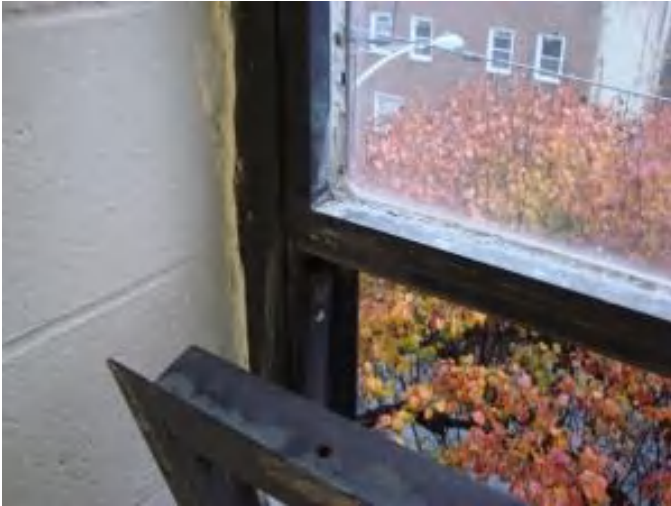
**Location:** Throughout

**System: B2020 - Exterior Windows**

**Distress:** Beyond Service Life

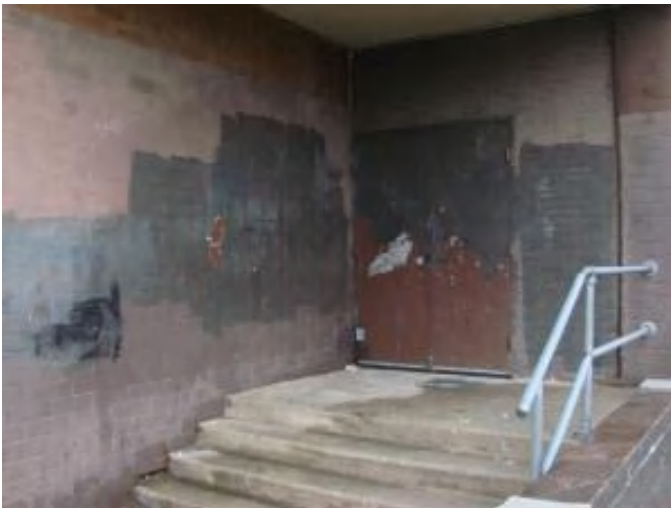
**Location:** Throughout

**System: B2030 - Exterior Doors**

**Distress:** Beyond Service Life

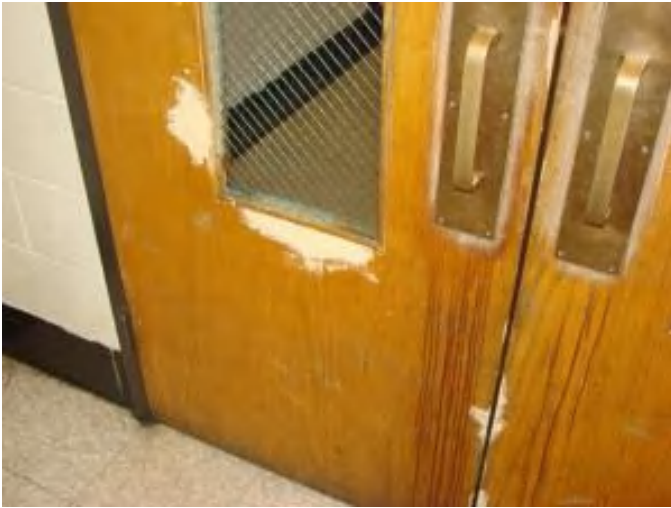
**Location:** Throughout

**System: C1020 - Interior Doors**

**Distress:** Beyond Service Life

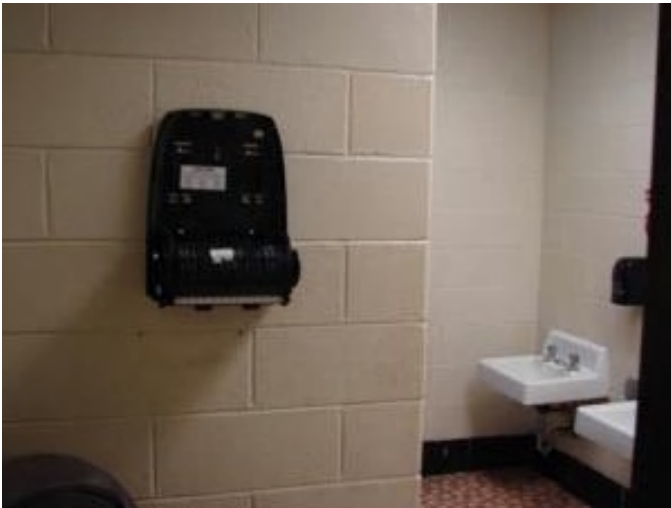
**Location:** Toilets

**System: C1030 - Fittings**

**Distress:** Damaged

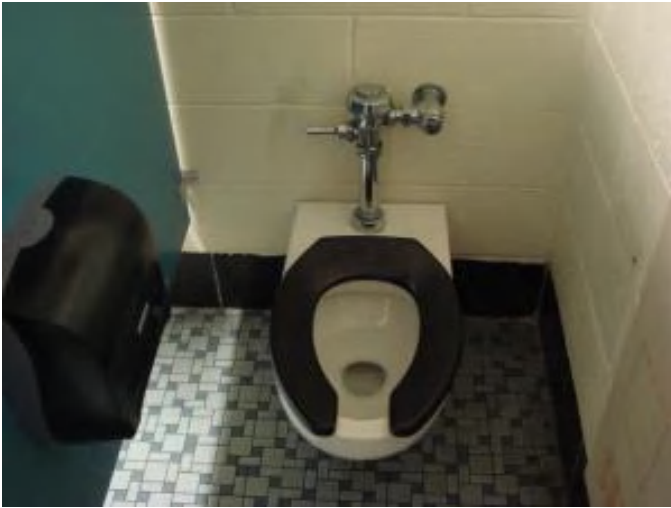
**Location:** Toilets

**System: C1030 - Fittings**

**Distress:** Accessibility

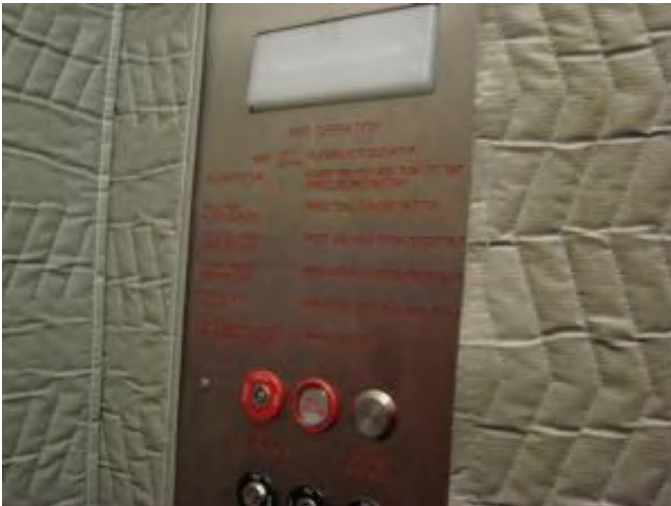
**Location:** Elevator

**System: D1010 - Elevators and Lifts**

**Distress:** Building / MEP Codes

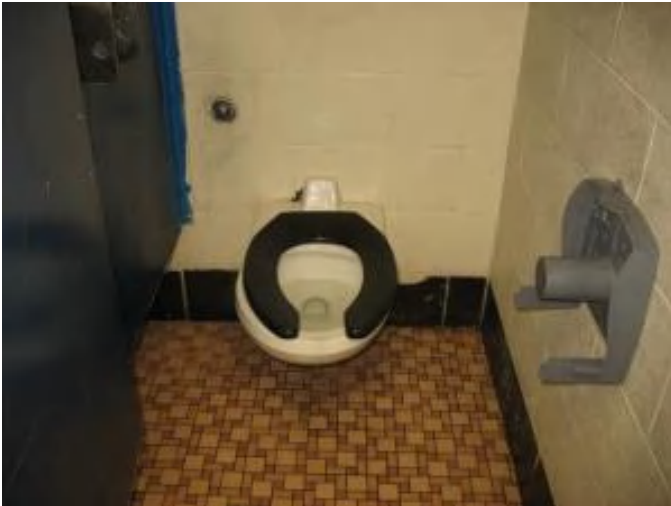
**System: D2010 - Plumbing Fixtures**

**Location:** Restrooms  
**Distress:** Beyond Service Life  
**Category:** 3 - Operations / Maint.  
**Priority:** 3 - Response Time (3-4 yrs)  
**Correction:** Remove and replace or replace water closet - quantify additional units  
**Qty:** 30.00  
**Unit of Measure:** Ea.  
**Estimate:** \$224,175.82  
**Assessor Name:** Craig Anding  
**Date Created:** 02/03/2016

**Notes:** Replace thirty (30) water closets, in use beyond their service life, with new code compliant fixtures.

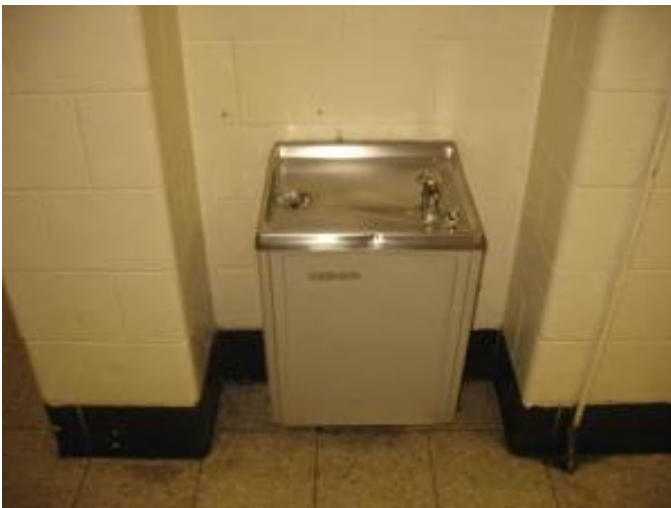
**System: D2010 - Plumbing Fixtures**

**Location:** Corridors  
**Distress:** Beyond Service Life  
**Category:** 3 - Operations / Maint.  
**Priority:** 3 - Response Time (3-4 yrs)  
**Correction:** Remove and replace water fountains to meet ADA - includes high and low fountains and new recessed alcove  
**Qty:** 5.00  
**Unit of Measure:** Ea.  
**Estimate:** \$78,464.48  
**Assessor Name:** Craig Anding  
**Date Created:** 02/03/2016

**Notes:** Replace five (5) wall hung drinking fountains and integral refrigerated coolers in the corridors. These units are beyond their service life and most are NOT accessible type.

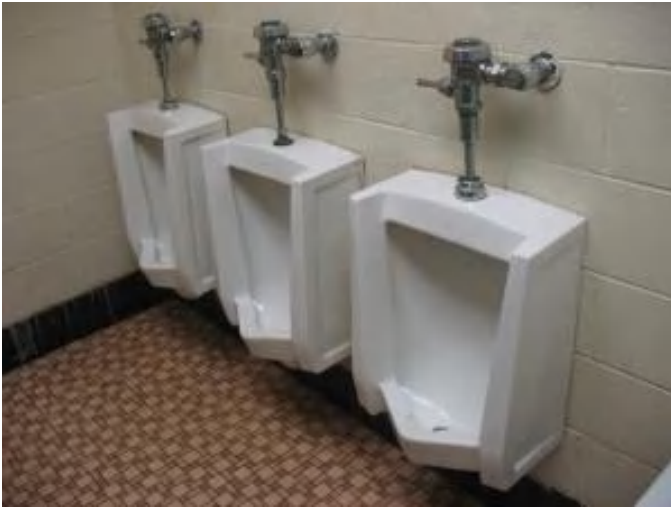
**Location:** Restrooms

**System: D2010 - Plumbing Fixtures**

**Distress:** Beyond Service Life

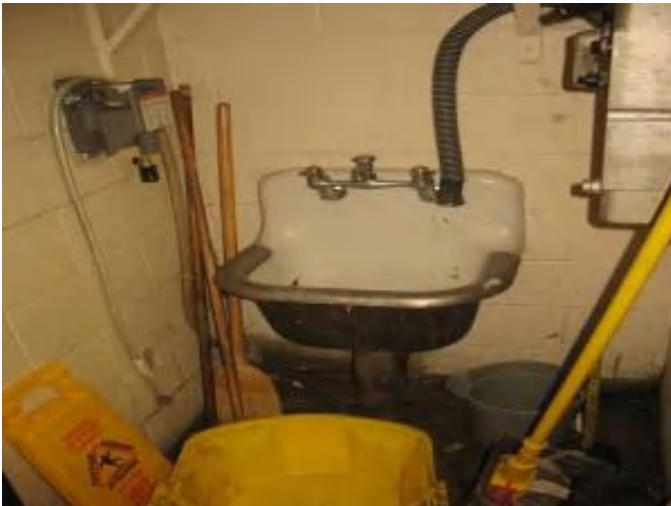
**Location:** Corridors

**System: D2010 - Plumbing Fixtures**

**Distress:** Beyond Service Life

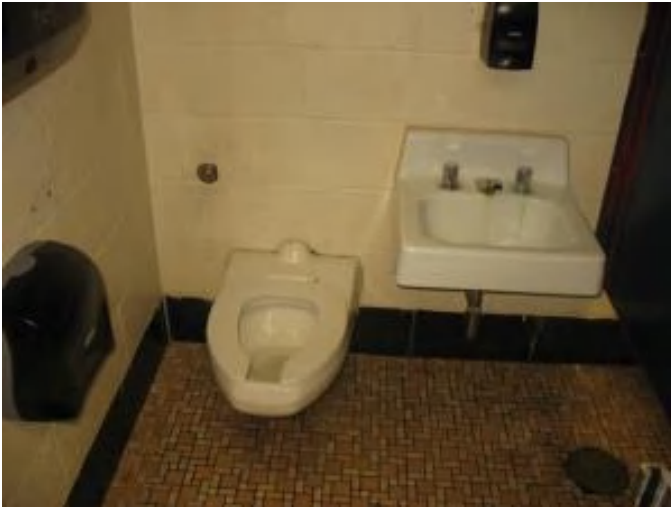
**Location:** Restrooms

**System: D2010 - Plumbing Fixtures**

**Distress:** Beyond Service Life

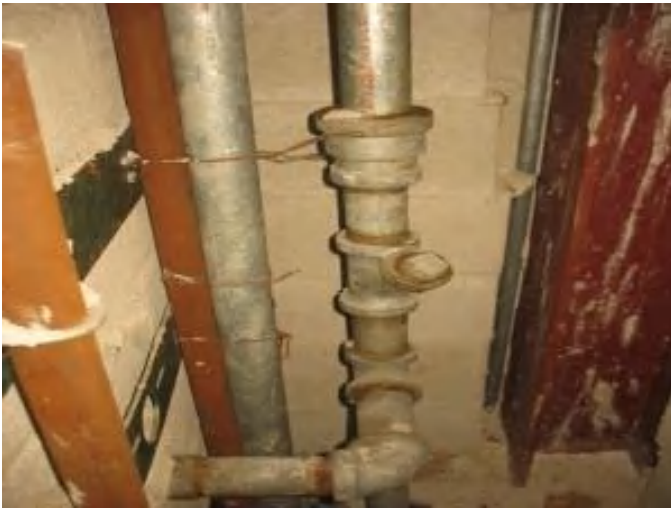
**Location:** Throughout building

**System: D2030 - Sanitary Waste**

**Distress:** Beyond Service Life

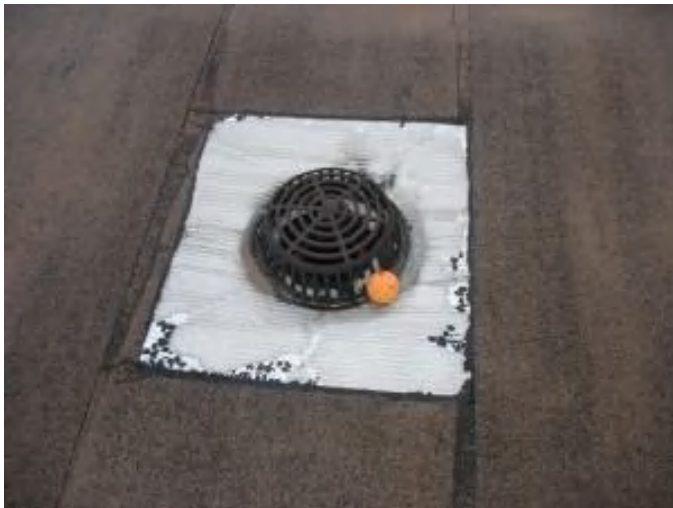
**Location:** Throughout building

**System: D2040 - Rain Water Drainage**

**Distress:** Beyond Service Life

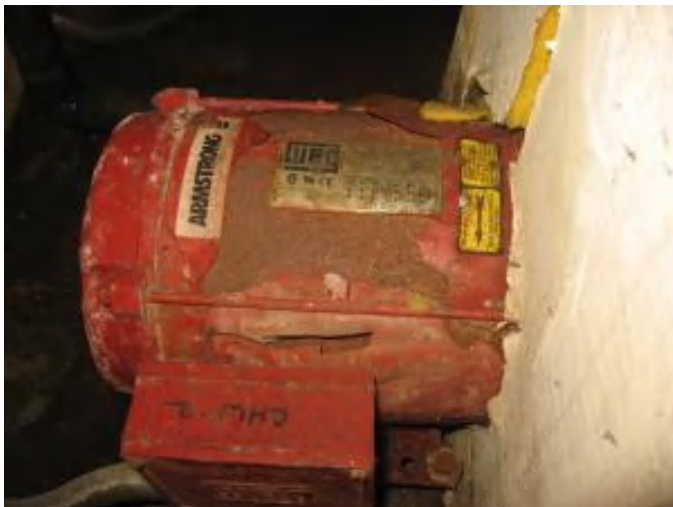
**Location:** Main mechanical room

**System: D3030 - Cooling Generating Systems**

**Distress:** Damaged

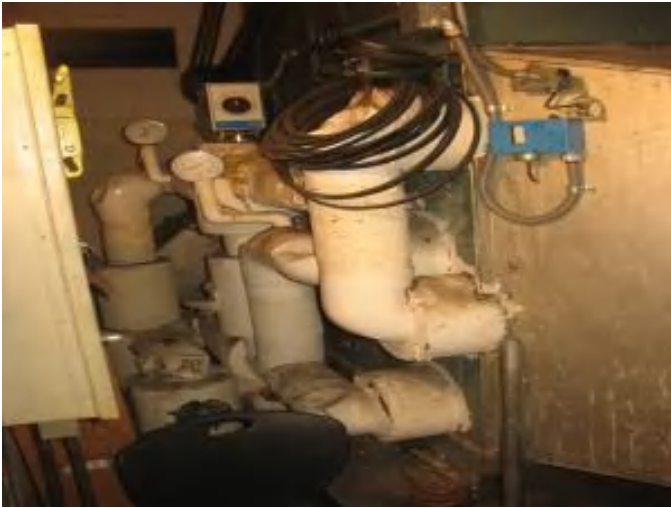
**Location:** 3rd floor mechanical room

**System: D3040 - Distribution Systems**

**Distress:** Beyond Service Life

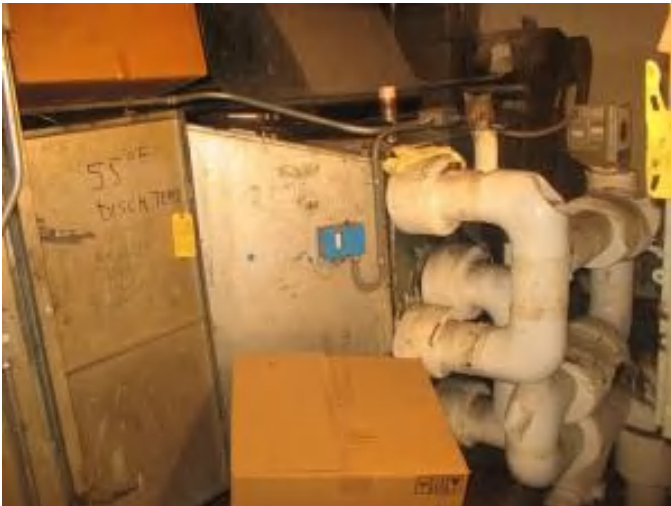
**Location:** 3rd floor mechanical room

**System: D3040 - Distribution Systems**

**Distress:** Beyond Service Life

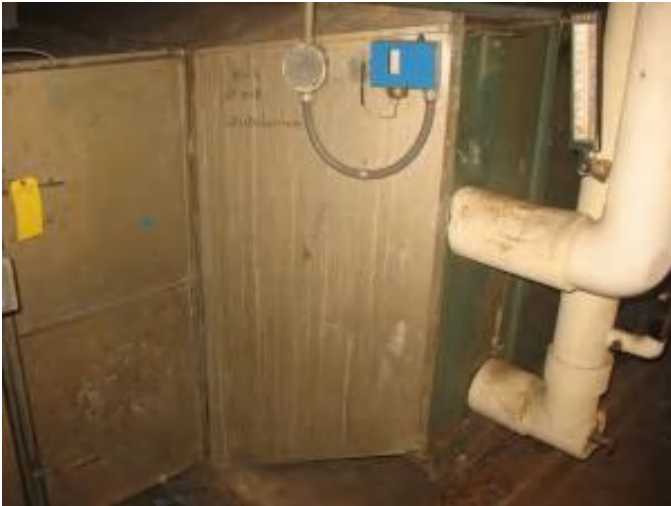
**Location:** 2nd floor mechanical room

**System: D3040 - Distribution Systems**

**Distress:** Beyond Service Life

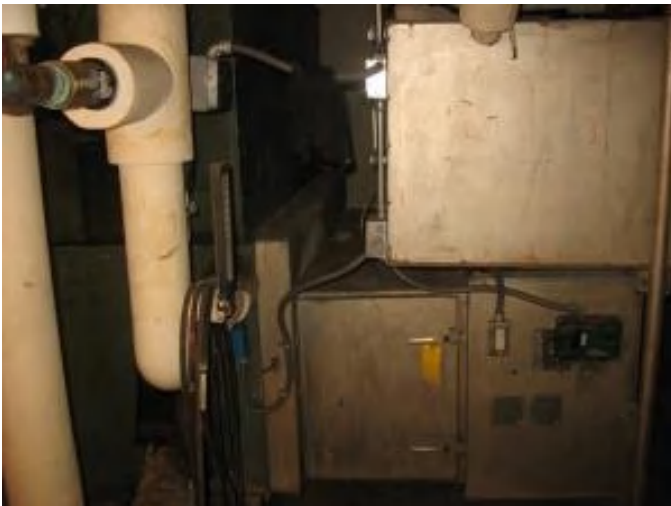
**Location:** 2nd floor mechanical room

**System: D3040 - Distribution Systems**

**Distress:** Beyond Service Life

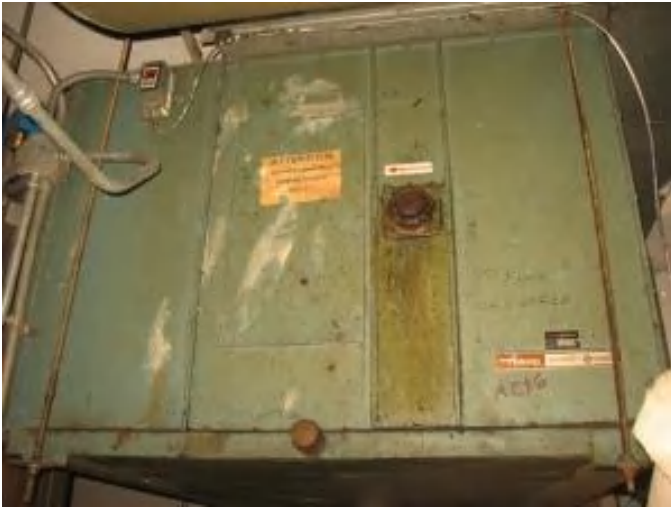
**Location:** Administration offices

**System: D3040 - Distribution Systems**

**Distress:** Beyond Service Life

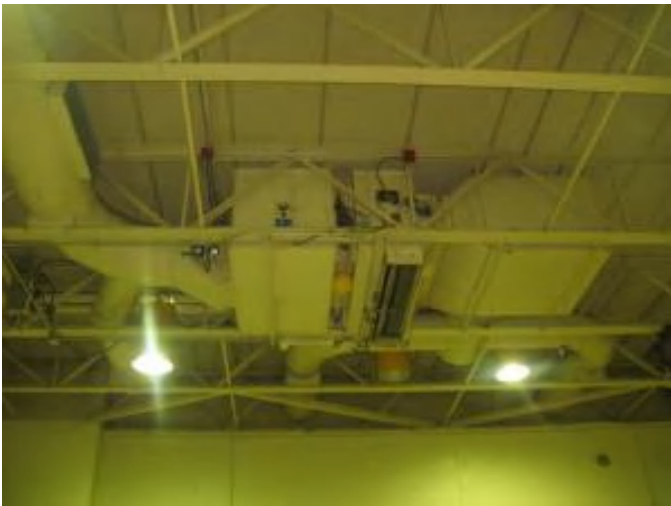
**Location:** Gymnasium

**System: D3040 - Distribution Systems**

**Distress:** Beyond Service Life

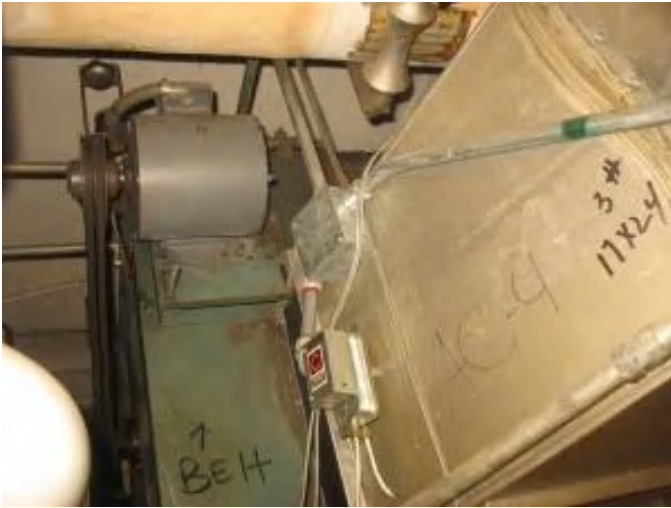
**Location:** 2nd floor mechanical room

**System: D3040 - Distribution Systems**

**Distress:** Beyond Service Life

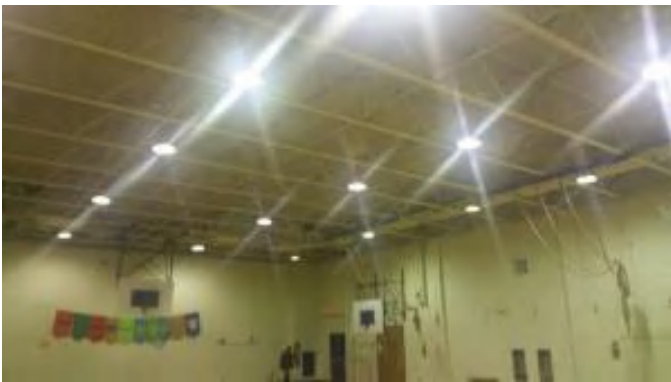
**Location:** throughout the building

**System: D5020 - Lighting and Branch Wiring**

**Distress:** Beyond Service Life

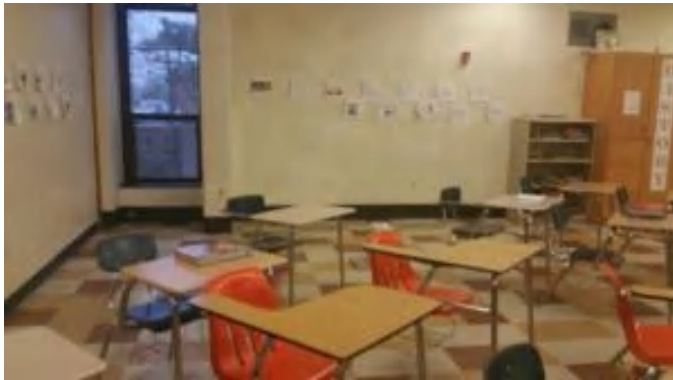
**Location:** throughout the building

**System: D5020 - Lighting and Branch Wiring**

**Distress:** Inadequate

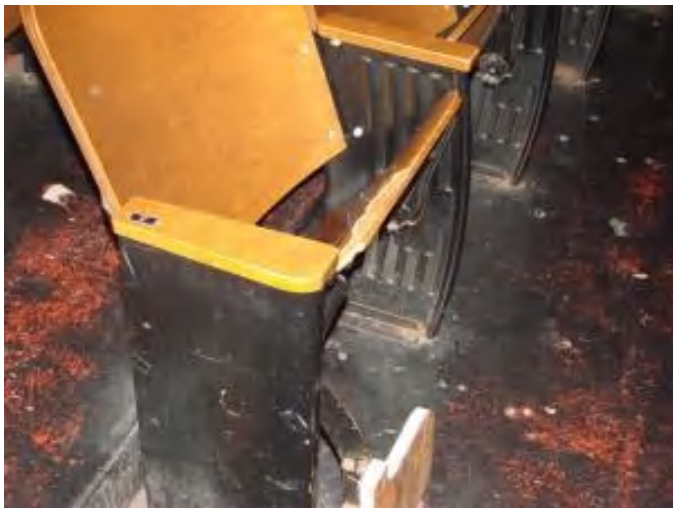
**Location:** Auditorium

**System: E2010 - Fixed Furnishings**

**Distress:** Damaged

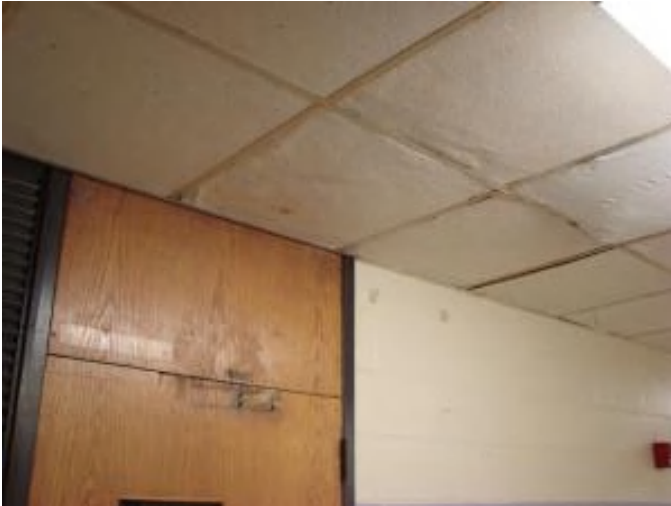
**Location:** Various

**System: C3030 - Ceiling Finishes**

**Distress:** Beyond Service Life

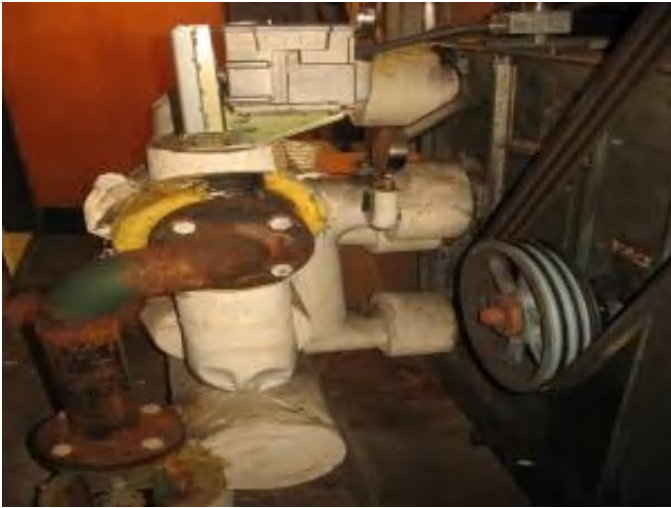
**System: D3040 - Distribution Systems**

**Location:** Throughout building  
**Distress:** Beyond Service Life  
**Category:** 3 - Operations / Maint.  
**Priority:** 4 - Response Time (4-5 yrs)  
**Correction:** Replace chilled water distribution piping (75KSF)  
**Qty:** 85,350.00  
**Unit of Measure:** S.F.  
**Estimate:** \$1,147,412.25  
**Assessor Name:** Craig Anding  
**Date Created:** 02/03/2016

**Notes:** Hire a qualified contractor to examine the chilled water distribution piping, in service for over 40 years, and replace any damaged piping and to further quantify the extent of potential failures.

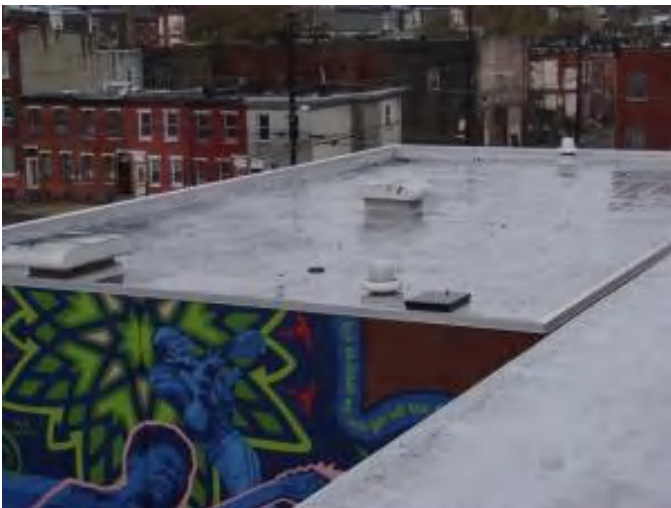
**System: D3040 - Distribution Systems**

**Location:** Roof  
**Distress:** Beyond Service Life  
**Category:** 3 - Operations / Maint.  
**Priority:** 4 - Response Time (4-5 yrs)  
**Correction:** Replace power roof ventilator (24" dia.)  
**Qty:** 3.00  
**Unit of Measure:** Ea.  
**Estimate:** \$125,465.78  
**Assessor Name:** Craig Anding  
**Date Created:** 02/03/2016

**Notes:** Replace the three (3) existing roof mounted power ventilators, which are beyond their useful service lives.

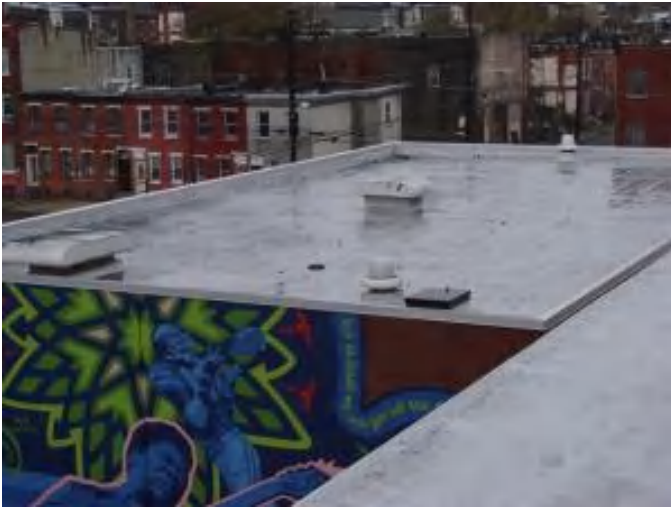
**System: D3040 - Distribution Systems**

**Location:** Roof  
**Distress:** Beyond Service Life  
**Category:** 3 - Operations / Maint.  
**Priority:** 4 - Response Time (4-5 yrs)  
**Correction:** Replace utility set exhaust fan (5 HP)  
**Qty:** 2.00  
**Unit of Measure:** Ea.  
**Estimate:** \$64,049.70  
**Assessor Name:** Craig Anding  
**Date Created:** 02/03/2016

**Notes:** Replace the two (2) existing roof mounted exhaust fans that are beyond their useful service lives.

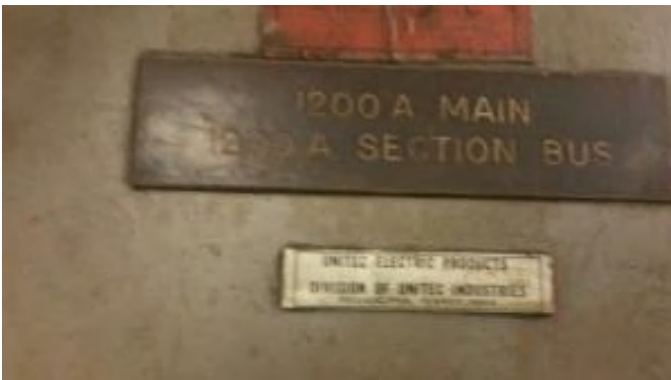
**System: D5010 - Electrical Service/Distribution**

**Location:** electrical room  
**Distress:** Beyond Service Life  
**Category:** 3 - Operations / Maint.  
**Priority:** 4 - Response Time (4-5 yrs)  
**Correction:** Replace Service Transformer, Add Switchboard  
**Qty:** 0.00  
**Unit of Measure:** Ea.  
**Estimate:** \$311,446.73  
**Assessor Name:** Craig Anding  
**Date Created:** 02/12/2016

**Notes:** Install a new and upgraded electrical service for this school to handle existing loads plus any additional mechanical loads.

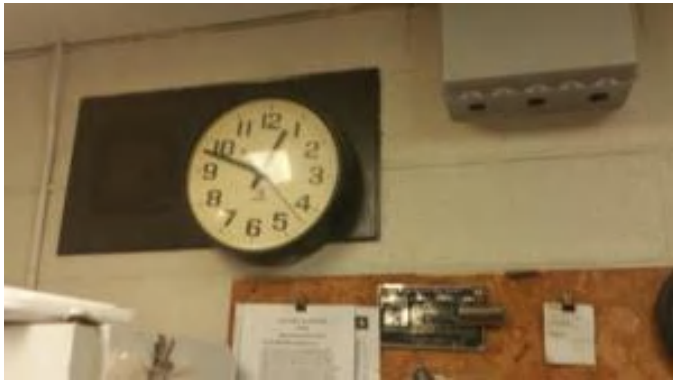
**Location:** throughout the building

**System: D5030 - Communications and Security**

**Distress:** Beyond Service Life

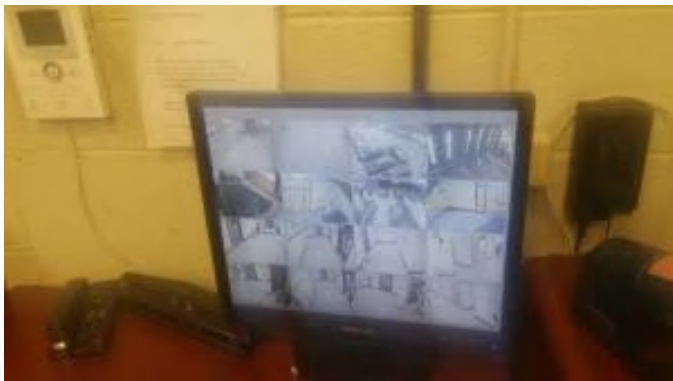
**Location:** throughout the building

**System: D5030 - Communications and Security**

**Distress:** Inadequate

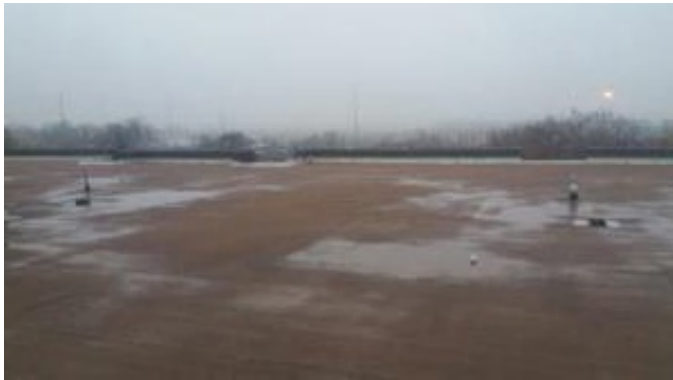
**Location:** roof

**System: D5090 - Other Electrical Systems**

**Distress:** Inadequate

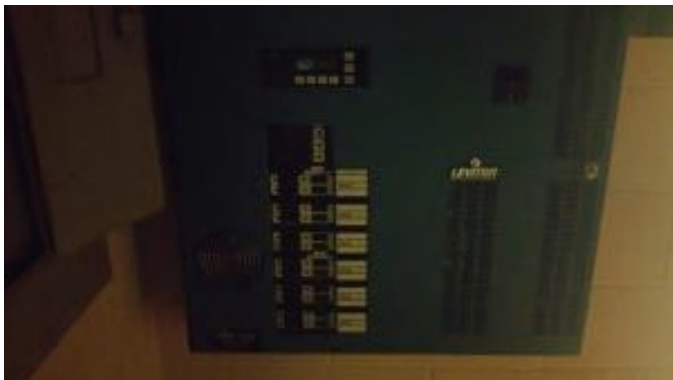
**Location:** auditorium

**System: E1020 - Institutional Equipment**

**Distress:** Beyond Service Life

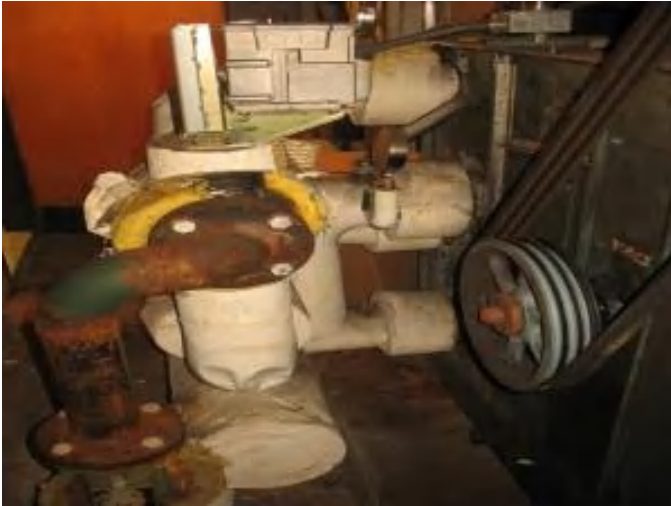
**Location:** Throughout building

**System: D3040 - Distribution Systems**

**Distress:** Beyond Service Life

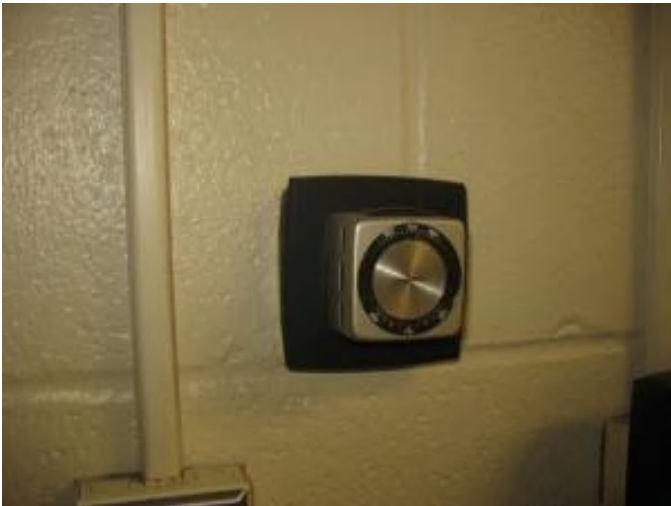
**Location:** Throughout building

**System: D3060 - Controls & Instrumentation**

**Distress:** Inadequate

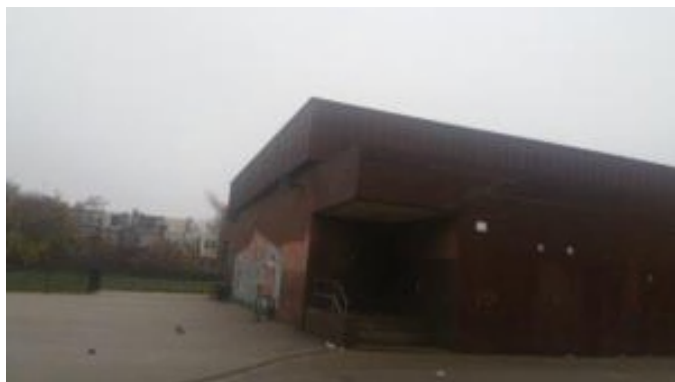
**Location:** grounds

#### System: G4020 - Site Lighting

**Distress:** Security Issue

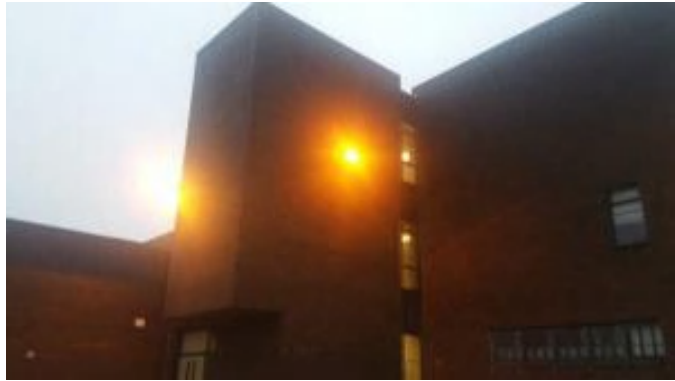
**Location:** grounds

**System: G4030 - Site Communications & Security**

**Distress:** Inadequate
