Facility Condition Assessment Summary Report

Stetson School

School District of Philadelphia
S512001;Stetson
Final
Site Assessment Report
February 1, 2017

Site Assessment Report

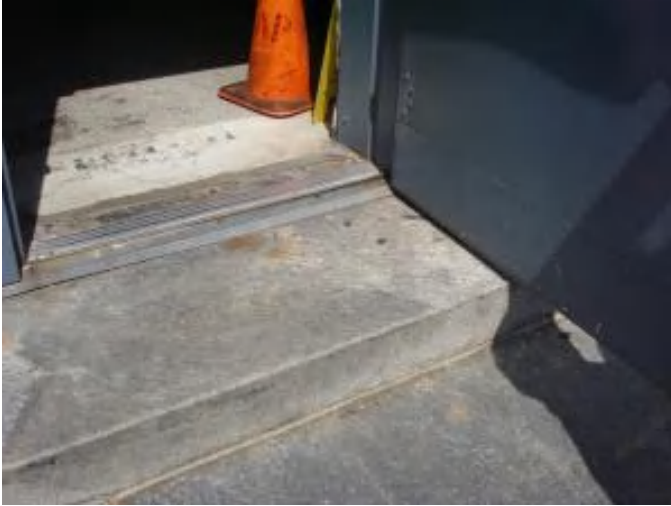
Location: Main Entrance

Distress: Life Safety / NFPA / PFD

Notes: The main entrance is a double door system that has been upgraded from the original construction. This system is in good condition however as indicated in the photo the concrete step does not meet the length of the door thus allowing a trip hazard. Special consideration for a new door system is required and a modification to the exterior step removing the hazard. Remove and replace door and step.

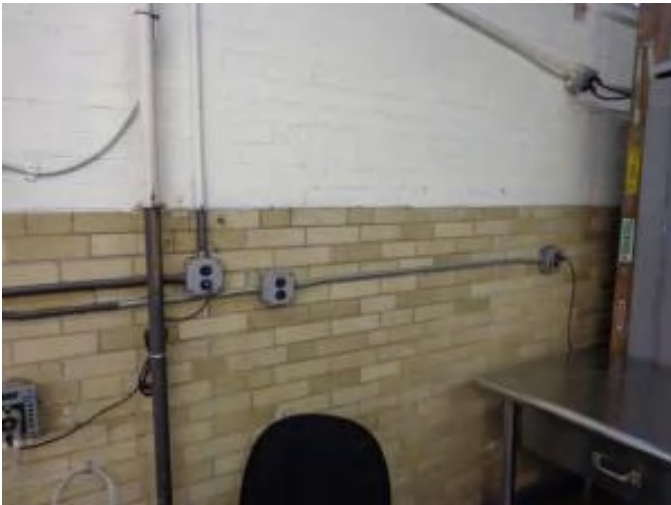
Location: Kitchen

Distress: Life Safety / NFPA / PFD

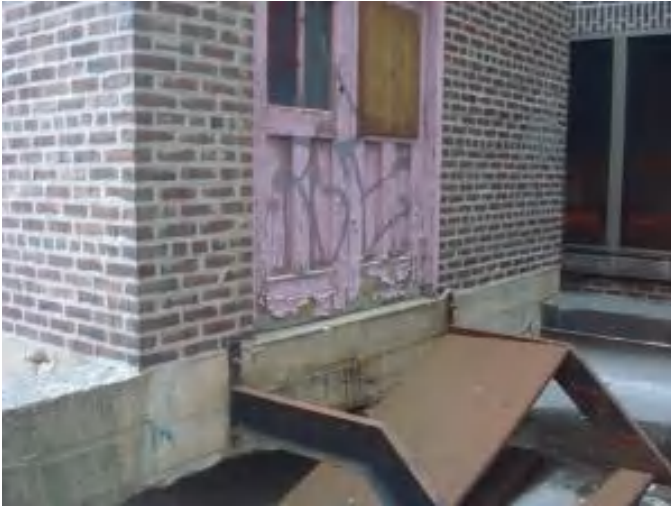
Location: Exterior Elevation

Distress: Beyond Service Life

Notes: The exterior doors are a combination of wooden and metal applications with wooden or metal frames. There is a storefront system at the main entrance with a metal-framed metal door application. The exterior door system for this school is a very high traffic system. The doors are in fair condition with the exception of the wooden doors to the air handling rooms and to the service rooms. These doors are out of service and need immediate attention. Other doors are aging at a faster rate than expected based on traffic and condition. The exterior door system, store front and service doors are recommended for upgrade.

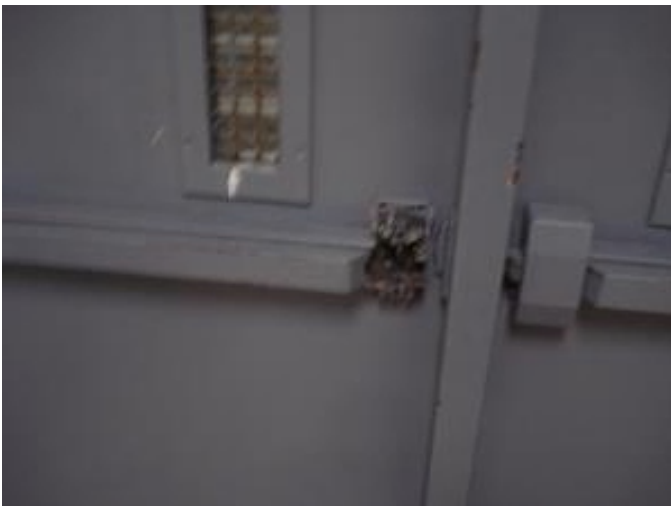
Location: Building Wide

Distress: Life Safety / NFPA / PFD

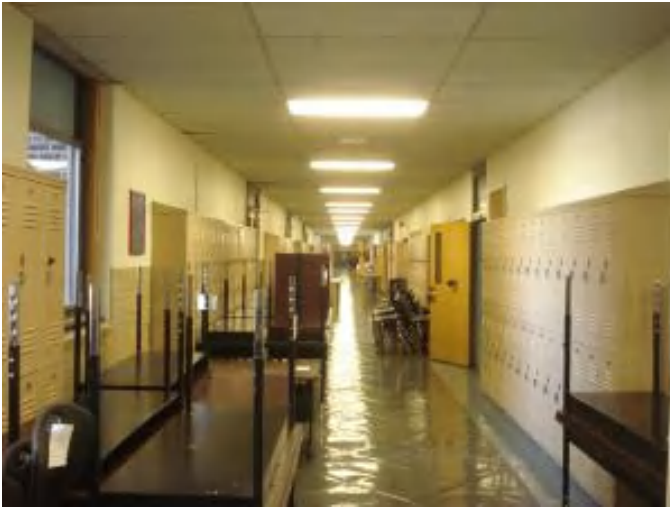
Location: Hallways

Distress: Life Safety / NFPA / PFD

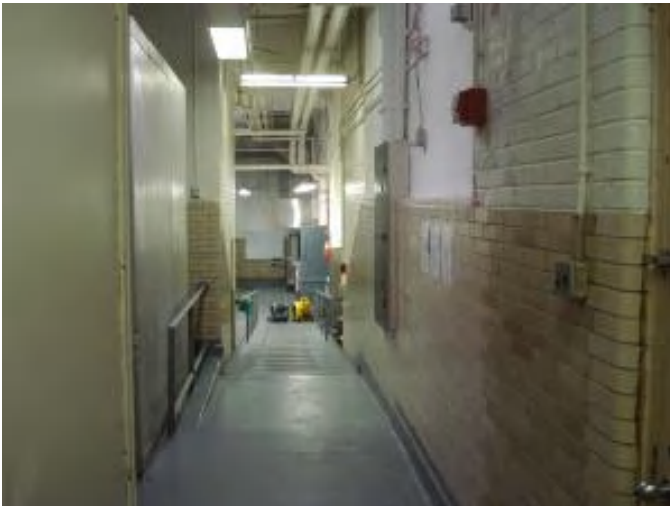
Location: Kitchen

Distress: Life Safety / NFPA / PFD

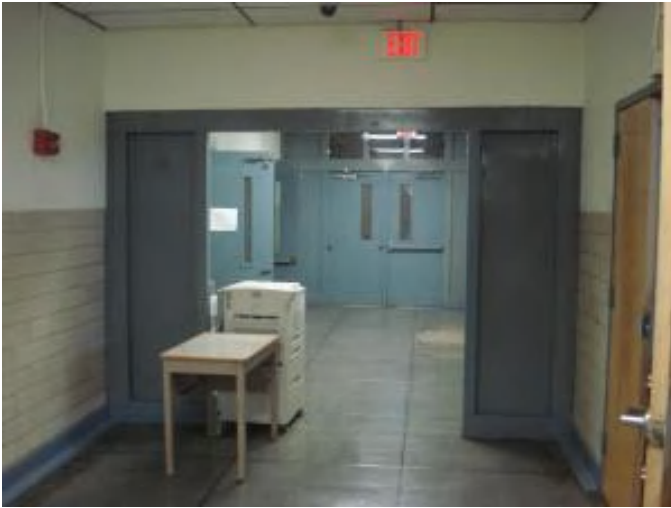
Location: Corridor doors

Distress: Life Safety / NFPA / PFD

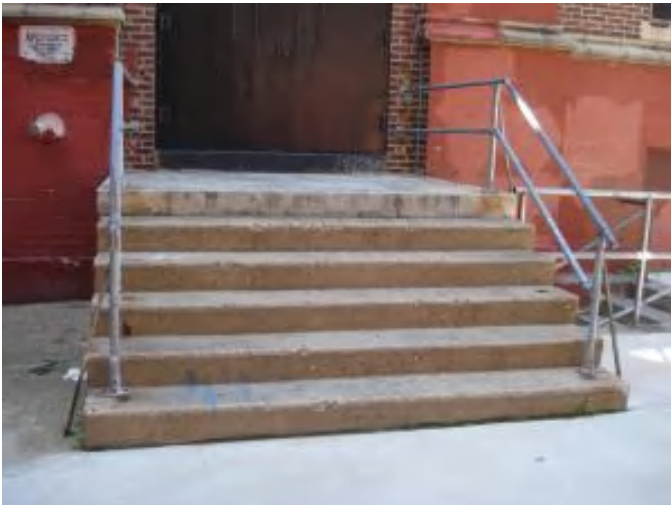
Location: Exterior Stair

Distress: Building / MEP Codes

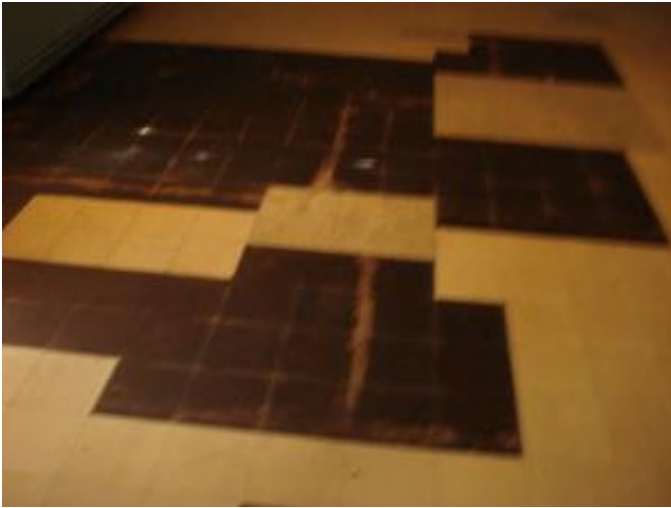
Location: Building Wide

Distress: Health Hazard / Risk

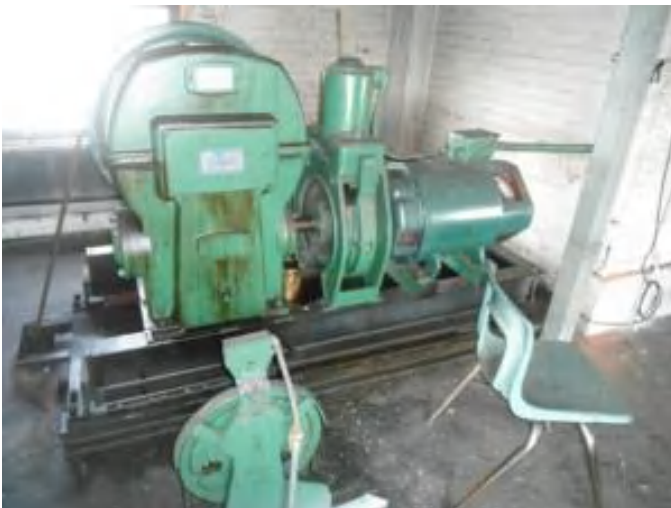
Location: Elevator

Distress: Beyond Service Life

Notes: Upgrade and modernize elevator hoist system, cab and machine room.

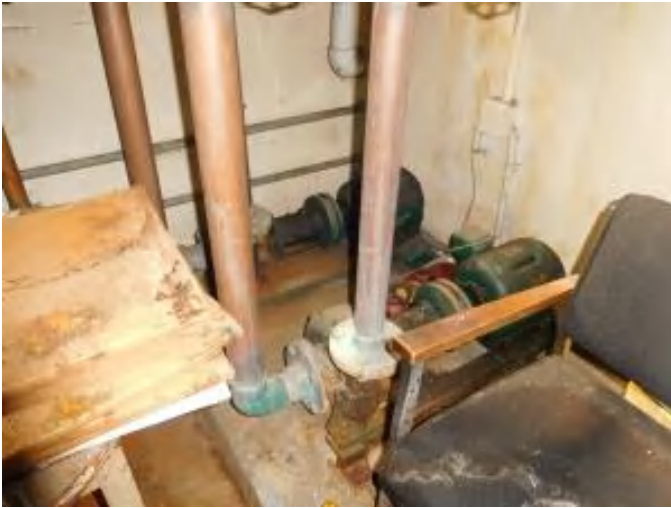
Location: mechanical room

Distress: Beyond Service Life

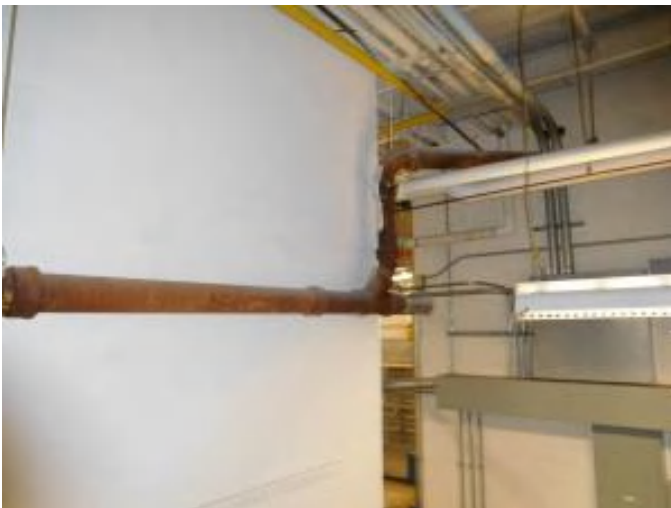
Location: entire building

Distress: Beyond Service Life

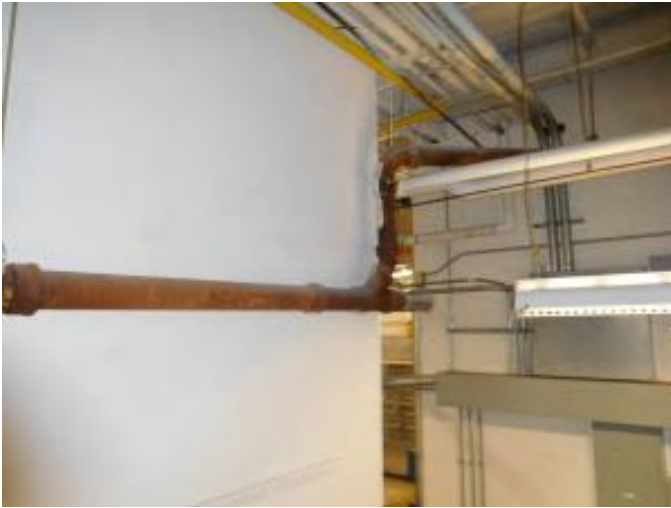
Location: entire building

Distress: Beyond Service Life

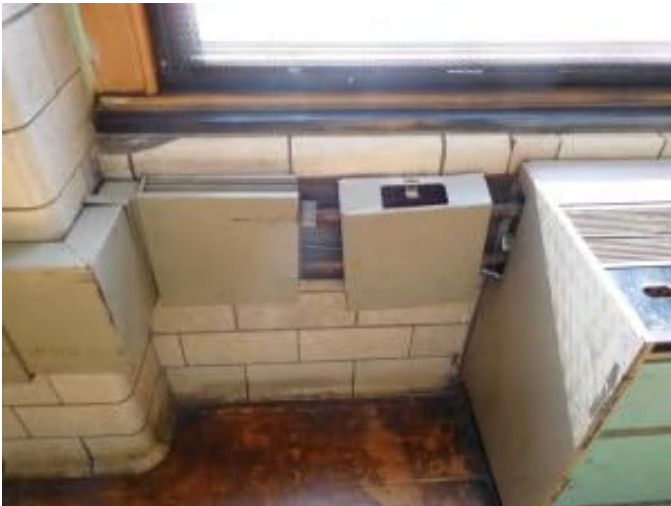
Location: classrooms

Distress: Building / MEP Codes

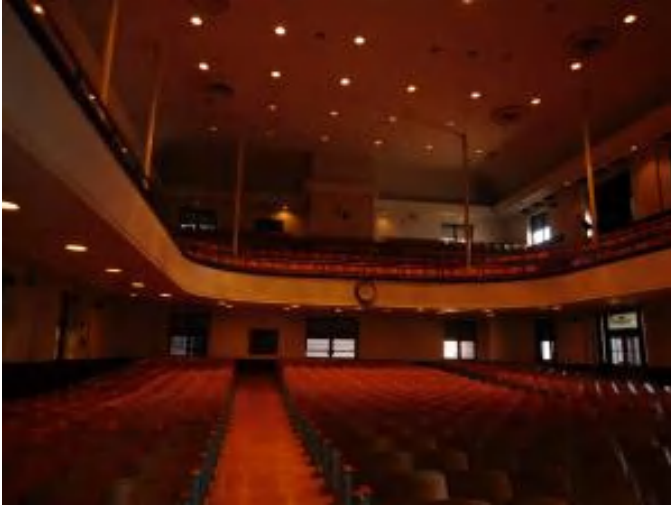
Location: auditorium

Distress: Building / MEP Codes

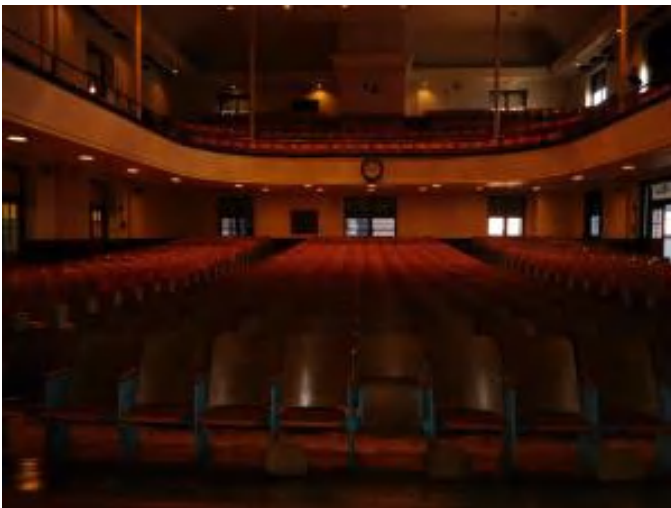
Location: auditorium

Distress: Health Hazard / Risk

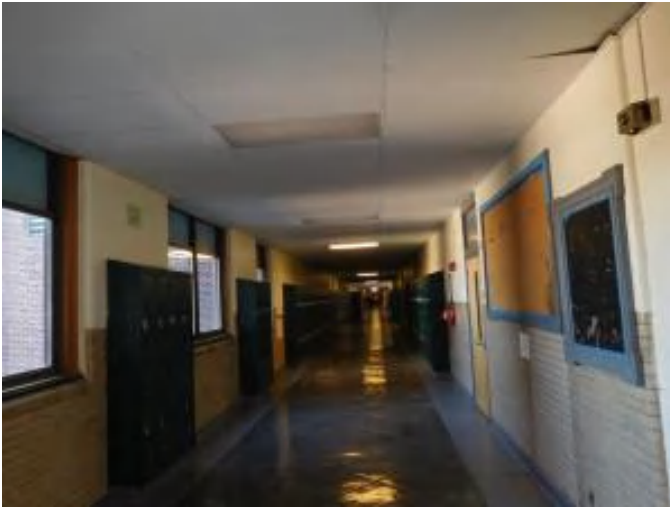
Location: entire building

Distress: Life Safety / NFPA / PFD

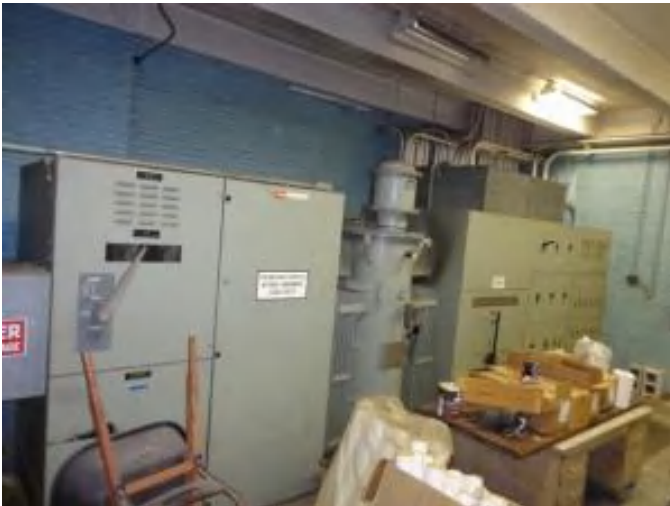
Location: Main Electrical Room

Distress: Beyond Service Life

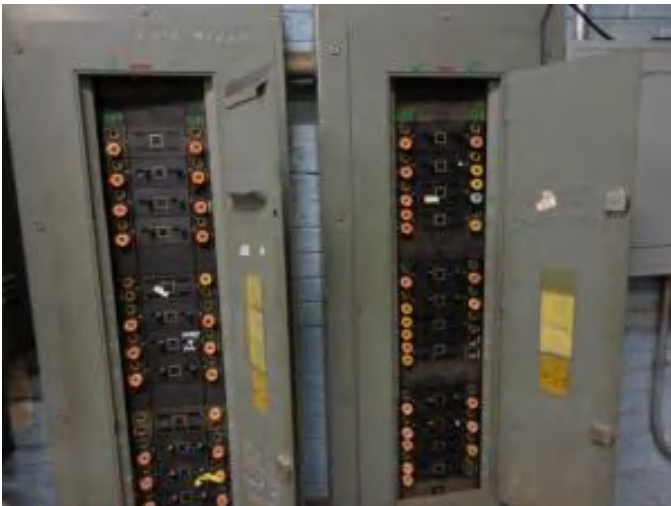
Location: Main Electrical Room

Distress: Beyond Service Life

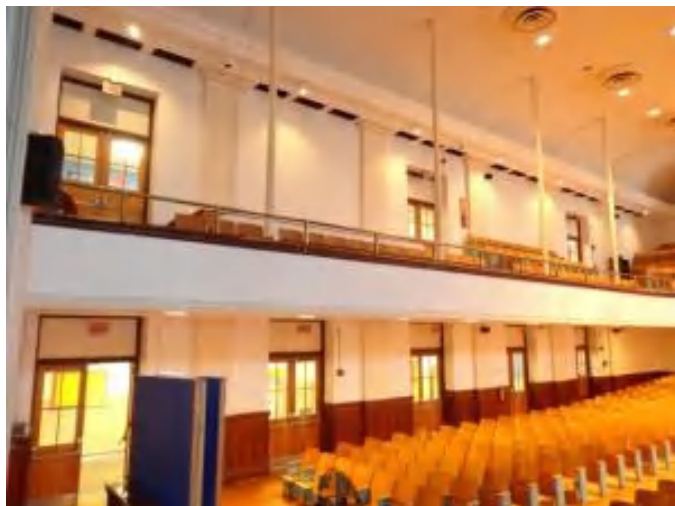
Location: Basement and Auditorium

Distress: Beyond Service Life

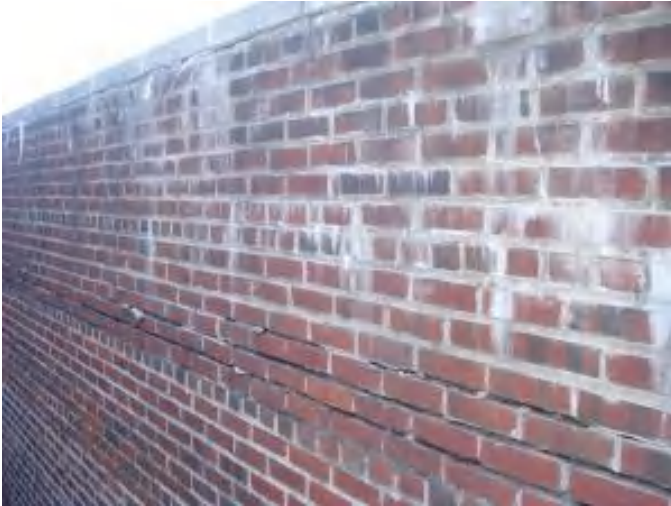
Location: Exterior Walls

Distress: Damaged

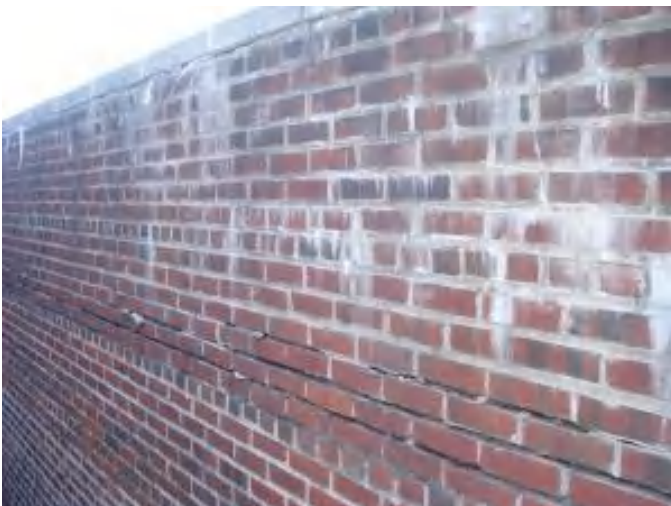
Location: Exterior Wall

Distress: Damaged

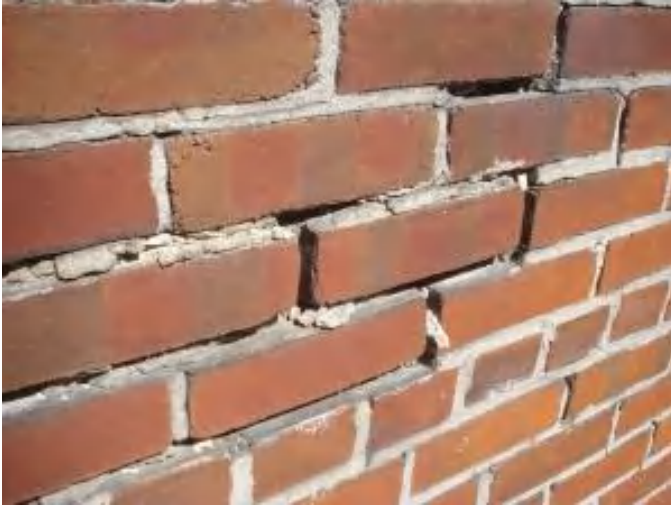
Location: Exterior Wall

Distress: Beyond Service Life

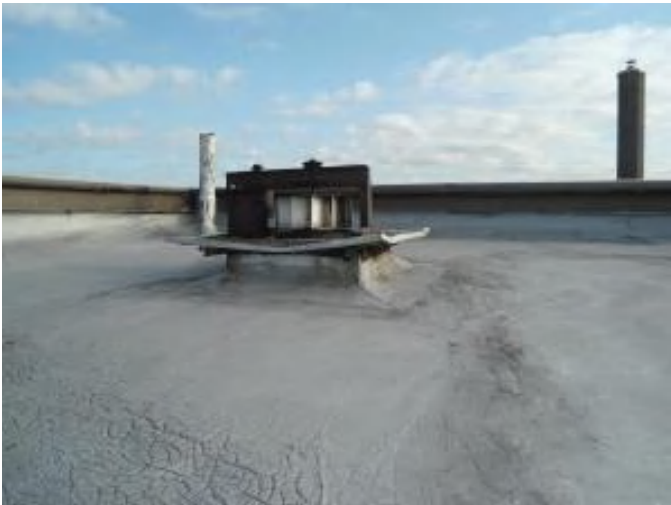
Location: Roof

Distress: Beyond Service Life

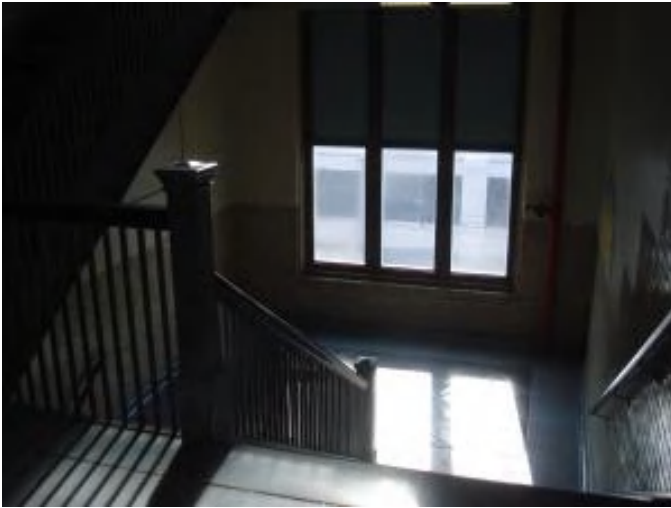
Location: Stair System

Distress: Inadequate

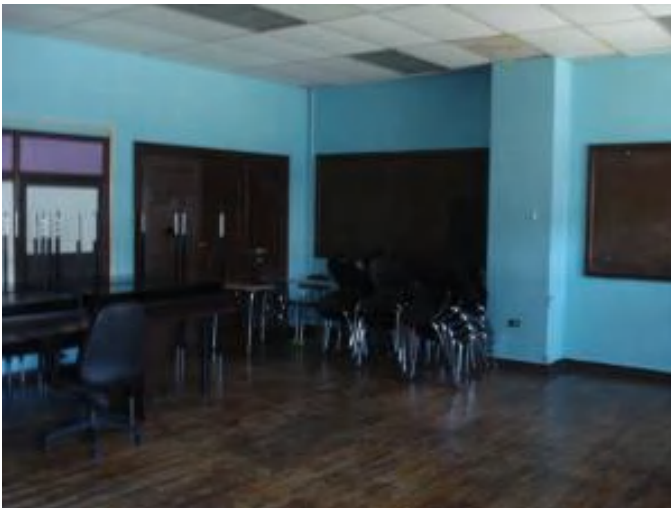
Location: Classrooms

Distress: Beyond Service Life

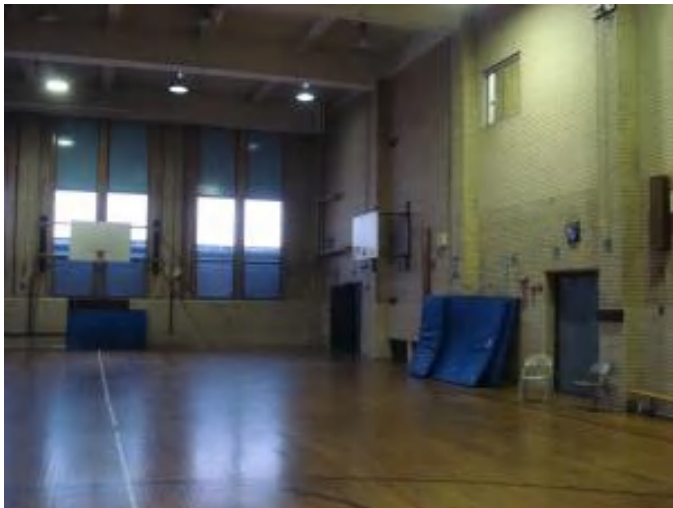
Location: Gym

Distress: Beyond Service Life

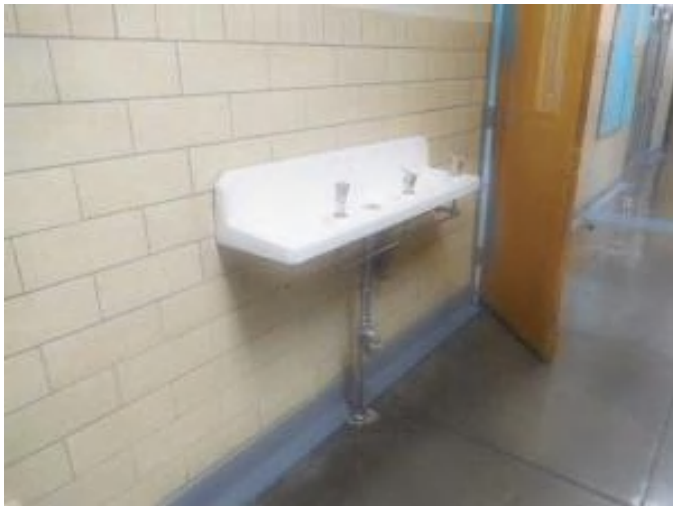
Location: corridors

Distress: Beyond Service Life

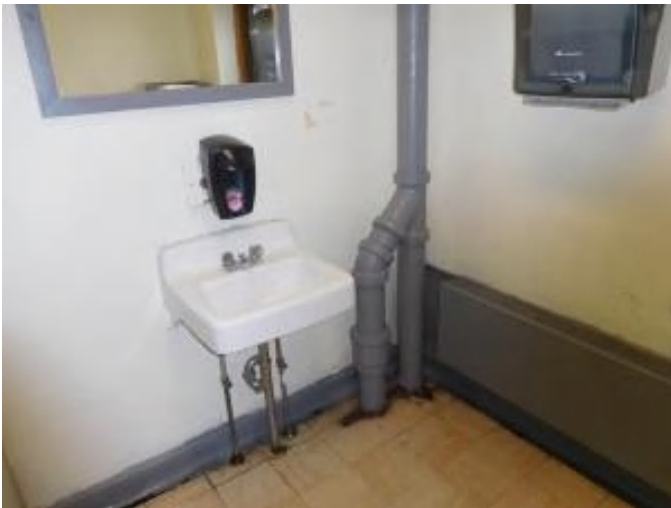
Location: toilet rooms

Distress: Beyond Service Life

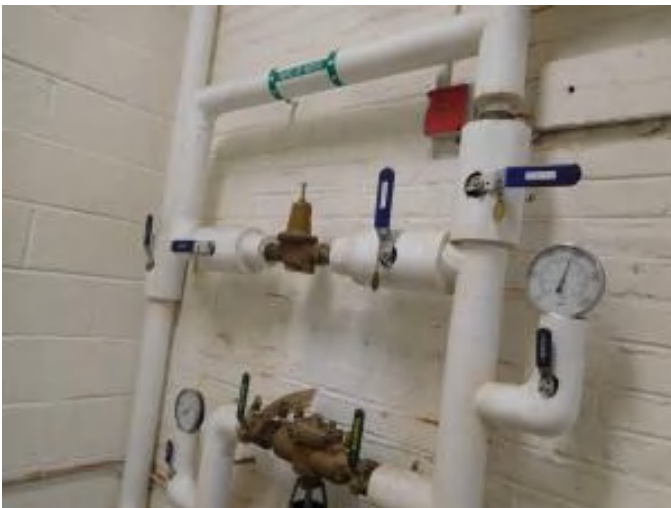
Location: entire building

Distress: Beyond Service Life

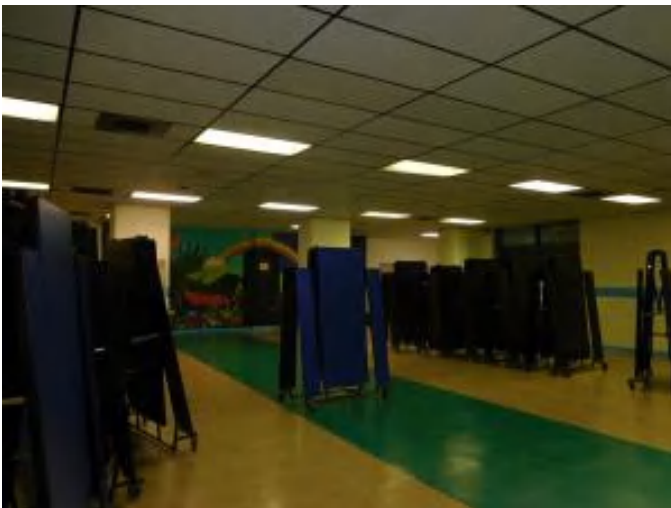
Location: cafeteria

Distress: Building / MEP Codes

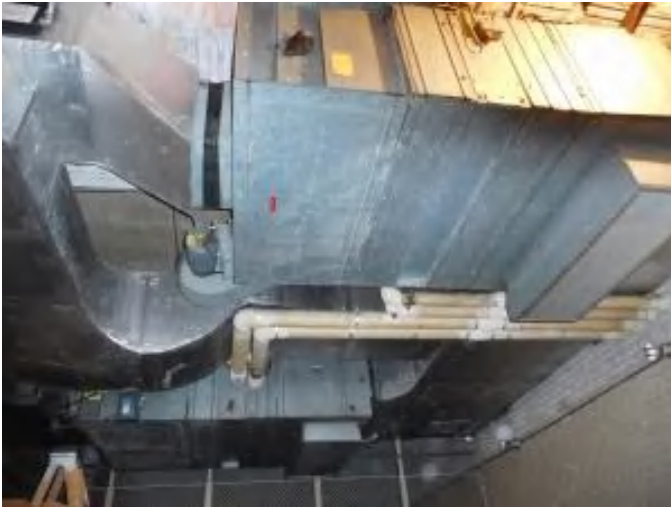
Location: office

Distress: Inadequate

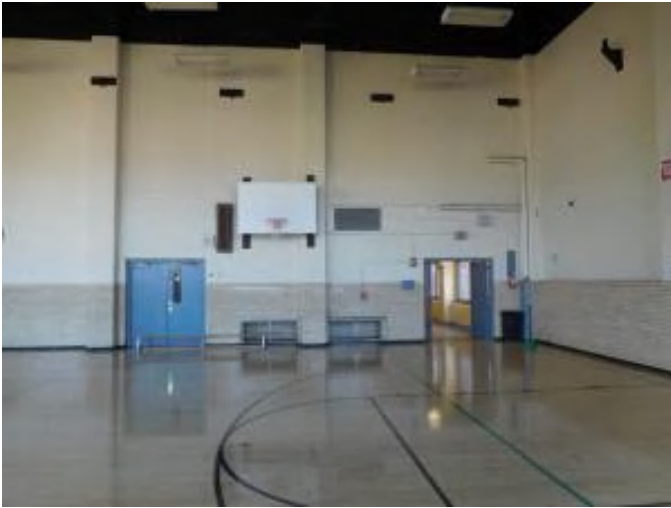
Location: boysgymnasium

Distress: Inadequate

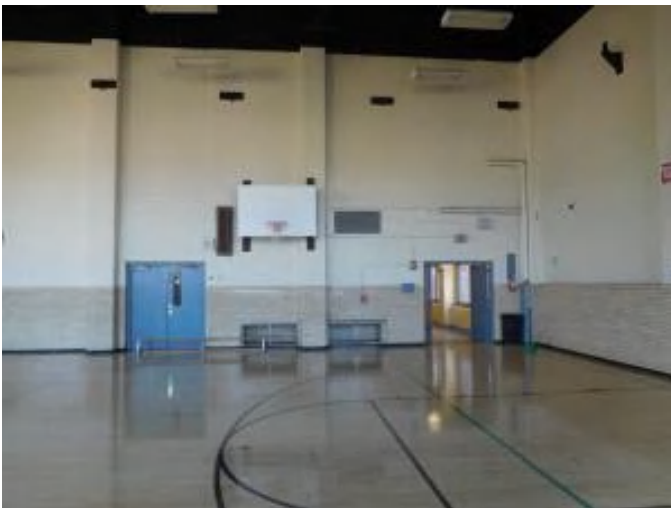
Location: girls gymnasium

Distress: Inadequate

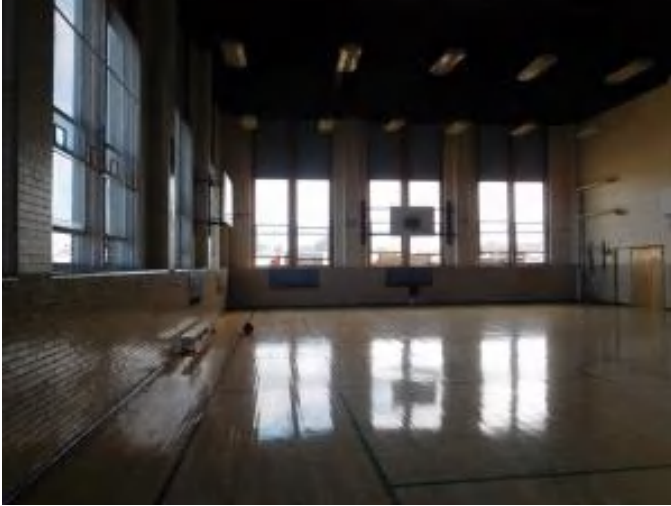
Location: girls gym

Distress: Building / MEP Codes

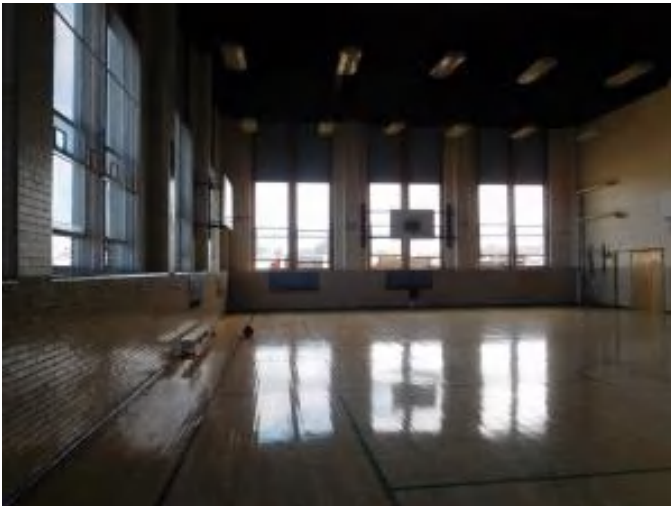
Location: boys gym

Distress: Building / MEP Codes

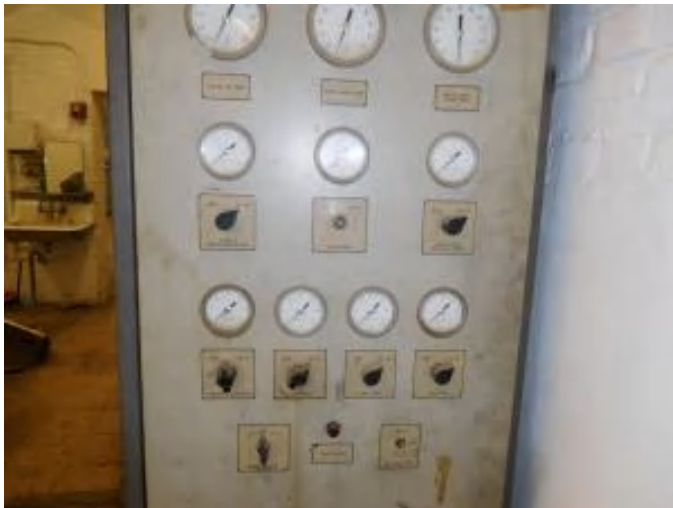
Location: entire building

Distress: Inadequate

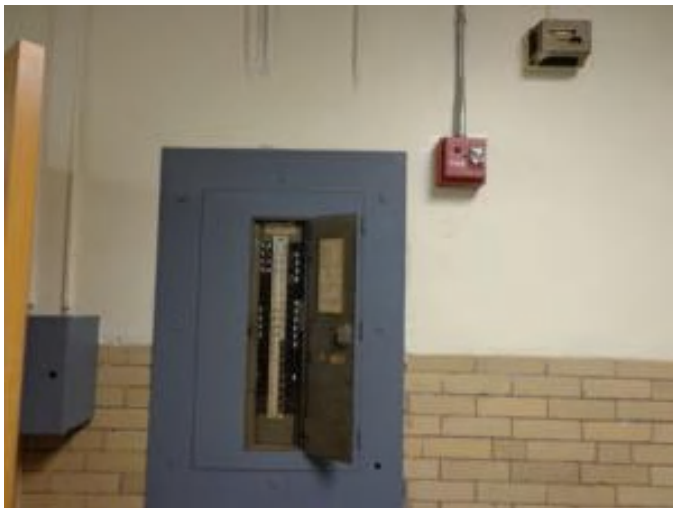
Location: Corridors - all floors

Distress: Beyond Service Life

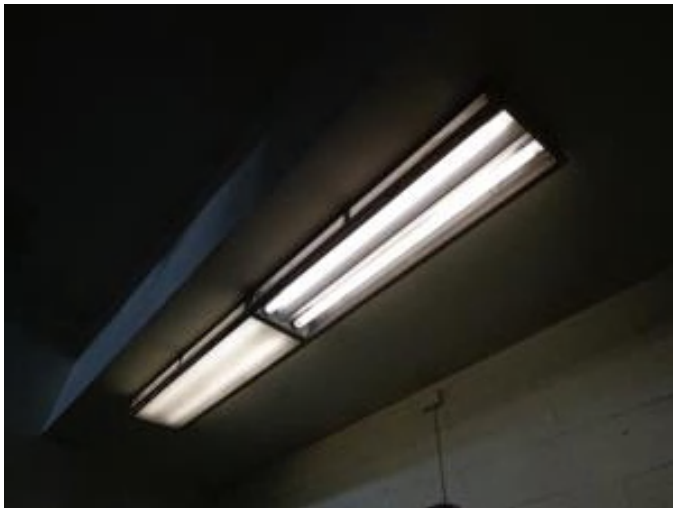
Location: Entire Building

Distress: Beyond Service Life

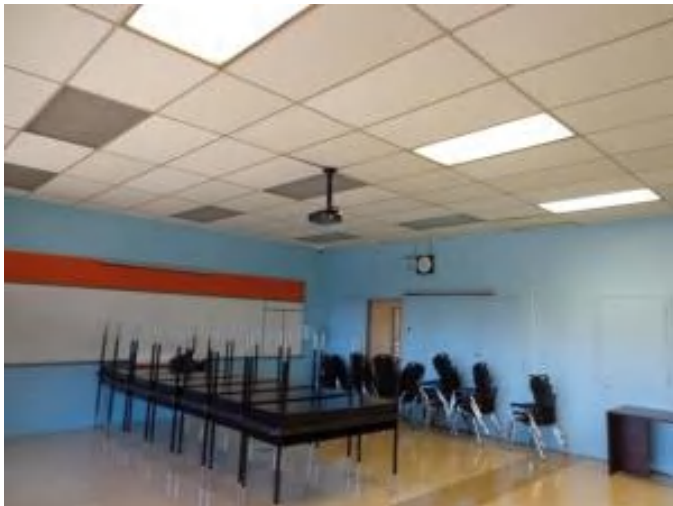
Location: Classrooms

Distress: Inadequate

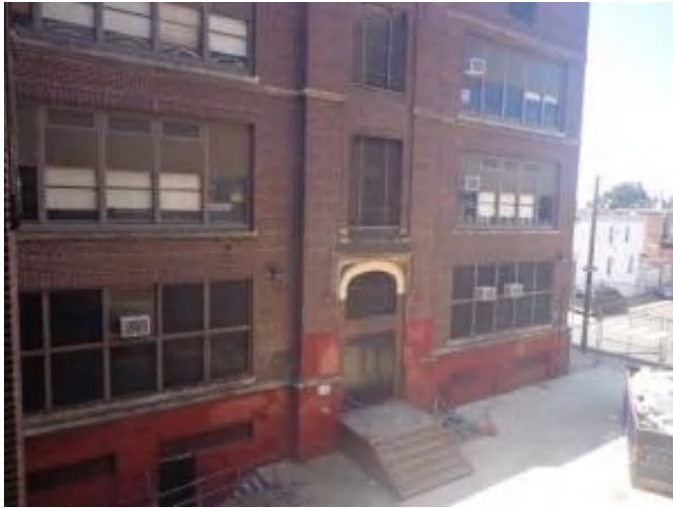
Location: Exterior Doors

Distress: Life Safety / NFPA / PFD

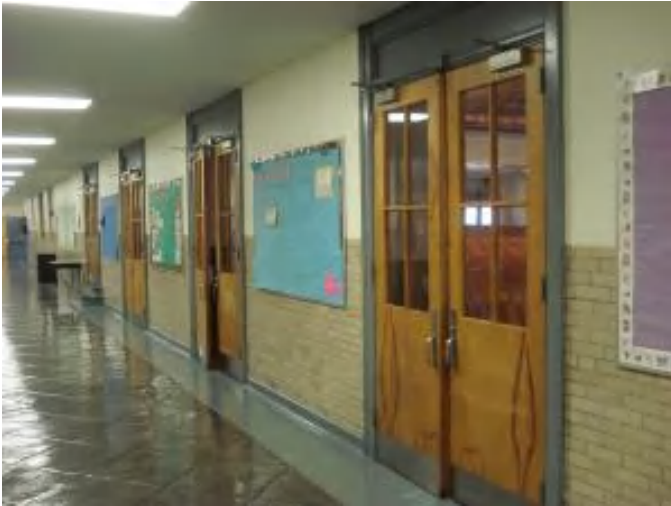
Location: Building Wide

Distress: Beyond Service Life

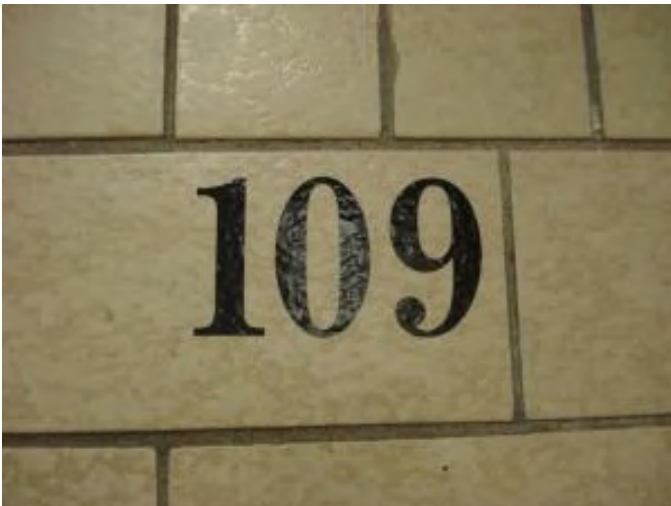
Location: Building Wide Signage

Distress: Inadequate

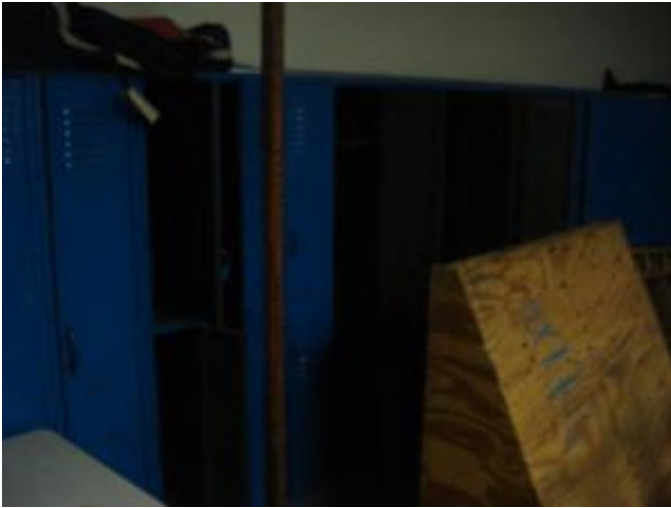
Location: Gym Locker-rooms

Distress: Beyond Service Life

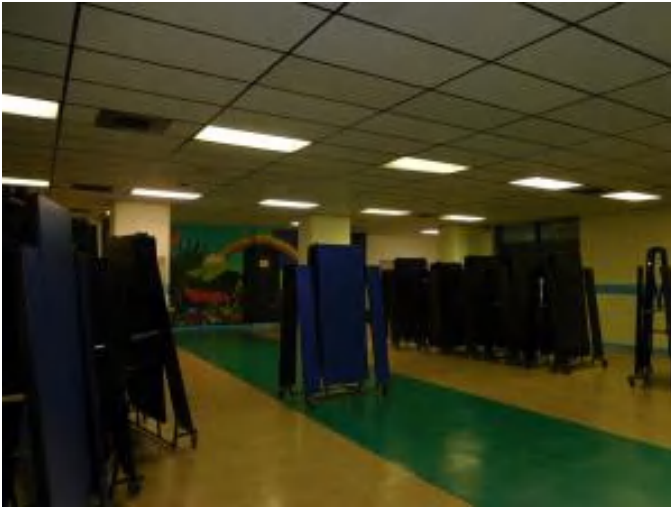
Location: cafeteria

Distress: Inadequate

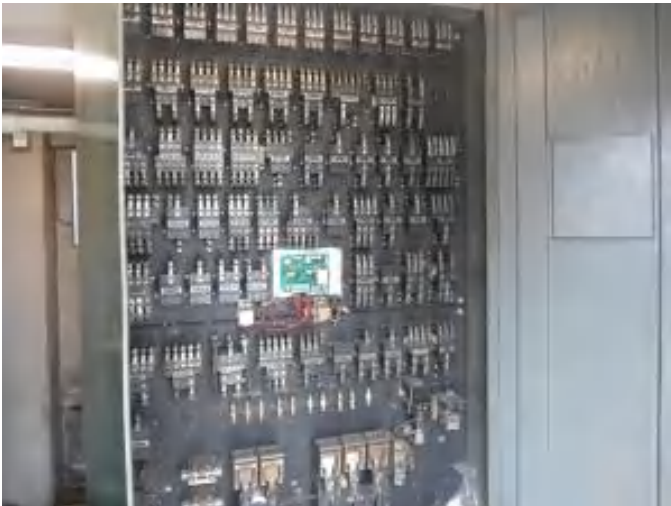
Location: roof

Distress: Inadequate

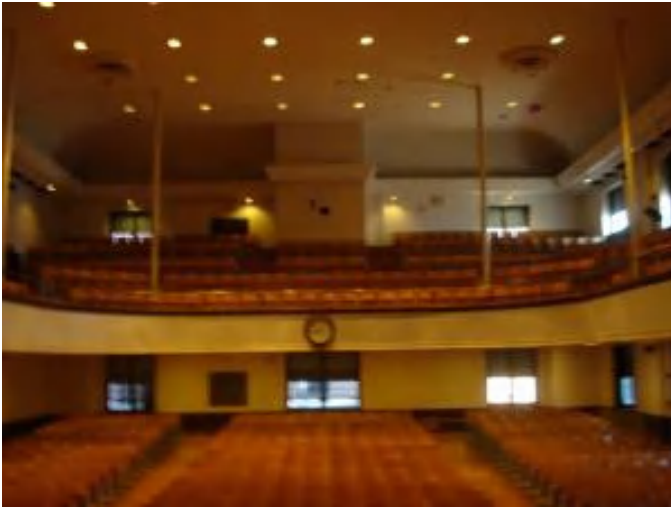
Location: Auditorium

Distress: Beyond Service Life

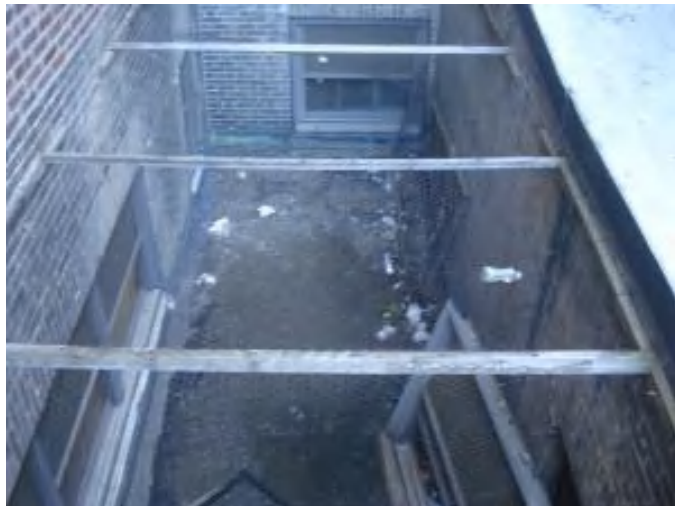
Location: Low Level Roof

Distress: Security Issue

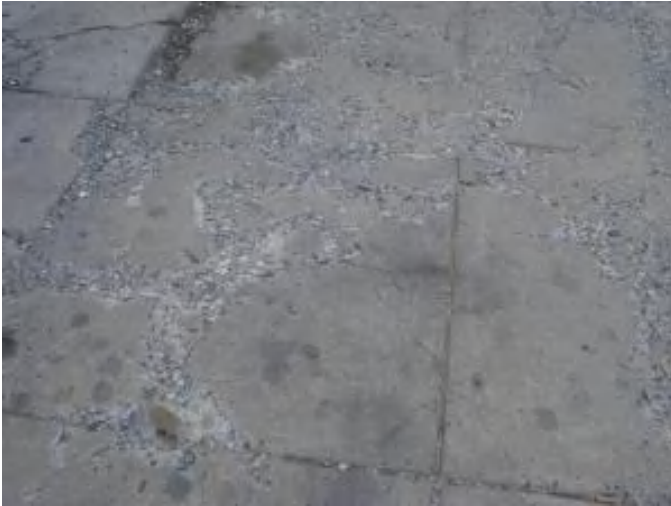
Location: Site

Distress: Damaged
