### Strawberry Mansion High School

# **S414001;Strawberry Mansion and Hill**

## **Site Assessment Report**

February 1, 2017

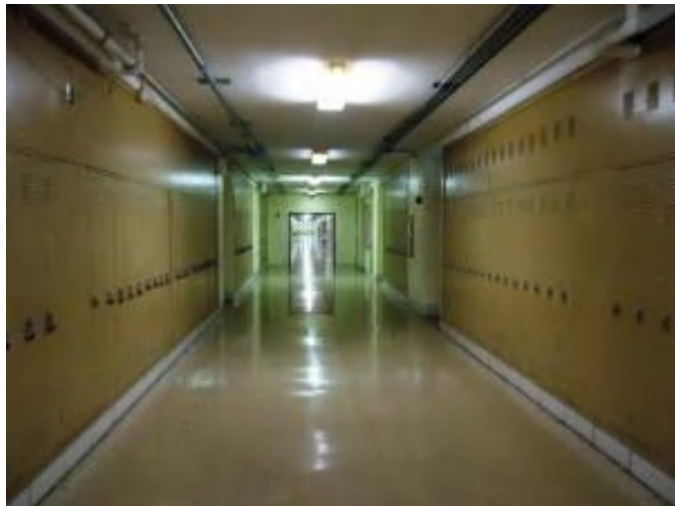
**Location:** Corridors

#### System: C1010 - Partitions

**Distress:** Life Safety / NFPA / PFD

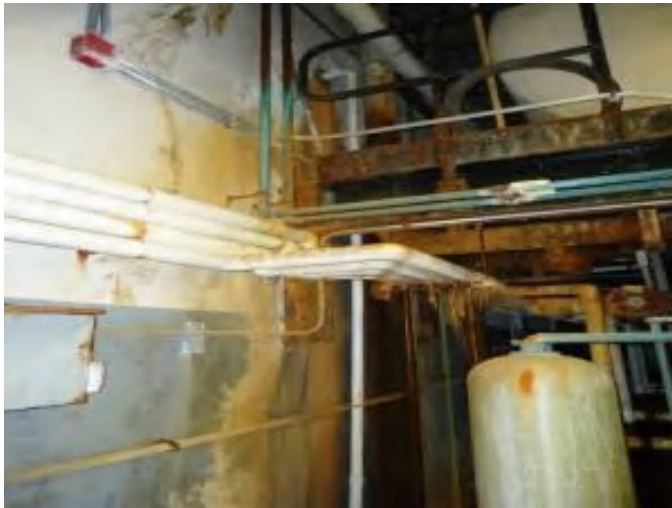
**Location:** Basement Mechanical

The basement and sub-basement mechanical space is showing signs of structural issues as a result of massive water infiltration. The Sub-Basement is completely submerged and the basement level ranges between 1 to 3 inches of water throughout. As indicated in the photos the concrete finish is showing signs of severe damage as a result of the infiltration. This deficiency provides a budgetary consideration to repair the concrete finishes. This deficiency is expected to completed only after the recommended study is complete and the work is expected to be coordinated as part of an overall effort to restore the basement and sub-basement areas.

**System: A2020 - Basement Walls**

**Distress:** Damaged

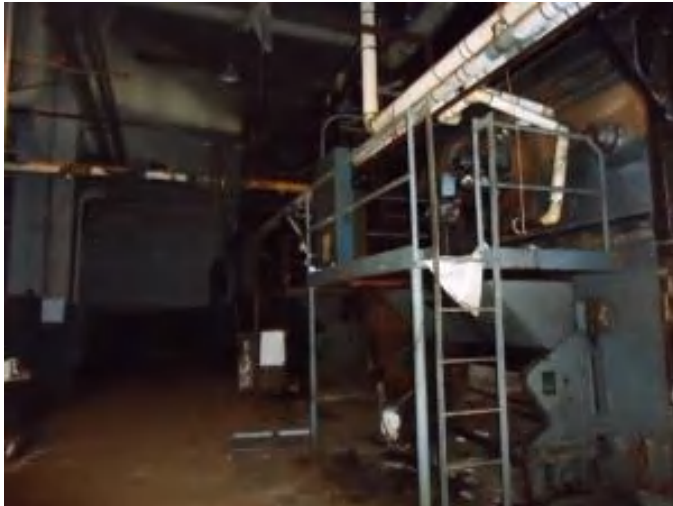
**Location:** Basement

**System: A2020 - Basement Walls**

**Distress:** Failing

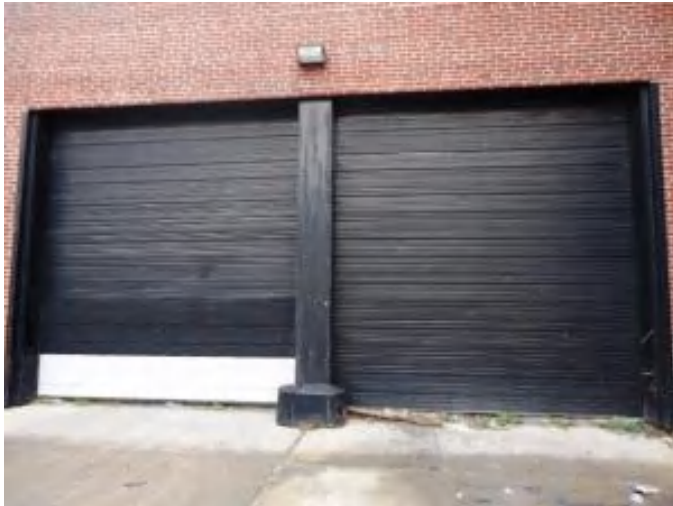
**Location:** Loading Dock

The loading dock exterior overhead door system is damaged. The protective safety devices have been damaged and no longer function. The doors themselves are damaged and one opens only partially, overall they are in poor condition. This deficiency recommends that the doors be removed and replaced with modern advanced performance in commercial and industrial applications where climate control, durability and ease of maintenance are primary concerns such as a loading dock with a primary purpose of food supply for the students.

**System: B2030 - Exterior Doors**

**Distress:** Damaged

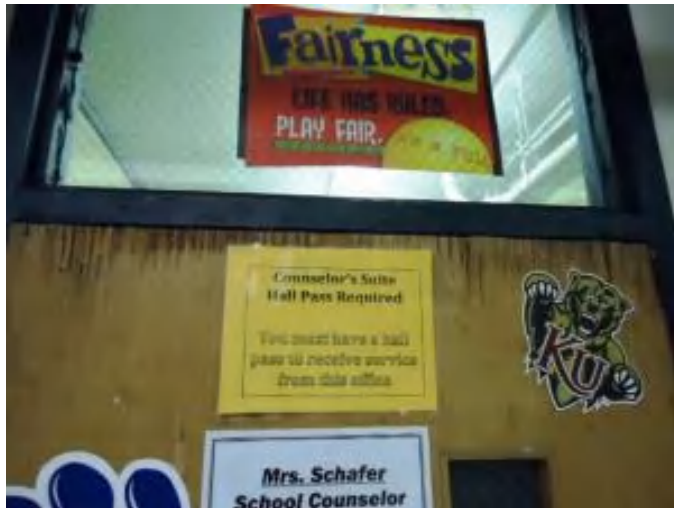
**Location:** Classroom Doors

**System: C1020 - Interior Doors**

**Distress:** Damaged

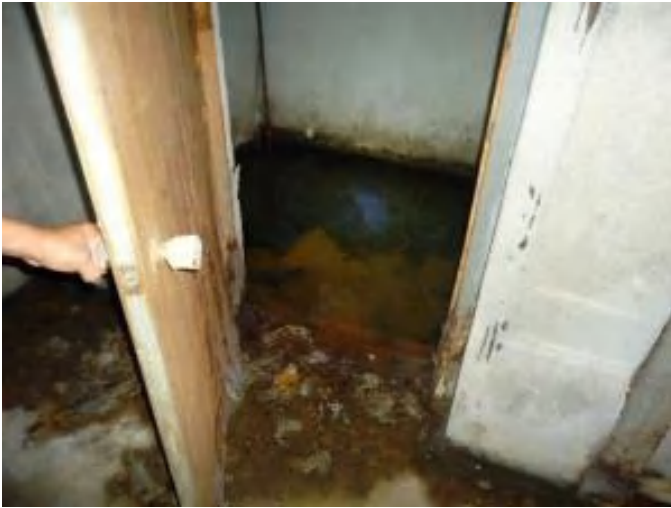
**Location:** Service Doors

Several of the interior service doors located mainly in the basement and sub-basement level are rusted and damaged. The doors no longer can support the design fire rating required for such spaces. This system is in very poor condition and universal upgrades are recommended. Remove and replace each service door with a suitable replacement to meet current requirements. This deficiency is expected to be completed as part of an effort to reclaim the basement and sub-basement areas of this school.

**System: C1020 - Interior Doors**

**Distress:** Failing

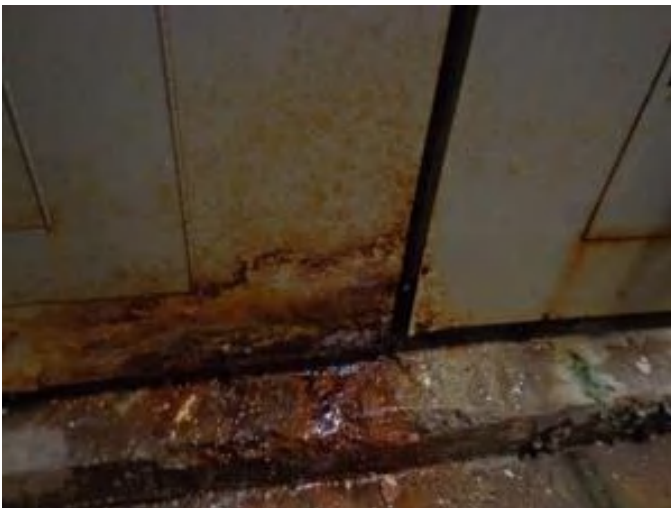
**Location:** Boiler Room

**System: D5010 - Electrical Service/Distribution**

**Distress:** Damaged

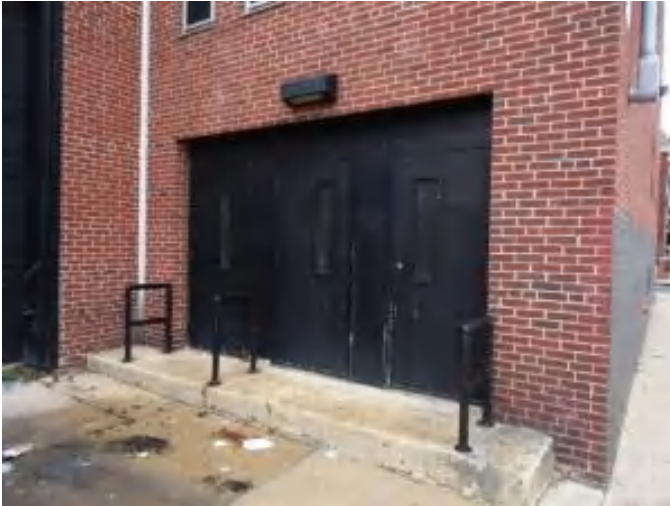
**Location:** Exterior Elevation

The exterior doors are metal applications with metal frames. The service doors and exterior door system for this school is a very high traffic system. The doors are in fair condition with a few minor issues but are aging at a faster rate than expected based on traffic and condition. The exterior door system and service doors are recommended for upgrade.

**System: B2030 - Exterior Doors**

**Distress:** Damaged

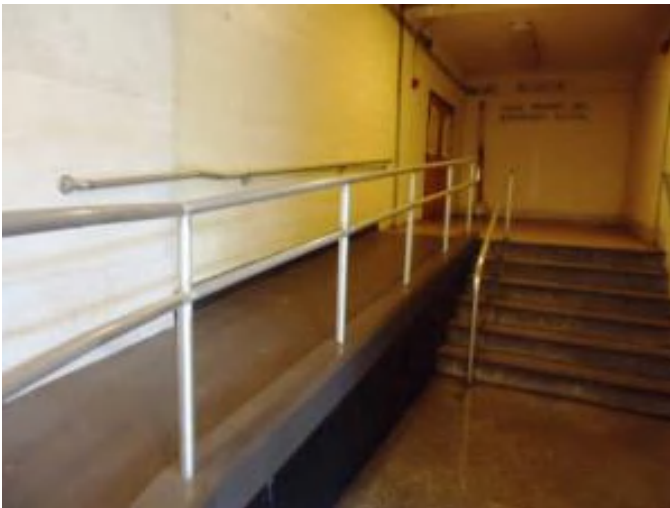
**Location:** Stairs

Current requirements for stairs indicate that they have graspable handrails on both sides, that the rails have a specific end geometry, and that the handrails continue horizontally at the landings. In addition, guardrails must prevent the passage of a 4 inch diameter sphere (6 inches in the triangle formed by the lower rail and tread/riser angle). Although the stairs are compliant with the code enforced at the time of construction until a major renovation occurs, they are deficient in handrail and guardrail design relative to current standards. Future efforts should include comprehensive stair railing removal and replacement upgrades.

**System: C2010 - Stair Construction**

**Distress:** Damaged

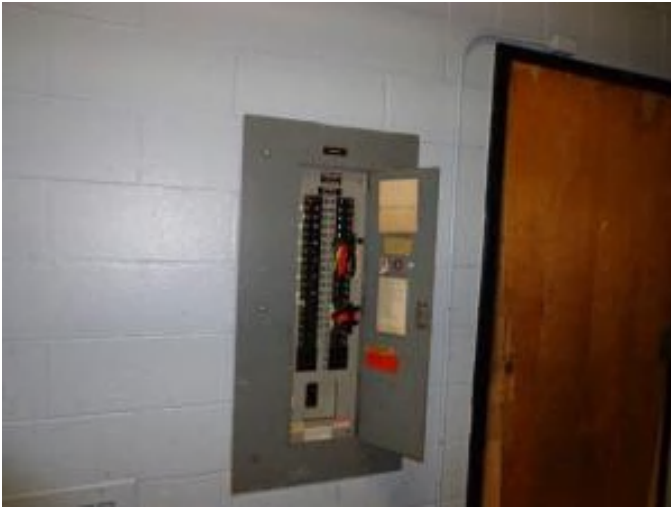
**Location:** Building wide

**System: D5010 - Electrical Service/Distribution**

**Distress:** Beyond Service Life

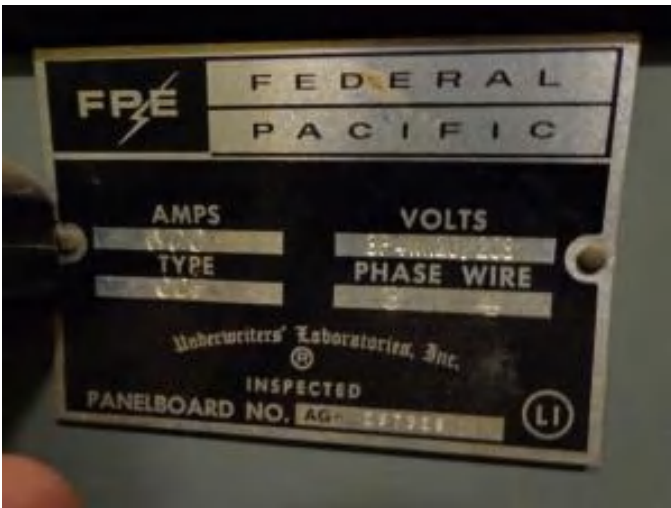
**Location:** Main Electrical Room and Boiler Room

**System: D5010 - Electrical Service/Distribution**

**Distress:** Beyond Service Life

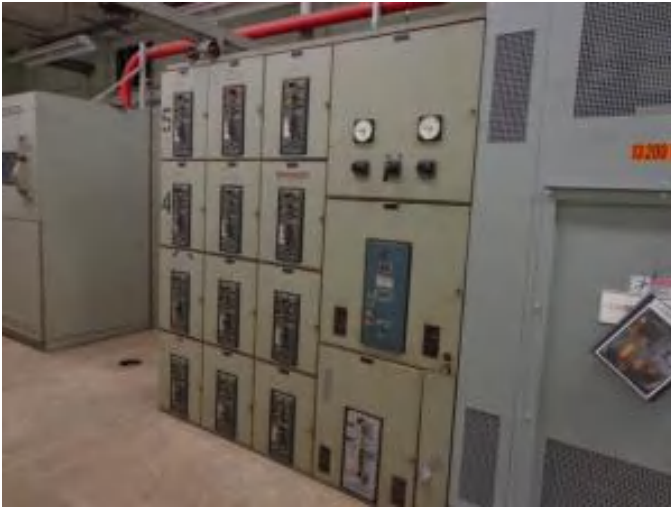
**Location:** Basement Room 005

**System: D5010 - Electrical Service/Distribution**

**Distress:** Beyond Service Life

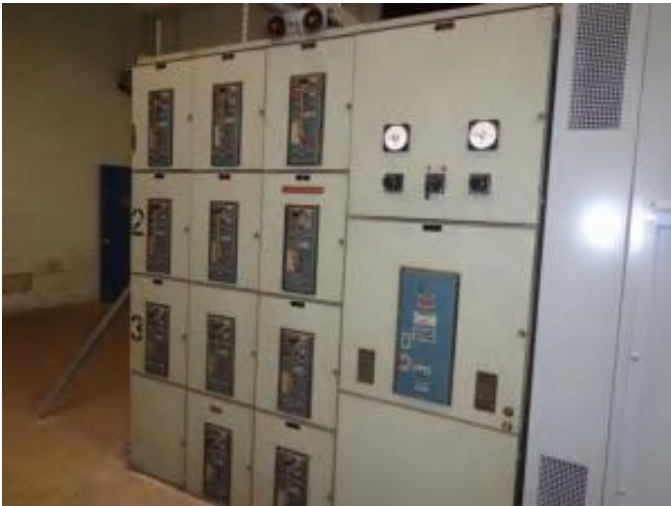
**Location:** Basement Room 005

**System: D5010 - Electrical Service/Distribution**

**Distress:** Beyond Service Life

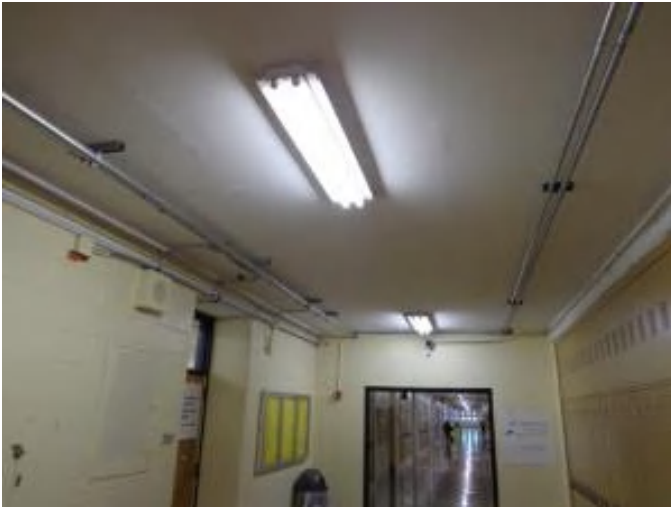
**Location:** Building wide

**System: D5020 - Lighting and Branch Wiring**

**Distress:** Beyond Service Life

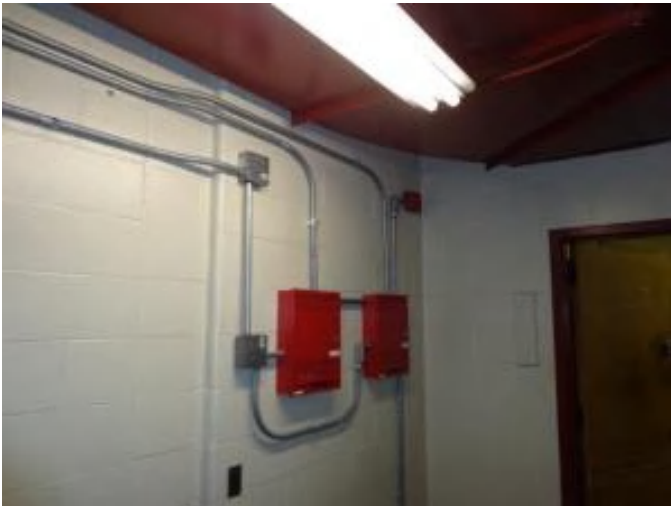
**Location:** Classrooms and multi-occupant rooms

**System: D5030 - Communications and Security**

**Distress:** Life Safety / NFPA / PFD

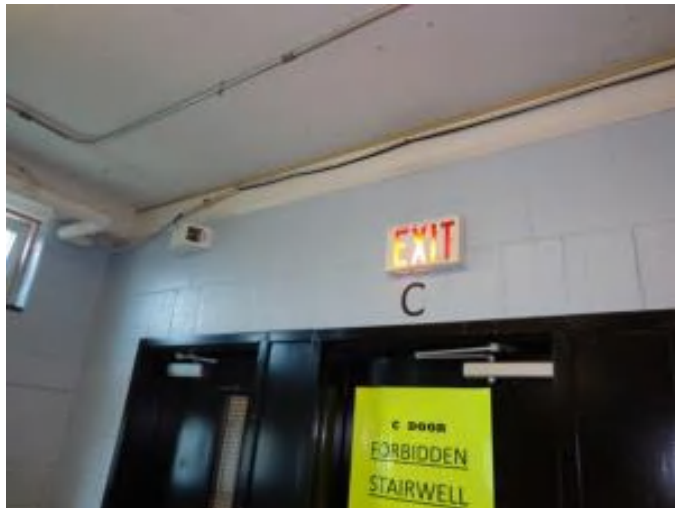
**Location:** Building wide

**System: D5090 - Other Electrical Systems**

**Distress:** Beyond Service Life

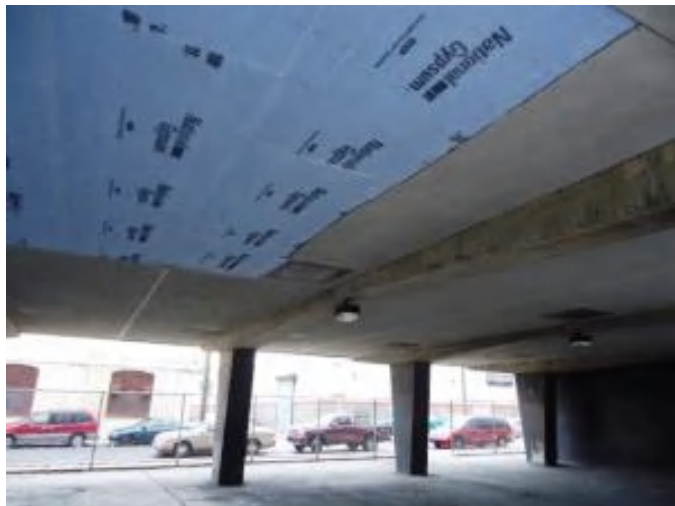
**Location:** North Wing Exterior

The elevated classrooms on the Northern section of the school are supported with custom concrete columns. The area is in good condition with a few minor exceptions such as the E.F.I.S. finish that acts as the ceiling to this covered student common area under the elevated section of this school. As indicated in the photos repairs were underway at one time however the work appears to have stopped. This deficiency provides a budgetary consideration for repair and resurfacing of the E.F.I.S. finish.

**System: B2010 - Exterior Walls**

**Distress:** Damaged

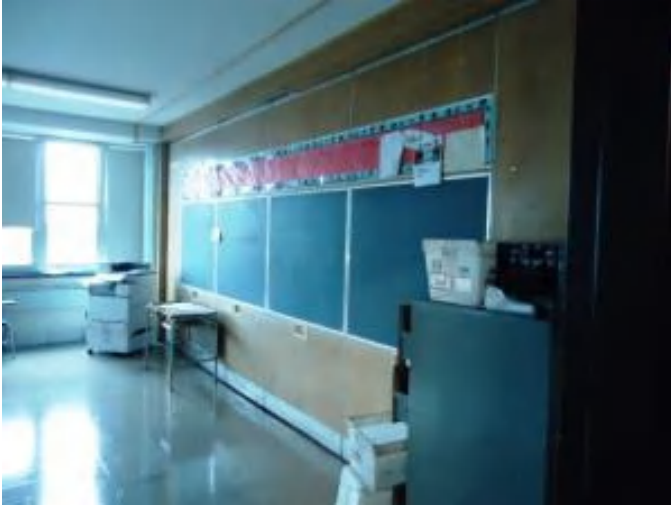
**Location:** Classrooms

There are several movable partitions that remain in classrooms such as the system in room 412. These wall systems are no longer used and in most cases cannot be used due to damage or wall modifications to support classroom needs. This deficiency provides a budgetary consideration to remove and replace the wall systems with universal removal of the existing movable partitions and upgrades to a permeate wall systems.

**System: C1010 - Partitions**

**Distress:** Damaged

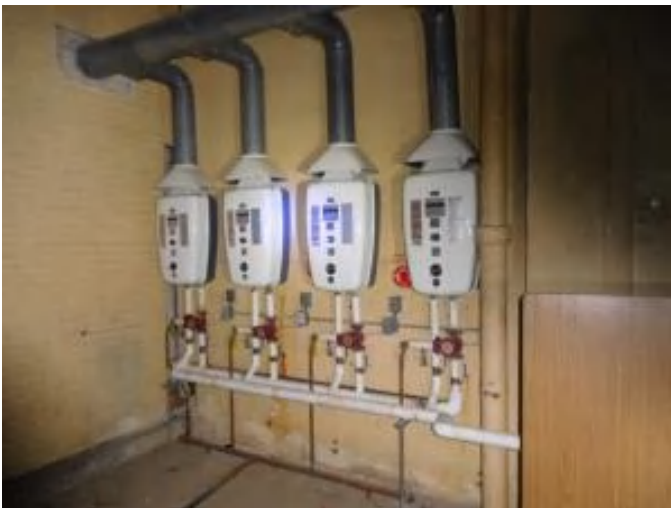
**Location:** entire building

**System: D2020 - Domestic Water Distribution**

**Distress:** Beyond Service Life

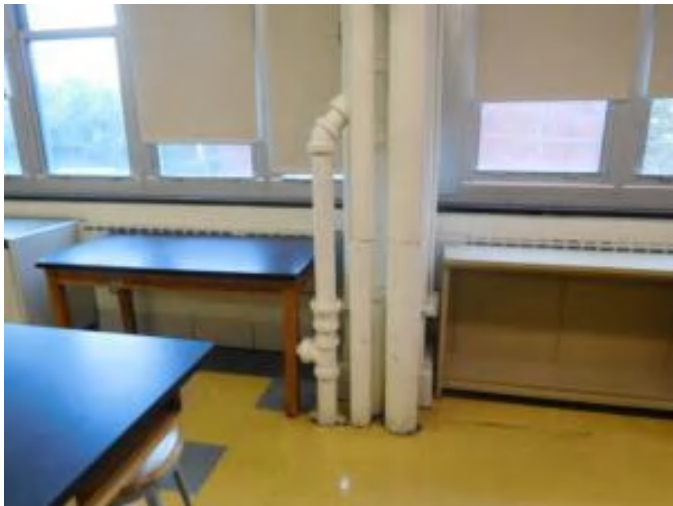
**Location:** entire building

**System: D2030 - Sanitary Waste**

**Distress:** Beyond Service Life

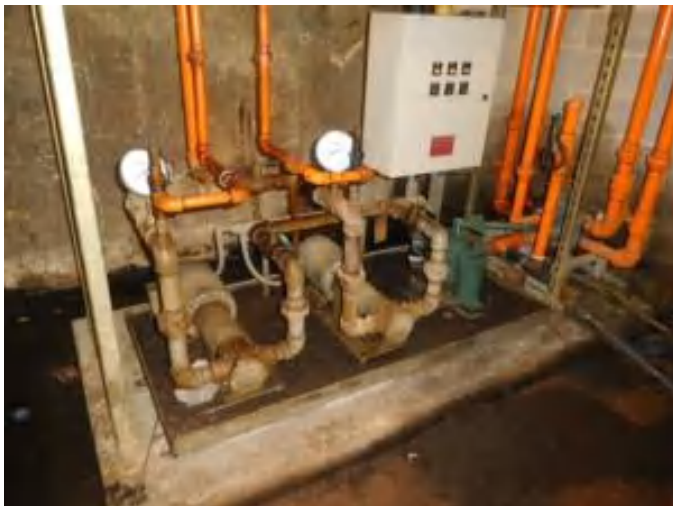
**Location:** exterior

**System: D3020 - Heat Generating Systems**

**Distress:** Health Hazard / Risk

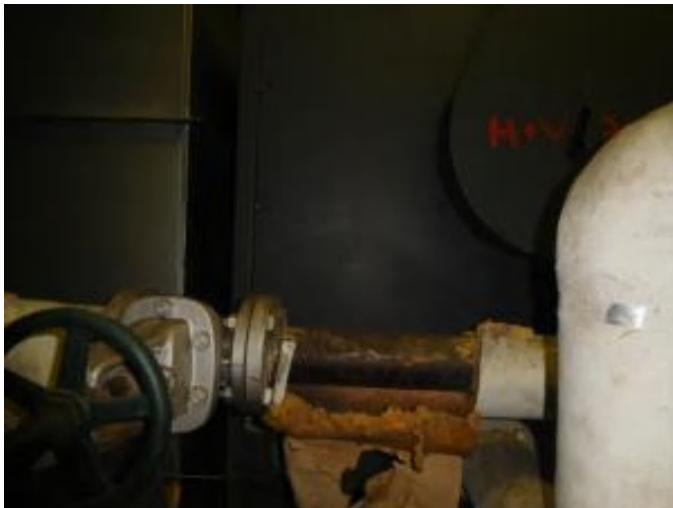
**Location:** mezzanine mechanical/ office

**System: D3040 - Distribution Systems**

**Distress:** Building / MEP Codes

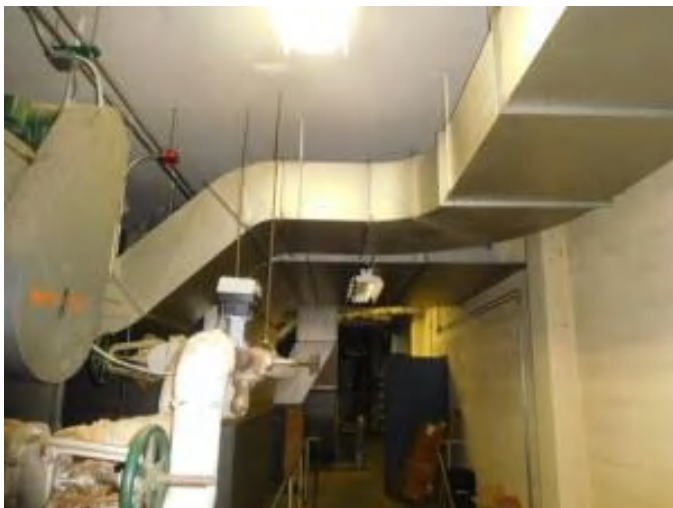
**Location:** mezzanine mechanical/ office

**System: D3040 - Distribution Systems**

**Distress:** Building / MEP Codes

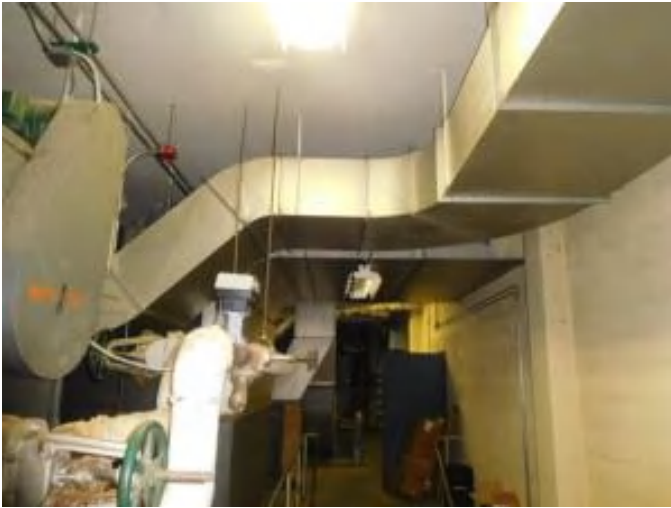
**Location:** mezzanine mechanical/ auditorium

**System: D3040 - Distribution Systems**

**Distress:** Building / MEP Codes

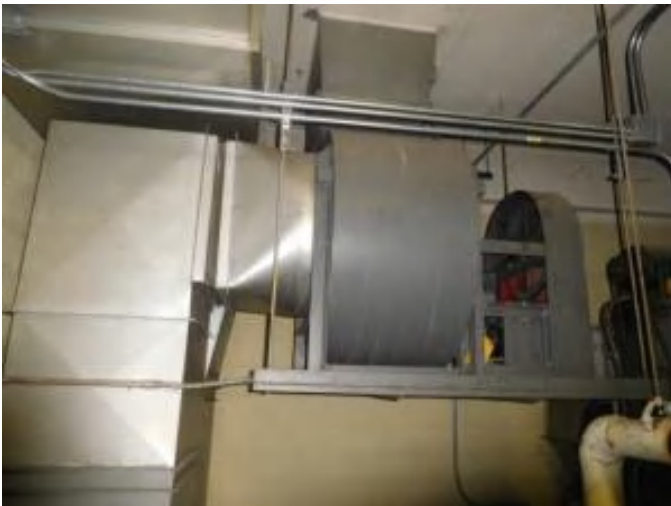
**Location:** mezzanine mechanical/ auditorium

**System: D3040 - Distribution Systems**

**Distress:** Building / MEP Codes

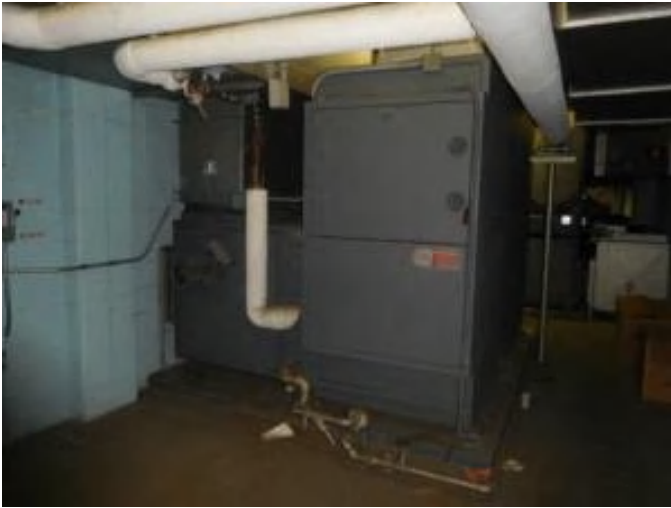
**Location:** mezzanine mechanical/ gymnasium

**System: D3040 - Distribution Systems**

**Distress:** Building / MEP Codes

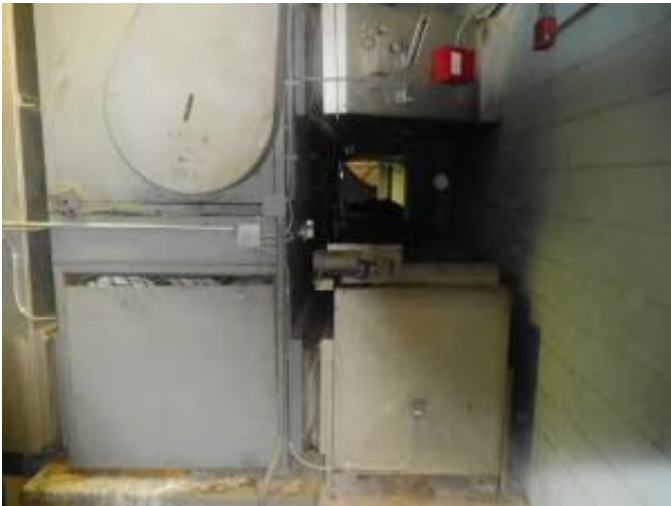
**Location:** mezzanine mechanical/ gymnasium

**System: D3040 - Distribution Systems**

**Distress:** Building / MEP Codes

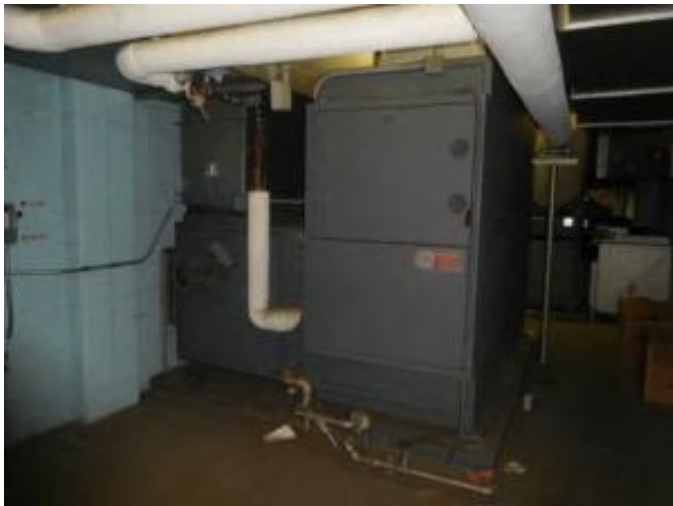
**Location:** mezzanine mechanical/ locker room

**System: D3040 - Distribution Systems**

**Distress:** Building / MEP Codes

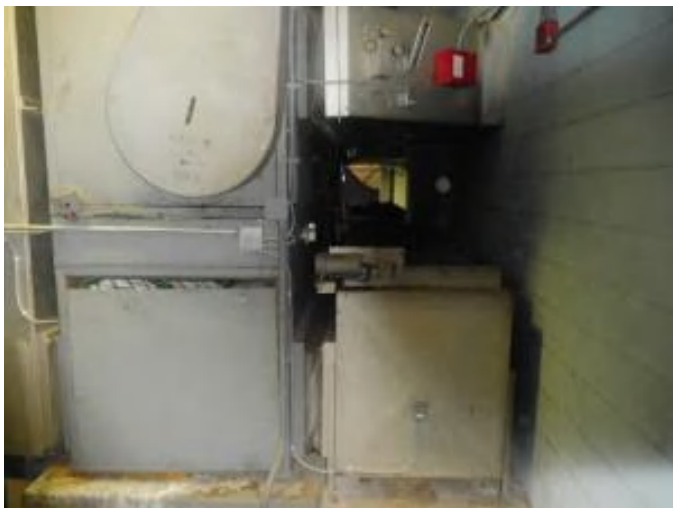
**Location:** mezzanine mechanical/ locker room

**System: D3040 - Distribution Systems**

**Distress:** Building / MEP Codes

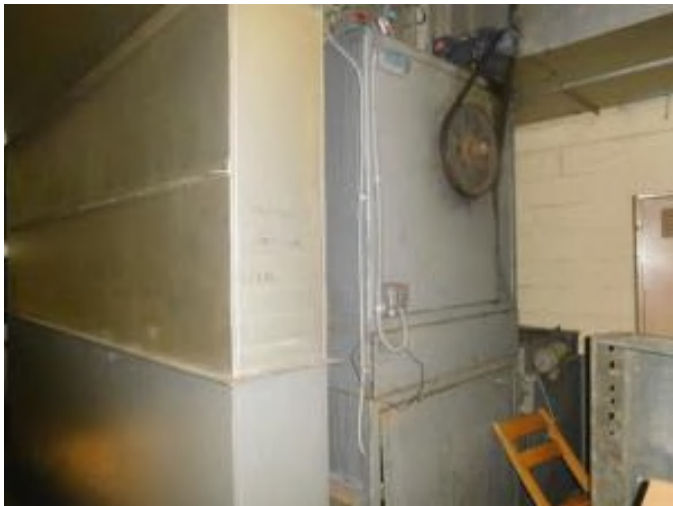
**Location:** mezzanine mechanical/ music

**System: D3040 - Distribution Systems**

**Distress:** Building / MEP Codes

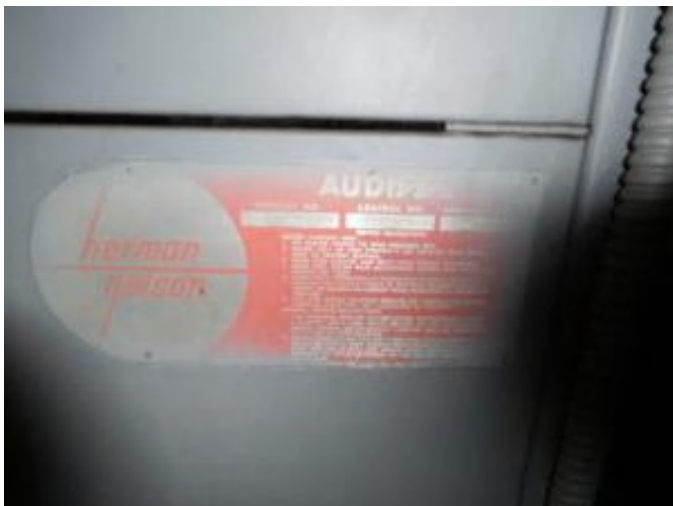
**Location:** mezzanine mechanical/ music

**System: D3040 - Distribution Systems**

**Distress:** Building / MEP Codes

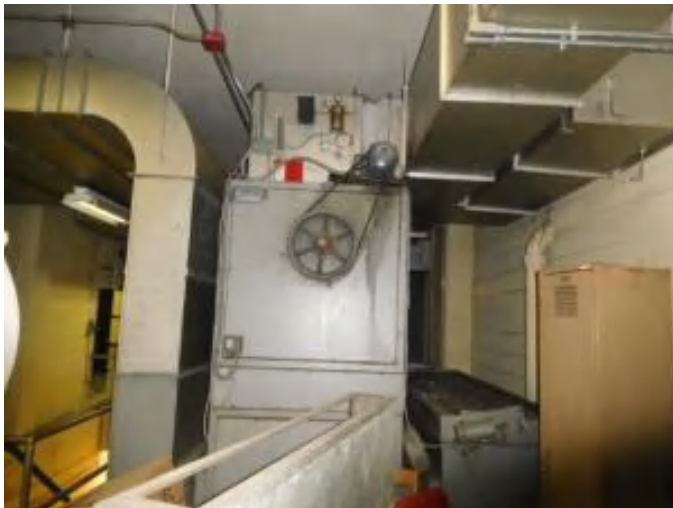
**Location:** mezzanine mechanical

**System: D3040 - Distribution Systems**

**Distress:** Building / MEP Codes

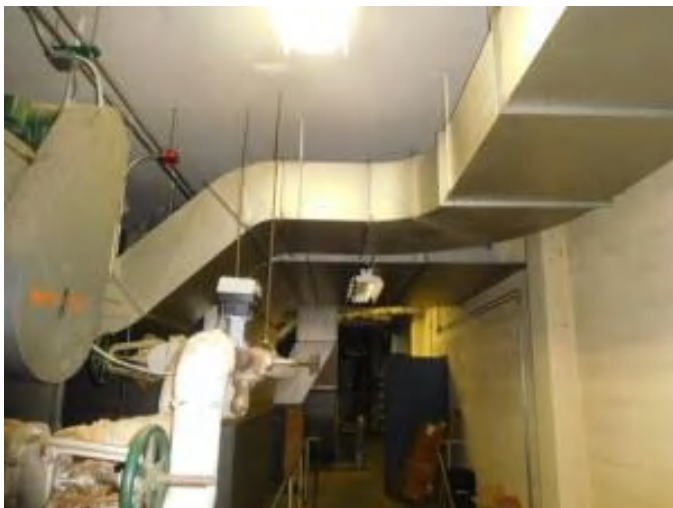
**Location:** mezzanine mechanical

**System: D3040 - Distribution Systems**

**Distress:** Building / MEP Codes

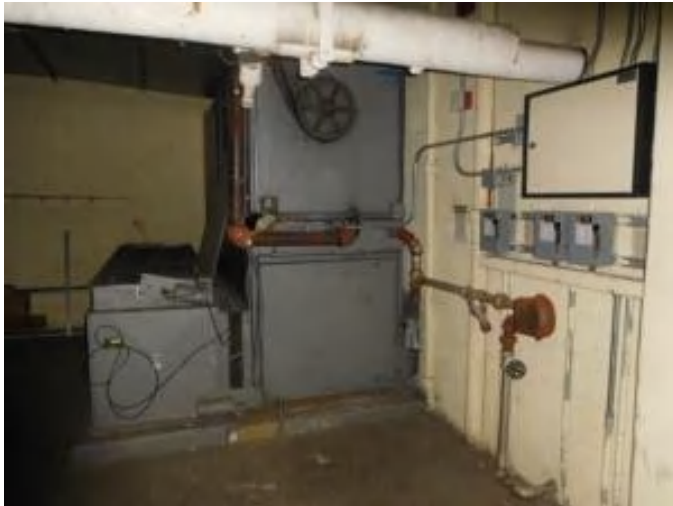
**Location:** entire building

**System: D3060 - Controls & Instrumentation**

**Distress:** Inadequate

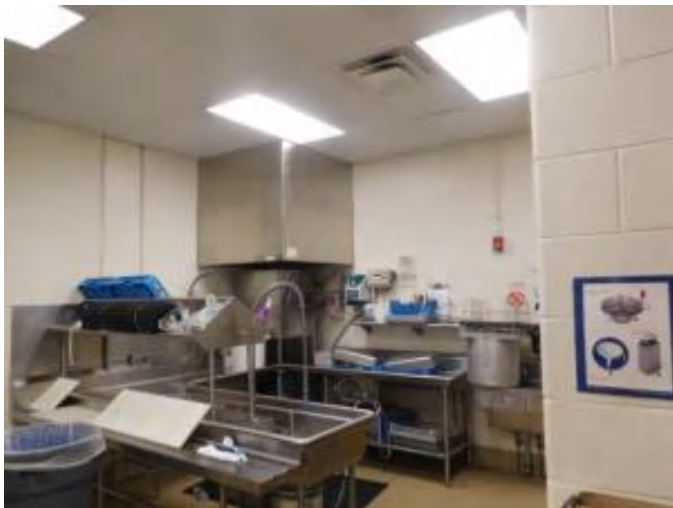
**Location:** entire building

**System: D4010 - Sprinklers**

**Distress:** Life Safety / NFPA / PFD

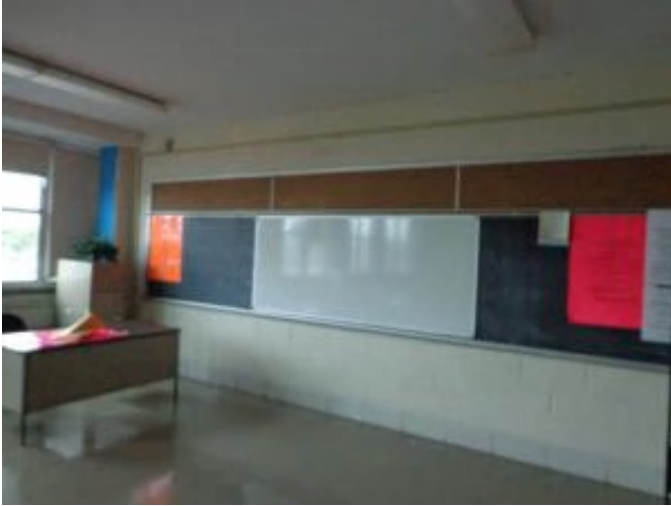
**Location:** Classrooms

**System: D5020 - Lighting and Branch Wiring**

**Distress:** Inadequate

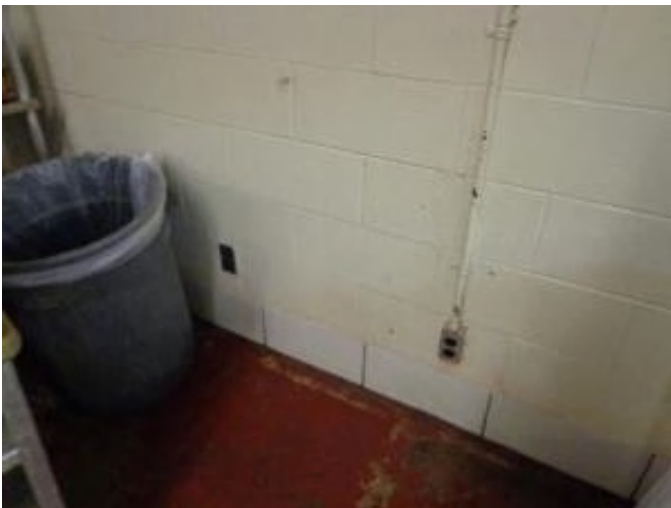
**Location:** Kitchen

**System: D5020 - Lighting and Branch Wiring**

**Distress:** Life Safety / NFPA / PFD

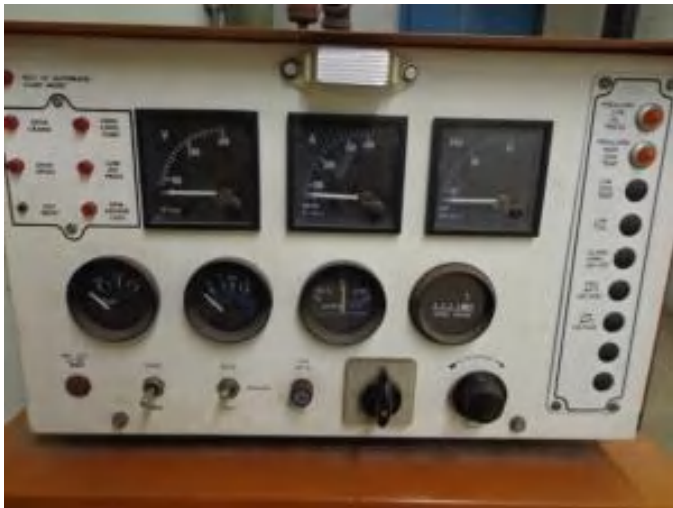
**Location:** Basement Room 005

**System: D5090 - Other Electrical Systems**

**Distress:** Beyond Service Life

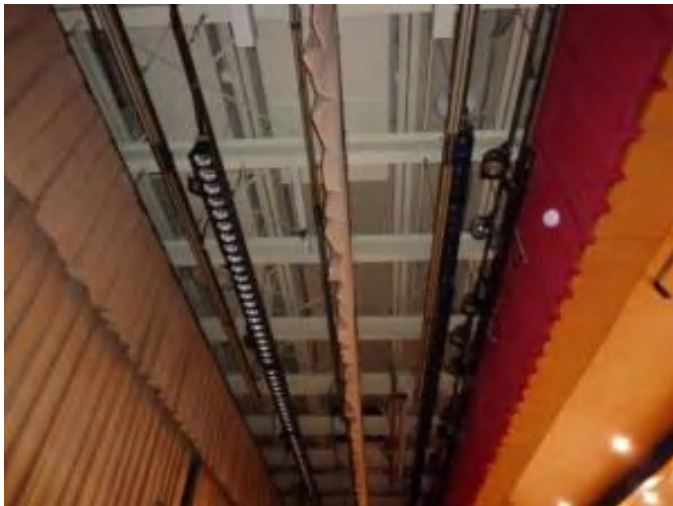
**Location:** Stage

The school stage has a stage curtain assembly that appears to be from the original construction. Modern applications are typically fire-proof applications with adjustable tracks and electric support for operation. The curtains are torn in a few section and the track is not functioning properly, overall the system is in poor condition. It is recommended that the curtain and track system be upgraded to a new system. Special care should be considered in regards to modern fire proofing for the new installation.

**System: E1020 - Institutional Equipment**

**Distress:** Beyond Service Life

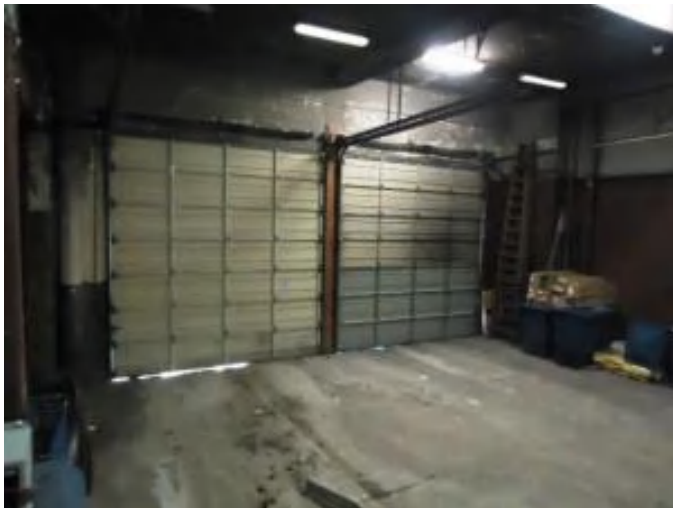
**Location:** Loading Dock

The loading dock is located on the North Thirty-First Street and has a small concrete drive that leads to two overhead doors. The doors are recommended for upgrade in this report. The loading dock area is not clearly marked and safety barriers are required to be placed to protect pedestrian traffic and mitigate possible issues related to loading and unloading materials and supplies. This deficiency provides a budgetary consideration to add the safety barriers and modify the loading dock.

**System: E1090 - Other Equipment**

**Distress:** Life Safety / NFPA / PFD

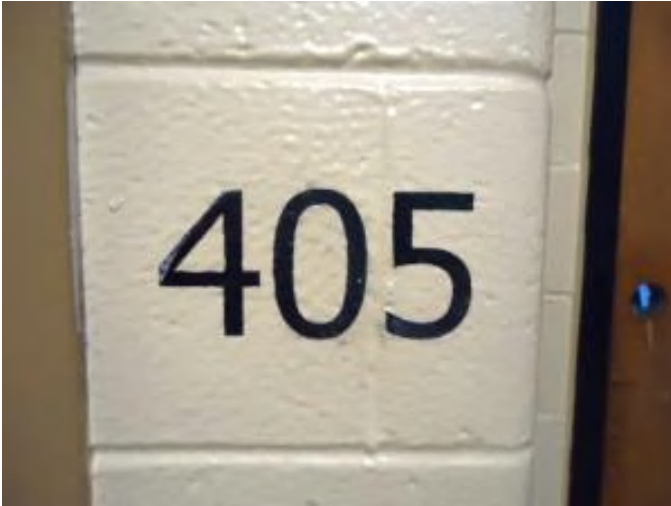
**Location:** Building Wide

**System: C1030 - Fittings**

**Distress:** Damaged

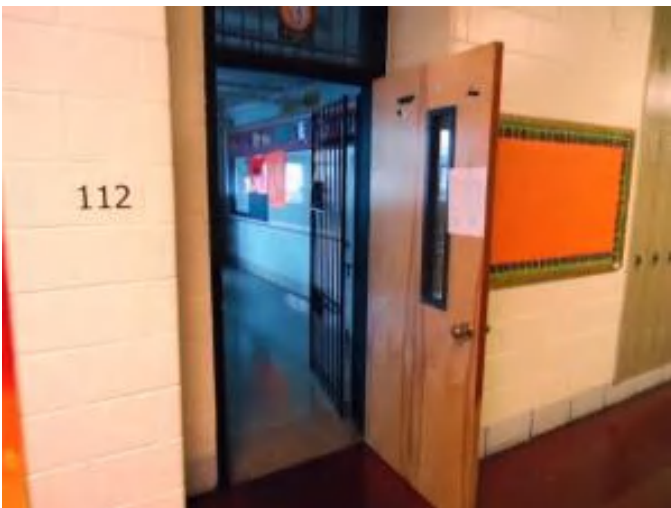
**Location:** Classrooms Hallways

There are several tack boards in the hallways and classrooms for student displays. As indicated in the photos these boards are damaged either from age or abuse. Overall the systems are beyond the expected service life for this application. Remove and replace tack boards is recommended.

**System: C1030 - Fittings**

**Distress:** Damaged

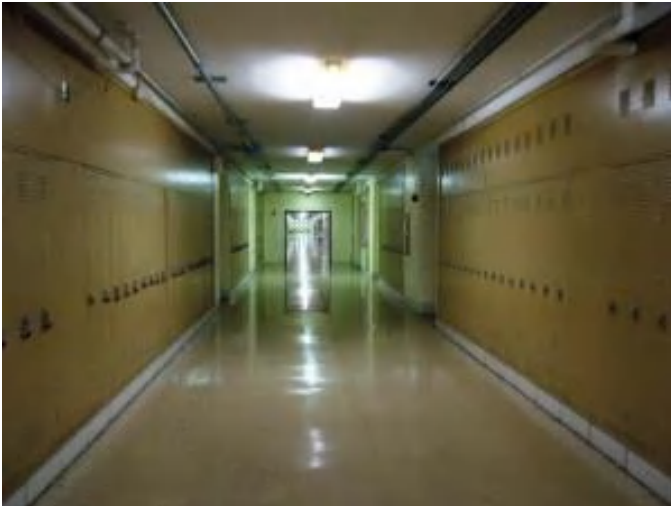
**Location:** Building Wide

The floor finish for this school is a combination of carpet in the administrative area, Terrazzo in the lobby, tile in the kitchen and service line areas, vinyl tile classrooms and hallways with a few concrete hallways and classrooms. Overall the floor finishes are in good condition and there were no reported issues during the time of the inspection. However, suspected asbestos containing materials (ACM) are believed to be limited to the original vinyl floor tile and mastic. While currently sound and manageable in place, future renovation efforts should include provision to test and abate any and all ACM.

**System: C3020413 - Vinyl Flooring**

**Distress:** Health Hazard / Risk

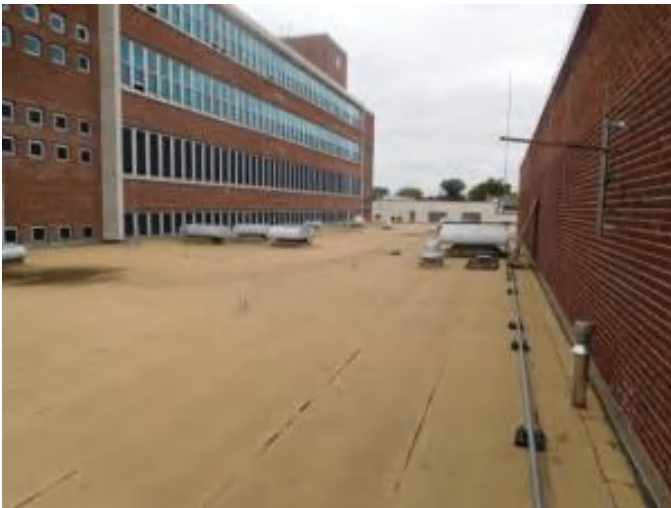
**Location:** mechanical room, roof

**System: D3030 - Cooling Generating Systems**

**Distress:** Inadequate

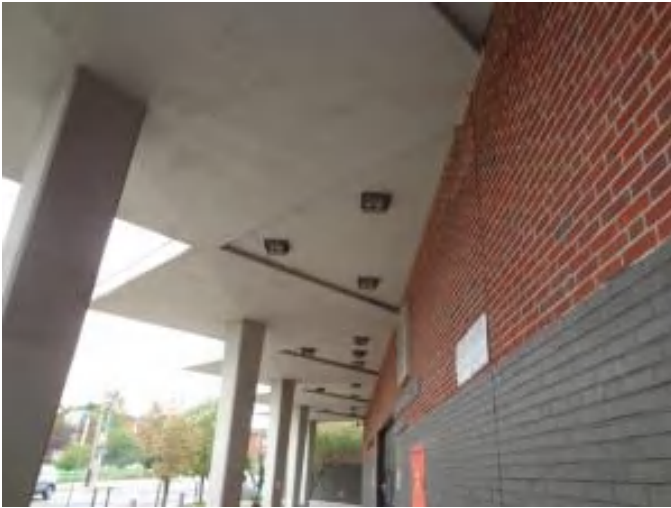
**Location:** Main Entrance Canopy

**System: D5020 - Lighting and Branch Wiring**

**Distress:** Energy Efficiency

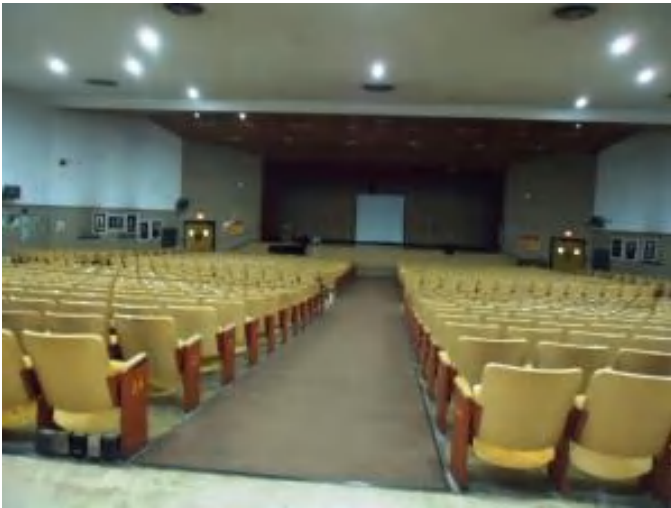
**Location:** Auditorium

The fixed seating for this school is from the original construction. The systems are in fair condition considering the age and usage. This project provides a budgetary consideration for universal upgrades for the fixed seating and furnishing of this school. Ensure that ADA requirements are followed with the new seating layout.

**System: E2010 - Fixed Furnishings**

**Distress:** Beyond Service Life

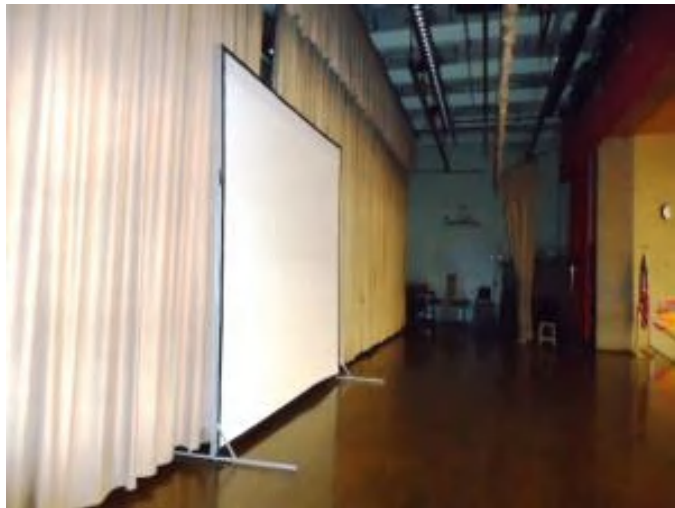
**Location:** Curtain

**System: E2010 - Fixed Furnishings**

**Distress:** Failing

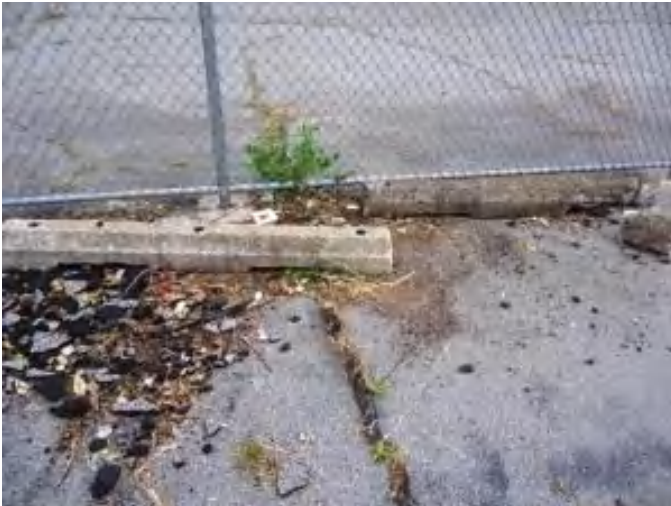
**Location:** Parking Lot

#### System: G2020 - Parking Lots

**Distress:** Accessibility

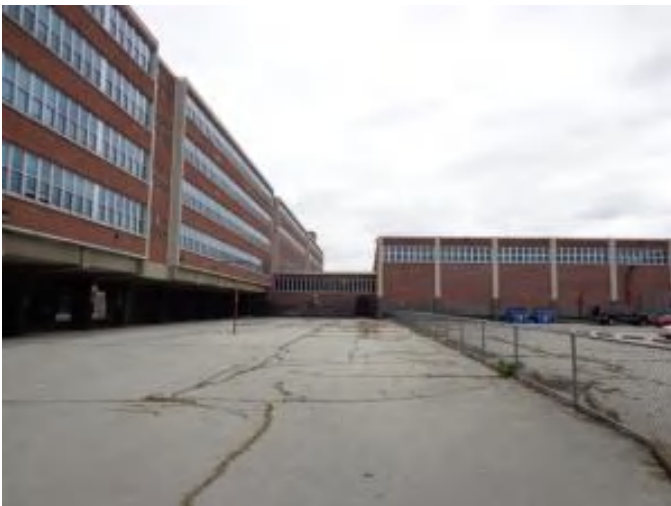
**Location:** Parking Lot - north side

#### System: G4020 - Site Lighting

**Distress:** Security Issue
