Facility Condition Assessment Summary Report

Sullivan School

School District of Philadelphia
S743001;Sullivan
Final
Site Assessment Report

January 31, 2017

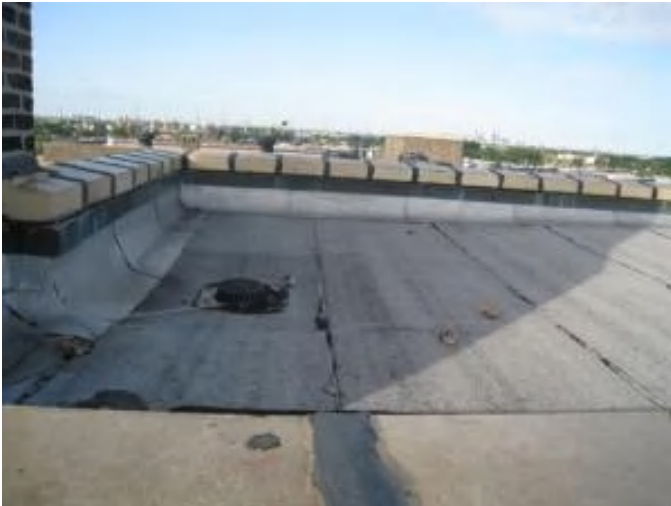
System: B3010105 - Built-Up

Location: main roof

Distress: Failing

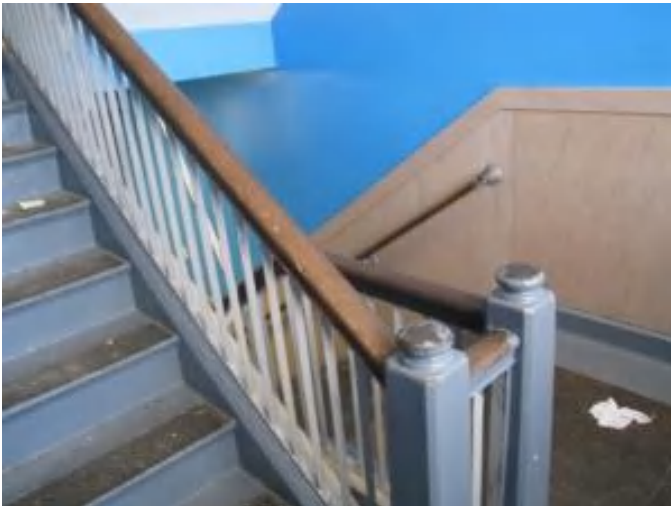
System: C2010 - Stair Construction

Location: stairways

Distress: Building / MEP Codes

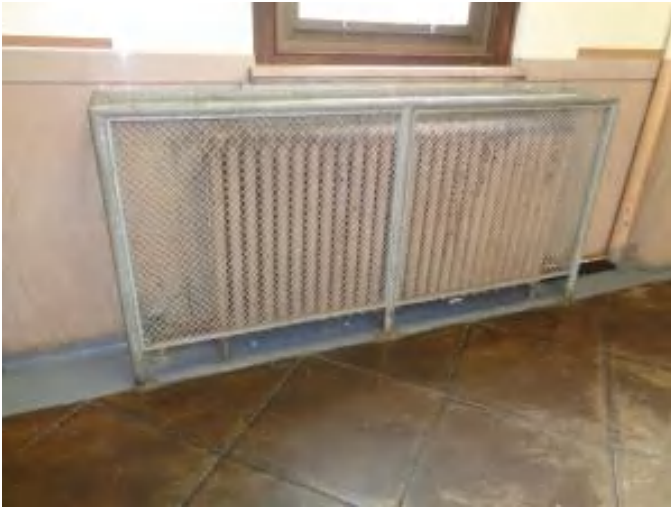
System: D3040 - Distribution Systems

Location: Throughout the building

Distress: Inadequate

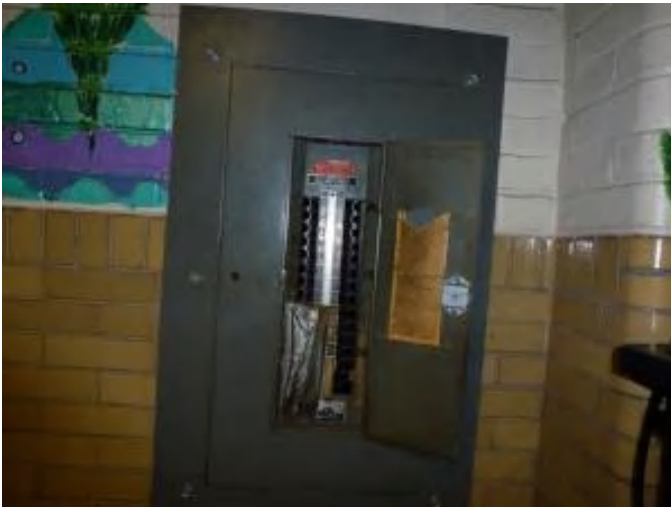
System: D5010 - Electrical Service/Distribution

Location: Entire Building

Distress: Beyond Service Life

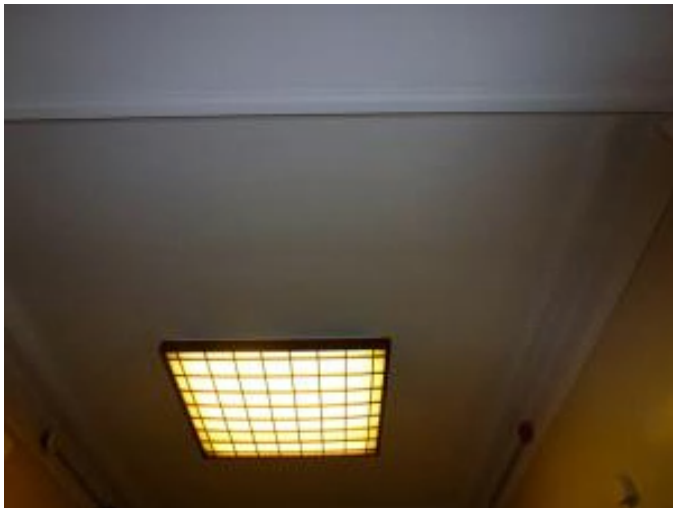
System: D5020 - Lighting and Branch Wiring

Location: Entire Building
Distress: Inadequate
Category: 4 - Capital Improvement
Priority: 1 - Response Time (< 2 yr)
Correction: Replace Lighting Fixtures (SF)
Qty: 1.00
Unit of Measure: S.F.
Estimate: \$651,097.78
Assessor Name: System
Date Created: 08/04/2015

Notes: Replace all lighting fixtures with new fluorescent lighting fixtures with T-5 lamp.

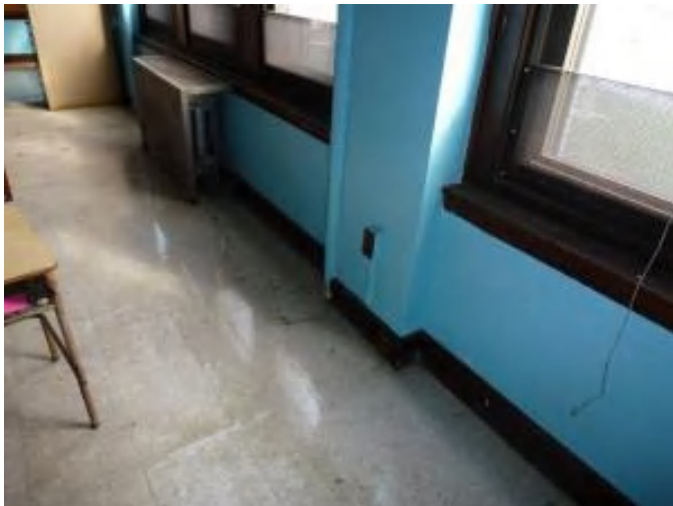
System: D5020 - Lighting and Branch Wiring

Location: Classrooms
Distress: Beyond Service Life
Category: 3 - Operations / Maint.
Priority: 1 - Response Time (< 2 yr)
Correction: Replace Wiring Devices (SF) - surface mounted conduit and boxes
Qty: 1.00
Unit of Measure: S.F.
Estimate: \$373,047.36
Assessor Name: System
Date Created: 08/04/2015

Notes: Install minimum two receptacles in each wall of class rooms and sufficient number of receptacles in other areas per NEC. We recommend adding a two-compartment surface mounted raceway, for data power, for the computer lab room.

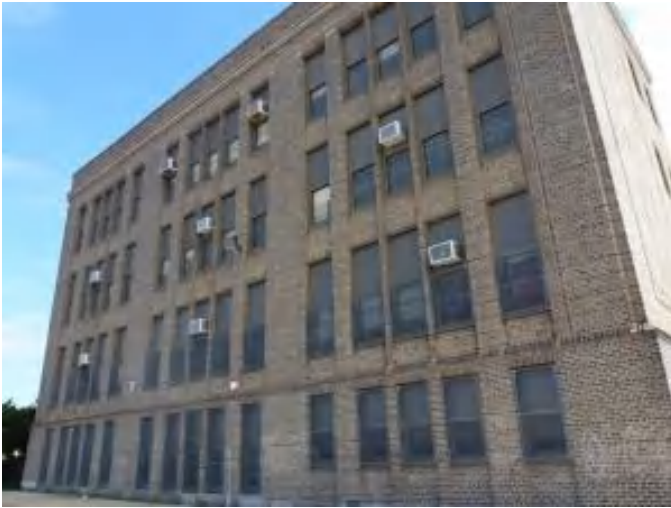
System: D5020 - Lighting and Branch Wiring

Location: Exterior Building
Distress: Inadequate
Category: 4 - Capital Improvement
Priority: 1 - Response Time (< 2 yr)
Correction: Add Exterior Lighting
Qty: 1.00
Unit of Measure: Ea.
Estimate: \$28,702.03
Assessor Name: System
Date Created: 02/10/2016

Notes: Provide 10 more flood lights on exterior wall.

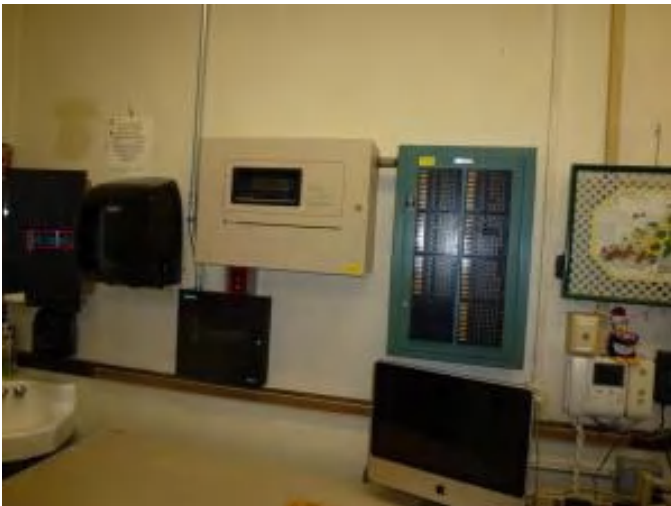
System: D5030 - Communications and Security

Location: Entire Building
Distress: Damaged
Category: 3 - Operations / Maint.
Priority: 1 - Response Time (< 2 yr)
Correction: Add/Replace Clock System or Components
Qty: 1.00
Unit of Measure: Ea.
Estimate: \$164,874.77
Assessor Name: System
Date Created: 08/04/2015

Notes: Replace existing master clock controller.

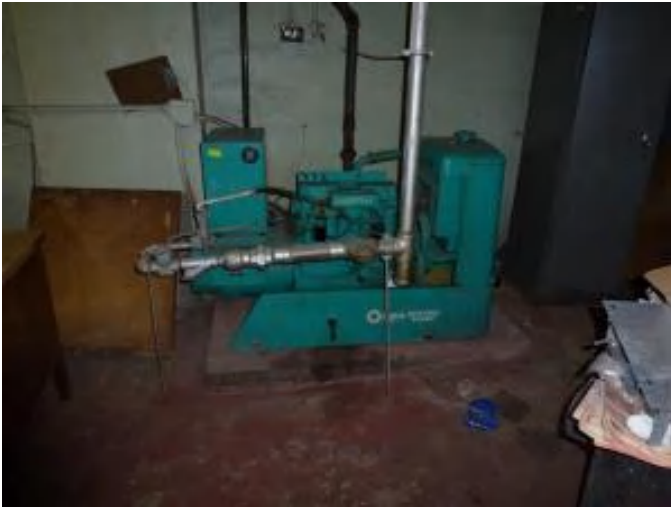
System: D5090 - Other Electrical Systems

Location: Exterior Building
Distress: Life Safety / NFPA / PFD
Category: 1 - Health & Safety
Priority: 1 - Response Time (< 2 yr)
Correction: Replace standby generator system
Qty: 1.00
Unit of Measure: Ea.
Estimate: \$248,110.21
Assessor Name: System
Date Created: 08/04/2015

Notes: Replace existing emergency generator 100KW diesel generator. Provide an auto transfer switch for the new Emergency system.

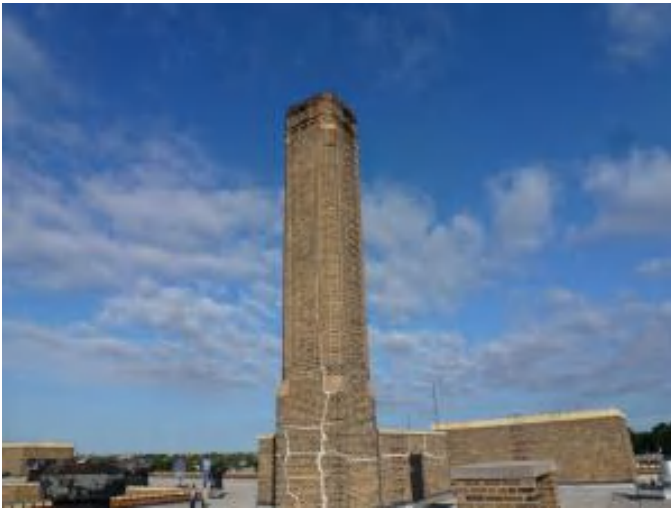
System: D5090 - Other Electrical Systems

Location: Roof
Distress: Life Safety / NFPA / PFD
Category: 1 - Health & Safety
Priority: 1 - Response Time (< 2 yr)
Correction: Repair Lightning Protection System
Qty: 1.00
Unit of Measure: Job
Estimate: \$27,269.60
Assessor Name: System
Date Created: 08/04/2015

Notes: Perform lightning protection studies to ascertain adequacy of existing systems.

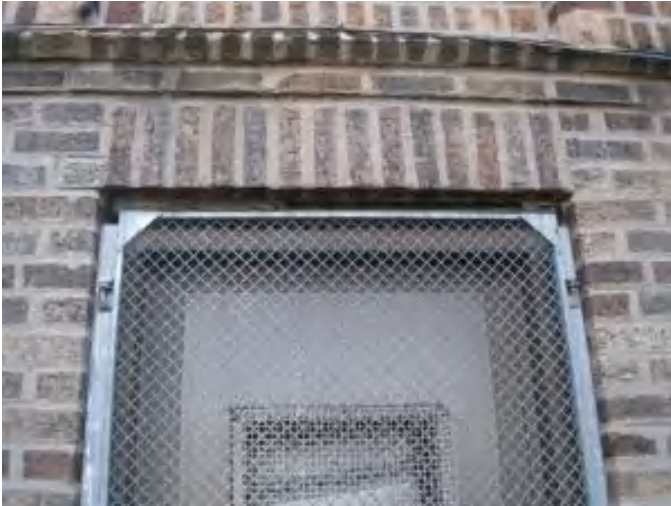
System: B2010 - Exterior Walls

Exterior walls are generally in good condition, however the lintels above most basement windows, some upper windows, and some doors are rusted with brick joint cracks extending from the lintels into the brick joints in the walls. Lintels should be replaced when windows are replaced. Many brick roof-structure walls and parapets have been repointed or caulked (not a good solution) and continue to show signs of cracking and joint failure. A more detailed inspection of masonry is required to repair all failing joints and ensure a minimum of leaks through the envelope.

Location: windows - lintels

Distress: Failing

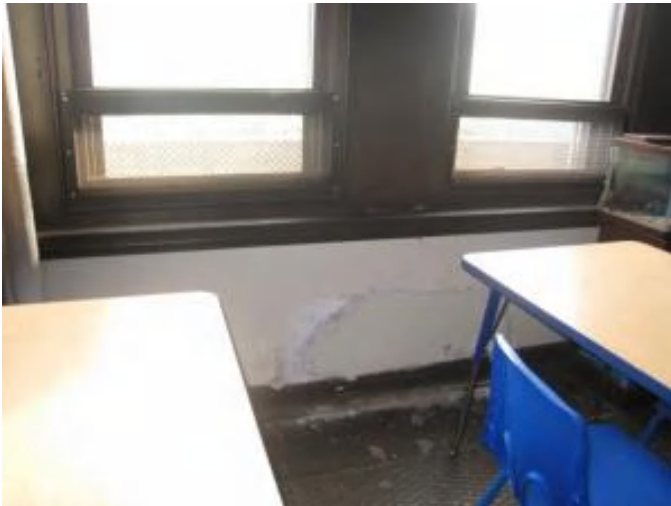
System: B2020 - Exterior Windows

Exterior windows were replaced in the 1990's with bronze anodized aluminum frame operable single hung units with single thickness clear plexiglass acrylic vision panel glazing. Windows are in poor condition with oxidized frames and severely scratched single-pane plexiglass vision panels. Operable units are difficult to operate up and down or do not stay open due to broken internal counterbalance weights, accidentally slamming closed in some cases – a potential safety hazard. Single pane plexiglass units do not meet today's energy code requirements and are large sources of heat loss. Basement level windows are at grade when viewed from the outside; galvanized steel security screens attached to basement windows, the lower section of 1st floor windows, and the auditorium windows are in good condition.

Location: windows

Distress: Beyond Service Life

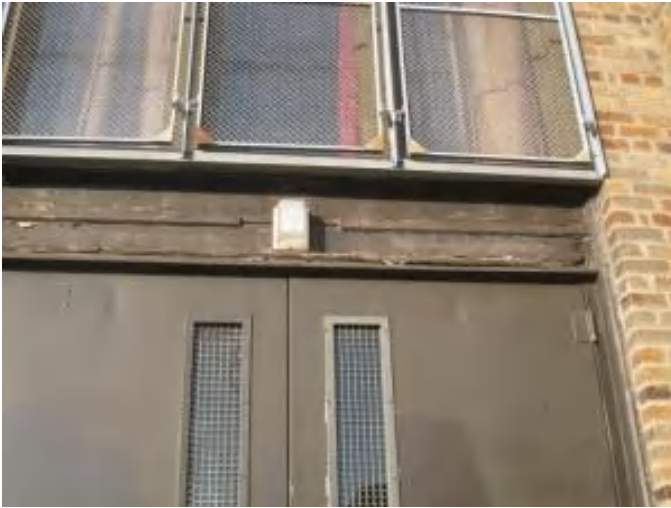
System: B2030 - Exterior Doors

Exterior doors are painted steel framed flush hollow metal units with steel frames. The main entrance and secondary main entrance on Harbison Street have decorative Romanesque-style tile arches around door openings. They can be cleaned to highlight their style and artistic technique. Some doors have small glazing vision panels. Doors are in generally poor condition, have broken or non-functioning panic hardware, rusted dented panels and frames, and are not ADA compliant. There are no handicap entrances, no accessible ramps and no elevators. All exterior steel doors, frames, and hardware systems need to be replaced.

Location: exterior doors
Distress: Obsolete
Category: 3 - Operations / Maint.
Priority: 2 - Response Time (2-3 yrs)
Correction: Replace hardware with compliant hardware, paint and weatherstrip - per leaf
Qty: 16.00
Unit of Measure: Ea.
Estimate: \$55,898.23
Assessor Name: System
Date Created: 08/04/2015

Notes: Replace all exterior doors with ADA and code compliant exit hardware; repaint doors and frames

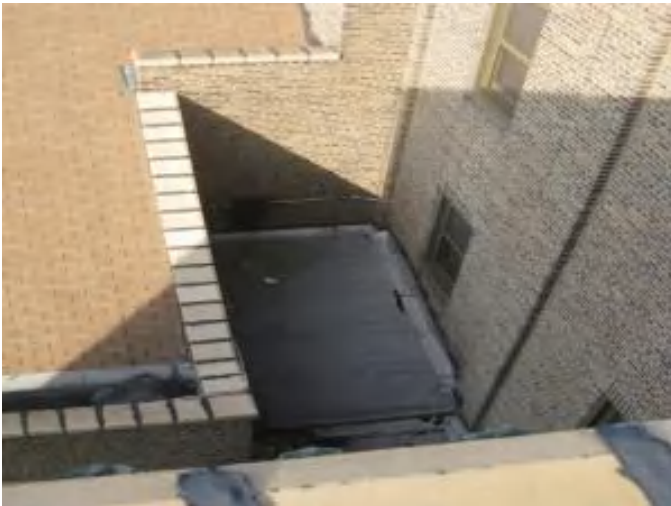
System: B3010140 - Shingle & Tile

Location: auditorium roof
Distress: Beyond Service Life
Category: 3 - Operations / Maint.
Priority: 2 - Response Time (2-3 yrs)
Correction: Remove and replace asphalt shingle roof - partial area
Qty: 6,000.00
Unit of Measure: S.F.
Estimate: \$205,810.25
Assessor Name: System
Date Created: 08/04/2015

Notes: Remove and replace existing sloped asphalt shingle roof over auditorium

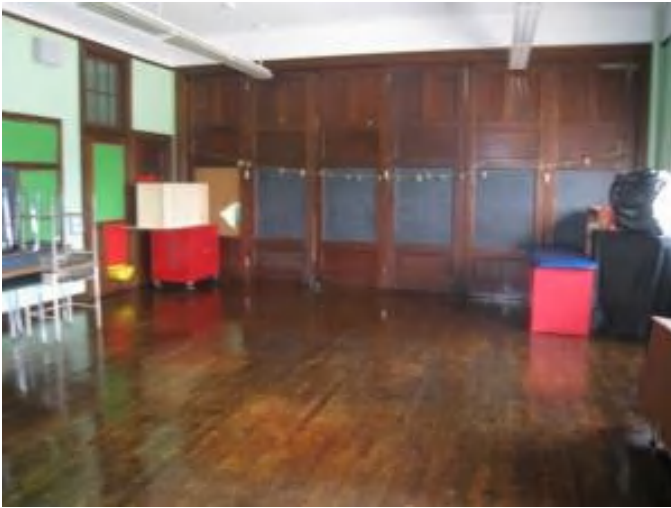
System: C1010 - Partitions

Location: classrooms

Distress: Failing

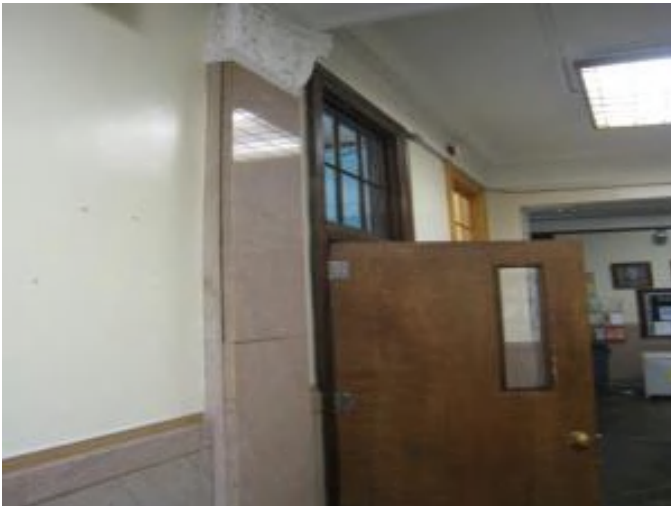
System: C1010 - Partitions

Location: corridors

Distress: Building / MEP Codes

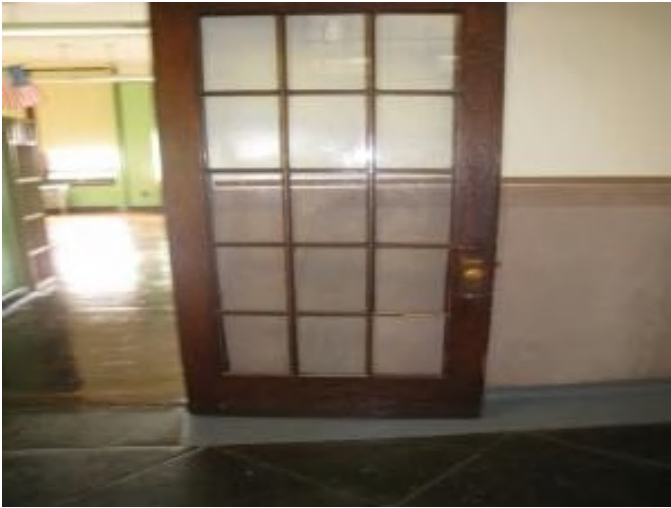
System: C1020 - Interior Doors

Location: interior doors

Distress: Failing

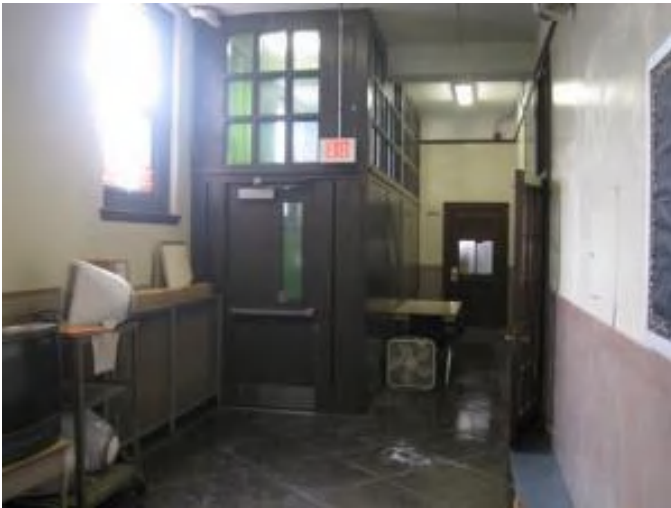
System: C1020 - Interior Doors

Location: mechanical rooms and stairways

Distress: Failing

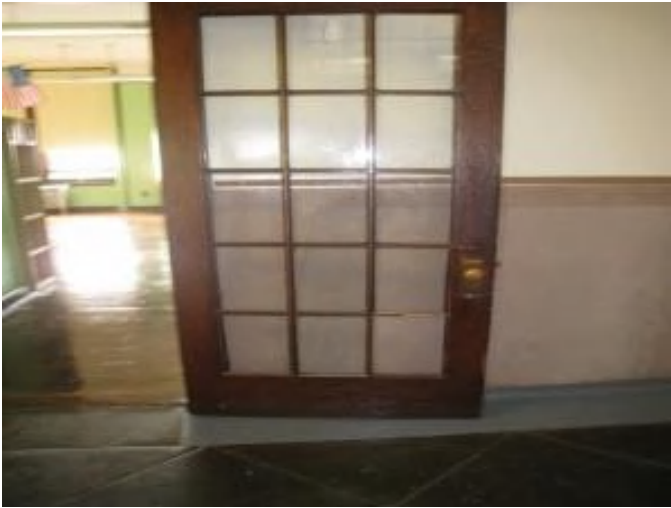
System: C1020 - Interior Doors

Location: classrooms

Distress: Building / MEP Codes

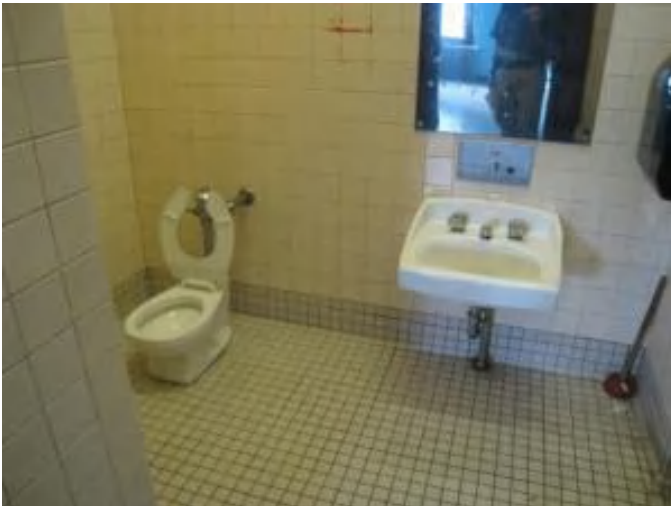
System: C1030 - Fittings

Location: toilet rooms

Distress: Damaged

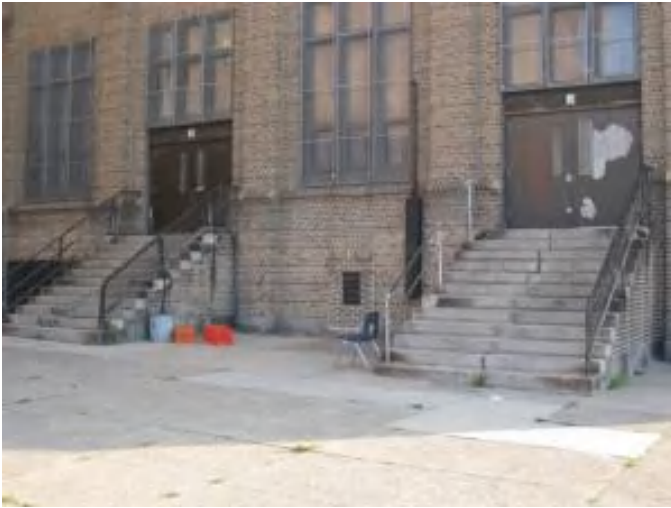
System: C2010 - Stair Construction

Location: exterior stairs

Distress: Failing

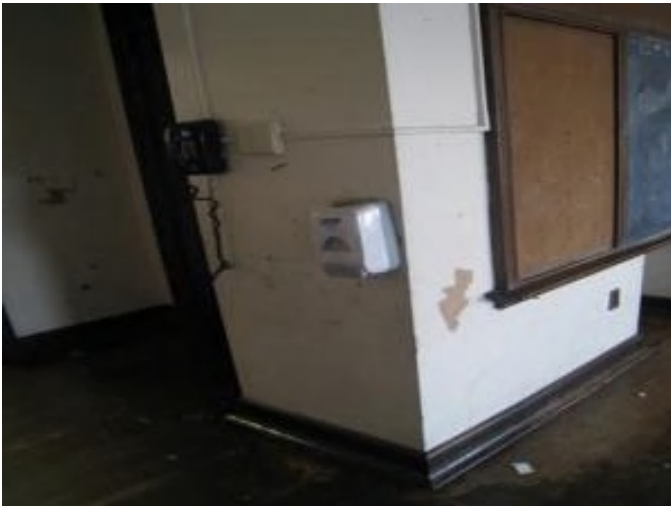
System: C3010230 - Paint & Covering

Location: interior walls

Distress: Damaged

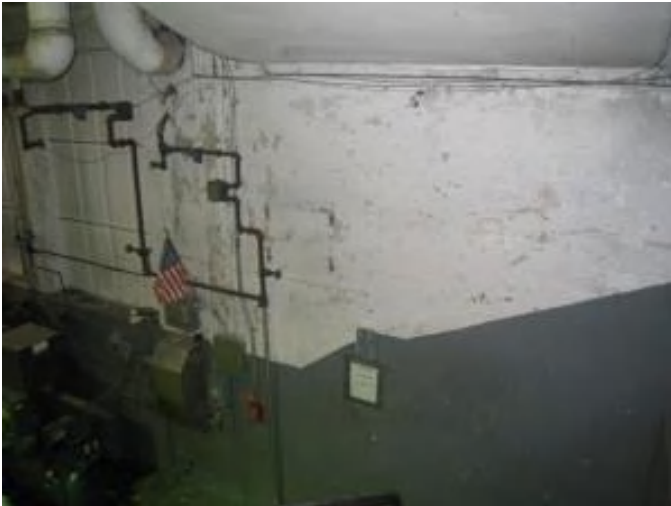
System: C3010230 - Paint & Covering

Location: mechanical rooms

Distress: Appearance

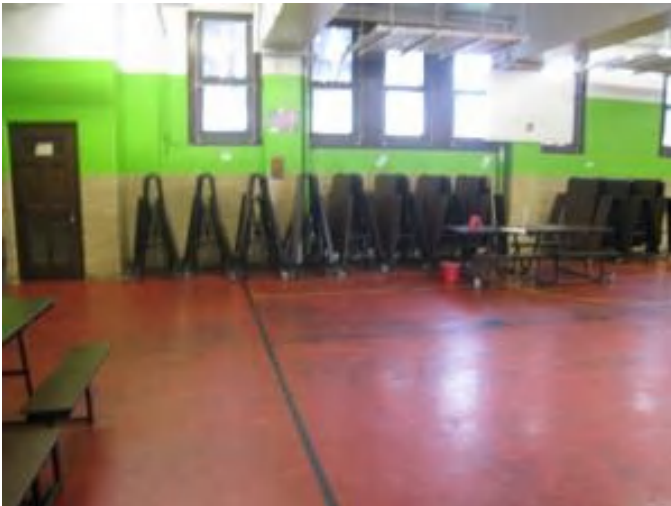
System: C3020413 - Vinyl Flooring

Location: gym and other areas

Distress: Failing

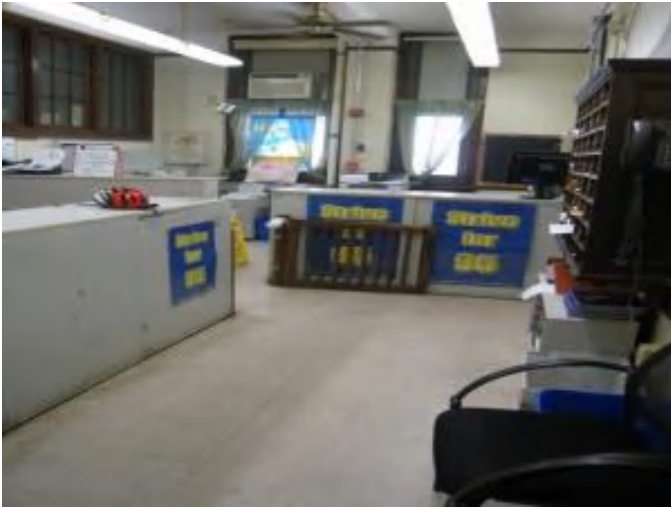
System: C3020413 - Vinyl Flooring

Location: offices

Distress: Beyond Service Life

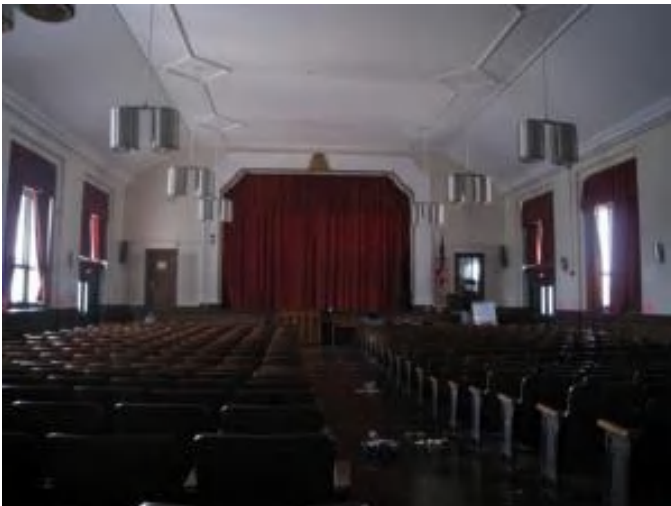
System: C3020414 - Wood Flooring

Floor finishes in the original building mostly consist of dark stained oak floors in classrooms and the auditorium. Most are in good enough condition to be stripped, sanded, and refinished. There are some rooms (main office and faculty lounge) with either 12"x12" vinyl composition tile (VCT) over the wood or 9"x9" VAT over wood. The gymnasium which also serves as the cafeteria is finished in VCT. All 12"x12" VCT floors need to be removed and replaced; 9"x9" floors may have asbestos and need to be addressed as possible asbestos containing materials. They should be removed using proper asbestos abatement procedures if they are found to contain asbestos and replaced with 12"x12" VCT. Stair walking surfaces are finished in exposed concrete that have years of dirt ground into the surfaces; these should be stripped, cleaned and resealed. All corridor floors are finished with 4'x4' (nominal size) concrete tiles which appear to be a monolithic system and highly durable. Edges along the walls are painted; These corridor floors have not recently been stripped and cleaned and have years of dirt sealed into the surface and corners, causing their color to be very dark and dingy. There is an especially large build-up of dirt at all corners. Basement toilet rooms have been recently refinished with new fixtures, plastic partitions and ceramic mosaic tile floors; a thorough cleaning of these rooms is required. The room in the basement originally designated as the cafeteria is now a food prep area finished with VCT; part of this space is being used as a teacher's lounge area and is finished with carpet.

Location: classrooms and auditorium

Distress: Damaged

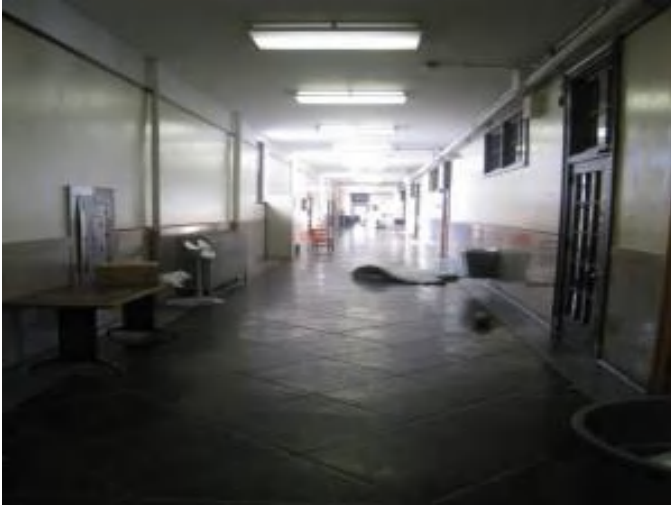
System: C3020415 - Concrete Floor Finishes

Location: mechanical rooms, corridors, stairways

Distress: Appearance

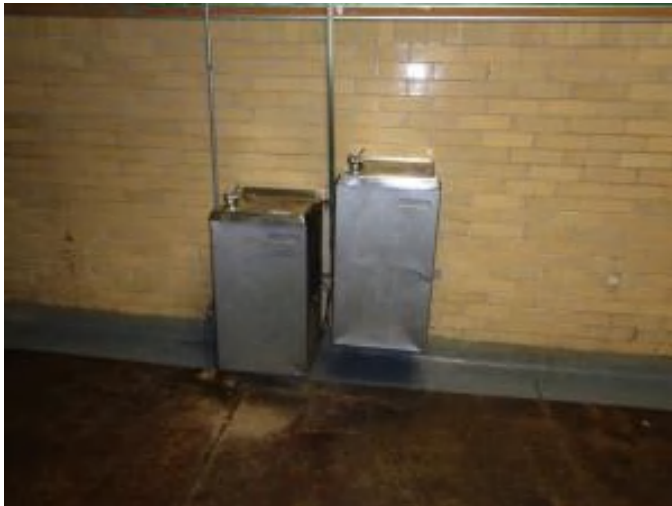
System: D2010 - Plumbing Fixtures

Drinking fountains in the corridors and at the restrooms are wall hung with integral refrigerated coolers. Most appear to be beyond their service life. Replacement of all drinking fountains is recommended.

Location: corridors

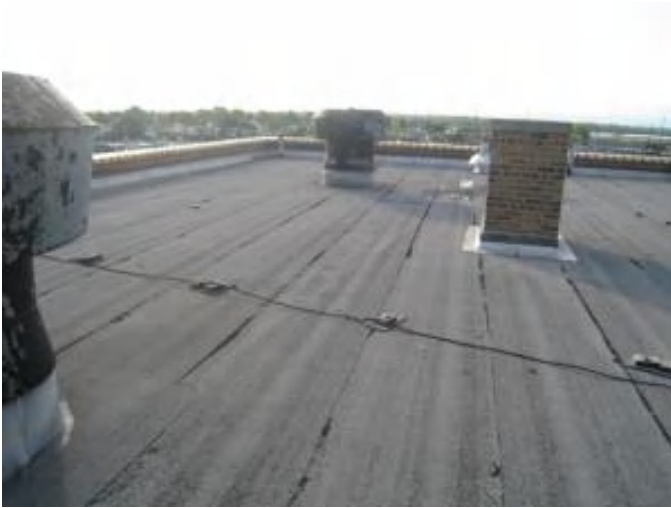
System: D2040 - Rain Water Drainage

Location: roof
Distress: Building / MEP Codes
Category: 2 - Code Compliance
Priority: 2 - Response Time (2-3 yrs)
Correction: Create new overflow scupper through a parapet with up to 100' downspout
Qty: 5.00
Unit of Measure: Ea.
Estimate: \$52,339.33
Assessor Name: System
Date Created: 10/23/2015

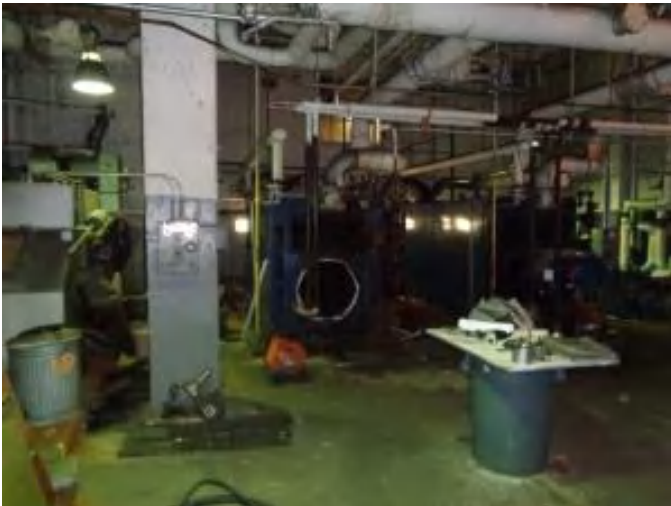
System: D3040 - Distribution Systems

Location: Throughout Building
Distress: Failing
Category: 3 - Operations / Maint.
Priority: 2 - Response Time (2-3 yrs)
Correction: Perform testing to identify and replace damaged steam and condensate piping.
Qty: 65,000.00
Unit of Measure: S.F.
Estimate: \$614,924.11
Assessor Name: System
Date Created: 08/06/2015

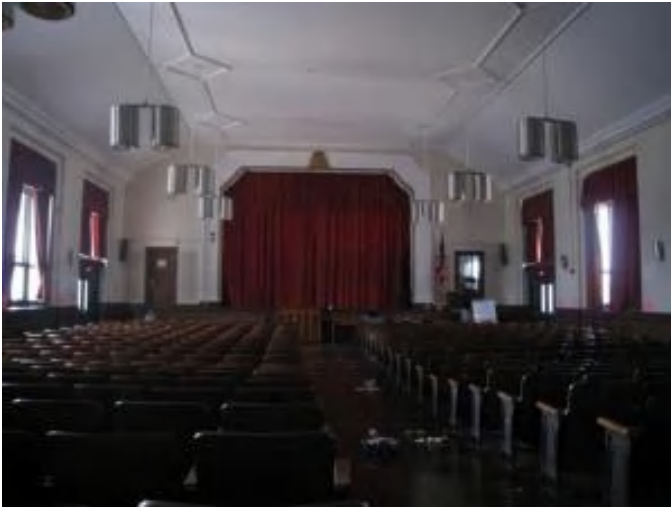
System: E2010 - Fixed Furnishings

Furnishings include the original folding wood seating in the auditorium is still in use; however many seats need to be repaired to operate properly and many are scratched; at least 75% are damaged. With the unavailability of parts for repair and the worn

condition of the seating, full replacement is required. Casework and storage cabinets in the classrooms and the office is damaged, worn and needs replacement.

Location: auditorium

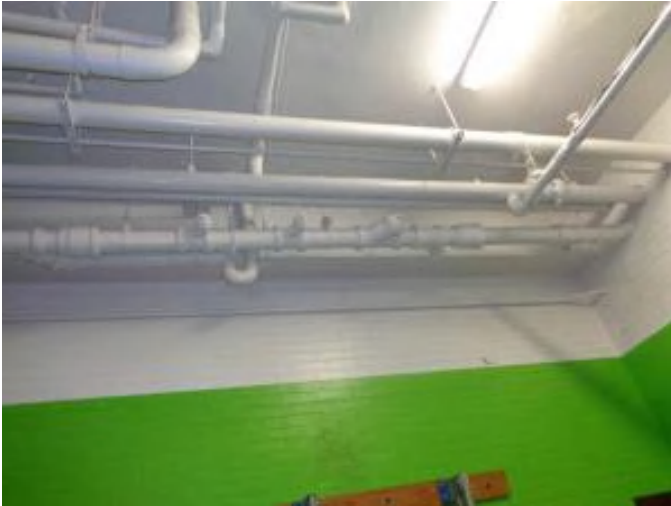
System: D2030 - Sanitary Waste

Sanitary Waste - The sanitary waste piping systems are threaded cast iron. There is a small sewer ejector pit is located in the basement with one pump. The complete sanitary system appears to be the original installed equipment and is well beyond its serviceable life. Inspection of the sanitary system throughout the main building is recommended.

Location: entire building

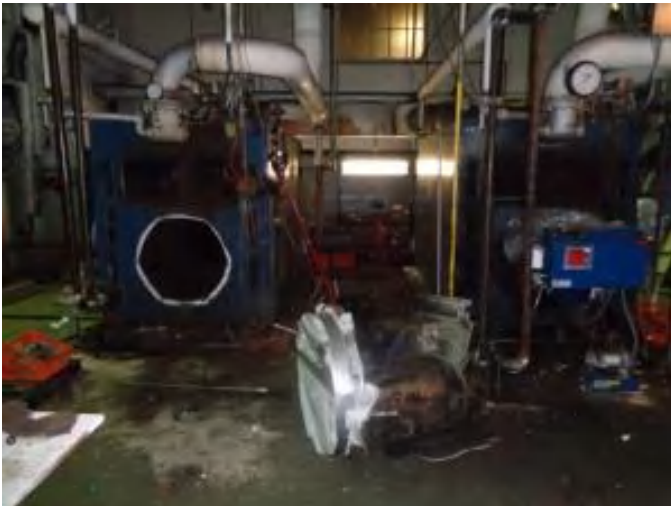
System: D3020 - Heat Generating Systems

Heat Generating Systems - Steam is generated in the main building by two Weil McLain 94 series oil fired boilers installed in 1972. The boilers have Power Flame oil burners. The boilers and burners appear to be at the end of their serviceable life and should be replaced within the next 5 years.

Location: boiler room

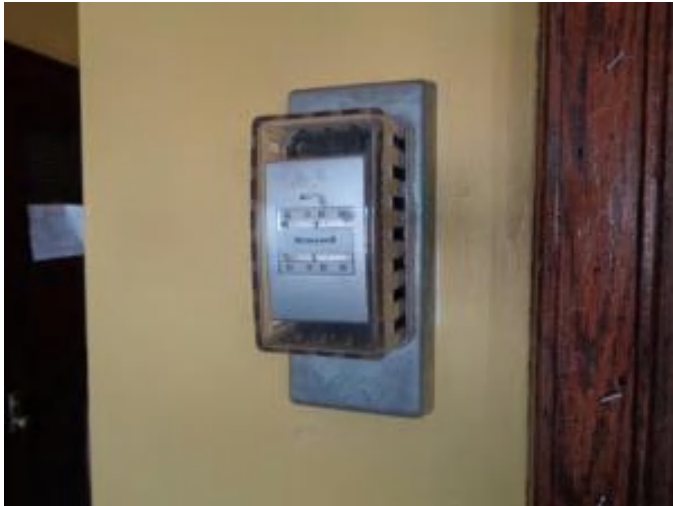
System: D3060 - Controls & Instrumentation

Controls & Instrumentation - There are some pneumatic thermostats on the walls that are not in service. The pneumatic control valves on the radiators are not in service. Most of the heating radiators are flowing 100% flow when the steam is on. This results in an "on-off" control for the whole building, i.e. when the boilers are on, the whole building has heat. And when the boilers are off, the whole building is without heat. Adding a new DDC system to the main building is recommended to provide the necessary control and comfort.

Location: entire building
Distress: Failing
Category: 3 - Operations / Maint.
Priority: 3 - Response Time (3-4 yrs)
Correction: Replace pneumatic controls with DDC (150KSF)
Qty: 65,000.00
Unit of Measure: S.F.
Estimate: \$1,164,240.84
Assessor Name: System
Date Created: 08/06/2015

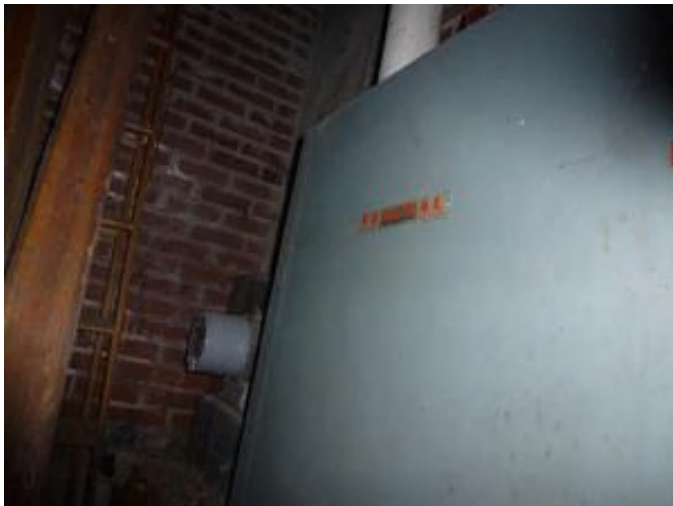
System: D5010 - Electrical Service/Distribution

Location: Boiler Room in the basement
Distress: Beyond Service Life
Category: 3 - Operations / Maint.
Priority: 3 - Response Time (3-4 yrs)
Correction: Replace Switchboard
Qty: 1.00
Unit of Measure: Ea.
Estimate: \$450,673.78
Assessor Name: System
Date Created: 08/04/2015

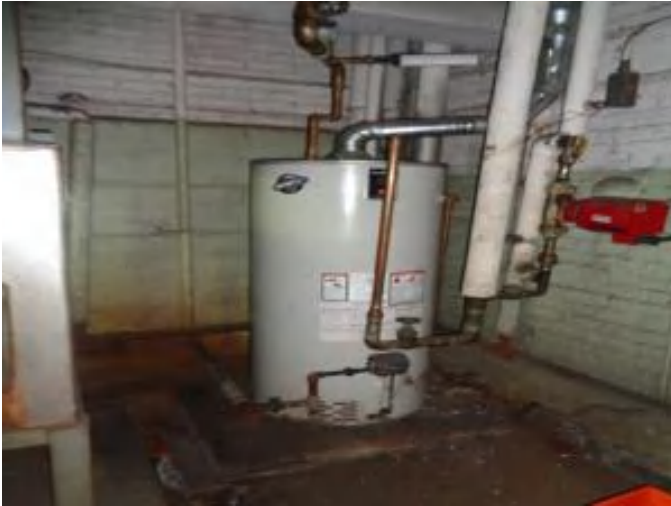
System: D2020 - Domestic Water Distribution

Location: boiler room

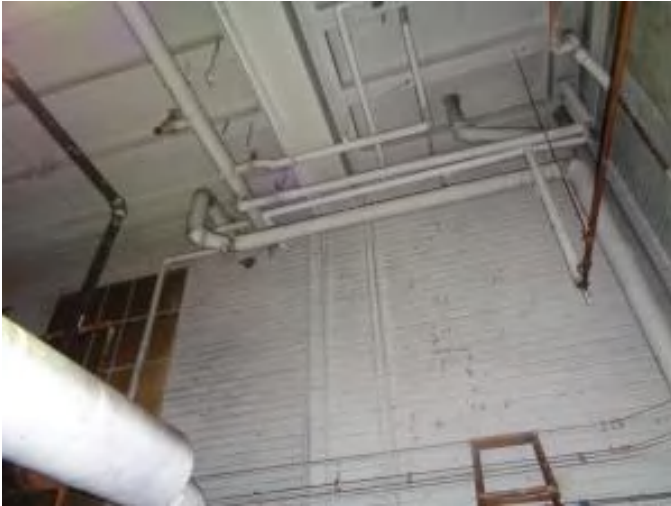
System: D2020 - Domestic Water Distribution

Domestic Water Distribution - Domestic water distribution piping is soldered copper. Water service enters the building in the basement, with backflow preventers and the water meter on the main line after entering the building. There is a domestic water pressure pump skid with duplex pumps after the backflow preventers to increase the water pressure supplied to the building. Inspection of the domestic water distribution piping throughout the building is recommended.

Location: Throughout the building

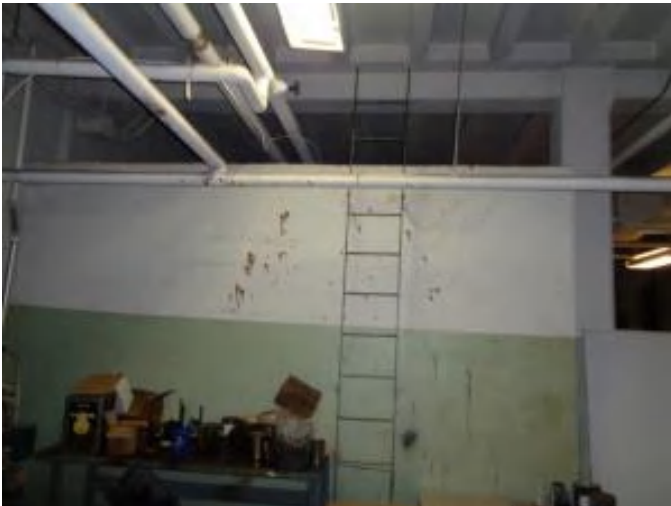
System: D3020 - Heat Generating Systems

Location: Locate new tank underground outside, location TBD

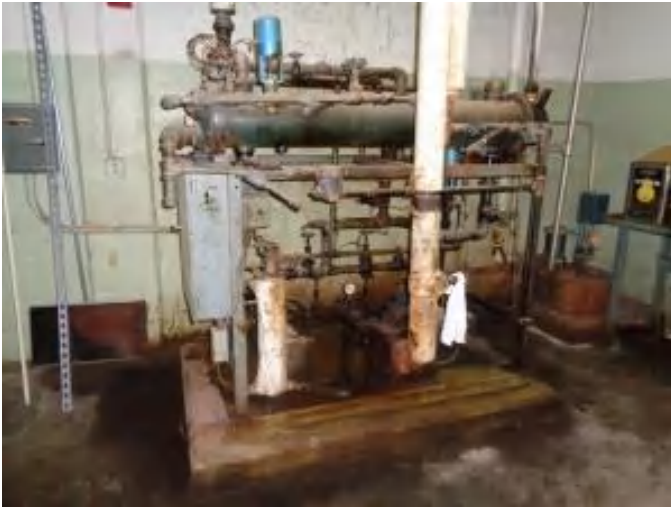
System: D3020 - Heat Generating Systems

Energy Supply - Duplex fuel oil supply pumps provide the required fuel to the boilers when operating on fuel oil. The concrete fuel tank is located in the basement alongside the fuel oil pumps. The pumps appear to be beyond their serviceable life and should be replaced. Inspection of the concrete fuel tank and the addition of required ventilation and fire suppression/alarm in the fuel storage area is recommended.

Location: Boiler Mechanical Equipment Room
Distress: Beyond Service Life
Category: 3 - Operations / Maint.
Priority: 5 - Response Time (> 5 yrs)
Correction: Replace fuel oil pumps
Qty: 1.00
Unit of Measure: Ea.
Estimate: \$26,678.08
Assessor Name: System
Date Created: 08/06/2015

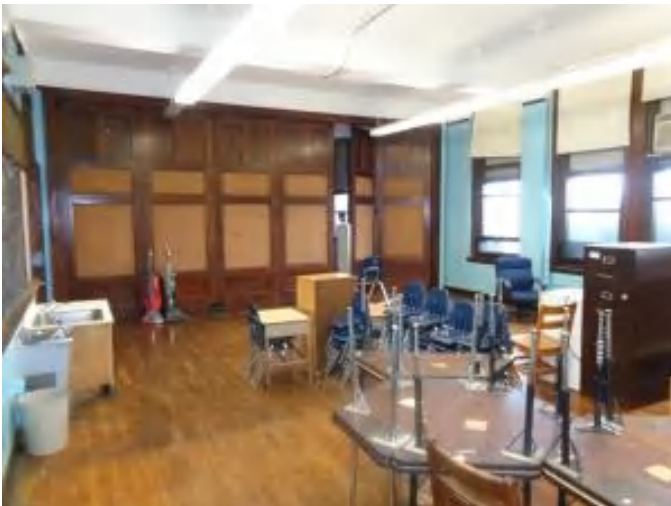
System: D3030 - Cooling Generating Systems

Location: entire building
Distress: Inadequate
Category: 4 - Capital Improvement
Priority: 5 - Response Time (> 5 yrs)
Correction: Install chilled water system with distribution piping and pumps. (+150KSF)
Qty: 65,000.00
Unit of Measure: S.F.
Estimate: \$1,081,056.68
Assessor Name: System
Date Created: 08/06/2015

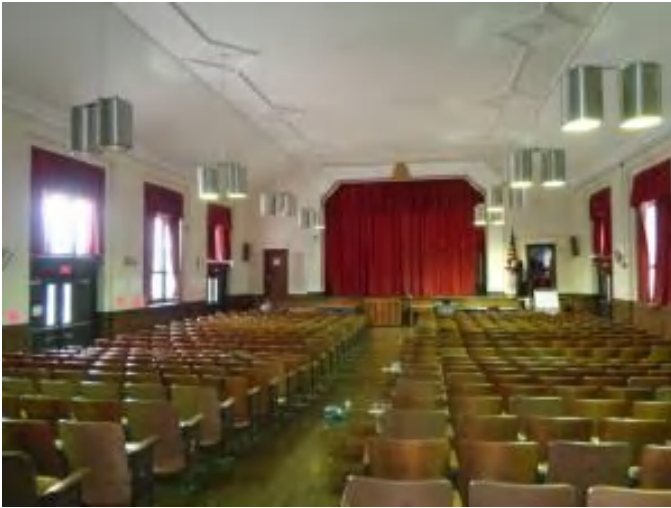
System: D3040 - Distribution Systems

Location: auditorium

- Install AHUs to condition the auditorium

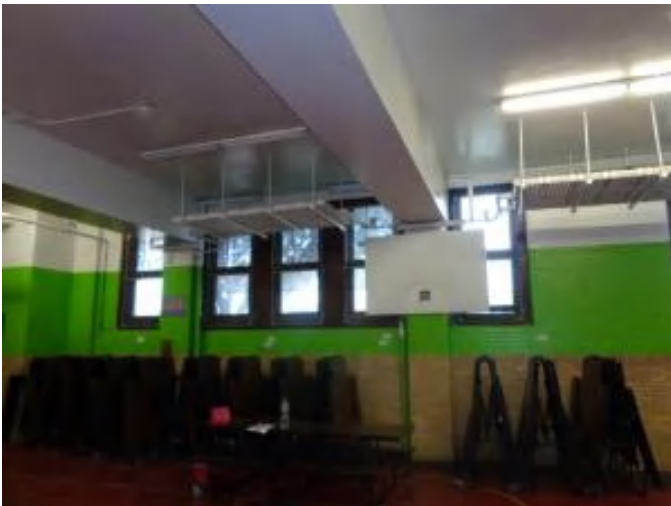
System: D3040 - Distribution Systems

Location: cafeteria

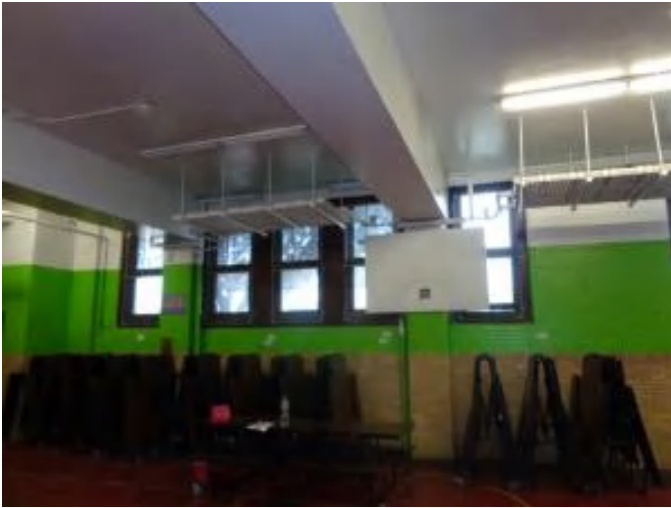
System: D4010 - Sprinklers

Location: entire building

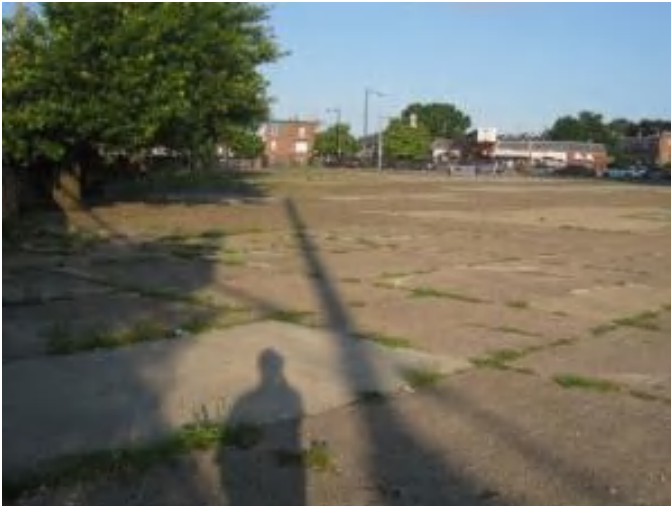
System: G2030 - Pedestrian Paving

Paving and parking is constructed of 4'x4' (nominal) concrete panels; roughly half are in need of replacement and although they are not all contiguous, it may be possible to replace only those that are failing. This expansive paved area serves as the playground and parking area. Parking and play area striping is worn and almost invisible. Clear separation of play area and parking, to provide a safe area for the children to play, is lacking. The number of required parking spaces for school staff is unknown. Restriping of parking areas and better designation of play and parking areas are required. Granite block stairways into the building are need resetting and regrouting. New handrails and guards are required at all stairs.

Location: parking and play area

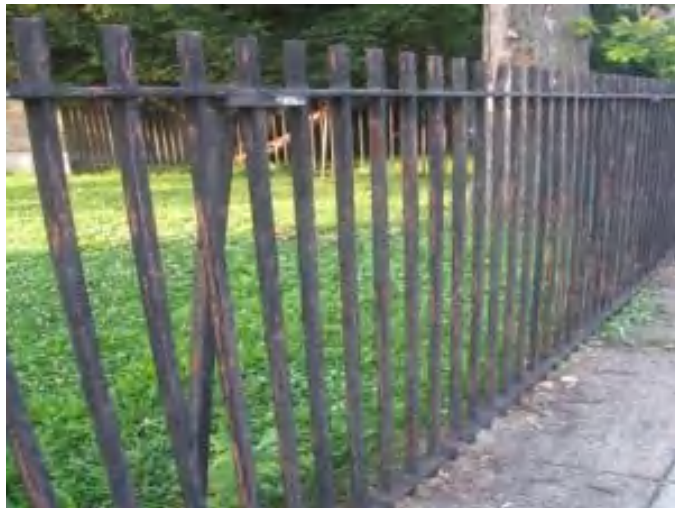
System: G2040 - Site Development

Location: site
