### Taggart School

School District of Philadelphia  
**S269001; Taggart**  
Final  
**Site Assessment Report**

January 31, 2017

JOHN H. TAGGART  
SCHOOL

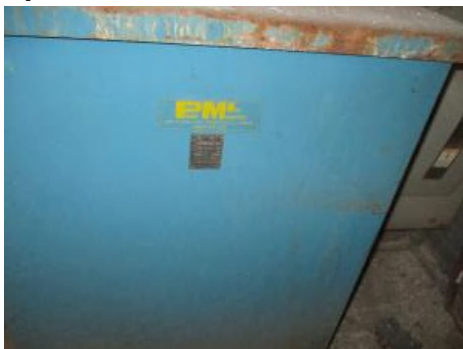
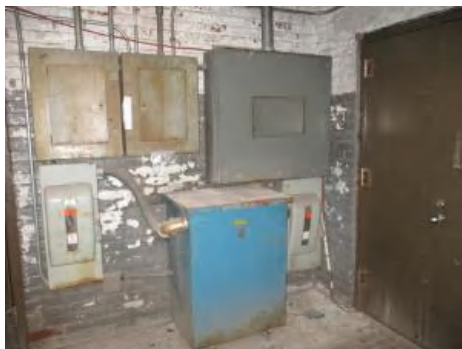
**System:** D5010 - Electrical Service/Distribution

**Note:** 75KVA 240V -120/208V phase converter manufactured by PMI ( Power Magnetics Inc)

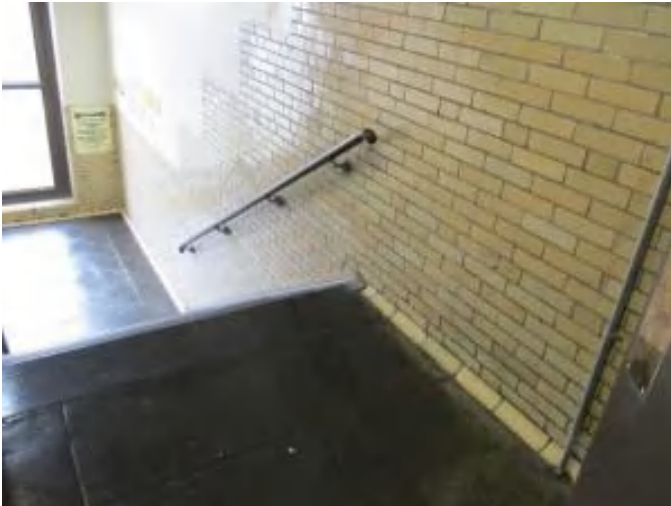
**Location:** Stairs

**Distress:** Building / MEP Codes

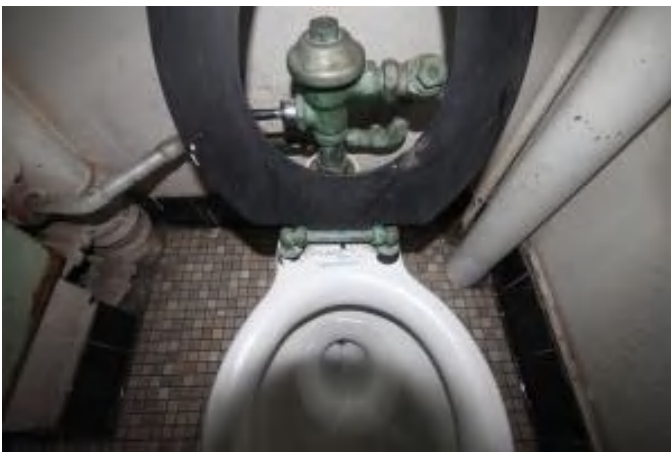
**Location:** Toilet rooms

**Distress:** Appearance

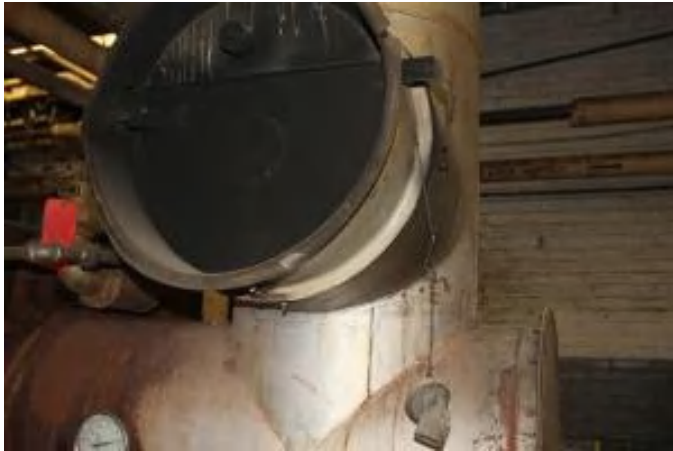
**Location:** Boiler room  
**Distress:** Failing  
**Category:** 3 - Operations / Maint.  
**Priority:** 1 - Response Time (< 2 yr)  
**Correction:** Repair boiler  
**Qty:** 2.00  
**Unit of Measure:** Ea.  
**Estimate:** \$5,223.09  
**Assessor Name:** System  
**Date Created:** 01/06/2016

**Notes:** Repair boiler constant draft dampers to improve exhaust flow

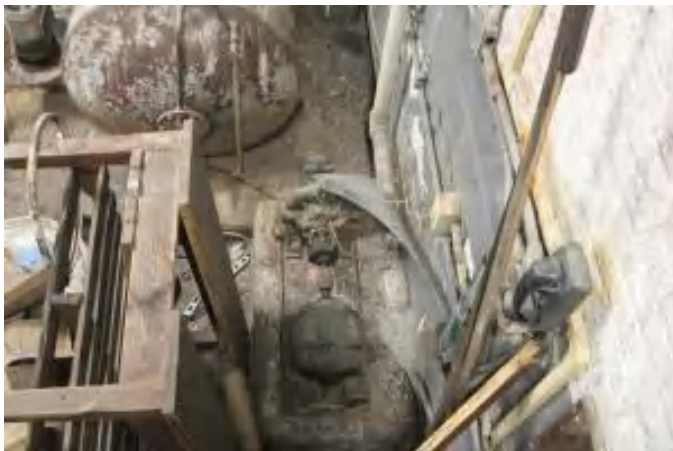
**Location:** classrooms  
**Distress:** Health Hazard / Risk  
**Category:** 1 - Health & Safety  
**Priority:** 1 - Response Time (< 2 yr)  
**Correction:** Provide classroom FC units and dedicated OA ventilation system. (20 clsrms)  
**Qty:** 27.00  
**Unit of Measure:** Room  
**Estimate:** \$2,242,646.71  
**Assessor Name:** System  
**Date Created:** 01/06/2016

**Notes:** Replace the central air handling unit with fan coil units and dedicated OA units to serve the classrooms.

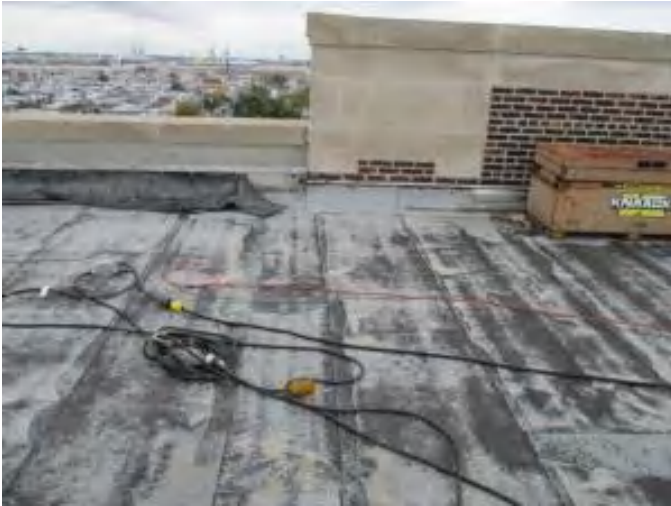
**Location:** Main building

**Distress:** Beyond Service Life

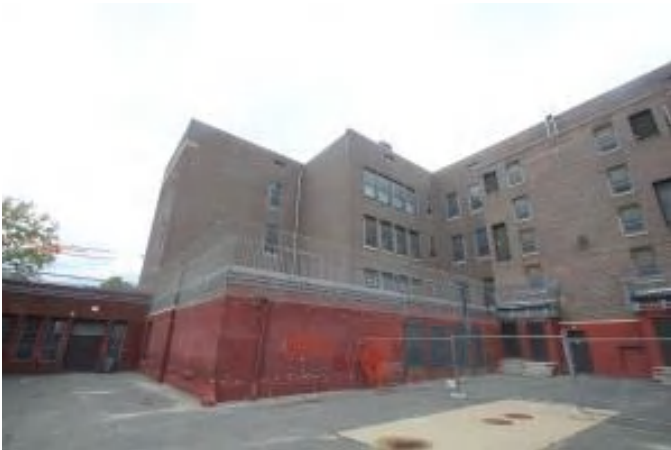
**Location:** 2nd and 3rd floors

**Distress:** Inadequate

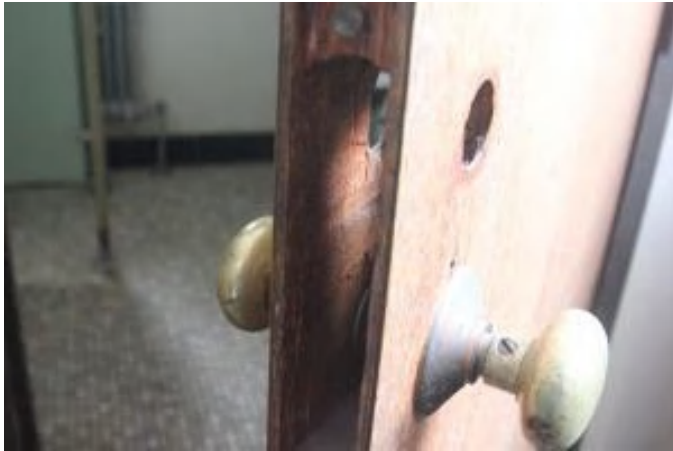
**Location:** Throughout

**Distress:** Beyond Service Life

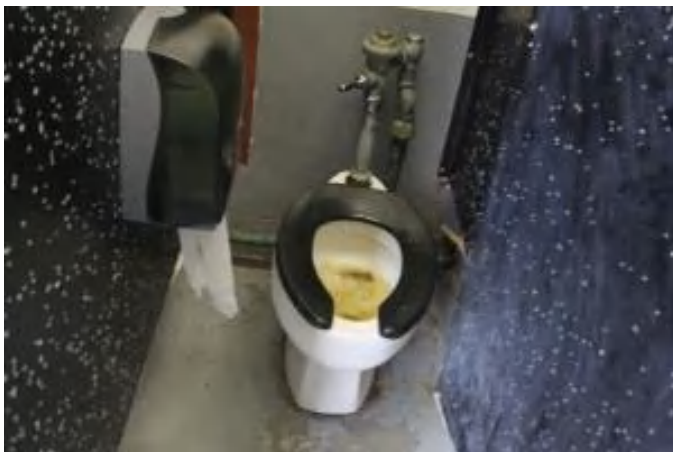
**Location:** Toilets

**Distress:** Accessibility

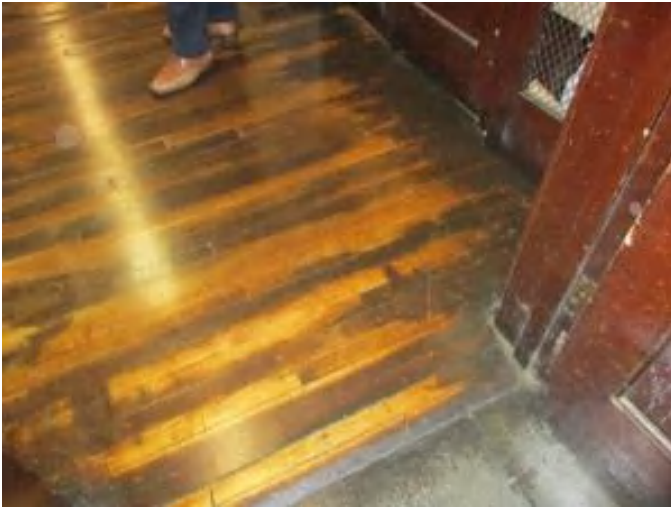
**Location:** Various  
**Distress:** Appearance  
**Category:** 3 - Operations / Maint.  
**Priority:** 2 - Response Time (2-3 yrs)  
**Correction:** Refinish wood floors  
**Qty:** 13,200.00  
**Unit of Measure:** S.F.  
**Estimate:** \$142,123.61  
**Assessor Name:** System  
**Date Created:** 11/23/2015

**Notes:** Refinish hardwood flooring (50% of hardwood flooring area)

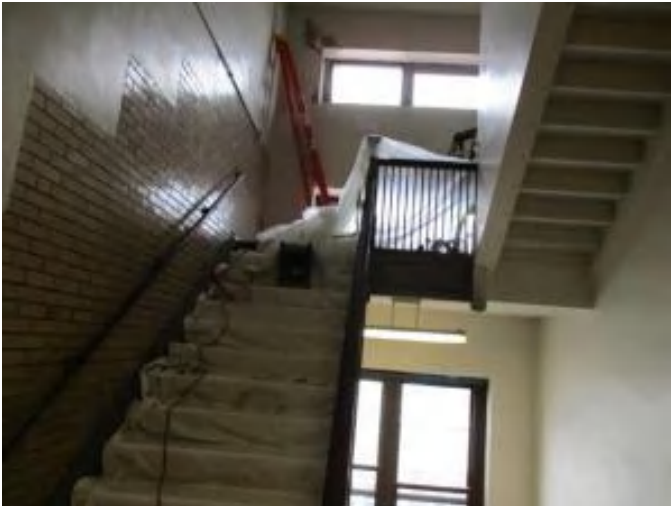
**Location:** TBD  
**Distress:** Accessibility  
**Category:** 2 - Code Compliance  
**Priority:** 2 - Response Time (2-3 yrs)  
**Correction:** Add external 4 stop elevator - adjust the electrical run lengths to hook up the elevator  
**Qty:** 1.00  
**Unit of Measure:** Ea.  
**Estimate:** \$1,012,601.25  
**Assessor Name:** System  
**Date Created:** 11/23/2015

**Notes:** Install elevator for accessibility ( location TBD)

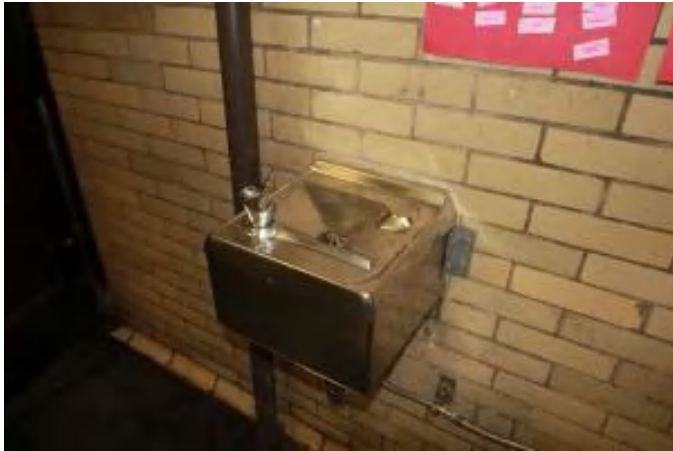
**Location:** Corridors

**Distress:** Accessibility

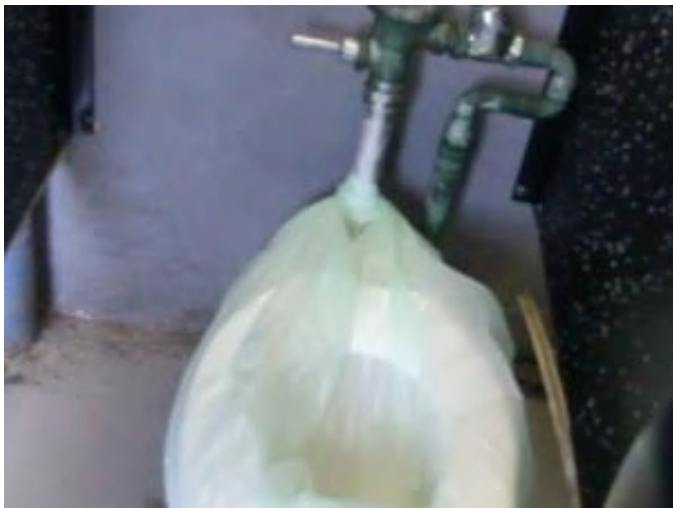
**Location:** Toilet rooms

**Distress:** Failing

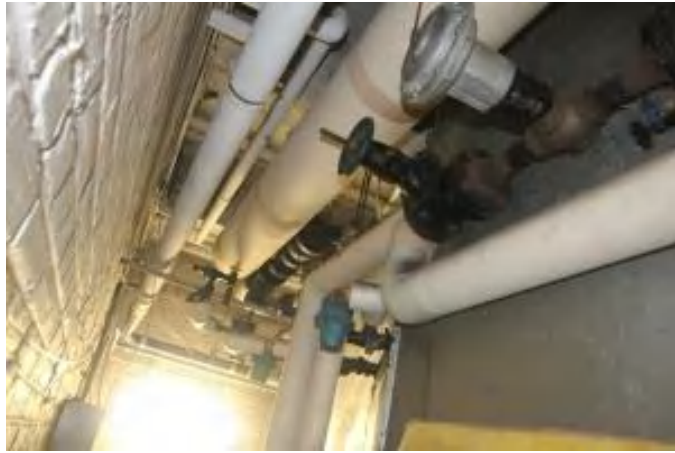
**Location:** Entire building

**Distress:** Obsolete

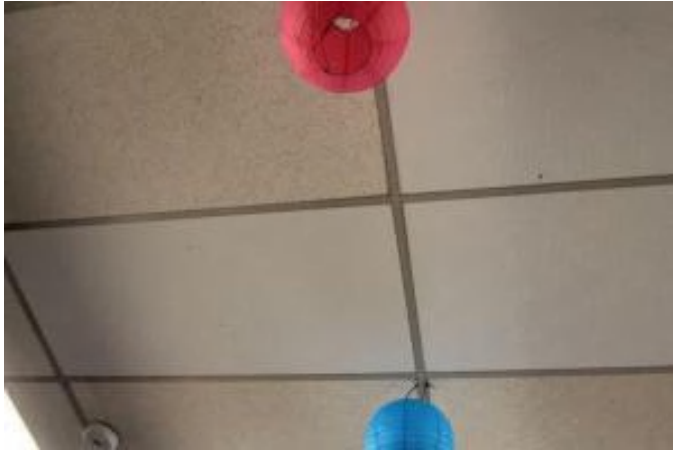
**Location:** Various

**Distress:** Beyond Service Life

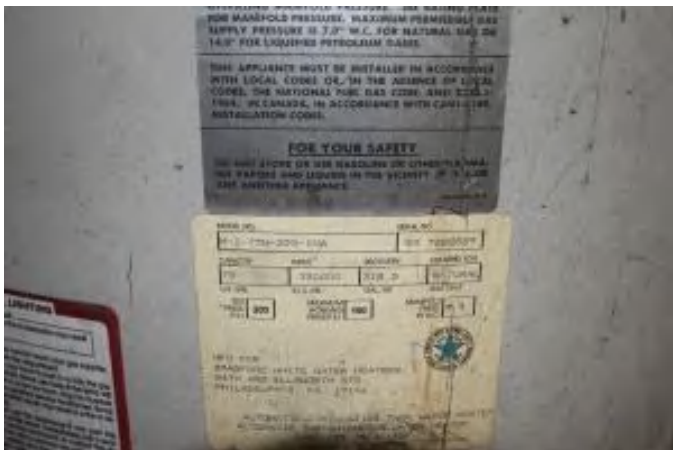
**Location:** Boiler room

**Distress:** Beyond Service Life

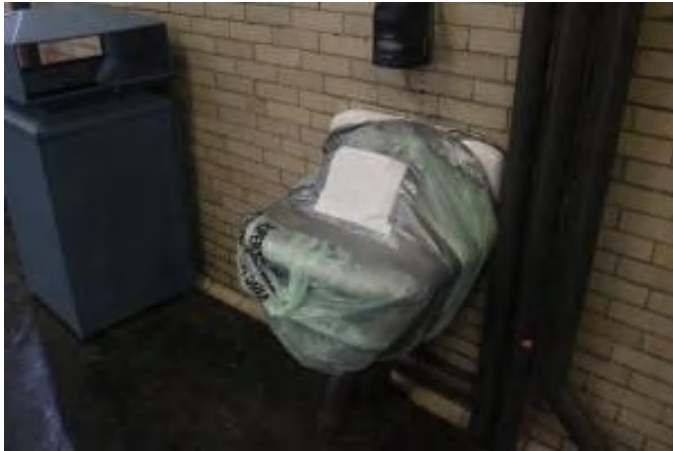
**Location:** Entire building

**Distress:** Failing

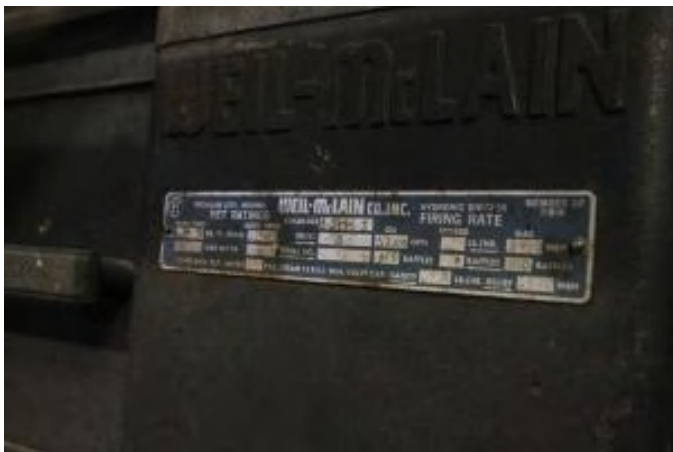
**Location:** Boiler room

**Distress:** Beyond Service Life

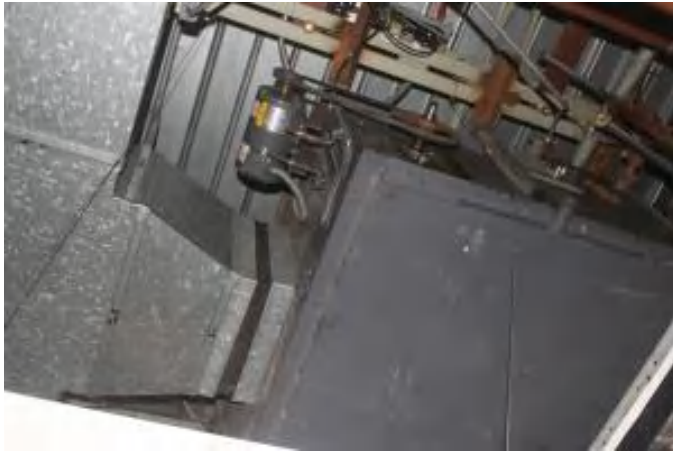
**Location:** Gym addition  
**Distress:** Beyond Service Life  
**Category:** 3 - Operations / Maint.  
**Priority:** 3 - Response Time (3-4 yrs)  
**Correction:** Replace HVAC unit for Gymnasium (single station)  
**Qty:** 8,400.00  
**Unit of Measure:** S.F.  
**Estimate:** \$318,465.50  
**Assessor Name:** System  
**Date Created:** 01/06/2016

**Notes:** Replace gymnasium HVAC to include cooling coils

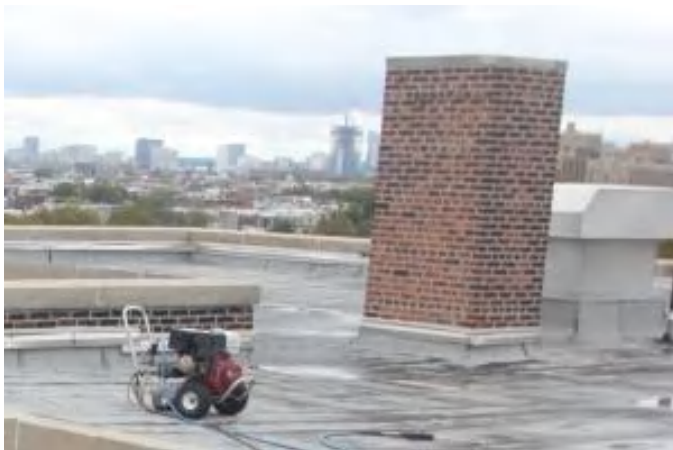
**Location:** Toilet rooms  
**Distress:** Building / MEP Codes  
**Category:** 2 - Code Compliance  
**Priority:** 3 - Response Time (3-4 yrs)  
**Correction:** Replace power roof ventilator (24" dia.)  
**Qty:** 3.00  
**Unit of Measure:** Ea.  
**Estimate:** \$65,156.45  
**Assessor Name:** System  
**Date Created:** 01/06/2016

**Notes:** Install rooftop exhaust fans to ventilate toilet room and remove odors

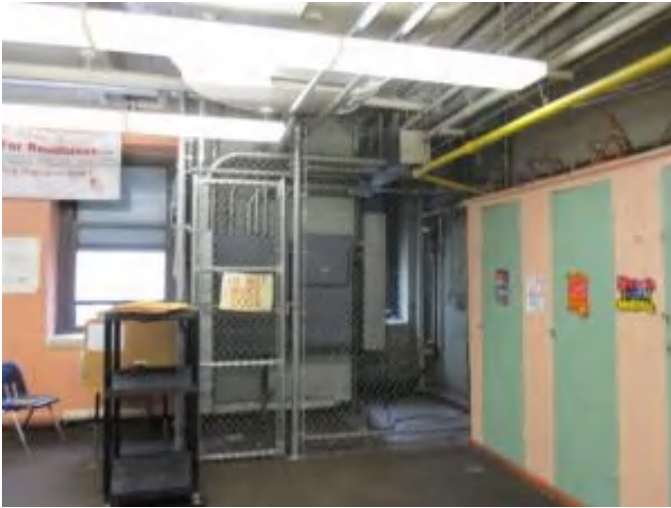
**Location:** Basement Fan Room

**Distress:** Inadequate

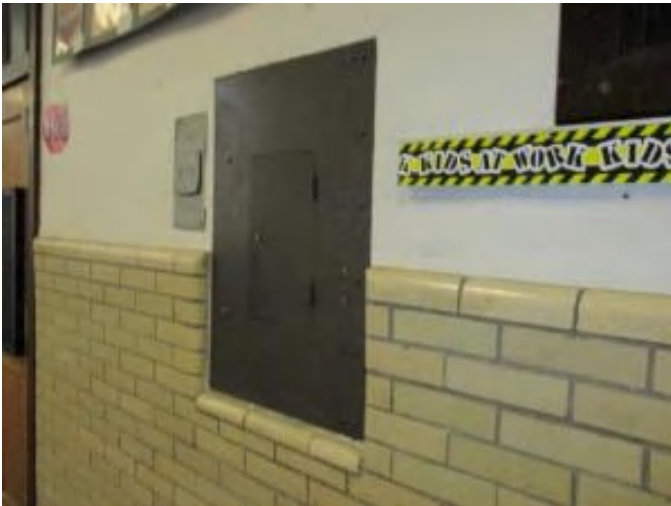
**Location:** Entire Building

**Distress:** Obsolete

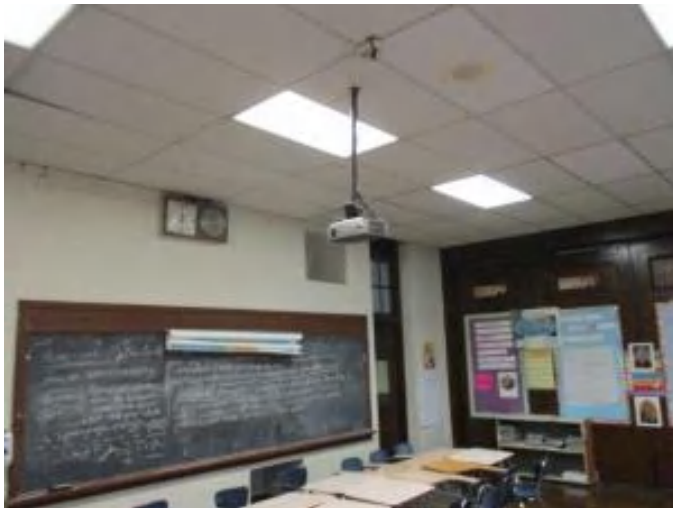
**Location:** Entire Building  
**Distress:** Inadequate  
**Category:** 4 - Capital Improvement  
**Priority:** 3 - Response Time (3-4 yrs)  
**Correction:** Add wiring device  
**Qty:** 320.00  
**Unit of Measure:** Ea.  
**Estimate:** \$117,558.72  
**Assessor Name:** System  
**Date Created:** 12/21/2015

**Notes:** Provide (2)25FT of surface raceways with receptacles spaced 24" on center/classroom and 4 wall mount receptacles/classroom. Approximate 320 receptacles.

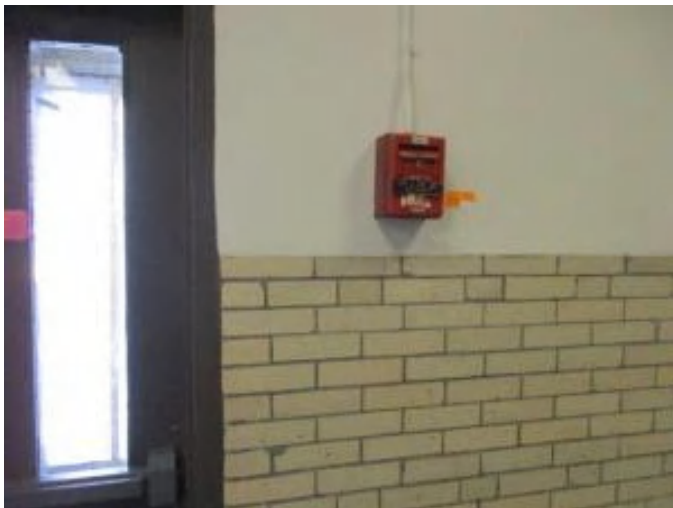
**Location:** Entire Building  
**Distress:** Life Safety / NFPA / PFD  
**Category:** 1 - Health & Safety  
**Priority:** 3 - Response Time (3-4 yrs)  
**Correction:** Replace fire alarm system  
**Qty:** 1.00  
**Unit of Measure:** S.F.  
**Estimate:** \$162,415.22  
**Assessor Name:** System  
**Date Created:** 12/21/2015

**Notes:** Replace old fire alarm system with addressable type with audio/visual devices at corridors and classrooms. Approximate 90 devices

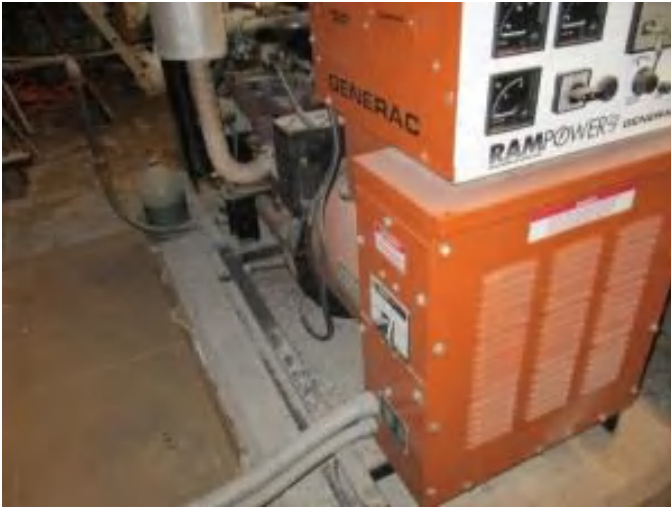
**Location:** Outdoor  
**Distress:** Inadequate  
**Category:** 4 - Capital Improvement  
**Priority:** 3 - Response Time (3-4 yrs)  
**Correction:** Add Standby Generator System  
**Qty:** 1.00  
**Unit of Measure:** Ea.  
**Estimate:** \$136,582.22  
**Assessor Name:** System  
**Date Created:** 12/21/2015

**Notes:** Provide 70KW, outdoor, diesel powered generator.

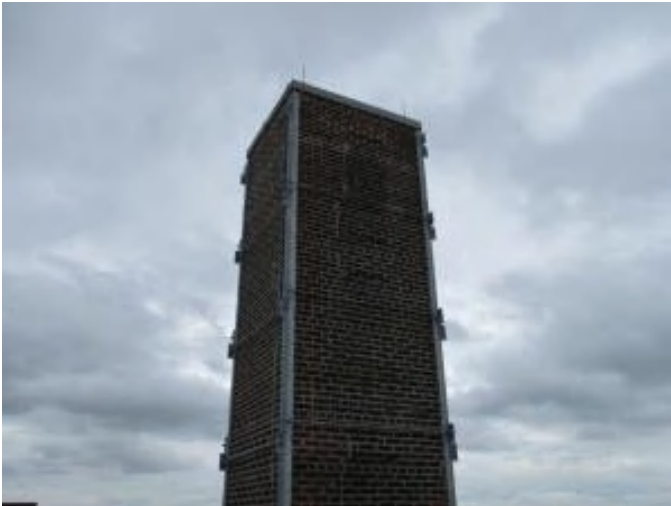
**Location:** Roof  
**Distress:** Building / MEP Codes  
**Category:** 2 - Code Compliance  
**Priority:** 3 - Response Time (3-4 yrs)  
**Correction:** Repair Lightning Protection System  
**Qty:** 1.00  
**Unit of Measure:** Job  
**Estimate:** \$24,249.82  
**Assessor Name:** System  
**Date Created:** 12/21/2015

**Notes:** Prepare a study to determine if the existing lightning system provide the proper protection to the school building.

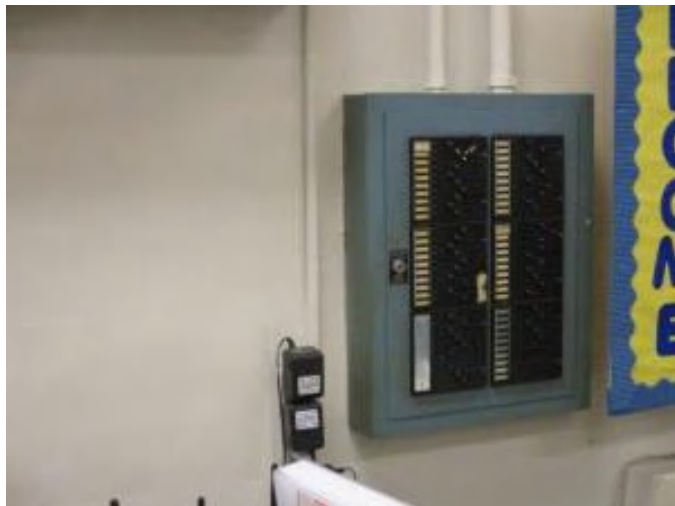
**Location:** Entire Building

**Distress:** Obsolete

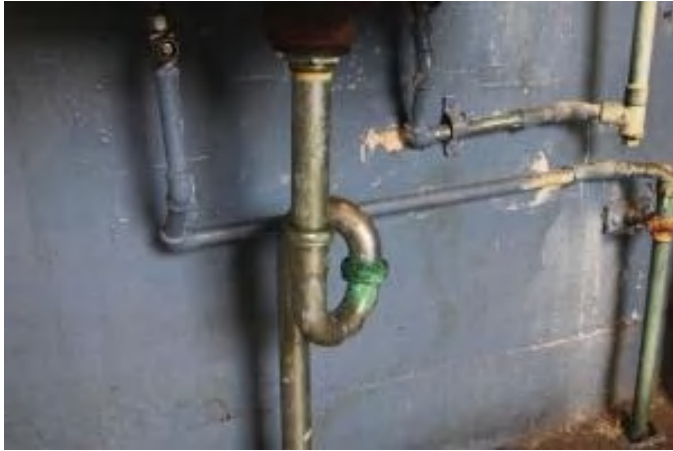
**Location:** Entire building

**Distress:** Beyond Service Life

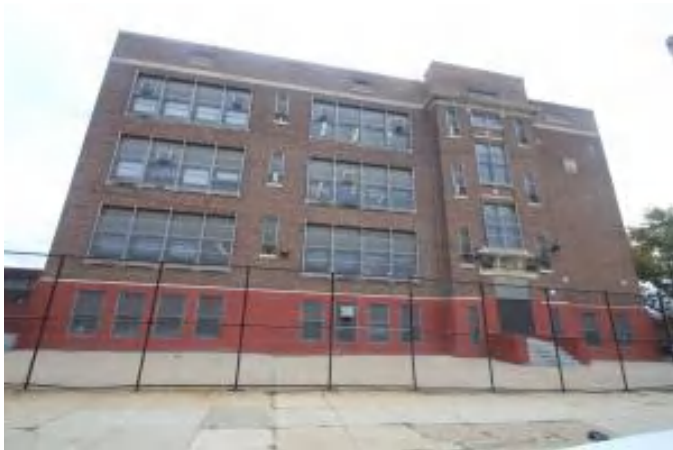
**Location:** Entire school

**Distress:** Inadequate

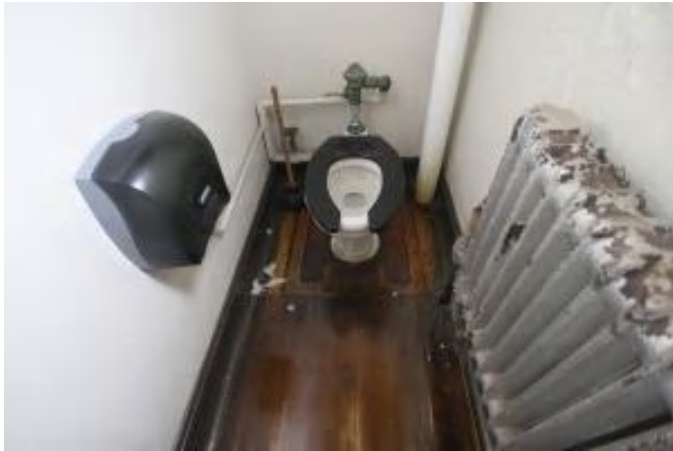
**Location:** Classrooms  
**Distress:** Beyond Service Life  
**Category:** 3 - Operations / Maint.  
**Priority:** 5 - Response Time (> 5 yrs)  
**Correction:** Replace finned tube radiation terminals (per 100 LF)  
**Qty:** 200.00  
**Unit of Measure:** L.F.  
**Estimate:** \$80,708.29  
**Assessor Name:** System  
**Date Created:** 01/07/2016

**Notes:** Replace radiators due to age

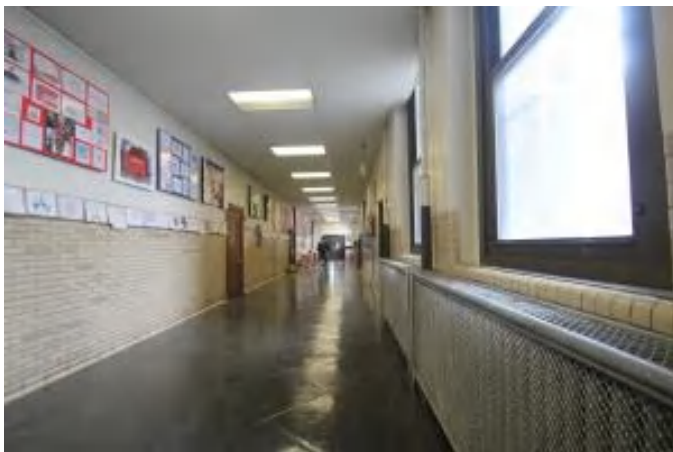
**Location:** Entire building  
**Distress:** Life Safety / NFPA / PFD  
**Category:** 1 - Health & Safety  
**Priority:** 5 - Response Time (> 5 yrs)  
**Correction:** Install a fire protection sprinkler system  
**Qty:** 66,000.00  
**Unit of Measure:** S.F.  
**Estimate:** \$944,159.46  
**Assessor Name:** System  
**Date Created:** 01/07/2016

**Notes:** Install fire suppression sprinkler system with pump if needed

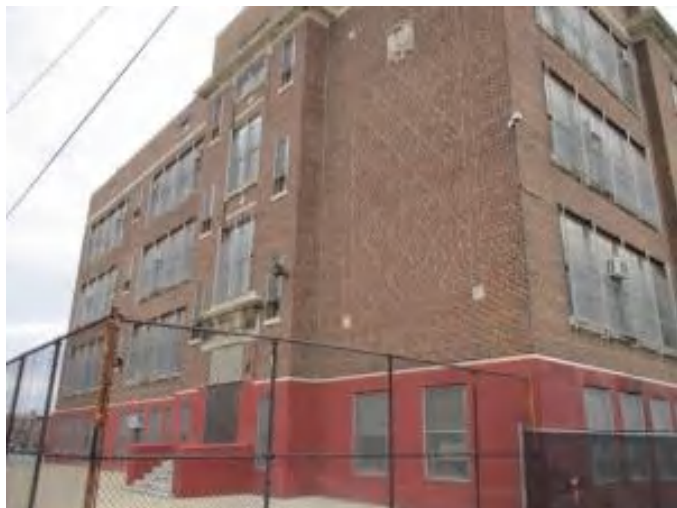
**Location:** Building Perimeter

**Distress:** Security Issue
