Facility Condition Assessment Summary Report

Taylor School

Taylor Annex (Our Lady of Pompei) School

S744001;Taylor

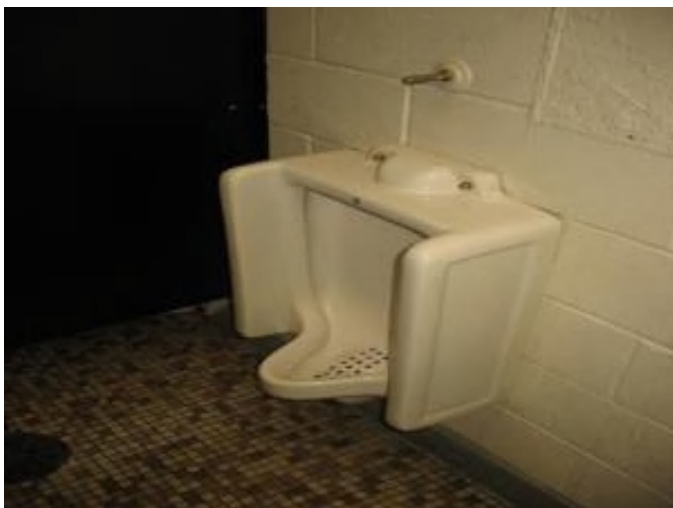
System: D2010 - Plumbing Fixtures

Location: Restrooms

Distress: Beyond Service Life

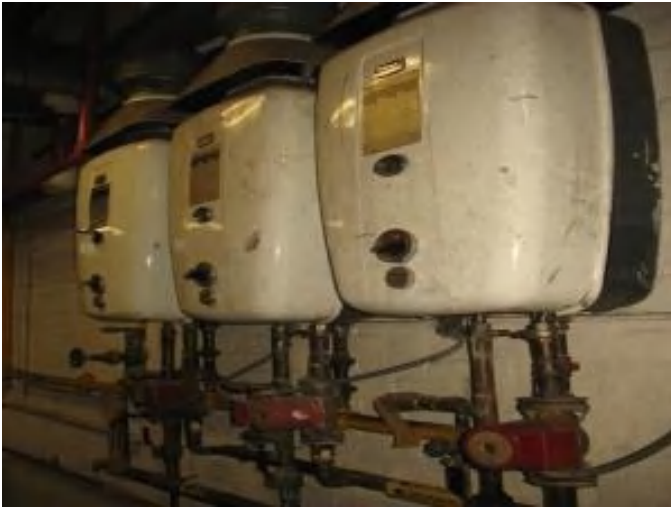
System: D2020 - Domestic Water Distribution

Location: Boiler room

Distress: Beyond Service Life

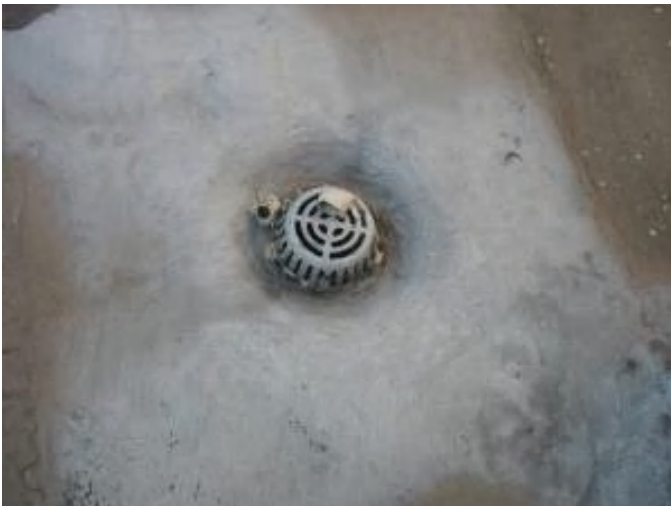
System: D2040 - Rain Water Drainage

Location: Throughout building

Distress: Beyond Service Life

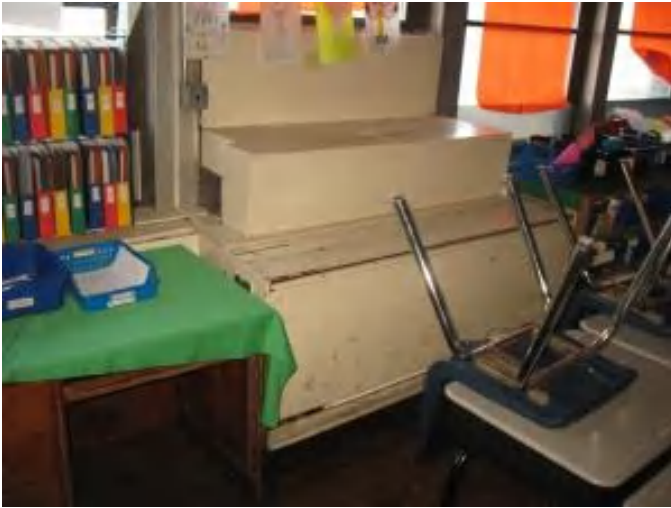
System: D3040 - Distribution Systems

Location: Classrooms

Distress: Beyond Service Life

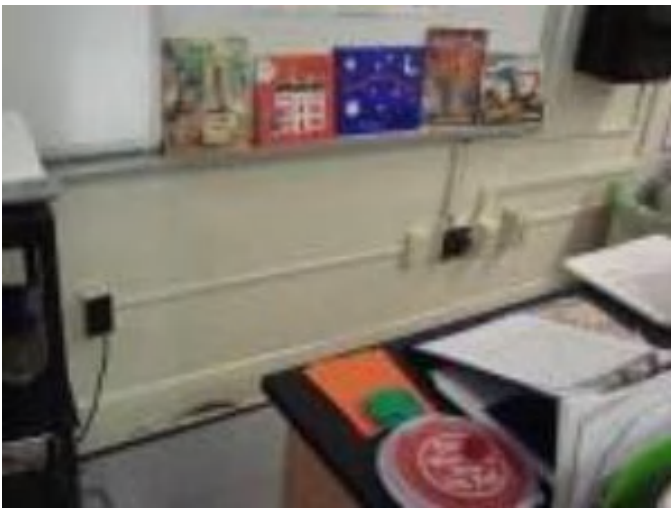
System: D5020 - Lighting and Branch Wiring

Location: throughout the building

Distress: Beyond Service Life

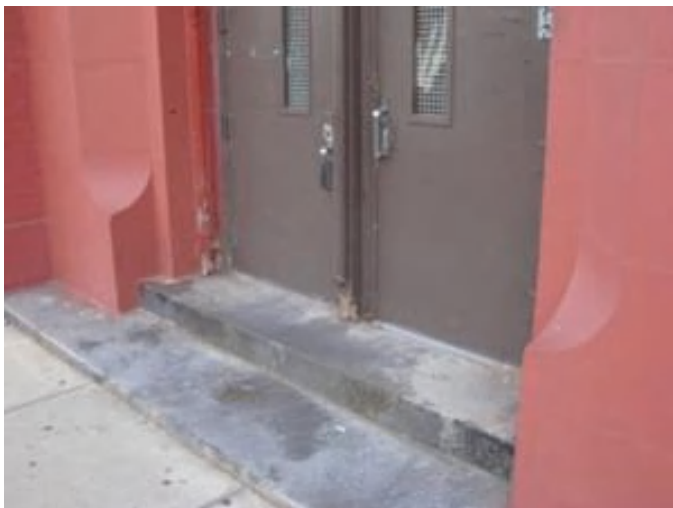
System: B2030 - Exterior Doors

Location: Exterior

Distress: Beyond Service Life

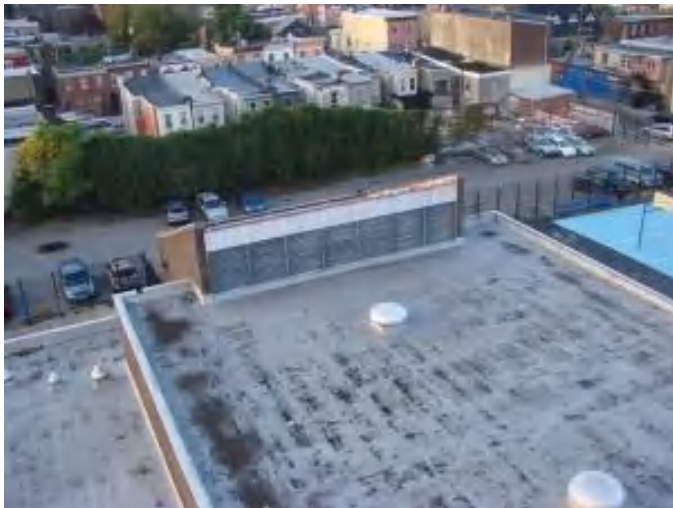
System: B3010130 - Preformed Metal Roofing

Location: Exterior

Distress: Beyond Service Life

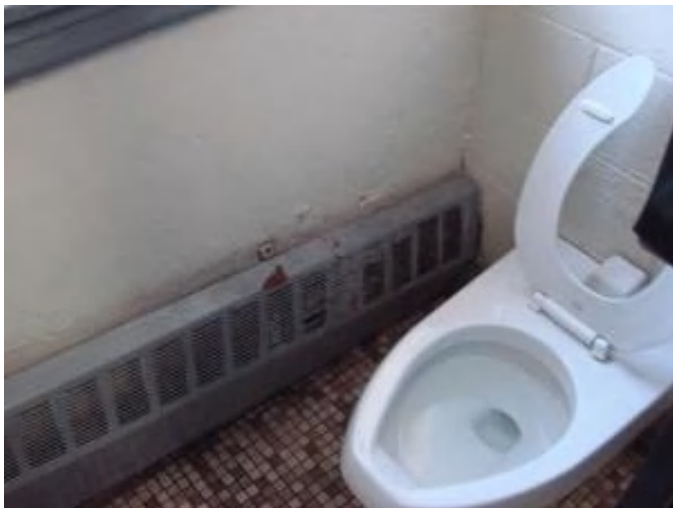
System: C1030 - Fittings

Location: Interior

Distress: Accessibility

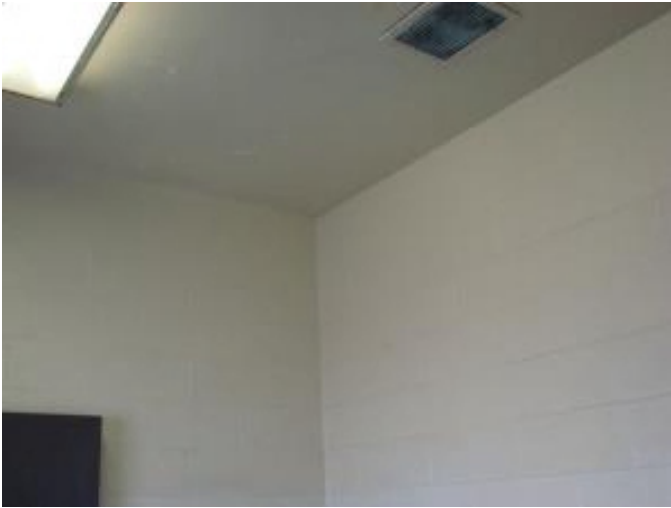
System: C3030 - Ceiling Finishes

Location: Interior

Distress: Beyond Service Life

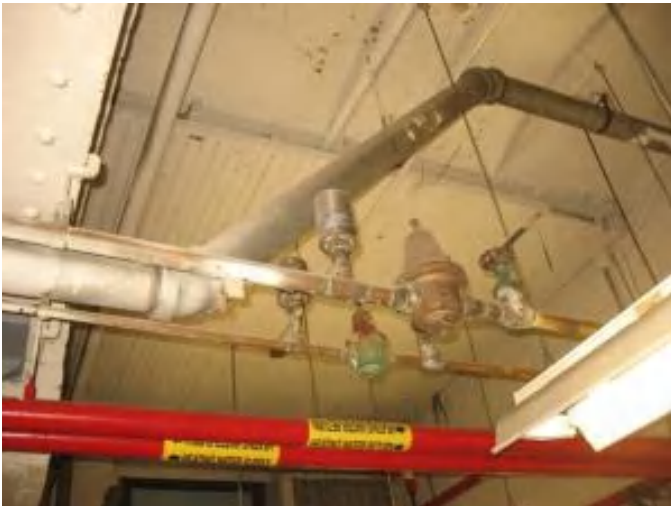
System: D2030 - Sanitary Waste

Location: Throughout building

Distress: Beyond Service Life

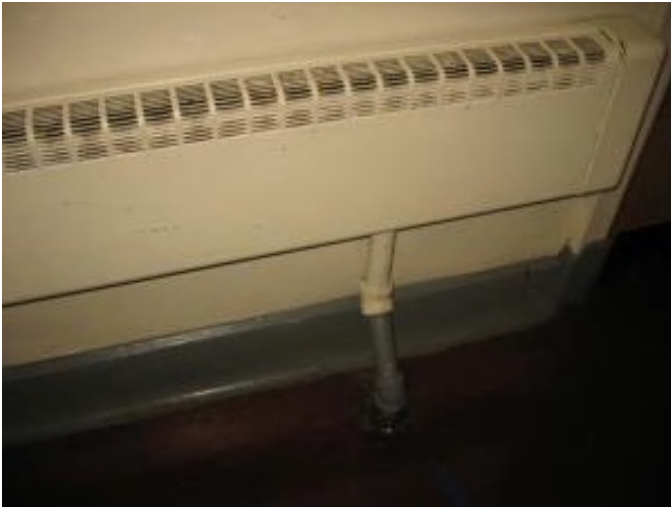
System: D3040 - Distribution Systems

Location: Throughout building

Distress: Beyond Service Life

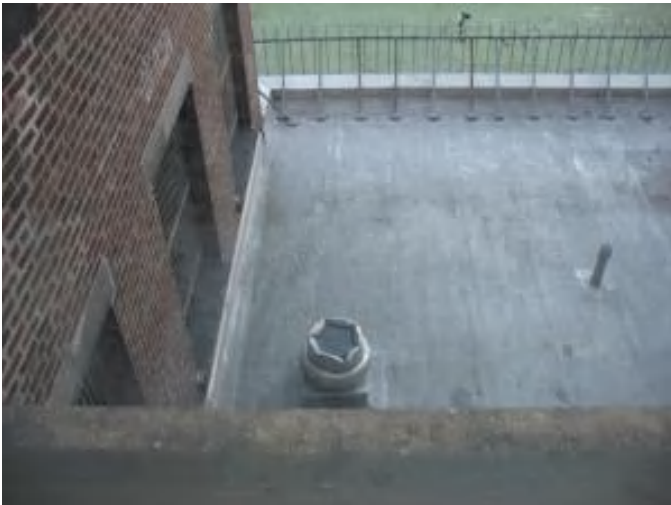
System: D3040 - Distribution Systems

Location: Roof

Distress: Damaged

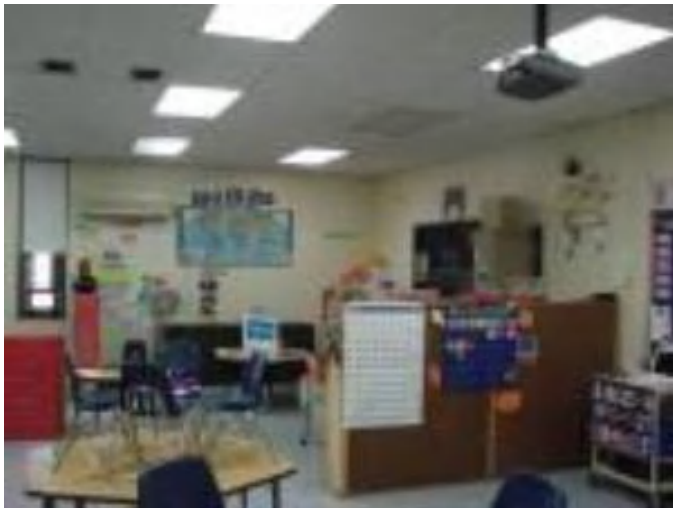
System: D5020 - Lighting and Branch Wiring

Location: throughout the building

Distress: Inadequate

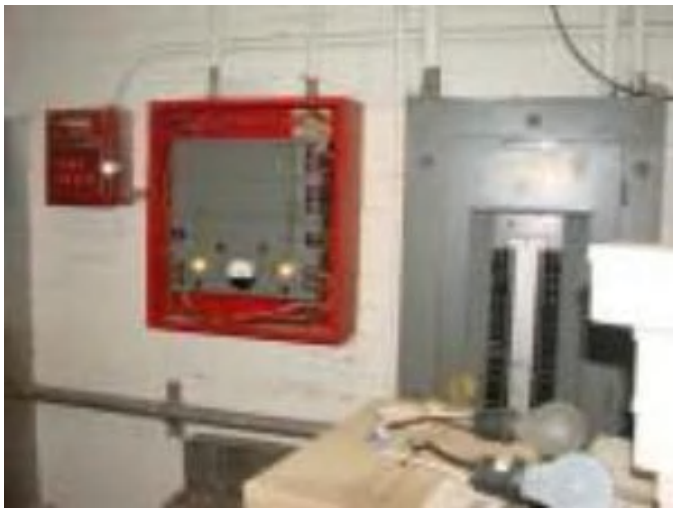
System: D5030 - Communications and Security

Location: throughout the building

Distress: Health Hazard / Risk

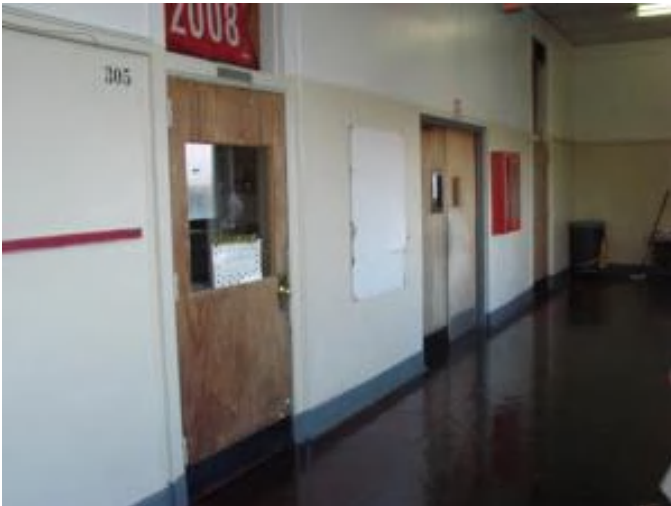
System: C1020 - Interior Doors

Location: Interior

Distress: Beyond Service Life

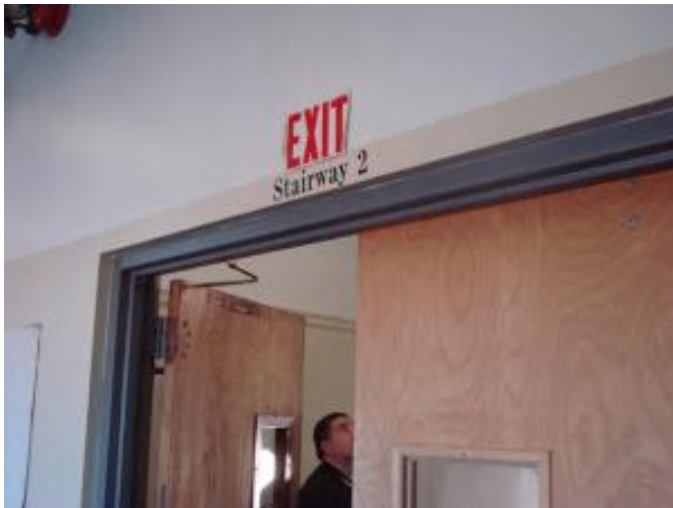
System: C1030 - Fittings

Location: Interior

Distress: Beyond Service Life

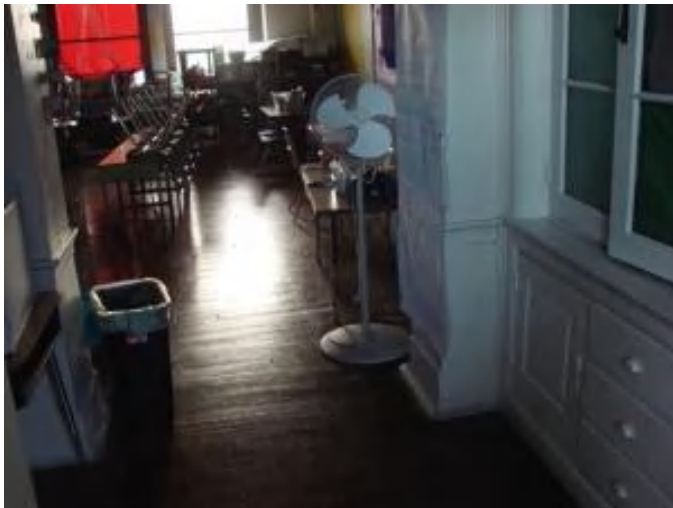
System: C3020414 - Wood Flooring

Location: Interior

Distress: Beyond Service Life

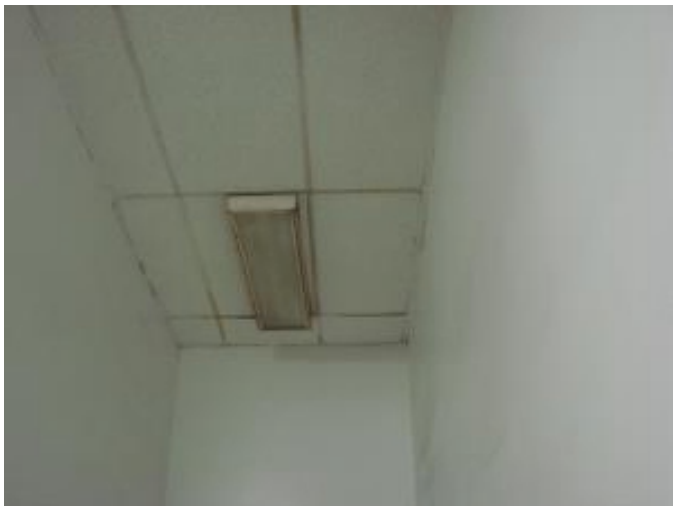
System: C3030 - Ceiling Finishes

Location: Interior

Distress: Beyond Service Life

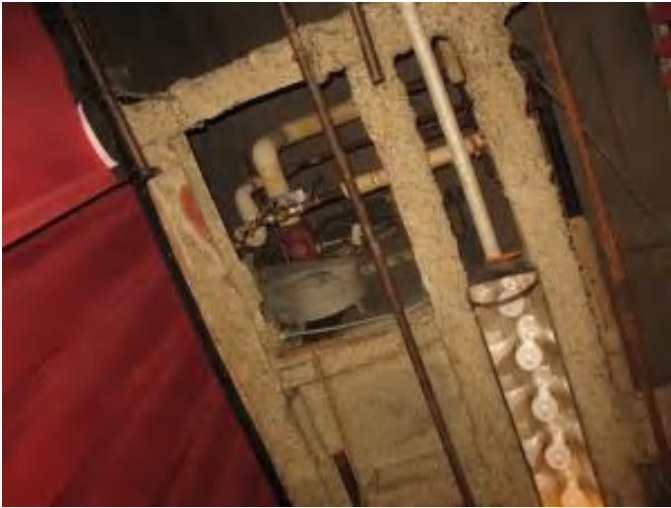
System: D3040 - Distribution Systems

Location: Gymnasium/Auditorium

Distress: Beyond Service Life

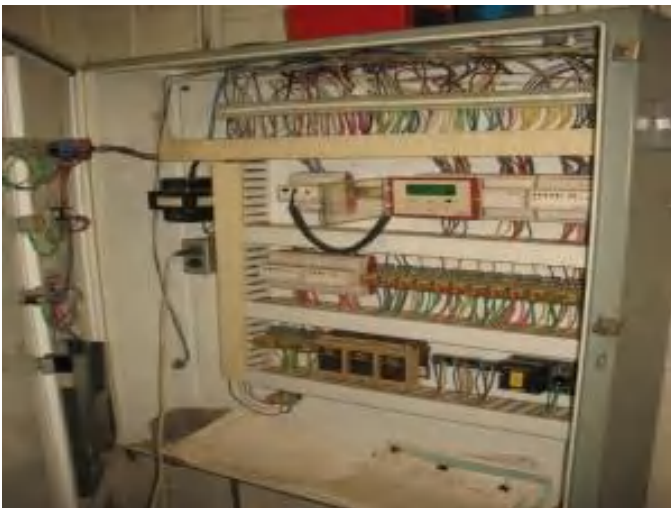
System: D3060 - Controls & Instrumentation

Location: Throughout building

Distress: Inadequate

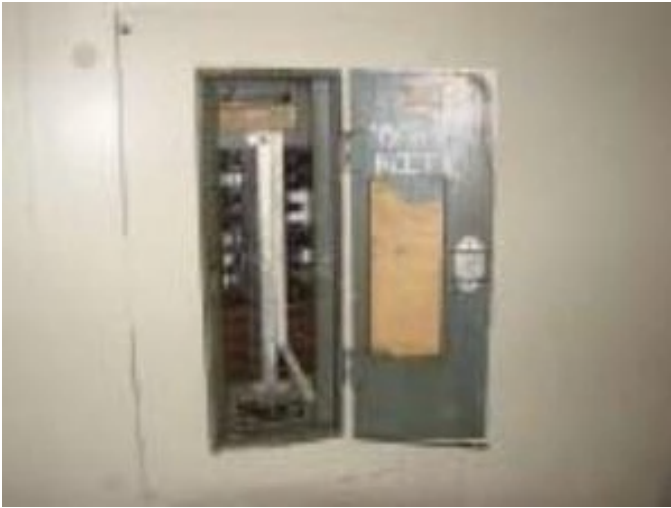
System: D5010 - Electrical Service/Distribution

Location: throughout the building

Distress: Beyond Service Life

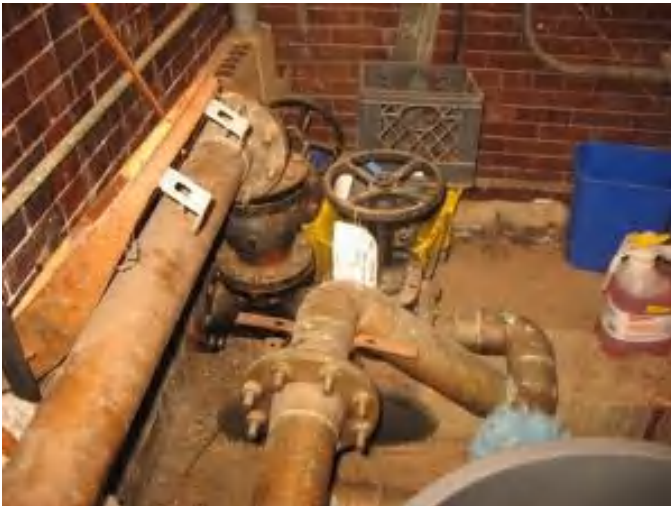
System: D2020 - Domestic Water Distribution

Location: Throughout building

Distress: Beyond Service Life

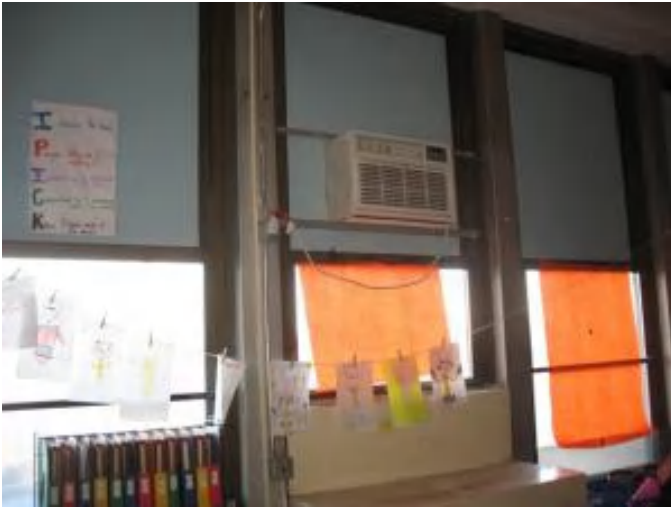
System: D3030 - Cooling Generating Systems

Location: Throughout building

Distress: Inadequate

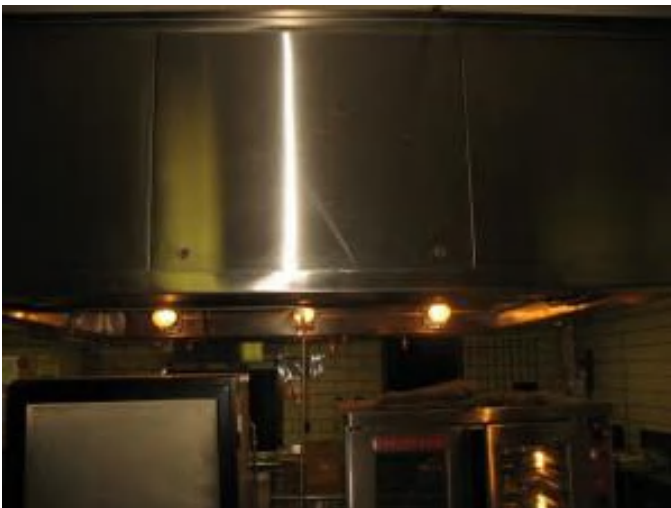
System: D3040 - Distribution Systems

Location: Kitchen

Distress: Inadequate

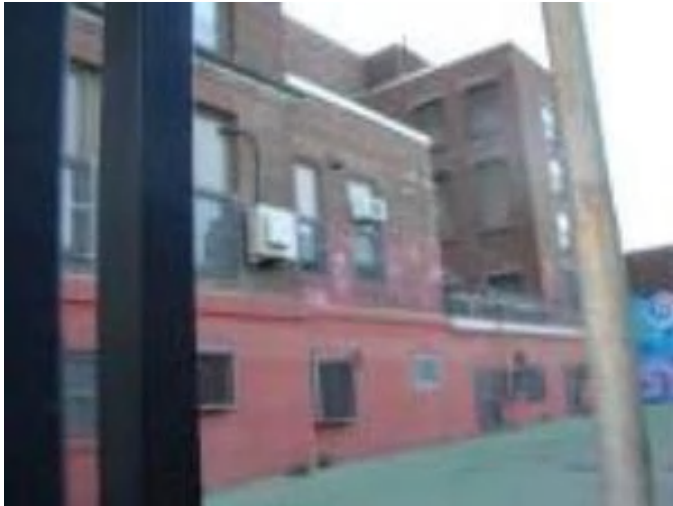
System: G4020 - Site Lighting

Location: Grounds

Distress: Inadequate

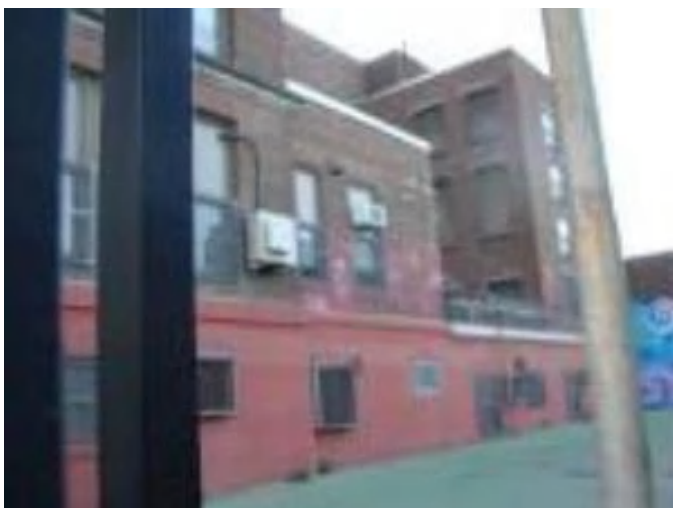
System: G4030 - Site Communications & Security

Location: Grounds

Distress: Inadequate
