Facility Condition Assessment Summary Report

The LINC (Clemente Middle) School

School District of Philadelphia
S773001;Clemente
Final
Site Assessment Report
February 1, 2017

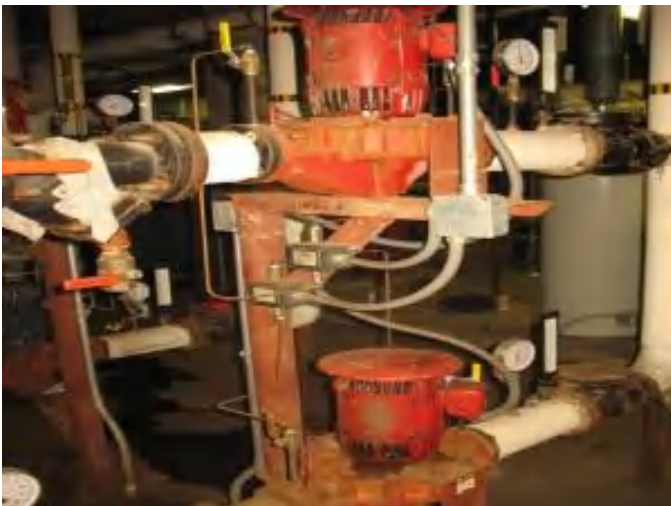
System: D3020 - Heat Generating Systems

Location: Basement mechanical room

Distress: Damaged

Notes: Replace four (4) 5HP in-line heating water supply pumps, CP-7, CP-8, CP-9, and CP-10, in the basement mechanical room which are damaged from rust and beyond their service life.

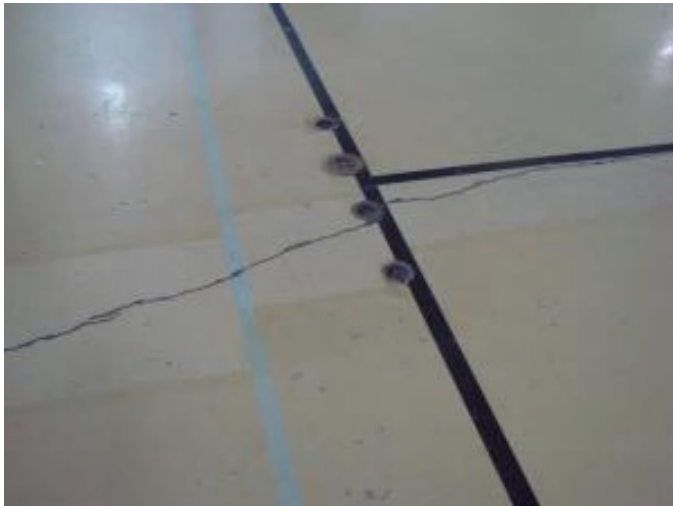
System: A1030 - Slab on Grade

Location: Interior/ Gym

Distress: Damaged

Notes: Repair cracks in gym slab

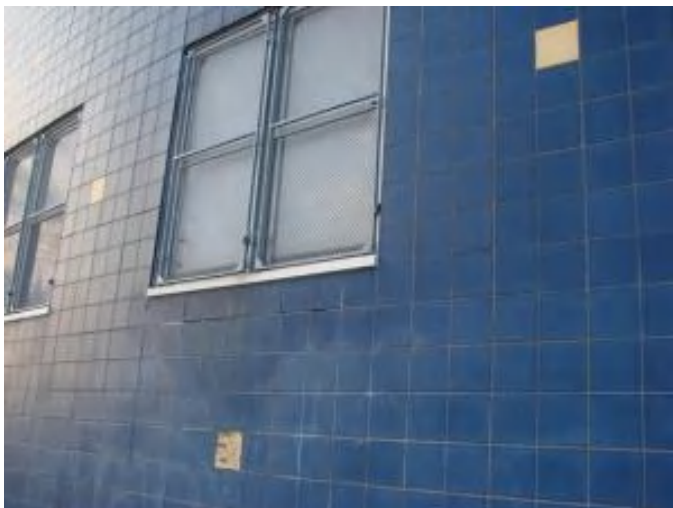
System: B2010 - Exterior Walls

Location: Exterior

Distress: Damaged

Notes: Tuck-point gazed CMU masonry

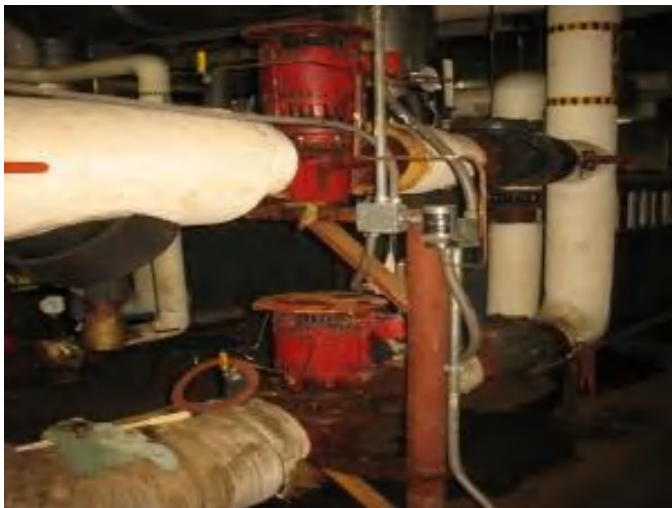
System: D3020 - Heat Generating Systems

Location: Basement mechanical room

Distress: Damaged

Notes: Replace four (4) 1.5HP in-line dual temperature and heating water supply pumps, CP-5, CP-6, CP-11, and CP-12, in the basement mechanical room which are damaged from rust and beyond their service life.

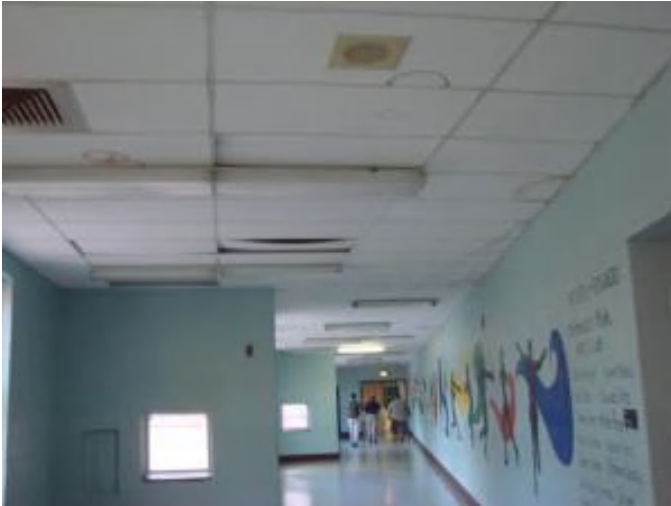
System: C3030 - Ceiling Finishes

Location: Interior

Distress: Damaged

Notes: Replace damaged acoustical ceilings

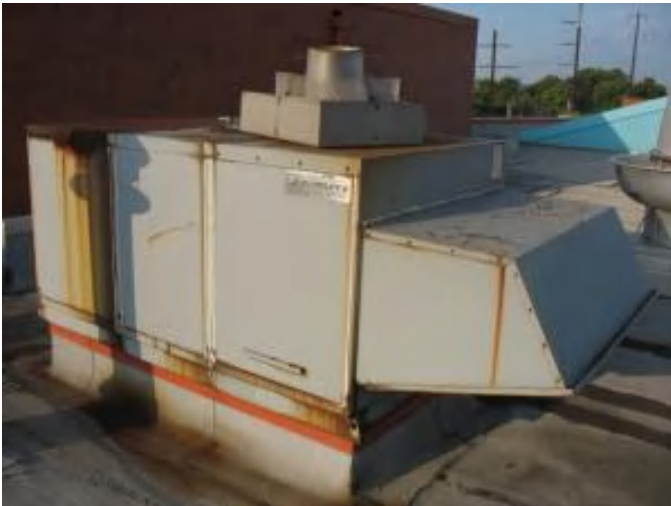
System: D3040 - Distribution Systems

Location: Roof

Distress: Failing

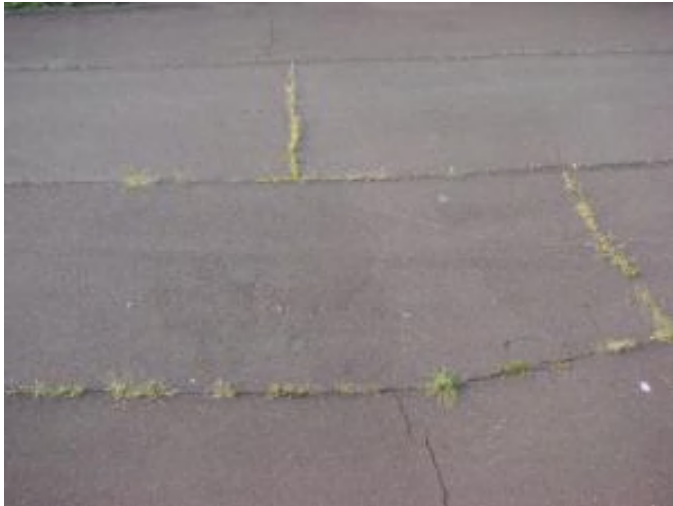
System: G2020 - Parking Lots

Location: Grounds/ site

Distress: Beyond Service Life

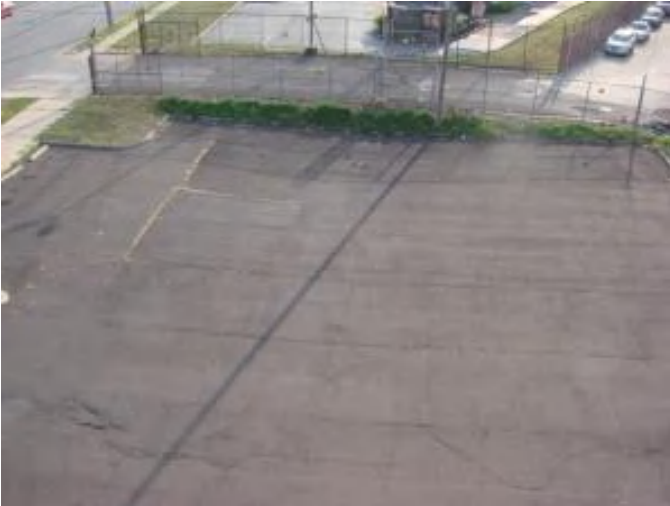
System: G2020 - Parking Lots

Location: Grounds/ site

Distress: Beyond Service Life

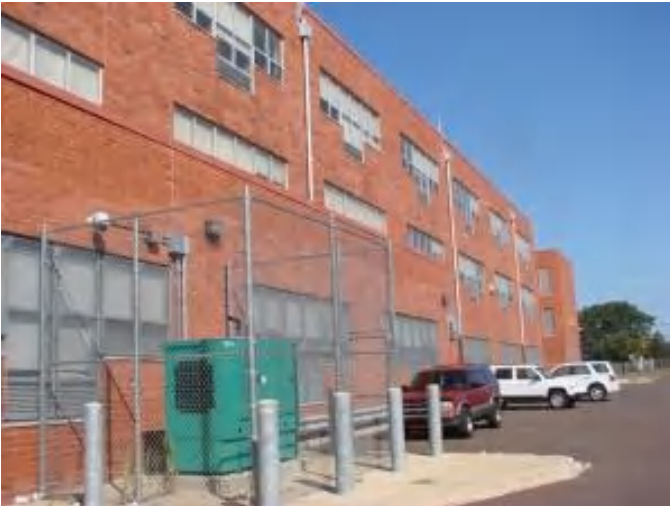
System: G4030 - Site Communications & Security

Location: Grounds

Distress: Inadequate
