## Facility Condition Assessment Summary Report

### The U School (Ferguson) School

School District of Philadelphia  
**S529001;Ferguson**  
Final  
**Site Assessment Report**

February 2, 2017

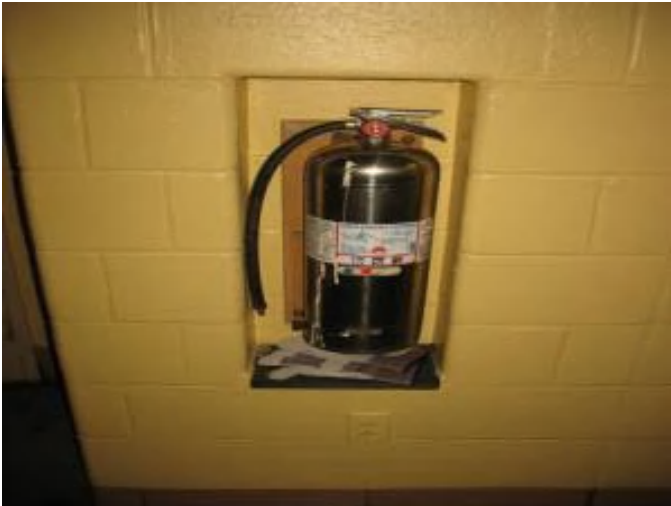
#### **System: D4010 - Sprinklers**

**Location:** Throughout building

**Distress:** Life Safety / NFPA / PFD

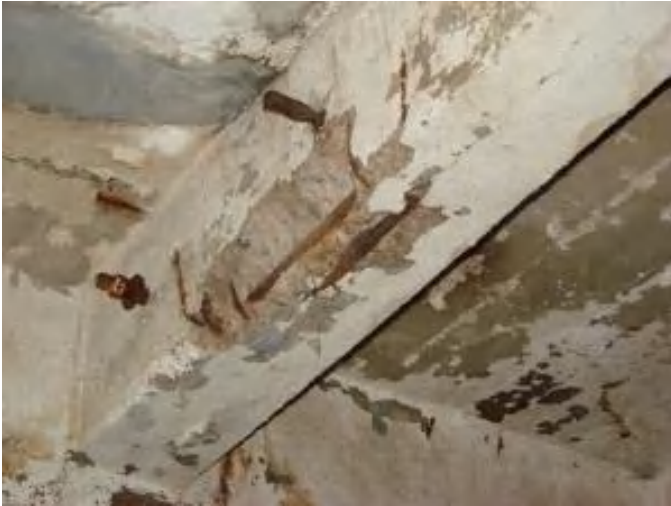
**System: B1010 - Floor Construction**

**Location:** Interior/ Basement

**Distress:** Damaged

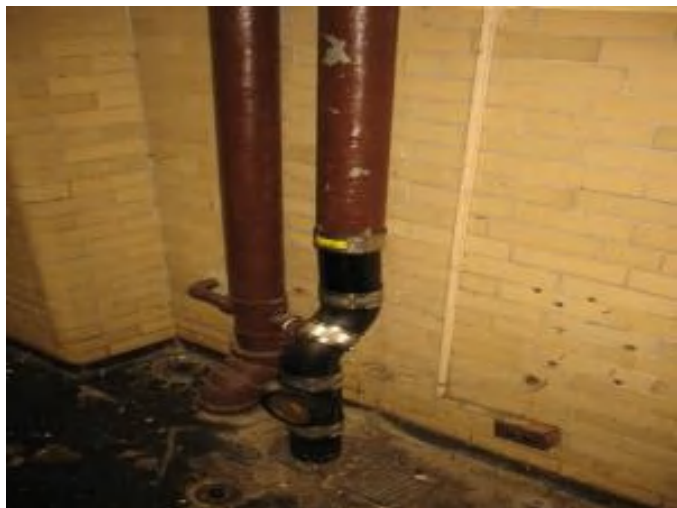
**System: D2030 - Sanitary Waste**

**Location:** Throughout building

**Distress:** Beyond Service Life

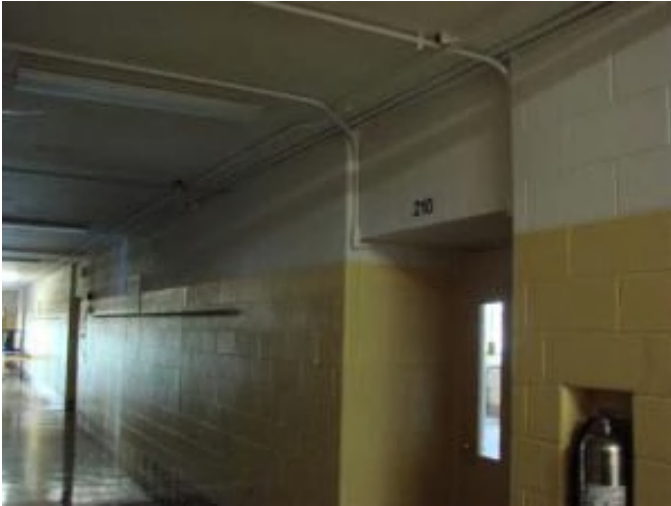
**System: C1020 - Interior Doors**

**Location:** Interior

**Distress:** Accessibility

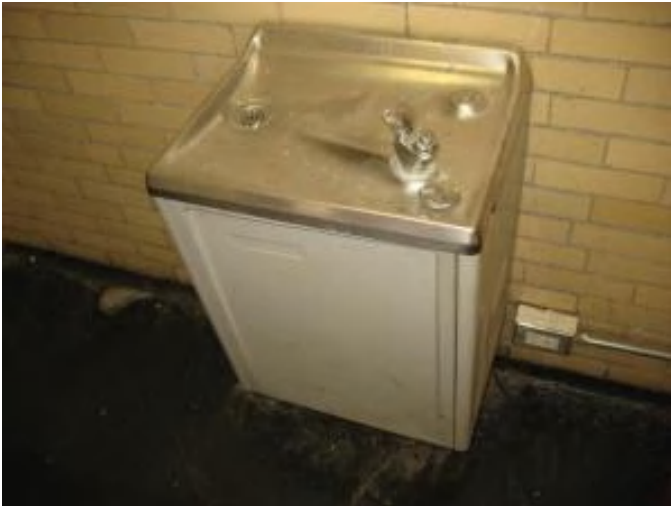
**System: D2010 - Plumbing Fixtures**

**Location:** Corridors

**Distress:** Beyond Service Life

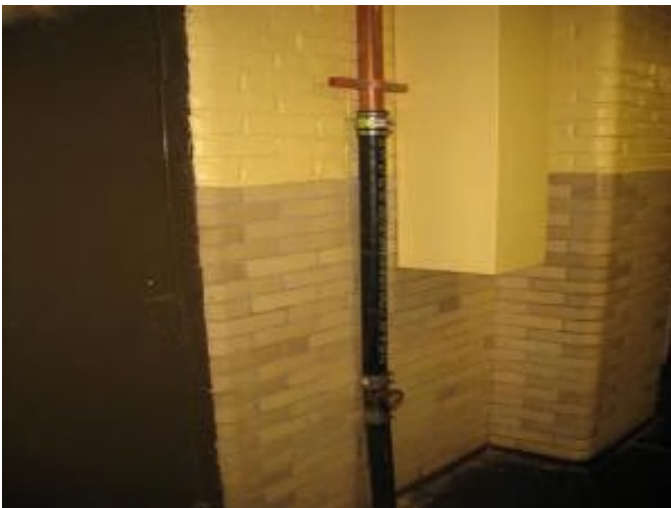
**System: D2020 - Domestic Water Distribution**

**Location:** Throughout building

**Distress:** Beyond Service Life

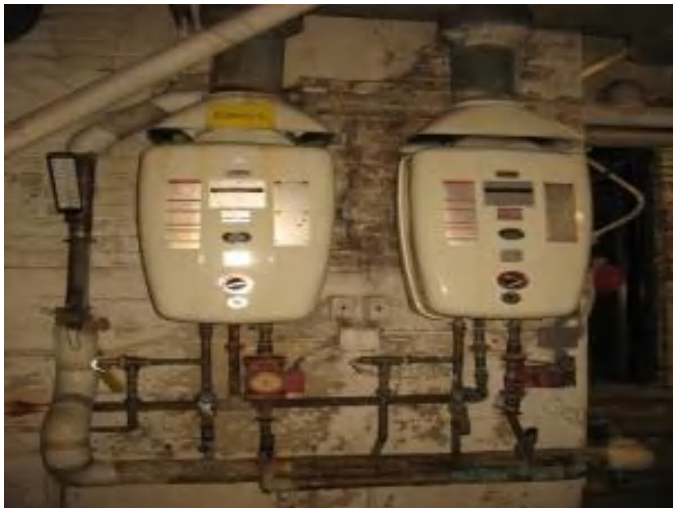
**System: D2020 - Domestic Water Distribution**

**Location:** Boiler room  
**Distress:** Beyond Service Life  
**Category:** 3 - Operations / Maint.  
**Priority:** 3 - Response Time (3-4 yrs)  
**Correction:** Replace instantaneous water heater  
**Qty:** 2.00  
**Unit of Measure:** Ea.  
**Estimate:** \$48,947.09  
**Assessor Name:** System  
**Date Created:** 09/10/2015

**Notes:** Replace existing Paloma gas fired instant hot water heaters with new gas fired instant hot water heaters.

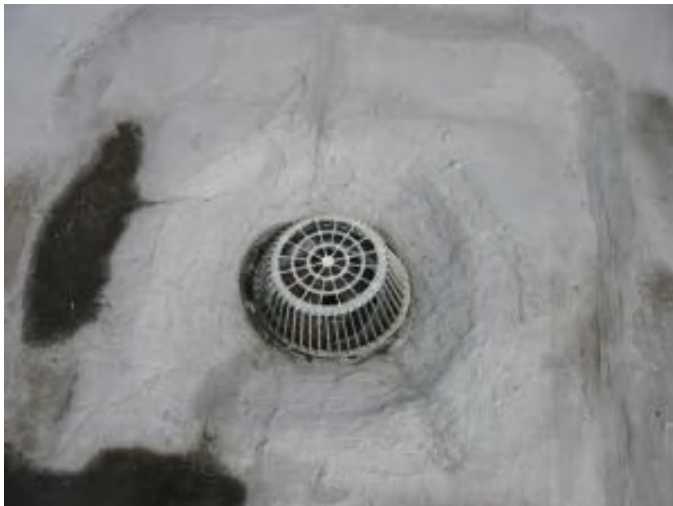
**System: D2040 - Rain Water Drainage**

**Location:** Roof  
**Distress:** Beyond Service Life  
**Category:** 3 - Operations / Maint.  
**Priority:** 3 - Response Time (3-4 yrs)  
**Correction:** Replace roof drains - per drain including piping  
**Qty:** 3.00  
**Unit of Measure:** Ea.  
**Estimate:** \$77,113.48  
**Assessor Name:** System  
**Date Created:** 09/10/2015

**Notes:** Hire a qualified contractor to perform a detailed examination of the rain water drainage piping using visual inspection and video cameras to locate and replace any damaged piping and to further quantify the extent of potential failures.

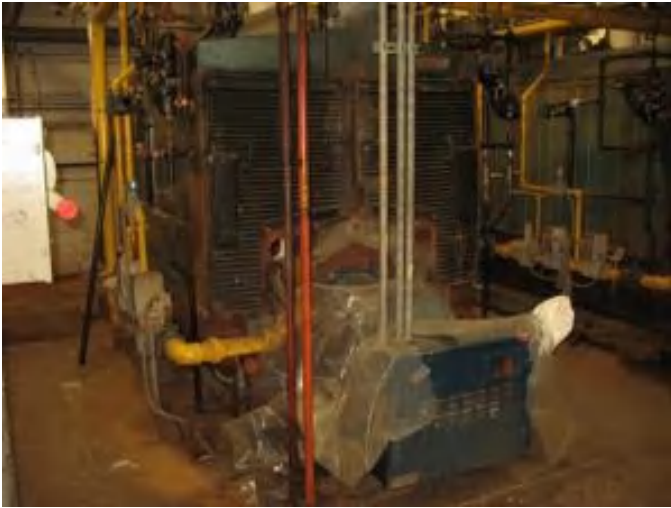
**System: D3020 - Heat Generating Systems**

**Location:** Boiler room  
**Distress:** Beyond Service Life  
**Category:** 3 - Operations / Maint.  
**Priority:** 3 - Response Time (3-4 yrs)  
**Correction:** Replace boiler, cast iron sectional (150 HP)  
**Qty:** 3.00  
**Unit of Measure:** Ea.  
**Estimate:** \$1,575,182.49  
**Assessor Name:** System  
**Date Created:** 09/10/2015

**Notes:** Replace the three existing cast iron boilers with three new 150HP boilers, which should be sufficient to heat the building. All burners and exhaust ductwork should be replaced as well.

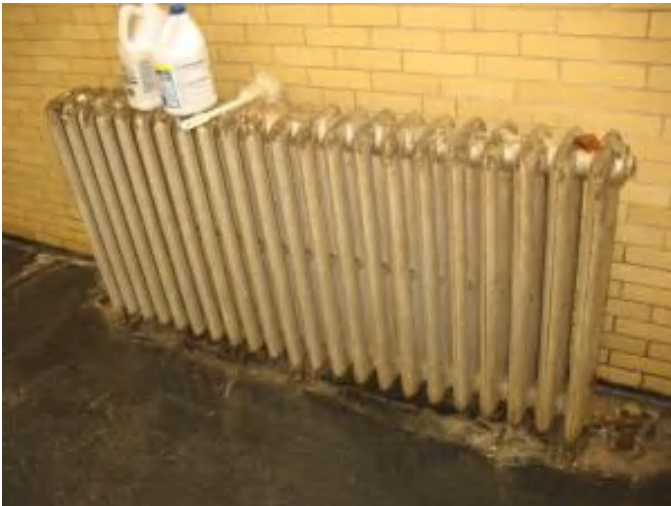
**System: D3040 - Distribution Systems**

**Location:** Throughout building  
**Distress:** Beyond Service Life  
**Category:** 3 - Operations / Maint.  
**Priority:** 3 - Response Time (3-4 yrs)  
**Correction:** Provide classroom FC units and dedicated OA ventilation system. (20 clsrms)  
**Qty:** 26.00  
**Unit of Measure:** C  
**Estimate:** \$2,159,585.75  
**Assessor Name:** System  
**Date Created:** 09/10/2015

**Notes:** Remove the existing cast iron steam radiators and install units with hot and chilled water coils and integral heat exchangers to introduce outdoor air to the building.

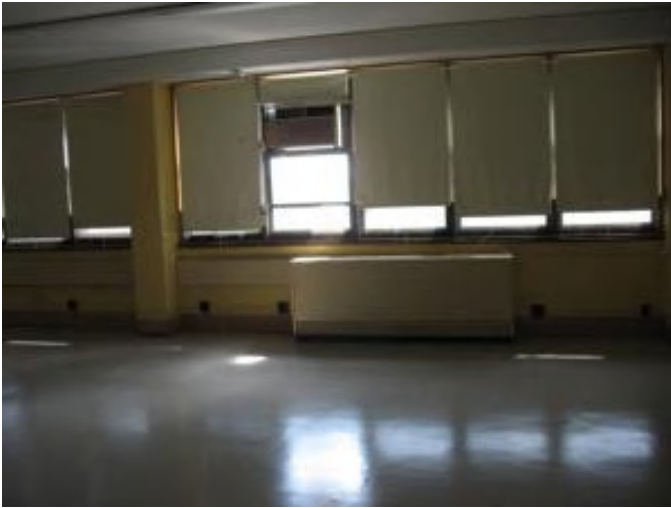
**System: D3040 - Distribution Systems**

**Location:** Classrooms

**Distress:** Beyond Service Life

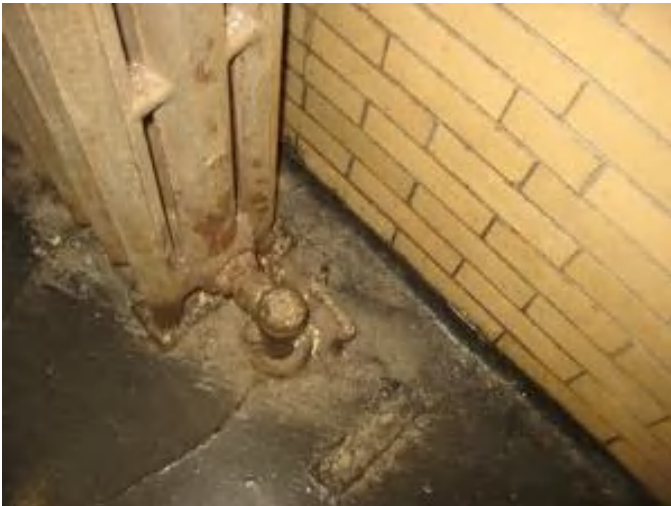
**System: D3040 - Distribution Systems**

**Location:** Throughout building

**Distress:** Beyond Service Life

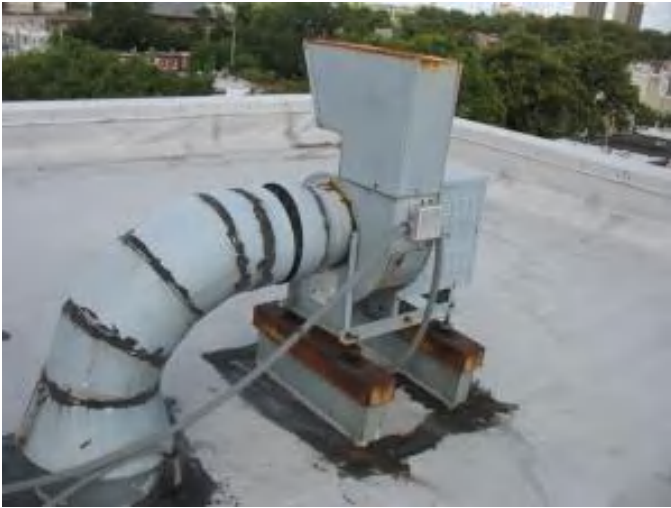
**System: D3040 - Distribution Systems**

**Location:** Roof  
**Distress:** Beyond Service Life  
**Category:** 3 - Operations / Maint.  
**Priority:** 3 - Response Time (3-4 yrs)  
**Correction:** Replace utility set exhaust fan (5 HP)  
**Qty:** 3.00  
**Unit of Measure:** Ea.  
**Estimate:** \$82,594.59  
**Assessor Name:** System  
**Date Created:** 09/10/2015

**Notes:** Replace three (3) existing roof mounted exhaust fans serving the restrooms and utilize the existing ductwork.

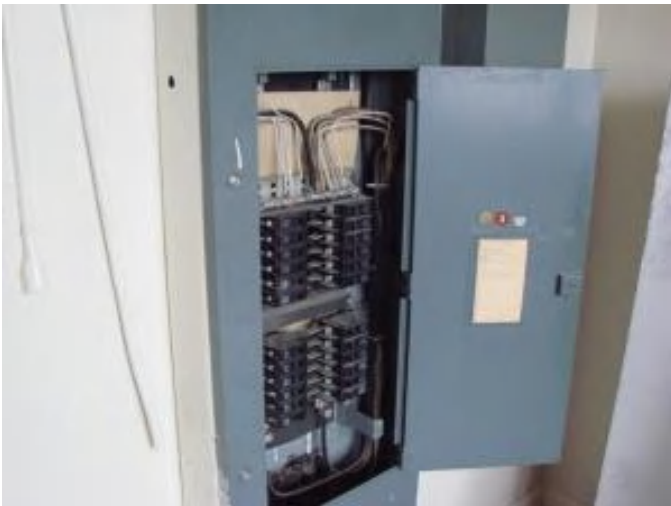
**System: D5010 - Electrical Service/Distribution**

**Location:** throughout the building  
**Distress:** Beyond Service Life  
**Category:** 3 - Operations / Maint.  
**Priority:** 3 - Response Time (3-4 yrs)  
**Correction:** Replace Electrical Distribution System (U)  
**Qty:** 1.00  
**Unit of Measure:** Ea.  
**Estimate:** \$840,055.40  
**Assessor Name:** System  
**Date Created:** 11/19/2015

**Notes:** Install new 480V, 3 phase switchgear.  
Install a new MCC for the new HVAC loads.  
Install new 120V panel-boards throughout the building for lighting, and receptacles loads.

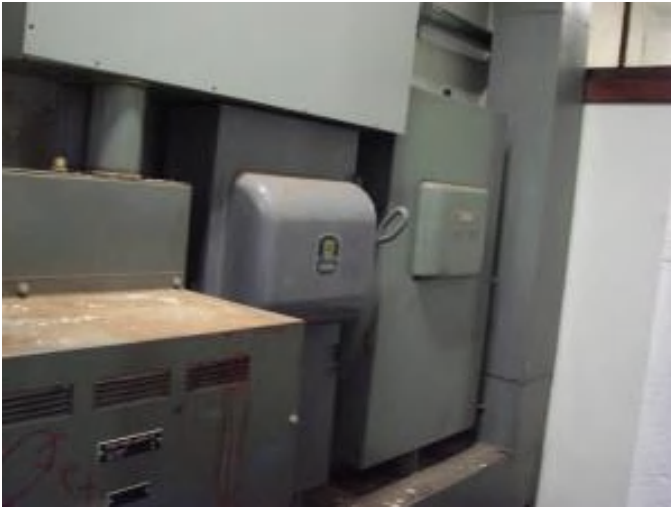
**System: D5010 - Electrical Service/Distribution**

**Location:** electrical room  
**Distress:** Beyond Service Life  
**Category:** 3 - Operations / Maint.  
**Priority:** 3 - Response Time (3-4 yrs)  
**Correction:** Replace unit substation  
**Qty:** 1.00  
**Unit of Measure:** Ea.  
**Estimate:** \$433,193.31  
**Assessor Name:** System  
**Date Created:** 11/19/2015

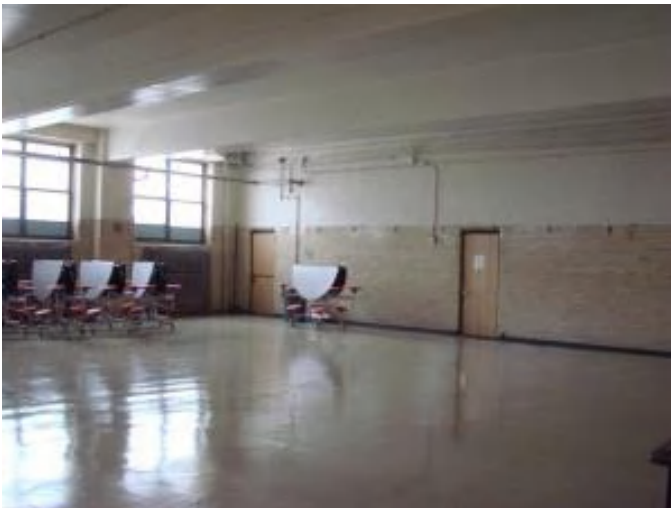
**System: D5020 - Lighting and Branch Wiring**

**Location:** throughout the building  
**Distress:** Beyond Service Life  
**Category:** 3 - Operations / Maint.  
**Priority:** 3 - Response Time (3-4 yrs)  
**Correction:** Replace Lighting Fixtures (SF)  
**Qty:** 0.00  
**Unit of Measure:** S.F.  
**Estimate:** \$1,283,568.63  
**Assessor Name:** System  
**Date Created:** 11/20/2015

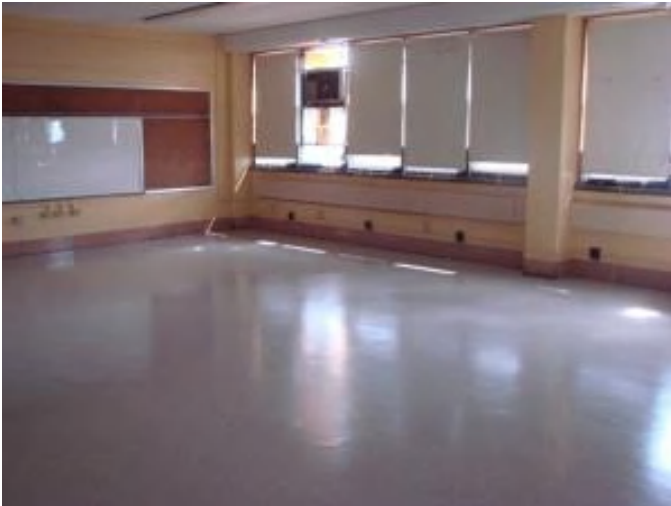
**System: D5020 - Lighting and Branch Wiring**

**Location:** throughout the building

**Distress:** Beyond Service Life

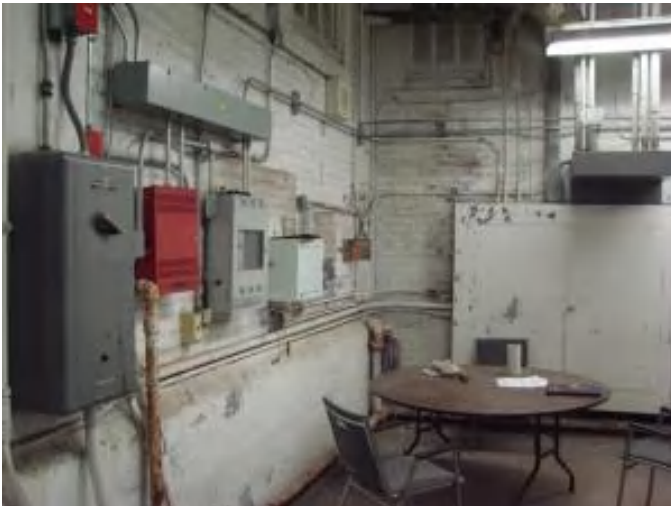
**System: D5030 - Communications and Security**

**Location:** throughout the building

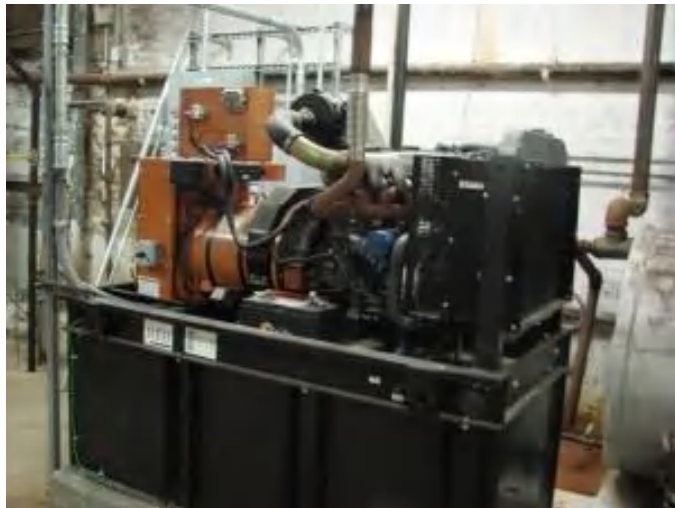
**System: D5090 - Other Electrical Systems**

**Location:** electrical room

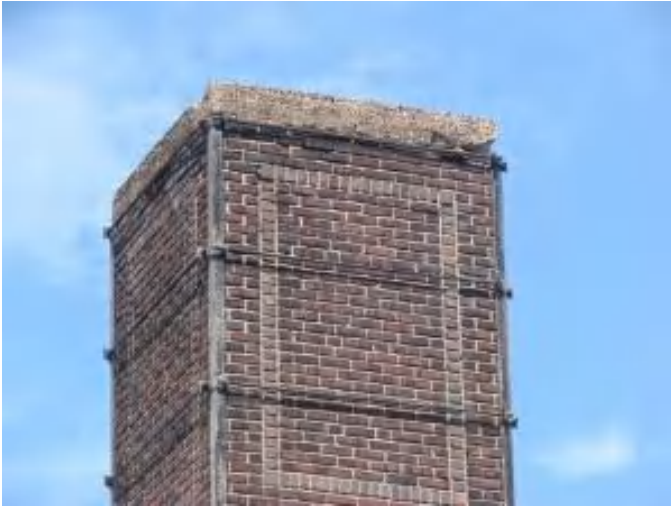
**System: B2010 - Exterior Walls**

**Location:** Exterior

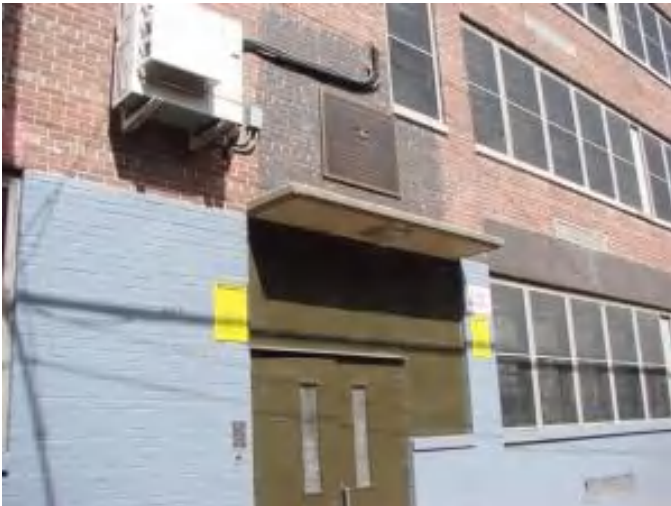
**System: B2030 - Exterior Doors**

**Location:** Exterior

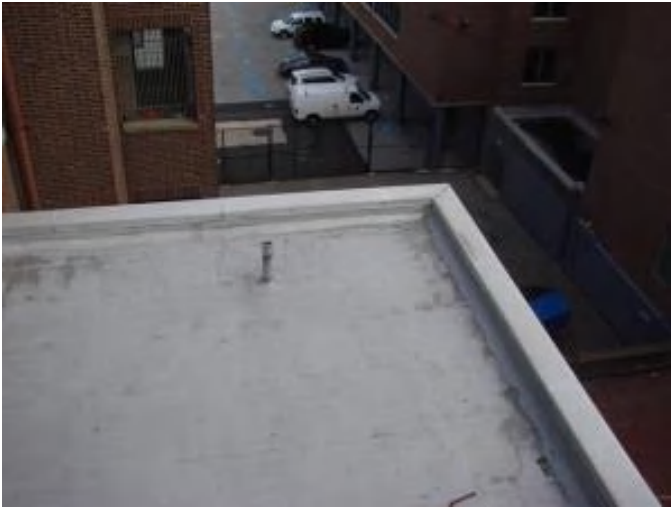
**System: B3010105 - Built-Up**

**Location:** Exterior

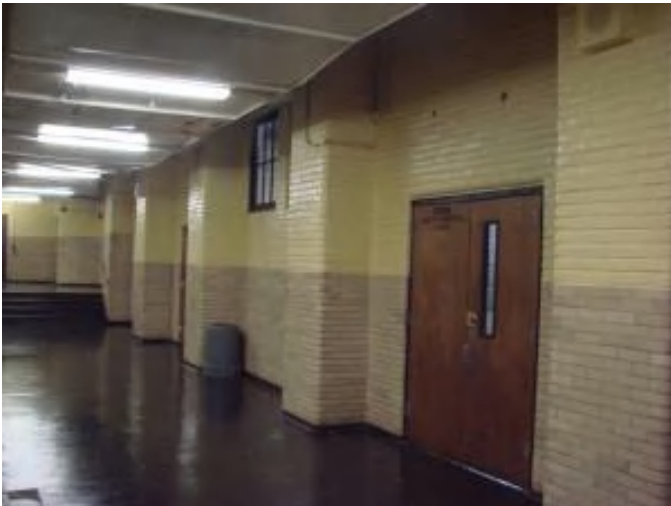
**System: C3020413 - Vinyl Flooring**

**Location:** Interior

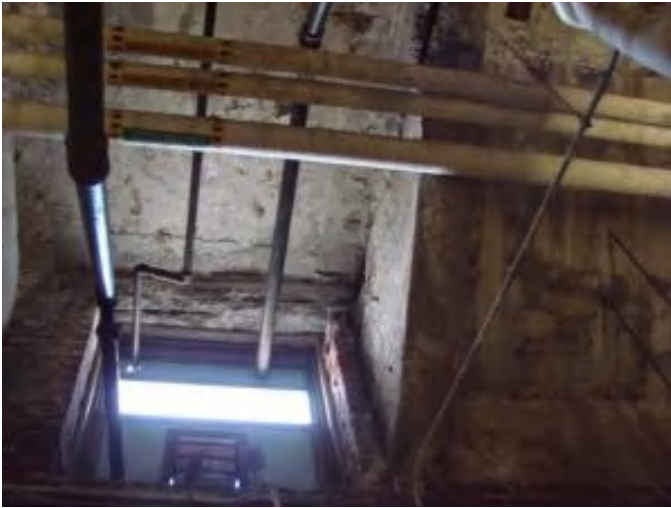
**System: C3030 - Ceiling Finishes**

**Location:** Interior  
**Distress:** Appearance  
**Category:** 3 - Operations / Maint.  
**Priority:** 4 - Response Time (4-5 yrs)  
**Correction:** Re-paint ceilings - SF of ceilings  
**Qty:** 65,400.00  
**Unit of Measure:** S.F.  
**Estimate:** \$313,071.63  
**Assessor Name:** System  
**Date Created:** 11/19/2015

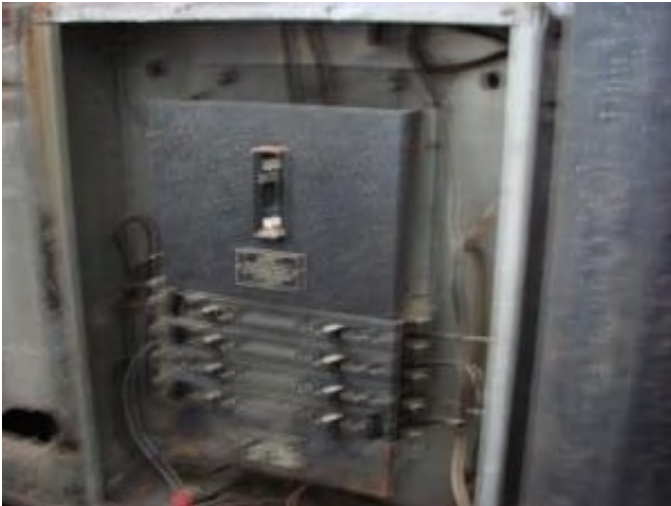
**System: D5010 - Electrical Service/Distribution**

**Location:** throughout tghe building  
**Distress:** Beyond Service Life  
**Category:** 3 - Operations / Maint.  
**Priority:** 4 - Response Time (4-5 yrs)  
**Correction:** Add Electrical Switchgear and Distribution System  
**Qty:** 0.00  
**Unit of Measure:** Ea.  
**Estimate:** \$269,073.87  
**Assessor Name:** System  
**Date Created:** 11/20/2015

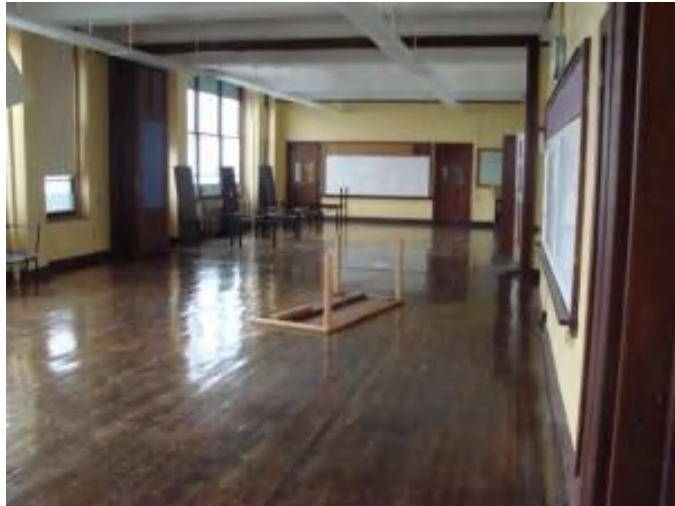
**System: D5030 - Communications and Security**

**Location:** throughout the building

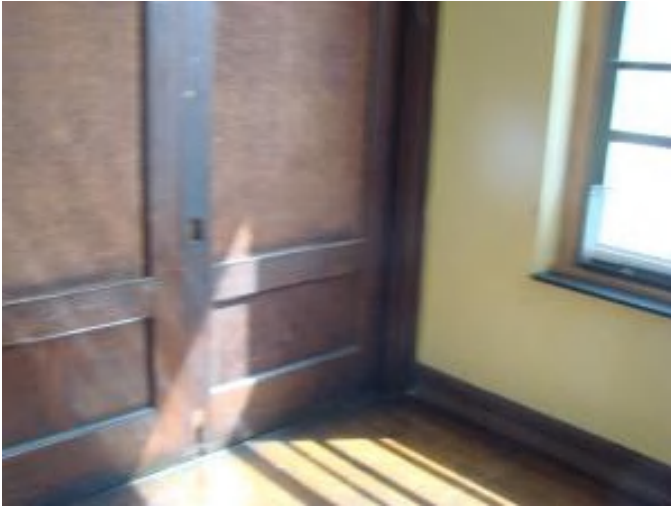
**System: C1010 - Partitions**

**Location:** Interior

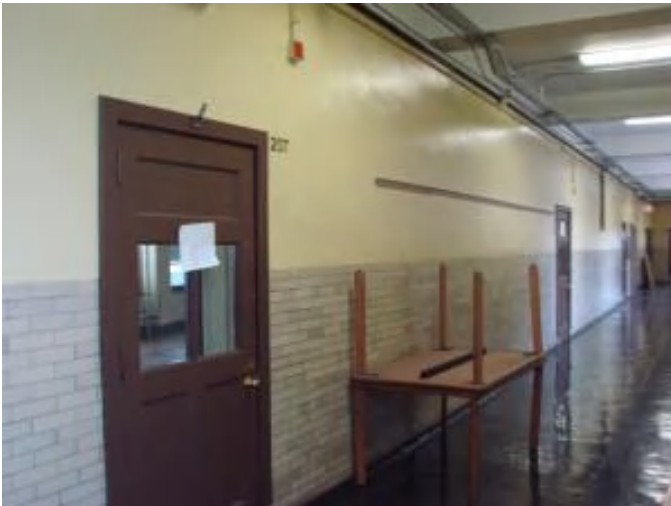
**System: C1020 - Interior Doors**

**Location:** Interior

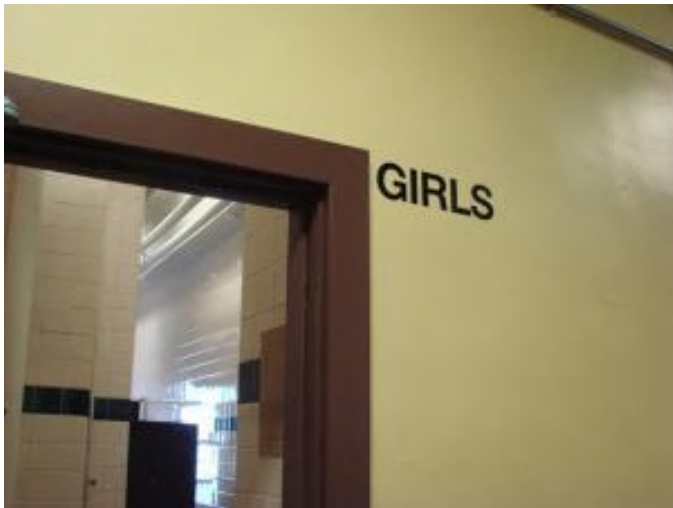
**System: C1030 - Fittings**

**Location:** Interior

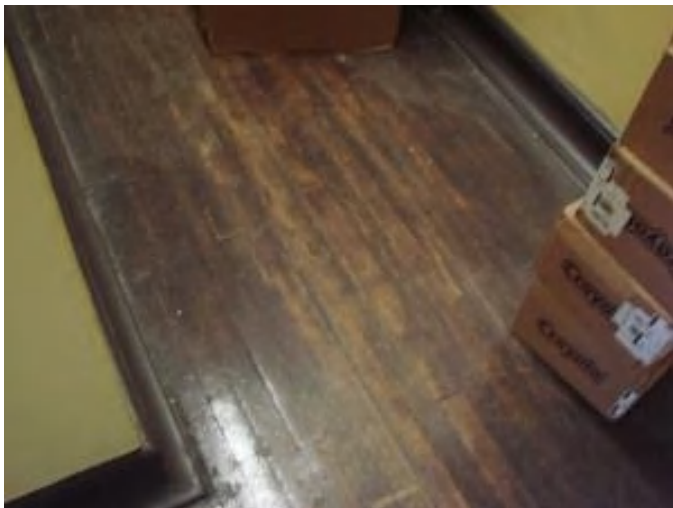
**System: C3020414 - Wood Flooring**

**Location:** Interior

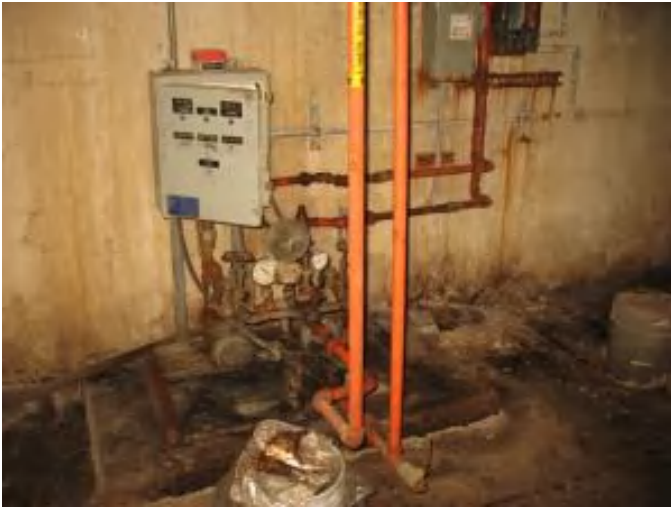
**System: D3020 - Heat Generating Systems**

**Location:** Boiler room  
**Distress:** Damaged  
**Category:** 3 - Operations / Maint.  
**Priority:** 5 - Response Time (> 5 yrs)  
**Correction:** Replace fuel oil pumps  
**Qty:** 1.00  
**Unit of Measure:** Ea.  
**Estimate:** \$23,617.24  
**Assessor Name:** System  
**Date Created:** 09/10/2015

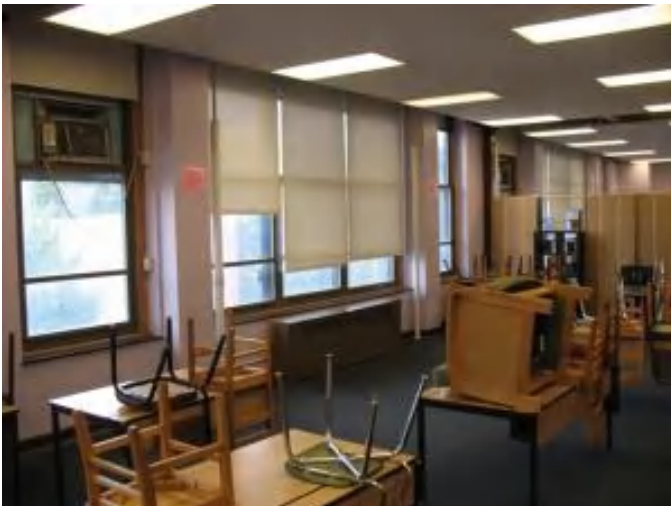
**System: D3030 - Cooling Generating Systems**

**Location:** Throughout building  
**Distress:** Inadequate  
**Category:** 4 - Capital Improvement  
**Priority:** 5 - Response Time (> 5 yrs)  
**Correction:** Install chilled water system with distribution piping and pumps. (+75KSF)  
**Qty:** 99,864.00  
**Unit of Measure:** S.F.  
**Estimate:** \$1,484,223.22  
**Assessor Name:** System  
**Date Created:** 09/10/2015

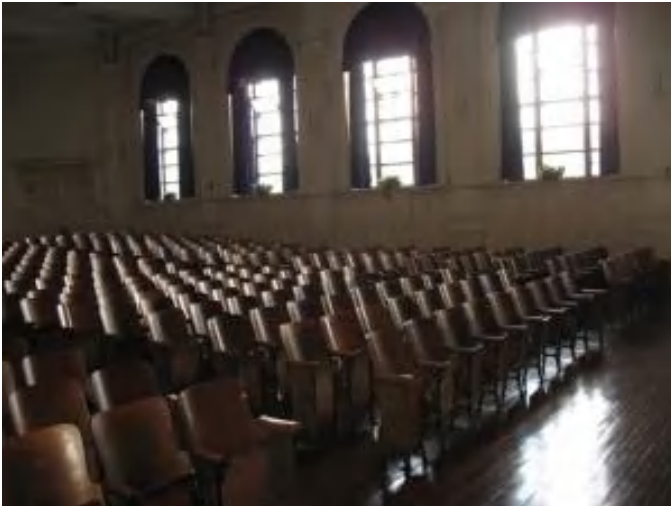
**System: D3040 - Distribution Systems**

**Location:** Auditorium

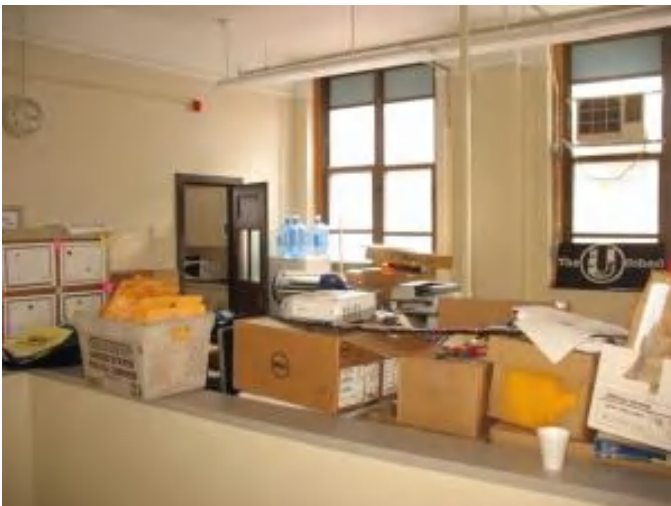
**System: D3040 - Distribution Systems**

**Location:** Administration

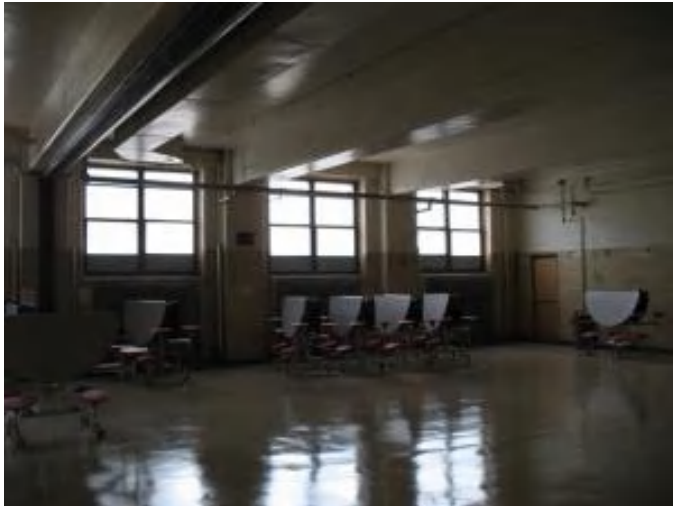
**System: D3040 - Distribution Systems**

**Location:** Gymnasium  
**Distress:** Building / MEP Codes  
**Category:** 2 - Code Compliance  
**Priority:** 5 - Response Time (> 5 yrs)  
**Correction:** Install HVAC unit for Gymnasium (single station).  
**Qty:** 6,000.00  
**Unit of Measure:** Ea.  
**Estimate:** \$308,301.04  
**Assessor Name:** System  
**Date Created:** 09/10/2015

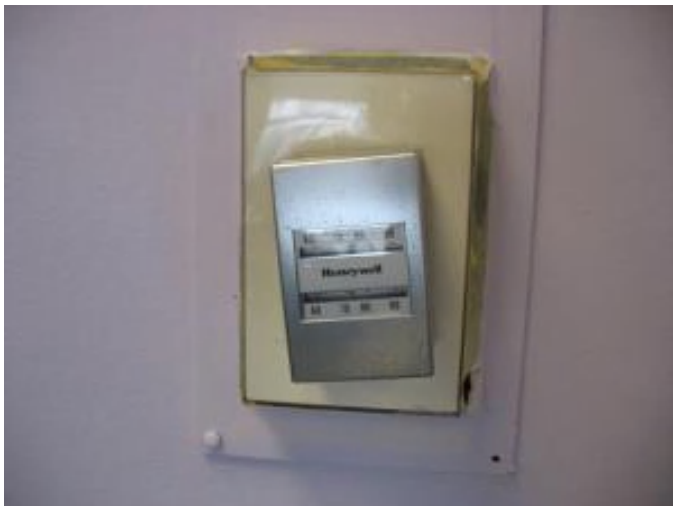
**System: D3060 - Controls & Instrumentation**

**Location:** Throughout building  
**Distress:** Inadequate  
**Category:** 4 - Capital Improvement  
**Priority:** 5 - Response Time (> 5 yrs)  
**Correction:** Replace pneumatic controls with DDC (75KSF)  
**Qty:** 99,640.00  
**Unit of Measure:** S.F.  
**Estimate:** \$2,137,483.84  
**Assessor Name:** System  
**Date Created:** 09/10/2015

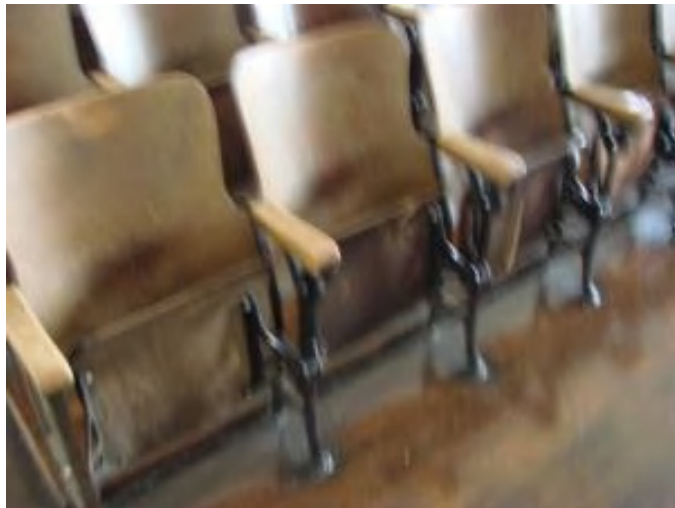
**System: E2010 - Fixed Furnishings**

**Location:** Interior

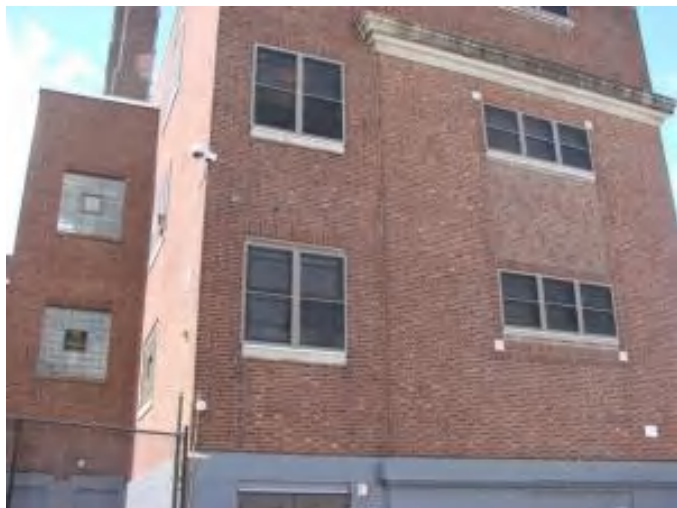
#### System: G4020 - Site Lighting

**Location:** Grounds

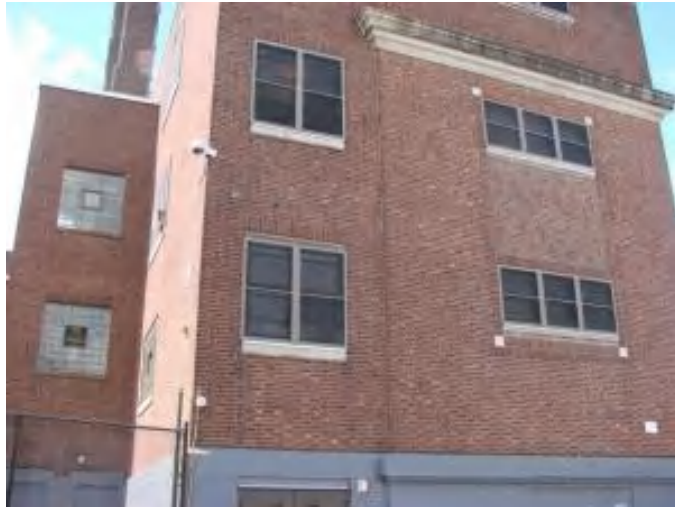
**System: G4030 - Site Communications & Security**

**Location:** Grounds

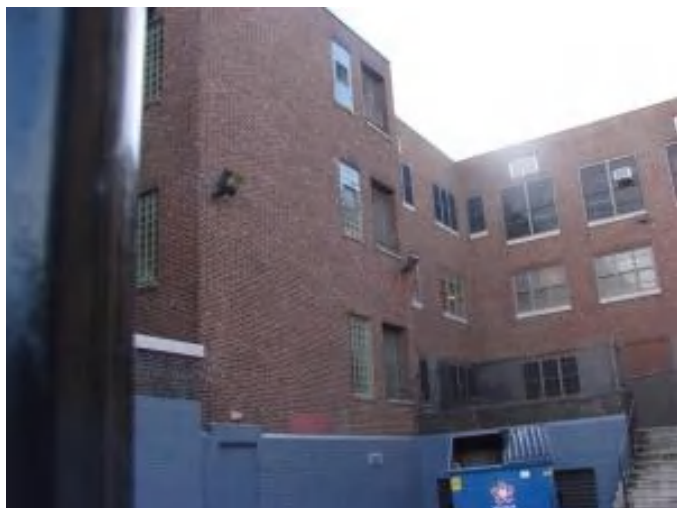
**System: G4030 - Site Communications & Security**

**Location:** grounds

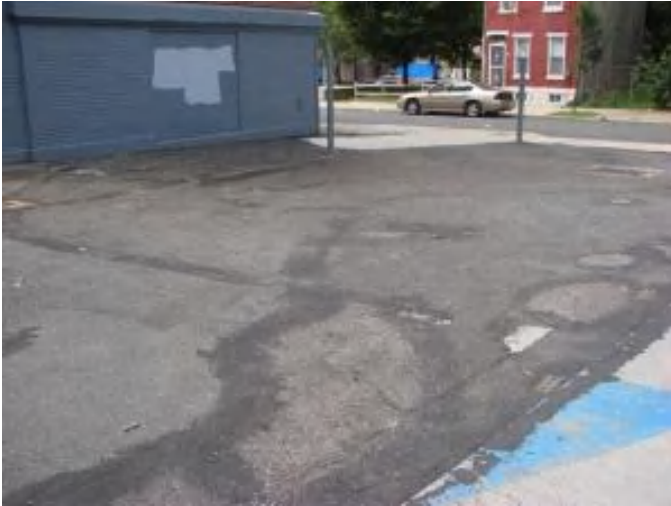
**System: G2030 - Pedestrian Paving**

**Location:** Grounds/ site

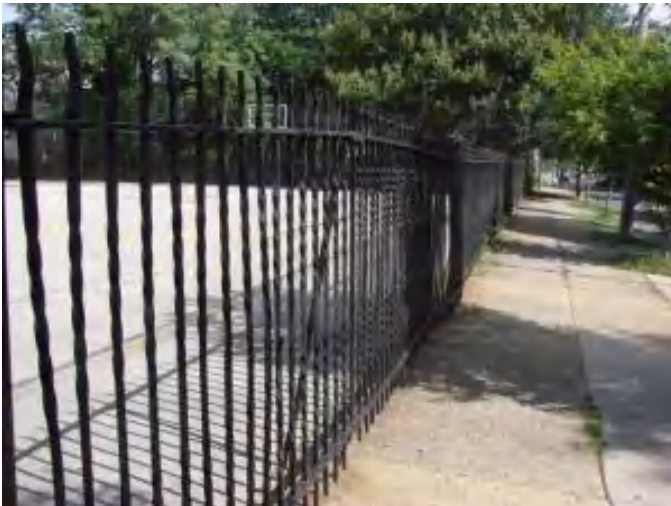
**System: G2040 - Site Development**

**Location:** Grounds/ site
