Facility Condition Assessment Summary Report

Thomas School

School District of Philadelphia
S219001;Fell and Thomas
Final
Site Assessment Report
February 1, 2017

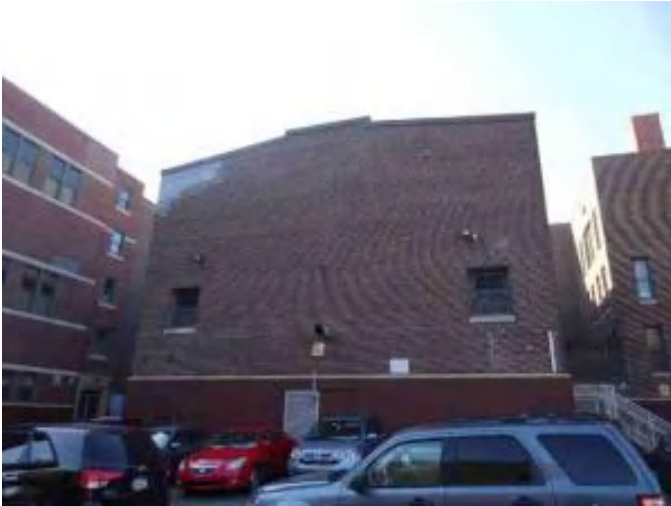
System: B2010 - Exterior Walls

The exterior brick surfaces are generally in good condition for their age. The Northern wall facing the parking lot has a section that raises some concern. The bricks have cracked or spalled in the alcove and should be replaced. As indicated in the photos this area is a consistent line of degradation. The repointing of deteriorated mortar joints is also recommended, using mortar of a similar color and consistency as the original. Following the detailed examination of the brick and repair of mortar construction joints, the entire building should be pressure washed to remove stains and embedded pollutants. If moisture is found to be penetrating the masonry facade, the application of a spray sealant to the suspected exterior masonry surface is recommended.

Location: Exterior Elevation

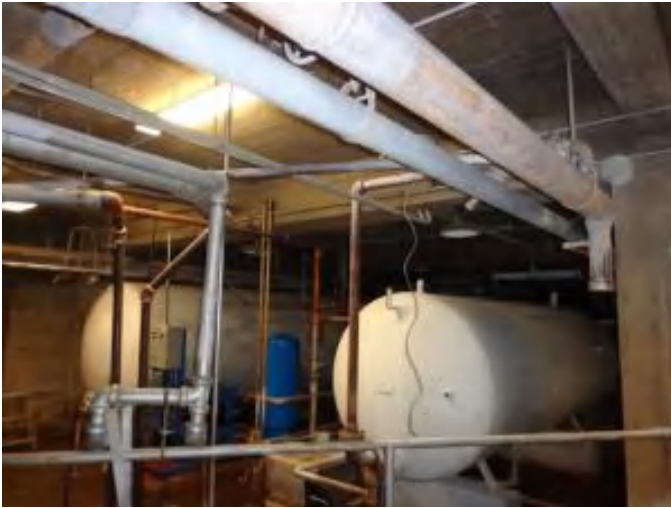
System: D5020 - Lighting and Branch Wiring

Lighting-- Lighting fixtures in most areas of the building were replaced when the building was renovated in 2008. There are only a few spaces, such as the mechanical/electrical rooms in the Basement, that still have some fluorescent fixtures with T12 lamps. All other areas with linear fluorescent fixtures have T8 lamps.

Location: Mechanical/electrical rooms
Distress: Obsolete
Category: 3 - Operations / Maint.
Priority: 3 - Response Time (3-4 yrs)
Correction: Replace lighting fixtures
Qty: 20.00
Unit of Measure: Ea.
Estimate: \$20,725.55
Assessor Name: Craig Anding
Date Created: 12/15/2015

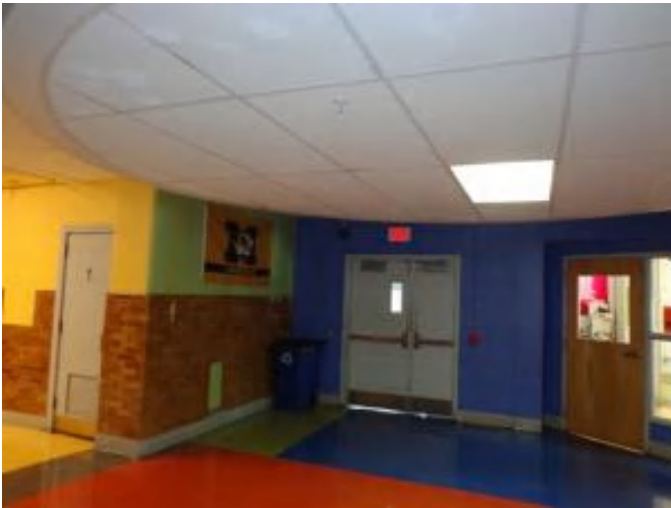
System: D5090 - Other Electrical Systems

Location: West end of Floors 1 to 4
Distress: Life Safety / NFPA / PFD
Category: 2 - Code Compliance
Priority: 3 - Response Time (3-4 yrs)
Correction: Add Emergency/Exit Lighting
Qty: 8.00
Unit of Measure: Ea.
Estimate: \$13,478.74
Assessor Name: Craig Anding
Date Created: 12/15/2015

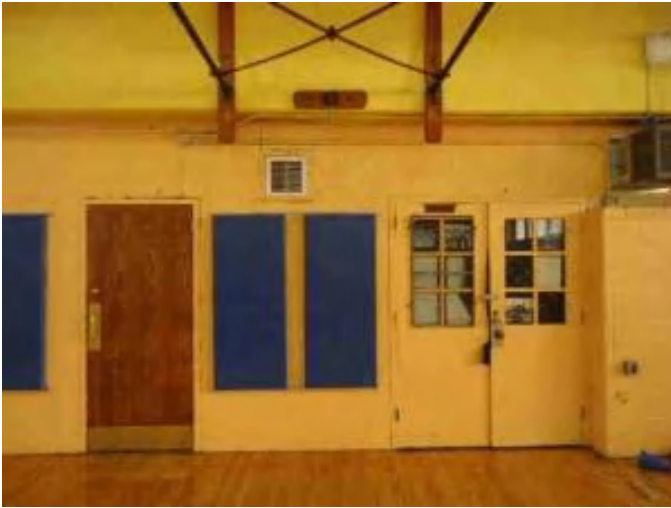
System: C1020 - Interior Doors

Location: Gym
Distress: Damaged
Category: 3 - Operations / Maint.
Priority: 4 - Response Time (4-5 yrs)
Correction: Remove and replace interior doors - wood doors with hollow metal frames - per leaf
Qty: 4.00
Unit of Measure: Ea.
Estimate: \$19,082.35
Assessor Name: Craig Anding
Date Created: 12/28/2015

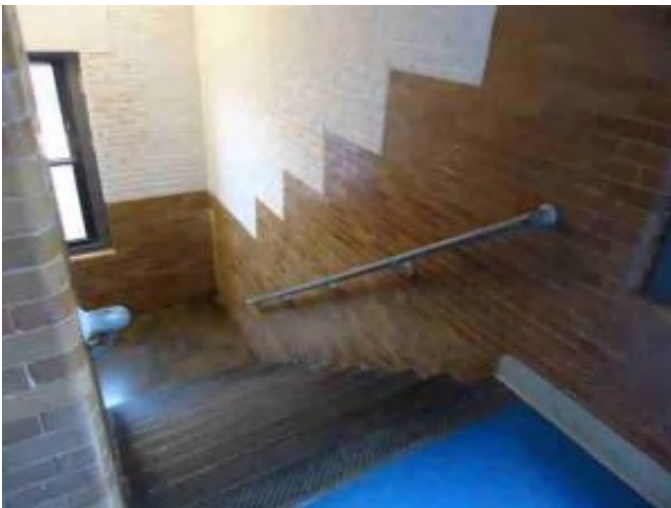
System: C2010 - Stair Construction

Current requirements for stairs indicate that they have graspable handrails on both sides, that the rails have a specific end geometry, and that the handrails continue horizontally at the landings. In addition, guardrails must prevent the passage of a 4 inch diameter sphere (6 inches in the triangle formed by the lower rail and tread/riser angle). It appears as if the entire hand and guard rail system was upgraded during the 2006 renovation effort. However, the rail extensions were not included in this effort. This deficiency provides a budgetary consideration for rail extension on each floor.

Location: Stairs
Distress: Life Safety / NFPA / PFD
Category: 1 - Health & Safety
Priority: 4 - Response Time (4-5 yrs)
Correction: Replace inadequate or install proper stair railing - select appropriate material
Qty: 1.00
Unit of Measure: L.F.
Estimate: \$30,674.24
Assessor Name: Craig Anding
Date Created: 12/28/2015

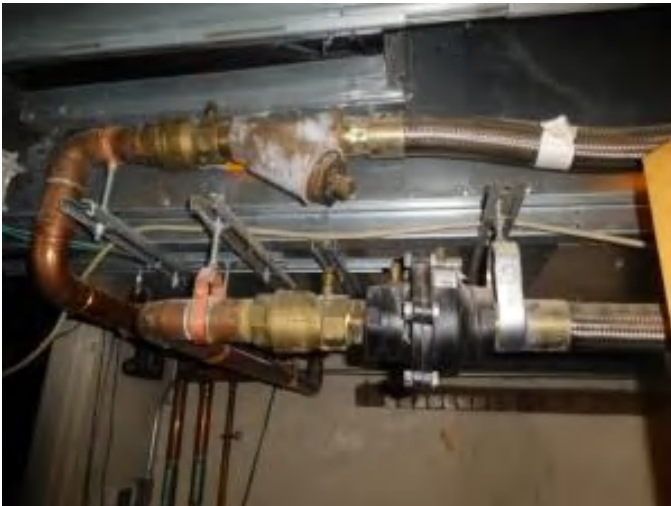
System: D3060 - Controls & Instrumentation

Location: entire building
Distress: Inadequate
Category: 4 - Capital Improvement
Priority: 4 - Response Time (4-5 yrs)
Correction: Replace pneumatic controls with DDC (75KSF)
Qty: 82,000.00
Unit of Measure: S.F.
Estimate: \$1,759,068.94
Assessor Name: Craig Anding
Date Created: 11/28/2015

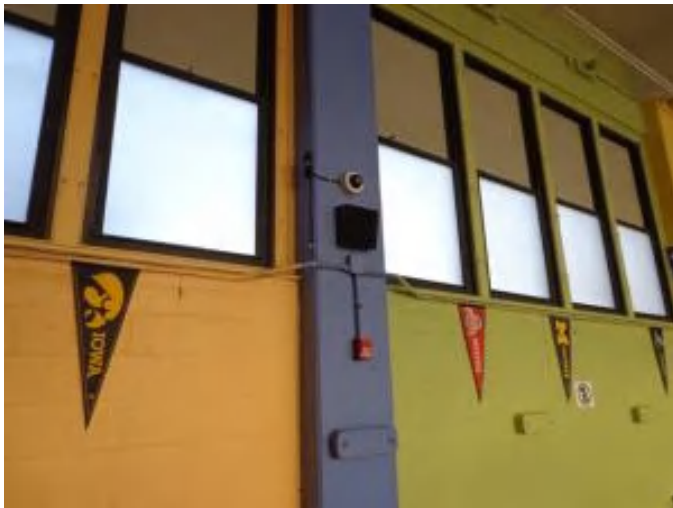
System: D5030 - Communications and Security

Location: Building wide
Distress: Beyond Service Life
Category: 3 - Operations / Maint.
Priority: 4 - Response Time (4-5 yrs)
Correction: Add/Replace Video Surveillance System
Qty: 12.00
Unit of Measure: Ea.
Estimate: \$102,439.03
Assessor Name: Craig Anding
Date Created: 12/15/2015

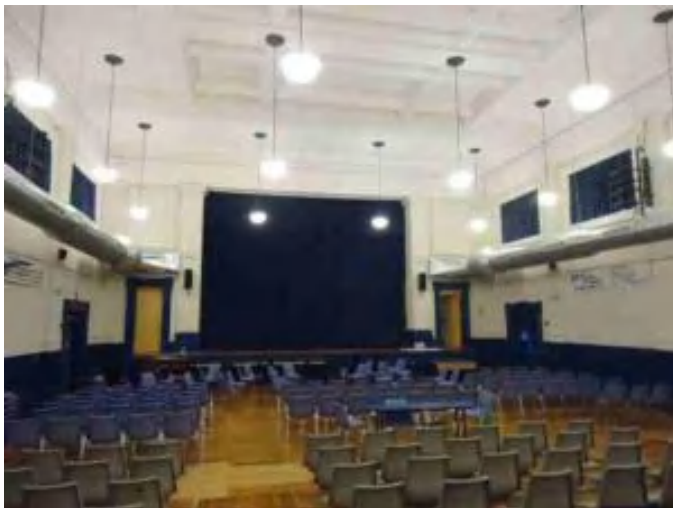
System: E2010 - Fixed Furnishings

The school stage has a stage curtain assembly that appears to be from the original construction. Modern applications are typically fire-proof applications with adjustable tracks and electric support for operation. The curtains are torn in a few sections and the track is not functioning properly, overall the system is in poor condition. It is recommended that the curtain and track system be upgraded to a new system. Special care should be considered in regards to modern fire proofing for the new installation.

Location: Stage
Distress: Life Safety / NFPA / PFD
Category: 1 - Health & Safety
Priority: 4 - Response Time (4-5 yrs)
Correction: Remove and replace stage curtain - insert the LF of track and SF of curtain
Qty: 1.00
Unit of Measure: Ea.
Estimate: \$13,831.55
Assessor Name: Craig Anding
Date Created: 12/28/2015

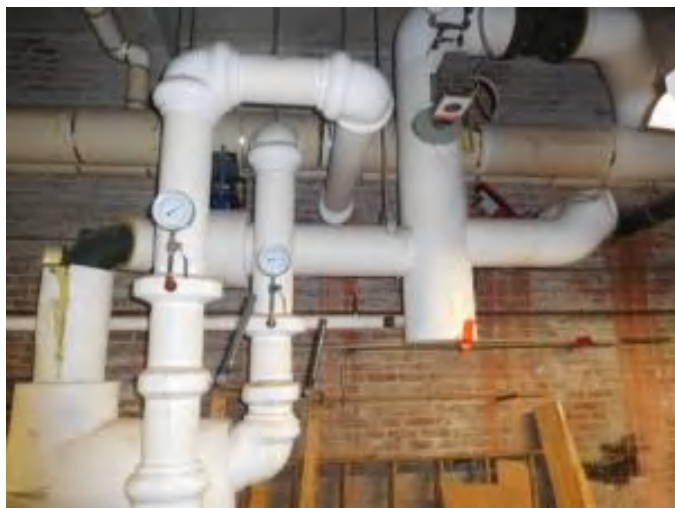
System: D3020 - Heat Generating Systems

Location: mechanical room

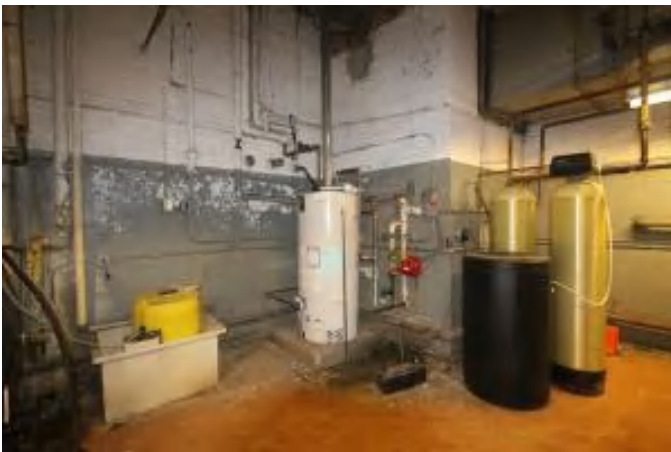
System: D2020 - Domestic Water Distribution

Location: Boiler room

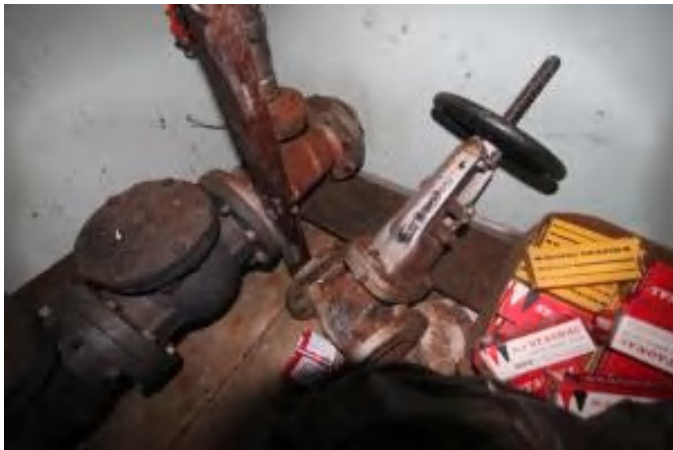
System: D2020 - Domestic Water Distribution

Location: Cafeteria dining room closet.

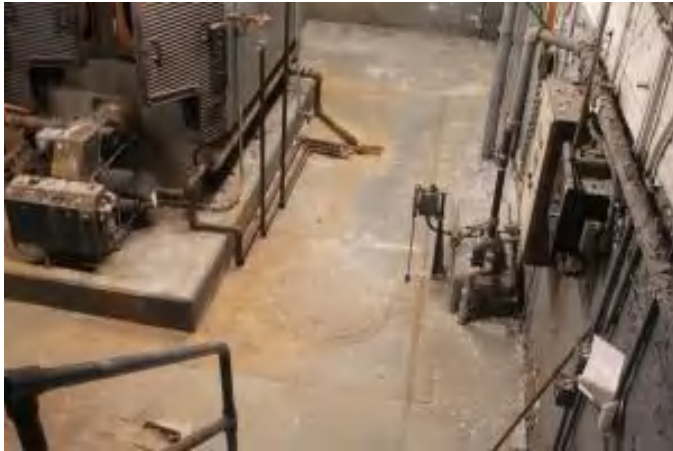
System: D2030 - Sanitary Waste

Location: Boiler room

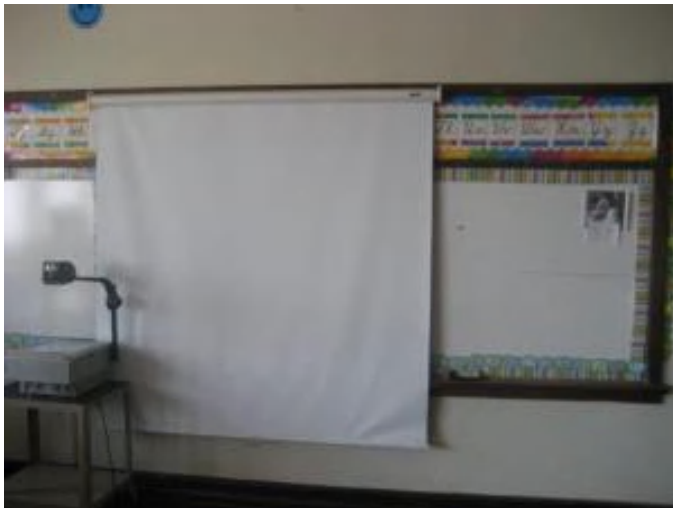
Location: Classrooms
Distress: Inadequate
Category: 4 - Capital Improvement
Priority: 2 - Response Time (2-3 yrs)
Correction: Add wiring device
Qty: 112.00
Unit of Measure: Ea.
Estimate: \$41,145.55
Assessor Name: System
Date Created: 10/20/2015

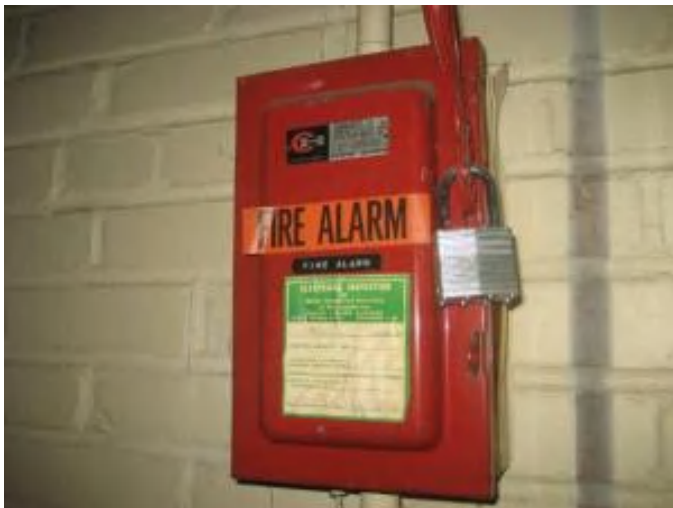
Location: Entire Building
Distress: Building / MEP Codes
Category: 2 - Code Compliance
Priority: 2 - Response Time (2-3 yrs)
Correction: Replace fire alarm system
Qty: 1.00
Unit of Measure: S.F.
Estimate: \$162,996.83
Assessor Name: System
Date Created: 10/20/2015

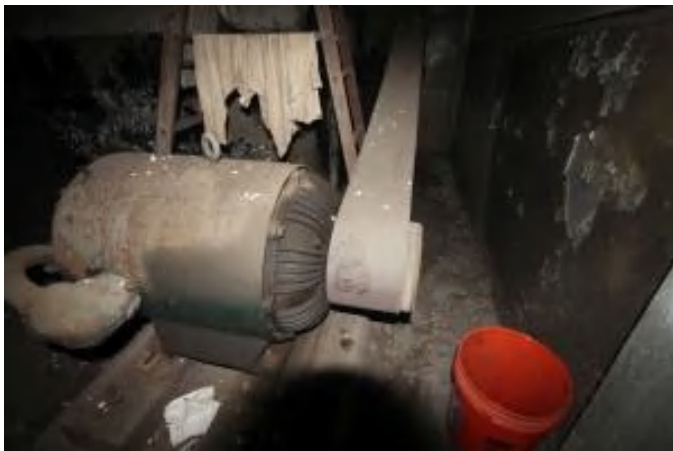
Location: Fan room
Distress: Beyond Service Life
Category: 3 - Operations / Maint.
Priority: 3 - Response Time (3-4 yrs)
Correction: Install / replace HVAC unit for Auditorium (800 seat).
Qty: 800.00
Unit of Measure: Seat
Estimate: \$524,646.20
Assessor Name: System
Date Created: 01/21/2016

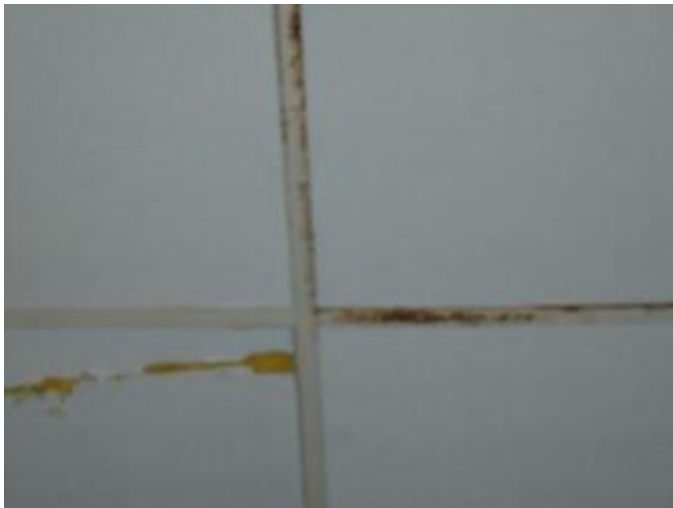
Location: Various
Distress: Beyond Service Life
Category: 3 - Operations / Maint.
Priority: 4 - Response Time (4-5 yrs)
Correction: Remove and replace suspended acoustic ceilings - lighting not included
Qty: 18,300.00
Unit of Measure: S.F.
Estimate: \$276,008.47
Assessor Name: System
Date Created: 09/16/2015

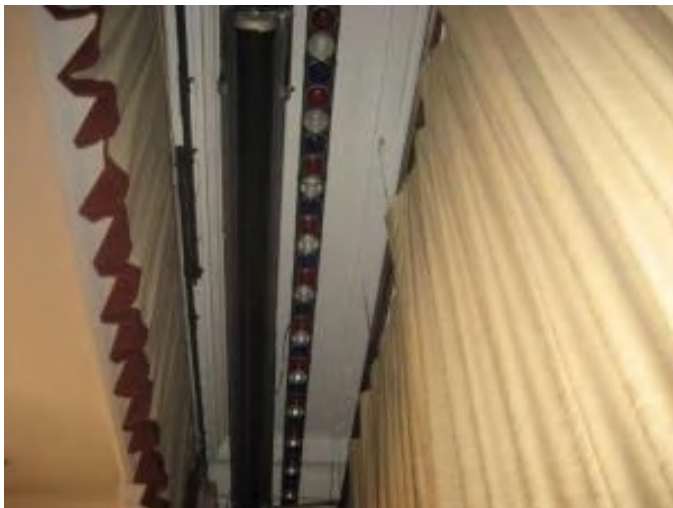
Location: Auditorium
Distress: Inadequate
Category: 4 - Capital Improvement
Priority: 4 - Response Time (4-5 yrs)
Correction: Add/Replace Stage Theatrical Lighting System
Qty: 1.00
Unit of Measure: Ea.
Estimate: \$323,055.06
Assessor Name: System
Date Created: 10/20/2015
