Facility Condition Assessment Summary Report

Tilden School

School District of Philadelphia
S101001; Bartram and Tilden
Final
Site Assessment Report
January 30, 2017

Site Assessment Report

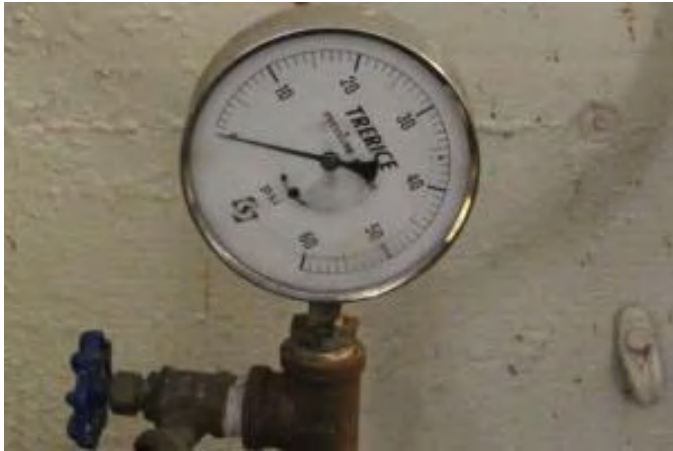
System: D3060 - Controls & Instrumentation

Location: Boiler room

Distress: Damaged

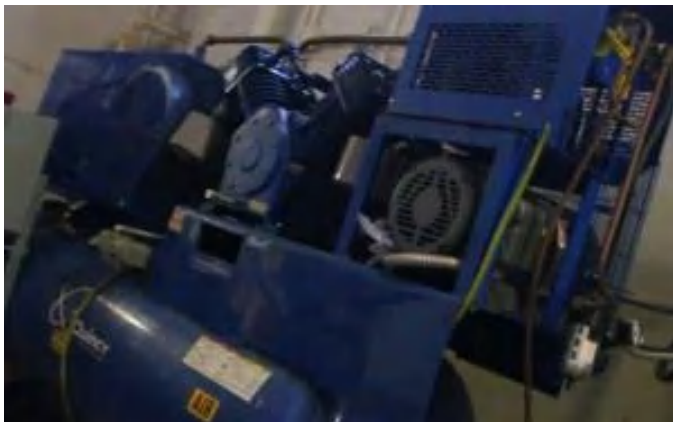
System: D3060 - Controls & Instrumentation

Location: Boiler room

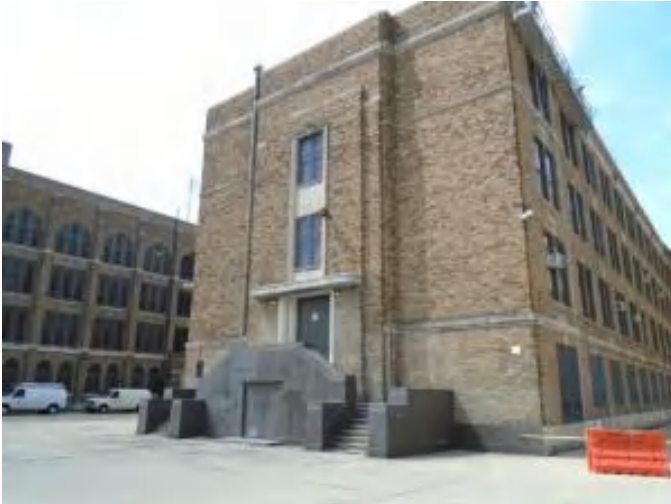
System: B2030 - Exterior Doors

Location: Entrance
Distress: Accessibility
Category: 2 - Code Compliance
Priority: 2 - Response Time (2-3 yrs)
Correction: Replace hardware with compliant hardware, paint and weatherstrip - per leaf
Qty: 2.00
Unit of Measure: Ea.
Estimate: \$6,987.28
Assessor Name: System
Date Created: 08/13/2015

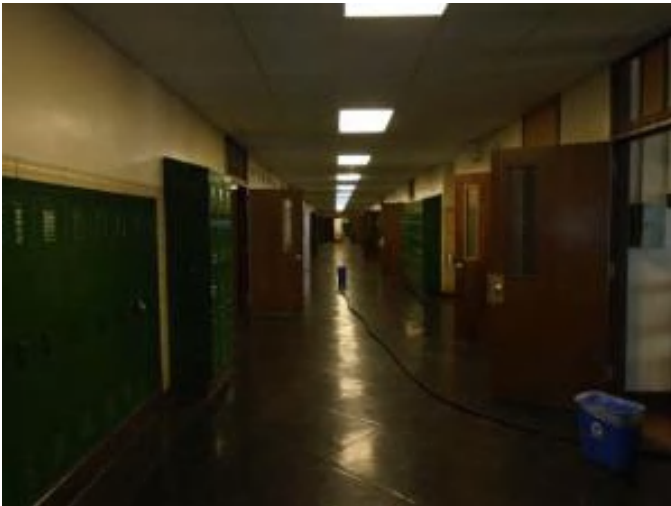
System: C1020 - Interior Doors

Location: Throughout
Distress: Accessibility
Category: 2 - Code Compliance
Priority: 2 - Response Time (2-3 yrs)
Correction: Replace door knobs with compliant lever type
Qty: 208.00
Unit of Measure: Ea.
Estimate: \$115,766.45
Assessor Name: System
Date Created: 08/13/2015

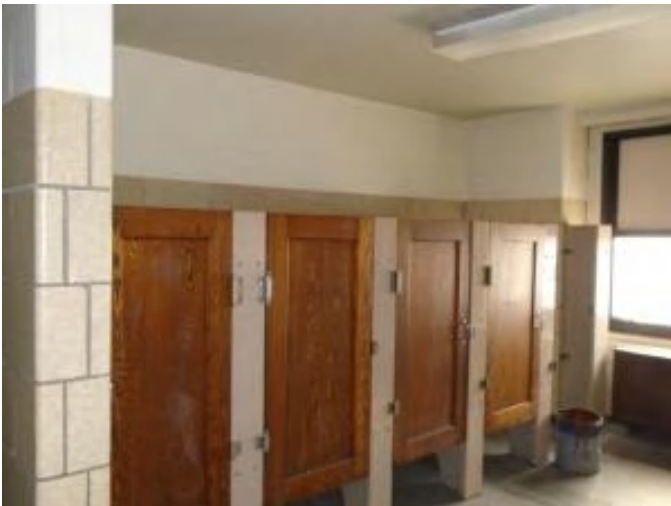
System: C1030 - Fittings

Location: Toilets

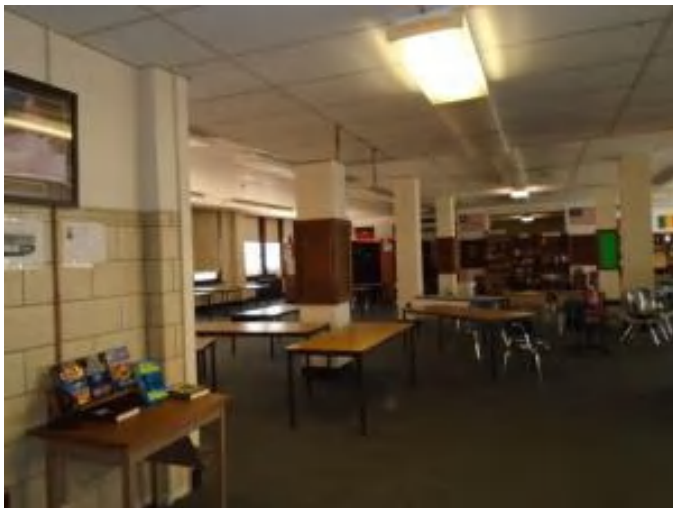
System: C3020411 - Carpet

Location: IMC, music, offices

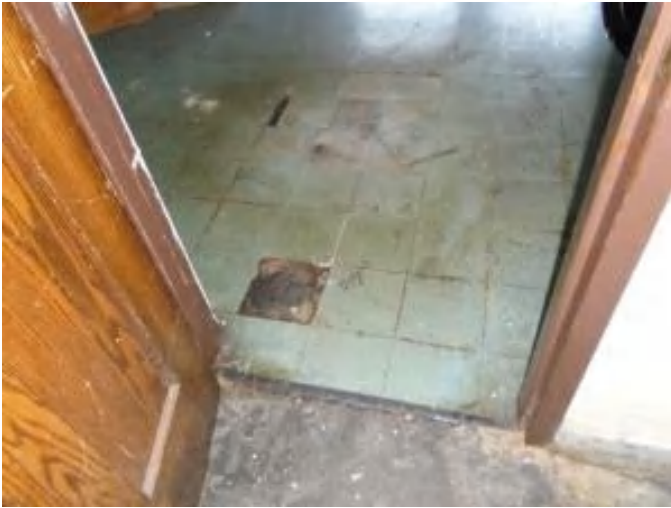
System: C3020413 - Vinyl Flooring

Location: Various

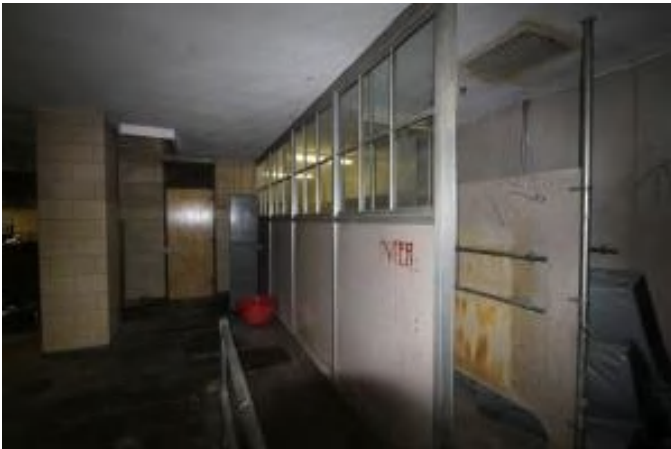
System: D2010 - Plumbing Fixtures

Location: Basement

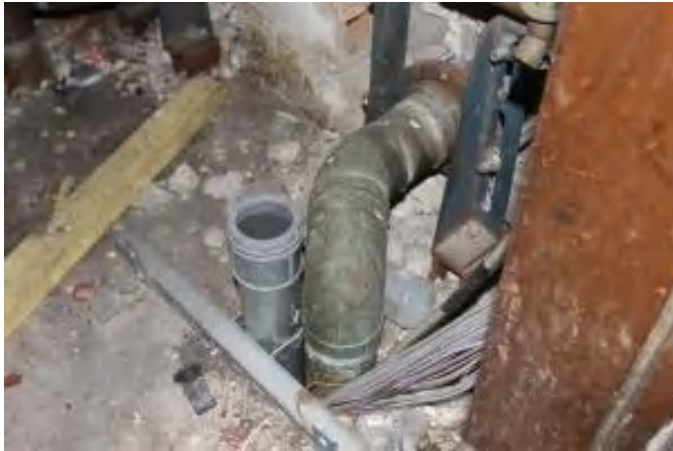
System: D2030 - Sanitary Waste

Location: Entire building

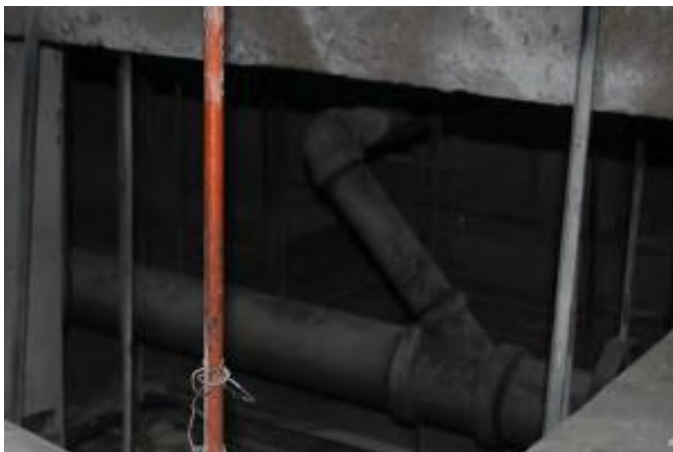
System: D2040 - Rain Water Drainage

Location: Entire building

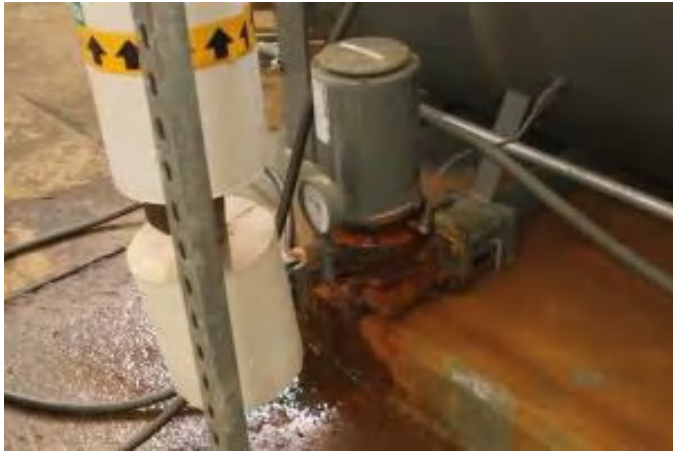
System: D3020 - Heat Generating Systems

Location: Boiler room
Distress: Failing
Category: 3 - Operations / Maint.
Priority: 2 - Response Time (2-3 yrs)
Correction: Rebuild pump, inline HHW (1 HP)
Qty: 4.00
Unit of Measure: Ea.
Estimate: \$46,401.41
Assessor Name: System
Date Created: 08/10/2015

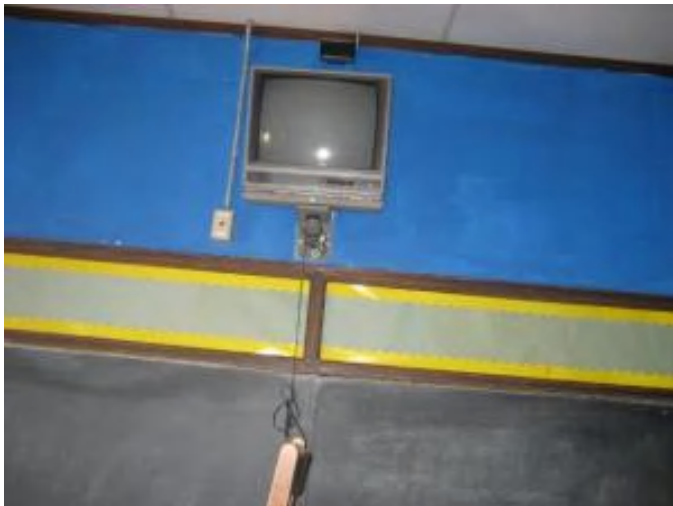
System: D5020 - Lighting and Branch Wiring

Location: Classrooms
Distress: Inadequate
Category: 4 - Capital Improvement
Priority: 2 - Response Time (2-3 yrs)
Correction: Add wiring device
Qty: 300.00
Unit of Measure: Ea.
Estimate: \$247,098.37
Assessor Name: System
Date Created: 08/07/2015

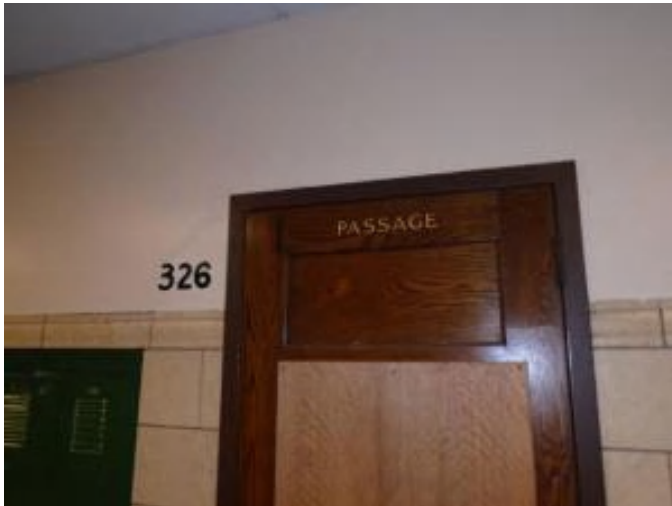
System: C1020 - Interior Doors

Location: Throughout

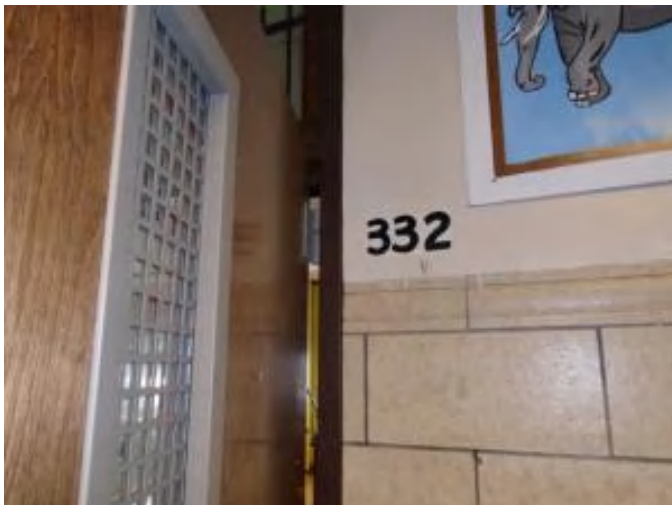
System: C1030 - Fittings

Location: Throughout

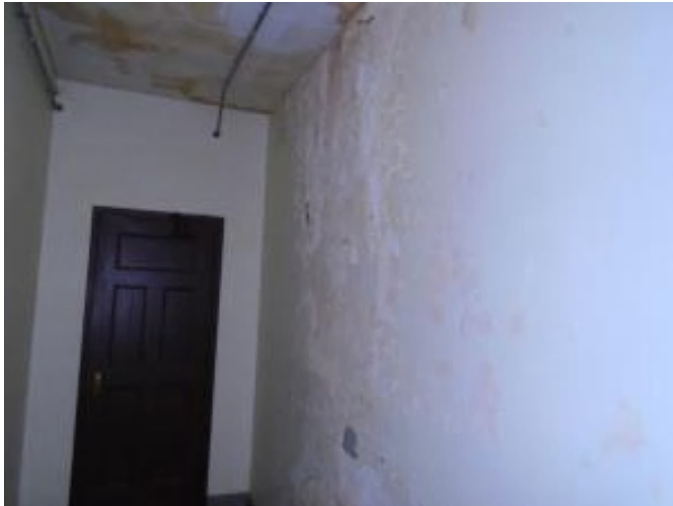
System: C3010230 - Paint & Covering

Location: Throughout

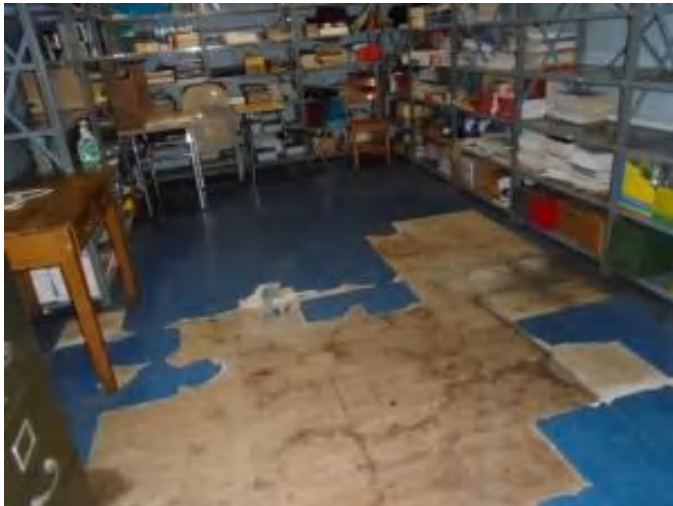
System: C3020413 - Vinyl Flooring

Location: Various

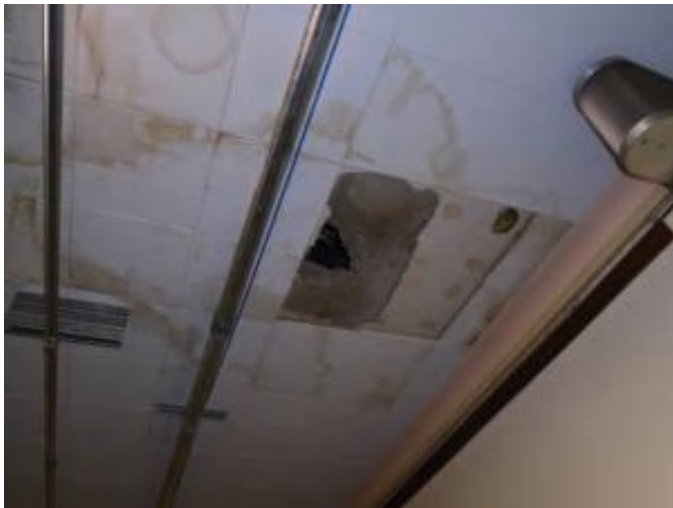
System: C3030 - Ceiling Finishes

Location: corridors, weight room

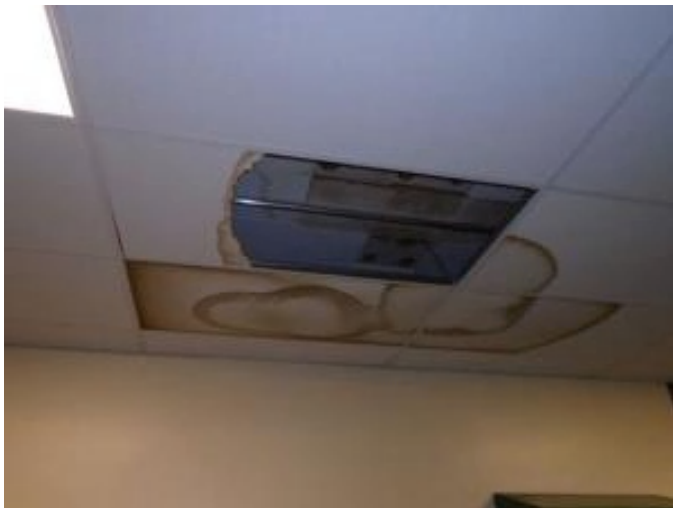
System: C3030 - Ceiling Finishes

Location: Throughout

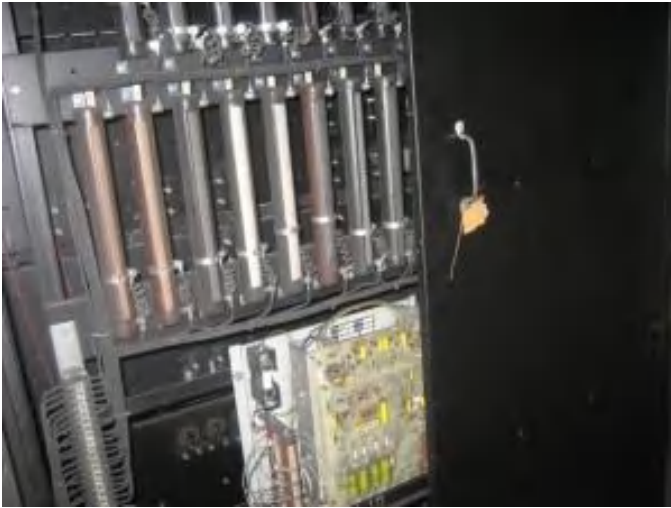
System: D1010 - Elevators and Lifts

Location: Elevator Machine room

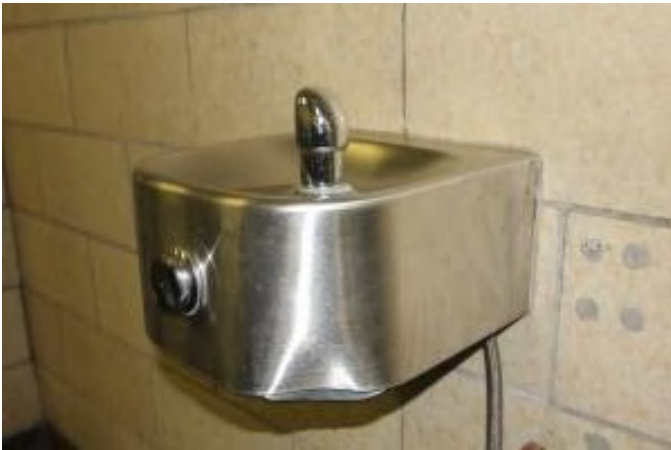
System: D2010 - Plumbing Fixtures

Location: Corridors

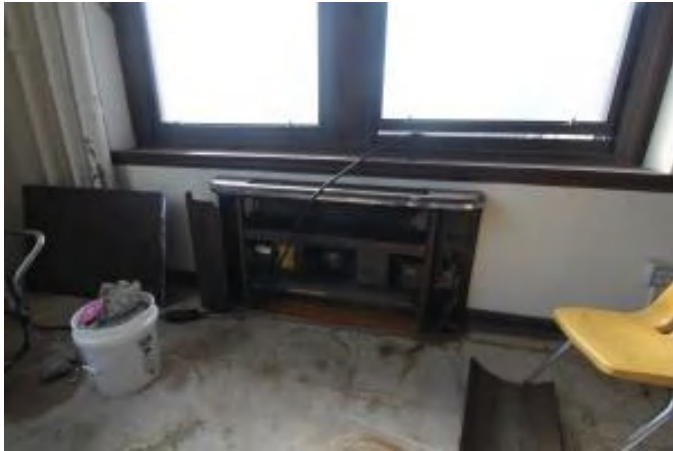
System: D3040 - Distribution Systems

Location: Entire building

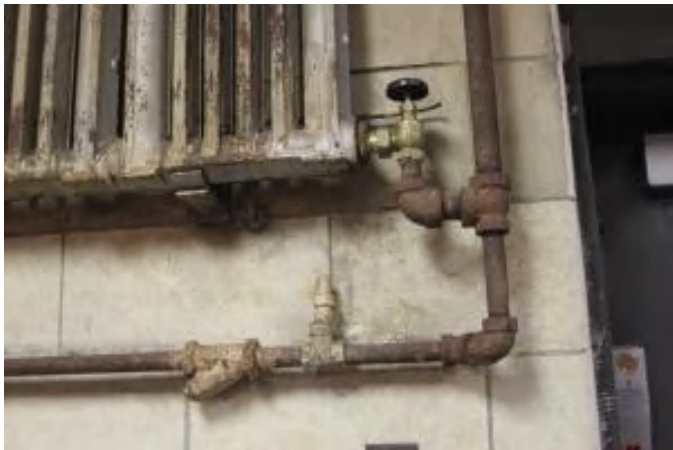
System: D3040 - Distribution Systems

Location: Entire building

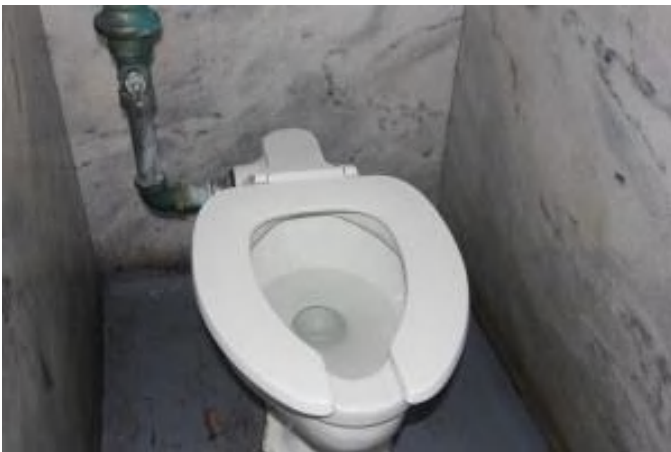
System: D2010 - Plumbing Fixtures

Location: Toilet rooms and classrooms

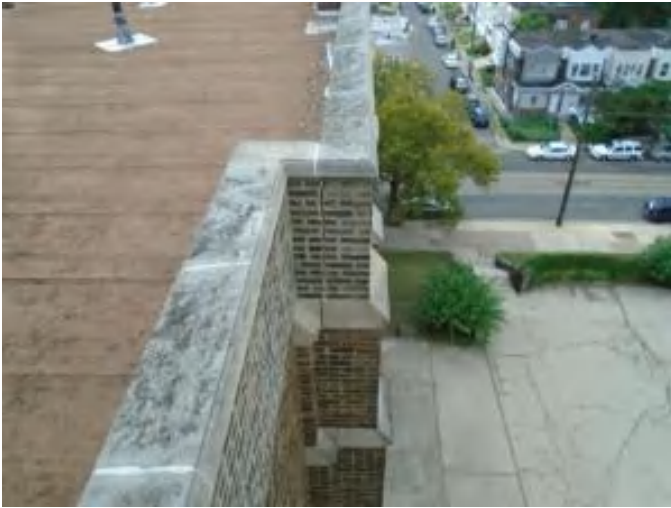
System: B2010 - Exterior Walls

Location: South wall

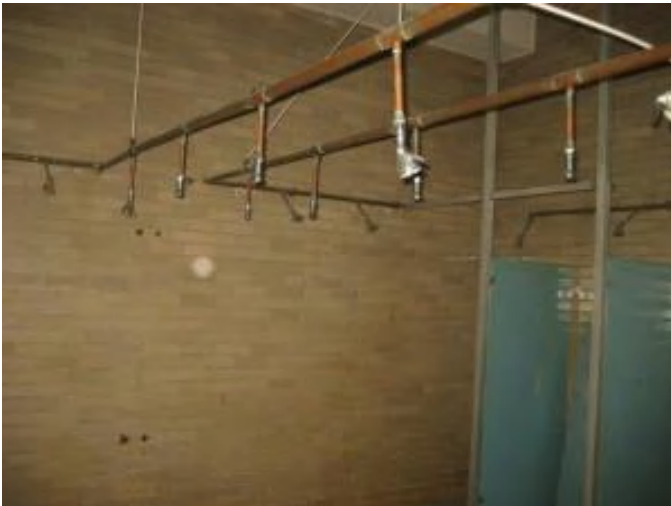
System: C1010 - Partitions

Location: Shower rooms

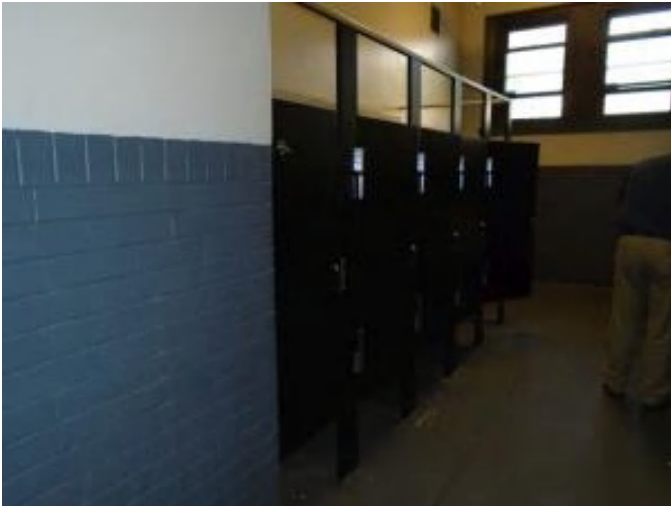
System: C1030 - Fittings

Location: Toilets
Distress: Accessibility
Category: 2 - Code Compliance
Priority: 2 - Response Time (2-3 yrs)
Correction: Remove and replace damaged toilet partitions - handicap units
Qty: 15.00
Unit of Measure: Ea.
Estimate: \$14,667.83
Assessor Name: System
Date Created: 09/23/2015

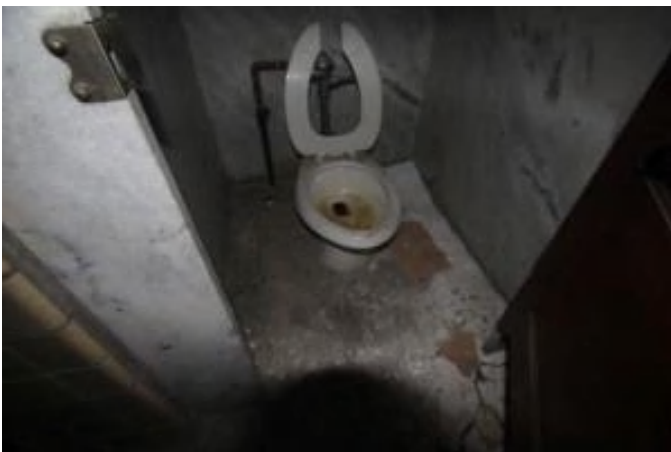
System: D2010 - Plumbing Fixtures

Location: Toilet rooms
Distress: Beyond Service Life
Category: 3 - Operations / Maint.
Priority: 2 - Response Time (2-3 yrs)
Correction: Remove and replace or replace water closet - quantify additional units
Qty: 16.00
Unit of Measure: Ea.
Estimate: \$228,884.69
Assessor Name: System
Date Created: 11/19/2015

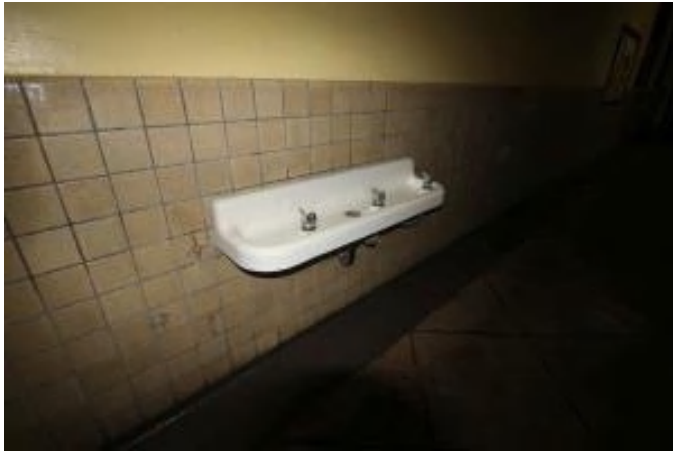
System: D2010 - Plumbing Fixtures

Location: Hallways

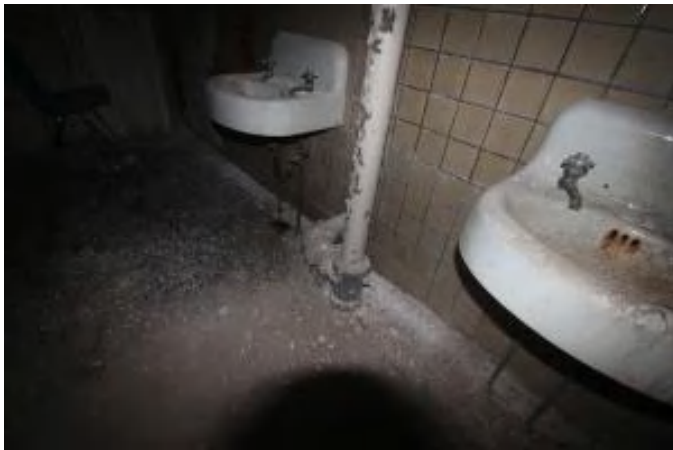
System: D2010 - Plumbing Fixtures

Location: Toilet rooms and classrooms

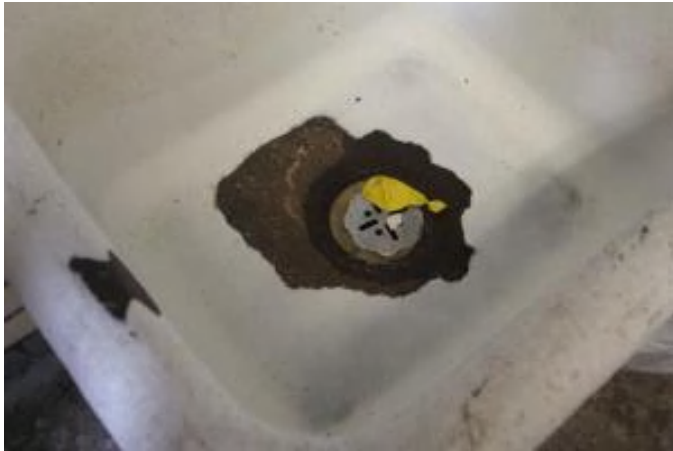
System: D2010 - Plumbing Fixtures

Location: Janitor closets

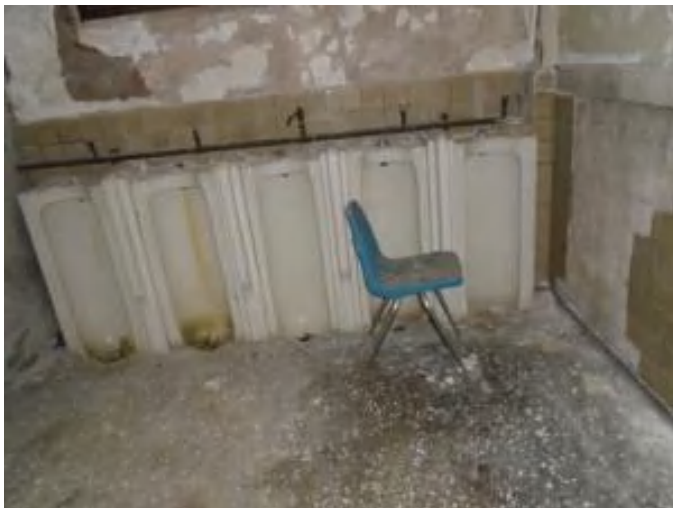
System: D2010 - Plumbing Fixtures

Location: Toilet rooms

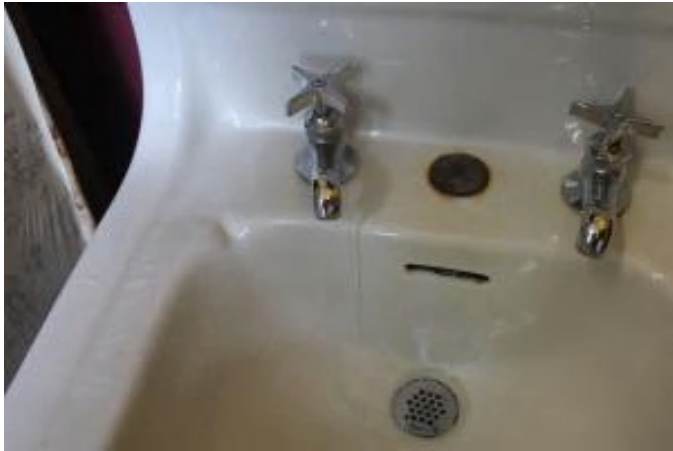
System: D2010 - Plumbing Fixtures

Location: Toilet rooms and classrooms

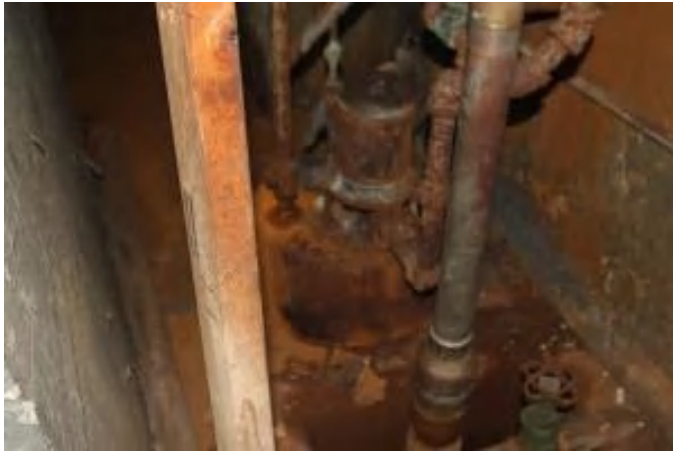
System: D2030 - Sanitary Waste

Location: Basement
Distress: Failing
Category: 3 - Operations / Maint.
Priority: 2 - Response Time (2-3 yrs)
Correction: Replace sanitary sewage ejector pit and pumps. (48" dia.)
Qty: 1.00
Unit of Measure: Ea.
Estimate: \$15,764.25
Assessor Name: System
Date Created: 11/19/2015

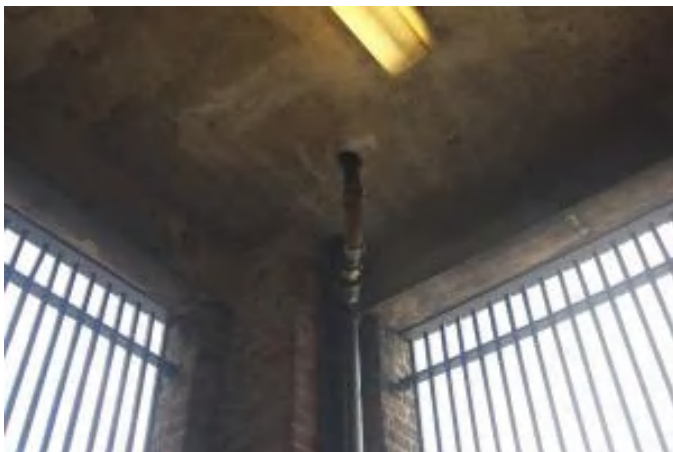
System: D2040 - Rain Water Drainage

Location: Entire building
Distress: Beyond Service Life
Category: 3 - Operations / Maint.
Priority: 2 - Response Time (2-3 yrs)
Correction: Remove and replace rain water drainage piping - based on +- 30 KSF roof area on 3-4 story building - insert the SF of roof area to be drained
Qty: 30,000.00
Unit of Measure: S.F.
Estimate: \$403,114.76
Assessor Name: System
Date Created: 11/19/2015

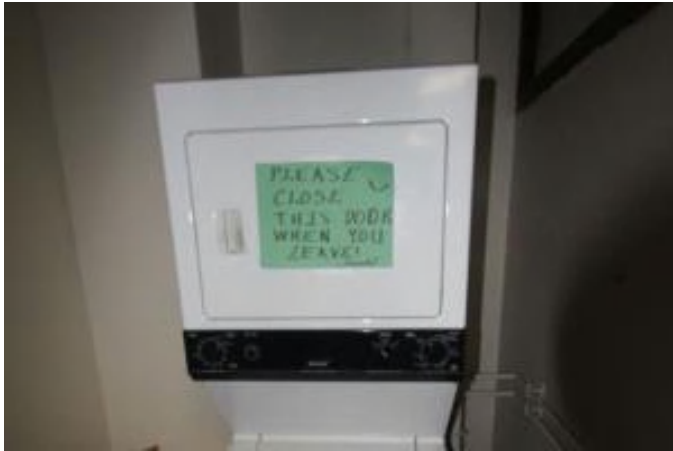
System: D3040 - Distribution Systems

Location: Life skills and parent resource center rooms.
Distress: Building / MEP Codes
Category: 2 - Code Compliance
Priority: 2 - Response Time (2-3 yrs)
Correction: Provide inline ceiling exhaust fan and wall outlet louver
Qty: 2.00
Unit of Measure: Ea.
Estimate: \$2,265.63
Assessor Name: System
Date Created: 11/19/2015

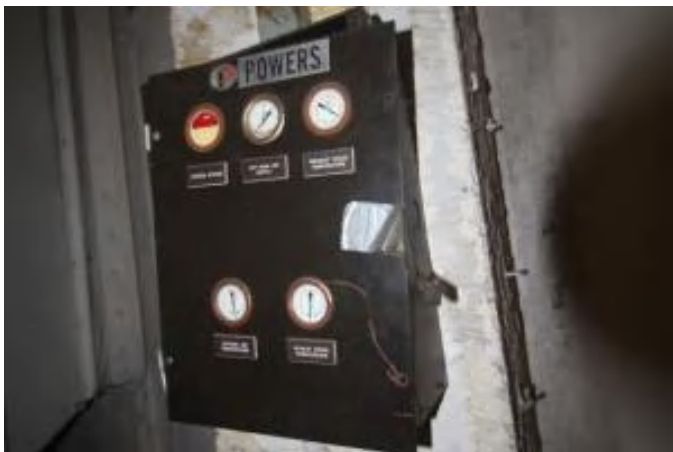
System: D3060 - Controls & Instrumentation

Location: Entire building
Distress: Obsolete
Category: 3 - Operations / Maint.
Priority: 2 - Response Time (2-3 yrs)
Correction: Replace pneumatic controls with DDC (150KSF)
Qty: 127,000.00
Unit of Measure: S.F.
Estimate: \$2,274,748.38
Assessor Name: System
Date Created: 11/19/2015

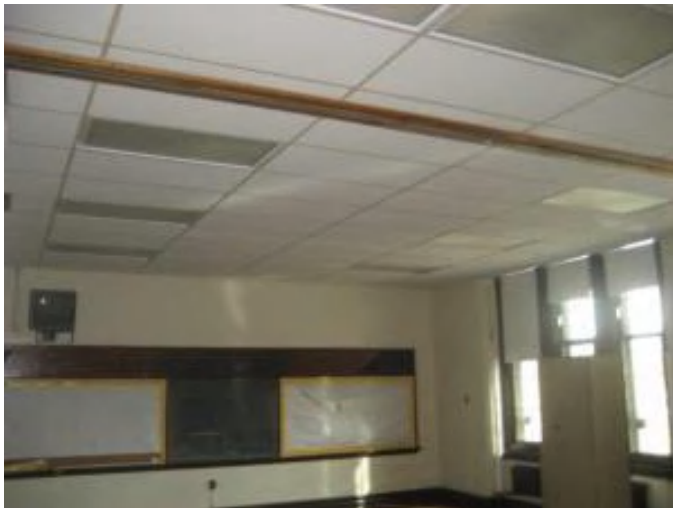
System: D5020 - Lighting and Branch Wiring

Location: Classrooms
Distress: Inadequate
Category: 4 - Capital Improvement
Priority: 2 - Response Time (2-3 yrs)
Correction: Add wiring device
Qty: 768.00
Unit of Measure: Ea.
Estimate: \$282,140.92
Assessor Name: System
Date Created: 10/22/2015

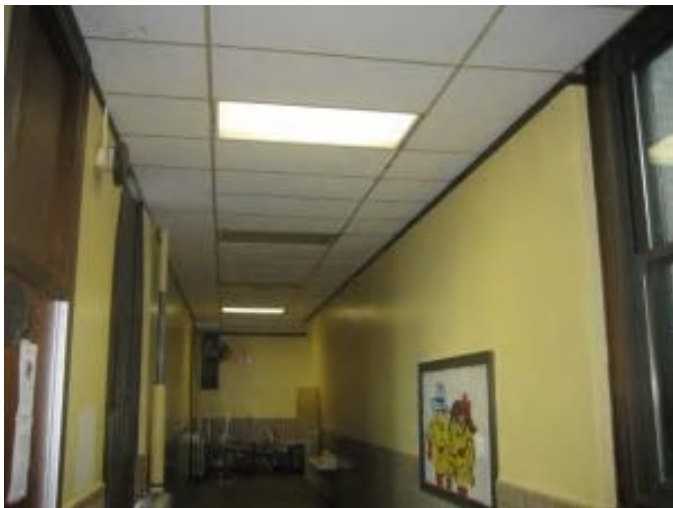
System: D5030 - Communications and Security

Location: Entire Building
Distress: Security Issue
Category: 1 - Health & Safety
Priority: 2 - Response Time (2-3 yrs)
Correction: Add/Replace Video Surveillance System
Qty: 85.00
Unit of Measure: Ea.
Estimate: \$278,537.83
Assessor Name: System
Date Created: 10/22/2015

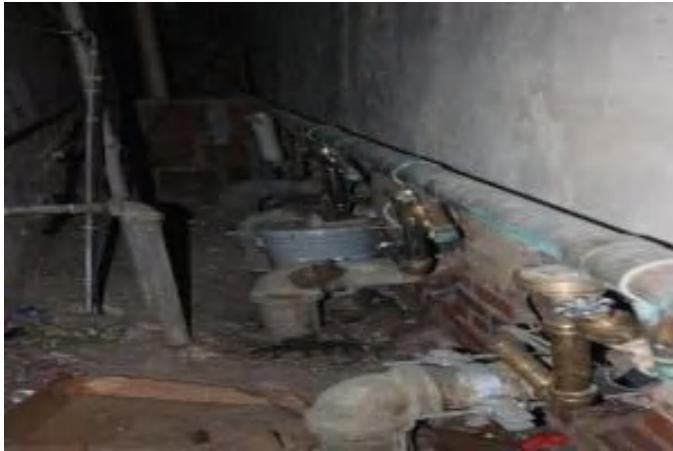
System: D2030 - Sanitary Waste

Location: Entire building

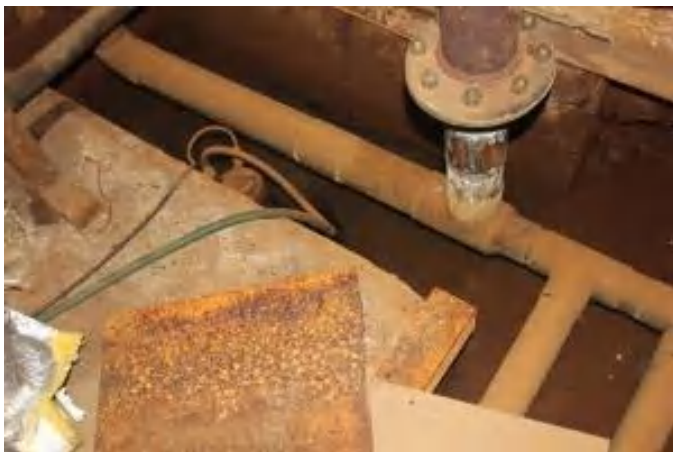
System: D3040 - Distribution Systems

Location: Entire building

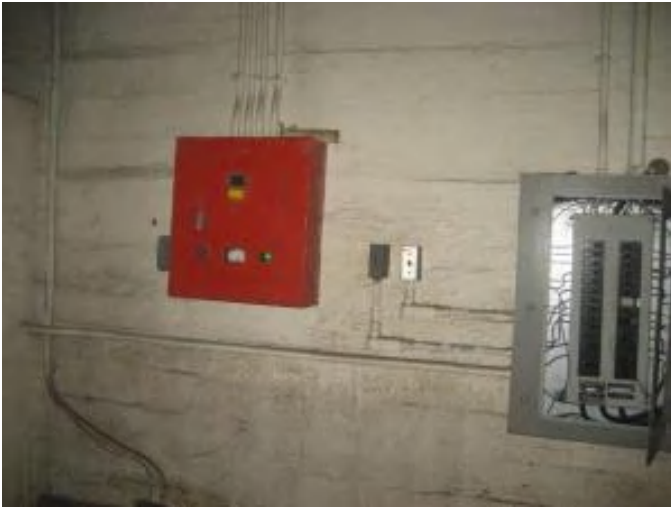
System: D5030 - Communications and Security

Location: Entire Building
Distress: Building / MEP Codes
Category: 2 - Code Compliance
Priority: 3 - Response Time (3-4 yrs)
Correction: Replace fire alarm system
Qty: 250.00
Unit of Measure: S.F.
Estimate: \$521,145.85
Assessor Name: System
Date Created: 10/22/2015

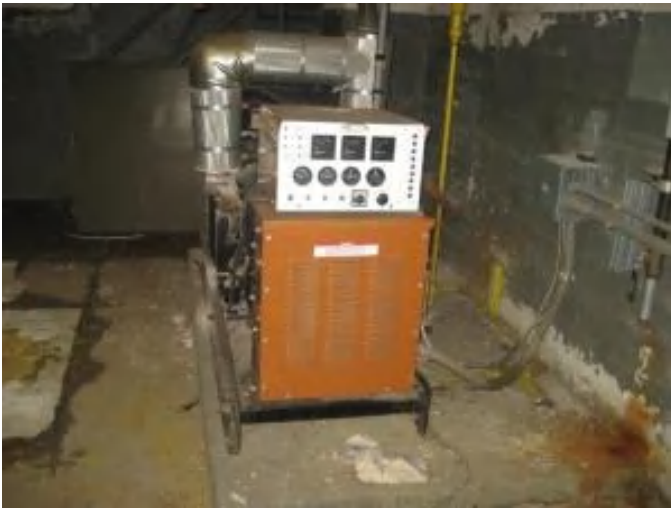
System: D5090 - Other Electrical Systems

Location: Roof
Distress: Inadequate
Category: 4 - Capital Improvement
Priority: 3 - Response Time (3-4 yrs)
Correction: Add Standby Generator System
Qty: 1.00
Unit of Measure: Ea.
Estimate: \$366,204.29
Assessor Name: System
Date Created: 10/22/2015

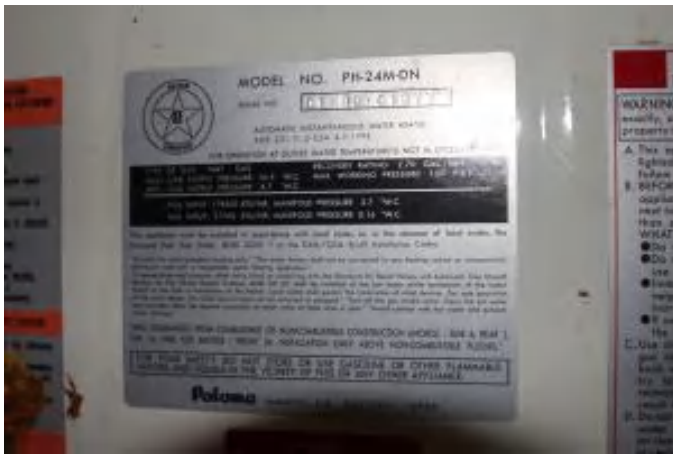
System: D2020 - Domestic Water Distribution

Location: Basement
Distress: Building / MEP Codes
Category: 2 - Code Compliance
Priority: 4 - Response Time (4-5 yrs)
Correction: Replace instantaneous water heater
Qty: 1.00
Unit of Measure: Ea.
Estimate: \$34,375.16
Assessor Name: System
Date Created: 11/19/2015

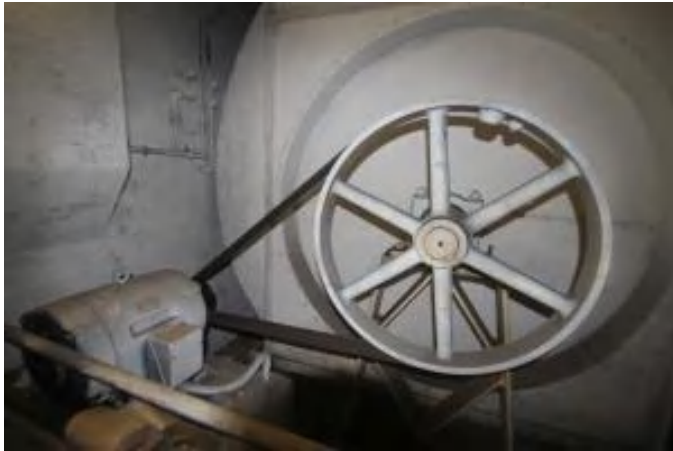
System: D3040 - Distribution Systems

Location: Basement fan rooms

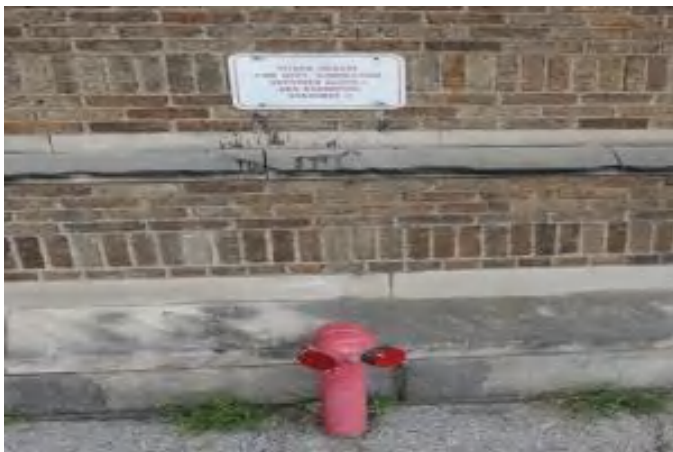
System: D4010 - Sprinklers

Location: Entire building.

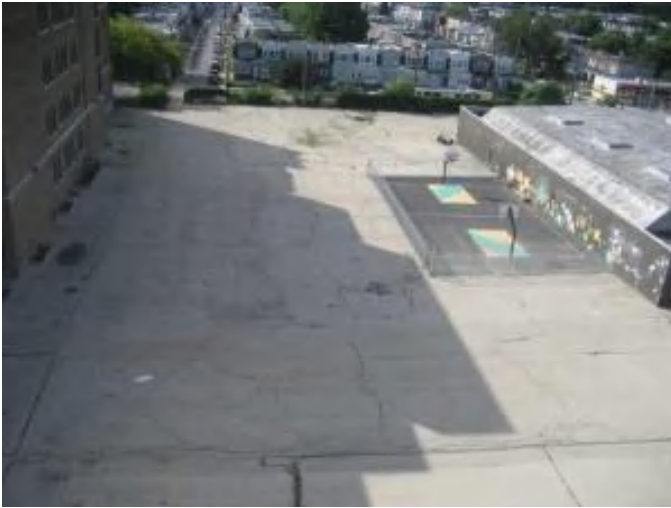
System: G4020 - Site Lighting

Location: Parkinglot/playground

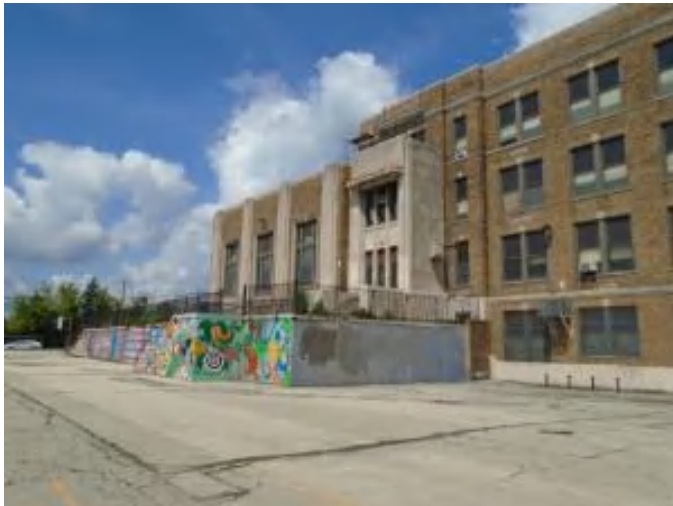
System: G2040 - Site Development

Location: Site
Distress: Security Issue
Category: 1 - Health & Safety
Priority: 3 - Response Time (3-4 yrs)
Correction: Paint steel picket fence - LF of fence 6' high
Qty: 2,000.00
Unit of Measure: L.F.
Estimate: \$130,520.10
Assessor Name: Craig Anding
Date Created: 08/13/2015
