## Facility Condition Assessment Summary Report

### Vare, EH Middle School

School District of Philadelphia  
**S212001;Vare, E H**  
Final  
**Site Assessment Report**  
February 1, 2017

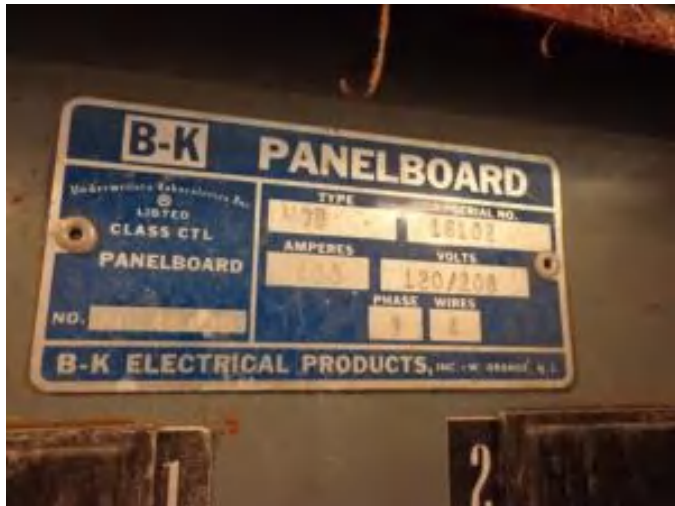
**Location:** Boiler Room

**Distress:** Beyond Service Life

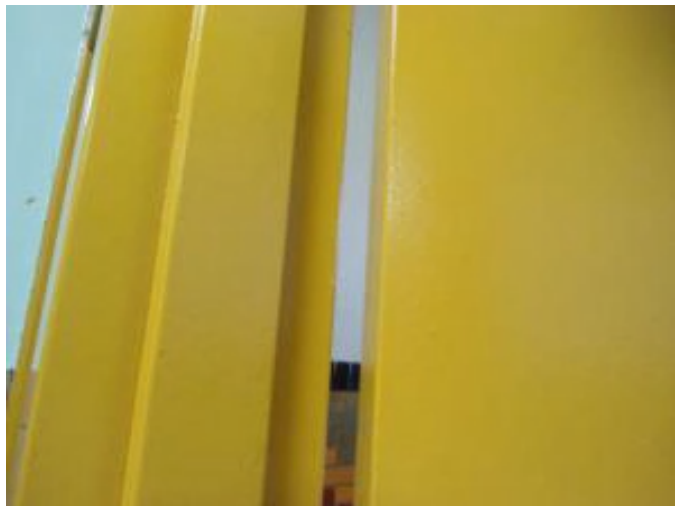
**Location:** Building Wide

**Distress:** Building / MEP Codes

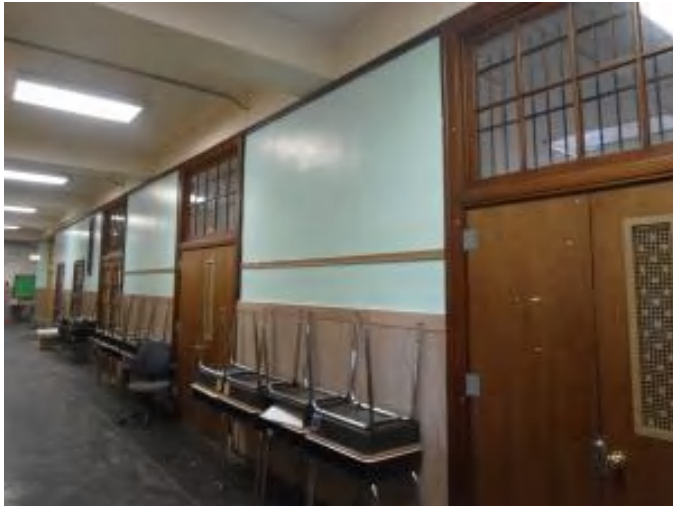
**Location:** Building Wide

**Distress:** Beyond Service Life

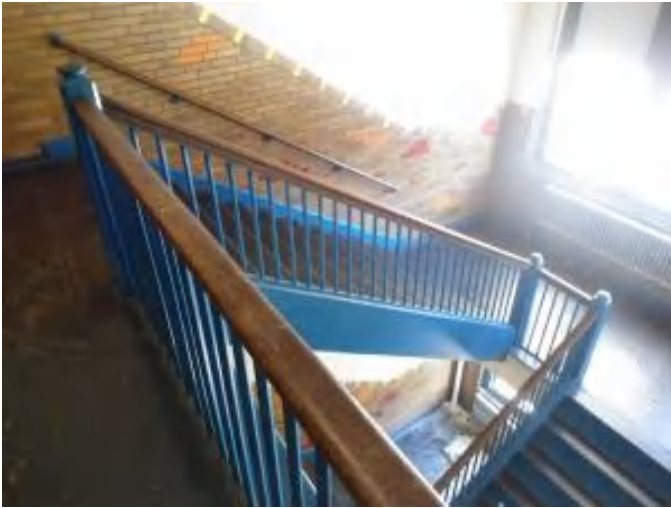
**Location:** Stairs

**Distress:** Life Safety / NFPA / PFD

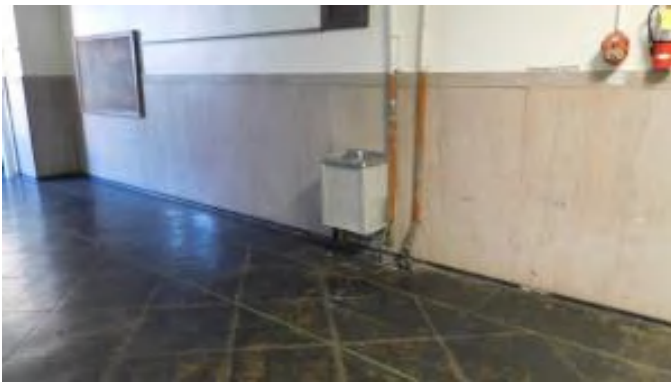
**Location:** entire building

**Distress:** Beyond Service Life

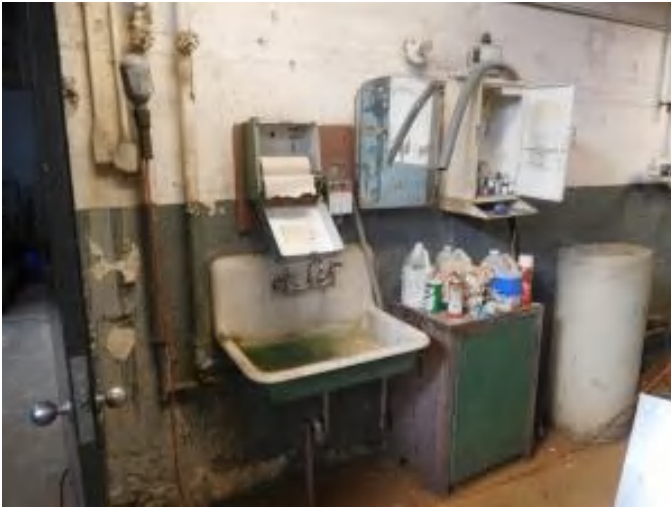
**Location:** entire building

**Distress:** Beyond Service Life

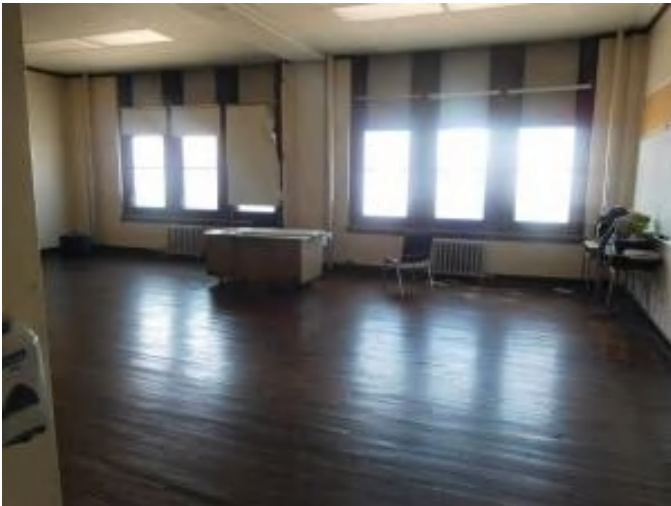
**Location:** classrooms

**Distress:** Building / MEP Codes

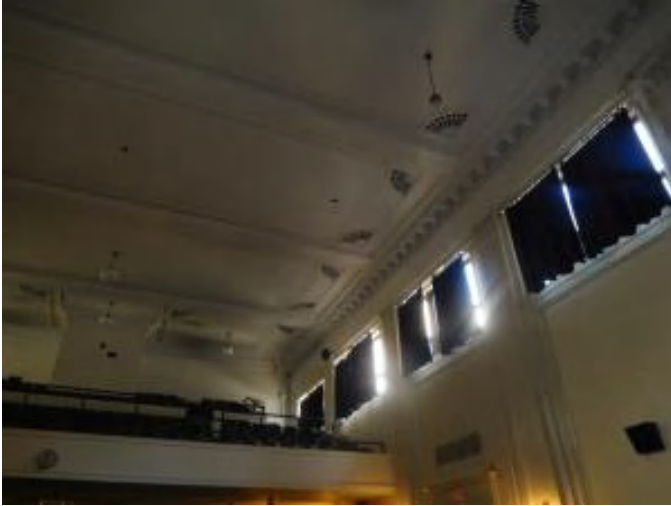
**Location:** auditorium

**Distress:** Building / MEP Codes

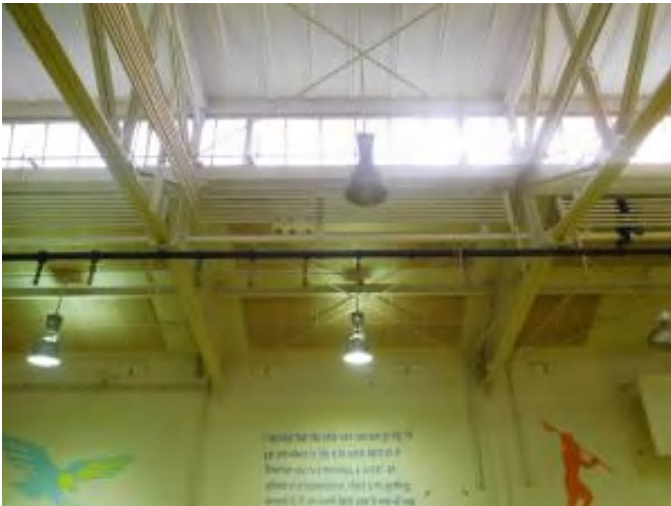
**Location:** gymnasium 1

**Distress:** Building / MEP Codes

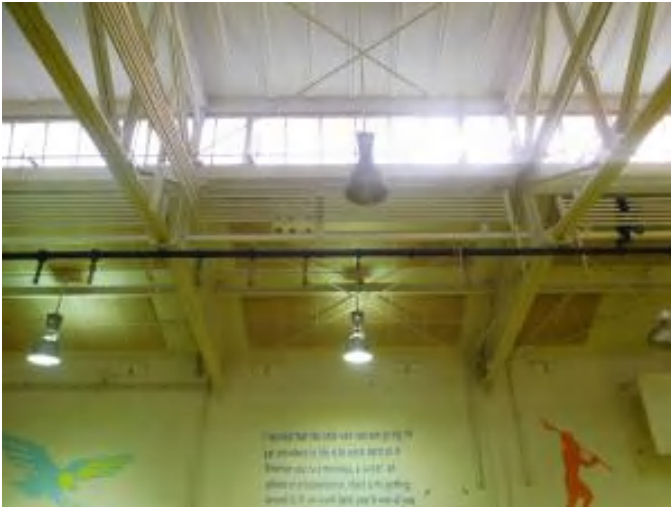
**Location:** gymnasium 2

**Distress:** Building / MEP Codes

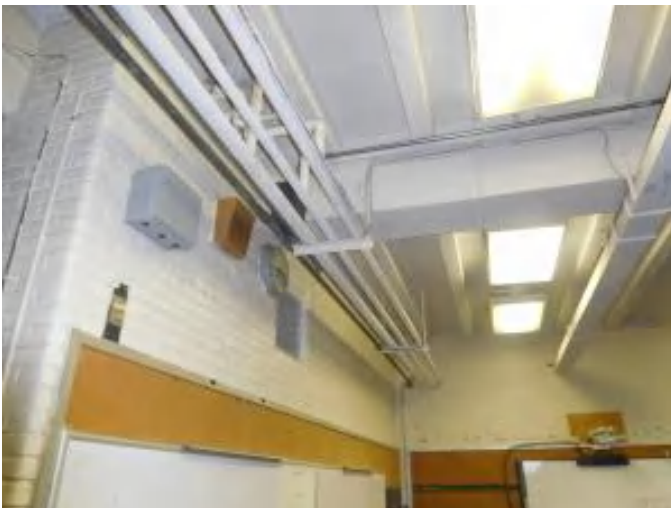
**Location:** entire building

**Distress:** Life Safety / NFPA / PFD

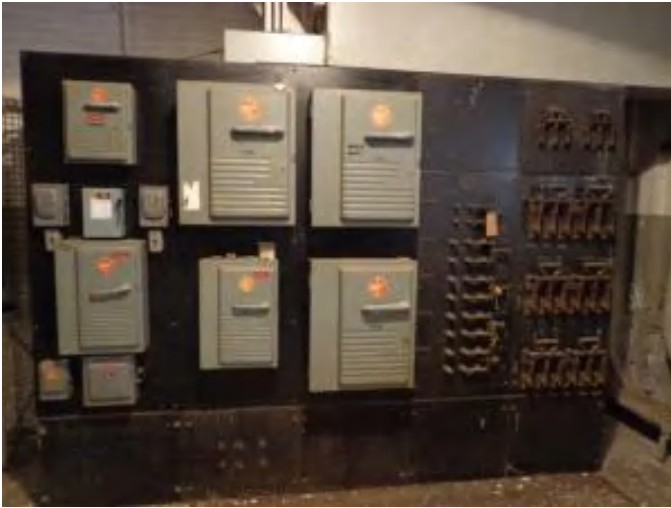
**Location:** Main Electrical Room

**Distress:** Beyond Service Life

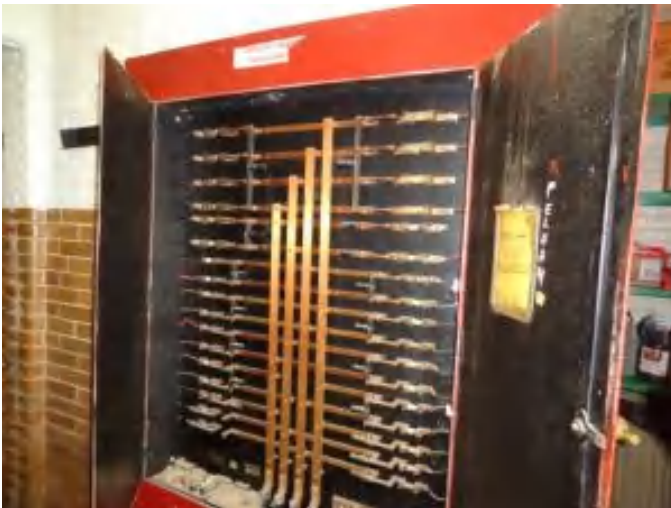
**Location:** Floors 1-3, Kitchen

**Distress:** Beyond Service Life

**Notes:** Replace 120/240V, 1 phase panelboards in corridors on Floors 1-3 and in the kitchen. Total of (13) panelboards.

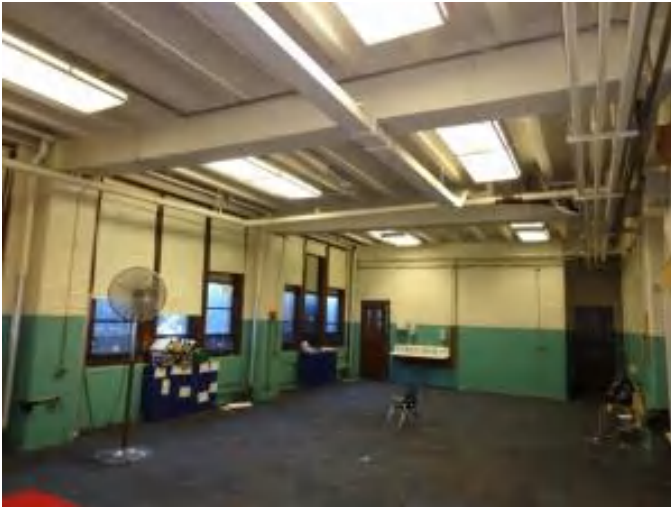
**Location:** Classrooms and Library

**Distress:** Beyond Service Life

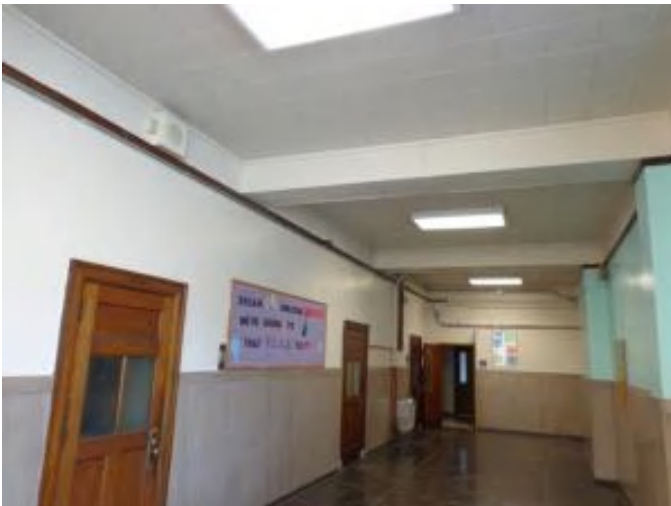
**Location:** Miscellaneous Rooms

**Distress:** Beyond Service Life

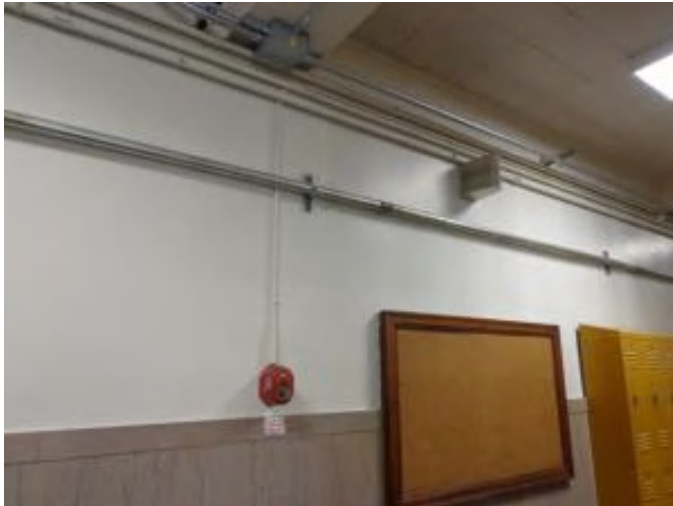
**Location:** Building wide

**Distress:** Building / MEP Codes

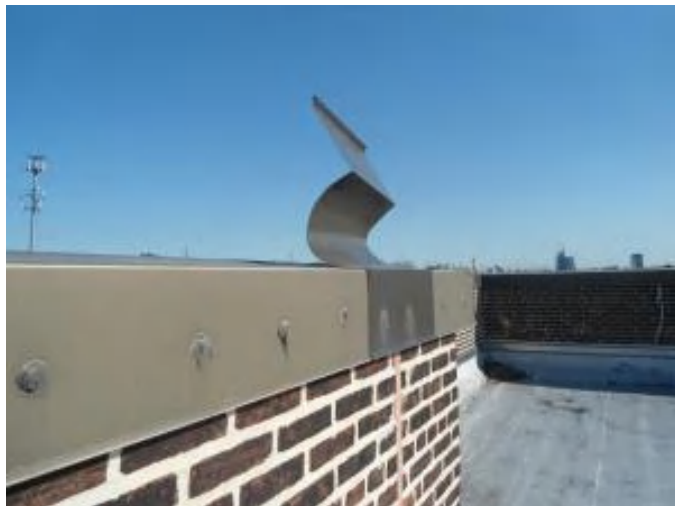
**Location:** Roof

**Distress:** Beyond Service Life

**Notes:** There are a number of roof sections and different roof elevations ranging from the main roof to the mechanical roof. Parapet heights, coping materials, and the height of the flashing also varies in different sections. The main roof is a built up application that was installed in the early 1990'S. The other built up roofs have not conclusive installation dates and have been seal coated several times to extend the life cycle of the application. Considering the age and condition of the roofing systems, universal upgrades are recommended. Remove and replace all roof sections.

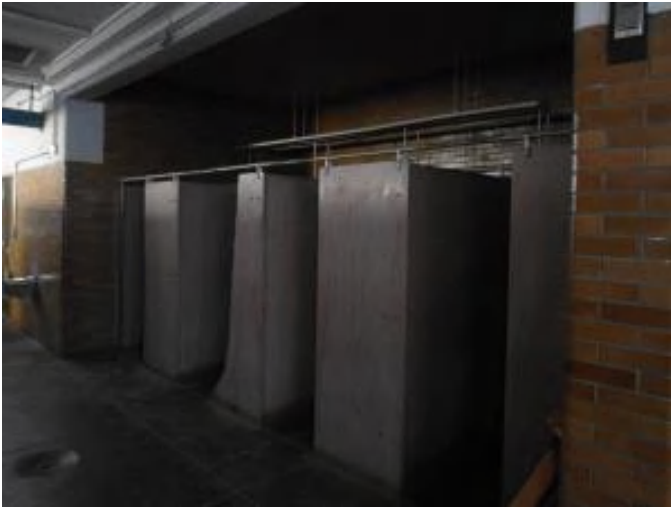
**Location:** Locker Rooms

**Distress:** Damaged

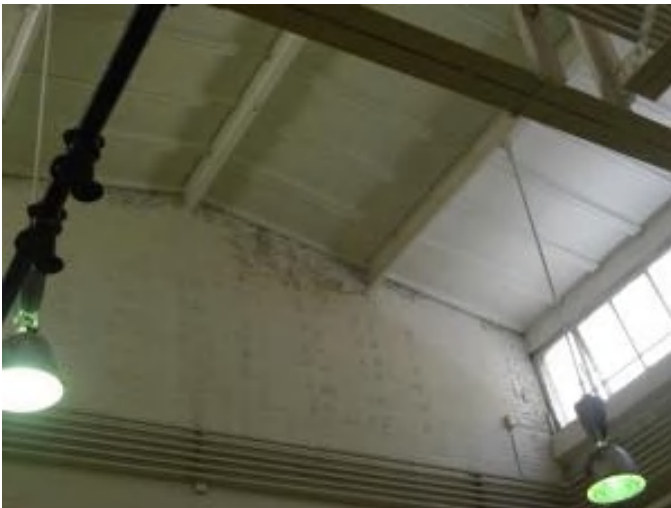
**Location:** Building Wide

**Distress:** Damaged

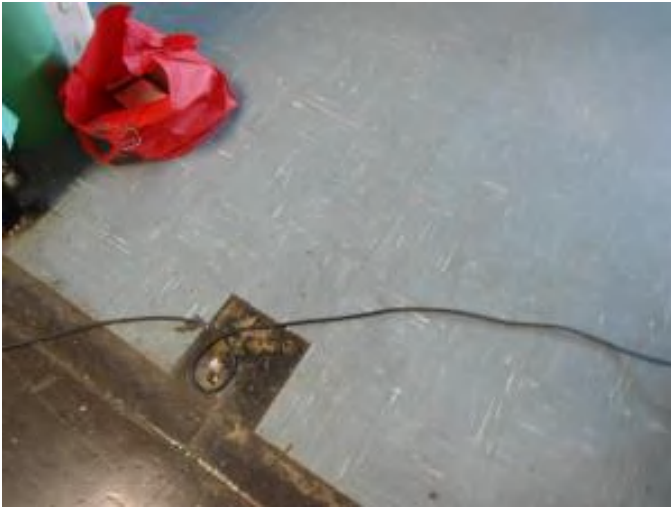
**Location:** Building Wide

**Distress:** Health Hazard / Risk

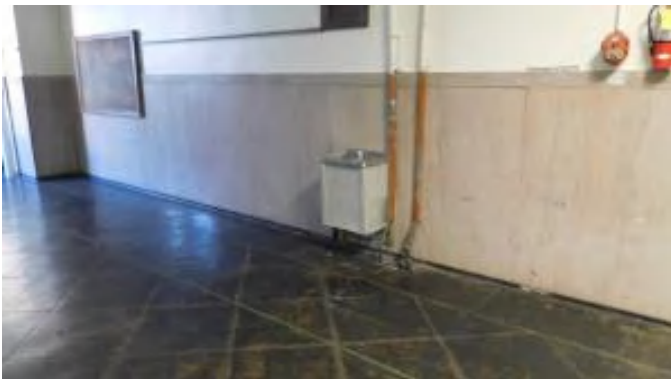
**Location:** basement corridors

**Distress:** Beyond Service Life

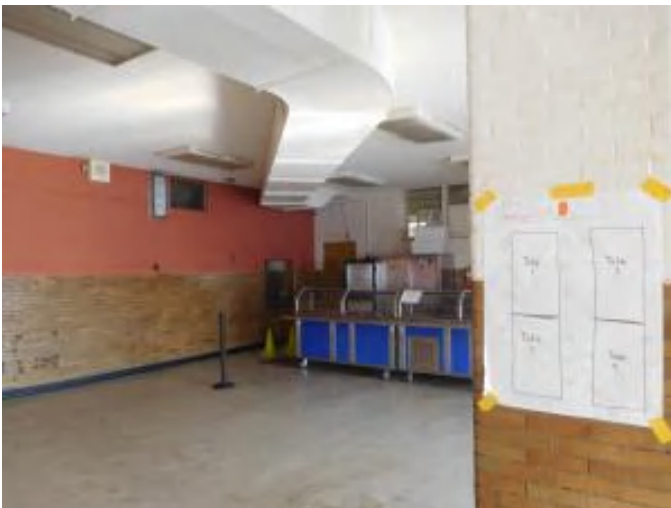
**Location:** cafeteria 1

**Distress:** Building / MEP Codes

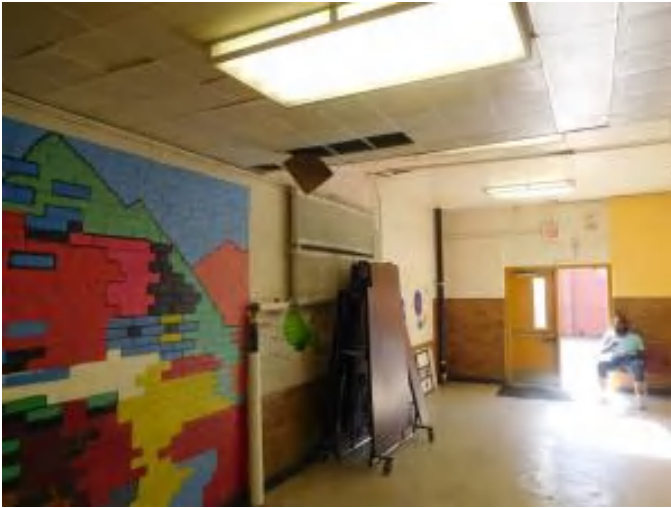
**Location:** cafeteria 2

**Distress:** Building / MEP Codes

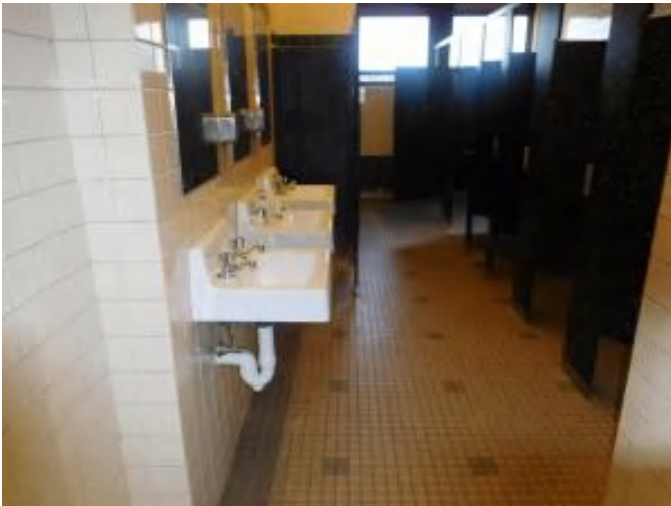
**Location:** toilet rooms

**Distress:** Building / MEP Codes

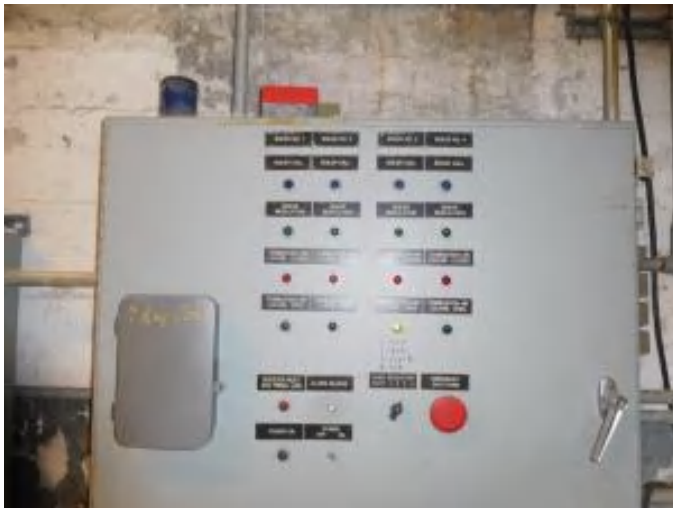
**Location:** entire building

**Distress:** Inadequate

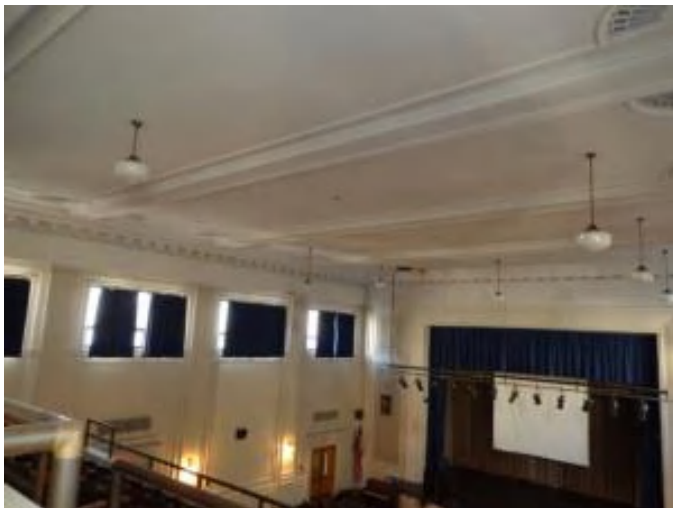
**Location:** Auditorium

**Distress:** Beyond Service Life

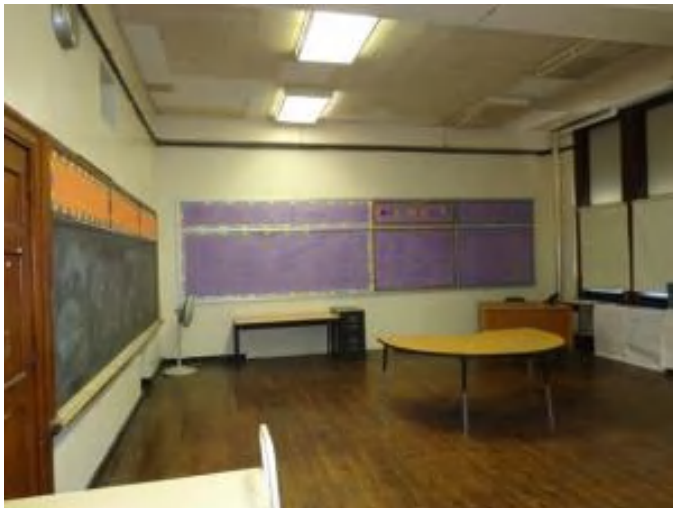
**Location:** Classrooms

**Distress:** Inadequate

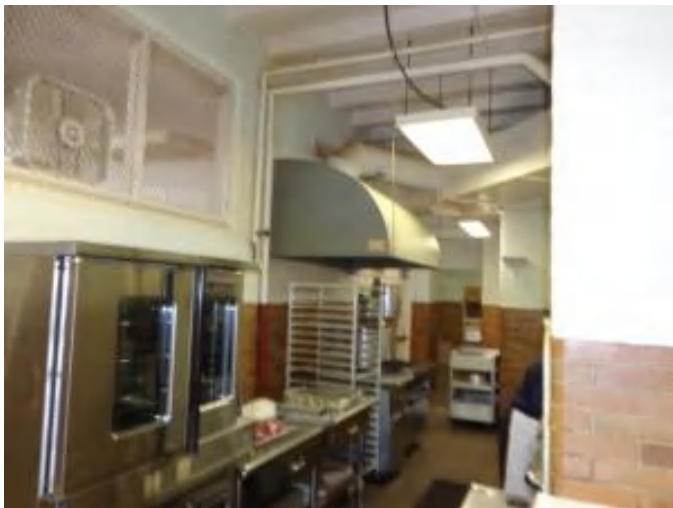
**Location:** Kitchen

**Distress:** Building / MEP Codes

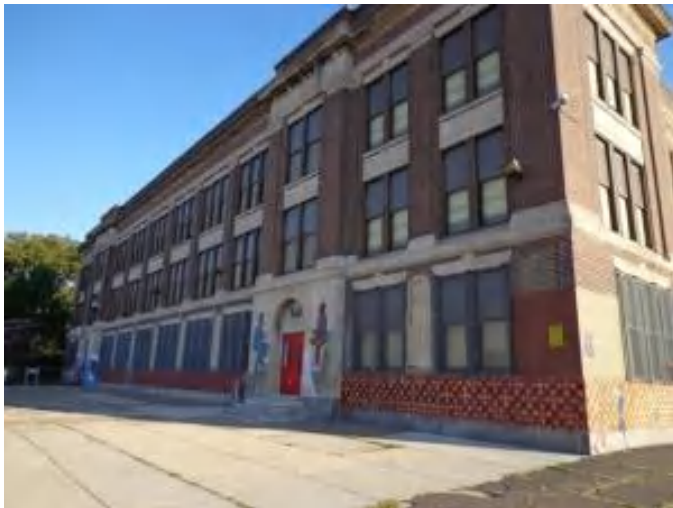
**Location:** Building wide

**Distress:** Beyond Service Life

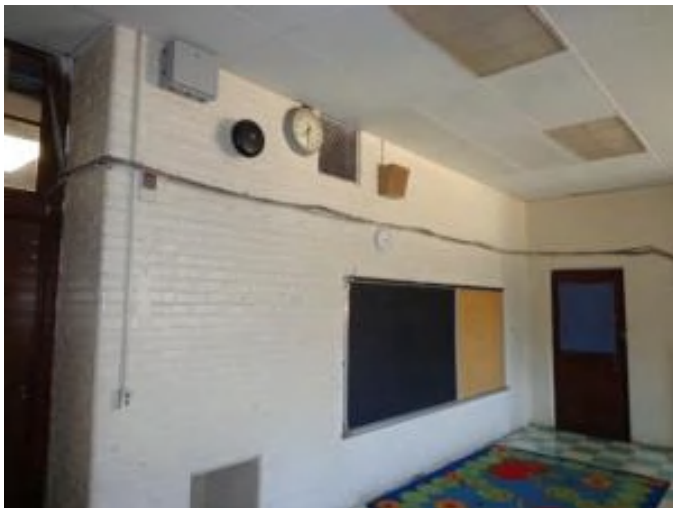
**Location:** Building wide

**Distress:** Beyond Service Life

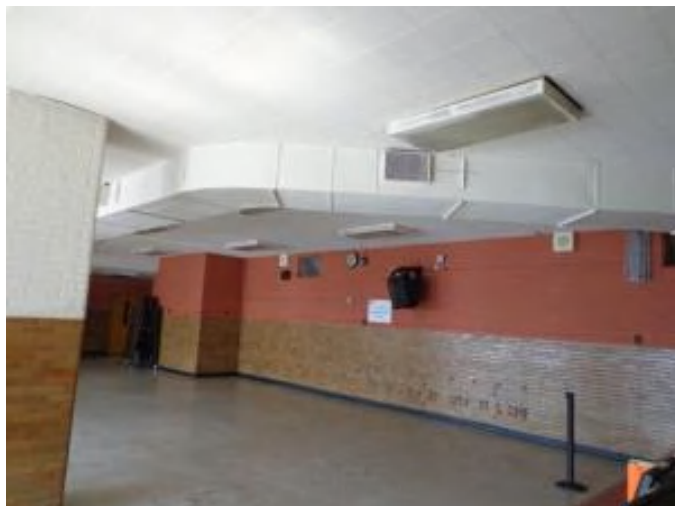
**Location:** Classrooms

**Distress:** Beyond Service Life

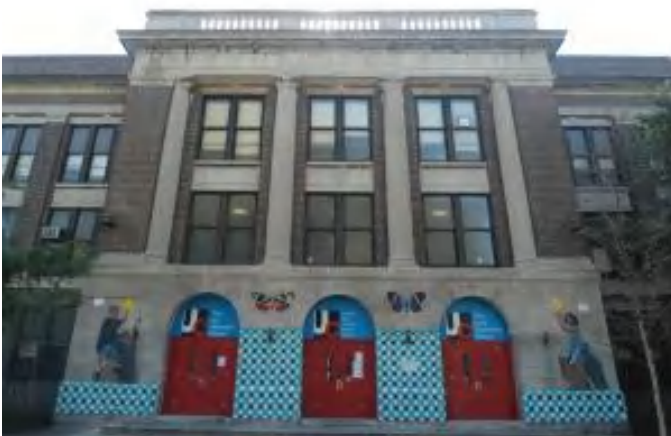
**Location:** Exterior Elevation

**Distress:** Damaged

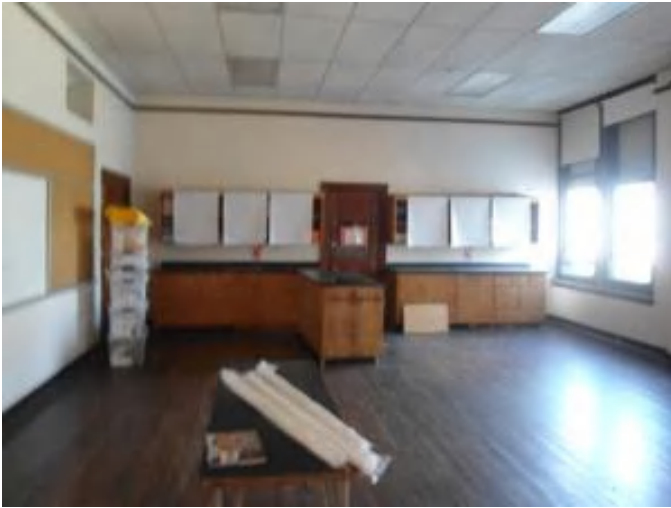
**Location:** Science Labs

**Distress:** Damaged

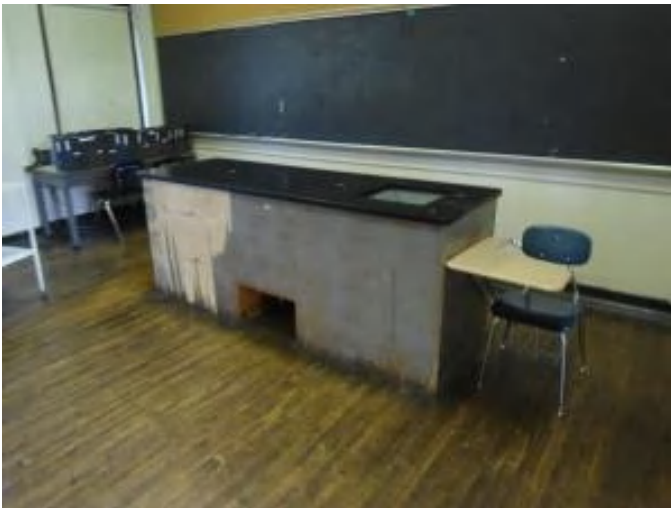
**Location:** Building Wide

**Distress:** Beyond Service Life

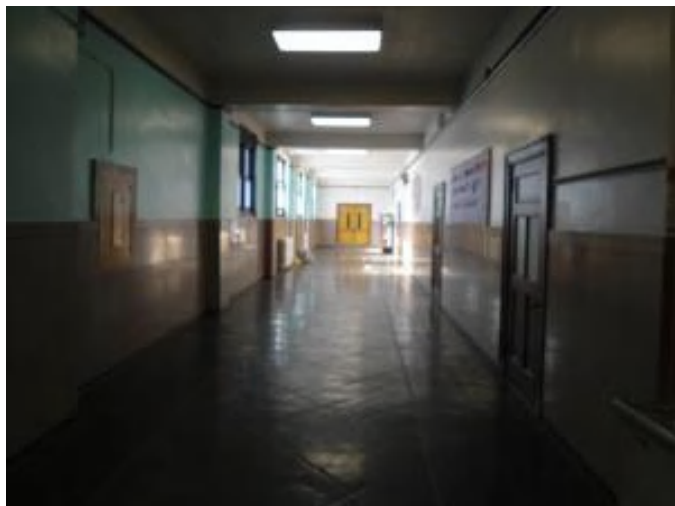
**Location:** Building Wide

**Distress:** Beyond Service Life

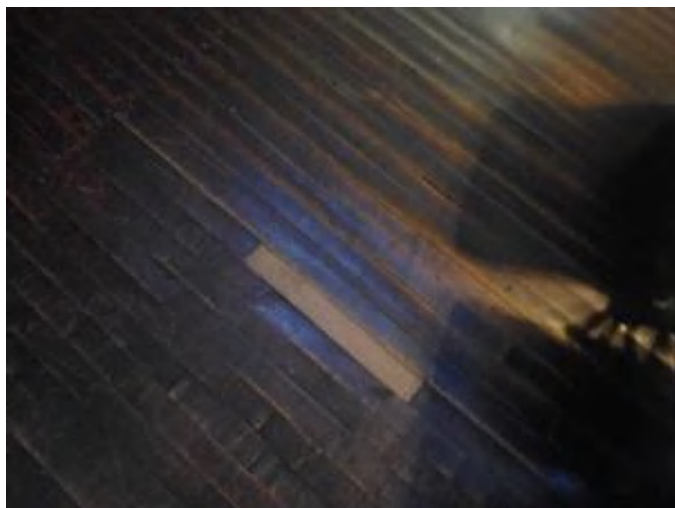
**Location:** Building Wide

**Distress:** Beyond Service Life

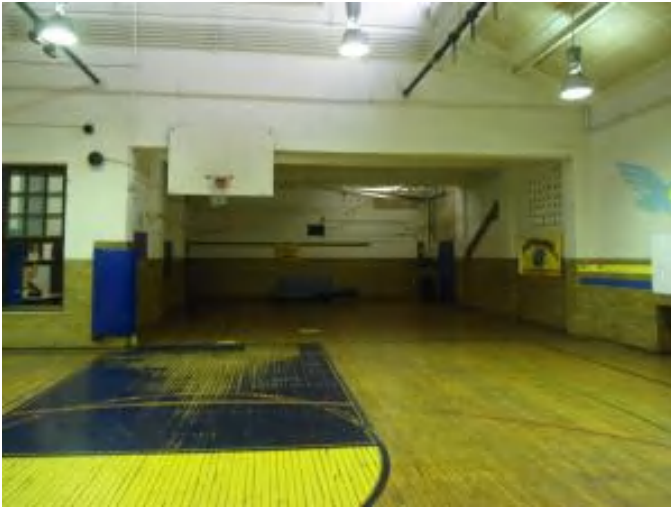
**Location:** Gym

**Distress:** Beyond Service Life

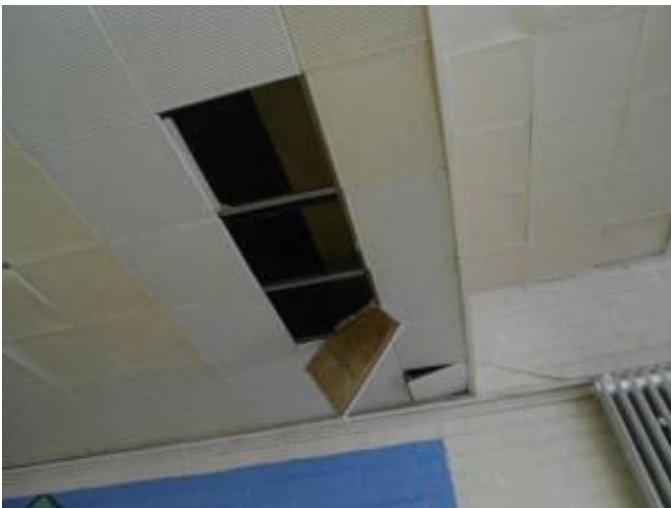
**Location:** Building Wide

**Distress:** Damaged

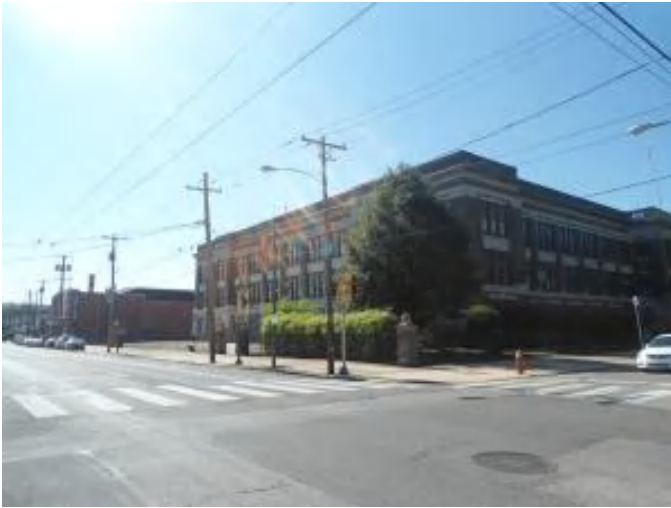
**Location:** Building Wide

**Distress:** Inadequate

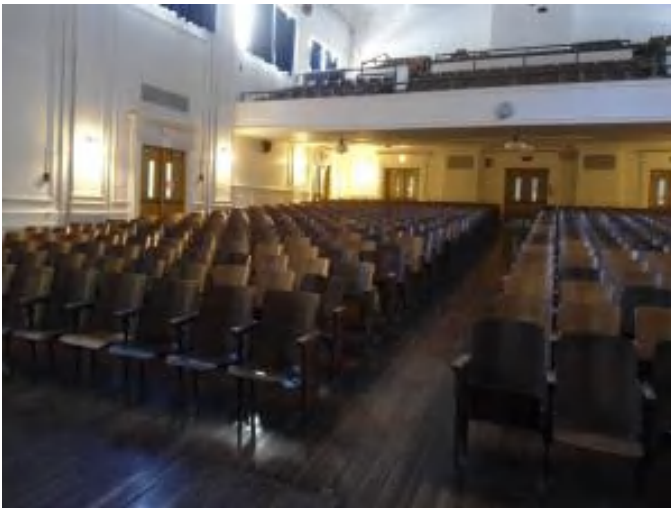
**Location:** Auditorium

**Distress:** Beyond Service Life

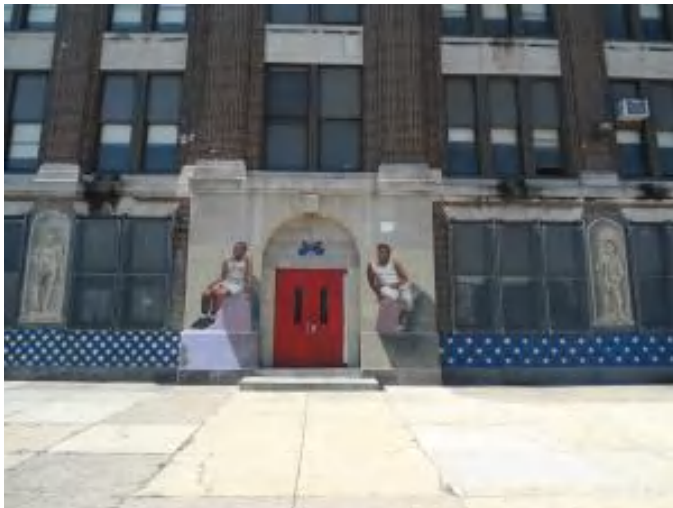
**Location:** Exterior Elevation

**Distress:** Health Hazard / Risk

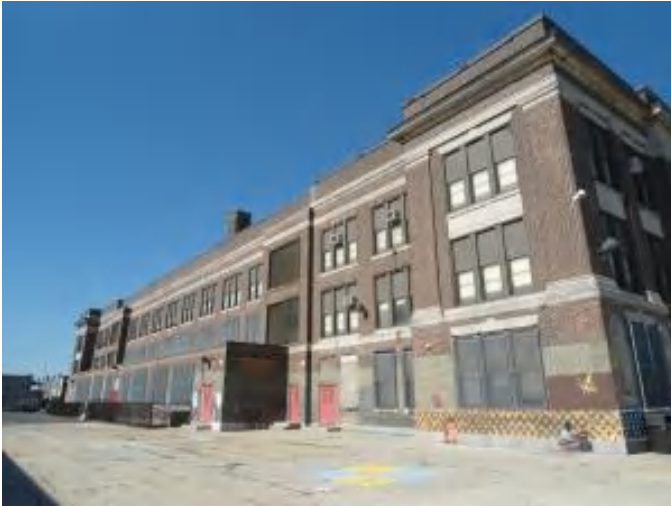
**Location:** Site

**Distress:** Damaged

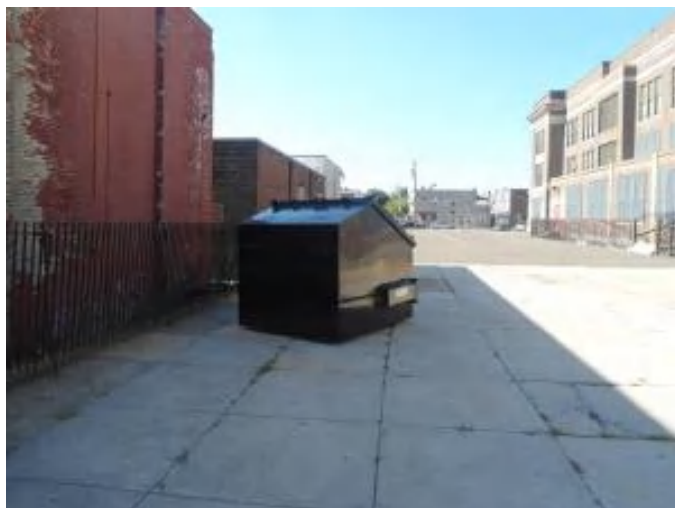
**Location:** Site

**Distress:** Health Hazard / Risk
