## Facility Condition Assessment Summary Report

### Wagner Middle School

School District of Philadelphia  
**S713001;Wagner**  
Final  
**Site Assessment Report**  
January 31, 2017

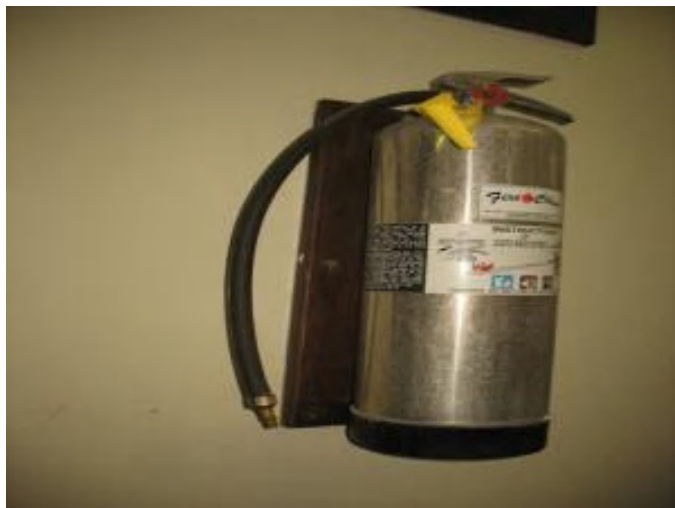
**Location:** Throughout building

#### System: D4010 - Sprinklers

**Distress:** Life Safety / NFPA / PFD

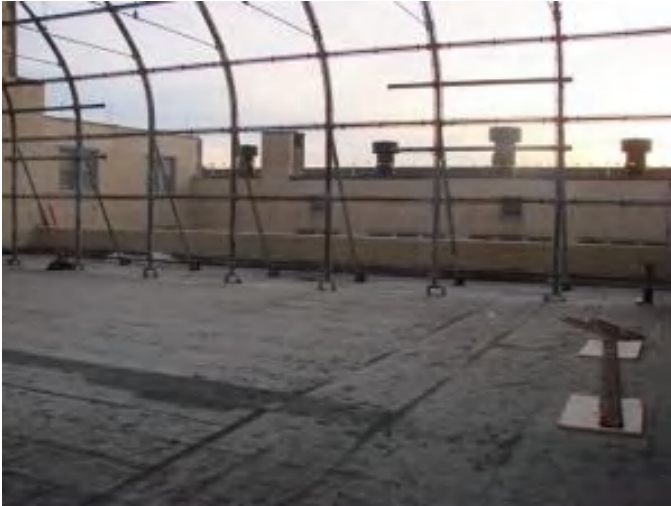
**Location:** Roof top

**System: B3010120 - Single Ply Membrane**

**Distress:** Maintenance Required

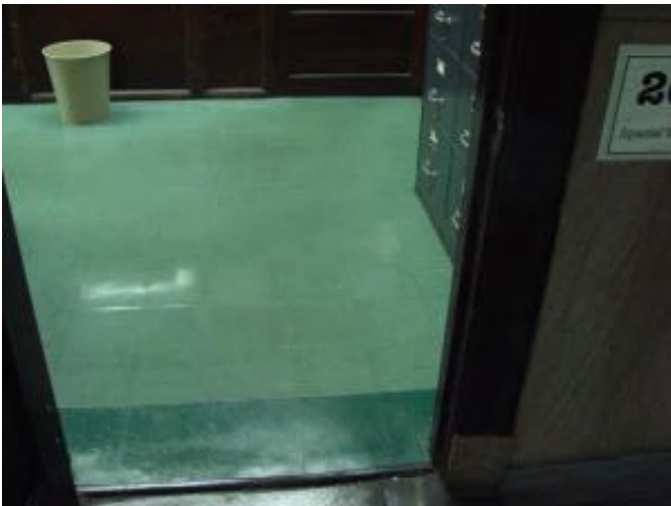
**Location:** Second and third floor; east and west wings

**System: C3020413 - Vinyl Flooring**

**Distress:** Health Hazard / Risk

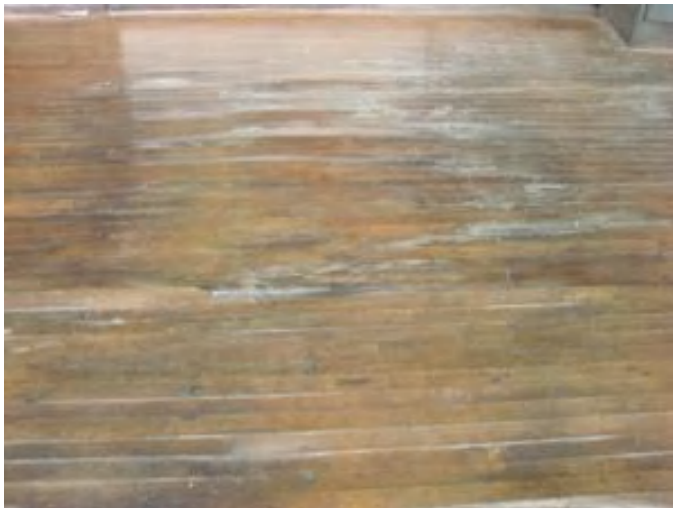
**Location:** Classrooms

**System: C3020414 - Wood Flooring**

**Distress:** Beyond Service Life

- Replace all VAT tile in office spaces.
- Repair (10%) & refinish hardwood flooring (50%).
- Repair (15%) and repaint all walls.
- Repair (10%) and repaint all ceilings.

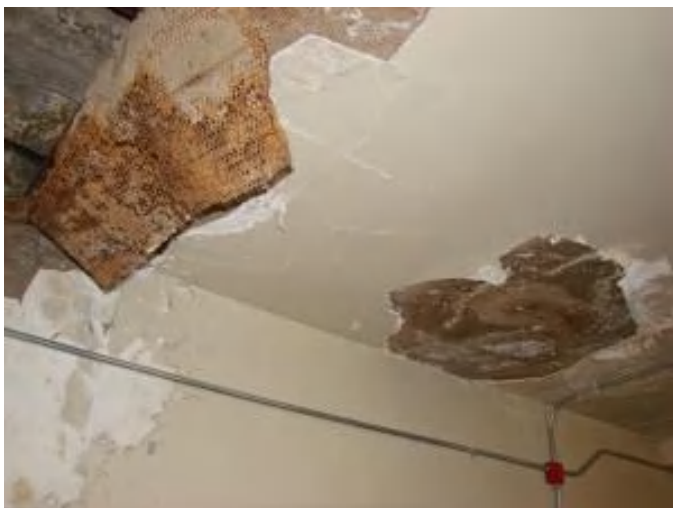
**Location:** Penthouse

**System: C3030 - Ceiling Finishes**

**Distress:** Damaged

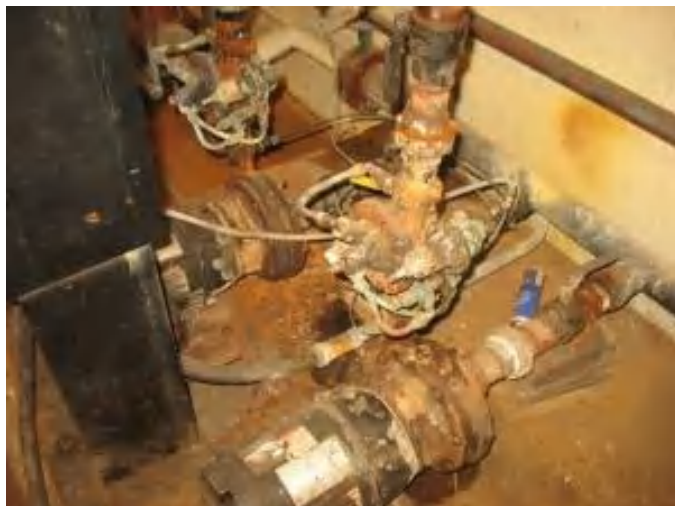
**Location:** Boiler room

**System: D2020 - Domestic Water Distribution**

**Distress:** Damaged

- Replace the skid mounted duplex 7.5HP domestic water booster pumps and isolation valves on the incoming domestic water line which are damaged from rust.

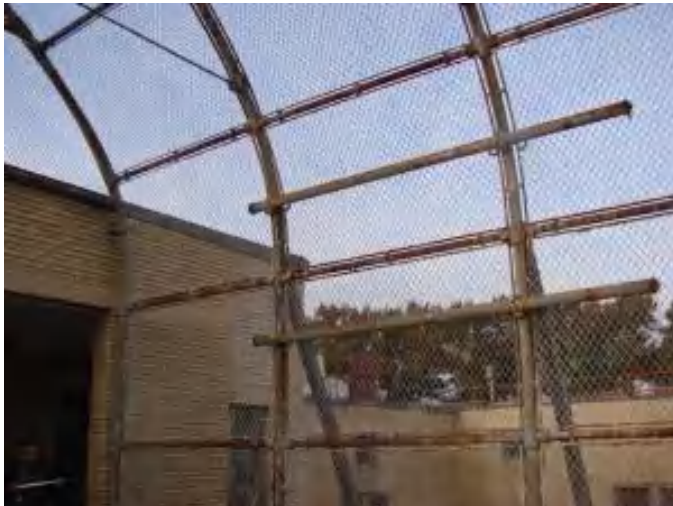
**Location:** Roof top

The roof structure is typically similar to floor construction. The outdoor gym on the 4<sup>th</sup> floor is enclosed with wire mesh netting supported by pipe framing. The structure is deteriorating and rusty.

**System: B1020 - Roof Construction**

**Distress:** Maintenance Required

- Refurbish wire mesh structure enclosing outdoor gym on 4<sup>th</sup> floor; clean and paint framing, install new wire mesh.
- Replace topping on outdoor gym floor, install new waterproofing membrane.

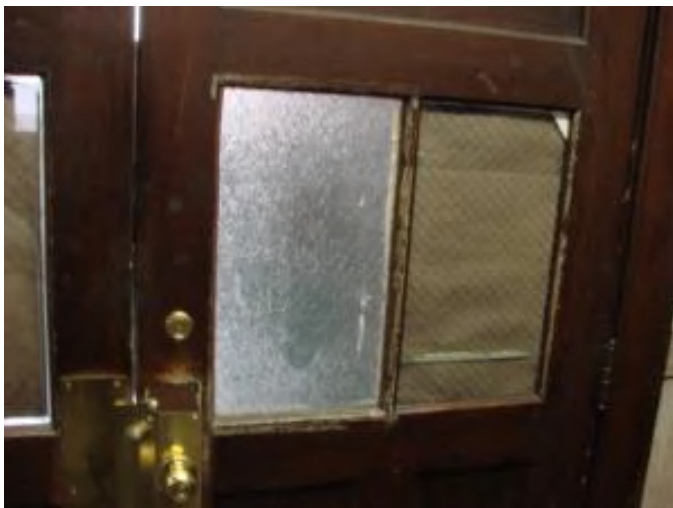
**Location:** Throughout building

Interior doors are generally rail and stile wood doors, most glazed, in wood frames with transoms and solid core in hollow metal frames. Doors are typically in good condition. Most doors are fitted with door knobs and are not ADA compliant.

**System: C1020 - Interior Doors**

**Distress:** Accessibility

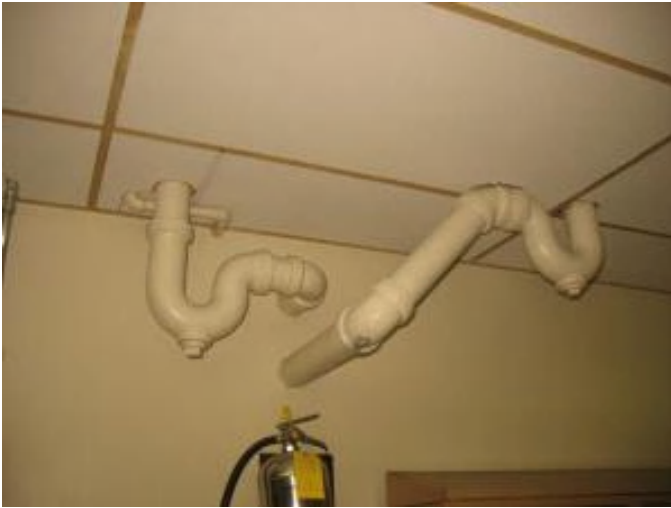
**Location:** Throughout building

The maintenance staff reported mostly minor problems with the sanitary waste piping systems. However, the sewer piping has been in service for an unknown amount of time and will require more frequent attention from the maintenance staff as time passes. The District should hire a qualified contractor to examine the sanitary waste piping using video cameras to locate and replace any damaged piping and to further quantify the extent of potential failures.

**System: D2030 - Sanitary Waste**

**Distress:** Beyond Service Life

- Hire a qualified contractor to perform a detailed examination of the sanitary waste piping using visual inspection and video cameras to locate and replace any damaged piping and to further quantify the extent of potential failures.

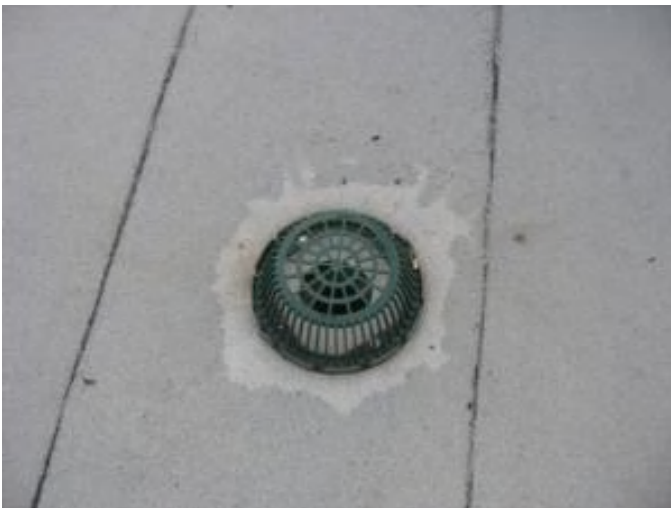
**Location:** Throughout building

Rain water from the roof is routed down through pipe chases in the interior of the building by galvanized piping with threaded fittings, repairs have been made with cast iron piping with no-hub fittings. The drain piping should be inspected by a qualified contractor and repaired as necessary. The Building Engineer reported no major issues with the rain water drainage piping in the addition.

**System: D2040 - Rain Water Drainage**

**Distress:** Beyond Service Life

- Hire a qualified contractor to perform a detailed examination of the rain water drainage piping using visual inspection and video cameras to locate and replace any damaged piping and to further quantify the extent of potential failures.

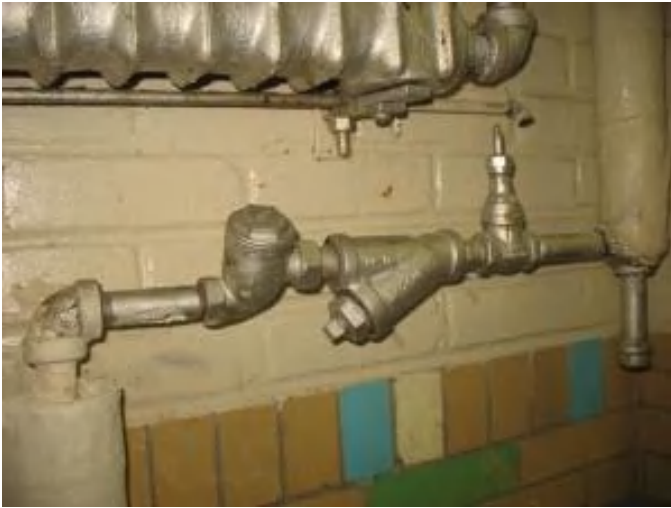
**Location:** Throughout building

Steam piping is black steel with welded and flanged fittings. The condensate piping is black steel with threaded fittings. Steam and condensate piping mains from the basement level run up through the building to the radiators on all four (4) floors. The distribution piping has been in use well beyond its service life and will require more frequent attention from the maintenance staff to address pipe/valve failures as time passes. The District should hire a qualified contractor to examine the steam and condensate piping and perform additional testing to locate and replace any damaged piping and to further quantify the extent of potential failures. The District should budget for replacing this piping over the next 10 years.

**System: D3040 - Distribution Systems**

**Distress:** Beyond Service Life

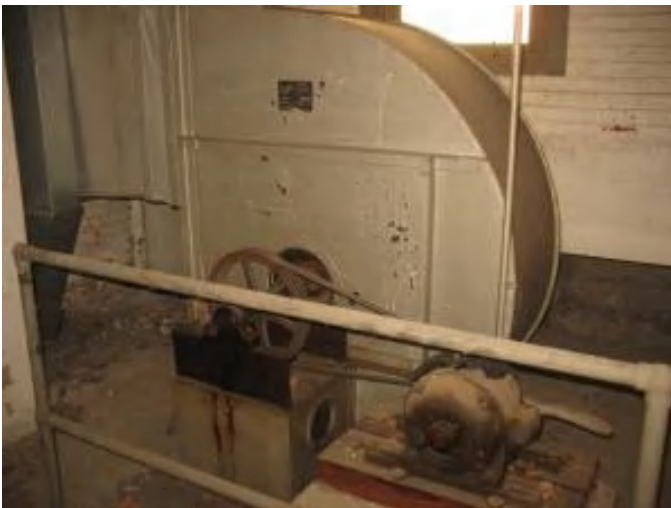
**Location:** Penthouse

Ventilation for the restrooms is supposed to be provided by two (2) exhaust fans; one (1) located on West side and one (1) located on the East side of the penthouse level. The fans were not operational during the site visit and according to the Building Engineer are out of commission due to environmental concerns. The fans look beyond their service life and should be replaced after abatement is complete; the Building Engineer did not know the year they were installed. The fan motors did not have OSHA required belt guards installed.

**System: D3040 - Distribution Systems**

**Distress:** Failing

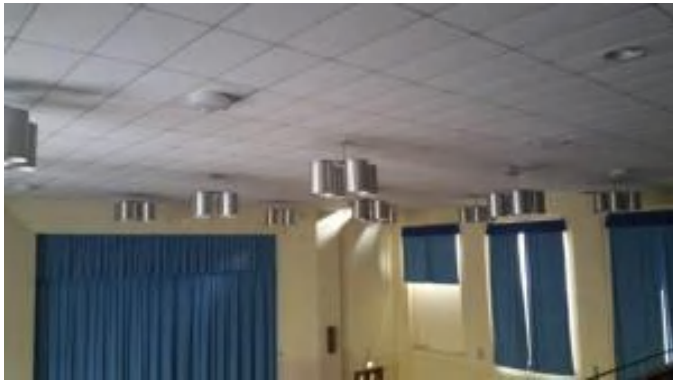
**Location:** throughout the building

Lighting - Interior building is illuminated by various types of fixtures. They include fluorescent lighting (T-8 and some T-12) in majority of the areas, including; classrooms, corridor, offices and Kitchen. Surface or pendant mounted industrial fluorescent fixtures are used in mechanical and electrical rooms. Gymnasium and cafeteria and multi-purpose rooms are illuminated by metal halide fixtures. The majority of interior lighting fixtures are in a poor condition and have reached the end of their service life.

**System: D5020 - Lighting and Branch Wiring**

**Distress:** Beyond Service Life

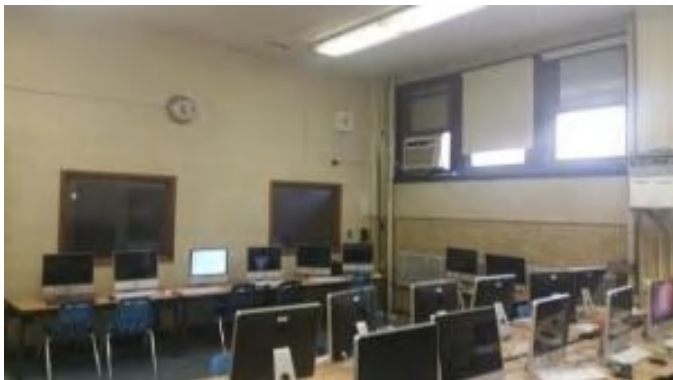
**Location:** throughout the building

**System: D5020 - Lighting and Branch Wiring**

**Distress:** Inadequate

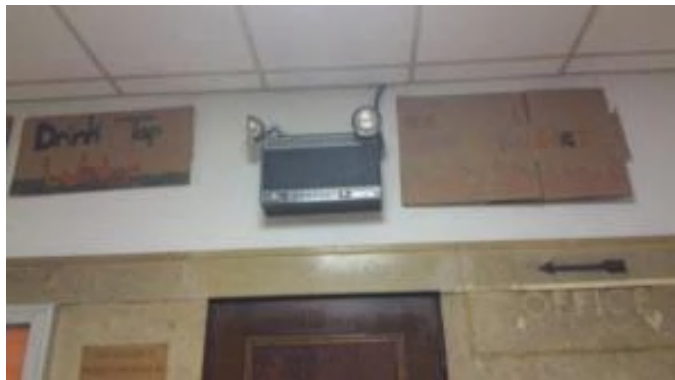
**Location:** throughout the building

**System: D5090 - Other Electrical Systems**

**Distress:** Beyond Service Life

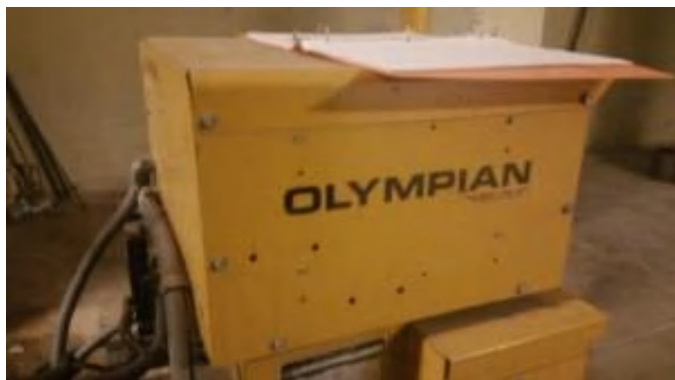
**Location:** electrical room

**System: D5090 - Other Electrical Systems**

**Distress:** Beyond Service Life

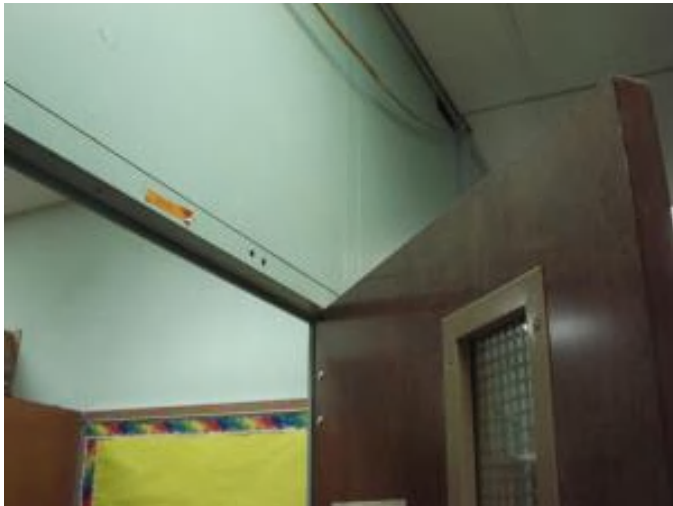
**Location:** Throughout building

**System: C1030 - Fittings**

**Distress:** Obsolete

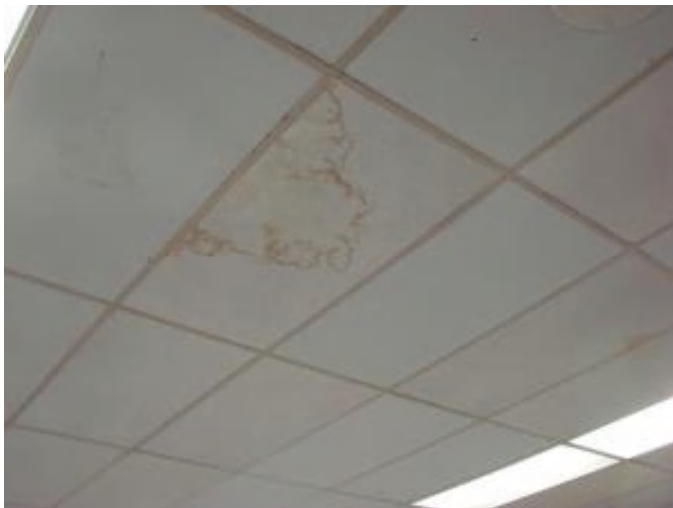
**Location:** Corridors, classrooms

**System: C3030 - Ceiling Finishes**

**Distress:** Beyond Service Life

- Replace all acoustic tile.
- Install new signage throughout.
- Provide ADA compliant hardware on interior doors.
- Install ADA compliant elevator.
- Reset retaining wall brick.

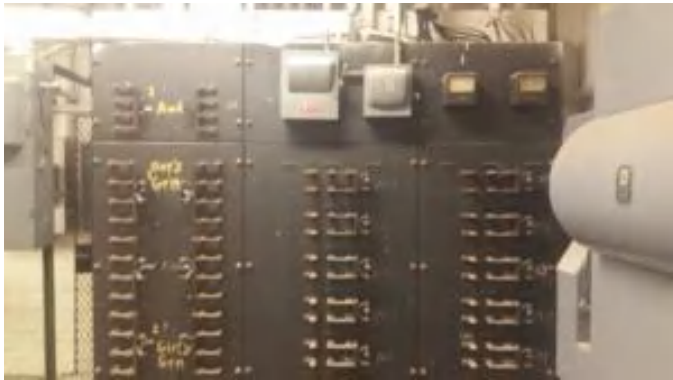
**Location:** electrical room

**System: D5010 - Electrical Service/Distribution**

**Distress:** Beyond Service Life

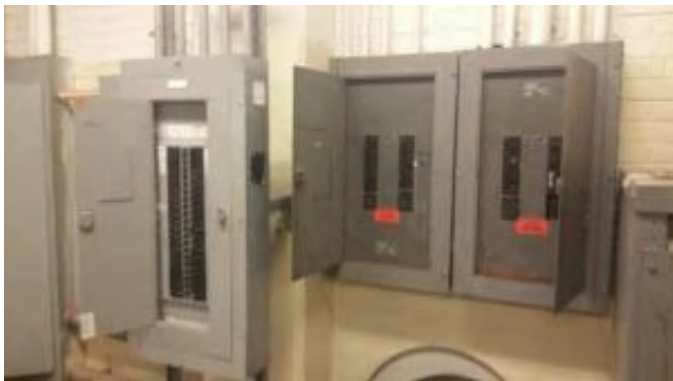
**Location:** throughout the building

Distribution System - The electrical distribution is accomplished with a 120V distribution switchboard, located in the electrical room, feeding several panels throughout the building (two panels in each floor). These panels are not in good condition. They have also reached the end of their useful service life.

**System: D5010 - Electrical Service/Distribution**

**Distress:** Beyond Service Life

**Notes:** Install new 120 V distribution panels throughout the building.

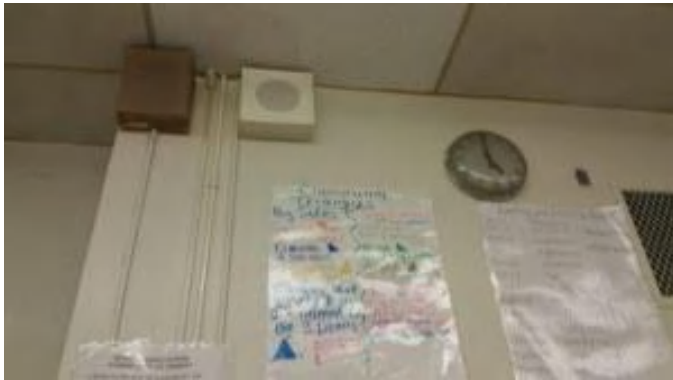
**Location:** throughout the building

**System: D5030 - Communications and Security**

**Distress:** Beyond Service Life

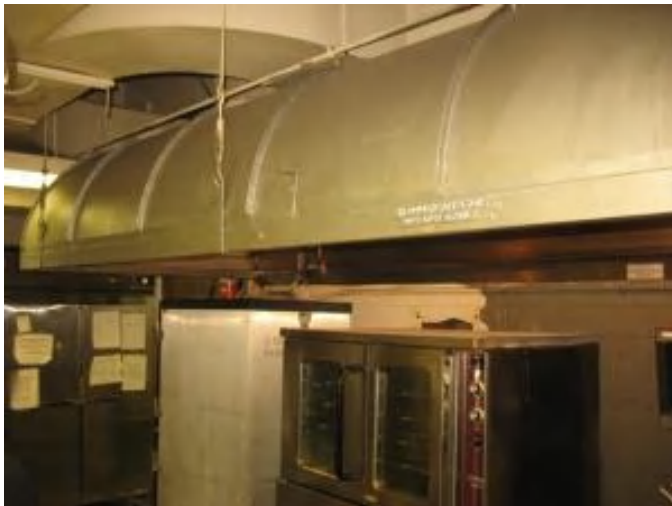
**Location:** Kitchen

system is installed with the kitchen equipment; the kitchen hood is beyond its service life and should be replaced. A make-up air unit is installed.

**System: E1090 - Other Equipment**

**Distress:** Beyond Service Life

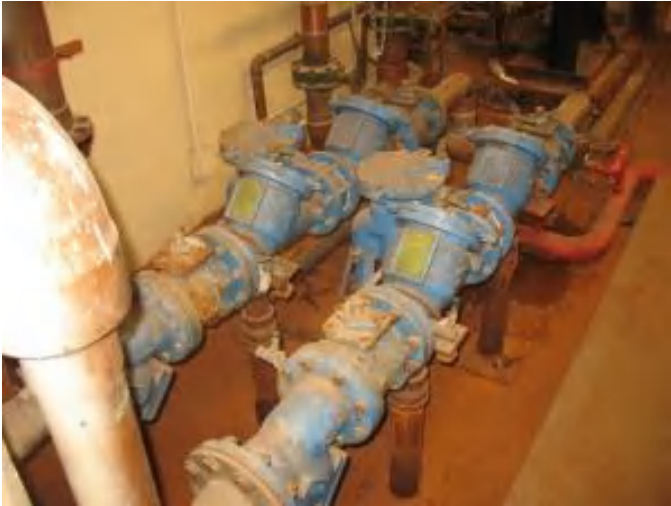
**Location:** Throughout building

**System: D2020 - Domestic Water Distribution**

**Distress:** Beyond Service Life

- Hire a qualified contractor to perform a detailed inspection of the domestic water piping, in use for an unknown amount of time, and replace any damaged piping.

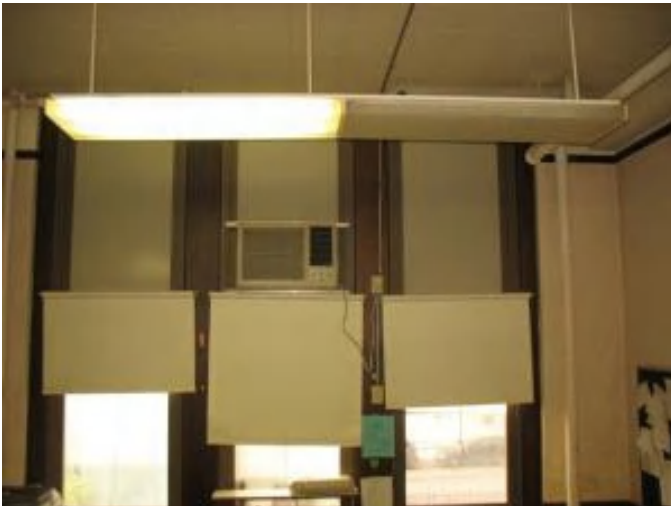
**Location:** Throughout building

Several of the classrooms in the school building have window air conditioning units that have an anticipated service life of only 10 years. Installing a 220 ton air-cooled chiller with pumps located in a mechanical room and chilled water distribution piping would supply more reliable air conditioning for the building with a much longer service life.

**System: D3030 - Cooling Generating Systems**

**Distress:** Inadequate

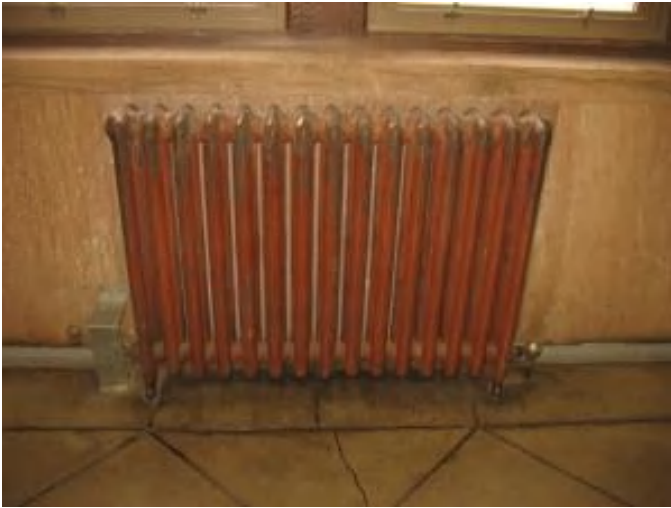
**Location:** Classrooms

**System: D3040 - Distribution Systems**

**Distress:** Building / MEP Codes

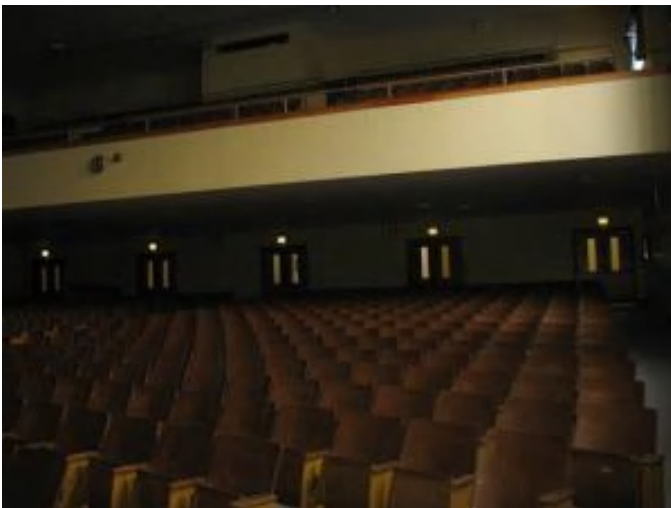
**Location:** Auditorium

**System: D3040 - Distribution Systems**

**Distress:** Building / MEP Codes

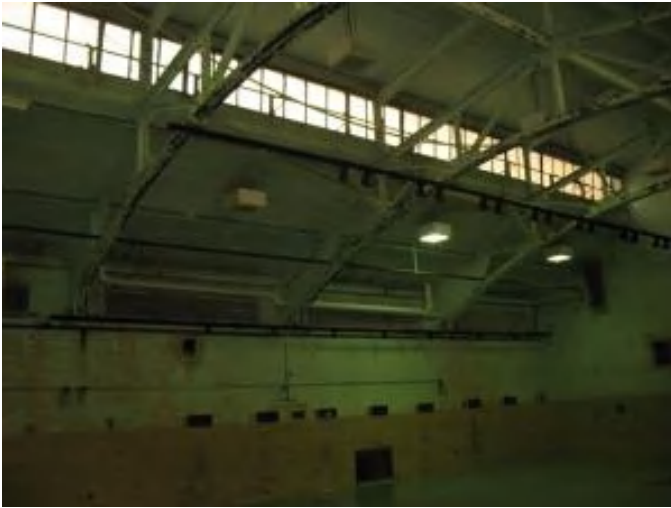
**Location:** Gymnasiums

**System: D3040 - Distribution Systems**

**Distress:** Building / MEP Codes

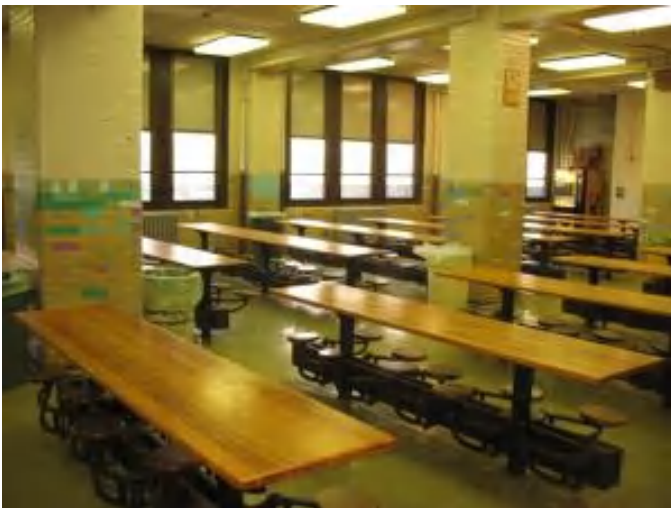
**Location:** Cafeteria

**System: D3040 - Distribution Systems**

**Distress:** Building / MEP Codes

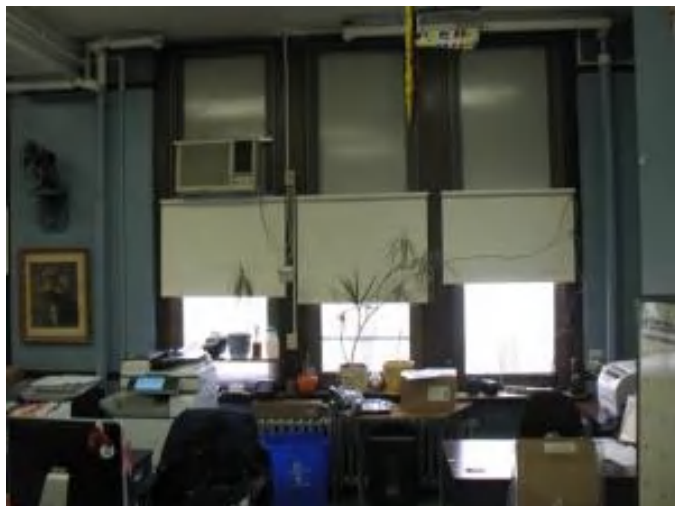
**Location:** Administration

**System: D3040 - Distribution Systems**

**Distress:** Building / MEP Codes

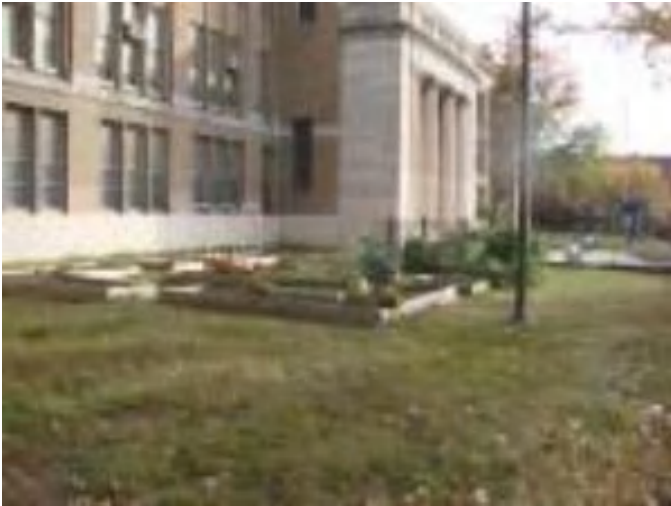
**Location:** grounds

#### System: G4030 - Site Communications & Security

**Distress:** Inadequate
