Facility Condition Assessment Summary Report

Waring School

School District of Philadelphia
S249001;Waring
Final
Site Assessment Report

January 31, 2017

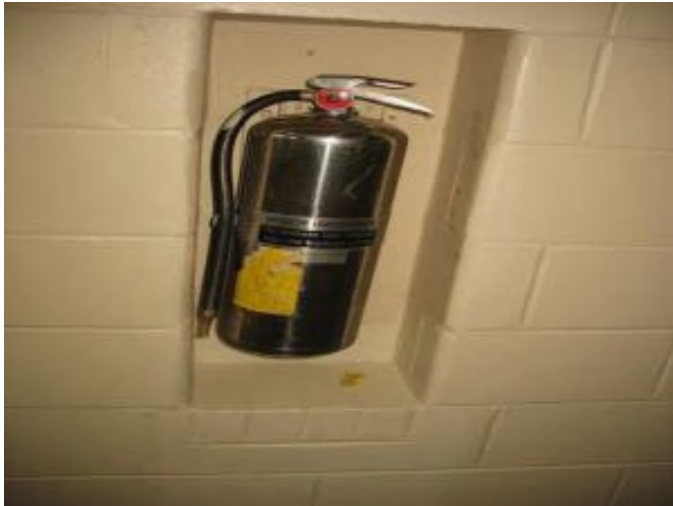
System: D4010 - Sprinklers

Location: Throughout building

Distress: Life Safety / NFPA / PFD

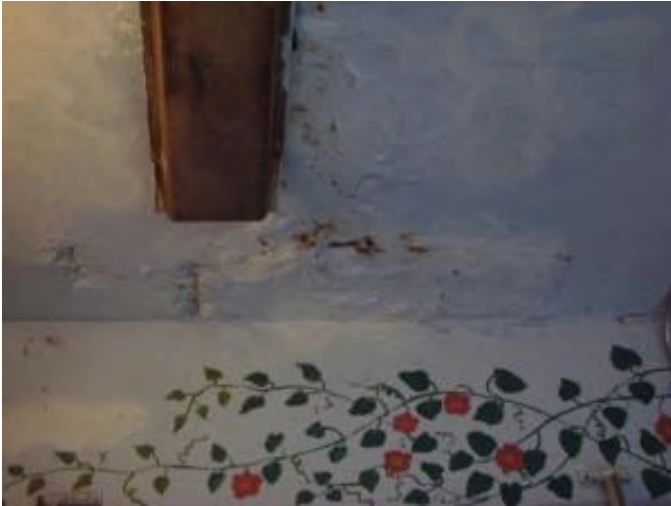
System: B1010 - Floor Construction

The main structure consists typically of cast-in-place concrete columns, beams and one-way concrete slabs. Above ground floor slabs are generally in good condition, however exterior floor slab above the basement entrance shows some structural deterioration including spalled concrete and exposed, and rusting reinforcement.

Location: Exterior

Distress: Damaged

Notes: Repair deteriorated slab sections above basement entrance; epoxy seal joints at terrace above

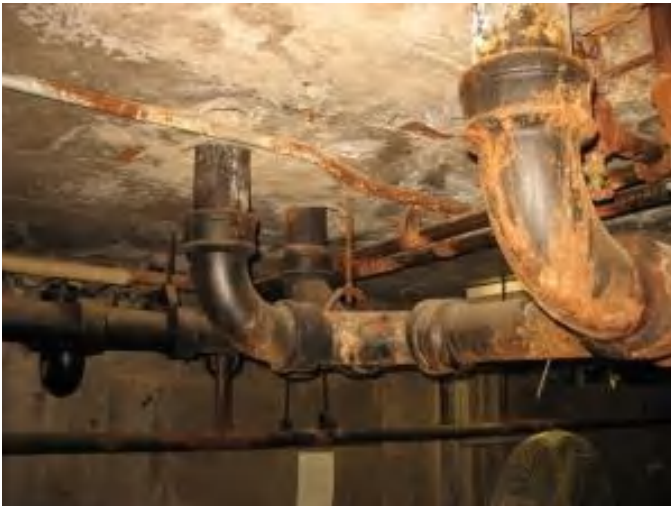
System: D2030 - Sanitary Waste

The maintenance staff reported mostly minor problems with the sanitary waste piping systems. However, the sewer piping has been in service for over 60 years and will require more frequent attention from the maintenance staff as time passes. The District should hire a qualified contractor to examine the sanitary waste piping using video cameras to locate and replace any damaged piping and to further quantify the extent of potential failures.

Location: Throughout building

Distress: Beyond Service Life

Notes: Hire a qualified contractor to perform a detailed examination of the sanitary waste piping using visual inspection and video cameras to locate and replace any damaged piping and to further quantify the extent of potential failures.

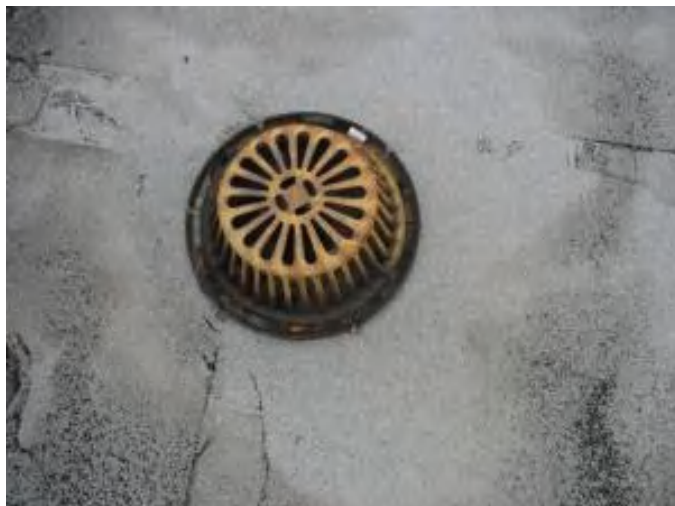
System: D2040 - Rain Water Drainage

Rain Water Drainage - Rain water drains from the roof are routed through mechanical chases in the building and appear to be original. Sections of the cast iron piping with hub and spigot fittings have been replaced with steel piping and no-hub fittings. The Building Engineer reported that rain leaders leak in several places within the building. The District should hire a qualified contractor to examine the rain water drainage piping using video cameras to locate and replace any damaged piping and to further quantify the extent of potential failures.

Location: Throughout building

Distress: Beyond Service Life

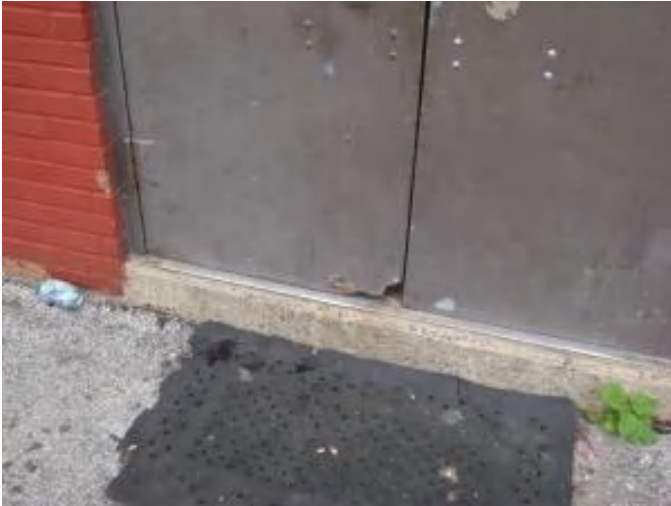
System: B2030 - Exterior Doors

Exterior doors are typically hollow metal in fair to poor condition; they are beyond their service life. Generally, the building is not accessible per ADA requirements due to first floor-grade separation, with no ramps or lifts.

Location: Exterior

Distress: Beyond Service Life

Notes: Replace exterior doors

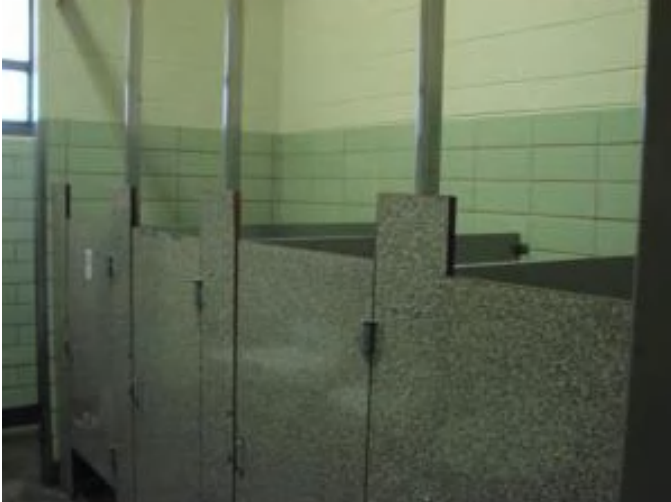
System: C1030 - Fittings

Location: Interior

Distress: Accessibility

Notes: Reconfigure toilets on each floor for accessibility, provide new toilet partitions

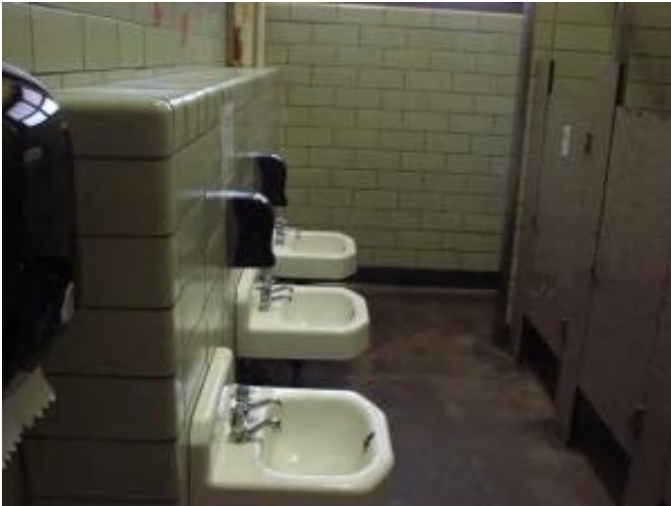
System: C1030 - Fittings

Location: Interior

Distress: Damaged

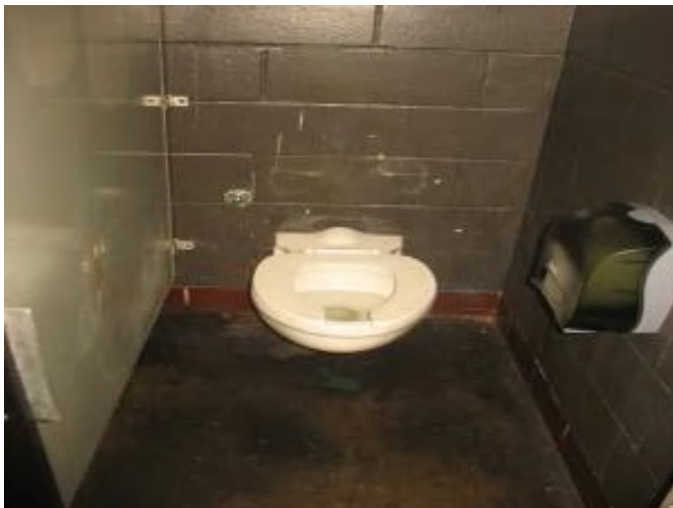
System: D2010 - Plumbing Fixtures

and wall mounted flush valve water closets, wall hung urinals, and lavatories with wheel handle faucets. The Building Engineer reported that the plumbing fixtures require frequent maintenance to stay in working order. The plumbing fixtures are beyond their service life and should be replaced within the next 5 years.

Location: Restrooms

Distress: Beyond Service Life

Notes: Replace thirty-six (36) wall hung water closets in the restrooms with new code compliant fixtures.

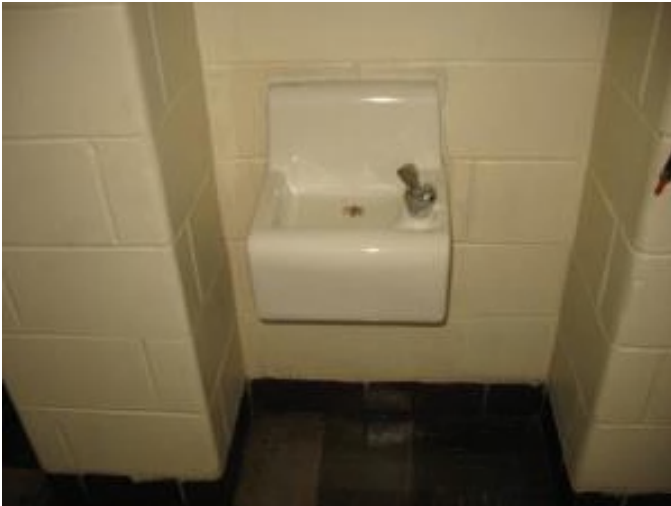
System: D2010 - Plumbing Fixtures

Drinking fountains in the corridors and at the restrooms are wall hung porcelain fountains. The porcelain fountains are well beyond their service life and should be replaced; most are NOT accessible type.

Location: Corridors

Distress: Beyond Service Life

Notes: Replace eight (8) porcelain wall hung drinking fountains in the corridors. These units are beyond their service life and most are NOT accessible type.

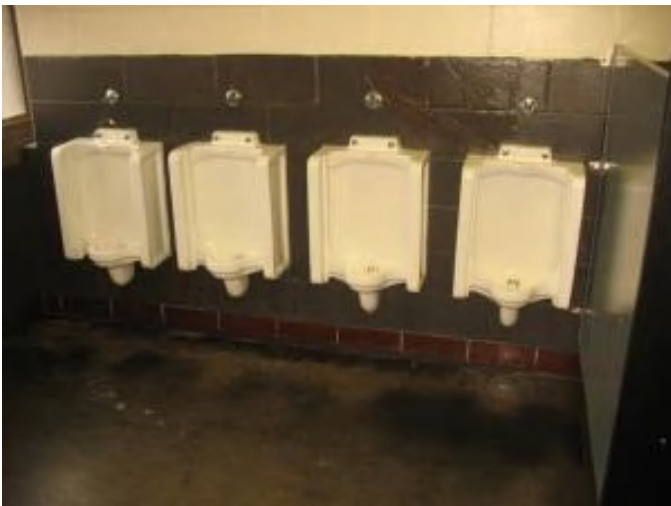
System: D2010 - Plumbing Fixtures

Location: Restrooms

Distress: Beyond Service Life

Notes: Replace fifteen (15) wall hung urinals in the restrooms with new low flow fixtures.

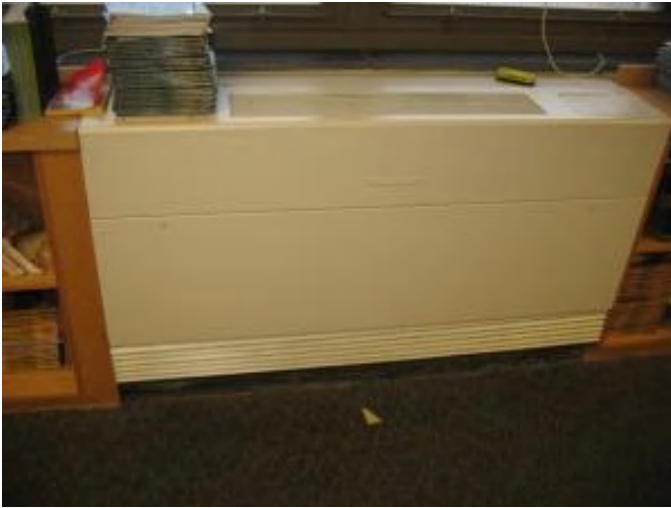
System: D3040 - Distribution Systems

Location: Classrooms

Distress: Beyond Service Life

Notes: Remove the existing unit ventilators and install units with hot and chilled water coils and integral heat exchangers to introduce outdoor air to the building.

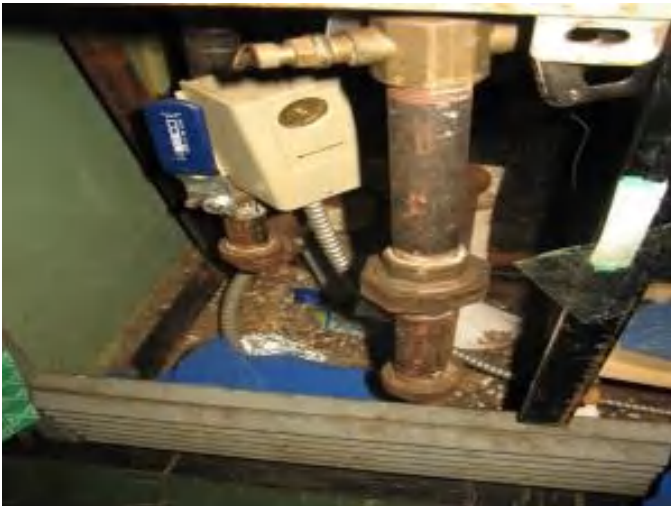
System: D3040 - Distribution Systems

Location: Throughout building

Distress: Beyond Service Life

Notes: Hire a qualified contractor to examine the building heating water distribution piping, in service for an unknown amount of time, and perform additional testing to locate and replace any damaged piping and to further quantify the extent of potential failures.

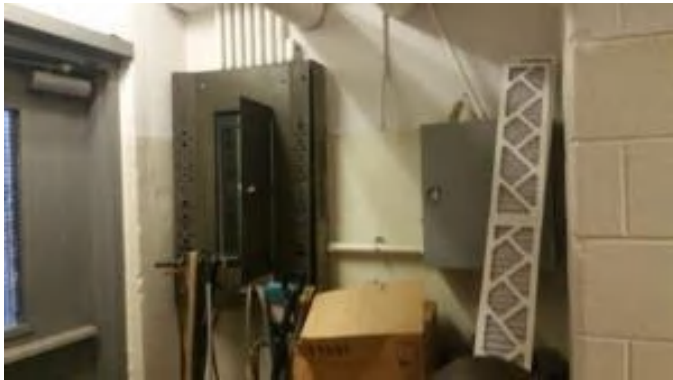
System: D5010 - Electrical Service/Distribution

Location: throughout the building

Distress: Beyond Service Life

Notes: Install new 120V panel-boards throughout the building for lighting, and receptacles loads.

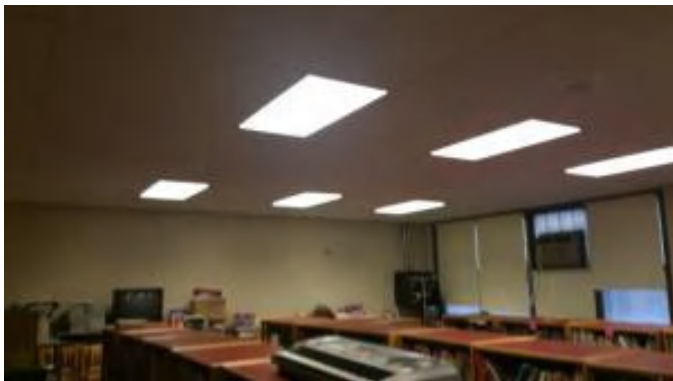
System: D5020 - Lighting and Branch Wiring

fixtures are used in mechanical and electrical rooms. The Gymnasium also has old HID fixtures. The majority of interior lighting fixtures is in a poor condition and has reached the end of their useful service.

Location: throughout the building

Distress: Beyond Service Life

Notes: Install new a lighting system for the entire building.

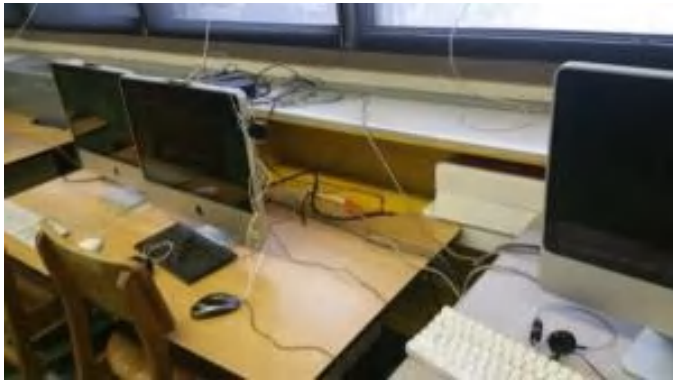
System: D5020 - Lighting and Branch Wiring

Location: throughout the building

Distress: Beyond Service Life

Notes: Install new receptacles in all classrooms and other areas (minimum two receptacles on each wall).

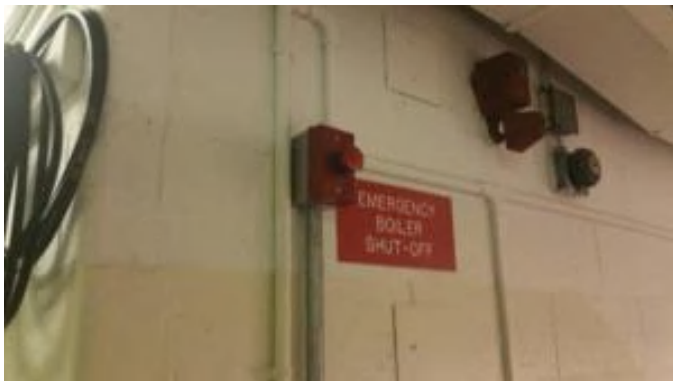
System: D5030 - Communications and Security

Location: throughout the building

Distress: Health Hazard / Risk

Notes: Install a new automated FA System

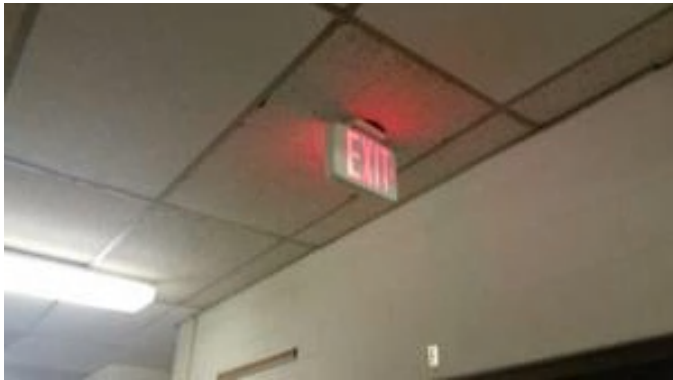
System: D5090 - Other Electrical Systems

Location: throughout the building

Distress: Beyond Service Life

Notes: Install new emergency exit signs emergency lights.

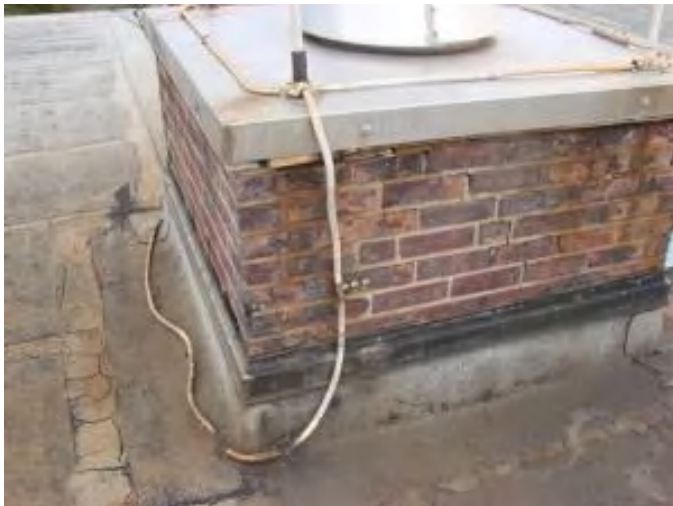
System: D5090 - Other Electrical Systems

Location: roof

Distress: Inadequate

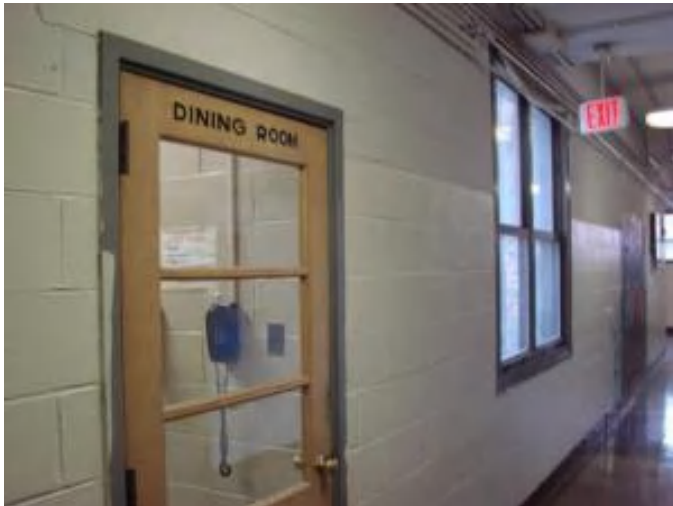
System: C1020 - Interior Doors

Location: Interior

Distress: Beyond Service Life

Notes: Replace interior doors

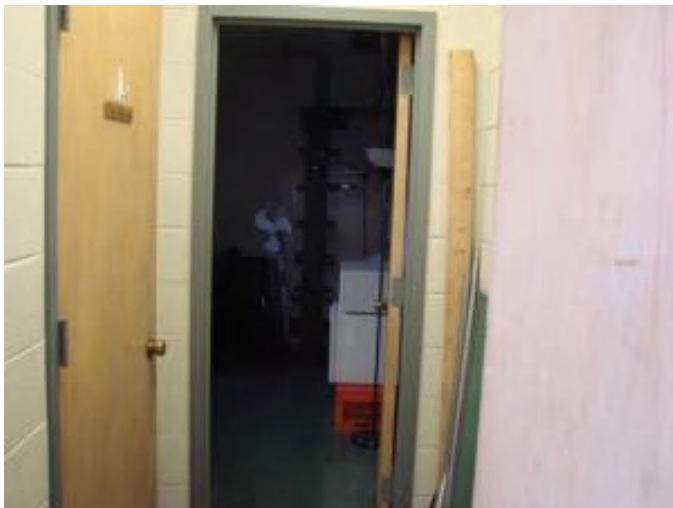
System: C1020 - Interior Doors

Location: Interior

Distress: Accessibility

Notes: Provide ADA compliant hardware on interior doors

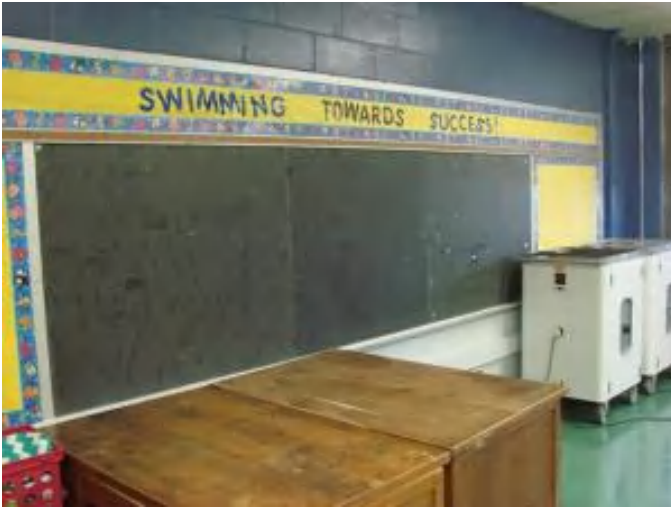
System: C1030 - Fittings

Location: Interior

Distress: Beyond Service Life

Notes: Replace original chalk boards with marker boards

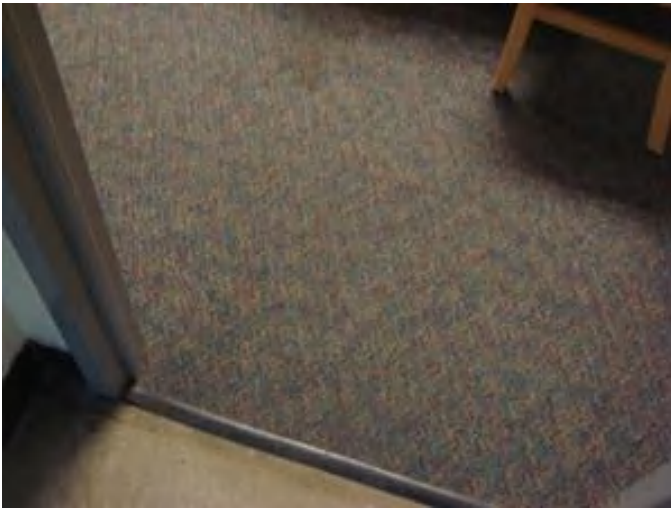
System: C3020411 - Carpet

Location: Interior

Distress: Beyond Service Life

Notes: Replace carpet in library

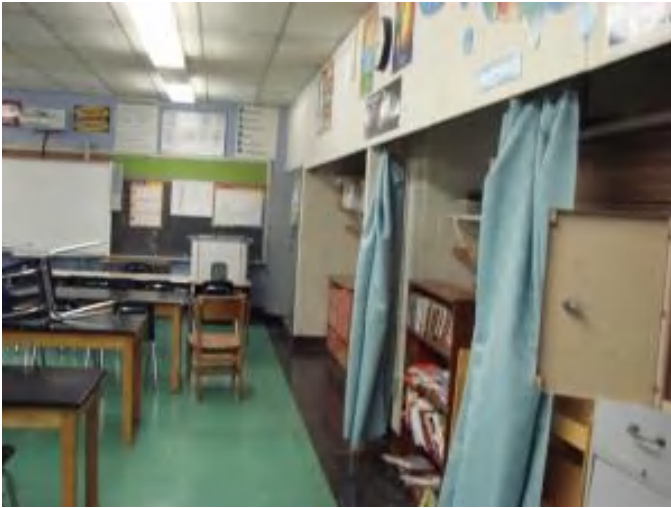
System: C3020413 - Vinyl Flooring

Location: Interior

Notes: Replace all VAT tile

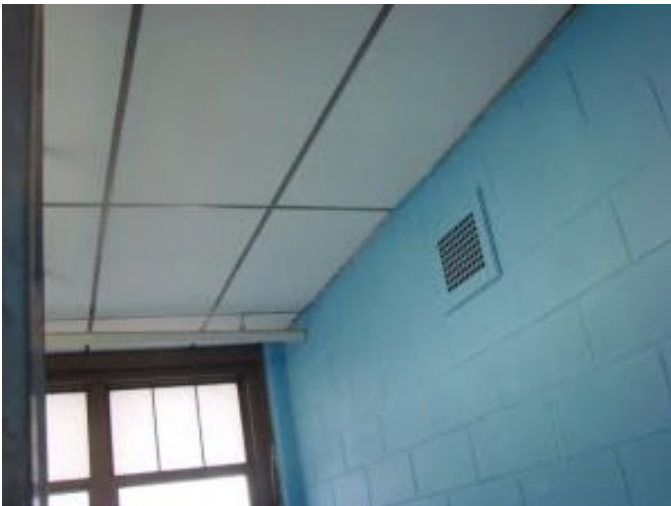
System: C3030 - Ceiling Finishes

Location: Interior

Notes: Replace acoustic ceilings

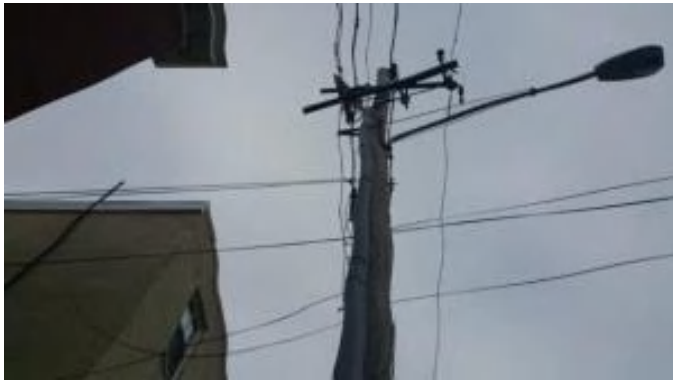
System: D5010 - Electrical Service/Distribution

Location: electrical room
Distress: Beyond Service Life
Category: 3 - Operations / Maint.
Priority: 4 - Response Time (4-5 yrs)
Correction: Replace Service Transformer, Add Switchboard
Qty: 0.00
Unit of Measure: Ea.
Estimate: \$428,693.29
Assessor Name: System
Date Created: 01/14/2016

Notes: Install new Site electrical service 750KVA, 480V, 3 Phase to feed the HVAC, lighting and receptacle loads. Install a new 480V, 3 phase switchgear.
Install a new 120V/208V, 3 phase switchgear.

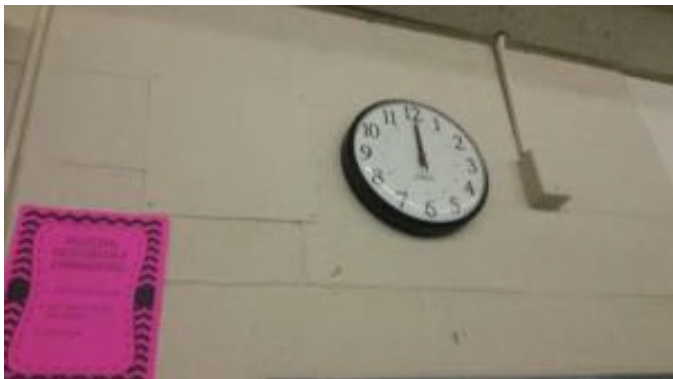
System: D5030 - Communications and Security

Location: throughout the building
Distress: Beyond Service Life
Category: 3 - Operations / Maint.
Priority: 4 - Response Time (4-5 yrs)
Correction: Add/Replace Clock System or Components
Qty: 0.00
Unit of Measure: Ea.
Estimate: \$157,584.31
Assessor Name: System
Date Created: 01/14/2016

Notes: Install a new Clock System.
Note: A multiplier of 1.4 (instead of 1.0) is used to cover the cost for additional related construction.

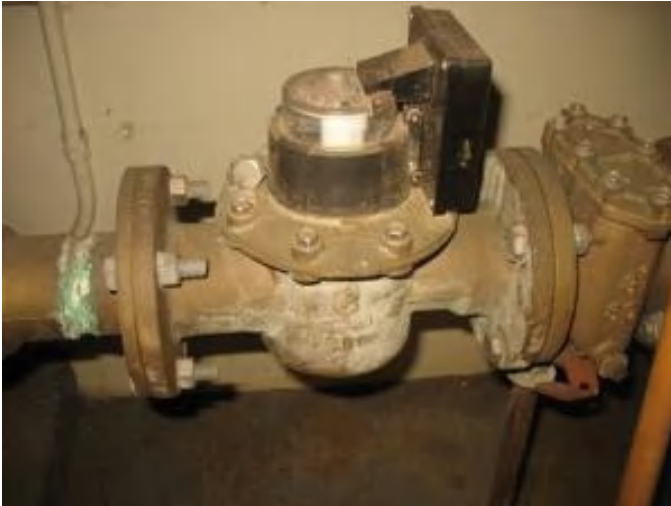
System: D2020 - Domestic Water Distribution

Location: Throughout building

Distress: Beyond Service Life

Notes: Hire a qualified contractor to perform a detailed inspection of the domestic water piping, in use for an unknown amount of time, and replace any damaged piping.

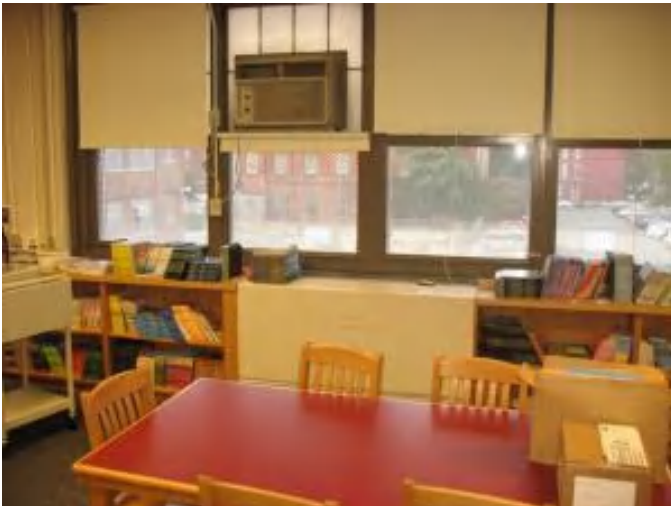
System: D3030 - Cooling Generating Systems

Terminal & Package Units - Several of the classrooms in the school building have window air conditioning units that have an anticipated service life of only 10 years. Installing a 120 ton air-cooled chiller, with pumps located in a mechanical room, and chilled water distribution piping would supply more reliable air conditioning for the building with a much longer service life.

Location: Throughout building

Distress: Inadequate

Notes: Remove the window air conditioning units and install a 120 ton air-cooled chiller with chilled water distribution piping and pumps located in a mechanical room to supply more reliable air conditioning for the building with a much longer service life.

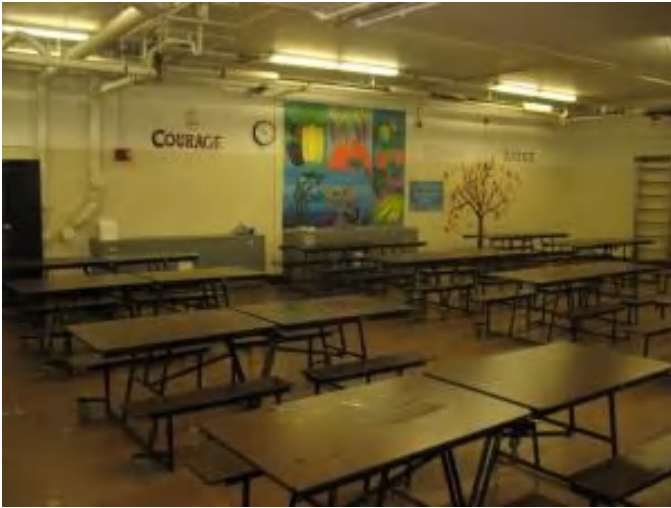
System: D3040 - Distribution Systems

Location: Cafeteria

Distress: Building / MEP Codes

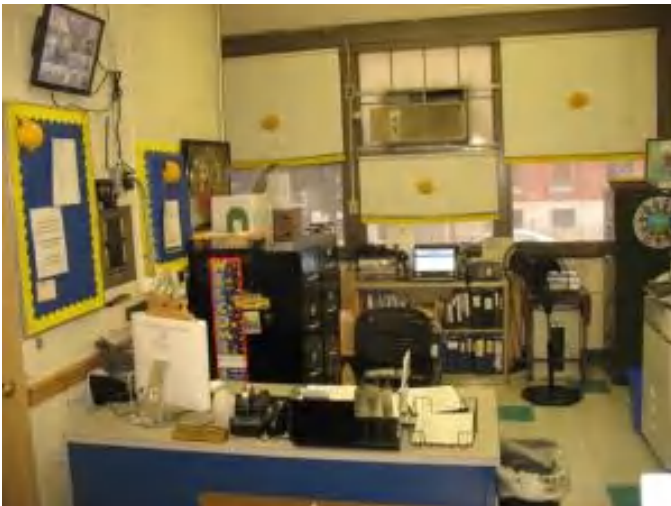
System: D3040 - Distribution Systems

Location: Administration

Distress: Building / MEP Codes

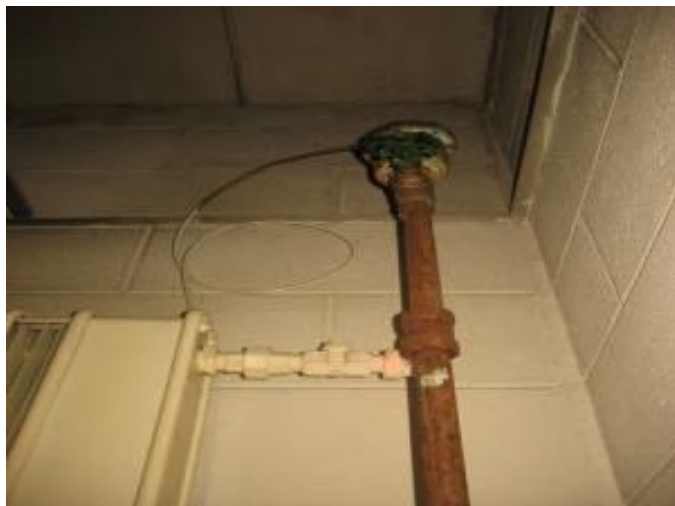
System: D3060 - Controls & Instrumentation

Controls & Instrumentation - The original pneumatic systems have been removed. Pneumatic room thermostats are intended to control the steam radiator control valves. The radiator control valves have been replaced with manually adjustable controls at each radiator and heating control is achieved via the boilers and to a smaller extent the control valves. These controls should be converted to DDC.

Location: Throughout building

Distress: Inadequate

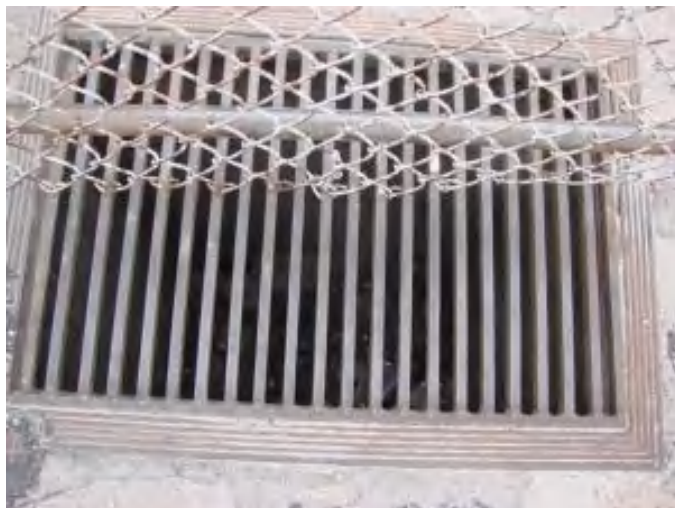
System: G2040 - Site Development

Location: Grounds

Distress: Damaged

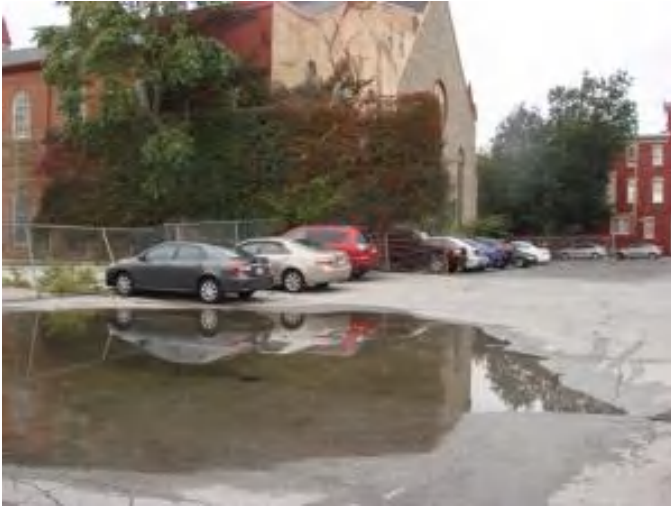
System: G2020 - Parking Lots

The parking lot at the site for approximately 46 vehicles is located west of the playground. Pavement is severely deteriorated; parking stalls are poorly marked with no accessible stalls and one fence mounted sign marking a stall with no aisle.

Location: Grounds

Distress: Beyond Service Life

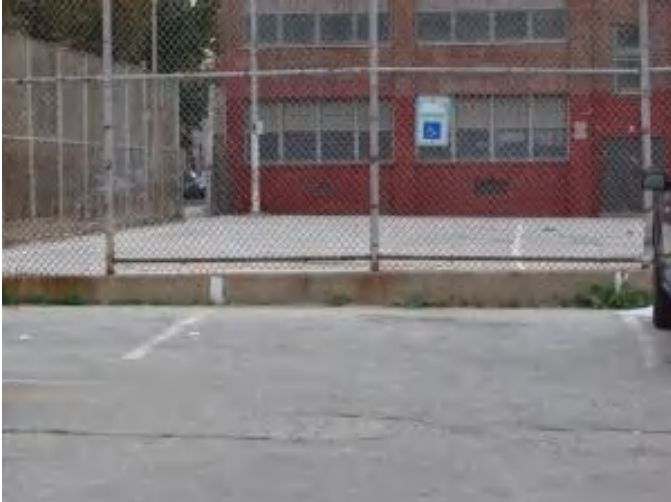
System: G2020 - Parking Lots

Location: Grounds

Distress: Beyond Service Life

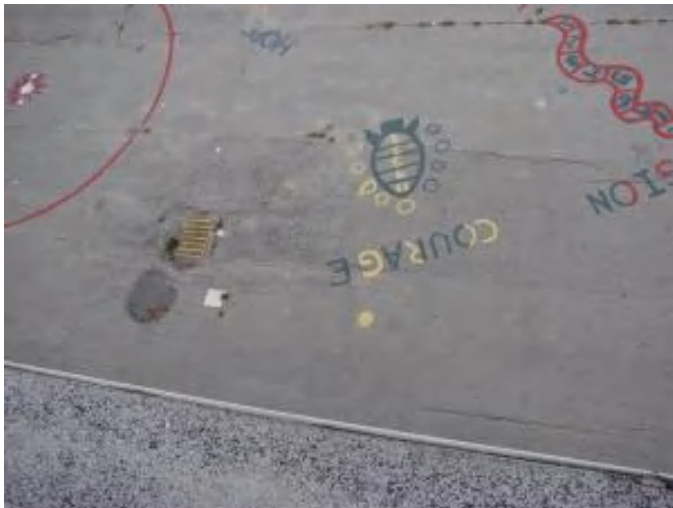
System: G2030 - Pedestrian Paving

Location: Grounds

Distress: Beyond Service Life

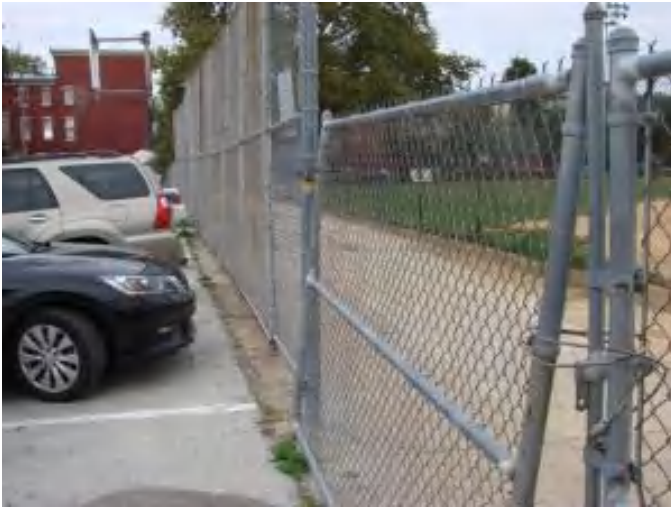
System: G2040 - Site Development

Location: Grounds

Notes: Replace chain link perimeter fence

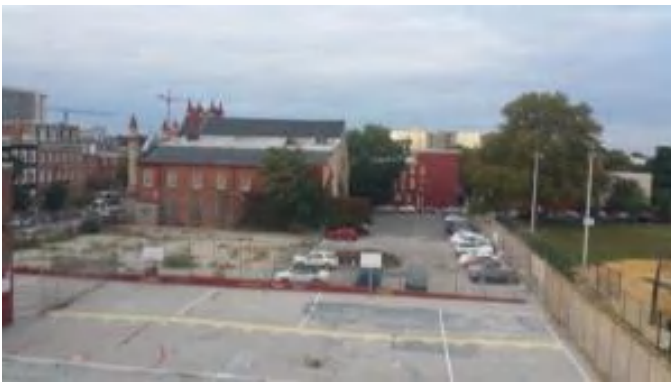
System: G4020 - Site Lighting

Location: Grounds

Notes: Install new site lighting for safety of the people and security of property.

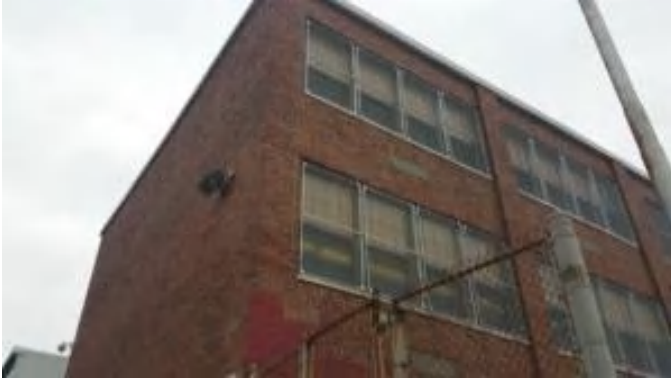
System: G4030 - Site Communications & Security

Location: Grounds

Distress: Inadequate
