Facility Condition Assessment Summary Report

Washington High School

School District of Philadelphia
S803001; Washington HS and Field
Final
Site Assessment Report
January 31, 2017

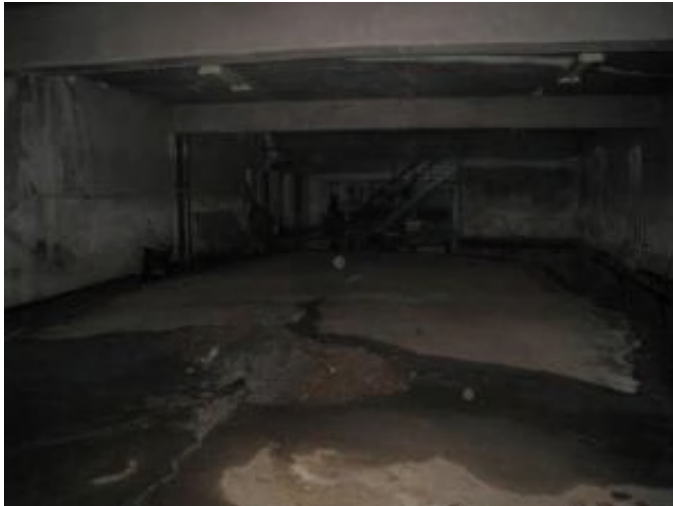
Location: boiler room basement

Foundations in the boiler room (basement) are constructed of concrete and block. Joints are in good condition with one area of major settlement cracks observed. When looking at the foundation support wall from the lowest level under the boilers, large cracks can be seen; this concrete foundation wall should be repaired soon. Also on this lowest basement level below the boiler level in an unused area of the basement, there is a leak through the outside wall through which water squirts like a small hose stream into the basement. A garbage can is kept in this area to catch the water; from there, it is piped over to a sump pump and pumped out of the basement. Apparently, this has been a constant leak for a long time; this is a bad condition that will eventually erode the foundation wall as it increases in volume. The exterior needs to be excavated (the courtyard area outside the building) and the leak needs to be repaired. The basement is an expansive space. It does not encompass the entire extent of the ground floor above and yet it is not fully utilized. Footings were not seen and their construction type or condition could not be ascertained.

System: A1010 - Standard Foundations

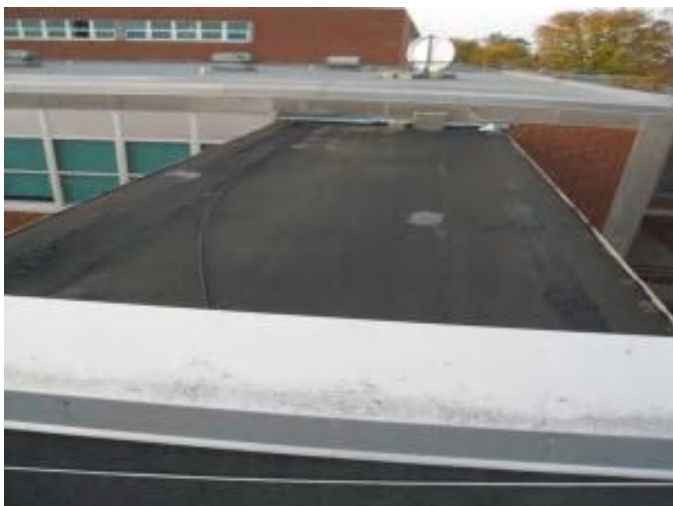
Location: Annex roof

Roof covering on the main building flat roof is a fully adhered rolled asphalt sheet system with light gray surface granules that was installed in 2006. The membrane and flashing appear to be in good condition. There are no crickets to direct the water towards the drains, however drains appear to have very slight dished areas around them to aid in water flow into the roof drain. In some areas, water is not completely draining from roofing membrane as telegraphed by dirty areas forming larger circular areas around some roof drains. At some point in time, insulation needs to be built up under the roof membrane to provide better drainage out of these low spots; this does not appear to be an immediate or extensive problem. Roof openings include toilet room vents, ventilation exhaust and gravity vent ductwork, and roof drains. Brick rooftop structures, and ventilation fan structures are flashed with asphalt-backed metal flashing material. Gravel stops are less than a foot in height, also flashed with the asphalt backed metal membrane. Taller brick building walls have aluminum counterflashing attached to the brick, counter flashed, and sealed with caulking along the top edge; this caulking is in good condition but needs to be periodically inspected to provide an effective seal. Aluminum coping used on the tops of all parapet walls is also thought to be as old as the roof, 10 years old, and is in good condition. The roofing material appears to be in good condition and with regular flashing, reglet, and joint maintenance, it could continue to provide good performance. The roof over the Annex was not replaced with the main building roof and is in poor condition with membrane wrinkles, cracks, and leaks showing in the 2nd floor ceilings and concrete deck below. This roof system needs to be replaced.

System: B3010105 - Built-Up

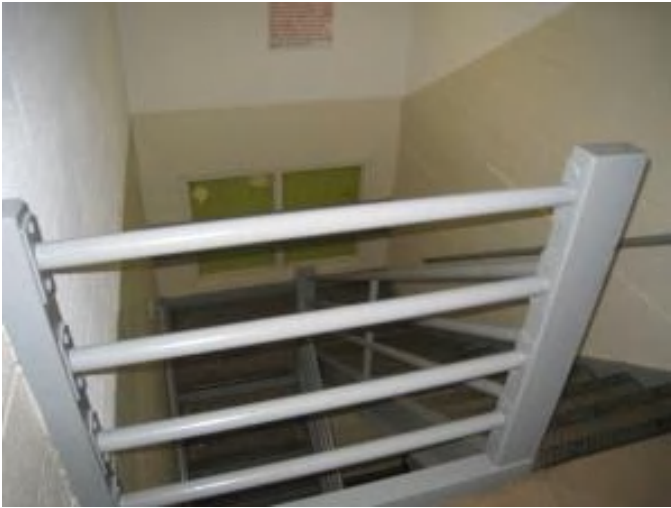
Location: stairways

System: C2010 - Stair Construction

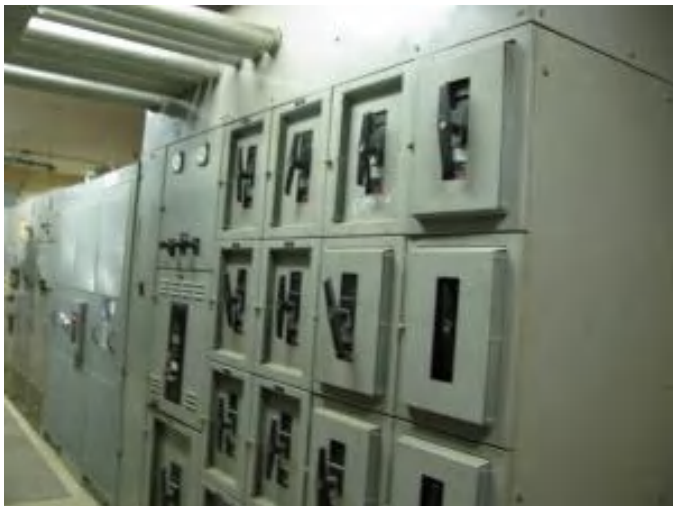
Location: Electrical Room

System: D5010 - Electrical Service/Distribution

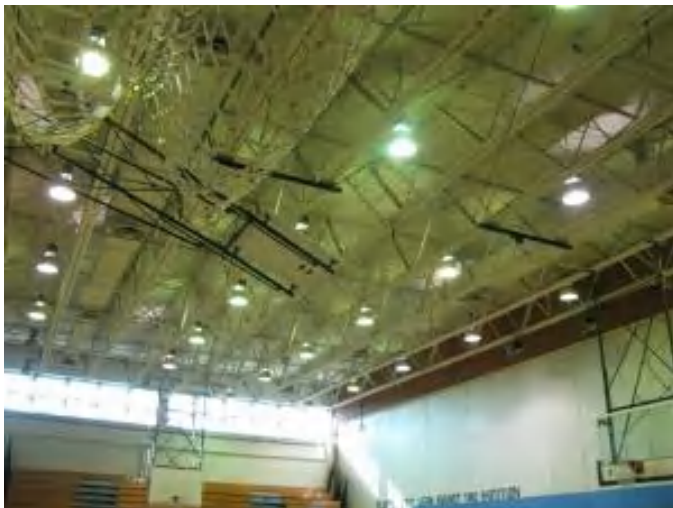
Location: Entire Building

System: D5020 - Lighting and Branch Wiring

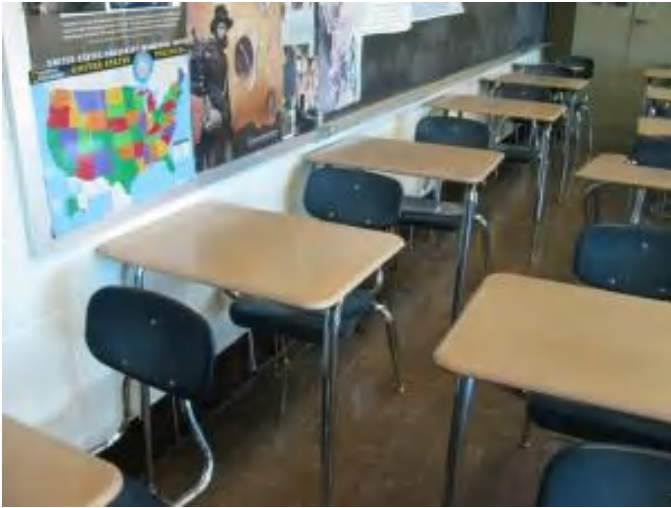
System: D5020 - Lighting and Branch Wiring

Location: Classrooms
Distress: Inadequate
Category: 3 - Operations / Maint.
Priority: 1 - Response Time (< 2 yr)
Correction: Add wiring device
Qty: 1.00
Unit of Measure: Ea.
Estimate: \$52,046.92
Assessor Name: Craig Anding
Date Created: 12/30/2015

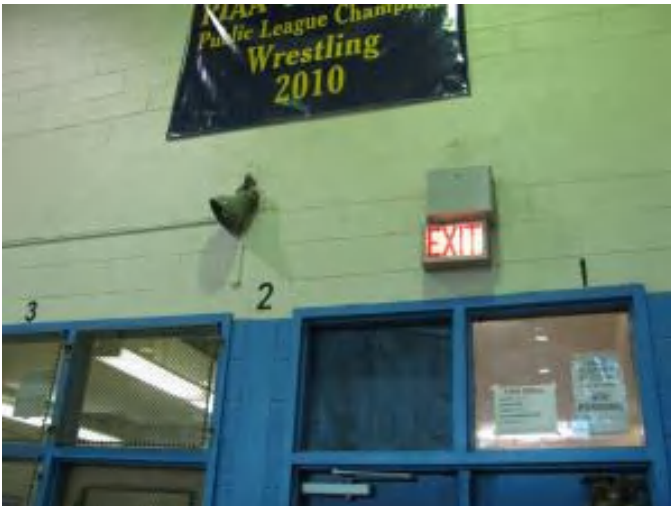
System: D5020 - Lighting and Branch Wiring

Location: Entire Building
Distress: Life Safety / NFPA / PFD
Category: 1 - Health & Safety
Priority: 1 - Response Time (< 2 yr)
Correction: Add Lighting Fixtures
Qty: 1.00
Unit of Measure: Ea.
Estimate: \$31,266.73
Assessor Name: Craig Anding
Date Created: 12/30/2015

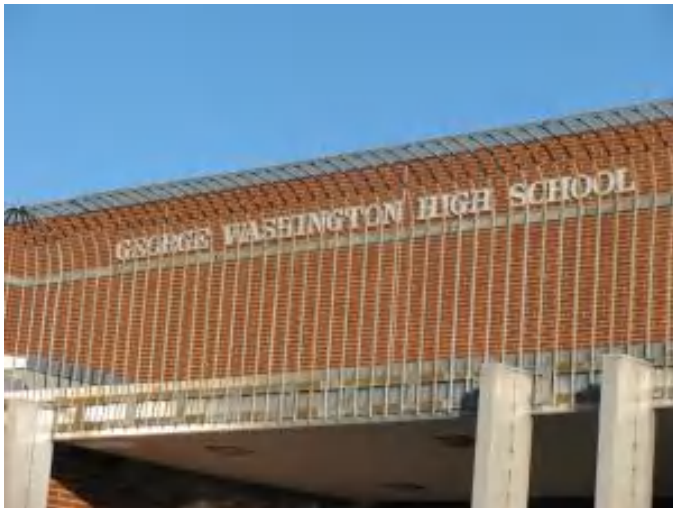
System: D5020 - Lighting and Branch Wiring

Location: Exterior Building
Distress: Security Issue
Category: 1 - Health & Safety
Priority: 1 - Response Time (< 2 yr)
Correction: Add Exterior Lighting
Qty: 1.00
Unit of Measure: Ea.
Estimate: \$8,610.61
Assessor Name: Craig Anding
Date Created: 12/30/2015

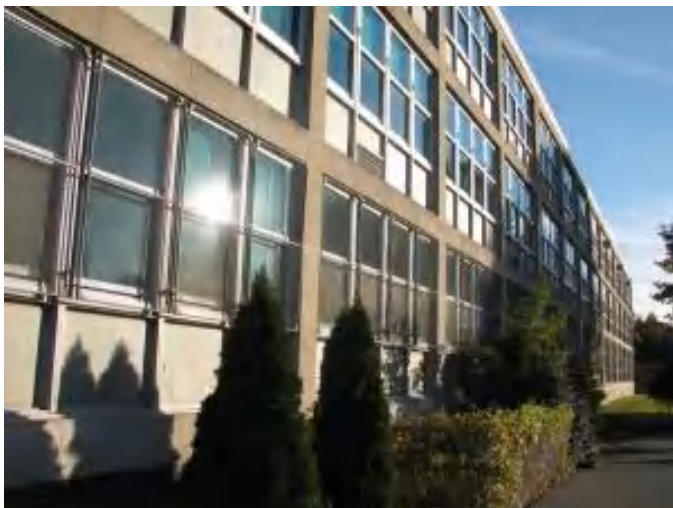
System: D5030 - Communications and Security

Location: Entire Building
Distress: Security Issue
Category: 1 - Health & Safety
Priority: 1 - Response Time (< 2 yr)
Correction: Add/Replace Video Surveillance System
Qty: 1.00
Unit of Measure: Ea.
Estimate: \$674,465.72
Assessor Name: Craig Anding
Date Created: 12/30/2015

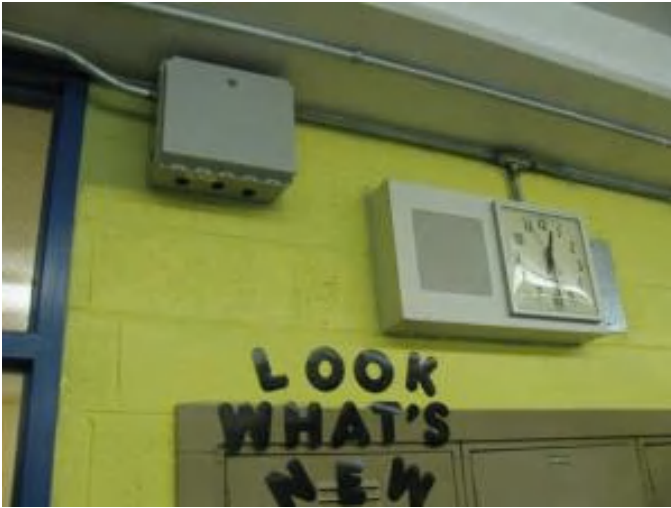
System: D5030 - Communications and Security

Location: Entier Building
Distress: Inadequate
Category: 3 - Operations / Maint.
Priority: 1 - Response Time (< 2 yr)
Correction: Add/Replace Clock System or Components
Qty: 1.00
Unit of Measure: Ea.
Estimate: \$81,893.62
Assessor Name: Craig Anding
Date Created: 12/30/2015

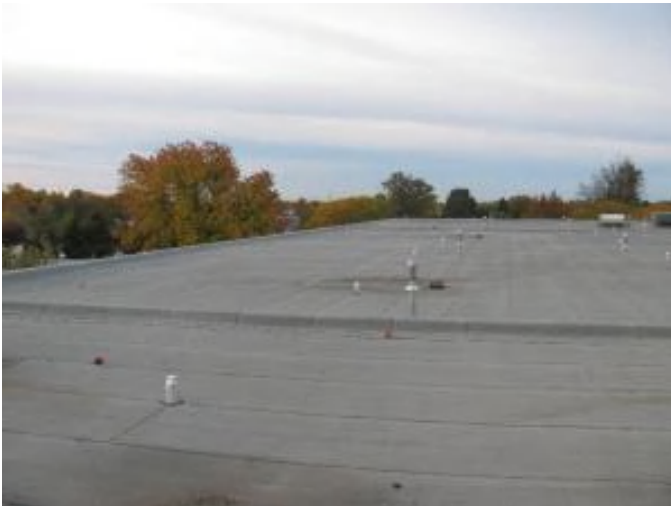
System: D5090 - Other Electrical Systems

Location: Roof
Distress: Life Safety / NFPA / PFD
Category: 1 - Health & Safety
Priority: 1 - Response Time (< 2 yr)
Correction: Repair Lightning Protection System
Qty: 1.00
Unit of Measure: Job
Estimate: \$23,167.32
Assessor Name: Craig Anding
Date Created: 12/30/2015

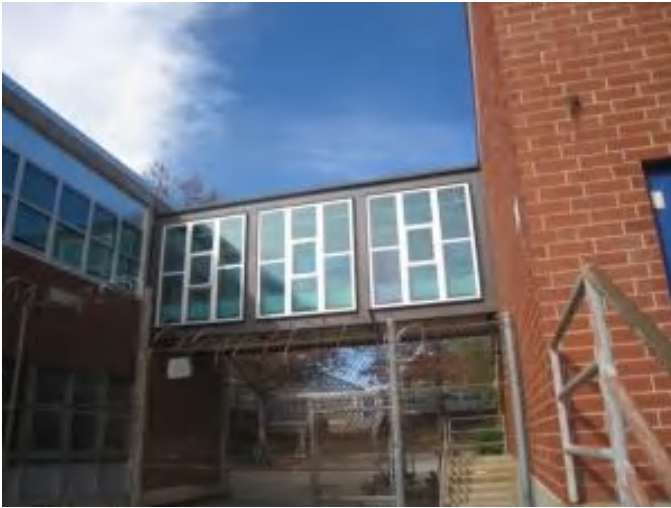
Location: support for overhead corridor

cracking; that section of concrete visible to the exterior appears to be structural and should be repaired structurally to ensure a solid, weatherproof connection and support of the corridor above. Some brick pointing is required on Annex north and south walls as grout is cracked and possibly letting moisture into the stairways. The horizontal joint above and below the first floor and roof concrete bands (beam lines) need to be repointed to prevent moisture intrusion.

System: B2010 - Exterior Walls

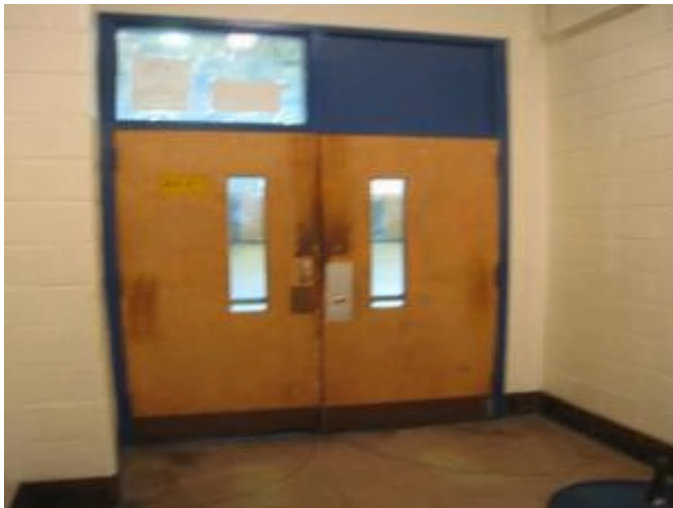
Location: interior doors

Interior doors are mostly the original oak wood and wired glass doors mounted in steel frames. Some doors have the original knob hardware; others have level lock sets. Some of the original wood doors are damaged with gouges, scratches and broken glass frames. Wired glass as required in a fire rated door is used in most doors, except for doors that have non-wired replacement glass. Classroom and other corridor doors have closures as required in a fire rated partition. Double doors into spaces like the recreation room do not positively latch as required of a fire door. Although wood doors can be purchased as fire rated units, there were no visible labels on classroom doors to ascertain this. Since the building is not sprinklered, corridors are required to be one-hour fire rated. Interior basement doors and interior stairway doors are hollow metal doors in metal frames, some with narrow lite vision panels. Many of these steel doors and frames are rusted where coming in contact with floors, due to cleaning solutions corroding the frames. Metal doors are generally in poor condition throughout the building with paint scratches and dents. They are not ADA compliant, do not have ADA or proper locking hardware, and do not have fire rated labels where required. Most stairway doors do not positively latch (panic hardware was not operating) as required of fire rated doors, therefore cannot be considered an approved fire

System: C1020 - Interior Doors

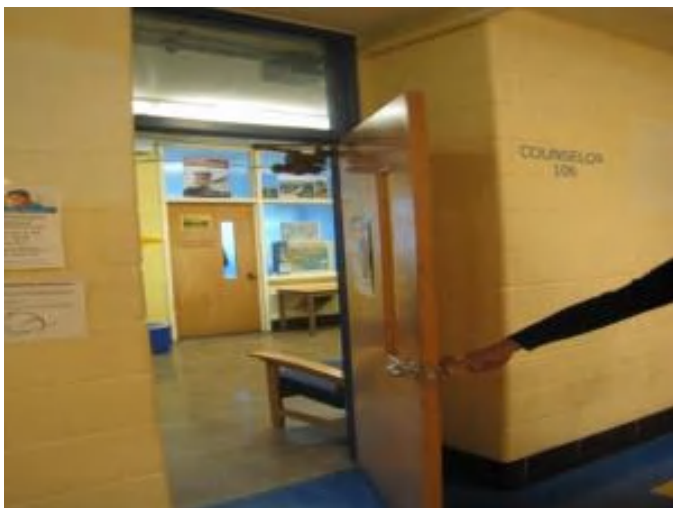
Location: corridor doors

System: C1020 - Interior Doors

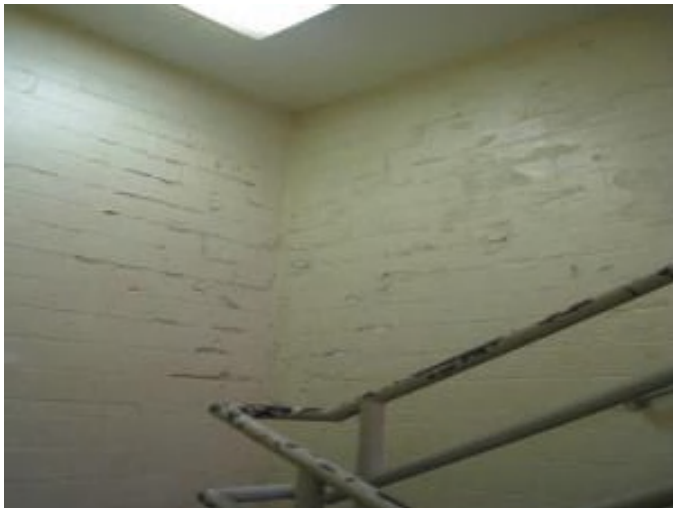
Location: interior block and concrete surfaces

System: C3010230 - Paint & Covering

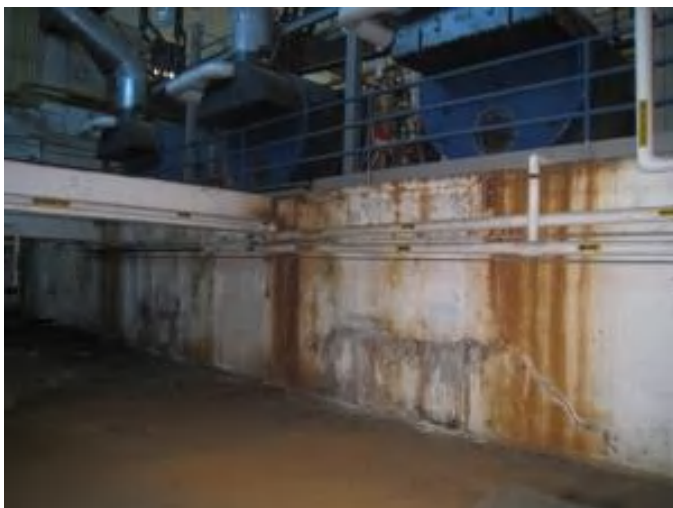
Location: mechanical rooms - basement

Paint is peeling on some basement walls and ceilings are dirty and peeling. Some cleaning and repainting is required to improve the appearance. Some of the boiler condensate pipes have been leaking and were leaking at the time of inspection, causing rust stains to become embedded on floor slabs, adding to the dirty appearance of the slabs. The physical condition of the boiler room slabs is good, with very few cracks. Outside the boiler room, basement slabs in classroom areas are also in good condition without any major cracks or settlement. There is a trap door in the boiler room wall that views the crawlspace. This area was poorly lit, but what could be seen was not damaged, however the space felt very humid and steel pipes that were seen were very rusty. There have been projects in recent past to document and remove asbestos pipe wrap from this area; it is not known if it has been completely abated. Upper floor slabs in the main building are constructed of cast-in-place concrete with cast-in-place concrete beams. Columns, beams and floor deck above also appeared to be in good condition. The 2nd floor concrete slab in the Annex has many lumpy areas; these need to be leveled when the flooring in those spaces is replaced.

System: C3010230 - Paint & Covering

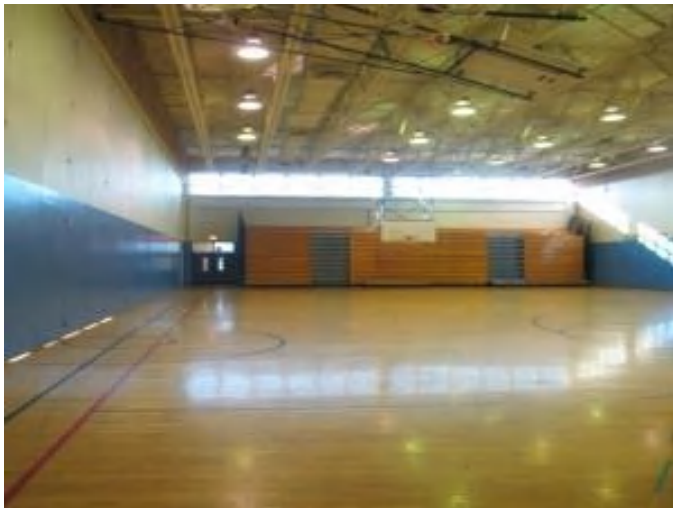
System: C3010230 - Paint & Covering

Location: gymnasium
Distress: Damaged
Category: 3 - Operations / Maint.
Priority: 2 - Response Time (2-3 yrs)
Correction: Repair substrate and repaint interior walls - SF of wall surface
Qty: 1,000.00
Unit of Measure: S.F.
Estimate: \$8,567.08
Assessor Name: Craig Anding
Date Created: 02/02/2016

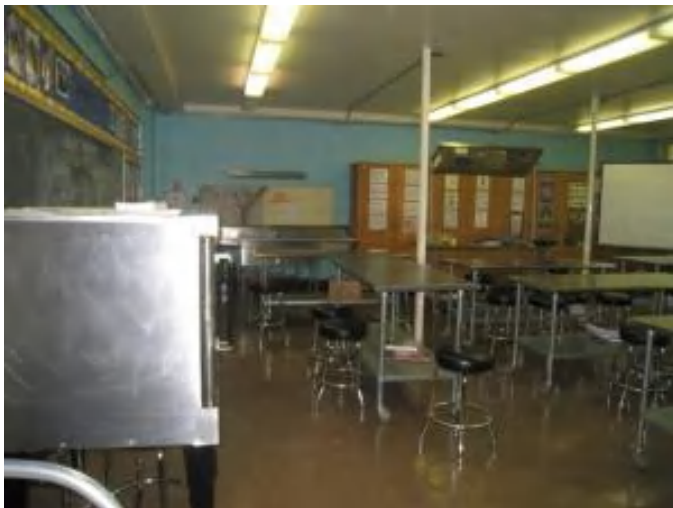
System: C3020413 - Vinyl Flooring

Location: classroom floors
Distress: Beyond Service Life
Category: 3 - Operations / Maint.
Priority: 2 - Response Time (2-3 yrs)
Correction: Remove VAT and replace with VCT - SF of area
Qty: 246,000.00
Unit of Measure: S.F.
Estimate: \$3,731,000.33
Assessor Name: Craig Anding
Date Created: 02/02/2016

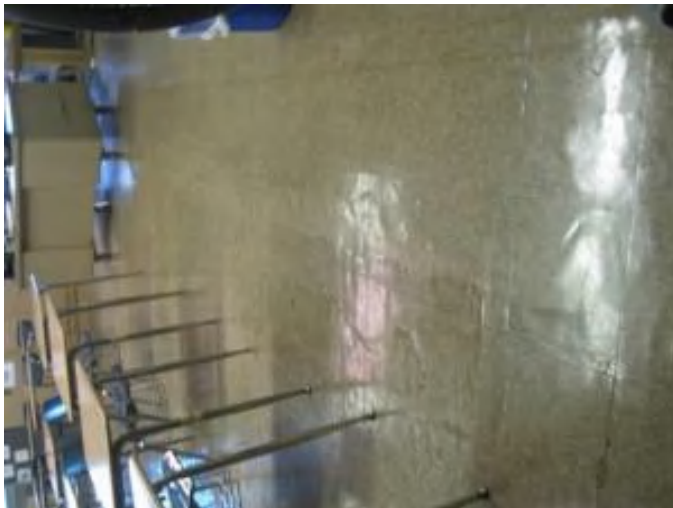
Location: cafeteria, classrooms and annex

System: C3020413 - Vinyl Flooring

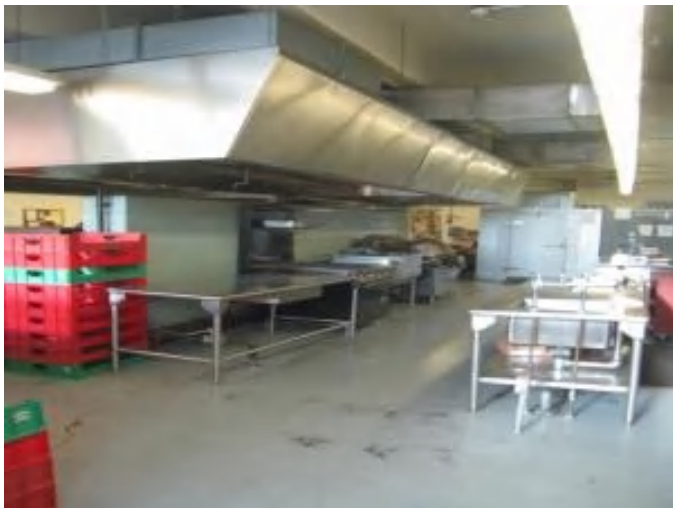
Location: floors - mechanical rooms, stairways, toilet rooms

System: C3020415 - Concrete Floor Finishes

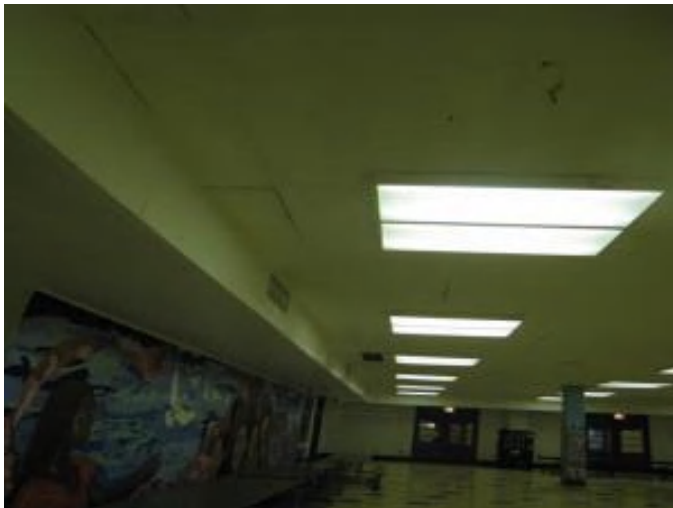
System: C3030 - Ceiling Finishes

Location: ceilings
Distress: Damaged
Category: 3 - Operations / Maint.
Priority: 2 - Response Time (2-3 yrs)
Correction: Remove and replace glued on or mechanically attached acoustical ceiling tiles
Qty: 23,000.00
Unit of Measure: S.F.
Estimate: \$287,012.54
Assessor Name: Craig Anding
Date Created: 02/02/2016

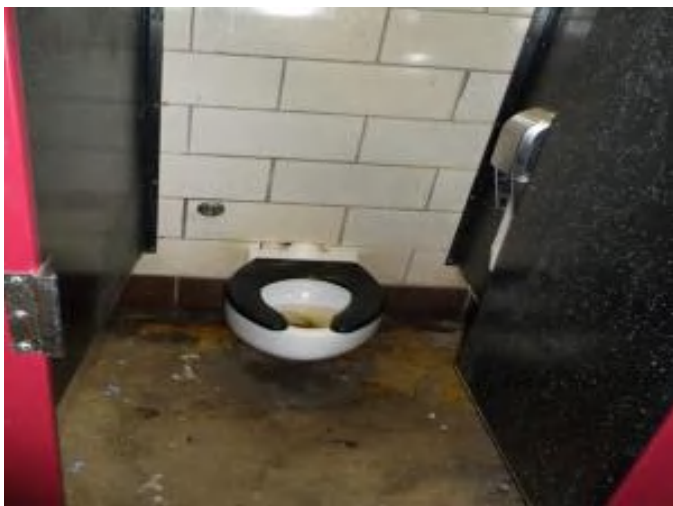
System: D2010 - Plumbing Fixtures

Location: Throughout the building
Distress: Beyond Service Life
Category: 3 - Operations / Maint.
Priority: 2 - Response Time (2-3 yrs)
Correction: Remove and replace or replace water closet - quantify additional units
Qty: 180.00
Unit of Measure: Ea.
Estimate: \$1,343,186.61
Assessor Name: Craig Anding
Date Created: 02/17/2016

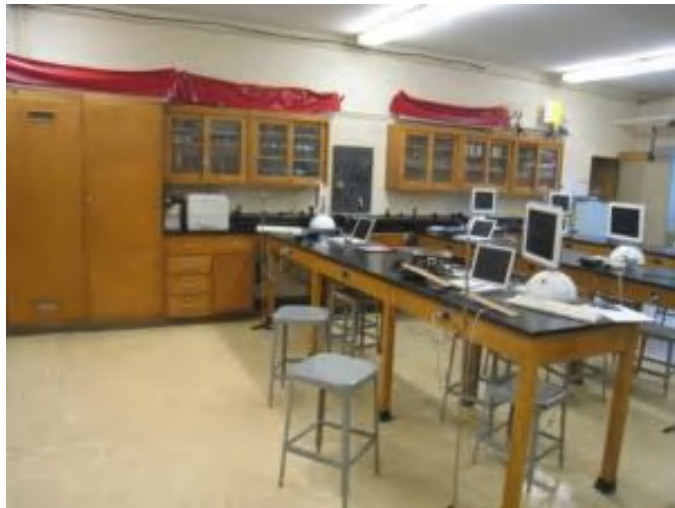
Location: lab cabinets

System: E1020 - Institutional Equipment

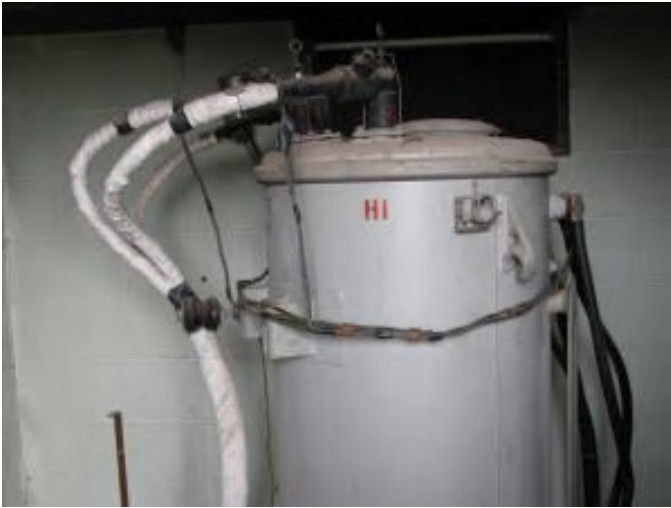
System: D5010 - Electrical Service/Distribution

Location: Fieldhouse Boiler Room
Distress: Beyond Service Life
Category: 4 - Capital Improvement
Priority: 1 - Response Time (< 2 yr)
Correction: Add Electrical Switchgear and Distribution System
Qty: 1.00
Unit of Measure: Ea.
Estimate: \$247,584.62
Assessor Name: Craig Anding
Date Created: 01/13/2016

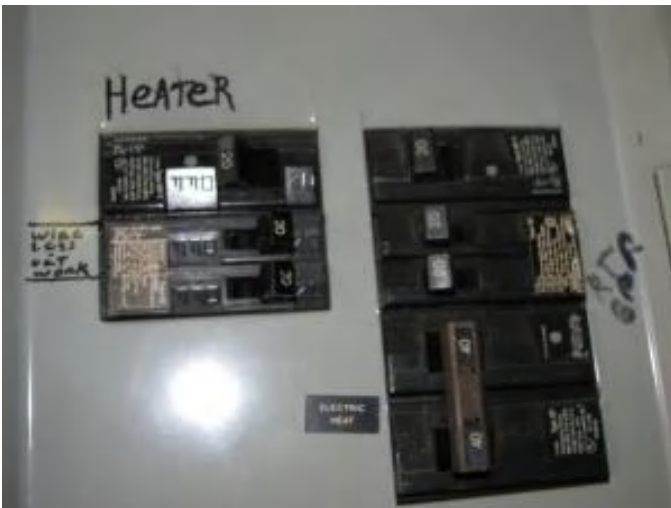
System: D5010 - Electrical Service/Distribution

Location: Fieldhouse Entire Building
Distress: Beyond Service Life
Category: 4 - Capital Improvement
Priority: 1 - Response Time (< 2 yr)
Correction: Replace Electrical Distribution System (U)
Qty: 1.00
Unit of Measure: Ea.
Estimate: \$113,221.64
Assessor Name: Craig Anding
Date Created: 01/13/2016

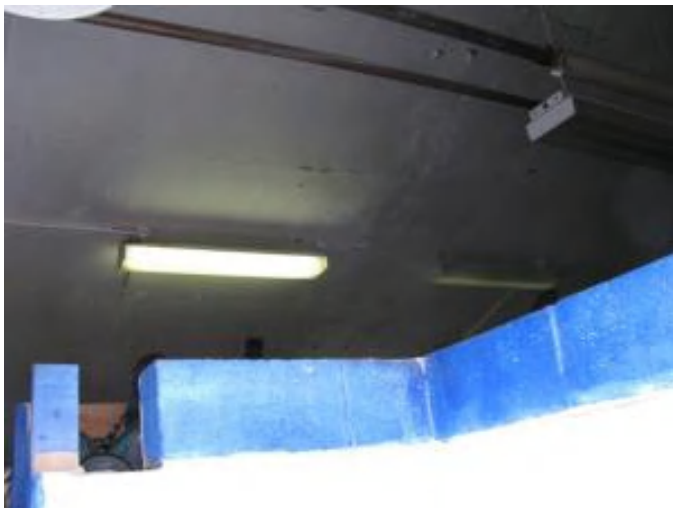
Location: Fieldhouse Entire Building

System: D5020 - Lighting and Branch Wiring

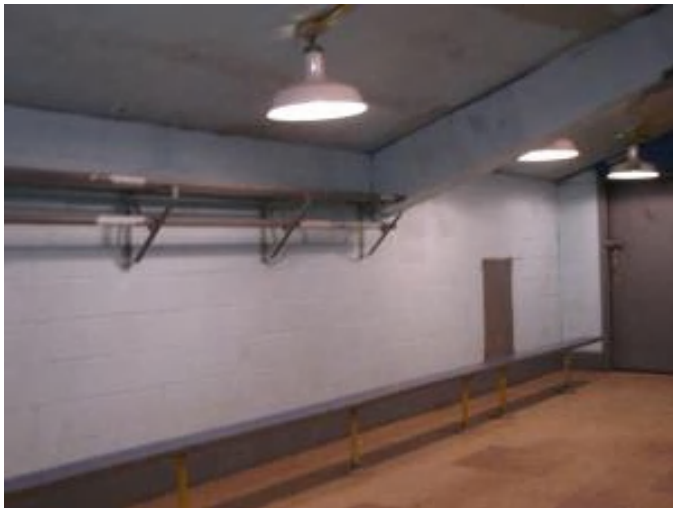
System: D5020 - Lighting and Branch Wiring

Location: Fieldhouse Entire Building
Distress: Life Safety / NFPA / PFD
Category: 1 - Health & Safety
Priority: 1 - Response Time (< 2 yr)
Correction: Add Lighting Fixtures
Qty: 1.00
Unit of Measure: Ea.
Estimate: \$18,151.59
Assessor Name: Craig Anding
Date Created: 01/13/2016

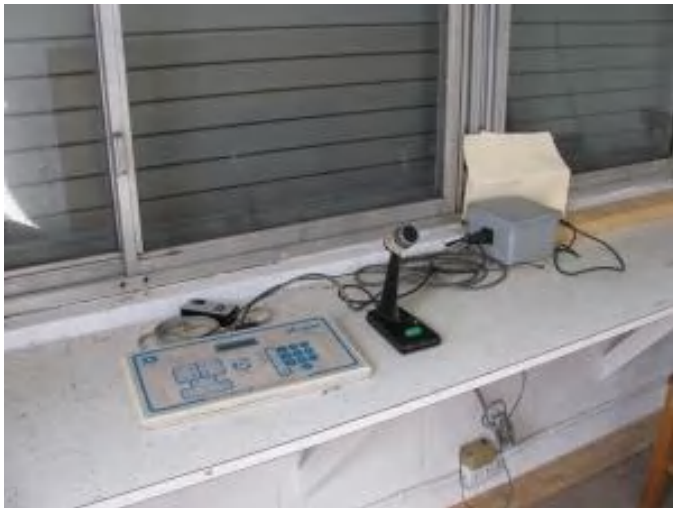
System: D5030 - Communications and Security

Location: Fieldhouse and field
Distress: Beyond Service Life
Category: 4 - Capital Improvement
Priority: 1 - Response Time (< 2 yr)
Correction: Add/Replace Sound System
Qty: 1.00
Unit of Measure: LS
Estimate: \$103,935.92
Assessor Name: Craig Anding
Date Created: 01/13/2016

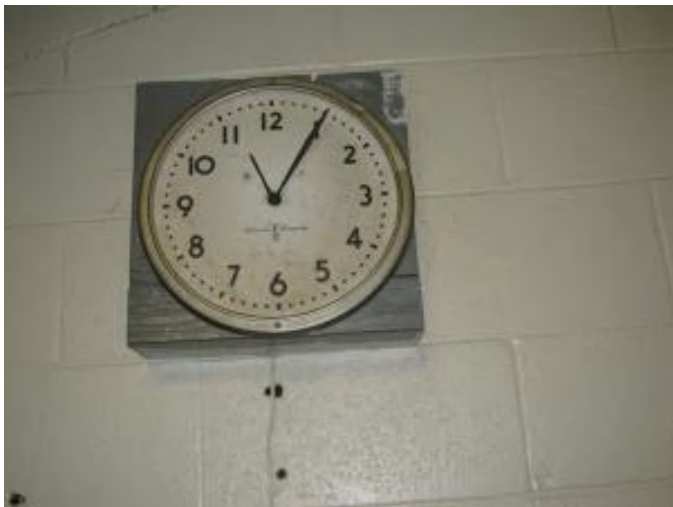
System: D5030 - Communications and Security

Location: Fieldhouse Interior Building
Distress: Inadequate
Category: 3 - Operations / Maint.
Priority: 1 - Response Time (< 2 yr)
Correction: Add/Replace Clock System or Components
Qty: 1.00
Unit of Measure: Ea.
Estimate: \$4,894.41
Assessor Name: Craig Anding
Date Created: 01/13/2016

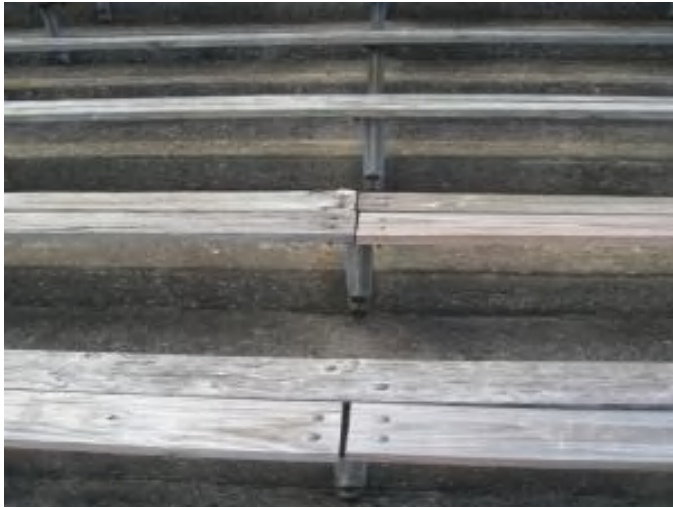
Location: Fieldhouse Stands

System: E1090 - Other Equipment

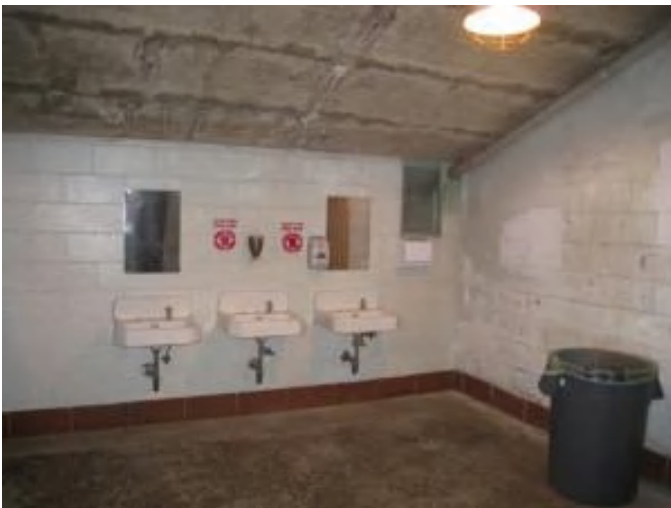
Location: Fieldhouse stands - underside of concrete seating surface

System: B1010 - Floor Construction

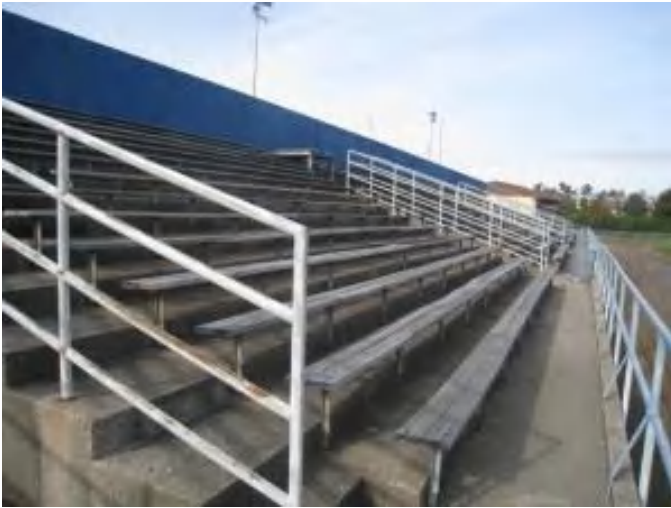
Location: Fieldhouse stands - concrete surface

System: B1010 - Floor Construction

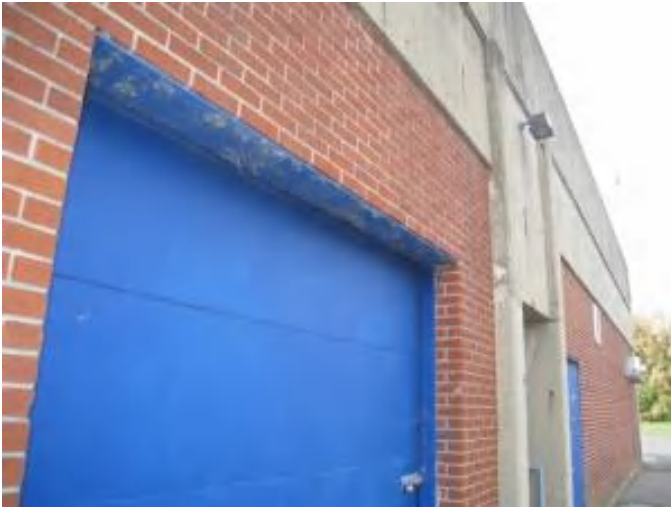
Location: Fieldhouse exterior

System: B2030 - Exterior Doors

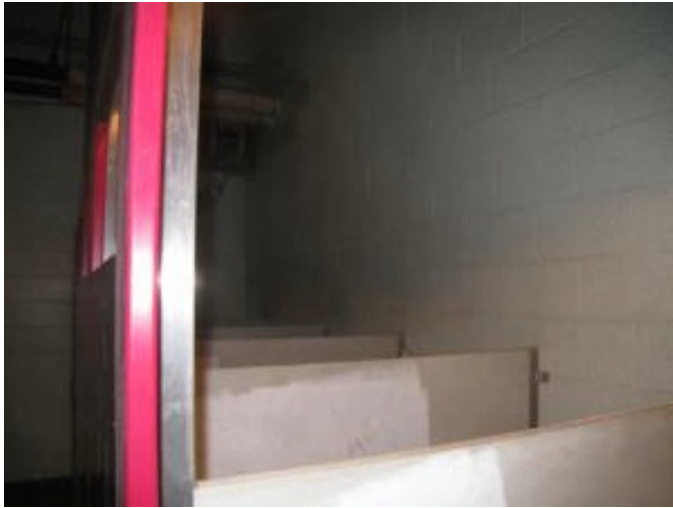
Location: Fieldhouse toilet rooms

System: C1030 - Fittings

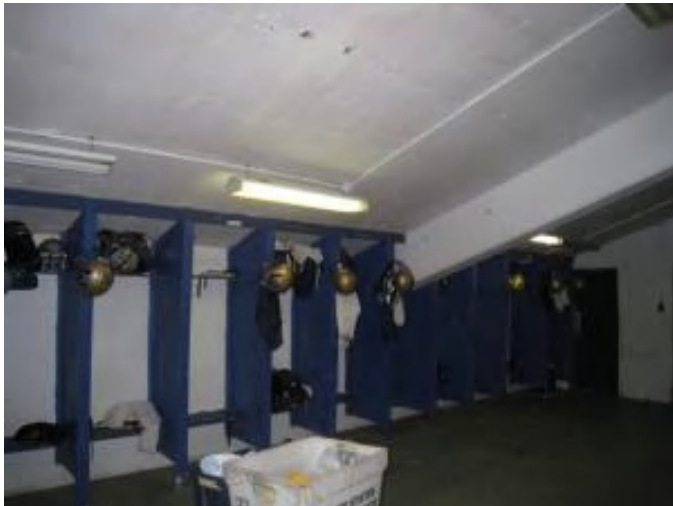
Location: Fieldhouse locker rooms

System: C1030 - Fittings

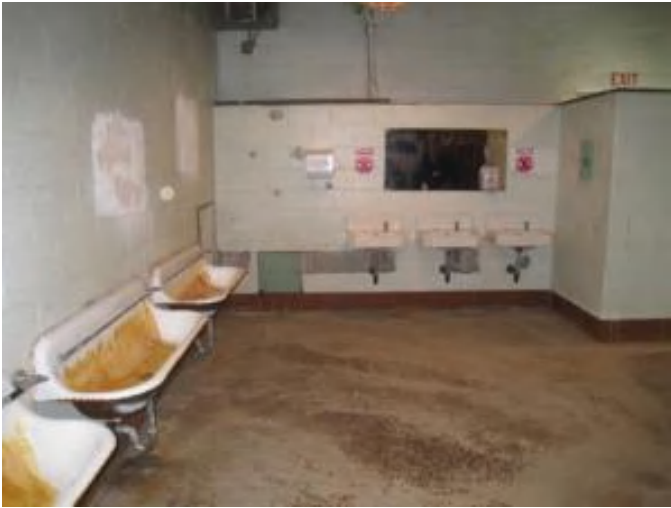
Location: Fieldhouse toilet rooms

System: C1030 - Fittings

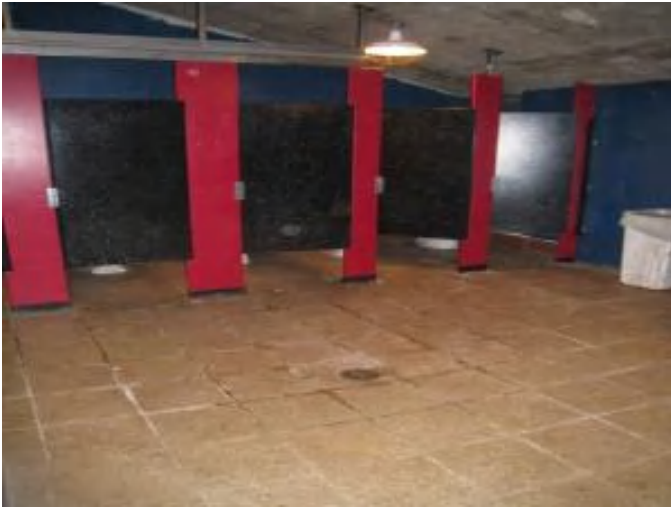
System: C3020413 - Vinyl Flooring

Location: Fieldhouse floors
Distress: Damaged
Category: 3 - Operations / Maint.
Priority: 2 - Response Time (2-3 yrs)
Correction: Remove VAT and replace with VCT - SF of area
Qty: 4,000.00
Unit of Measure: S.F.
Estimate: \$60,666.67
Assessor Name: Craig Anding
Date Created: 02/03/2016

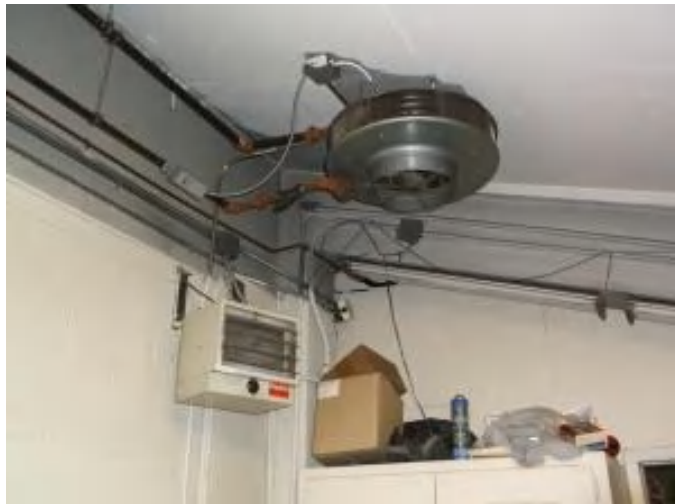
Location: Throughout the building

System: D3060 - Controls & Instrumentation

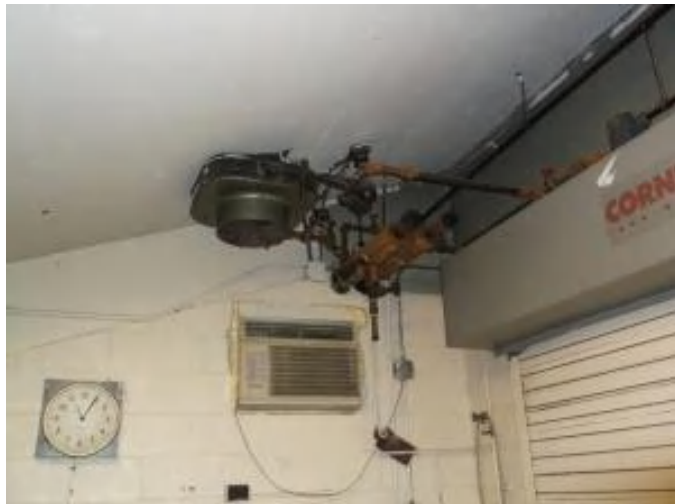
Location: Throughout the building

System: D3040 - Distribution Systems

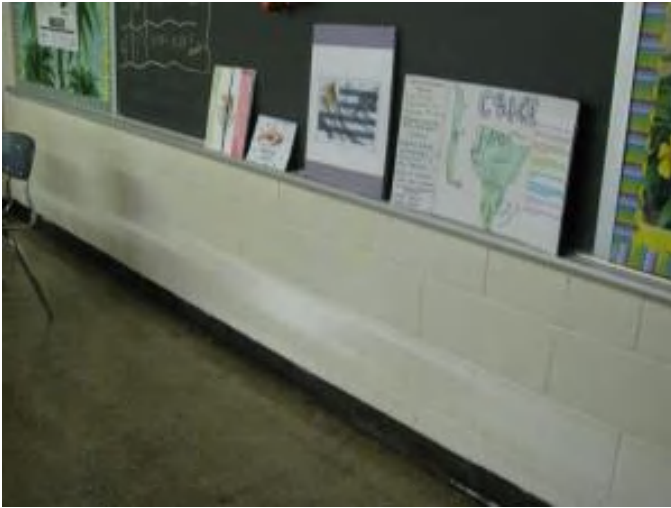
System: D5020 - Lighting and Branch Wiring

Location: Classrooms
Distress: Inadequate
Category: 3 - Operations / Maint.
Priority: 1 - Response Time (< 2 yr)
Correction: Add wiring device
Qty: 1.00
Unit of Measure: Ea.
Estimate: \$52,046.92
Assessor Name: Tom Moe
Date Created: 12/30/2015

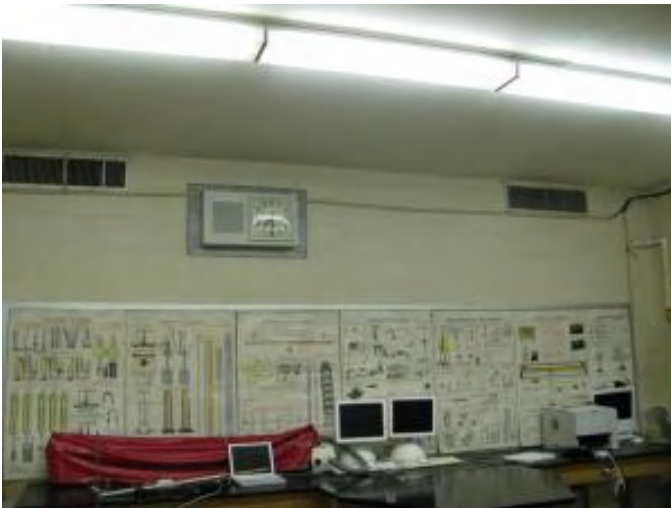
Location: Annex Building
Distress: Beyond Service Life
Category: 4 - Capital Improvement
Priority: 1 - Response Time (< 2 yr)
Correction: Add/Replace Clock System or Components
Qty: 0.00
Unit of Measure: Ea.
Estimate: \$9,957.10
Assessor Name: Steven Litman
Date Created: 01/13/2016
