Facility Condition Assessment Summary Report

Washington, Martha School

S142001; Washington, Martha

Site Assessment Report

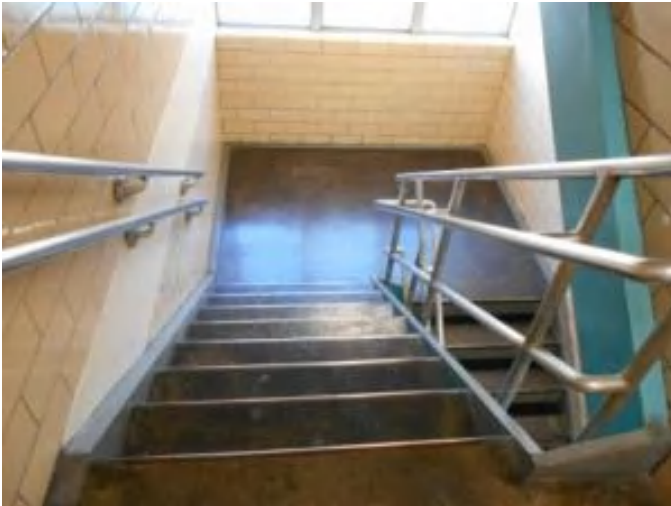
System: C2010 - Stair Construction

Location: Stairways

Distress: Building / MEP Codes

Notes: Replace handrails in exit stairwells and at the main entry

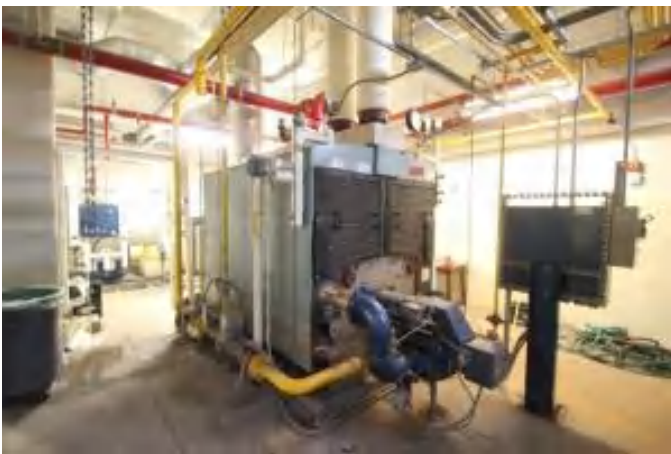
System: D3020 - Heat Generating Systems

Location: Boiler room

Distress: Maintenance Required

Notes: Repair steam leak on boiler steam drum

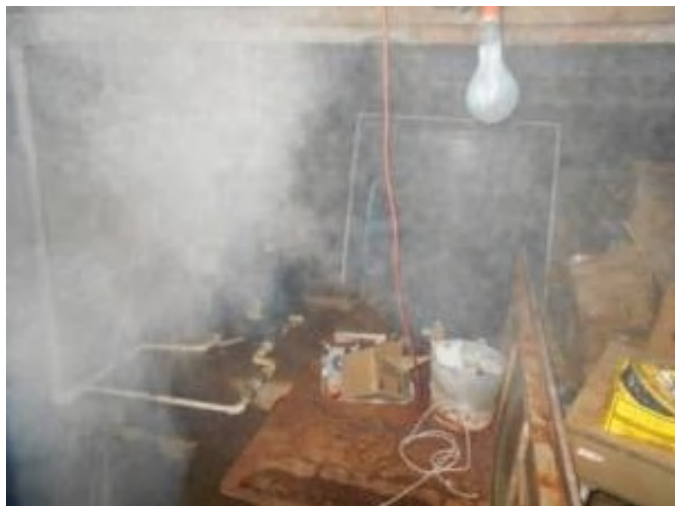
System: D3040 - Distribution Systems

Location: Entire building

Distress: Failing

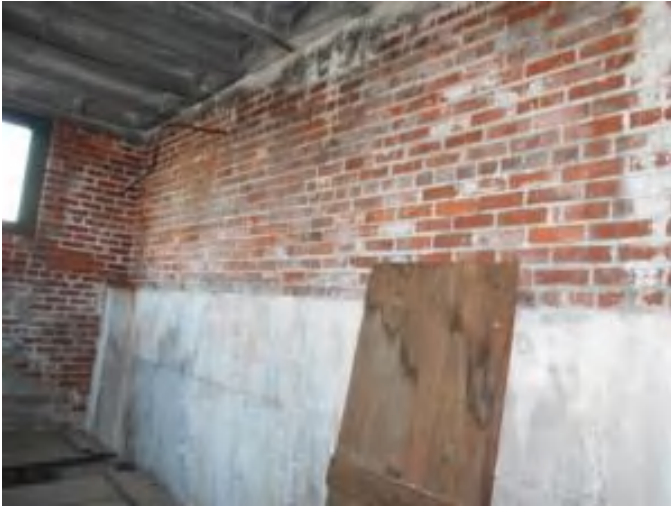
System: B1010 - Floor Construction

Location: Basement mech rooms

Distress: Failing

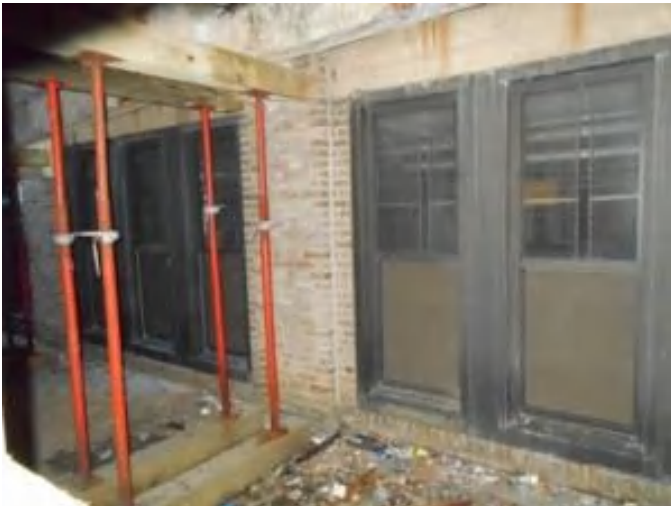
System: B1010 - Floor Construction

Location: Elevated floor

Distress: Failing

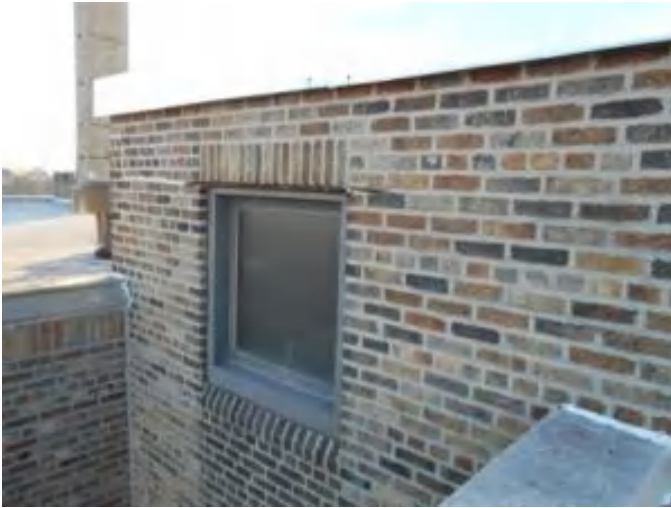
System: B2010 - Exterior Walls

Location: Exterior windows

Distress: Failing

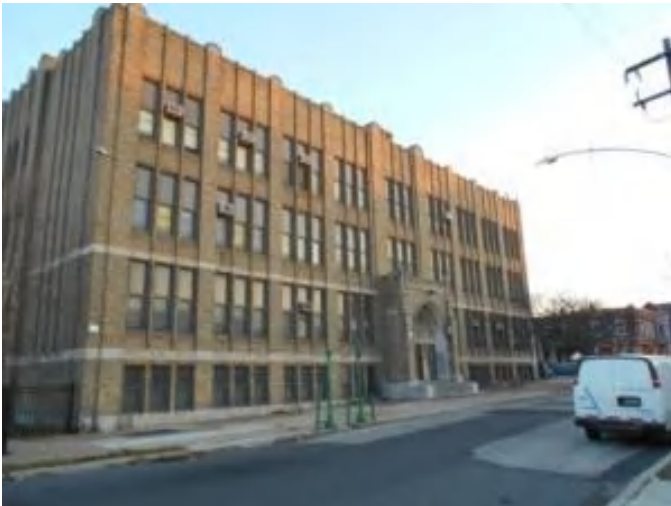
System: B2010 - Exterior Walls

Location: Exterior walls

Distress: Failing

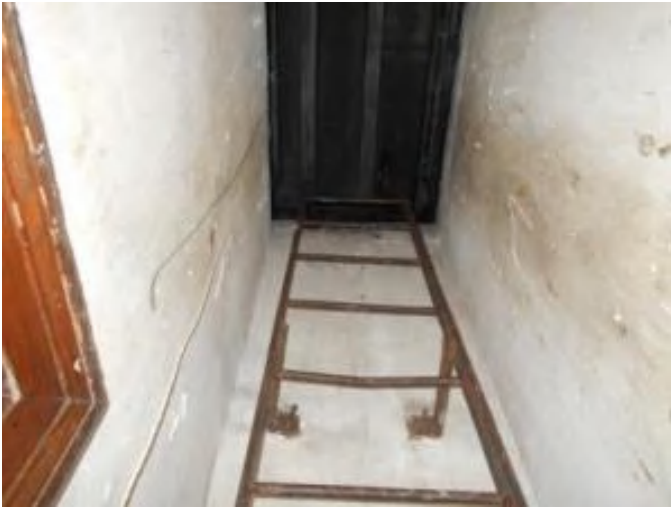
System: B2010 - Exterior Walls

Location: Ladder access

Distress: Failing

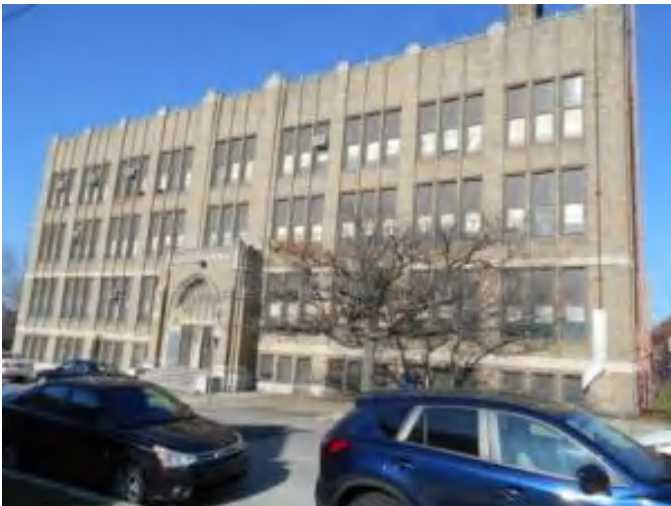
System: B2030 - Exterior Doors

Location: Exterior doors

Distress: Beyond Service Life

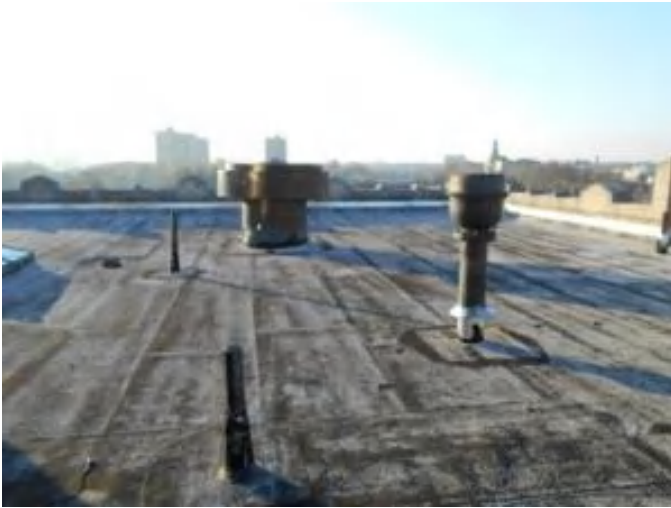
System: B3010105 - Built-Up

Location: Roof

Distress: Beyond Service Life

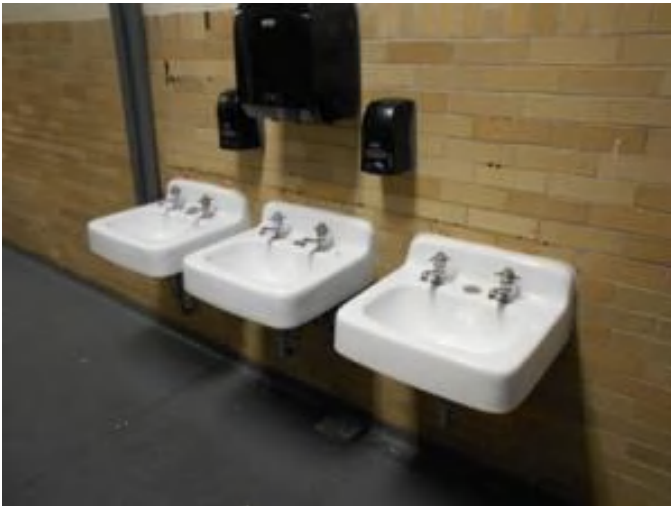
System: C1010 - Partitions

Location: Throughtout the building

Distress: Accessibility

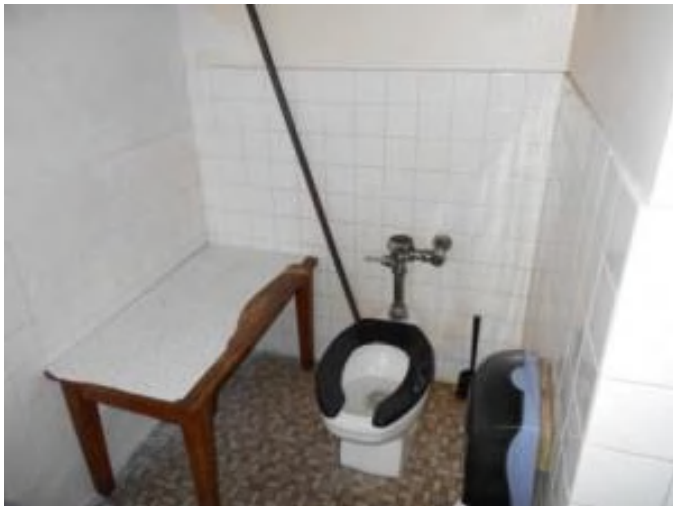
System: C1010 - Partitions

Location: Throughout the building

Distress: Accessibility

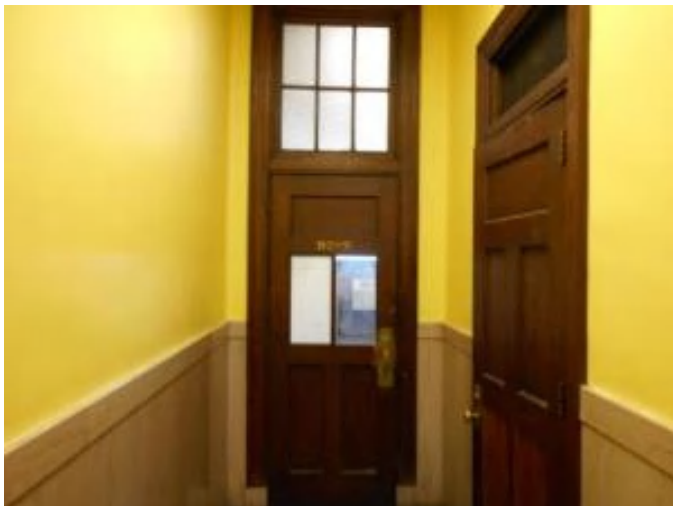
System: C1020 - Interior Doors

Location: Throughout the building

Distress: Beyond Service Life

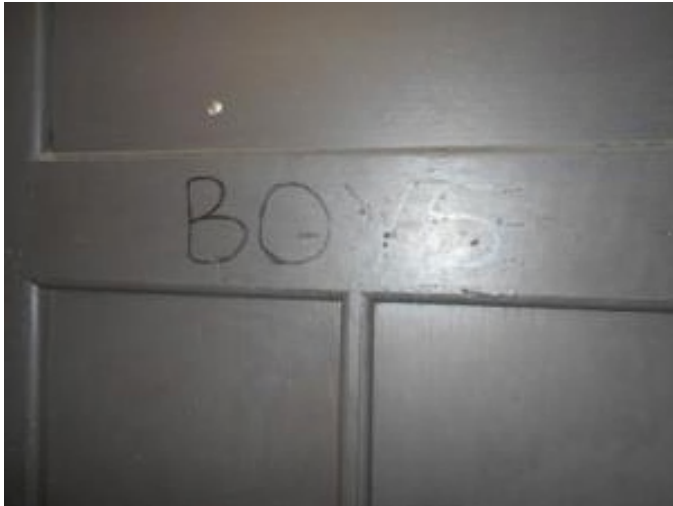
System: C1030 - Fittings

Location: Throughout the building

Distress: Building / MEP Codes

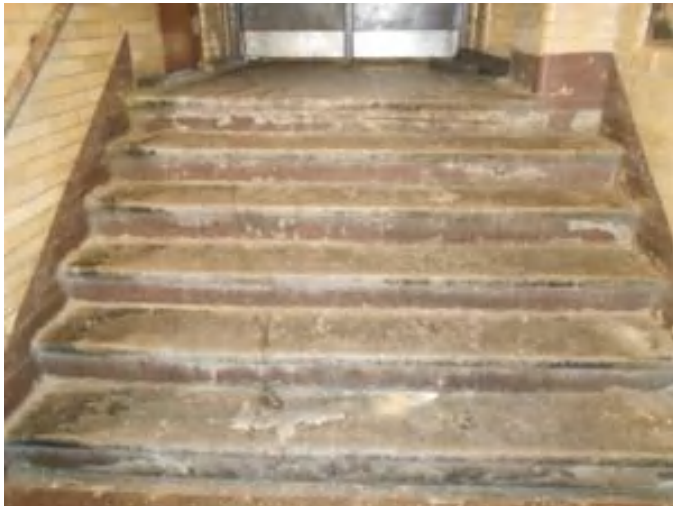
System: C2010 - Stair Construction

Location: Stairway

Distress: Failing

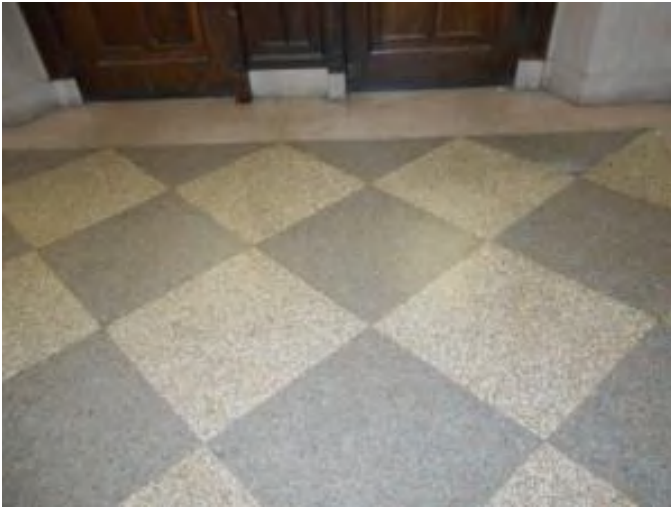
System: C3020413 - Vinyl Flooring

Location: Throughout the building
Distress: Damaged
Category: 3 - Operations / Maint.
Priority: 2 - Response Time (2-3 yrs)
Correction: Remove and replace VCT
Qty: 61,300.00

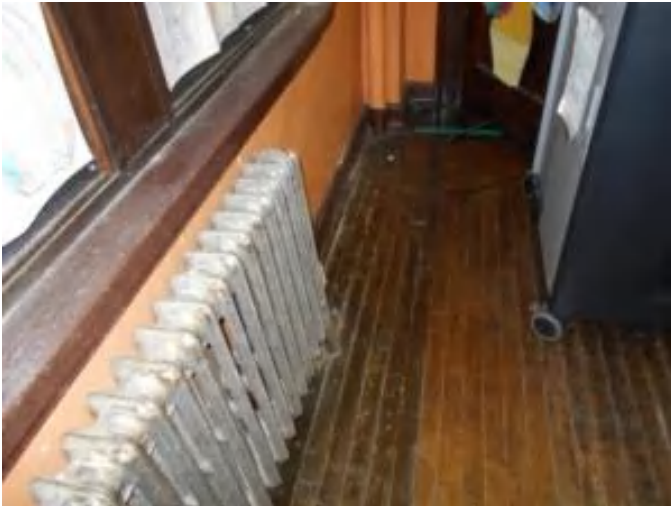
System: C3020414 - Wood Flooring

Location: Throughout the building
Distress: Damaged
Category: 3 - Operations / Maint.
Priority: 2 - Response Time (2-3 yrs)
Correction: Remove and replace wood flooring
Qty: 3,000.00

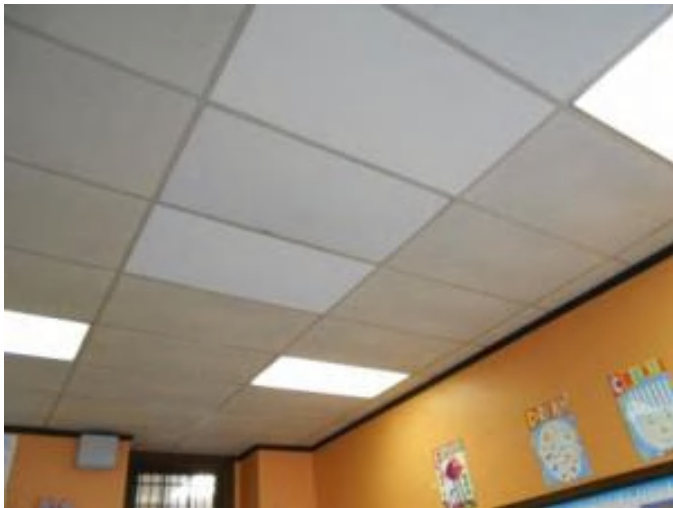
System: C3030 - Ceiling Finishes

Location: Throughout the building

Distress: Damaged

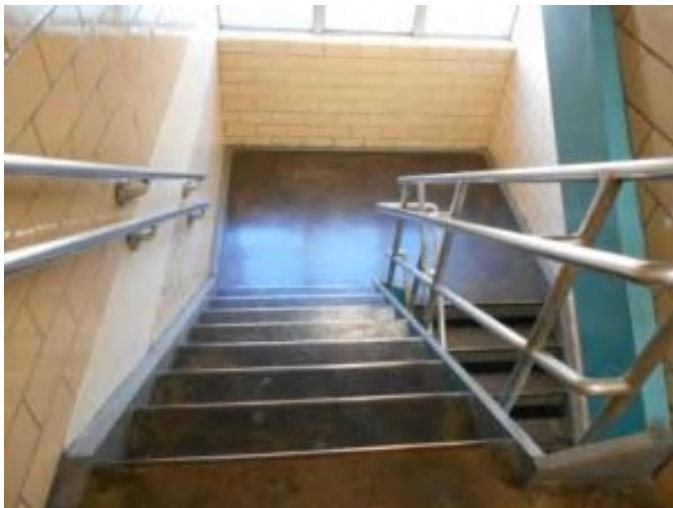
System: D1010 - Elevators and Lifts

Location: In the building

Distress: Accessibility

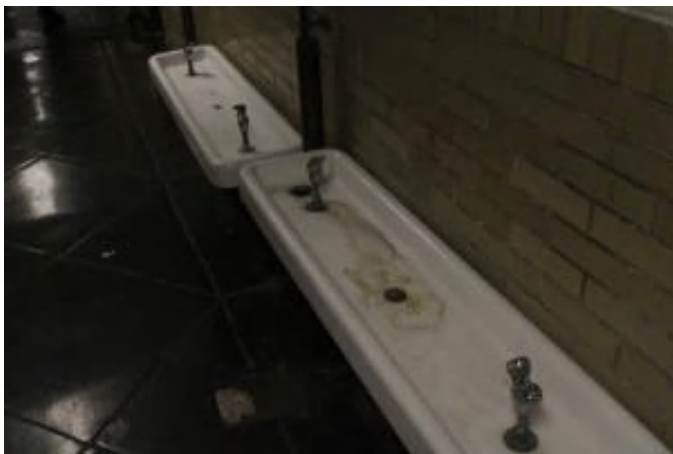
System: D2010 - Plumbing Fixtures

Location: Corridors

Distress: Accessibility

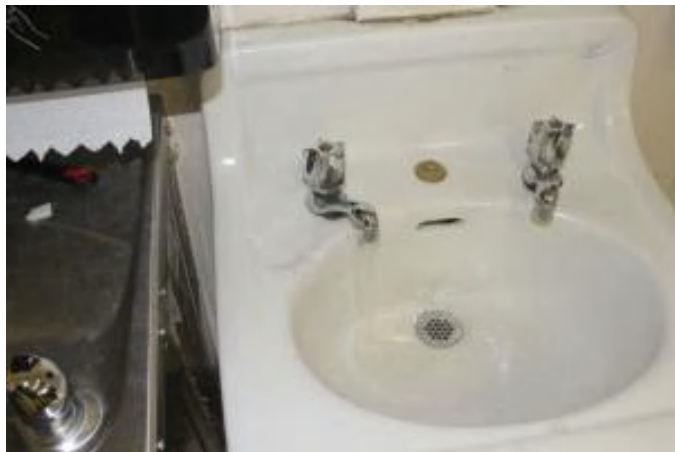
System: D2010 - Plumbing Fixtures

Location: Toilet rooms

Distress: Beyond Service Life

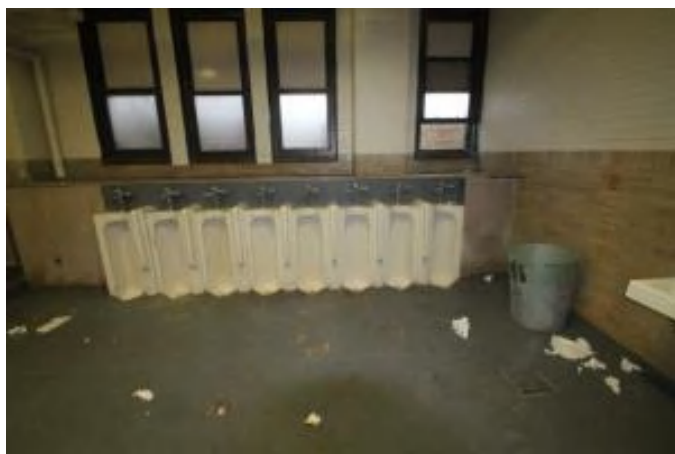
System: D2010 - Plumbing Fixtures

Location: Toilet rooms

Distress: Beyond Service Life

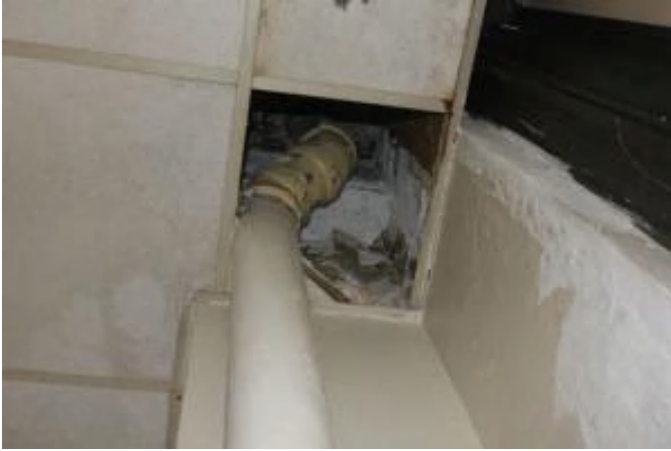
System: D2030 - Sanitary Waste

Location: Entire building

Distress: Beyond Service Life

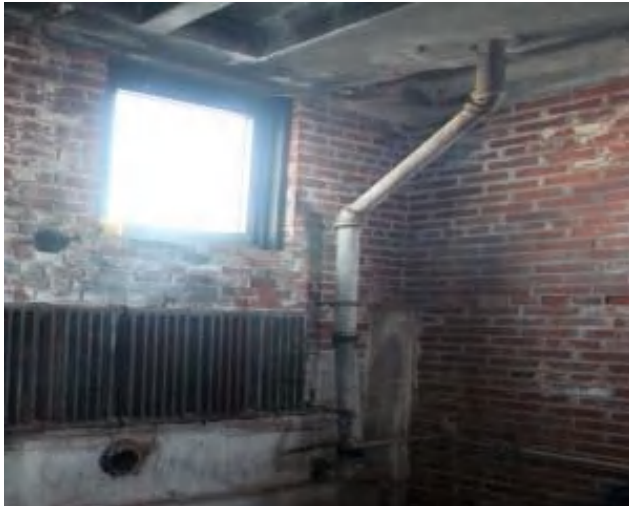
System: D2040 - Rain Water Drainage

Location: Entire building

Distress: Beyond Service Life

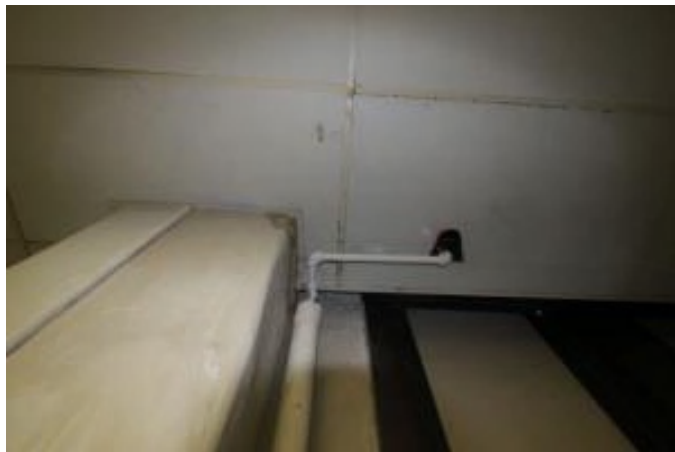
System: D3040 - Distribution Systems

Location: Entire building

Distress: Failing

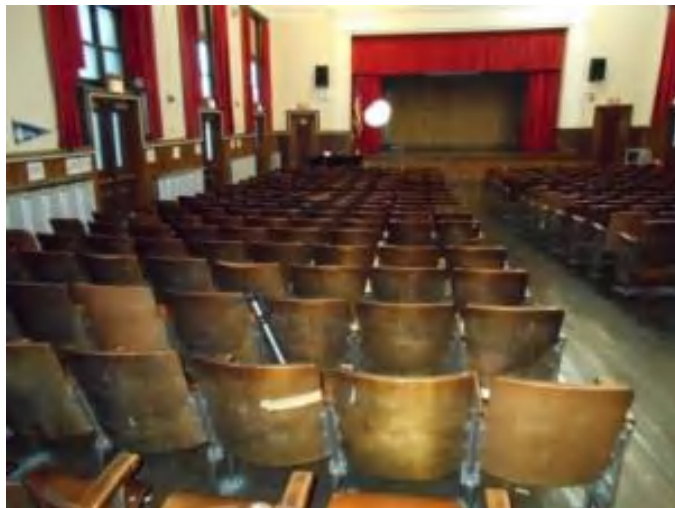
System: E2010 - Fixed Furnishings

Location: Auditorium

Distress: Beyond Service Life

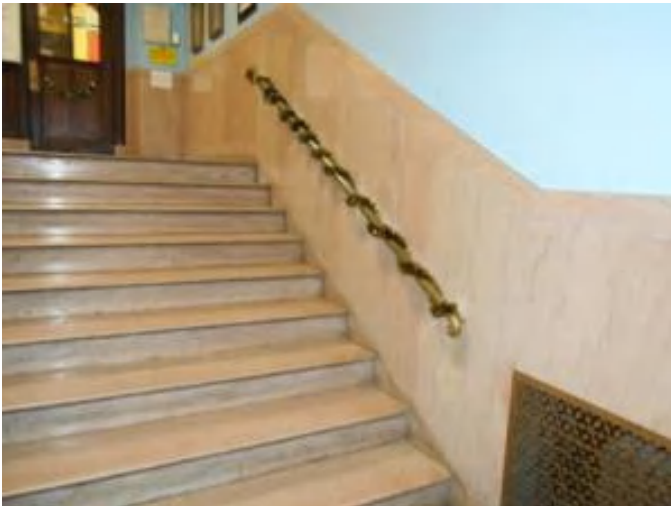
System: A1030 - Slab on Grade

Location: Entrance

Distress: Accessibility

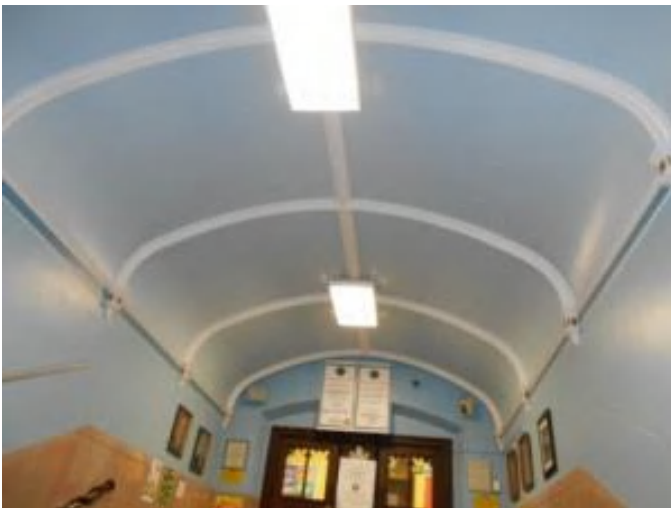
System: C3030 - Ceiling Finishes

Location: Ceilings

Distress: Appearance

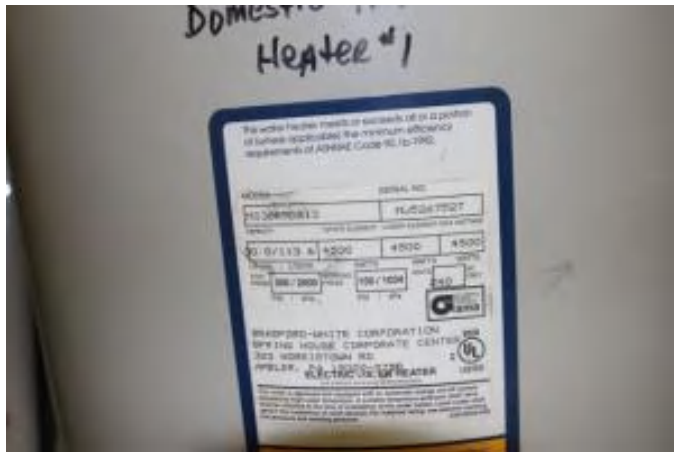
System: D2020 - Domestic Water Distribution

Location: Addition

Distress: Beyond Service Life

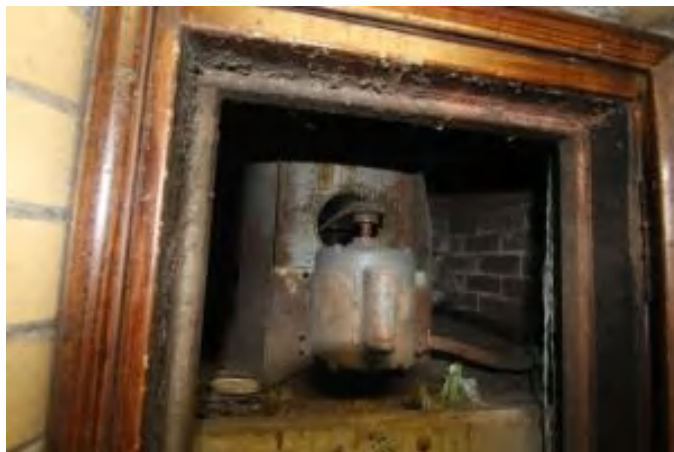
System: D3040 - Distribution Systems

Location: Toilet rooms

Distress: Beyond Service Life

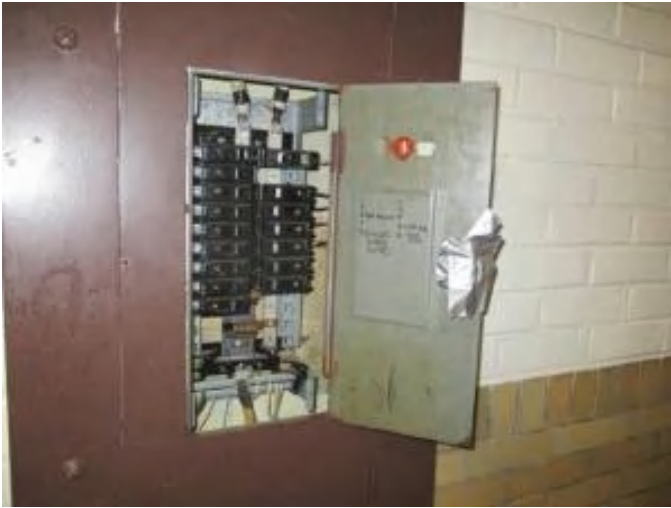
System: D5010 - Electrical Service/Distribution

Location: Entire Building

Distress: Beyond Service Life

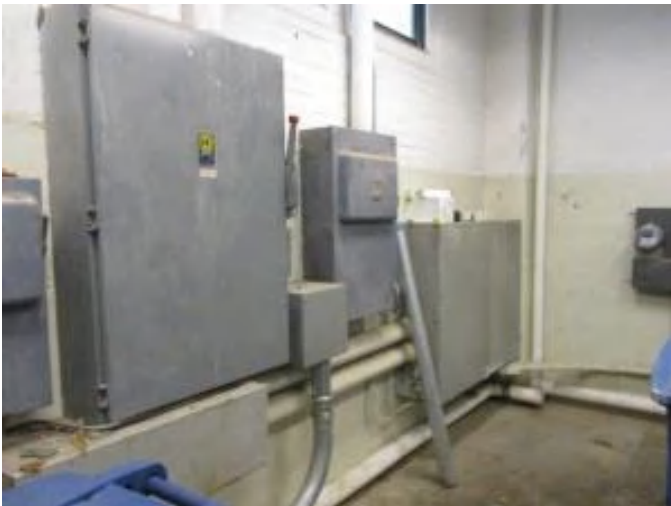
System: D5010 - Electrical Service/Distribution

Location: Basement

Distress: Inadequate

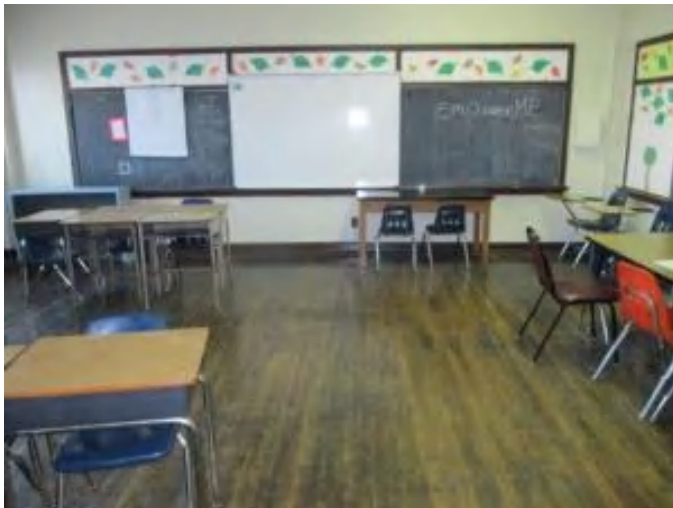
System: D5020 - Lighting and Branch Wiring

Location: Entire Building

Distress: Inadequate

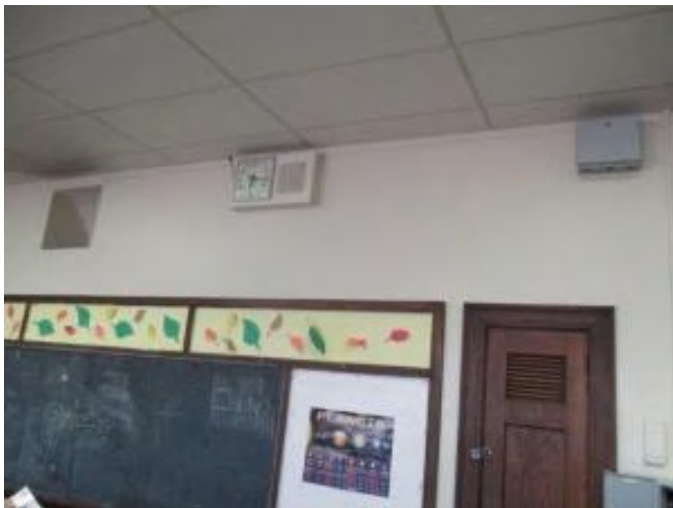
System: D5030 - Communications and Security

Location: Entire Building

Distress: Life Safety / NFPA / PFD

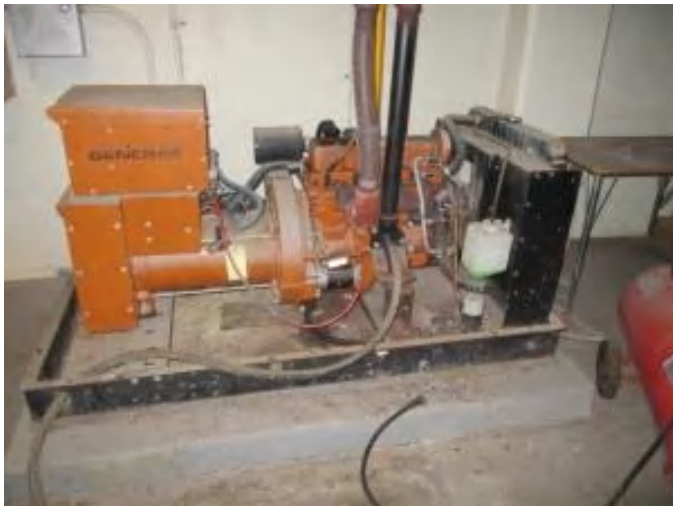
System: D5090 - Other Electrical Systems

Location: Outdoor

Distress: Inadequate

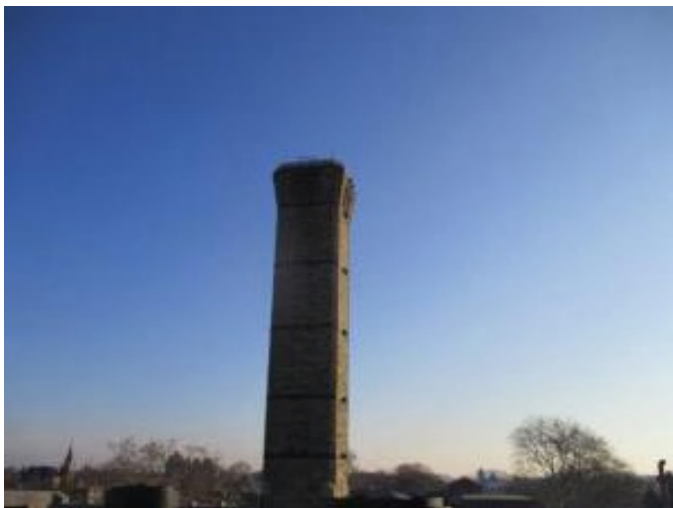
System: D5090 - Other Electrical Systems

Location: Roof

Distress: Building / MEP Codes

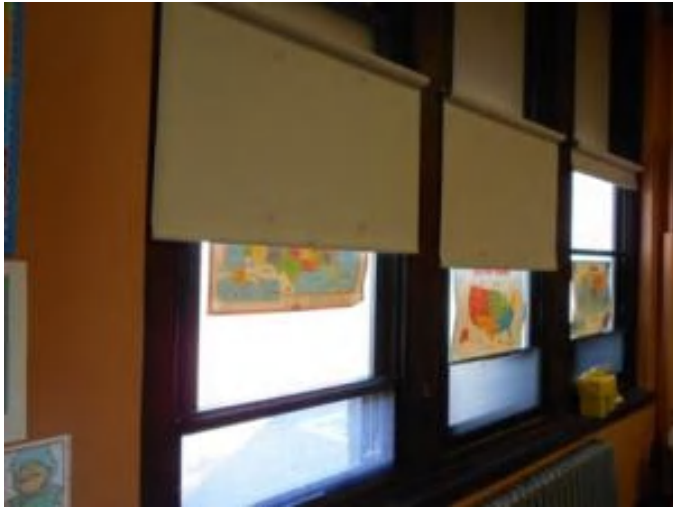
System: E2010 - Fixed Furnishings

Location: Windows

Distress: Appearance

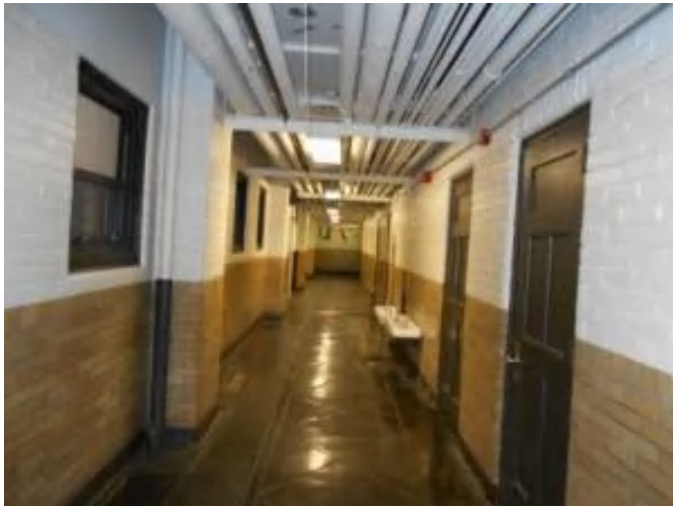
System: C3010230 - Paint & Covering

Location: Interior walls

Distress: Appearance

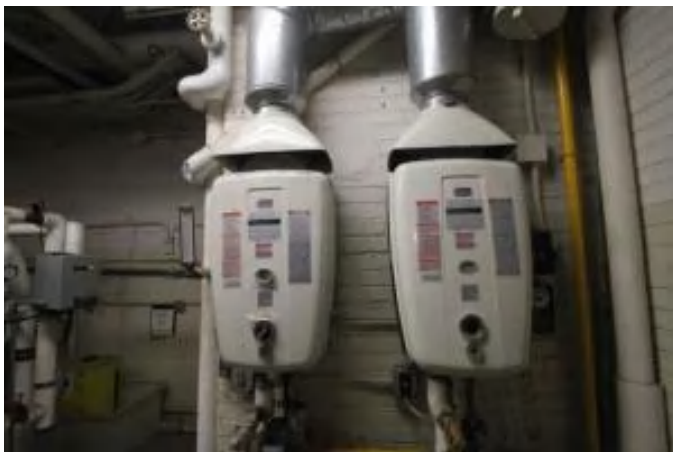
System: D2020 - Domestic Water Distribution

Location: Boiler room

Distress: Failing

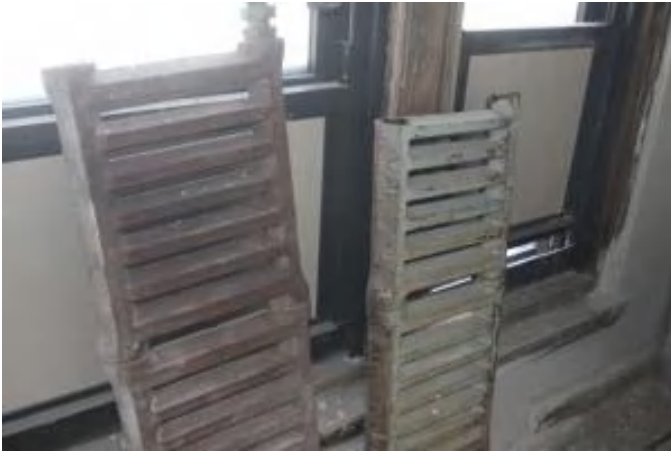
System: D3040 - Distribution Systems

Location: Entire building

Distress: Beyond Service Life

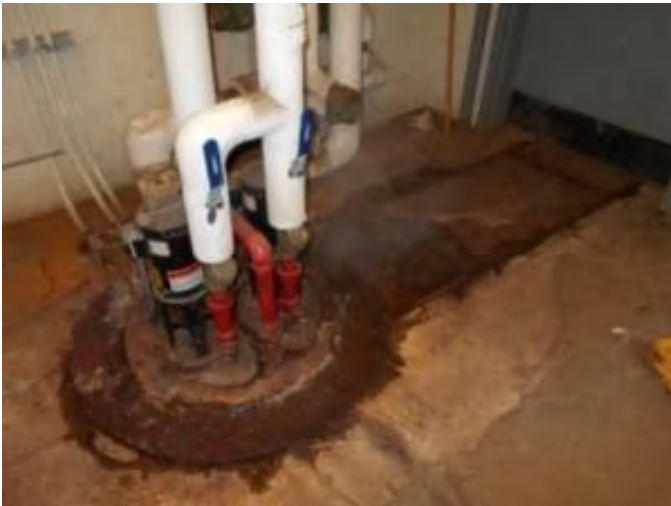
System: D3060 - Controls & Instrumentation

Location: Boiler room

Distress: Maintenance Required

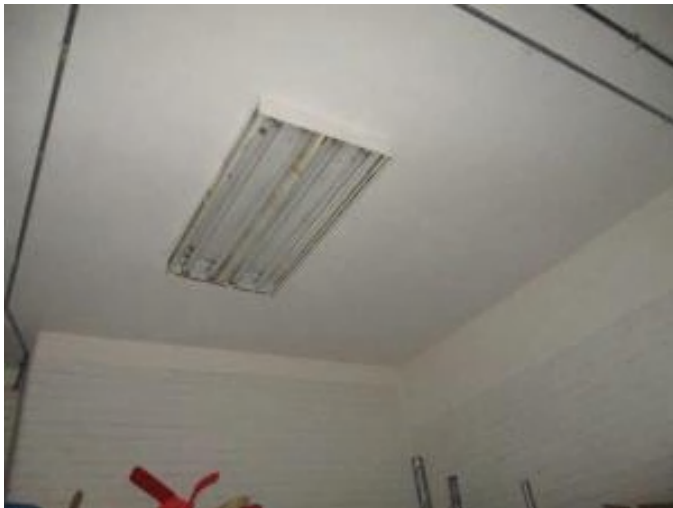
System: D5020 - Lighting and Branch Wiring

Location: Entire Building

Distress: Obsolete

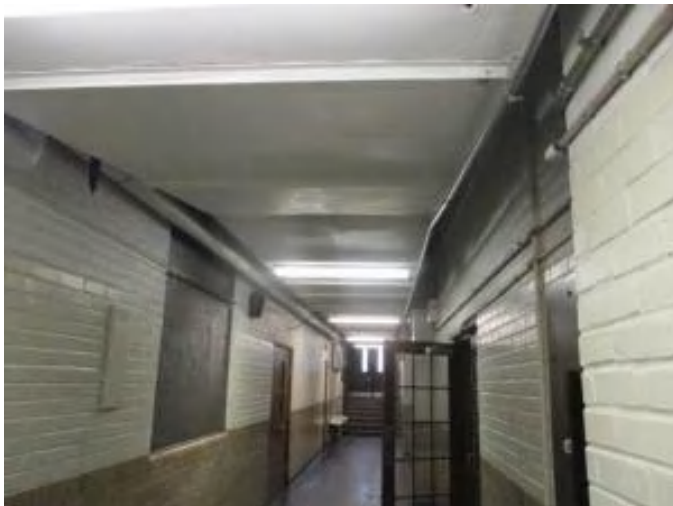
System: D5030 - Communications and Security

Location: Entire Building

Distress: Security Issue

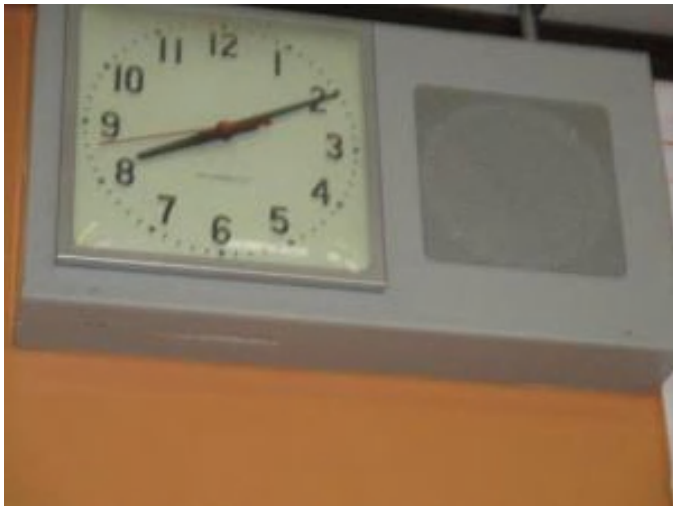
System: D5030 - Communications and Security

Location: Entire Building

Distress: Obsolete

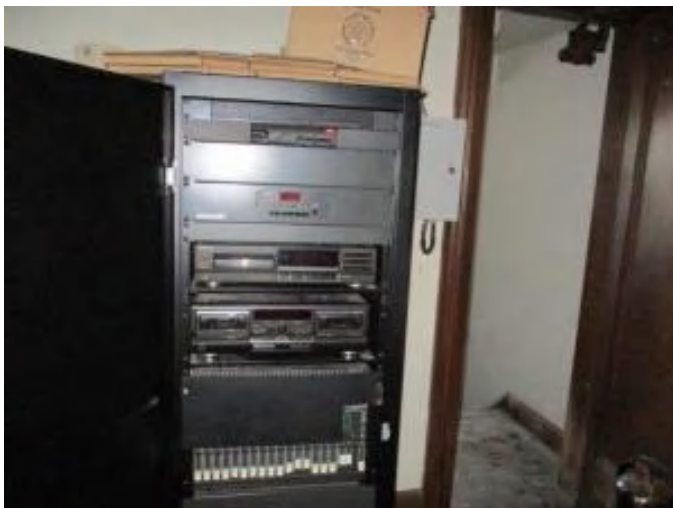
System: D5030 - Communications and Security

Location: Auditorium

Distress: Inadequate

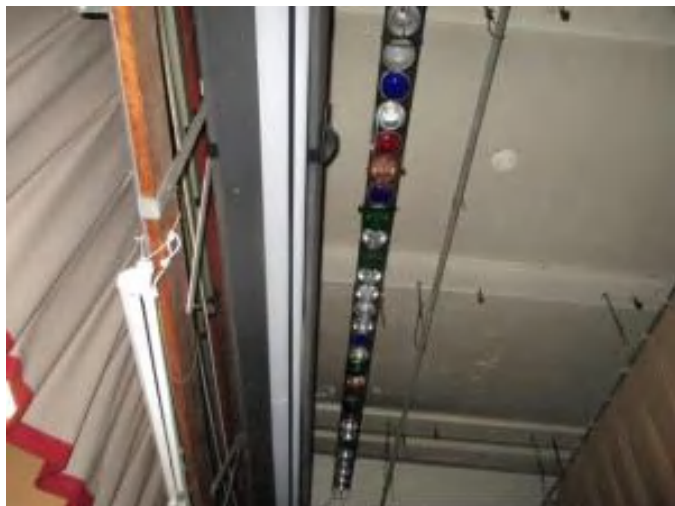
System: E1020 - Institutional Equipment

Location: Auditorium

Distress: Inadequate

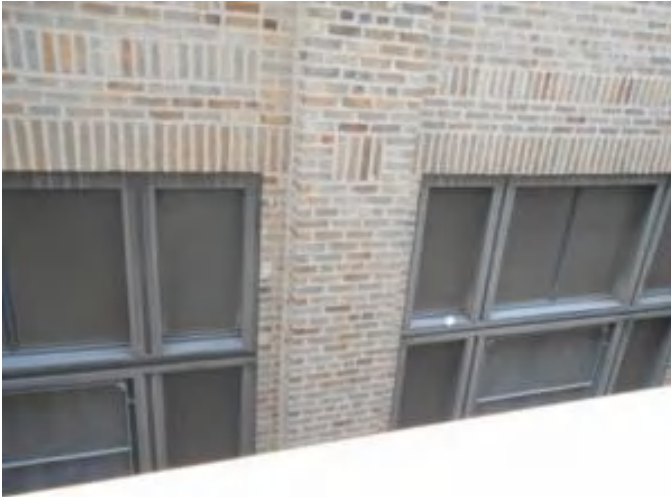
System: B2020 - Exterior Windows

Location: Exterior windows

Distress: Beyond Service Life

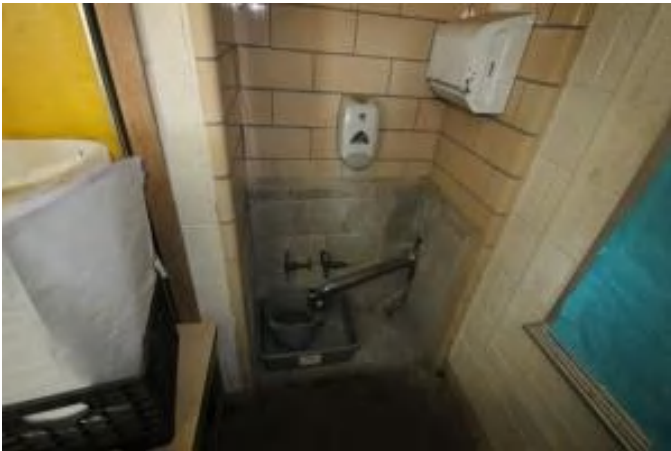
System: D2020 - Domestic Water Distribution

Location: Entire building

Distress: Beyond Service Life

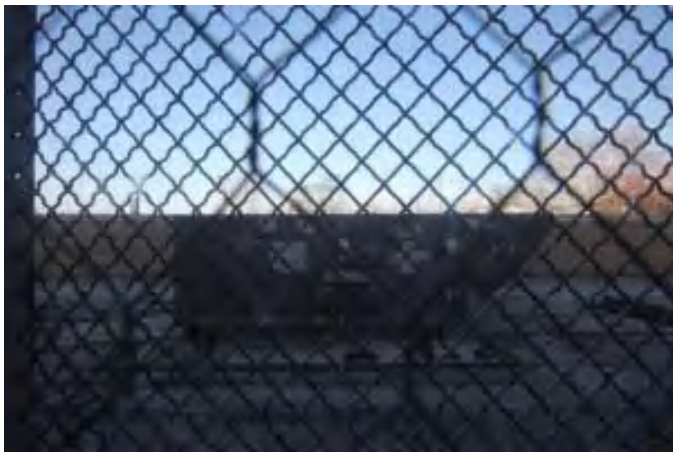
System: D3030 - Cooling Generating Systems

Location: Entire building

Distress: Inadequate

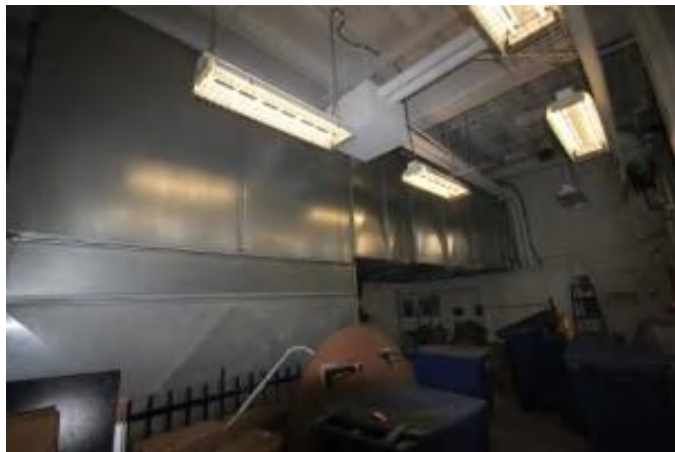
System: D3040 - Distribution Systems

Location: Basement

Distress: Inadequate

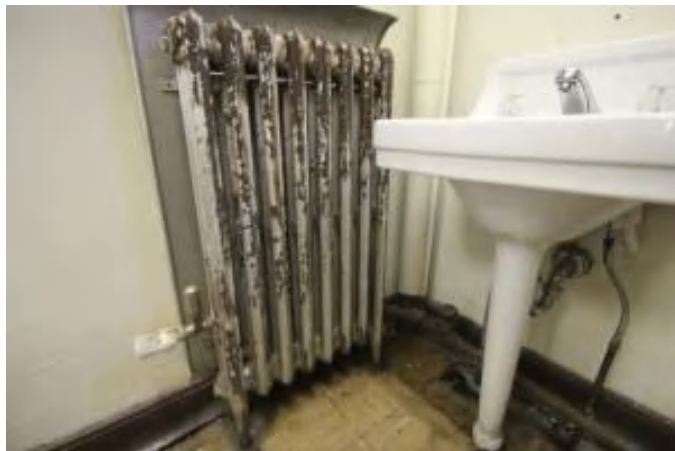
System: D3060 - Controls & Instrumentation

Location: Entire building

Distress: Obsolete

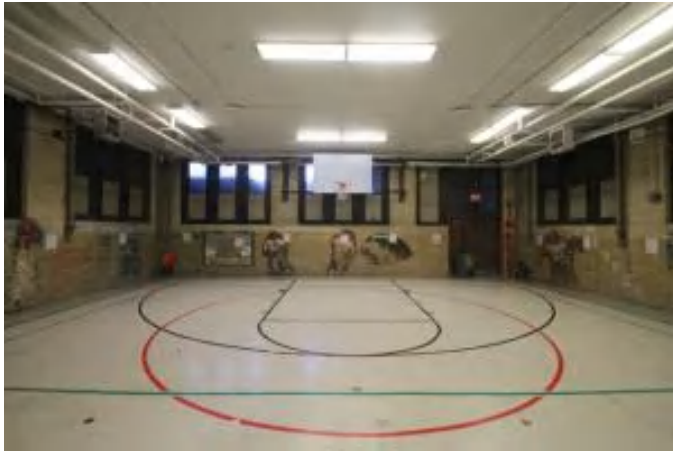
System: D4010 - Sprinklers

Location: Entire building

Distress: Life Safety / NFPA / PFD

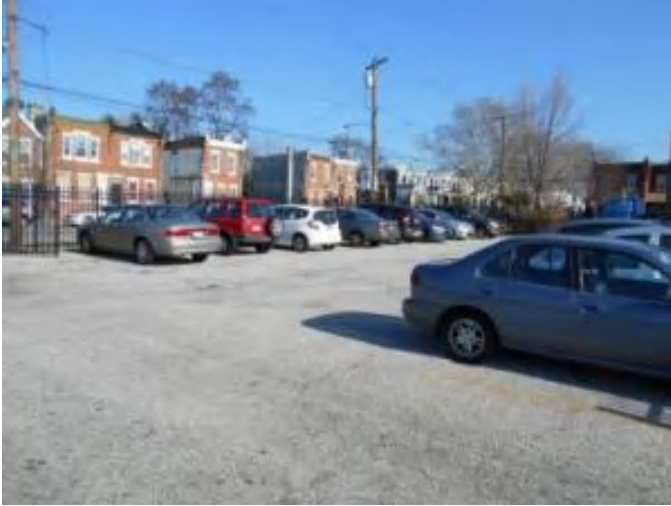
System: G2020 - Parking Lots

Location: Parking lot

Distress: Failing

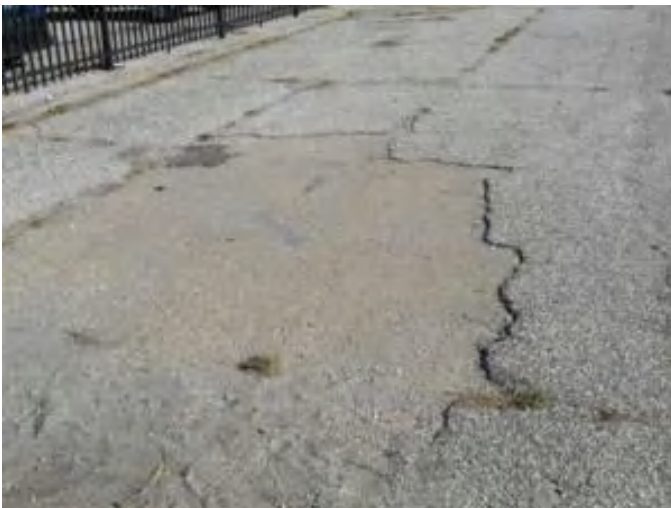
System: G2030 - Pedestrian Paving

Location: Playground

Distress: Failing

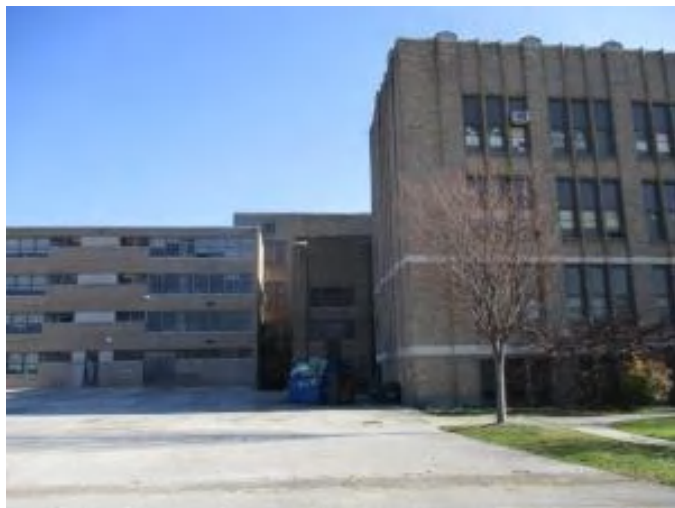
System: G4030 - Site Communications & Security

Location: Building Perimeter

Distress: Security Issue

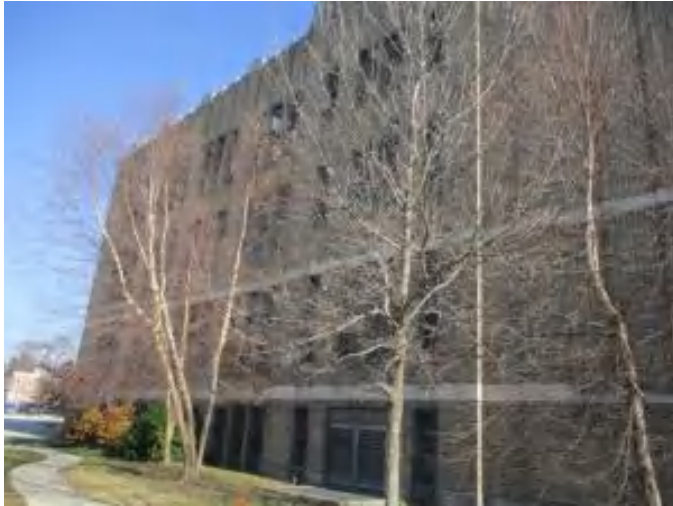
System: G4020 - Site Lighting

Location: Building Perimeter

Distress: Security Issue
