## Facility Condition Assessment Summary Report

### Webster School

School District of Philadelphia  
**S559001; Webster**  
Final  
**Site Assessment Report**  
January 31, 2017

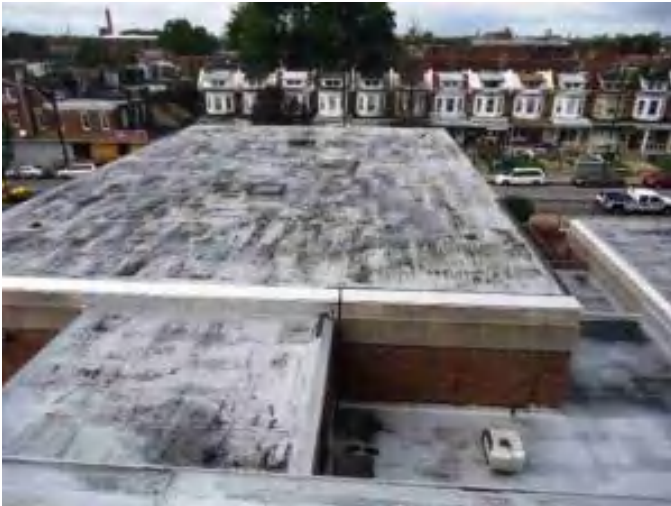
#### **System: B3010105 - Built-Up**

The existing built up roofing system has clear signs of ponding and there reportedly has been an increase of roofing maintenance on this single ply roofing system. It is recommended that a new built-up roofing system be installed within the next ten years.

**Location:** Roof  
**Distress:** Damaged  
**Category:** 3 - Operations / Maint.  
**Priority:** 2 - Response Time (2-3 yrs)  
**Correction:** Remove and Replace Built Up Roof

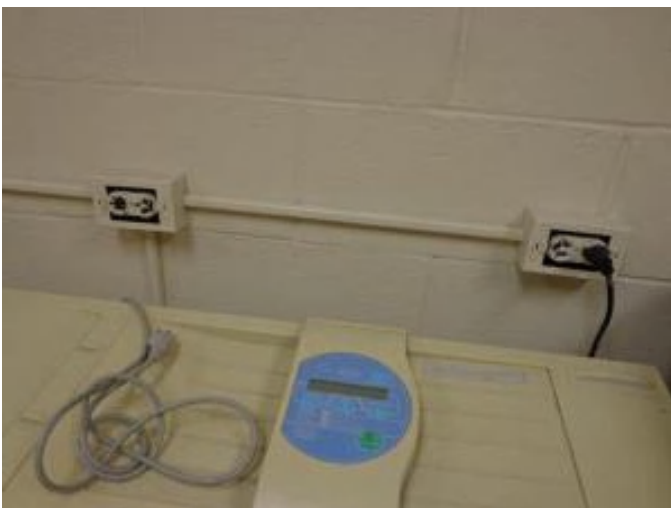
#### **System: D5020 - Lighting and Branch Wiring**

**Location:** Main Office Workroom and receptacles at sinks  
**Distress:** Life Safety / NFPA / PFD  
**Category:** 1 - Health & Safety  
**Priority:** 2 - Response Time (2-3 yrs)

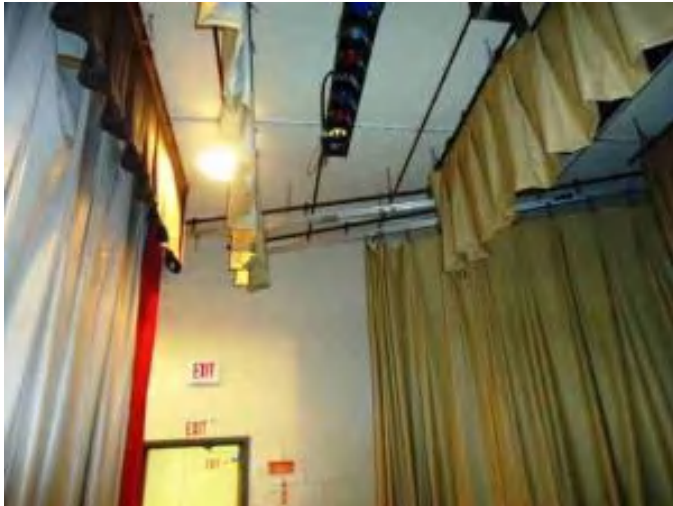
**System: E2010 - Fixed Furnishings**

**Location:** Stage

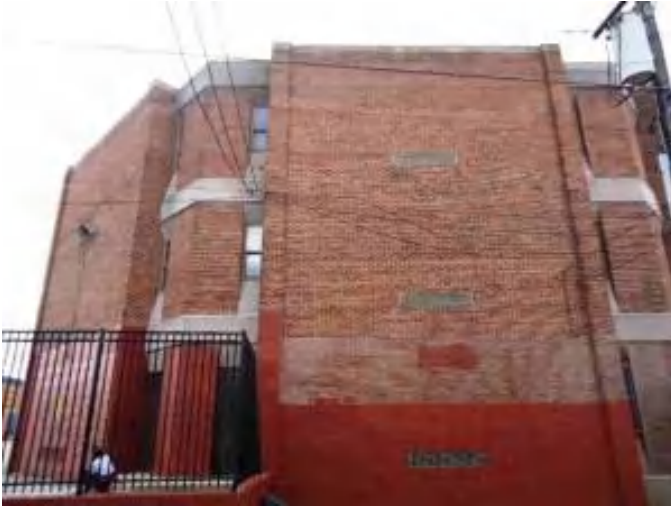
**System: B2010 - Exterior Walls**

The exterior brick surfaces are generally in fair to good condition for their age. In some locations, bricks have cracked or spalled and should be replaced. The repointing of deteriorated mortar joints is also recommended, using mortar of a similar color and consistency as the original. Following the detailed examination of the brick and repair of mortar construction joints, the entire building should be pressure washed to remove stains and embedded pollutants. If moisture is found to be penetrating the masonry facade, the application of a spray sealant to the suspected exterior masonry surface is recommended.

**Location:** Exterior Elevation

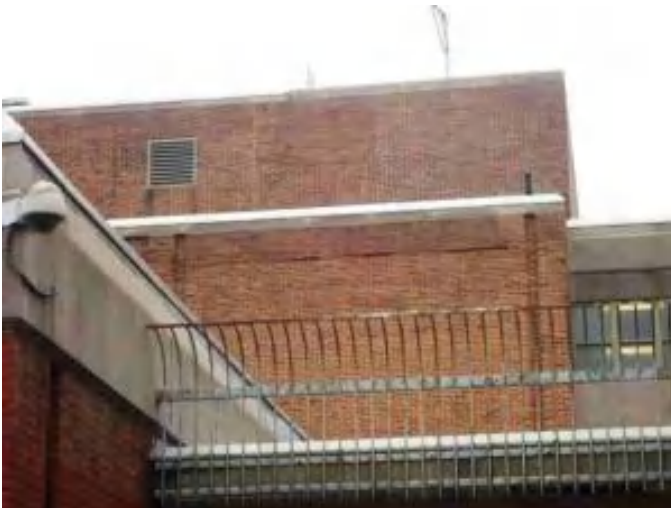
**System: B2010 - Exterior Walls**

There is significant cracking starting on the roof with a section of concrete finish leading to the next floor. This cracking is exhibiting moisture penetration, such displacement is normally cause for a more detailed destructive structural analysis. A physical analysis of the load-bearing structural scheme is advised. An unqualified allocation for correction of the unspecified problem is included in this deficiency cost estimate to repair and research this issue.

**Location:** Roof

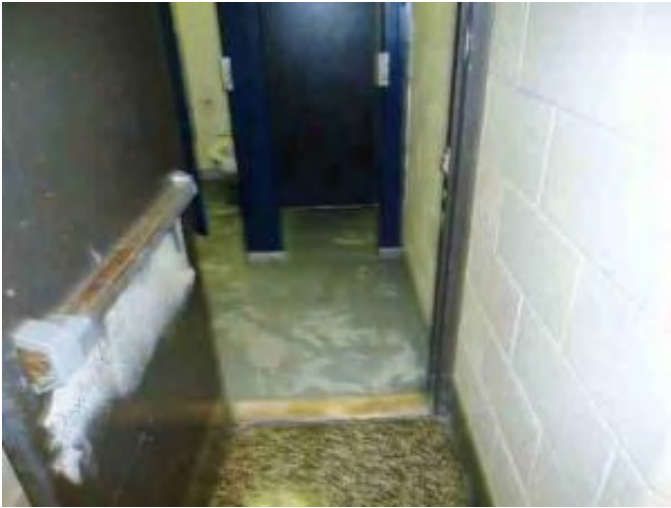
**System: C1020 - Interior Doors**

Interior doors are typically wood in metal frames with some glass glazing. Other interior doors include metal glass pane doors with hollow metal frames. Doors are generally in good condition considering the age of the application. There are a select few doors that are very high traffic and are showing signs of age such as damaged locksets, warn hinges and finish issues. Selective upgrades are required for the interior door systems, it is recommended that the damaged interior doors system be removed and replaced with a

**Location:** Classroom  
**Distress:** Damaged  
**Category:** 3 - Operations / Maint.  
**Priority:** 3 - Response Time (3-4 yrs)  
**Correction:** Remove and replace interior doors - wood doors with hollow metal frames - per leaf  
**Qty:** 20.00  
**Unit of Measure:** Ea.  
**Estimate:** \$95,411.74  
**Assessor Name:** Ed Davis  
**Date Created:** 12/29/2015

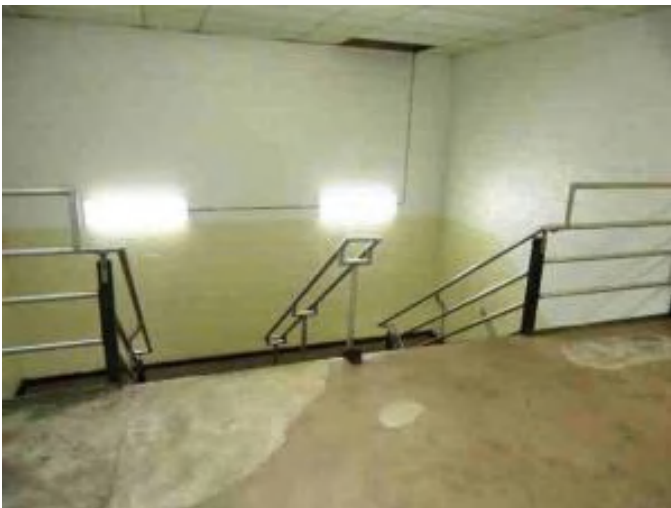
**System: C2010 - Stair Construction**

Current requirements for stairs indicate that they have graspable handrails on both sides, that the rails have a specific end geometry, and that the handrails continue horizontally at the landings. In addition, guardrails must prevent the passage of a 4 inch diameter sphere (6 inches in the triangle formed by the lower rail and tread/riser angle). Although the stairs are compliant with the code enforced at the time of construction until a major renovation occurs, they are deficient in handrail and guardrail design relative to current standards. Future efforts should include comprehensive stair railing removal and replacement upgrades.

**Location:** Stairs  
**Distress:** Life Safety / NFPA / PFD  
**Category:** 1 - Health & Safety  
**Priority:** 3 - Response Time (3-4 yrs)  
**Correction:** Replace inadequate or install proper stair railing - select appropriate material  
**Qty:** 1,800.00  
**Unit of Measure:** L.F.  
**Estimate:** \$266,412.05  
**Assessor Name:** Ed Davis  
**Date Created:** 12/29/2015

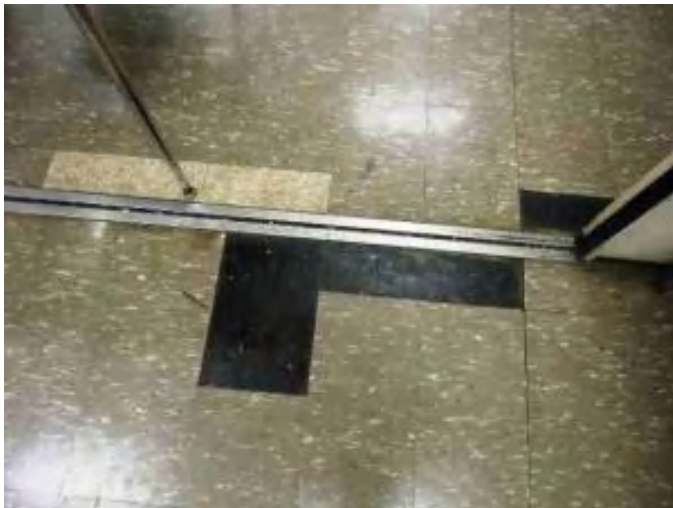
**System: C3020413 - Vinyl Flooring**

**Location:** Building Wide

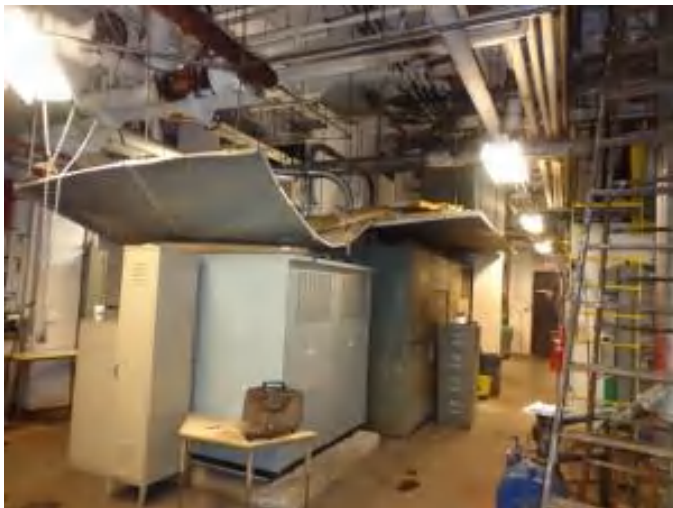
**System: D5010 - Electrical Service/Distribution**

**Location:** Boiler Room 014B

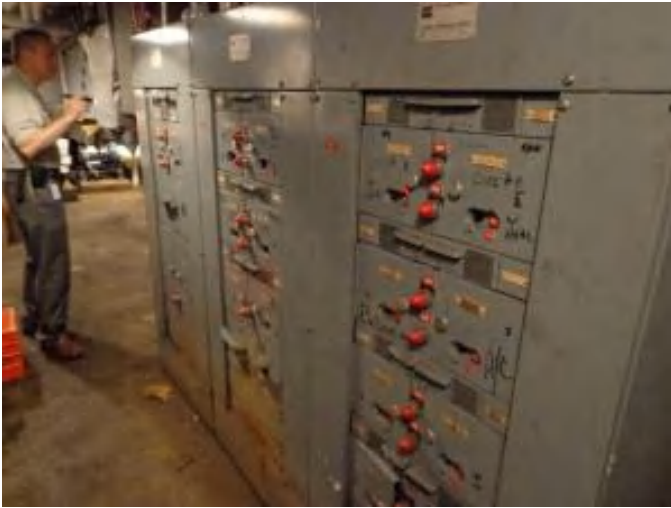
**System: D5010 - Electrical Service/Distribution**

In general, the entire electrical distribution system, including the service entrance equipment, motor control centers and all panelboards and feeder conductors need to be replaced.

**Location:** Building wide  
**Distress:** Beyond Service Life  
**Category:** 3 - Operations / Maint.  
**Priority:** 3 - Response Time (3-4 yrs)  
**Correction:** Replace Electrical Distribution System (U)  
**Qty:** 27.00  
**Unit of Measure:** Ea.  
**Estimate:** \$966,236.68  
**Assessor Name:** Ed Davis  
**Date Created:** 12/16/2015

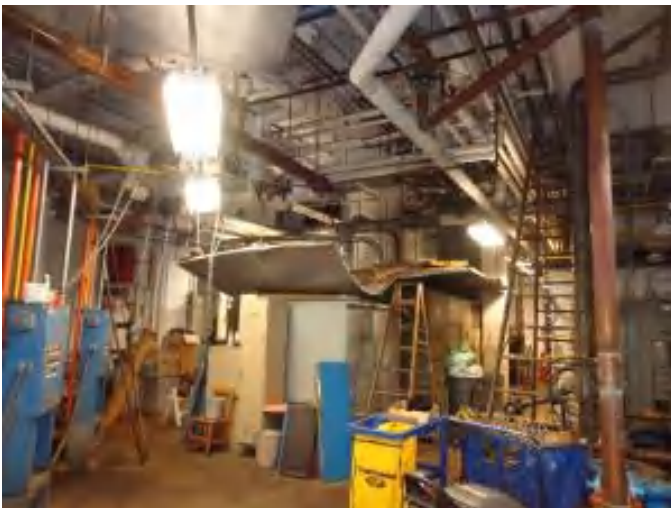
**System: D5020 - Lighting and Branch Wiring**

**Location:** First Floor corridor, Fourth Floor Mechanical Room  
**Distress:** Beyond Service Life  
**Category:** 3 - Operations / Maint.  
**Priority:** 3 - Response Time (3-4 yrs)  
**Correction:** Replace lighting fixtures  
**Qty:** 1.00  
**Unit of Measure:** Ea.  
**Estimate:** \$21,287.89  
**Assessor Name:** Ed Davis  
**Date Created:** 12/17/2015

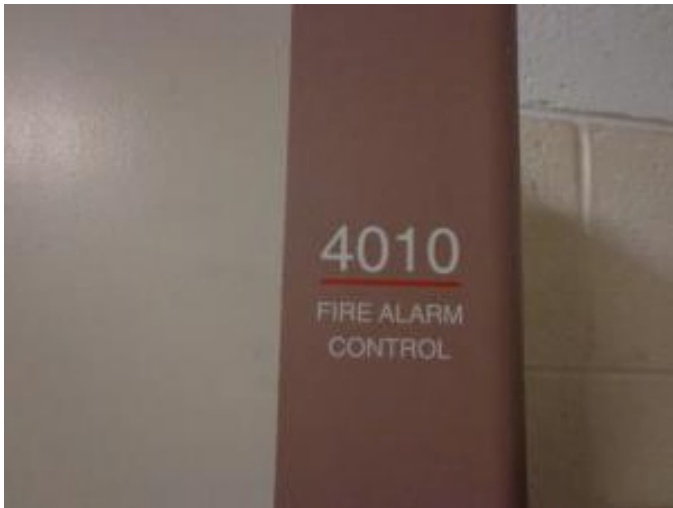
**System: D5030 - Communications and Security**

**Location:** Building wide  
**Distress:** Life Safety / NFPA / PFD  
**Category:** 1 - Health & Safety  
**Priority:** 3 - Response Time (3-4 yrs)  
**Correction:** Replace fire alarm system  
**Qty:** 92,275.00  
**Unit of Measure:** S.F.  
**Estimate:** \$489,057.56  
**Assessor Name:** Ed Davis  
**Date Created:** 12/17/2015

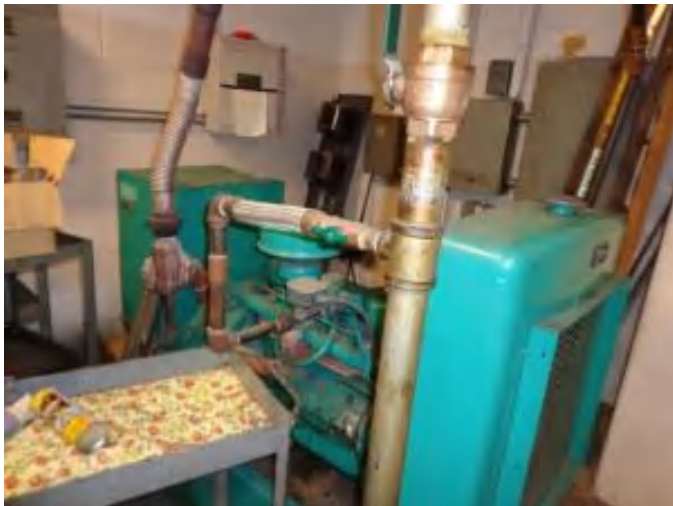
**System: D5090 - Other Electrical Systems**

**Location:** Boiler Room  
**Distress:** Beyond Service Life  
**Category:** 3 - Operations / Maint.  
**Priority:** 3 - Response Time (3-4 yrs)  
**Correction:** Replace standby generator system  
**Qty:** 1.00  
**Unit of Measure:** Ea.  
**Estimate:** \$346,257.61  
**Assessor Name:** Ed Davis  
**Date Created:** 12/17/2015

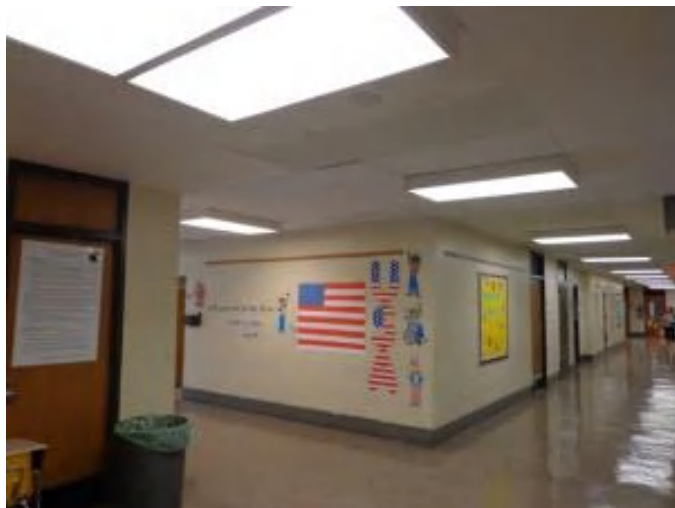
**System: D5090 - Other Electrical Systems**

**Location:** Classroom Corridors

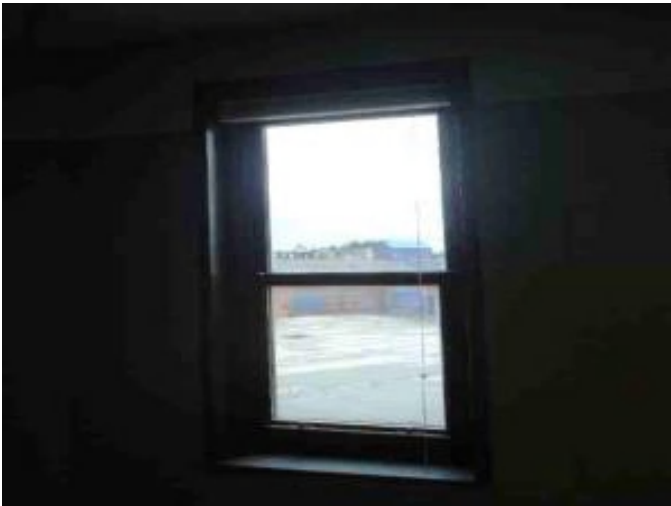
**System: B2020 - Exterior Windows**

The exterior windows are industrial metal framed single pane applications. Some of the windows are operable while others no longer function. The window system was reported to have been upgraded in the early 1990s and some selective upgrades based on damage. It is recommended that the exterior window system be replaced with units that retain their dimensions and profiles, but that incorporate updated energy-efficient features.

**Location:** Exterior Elevation  
**Distress:** Damaged  
**Category:** 3 - Operations / Maint.  
**Priority:** 4 - Response Time (4-5 yrs)  
**Correction:** Remove and replace aluminum windows - pick the appropriate size and style and insert the number of units  
**Qty:** 90.00  
**Unit of Measure:** Ea.  
**Estimate:** \$540,832.50  
**Assessor Name:** Ed Davis  
**Date Created:** 12/29/2015

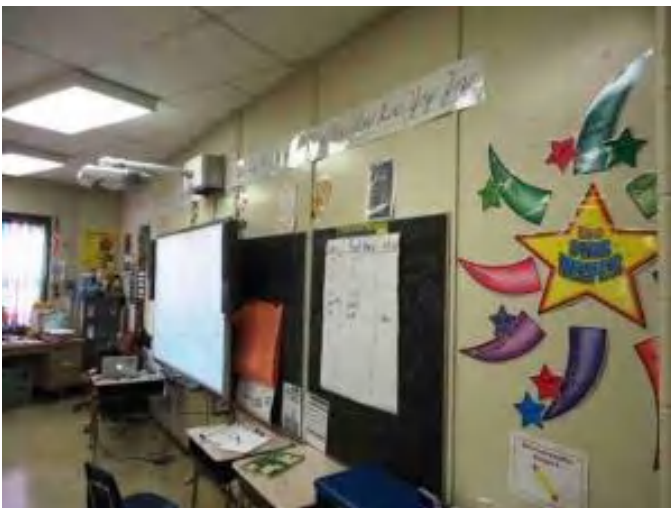
**System: C1010 - Partitions**

The interior partitions include CMU and gypsum wallboard finishes. There are several movable partitions that remain in classrooms. These wall systems are no longer used and in most cases cannot be used due to damage or wall modifications to support classroom needs. This deficiency provides a budgetary consideration to remove and replace the wall systems with universal removal of the existing movable partitions and upgrades to a permeate wall systems.

**Location:** Classroom  
**Distress:** Damaged  
**Category:** 3 - Operations / Maint.  
**Priority:** 4 - Response Time (4-5 yrs)  
**Correction:** Remove folding wood partitions; replace with metal studs and gypsum board painted  
**Qty:** 10,000.00  
**Unit of Measure:** S.F.  
**Estimate:** \$222,794.98  
**Assessor Name:** Ed Davis  
**Date Created:** 12/29/2015

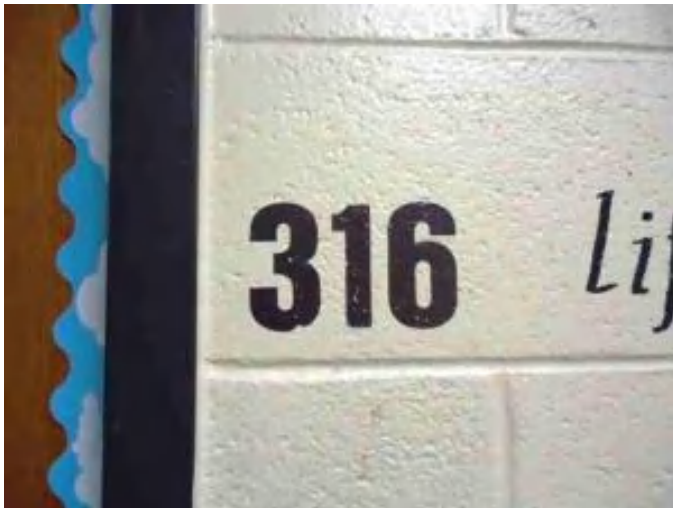
**System: C1030 - Fittings**

There is no directional signage and room signage is a custom design in places and scarce or painted with no consistency in others. Accessibility signage criteria have been established for the physically challenged. These include mounting heights, contrast and finish, raised and Braille characters and pictograms, and character proportions and heights. It is recommended that compliant signage be installed throughout the building.

**Location:** Building Wide  
**Distress:** Damaged  
**Category:** 3 - Operations / Maint.  
**Priority:** 4 - Response Time (4-5 yrs)  
**Correction:** Replace missing or damaged signage - insert the number of rooms  
**Qty:** 200.00  
**Unit of Measure:** Ea.  
**Estimate:** \$54,182.50  
**Assessor Name:** Ed Davis  
**Date Created:** 12/29/2015

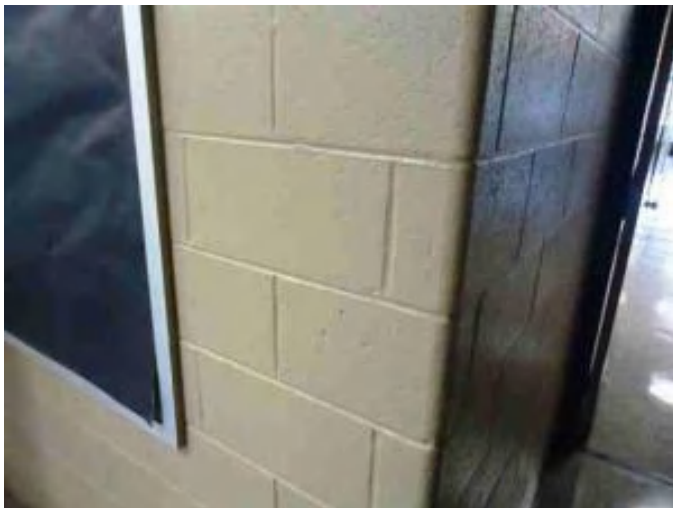
**System: C1030 - Fittings**

There are several tack boards in the hallways for student displays. The systems are damaged and beyond the expected service life for this application. Remove and replace tack boards is recommended.

**Location:** Hallway  
**Distress:** Damaged  
**Category:** 3 - Operations / Maint.  
**Priority:** 4 - Response Time (4-5 yrs)  
**Correction:** Remove and replace tackboards - select size  
**Qty:** 10.00  
**Unit of Measure:** Ea.  
**Estimate:** \$7,927.26  
**Assessor Name:** Ed Davis  
**Date Created:** 12/29/2015

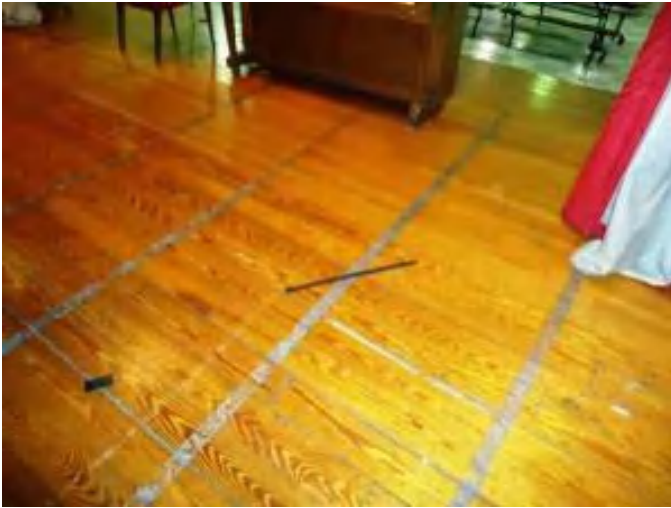
**System: C3020414 - Wood Flooring**

**Location:** Stage

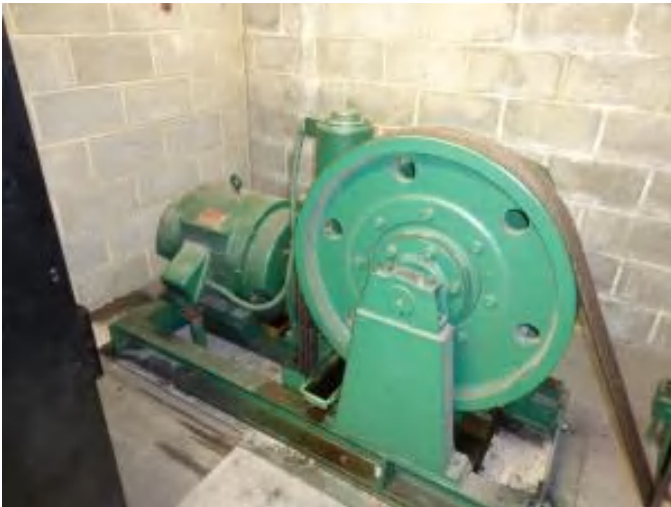
**System: D1010 - Elevators and Lifts**

**Location:** Elevator Machine Room

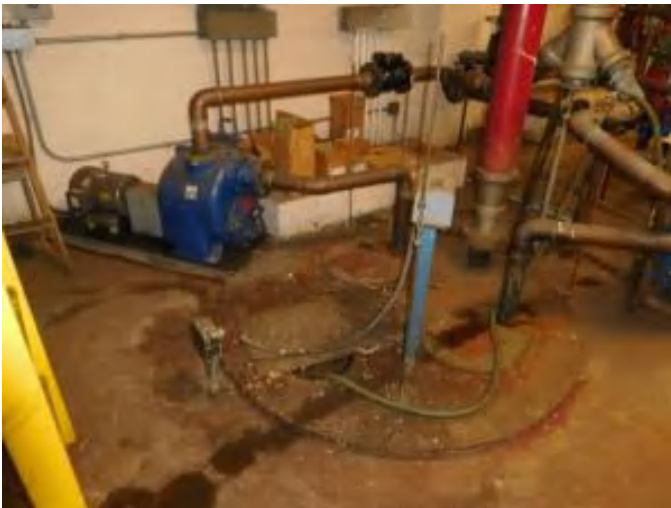
**System: D2030 - Sanitary Waste**

**Location:** entire building  
**Distress:** Beyond Service Life  
**Category:** 3 - Operations / Maint.  
**Priority:** 4 - Response Time (4-5 yrs)  
**Correction:** Inspect sanitary waste piping and replace damaged sections. (+100KSF)  
**Qty:** 92,275.00  
**Unit of Measure:** S.F.  
**Estimate:** \$391,855.60  
**Assessor Name:** Ed Davis  
**Date Created:** 12/29/2015

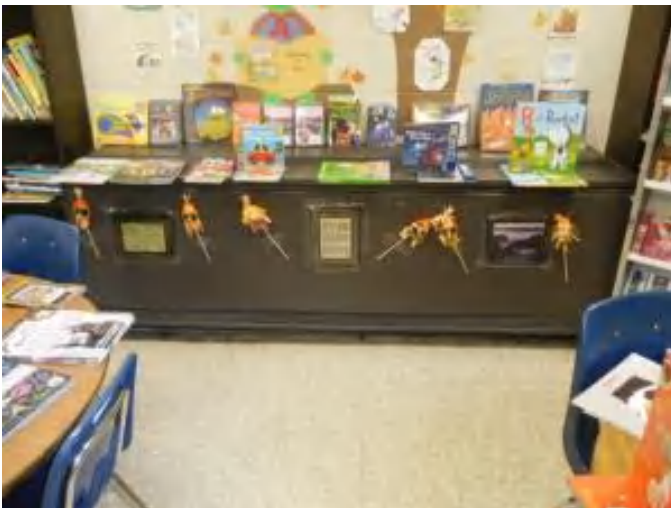
**System: D3040 - Distribution Systems**

**Location:** classrooms  
**Distress:** Building / MEP Codes  
**Category:** 2 - Code Compliance  
**Priority:** 4 - Response Time (4-5 yrs)  
**Correction:** Replace the existing unit ventilators with new units designed to provide adequate ventilation per ASHRAE Std 62 - insert the SF of bldg. in the qty.  
**Qty:** 92,275.00  
**Unit of Measure:** S.F.  
**Estimate:** \$4,201,731.22  
**Assessor Name:** Ed Davis  
**Date Created:** 12/29/2015

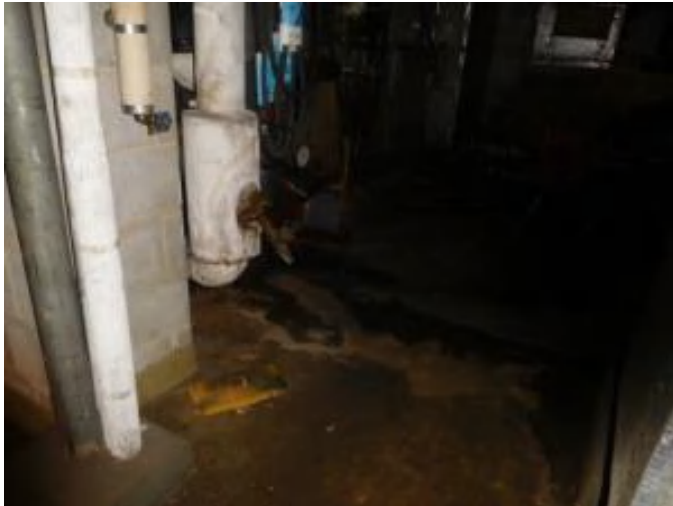
**System: D3040 - Distribution Systems**

**Location:** mezzanine mechanical room

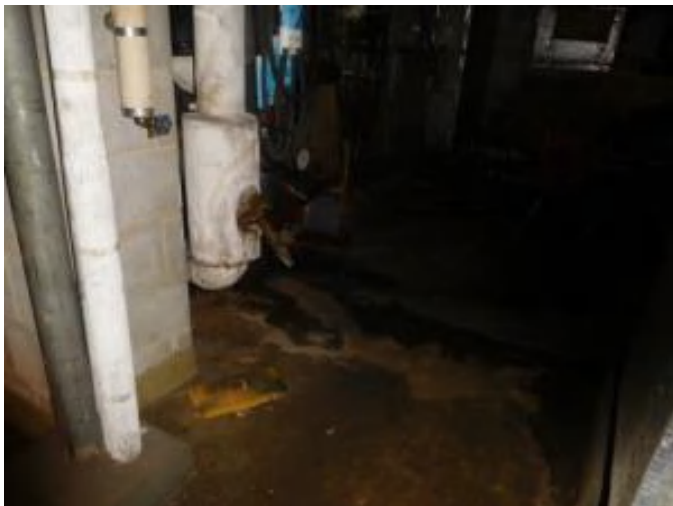
**System: D3040 - Distribution Systems**

**Location:** mezzanine mechanical room

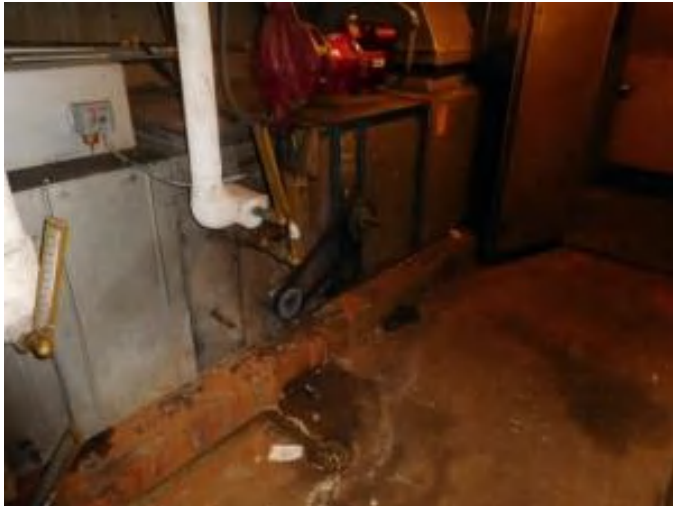
**System: D3040 - Distribution Systems**

**Location:** mezzanine mechanical room

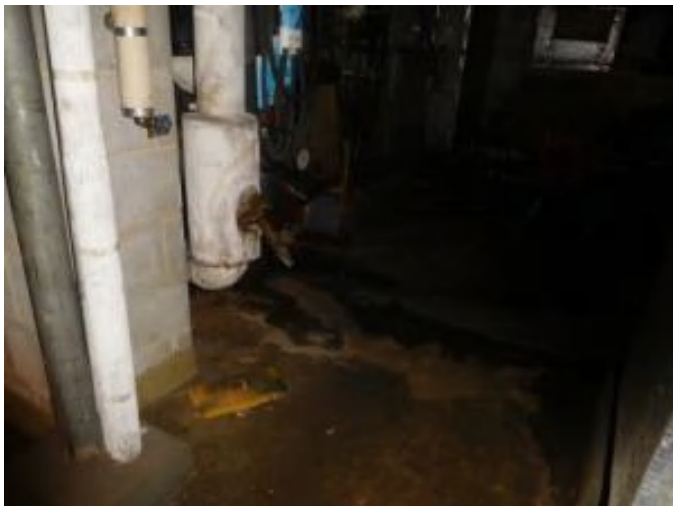
**System: D3040 - Distribution Systems**

**Location:** mezzanine mechanical room

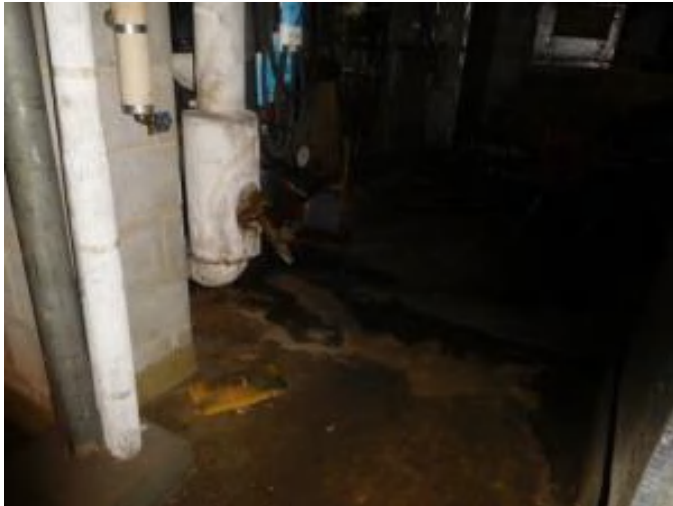
**System: D3040 - Distribution Systems**

**Location:** mezzanine mechanical room

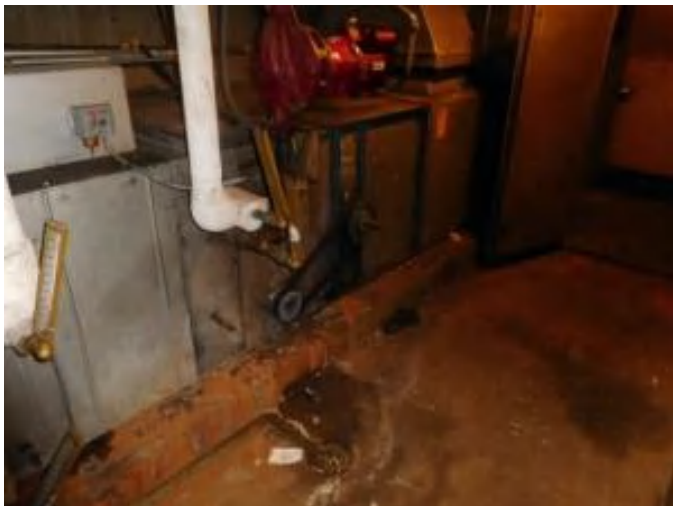
**System: D3040 - Distribution Systems**

**Location:** mezzanine mechanical room

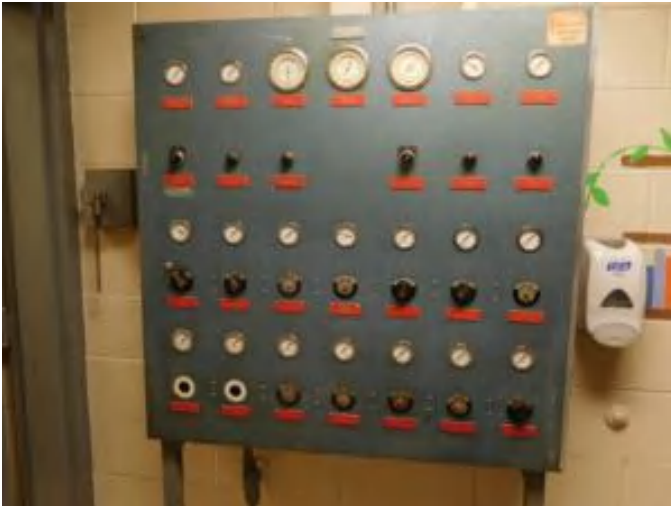
**System: D3060 - Controls & Instrumentation**

**Location:** entire building  
**Distress:** Inadequate  
**Category:** 4 - Capital Improvement  
**Priority:** 4 - Response Time (4-5 yrs)  
**Correction:** Replace pneumatic controls with DDC (75KSF)  
**Qty:** 92,275.00  
**Unit of Measure:** S.F.  
**Estimate:** \$1,827,090.29  
**Assessor Name:** Ed Davis  
**Date Created:** 12/29/2015

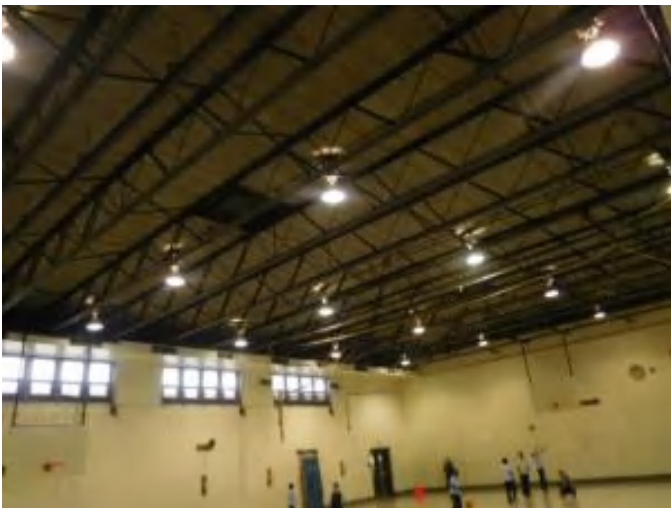
**System: D4010 - Sprinklers**

**Location:** entire building  
**Distress:** Life Safety / NFPA / PFD  
**Category:** 1 - Health & Safety  
**Priority:** 4 - Response Time (4-5 yrs)  
**Correction:** Install a fire protection sprinkler system  
**Qty:** 92,275.00  
**Unit of Measure:** S.F.  
**Estimate:** \$1,320,034.36  
**Assessor Name:** Ed Davis  
**Date Created:** 12/29/2015

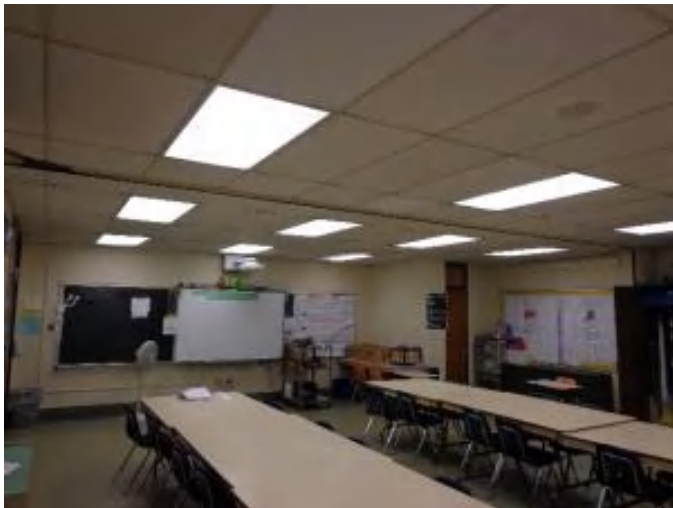
**System: D5020 - Lighting and Branch Wiring**

**Location:** Classrooms  
**Distress:** Inadequate  
**Category:** 4 - Capital Improvement  
**Priority:** 4 - Response Time (4-5 yrs)  
**Correction:** Provide surface raceway system and wiring devices  
**Qty:** 840.00  
**Unit of Measure:** L.F.  
**Estimate:** \$107,462.78  
**Assessor Name:** Ed Davis  
**Date Created:** 12/17/2015

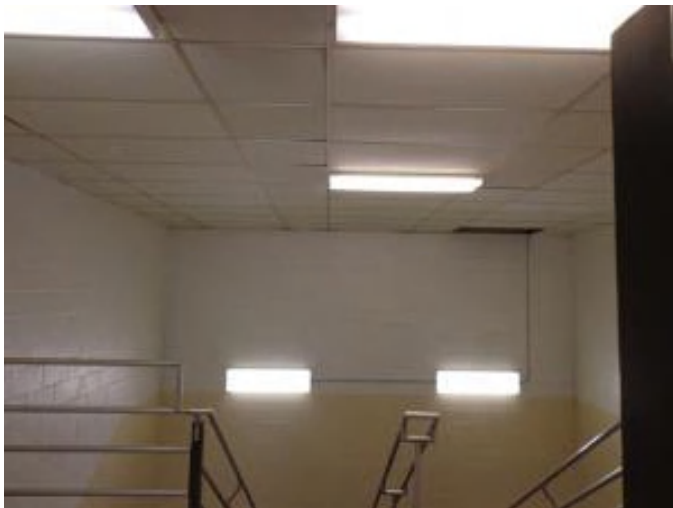
**System: D5030 - Communications and Security**

**Location:** Building wide  
**Distress:** Security Issue  
**Category:** 1 - Health & Safety  
**Priority:** 4 - Response Time (4-5 yrs)  
**Correction:** Add/Replace Video Surveillance System  
**Qty:** 1.00  
**Unit of Measure:** Ea.  
**Estimate:** \$53,537.66  
**Assessor Name:** Ed Davis  
**Date Created:** 12/17/2015

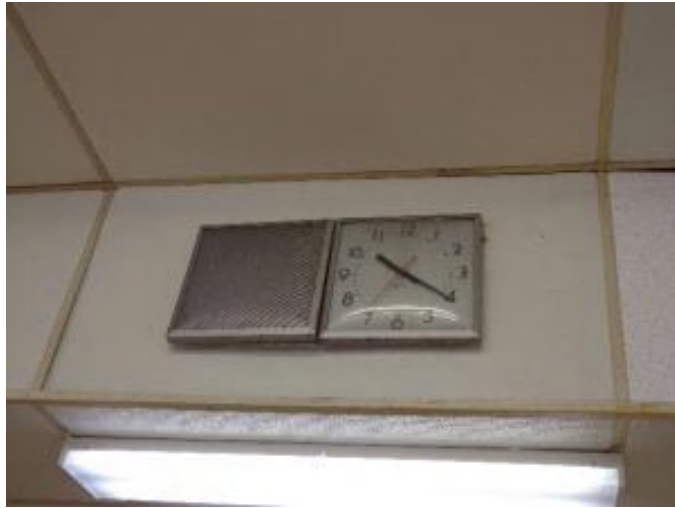
**System: D5030 - Communications and Security**

**Location:** Building wide

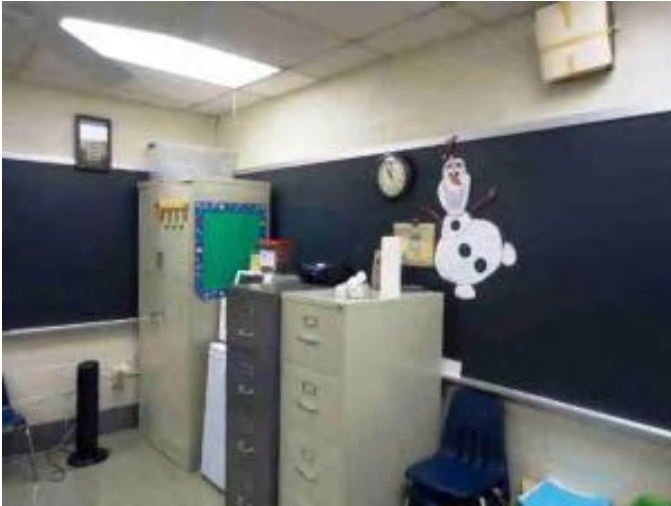
**System: C1030 - Fittings**

Some of the classroom chalk boards are original to the buildings construction. This system is damaged and beyond its expected life, universal upgrades are warranted. Remove and upgrade damaged chalk boards to new marker board systems.

**Location:** Classroom  
**Distress:** Damaged  
**Category:** 3 - Operations / Maint.  
**Priority:** 5 - Response Time (> 5 yrs)  
**Correction:** Replace blackboards with marker boards - pick the appropriate size and insert the quantities  
**Qty:** 20.00  
**Unit of Measure:** Ea.  
**Estimate:** \$13,764.64  
**Assessor Name:** Ed Davis  
**Date Created:** 12/29/2015

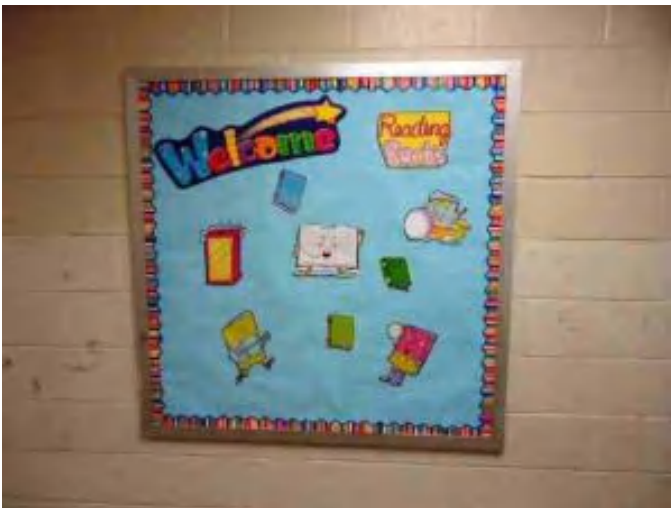
**System: C3010230 - Paint & Covering**

There are painted walls, trim, and some painted ceilings in this building. The interior finishes are in fair condition. Cyclical painting should be considered for a standard approach to maintaining the quality of the interior finishes. It is recommended that all previously painted surfaces be repainted according to established cycles for this occupancy and use type. Minor repairs should be completed before work begins. The abandoned section of the building is expected to require major repairs and additional efforts to restore the finishes. This effort is expected to be coordinated with other mechanical electrical efforts in order to prevent overlapping efforts.

**Location:** Building Wide  
**Distress:** Damaged  
**Category:** 3 - Operations / Maint.  
**Priority:** 5 - Response Time (> 5 yrs)  
**Correction:** Repair and repaint all interior walls - SF of wall surface  
**Qty:** 40,000.00  
**Unit of Measure:** S.F.  
**Estimate:** \$270,955.08  
**Assessor Name:** Ed Davis  
**Date Created:** 12/29/2015

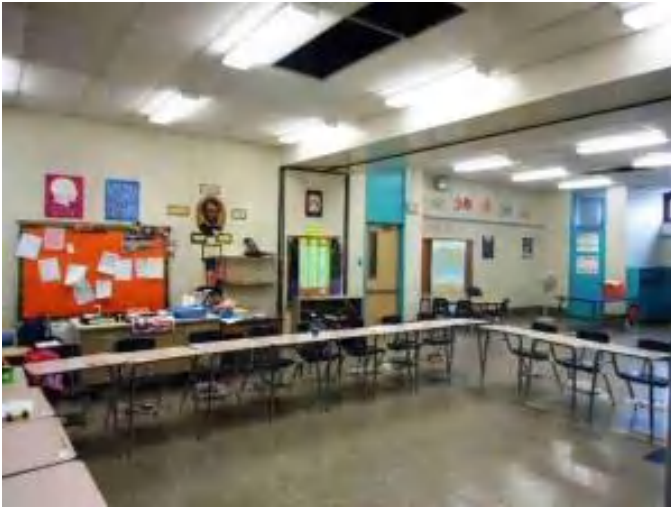
**System: C3030 - Ceiling Finishes**

**Location:** Building Wide  
**Distress:** Damaged  
**Category:** 3 - Operations / Maint.  
**Priority:** 5 - Response Time (> 5 yrs)  
**Correction:** Remove and replace suspended acoustic ceilings - lighting not included  
**Qty:** 80,000.00  
**Unit of Measure:** S.F.  
**Estimate:** \$1,206,594.42  
**Assessor Name:** Ed Davis  
**Date Created:** 12/29/2015

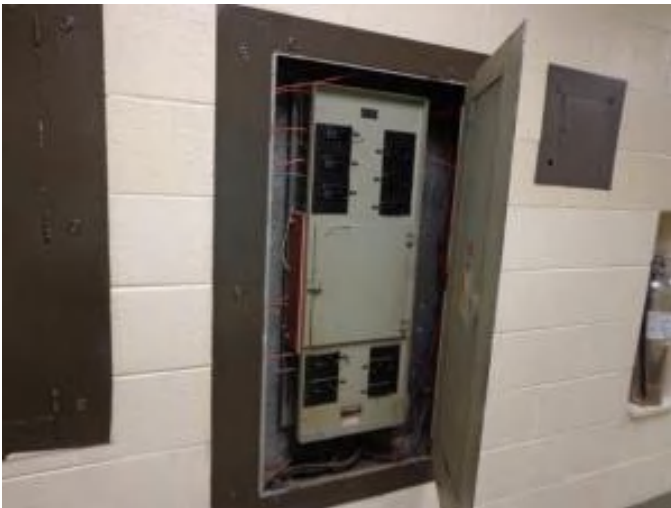
**System: D5020 - Lighting and Branch Wiring**

**Location:** Classroom Corridors  
**Distress:** Inadequate  
**Category:** 4 - Capital Improvement  
**Priority:** 5 - Response Time (> 5 yrs)  
**Correction:** Provide lighting control  
**Qty:** 4.00  
**Unit of Measure:** Ea.  
**Estimate:** \$11,004.35  
**Assessor Name:** Ed Davis  
**Date Created:** 12/17/2015

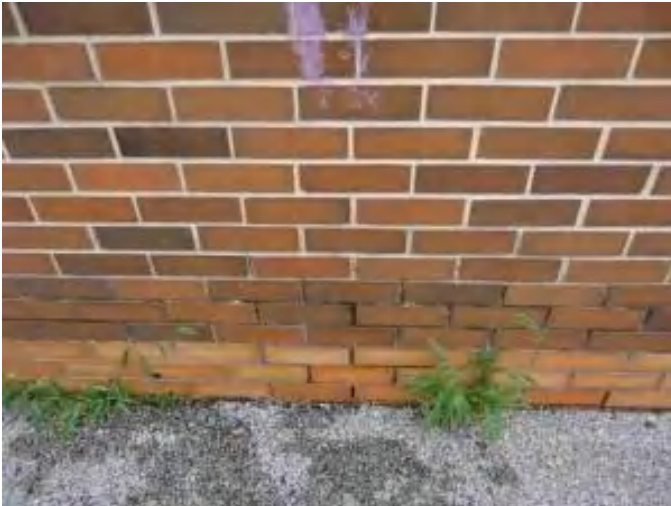
**Location:** Exterior Elevation

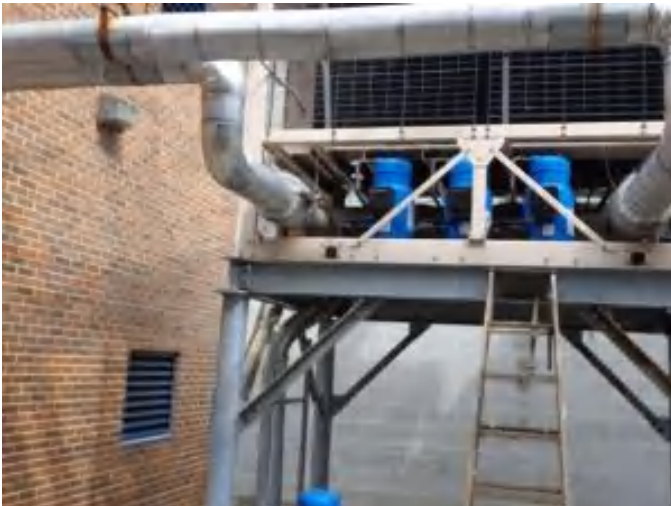
**Location:** Boiler and Chiller Rooms

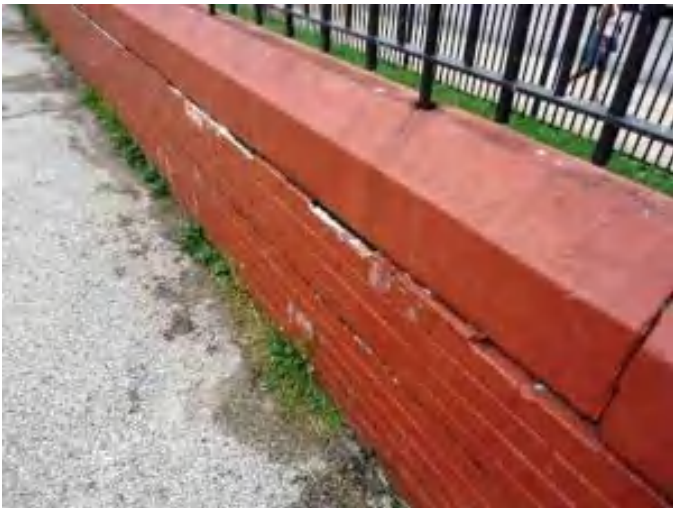
**Location:** Site

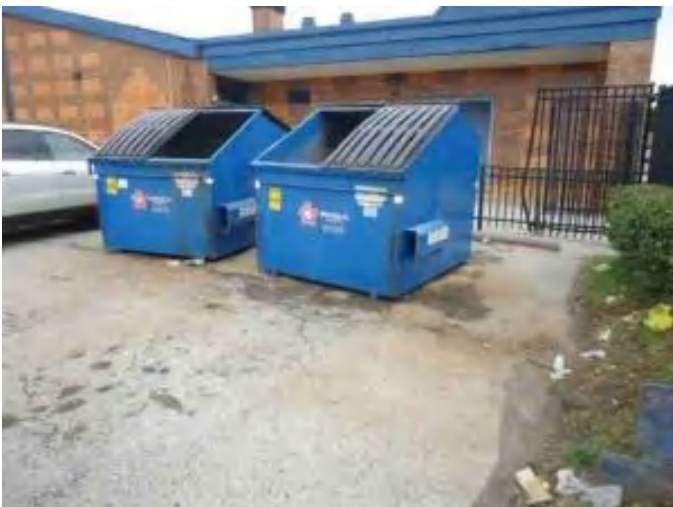
**Location:** Site

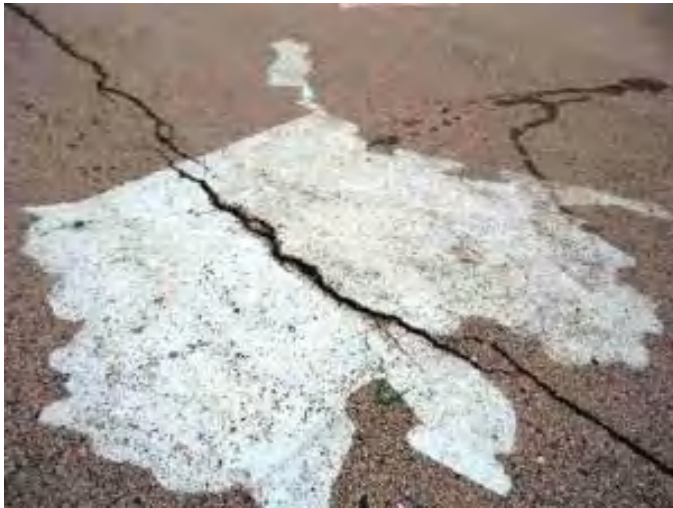
**Location:** Parking Log

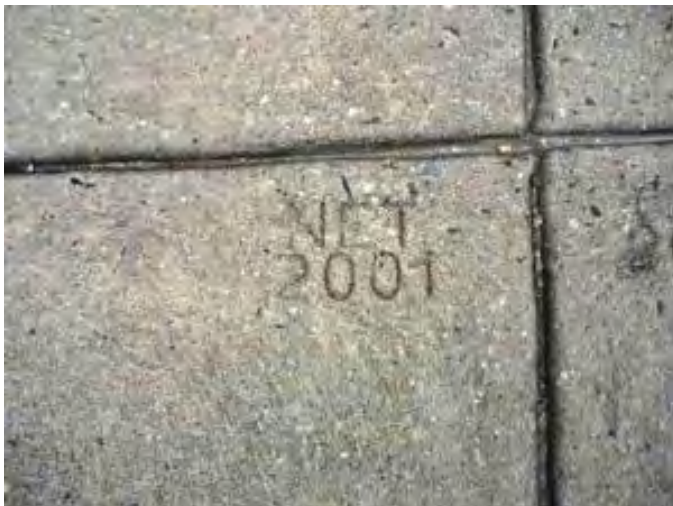
**Location:** Site

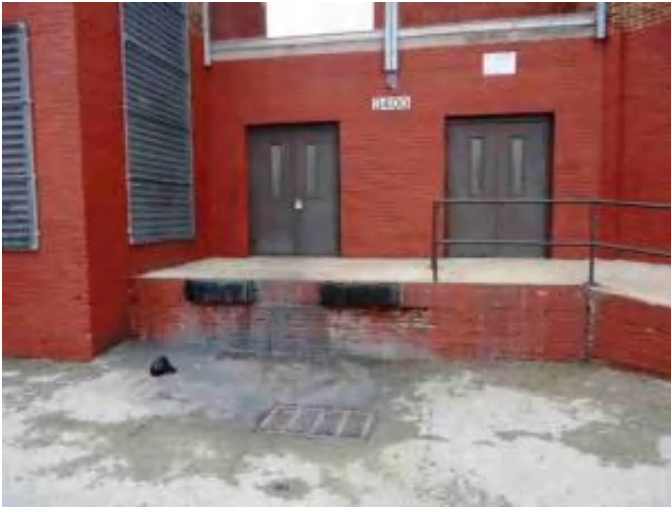
**Location:** Site  
**Distress:** Damaged  
**Category:** 3 - Operations / Maint.  
**Priority:** 3 - Response Time (3-4 yrs)  
**Correction:** Add safety barriers and guide lines at parking and loading dock areas  
**Qty:** 1.00  
**Unit of Measure:** Ea.  
**Estimate:** \$7,483.49  
**Assessor Name:** Hayden Collins  
**Date Created:** 12/29/2015

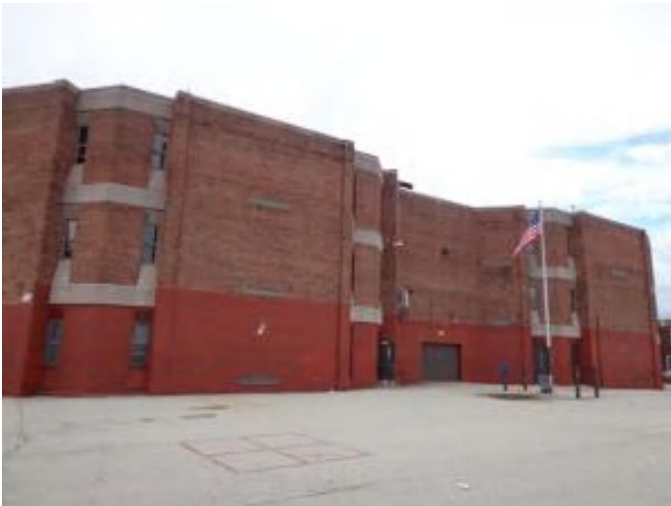
**Location:** Parking lot and play area  
**Distress:** Security Issue  
**Category:** 1 - Health & Safety  
**Priority:** 3 - Response Time (3-4 yrs)  
**Correction:** Add Video Surveillance System  
**Qty:** 2.00  
**Unit of Measure:** Ea.  
**Estimate:** \$17,776.92  
**Assessor Name:** Hayden Collins  
**Date Created:** 12/17/2015

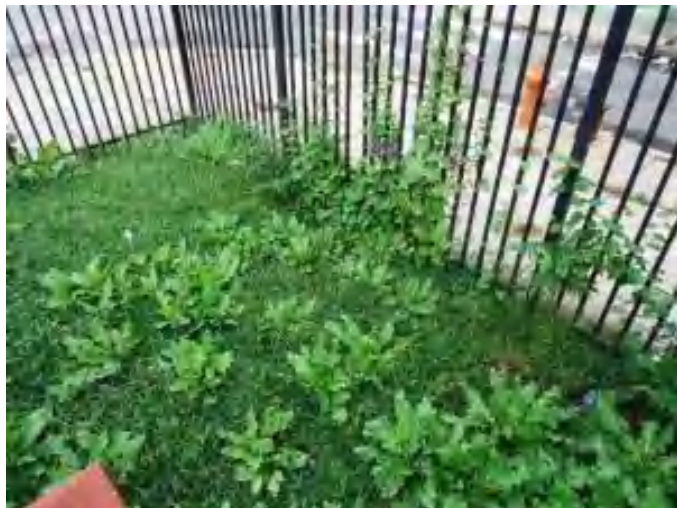
**Location:** Site
