Facility Condition Assessment Summary Report

West Philadelphia High School

S102002; West Philadelphia

Site Assessment Report

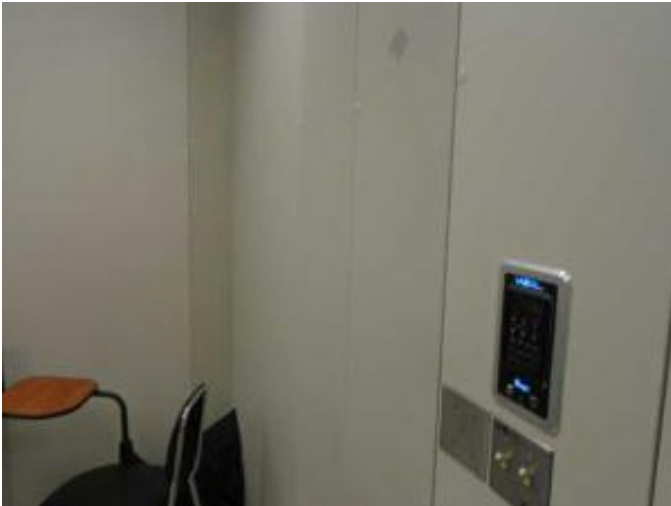
System: C1020 - Interior Doors

Location: Music room

Distress: Failing

- Replace door hardware on soundproof doors
- Repair exterior steps and railing on front entrance

Notes: Replace door hardware on soundproof doors

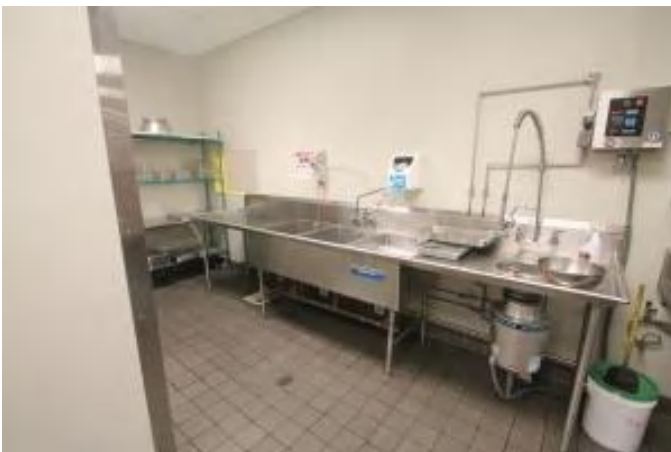
System: D2010 - Plumbing Fixtures

Location: Kitchen

Distress: Failing

Correction: Replace lavatory faucet

Notes: Repair or replace 2 kitchen disposals

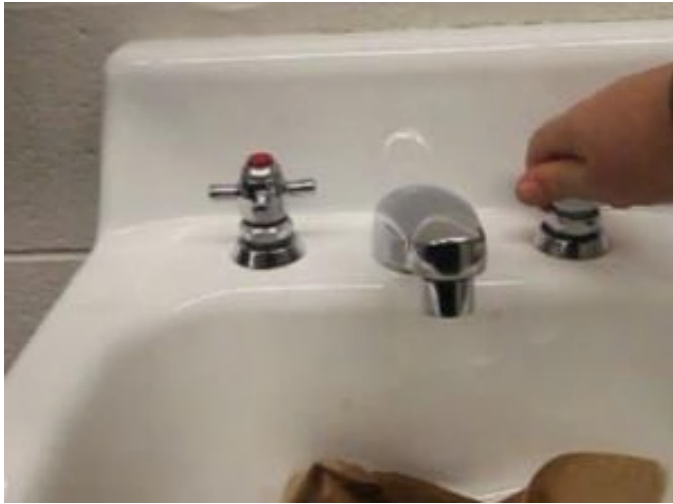
System: D2010 - Plumbing Fixtures

Location: Entire building

Distress: Failing

Correction: Replace lavatory faucet

Notes: Replace 20% of faucets due to leaks

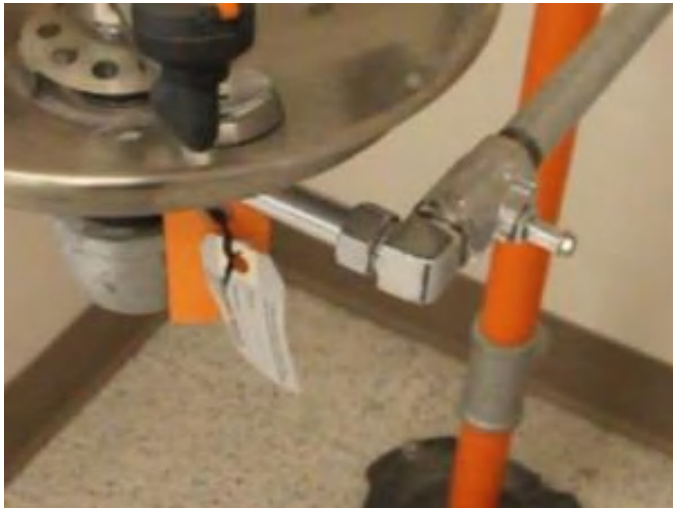
System: D2030 - Sanitary Waste

Location: Science rooms

Distress: Health Hazard / Risk

Notes: Install floor drains for safety showers and repair safety shower and eyewash supply valves

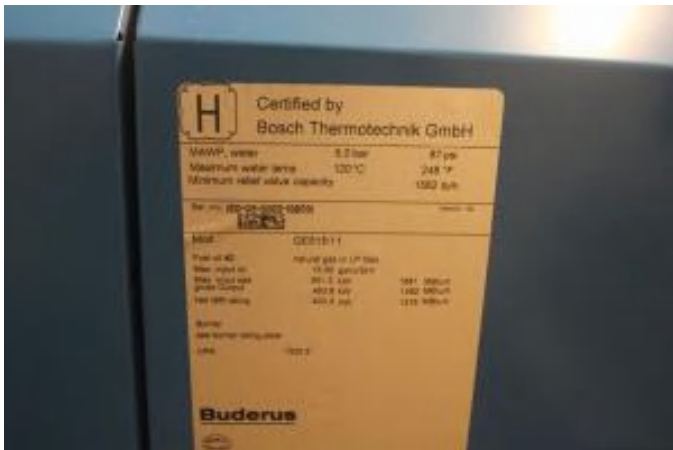
System: D3020 - Heat Generating Systems

Location: Boiler room

Distress: Inadequate

Correction: Replace boiler, cast iron sectional (50 HP)

Notes: Add additional boiler to meet building heat demand during cold weather

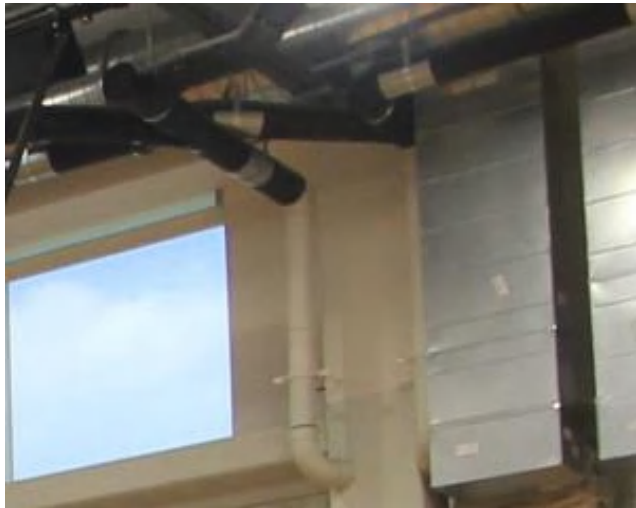
System: D3040 - Distribution Systems

Roof drain pipes are hubless cast iron with banded couplings. They run inside the building. Roof top strainers are plastic. There are no overflow drains. In the gym, they cause water damage because they are uninsulated and the cold rain water inside them causes condensate to form on the outside which drips on the floor near the walls. The portions of the rain water drain pipe in the middle of the gym are insulated. The uninsulated pipes near the walls should be insulated. Aside from this, the rain water drain pipes have 30 or more years of lifespan remaining. There are no groundwater sumps.

Location: Gym

Distress: Maintenance Required

Correction: Replace hydronic distribution piping insulation - 100 LF of piping

Notes: Insulate rain water drain pipes to prevent water damage from condensation

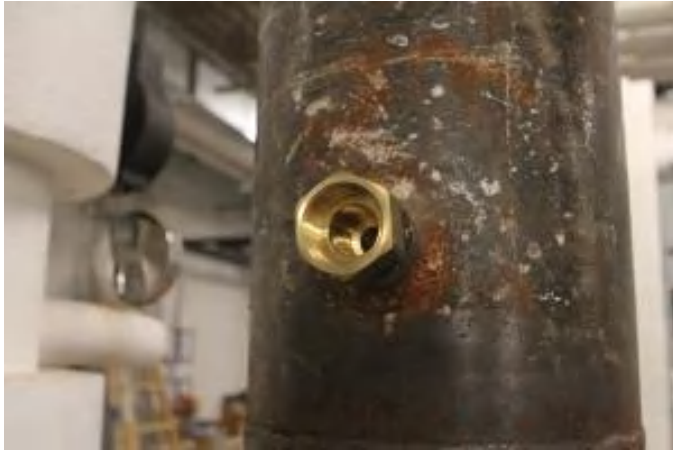
System: D3060 - Controls & Instrumentation

HVAC controls are digital and were working well during the inspection. They should provide reliable service for 20 years. There is an air compressor with dryer for the science classroom, but it is not in operation. There is a broken pressure gauge on the domestic booster system and a missing thermometer in the cooling water piping. These instruments should be replaced.

Location: Boiler room

Distress: Damaged

Correction: Replace temperature, pressure gauges (enter estimate)

Notes: Replace broken and missing gauges in boiler room

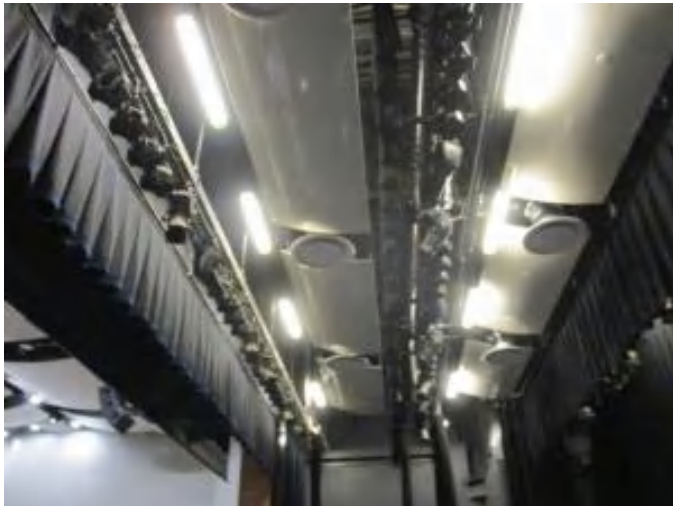
System: E1020 - Institutional Equipment

The auditorium is provided with STRAND LIGHTING dimmable theatrical lighting which is composed of spot lights, flood lights and downlights. Building Engineer indicated that the lamps do not last when the dimming system is used. Obtain the service of STRAND LIGHTING to determine the cause of the early failure of the lamps.

Location: Auditorium

Distress: Failing

- Obtain the service of STRAND LIGHTING to determine the cause of the early failure of the theatrical lighting lamps.

Correction: Add/Replace Stage Theatrical Lighting System

Notes: Obtain the service of STRAND LIGHTING to determine the cause of the early failure of the theatrical lighting lamps.

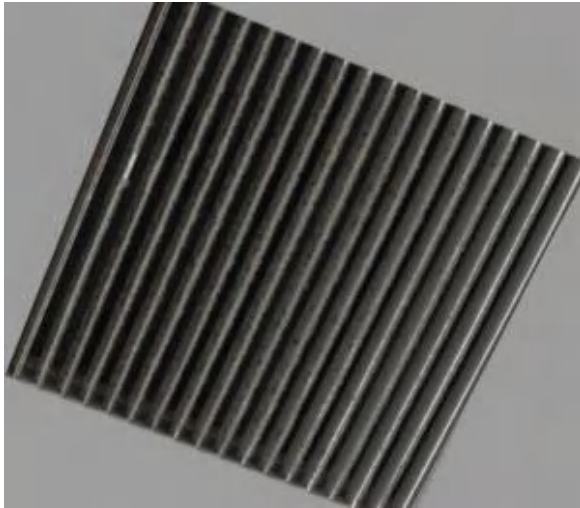
System: D3040 - Distribution Systems

Location: Entire building

Distress: Health Hazard / Risk

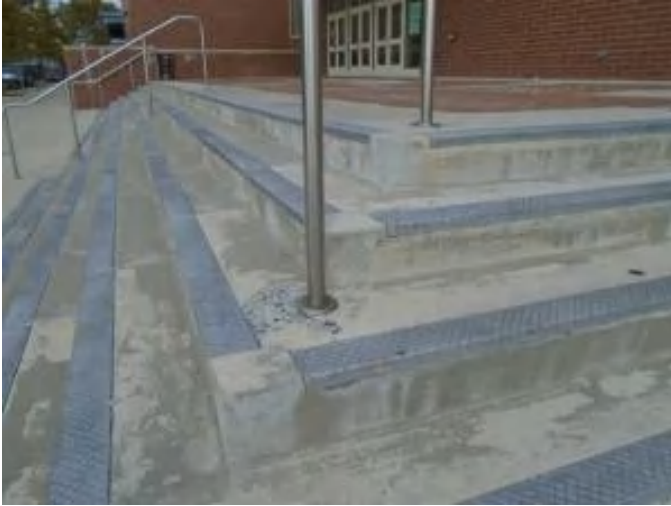
System: G2030 - Pedestrian Paving

The site surrounds the building on all four sides and is set back from the street. Front entry along Chestnut St. has concrete stairs and stoop in fair condition with spalling and failing rails needing repair. Parking on southwest side is asphalt paving in very good condition and accessible via Chestnut and 50th St. Entry courtyard on west side is concrete and brick paving in very good condition. Metal fencing and gates are in good condition and provide good site security. Landscaping is new and mature trees along streets, parking and in courtyard and grass on west side in good condition.

Location: Front Entrance

Distress: Damaged
