## Facility Condition Assessment Summary Report

### Widener School

Final

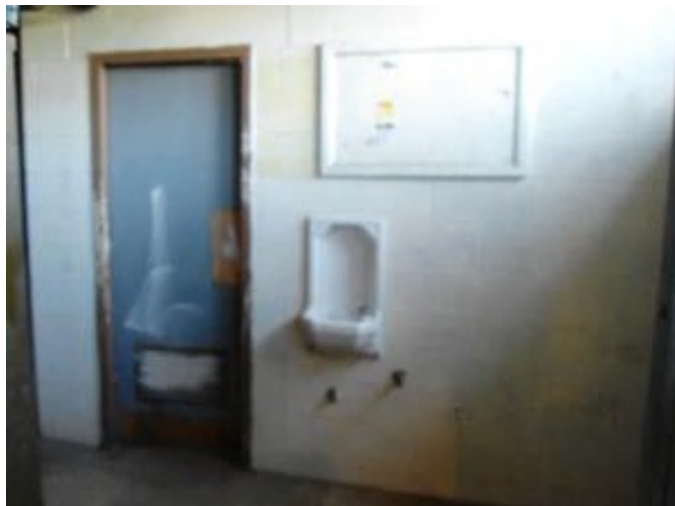
**System: C1020 - Interior Doors**

**Location:** Locker Room

**Distress:** Damaged

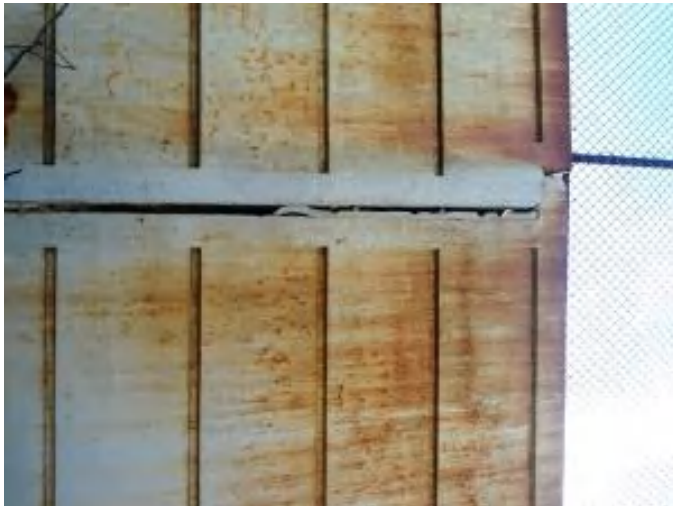
**System: B2010 - Exterior Walls**

**Location:** Exterior Elevation Basement

**Distress:** Damaged

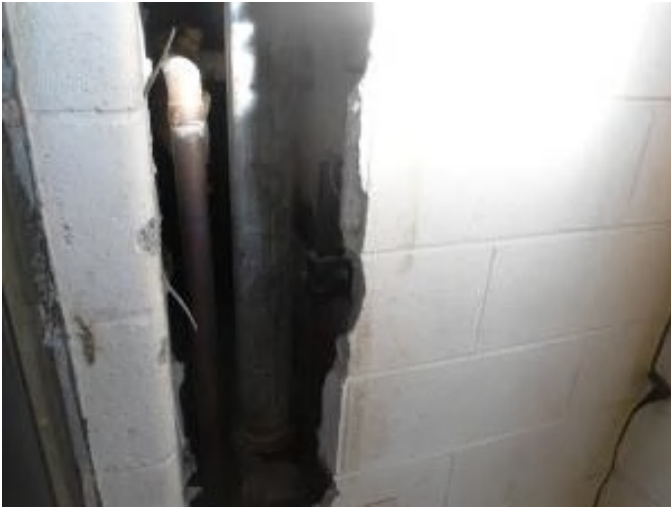
### **System: C3010230 - Paint & Covering**

**Location:** Building Wide

**Distress:** Damaged

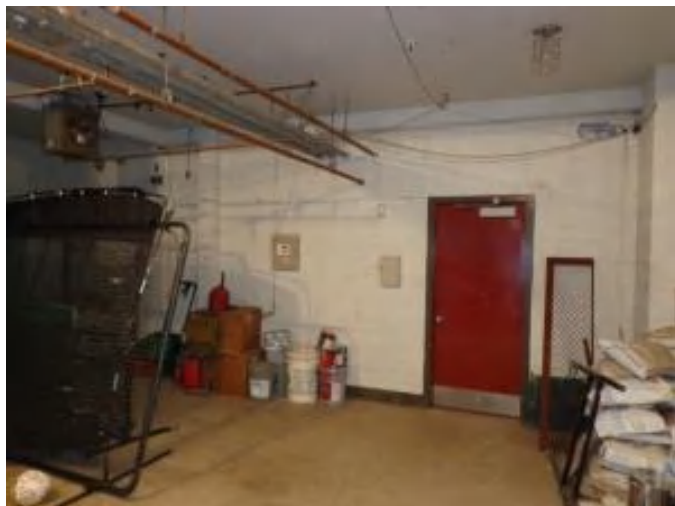
**System: D5090 - Other Electrical Systems**

**Location:** Entire Building

**Distress:** Health Hazard / Risk

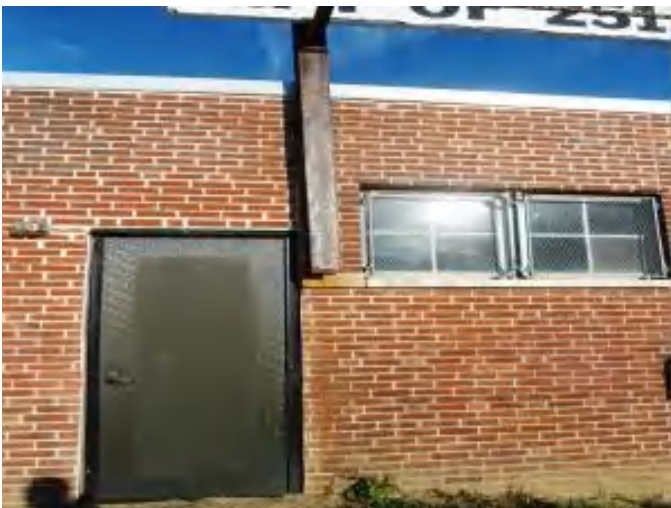
**System: B2030 - Exterior Doors**

**Location:** Exterior Elevation

**Distress:** Damaged

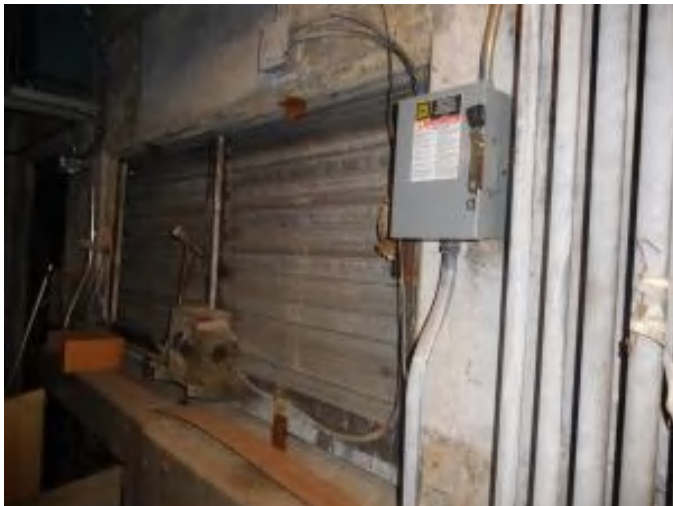
**System: D3060 - Controls & Instrumentation**

**Location:** entire building

**Distress:** Inadequate

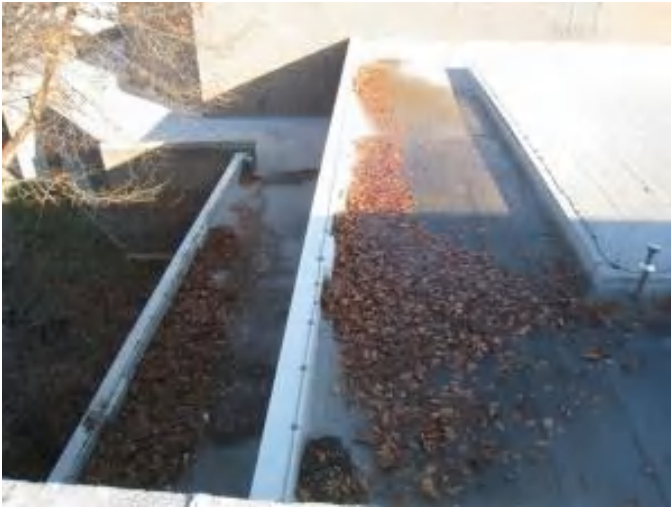
**System: B3010105 - Built-Up**

**Location:** Girls HS - roof

**Distress:** Inadequate

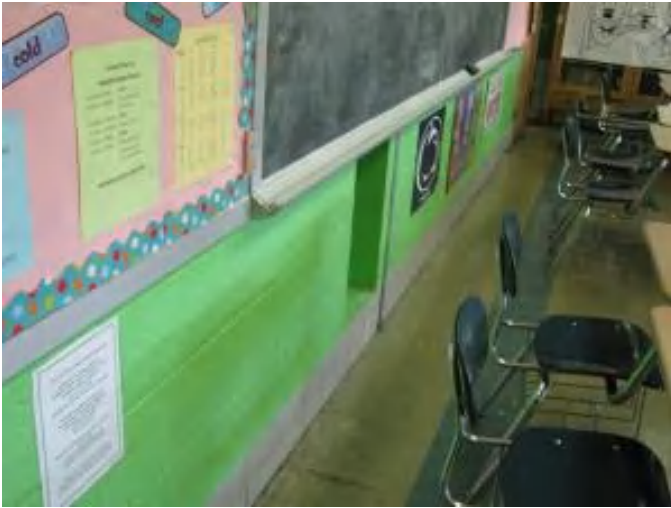
**System: D5020 - Lighting and Branch Wiring**

**Location:** Girls HS- Entire Building

**Distress:** Inadequate

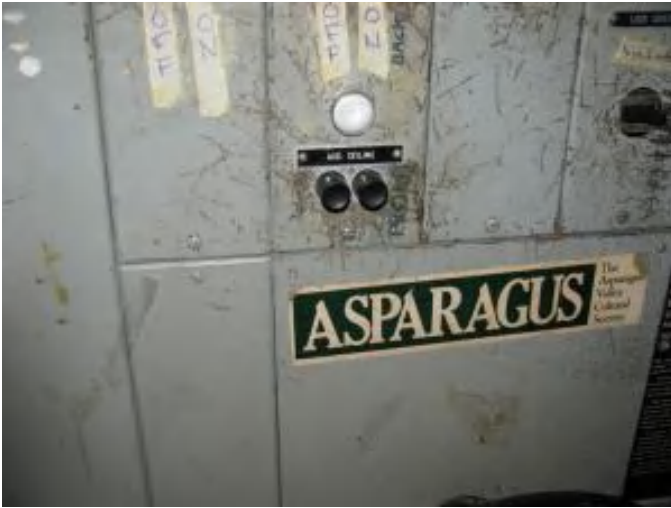
**System: D5030 - Communications and Security**

**Location:** Girls HS- Auditorium

**Distress:** Inadequate

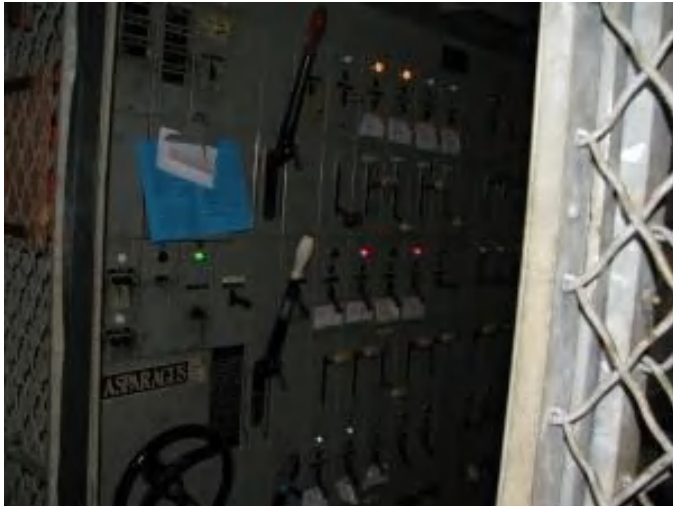
**System: E1020 - Institutional Equipment**

**Location:** Girls HS- Auditorium

**Distress:** Inadequate

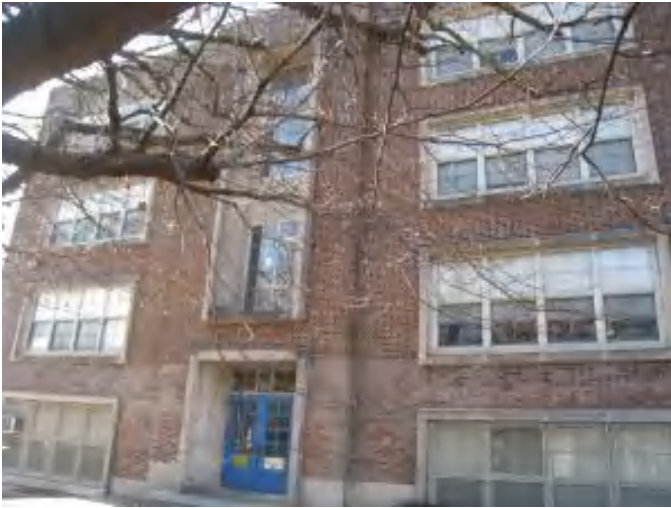
**System: B2030 - Exterior Doors**

**Location:** Girls HS - exterior doors

**Distress:** Failing

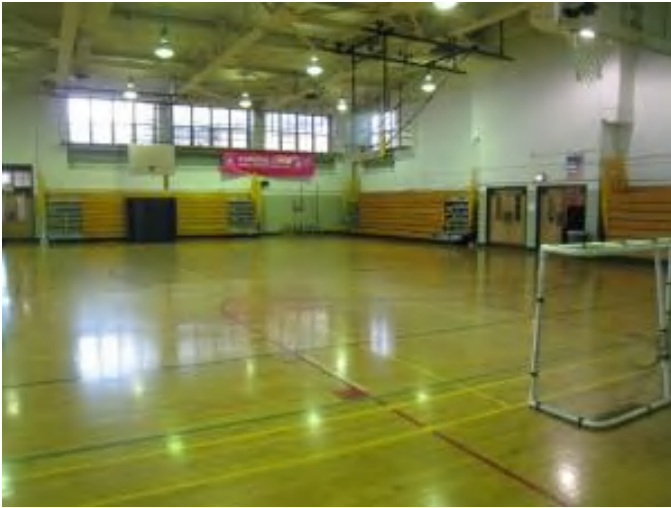
**System: C1010 - Partitions**

**Location:** Girls HS - gymnasium

**Distress:** Damaged

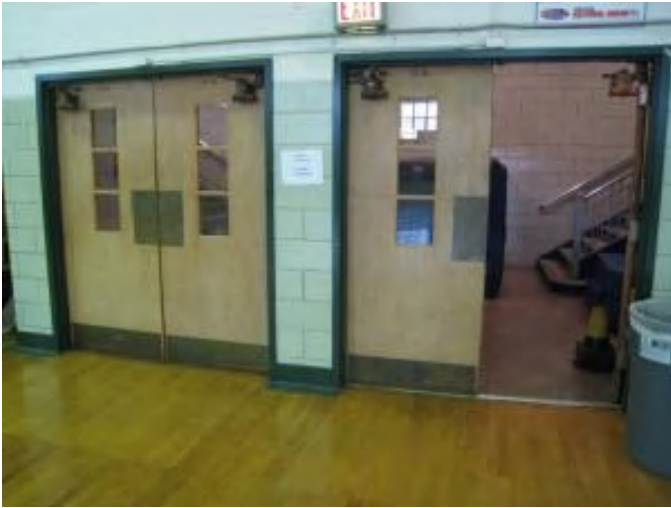
**System: C1020 - Interior Doors**

**Location:** Girls HS - interior doors

**Distress:** Damaged

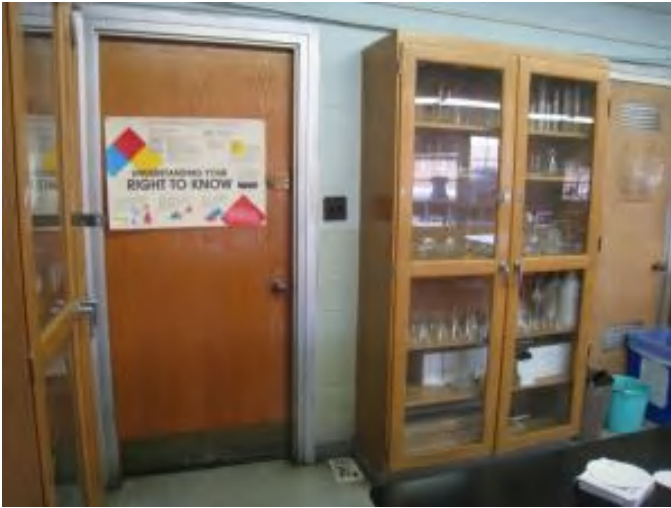
**System: C1020 - Interior Doors**

**Location:** Girls HS - interior doors

**Distress:** Failing

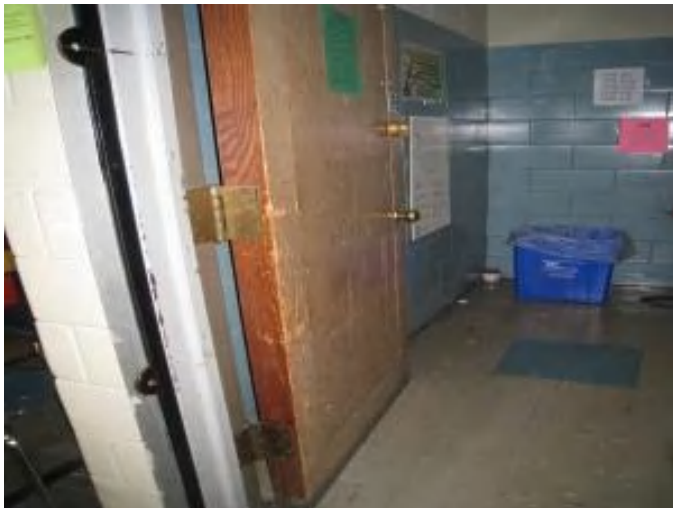
**System: C1020 - Interior Doors**

**Location:** Girls HS - music room doors

**Distress:** Damaged

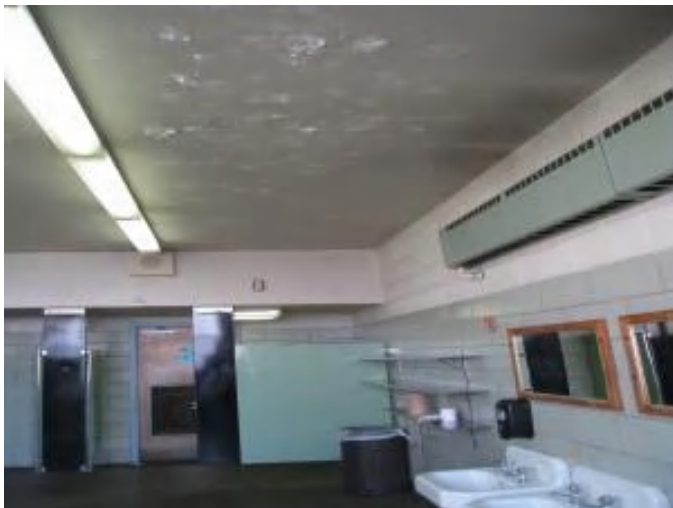
**System: C1030 - Fittings**

**Location:** Girls HS - toilet rooms

**Distress:** Inadequate

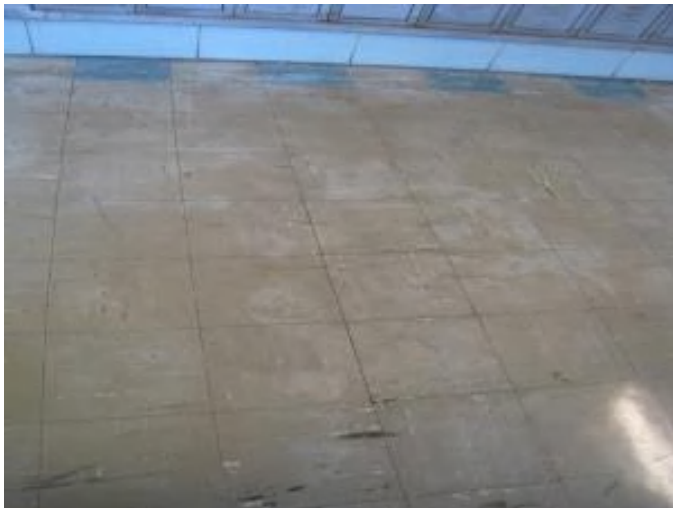
**System: C3010230 - Paint & Covering**

**Location:** Girls HS - corridors

**Distress:** Damaged

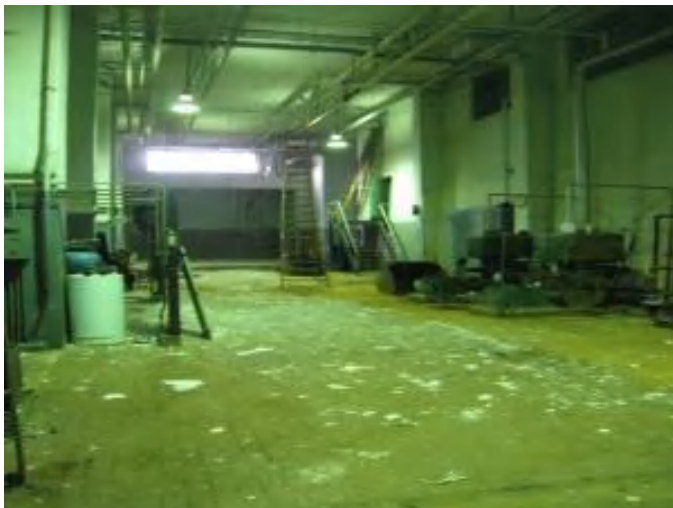
**System: C3010230 - Paint & Covering**

**Location:** Girls HS - boiler room

**Distress:** Damaged

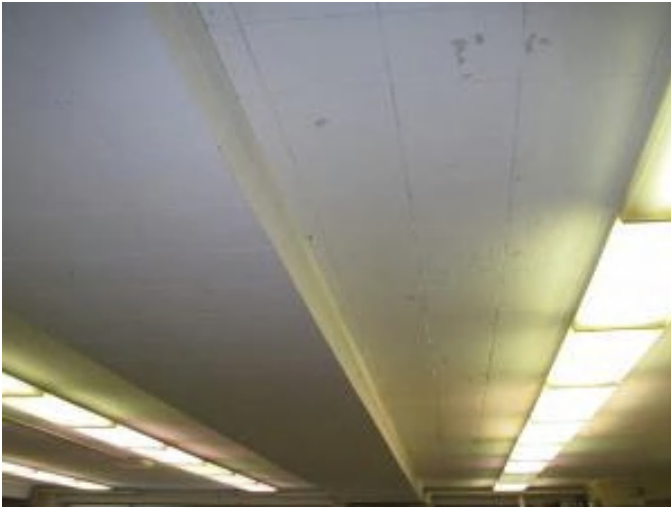
**System: C3030 - Ceiling Finishes**

**Location:** Girls HS - ceilings

**Distress:** Damaged

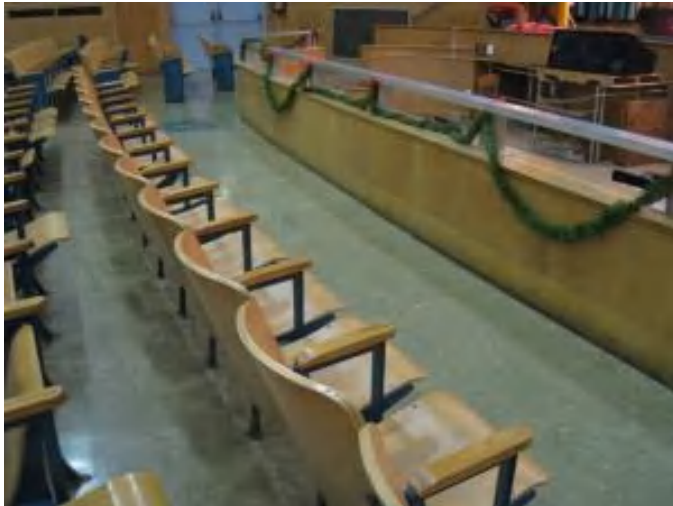
**System: E2010 - Fixed Furnishings**

**Location:** Girls HS - auditorium

**Distress:** Damaged

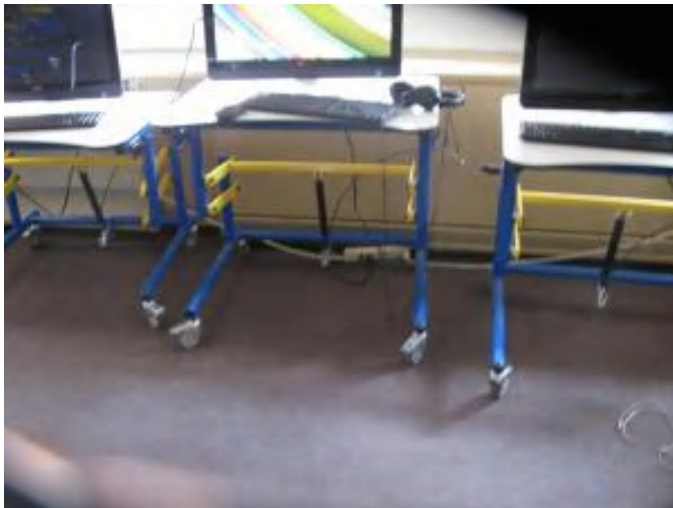
**System: D5020 - Lighting and Branch Wiring**

**Location:** Windener-Class Rooms

**Distress:** Inadequate

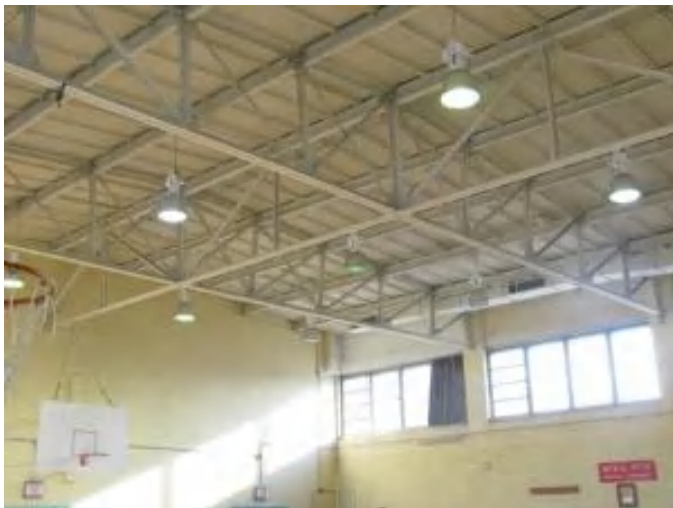
**System: D5020 - Lighting and Branch Wiring**

**Location:** Gymnasium

**Distress:** Inadequate

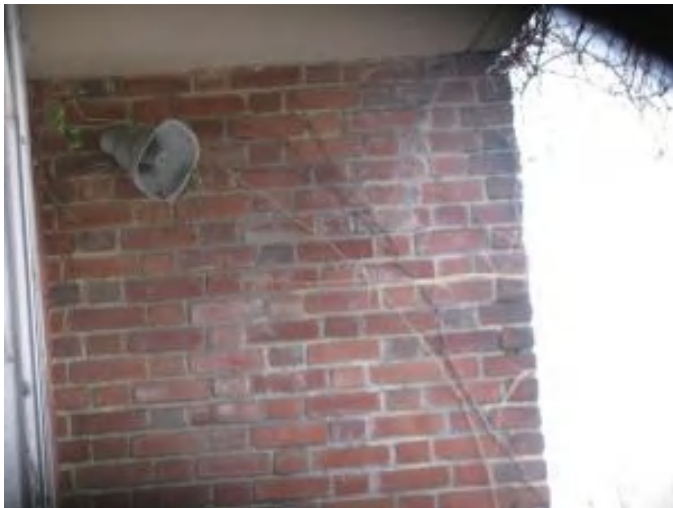
**System: D5030 - Communications and Security**

**Location:** Windener-Exterior Building

**Distress:** Inadequate

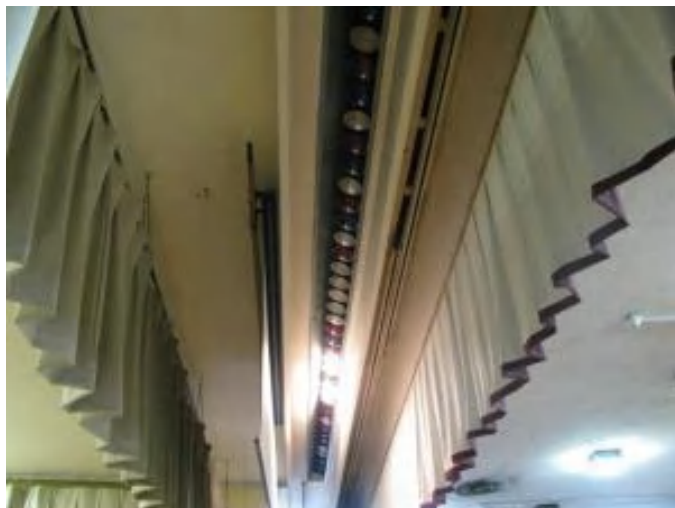
**System: E1020 - Institutional Equipment**

**Location:** Windener-Auditorium

**Distress:** Inadequate

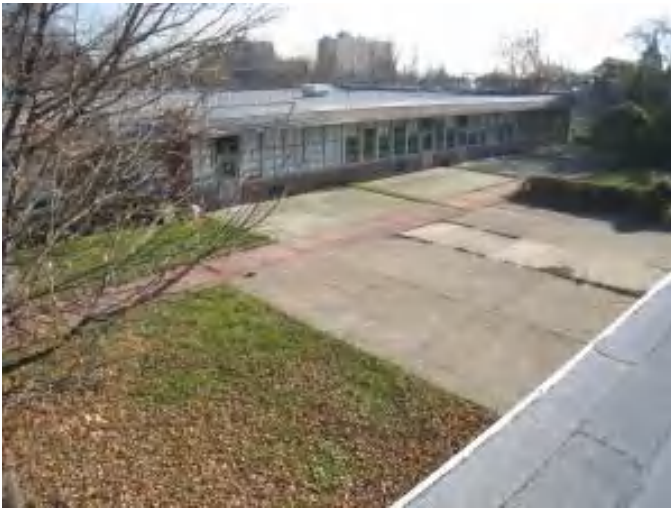
**System: B1020 - Roof Construction**

**Location:** Widener - roof overhangs

**Distress:** Damaged

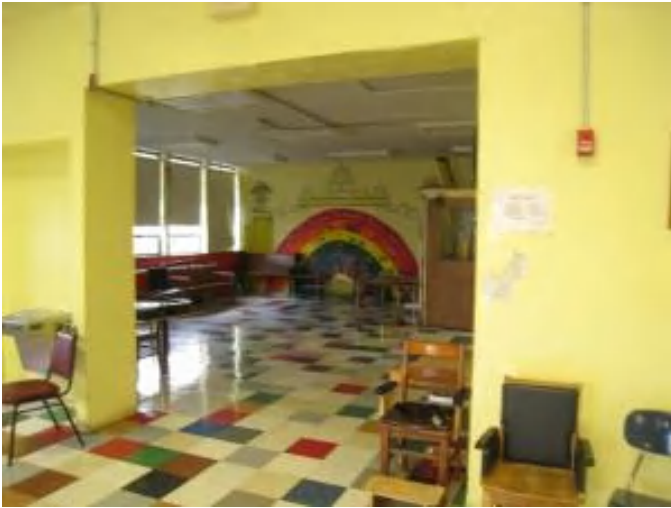
**System: B2010 - Exterior Walls**

**Location:** Widener - interior block

**Distress:** Damaged

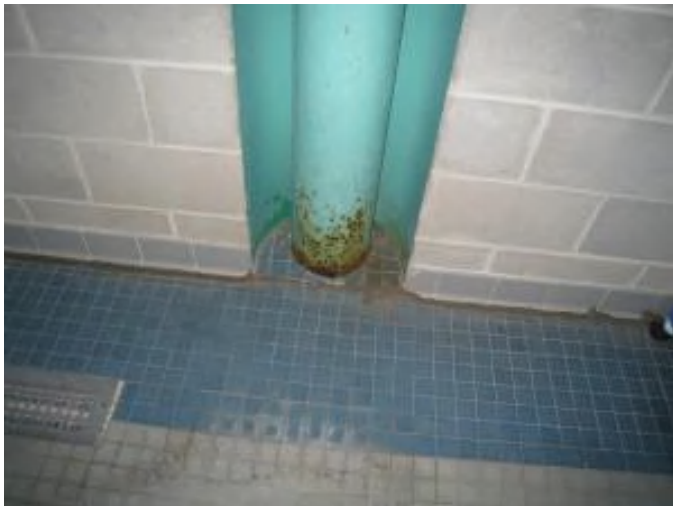
**System: B2010 - Exterior Walls**

**Location:** Widener - steel columns

**Distress:** Damaged

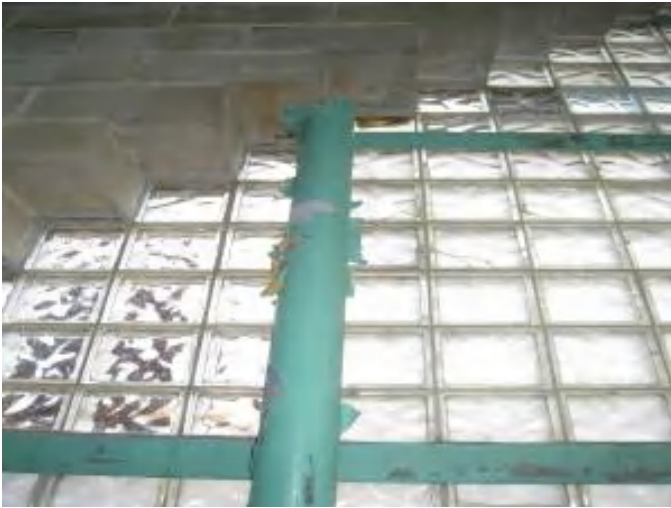
**System: B2010 - Exterior Walls**

**Location:** Widener - pool house lintels

**Distress:** Failing

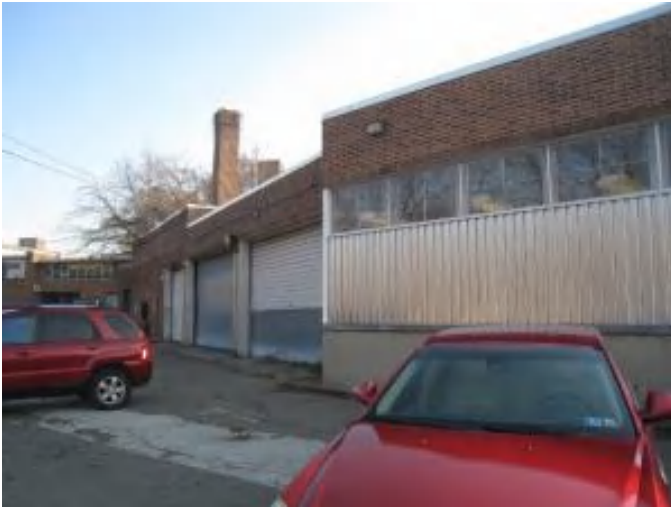
**System: B2020 - Exterior Windows**

**Location:** Widener - vehicle maint facility

**Distress:** Damaged

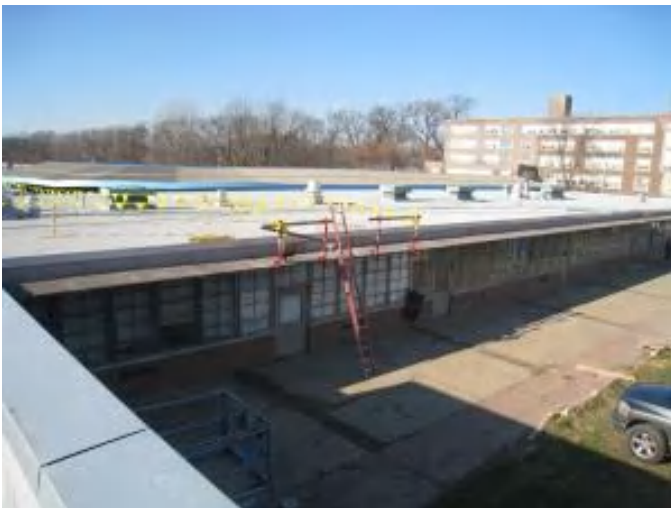
**System: B2030 - Exterior Doors**

**Location:** Widener - exterior doors

**Distress:** Damaged

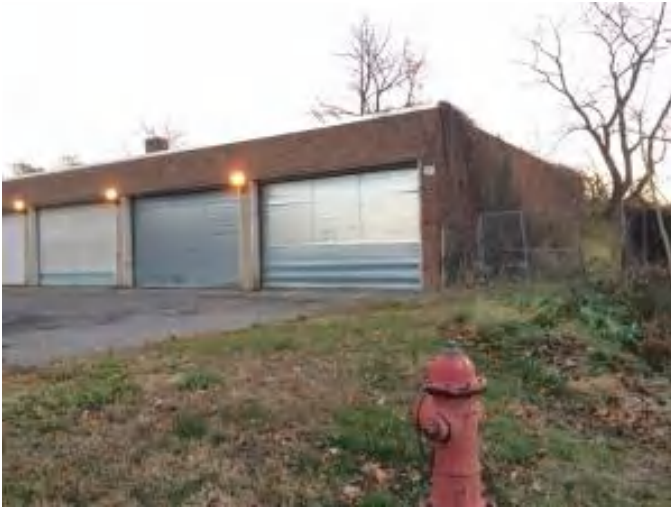
**System: B2030 - Exterior Doors**

**Location:** Widener - vehicle main facility

**Distress:** Failing

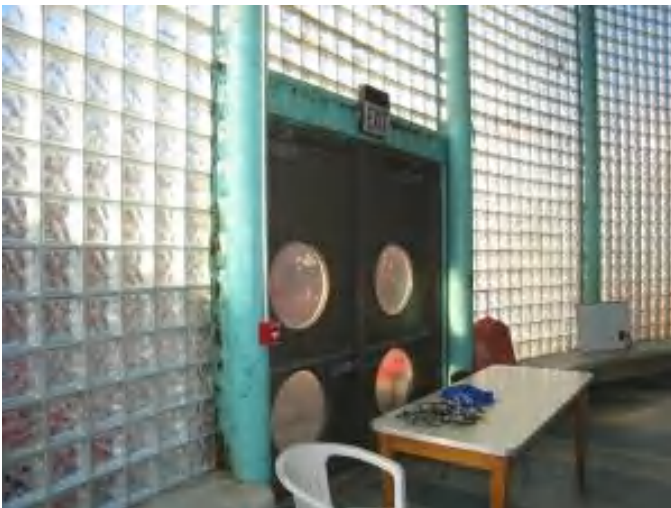
**System: B2030 - Exterior Doors**

**Location:** Widener - pool house doors

**Distress:** Damaged

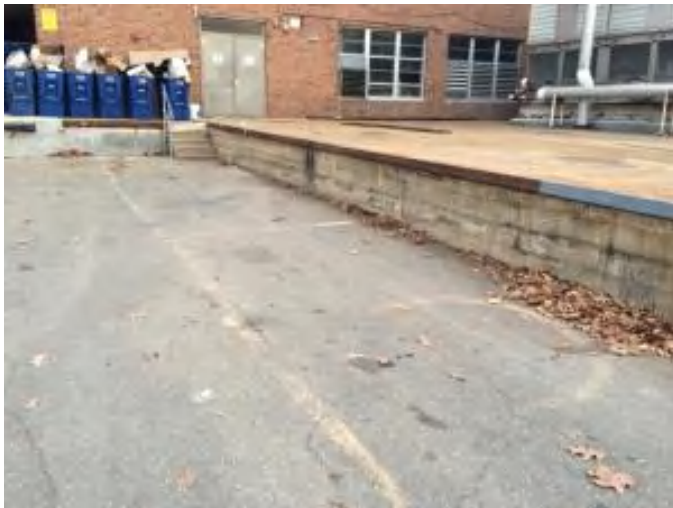
**System: B2030 - Exterior Doors**

**Location:** Widener - vehicle maint facility

**Distress:** Failing

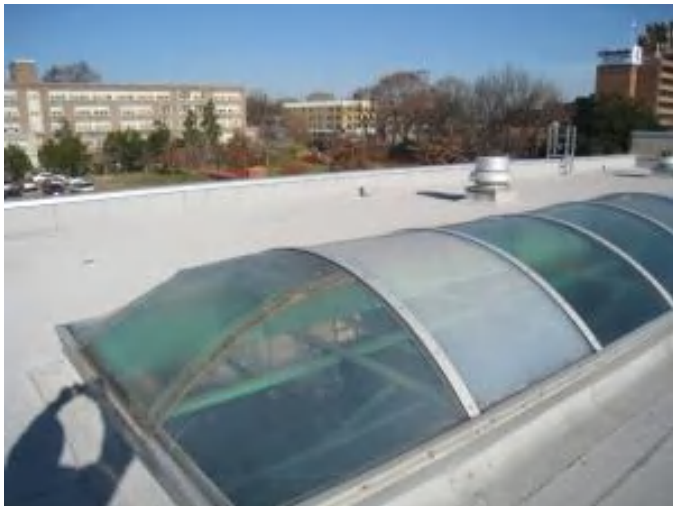
**System: B3020 - Roof Openings**

**Location:** Widener - pool house roof

**Distress:** Damaged

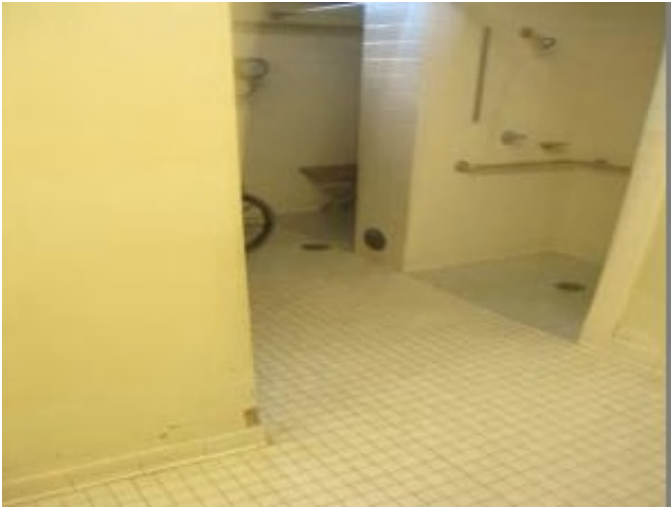
**System: C1030 - Fittings**

**Location:** Widener - interior walls

**Distress:** Inadequate

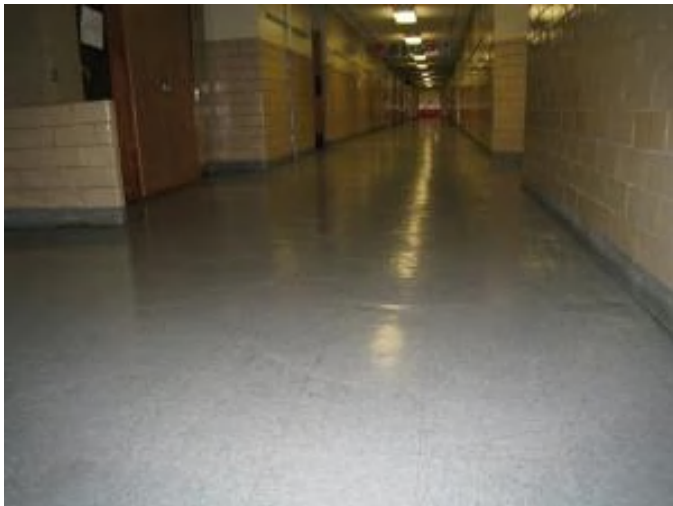
**System: C3020413 - Vinyl Flooring**

**Location:** Widener - floors

**Distress:** Failing

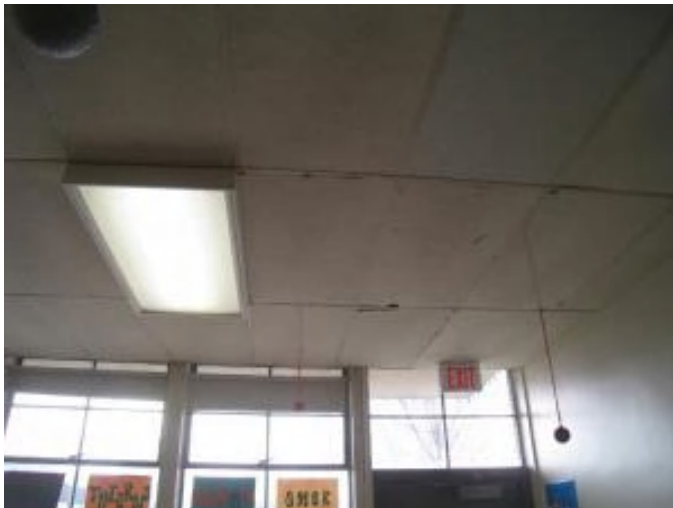
**System: C3030 - Ceiling Finishes**

**Location:** Widener - ceilings

**Distress:** Failing

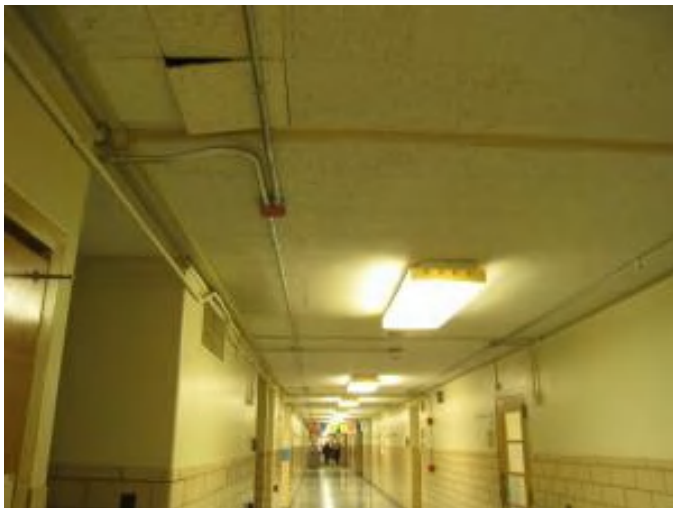
**System: C3030 - Ceiling Finishes**

**Location:** Widener - ceilings

**Distress:** Damaged

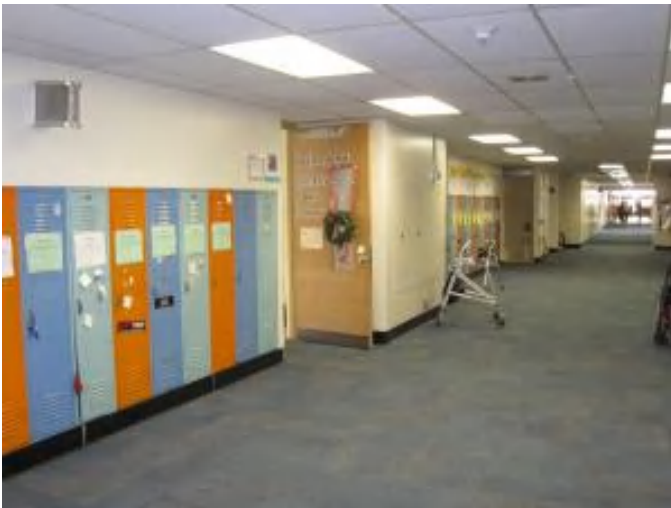
**System: D3040 - Distribution Systems**

**Location:** Corridors

**Distress:** Health Hazard / Risk

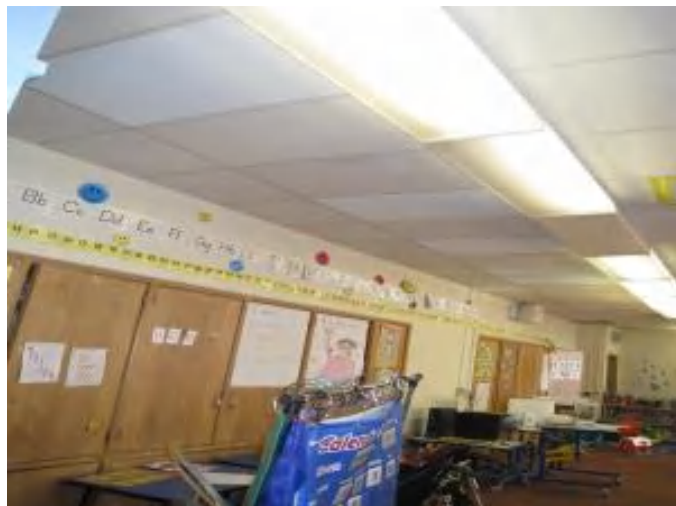
**System: E1020 - Institutional Equipment**

**Location:** Widener - kindergartens

**Distress:** Damaged

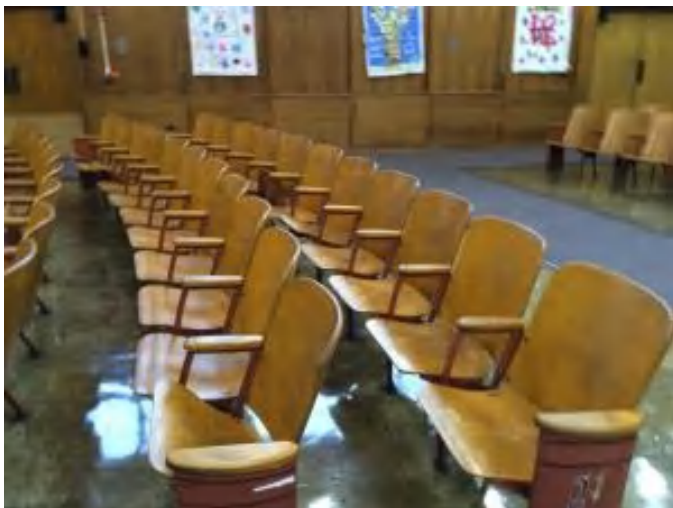
**System: E2010 - Fixed Furnishings**

**Location:** Widener - auditorium

**Distress:** Damaged

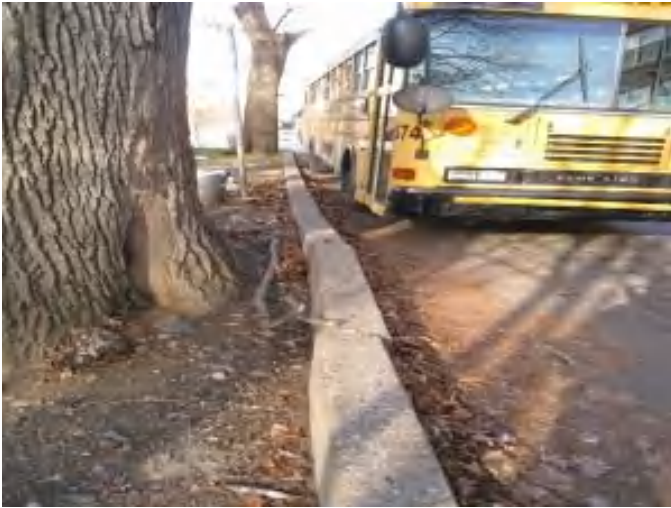
#### System: G2020 - Parking Lots

**Location:** Girls HS - curb along W. Olney drop-off

**Distress:** Damaged

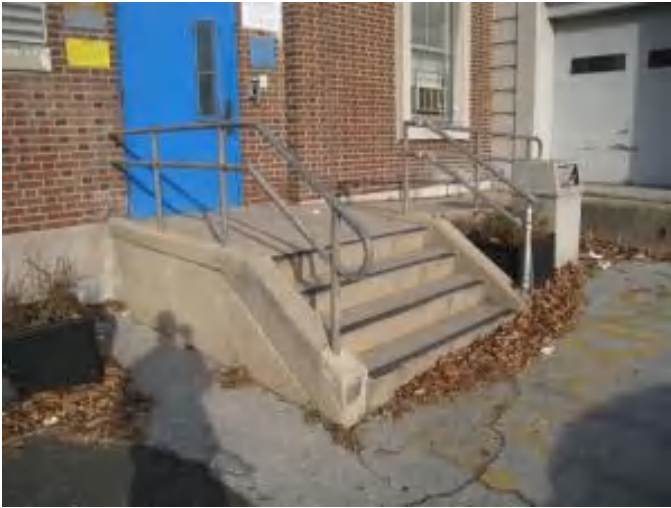
**System: G2030 - Pedestrian Paving**

**Location:** Girls HS - exterior concrete stairs

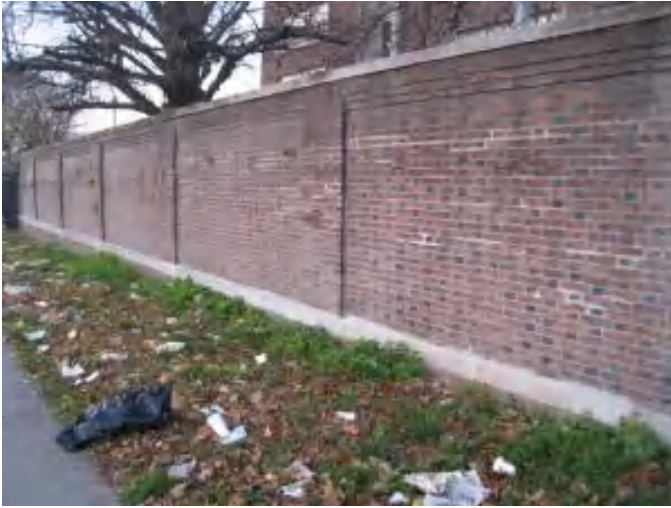
**System: G2040 - Site Development**

**Location:** Girls HS - retaining wall along W. Olney Ave. and Broad St.

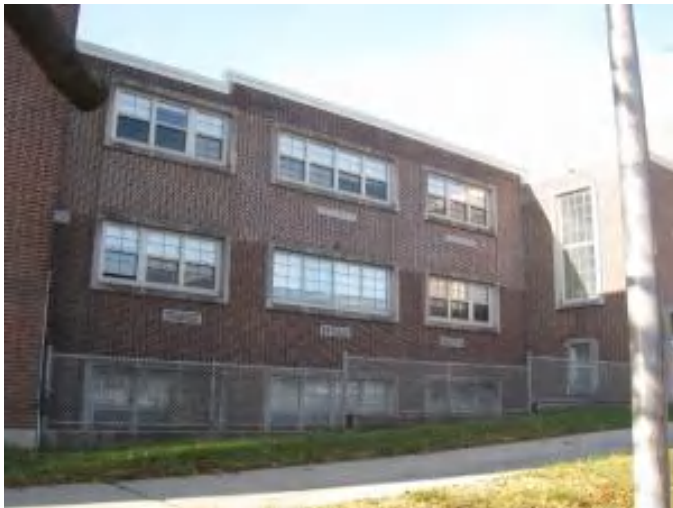
### **System: G2040 - Site Development**

**Location:** Girls HS - fencing

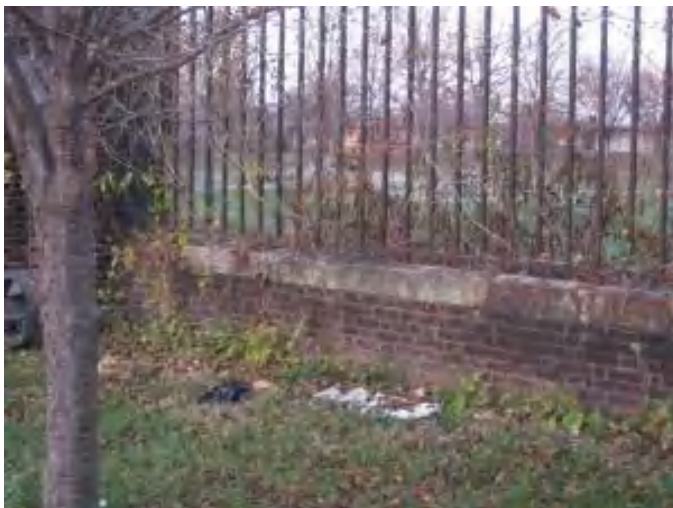
### **System: G2040 - Site Development**

**Location:** Widener - site fence and wall

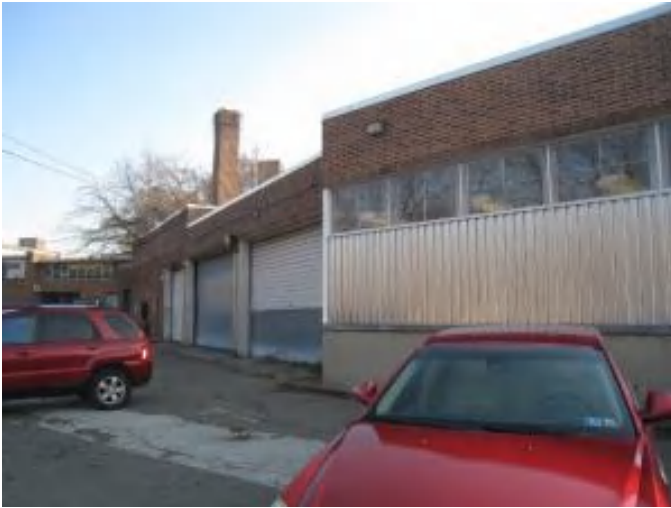
**System: G2020 - Parking Lots**

**Location:** Widener - parking lots

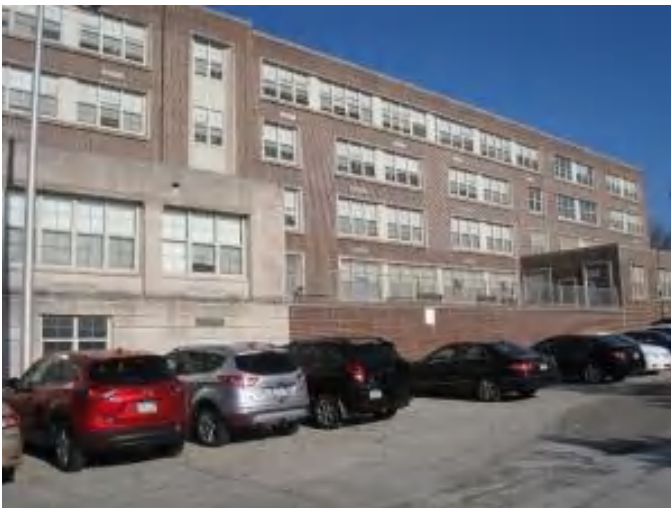
**System: G2020 - Parking Lots**

**Location:** Girls HS - parking lots
