### Willard School

### Willard Annex School

School District of Philadelphia  
**S544001;Willard**  
Final  
**Site Assessment Report**

January 31, 2017

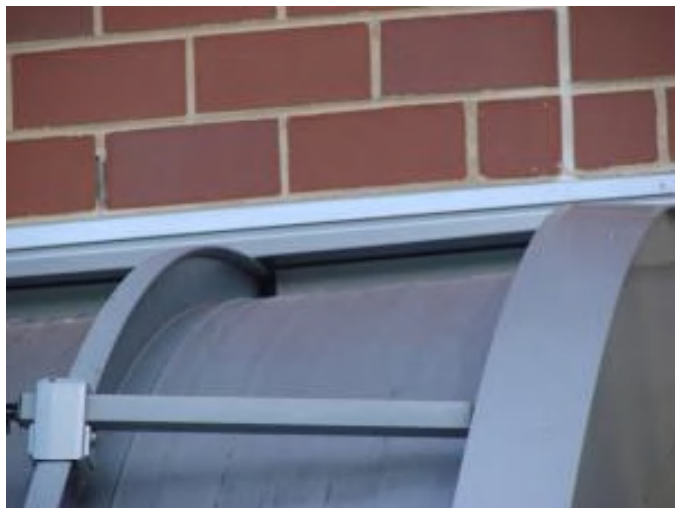
#### **System: B3010130 - Preformed Metal Roofing**

Roofing typically consists of 2 types: mult-up over rigid insulation, and prefinished metal, standing seam roofing over curved roofs. All roofing is generally in very good condition except a small leak developing along the metal roof lashing above 3 kindergarten classrooms on the first floor.

**Location:** Exterior

**Distress:** Failing

- Repair flashing on standing seam metal roof above kindergarten classrooms
- Stripe 2 accessible parking spaces and aisle on staff parking; install signage
- Re-sod grass section on the north side of the building
- Install an upgraded Clock System with enough capacity to provide clocks for the entire building

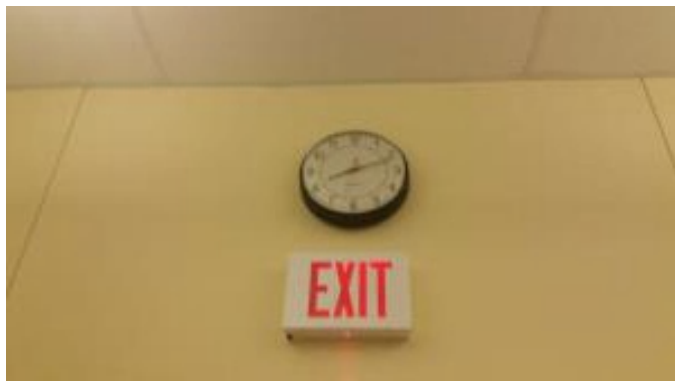
**System: D5030 - Communications and Security**

**Location:** throughout the building

**Distress:** Inadequate

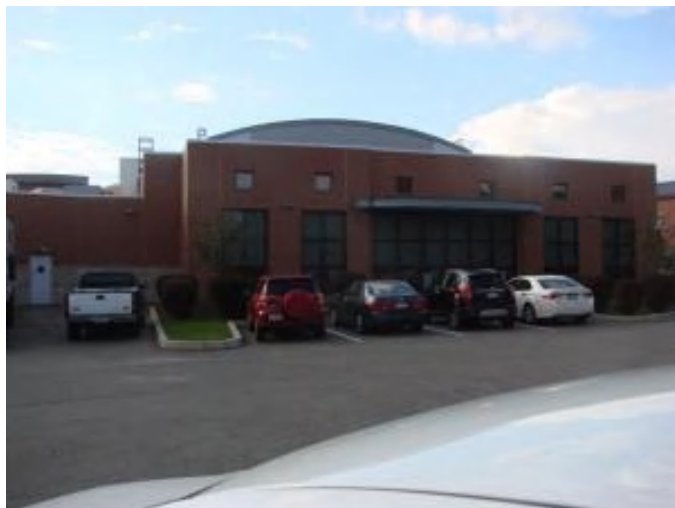
#### System: G2020 - Parking Lots

There are two parking lots at the site, in good condition. Public parking for 48 vehicles has 3 accessible spaces; staff parking for 35 vehicles has no spaces designated as accessible. Compliant accessible signage is in good condition. Per ADA requirements 2 spaces are needed at staff parking.

**Location:** Grounds

**Distress:** Accessibility

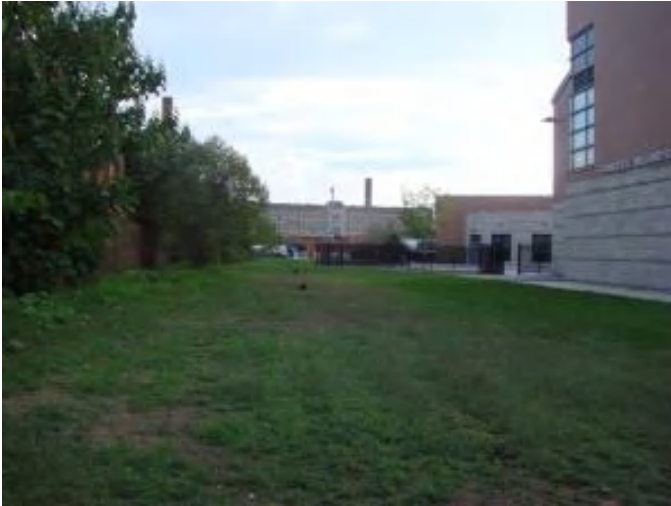
**System: G2050 - Landscaping & Irrigation**

**Location:** Grounds

**Distress:** Damaged

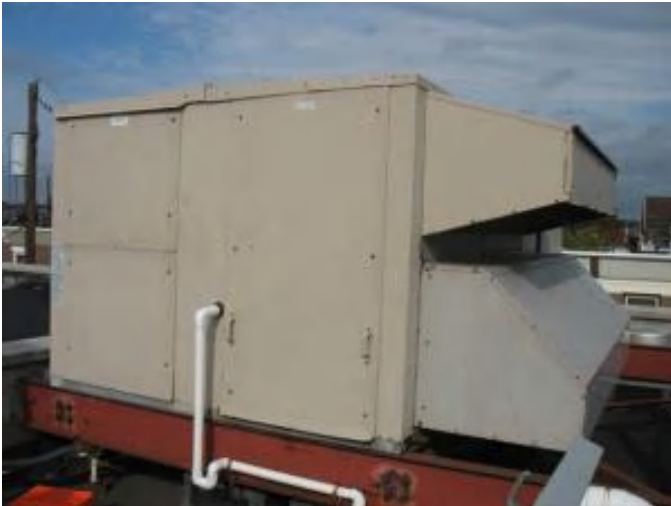
#### System: D3040 - Distribution Systems

**Location:** Roof

**Distress:** Beyond Service Life

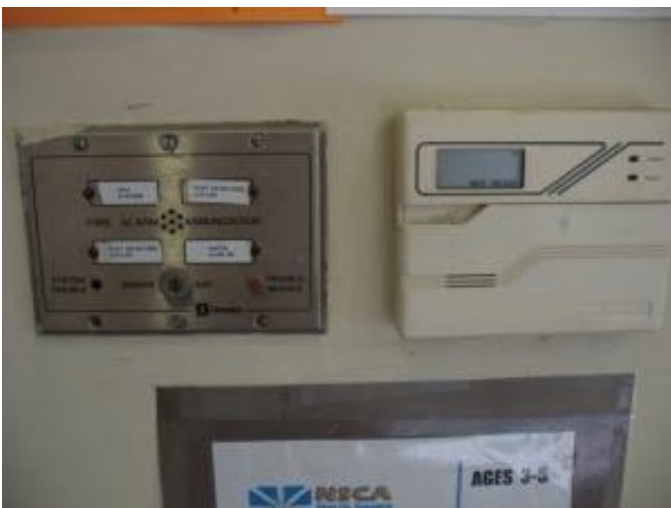
#### System: D3060 - Controls & Instrumentation

**Location:** Throughout building

**Distress:** Inadequate

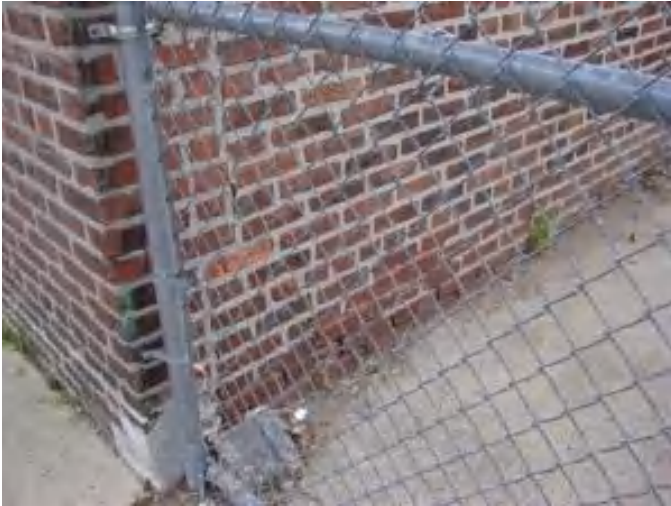
**System: B2010 - Exterior Walls**

**Location:** Exterior

**Distress:** Building Envelope Integrity

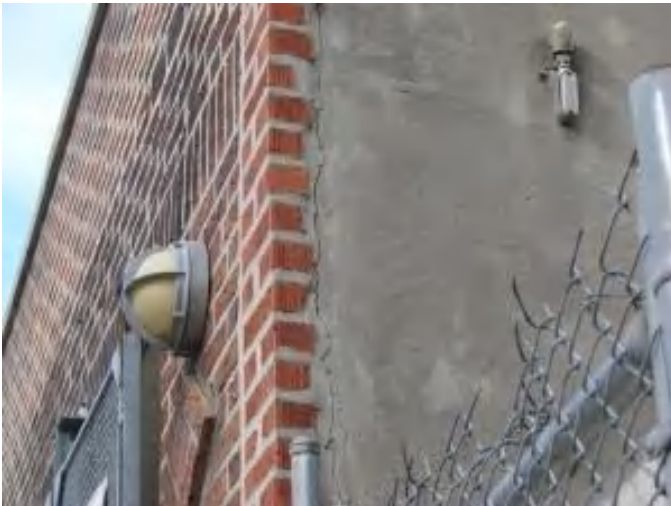
**System: B2010 - Exterior Walls**

**Location:** Exterior

**Distress:** Maintenance Required

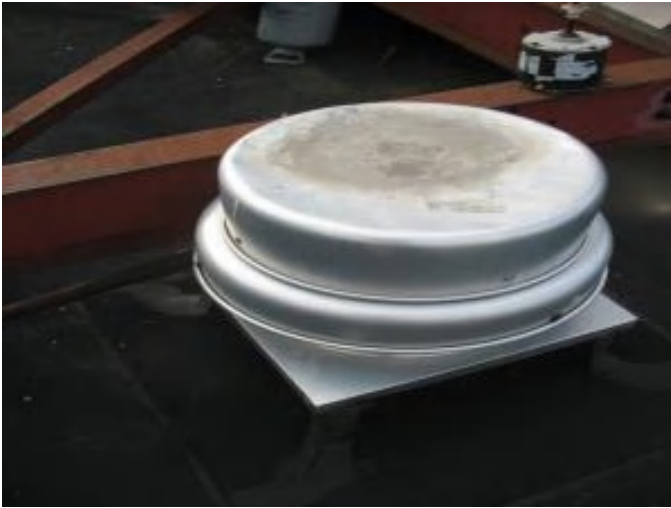
**System: D3040 - Distribution Systems**

**Location:** Roof  
**Distress:** Beyond Service Life  
**Category:** 3 - Operations / Maint.  
**Priority:** 3 - Response Time (3-4 yrs)  
**Correction:** Replace utility set exhaust fan (5 HP)  
**Qty:** 2.00  
**Unit of Measure:** Ea.  
**Estimate:** \$79,043.82  
**Assessor Name:** Craig Anding  
**Date Created:** 12/18/2015

**Notes:** Replace the two (2) roof mounted exhaust fans serving the Kitchen and restrooms, which are approaching the end of its service life.

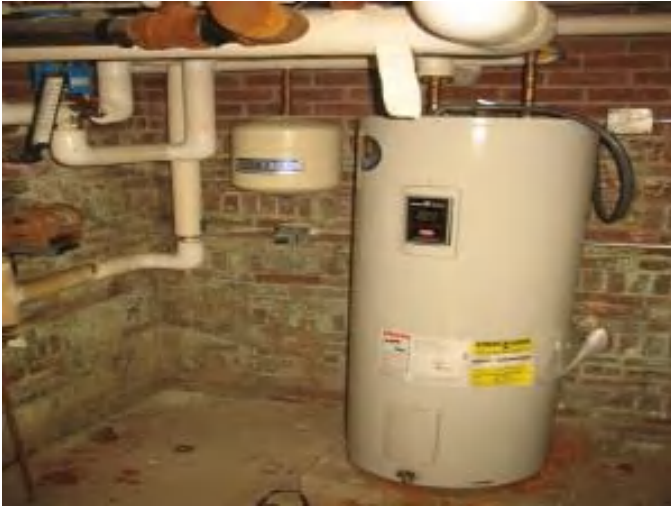
**System: D2020 - Domestic Water Distribution**

**Location:** Basement

**Distress:** Beyond Service Life

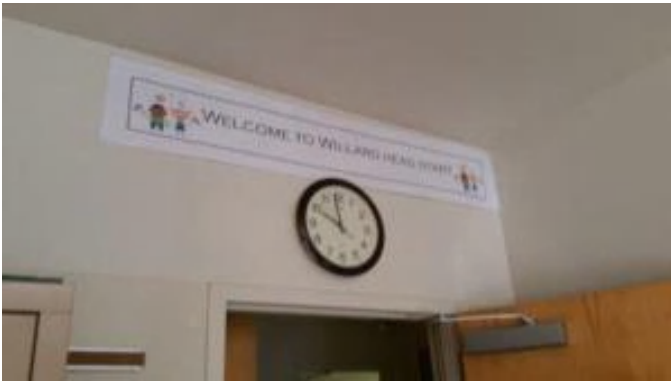
**System: D5030 - Communications and Security**

**Location:** throughout the building

**Distress:** Beyond Service Life

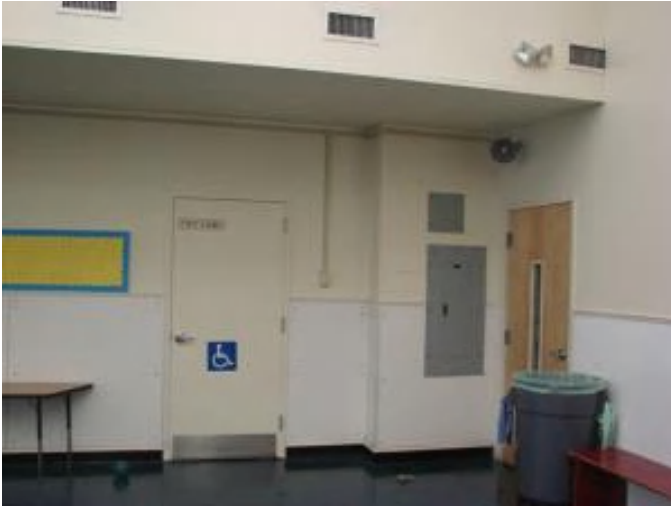
**System: C1030 - Fittings**

**Location:** Interior

**Distress:** Inadequate

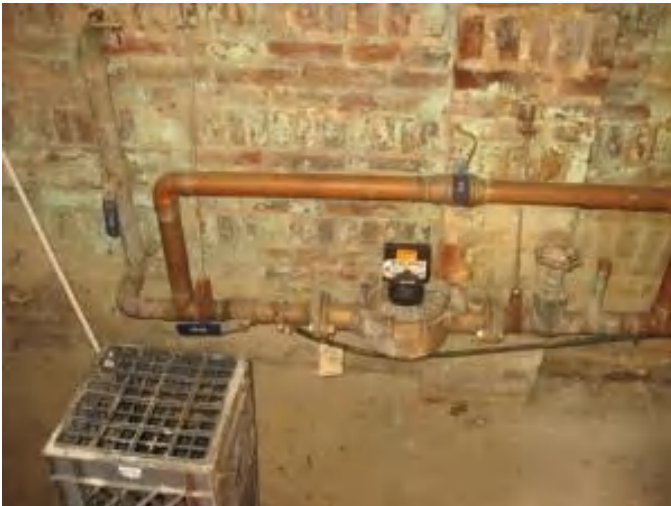
**System: D2020 - Domestic Water Distribution**

**Location:** Throughout building

**Distress:** Beyond Service Life

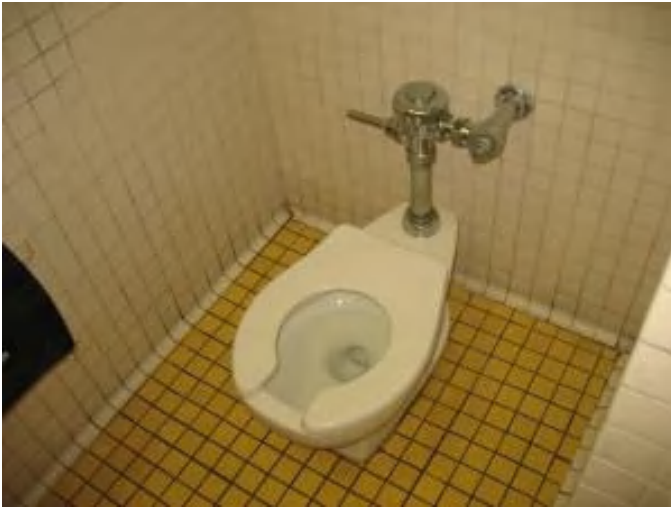
**System: D2030 - Sanitary Waste**

**Location:** Throughout building

**Distress:** Beyond Service Life

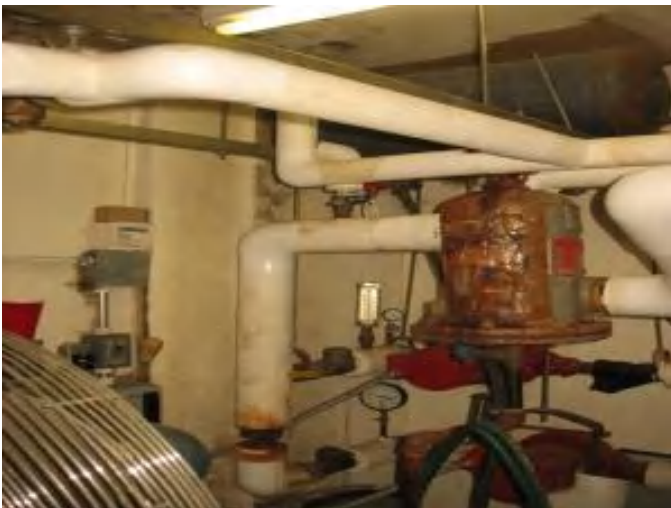
**System: D3040 - Distribution Systems**

**Location:** Throughout building

**Distress:** Beyond Service Life

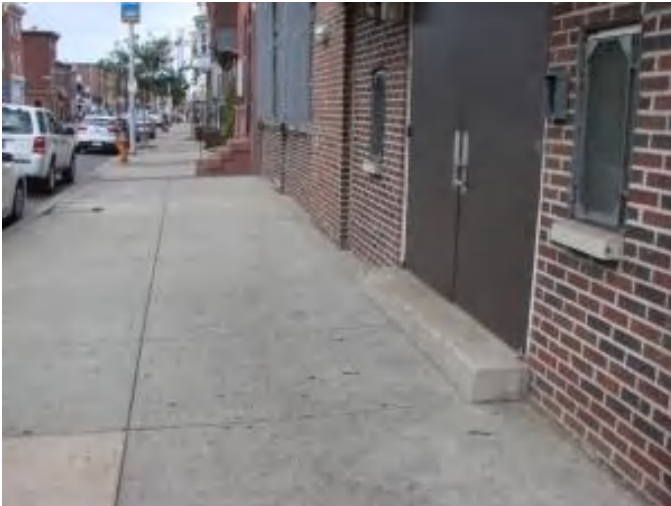
#### System: G2030 - Pedestrian Paving

**Location:** Grounds

**Distress:** Accessibility

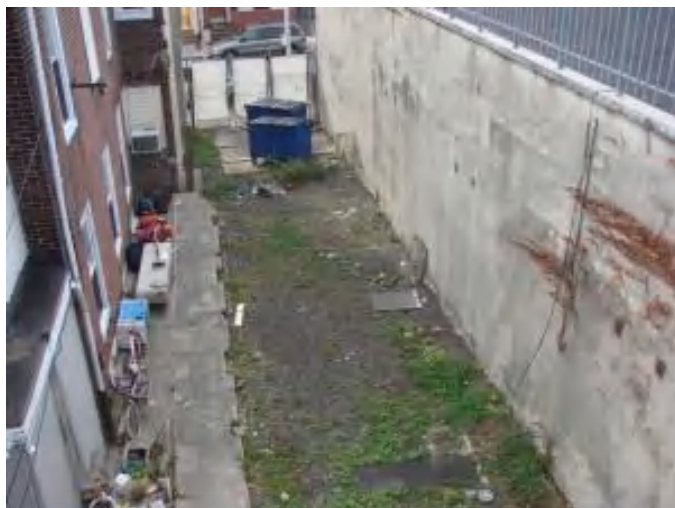
**System: G2030 - Pedestrian Paving**

**Location:** Grounds

**Distress:** Beyond Service Life
