Facility Condition Assessment Summary Report

Wilson, W Middle School

School District of Philadelphia
S812001;Wilson, W
Final
Site Assessment Report
January 31, 2017

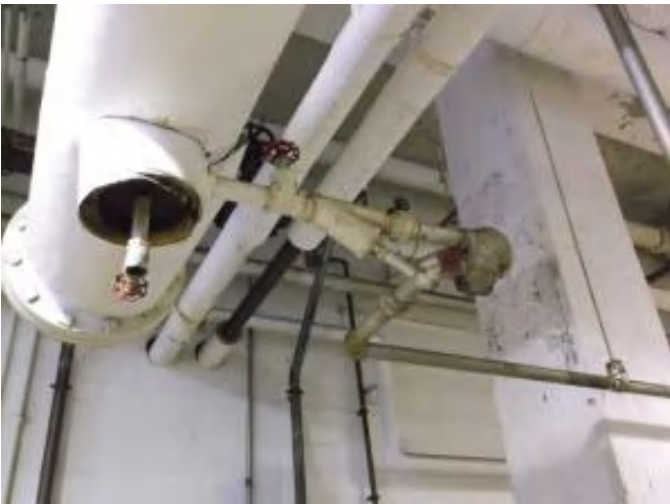
System: D3040 - Distribution Systems

Location: Throughout the building

Distress: Beyond Service Life

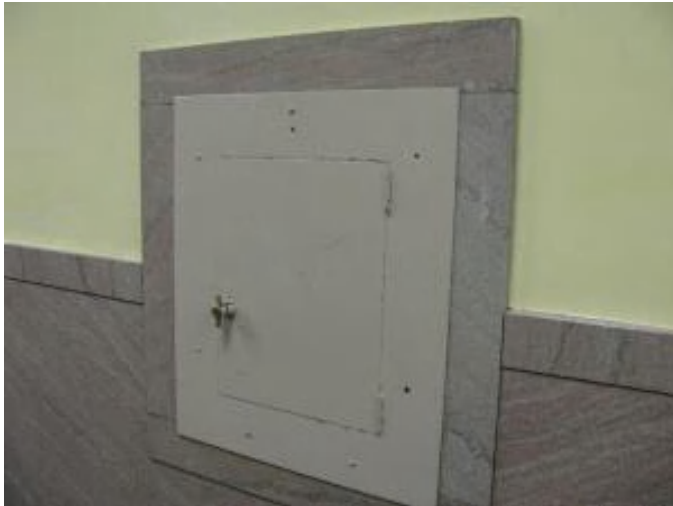
System: D5010 - Electrical Service/Distribution

Location: Entire Building

Distress: Beyond Service Life

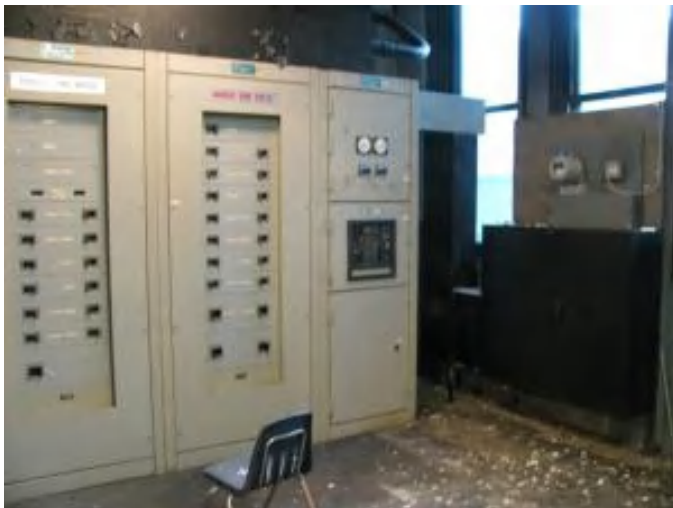
System: D5010 - Electrical Service/Distribution

Location: Boiler Room

Distress: Beyond Service Life

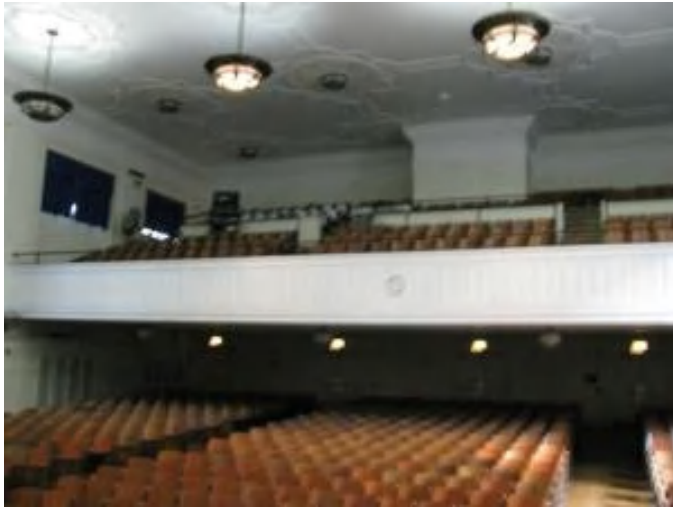
System: D5020 - Lighting and Branch Wiring

Location: Entire Building

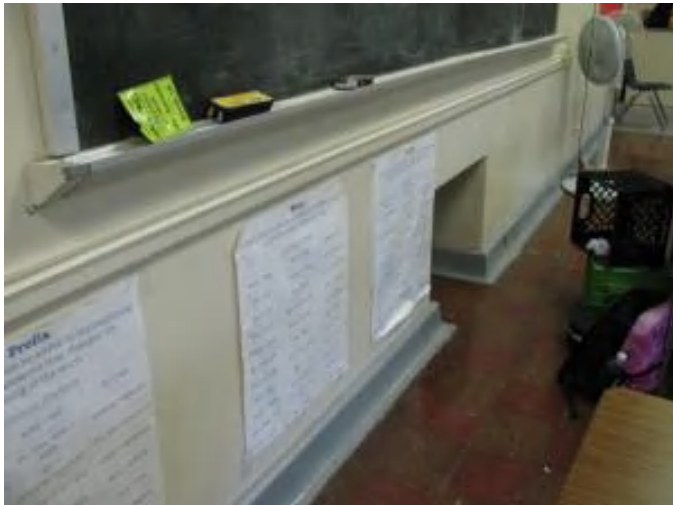
System: D5020 - Lighting and Branch Wiring

Location: Entire Building

Distress: Inadequate

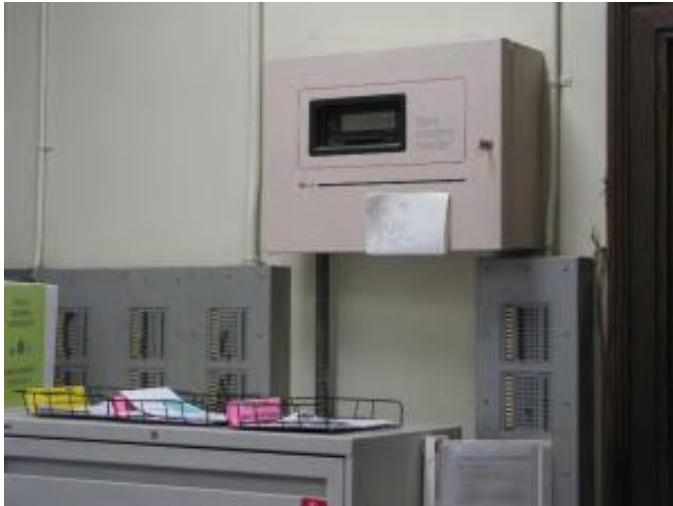
System: D5030 - Communications and Security

Location: Entire Building
Distress: Damaged
Category: 3 - Operations / Maint.
Priority: 1 - Response Time (< 2 yr)
Correction: Add/Replace Clock System or Components
Qty: 1.00
Unit of Measure: Ea.
Estimate: \$43,670.01
Assessor Name: System
Date Created: 11/12/2015

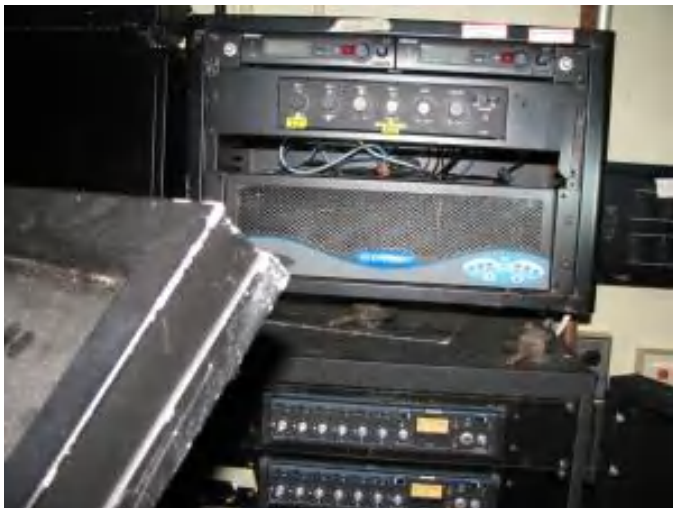
System: D5030 - Communications and Security

Location: Auditorium
Distress: Beyond Service Life
Category: 3 - Operations / Maint.
Priority: 1 - Response Time (< 2 yr)
Correction: Add/Replace Sound System
Qty: 1.00
Unit of Measure: LS
Estimate: \$39,783.80
Assessor Name: System
Date Created: 11/12/2015

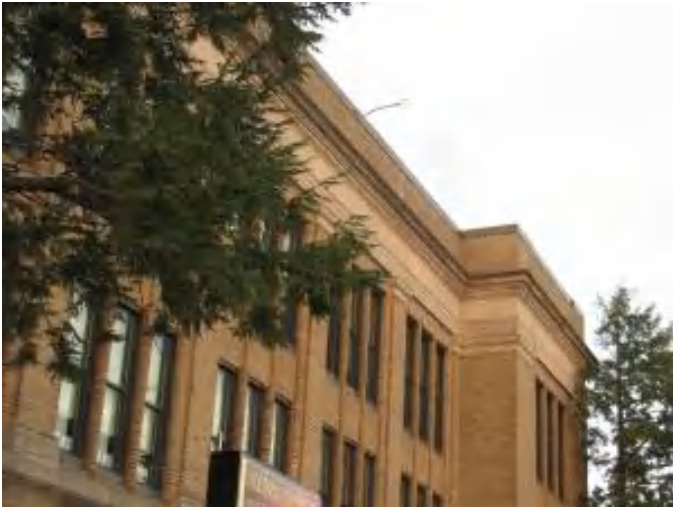
System: D5030 - Communications and Security

Location: Building Exterior

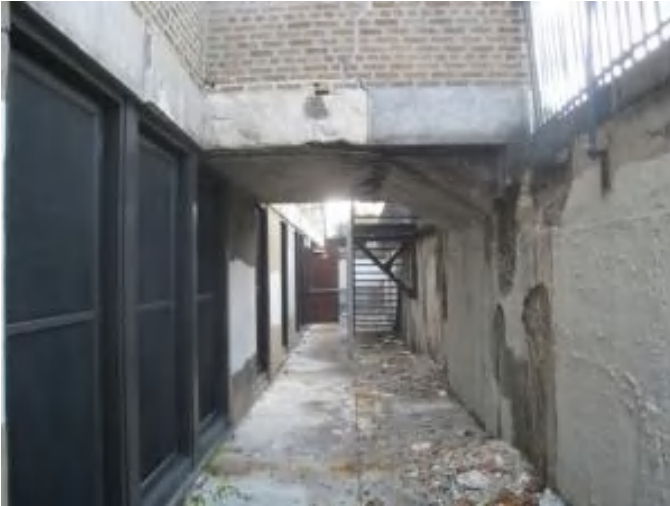
System: A2020 - Basement Walls

Location: areaway

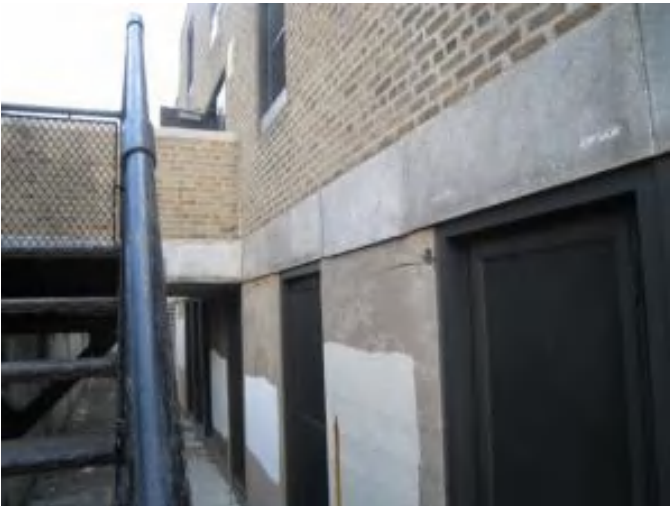
System: A2020 - Basement Walls

Location: areaway

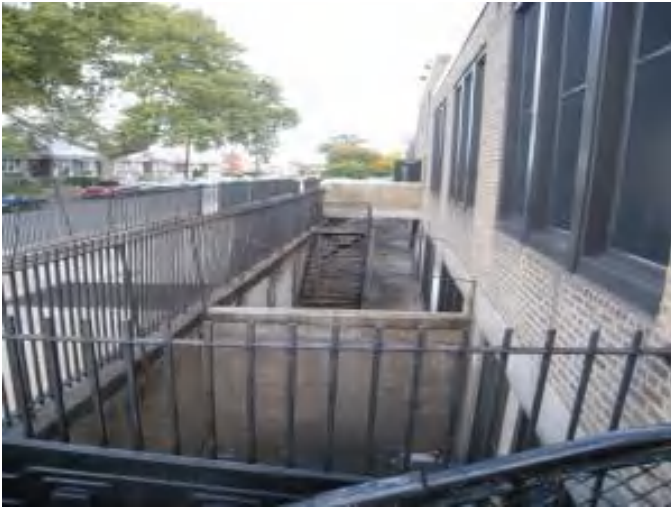
System: B1010 - Floor Construction

Location: concrete bridge over areaway

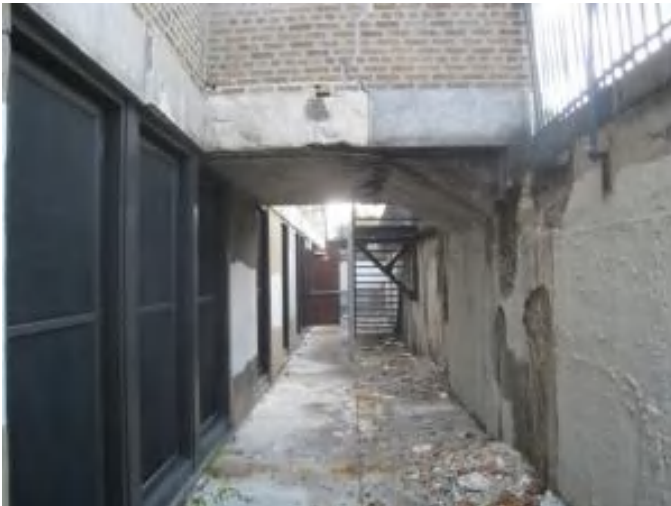
System: B1010 - Floor Construction

Location: areaway

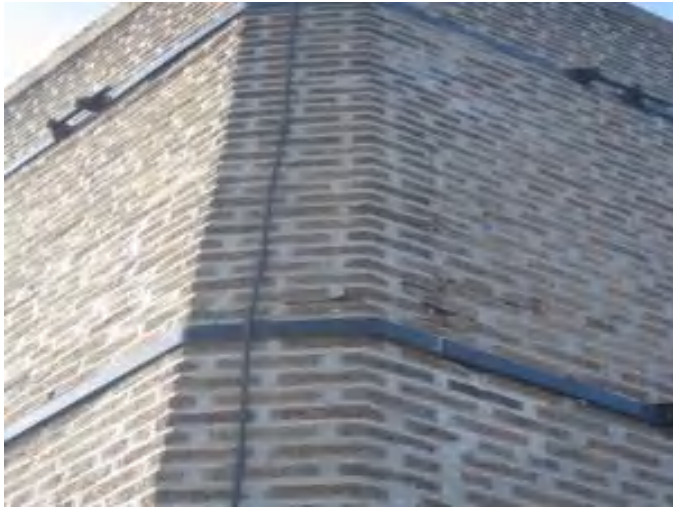
System: B2010 - Exterior Walls

Location: masonry walls above roof
Distress: Failing
Category: 3 - Operations / Maint.
Priority: 2 - Response Time (2-3 yrs)
Correction: Repair cracks in masonry - replace missing mortar and repoint - SF of wall area
Qty: 400.00
Unit of Measure: S.F.
Estimate: \$12,915.80
Assessor Name: System
Date Created: 12/21/2015

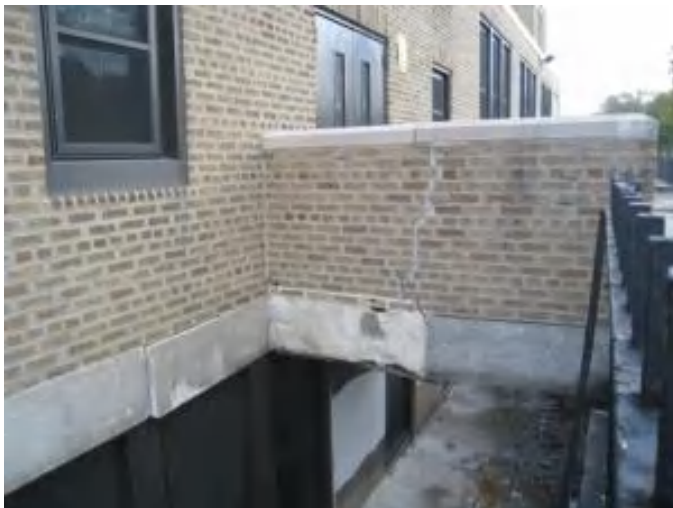
System: B2010 - Exterior Walls

Location: concrete bridge over areaway
Distress: Failing
Category: 3 - Operations / Maint.
Priority: 2 - Response Time (2-3 yrs)
Correction: Repair spalled concrete wall structure
Qty: 200.00
Unit of Measure: S.F.
Estimate: \$11,343.24
Assessor Name: System
Date Created: 12/21/2015

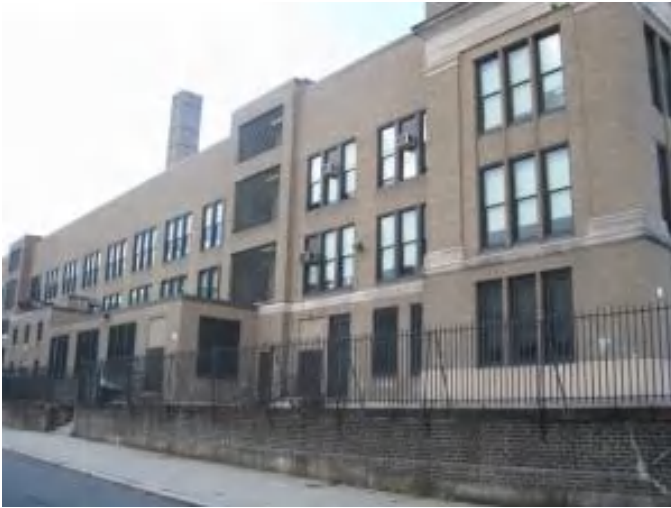
System: B2010 - Exterior Walls

Location: exterior limestone band and walls

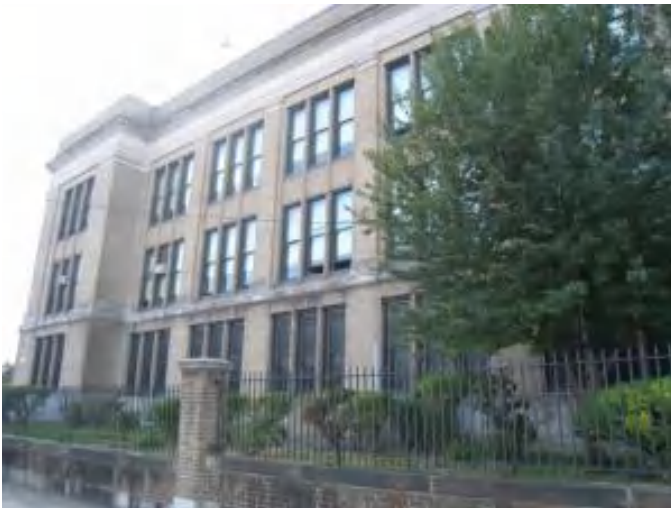
System: B2010 - Exterior Walls

Location: brick window mullions

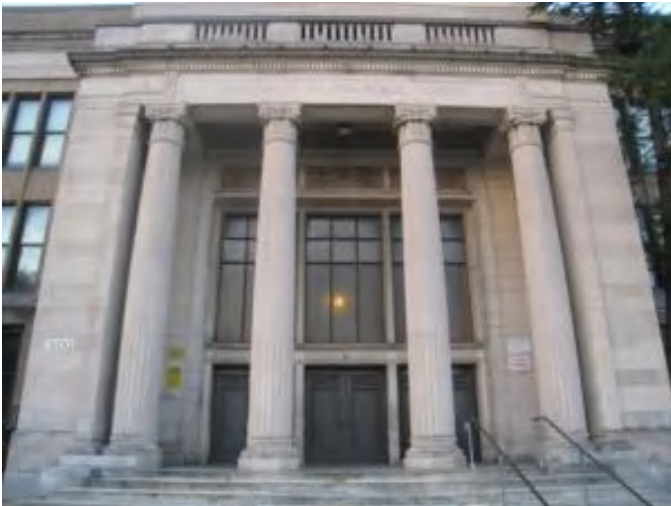
System: B2030 - Exterior Doors

Location: main entrance - front doors

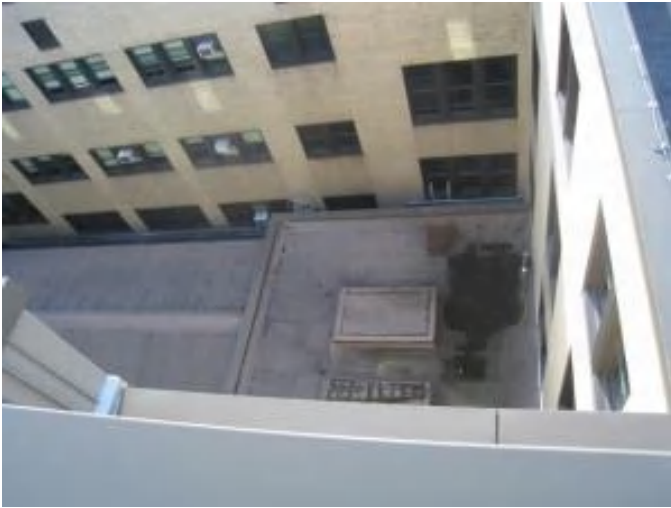
System: B3010105 - Built-Up

Location: roof
Distress: Failing
Category: 3 - Operations / Maint.
Priority: 2 - Response Time (2-3 yrs)
Correction: Remove and replace or replace parapet caps - BUR
Qty: 250.00
Unit of Measure: L.F.
Estimate: \$21,397.65
Assessor Name: System
Date Created: 12/21/2015

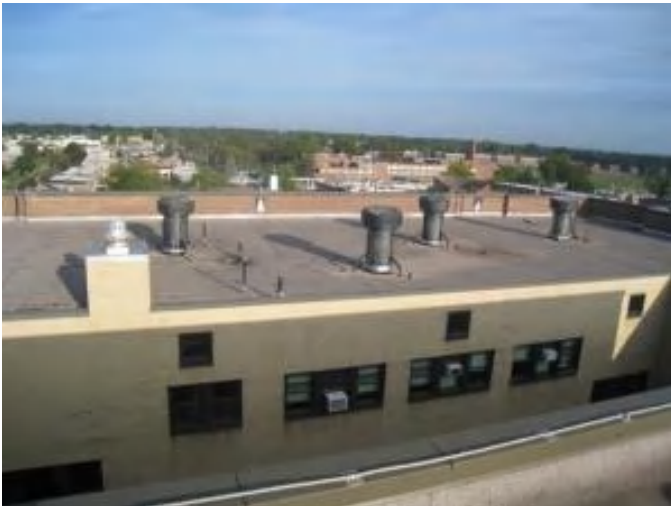
System: B3010105 - Built-Up

Location: roof
Distress: Building Envelope Integrity
Category: 3 - Operations / Maint.
Priority: 2 - Response Time (2-3 yrs)
Correction: Repair pourable pockets for rooftop mounted items
Qty: 25.00
Unit of Measure: Ea.
Estimate: \$16,274.60
Assessor Name: System
Date Created: 12/21/2015

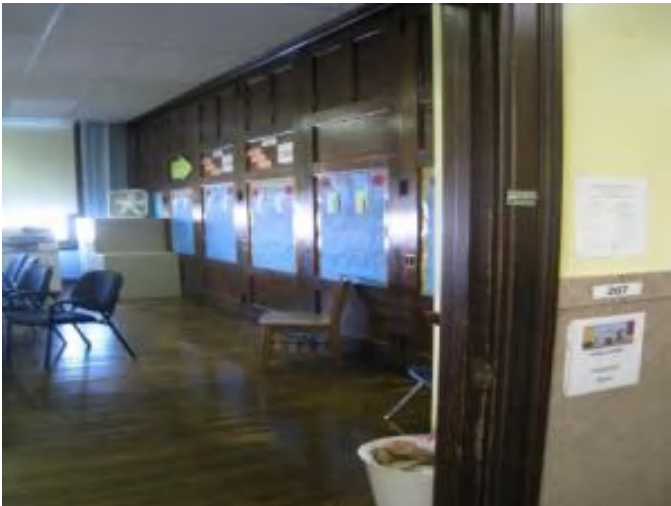
System: C1010 - Partitions

Location: folding partitions in classrooms

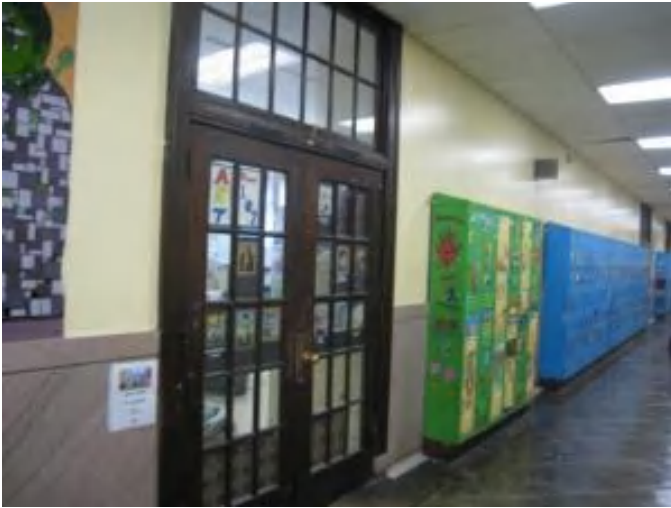
System: C1010 - Partitions

Location: corridor walls

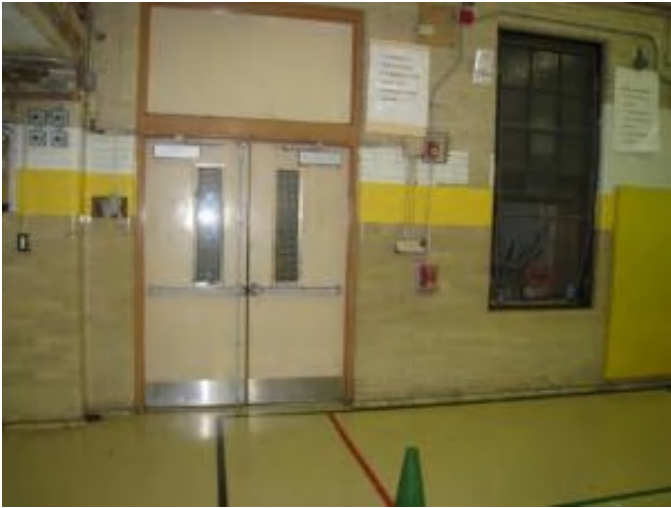
System: C1020 - Interior Doors

Location: steel doors in basement and stairs

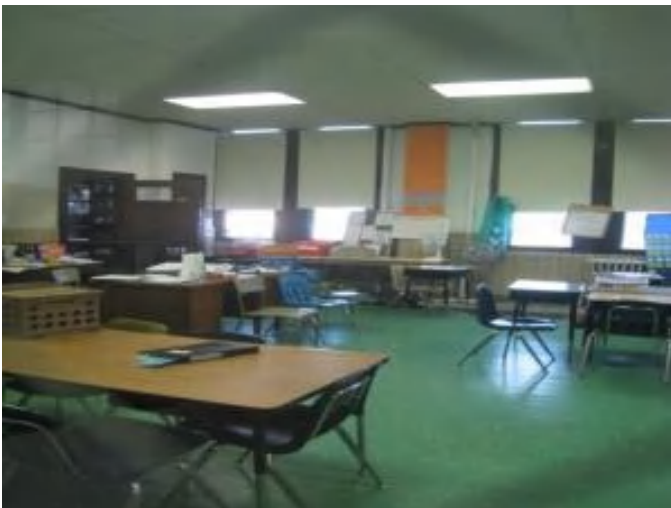
System: C1020 - Interior Doors

Location: interior doors inside classrooms and offices

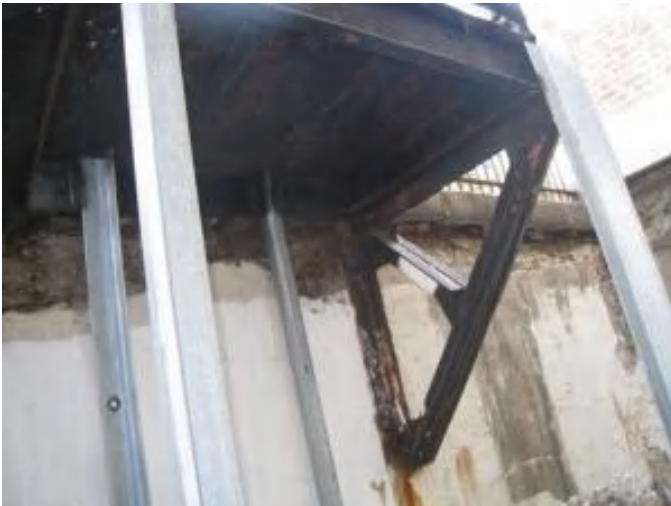
System: C2010 - Stair Construction

Location: areaway

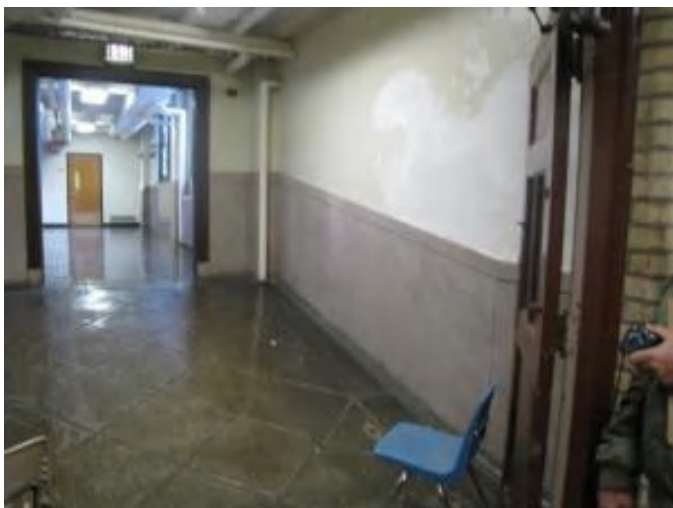
System: C3010230 - Paint & Covering

Location: interior walls

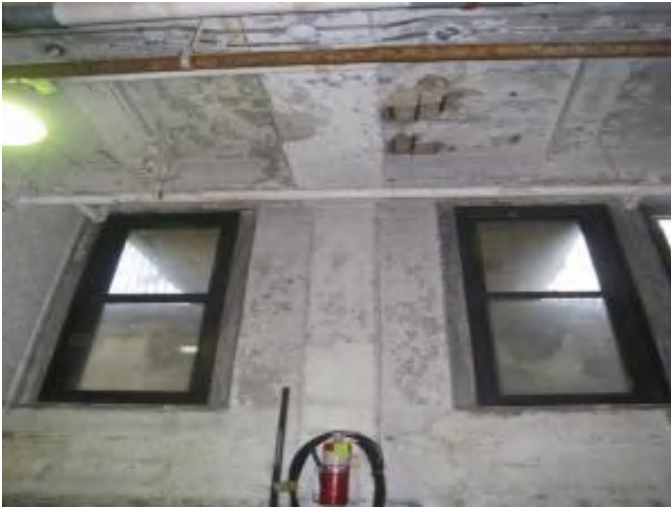
System: C3010230 - Paint & Covering

Location: boiler room walls

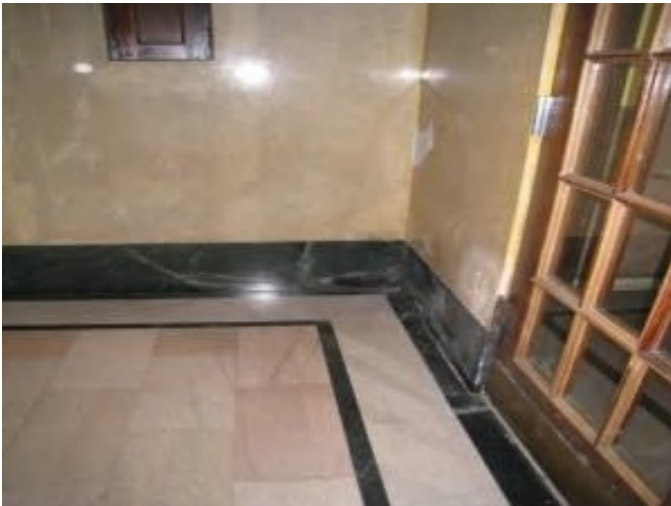
System: C3010232 - Wall Tile

Location: marble panels near auditorium

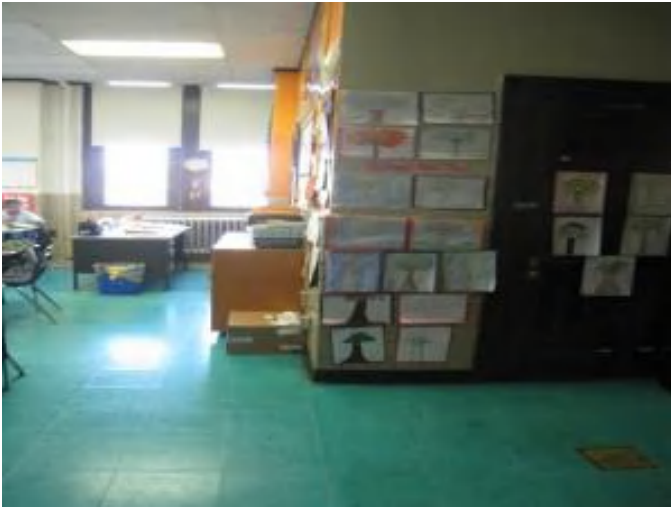
System: C3020413 - Vinyl Flooring

Location: cafeteria, classrooms

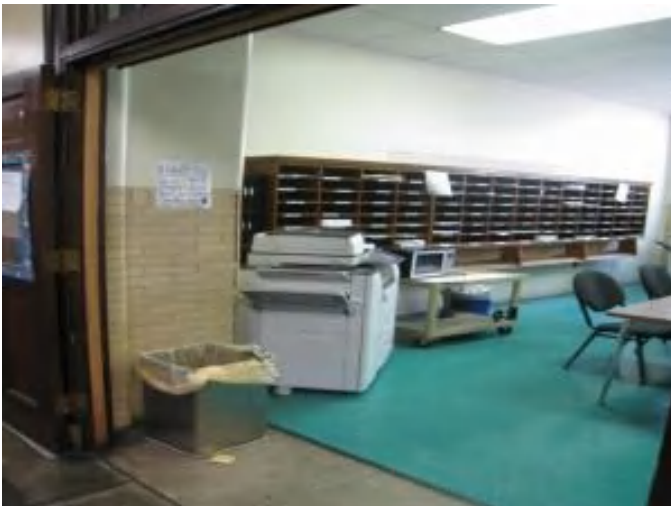
System: C3020413 - Vinyl Flooring

Location: classrooms

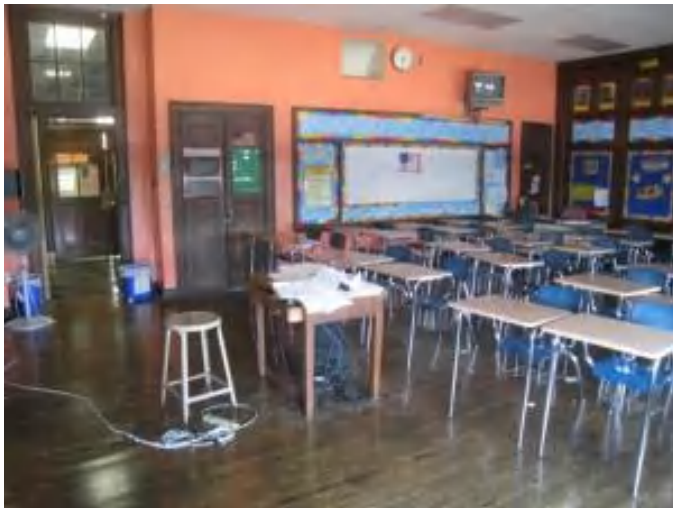
System: C3020414 - Wood Flooring

Location: wood floors - classrooms, auditorium

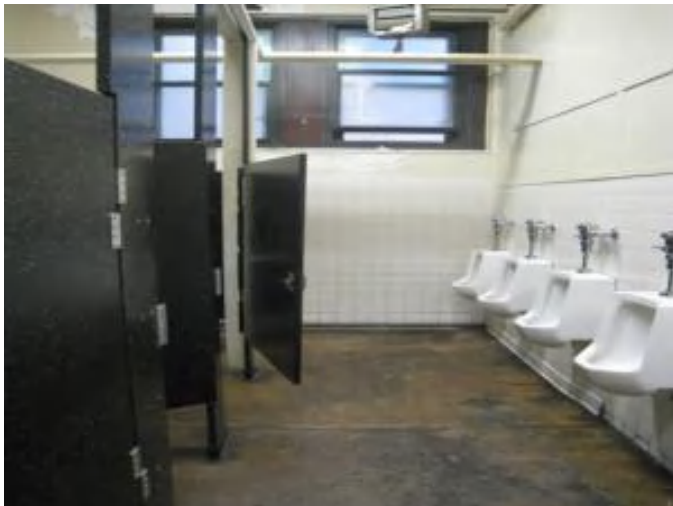
System: C3020415 - Concrete Floor Finishes

Location: concrete slabs

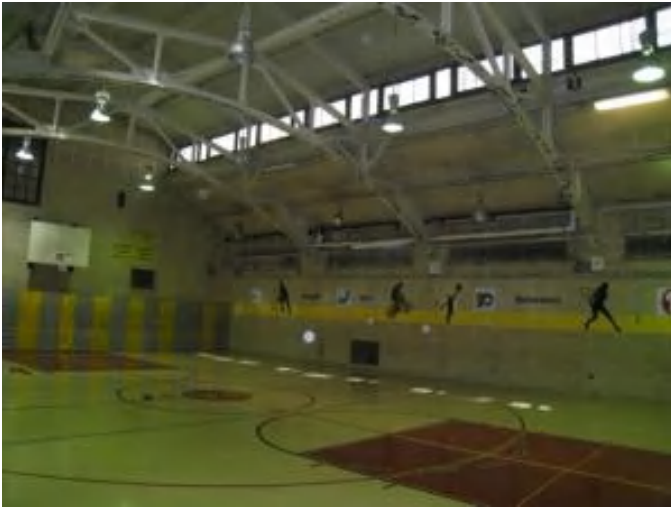
System: C3020415 - Concrete Floor Finishes

Location: gymnasium floors

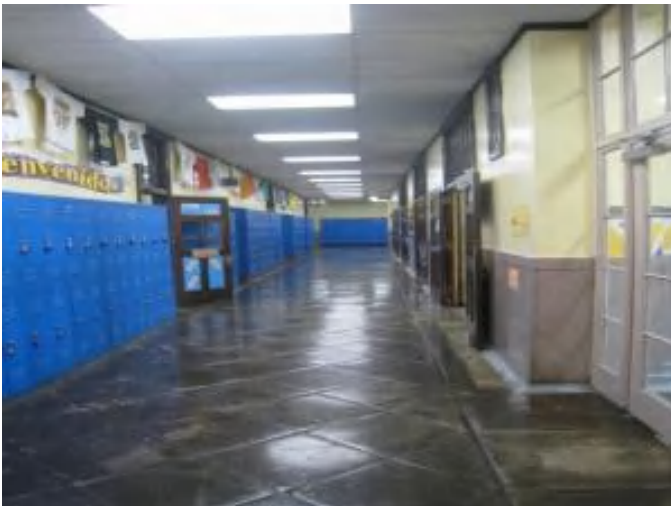
System: C3030 - Ceiling Finishes

Location: interiors

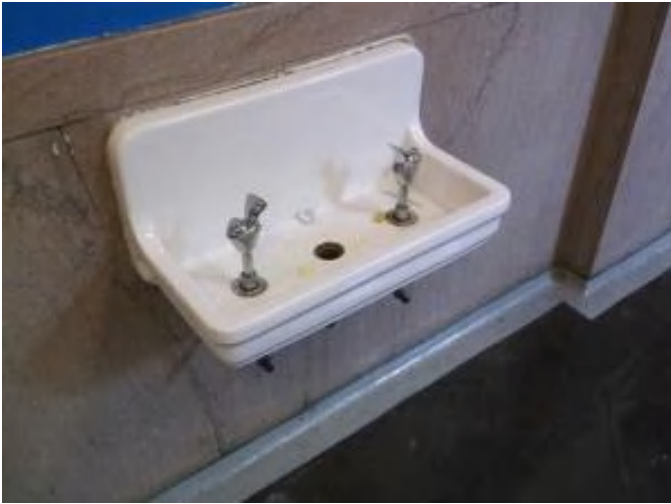
System: D2010 - Plumbing Fixtures

Location: Throughout the building

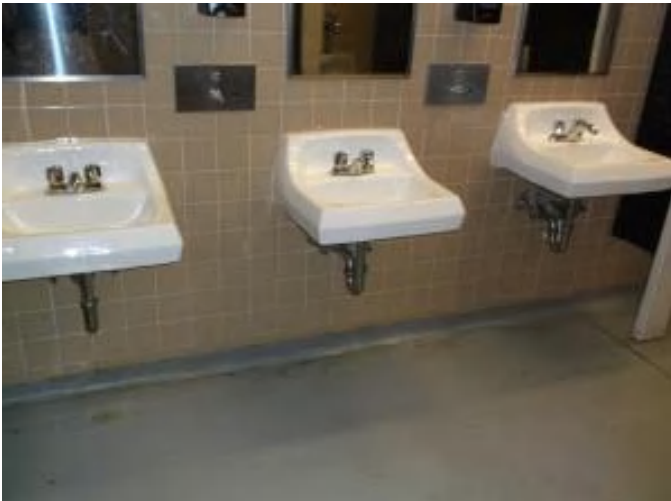
System: D2010 - Plumbing Fixtures

Location: Throughout the building

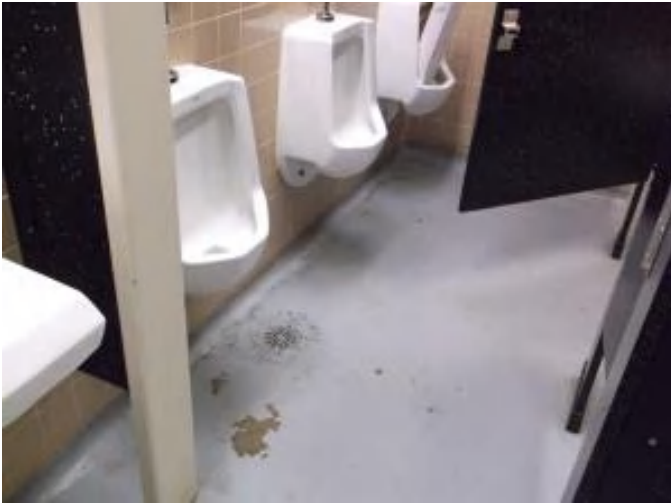
System: D2010 - Plumbing Fixtures

Location: Throughout the building
Distress: Beyond Service Life
Category: 3 - Operations / Maint.
Priority: 2 - Response Time (2-3 yrs)
Correction: Remove and replace or replace wall hung urinals
Qty: 26.00
Unit of Measure: Ea.
Estimate: \$96,357.41
Assessor Name: System
Date Created: 02/07/2016

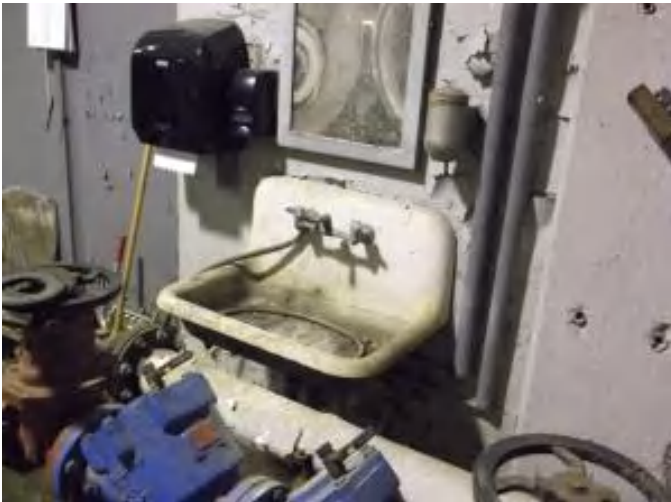
System: D2010 - Plumbing Fixtures

Location: Throughout the building
Distress: Beyond Service Life
Category: 3 - Operations / Maint.
Priority: 2 - Response Time (2-3 yrs)
Correction: Remove and replace wall janitor or mop sink - insert the quantity
Qty: 8.00
Unit of Measure: Ea.
Estimate: \$62,917.66
Assessor Name: System
Date Created: 02/07/2016

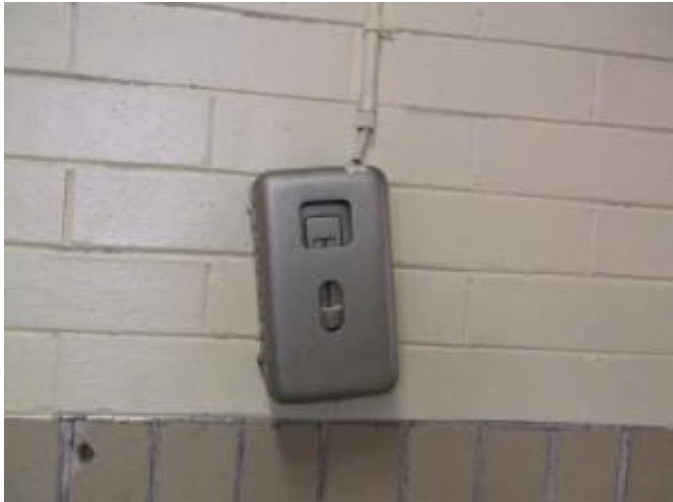
System: D3060 - Controls & Instrumentation

Location: Throughout the building

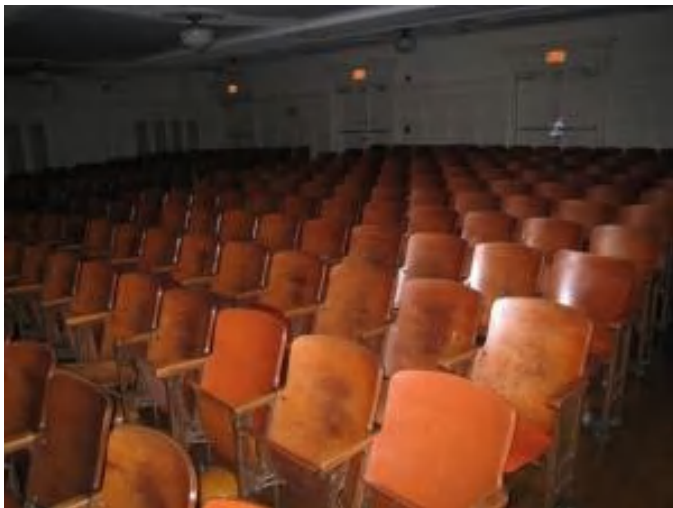
System: E2010 - Fixed Furnishings

Location: auditorium

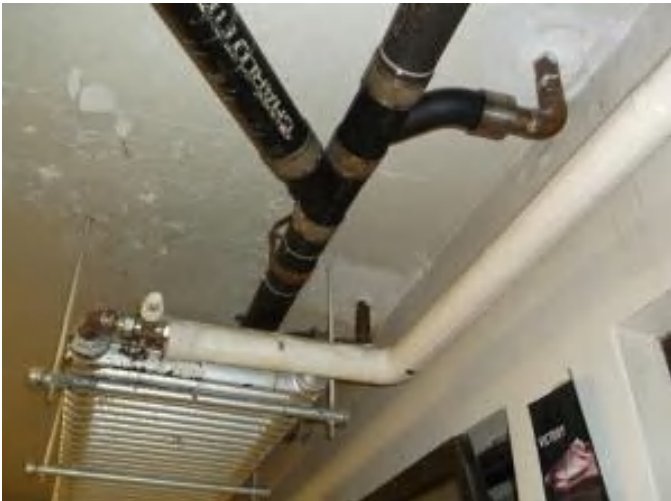
System: D2030 - Sanitary Waste

Location: Throughout the building

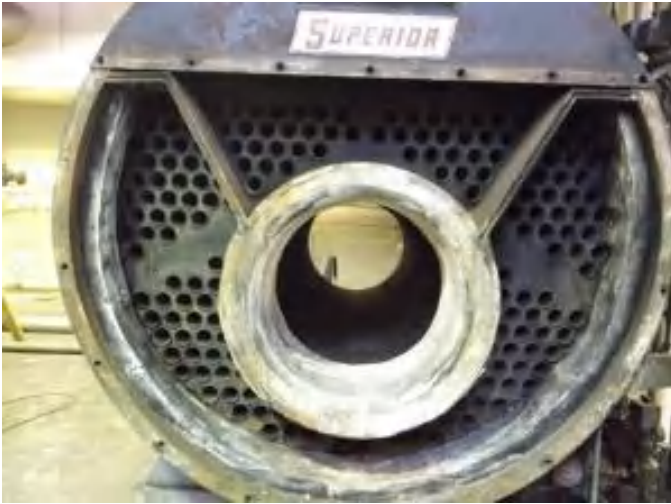
System: D3020 - Heat Generating Systems

Location: Main boiler mechanical equipment room
Distress: Beyond Service Life
Category: 3 - Operations / Maint.
Priority: 3 - Response Time (3-4 yrs)
Correction: Replace boiler, fire tube (300 HP)
Qty: 3.00
Unit of Measure: Ea.
Estimate: \$1,652,896.22
Assessor Name: System
Date Created: 02/07/2016

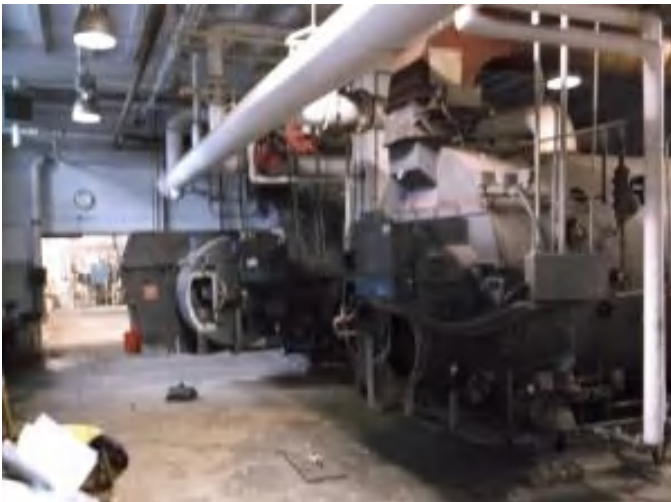
System: D3040 - Distribution Systems

Location: Throughout the building
Distress: Beyond Service Life
Category: 3 - Operations / Maint.
Priority: 3 - Response Time (3-4 yrs)
Correction: Perform testing to identify and replace damaged steam and condensate piping.
Qty: 139,500.00
Unit of Measure: S.F.
Estimate: \$1,319,721.98
Assessor Name: System
Date Created: 02/07/2016

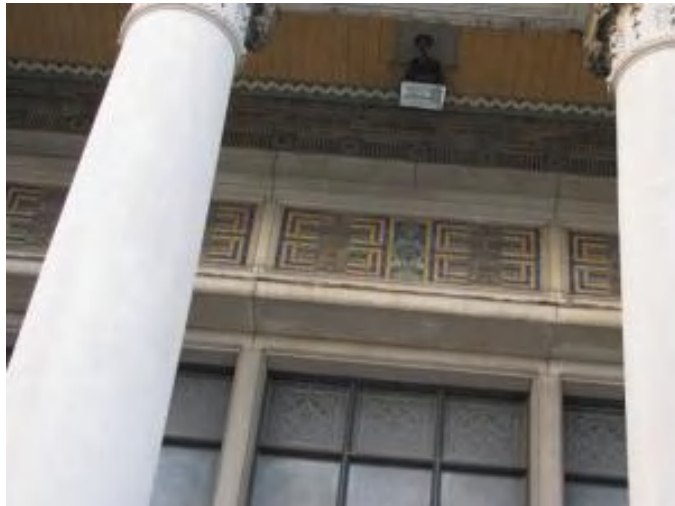
System: D5020 - Lighting and Branch Wiring

Location: Building Exterior

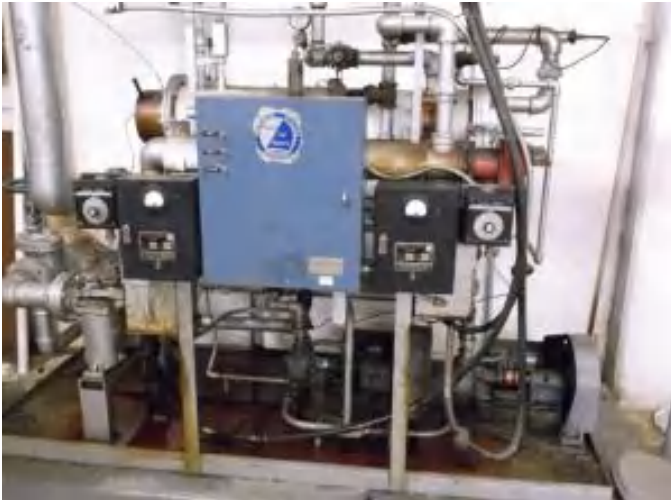
System: D3020 - Heat Generating Systems

Location: Main boiler mechanical equipment room

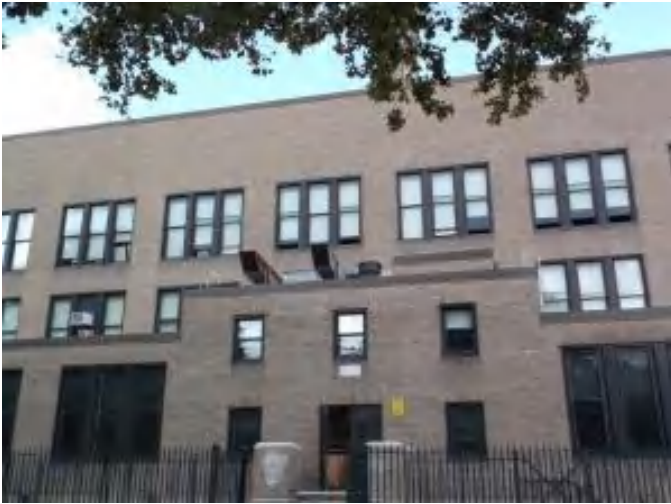
System: D3030 - Cooling Generating Systems

Location: Throughout the building
Distress: Inadequate
Category: 4 - Capital Improvement
Priority: 5 - Response Time (> 5 yrs)
Correction: Install chilled water system with distribution piping and pumps. (+75KSF)
Qty: 139,500.00
Unit of Measure: S.F.
Estimate: \$2,240,285.44
Assessor Name: System
Date Created: 02/07/2016

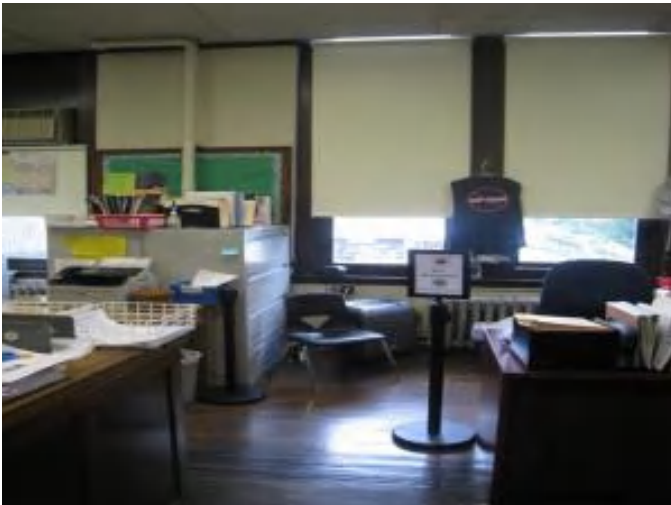
System: D3040 - Distribution Systems

Location: Throughout the building
Distress: Beyond Service Life
Category: 3 - Operations / Maint.
Priority: 5 - Response Time (> 5 yrs)
Correction: Provide classroom FC units and dedicated OA ventilation system. (20 clsrms)
Qty: 50.00
Unit of Measure: C
Estimate: \$4,153,049.46
Assessor Name: System
Date Created: 02/07/2016

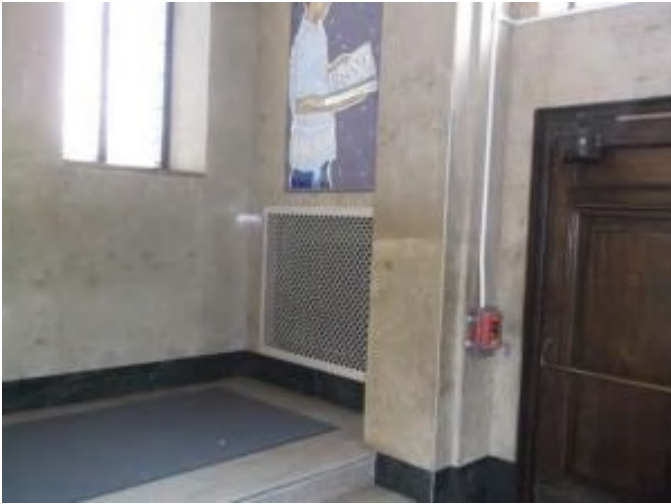
System: D3040 - Distribution Systems

Location: Throughout the building

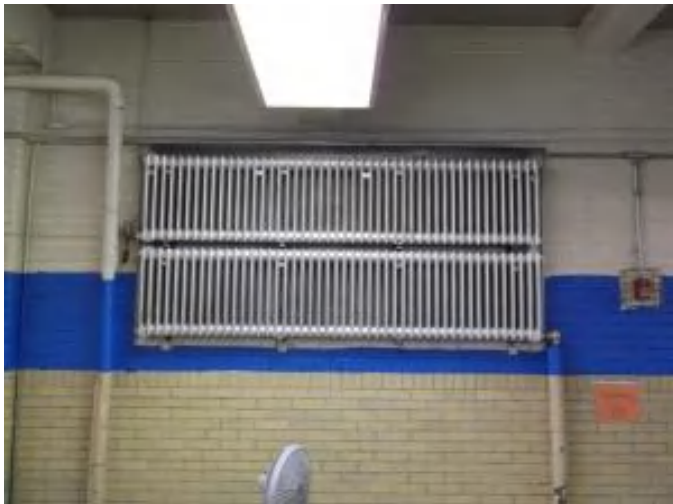
System: D3040 - Distribution Systems

Location: Throughout the building
Distress: Beyond Service Life
Category: 3 - Operations / Maint.
Priority: 5 - Response Time (> 5 yrs)
Correction: Replace finned tube radiation terminals (per 100 LF)
Qty: 200.00
Unit of Measure: L.F.
Estimate: \$80,708.29
Assessor Name: System
Date Created: 02/07/2016

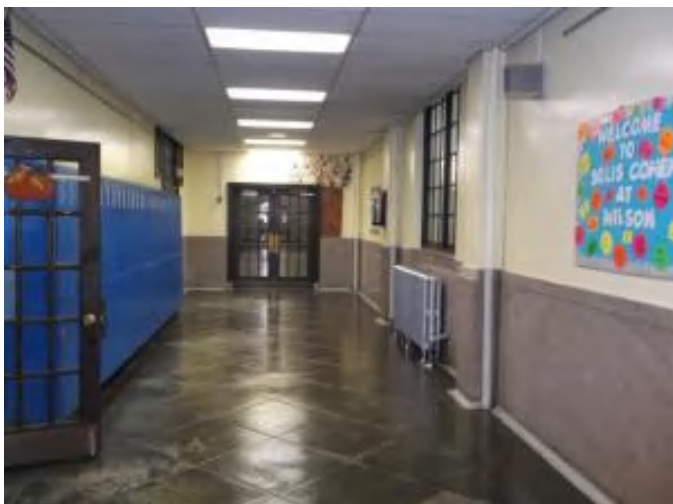
System: D4010 - Sprinklers

Location: Throughout the building
Distress: Beyond Service Life
Category: 3 - Operations / Maint.
Priority: 5 - Response Time (> 5 yrs)
Correction: Install a fire protection sprinkler system
Qty: 139,500.00
Unit of Measure: S.F.
Estimate: \$1,995,609.76
Assessor Name: System
Date Created: 02/07/2016

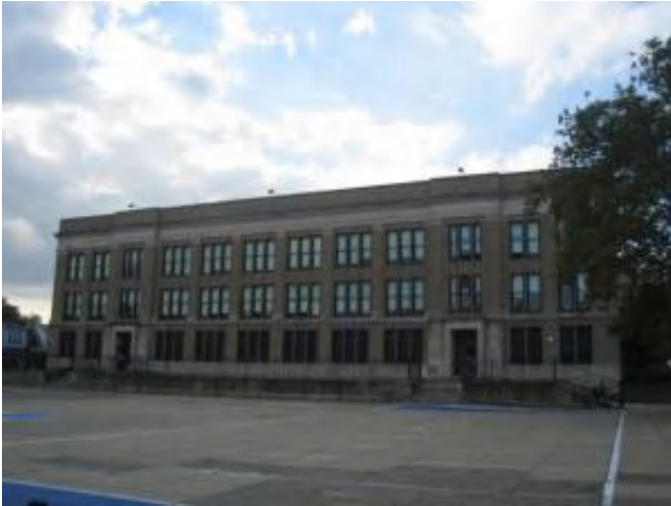
System: G2030 - Pedestrian Paving

Location: sidewalk and playground
Distress: Damaged
Category: 3 - Operations / Maint.
Priority: 2 - Response Time (2-3 yrs)
Correction: Remove and replace concrete sidewalk or concrete paving - 4" concrete thickness
Qty: 6,000.00
Unit of Measure: S.F.
Estimate: \$86,297.10
Assessor Name: Craig Anding
Date Created: 12/21/2015

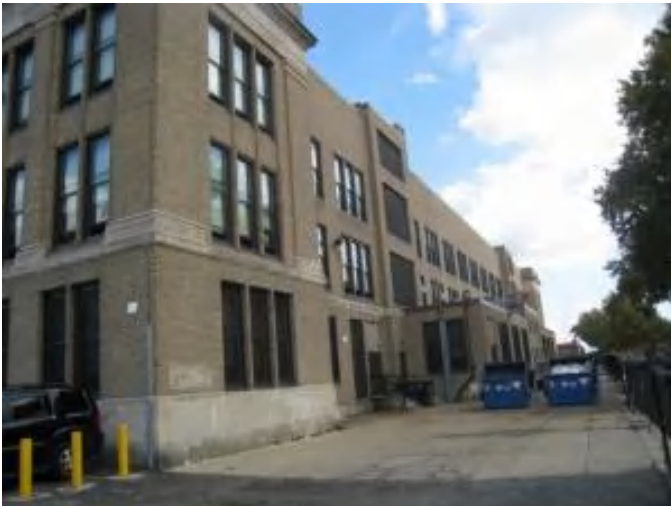
System: G2030 - Pedestrian Paving

Location: dumpster slab
Distress: Damaged
Category: 3 - Operations / Maint.
Priority: 2 - Response Time (2-3 yrs)
Correction: Remove and replace concrete paving - pedestrian or parking - 8" concrete thickness
Qty: 2,000.00
Unit of Measure: S.F.
Estimate: \$52,547.10
Assessor Name: Craig Anding
Date Created: 12/21/2015

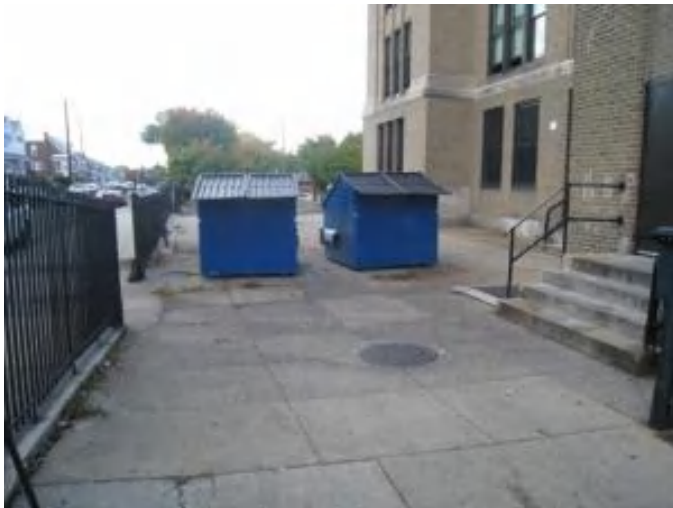
System: G2030 - Pedestrian Paving

Location: exterior stairs
Distress: Failing
Category: 3 - Operations / Maint.
Priority: 2 - Response Time (2-3 yrs)
Correction: Regrout joints between stone treads and risers - LF of grout
Qty: 60.00
Unit of Measure: L.F.
Estimate: \$975.88
Assessor Name: Craig Anding
Date Created: 12/21/2015

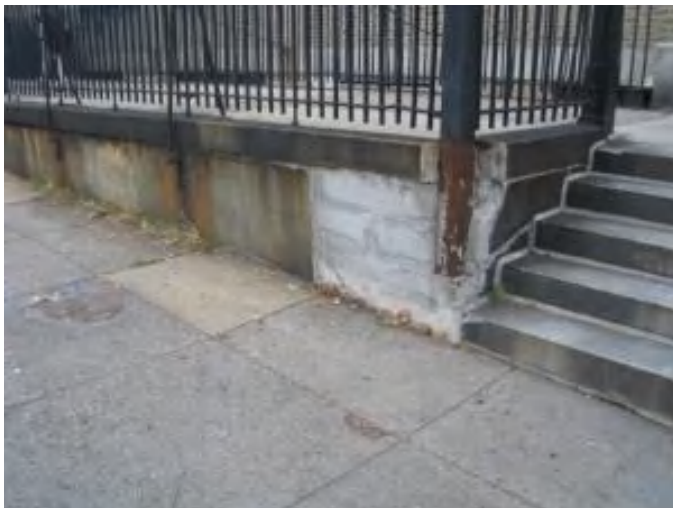
System: G2040 - Site Development

Location: sidewalks and play area
Distress: Failing
Category: 3 - Operations / Maint.
Priority: 2 - Response Time (2-3 yrs)
Correction: Repair exterior brick retaining wall - per LF of wall - up to 4' tall
Qty: 400.00
Unit of Measure: L.F.
Estimate: \$206,250.07
Assessor Name: Craig Anding
Date Created: 12/21/2015

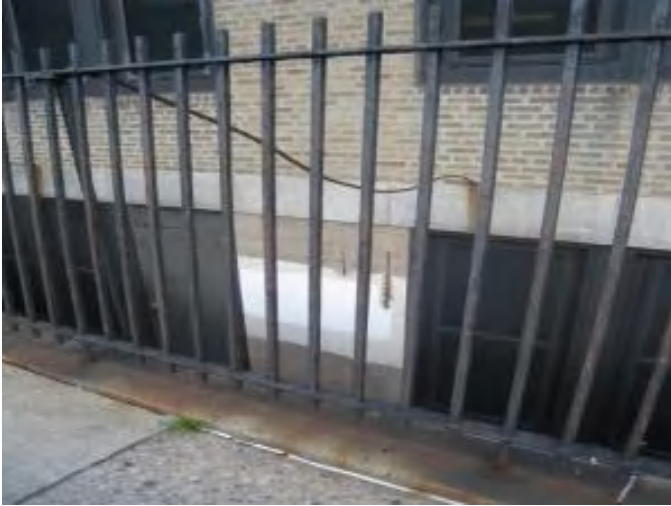
System: G2040 - Site Development

Location: site fence

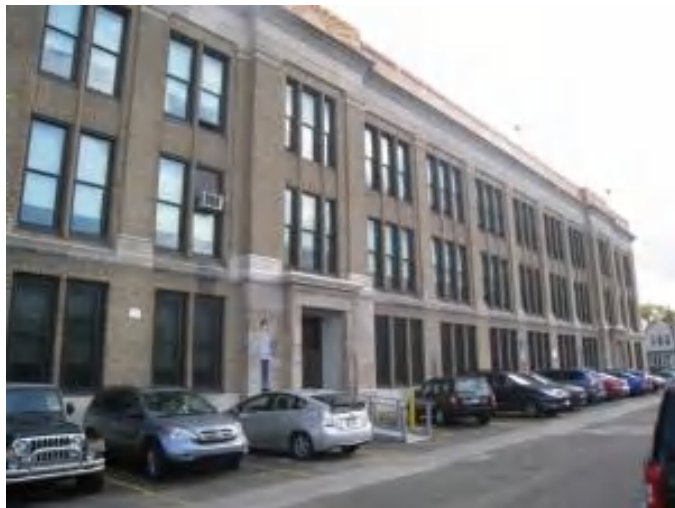
System: G2020 - Parking Lots

Location: faculty parking lot
