Facility Condition Assessment Summary Report

Wister School

S643001;Wister

Site Assessment Report

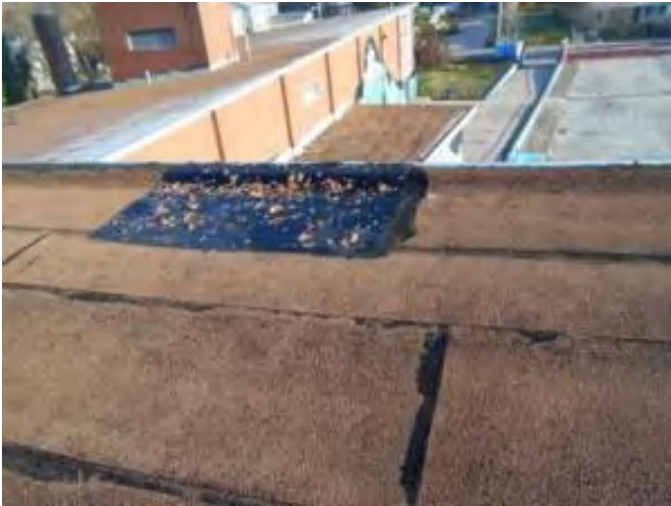
System: B3010105 - Built-Up

Location: Roofs

Distress: Building Envelope Integrity

Notes: Replace roofs at the end of expected service life. Roofs are in poor condition with some patching evident, wrinkling and splitting, and considerable loss of granules on the wear surface.

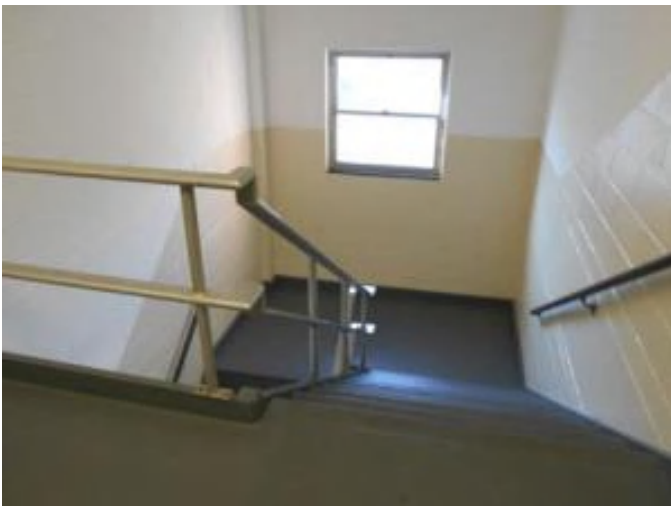
System: C2010 - Stair Construction

Location: Interior stairs

Distress: Building / MEP Codes

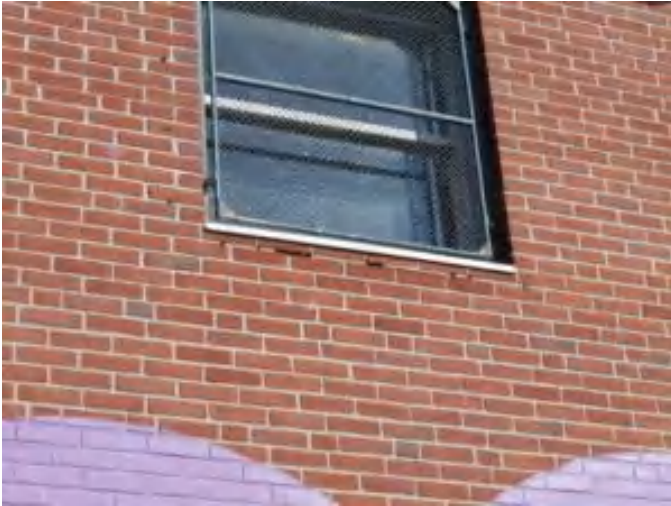
System: B2010 - Exterior Walls

Location: Around the building

Distress: Damaged

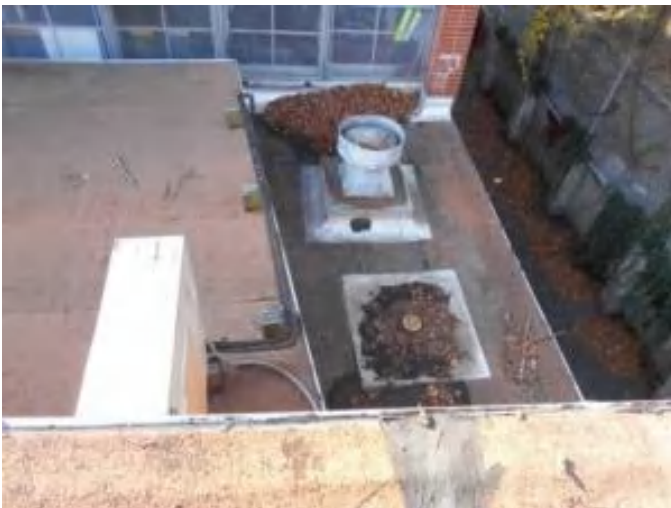
System: B2010 - Exterior Walls

Location: Northwest wing

Distress: OSHA

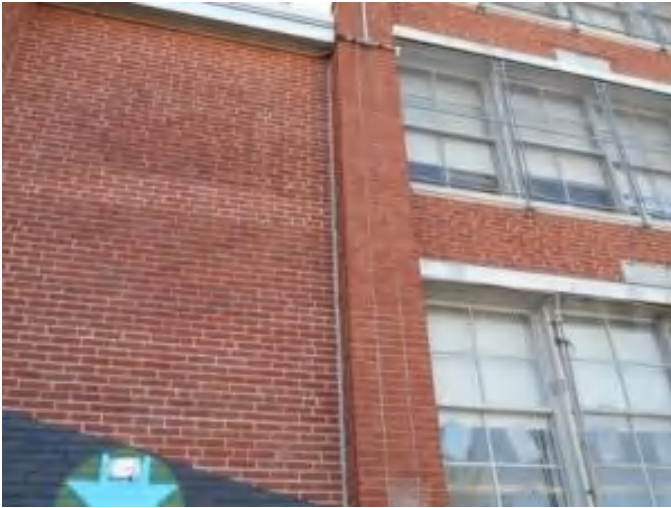
System: B2010 - Exterior Walls

Location: At addition

Distress: Building Envelope Integrity

Notes: Provide expansion joint between original building and addition. Caulk joint is failing.

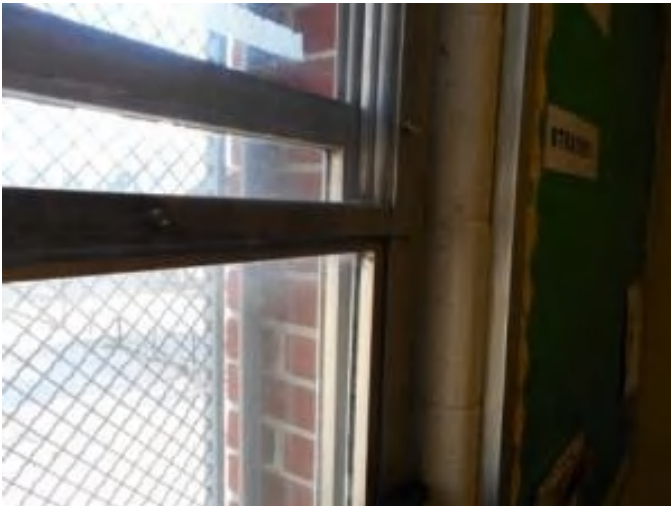
System: B2020 - Exterior Windows

Location: Exterior windows

Distress: Building Envelope Integrity

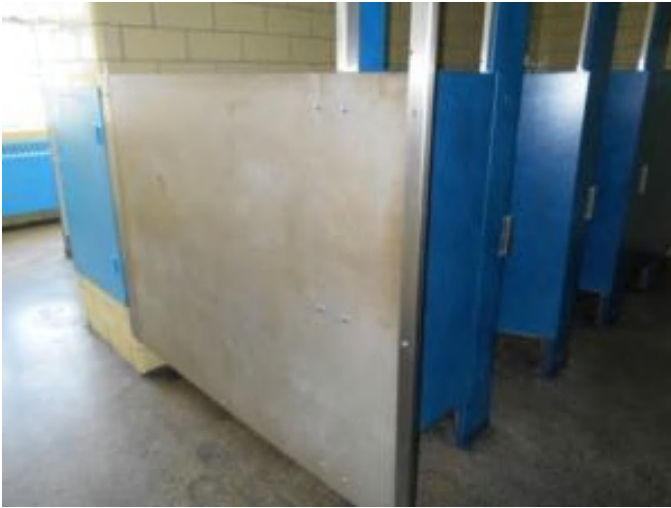
System: C1010 - Partitions

Location: Student restrooms

Distress: Accessibility

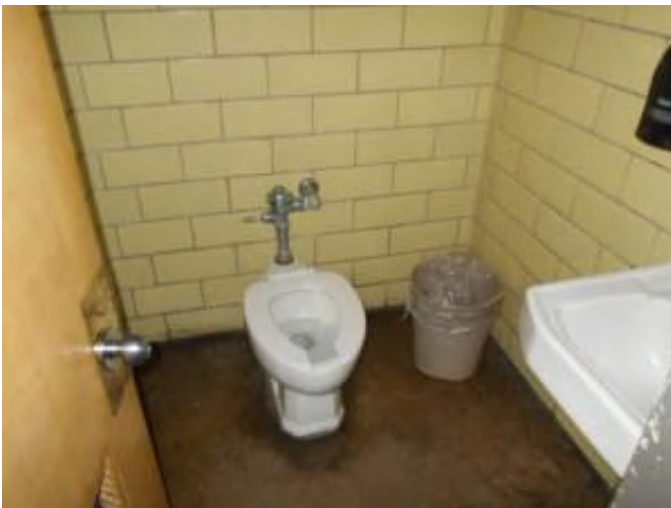
System: C1010 - Partitions

Location: TBD

Distress: Accessibility

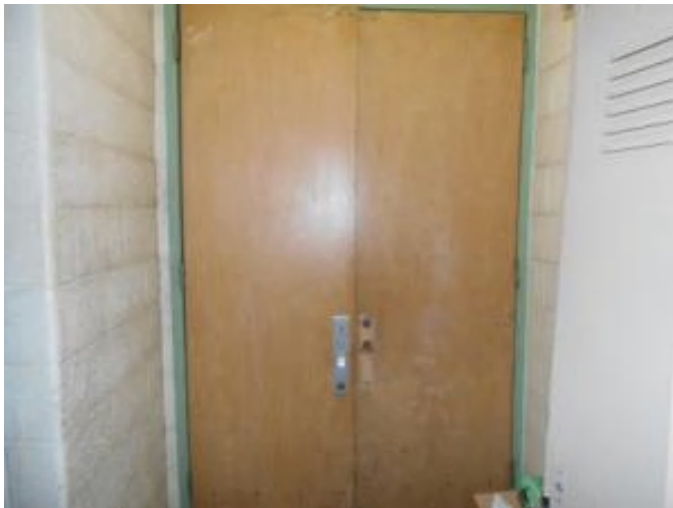
System: C1020 - Interior Doors

Location: Interior doors

Distress: Beyond Service Life

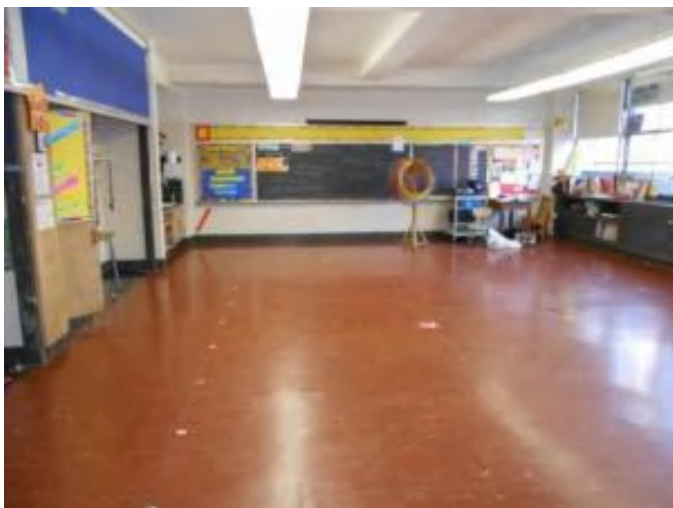
System: C1030 - Fittings

Location: Classrooms

Distress: Obsolete

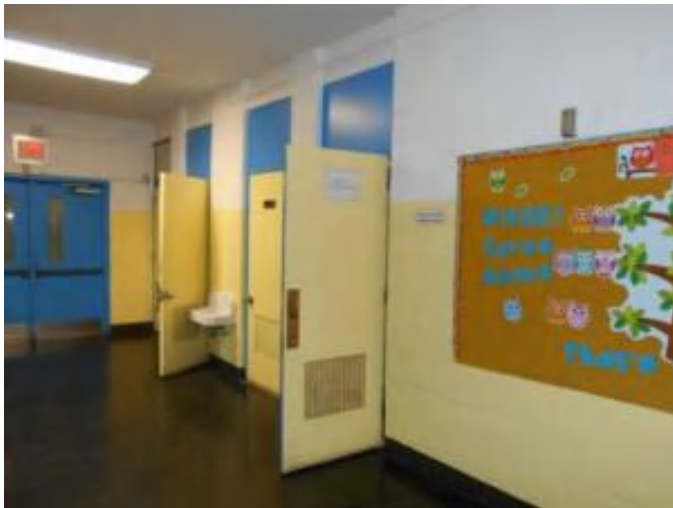
System: C1030 - Fittings

Location: Interiors throughout

Distress: Building / MEP Codes

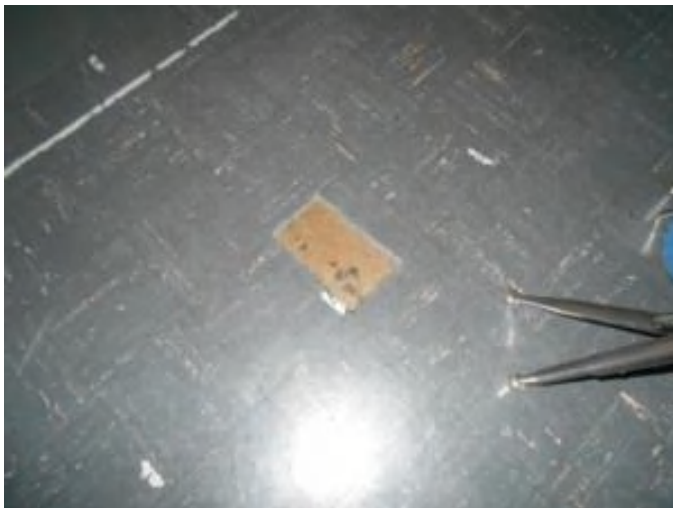
System: C3020413 - Vinyl Flooring

Location: Auditorium, classrooms, corridors

Distress: Health Hazard / Risk

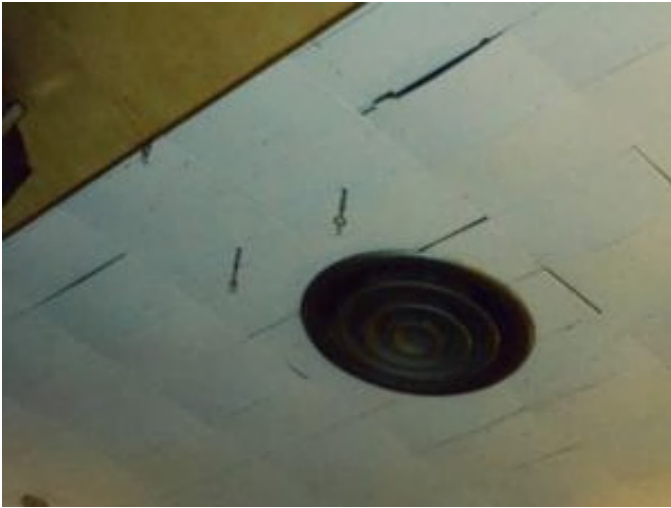
System: C3030 - Ceiling Finishes

Location: Auditorium, lobby, misc. spaces

Distress: Damaged

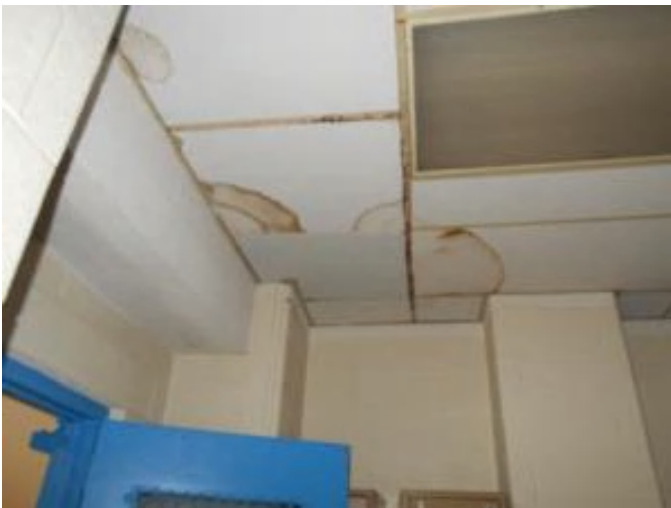
System: C3030 - Ceiling Finishes

Location: Classroom addition

Distress: Damaged

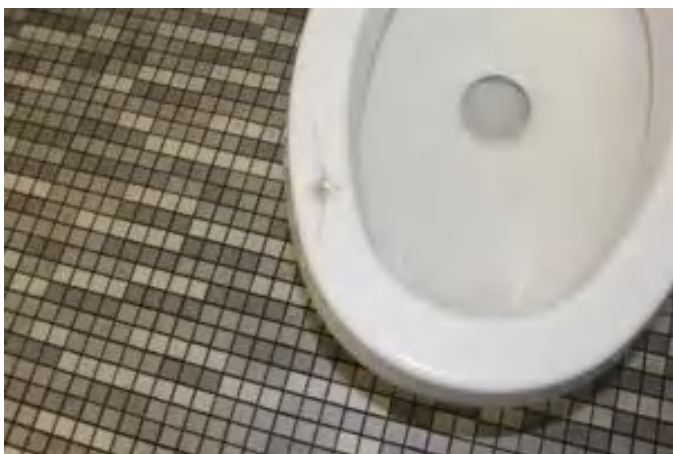
System: D2010 - Plumbing Fixtures

Location: Toilet rooms

Distress: Beyond Service Life

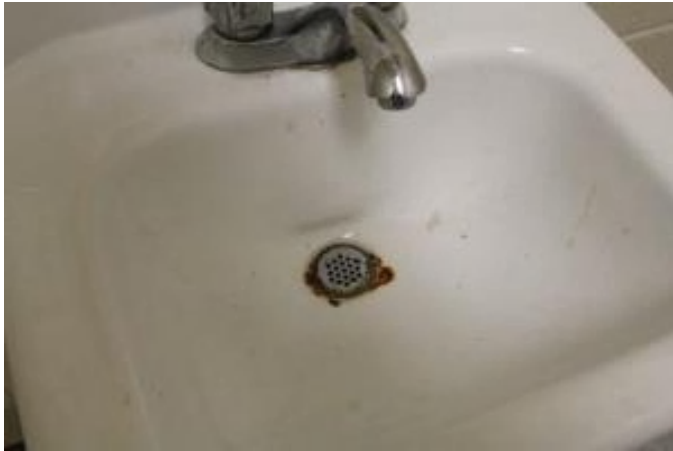
System: D2010 - Plumbing Fixtures

Location: Toilet rooms

Distress: Beyond Service Life

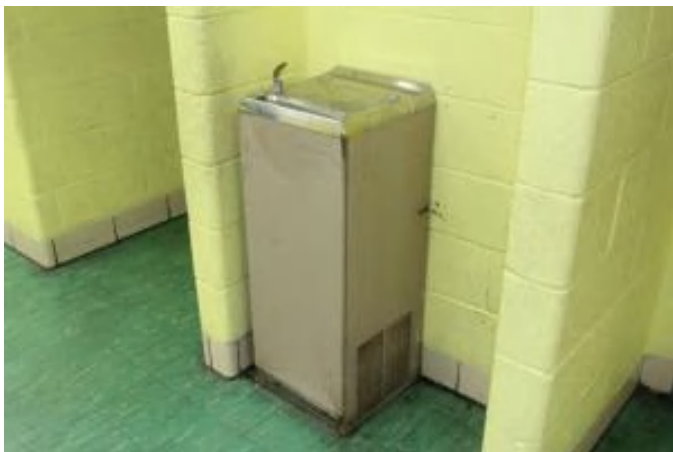
System: D2010 - Plumbing Fixtures

Location: Corridors

Distress: Beyond Service Life

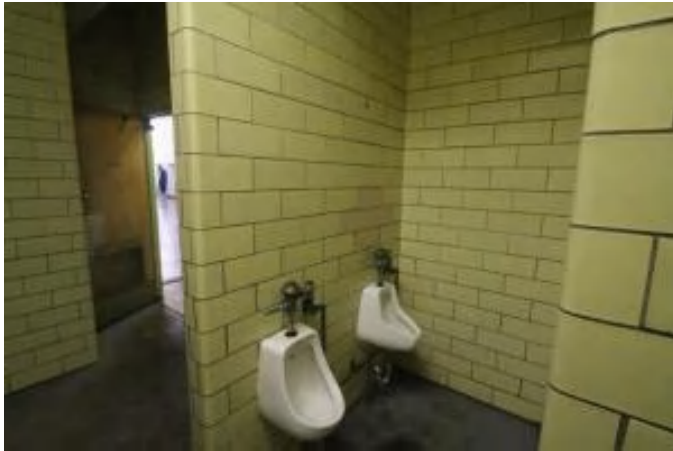
System: D2010 - Plumbing Fixtures

Location: Toilet rooms

Distress: Beyond Service Life

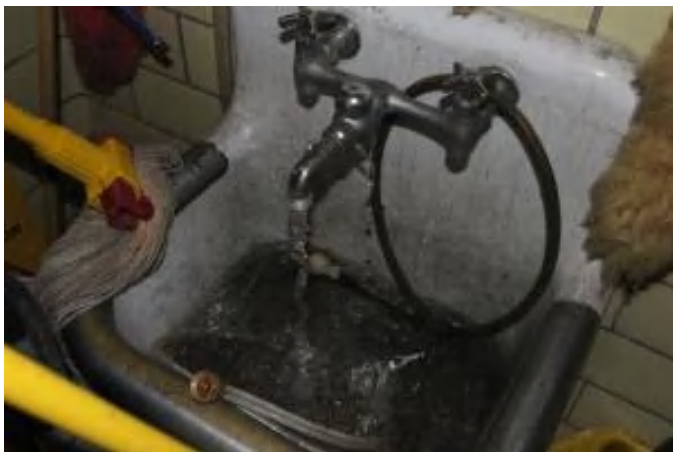
System: D2010 - Plumbing Fixtures

Location: Service closets

Distress: Beyond Service Life

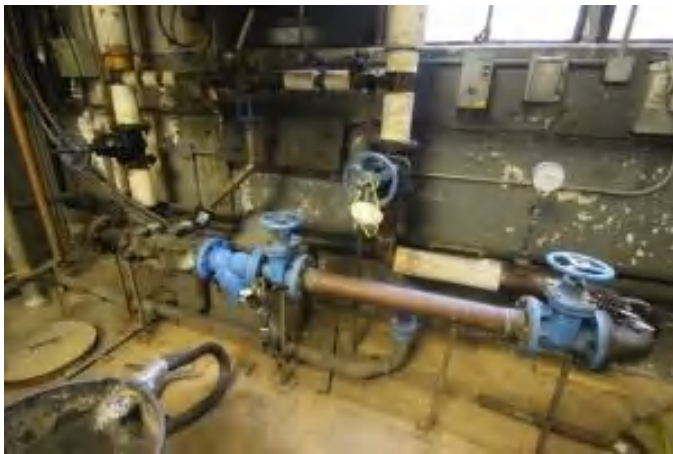
System: D2020 - Domestic Water Distribution

Location: Boiler room

Distress: Building / MEP Codes

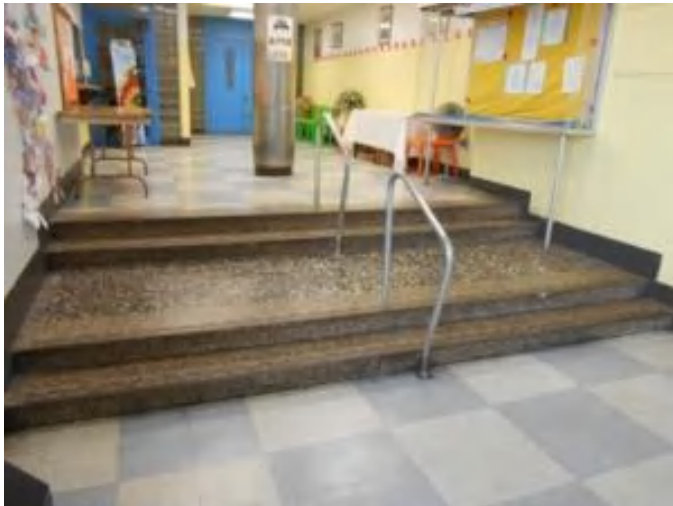
System: B1010 - Floor Construction

Location: Lobby

Distress: Accessibility

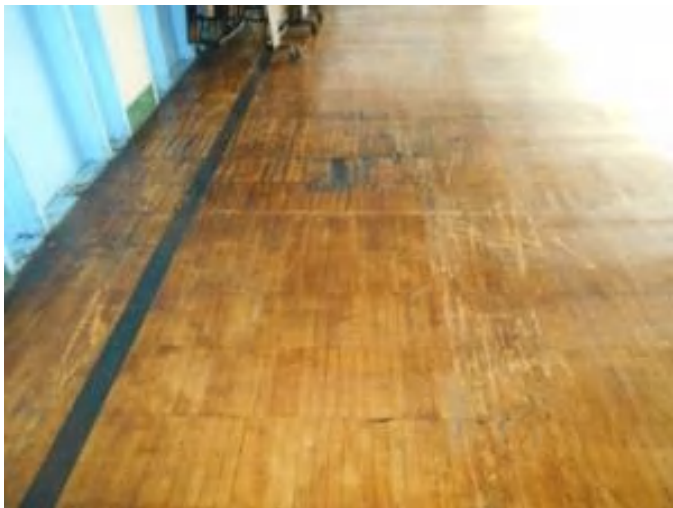
System: C3020414 - Wood Flooring

Location: Gym and stage

Distress: Maintenance Required

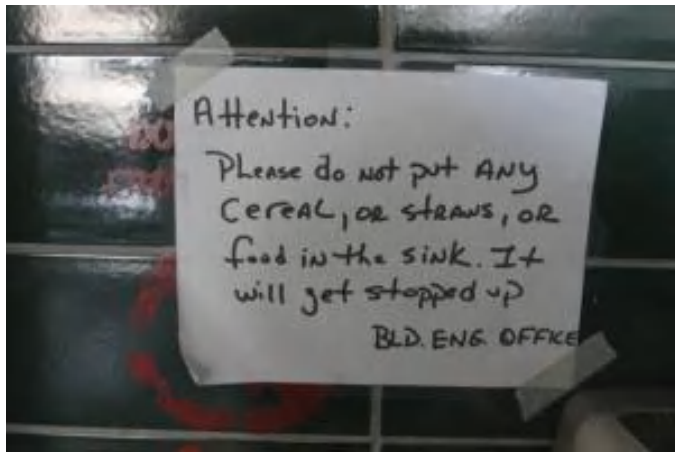
System: D2030 - Sanitary Waste

Location: Entire building

Distress: Beyond Service Life

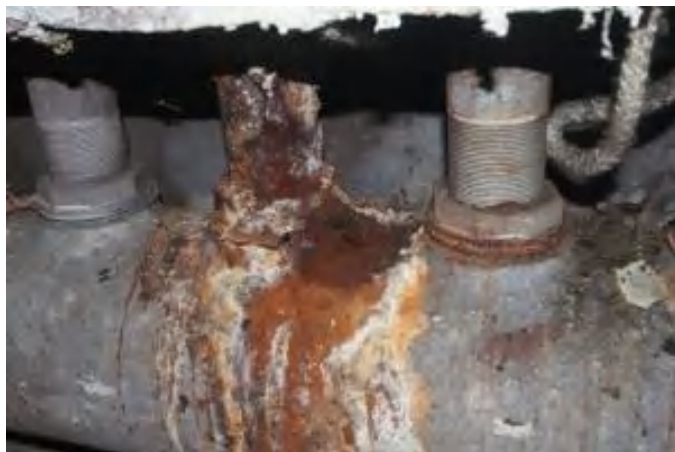
System: D3020 - Heat Generating Systems

Location: Boiler room

Distress: Failing

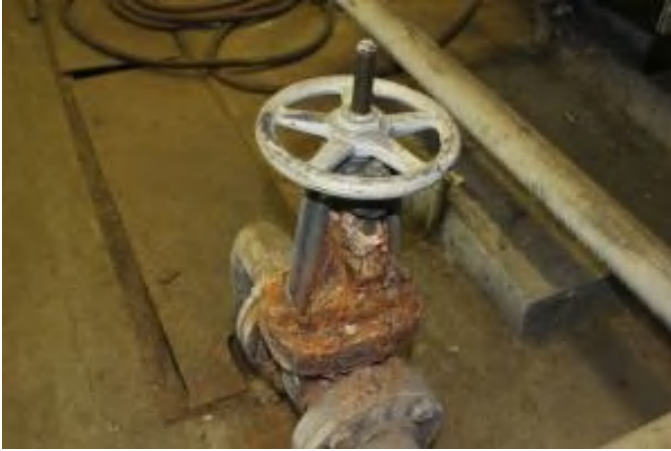
System: D3040 - Distribution Systems

Location: Original building

Distress: Beyond Service Life

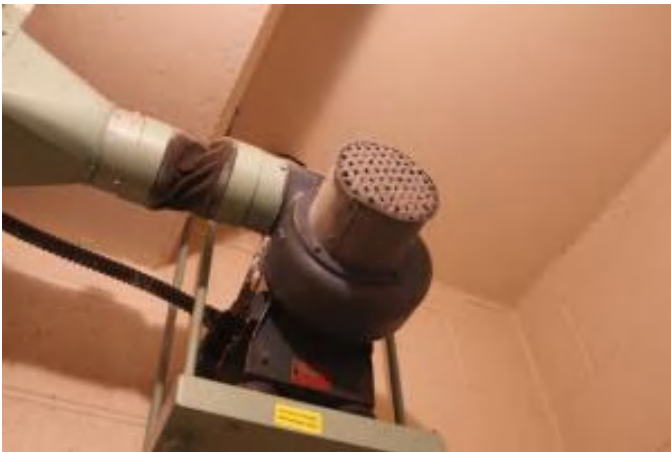
System: D3040 - Distribution Systems

Location: Toilet room

Distress: Failing

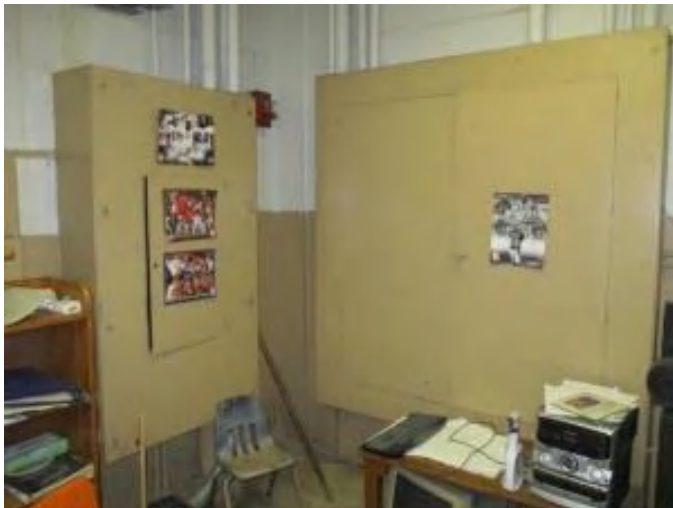
System: D5010 - Electrical Service/Distribution

Location: Basement

Distress: Inadequate

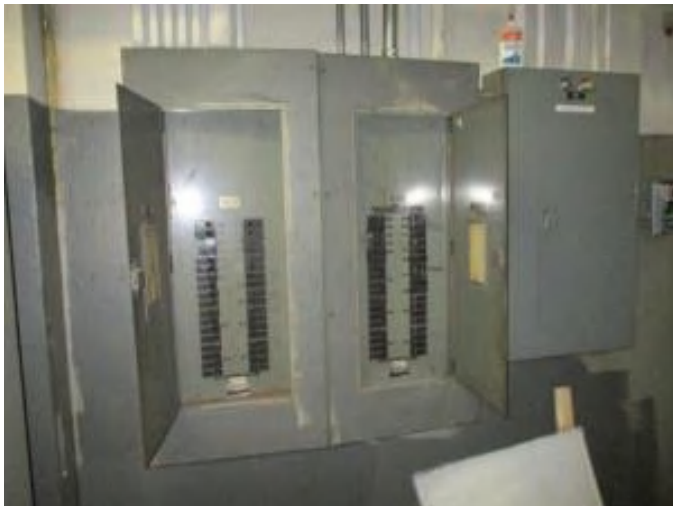
System: D5010 - Electrical Service/Distribution

Location: Entire Building

Distress: Inadequate

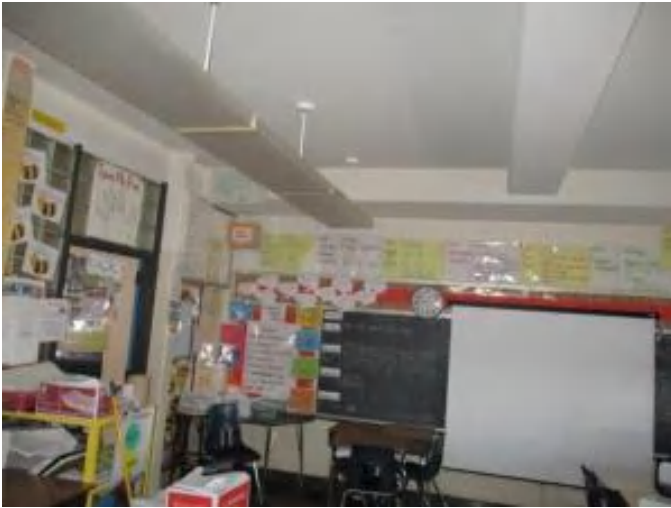
System: D5020 - Lighting and Branch Wiring

Location: Entire Building

Distress: Inadequate

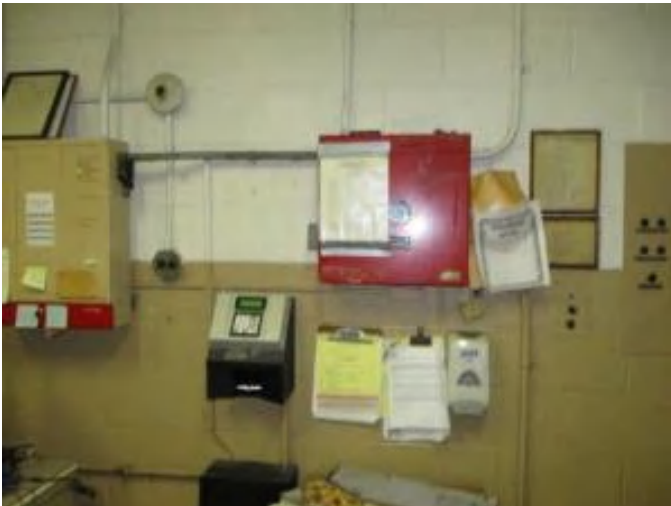
System: D5030 - Communications and Security

Location: Entire Building

Distress: Life Safety / NFPA / PFD

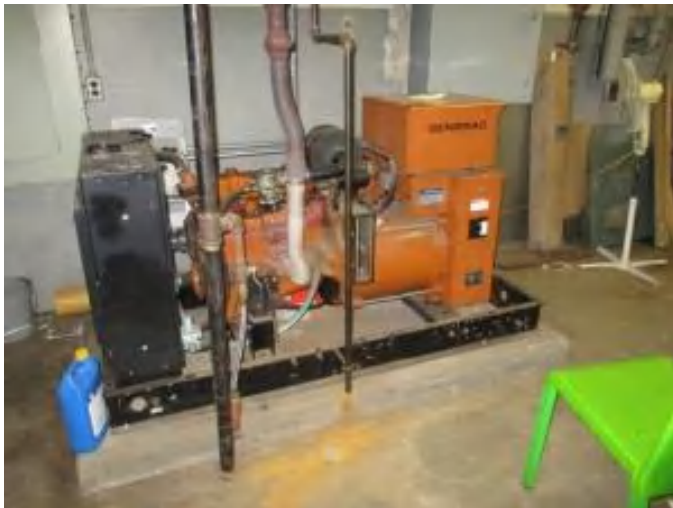
System: D5090 - Other Electrical Systems

Location: Outdoor

Distress: Inadequate

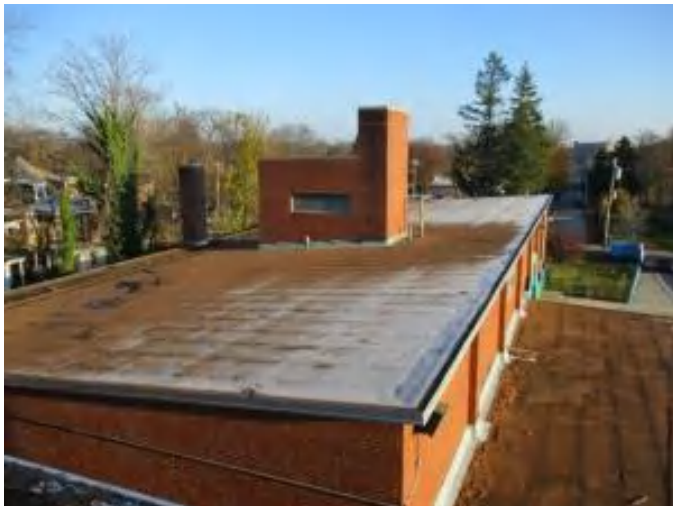
System: D5090 - Other Electrical Systems

Location: Roof

Distress: Building / MEP Codes

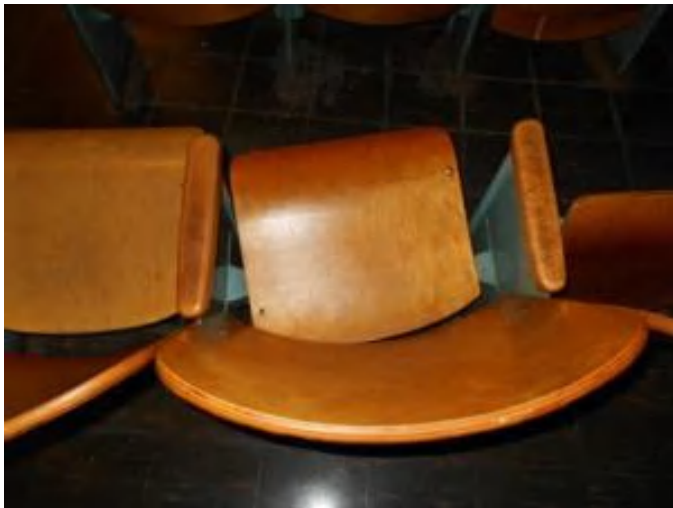
System: E2010 - Fixed Furnishings

Location: Auditorium

Notes: Refurbish auditorium seating.

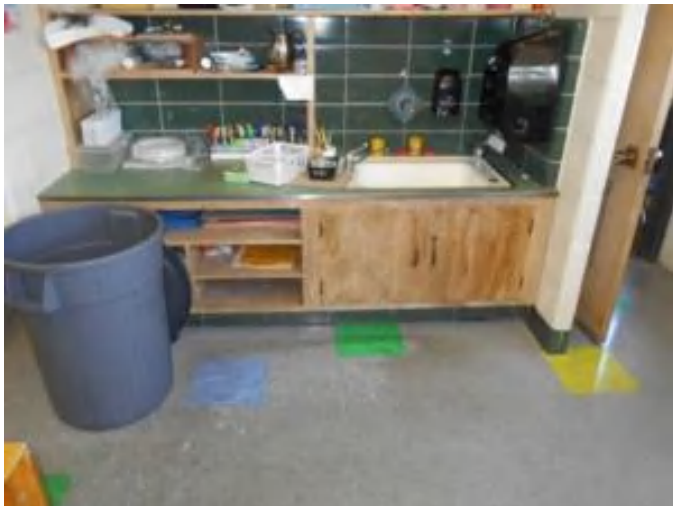
System: E2010 - Fixed Furnishings

Notes: Replace classroom cabinetry that is delaminated, missing hardware, and generally in disrepair.

Location: Classrooms

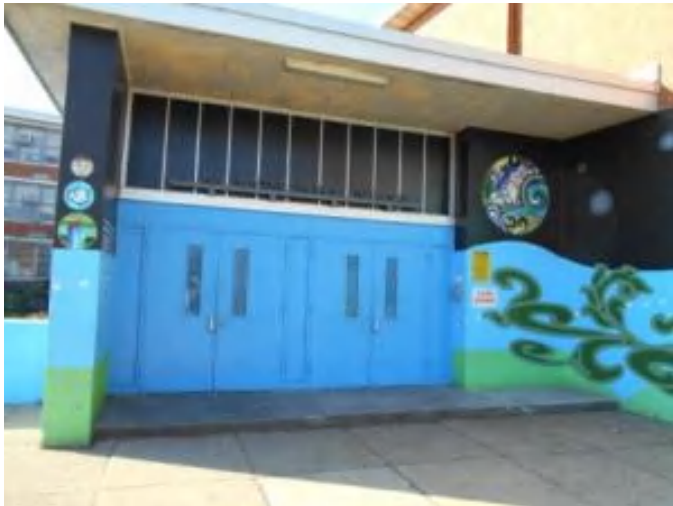
System: B2030 - Exterior Doors

Location: Exterior doors throughout the building

Distress: Beyond Service Life

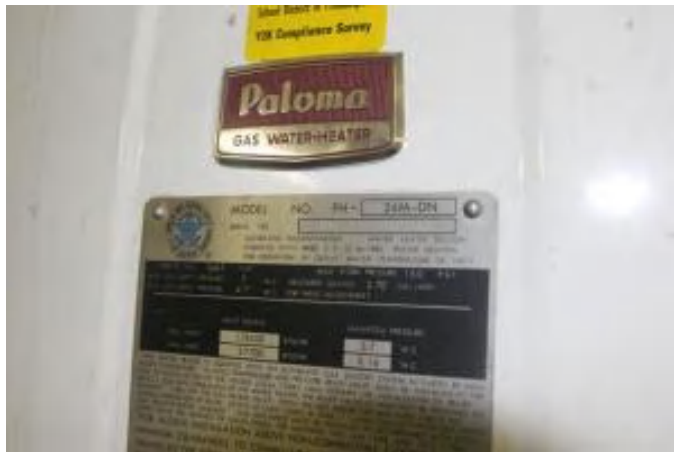
System: D2020 - Domestic Water Distribution

Location: Boiler room

Distress: Beyond Service Life

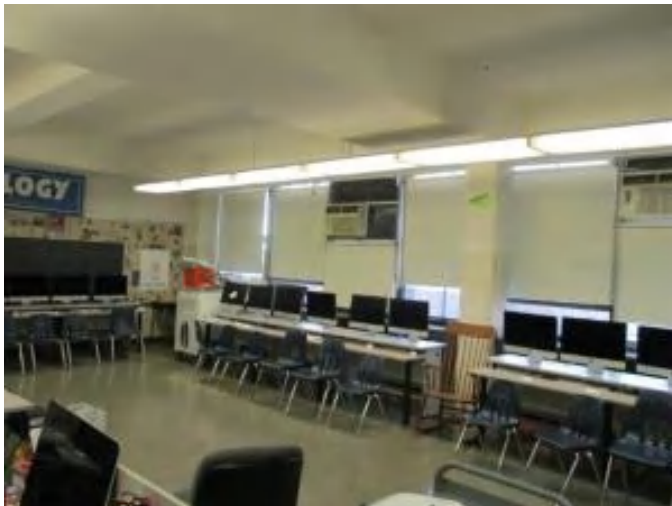
System: D5020 - Lighting and Branch Wiring

Location: Entire Building

Distress: Obsolete

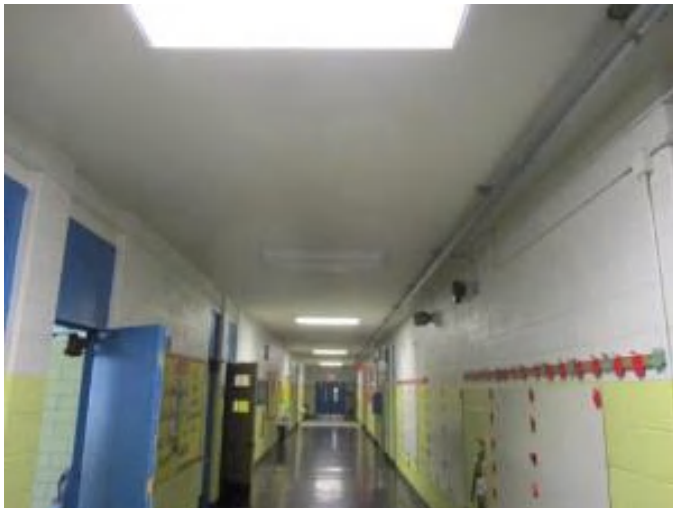
System: D5030 - Communications and Security

Location: Entire Building

Distress: Security Issue

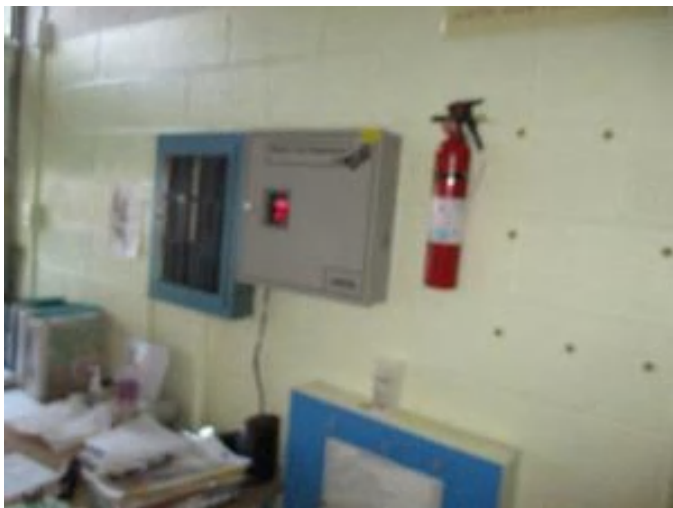
System: D5030 - Communications and Security

Location: Entire Building

Distress: Obsolete

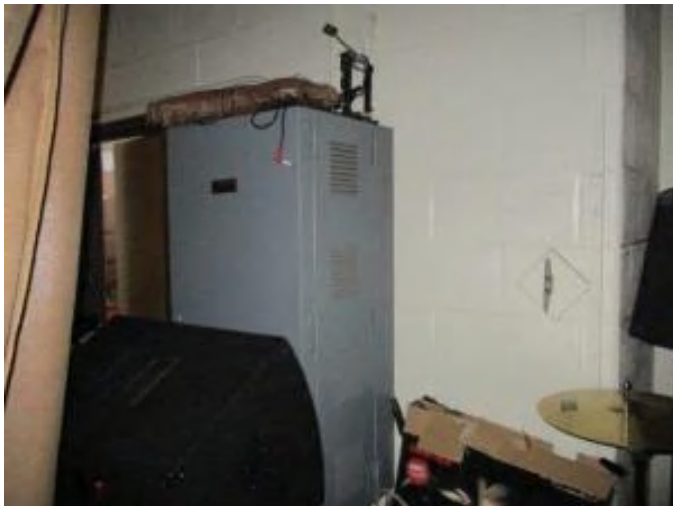
System: D5030 - Communications and Security

Location: Auditorium

Distress: Inadequate

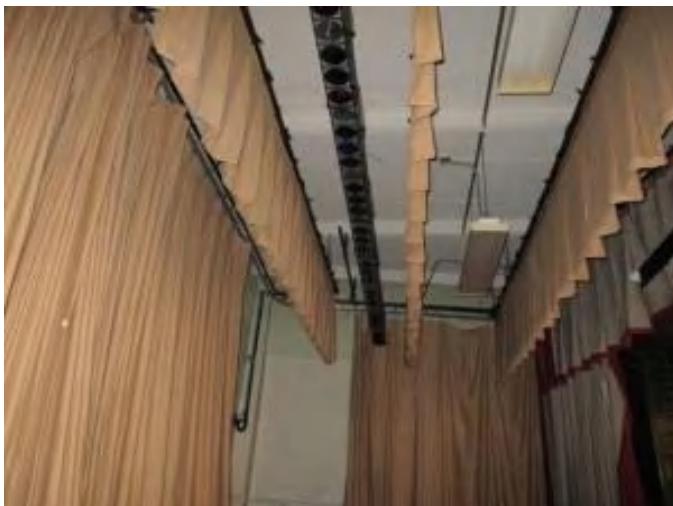
System: E1020 - Institutional Equipment

Location: Auditorium

Distress: Inadequate

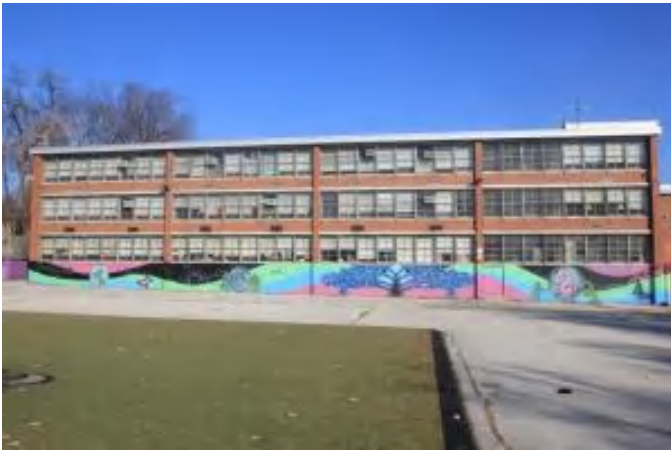
System: D3030 - Cooling Generating Systems

Location: Entire building

Distress: Inadequate

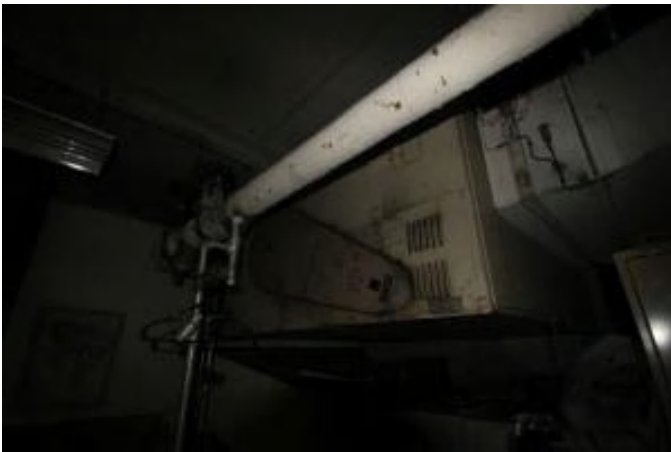
System: D3040 - Distribution Systems

Location: Auditorium

Distress: Beyond Service Life

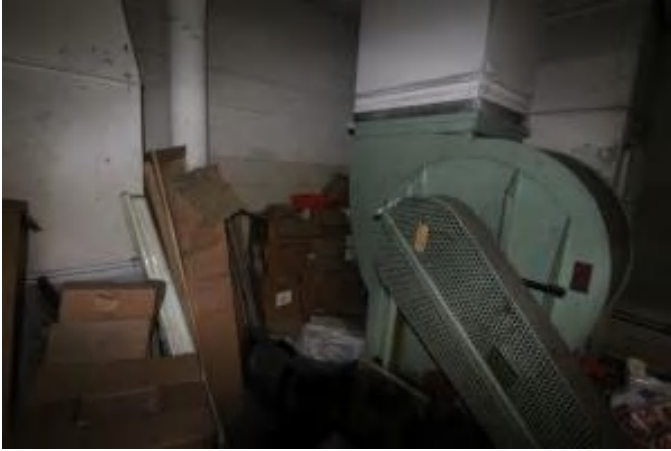
System: D3040 - Distribution Systems

Location: Gym

Distress: Beyond Service Life

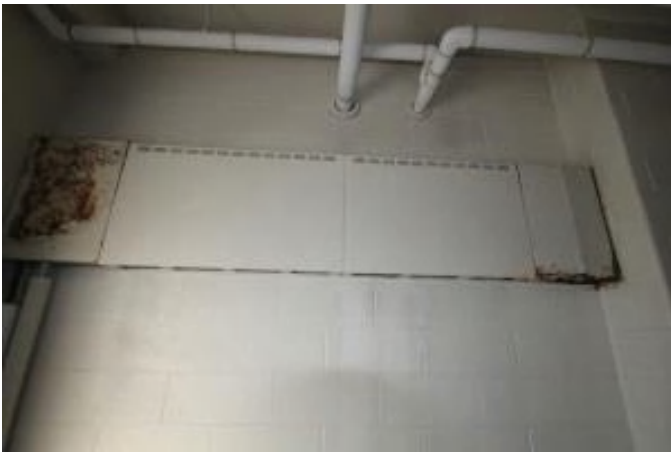
System: D3040 - Distribution Systems

Location: Entire building

Distress: Beyond Service Life

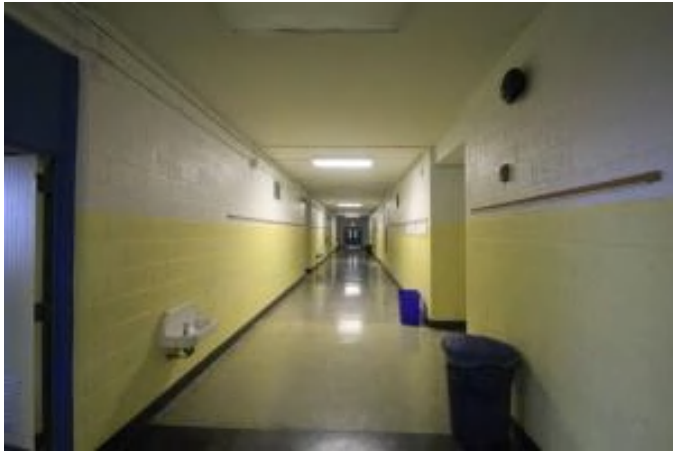
System: D4010 - Sprinklers

Location: Entire building

Distress: Life Safety / NFPA / PFD

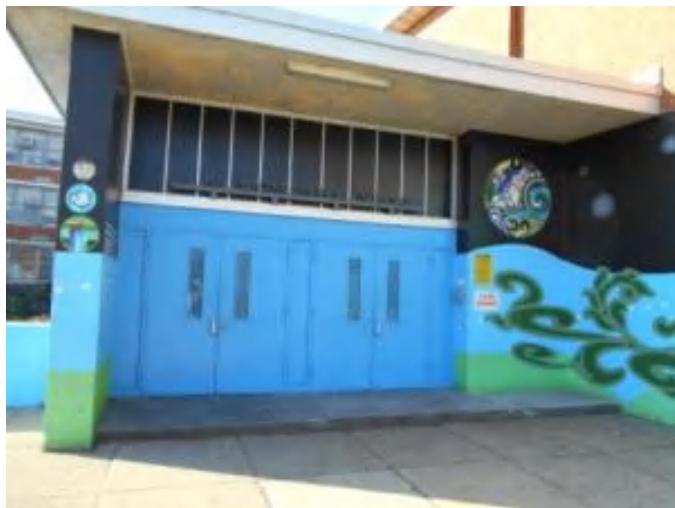
System: G2030 - Pedestrian Paving

Location: Front entry

Distress: Accessibility

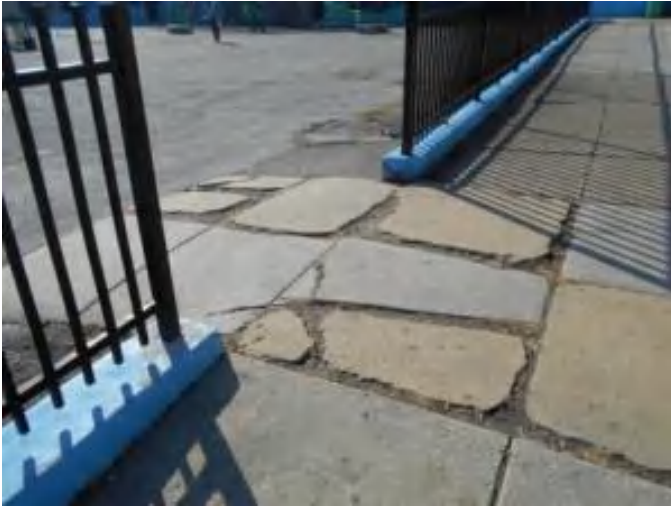
System: G2030 - Pedestrian Paving

Location: Entry area to Wakefield St. and city sidewalks

Distress: Health Hazard / Risk

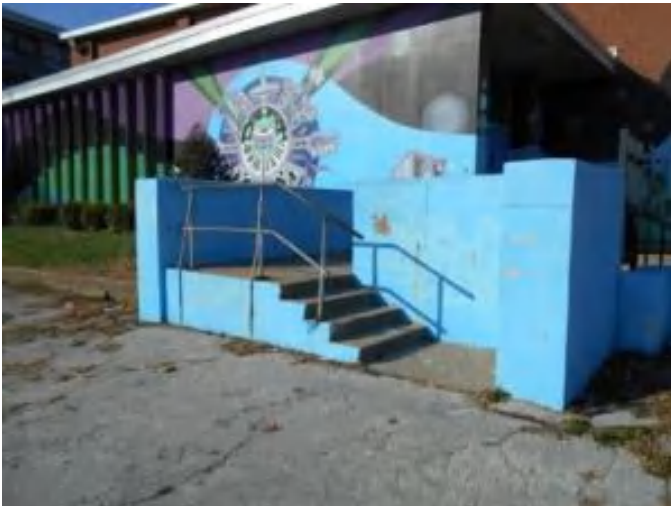
System: G2030 - Pedestrian Paving

Location: Gym exit and steps near main entrance

Distress: Health Hazard / Risk

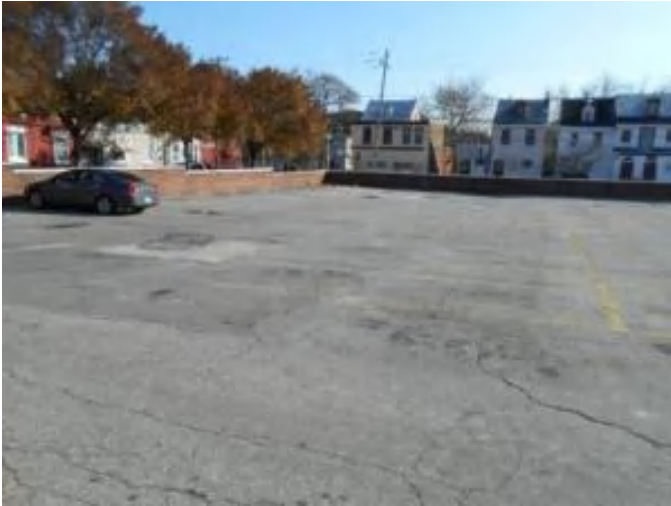
System: G2020 - Parking Lots

Location: Site

Distress: Damaged

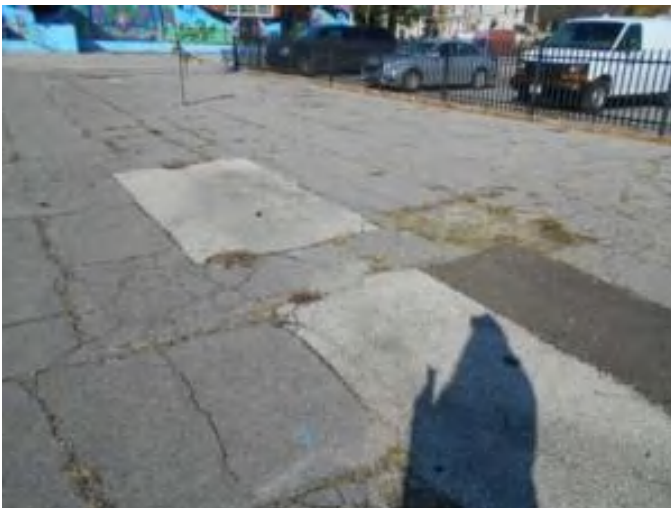
System: G2030 - Pedestrian Paving

Location: Site

Distress: Health Hazard / Risk

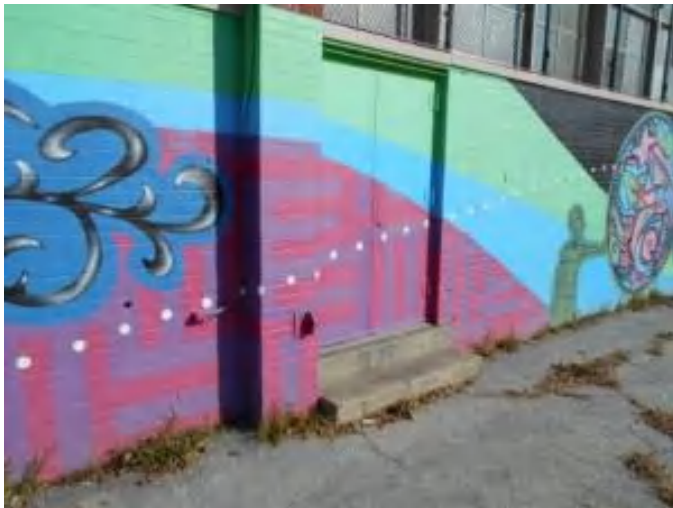
System: G2030 - Pedestrian Paving

Location: At exterior doors

Distress: Health Hazard / Risk

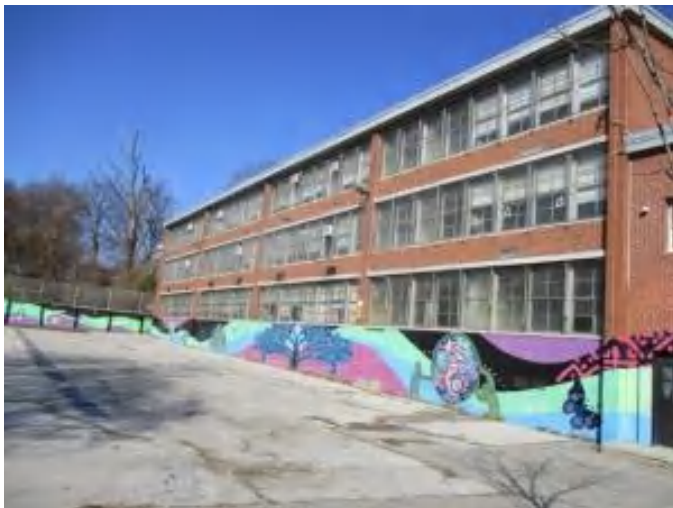
System: G4030 - Site Communications & Security

Location: Building Perimeter

Distress: Security Issue
